# Access Audit Site Report

**Lake Bob Sandlin State Park**

**Accessibility Evaluation**

**Inspection Date: 04/06/2022**

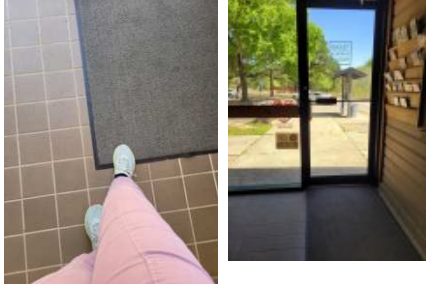
| Finding Number | Area Description | Lat/Long | Finding | As Built | Recommendation | Citation | Photos | Figure |
|---|---|---|---|--|--|---|--|---|
| 8 | Headquarters Area: HQ Public Spaces | [33.0539793 , -95.0991943] | Exterior doors are recommended to be maintained at 8.5 lbf as a smart practice. Force is to be measured at the operating hardware or 30 inches from the hinges, whichever is greater. The doormat is not secured in place at the entry door. If carpet or carpet tile is used on a ground or floor surface, then it shall be securely attached; have a firm cushion, pad or backing or no cushion or pad; and have a level loop, textured loop, level-cut pile or level-cut/uncut pile texture. The maximum pile height shall be 1/2 inch. Exposed edges of carpet shall be fastened to floor surfaces and have trim along the entire length of the exposed edge. Recessed doormats shall be adequately anchored to prevent interference with wheelchair traffic. | Exterior entry door - 14# push, lacks secure floor mat<br>Interior door into office - 12# push | For all doors along the public circulation route, inspect, adjust, and maintain 8.5 lbf to open exterior doors as a smart practice. Remove or secure mat at door to prevent trip hazard. | 2010 ADAS Section: 404.2.3, 404.2.7, 404.2.4, 404.2.11, 404.2.11 Exception | | |

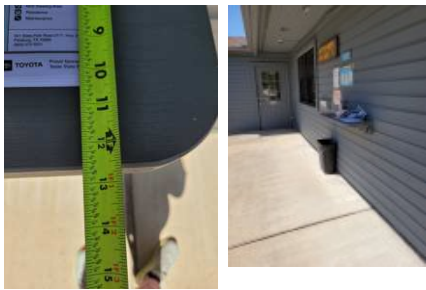
| Finding Number | Area Description | Lat/Long | Finding | As Built | Recommendation | Citation | Photos | Figure |
|---|---|---|---|--|--|---|--|--|
| 12 | Headquarters Area: HQ Public Spaces | [33.0539827, -95.0991581] | An item or items project more than 4 inches into the circulation path. Wall-mounted objects that have leading edges between 27 inches and 80 inches from the floor must not project more than 4 inches into the circulation path. Protruding objects that extend to the floor or within 27 inches of the floor are cane detectable and are therefore not hazardous. Where it is necessary or desirable to have objects protrude from the wall, a manner of cane detection must be provided. | After hours counter projects 12.75" | Relocate protruding objects or place cane detectable warning or bollard at foot of item. | 2015 ABAAS Section: 307.2<br>2012 TAS Section: 307.2<br>2010 ADAS Section: 307.2 | | |

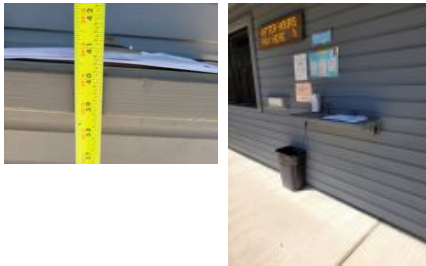
| Finding Number | Area Description | Lat/Long | Finding | As Built | Recommendation | Citation | Photos | Figure |
|---|---|---|---|--|--|---|--|--|
| 13 | Headquarters Area: HQ Public Spaces | [33.0539793, -95.0991528] | The transaction counter is too high. A portion of the counter surface that is 36 inches long minimum and 36 inches high maximum above the finish floor shall be provided. Knee and toe space must be provided for a forward approach. A 30 inch by 48 inch clear floor space on an accessible route must be provided for either a forward or parallel approach. | Service counter at 40.5" AFF | Lower 36" wide segment of service counter to max 36" AFF. | 2015 ABAAS Section: 904.4.2, 904.4.1<br>2012 TAS Section: 904.4.1, 904.4.2<br>2010 ADAS Section: 904.4.2, 904.4.1 | | |

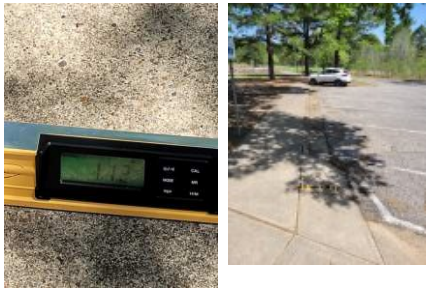
| Finding Number | Area Description | Lat/Long | Finding | As Built | Recommendation | Citation | Photos | Figure |
|---|---|---|---|--|--|---|--|--|
| 14 | Headquarters Area: HQ Public Spaces | [33.0539838, -95.0989811] | The curb ramp slope exceeds the maximum running slope (Parallel to the direction of travel) allowable of 8.33%. Curb ramps should have the least possible slope but in no case more than 8.3% (1:12). | Slope of 11.2% at parking access aisle curb ramp | Correct curb ramp running slope to max 8.33%. | 2015 ABAAS Section: 406.1<br>2012 TAS Section: 406.1<br>2010 ADAS Section: 406.1 | | |

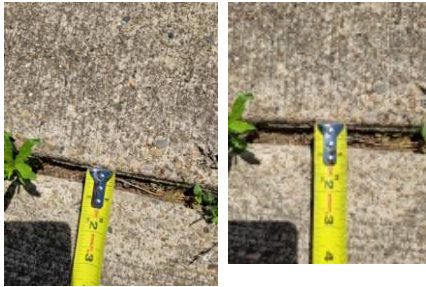
| Finding Number | Area Description | Lat/Long | Finding | As Built | Recommendation | Citation | Photos | Figure |
|---|---|---|--|--|---|--|---|---|
| 22 | Headquarters Area: HQ Public Spaces | [33.0539542, -95.0991294] | There is a gap spaced greater than a 1/2 inch. Openings in floor or ground surfaces shall not allow passage of a sphere more than 1/2 inch diameter. Elongated openings shall be placed so that the long dimension is perpendicular to the dominant direction of travel. | 1.75" gap at exit parking, 2" gap near exit side parking, 1", 1.25", 1.5" gaps near front parking, .75" and 3" gaps in route near entry, 1.25" and 3" gaps at sign | Correct or fill gaps to be max .5". | 2015 ABAAS Section: 302.3<br><br>2012 TAS Section: 302.3<br><br>2010 ADAS Section: 302.3 | | |

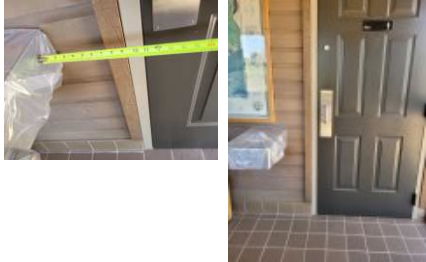
| Finding Number | Area Description | Lat/Long | Finding | As Built | Recommendation | Citation | Photos | Figure |
|---|---|---|---|--|--|---|--|---|
| 25 | Headquarters Area: HQ Men's Restroom | [33.0539793, -95.0991997] | Minimum maneuvering clearances at doors and gates shall comply with 404.2.4. Maneuvering clearances shall extend the full width of the doorway and the required latch side or hinge side clearance. Exterior doors are recommended to be maintained at 8.5 lbf as a smart practice. Force is to be measured at the operating hardware or 30 inches from the hinges, whichever is greater. Hand-activated door opening hardware, handles, pulls, latches, locks, and other operating devices on accessible doors shall have a shape that is easy to grasp with one hand and does not require tight grasping, tight pinching or twisting of the wrist to operate. Hardware shall be 34 inches minimum and 48 inches maximum above the finish floor or ground. | HQ men's restroom door - 12# push, lock hardware at 59" AFF, 11" clearance on pull due to fountain | For all doors along the public circulation route, provide required maneuvering clearance on push and pull side of doors. For all doors along the public circulation route, inspect, adjust, and maintain 8.5 lbf to open exterior doors as a smart practice. For all doors along the public circulation route, replace hardware with lever hardware or hardware operable without a tight pinch or grasp, 34" to 48" AFF. | 2010 ADAS Section: 404.2.3, 404.2.7, 404.2.4, 404.2.11, 404.2.11 Exception | | |

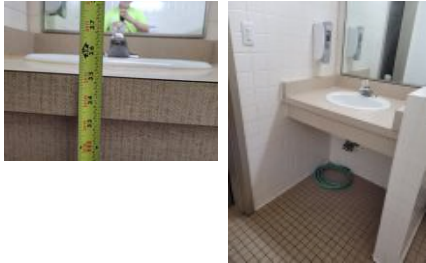
| Finding Number | Area Description | Lat/Long | Finding | As Built | Recommendation | Citation | Photos | Figure |
|---|---|---|---|--|--|---|--|---|
| 27 | Headquarters Area: HQ Men's Restroom | [33.0539748 , -95.0992145] | The top rim of the sink is too high. All lavatories/sinks that are designated to be accessible shall be a minimum 17 inches in horizontal depth and mounted with the rim or counter edge no higher than 34 inches above the finished floor. | Rim of sink at 35.5" AFF | Lower sinks to max 34" above the finished floor (AFF) to front of rim. | 2015 ABAAS Section: 606.3<br><br>2012 TAS Section: 606.3<br><br>2010 ADAS Section: 606.3 | | |

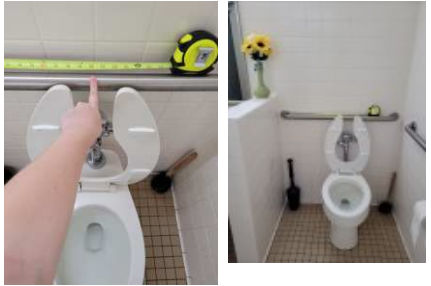
| Finding Number | Area Description | Lat/Long | Finding | As Built | Recommendation | Citation | Photos | Figure |
|---|---|---|---|---|---|---|--|---|
| 30 | Headquarters Area: HQ Men's Restroom | [33.0539737, -95.0992104] | The rear grab bar is not 36" long or is not mounted in the correct location. The rear grab bar must be a minimum of 36" long and extend from the toilet centerline a minimum 12" towards the wall side and a minimum 24" towards the open side of the toilet. Grab bars shall be installed in a horizontal position, 33 inches minimum and 36 inches maximum above the finish floor measured to the top of the gripping surface and the space between the grab bar and the top of the tank shall be 1-1/2 inches minimum. | 20" to centerline | Remount rear grab bar to behind the toilet, 12" to the wall side of center and 24" to the open side and 33" to 36" AFF. | 2015 ABAAS Section: 604.5.2<br><br>2012 TAS Section: 604.5.2<br><br>2010 ADAS Section: 604.5.2 | | |

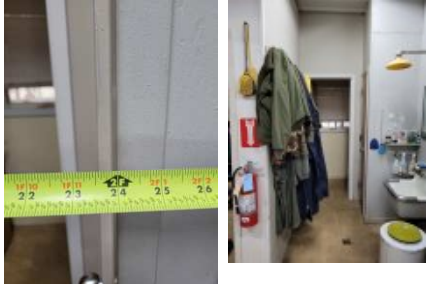
| Finding Number | Area Description | Lat/Long | Finding | As Built | Recommendation | Citation | Photos | Figure |
|---|---|---|---|---|---|---|---|---|
| 43 | Employee Areas: Maintenance | [33.0599434 , -95.087585 7] | The route of travel at this location does not provide a minimum width of 36 inches. The clear width shall be permitted to be reduced to 32 inches minimum for a length of 24 inches maximum provided that reduced width segments are separated by segments that are 48 inches long minimum and 36 inches wide minimum. | 24" width to restroom in maintenance due to hanging coats | Widen AR to compliant 36" clear width. | 2015 ABAAS Section: 403.5.1<br>2012 TAS Section: 403.5.1<br>2010 ADAS Section: 403.5.1 | | |

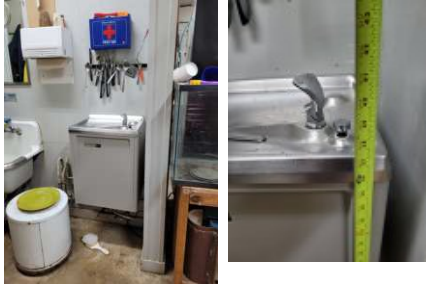
| Finding Number | Area Description | Lat/Long | Finding | As Built | Recommendation | Citation | Photos | Figure |
|---|---|---|---|---|---|---|--|--|
| 46 | Employee Areas: Maintenance | [33.0599366 , -95.087583 1] | The there is no lower drinking fountain meeting the requirements for persons using wheelchairs. Spout outlets of the lower bowl drinking fountains shall be 36 inches maximum above the finish floor or ground. Lower bowl drinking fountains shall provide knee and toe clearance centered on the unit. | Standing fountain only within maintenance | Add second low bowl fountain for persons using wheelchairs. | 2015 ABAAS Section: 602.4<br><br>2012 TAS Section: 602.4<br><br>2010 ADAS Section: 211.2 | | |

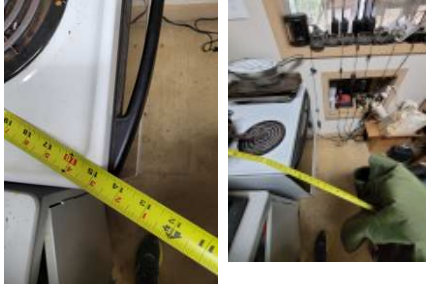
| Finding Number | Area Description | Lat/Long | Finding | As Built | Recommendation | Citation | Photos | Figure |
|---|---|---|---|--|--|---|---|---|
| 52 | Employee Areas: Maintenance | [33.0599321 , -95.087591 1] | Employee Work Areas. Common use circulation paths within employee work areas shall comply with 402. EXCEPTIONS: 1. Common use circulation paths located within employee work areas that are less than 1000 square feet (93 m2) and defined by permanently installed partitions, counters, casework, or furnishings shall not be required to comply with 402. 2. Common use circulation paths located within employee work areas that are an integral component of work area equipment shall not be required to comply with 402. 3. Common use circulation paths located within exterior employee work areas that are fully exposed to the weather shall not be required to comply with 402. | Office with range and microwave - chair obstructs route, 14.5" width | Make corrections for compliant circulation path. | 2015 ABAAS Section: F206.2.8, F206.2.8.1, F206.2.8.2<br><br>2012 TAS Section: 206.2.8, 206.2.8 Exception 1, 206.2.8 Exception 2, 206.2.8 Exception 3, 206.2.8 Advisory 1, 206.2.8 Advisory 2<br><br>2010 ADAS Section: 206.2.8, 206.2.8 Exception 1, 206.2.8 Exception 2, 206.2.8 Exception 3 | | |

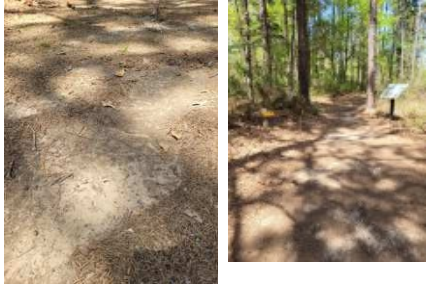
| Finding Number | Area Description | Lat/Long | Finding | As Built | Recommendation | Citation | Photos | Figure |
|---|--|---|--|--|--|--|--|---|
| 61 | Trailhead:<br>Trailhead | [33.05441,<br>-95.09649] | The surface of trails, passing spaces, and resting intervals shall be firm and stable | Brim Pond Trail-<br>surface not firm and stable | Establish protocols for regular and frequent inspection and maintenance of accessible trail surface as a smart practice. Frequently maintain trail surface in identified washout areas to assure CIL's remain 2" or less and gaps are filled as a smart practice. Replace surface of trail with one that is firm and stable as a smart practice. | 2015 ABAAS<br>Section:<br>1017.2 | | |

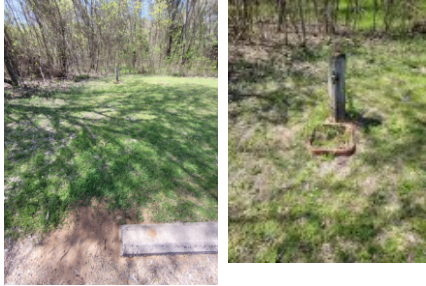
| Finding Number | Area Description | Lat/Long | Finding | As Built | Recommendation | Citation | Photos | Figure |
|---|--|---|--|--|--|--|--|---|
| 62 | Trailhead:<br>Trailhead | [33.04984,<br>-95.09371] | At least one accessible route shall connect accessible buildings, accessible facilities, accessible elements, and accessible spaces that are on the same site. | Parking near<br>basketball court -<br>lacks AR to water<br>spout | Provide an accessible route to each element within the site. | 2010 ADAS<br>Section:<br>206.2.2,<br>206.2 | | |

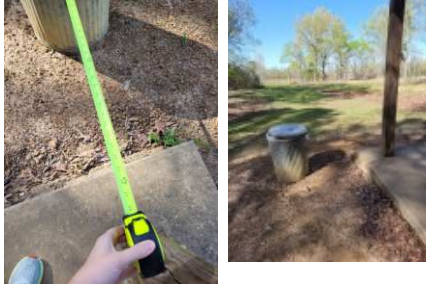
| Finding Number | Area Description | Lat/Long | Finding | As Built | Recommendation | Citation | Photos | Figure |
|---|---|---|---|--|---|--|---|---|
| 66 | Trailhead: Trail Primitive Camping | [33.0613776<br>,<br>-95.091421<br>3] | Where picnic facilities contain two or fewer picnic units, each picnic unit shall provide mobility features complying with F245.2. | 35" to trash | Relocate 20% of garbage cans to be along AR. | 2015 ABAAS<br>Section:<br>F245.2.1 | | |

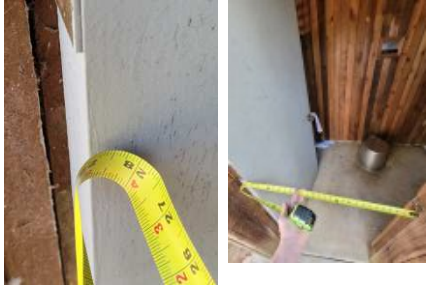
| Finding Number | Area Description | Lat/Long | Finding | As Built | Recommendation | Citation | Photos | Figure |
|---|---|---|---|---|--|--|--|---|
| 71 | Trailhead: Trail Restrooms | [33.0609842, -95.091786 1] | The door opening does not provide at least 32 inches between the face of the door and the opposite stop. Door openings shall provide a clear width of 32 inches minimum. Clear openings of doorways with swinging doors shall be measured between the face of the door and the stop, with the door open 90 degrees. There shall be no projections into the required clear opening width lower than 34 inches above the finish floor or ground. Projections into the clear opening width between 34 inches and 80 inches above the finish floor or ground shall not exceed 4 inches. | 28.5" width | Replace door with one having 32" clear width. | 2015 ABAAS Section: 404.2.3<br>2012 TAS Section: 404.2.3<br>2010 ADAS Section: 404.2.3 | | <p>Hinged Door or Gate</p> |

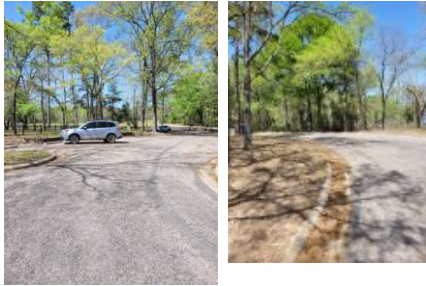
| Finding Number | Area Description | Lat/Long | Finding | As Built | Recommendation | Citation | Photos | Figure |
|---|---|---|---|---|---|--|--|--|
| 73 | Day Use Area:<br>Day Use -<br>Parking | [33.0484949<br>,<br>-95.093107<br>1] | There are no or not enough accessible parking stalls. Each lot where parking is provided for the public as clients, guests or employees, shall provide accessible parking and shall be located on the shortest accessible route of travel from adjacent parking to an accessible entrance. There are a total of 35 parking stalls in the parking lot that could be reasonably associated with this facility. There should be a minimum of 2 accessible stalls with a minimum of 1 being designed as van accessible. | Day use area parking<br>- 35 standard, 0<br>accessible | Create two or more 8' accessible parking stalls, with one 5' adjacent access aisle, with proper signage and striping based on the total number of stalls. | 2015 ABAAS<br>Section:<br>F208.2<br><br>2012 TAS<br>Section:<br>208.2<br><br>2010 ADAS<br>Section:<br>208.2 | | |

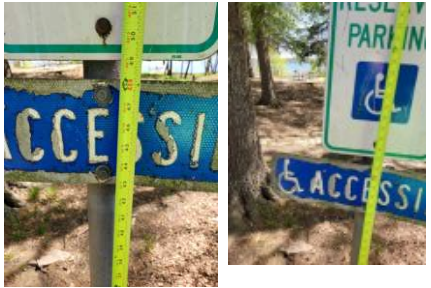
| Finding Number | Area Description | Lat/Long | Finding | As Built | Recommendation | Citation | Photos | Figure |
|---|---|---|---|---|--|--|--|--|
| 79 | Day Use Area:<br>Day Use -<br>Parking | [33.0483555<br>,<br>-95.094163<br>9] | The parking sign is mounted too low. Parking space identification signs shall include the International Symbol of Accessibility complying with. Signs identifying van parking spaces shall contain the designation "van accessible." Signs shall be 60 inches minimum above the finish floor or ground surface measured to the bottom of the sign. | On boat ramp side, closest to playground<br>- Sign mounted too low - 49" AGL to bottom of required sign | Raise existing accessible parking signs so lowest end of bottom sign is min 60" above ground level (agl) measured from the surface of the stall. | 2015 ABAAS<br>Section:<br>502.6<br><br>2012 TAS<br>Section:<br>502.6<br><br>2010 ADAS<br>Section:<br>502.6 | | |

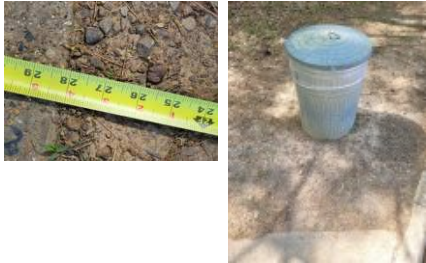
| Finding Number | Area Description | Lat/Long | Finding | As Built | Recommendation | Citation | Photos | Figure |
|---|--|---|---|---|---|--|--|--|
| 80 | Day Use Area:<br>Day Use - Fish Cleaning | [33.0485245<br>,<br>-95.095168] | There is no accessible route to the trash can. At least one accessible route shall connect accessible buildings, accessible facilities, accessible elements, and accessible spaces that are on the same site. | Lacks AR to trash can - 28" | Relocate 20% of garbage cans to be along AR. | 2015 ABAAS<br>Section:<br>F206.2.2<br><br>2012 TAS<br>Section:<br>206.2.2<br><br>2010 ADAS<br>Section:<br>206.2.2 | | |

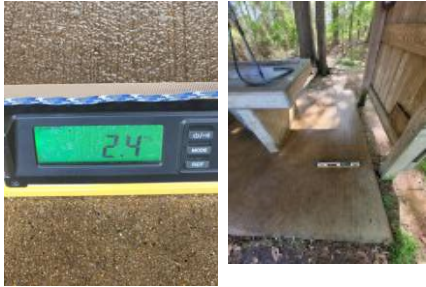
| Finding Number | Area Description | Lat/Long | Finding | As Built | Recommendation | Citation | Photos | Figure |
|---|--|---|---|---|---|--|--|--|
| 82 | Day Use Area:<br>Day Use - Fish Cleaning | [33.0484915<br>,<br>-95.095168<br>3] | The accessible route contains running slopes greater than 5 percent and cross slopes greater than 2 percent across the width of the walk and has not been constructed as a ramp (i.e. handrails, wheel guides, etc.). When the slope in the direction of travel of any walk exceeds 1 unit vertical in 20 units horizontal (5-percent slope), it must be constructed as ramp. Surface cross slopes must not exceed one unit vertical in 48 units. Horizontal (2-percent slope). | 2.4% cross slope | Correct or repair slope to max 5% running and 2.08% cross. | 2015 ABAAS<br>Section:<br>403.3<br><br>2012 TAS<br>Section:<br>403.3<br><br>2010 ADAS<br>Section:<br>403.3 | | |

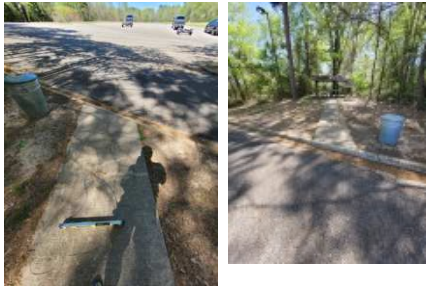
| Finding Number | Area Description | Lat/Long | Finding | As Built | Recommendation | Citation | Photos | Figure |
|---|--|---|---|---|--|--|---|---|
| 87 | Day Use Area:<br>Day Use - Fish Cleaning | [33.0485, -95.09515] | The transition from the curb ramp to the walk, gutter or street is not flush and free of abrupt changes in level. Transitions from ramps to walks, gutters or streets shall be flush and free of abrupt change. Maximum slopes of adjoining gutters, road surface immediately adjacent to the curb ramp, or accessible route shall not exceed one unit vertical in 20 units horizontal (5-percent slope). | Lacks curb ramp | Create a curb ramp to be max running slope 8.33%, max cross slope 2.08%, having a top landing as wide as the ramp and 36" deep and side flares with a max slope 10%. | 2015 ABAAS Section: 406.2<br><br>2012 TAS Section: 406.2<br><br>2010 ADAS Section: 406.2 | | |

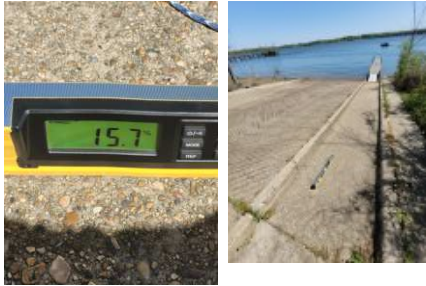
| Finding Number | Area Description | Lat/Long | Finding | As Built | Recommendation | Citation | Photos | Figure |
|---|---|---|--|---|--|---|---|---|
| 88 | Day Use Area:<br>Day Use - Boat Ramp | [33.0480306<br>,<br>-95.094778<br>1] | There is no accessible route to/on the boating facility. Accessible routes serving recreational boating facilities, including gangways and floating piers, shall comply with accessible route requirements except as modified by section Recreational Boating Facilities - Accessible Routes. | 15.7% slope, lacks handrails | Create an accessible route to the boat pier or make corrections for a compliant route. | 2015 ABAAS<br>Section:<br>1003.2<br><br>2010 ADAS<br>Section:<br>1003.2 | | |

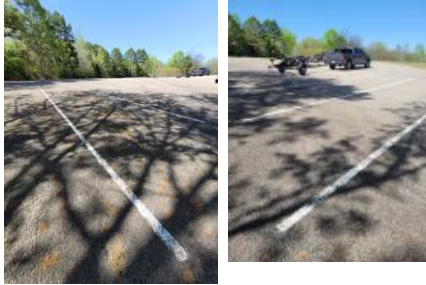
| Finding Number | Area Description | Lat/Long | Finding | As Built | Recommendation | Citation | Photos | Figure |
|---|---|---|---|--|---|---|---|---|
| 91 | Day Use Area:<br>Day Use - Boat Ramp | [33.0488153<br>,<br>-95.0948706] | There are no or not enough accessible parking stalls. Each lot where parking is provided for the public as clients, guests or employees, shall provide accessible parking and shall be located on the shortest accessible route of travel from adjacent parking to an accessible entrance. There are a total of 29 parking stalls in the parking lot that could be reasonably associated with this facility. There should be a minimum of 2 accessible stalls with a minimum of 1 being designed as van accessible. | Parking at Day Use area boat ramp - 29 standard, 0 accessible | Create one or more 8' accessible parking stalls, with one 5' adjacent access aisle, with proper signage and striping based on the total number of stalls. | 2015 ABAAS<br>Section:<br>F208.2<br><br>2012 TAS<br>Section:<br>208.2<br><br>2010 ADAS<br>Section:<br>208.2 | | |

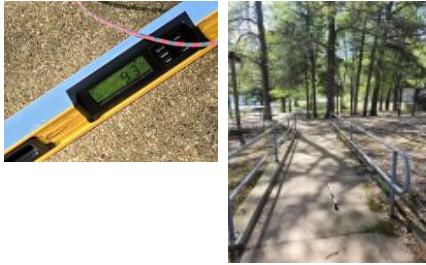
| Finding Number | Area Description | Lat/Long | Finding | As Built | Recommendation | Citation | Photos | Figure |
|---|---|---|---|--|---|---|---|---|
| 93 | Day Use Area:<br>Day Use - Fishing | [33.0481666<br>,<br>-95.0939251] | The ramps slope exceeds the maximum running slope (direction of travel) allowable of 8.33%. Ramps should have the least possible slope but in no case more than 8.3% (1:12). | long ramp from restroom to pier -<br>From top to bottom -<br>Set 2 - 9.3% at top and 8.4% at bottom,<br>Set 3 - 9.9% at bottom, Set 5 - 9% at top and 9.3% at bottom | Correct slope of ramp to max 8.33%. | 2015 ABAAS<br>Section:<br>405.2<br><br>2012 TAS<br>Section:<br>405.2<br><br>2010 ADAS<br>Section: | | |

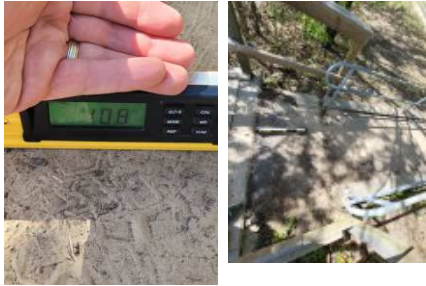
| Finding Number | Area Description | Lat/Long | Finding | As Built | Recommendation | Citation | Photos | Figure |
|---|---|---|--|---|---|---|---|---|
| 99 | Day Use Area:<br>Day Use - Fishing | [33.0478463<br>,<br>-95.093799<br>1] | The landing at the bottom of the ramp has a slope greater than 2%. Bottom landings shall have a dimension in the direction of ramp run of not less than 60 inches and have a slope of less than 2% in any direction. | at fishing pier- 10.8% slope at bottom landing - top ok | Correct ramp landing slope to max 2.08%. | 2015 ABAAS<br>Section:<br>405.7.1,<br>405.7.1<br>EXCEPTION<br><br>2012 TAS<br>Section:<br>405.7.1,<br>405.7.1<br>Exception<br><br>2010 ADAS<br>Section:<br>405.7.1,<br>405.7.1<br>Exception | | |

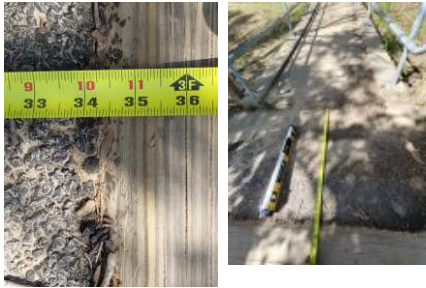
| Finding Number | Area Description | Lat/Long | Finding | As Built | Recommendation | Citation | Photos | Figure |
|---|---|---|--|---|---|---|---|---|
| 100 | Day Use Area:<br>Day Use - Fishing | [33.0477934<br>,<br>-95.093839<br>3] | The landing is not the correct length. Landings shall have a dimension in the direction of ramp run of not less than 60 inches. | at fishing pier- Bottom landing 34.5" long | Enlarge landing to be 60" deep and as wide as the ramp. | 2015 ABAAS<br>Section:<br>405.7.3<br><br>2012 TAS<br>Section:<br>405.7.3<br><br>2010 ADAS<br>Section:<br>405.7.3 | | |

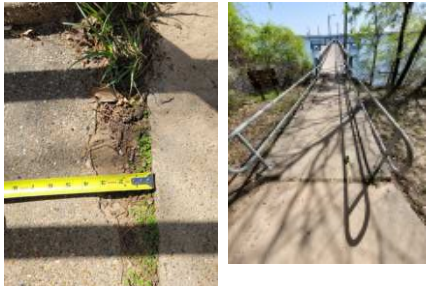
| Finding Number | Area Description | Lat/Long | Finding | As Built | Recommendation | Citation | Photos | Figure |
|---|---|---|--|---|---|---|---|---|
| 101 | Day Use Area:<br>Day Use - Fishing | [33.047844,<br>-95.093807<br>1] | Openings in floor or ground surfaces shall not allow passage of a sphere more than 1/2 inch (13 mm) diameter except as allowed in 407.4.3, 409.4.3, 410.4, 810.5.3 and 810.10. Elongated openings shall be placed so that the long dimension is perpendicular to the dominant direction of travel. | at fishing pier- 3" gap at ramp entry | Fill and maintain gaps to max .5". | 2015 ABAAS<br>Section:<br>302.3<br><br>2012 TAS<br>Section:<br>302.3<br><br>2010 ADAS<br>Section:<br>302.3 | | |

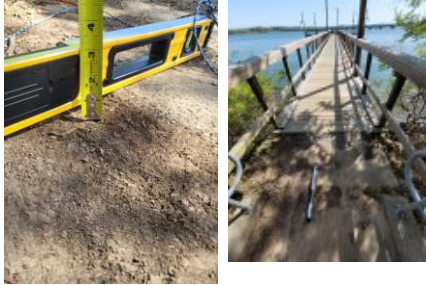
| Finding Number | Area Description | Lat/Long | Finding | As Built | Recommendation | Citation | Photos | Figure |
|---|---|---|--|---|--|--|--|---|
| 102 | Day Use Area:<br>Day Use - Fishing | [33.0477889<br>,<br>-95.093835<br>3] | There is a change in level greater than 1/4 inch. 1/4 inch is the maximum vertical rise. Changes in level between 1/4 inch and 1/2 inch must be beveled at 1:2 or less. Changes in level greater than 1/2 inch must be by way of a ramp. | at fishing pier- .75" CIL near bottom of ramp | Repair, bevel or ramp CIL along accessible route (AR) to max .25". | 2015 ABAAS<br>Section:<br>303.3<br><br>2012 TAS<br>Section:<br>303.3<br><br>2010 ADAS<br>Section:<br>303.3 | | |

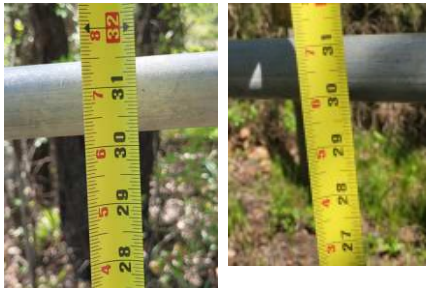
| Finding Number | Area Description | Lat/Long | Finding | As Built | Recommendation | Citation | Photos | Figure |
|---|---|---|--|---|--|--|--|---|
| 103 | Day Use Area:<br>Day Use - Fishing | [33.0478137<br>,<br>-95.093823<br>2] | The handrail is mounted incorrectly. Handrails are measured at the top and must be between 34 inches and 38 inches above the ramp surface. Handrails must extend horizontally beyond the top and bottom of the ramp 12 inches minimum. | at fishing pier- Both rails less than 34" AGL - 31.5" and 31" AGL | Remount handrails to 34" to 38" AGL. | 2015 ABAAS<br>Section:<br>505.4<br><br>2012 TAS<br>Section:<br>505.4<br><br>2010 ADAS<br>Section:<br>505.4 | | |

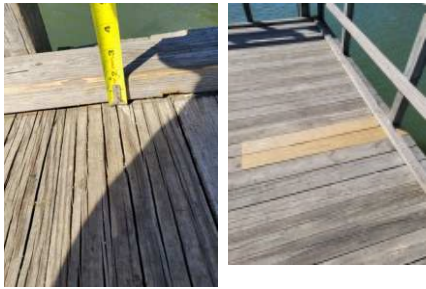
| Finding Number | Area Description | Lat/Long | Finding | As Built | Recommendation | Citation | Photos | Figure |
|---|---|---|--|---|--|--|--|---|
| 104 | Day Use Area:<br>Day Use - Fishing | [33.0474022<br>,<br>-95.094005<br>6] | The required edge protection is not provided. Where compliant railings, guards, or handrails are provided, edge protection shall also be provided. Curbs or barriers shall extend 2 inches minimum above the surface of the fishing pier or platform or The ground or deck surface shall extend 12 inches minimum beyond the inside face of the railing. Toe clearance shall be provided and shall be 30 inches wide minimum and 9 inches minimum above the ground or deck surface beyond the railing. | Fishing pier - 1.75" high edge protection | Provide 2" high curb or 12" extended surface beyond railing for edge protection. | 2015 ABAAS<br>Section:<br>1005.3.1,<br>1005.3.2<br><br>2010 ADAS<br>Section:<br>1005.3.1,<br>1005.3.2 | | |

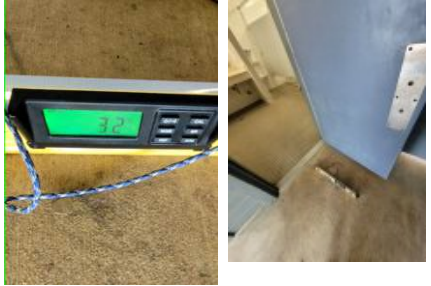
| Finding Number | Area Description | Lat/Long | Finding | As Built | Recommendation | Citation | Photos | Figure |
|---|--|---|--|---|--|--|---|---|
| 115 | Day Use Area:<br>Day Use - Men's<br>Restroom | [33.0482195<br>,<br>-95.093871<br>5] | The door does not have a compliant landing. Doors with an approach from the hinge side must have a landing on the pull side that is a minimum of 60 inches in depth perpendicular to the door in a close position by a minimum width dimension of 36 inches plus the door width. The additional 36 inches must extend past the door on the latch side. The entire landing must be free of obstructions and must be flat (2% max. slope is considered flat in any direction). | men's- 3.2% slope in pull side clearance | For all doors along the public circulation route, correct or repair slope at doorway landing to max 2.08% in any direction | 2015 ABAAS<br>Section:<br>404.2.4.1<br><br>2012 TAS<br>Section:<br>404.2.4.1<br><br>2010 ADAS<br>Section:<br>404.2.4.1 | | |

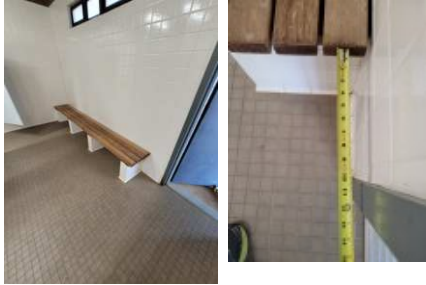
| Finding Number | Area Description | Lat/Long | Finding | As Built | Recommendation | Citation | Photos | Figure |
|---|---|---|--|---|--|---|--|---|
| 116 | Day Use Area:<br>Day Use - Men's Restroom | [33.0482168<br>,<br>-95.093857<br>5] | The bench is not deep enough or long enough or is missing. Benches shall be provided having seats that are 42 inches long minimum and 20 inches deep minimum and 24 inches deep maximum. The bench shall provide for back support or shall be affixed to a wall. Back support shall be 42 inches (1065 mm) long minimum and shall extend from a point 2 inches (51 mm) maximum above the seat surface to a point 18 inches (455 mm) minimum above the seat surface. Back support shall be 2½ inches (64 mm) maximum from the rear edge of the seat measured horizontally. The top of the bench seat surface shall be 17 inches (430 mm) minimum and 19 inches (485 mm) maximum above the finish floor or ground. Clear floor or ground space complying with 305 shall be provided and shall be positioned at the end of the bench seat and parallel to the short axis of the bench | bench lacks CFS, not compliant | Replace bench in dressing area with one having a seat depth of 20" to 24" deep, 42" long, affixed to the wall or having a back and mounted 17" to 19" AFF and provide required clear floor space on the short axis of the bench. | 2012 TAS<br>Section:<br>903.4, 903.2,<br>903.3, 903.5<br><br>2010 ADAS<br>Section:<br>903.4, 903.2,<br>903.3, 903.5 | | |

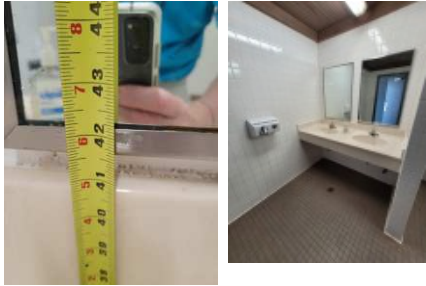
| Finding Number | Area Description | Lat/Long | Finding | As Built | Recommendation | Citation | Photos | Figure |
|---|---|---|--|---|---|---|---|---|
| 118 | Day Use Area:<br>Day Use - Men's Restroom | [33.0482112<br>,<br>-95.093854<br>6] | The mirror is mounted too high. Mirrors must have the bottom edge of the reflecting surface a maximum of 40 inches above the floor if above a sink or counter. Mirrors not located above lavatories or countertops shall be installed with the bottom edge of the reflecting surface 35 inches maximum above the finish floor or ground. | Bottom edge at 42.25" AFF | Lower mirror so bottom reflective surface is max 40" AFF and 74" at the top. | 2015 ABAAS<br>Section:<br>603.3<br><br>2012 TAS<br>Section:<br>603.3<br><br>2010 ADAS<br>Section:<br>603.3 | | |

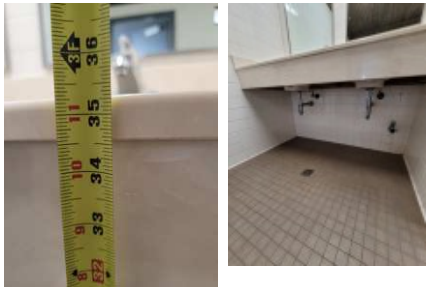
| Finding Number | Area Description | Lat/Long | Finding | As Built | Recommendation | Citation | Photos | Figure |
|---|---|---|--|---|---|---|---|---|
| 119 | Day Use Area:<br>Day Use - Men's Restroom | [33.0482123<br>,<br>-95.093856] | The top rim of the sink is too high. All lavatories/sinks that are designated to be accessible shall be a minimum 17 inches in horizontal depth and mounted with the rim or counter edge no higher than 34 inches above the finished floor. | Sink rim at 35.25" AFF | Lower sinks to max 34" above the finished floor (AFF) to front of rim. | 2015 ABAAS<br>Section:<br>606.3<br><br>2012 TAS<br>Section:<br>606.3<br><br>2010 ADAS<br>Section:<br>606.3 | | |

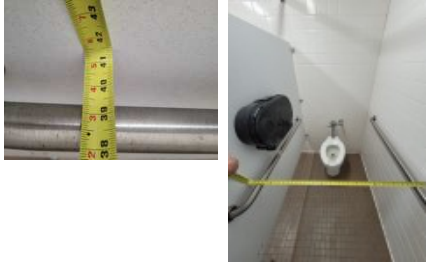
| Finding Number | Area Description | Lat/Long | Finding | As Built | Recommendation | Citation | Photos | Figure |
|---|---|---|---|--|---|--|--|---|
| 122 | Day Use Area:<br>Day Use - Men's Restroom | [33.0482235 ,<br>-95.093868] | The ambulatory stall is not between 35" to 37" wide and 60" deep. | ambulatory stall<br>41.25" wide | Correct ambulatory stall to be 35" to 37" wide and minimum 60" deep. | 2015 ABAAS<br>Section:<br>604.8.2.1<br><br>2012 TAS<br>Section:<br>604.8.2.1<br><br>2010 ADAS<br>Section:<br>604.8.2.1 | | |

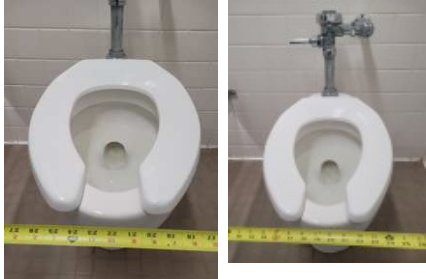
| Finding Number | Area Description | Lat/Long | Finding | As Built | Recommendation | Citation | Photos | Figure |
|---|---|---|---|--|---|--|--|---|
| 123 | Day Use Area:<br>Day Use - Men's Restroom | [33.048219,<br>-95.093854<br>6] | The toilet is not located within the range to the side wall or partition. The centerline of the toilet shall be 17 inches minimum and 19 inches maximum side wall or partition in the ambulatory accessible toilet compartment. | 22" to one wall,<br>19.75" to other wall | Remount toilet to 17" to 19" from the side wall to center line in ambulatory stalls. | 2015 ABAAS<br>Section:<br>604.9.1<br><br>2012 TAS<br>Section:<br>604.9.1<br><br>2010 ADAS<br>Section:<br>604.9.1 | | |

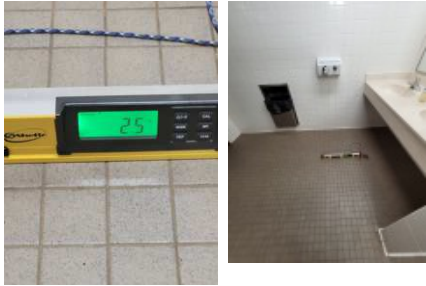
| Finding Number | Area Description | Lat/Long | Finding | As Built | Recommendation | Citation | Photos | Figure |
|---|---|---|---|---|---|--|--|---|
| 128 | Day Use Area:<br>Day Use - Men's Restroom | [33.0482157 ,<br>-95.093845 2] | The accessible route contains running slopes greater than 5 percent and cross slopes greater than 2 percent across the width of the walk and has not been constructed as a ramp (i.e. handrails, wheel guides, etc.). When the slope in the direction of travel of any walk exceeds 1 unit vertical in 20 units horizontal (5-percent slope), it must be constructed as ramp. Surface cross slopes must not exceed one unit vertical in 48 units. Horizontal (2-percent slope). | Slope of 2.5% near sinks | Correct or repair slope to max 2.08% in restroom. | 2015 ABAAS Section: 403.3<br><br>2012 TAS Section: 403.3<br><br>2010 ADAS Section: 403.3 | | |

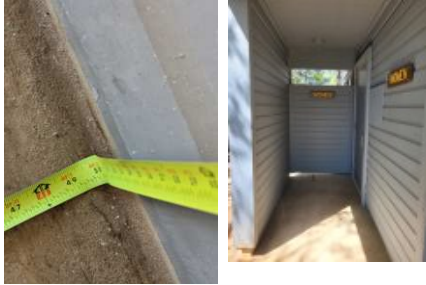
| Finding Number | Area Description | Lat/Long | Finding | As Built | Recommendation | Citation | Photos | Figure |
|---|---|---|--|---|--|---|---|---|
| 130 | Day Use Area:<br>Day Use -<br>Women's<br>Restroom | [33.0482195<br>,<br>-95.093854<br>1] | The landing on the pull side of the door is obstructed. Landings for doors on the pull side equipped with a closer must be flat (2% max. slope in any direction) for a minimum distance of 54 inches perpendicular to the door. The width of the landing must be as wide as the door plus an additional 24 inches on the latch side. This latch side clearance must also be flat (2% max. slope in any direction) and clear of obstructions. | women's- 50" back pull side due to wall | Provide required maneuvering clearance on pull side of doors of 54" with closer | 2015 ABAAS<br>Section:<br>404.2.4.1<br><br>2012 TAS<br>Section:<br>404.2.4.1<br><br>2010 ADAS<br>Section:<br>404.2.4.1 | | |

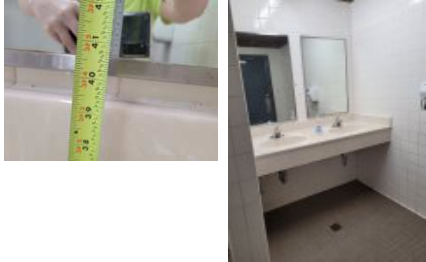
| Finding Number | Area Description | Lat/Long | Finding | As Built | Recommendation | Citation | Photos | Figure |
|---|---|---|--|---|--|---|---|---|
| 132 | Day Use Area:<br>Day Use -<br>Women's<br>Restroom | [33.0482195<br>,<br>-95.093858<br>1] | The mirror is mounted too high. Mirrors must have the bottom edge of the reflecting surface a maximum of 40 inches above the floor if above a sink or counter. Mirrors not located above lavatories or countertops shall be installed with the bottom edge of the reflecting surface 35 inches maximum above the finish floor or ground. | Bottom edge of mirror at 40.5" AFF | Lower mirror so reflective surface is max 40" AFF. | 2015 ABAAS<br>Section:<br>603.3<br><br>2012 TAS<br>Section:<br>603.3<br><br>2010 ADAS<br>Section:<br>603.3 | | |

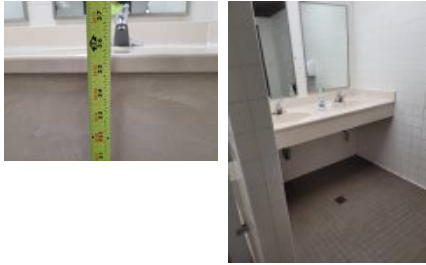
| Finding Number | Area Description | Lat/Long | Finding | As Built | Recommendation | Citation | Photos | Figure |
|---|---|---|--|---|---|--|---|---|
| 133 | Day Use Area:<br>Day Use -<br>Women's<br>Restroom | [33.0482172<br>,<br>-95.093858<br>1] | The top rim of the sink is too high. All lavatories/sinks that are designated to be accessible shall be a minimum 17 inches in horizontal depth and mounted with the rim or counter edge no higher than 34 inches above the finished floor. | Sink rim at 35.5" AFF | Lower sinks to max 34" above the finished floor (AFF) to front of rim. | 2015 ABAAS<br>Section:<br>606.3<br><br>2012 TAS<br>Section:<br>606.3<br><br>2010 ADAS<br>Section:<br>606.3 | | |

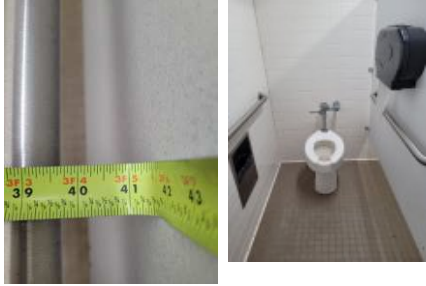
| Finding Number | Area Description | Lat/Long | Finding | As Built | Recommendation | Citation | Photos | Figure |
|---|---|---|--|---|---|--|---|---|
| 136 | Day Use Area:<br>Day Use -<br>Women's<br>Restroom | [33.0482127<br>,<br>-95.093864<br>8] | The ambulatory stall is not between 35" to 37" wide and 60" deep. | ambulatory stall 41.5" wide | Correct ambulatory stall to be 35" to 37" wide and minimum 60" deep. | 2015 ABAAS<br>Section:<br>604.8.2.1<br><br>2012 TAS<br>Section:<br>604.8.2.1<br><br>2010 ADAS<br>Section:<br>604.8.2.1 | | |

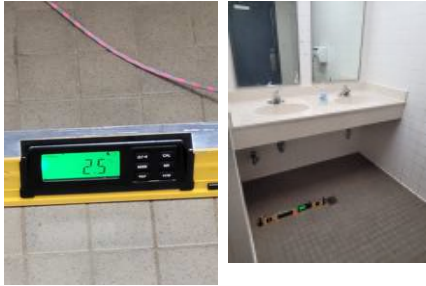
| Finding Number | Area Description | Lat/Long | Finding | As Built | Recommendation | Citation | Photos | Figure |
|---|---|---|--|--|--|---|---|---|
| 141 | Day Use Area:<br>Day Use -<br>Women's<br>Restroom | [33.0482195<br>,<br>-95.093867<br>5] | The accessible route contains running slopes greater than 5 percent and cross slopes greater than 2 percent across the width of the walk and has not been constructed as a ramp (i.e. handrails, wheel guides, etc.). When the slope in the direction of travel of any walk exceeds 1 unit vertical in 20 units horizontal (5-percent slope), it must be constructed as ramp. Surface cross slopes must not exceed one unit vertical in 48 units. Horizontal (2-percent slope). | 2.5" cross slope at sink | Correct or repair slope to max 2.08% in restroom. | 2015 ABAAS<br>Section:<br>403.3<br><br>2012 TAS<br>Section:<br>403.3<br><br>2010 ADAS<br>Section:<br>403.3 | | |

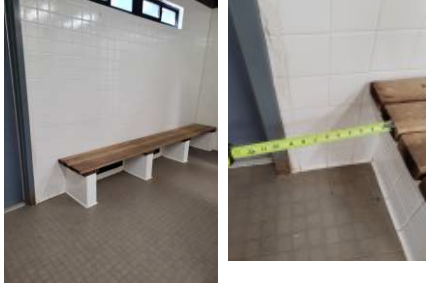
| Finding Number | Area Description | Lat/Long | Finding | As Built | Recommendation | Citation | Photos | Figure |
|---|---|---|--|--|--|---|---|---|
| 142 | Day Use Area:<br>Day Use -<br>Women's<br>Restroom | [33.0482184<br>,<br>-95.093859<br>4] | The bench is not deep enough or long enough or is missing. Benches shall be provided having seats that are 42 inches long minimum and 20 inches deep minimum and 24 inches deep maximum. The bench shall provide for back support or shall be affixed to a wall. Back support shall be 42 inches (1065 mm) long minimum and shall extend from a point 2 inches (51 mm) maximum above the seat surface to a point 18 inches (455 mm) minimum above the seat surface. Back support shall be 2½ inches (64 mm) maximum from the rear edge of the seat measured horizontally. The top of the bench seat surface shall be 17 inches (430 mm) minimum and 19 inches (485 mm) maximum above the finish floor or ground. Clear floor or ground space complying with 305 shall be provided and shall be positioned at the end of the bench seat and parallel to the short axis of the bench | bench lacks CFS, not accessible | Replace bench in dressing area with one having a seat depth of 20" to 24" deep, 42" long, affixed to the wall or having a back and mounted 17" to 19" AFF and provide required clear floor space on the short axis of the bench. | 2012 TAS<br>Section:<br>903.4, 903.2,<br>903.3, 903.5<br><br>2010 ADAS<br>Section:<br>903.4, 903.2,<br>903.3, 903.5 | | |

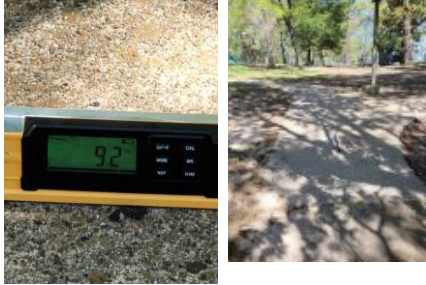
| Finding Number | Area Description | Lat/Long | Finding | As Built | Recommendation | Citation | Photos | Figure |
|---|---|---|--|--|--|---|---|---|
| 143 | Day Use Area:<br>Day Use -<br>Women's<br>Restroom | [33.0482802<br>,<br>-95.093919<br>8] | The running slope of walking surfaces shall not be steeper than 1:20. | 9.2% running from accessible parking to restroom and play area | Correct running slope along the AR to max 5%. | 2015 ABAAS<br>Section:<br>403.3<br><br>2012 TAS<br>Section:<br>403.3<br><br>2010 ADAS<br>Section:<br>403.3 | | |

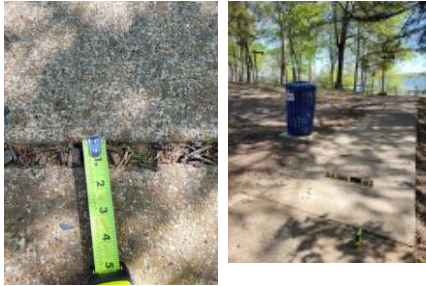
| Finding Number | Area Description | Lat/Long | Finding | As Built | Recommendation | Citation | Photos | Figure |
|---|---|---|--|---|--|--|--|---|
| 144 | Day Use Area:<br>Day Use -<br>Women's<br>Restroom | [33.0481734<br>,<br>-95.094067<br>3] | There is a gap spaced greater than a 1/2 inch. Openings in floor or ground surfaces shall not allow passage of a sphere more than 1/2 inch diameter. Elongated openings shall be placed so that the long dimension is perpendicular to the dominant direction of travel. | 1.25" gap before recycling at route to pier | Correct or fill gaps to be max .5". | 2015 ABAAS<br>Section:<br>302.3<br><br>2012 TAS<br>Section:<br>302.3<br><br>2010 ADAS<br>Section:<br>302.3 | | |

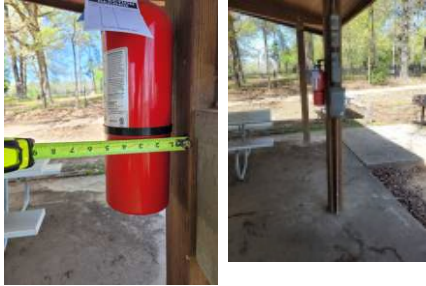
| Finding Number | Area Description | Lat/Long | Finding | As Built | Recommendation | Citation | Photos | Figure |
|---|---|---|--|---|--|--|---|---|
| 150 | Day Use Area:<br>Day Use - Group Pavilion | [33.0480711 ,<br>-95.09339] | Objects project more than 4 inches into the circulation path. Wall-mounted objects that have leading edges between 27 inches and 80 inches from the floor must not project more than 4 inches into the circulation path. Protruding objects that extend to the floor or within 27 inches of the floor are cane detectable and are therefore not hazardous. Where it is necessary or desirable to have objects protrude from the wall, a manner of cane detection must be provided. | Fire extinguisher projects 5" | Relocate object to not protrude into the circulation path. | 2015 ABAAS<br>Section:<br>307.2<br><br>2012 TAS<br>Section:<br>307.2<br><br>2010 ADAS<br>Section:<br>307.2 | | |

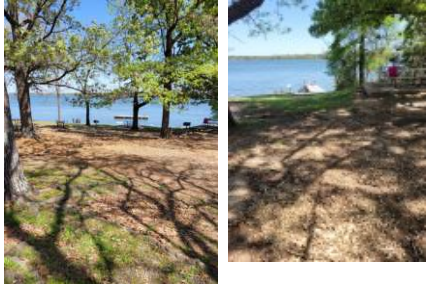
| Finding Number | Area Description | Lat/Long | Finding | As Built | Recommendation | Citation | Photos | Figure |
|---|--|---|--|---|---|---|---|---|
| 153 | Day Use Area:<br>Day Use -<br>Swimming | [33.0481442<br>,<br>-95.092365<br>4] | Beach access routes shall connect an entry point to the beach to the: 1. High tide level at tidal beaches; 2. Mean high water level at river beaches; or 3. Normal recreation water level at lake, pond, and reservoir beaches | Lacks AR to swimming area | Create a beach access route to normal recreational water level of a firm and stable material as a smart practice. | 2015 ABAAS<br>Section:<br>1018.2 | | |

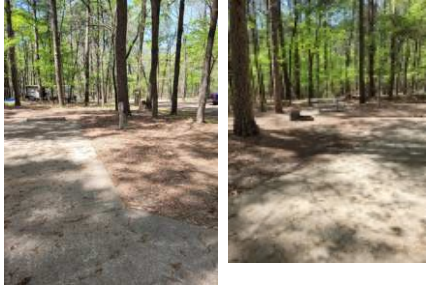
| Finding Number | Area Description | Lat/Long | Finding | As Built | Recommendation | Citation | Photos | Figure |
|---|---|---|--|--|--|---|---|---|
| 161 | Fort Sherman/Cherokee Trace (FS/CT) Camping Areas: FS/CT - Campsite | [33.0544627 , -95.088658 6] | An accessible access route is not provided between elements, spaces and the facilities provided within the accessible camping unit. At least one outdoor recreation access route shall connect accessible elements, spaces and facilities provided within camping units with mobility features. | Site 33 - Lacks ORAR to campsite elements | Create AR with crushed and compacted stone or similar outdoor material to camp sites and one of each type of amenity. | 2015 ABAAS Section: F244.5.1 | | |

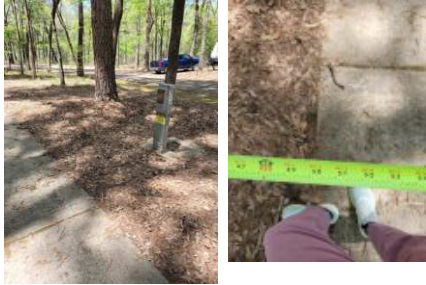
| Finding Number | Area Description | Lat/Long | Finding | As Built | Recommendation | Citation | Photos | Figure |
|---|---|---|---|---|--|---|---|---|
| 168 | Fort Sherman/Cherokee Trace (FS/CT) Camping Areas: FS/CT - Campsite | [33.0544458 , -95.088694 8] | 30 inches (760 mm) by 60 inches (1525 mm) with the long side of the space adjoining or overlapping an accessible parking space or pull-up space for recreational vehicles. Locate the space so that the hook-ups are at the rear center of the space. Bollards or other barriers shall not obstruct the clear ground space in front of the hook-ups | Site 33 - Lacks ORAR and CGS at utility hookup - 52" reach | Provide required 30" by 60" clear ground space with hook ups at the rear of the space as a smart practice. | 2015 ABAAS Section: 1011.2 | | |

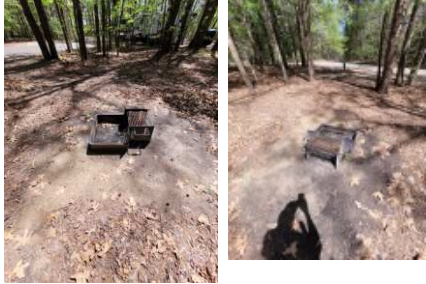
| Finding Number | Area Description | Lat/Long | Finding | As Built | Recommendation | Citation | Photos | Figure |
|---|---|---|---|---|--|---|---|---|
| 170 | Fort Sherman/Cherokee Trace (FS/CT) Camping Areas: FS/CT - Campsite | [33.0541176 , -95.087351] | 48 inches (1220 mm) by 48 inches (1220 mm) on all usable sides of the fire ring, grill, fireplace, and woodstove. Center the space on each usable side of the grill, fireplace, and woodstove | Site 34 - Lacks firm and stable surface in CGS of fire pit | Provide required 48" clear ground space centered along usable side of fire ring, grill, fireplace, or woodstove as a smart practice. | 2015 ABAAS Section: 1011.2 | | |

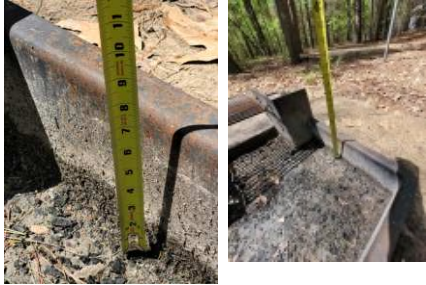
| Finding Number | Area Description | Lat/Long | Finding | As Built | Recommendation | Citation | Photos | Figure |
|---|---|---|--|---|--|--|---|---|
| 171 | Fort Sherman/Cherokee Trace (FS/CT) Camping Areas: FS/CT - Campsite | [33.0541142 , -95.0873578] | Fire building surfaces shall be 9 inches (230 mm) minimum above the ground | Site 34 - Fire building surface is not 9" above the ground | Correct fire building surface to be 9" min above the ground as a smart practice. | 2015 ABAAS Section: 1011.5.1 | | |

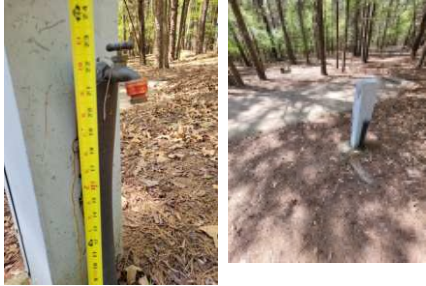
| Finding Number | Area Description | Lat/Long | Finding | As Built | Recommendation | Citation | Photos | Figure |
|---|---|---|--|---|--|--|---|---|
| 172 | Fort Sherman/Cherokee Trace (FS/CT) Camping Areas: FS/CT - Campsite | [33.0541131 , -95.087351] | Water spouts at water hydrants and water utility hook-ups shall be 28 inches (710 mm) minimum and 36 inches (915 mm) maximum above the ground. An accessible access route is not provided between elements, spaces and the facilities provided within the accessible camping unit. At least one outdoor recreation access route shall connect accessible elements, spaces and facilities provided within camping units with mobility features. | Site 34 - Lacks ORAR to water spout, and spout is 20.5" AGL | Remount water spouts to 28" min or 36" max above the ground as a smart practice. Create AR with crushed and compacted stone or similar outdoor material to camp sites and one of each type of amenity. | 2015 ABAAS Section: 1011.6 | | |

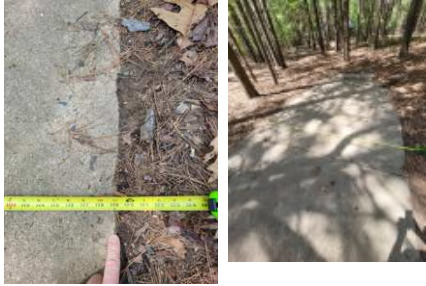
| Finding Number | Area Description | Lat/Long | Finding | As Built | Recommendation | Citation | Photos | Figure |
|---|---|---|--|---|--|--|---|---|
| 173 | Fort Sherman/Cherokee Trace (FS/CT) Camping Areas: FS/CT - Campsite | [33.0541176 , -95.0873671] | Parking spaces and pull-up spaces for recreational vehicles shall be 20 feet (6100 mm) wide minimum. EXCEPTION: Where two adjacent parking spaces are provided for recreational vehicles, one parking space shall be permitted to be 16 feet (4880 mm) wide minimum. | Site 34 - Parking space 9'11" wide | Correct RV parking space to be 20' wide minimum; or 16' for two adjacent spaces as a smart practice. | 2015 ABAAS Section: 1012.2, 1012.2 EXCEPTION | | |

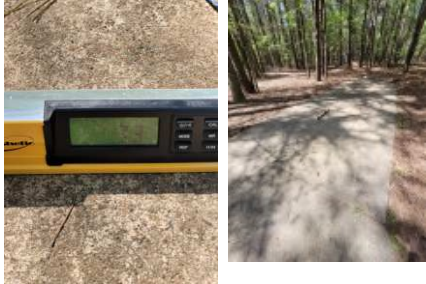
| Finding Number | Area Description | Lat/Long | Finding | As Built | Recommendation | Citation | Photos | Figure |
|---|---|---|--|---|--|--|---|---|
| 174 | Fort Sherman/Cherokee Trace (FS/CT) Camping Areas: FS/CT - Campsite | [33.0541108 , -95.0873537] | The surface of parking spaces and pull-up spaces shall be firm and stable. The slope of the surface of parking spaces and pull-up spaces shall not be steeper than 1:48 in any direction. EXCEPTION: Where the surface is other than asphalt, concrete, or boards, slopes not steeper than 1:20 shall be permitted when necessary for drainage. | Site 34 - 3.3% slope at middle of space | Correct surface of parking spaces to be firm and stable with slopes max of 2.08% or 5% for surfaces other than concrete, asphalt or boards as a smart practice. | 2015 ABAAS Section: 1012.4, 1012.5, 1012.5 EXCEPTION | | |

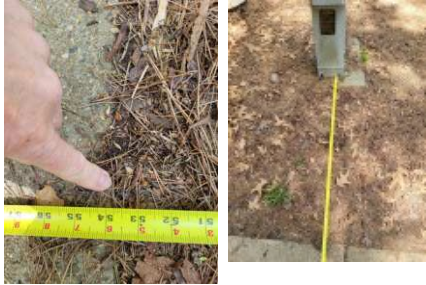
| Finding Number | Area Description | Lat/Long | Finding | As Built | Recommendation | Citation | Photos | Figure |
|---|---|---|---|---|--|---|---|---|
| 175 | Fort Sherman/Cherokee Trace (FS/CT) Camping Areas: FS/CT - Campsite | [33.0541142 , -95.087356 4] | 30 inches (760 mm) by 60 inches (1525 mm) with the long side of the space adjoining or overlapping an accessible parking space or pull-up space for recreational vehicles. Locate the space so that the hook-ups are at the rear center of the space. Bollards or other barriers shall not obstruct the clear ground space in front of the hook-ups | Site 34 - Lacks route to and CGS at utility box - 54" gap | Provide required 30" by 60" clear ground space with hook ups at the rear of the space as a smart practice. | 2015 ABAAS Section: 1011.2 | | |

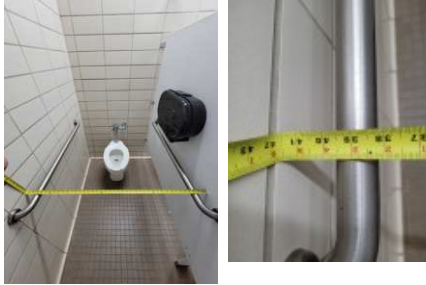
| Finding Number | Area Description | Lat/Long | Finding | As Built | Recommendation | Citation | Photos | Figure |
|---|---|---|---|---|---|--|--|---|
| 185 | Fort Sherman/Cherokee Trace (FS/CT) Camping Areas: FS/CT - Men's Restroom | [33.0542941, -95.0880739] | The ambulatory stall is not between 35" to 37" wide and 60" deep. | ambulatory stall 41.5" wide | Correct ambulatory stall to be 35" to 37" wide and minimum 60" deep. | 2015 ABAAS Section: 604.8.2.1<br>2012 TAS Section: 604.8.2.1<br>2010 ADAS Section: 604.8.2.1 | | |

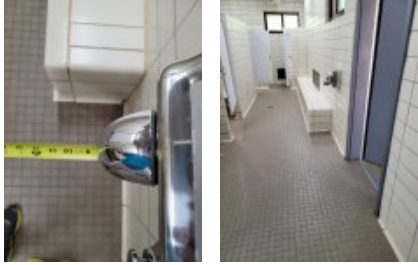
| Finding Number | Area Description | Lat/Long | Finding | As Built | Recommendation | Citation | Photos | Figure |
|---|---|---|---|--|--|--|--|---|
| 190 | Fort Sherman/Cherokee Trace (FS/CT) Camping Areas: FS/CT - Men's Restroom | [33.0542986 , -95.0880766] | An item or items project more than 4 inches into the circulation path. Wall-mounted objects that have leading edges between 27 inches and 80 inches from the floor must not project more than 4 inches into the circulation path. Protruding objects that extend to the floor or within 27 inches of the floor are cane detectable and are therefore not hazardous. Where it is necessary or desirable to have objects protrude from the wall, a manner of cane detection must be provided. | Hand dryer protrudes 8.5" | Relocate protruding objects or place cane detectable warning or bollard at foot of item. | 2015 ABAAS Section: 307.2<br>2012 TAS Section: 307.2<br>2010 ADAS Section: 307.2 | | |

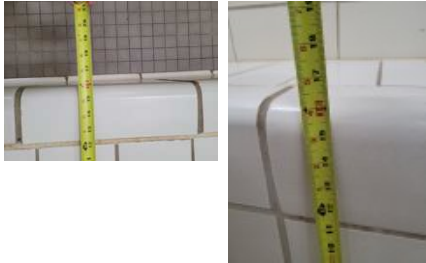
| Finding Number | Area Description | Lat/Long | Finding | As Built | Recommendation | Citation | Photos | Figure |
|---|---|---|--|--|--|---|---|---|
| 192 | Fort Sherman/Cherokee Trace (FS/CT) Camping Areas: FS/CT - Men's Restroom | [33.0542929 , -95.0880699] | The bench is not deep enough or long enough or is missing. Benches shall be provided having seats that are 42 inches long minimum and 20 inches deep minimum and 24 inches deep maximum. The bench shall provide for back support or shall be affixed to a wall. Back support shall be 42 inches (1065 mm) long minimum and shall extend from a point 2 inches (51 mm) maximum above the seat surface to a point 18 inches (455 mm) minimum above the seat surface. Back support shall be 2½ inches (64 mm) maximum from the rear edge of the seat measured horizontally. The top of the bench seat surface shall be 17 inches (430 mm) minimum and 19 inches (485 mm) maximum above the finish floor or ground. Clear floor or ground space complying with 305 shall be provided and shall be positioned at the end of the bench seat and parallel to the short axis of the bench | Bench 16" wide, 16" high | Replace bench in dressing area with one having a seat depth of 20" to 24" deep, 42" long, affixed to the wall or having a back and mounted 17" to 19" AFF and provide required clear floor space on the short axis of the bench. | 2012 TAS Section: 903.4, 903.2, 903.3, 903.5<br><br>2010 ADAS Section: 903.4, 903.2, 903.3, 903.5 | | |

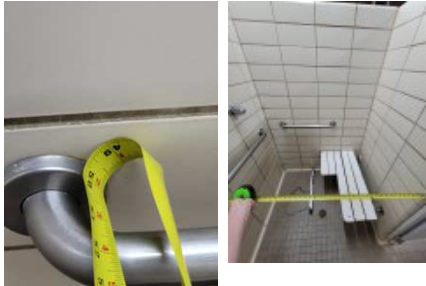
| Finding Number | Area Description | Lat/Long | Finding | As Built | Recommendation | Citation | Photos | Figure |
|---|---|---|--|--|--|---|---|---|
| 193 | Fort Sherman/Cherokee Trace (FS/CT) Camping Areas: FS/CT - Men's Restroom | [33.0542963 , -95.0880766] | Alternate roll-in type shower compartments shall be 36 inches (915 mm) wide and 60 inches (1525 mm) deep minimum clear inside dimensions measured at center points of opposing sides. A 36 inch (915 mm) wide minimum entry shall be provided at one end of the long side of the compartment. | shower 48" deep | Renovate shower stall, if feasible, to compliant dimensions for an alternate roll in shower of 36" deep by 60" wide with a 36" opening on the long dimension. | 2015 ABAAS Section: 608.2.3<br><br>2012 TAS Section: 608.2.3<br><br>2010 ADAS Section: 608.2.3 | | |

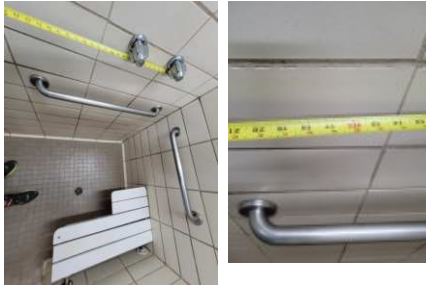
| Finding Number | Area Description | Lat/Long | Finding | As Built | Recommendation | Citation | Photos | Figure |
|---|---|---|--|---|---|---|---|--|
| 195 | Fort Sherman/Cherokee Trace (FS/CT) Camping Areas: FS/CT - Men's Restroom | [33.0542941, -95.0880752] | The operable parts of controls are incorrectly installed. In alternate roll-in type shower compartments, the controls, faucets, and shower spray unit shall be located above the grab bar, but no higher than 48 inches (1220 mm) above the shower floor. Where a seat is provided, the controls, faucets, and shower spray unit shall be located on the side wall adjacent to the seat 27 inches (685 mm) maximum from the side wall behind the seat or shall be located on the back wall opposite the seat 15 inches (380 mm) maximum, left or right, of the centerline of the seat. Where a seat is not provided, the controls, faucets, and shower spray unit shall be installed on the side wall farthest from the compartment entry. | one control closer to back wall | Remount shower controls to the correct location in the alternate shower. | 2015 ABAAS Section: 608.5.3<br>2012 TAS Section: 608.5.3<br>2010 ADAS Section: 608.5.3 | | |

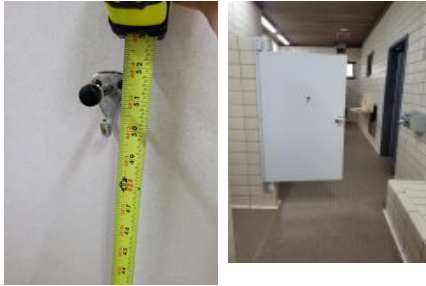
| Finding Number | Area Description | Lat/Long | Finding | As Built | Recommendation | Citation | Photos | Figure |
|---|---|---|--|---|--|---|---|---|
| 200 | Fort Sherman/Cherokee Trace (FS/CT) Camping Areas: FS/CT - Women's Restroom | [33.0542986, -95.0880766] | The coat hook is installed greater than 48 inches above the finished floor. Where a forward reach is unobstructed, the high forward reach shall be 48 inches maximum above the finished floor. | Hook in stall at 50" AFF | Lower hooks in locker area to max 48" AFF. | 2015 ABAAS Section: 308.2.1<br><br>2012 TAS Section: 308.2.1<br><br>2010 ADAS Section: 308.2.1 | | |
