# Access Audit Site Report

**Lake Bob Sandlin State Park**

**Accessibility Evaluation**

**Inspection Date: 04/06/2022**

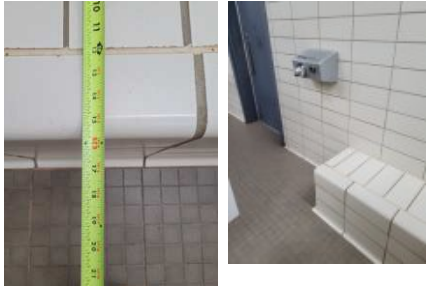
| Finding Number | Area Description | Lat/Long | Finding | As Built | Recommendation | Citation | Photos | Figure |
|---|---|---|--|---|--|---|---|---|
| 201 | Fort Sherman/Cherokee Trace (FS/CT) Camping Areas: FS/CT - Women's Restroom | [33.0542941, -95.0880793] | The bench is not deep enough or long enough or is missing. Benches shall be provided having seats that are 42 inches long minimum and 20 inches deep minimum and 24 inches deep maximum. The bench shall provide for back support or shall be affixed to a wall. Back support shall be 42 inches (1065 mm) long minimum and shall extend from a point 2 inches (51 mm) maximum above the seat surface to a point 18 inches (455 mm) minimum above the seat surface. Back support shall be 2½ inches (64 mm) maximum from the rear edge of the seat measured horizontally. The top of the bench seat surface shall be 17 inches (430 mm) minimum and 19 inches (485 mm) maximum above the finish floor or ground. Clear floor or ground space complying with 305 shall be provided and shall be positioned at the end of the bench seat and parallel to the short axis of the bench | 15.75" depth, hand dryer in CFS | Replace bench in dressing area with one having a seat depth of 20" to 24" deep, 42" long, affixed to the wall or having a back and mounted 17" to 19" AFF and provide required clear floor space on the short axis of the bench. | 2012 TAS Section: 903.4, 903.2, 903.3, 903.5<br><br>2010 ADAS Section: 903.4, 903.2, 903.3, 903.5 | | |

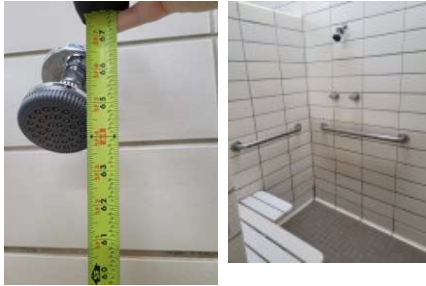
| Finding Number | Area Description | Lat/Long | Finding | As Built | Recommendation | Citation | Photos | Figure |
|---|---|---|--|---|--|---|--|--|
| 204 | Fort Sherman/Cherokee Trace (FS/CT) Camping Areas: FS/CT - Women's Restroom | [33.0542851, -95.0880766] | There is no hand held sprayer unit. The sprayer unit must have a 59 inches hose and be mounted 48 inches maximum to the top of mounting bracket off the floor. The shower spray unit shall have an on/off control with a non-positive shutoff. If an adjustable-height shower head on a vertical bar is used, the bar shall be installed so as not to obstruct the use of grab bars. | Fixed shower head only at 64" AFF | Replace shower control with a compliant lever control with a shower head on a 59" hose and usable as hand held; in the alternative, remount fixed shower head max 48" aff. | 2015 ABAAS Section: 608.6<br>2012 TAS Section: 608.6<br>2010 ADAS Section: 608.6 | | <p><b>SHOWER SPRAY UNIT</b></p> <p>59" Long Flexible Hose<br/>Water Temperature: 120° F Max.<br/>48"<br/>Top of mounting bracket: 48" Max. above the shower floor.<br/>©Builder's Book, Inc.</p> |

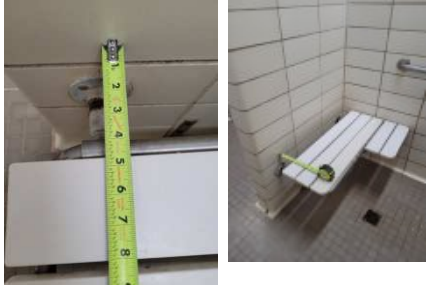
| Finding Number | Area Description | Lat/Long | Finding | As Built | Recommendation | Citation | Photos | Figure |
|---|---|---|--|---|--|---|--|--|
| 205 | Fort Sherman/Cherokee Trace (FS/CT) Camping Areas: FS/CT - Women's Restroom | [33.0542941, -95.0880739] | The shower seat does not have a compliant space between it and the wall. The folding seat must be mounted 17-19 inches above the floor, and have a maximum space of 1-1/2 inches between the edge of the seat and the side wall and 2-1/2 inches maximum to the seat wall. | 4" gap on backside | Remount shower seat to the correct location and height in the shower. | 2015 ABAAS Section: 610.3.2<br>2012 TAS Section: 610.3.2<br>2010 ADAS Section: 610.3.2 | | <p>(a) size<br/>(b) distance from wall</p> |

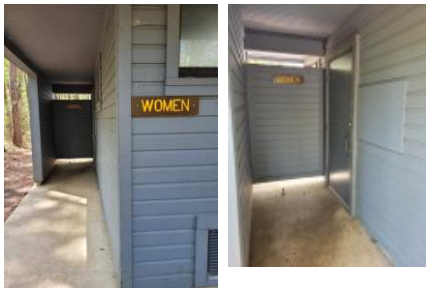
| Finding Number | Area Description | Lat/Long | Finding | As Built | Recommendation | Citation | Photos | Figure |
|---|---|---|--|---|--|---|--|--|
| 206 | Fort Sherman/Cherokee Trace (FS/CT) Camping Areas: FS/CT - Women's Restroom | [33.0542941, -95.0880766] | The restroom sign does not comply with one or more applicable requirements for the location, height, and properties of the sign. | Lacks compliant signage and mounting location | Replace sign with one of contrasting colors that includes Braille, raised characters, and the symbol of accessibility and mount on the wall, latch side of the door, 48" to the baseline of the lowest character and 60" to the baseline of the highest character. | 2015 ABAAS Section: F216.2, 703.1, 703.2, 703.5, 703.6<br>2012 TAS Section: 216.2, 703.1, 703.2, 703.5, 703.6<br>2010 ADAS Section: 216.2, 703.1, 703.2, 703.5, 703.6 | | <p>FUG</p> |

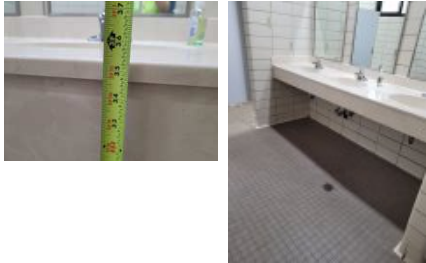
| Finding Number | Area Description | Lat/Long | Finding | As Built | Recommendation | Citation | Photos | Figure |
|---|---|---|--|---|--|--|---|---|
| 207 | Fort Sherman/Cherokee Trace (FS/CT) Camping Areas: FS/CT - Women's Restroom | [33.0542918 , -95.088073 9] | The top rim of the sink is too high. All lavatories/sinks that are designated to be accessible shall be a minimum 17 inches in horizontal depth and mounted with the rim or counter edge no higher than 34 inches above the finished floor. | Rim of sink at 35.5" AFF | Lower sinks to max 34" above the finished floor (AFF) to front of rim. | 2015 ABAAS Section: 606.3<br><br>2012 TAS Section: 606.3<br><br>2010 ADAS Section: 606.3 | | |

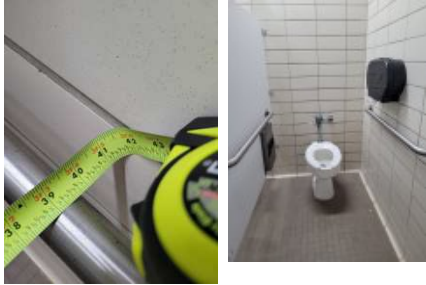
| Finding Number | Area Description | Lat/Long | Finding | As Built | Recommendation | Citation | Photos | Figure |
|---|---|---|---|--|--|--|--|---|
| 211 | Fort Sherman/Cherokee Trace (FS/CT) Camping Areas: FS/CT - Women's Restroom | [33.0542952, -95.0880766] | The ambulatory stall is not between 35" to 37" wide and 60" deep. | ambulatory stall 41.5" width | Correct ambulatory stall to be 35" to 37" wide and minimum 60" deep. | 2015 ABAAS Section: 604.8.2.1<br>2012 TAS Section: 604.8.2.1<br>2010 ADAS Section: 604.8.2.1 | | |

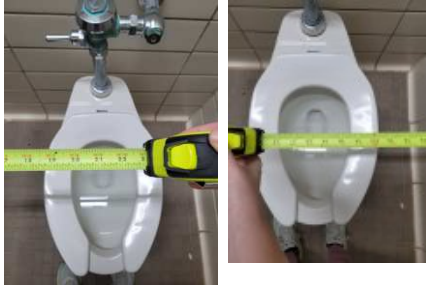
| Finding Number | Area Description | Lat/Long | Finding | As Built | Recommendation | Citation | Photos | Figure |
|---|---|---|---|--|--|--|--|---|
| 212 | Fort Sherman/Cherokee Trace (FS/CT) Camping Areas: FS/CT - Women's Restroom | [33.0542941, -95.0880739] | The toilet is not located within the range to the side wall or partition. The centerline of the toilet shall be 17 inches minimum and 19 inches maximum side wall or partition in the ambulatory accessible toilet compartment. | 21.5" from partition side, 19.5" from other side | Remount toilet to 17" to 19" from the side wall to center line in ambulatory stalls. | 2015 ABAAS Section: 604.9.1<br>2012 TAS Section: 604.9.1<br>2010 ADAS Section: 604.9.1 | | |

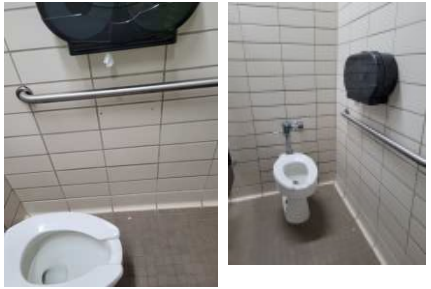
| Finding Number | Area Description | Lat/Long | Finding | As Built | Recommendation | Citation | Photos | Figure |
|---|---|---|--|---|---|---|---|---|
| 215 | Fort Sherman/Cherokee Trace (FS/CT) Camping Areas: FS/CT - Women's Restroom | [33.0542974, -95.0880779] | The toilet paper is not installed within the compliant range in front of the toilet. Toilet paper dispensers shall be 7 inches minimum and 9 inches maximum in front of the water closet measured to the centerline of the dispenser. The outlet of the dispenser shall be 15 inches minimum and 48 inches maximum above the finish floor and shall not be located behind grab bars. Dispensers shall not be of a type that controls delivery or that does not allow continuous paper flow. There shall be a clearance of 1 1/2 inches minimum below the grab bar. | TP too close to front of toilet | Remount toilet paper dispenser max 7" to 9" from front of toilet, 15" to 48" AFF and min 12" above or 1.5" below grab bar. | 2015 ABAAS Section: 604.7<br><br>2012 TAS Section: 604.7<br><br>2010 ADAS Section: 604.7 | | |

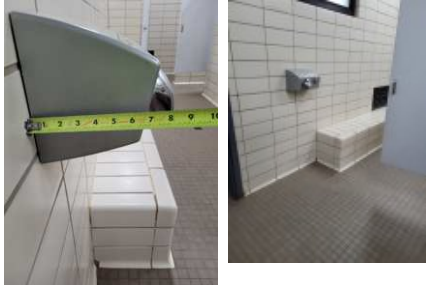
| Finding Number | Area Description | Lat/Long | Finding | As Built | Recommendation | Citation | Photos | Figure |
|---|---|---|--|---|---|---|---|---|
| 216 | Fort Sherman/Cherokee Trace (FS/CT) Camping Areas: FS/CT - Women's Restroom | [33.0542941, -95.0880752] | An item or items project more than 4 inches into the circulation path. Wall-mounted objects that have leading edges between 27 inches and 80 inches from the floor must not project more than 4 inches into the circulation path. Protruding objects that extend to the floor or within 27 inches of the floor are cane detectable and are therefore not hazardous. Where it is necessary or desirable to have objects protrude from the wall, a manner of cane detection must be provided. | Hand dryer projects 8" | Relocate protruding objects or place cane detectable warning or bollard at foot of item. | 2015 ABAAS Section: 307.2<br><br>2012 TAS Section: 307.2<br><br>2010 ADAS Section: 307.2 | | |

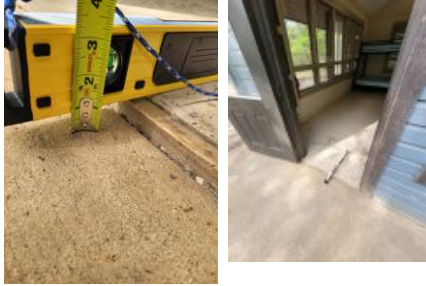
| Finding Number | Area Description | Lat/Long | Finding | As Built | Recommendation | Citation | Photos | Figure |
|---|---|---|---|---|--|---|--|---|
| 238 | Moccasin Track/Broken Bow (MT/BB) Camping Areas: MT/BB - Campsite | [33.0561071 , -95.081534 7] | Thresholds, if provided at doorways, shall be 1/2 inch (13 mm) high maximum. Raised thresholds and changes in level at doorways shall comply with 302 and 303. Changes in level of 1/4 inch (6.4 mm) high maximum shall be permitted to be vertical. Changes in level between 1/4 inch (6.4 mm) high minimum and 1/2 inch (13 mm) high maximum shall be beveled with a slope not steeper than 1:2. Changes in level greater than 1/2 inch (13 mm) high shall be ramped, and shall comply with 405 or 406. | Cottage 66 door - 1" CIL at door | Repair, bevel or ramp CIL at doorway. | 2015 ABAAS Section: 303.3, 404.2.5, 303.2, 303.4<br><br>2012 TAS Section: 303.3, 404.2.5, 303.2, 303.4<br><br>2010 ADAS Section: 303.3, 404.2.5, 303.2, 303.4 | | |

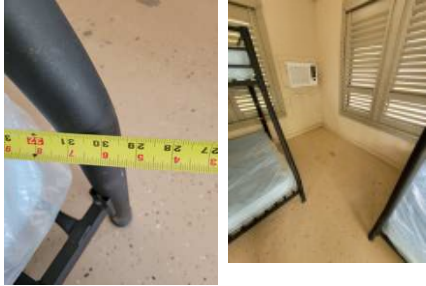
| Finding Number | Area Description | Lat/Long | Finding | As Built | Recommendation | Citation | Photos | Figure |
|---|---|---|---|--|---|--|---|---|
| 242 | Moccasin Track/Broken Bow (MT/BB) Camping Areas: MT/BB - Campsite | [33.0561038 , -95.081529 3] | The route of travel at this location does not provide a minimum width of 36 inches. The clear width shall be permitted to be reduced to 32 inches minimum for a length of 24 inches maximum provided that reduced width segments are separated by segments that are 48 inches long minimum and 36 inches wide minimum. | Cottage 66 - Route to AC unit reduces to 29.5" | Relocate or reposition beds to widen AR to compliant 36" clear width. | 2015 ABAAS Section: 403.5.1<br>2012 TAS Section: 403.5.1<br>2010 ADAS Section: 403.5.1 | | |

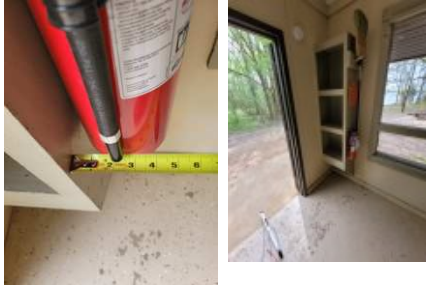
| Finding Number | Area Description | Lat/Long | Finding | As Built | Recommendation | Citation | Photos | Figure |
|---|---|---|---|--|---|--|---|---|
| 243 | Moccasin Track/Broken Bow (MT/BB) Camping Areas: MT/BB - Campsite | [33.056106, -95.081529 3] | An item or items project more than 4 inches into the circulation path. Wall-mounted objects that have leading edges between 27 inches and 80 inches from the floor must not project more than 4 inches into the circulation path. Protruding objects that extend to the floor or within 27 inches of the floor are cane detectable and are therefore not hazardous. Where it is necessary or desirable to have objects protrude from the wall, a manner of cane detection must be provided. | Cottage 66 - Fire extinguisher projects 4.5" | Relocate protruding objects or place cane detectable warning or bollard at foot of item. | 2015 ABAAS Section: 307.2<br>2012 TAS Section: 307.2<br>2010 ADAS Section: 307.2 | | |

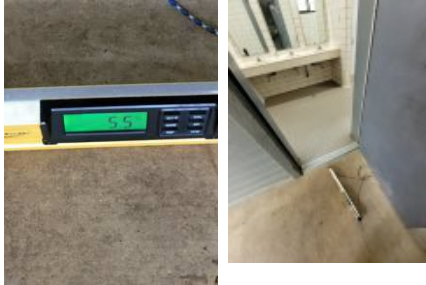
| Finding Number | Area Description | Lat/Long | Finding | As Built | Recommendation | Citation | Photos | Figure |
|---|---|---|--|---|---|--|---|---|
| 250 | Moccasin Track/Broken Bow (MT/BB) Camping Areas: MT/BB - Men's Restroom | [33.0566748 , -95.0815588] | The door does not have a compliant landing. Doors with an approach from the hinge side must have a landing on the pull side that is a minimum of 60 inches in depth perpendicular to the door in a close position by a minimum width dimension of 36 inches plus the door width. The additional 36 inches must extend past the door on the latch side. The entire landing must be free of obstructions and must be flat (2% max. slope is considered flat in any direction). | 5.5% slope pull side | For all doors along the public circulation route, correct or repair slope at doorway landing to max 2.08% in any direction for level CFS. | 2015 ABAAS Section: 404.2.4.1<br><br>2012 TAS Section: 404.2.4.1<br><br>2010 ADAS Section: 404.2.4.1 | | |

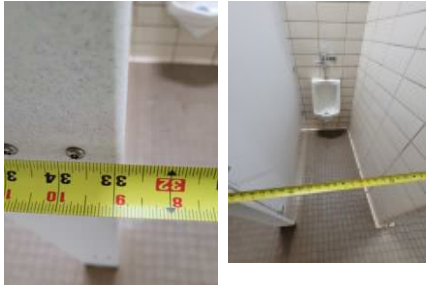
| Finding Number | Area Description | Lat/Long | Finding | As Built | Recommendation | Citation | Photos | Figure |
|---|---|---|--|---|---|--|--|--|
| 255 | Moccasin Track/Broken Bow (MT/BB) Camping Areas: MT/BB - Men's Restroom | [33.0566815 , -95.0815615] | The route of travel at this location does not provide a minimum width of 36 inches. The clear width shall be permitted to be reduced to 32 inches minimum for a length of 24 inches maximum provided that reduced width segments are separated by segments that are 48 inches long minimum and 36 inches wide minimum. | Lacks 36" route to access urinal - 33" wide | Widen AR to compliant 36" clear width. | 2015 ABAAS Section: 403.5.1<br>2012 TAS Section: 403.5.1<br>2010 ADAS Section: 403.5.1 | | |

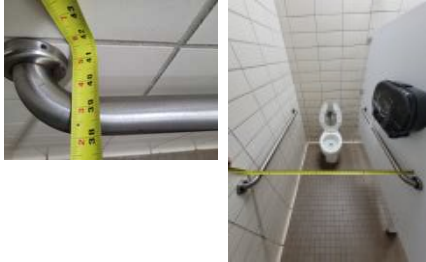
| Finding Number | Area Description | Lat/Long | Finding | As Built | Recommendation | Citation | Photos | Figure |
|---|---|---|--|---|---|--|--|--|
| 257 | Moccasin Track/Broken Bow (MT/BB) Camping Areas: MT/BB - Men's Restroom | [33.0566849 , -95.0815481] | The ambulatory stall is not between 35" to 37" wide and 60" deep. | Stall width - 41.5" | Correct ambulatory stall to be 35" to 37" wide and minimum 60" deep. | 2015 ABAAS Section: 604.8.2.1<br>2012 TAS Section: 604.8.2.1<br>2010 ADAS Section: 604.8.2.1 | | |

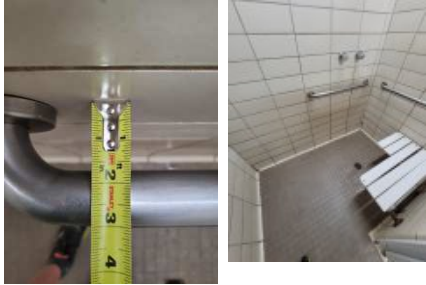
| Finding Number | Area Description | Lat/Long | Finding | As Built | Recommendation | Citation | Photos | Figure |
|---|---|---|--|--|--|---|---|---|
| 269 | Moccasin Track/Broken Bow (MT/BB) Camping Areas: MT/BB - Men's Restroom | [33.0566973 , -95.081564 2] | Grab bars shall be installed in a horizontal position, 33 inches (840 mm) minimum and 36 inches (915 mm) maximum above the finish floor measured to the top of the gripping surface | 1.75" gap between rail and wall, bars do not extend across back of shower | Replace grab bars with ones that provide 1.5" gap and mount to 33" min. and 36" max. AFF to the top of the gripping surface. | 2015 ABAAS Section: 609.3 Exception, 609.4<br><br>2012 TAS Section: 609.4, 609.3 Exception<br><br>2010 ADAS Section: 609.4, 609.3 Exception | | |

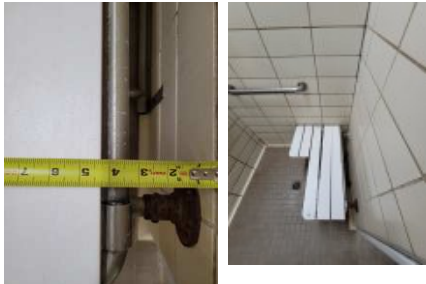
| Finding Number | Area Description | Lat/Long | Finding | As Built | Recommendation | Citation | Photos | Figure |
|---|---|---|--|--|--|---|---|---|
| 270 | Moccasin Track/Broken Bow (MT/BB) Camping Areas: MT/BB - Men's Restroom | [33.0566916 , -95.081554 8] | The shower seat does not have a compliant space between it and the wall. The folding seat must be mounted 17-19 inches above the floor, and have a maximum space of 1-1/2 inches between the edge of the seat and the side wall and 2-1/2 inches maximum to the seat wall. | 4.5" gap at back of seat, 16" to back L from wall, 23.5" to end of L from wall | Remount shower seat to the correct location and height in the shower. | 2015 ABAAS Section: 610.3.2<br><br>2012 TAS Section: 610.3.2<br><br>2010 ADAS Section: 610.3.2 | | |

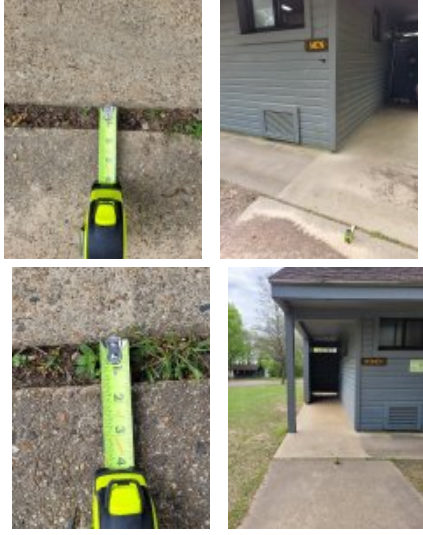
| Finding Number | Area Description | Lat/Long | Finding | As Built | Recommendation | Citation | Photos | Figure |
|---|---|---|--|--|--|--|--|---|
| 272 | Moccasin Track/Broken Bow (MT/BB) Camping Areas: MT/BB - Women's Restroom | [33.056713, -95.08154] | The restroom sign does not comply with one or more applicable requirements for the location, height, and properties of the sign. | Signage lacks symbol of accessibility, lacks Braille, wrong location | Replace sign with one of contrasting colors that includes Braille, raised characters, and the symbol of accessibility and mount on the wall, latch side of the door, 48" to the baseline of the lowest character and 60" to the baseline of the highest character. | <p>2015 ABAAS Section: F216.2, 703.1, 703.2, 703.5, 703.6</p> <p>2012 TAS Section: 216.2, 703.1, 703.2, 703.5, 703.6</p> <p>2010 ADAS Section: 216.2, 703.1, 703.2, 703.5, 703.6</p> | | |

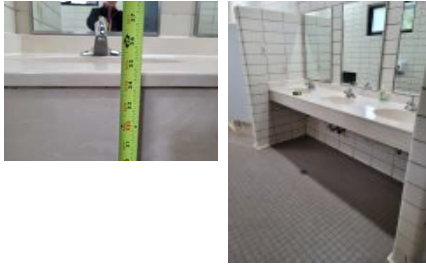
| Finding Number | Area Description | Lat/Long | Finding | As Built | Recommendation | Citation | Photos | Figure |
|---|---|---|--|---|---|--|---|---|
| 273 | Moccasin Track/Broken Bow (MT/BB) Camping Areas: MT/BB - Women's Restroom | [33.0566995, -95.0815427] | The top rim of the sink is too high. All lavatories/sinks that are designated to be accessible shall be a minimum 17 inches in horizontal depth and mounted with the rim or counter edge no higher than 34 inches above the finished floor. | Sink rim at 34.75" AFF | Lower sinks to max 34" above the finished floor (AFF) to front of rim. | 2015 ABAAS Section: 606.3<br>2012 TAS Section: 606.3<br>2010 ADAS Section: 606.3 | | |

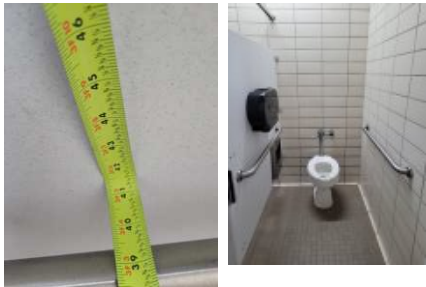
| Finding Number | Area Description | Lat/Long | Finding | As Built | Recommendation | Citation | Photos | Figure |
|---|---|---|--|---|---|--|---|---|
| 276 | Moccasin Track/Broken Bow (MT/BB) Camping Areas: MT/BB - Women's Restroom | [33.056704, -95.0815508] | The ambulatory stall is not between 35" to 37" wide and 60" deep. | ambulatory stall 41.5" width | Correct ambulatory stall to be 35" to 37" wide and minimum 60" deep. | 2015 ABAAS Section: 604.8.2.1<br>2012 TAS Section: 604.8.2.1<br>2010 ADAS Section: 604.8.2.1 | | |

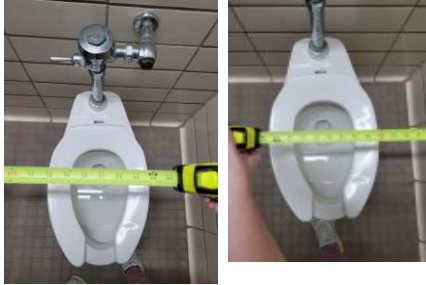
| Finding Number | Area Description | Lat/Long | Finding | As Built | Recommendation | Citation | Photos | Figure |
|---|---|---|---|---|--|--|---|---|
| 277 | Moccasin Track/Broken Bow (MT/BB) Camping Areas: MT/BB - Women's Restroom | [33.0566838, -95.0815588] | The toilet is not located within the range to the side wall or partition. The centerline of the toilet shall be 17 inches minimum and 19 inches maximum side wall or partition in the ambulatory accessible toilet compartment. | TP side 21", tile side 20.5" | Remount toilet to 17" to 19" from the side wall to center line in ambulatory stalls. | 2015 ABAAS Section: 604.9.1<br>2012 TAS Section: 604.9.1<br>2010 ADAS Section: 604.9.1 | | |

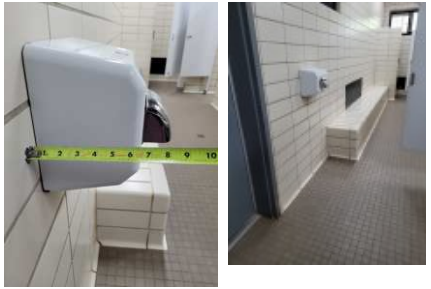
| Finding Number | Area Description | Lat/Long | Finding | As Built | Recommendation | Citation | Photos | Figure |
|---|---|---|---|--|---|---|---|---|
| 280 | Moccasin Track/Broken Bow (MT/BB) Camping Areas: MT/BB - Women's Restroom | [33.056686, -95.0815508] | An item or items project more than 4 inches into the circulation path. Wall-mounted objects that have leading edges between 27 inches and 80 inches from the floor must not project more than 4 inches into the circulation path. Protruding objects that extend to the floor or within 27 inches of the floor are cane detectable and are therefore not hazardous. Where it is necessary or desirable to have objects protrude from the wall, a manner of cane detection must be provided. | Hand dryer projects 8" | Relocate protruding objects or place cane detectable warning or bollard at foot of item. | 2015 ABAAS Section: 307.2<br><br>2012 TAS Section: 307.2<br><br>2010 ADAS Section: 307.2 | | |

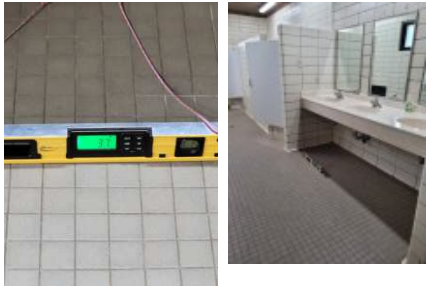
| Finding Number | Area Description | Lat/Long | Finding | As Built | Recommendation | Citation | Photos | Figure |
|---|---|---|---|--|---|---|---|---|
| 281 | Moccasin Track/Broken Bow (MT/BB) Camping Areas: MT/BB - Women's Restroom | [33.056704, -95.0815561] | The accessible route contains running slopes greater than 5 percent and cross slopes greater than 2 percent across the width of the walk and has not been constructed as a ramp (i.e. handrails, wheel guides, etc.). When the slope in the direction of travel of any walk exceeds 1 unit vertical in 20 units horizontal (5-percent slope), it must be constructed as ramp. Surface cross slopes must not exceed one unit vertical in 48 units. Horizontal (2-percent slope). | 3.7% slope at left sink | Correct or repair slope to max 2.08% in restroom. | 2015 ABAAS Section: 403.3<br><br>2012 TAS Section: 403.3<br><br>2010 ADAS Section: 403.3 | | |

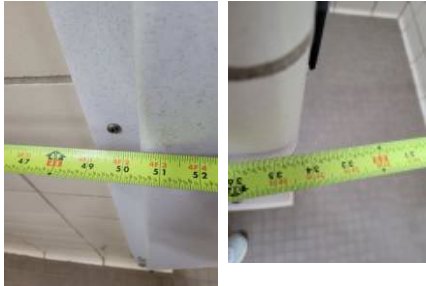
| Finding Number | Area Description | Lat/Long | Finding | As Built | Recommendation | Citation | Photos | Figure |
|---|---|---|--|--|--|---|--|--|
| 283 | Moccasin Track/Broken Bow (MT/BB) Camping Areas: MT/BB - Women's Restroom | [33.0566883 , -95.081561 5] | Alternate roll-in type shower compartments shall be 36 inches (915 mm) wide and 60 inches (1525 mm) deep minimum clear inside dimensions measured at center points of opposing sides. A 36 inch (915 mm) wide minimum entry shall be provided at one end of the long side of the compartment. | shower 49" depth, 34.5" entry | Renovate shower stall, if feasible, to compliant dimensions for an alternate roll in shower of 36" deep by 60" wide with a 36" opening on the long dimension. | 2015 ABAAS Section: 608.2.3<br><br>2012 TAS Section: 608.2.3<br><br>2010 ADAS Section: 608.2.3 | | <p><small>Note: Inside widths do not include thickness of the corner panels of opposing sides.</small></p> |

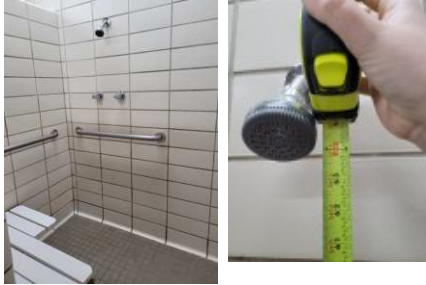
| Finding Number | Area Description | Lat/Long | Finding | As Built | Recommendation | Citation | Photos | Figure |
|---|---|---|--|--|---|--|--|---|
| 286 | Moccasin Track/Broken Bow (MT/BB) Camping Areas: MT/BB - Women's Restroom | [33.056686, -95.081557 5] | There is no hand held sprayer unit. The sprayer unit must have a 59 inches hose and be mounted 48 inches maximum to the top of mounting bracket off the floor. The shower spray unit shall have an on/off control with a non-positive shutoff. If an adjustable-height shower head on a vertical bar is used, the bar shall be installed so as not to obstruct the use of grab bars. | Fixed shower head mounted 64" AFF, lacks hose | Replace shower control with a compliant lever control with a shower head on a 59" hose and usable as hand held; in the alternative, remount fixed shower head to max 48" aff. | 2015 ABAAS Section: 608.6<br>2012 TAS Section: 608.6<br>2010 ADAS Section: 608.6 | | <p><b>SHOWER SPRAY UNIT</b></p> <p>Water Temperature: 120° F Max.</p> <p>Top of mounting bracket: 48" Max. above the shower floor.</p> <p>©Builder's Book, Inc.</p> |
