Access Audit Site Report

Lake Brownwood State Park
200 State Hwy Park Rd 15
Brownwood, TX 76801
Accessibility Evaluation
Inspection Date: 02/28/2022
Inspectors: Tanya Scheibe

Prepared By
WT Group

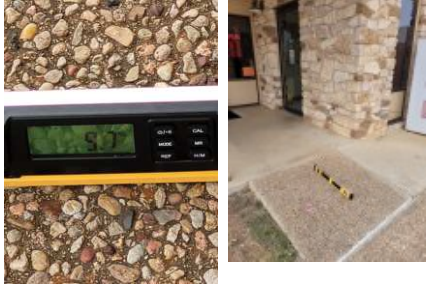
6	Headquarters (HQ) : HQ - Exterior Accessible Route	[31.8569812, -99.028524]	The running slope of walking surfaces shall not be steeper than 1:20.	9.7% slope up to HQ	Correct running slope along the AR to max 5%	2015 ABAAS Section: 403.3 2012 TAS Section: 403.3 2010 ADAS Section: 403.3

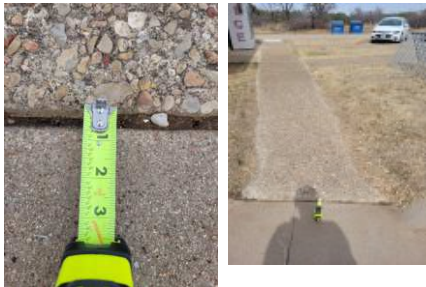
7	Headquarters (HQ) : HQ - Exterior Accessible Route	[31.8569317, -99.0285267]	There is a gap spaced greater than a 1/2 inch. Openings in floor or ground surfaces shall not allow passage of a sphere more than 1/2 inch diameter. Elongated openings shall be placed so that the long dimension is perpendicular to the dominant direction of travel.	1" gap at curb ramp at HQ	Correct or fill gaps to be max .5"	2015 ABAAS Section: 302.3 2012 TAS Section: 302.3 2010 ADAS Section: 302.3

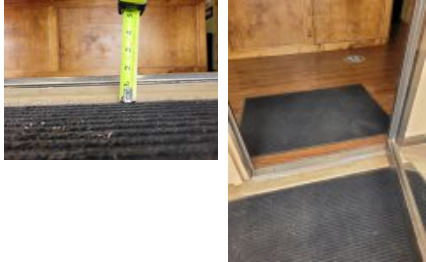
Finding Number	Area Description	Lat/Long	Finding	As Built	Recommendation	Citation	Photos	Figure
10	Headquarters (HQ) : HQ - Public Spaces	[31.8569989 , -99.0285991]	Thresholds, if provided at doorways, shall be 1/2 inch (13 mm) high maximum. Raised thresholds and changes in level at doorways shall comply with 302 and 303. Changes in level of 1/4 inch (6.4 mm) high maximum shall be permitted to be vertical. Changes in level between 1/4 inch (6.4 mm) high minimum and 1/2 inch (13 mm) high maximum shall be beveled with a slope not steeper than 1:2. Changes in level greater than 1/2 inch (13 mm) high shall be ramped, and shall comply with 405 or 406.	main entry door - 1.5" CIL	Repair, bevel or ramp CIL at doorway	2015 ABAAS Section: 303.3, 404.2.5, 303.2, 303.4 2012 TAS Section: 303.3, 404.2.5, 303.2, 303.4 2010 ADAS Section: 303.3, 404.2.5, 303.2, 303.4

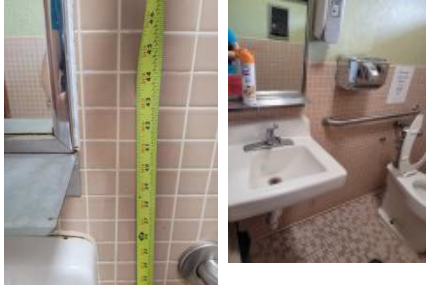
14	Headquarters (HQ) : HQ - Men's Restroom	[31.8570102 , -99.028580 3]	The mirror is mounted too high. Mirrors must have the bottom edge of the reflecting surface a maximum of 40 inches above the floor if above a sink or counter. Mirrors not located above lavatories or countertops shall be installed with the bottom edge of the reflecting surface 35 inches maximum above the finish floor or ground.	mirror 41.5" AFF	Lower mirror so reflective surface is max 40" aff	2015 ABAAS Section: 603.3 2012 TAS Section: 603.3 2010 ADAS Section: 603.3

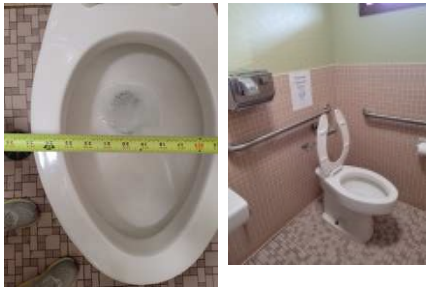
16	Headquarters (HQ) : HQ - Men's Restroom	[31.8570034 , -99.0285937]	The toilet is not located within the range allowed from the side wall or partition. The centerline of the toilet must be 16 to 18 inches from the side wall.	20" centerline	Remount toilets to 16" to 18" from the side wall to centerline	2015 ABAAS Section: 604.2 2012 TAS Section: 604.2 2010 ADAS Section: 604.2

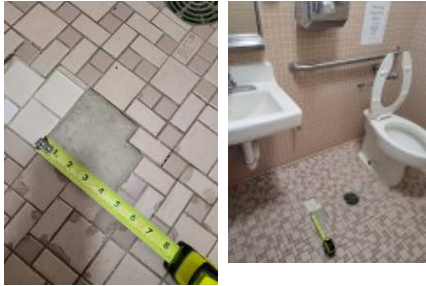
Finding Number	Area Description	Lat/Long	Finding	As Built	Recommendation	Citation	Photos	Figure
20	Headquarters (HQ) : HQ - Men's Restroom	[31.8570011 , -99.0285776]	Openings in floor or ground surfaces shall not allow passage of a sphere more than 1/2 inch (13 mm) diameter except as allowed in 407.4.3, 409.4.3, 410.4, 810.5.3 and 810.10. Elongated openings shall be placed so that the long dimension is perpendicular to the dominant direction of travel.	4.5" gap in front of hand dryer	Fill and maintain gaps to max .5"	2015 ABAAS Section: 302.3 2012 TAS Section: 302.3 2010 ADAS Section: 302.3

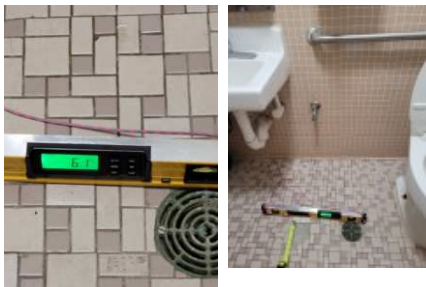
21	Headquarters (HQ) : HQ - Men's Restroom	[31.8570011 , -99.0286018]	The accessible route contains running slopes greater than 5 percent and cross slopes greater than 2 percent across the width of the walk and has not been constructed as a ramp (i.e. handrails, wheel guides, etc.). When the slope in the direction of travel of any walk exceeds 1 unit vertical in 20 units horizontal (5-percent slope), it must be constructed as ramp. Surface cross slopes must not exceed one unit vertical in 48 units. Horizontal (2-percent slope).	6.1% cross slope by drain	Correct or repair slope to max 2.08% in restroom.	2015 ABAAS Section: 403.3 2012 TAS Section: 403.3 2010 ADAS Section: 403.3

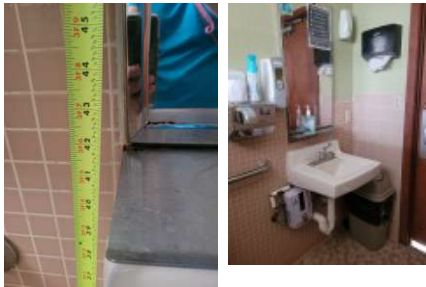
22	Headquarters (HQ) : HQ - Women's Restroom	[31.8570011 , -99.0286018]	The mirror is mounted too high. Mirrors must have the bottom edge of the reflecting surface a maximum of 40 inches above the floor if above a sink or counter. Mirrors not located above lavatories or countertops shall be installed with the bottom edge of the reflecting surface 35 inches maximum above the finish floor or ground.	mirror 42.5" AFF	Lower mirror so reflective surface is max 40" aff	2015 ABAAS Section: 603.3 2012 TAS Section: 603.3 2010 ADAS Section: 603.3

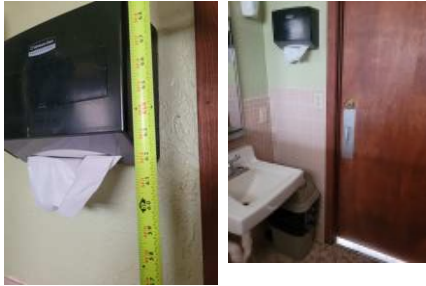
Finding Number	Area Description	Lat/Long	Finding	As Built	Recommendation	Citation	Photos	Figure
23	Headquarters (HQ) : HQ - Women's Restroom	[31.8570034, -99.0285857]	Where a high forward reach is over an obstruction, the clear floor space shall extend beneath the element for a distance not less than the required reach depth over the obstruction. The high forward reach shall be 48 inches (1220 mm) maximum where the reach depth is 20 inches (510 mm) maximum. Where the reach depth exceeds 20 inches (510 mm), the high forward reach shall be 44 inches (1120 mm) maximum and the reach depth shall be 25 inches (635 mm) maximum. Where a clear floor or ground space allows a parallel approach to an element and the high side reach is over an obstruction, the height of the obstruction shall be 34 inches (865 mm) maximum and the depth of the obstruction shall be 24 inches (610 mm) maximum. The high side reach shall be 48 inches (1220 mm) maximum for a reach depth of 10 inches (255 mm) maximum. Where the reach depth exceeds 10 inches (255 mm), the high side reach shall be 46 inches (1170 mm) maximum for a reach depth of 24 inches (610 mm) maximum.	paper towels 60" AFF	Lower operating mechanisms to max 48" above the finished floor (AFF) to highest operable part.	2015 ABAAS Section: 308.2.1, 308.3.2 2012 TAS Section: 308.2.1, 308.3.2 2010 ADAS Section: 308.2.1, 308.3.2

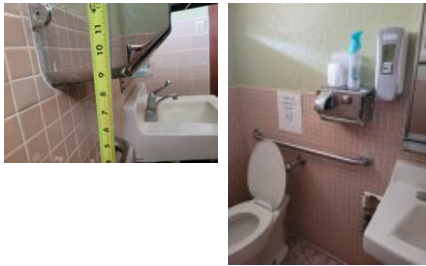
24	Headquarters (HQ) : HQ - Women's Restroom	[31.857008, -99.0286045]	The grab bar height and/or spacing fails. Grab bars must be mounted between 33" and 36" to the top of the gripping surface. There must be 1.5" of clearance between the grab bar and the wall. There must be a minimum of 1.5" of clearance below and minimum 12" above the grab bar to any dispenser or other obstruction.	hand dryer 9" above rear grab bar	Remount hand dryer 15" to 48" above the finished floor (AFF) and min 12" above or 1.5" below grab bar.	2015 ABAAS Section: 609.3, 609.4 2012 TAS Section: 609.4, 609.3 2010 ADAS Section: 609.3, 609.4

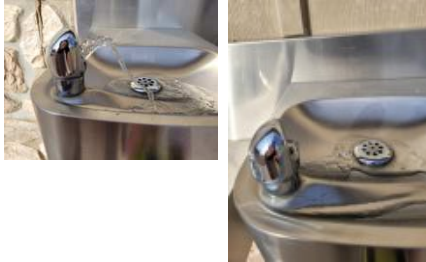
Finding Number	Area Description	Lat/Long	Finding	As Built	Recommendation	Citation	Photos	Figure
32	Park Site: Park Elements	[31.862947, -99.0244309]	The water flow from the spout is too low. The spout shall provide a flow of water 4 inches high minimum.	Willow Point restroom fountain - less than 4"	Adjust spout flow height to min. 4".	2015 ABAAS Section: 602.6 2012 TAS Section: 602.6 2010 ADAS Section: 602.6

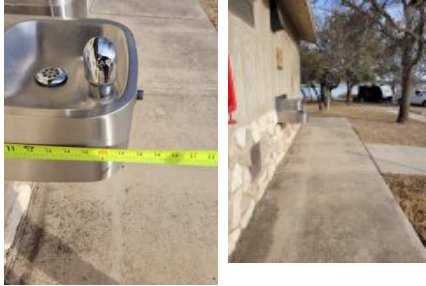
33	Park Site: Park Elements	[31.8629202, -99.0244484]	An item or items project more than 4 inches into the circulation path. Wall-mounted objects that have leading edges between 27 inches and 80 inches from the floor must not project more than 4 inches into the circulation path. Protruding objects that extend to the floor or within 27 inches of the floor are cane detectable and are therefore not hazardous. Where it is necessary or desirable to have objects protrude from the wall, a manner of cane detection must be provided.	Willow Point restroom fountain - projects 17.5" into the pedestrian way	Relocate protruding objects or place cane detectable warning or bollard at foot of item	2015 ABAAS Section: 307.2 2012 TAS Section: 307.2 2010 ADAS Section: 307.2

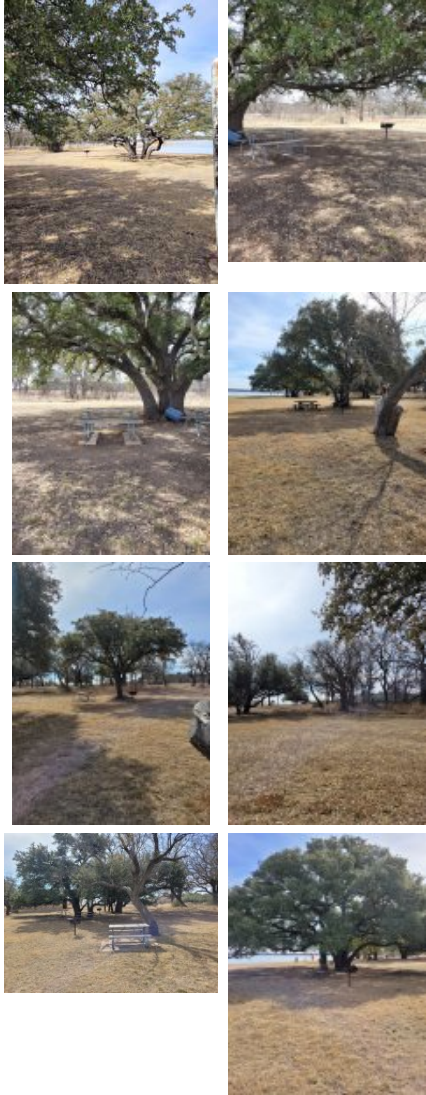
Finding Number	Area Description	Lat/Long	Finding	As Built	Recommendation	Citation	Photos	Figure
34	Park Site: Park Elements	[31.8611861 , -99.021636 1]	There is no accessible route to the picnic area. At least one accessible route shall connect accessible buildings, accessible facilities, accessible elements, and accessible spaces that are on the same site.	0 of 28 grills and picnic tables at day use area on an accessible route	Create an accessible route with crushed stone or other outdoor material from parking or walkway to 20% of the picnic areas as a smart practice	2015 ABAAS Section: F206.2.2 2012 TAS Section: 206.2.2 2010 ADAS Section: 206.2.2

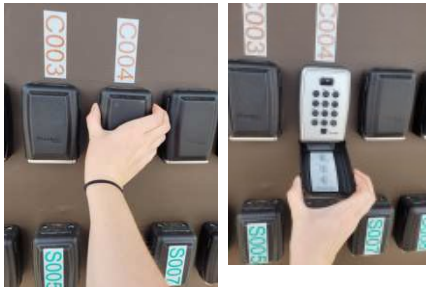
38	Park Site: Park Elements	[31.856967, -99.0281726]	The operable part is not accessible because it requires tight grasping, pinching or twisting of the wrist.	after hour key box openings require tight pinch	Replace operable part with ones usable without a tight pinch or grasp	2015 ABAAS Section: 309.4 2012 TAS Section: 309.4 2010 ADAS Section: 309.4

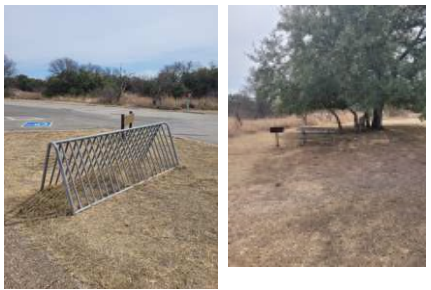
Finding Number	Area Description	Lat/Long	Finding	As Built	Recommendation	Citation	Photos	Figure
39	Park Site: Park Elements	[31.8569539 , -99.0284569]	There is no accessible route to the bike rack, grill, table, and bench. At least one accessible route shall connect accessible buildings, accessible facilities, accessible elements, and accessible spaces that are on the same site.	At HQ - No AR to bike rack, grill, table, bench	Create an accessible route with crushed stone or other outdoor material from parking or walkway to bike rack, grill, table, and bench.	2015 ABAAS Section: F206.2.2 2012 TAS Section: 206.2.2 2010 ADAS Section: 206.2.2

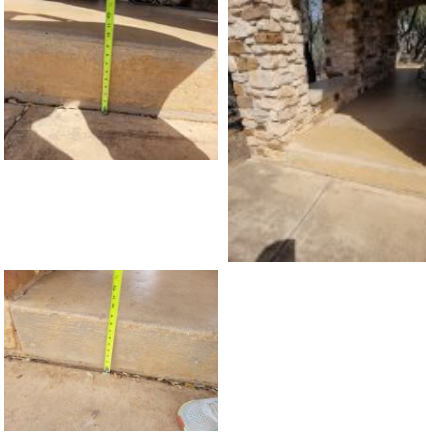
Finding Number	Area Description	Lat/Long	Finding	As Built	Recommendation	Citation	Photos	Figure
49	Park Site: Shelters	[31.8590378 , -99.029576 8]	Picnic facilities shall provide outdoor recreation access routes complying with 1016 in accordance with F245.4 and 245.4 of IAC	Council Bluff shelter - no AR to shelter due to 8.5" CIL on both sides	Create ORAR with crushed and compacted stone or similar outdoor material from parking or sidewalk to shelter or picnic area	2015 ABAAS Section: F245.4

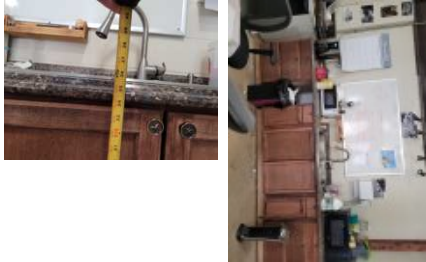
Finding Number	Area Description	Lat/Long	Finding	As Built	Recommendation	Citation	Photos	Figure
53	Employee Areas: Maintenance	[31.856443, -99.019629 8]	The top rim of the sink is too high. All lavatories/sinks that are designated to be accessible shall be a minimum 17 inches in horizontal depth and mounted with the rim or counter edge no higher than 34 inches above the finished floor.	break room- sink 36" AFF	Lower sinks to max 34" above the finished floor (AFF) to front of rim.	2015 ABAAS Section: 606.3 2012 TAS Section: 606.3 2010 ADAS Section: 606.3

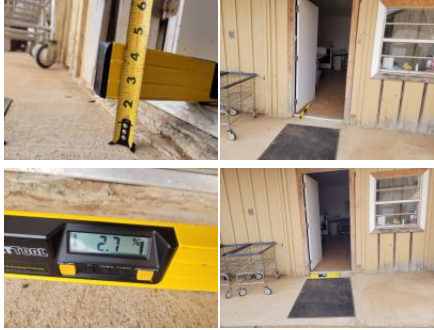
59	Employee Areas: Maintenance	[31.85635, -99.01966]	Minimum maneuvering clearances at doors and gates shall comply with 404.2.4. Maneuvering clearances shall extend the full width of the doorway and the required latch side or hinge side clearance. Maneuvering clearances shall have a max slope of 2.08%. The threshold has a vertical change greater than 1/4 inch high. Hand-activated door opening hardware, handles, pulls, latches, locks, and other operating devices on accessible doors shall have a shape that is easy to grasp with one hand and does not require tight grasping, tight pinching or twisting of the wrist to operate. Hardware shall be 34 inches minimum and 48 inches maximum above the finish floor or ground.	laundry- 2" CIL, knob, 2.7% slope	For all doors along the public circulation route, correct slope in door clearance to max 2.08%. For all doors along the public circulation route, repair, bevel, or ramp CILs at door entries to max .25". For all doors along the public circulation route, replace hardware with lever hardware or hardware operable without a tight pinch or grasp.	2010 ADAS Section: 404.2.3, 404.2.7, 404.2.4, 404.2.11, 404.2.11 Exception

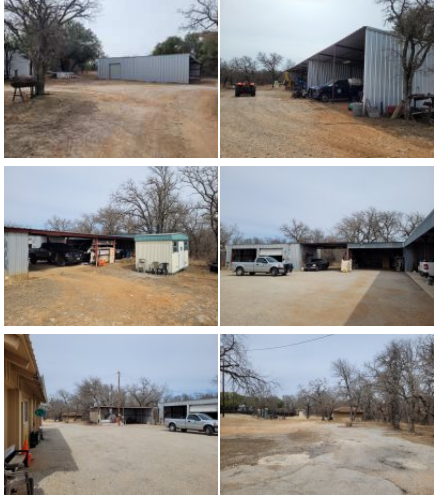
61	Employee Areas: Maintenance	[31.8563053, -99.0196229]	There is no accessible route between the buildings. At least one accessible route shall connect accessible buildings, facilities, elements and spaces that are on the same site.	no AR to maintenance buildings	Create AR with crushed and compacted stone or similar outdoor material from building to building within the site	2015 ABAAS Section: F206.2.2 2012 TAS Section: 206.2.2 2010 ADAS Section: 206.2.2

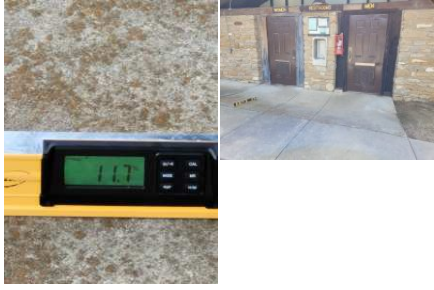
Finding Number	Area Description	Lat/Long	Finding	As Built	Recommendation	Citation	Photos	Figure
71	Council Bluff (CB) Area: CB - Exterior Accessible Route	[31.8586813 , -99.029187 8]	The running slope of walking surfaces shall not be steeper than 1:20.	11.7% slope outside of men's and women's restrooms at Council Bluff loop	Correct running slope along the AR to max 5%	2015 ABAAS Section: 403.3 2012 TAS Section: 403.3 2010 ADAS Section: 403.3

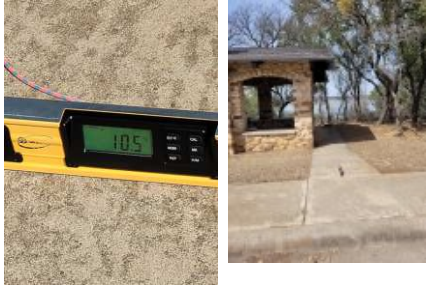
72	Council Bluff (CB) Area: CB - Exterior Accessible Route	[31.8590577 , -99.029525 8]	The running slope of walking surfaces shall not be steeper than 1:20.	10.5% slope on path to shelter at Council Bluff	Correct running slope along the AR to max 5%	2015 ABAAS Section: 403.3 2012 TAS Section: 403.3 2010 ADAS Section: 403.3

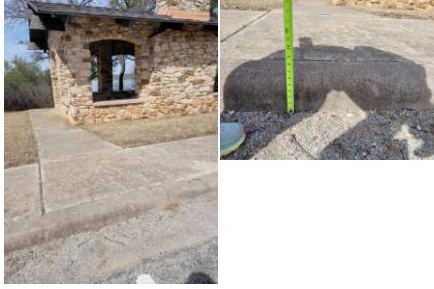
73	Council Bluff (CB) Area: CB - Exterior Accessible Route	[31.8589757 , -99.029541 2]	Changes in level greater than 1/2 inch (13 mm) high shall be ramped, and shall comply with 405 or 406.	lacks curb ramp to shelter by Council Bluff	Create a curb ramp to be max running slope 8.33%, max cross slope 2.08%, having a top landing as wide as the ramp and 36" deep and side flares with a max slope 10% along the AR where curbs are present.	2015 ABAAS Section: 303.4 2012 TAS Section: 303.4 2010 ADAS Section: 303.4

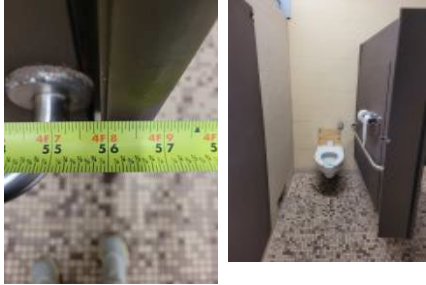
Finding Number	Area Description	Lat/Long	Finding	As Built	Recommendation	Citation	Photos	Figure
81	Council Bluff (CB) Area: CB - Men's Restroom	[31.8586255 , -99.029189 2]	The ambulatory stall is not between 35" to 37" wide and 60" deep.	ambulatory stall 56" deep	Correct ambulatory stall to be 35" to 37" wide and minimum 60" deep	2015 ABAAS Section: 604.8.2.1 2012 TAS Section: 604.8.2.1 2010 ADAS Section: 604.8.2.1

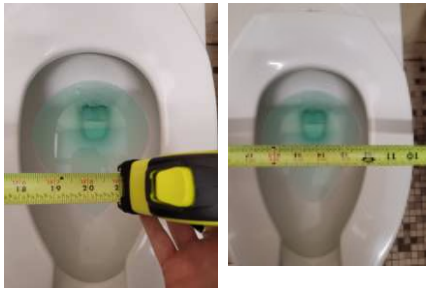
82	Council Bluff (CB) Area: CB - Men's Restroom	[31.8586437 , -99.029199 9]	The toilet is not located within the range to the side wall or partition. The centerline of the toilet shall be 17 inches minimum and 19 inches maximum side wall or partition in the ambulatory accessible toilet compartment.	20" centerline from tile wall, 14.5" from partition	Remount toilet to 17" to 19" from the side wall to center line in ambulatory stalls	2015 ABAAS Section: 604.9.1 2012 TAS Section: 604.9.1 2010 ADAS Section: 604.9.1

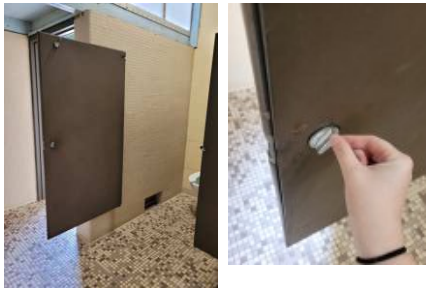
83	Council Bluff (CB) Area: CB - Men's Restroom	[31.85863, -99.029181 1]	The stall door fails to comply with all of the door requirements. The stall door must be a minimum of 32" wide and have compliant hardware on both sides. The stall door must be self-closing.	not self closing, requires pinch to shut	Adjust stall door to be self-closing Replace stall hardware with hardware operable without a tight pinch or grasp on both sides of the stall door	2015 ABAAS Section: 404.2.3, 404.2.7, 604.8.2.2 2012 TAS Section: 404.2.3, 404.2.7, 604.8.2.2 2010 ADAS Section: 404.2.3, 404.2.7, 604.8.2.2

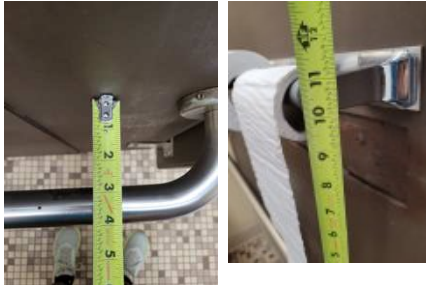
85	Council Bluff (CB) Area: CB - Men's Restroom	[31.85863, -99.0291892]	The grab bar height and/or spacing fails. Grab bars must be mounted between 33" and 36" to the top of the gripping surface. There must be 1.5" of clearance between the grab bar and the wall. There must be a minimum of 1.5" of clearance below and minimum 12" above the grab bar to any dispenser or other obstruction.	3" grab bar clearance. 9.5" toilet pper	Replace grab bar with 42" long bar mounted max 12" from the wall on close end and extending 54" from rear wall on far end, with 1.5" gap between bar and partition. Remount toilet paper dispenser max 7" to 9" from front of toilet, 15" to 48" above the finished floor (AFF) and min 12" above or 1.5" below grab bar.	2015 ABAAS Section: 609.3, 609.4 2012 TAS Section: 609.4, 609.3 2010 ADAS Section: 609.3, 609.4

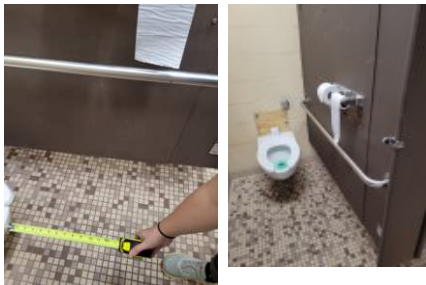
86	Council Bluff (CB) Area: CB - Men's Restroom	[31.8586414, -99.0291865]	The toilet paper is not installed within the compliant range in front of the toilet. Toilet paper dispensers shall be 7 inches minimum and 9 inches maximum in front of the water closet measured to the centerline of the dispenser. The outlet of the dispenser shall be 15 inches minimum and 48 inches maximum above the finish floor and shall not be located behind grab bars. Dispensers shall not be of a type that controls delivery or that does not allow continuous paper flow. There shall be a clearance of 1 1/2 inches minimum below the grab bar.	tp too far from front of toilet	Remount toilet paper dispenser max 7" to 9" from front of toilet, 15" to 48" aff and min 12" above or 1.5" below grab bar	2015 ABAAS Section: 604.7 2012 TAS Section: 604.7 2010 ADAS Section: 604.7

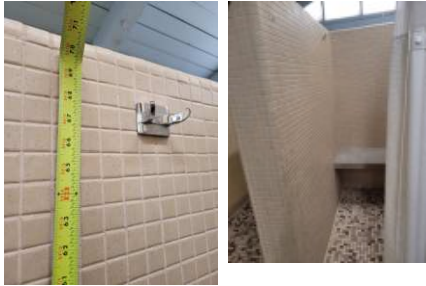
Finding Number	Area Description	Lat/Long	Finding	As Built	Recommendation	Citation	Photos	Figure
87	Council Bluff (CB) Area: CB - Women's Restroom	[31.8586255 , -99.029186 5]	Coat hooks provided within the room shall be located within one of the reach ranges specified in 308. Shelves shall be 40 inches (1015 mm) minimum and 48 inches (1220 mm) maximum above the finish floor or ground. Where coat hooks or shelves are provided in dressing, fitting or locker rooms without individual compartments, at least one of each type shall comply with 803.5. Where coat hooks or shelves are provided in individual compartments at least one of each type complying with 803.5 shall be provided in individual compartments in dressing, fitting, or locker rooms required to comply with 222.1.	hooks 67" AFF	Remount at least one hook to max 48" aff and shelves to 40" - 48" AFF.	2015 ABAAS Section: 308.2.1, 308.1, F222.2, 803.5 2012 TAS Section: 308.2.1, 308.1, 222.2, 803.5 2010 ADAS Section: 308.2.1, 308.1, 222.2, 803.5

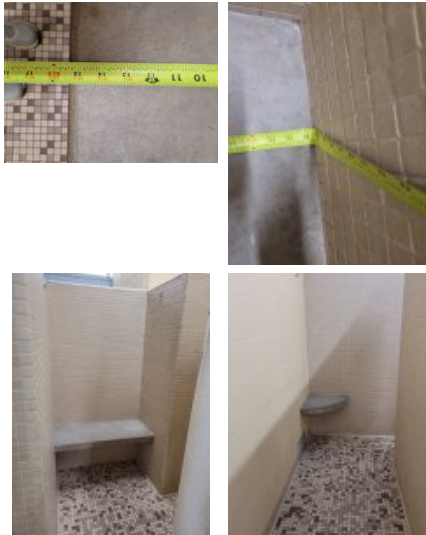
88	Council Bluff (CB) Area: CB - Women's Restroom	[31.8586334 , -99.029197 2]	The bench is not deep enough or long enough or is missing. Benches shall be provided having seats that are 42 inches long minimum and 20 inches deep minimum and 24 inches deep maximum. The bench shall provide for back support or shall be affixed to a wall. Back support shall be 42 inches (1065 mm) long minimum and shall extend from a point 2 inches (51 mm) maximum above the seat surface to a point 18 inches (455 mm) minimum above the seat surface. Back support shall be 2½ inches (64 mm) maximum from the rear edge of the seat measured horizontally. The top of the bench seat surface shall be 17 inches (430 mm) minimum and 19 inches (485 mm) maximum above the finish floor or ground. Clear floor or ground space complying with 305 shall be provided and shall be positioned at the end of the bench seat and parallel to the short axis of the bench	15.5" depth by 35.5" width, corner bench non compliant	Replace bench in dressing area with one having a seat depth of 20" to 24" deep, 42" long, affixed to the wall or having a back and mounted 17" to 19" aff and provide required clear floor space on the short axis of the bench.	2012 TAS Section: 903.4, 903.2, 903.3, 903.5 2010 ADAS Section: 903.4, 903.2, 903.3, 903.5

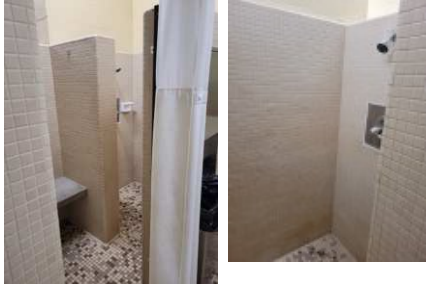
Finding Number	Area Description	Lat/Long	Finding	As Built	Recommendation	Citation	Photos	Figure
89	Council Bluff (CB) Area: CB - Women's Restroom	[31.8586323 , -99.029199 9]	There are no accessible bathing or shower facilities. Where facilities for bathing are provided for the public, clients or employees, including showers or bathtubs, at least one shower or bathtub and support facilities such as lockers, and not less than 1 percent of all facilities, shall be accessible.	2 standard showers, 0 accessible	Create an accessible shower in locker/bathing room.	2015 ABAAS Section: F213.3.6 2012 TAS Section: 213.3.6 2010 ADAS Section: 213.3.6

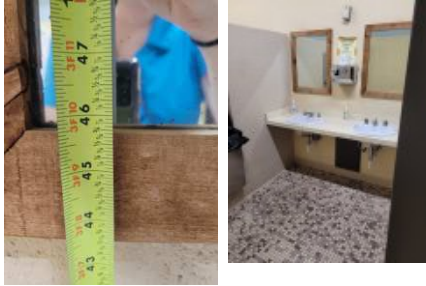
90	Council Bluff (CB) Area: CB - Women's Restroom	[31.8586243 , -99.029193 2]	The mirror is mounted too high. Mirrors must have the bottom edge of the reflecting surface a maximum of 40 inches above the floor if above a sink or counter. Mirrors not located above lavatories or countertops shall be installed with the bottom edge of the reflecting surface 35 inches maximum above the finish floor or ground.	mounted 46" AFF	Lower mirror so reflective surface is max 40" aff.	2015 ABAAS Section: 603.3 2012 TAS Section: 603.3 2010 ADAS Section: 603.3

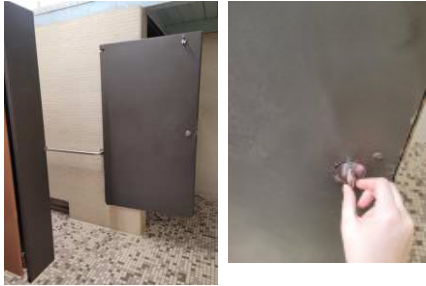
Finding Number	Area Description	Lat/Long	Finding	As Built	Recommendation	Citation	Photos	Figure
95	Council Bluff (CB) Area: CB - Women's Restroom	[31.85863, -99.029178 5]	The stall door fails to comply with all of the door requirements. The stall door must be a minimum of 32" wide and have compliant hardware on both sides. The stall door must be self-closing.	not self closing, requires tight pinch to close	Adjust stall door to be self-closing. Replace stall hardware with hardware operable without a tight pinch or grasp on both sides of the stall door.	2015 ABAAS Section: 404.2.3, 404.2.7, 604.8.2.2 2012 TAS Section: 404.2.3, 404.2.7, 604.8.2.2 2010 ADAS Section: 404.2.3, 404.2.7, 604.8.2.2

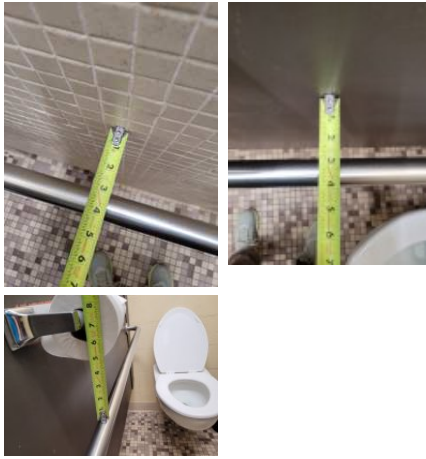
96	Council Bluff (CB) Area: CB - Women's Restroom	[31.8586346 , -99.029189 2]	The grab bar height and/or spacing fails. Grab bars must be mounted between 33" and 36" to the top of the gripping surface. There must be 1.5" of clearance between the grab bar and the wall. There must be a minimum of 1.5" of clearance below and minimum 12" above the grab bar to any dispenser or other obstruction.	3" clearance between grab bars and walls, toilet paper is 5" above grab bar	Replace grab bar with one providing 1.5" clearance between grab bar and wall. Remount toilet paper to provide 1.5" of clearance below and minimum 12" above the grab bar.	2015 ABAAS Section: 609.3, 609.4 2012 TAS Section: 609.4, 609.3 2010 ADAS Section: 609.3, 609.4

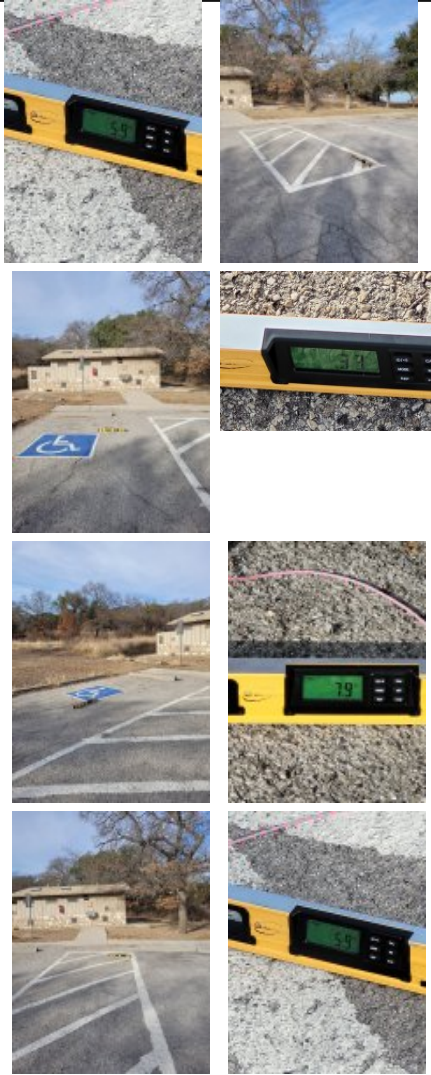
107	Willow Point (WP) Area: WP - Parking	[31.861841, -99.025745 2]	The cross slopes (narrow dimension) and/or running slopes (long dimension) of the access aisle exceeds 2%. The running slope and the cross slope in an accessible parking stall and the access aisle must not exceed 2%.	WP restroom building by site 10, stall - 3% slope, 3.3% slope. access aisle - 7.9% slope, 5.9% slope	Repair or correct slope of parking space and access aisle to max 2.08% in any direction.	2015 ABAAS Section: 502.4 2012 TAS Section: 502.4 2010 ADAS Section: 502.4

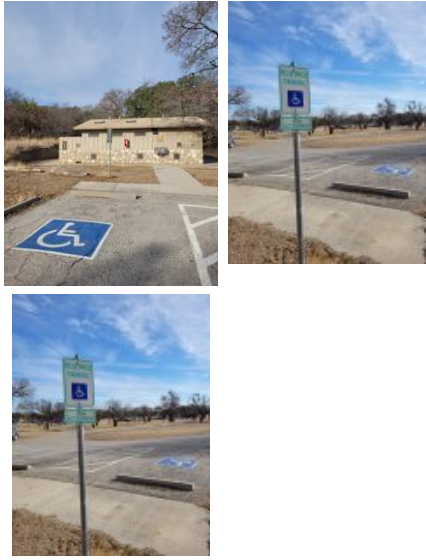
109	Willow Point (WP) Area: WP - Parking	[31.8618513, -99.0257506]	The accessible parking stall signage is incorrect and/or missing from each accessible parking space. Parking space identification signs shall include the International Symbol of Accessibility. Signs identifying van parking spaces shall contain the designation "van accessible." Signs shall be 60 inches minimum above the finish floor or ground surface measured to the bottom of the sign.	WP restroom building by site 10 - signage is here but facing wrong direction, won't rotate	Remount signage to min 60" above parking surface and facing parking stall	2015 ABAAS Section: 502.6 2012 TAS Section: 502.6

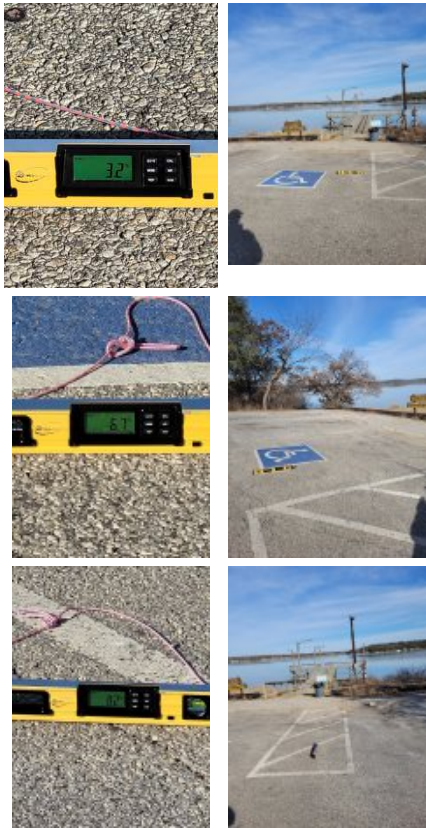
111	Willow Point (WP) Area: WP - Parking	[31.8622932 , -99.026676]	The cross slopes (narrow dimension) and/or running slopes (long dimension) of the access aisle exceeds 2%. The running slope and the cross slope in an accessible parking stall and the access aisle must not exceed 2%.	fishing pier/ fish cleaning near WP, stall - 3.2% slope, 6.7% slope. access aisle - 8.2% slope, 5.1% slope	Repair or correct slope of parking space and access aisle to max 2.08% in any direction.	2015 ABAAS Section: 502.4 2012 TAS Section: 502.4 2010 ADAS Section: 502.4

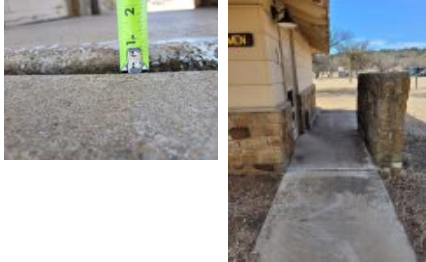
Finding Number	Area Description	Lat/Long	Finding	As Built	Recommendation	Citation	Photos	Figure
122	Willow Point (WP) Area: WP - Exterior Accessible Route	[31.8629675 , -99.024479 2]	The walkway contains abrupt vertical edges and/or variations over a 1/4 inch. 1/4 inch is the maximum vertical rise. Changes in level between 1/4 inch and 1/2 inch must be beveled at 1:2 or less. Changes in level greater than 1/2 inch must be by way of a ramp.	men's WP by site 20 Restroom entry 1.5" CIL	Repair, bevel or ramp CIL along AR	2012 TAS Section: 303.2, 303.3 2010 ADAS Section: 303.2, 303.3

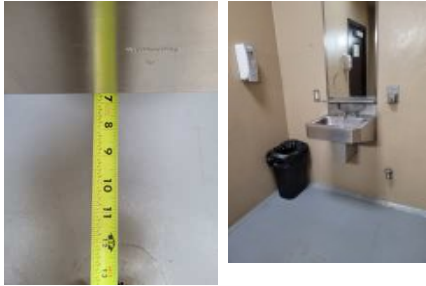
Finding Number	Area Description	Lat/Long	Finding	As Built	Recommendation	Citation	Photos	Figure
130	Willow Point (WP) Area: WP - Men's Restroom (near site 10)	[31.8618216 , -99.025882]	Knee clearance at 27 inches off the floor is not 8 inches minimum deep. The knee clearance, measured from the bottom of the apron or the outside bottom edge of the lavatory, must be 27 inches at a point located 8 inches back from the front edge and continuing to 11 inches minimum in depth at 9 inches above the floor. The top of the lavatory rim may be no higher than 34 inches.	7" deep knee clearance	Replace sink with one providing 27" knee clearance that is a min 8" deep.	2015 ABAAS Section: 306.3.1, 306.3.2, 306.3.3, 306.3.4 , 306.3.5 2012 TAS Section: 306.3.2, 306.3.3, 306.3.4, 306.3.5, 306.3.1 2010 ADAS Section: 306.3.3, 306.3.2, 306.3.4, 306.3.5, 306.3.1

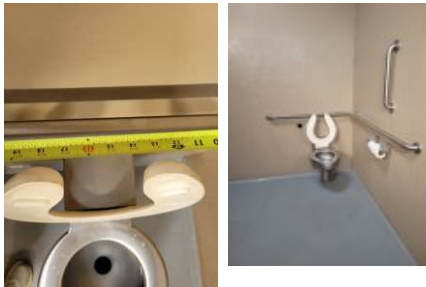
131	Willow Point (WP) Area: WP - Men's Restroom (near site 10)	[31.8618148 , -99.0258686]	The rear grab bar is not 36" long or is not mounted in the correct location. The rear grab bar must be a minimum of 36" long and extend from the toilet centerline a minimum 12" towards the wall side and a minimum 24" towards the open side of the toilet. Grab bars shall be installed in a horizontal position, 33 inches minimum and 36 inches maximum above the finish floor measured to the top of the gripping surface and the space between the grab bar and the top of the tank shall be 1-1/2 inches minimum.	rear bar 15" at toilet centerline, lacks 24" to open side	Remount rear grab bar to behind the toilet, 12" to one side of center and 24" to the other and 33" to 36" aff.	2015 ABAAS Section: 604.5.2 2012 TAS Section: 604.5.2 2010 ADAS Section: 604.5.2

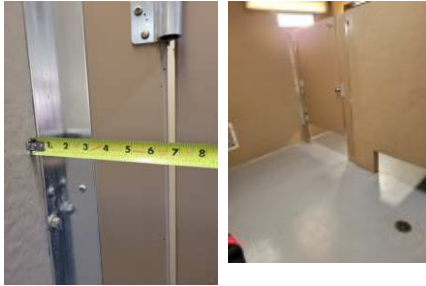
Finding Number	Area Description	Lat/Long	Finding	As Built	Recommendation	Citation	Photos	Figure
132	Willow Point (WP) Area: WP - Men's Restroom (near site 10)	[31.8618285, -99.025874]	The compartment door is located too far from the partition or wall. The door shall be located in front of the clear space and diagonal to the water closet. Where located in the front partition, the door opening shall be 4 inches maximum from the side wall or partition farthest from the water closet. Where located in the side wall or partition, the door opening shall be 4 inches maximum from the front partition. Toilet compartment doors shall not swing into the minimum required compartment area.	6.5" partition	Rehang stall door to be max 4" from adjacent stall partition and on the stall wall farthest from the toilet	2015 ABAAS Section: 604.8.1.2 2012 TAS Section: 604.8.1.2 2010 ADAS Section: 604.8.1.2

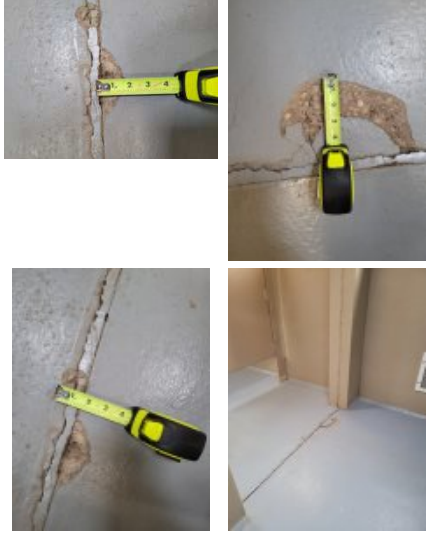
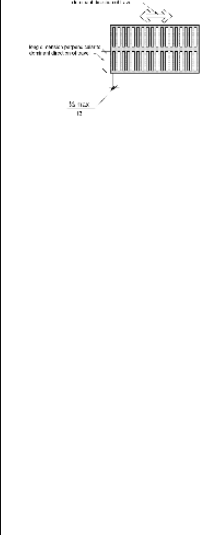
133	Willow Point (WP) Area: WP - Men's Restroom (near site 10)	[31.8618285, -99.0258901]	Openings in floor or ground surfaces shall not allow passage of a sphere more than 1/2 inch (13 mm) diameter except as allowed in 407.4.3, 409.4.3, 410.4, 810.5.3 and 810.10. Elongated openings shall be placed so that the long dimension is perpendicular to the dominant direction of travel.	gaps - 1.5", 1.5", 4"	Fill and maintain gaps to max .5"	2015 ABAAS Section: 302.3 2012 TAS Section: 302.3 2010 ADAS Section: 302.3

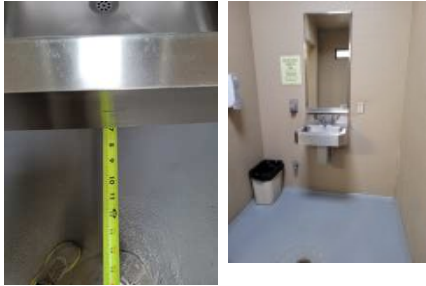
Finding Number	Area Description	Lat/Long	Finding	As Built	Recommendation	Citation	Photos	Figure
135	Willow Point (WP) Area: WP - Women's Restroom (near site 10)	[31.8618285 , -99.025879 3]	Knee clearance at 27 inches off the floor is not 8 inches minimum deep. The knee clearance, measured from the bottom of the apron or the outside bottom edge of the lavatory, must be 27 inches at a point located 8 inches back from the front edge and continuing to 11 inches minimum in depth at 9 inches above the floor. The top of the lavatory rim may be no higher than 34 inches.	7" knee clearance	Replace sink with one providing 27" knee clearance that is a min 8" deep.	2015 ABAAS Section: 306.3.1, 306.3.2, 306.3.3, 306.3.4 , 306.3.5 2012 TAS Section: 306.3.2, 306.3.3, 306.3.4, 306.3.5, 306.3.1 2010 ADAS Section: 306.3.3, 306.3.2, 306.3.4, 306.3.5, 306.3.1

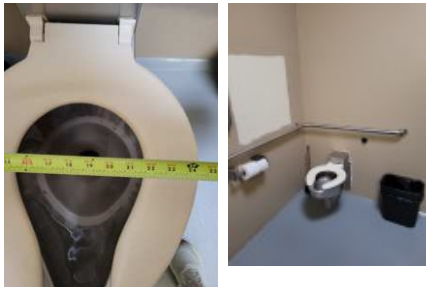
136	Willow Point (WP) Area: WP - Women's Restroom (near site 10)	[31.8618216 , -99.025884 7]	The toilet is not located within the range allowed from the side wall or partition. The centerline of the toilet must be 16 to 18 inches from the side wall.	19" centerline	Remount toilets to 16" to 18" from the side wall to centerline.	2015 ABAAS Section: 604.2 2012 TAS Section: 604.2 2010 ADAS Section: 604.2

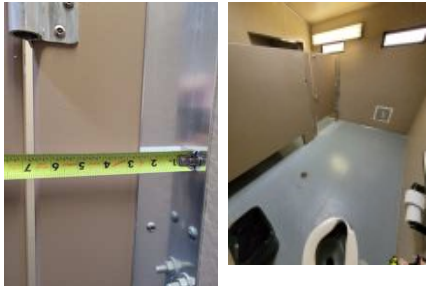
138	Willow Point (WP) Area: WP - Women's Restroom (near site 10)	[31.8618194 , -99.025884 7]	The compartment door is located too far from the partition or wall. The door shall be located in front of the clear space and diagonal to the water closet. Where located in the front partition, the door opening shall be 4 inches maximum from the side wall or partition farthest from the water closet. Where located in the side wall or partition, the door opening shall be 4 inches maximum from the front partition. Toilet compartment doors shall not swing into the minimum required compartment area.	6.5" from wall	Rehang stall door to be max 4" from adjacent stall partition and on the stall wall farthest from the toilet.	2015 ABAAS Section: 604.8.1.2 2012 TAS Section: 604.8.1.2 2010 ADAS Section: 604.8.1.2

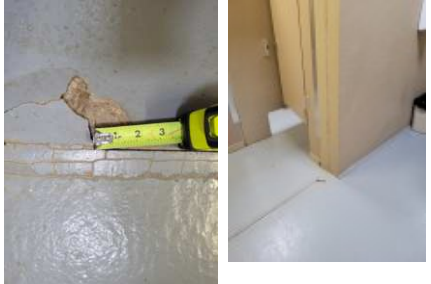
139	Willow Point (WP) Area: WP - Women's Restroom (near site 10)	[31.8618239 , -99.025874]	Openings in floor or ground surfaces shall not allow passage of a sphere more than 1/2 inch (13 mm) diameter except as allowed in 407.4.3, 409.4.3, 410.4, 810.5.3 and 810.10. Elongated openings shall be placed so that the long dimension is perpendicular to the dominant direction of travel.	2" gap by standard stall	Fill and maintain gaps to max .5"	2015 ABAAS Section: 302.3 2012 TAS Section: 302.3 2010 ADAS Section: 302.3

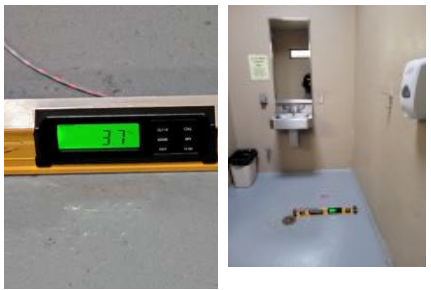
Finding Number	Area Description	Lat/Long	Finding	As Built	Recommendation	Citation	Photos	Figure
140	Willow Point (WP) Area: WP - Women's Restroom (near site 10)	[31.8618262 , -99.025887 4]	The accessible route contains running slopes greater than 5 percent and cross slopes greater than 2 percent across the width of the walk and has not been constructed as a ramp (i.e. handrails, wheel guides, etc.). When the slope in the direction of travel of any walk exceeds 1 unit vertical in 20 units horizontal (5-percent slope), it must be constructed as ramp. Surface cross slopes must not exceed one unit vertical in 48 units. Horizontal (2-percent slope).	3.7% cross slope at sink	Correct or repair slope to max 5% running and 2.08% cross.	2015 ABAAS Section: 403.3 2012 TAS Section: 403.3 2010 ADAS Section: 403.3

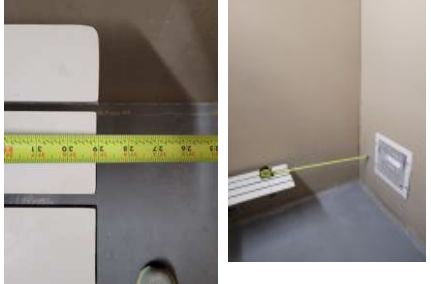
142	Willow Point (WP) Area: WP - Accessible Shower	[31.8618239 , -99.025876 7]	The clearance in front of the shower is not compliant. A 30 inch wide minimum by 60 inch long minimum clearance shall be provided adjacent to the open face of the shower compartment.	29" width between seat and wall	Reconfigure shower to provide required 30" X 60" clearance on the exterior of the shower	2015 ABAAS Section: 608.2.2.1 2012 TAS Section: 608.2.2.1 2010 ADAS Section: 608.2.2.1

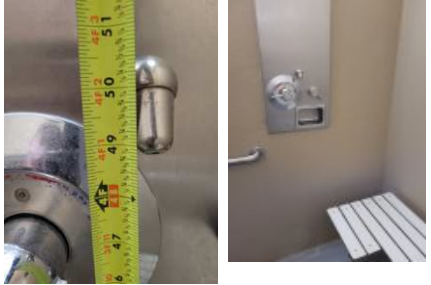
Finding Number	Area Description	Lat/Long	Finding	As Built	Recommendation	Citation	Photos	Figure
143	Willow Point (WP) Area: WP - Accessible Shower	[31.8618239 , -99.025879 3]	There is no hand held sprayer unit. The sprayer unit must have a 59 inches hose and be mounted 48 inches maximum to the top of mounting bracket off the floor. The shower spray unit shall have an on/off control with a non-positive shutoff. If an adjustable-height shower head on a vertical bar is used, the bar shall be installed so as not to obstruct the use of grab bars.	shower head is 49" AFF	Replace shower control with a compliant lever control with a shower head on a 59" hose and usable as hand held; in the alternative, remount fixed shower head to max 48" aff	2015 ABAAS Section: 608.6 2012 TAS Section: 608.6 2010 ADAS Section: 608.6

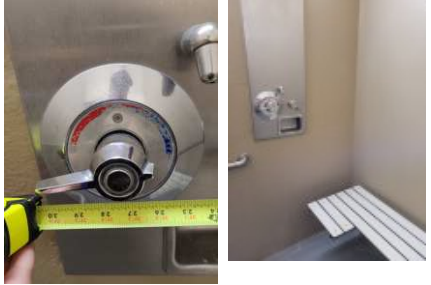
144	Willow Point (WP) Area: WP - Accessible Shower	[31.8618216 , -99.025882]	The operable parts of controls are not located correctly. In standard roll-in type shower compartments, the controls, faucets, and shower spray unit shall be located above the grab bar, but no higher than 48 inches (1220 mm) above the shower floor. Where a seat is provided, the controls, faucets, and shower spray unit shall be installed on the back wall adjacent to the seat wall and shall be located 27 inches (685 mm) maximum from the seat wall. Advisory 608.5.2 Standard Roll-In Type Shower Compartments. In standard roll-in type showers without seats, the shower head and operable parts can be located on any of the three walls of the shower without adversely affecting accessibility.	control lever is 30" from seat wall	Remount shower controls to the correct location in the roll in shower.	2015 ABAAS Section: 608.5.2 2012 TAS Section: 608.5.2 2010 ADAS Section: 608.5.2

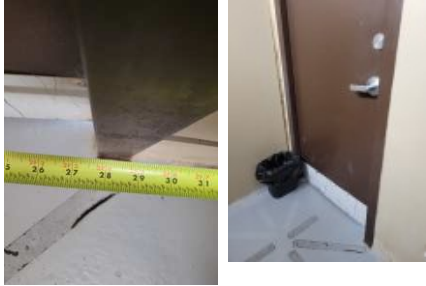
Finding Number	Area Description	Lat/Long	Finding	As Built	Recommendation	Citation	Photos	Figure
147	Willow Point (WP) Area: WP - Standard Shower Doors	[31.8618262 , -99.025882]	Minimum maneuvering clearances at doors and gates shall comply with 404.2.4.4. Maneuvering clearances shall extend the full width of the doorway and the required latch side or hinge side clearance.	2nd from woods - trash in MC on push side making width 27"	Provide required maneuvering clearance on push side of door.	2015 ABAAS Section: 404.2.4.4, 404.2.4.1 2012 TAS Section: 404.2.4.4, 404.2.4.1 2010 ADAS Section: 404.2.4.4, 404.2.4.1

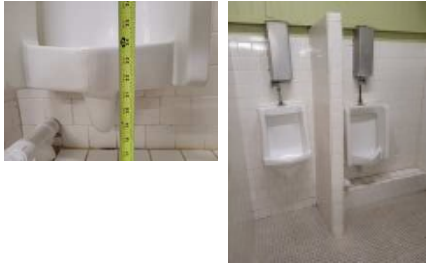
Finding Number	Area Description	Lat/Long	Finding	As Built	Recommendation	Citation	Photos	Figure
151	Willow Point (WP) Area: WP - Men's Restroom (near site 20)	[31.8629151 , -99.024447]	The rim of the urinal is too high. Wall-hung urinals must be provided with an elongated rim projecting a minimum of 13 1/2 inches from the wall and a maximum of 17 inches above the floor.	lower urinal rim is 24" AFF	Lower urinal so that rim height is max 17" AFF.	2015 ABAAS Section: 605.2 2012 TAS Section: 605.2 2010 ADAS Section: 605.2

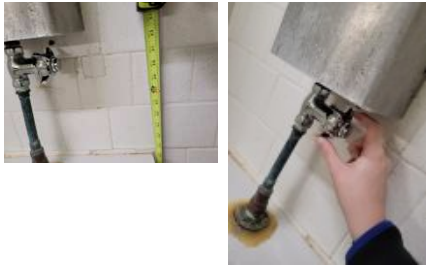
152	Willow Point (WP) Area: WP - Men's Restroom (near site 20)	[31.8629174 , -99.0244417]	The urinals flush handle is mounted too high. Flush controls shall be operable with one hand and shall not require tight grasping, pinching or twisting of the wrist and shall be mounted no more than 48 inches above the floor. The force required to activate controls shall be no greater than 5 lb. Electronic automatic flushing controls are acceptable and preferable.	urinal flush 50" AFF, requires twist	Lower flush handle at urinal to max 48" AFF. Replace flush handle with one that does not require a tight pinch or grasp.	2015 ABAAS Section: 605.4 2012 TAS Section: 605.4 2010 ADAS Section: 605.4

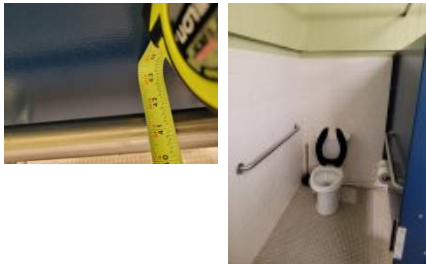
154	Willow Point (WP) Area: WP - Men's Restroom (near site 20)	[31.8629208 , -99.024435]	The ambulatory stall is not between 35" to 37" wide and 60" deep.	43.5" width	Correct ambulatory stall to be 35" to 37" wide and minimum 60" deep.	2015 ABAAS Section: 604.8.2.1 2012 TAS Section: 604.8.2.1 2010 ADAS Section: 604.8.2.1

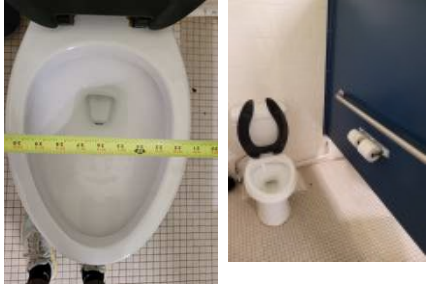
Finding Number	Area Description	Lat/Long	Finding	As Built	Recommendation	Citation	Photos	Figure
155	Willow Point (WP) Area: WP - Men's Restroom (near site 20)	[31.8629219, -99.024447]	The toilet is not located within the range to the side wall or partition. The centerline of the toilet shall be 17 inches minimum and 19 inches maximum side wall or partition in the ambulatory accessible toilet compartment.	26" centerline on partition side	Remount toilet to 17" to 19" from the side wall to center line in ambulatory stalls.	2015 ABAAS Section: 604.9.1 2012 TAS Section: 604.9.1 2010 ADAS Section: 604.9.1

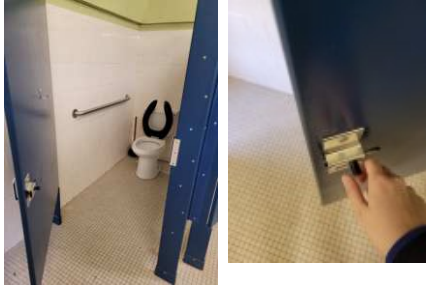
156	Willow Point (WP) Area: WP - Men's Restroom (near site 20)	[31.8629174, -99.0244524]	The stall door fails to comply with all of the door requirements. The stall door must be a minimum of 32" wide and have compliant hardware on both sides. The stall door must be self-closing.	stall door not self closing	Adjust stall door to be self-closing	2015 ABAAS Section: 404.2.3, 404.2.7, 604.8.2.2 2012 TAS Section: 404.2.3, 404.2.7, 604.8.2.2 2010 ADAS Section: 404.2.3, 404.2.7, 604.8.2.2

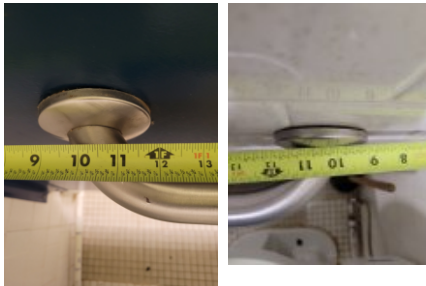
157	Willow Point (WP) Area: WP - Men's Restroom (near site 20)	[31.8629311, -99.024447]	The side grab bars are not in the correct location. Grab bars on the side wall must be installed so that the end closest to the rear wall is maximum 12" from the rear wall. The end furthest from the rear wall must be mounted minimum 54" from the rear wall.	42" grab bars, mounted 10.5" from rear wall, do not extend to 54"	Remount side grab bar to max 12" from the rear wall at the close end and min 54" on the far end, and 33" to 36" aff.	2015 ABAAS Section: 604.5.1 2012 TAS Section: 604.5.1 2010 ADAS Section: 604.5.1

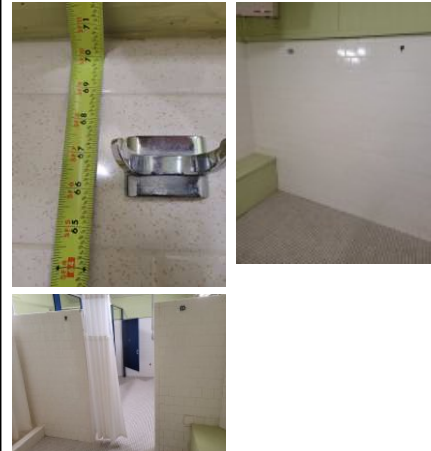
161	Willow Point (WP) Area: WP - Women's Restroom (near site 20)	[31.8629242 , -99.024447]	Coat hooks provided within the room shall be located within one of the reach ranges specified in 308. Shelves shall be 40 inches (1015 mm) minimum and 48 inches (1220 mm) maximum above the finish floor or ground. Where coat hooks or shelves are provided in dressing, fitting or locker rooms without individual compartments, at least one of each type shall comply with 803.5. Where coat hooks or shelves are provided in individual compartments at least one of each type complying with 803.5 shall be provided in individual compartments in dressing, fitting, or locker rooms required to comply with 222.1.	4 of 4 hooks are 66.5" AFF	Remount at least one hook to max 48" aff	2015 ABAAS Section: 308.2.1, 308.1, F222.2, 803.5 2012 TAS Section: 308.2.1, 308.1, 222.2, 803.5 2010 ADAS Section: 308.2.1, 308.1, 222.2, 803.5

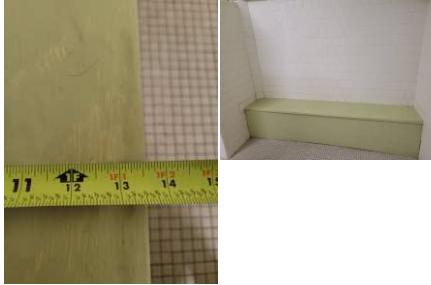
Finding Number	Area Description	Lat/Long	Finding	As Built	Recommendation	Citation	Photos	Figure
162	Willow Point (WP) Area: WP - Women's Restroom (near site 20)	[31.8629242 , -99.024428 3]	The bench is not deep enough or long enough or is missing. Benches shall be provided having seats that are 42 inches long minimum and 20 inches deep minimum and 24 inches deep maximum. The bench shall provide for back support or shall be affixed to a wall. Back support shall be 42 inches (1065 mm) long minimum and shall extend from a point 2 inches (51 mm) maximum above the seat surface to a point 18 inches (455 mm) minimum above the seat surface. Back support shall be 2½ inches (64 mm) maximum from the rear edge of the seat measured horizontally. The top of the bench seat surface shall be 17 inches (430 mm) minimum and 19 inches (485 mm) maximum above the finish floor or ground. Clear floor or ground space complying with 305 shall be provided and shall be positioned at the end of the bench seat and parallel to the short axis of the bench	bench 13.5" deep	Replace bench in dressing area with one having a seat depth of 20" to 24" deep, 42" long, affixed to the wall or having a back and mounted 17" to 19" aff and provide required clear floor space on the short axis of the bench.	2012 TAS Section: 903.4, 903.2, 903.3, 903.5 2010 ADAS Section: 903.4, 903.2, 903.3, 903.5

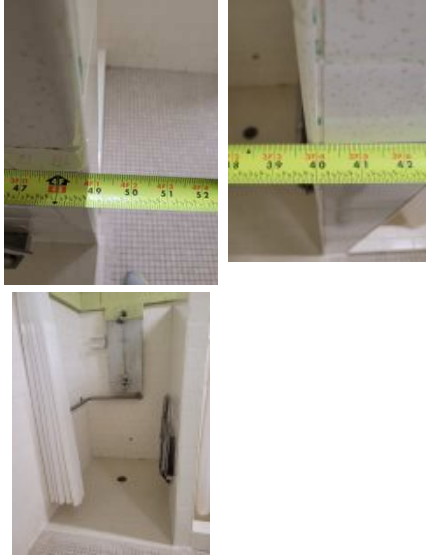
163	Willow Point (WP) Area: WP - Women's Restroom (near site 20)	[31.8629197 , -99.024449 7]	Transfer type shower compartments shall be 36 inches (915 mm) by 36 inches (915 mm) clear inside dimensions measured at the center points of opposing sides and shall have a 36 inch (915 mm) wide minimum entry on the face of the shower compartment. Clearance of 36 inches (915 mm) wide minimum by 48 inches (1220 mm) long minimum measured from the control wall shall be provided.	shower 49" deep by 39.75" wide	Enlarge transfer shower to compliant 36" by 36" clear inside dimension.	2015 ABAAS Section: 608.2.1 2012 TAS Section: 608.2.1 2010 ADAS Section: 608.2.1

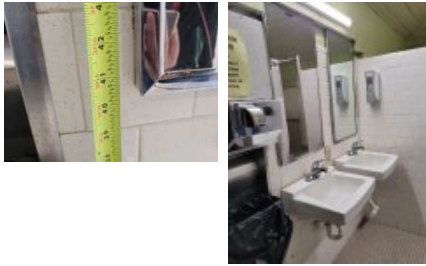
168	Willow Point (WP) Area: WP - Women's Restroom (near site 20)	[31.8629197 , -99.024441 7]	The mirror is mounted too high. Mirrors must have the bottom edge of the reflecting surface a maximum of 40 inches above the floor if above a sink or counter. Mirrors not located above lavatories or countertops shall be installed with the bottom edge of the reflecting surface 35 inches maximum above the finish floor or ground.	mirror 41" aff	Lower mirror so reflective surface is max 40" AFF.	2015 ABAAS Section: 603.3 2012 TAS Section: 603.3 2010 ADAS Section: 603.3

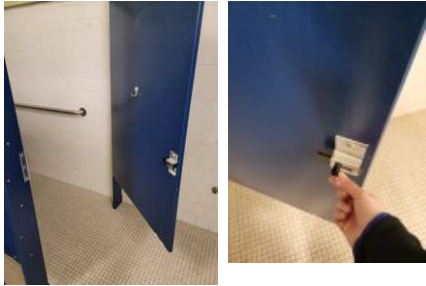
Finding Number	Area Description	Lat/Long	Finding	As Built	Recommendation	Citation	Photos	Figure
172	Willow Point (WP) Area: WP - Women's Restroom (near site 20)	[31.8629208 , -99.024444 4]	The stall door fails to comply with all of the door requirements. The stall door must be a minimum of 32" wide and have compliant hardware on both sides. The stall door must be self-closing.	stall door not self closing	Adjust stall door to be self-closing.	2015 ABAAS Section: 404.2.3, 404.2.7, 604.8.2.2 2012 TAS Section: 404.2.3, 404.2.7, 604.8.2.2 2010 ADAS Section: 404.2.3, 404.2.7, 604.8.2.2

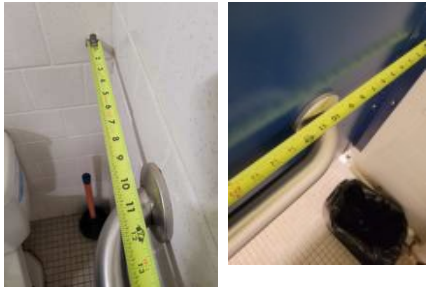
173	Willow Point (WP) Area: WP - Women's Restroom (near site 20)	[31.8629208 , -99.024449 7]	The side grab bars are not in the correct location. Grab bars on the side wall must be installed so that the end closest to the rear wall is maximum 12" from the rear wall. The end furthest from the rear wall must be mounted minimum 54" from the rear wall.	42" grab bars mounted 11" from rear wall and extend 53" to grab bar end	Remount side grab bar to max 12" from the rear wall at the close end and min 54" on the far end, and 33" to 36" aff.	2015 ABAAS Section: 604.5.1 2012 TAS Section: 604.5.1 2010 ADAS Section: 604.5.1

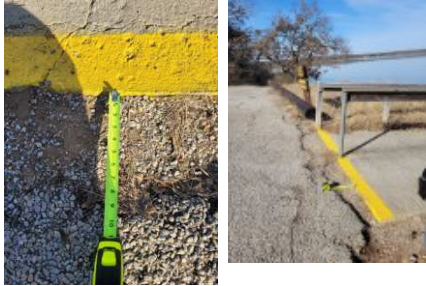
180	Willow Point (WP) Area: WP - Fishing Pier	[31.8623297 , -99.026716 2]	There is a gap spaced greater than a 1/2 inch. Openings in floor or ground surfaces shall not allow passage of a sphere more than 1/2 inch diameter. Elongated openings shall be placed so that the long dimension is perpendicular to the dominant direction of travel.	9" gap at walkway to pier by fish cleaning	Correct or fill gaps to be max .5"	2015 ABAAS Section: 302.3 2012 TAS Section: 302.3 2010 ADAS Section: 302.3

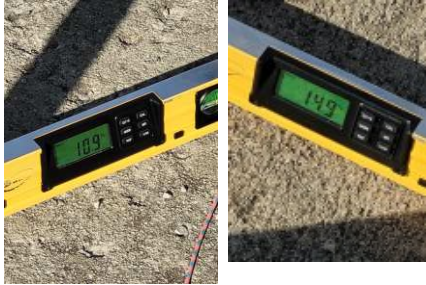
Finding Number	Area Description	Lat/Long	Finding	As Built	Recommendation	Citation	Photos	Figure
181	Willow Point (WP) Area: WP - Fishing Pier	[31.8623593, -99.0267323]	The ramps slope exceeds the maximum running slope (direction of travel) allowable of 8.33%. Ramps should have the least possible slope but in no case more than 8.3% (1:12).	10.9% at top, 14.9% at bottom	Correct slope of ramp to max 8.33%	2015 ABAAS Section: 405.2 2012 TAS Section: 405.2 2010 ADAS Section: 405.2

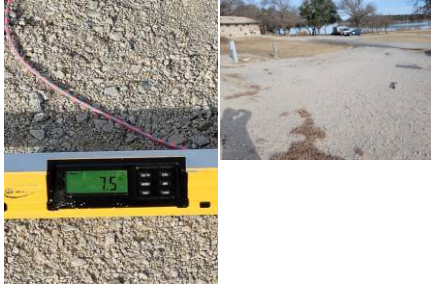
Finding Number	Area Description	Lat/Long	Finding	As Built	Recommendation	Citation	Photos	Figure
188	Willow Point (WP) Area: WP - Campsite 11	[31.8617522 , -99.025588 3]	The cross slope shall not be steeper than 1:48. EXCEPTION: Where the surface is other than concrete, asphalt, or boards, cross slopes not steeper than 1:20 shall be permitted when necessary for drainage.	site 11 - 7.5% slope parallel to parking	Correct or repair ORAR cross slope to max 2.08% or 5% for surfaces other than concrete, asphalt or board as a smart practices	2015 ABAAS Section: 1016.7.2, 1016.7.2 EXCEPTION

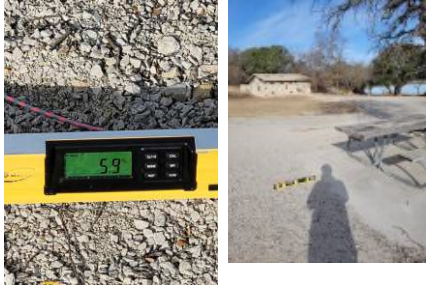
189	Willow Point (WP) Area: WP - Campsite 11	[31.8617191 , -99.025568 2]	36 inches (915 mm) on all usable sides of the table measured from the back edge of the benches	site 11 - crusher fines - 5.9% slope	Provide required 36" clear ground space around all usable portions of the table as a smart practice	2015 ABAAS Section: 1011.2.1
