Access Audit Site Report

Lake Brownwood State Park
200 State Hwy Park Rd 15
Brownwood, TX 76801
Accessibility Evaluation
Inspection Date: 02/28/2022
Inspectors: Tanya Scheibe

Prepared By
WT Group

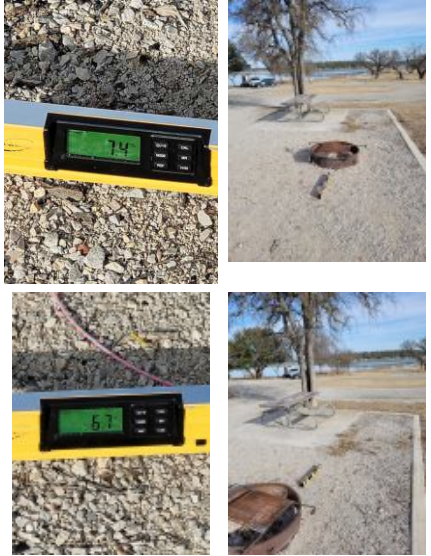
190	Willow Point (WP) Area: WP - Campsite 11	[31.8617248 , -99.025526]	48 inches (1220 mm) by 48 inches (1220 mm) on all usable sides of the fire ring, grill, fireplace, and woodstove Center the space on each usable side of the grill, fireplace, and woodstove	site 11 - 7.4% slope on backside, 6.7% on picnic table side	Provide required 48" clear ground space centered along usable side of fire ring, grill, fireplace, or woodstove as a smart practice	2015 ABAAS Section: 1011.2

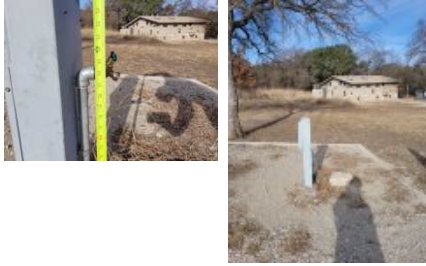
192	Willow Point (WP) Area: WP - Campsite 11	[31.8617009 , -99.025629 2]	Water spouts at water hydrants and water utility hook-ups shall be 28 inches (710 mm) minimum and 36 inches (915 mm) maximum above the ground	site 11 - spigot is 21" above ground level	Remount water spouts to 28" min or 36" max above the ground as a smart practice	2015 ABAAS Section: 1011.6

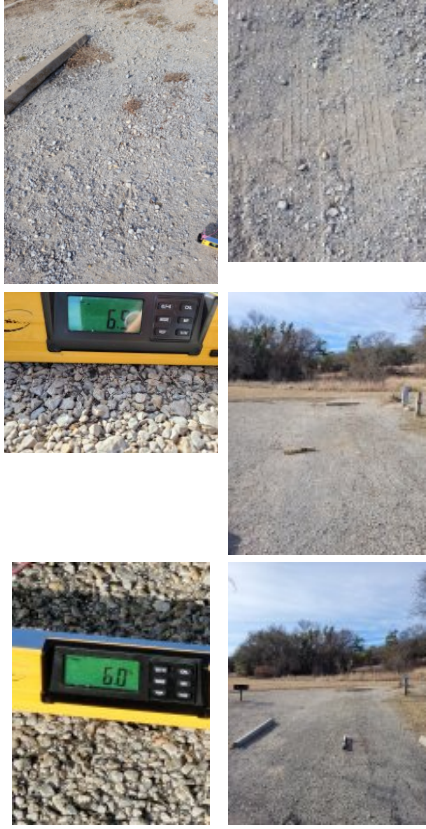
Finding Number	Area Description	Lat/Long	Finding	As Built	Recommendation	Citation	Photos	Figure
194	Willow Point (WP) Area: WP - Campsite 11	[31.8617328 , -99.025565 5]	The surface of parking spaces and pull-up spaces shall be firm and stable. The slope of the surface of parking spaces and pull-up spaces shall not be steeper than 1:48 in any direction. EXCEPTION: Where the surface is other than asphalt, concrete, or boards, slopes not steeper than 1:20 shall be permitted when necessary for drainage.	sand, loose gravel towards top. 6.9% slope, 6% slope	Correct surface of parking spaces to be firm and stable with slopes max of 2.08% or 5% for surfaces other than concrete, asphalt or boards as a smart practice.	2015 ABAAS Section: 1012.4, 1012.5, 1012.5 EXCEPTION

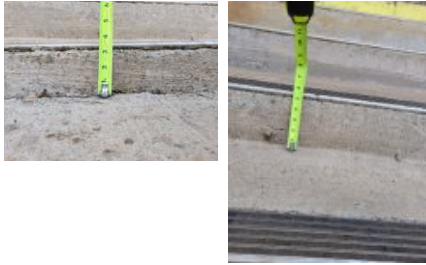
Finding Number	Area Description	Lat/Long	Finding	As Built	Recommendation	Citation	Photos	Figure
201	Day Use Restroom Buildings : Day Use - Exterior Accessible Route	[31.862767, -99.022550 7]	The stair risers are not uniform in height. Stair riser heights shall be 7 inches maximum and 4 inches minimum. On any given flight of stairs, all steps shall have uniform riser height and uniform tread widths.	Stairs behind Day Use restroom - first step riser is 3.75" , rest are 5"	Correct riser heights on stairs to consistent height between 4" to 7", leave as is if technically infeasible	2015 ABAAS Section: 504.2 2012 TAS Section: 504.2 2010 ADAS Section: 504.2

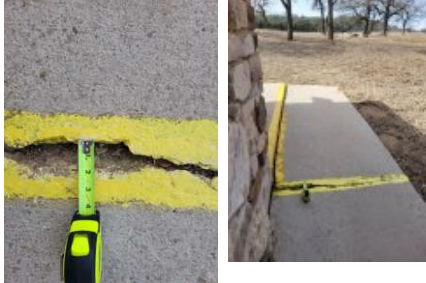
202	Day Use Restroom Buildings : Day Use - Exterior Accessible Route	[31.8627146, -99.022558 8]	There is a gap spaced greater than a 1/2 inch. Openings in floor or ground surfaces shall not allow passage of a sphere more than 1/2 inch diameter. Elongated openings shall be placed so that the long dimension is perpendicular to the dominant direction of travel.	Women's side of day use restrooms - 2" gap	Correct or fill gaps to be max .5"	2015 ABAAS Section: 302.3 2012 TAS Section: 302.3 2010 ADAS Section: 302.3

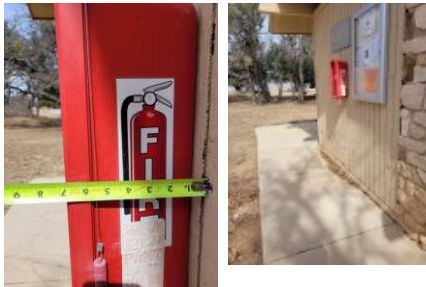
203	Day Use Restroom Buildings : Day Use - Exterior Accessible Route	[31.8627761, -99.022558 8]	An item or items project more than 4 inches into the circulation path. Wall-mounted objects that have leading edges between 27 inches and 80 inches from the floor must not project more than 4 inches into the circulation path. Protruding objects that extend to the floor or within 27 inches of the floor are cane detectable and are therefore not hazardous. Where it is necessary or desirable to have objects protrude from the wall, a manner of cane detection must be provided.	fire extinguisher at day use restroom building projects 7"	Relocate protruding objects or place cane detectable warning or bollard at foot of item	2015 ABAAS Section: 307.2 2012 TAS Section: 307.2 2010 ADAS Section: 307.2

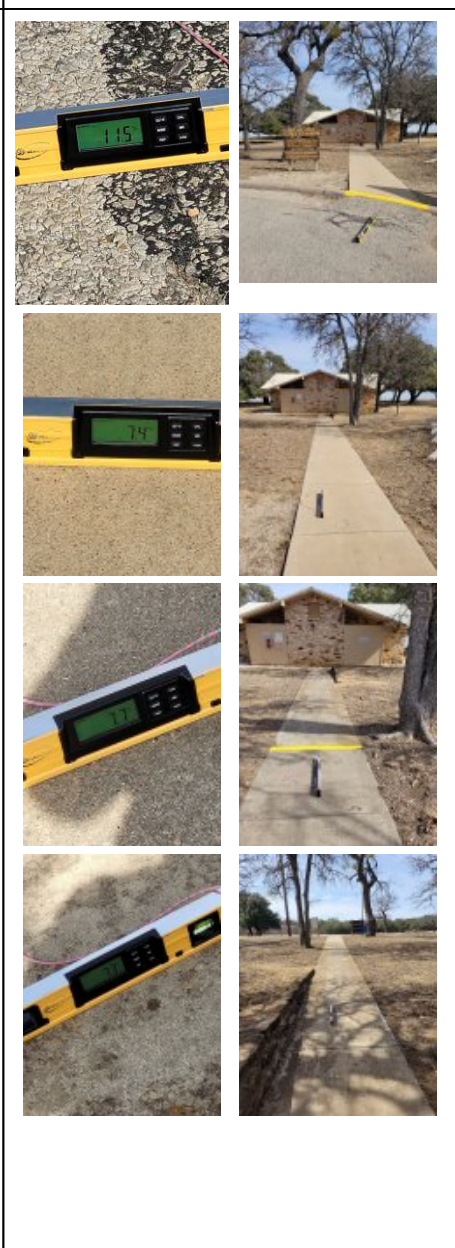
Finding Number	Area Description	Lat/Long	Finding	As Built	Recommendation	Citation	Photos	Figure
205	Day Use Restroom Buildings : Day Use - Exterior Accessible Route	[31.862615, -99.022727 1]	The running slope of walking surfaces shall not be steeper than 1:20.	11.5% slope at entry to day use restroom building, 7.4% at top of path to restroom, 7.7% in middle, 7.3% at bottom	Correct running slope along the AR to max 5%	2015 ABAAS Section: 403.3 2012 TAS Section: 403.3 2010 ADAS Section: 403.3

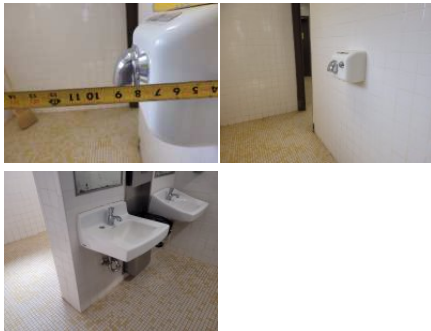
228	Day Use Restroom Buildings : Day Use - Men's Restroom (by dining hall)	[31.862783, -99.0225453]	An item or items project more than 4 inches into the circulation path. Wall-mounted objects that have leading edges between 27 inches and 80 inches from the floor must not project more than 4 inches into the circulation path. Protruding objects that extend to the floor or within 27 inches of the floor are cane detectable and are therefore not hazardous. Where it is necessary or desirable to have objects protrude from the wall, a manner of cane detection must be provided.	hand dryer 9", sinks protrude	Relocate protruding objects or place cane detectable warning or bollard at foot of item	2015 ABAAS Section: 307.2 2012 TAS Section: 307.2 2010 ADAS Section: 307.2

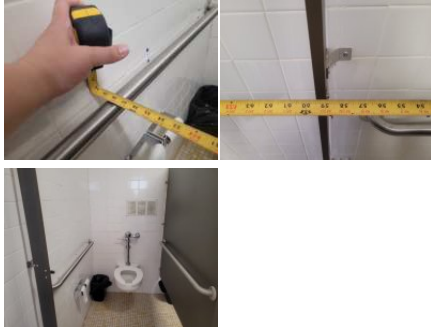
Finding Number	Area Description	Lat/Long	Finding	As Built	Recommendation	Citation	Photos	Figure
235	Day Use Restroom Buildings : Day Use - Women's Restroom (by dining hall)	[31.8627898 , -99.02254]	The ambulatory stall is not between 35" to 37" wide and 60" deep.	40" wide, 59" deep	Correct ambulatory stall to be 35" to 37" wide and minimum 60" deep	2015 ABAAS Section: 604.8.2.1 2012 TAS Section: 604.8.2.1 2010 ADAS Section: 604.8.2.1

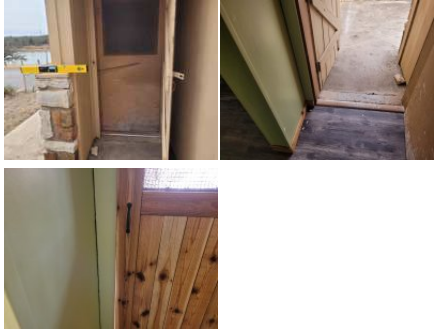
Finding Number	Area Description	Lat/Long	Finding	As Built	Recommendation	Citation	Photos	Figure
262	Day Use Restroom Buildings : Day Use - Men's Restroom (by beach lodge)	[31.8609374 , -99.019614 4]	Minimum maneuvering clearances at doors and gates shall comply with 404.2.4. Maneuvering clearances shall extend the full width of the doorway and the required latch side or hinge side clearance. Maneuvering clearances shall have a max slope of 2.08%. Hand-activated door opening hardware, handles, pulls, latches, locks, and other operating devices on accessible doors shall have a shape that is easy to grasp with one hand and does not require tight grasping, tight pinching or twisting of the wrist to operate. Hardware shall be 34 inches minimum and 48 inches maximum above the finish floor or ground.	outer door has wall pull side, inner door has door push side and wall pull side, small hardware	For all doors along the public circulation route, provide required maneuvering clearance on push and pull side of doors. For all doors along the public circulation route, replace hardware with lever hardware or hardware operable without a tight pinch or grasp.	2010 ADAS Section: 404.2.3, 404.2.7, 404.2.4, 404.2.11, 404.2.11 Exception

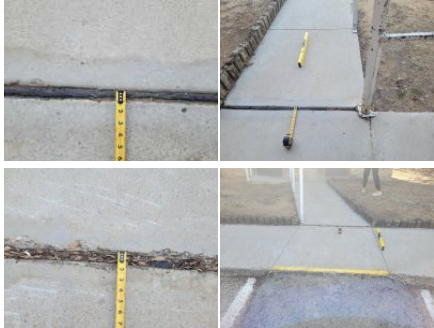
288	Comanche Trails (CT) Area: CT - Exterior Accessible Route	[31.8521257 , -99.0176792]	There is a gap spaced greater than a 1/2 inch. Openings in floor or ground surfaces shall not allow passage of a sphere more than 1/2 inch diameter. Elongated openings shall be placed so that the long dimension is perpendicular to the dominant direction of travel.	1" and 1.5" gaps near restroom	Correct or fill gaps to be max .5"	2015 ABAAS Section: 302.3 2012 TAS Section: 302.3 2010 ADAS Section: 302.3

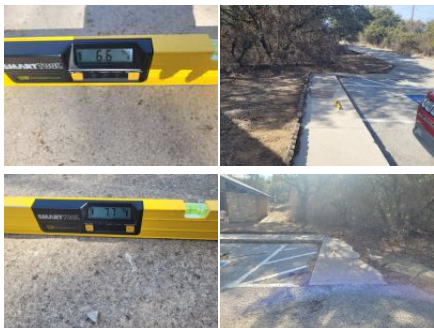
290	Comanche Trails (CT) Area: CT - Exterior Accessible Route	[31.8521771 , -99.017702 1]	The running slope of walking surfaces shall not be steeper than 1:20.	6.6% slope along parking, 7.7% slope at accessible parking stall	Correct running slope along the AR to max 5%	2015 ABAAS Section: 403.3 2012 TAS Section: 403.3 2010 ADAS Section: 403.3

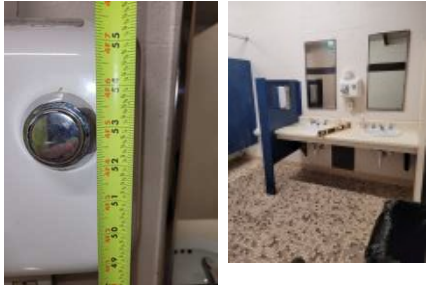
Finding Number	Area Description	Lat/Long	Finding	As Built	Recommendation	Citation	Photos	Figure
293	Comanche Trails (CT) Area: CT - Men's Restroom	[31.8520779 , -99.0177308]	Where a high forward reach is over an obstruction, the clear floor space shall extend beneath the element for a distance not less than the required reach depth over the obstruction. The high forward reach shall be 48 inches (1220 mm) maximum where the reach depth is 20 inches (510 mm) maximum. Where the reach depth exceeds 20 inches (510 mm), the high forward reach shall be 44 inches (1120 mm) maximum and the reach depth shall be 25 inches (635 mm) maximum. Where a clear floor or ground space allows a parallel approach to an element and the high side reach is over an obstruction, the height of the obstruction shall be 34 inches (865 mm) maximum and the depth of the obstruction shall be 24 inches (610 mm) maximum. The high side reach shall be 48 inches (1220 mm) maximum for a reach depth of 10 inches (255 mm) maximum. Where the reach depth exceeds 10 inches (255 mm), the high side reach shall be 46 inches (1170 mm) maximum for a reach depth of 24 inches (610 mm) maximum.	dryer 52.5" AFF, over sink	Lower hand dryer to max 44" above the finished floor (AFF) for a forward reach over counter.	2015 ABAAS Section: 308.2.1, 308.3.2 2012 TAS Section: 308.2.1, 308.3.2 2010 ADAS Section: 308.2.1, 308.3.2

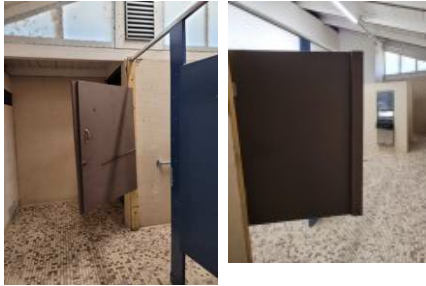
Finding Number	Area Description	Lat/Long	Finding	As Built	Recommendation	Citation	Photos	Figure
295	Comanche Trails (CT) Area: CT - Men's Restroom	[31.8520756 , -99.017738 8]	The stall door fails to comply with all of the door requirements. The stall door must be a minimum of 32" wide and have compliant hardware on both sides. The stall door must be self-closing.	stall door lacks hardware, not self closing	Adjust stall door to be self-closing Replace stall hardware with hardware operable without a tight pinch or grasp on both sides of the stall door	2015 ABAAS Section: 404.2.3, 404.2.7, 604.8.2.2 2012 TAS Section: 404.2.3, 404.2.7, 604.8.2.2 2010 ADAS Section: 404.2.3, 404.2.7, 604.8.2.2

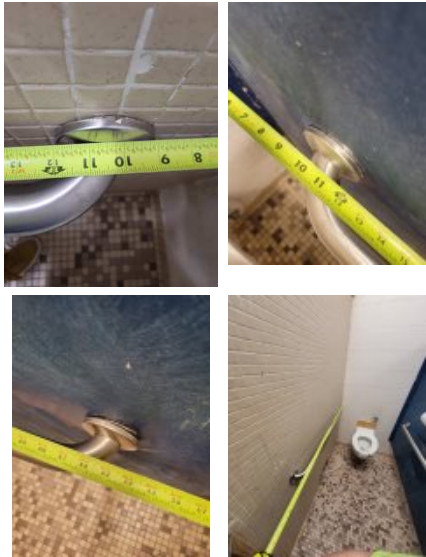
296	Comanche Trails (CT) Area: CT - Men's Restroom	[31.8520665 , -99.017728 1]	The side grab bars are not in the correct location. Grab bars on the side wall must be installed so that the end closest to the rear wall is maximum 12" from the rear wall. The end furthest from the rear wall must be mounted minimum 54" from the rear wall.	tile side mounted 10.5" from rear wall so it's 52.5" to end, partition side is 11" from rear wall and 53" to grab bar end	Remount side grab bar to max 12" from the rear wall at the close end and min 54" on the far end, and 33" to 36" aff.	2015 ABAAS Section: 604.5.1 2012 TAS Section: 604.5.1 2010 ADAS Section: 604.5.1

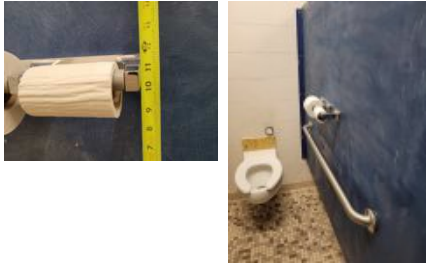
Finding Number	Area Description	Lat/Long	Finding	As Built	Recommendation	Citation	Photos	Figure
297	Comanche Trails (CT) Area: CT - Men's Restroom	[31.8520596 , -99.017744 2]	The grab bar height and/or spacing fails. Grab bars must be mounted between 33" and 36" to the top of the gripping surface. There must be 1.5" of clearance between the grab bar and the wall. There must be a minimum of 1.5" of clearance below and minimum 12" above the grab bar to any dispenser or other obstruction.	toilet paper 9" above	Remount toilet paper dispenser max 7" to 9" from front of toilet, 15" to 48" above the finished floor (AFF) and min 12" above or 1.5" below grab bar.	2015 ABAAS Section: 609.3, 609.4 2012 TAS Section: 609.4, 609.3 2010 ADAS Section: 609.3, 609.4

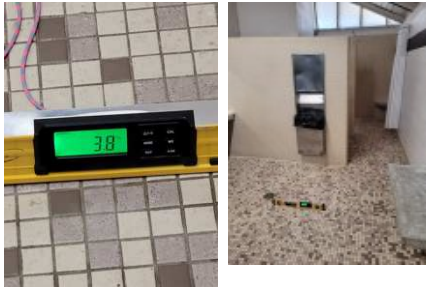
298	Comanche Trails (CT) Area: CT - Men's Restroom	[31.8520619 , -99.017720 1]	The accessible route contains running slopes greater than 5 percent and cross slopes greater than 2 percent across the width of the walk and has not been constructed as a ramp (i.e. handrails, wheel guides, etc.). When the slope in the direction of travel of any walk exceeds 1 unit vertical in 20 units horizontal (5-percent slope), it must be constructed as ramp. Surface cross slopes must not exceed one unit vertical in 48 units. Horizontal (2-percent slope).	3.8% cross slope in front of trash can	Correct or repair slope to max 5% running and 2.08% cross.	2015 ABAAS Section: 403.3 2012 TAS Section: 403.3 2010 ADAS Section: 403.3

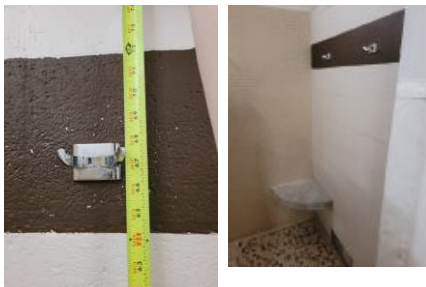
299	Comanche Trails (CT) Area: CT - Men's Restroom	[31.8520619 , -99.017722 7]	Coat hooks provided within the room shall be located within one of the reach ranges specified in 308. Shelves shall be 40 inches (1015 mm) minimum and 48 inches (1220 mm) maximum above the finish floor or ground. Where coat hooks or shelves are provided in dressing, fitting or locker rooms without individual compartments, at least one of each type shall comply with 803.5. Where coat hooks or shelves are provided in individual compartments at least one of each type complying with 803.5 shall be provided in individual compartments in dressing, fitting, or locker rooms required to comply with 222.1.	hooks 67" AFF	Remount at least one hook to max 48" aff	2015 ABAAS Section: 308.2.1, 308.1, F222.2, 803.5 2012 TAS Section: 308.2.1, 308.1, 222.2, 803.5 2010 ADAS Section: 308.2.1, 308.1, 222.2, 803.5

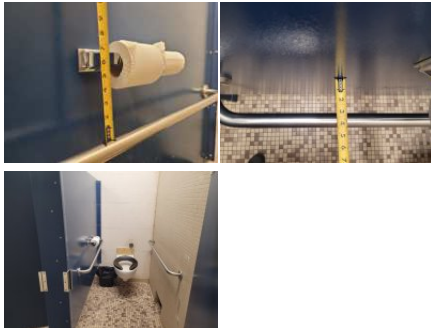
313	Comanche Trails (CT) Area: CT - Women's Restroom	[31.8520687, -99.017725 4]	The grab bar height and/or spacing fails. Grab bars must be mounted between 33" and 36" to the top of the gripping surface. There must be 1.5" of clearance between the grab bar and the wall. There must be a minimum of 1.5" of clearance below and minimum 12" above the grab bar to any dispenser or other obstruction.	toilet paper 4" above bar, 3" gap between bar and wall	Remount toilet paper dispenser max 7" to 9" from front of toilet, 15" to 48" above the finished floor (AFF) and min 12" above or 1.5" below grab bar. Replace grab bars to provide 1.5" clearance between the grab bar and the wall.	2015 ABAAS Section: 609.3, 609.4 2012 TAS Section: 609.4, 609.3 2010 ADAS Section: 609.3, 609.4

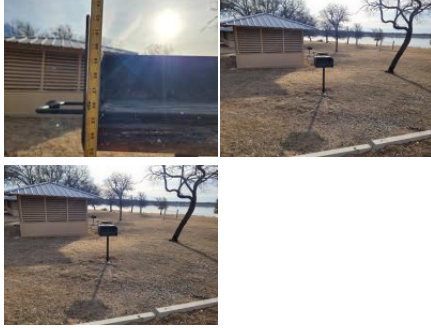
333	Comanche Trails (CT) Area: CT - Sample Shelter Campsite	[31.851811, -99.0171659]	Where provided, cooking surfaces shall be 15 inches (380 mm) minimum and 34 inches (865 mm) maximum above the ground	shelter 1 - grill 36" AFF at lowest	Raise or lower cooking surface to be 15" min to 34" max above the ground; in the alternative, replace with a compliant surface as a smart practice	2015 ABAAS Section: 1011.5.2

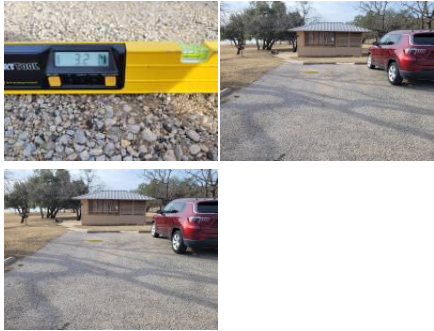
337	Comanche Trails (CT) Area: CT - Sample Shelter Campsite	[31.8519056 , -99.017295 9]	The surface of parking spaces and pull-up spaces shall be firm and stable. The slope of the surface of parking spaces and pull-up spaces shall not be steeper than 1:48 in any direction. EXCEPTION: Where the surface is other than asphalt, concrete, or boards, slopes not steeper than 1:20 shall be permitted when necessary for drainage.	shelter 1 - 3.2% slope, gravel surface	Correct surface of parking spaces to be firm and stable with slopes max of 2.08% or 5% for surfaces other than concrete, asphalt or boards as a smart practice.	2015 ABAAS Section: 1012.4, 1012.5, 1012.5 EXCEPTION

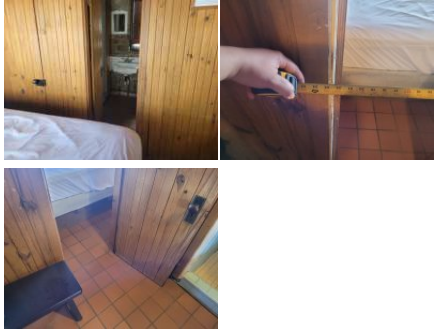
Finding Number	Area Description	Lat/Long	Finding	As Built	Recommendation	Citation	Photos	Figure
341	Cabin Area: Sample Cabin Campsite	[31.85331, -99.0148]	<p>Minimum maneuvering clearances at doors and gates shall comply with 404.2.4. Maneuvering clearances shall extend the full width of the doorway and the required latch side or hinge side clearance. Maneuvering clearances shall have a max slope of 2.08%. Door openings shall provide a clear width of 32 inches (815 mm) minimum. Clear openings of doorways with swinging doors shall be measured between the face of the door and the stop, with the door open 90 degrees. Openings more than 24 inches (610 mm) deep shall provide a clear opening of 36 inches (915 mm) minimum. There shall be no projections into the required clear opening width lower than 34 inches (865 mm) above the finish floor or ground. Projections into the clear opening width between 34 inches (865 mm) and 80 inches (2030 mm) above the finish floor or ground shall not exceed 4 inches (100 mm). Hand-activated door opening hardware, handles, pulls, latches, locks, and other operating devices on accessible doors shall have a shape that is easy to grasp with one hand and does not require tight grasping, tight pinching or twisting of the wrist to operate. Hardware shall be 34 inches minimum and 48 inches maximum above the finish floor or ground.</p>	cabin 7 bathroom door - knob, bed push side, bench pull side, 21.75" wide	<p>For all doors along the public circulation route, provide required maneuvering clearance on push and pull side of doors. For all doors along the public circulation route, correct slope in door clearance to max 2.08%. For all doors along the public circulation route, replace doors with doors having 80" overhead clearance and 32" clear width. For all doors along the public circulation route, replace hardware with lever hardware or hardware operable without a tight pinch or grasp.</p>	2010 ADAS Section: 404.2.3, 404.2.7, 404.2.4, 404.2.11, 404.2.11 Exception

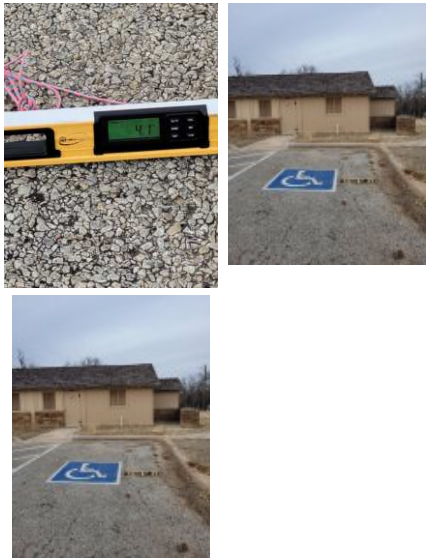
Finding Number	Area Description	Lat/Long	Finding	As Built	Recommendation	Citation	Photos	Figure
373	Group Dining Hall : Dining Hall - Parking	[31.8616781 , -99.0221309]	Element meets all standards and requirements	Group Dining Hall - 5 standard stalls, 1 accessible stall	None	2010 ADAS Section: N/A		
374	Group Dining Hall : Dining Hall - Parking	[31.8617015 , -99.022088]	The cross slopes (narrow dimension) and/or running slopes (long dimension) of the access aisle exceeds 2%. The running slope and the cross slope in an accessible parking stall and the access aisle must not exceed 2%.	Group Dining Hall, stall - 4.1% slope	Repair or correct slope of parking space and access aisle to max 2.08% in any direction.	2015 ABAAS Section: 502.4 2012 TAS Section: 502.4 2010 ADAS Section: 502.4

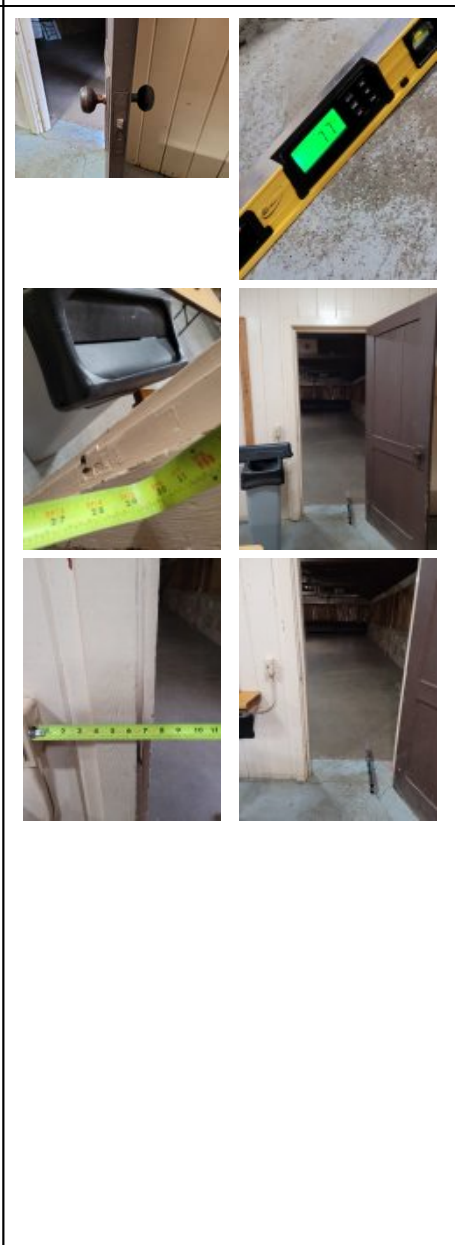
Finding Number	Area Description	Lat/Long	Finding	As Built	Recommendation	Citation	Photos	Figure
390	Group Dining Hall : Dining Hall - Public Spaces	[31.8617647 , -99.022151 1]	<p>Minimum maneuvering clearances at doors and gates shall comply with 404.2.4. Maneuvering clearances shall extend the full width of the doorway and the required latch side or hinge side clearance. Maneuvering clearances shall have a max slope of 2.08%. Door openings shall provide a clear width of 32 inches (815 mm) minimum. Clear openings of doorways with swinging doors shall be measured between the face of the door and the stop, with the door open 90 degrees. Openings more than 24 inches (610 mm) deep shall provide a clear opening of 36 inches (915 mm) minimum. There shall be no projections into the required clear opening width lower than 34 inches (865 mm) above the finish floor or ground. Projections into the clear opening width between 34 inches (865 mm) and 80 inches (2030 mm) above the finish floor or ground shall not exceed 4 inches (100 mm). Hand-activated door opening hardware, handles, pulls, latches, locks, and other operating devices on accessible doors shall have a shape that is easy to grasp with one hand and does not require tight grasping, tight pinching or twisting of the wrist to operate. Hardware shall be 34 inches minimum and 48 inches maximum above the finish floor or ground.</p>	<p>door from kitchen to main space - knob, 7.7% slope, 29.5" width, 7.5" clearance on pull due to outlet</p>	<p>For all doors along the public circulation route, provide required maneuvering clearance on push and pull side of doors. For all doors along the public circulation route, correct slope in door clearance to max 2.08%. For all doors along the public circulation route, replace doors with doors having 80" overhead clearance and 32" clear width. For all doors along the public circulation route, replace hardware with lever hardware or hardware operable without a tight pinch or grasp.</p>	<p>2010 ADAS Section: 404.2.3, 404.2.7, 404.2.4, 404.2.11, 404.2.11 Exception</p>

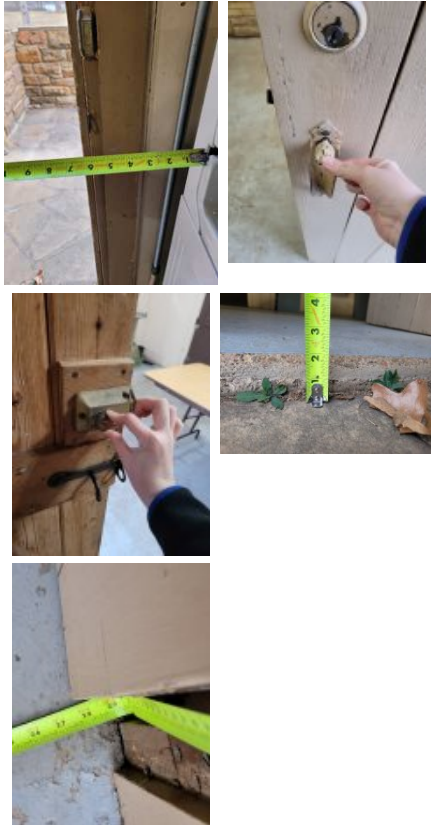
Finding Number	Area Description	Lat/Long	Finding	As Built	Recommendation	Citation	Photos	Figure
391	Group Dining Hall : Dining Hall - Public Spaces	[31.8617647 , -99.0221578]	<p>Minimum maneuvering clearances at doors and gates shall comply with 404.2.4. Maneuvering clearances shall extend the full width of the doorway and the required latch side or hinge side clearance. Maneuvering clearances shall have a max slope of 2.08%. Door openings shall provide a clear width of 32 inches (815 mm) minimum. Clear openings of doorways with swinging doors shall be measured between the face of the door and the stop, with the door open 90 degrees. Openings more than 24 inches (610 mm) deep shall provide a clear opening of 36 inches (915 mm) minimum. There shall be no projections into the required clear opening width lower than 34 inches (865 mm) above the finish floor or ground. Projections into the clear opening width between 34 inches (865 mm) and 80 inches (2030 mm) above the finish floor or ground shall not exceed 4 inches (100 mm). The threshold has a vertical change greater than 1/4 inch high. Hand-activated door opening hardware, handles, pulls, latches, locks, and other operating devices on accessible doors shall have a shape that is easy to grasp with one hand and does not require tight grasping, tight pinching or twisting of the wrist to operate. Hardware shall be 34 inches minimum and 48 inches maximum above the finish floor or ground.</p>	side door entry to kitchen - 6" clearance due to oven, pinch required on both sides, 2" change in level, 28.5" width	<p>For all doors along the public circulation route, provide required maneuvering clearance on push and pull side of doors. For all doors along the public circulation route, replace doors with doors having 80" overhead clearance and 32" clear width. For all doors along the public circulation route, repair, bevel, or ramp CILs at door entries to max .25". For all doors along the public circulation route, replace hardware with lever hardware or hardware operable without a tight pinch or grasp.</p>	2010 ADAS Section: 404.2.3, 404.2.7, 404.2.4, 404.2.11, 404.2.11 Exception

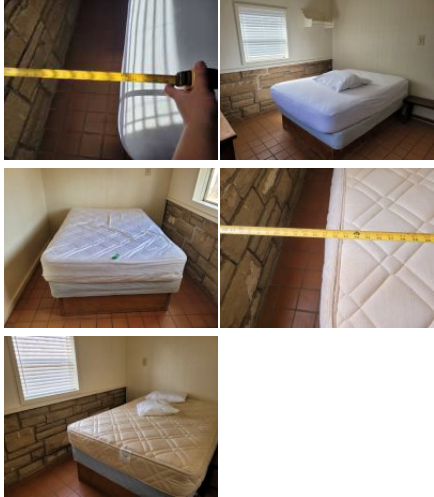
409	Fisherman's Lodge: Fisherman's Lodge - Public Spaces	[31.8604106 , -99.0210348]	Element meets all standards and requirements	3 of 5 beds lack CFS on both sides of bed, 2 comply	None	2010 ADAS Section: N/A

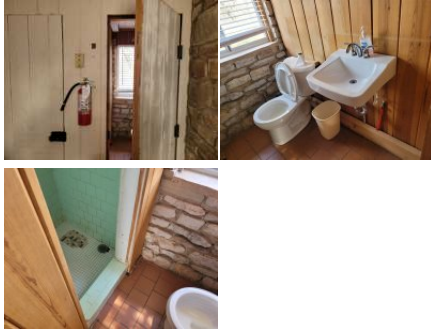
450	Oak Lodge: Oak Lodge - Restroom	[31.8595367, -99.0181841]	This restroom is not accessible. Where existing toilet rooms or bathing rooms do not comply, directional signs indicating the location of the nearest accessible toilet room or bathing room within the facility shall be provided. Signs shall include the International Symbol of Accessibility. Where existing toilet rooms or bathing rooms do comply), the accessible toilet rooms or bathing rooms shall be identified by the International Symbol of Where clustered single user toilet rooms or bathing facilities are permitted, accessible toilet rooms or bathing facilities shall be identified by the International Symbol of Accessibility unless all toilet rooms and bathing facilities are accessible.	bathroom in lodge lacks accessible features, lacks signage, lacks directional signage to nearest accessible restroom	Restroom not accessible, acquire and mount signage directing patrons to accessible restroom until accessible restroom provided at Oak Lodge	2015 ABAAS Section: F216.8 2012 TAS Section: 216.8 2010 ADAS Section: 216.8

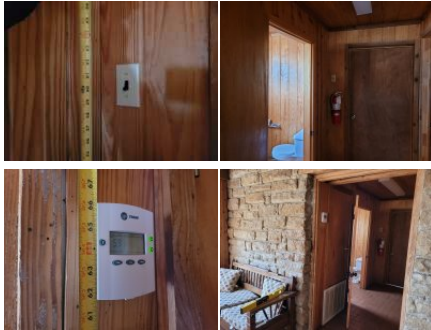
Finding Number	Area Description	Lat/Long	Finding	As Built	Recommendation	Citation	Photos	Figure
458	Beach Lodge : Beach Lodge - Public Space	[31.8604476 , -99.019027 9]	The operable part is positioned too high for either a side or front approach. Where a clear floor or ground space allows a parallel approach to an element and the side reach is unobstructed, the high side reach shall be 48 inches maximum and the low side reach shall be 15 inches minimum above the finish floor or ground. Where a forward reach is unobstructed, the high forward reach shall be 48 inches maximum and the low forward reach shall be 15 inches minimum above the finish floor or ground.	light switch and thermostat 62" AFF in back hall	Remount operable parts to be in reach range of 15" min to 48" max	2015 ABAAS Section: 308.1 2012 TAS Section: 308.1 2010 ADAS Section: 308.1

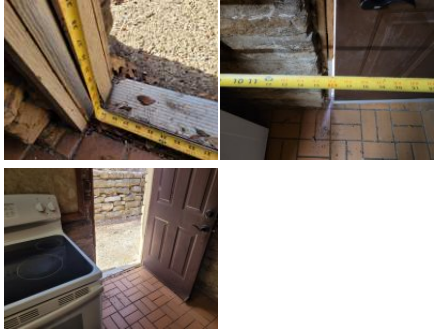
Finding Number	Area Description	Lat/Long	Finding	As Built	Recommendation	Citation	Photos	Figure
469	Beach Lodge : Beach Lodge - Public Space	[31.8604999 , -99.019053 2]	Minimum maneuvering clearances at doors and gates shall comply with 404.2.4. Maneuvering clearances shall extend the full width of the doorway and the required latch side or hinge side clearance. Maneuvering clearances shall have a max slope of 2.08%. Door openings shall provide a clear width of 32 inches (815 mm) minimum. Clear openings of doorways with swinging doors shall be measured between the face of the door and the stop, with the door open 90 degrees. Openings more than 24 inches (610 mm) deep shall provide a clear opening of 36 inches (915 mm) minimum. There shall be no projections into the required clear opening width lower than 34 inches (865 mm) above the finish floor or ground. Projections into the clear opening width between 34 inches (865 mm) and 80 inches (2030 mm) above the finish floor or ground shall not exceed 4 inches (100 mm).	kitchen - oven in pull side clearance, 29.5" wide	For all doors along the public circulation route, provide required maneuvering clearance on push and pull side of doors. For all doors along the public circulation route, replace doors with doors having 80" overhead clearance and 32" clear width.	2010 ADAS Section: 404.2.3, 404.2.7, 404.2.4, 404.2.11, 404.2.11 Exception

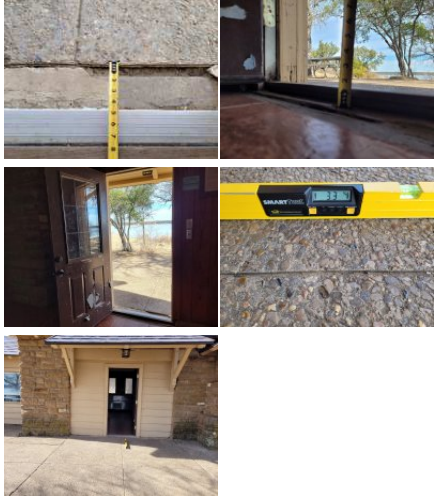
473	Beach Lodge : Beach Lodge - Public Space	[31.8605139 , -99.019108 8]	Minimum maneuvering clearances at doors and gates shall comply with 404.2.4. Maneuvering clearances shall extend the full width of the doorway and the required latch side or hinge side clearance. Maneuvering clearances shall have a max slope of 2.08%. The threshold has a gap greater than 1/2 inch wide. The threshold at a doorway shall be no higher than 1/2 inch. Changes in level between 1/4 inch and 1/2 inch must be beveled at 1:2 or less. 1/4 inch is the maximum vertical rise.	dining entry- 4.5" gap, 1.5" threshold, 3.3% slope	For all doors along the public circulation route, correct slope in door clearance to max 2.08%. For all doors along the public circulation fill gaps at door entries to max .5". For all doors along the public circulation route, repair, provide beveled threshold.	2010 ADAS Section: 404.2.3, 404.2.7, 404.2.4, 404.2.11, 404.2.11 Exception

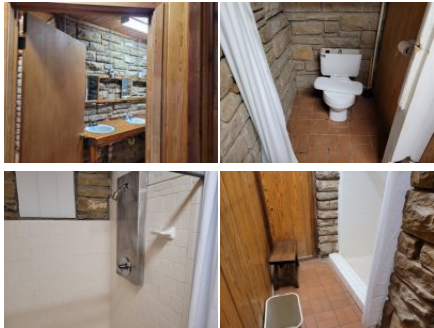
485	Beach Lodge : Beach Lodge - Restroom	[31.8605072 , -99.019093 3]	This restroom is not accessible. Where existing toilet rooms or bathing rooms do not comply, directional signs indicating the location of the nearest accessible toilet room or bathing room within the facility shall be provided. Signs shall include the International Symbol of Accessibility. Where existing toilet rooms or bathing rooms do comply), the accessible toilet rooms or bathing rooms shall be identified by the International Symbol of Where clustered single user toilet rooms or bathing facilities are permitted, accessible toilet rooms or bathing facilities shall be identified by the International Symbol of Accessibility unless all toilet rooms and bathing facilities are accessible.	front restroom- lacks signage, lacks accessible toilet and shower, no other accessible restroom in lodge, lacks signage indicating nearest accessible restroom	Restroom not accessible, acquire and mount signage directing patrons to accessible restroom until accessible restroom provided in beach lodge	2015 ABAAS Section: F216.8 2012 TAS Section: 216.8 2010 ADAS Section: 216.8

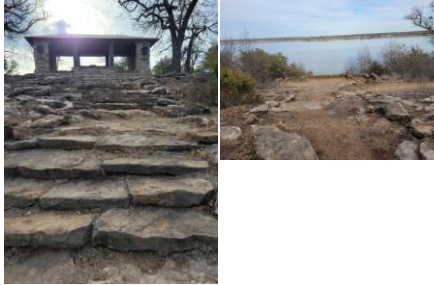
Finding Number	Area Description	Lat/Long	Finding	As Built	Recommendation	Citation	Photos	Figure
493	Group Rec Bldg: Rec Bldg- Exterior Accessible Route	[31.8590931 , -99.017282 9]	Stairways must have handrails on both sides. Handrails and their extensions must be between 34 inches and 38 inches above the stair nosing or ground. The top handrails shall extend a minimum of 12 inches beyond the top nosing and shall be parallel with the floor or ground surface. At the bottom of a stair flight, handrails shall extend at the slope of the stair flight for a horizontal distance at least equal to one tread depth beyond the last riser nosing. Extension shall return to a wall, guard, or the landing surface, or shall be continuous to the handrail of an adjacent stair flight. The orientation of at least one handrail, including the extension, shall be in the direction of the run of the stair and perpendicular to the direction of the stair nosing. Handrail gripping surfaces with a circular cross section shall have an outside diameter of 1-1/4 inches minimum and 2 inches maximum. Handrail gripping surfaces with a non-circular cross section shall have a perimeter dimension of 4 inches minimum and 6 1/4 inches maximum, and a cross-section dimension of 2-1/4 inches maximum. The hand grip portion of handrails shall have a smooth surface with no sharp corners. Gripping surfaces (top or sides) shall be uninterrupted by newel posts, other construction elements or obstructions. Any wall or other surface adjacent to the handrail shall be free of sharp or abrasive elements. Handrails projecting from a wall shall have a space of 1-1/2 inches minimum between the wall and the handrail.	stone staircase off shelter by dining hall lacks handrails	Install handrails on both sides of stairway, mounted 34" to 38" aff with top and bottom extensions and having a 1.25" – 2" in diameter, or a non-circular grip that has a perimeter dimension of 4"- 6.25" max with a min gap of 1.5" between handrail and wall	2015 ABAAS Section: 505.2 2012 TAS Section: 505.2 2010 ADAS Section: 505.2

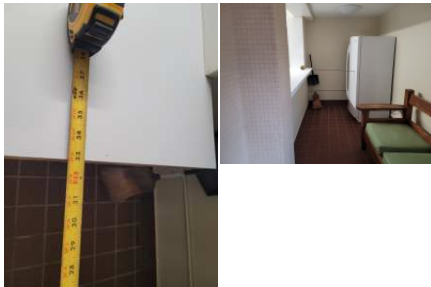
500	Group Rec Bldg: Rec Bldg- Kitchen	[31.859334, -99.017752 2]	Combination refrigerators and freezers shall have at least 50 percent of the freezer space 54 inches (1370 mm) maximum above the finish floor or ground. The clear floor or ground space shall be positioned for a parallel approach to the space dedicated to a refrigerator/freezer with the centerline of the clear floor or ground space offset 24 inches (610 mm) maximum from the centerline of the dedicated space.	only 32" wide at freezer	Relocate items for required CFS at refrigerator.	2015 ABAAS Section: 804.6.6 2012 TAS Section: 804.6.6 2010 ADAS Section: 804.6.6

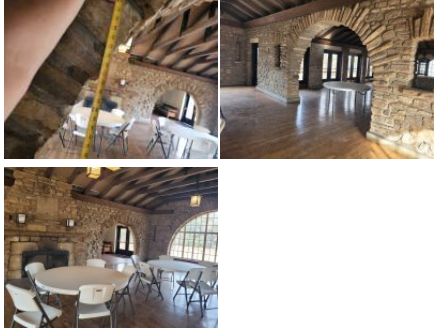
504	Group Rec Bldg: Rec Bldg- Main Room	[31.8593226 , -99.017784 4]	The arches extend down too close to the route of travel. Any obstruction that overhangs a route of travel must be a minimum of 80 inches above the walking surface as measured from the bottom of the obstruction.	reduces at arches	Raise posts to min 80", or pad object to prevent hazard in overhead clearance along AR	2015 ABAAS Section: 307.4 2012 TAS Section: 307.4 2010 ADAS Section: 307.4

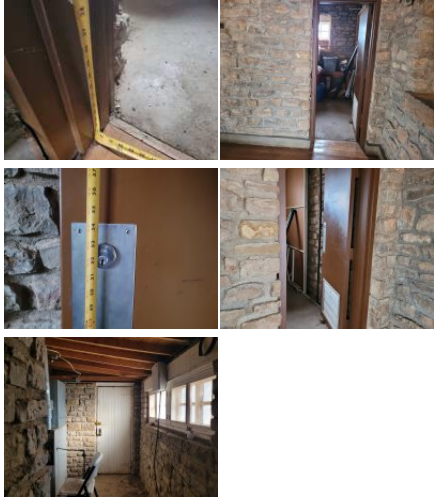
Finding Number	Area Description	Lat/Long	Finding	As Built	Recommendation	Citation	Photos	Figure
512	Group Rec Bldg: Rec Bldg- Employee Spaces	[31.8593442 , -99.017750 9]	Spaces and elements within employee work areas shall only be required to comply with 206.2.8, 207.1, and 215.3 and shall be designed and constructed so that individuals with disabilities can approach, enter, and exit the employee work area. Employee work areas, or portions of employee work areas, other than raised courtroom stations, that are less than 300 square feet (28 m2) and elevated 7 inches (180 mm) or more above the finish floor or ground where the elevation is essential to the function of the space shall not be required to comply with these requirements or to be on an accessible route.	storage entry- 26.5" wide, 19#, closes fast, lock 52" AFF; inner door has knob and twist hardware	For employee spaces, relocate storage, furniture, and other obstacles at doorways to provide approach, enter and exit at the employee space. Replace doors with doors having 80" overhead clearance and 32" clear width. Inspect, adjust, and maintain closing speed on door closers. Inspect, adjust, and maintain 8.5 lbf to open exterior doors as a smart practice. Replace hardware with lever hardware or hardware operable without a tight pinch or grasp, mounted maximum 48" AFF.	2015 ABAAS Section: F203.9 2012 TAS Section: 203.9 2010 ADAS Section: 203.9

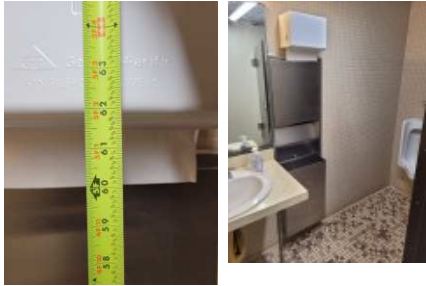
Finding Number	Area Description	Lat/Long	Finding	As Built	Recommendation	Citation	Photos	Figure
514	Group Rec Bldg: Rec Bldg - Mens Restroom	[31.8593476 , -99.017773 7]	Where a high forward reach is over an obstruction, the clear floor space shall extend beneath the element for a distance not less than the required reach depth over the obstruction. The high forward reach shall be 48 inches (1220 mm) maximum where the reach depth is 20 inches (510 mm) maximum. Where the reach depth exceeds 20 inches (510 mm), the high forward reach shall be 44 inches (1120 mm) maximum and the reach depth shall be 25 inches (635 mm) maximum. Where a clear floor or ground space allows a parallel approach to an element and the high side reach is over an obstruction, the height of the obstruction shall be 34 inches (865 mm) maximum and the depth of the obstruction shall be 24 inches (610 mm) maximum. The high side reach shall be 48 inches (1220 mm) maximum for a reach depth of 10 inches (255 mm) maximum. Where the reach depth exceeds 10 inches (255 mm), the high side reach shall be 46 inches (1170 mm) maximum for a reach depth of 24 inches (610 mm) maximum.	paper towels 60" AFF	Lower operating mechanisms to max 48" above the finished floor (AFF) to highest operable part.	2015 ABAAS Section: 308.2.1, 308.3.2 2012 TAS Section: 308.2.1, 308.3.2 2010 ADAS Section: 308.2.1, 308.3.2

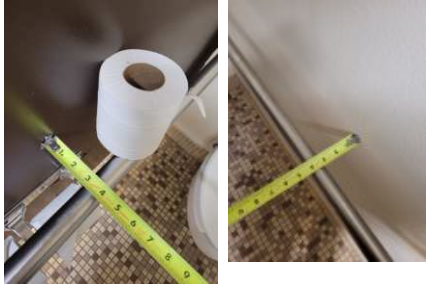
Finding Number	Area Description	Lat/Long	Finding	As Built	Recommendation	Citation	Photos	Figure
516	Group Rec Bldg: Rec Bldg - Mens Restroom	[31.8593317 , -99.017757 6]	The grab bar height and/or spacing fails. Grab bars must be mounted between 33" and 36" to the top of the gripping surface. There must be 1.5" of clearance between the grab bar and the wall. There must be a minimum of 1.5" of clearance below and minimum 12" above the grab bar to any dispenser or other obstruction.	3" between bar and wall on both, toilet paper stored on bar	Replace grab bars with ones that provide 1.5" clearance between wall and bar Remount toilet paper dispenser max 7" to 9" from front of toilet, 15" to 48" above the finished floor (AFF) and min 12" above or 1.5" below grab bar, with 1.5" clearance between grab bar and wall.	2015 ABAAS Section: 609.3, 609.4 2012 TAS Section: 609.4, 609.3 2010 ADAS Section: 609.3, 609.4

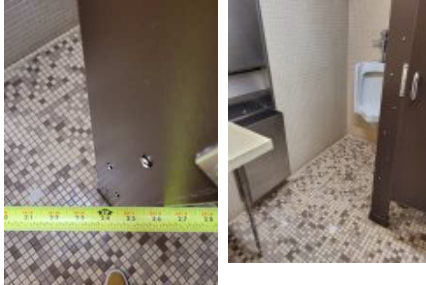
517	Group Rec Bldg: Rec Bldg - Mens Restroom	[31.8593454 , -99.017763]	The route of travel at this location does not provide a minimum width of 36 inches. The clear width shall be permitted to be reduced to 32 inches minimum for a length of 24 inches maximum provided that reduced width segments are separated by segments that are 48 inches long minimum and 36 inches wide minimum.	25" width to urinal due to sink	Widen AR to compliant 36" clear width.	2015 ABAAS Section: 403.5.1 2012 TAS Section: 403.5.1 2010 ADAS Section: 403.5.1

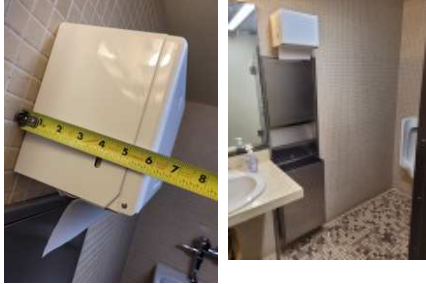
518	Group Rec Bldg: Rec Bldg - Mens Restroom	[31.8593499 , -99.017744 2]	An item or items project more than 4 inches into the circulation path. Wall-mounted objects that have leading edges between 27 inches and 80 inches from the floor must not project more than 4 inches into the circulation path. Protruding objects that extend to the floor or within 27 inches of the floor are cane detectable and are therefore not hazardous. Where it is necessary or desirable to have objects protrude from the wall, a manner of cane detection must be provided.	paper towels project 6"	Relocate protruding objects or place cane detectable warning or bollard at foot of item	2015 ABAAS Section: 307.2 2012 TAS Section: 307.2 2010 ADAS Section: 307.2

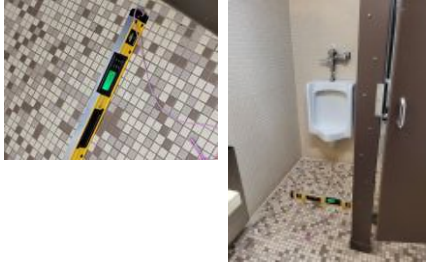
Finding Number	Area Description	Lat/Long	Finding	As Built	Recommendation	Citation	Photos	Figure
519	Group Rec Bldg: Rec Bldg - Mens Restroom	[31.8593476 , -99.017779 1]	The accessible route contains running slopes greater than 5 percent and cross slopes greater than 2 percent across the width of the walk and has not been constructed as a ramp (i.e. handrails, wheel guides, etc.). When the slope in the direction of travel of any walk exceeds 1 unit vertical in 20 units horizontal (5-percent slope), it must be constructed as ramp. Surface cross slopes must not exceed one unit vertical in 48 units. Horizontal (2-percent slope).	4.5% slope in front of urinal	Correct or repair slope to max 5% running and 2.08% cross.	2015 ABAAS Section: 403.3 2012 TAS Section: 403.3 2010 ADAS Section: 403.3

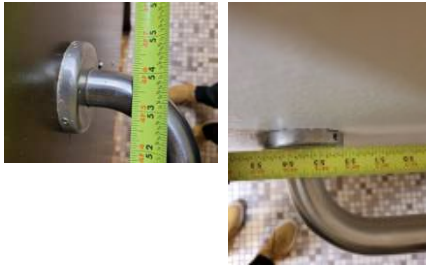
526	Group Rec Bldg: Rec Bldg - Women's Restroom	[31.8593419 , -99.017754 9]	The side grab bars are not in the correct location. Grab bars on the side wall must be installed so that the end closest to the rear wall is maximum 12" from the rear wall. The end furthest from the rear wall must be mounted minimum 54" from the rear wall.	grab bars are 48" in length and extend 53.5" to grab bar end	Replace side grab bar with a 42" long bar mounted to max 12" from the rear wall at the close end and min 54" on the far end, and 33" to 36" aff.	2015 ABAAS Section: 604.5.1 2012 TAS Section: 604.5.1 2010 ADAS Section: 604.5.1

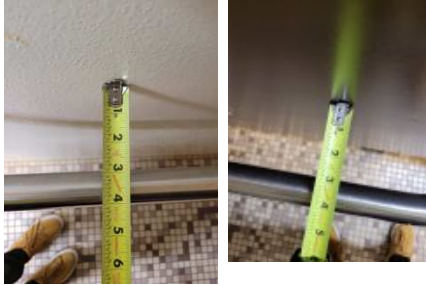
Finding Number	Area Description	Lat/Long	Finding	As Built	Recommendation	Citation	Photos	Figure
527	Group Rec Bldg: Rec Bldg - Women's Restroom	[31.8593362 , -99.017763]	The grab bar height and/or spacing fails. Grab bars must be mounted between 33" and 36" to the top of the gripping surface. There must be 1.5" of clearance between the grab bar and the wall. There must be a minimum of 1.5" of clearance below and minimum 12" above the grab bar to any dispenser or other obstruction.	both have 3" width	Replace both grab bars with ones that provide 1.5" gap between wall and bar Remount toilet paper dispenser max 7" to 9" from front of toilet, 15" to 48" above the finished floor (AFF) and min 12" above or 1.5" below grab bar, providing 1.5" between grab bar and wall.	2015 ABAAS Section: 609.3, 609.4 2012 TAS Section: 609.4, 609.3 2010 ADAS Section: 609.3, 609.4

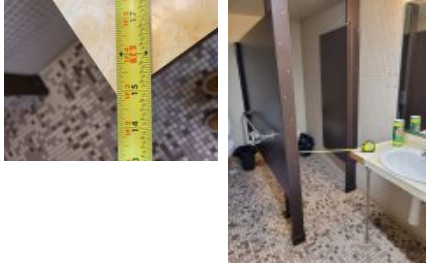
528	Group Rec Bldg: Rec Bldg - Women's Restroom	[31.8593249 , -99.017760 3]	The route of travel at this location does not provide a minimum width of 36 inches. The clear width shall be permitted to be reduced to 32 inches minimum for a length of 24 inches maximum provided that reduced width segments are separated by segments that are 48 inches long minimum and 36 inches wide minimum.	15" to standard stall due to sink	Widen AR to compliant 36" clear width	2015 ABAAS Section: 403.5.1 2012 TAS Section: 403.5.1 2010 ADAS Section: 403.5.1

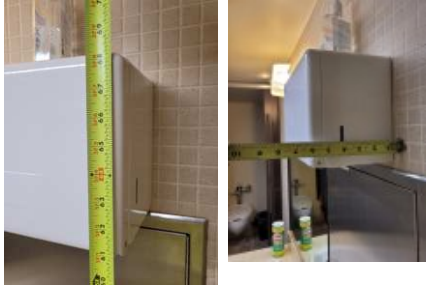
529	Group Rec Bldg: Rec Bldg - Women's Restroom	[31.8593431 , -99.017776 4]	An item or items project more than 4 inches into the circulation path. Wall-mounted objects that have leading edges between 27 inches and 80 inches from the floor must not project more than 4 inches into the circulation path. Protruding objects that extend to the floor or within 27 inches of the floor are cane detectable and are therefore not hazardous. Where it is necessary or desirable to have objects protrude from the wall, a manner of cane detection must be provided.	paper towel projects 6"	Relocate protruding objects or place cane detectable warning or bollard at foot of item	2015 ABAAS Section: 307.2 2012 TAS Section: 307.2 2010 ADAS Section: 307.2

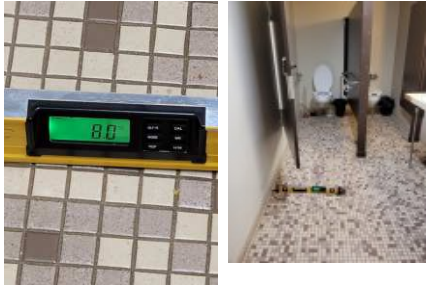
Finding Number	Area Description	Lat/Long	Finding	As Built	Recommendation	Citation	Photos	Figure
530	Group Rec Bldg: Rec Bldg - Women's Restroom	[31.8593271 , -99.017779 1]	The accessible route contains running slopes greater than 5 percent and cross slopes greater than 2 percent across the width of the walk and has not been constructed as a ramp (i.e. handrails, wheel guides, etc.). When the slope in the direction of travel of any walk exceeds 1 unit vertical in 20 units horizontal (5-percent slope), it must be constructed as ramp. Surface cross slopes must not exceed one unit vertical in 48 units. Horizontal (2-percent slope).	8% slope in front of stall	Correct or repair slope to max 5% running and 2.08% cross.	2015 ABAAS Section: 403.3 2012 TAS Section: 403.3 2010 ADAS Section: 403.3

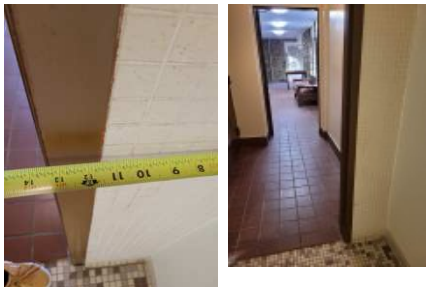
531	Group Rec Bldg: Rec Bldg - Women's Restroom	[31.8593408 , -99.017781 7]	Minimum maneuvering clearances at doors and gates shall comply with 404.2.4. Maneuvering clearances shall extend the full width of the doorway and the required latch side or hinge side clearance. Maneuvering clearances shall have a max slope of 2.08%. All interior doors must be maintained so that the operating pressure does not exceed 5 lb. force to open.	women's restroom door - 15lbf, 13.5" clearance on pull	For all doors along the public circulation route, provide required maneuvering clearance on push and pull side of doors. For all doors along the public circulation route, inspect, adjust, and maintain 5 lbf to open interior doors.	2010 ADAS Section: 404.2.3, 404.2.7, 404.2.4, 404.2.11, 404.2.11 Exception

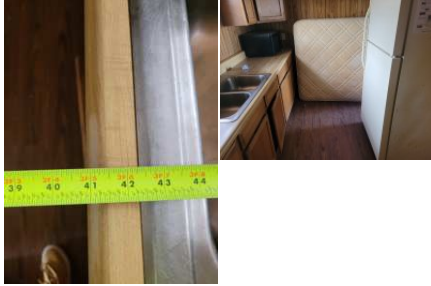
535	Loma Vista Lodge : LV - Public Space	[31.8530894 , -99.0151988]	Combination refrigerators and freezers shall have at least 50 percent of the freezer space 54 inches (1370 mm) maximum above the finish floor or ground. The clear floor or ground space shall be positioned for a parallel approach to the space dedicated to a refrigerator/freezer with the centerline of the clear floor or ground space offset 24 inches (610 mm) maximum from the centerline of the dedicated space.	kitchen- 41" between counter and fridge	Relocate items for required CFS at reifridgator.	2015 ABAAS Section: 804.6.6 2012 TAS Section: 804.6.6 2010 ADAS Section: 804.6.6

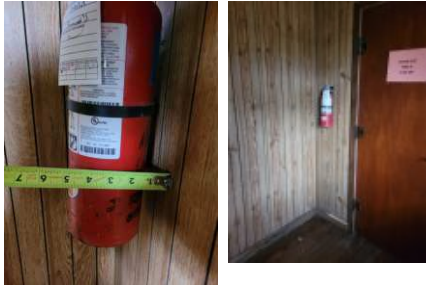
Finding Number	Area Description	Lat/Long	Finding	As Built	Recommendation	Citation	Photos	Figure
536	Loma Vista Lodge : LV - Public Space	[31.8530803 , -99.015204 1]	An item or items project more than 4 inches into the circulation path. Wall-mounted objects that have leading edges between 27 inches and 80 inches from the floor must not project more than 4 inches into the circulation path. Protruding objects that extend to the floor or within 27 inches of the floor are cane detectable and are therefore not hazardous. Where it is necessary or desirable to have objects protrude from the wall, a manner of cane detection must be provided.	kitchen- fire extinguisher projects 4.75"	Relocate protruding objects or place cane detectable warning or bollard at foot of item	2015 ABAAS Section: 307.2 2012 TAS Section: 307.2 2010 ADAS Section: 307.2

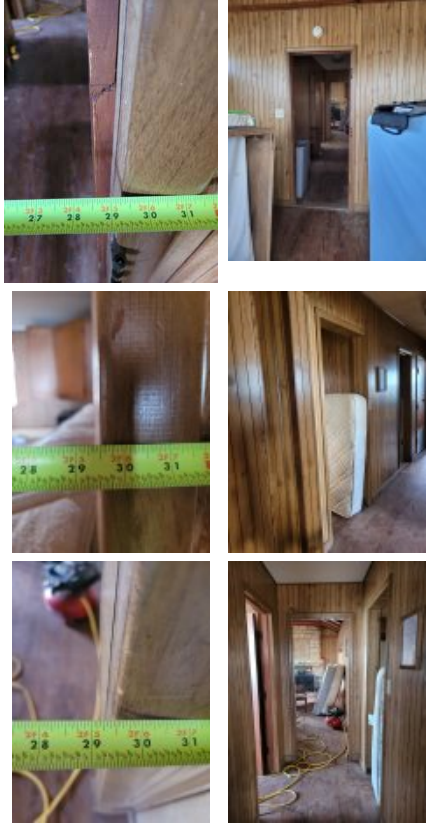
537	Loma Vista Lodge : LV - Public Space	[31.8530894 , -99.015188]	The route of travel at this location does not provide a minimum width of 36 inches. The clear width shall be permitted to be reduced to 32 inches minimum for a length of 24 inches maximum provided that reduced width segments are separated by segments that are 48 inches long minimum and 36 inches wide minimum.	28" width at walkway past entry room, 29" width at kitchen entry, 29.25" into main room	Widen AR to compliant 36" clear width.	2015 ABAAS Section: 403.5.1 2012 TAS Section: 403.5.1 2010 ADAS Section: 403.5.1

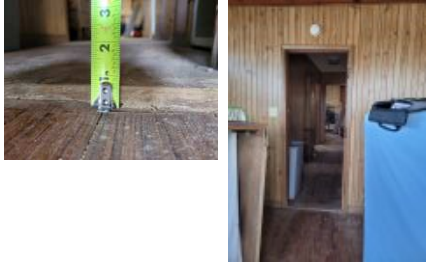
Finding Number	Area Description	Lat/Long	Finding	As Built	Recommendation	Citation	Photos	Figure
538	Loma Vista Lodge : LV - Public Space	[31.8530837, -99.0151894]	There is a change in level greater than 1/4 inch. 1/4 inch is the maximum vertical rise. Changes in level between 1/4 inch and 1/2 inch must be beveled at 1:2 or less. Changes in level greater than 1/2 inch must be by way of a ramp.	.75" change in level at hallway past entry	Repair, bevel or ramp CIL along accessible route (AR) to max .25".	2015 ABAAS Section: 303.3 2012 TAS Section: 303.3 2010 ADAS Section: 303.3

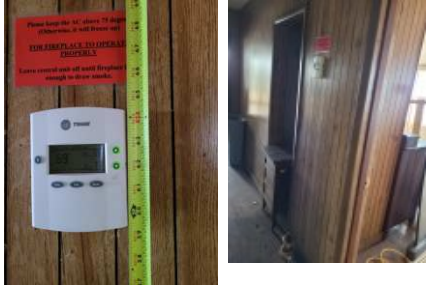
539	Loma Vista Lodge : LV - Public Space	[31.853086, -99.0151787]	The operable part is positioned too high for either a side or front approach. Where a clear floor or ground space allows a parallel approach to an element and the side reach is unobstructed, the high side reach shall be 48 inches maximum and the low side reach shall be 15 inches minimum above the finish floor or ground. Where a forward reach is unobstructed, the high forward reach shall be 48 inches maximum and the low forward reach shall be 15 inches minimum above the finish floor or ground.	thermostat is 62.75" AFF	Remount operable parts to be in reach range of 15" min to 48" max	2015 ABAAS Section: 308.1 2012 TAS Section: 308.1 2010 ADAS Section: 308.1

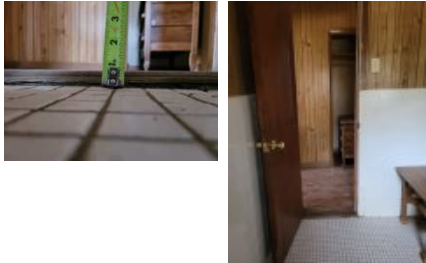
Finding Number	Area Description	Lat/Long	Finding	As Built	Recommendation	Citation	Photos	Figure
544	Loma Vista Lodge : LV - Public Space	[31.8530894 , -99.0151988]	Thresholds, if provided at doorways, shall be 1/2 inch (13 mm) high maximum. Raised thresholds and changes in level at doorways shall comply with 302 and 303. Changes in level of 1/4 inch (6.4 mm) high maximum shall be permitted to be vertical. Changes in level between 1/4 inch (6.4 mm) high minimum and 1/2 inch (13 mm) high maximum shall be beveled with a slope not steeper than 1:2. Changes in level greater than 1/2 inch (13 mm) high shall be ramped, and shall comply with 405 or 406.	restroom- .75" change in level	Repair, bevel or ramp CIL at doorway	2015 ABAAS Section: 303.3, 404.2.5, 303.2, 303.4 2012 TAS Section: 303.3, 404.2.5, 303.2, 303.4 2010 ADAS Section: 303.3, 404.2.5, 303.2, 303.4

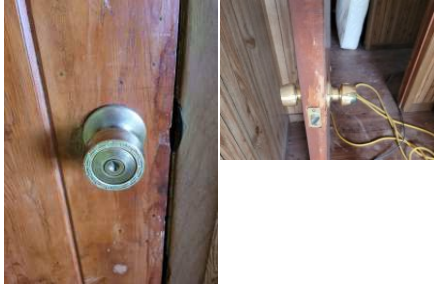
Finding Number	Area Description	Lat/Long	Finding	As Built	Recommendation	Citation	Photos	Figure
547	Loma Vista Lodge : LV - Public Space	[31.8530849 , -99.015204 1]	The door operating hardware is not accessible. Hand-activated door opening hardware, handles, pulls, latches, locks, and other operating devices on accessible doors shall have a shape that is easy to grasp with one hand and does not require tight grasping, tight pinching or twisting of the wrist to operate. Hardware shall be 34 inches minimum and 48 inches maximum above the finish floor or ground.	knob to bedroom, knob to closet	Replace hardware with lever hardware or hardware operable without a tight pinch or grasp	2015 ABAAS Section: 404.2.7 2012 TAS Section: 404.2.7 2010 ADAS Section: 404.2.7
