Access Audit Site Report

Lake Brownwood State Park
200 State Hwy Park Rd 15
Brownwood, TX 76801
Accessibility Evaluation
Inspection Date: 02/28/2022
Inspectors: Tanya Scheibe

Prepared By
WT Group

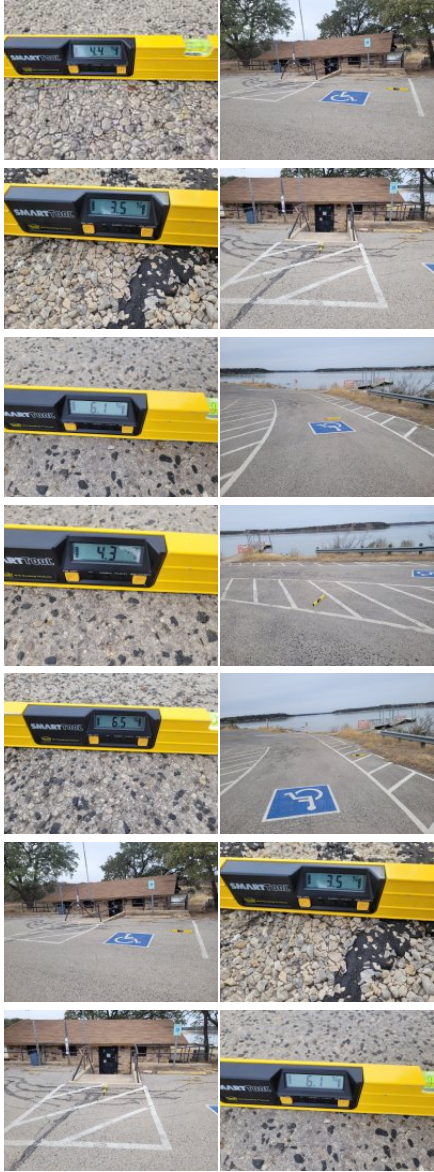
Finding Number	Area Description	Lat/Long	Finding	As Built	Recommendation	Citation	Photos	Figure
562	Boat Ramp Area: Boat Ramps - Parking	[31.861366, -99.019706 2], [31.861448, -99.019207 3]	The cross slopes (narrow dimension) and/or running slopes (long dimension) of the access aisle exceeds 2%. The running slope and the cross slope in an accessible parking stall and the access aisle must not exceed 2%.	boat ramps, park store - 4.4% slope in standard sized stall, 3.5% slope in access aisle, 6.1% slope in trailer stall, 4.3% slope trailer aisle, 6.5% slope in striped walkway/aisle	Repair or correct slope of parking space and access aisle to max 2.08% in any direction.	2015 ABAAS Section: 502.4 2012 TAS Section: 502.4 2010 ADAS Section: 502.4

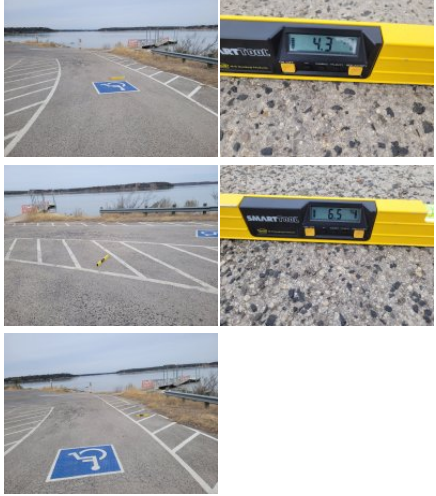
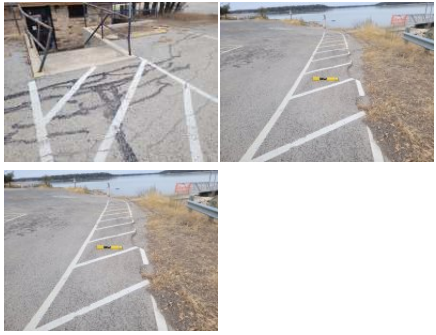
563	Boat Ramp Area: Boat Ramps - Parking	[31.8613376 , -99.019710 3]	The parking stall contains abrupt edges and surface irregularities over a 1/4 inch vertical. Parking spaces and access aisles serving them shall be stable, firm, and slip resistant. Access aisles shall be at the same level as the parking spaces they serve. Changes in level are not permitted and shall not be sloped steeper than 2% in any direction.	boat ramps, park store - stone loose near head of stall, heaving, erosion in walkway aisle	Resurface stalls and access aisles to eliminate gaps and cracks	2015 ABAAS Section: 502.4 2012 TAS Section: 502.4 2010 ADAS Section: 502.4

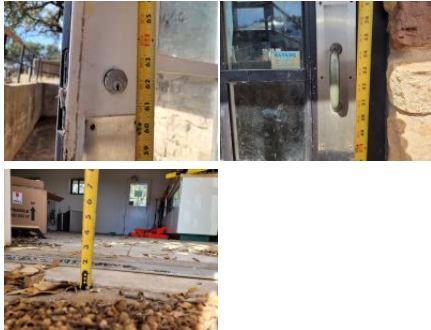
Finding Number	Area Description	Lat/Long	Finding	As Built	Recommendation	Citation	Photos	Figure
567	Boat Ramp Area: Storage (Old Park Store)	[31.861366, -99.019820 2]	Spaces and elements within employee work areas shall only be required to comply with 206.2.8, 207.1, and 215.3 and shall be designed and constructed so that individuals with disabilities can approach, enter, and exit the employee work area. Employee work areas, or portions of employee work areas, other than raised courtroom stations, that are less than 300 square feet (28 m2) and elevated 7 inches (180 mm) or more above the finish floor or ground where the elevation is essential to the function of the space shall not be required to comply with these requirements or to be on an accessible route.	entry from parking - lock and handle high, 13lbf, 1.5" CIL	For employee spaces, relocate storage, furniture, and other obstacles at doorways to provide approach, enter and exit at the employee space. Remount hardware to be 34" to 48" AFF. Inspect, adjust, and maintain 8.5 lbf to open exterior doors as a smart practice. Repair, bevel, or ramp CILs at door entries to max .25".	2015 ABAAS Section: F203.9 2012 TAS Section: 203.9 2010 ADAS Section: 203.9

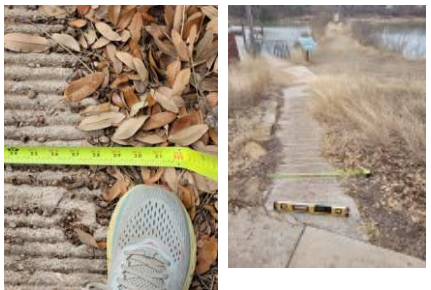
573	Boat Ramp Area: Boat Ramps - Old Park Store	[31.8613176 , -99.019887 3]	The route of travel at this location does not provide the required minimum width. The minimum clear width for sidewalks and walks is 36 inches.	29" width to path to pier behind storage	Widen EAR to min 36" clear width	2015 ABAAS Section: 403.5.1 2012 TAS Section: 403.5.1 2010 ADAS Section: 403.5.1

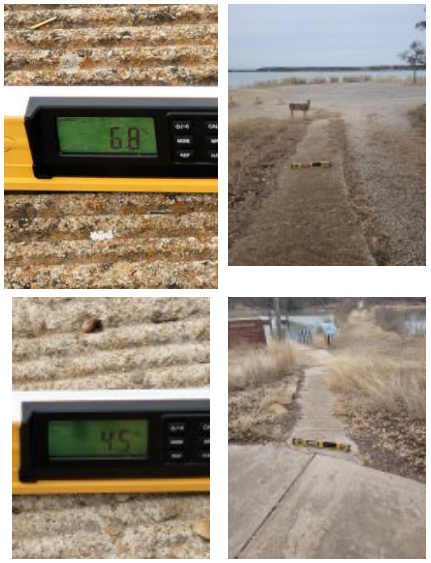
574	Boat Ramp Area: Boat Ramps - Old Park Store	[31.8613182 , -99.01988 53], [31.8614959 , -99.019851 7]	The accessible route of travel contains cross slopes greater than 2%. Cross slopes shall not exceed one unit vertical in 48 units horizontal (2-percent slope).	6.8% slope on path to pier/bridge, 4.5% cross slope at top of path to pier behind storage	Correct or repair cross slope along AR to max 2.08%.	2015 ABAAS Section: 403.3 2012 TAS Section: 403.3 2010 ADAS Section: 403.3

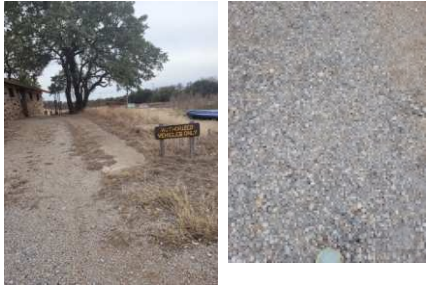
Finding Number	Area Description	Lat/Long	Finding	As Built	Recommendation	Citation	Photos	Figure
575	Boat Ramp Area: Boat Ramps - Old Park Store	[31.8614947 , -99.019851 1]	There is no accessible route to the bridge or pier. At least one accessible route shall connect accessible buildings, accessible facilities, accessible elements, and accessible spaces that are on the same site.	no AR to path by bridge and pier	Create an accessible route with crushed stone or other outdoor material from parking or walkway to bridge or pier	2015 ABAAS Section: F206.2.2 2012 TAS Section: 206.2.2 2010 ADAS Section: 206.2.2

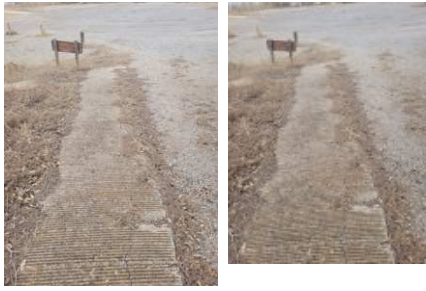
577	Boat Ramp Area: Boat Ramps - Old Park Store	[31.8614879 , -99.019849 7]	The accessible route contains loose gravel and/or surfaces that do not provide for a stable, firm slip resistant surface.	deterioration at path to storage by bridge	Resurface AR where deterioration occurs	2015 ABAAS Section: 302.1 2012 TAS Section: 302.1 2010 ADAS Section: 302.1

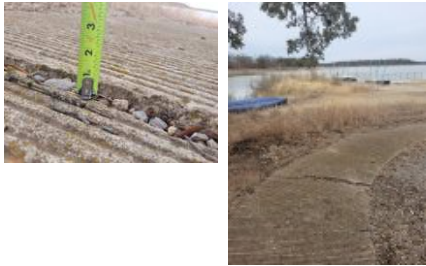
578	Boat Ramp Area: Boat Ramps - Old Park Store	[31.8614013 , -99.019861 8]	The walkway contains abrupt vertical edges and/or variations over a 1/4 inch. 1/4 inch is the maximum vertical rise. Changes in level between 1/4 inch and 1/2 inch must be beveled at 1:2 or less. Changes in level greater than 1/2 inch must be by way of a ramp.	1" CIL behind storage building by bridge	Repair, bevel or ramp CIL along AR	2012 TAS Section: 303.2, 303.3 2010 ADAS Section: 303.2, 303.3

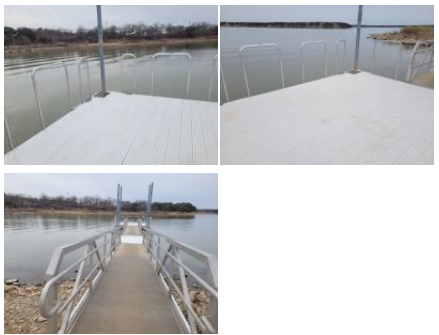
Finding Number	Area Description	Lat/Long	Finding	As Built	Recommendation	Citation	Photos	Figure
579	Boat Ramp Area: Boat Ramps	[31.8617727 , -99.020252 7]	The boat slip/pier does not provide the required clear opening at the edge of the pier. Boat slips and boarding piers at boat launch ramps shall provide clear pier space 60 inches wide minimum and at least as long as the boat slip/boarding pier. Each 10 feet maximum of linear pier edge serving boat slips/boarding piers shall contain at least one continuous clear opening 60 inches wide minimum.	lower pier has 8 tie offs, lacks 60" wide openings	Provide 60" wide openings on boarding pier	2015 ABAAS Section: 1003.3.1, 1003.3.2 2012 TAS Section: 1003.3.1, 1003.3.2 2010 ADAS Section: 1003.3.1, 1003.3.2

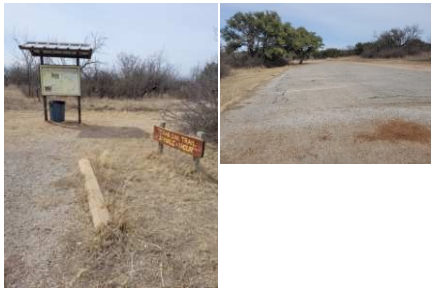
583	Trails: Trailhead Parking	[31.8578076, -99.0303828]	There are no or not enough accessible parking stalls. Each lot where parking is provided for the public as clients, guests or employees, shall provide accessible parking and shall be located on the shortest accessible route of travel from adjacent parking to an accessible entrance. There are a total of 10 parking stalls in the parking lot that could be reasonably associated with this facility. There should be a minimum of 1 accessible stalls with a minimum of 1 being designed as van accessible.	0 of 10 stalls accessible at Texas Oak trail head	Create one or more 8' accessible parking stalls, with one 5' adjacent access aisle, with proper signage and striping based on the total number of stalls.	2015 ABAAS Section: F208.2 2012 TAS Section: 208.2 2010 ADAS Section: 208.2

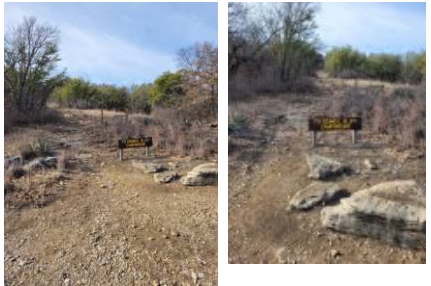
584	Trails: Trail Surface	[31.861669, -99.0267859]	The surface of trails, passing spaces, and resting intervals shall be firm and stable	Council Bluff Trail - not accessible surface	Establish protocols for regular and frequent inspection and maintenance of accessible trail surface as a smart practice. Frequently maintain trail surface in identified washout areas to assure CIL's remain 2" or less and gaps are filled as a smart practice. Replace surface of trail with one that is firm and stable as a smart practice.	2015 ABAAS Section: 1017.2

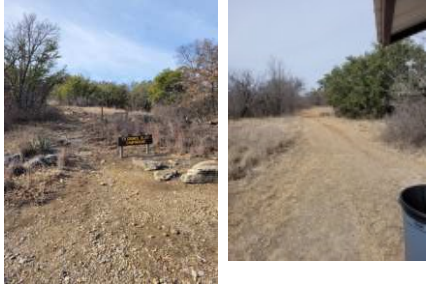
587	Trails: Trail Surface	[31.8619105 , -99.027040 7]	The surface of trails, passing spaces, and resting intervals shall be firm and stable	Texas Oak Trail by pier not accessible due to surface	Replace surface of trail with one that is firm and stable as a smart practice.	2015 ABAAS Section: 1017.2
