Access Audit Site Report

Lake Colorado City State Park

Accessibility Evaluation

Inspection Date: 12/13/2021

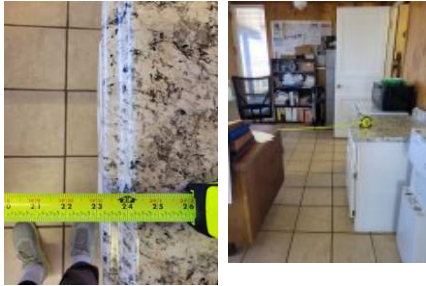
Finding Number	Area Description	Lat/Long	Finding	As Built	Recommendation	Citation	Photos	Figure
10	Headquarters : Employee Spaces	[32.31572, -100.9417]	Employee Work Areas. Common use circulation paths within employee work areas shall comply with 402. EXCEPTIONS: 1. Common use circulation paths located within employee work areas that are less than 1000 square feet (93 m2) and defined by permanently installed partitions, counters, casework, or furnishings shall not be required to comply with 402. 2. Common use circulation paths located within employee work areas that are an integral component of work area equipment shall not be required to comply with 402. 3. Common use circulation paths located within exterior employee work areas that are fully exposed to the weather shall not be required to comply with 402.	23" between desk and counter	Make corrections for compliant circulation path. Widen passage to employee area to min. 32" clear width.	2015 ABAAS Section: F206.2.8, F206.2.8.1, F206.2.8.2 2012 TAS Section: 206.2.8, 206.2.8 Exception 1, 206.2.8 Exception 2, 206.2.8 Exception 3, 206.2.8 Advisory 1, 206.2.8 Advisory 2 2010 ADAS Section: 206.2.8, 206.2.8 Exception 1, 206.2.8 Exception 2, 206.2.8 Exception 3

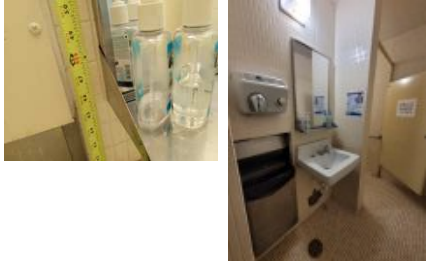
16	Headquarters : HQ Women's Restroom	[32.31572, -100.9417]	The mirror is mounted too high. Mirrors must have the bottom edge of the reflecting surface a maximum of 40 inches above the floor if above a sink or counter. Mirrors not located above lavatories or countertops shall be installed with the bottom edge of the reflecting surface 35 inches maximum above the finish floor or ground.	Women's Restroom - mirror 46" aff	Lower mirror so reflective surface is max 40" aff	2015 ABAAS Section: 603.3 2012 TAS Section: 603.3 2010 ADAS Section: 603.3

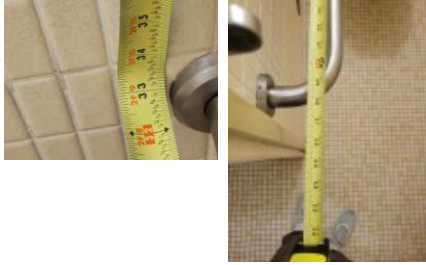
Finding Number	Area Description	Lat/Long	Finding	As Built	Recommendation	Citation	Photos	Figure
19	Headquarters : HQ Women's Restroom	[32.31572, -100.9417]	The ambulatory stall is not between 35" to 37" wide and 60" deep.	Women's Restroom - 33" x 51.75"	Correct ambulatory stall to be 35" to 37" wide and minimum 60" deep or use existing stall to create required wheelchair stall.	2015 ABAAS Section: 604.8.2.1 2012 TAS Section: 604.8.2.1 2010 ADAS Section: 604.8.2.1

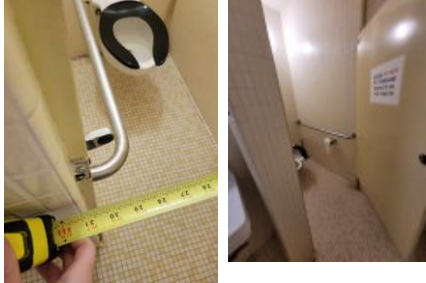
20	Headquarters : HQ Women's Restroom	[32.31572, -100.9417]	The stall door fails to comply with all of the door requirements. The stall door must be a minimum of 32" wide and have compliant hardware on both sides. The stall door must be self-closing.	Women's Restroom - 30" width	Widen stall doors to 32" when opened to 90 degrees.	2015 ABAAS Section: 404.2.3, 404.2.7, 604.8.2.2 2012 TAS Section: 404.2.3, 404.2.7, 604.8.2.2 2010 ADAS Section: 404.2.3, 404.2.7, 604.8.2.2

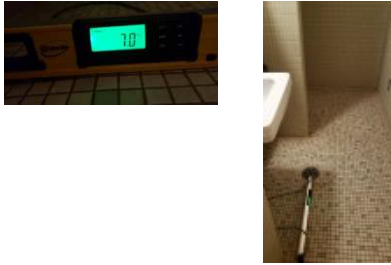
Finding Number	Area Description	Lat/Long	Finding	As Built	Recommendation	Citation	Photos	Figure
24	Headquarters : HQ Men's Restroom	[32.31572, -100.9417]	The accessible route contains running slopes greater than 5 percent and cross slopes greater than 2 percent across the width of the walk and has not been constructed as a ramp (i.e. handrails, wheel guides, etc.). When the slope in the direction of travel of any walk exceeds 1 unit vertical in 20 units horizontal (5-percent slope), it must be constructed as ramp. Surface cross slopes must not exceed one unit vertical in 48 units. Horizontal (2-percent slope).	Men's Restroom - 7% slope at drain	Correct or repair slope to max 2.08%.	2015 ABAAS Section: 403.3 2012 TAS Section: 403.3 2010 ADAS Section: 403.3

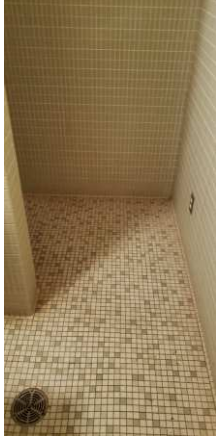
25	Headquarters : HQ Men's Restroom	[32.31572, -100.9417]	There is insufficient turning space within this room or space. The space required for a wheelchair to make a 180-degree turn is a clear space of 60 inches in diameter or a T-shaped space.	Men's Restroom - no turning space	Reconfigure restroom to provide required turning space if feasible. This may require creation of a single user restroom.	2015 ABAAS Section: 304.3.1, 304.3.2 2012 TAS Section: 304.3.1, 304.3.2 2010 ADAS Section: 304.3.1, 304.3.2

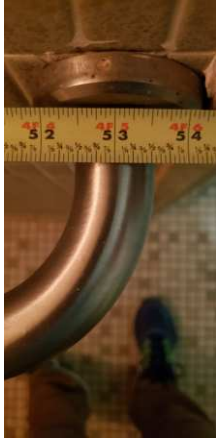
Finding Number	Area Description	Lat/Long	Finding	As Built	Recommendation	Citation	Photos	Figure
28	Headquarters : HQ Men's Restroom	[32.31572, -100.9417]	The side grab bars are not in the correct location. Grab bars on the side wall must be installed so that the end closest to the rear wall is maximum 12" from the rear wall. The end furthest from the rear wall must be mounted minimum 54" from the rear wall.	Men's Restroom - grab bar extends 53" from rear wall	Replace and remount side grab bar to max 12" from the rear wall at the close end and min 54" on the far end, and 33" to 36" aff and having a gap of 1.5" between the bar and wall.	2015 ABAAS Section: 604.5.1 2012 TAS Section: 604.5.1 2010 ADAS Section: 604.5.1

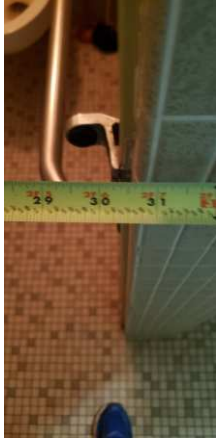
29	Headquarters : HQ Men's Restroom	[32.31572, -100.9417]	The stall door fails to comply with all of the door requirements. The stall door must be a minimum of 32" wide and have compliant hardware on both sides. The stall door must be self-closing.	Men's Restroom - 30.5" wide, not self closing	Widen stall doors to 32" when opened to 90 degrees Adjust stall door to be self-closing	2015 ABAAS Section: 404.2.3, 404.2.7, 604.8.2.2 2012 TAS Section: 404.2.3, 404.2.7, 604.8.2.2 2010 ADAS Section: 404.2.3, 404.2.7, 604.8.2.2

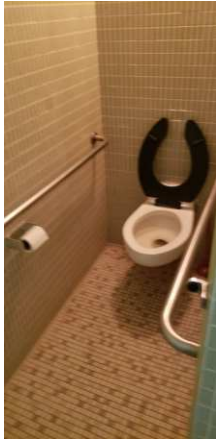
Finding Number	Area Description	Lat/Long	Finding	As Built	Recommendation	Citation	Photos	Figure
32	Headquarters : HQ Men's Restroom	[32.31572, -100.9417]	There are not enough accessible toilet compartments. The room contains toilet compartments. A minimum of 1 must be wheelchair accessible .	Men's Restroom - lacks wheelchair accessible stall, ambulatory only	Create a wheelchair accessible stall with grab bars and fixtures mounted in correct locations and at correct heights.	2015 ABAAS Section: F213.3.1 2012 TAS Section: 213.3.1 2010 ADAS Section: 213.3.1

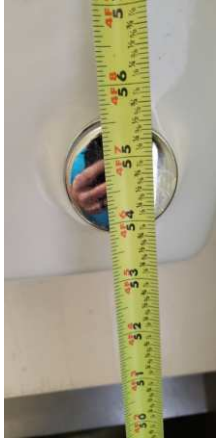
33	Headquarters : HQ Men's Restroom	[32.31572, -100.9417]	Where a high forward reach is over an obstruction, the clear floor space shall extend beneath the element for a distance not less than the required reach depth over the obstruction. The high forward reach shall be 48 inches (1220 mm) maximum where the reach depth is 20 inches (510 mm) maximum. Where the reach depth exceeds 20 inches (510 mm), the high forward reach shall be 44 inches (1120 mm) maximum and the reach depth shall be 25 inches (635 mm) maximum.	Men's Restroom - hand dryer 54" aff	Lower operating mechanisms in Men's HQ Restroom to max 48" aff to highest operable par, leave as is if installed prior to March 15, 2012 citing safe harbor.	2015 ABAAS Section: 308.2.1, 308.3.2 2012 TAS Section: 308.2.1, 308.3.2 2010 ADAS Section: 308.2.1, 308.3.2

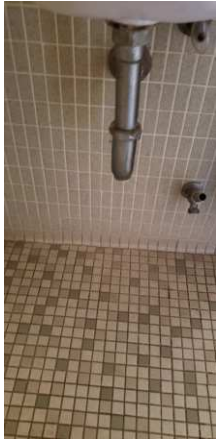
Finding Number	Area Description	Lat/Long	Finding	As Built	Recommendation	Citation	Photos	Figure
34	Headquarters : HQ Men's Restroom	[32.31572, -100.9417]	The water and drain pipes under the lavatory are not adequately insulated. Water supply and drain pipes under lavatories and sinks shall be insulated or otherwise configured to protect against contact. There shall be no sharp or abrasive surfaces under lavatories and sinks.	Men's Restroom - sink pipes lack insulation	Insulate exposed pipes under one sink	2015 ABAAS Section: 606.5 2012 TAS Section: 606.5 2010 ADAS Section: 606.5

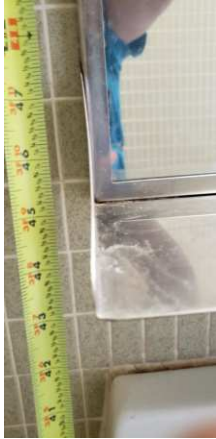
Finding Number	Area Description	Lat/Long	Finding	As Built	Recommendation	Citation	Photos	Figure
36	Headquarters : HQ Men's Restroom	[32.31572, -100.9417]	The mirror is mounted too high. Mirrors must have the bottom edge of the reflecting surface a maximum of 40 inches above the floor if above a sink or counter. Mirrors not located above lavatories or countertops shall be installed with the bottom edge of the reflecting surface 35 inches maximum above the finish floor or ground.	Men's Restroom - mirror at 45.5" aff	Lower mirror so reflective surface is max 40" aff.	2015 ABAAS Section: 603.3 2012 TAS Section: 603.3 2010 ADAS Section: 603.3

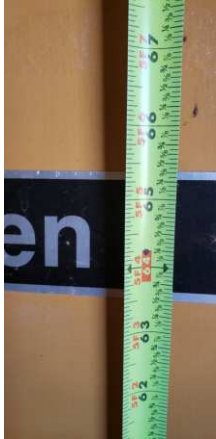
37	Headquarters : HQ Men's Restroom	[32.31572, -100.9417]	The restroom sign does not comply with one or more applicable requirements for the location, height, and properties of the sign.	Men's Restroom - sign mounted 64" on door, no Braille	Replace sign with one of contrasting colors that includes Braille, raised characters, and the symbol of accessibility and mount on the wall, latch side of the door, 48" to the baseline of the lowest character and 60" to the baseline of the highest character	2015 ABAAS Section: F216.2, 703.1, 703.2, 703.5, 703.6 2012 TAS Section: 216.2, 703.1, 703.2, 703.5, 703.6 2010 ADAS Section: 216.2, 703.1, 703.2, 703.5, 703.6

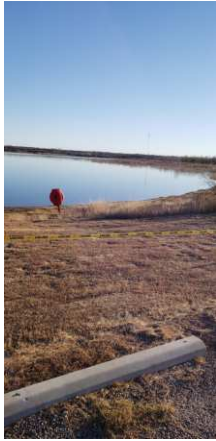
Finding Number	Area Description	Lat/Long	Finding	As Built	Recommendation	Citation	Photos	Figure
39	Park Site: Park Elements	[32.31572, -100.9417]	The surface of beach access routes and resting intervals shall be firm and stable	no accessible route (AR) to swimming area	Create a beach access route of a firm and stable material as a smart practice.	2015 ABAAS Section: 1018.3

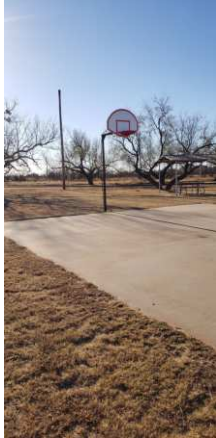
40	Park Site: Park Elements	[32.3386183, -100.9293229]	There is no accessible route to the basketball court. At least one accessible route shall connect accessible buildings, accessible facilities, accessible elements, and accessible spaces that are on the same site.	No accessible route to Sport court. Court surface is smooth, level, and free of gaps and CILs.	Create an accessible route with crushed stone or other outdoor material from parking or walkway to basketball court.	2015 ABAAS Section: F206.2.2 2012 TAS Section: 206.2.2 2010 ADAS Section: 206.2.2

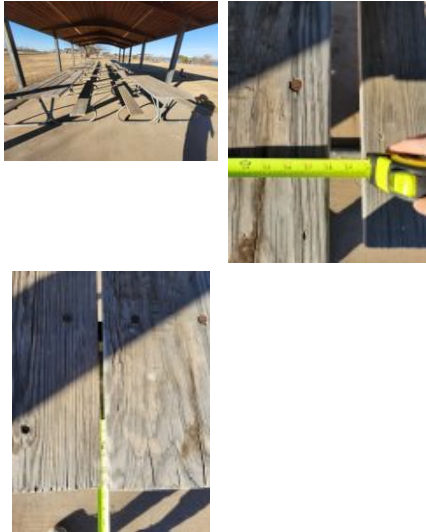
Finding Number	Area Description	Lat/Long	Finding	As Built	Recommendation	Citation	Photos	Figure
42	Park Site: Park Elements	[32.3385243, -100.9294919]	Picnic tables shall provide at least one wheelchair space for each 24 linear feet (7320 mm) of usable table surface perimeter. Wheelchair spaces shall be 30 inches (760 mm) minimum by 48 inches (1220 mm) minimum. Wheelchair spaces shall be positioned for a forward approach to the table and provide knee and toe clearance complying with 306 under the table	Group shelter at boat ramp - 0 of 10 accessible	Replace two picnic tables with ones of an accessible design as a smart practice	2015 ABAAS Section: 1011.4.2

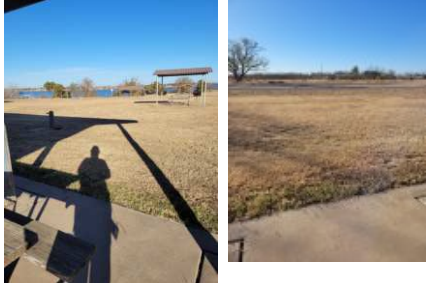
43	Park Site: Park Elements	[32.3385243, -100.9294772]	Picnic facilities shall provide outdoor recreation access routes complying with 1016 in accordance with F245.4 and 245.4 of IAC	Group shelter at boat ramp - no route to shelter	Create ORAR with crushed and compacted stone or similar outdoor material from parking or sidewalk to shelter or picnic area as a smart practice.	2015 ABAAS Section: F245.4

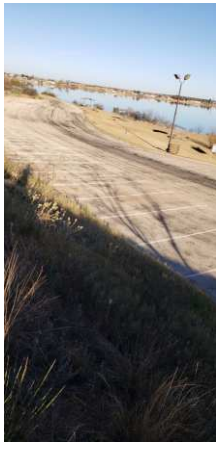
49	Park Site: Boat Ramp	[32.3390154 , -100.9288985]	There are no accessible parking stalls. Each lot where parking is provided for the public as clients, guests or employees, shall provide accessible parking and shall be located on the shortest accessible route of travel from adjacent parking to an accessible entrance. There are a total of 28 parking stalls in the parking lot that could be reasonably associated with this facility. There should be a minimum of 2 accessible stalls with a minimum of 1 being designed as van accessible.	Boat Ramp Parking has 0 of 28 accessible stalls	Create one or more 8' accessible parking stalls, with one 5' adjacent access aisle, with proper signage and striping based on the total number of stalls	2015 ABAAS Section: F208.2 2012 TAS Section: 208.2 2010 ADAS Section: 208.2

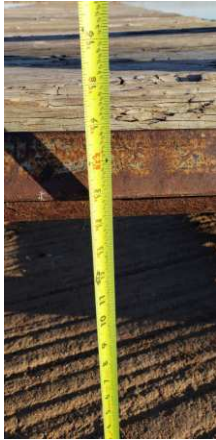
Finding Number	Area Description	Lat/Long	Finding	As Built	Recommendation	Citation	Photos	Figure
50	Park Site: Boat Ramp	[32.31572, -100.9417]	The minimum number of boarding piers are not accessible. Where boarding piers are provided at boat launch ramps, at least 5 percent, but no fewer than one, of the boarding piers be accessible.	28" CIL at boarding Pier	Provide 5%, but not less than one accessible boarding pier at boat launches. Provide a ramp for access to the pier.	2015 ABAAS Section: F235.3 2010 ADAS Section: 235.3

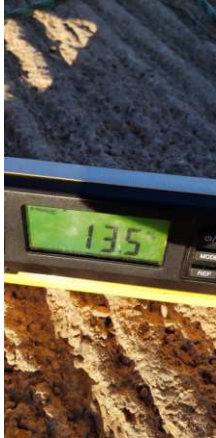
51	Park Site: Boat Ramp	[32.31572, -100.9417]	The running slope of walking surfaces shall not be steeper than 1:20.	13.5% slope	Correct running slope along the route to the pier to max 5%	2015 ABAAS Section: 403.3 2012 TAS Section: 403.3 2010 ADAS Section: 403.3

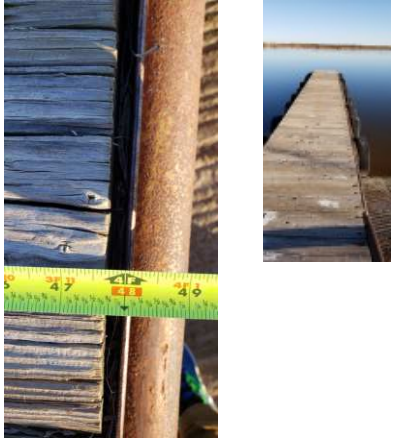
Finding Number	Area Description	Lat/Long	Finding	As Built	Recommendation	Citation	Photos	Figure
52	Park Site: Boat Ramp	[32.31572, -100.9417]	The boat slip/pier is not wide enough. Boat slips and boarding piers shall provide clear pier space 60 inches wide minimum and at least as long as the boat slips/boarding pier. Each 10 feet maximum of linear pier edge serving boat slips and boarding piers shall contain at least one continuous clear opening 60 inches wide minimum. The clear width shall be permitted to be reduced to 36 inches minimum for a length of 24 inches maximum provided that reduced width segments are separated by segments that are 60 inches long minimum and 60 inches wide minimum.	boarding pier 48" wide	Provide 60" wide clearance at accessible slips and a 60" wide opening every 10'.	2015 ABAAS Section: 1003.3.1 2012 TAS Section: 1003.3.1 2010 ADAS Section: 1003.3.1

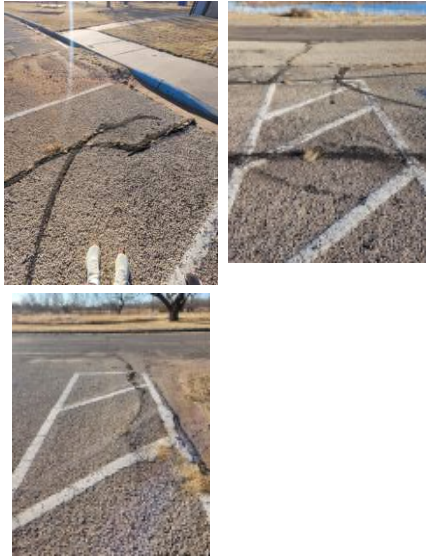
Finding Number	Area Description	Lat/Long	Finding	As Built	Recommendation	Citation	Photos	Figure
58	Park Site: Restroom 5 Parking	[32.3387282, -100.9289622]	The parking stall contains abrupt edges and surface irregularities over a 1/4 inch vertical. Parking spaces and access aisles serving them shall be stable, firm, and slip resistant. Access aisles shall be at the same level as the parking spaces they serve. Changes in level are not permitted and shall not be sloped steeper than 2% in any direction.	Boat ramp restroom/ restroom 5 - water side - cracks in access aisle and stall. not water side - cracks in access aisle	Resurface accessible stalls and access aisles with a firm, stable, and slip resistant material	2015 ABAAS Section: 502.4 2012 TAS Section: 502.4 2010 ADAS Section: 502.4

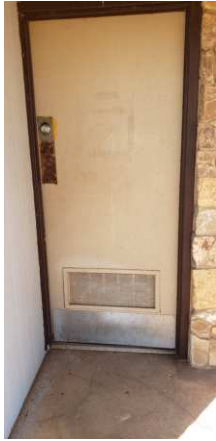
Finding Number	Area Description	Lat/Long	Finding	As Built	Recommendation	Citation	Photos	Figure
60	Park Site: Restroom Building 5 Boat Ramp - Women's	[32.31572, -100.9417]	Minimum maneuvering clearances at doors and gates shall comply with 404.2.4. Maneuvering clearances shall extend the full width of the doorway and the required latch side or hinge side clearance. The sweep period for doors with closers shall be adjusted so that from an open position of 70 degrees, the door will take at least 3 seconds to move to a point 3 inches from the latch, measured to the leading edge of the door. Exterior doors are recommended to be maintained at 8.5 lbf as a smart practice. Force is to be measured at the operating hardware or 30 inches from the hinges, whichever is greater.	Women's Restroom Door - wall in push side clearance, 25# push, fast close	For all doors along the public circulation route, provide required maneuvering clearance on push and pull side of doors For all doors along the public circulation route, inspect, adjust, and maintain closing speed on door closers For all doors along the public circulation route, inspect, adjust, and maintain 8.5 lbf to open exterior doors as a smart practice	2010 ADAS Section: 404.2.3, 404.2.7, 404.2.4, 404.2.11, 404.2.11 Exception

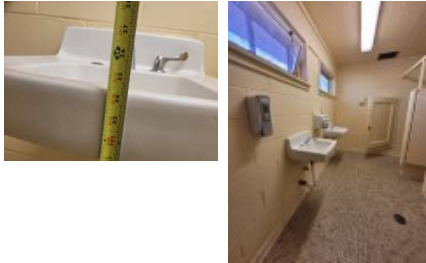
Finding Number	Area Description	Lat/Long	Finding	As Built	Recommendation	Citation	Photos	Figure
63	Park Site: Restroom Building 5 Boat Ramp - Women's	[32.31572, -100.9417]	The top rim of the sink is too high. All lavatories/sinks that are designated to be accessible shall be a minimum 17 inches in horizontal depth and mounted with the rim or counter edge no higher than 34 inches above the finished floor.	Women's Restroom - sink rim is 34.5" aff	Lower sinks to max 34" aff to front of rim, in the alternative, leave as is citing construction tolerance.	2015 ABAAS Section: 606.3 2012 TAS Section: 606.3 2010 ADAS Section: 606.3

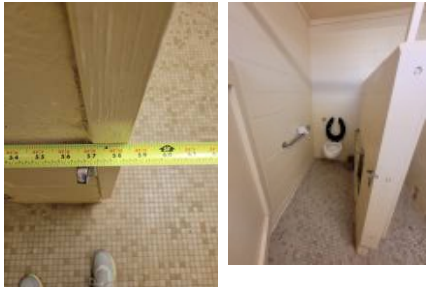
64	Park Site: Restroom Building 5 Boat Ramp - Women's	[32.31572, -100.9417]	The ambulatory stall is not between 35" to 37" wide and 60" deep.	Women's Restroom - 57" depth	Correct ambulatory stall to be 35" to 37" wide and minimum 60" deep, in the alternative, use existing stall to create required wheelchair stall.	2015 ABAAS Section: 604.8.2.1 2012 TAS Section: 604.8.2.1 2010 ADAS Section: 604.8.2.1

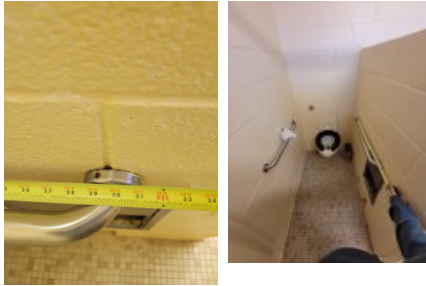
Finding Number	Area Description	Lat/Long	Finding	As Built	Recommendation	Citation	Photos	Figure
66	Park Site: Restroom Building 5 Boat Ramp - Women's	[32.31572, -100.9417]	Grab bars shall comply with 609. A side-wall grab bar complying with 604.5.1 shall be provided on both sides of the compartment. The space between the wall and the grab bar shall be 1½ inches (38 mm). The space between the grab bar and projecting objects below and at the ends shall be 1½ inches (38 mm) minimum. The space between the grab bar and projecting objects above shall be 12 inches (305 mm) minimum. Grab bars shall be installed in a horizontal position, 33 inches (840 mm) minimum and 36 inches (915 mm) maximum above the finish floor measured to the top of the gripping surface, except that at water closets for children's use complying with 604.9, grab bars shall be installed in a horizontal position 18 inches (455 mm) minimum and 27 inches (685 mm) max	Women's Restroom - grab bars are both 30" in length	Replace grab bars with a 42" long grab bar, mounted max 12" from the rear wall at the close end and min 54" on the far end and 33" to 36" aff.	2015 ABAAS Section: 604.8.2.3, 609.3, 609.4 2012 TAS Section: 609.4, 609.3, 604.8.2.3 2010 ADAS Section: 609.3, 609.4, 604.8.2.3

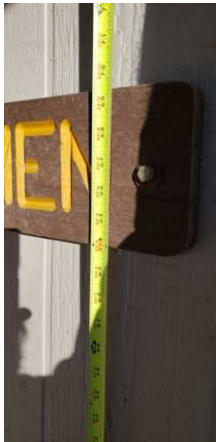
70	Park Site: Restroom Building 5 Boat Ramp - Men's	[32.31572, -100.9417]	The restroom sign does not comply with one or more applicable requirements for the location, height, and properties of the sign.	Men's Restroom - 65" high, no Braille, not adjacent to door, no ISA	Replace sign with one of contrasting colors that includes Braille, raised characters, and the symbol of accessibility and mount on the wall, latch side of the door, 48" to the baseline of the lowest character and 60" to the baseline of the highest character	2015 ABAAS Section: F216.2, 703.1, 703.2, 703.5, 703.6 2012 TAS Section: 216.2, 703.1, 703.2, 703.5, 703.6 2010 ADAS Section: 216.2, 703.1, 703.2, 703.5, 703.6

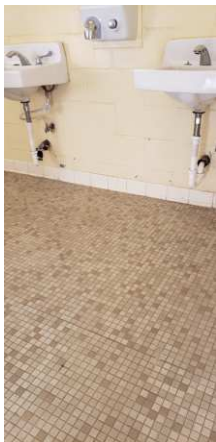
Finding Number	Area Description	Lat/Long	Finding	As Built	Recommendation	Citation	Photos	Figure
71	Park Site: Restroom Building 5 Boat Ramp - Men's	[32.31572, -100.9417]	The water and drain pipes under the lavatory are not adequately insulated. Water supply and drain pipes under lavatories and sinks shall be insulated or otherwise configured to protect against contact. There shall be no sharp or abrasive surfaces under lavatories and sinks.	Men's Restroom - sink pipes lack insulation	Insulate exposed pipes under one sink.	2015 ABAAS Section: 606.5 2012 TAS Section: 606.5 2010 ADAS Section: 606.5

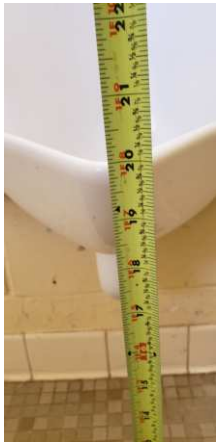
72	Park Site: Restroom Building 5 Boat Ramp - Men's	[32.31572, -100.9417]	The rim of the urinal is too high. Wall-hung urinals must be provided with an elongated rim projecting a minimum of 13 1/2 inches from the wall and a maximum of 17 inches above the floor.	Men's Restroom - low urinal, 20" to rim	Lower urinal so that rim height is max 17" aff	2015 ABAAS Section: 605.2 2012 TAS Section: 605.2 2010 ADAS Section: 605.2

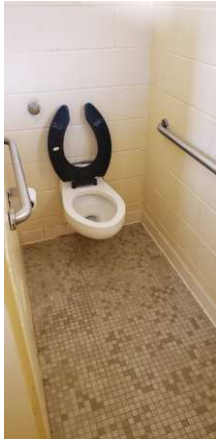
Finding Number	Area Description	Lat/Long	Finding	As Built	Recommendation	Citation	Photos	Figure
73	Park Site: Restroom Building 5 Boat Ramp - Men's	[32.31572, -100.9417]	There are not enough accessible toilet compartments. The room contains toilet compartments. A minimum of 1 must be wheelchair accessible .	Men's Restroom - no wheelchair accessible compartment, ambulatory only	Create a wheelchair accessible stall with grab bars and fixtures mounted in correct locations and at correct heights.	2015 ABAAS Section: F213.3.1 2012 TAS Section: 213.3.1 2010 ADAS Section: 213.3.1

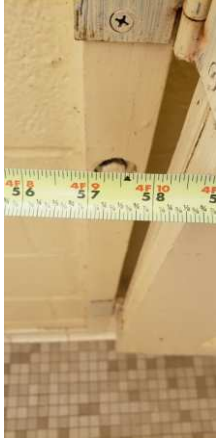
74	Park Site: Restroom Building 5 Boat Ramp - Men's	[32.31572, -100.9417]	The ambulatory stall is not between 35" to 37" wide and 60" deep.	Men's Restroom - ambulatory stall 57" deep	Correct ambulatory stall to be 35" to 37" wide and minimum 60" deep, in the alternative, use existing stall to create required wheelchair stall.	2015 ABAAS Section: 604.8.2.1 2012 TAS Section: 604.8.2.1 2010 ADAS Section: 604.8.2.1

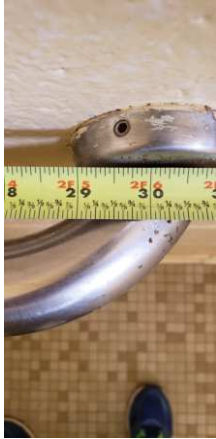
Finding Number	Area Description	Lat/Long	Finding	As Built	Recommendation	Citation	Photos	Figure
75	Park Site: Restroom Building 5 Boat Ramp - Men's	[32.31572, -100.9417]	Grab bars shall comply with 609. A side-wall grab bar complying with 604.5.1 shall be provided on both sides of the compartment. The space between the wall and the grab bar shall be 1½ inches (38 mm). The space between the grab bar and projecting objects below and at the ends shall be 1½ inches (38 mm) minimum. The space between the grab bar and projecting objects above shall be 12 inches (305 mm) minimum. Grab bars shall be installed in a horizontal position, 33 inches (840 mm) minimum and 36 inches (915 mm) maximum above the finish floor measured to the top of the gripping surface, except that at water closets for children's use complying with 604.9, grab bars shall be installed in a horizontal position 18 inches (455 mm) minimum and 27 inches (685 mm) max	Men's Restroom - 30" grab bars	Replace or add side grab bars with a 42" long grab bar, mounted max 12" from the rear wall at the close end and min 54" on the far end and 33" to 36" aff.	2015 ABAAS Section: 604.8.2.3, 609.3, 609.4 2012 TAS Section: 609.4, 609.3, 604.8.2.3 2010 ADAS Section: 609.3, 609.4, 604.8.2.3

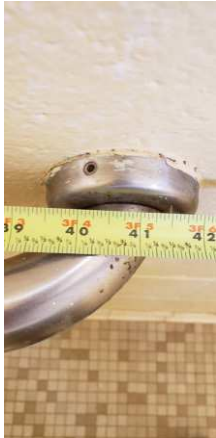
76	Park Site: Restroom Building 5 Boat Ramp - Men's	[32.31572, -100.9417]	The side grab bars are not in the correct location. Grab bars on the side wall must be installed so that the end closest to the rear wall is maximum 12" from the rear wall. The end furthest from the rear wall must be mounted minimum 54" from the rear wall.	Men's Restroom - 40.5" from rear wall	Remount side grab bar to max 12" from the rear wall at the close end and min 54" on the far end, and 33" to 36" aff. Cost included in previous finding.	2015 ABAAS Section: 604.5.1 2012 TAS Section: 604.5.1 2010 ADAS Section: 604.5.1

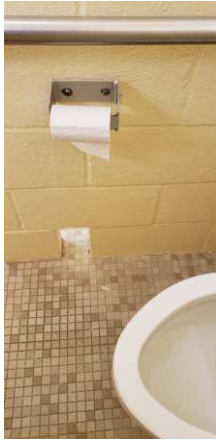
Finding Number	Area Description	Lat/Long	Finding	As Built	Recommendation	Citation	Photos	Figure
77	Park Site: Restroom Building 5 Boat Ramp - Men's	[32.31572, -100.9417]	The toilet paper is not installed within the compliant range in front of the toilet. Toilet paper dispensers shall be 7 inches minimum and 9 inches maximum in front of the water closet measured to the centerline of the dispenser. The outlet of the dispenser shall be 15 inches minimum and 48 inches maximum above the finish floor and shall not be located behind grab bars. Dispensers shall not be of a type that controls delivery or that does not allow continuous paper flow. There shall be a clearance of 1 1/2 inches minimum below the grab bar.	Men's Restroom - toilet paper too close to front of toilet	Remount toilet paper dispenser max 7" to 9" from front of toilet, 15" to 48" aff and min 12" above or 1.5" below grab bar.	2015 ABAAS Section: 604.7 2012 TAS Section: 604.7 2010 ADAS Section: 604.7

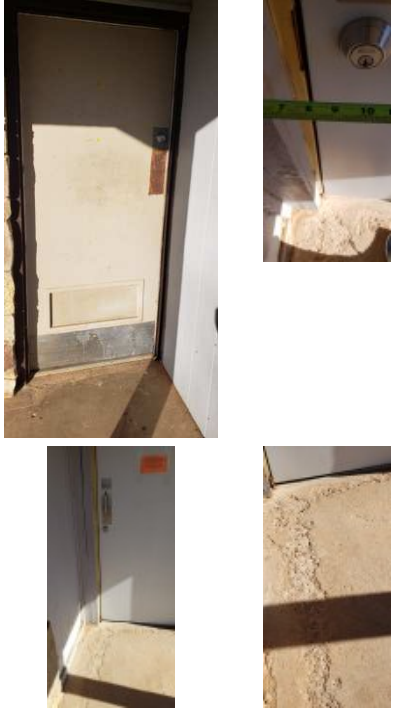
78	Park Site: Restroom Building 5 Boat Ramp - Men's	[32.31572, -100.9417]	Minimum maneuvering clearances at doors and gates shall comply with 404.2.4. Maneuvering clearances shall extend the full width of the doorway and the required latch side or hinge side clearance. The threshold has a vertical change greater than 1/4 inch high. The threshold at a doorway shall be no higher than 1/2 inch. Changes in level between 1/4 inch and 1/2 inch must be beveled at 1:2 or less. 1/4 inch is the maximum vertical rise. Exterior doors are recommended to be maintained at 8.5 lbf as a smart practice. Force is to be measured at the operating hardware or 30 inches from the hinges, whichever is greater.	Mens Restroom Door - 8" clearance on the pull side, 25# push, concrete in front of door deteriorated	For all doors along the public circulation route, provide required maneuvering clearance on push and pull side of doors For all doors along the public circulation route, repair, bevel, or ramp CILs at door entries to max .25" For all doors along the public circulation route, inspect, adjust, and maintain 8.5 lbf to open exterior doors as a smart practice	2010 ADAS Section: 404.2.3, 404.2.7, 404.2.4, 404.2.11, 404.2.11 Exception

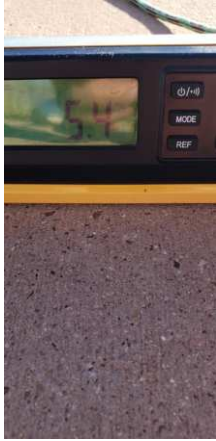
80	Park Site: Fishing Pier	[32.3321878, -100.9276412]	The running slope of walking surfaces shall not be steeper than 1:20.	Path to fishing Pier - 5.4% slope	Correct running slope along the AR to max 5%	2015 ABAAS Section: 403.3 2012 TAS Section: 403.3 2010 ADAS Section: 403.3

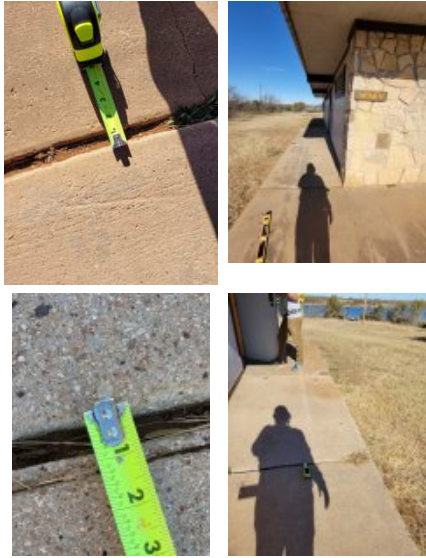
Finding Number	Area Description	Lat/Long	Finding	As Built	Recommendation	Citation	Photos	Figure
84	Park Site: Restroom 3 Parking	[32.3314251 , -100.9284 418]	There is a gap spaced greater than a 1/2 inch. Openings in floor or ground surfaces shall not allow passage of a sphere more than 1/2 inch diameter. Elongated openings shall be placed so that the long dimension is perpendicular to the dominant direction of travel.	Restroom building 3/ fishing pier restroom - 1" gap at entry to women's restroom, 1" gap at same location on men's side	Correct or fill gaps to be max .5"	2015 ABAAS Section: 302.3 2012 TAS Section: 302.3 2010 ADAS Section: 302.3

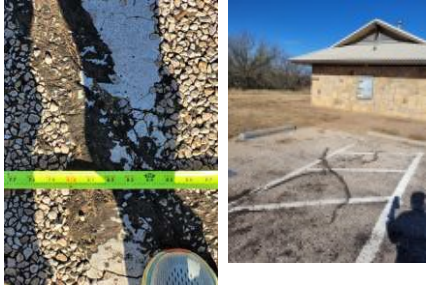
85	Park Site: Restroom 3 Parking	[32.31572, -100.9417]	Element meets all standards and requirements	Restroom building 3/ near fishing pier - lot complies with scoping - 24 standard stalls, 2 accessible	None	2010 ADAS Section: N/A		
86	Park Site: Restroom 3 Parking	[32.3313447 , -100.9284 566]	The accessible parking stall is not wide enough. Each parking space must be at least 8' feet wide and shall be marked to define the width. The measurements of parking spaces and access aisles shall be made from the centerline of the markings. Where the parking space is not adjacent to another parking space or access aisle, the measurement shall be permitted to include the full width of the line defining the parking space.	Restroom building 3/ near fishing pier - left stall - 42.5" wide	Repaint stalls to be 8' wide each.	2015 ABAAS Section: 502.2 2012 TAS Section: 502.2 2010 ADAS Section: 502.2

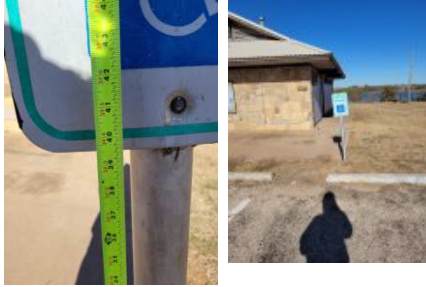
90	Park Site: Restroom 3 Parking	[32.3313707, -100.9284 553]	The parking sign is mounted too low. Parking space identification signs shall include the International Symbol of Accessibility complying with. Signs identifying van parking spaces shall contain the designation "van accessible." Signs shall be 60 inches minimum above the finish floor or ground surface measured to the bottom of the sign.	Restroom building 3/ near fishing pier - sign height - 39.5" agl	Raise existing accessible parking signs so lowest end of bottom sign is min 60" aff.	2015 ABAAS Section: 502.6 2012 TAS Section: 502.6 2010 ADAS Section: 502.6

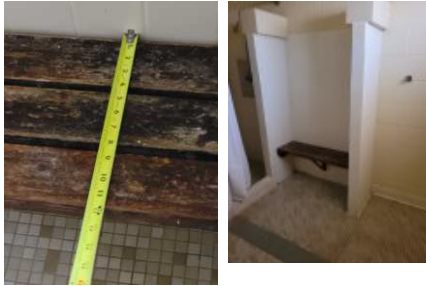
Finding Number	Area Description	Lat/Long	Finding	As Built	Recommendation	Citation	Photos	Figure
92	Park Site: Restroom Building 3 Near Fishing Pier - Women's	[32.31572, -100.9417]	The bench is not deep enough or long enough or is missing. Benches shall be provided having seats that are 42 inches long minimum and 20 inches deep minimum and 24 inches deep maximum. The bench shall provide for back support or shall be affixed to a wall. Back support shall be 42 inches (1065 mm) long minimum and shall extend from a point 2 inches (51 mm) maximum above the seat surface to a point 18 inches (455 mm) minimum above the seat surface. Back support shall be 2½ inches (64 mm) maximum from the rear edge of the seat measured horizontally. The top of the bench seat surface shall be 17 inches (430 mm) minimum and 19 inches (485 mm) maximum above the finish floor or ground. Clear floor or ground space complying with 305 shall be provided and shall be positioned at the end of the bench seat and parallel to the short axis of the bench	Women's Restroom - bench 12" in depth	Replace bench in dressing area with one having a seat depth of 20" to 24" deep, 42" long, affixed to the wall or having a back and mounted 17" to 19" AFF and provide required clear floor space on the short axis of the bench.	2012 TAS Section: 903.4, 903.2, 903.3, 903.5 2010 ADAS Section: 903.4, 903.2, 903.3, 903.5

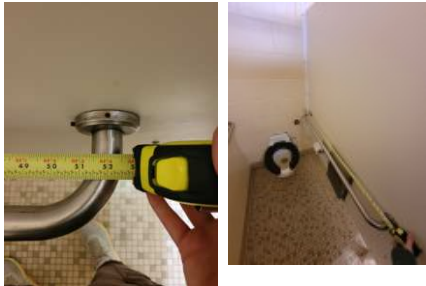
99	Park Site: Restroom Building 3 Near Fishing Pier - Women's	[32.31572, -100.9417]	The side grab bars are not in the correct location. Grab bars on the side wall must be installed so that the end closest to the rear wall is maximum 12" from the rear wall. The end furthest from the rear wall must be mounted minimum 54" from the rear wall.	Women's Restroom - both 52" from rear wall	Remount side grab bar to max 12" from the rear wall at the close end and min 54" on the far end, and 33" to 36" aff.	2015 ABAAS Section: 604.5.1 2012 TAS Section: 604.5.1 2010 ADAS Section: 604.5.1

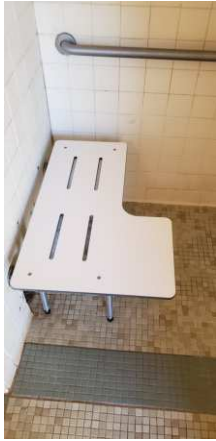
Finding Number	Area Description	Lat/Long	Finding	As Built	Recommendation	Citation	Photos	Figure
103	Park Site: Restroom Building 3 Near Fishing Pier - Men's	[32.31572, -100.9417]	The shower seat does not have a compliant space between it and the wall. The folding seat must be mounted 17-19 inches above the floor, and have a maximum space of 1-1/2 inches between the edge of the seat and the side wall and 2-1/2 inches maximum to the seat wall.	Men's Restroom - seat installed backwards	Remount shower seat to the correct location and height in the shower	2015 ABAAS Section: 610.3.2 2012 TAS Section: 610.3.2 2010 ADAS Section: 610.3.2

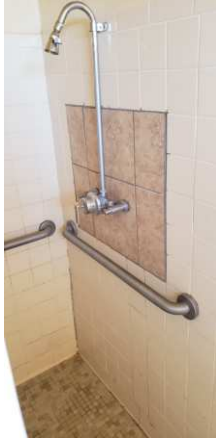
104	Park Site: Restroom Building 3 Near Fishing Pier - Men's	[32.31572, -100.9417]	There is no hand held sprayer unit. The sprayer unit must have a 59 inches hose and be mounted 48 inches maximum to the top of mounting bracket off the floor. The shower spray unit shall have an on/off control with a non-positive shutoff. If an adjustable-height shower head on a vertical bar is used, the bar shall be installed so as not to obstruct the use of grab bars.	Men's Restroom - no hose or fixed 48" shower head	Replace shower control with a compliant lever control with a shower head on a 59" hose and usable as hand held or provide a lower fixed shower head at 48" AFF.	2015 ABAAS Section: 608.6 2012 TAS Section: 608.6 2010 ADAS Section: 608.6

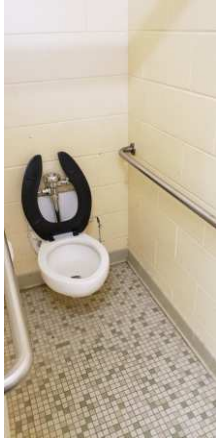
Finding Number	Area Description	Lat/Long	Finding	As Built	Recommendation	Citation	Photos	Figure
107	Park Site: Restroom Building 3 Near Fishing Pier - Men's	[32.31572, -100.9417]	There are not enough accessible toilet compartments. The room contains toilet compartments. A minimum of 1 must be wheelchair accessible .	Men's Restroom - lacks wheelchar stall, ambulatory only	Create a wheelchair accessible stall with grab bars and fixtures mounted in correct locations and at correct heights.	2015 ABAAS Section: F213.3.1 2012 TAS Section: 213.3.1 2010 ADAS Section: 213.3.1

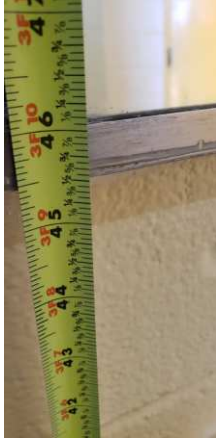
108	Park Site: Restroom Building 3 Near Fishing Pier - Men's	[32.31572, -100.9417]	The mirror is mounted too high. Mirrors must have the bottom edge of the reflecting surface a maximum of 40 inches above the floor if above a sink or counter. Mirrors not located above lavatories or countertops shall be installed with the bottom edge of the reflecting surface 35 inches maximum above the finish floor or ground.	Men's Restroom - 46" to bottom of mirror, 68.5" to top of mirror	Replace mirror mount to max 35" AFF to the bottom reflective surface and 74" to the top.	2015 ABAAS Section: 603.3 2012 TAS Section: 603.3 2010 ADAS Section: 603.3

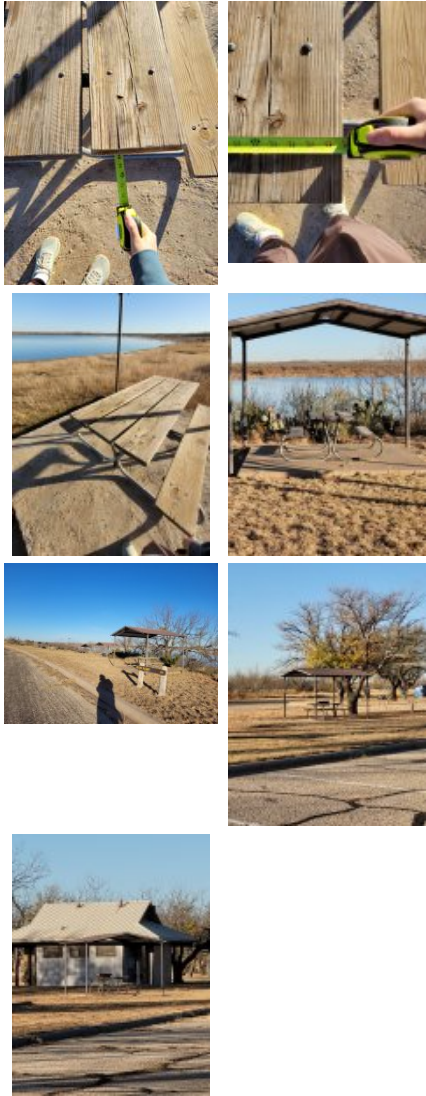
Finding Number	Area Description	Lat/Long	Finding	As Built	Recommendation	Citation	Photos	Figure
109	Park Site: Picnic Area	[32.3394455 , -100.92927 6]	Picnic tables shall provide at least one wheelchair space for each 24 linear feet (7320 mm) of usable table surface perimeter. Wheelchair spaces shall be 30 inches (760 mm) minimum by 48 inches (1220 mm) minimum. Wheelchair spaces shall be positioned for a forward approach to the table and provide knee and toe clearance complying with 306 under the table	Picnic area near boat ramp - 36 of 36 tables not of accessible design	Replace 20% of picnic tables with ones of an accessible design as a smart practice	2015 ABAAS Section: 1011.4.2

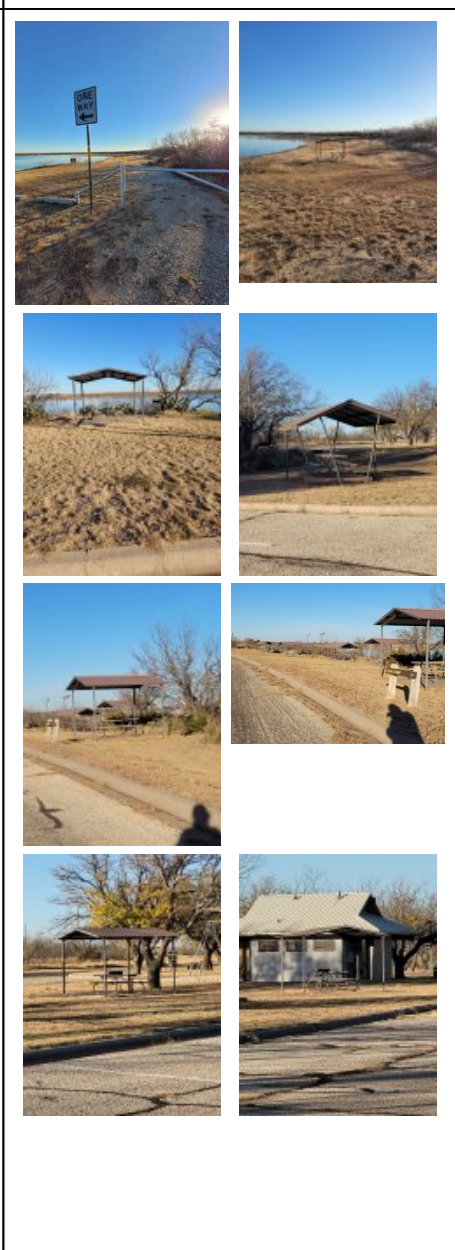
Finding Number	Area Description	Lat/Long	Finding	As Built	Recommendation	Citation	Photos	Figure
110	Park Site: Picnic Area	[32.3394364, -100.9292331]	There is no accessible route to the picnic tables by the boat ramp. At least one accessible route shall connect accessible buildings, accessible facilities, accessible elements, and accessible spaces that are on the same site.	no route to picnic tables by picnic near boat ramp - 36 of 36 total	Provide an accessible route to 20% of picnic tables	2015 ABAAS Section: F206.2.2 2012 TAS Section: 206.2.2 2010 ADAS Section: 206.2.2

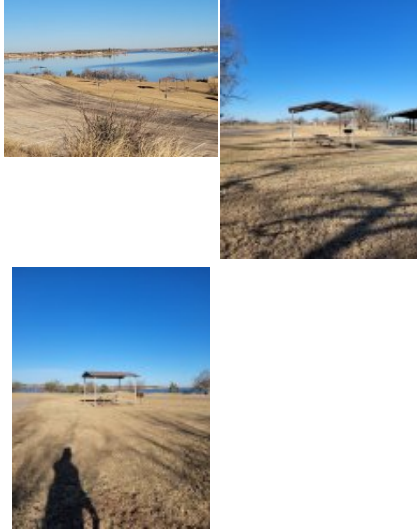
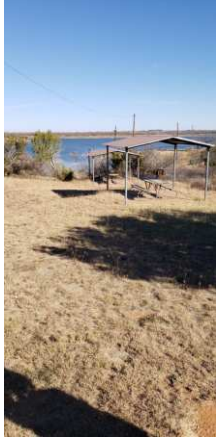
111	Park Site: Picnic Area	[32.3321781, -100.9273478]	There is no accessible route to the picnic tables by piers. At least one accessible route shall connect accessible buildings, accessible facilities, accessible elements, and accessible spaces that are on the same site.	No accessible route to picnic areas near fishing pier	Create an accessible route with crushed stone or other outdoor material from parking or walkway to the picnic tables as a smart practice.	2015 ABAAS Section: F206.2.2 2012 TAS Section: 206.2.2 2010 ADAS Section: 206.2.2

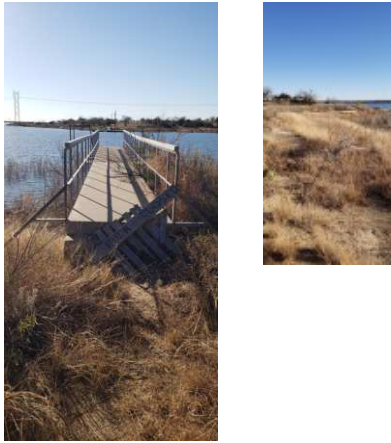
115	Park Site: Kayak Launch	[32.3345602, -100.927954]	There is no accessible route to the kayak launch or closed pier. At least one accessible route shall connect accessible buildings, accessible facilities, accessible elements, and accessible spaces that are on the same site.	No accessible route to closed pier or kayak launch area	Create an accessible route with crushed stone or other outdoor material from parking or walkway to pier and kayak launch. Provide a ramp for access.	2015 ABAAS Section: F206.2.2 2012 TAS Section: 206.2.2 2010 ADAS Section: 206.2.2

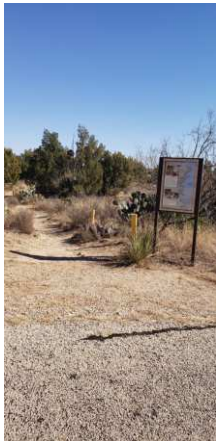
118	Park Site: Trails	[32.3216287, -100.930305]	There is no accessible route to the Cactus Cat Trailhead. At least one accessible route shall connect accessible buildings, accessible facilities, accessible elements, and accessible spaces that are on the same site.	No accessible route to cactus cat trailhead.	Create an accessible route with crushed stone or other outdoor material from parking or walkway to Cactus Cat Trailhead as a smart practice.	2015 ABAAS Section: F206.2.2 2012 TAS Section: 206.2.2 2010 ADAS Section: 206.2.2

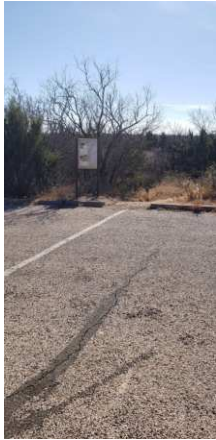
Finding Number	Area Description	Lat/Long	Finding	As Built	Recommendation	Citation	Photos	Figure
119	Park Site: Trails	[32.3213714, -100.9306523]	There is no accessible route to the Roadrunner Trailhead. At least one accessible route shall connect accessible buildings, accessible facilities, accessible elements, and accessible spaces that are on the same site.	No accessible route to Roadrunner trailhead	Create an accessible route with crushed stone or other outdoor material from parking or walkway to Roadrunner Trailhead as a smart practice.	2015 ABAAS Section: F206.2.2 2012 TAS Section: 206.2.2 2010 ADAS Section: 206.2.2

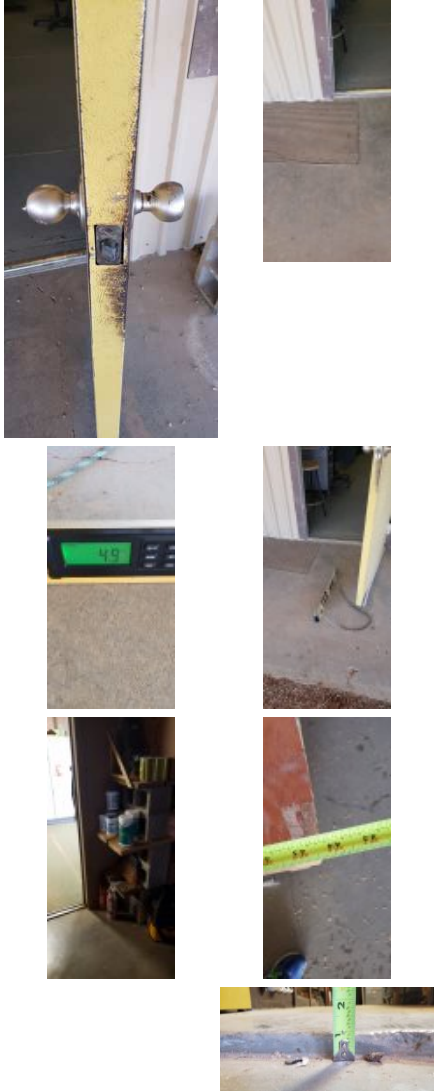
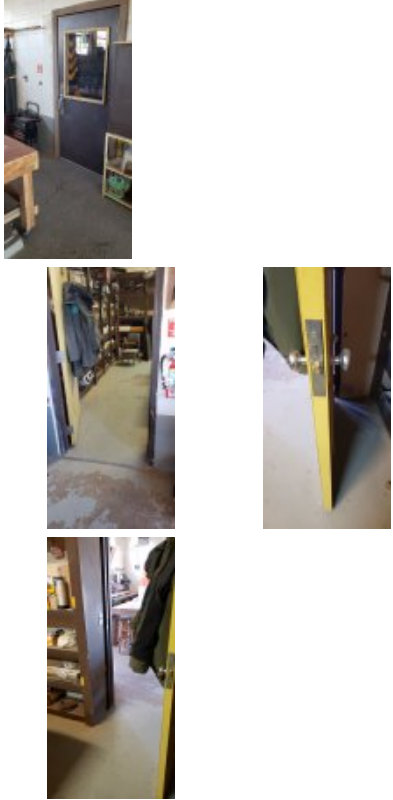
Finding Number	Area Description	Lat/Long	Finding	As Built	Recommendation	Citation	Photos	Figure
121	Buildings: Maintenance	[32.31572, -100.9417]	Spaces and elements within employee work areas shall only be required to comply with 206.2.8, 207.1, and 215.3 and shall be designed and constructed so that individuals with disabilities can approach, enter, and exit the employee work area. Employee work areas, or portions of employee work areas, other than raised courtroom stations, that are less than 300 square feet (28 m2) and elevated 7 inches (180 mm) or more above the finish floor or ground where the elevation is essential to the function of the space shall not be required to comply with these requirements or to be on an accessible route.	Entrance door - knob, loose mat, 4.9% slope; storage room door - shelves in pull side clearance; shop door - items stored in pull side clearance; shop storage door - 0.5" change in level, knob, shelves in pull side clearance	For employee spaces, relocate storage, furniture, and other obstacles at doorways to provide approach, enter and exit at the employee space. Provide required maneuvering clearance on push and pull side of doors. Secure rug at door to prevent trip hazard. Correct slope in door clearance to max 2.08%. Replace doors with doors having 80" overhead clearance and 32" clear width. Repair, bevel, or ramp CILs at door entries to max .25". Replace hardware with lever hardware or hardware operable without a tight pinch or grasp.	2015 ABAAS Section: F203.9 2012 TAS Section: 203.9 2010 ADAS Section: 203.9

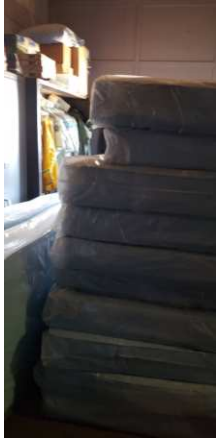
Finding Number	Area Description	Lat/Long	Finding	As Built	Recommendation	Citation	Photos	Figure
122	Buildings: Maintenance	[32.31572, -100.9417]	Employee Work Areas. Common use circulation paths within employee work areas shall comply with 402. EXCEPTIONS: 1. Common use circulation paths located within employee work areas that are less than 1000 square feet (93 m2) and defined by permanently installed partitions, counters, casework, or furnishings shall not be required to comply with 402. 2. Common use circulation paths located within employee work areas that are an integral component of work area equipment shall not be required to comply with 402. 3. Common use circulation paths located within exterior employee work areas that are fully exposed to the weather shall not be required to comply with 402.	Interior - mattresses blocking access to shelves, 22" width to shop storage	Make corrections for compliant circulation path.	2015 ABAAS Section: F206.2.8, F206.2.8.1, F206.2.8.2 2012 TAS Section: 206.2.8, 206.2.8 Exception 1, 206.2.8 Exception 2, 206.2.8 Exception 3, 206.2.8 Advisory 1, 206.2.8 Advisory 2 2010 ADAS Section: 206.2.8, 206.2.8 Exception 1, 206.2.8 Exception 2, 206.2.8 Exception 3

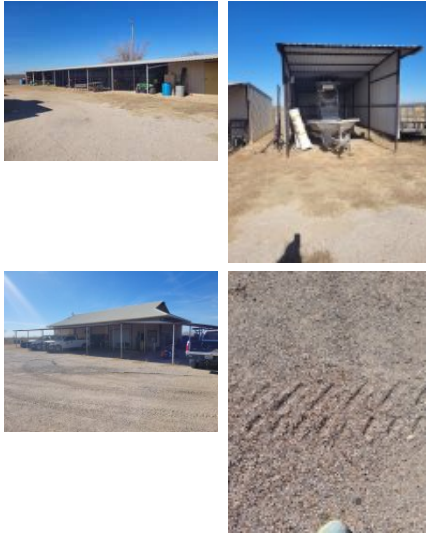
Finding Number	Area Description	Lat/Long	Finding	As Built	Recommendation	Citation	Photos	Figure
123	Buildings: Maintenance	[32.3223297, -100.9354344]	Spaces and elements within employee work areas shall only be required to comply with 206.2.8, 207.1, and 215.3 and shall be designed and constructed so that individuals with disabilities can approach, enter, and exit the employee work area. Employee work areas, or portions of employee work areas, other than raised courtroom stations, that are less than 300 square feet (28 m2) and elevated 7 inches (180 mm) or more above the finish floor or ground where the elevation is essential to the function of the space shall not be required to comply with these requirements or to be on an accessible route.	no route to garage bays or building	Extend an exterior accessible route to the outbuildings.	2015 ABAAS Section: F203.9 2012 TAS Section: 203.9 2010 ADAS Section: 203.9

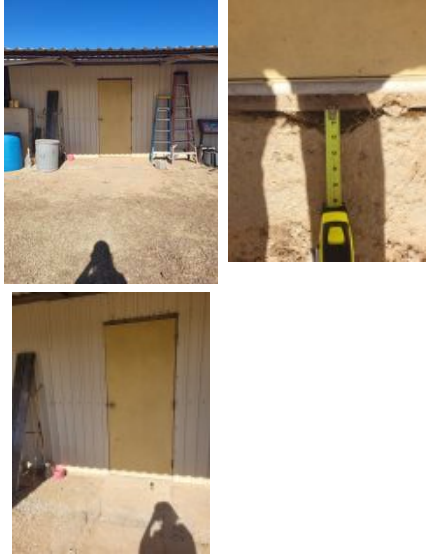
124	Buildings: Maintenance	[32.31572, -100.9417]	Spaces and elements within employee work areas shall only be required to comply with 206.2.8, 207.1, and 215.3 and shall be designed and constructed so that individuals with disabilities can approach, enter, and exit the employee work area. Employee work areas, or portions of employee work areas, other than raised courtroom stations, that are less than 300 square feet (28 m2) and elevated 7 inches (180 mm) or more above the finish floor or ground where the elevation is essential to the function of the space shall not be required to comply with these requirements or to be on an accessible route.	Yellow door - knob, 1.75" gap at entry	For employee spaces, relocate storage, furniture, and other obstacles at doorways to provide approach, enter and exit at the employee space. Provide required maneuvering clearance on push and pull side of doors. Fill gaps at door entries to max .5". Replace hardware with lever hardware or hardware operable without a tight pinch or grasp.	2015 ABAAS Section: F203.9 2012 TAS Section: 203.9 2010 ADAS Section: 203.9

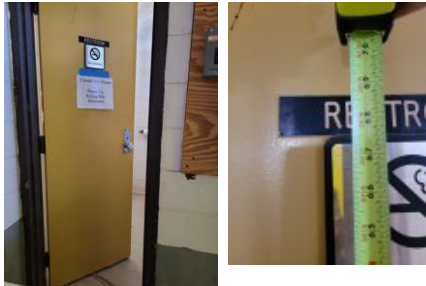
126	Buildings: Maintenance	[32.31572, -100.9417]	The restroom sign does not comply with one or more applicable requirements for the location, height, and properties of the sign.	signage too high, on door, 67.5" aff	Remount signage on wall, latch side of the door, 48" to baseline of lowest character and 60" to baseline of highest character	2015 ABAAS Section: F216.2, 703.1, 703.2, 703.5, 703.6 2012 TAS Section: 216.2, 703.1, 703.2, 703.5, 703.6 2010 ADAS Section: 216.2, 703.1, 703.2, 703.5, 703.6

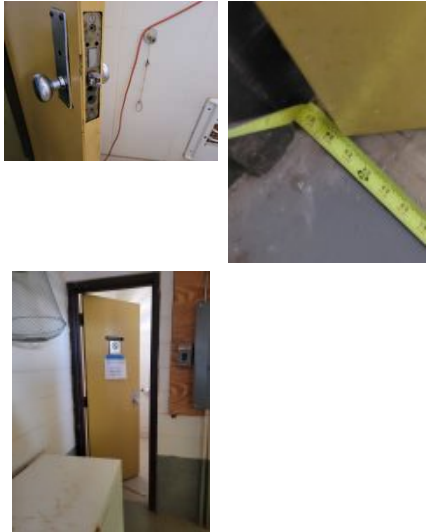
Finding Number	Area Description	Lat/Long	Finding	As Built	Recommendation	Citation	Photos	Figure
127	Buildings: Maintenance	[32.31572, -100.9417]	<p>Door openings shall provide a clear width of 32 inches (815 mm) minimum. Clear openings of doorways with swinging doors shall be measured between the face of the door and the stop, with the door open 90 degrees. Openings more than 24 inches (610 mm) deep shall provide a clear opening of 36 inches (915 mm) minimum. There shall be no projections into the required clear opening width lower than 34 inches (865 mm) above the finish floor or ground. Projections into the clear opening width between 34 inches (865 mm) and 80 inches (2030 mm) above the finish floor or ground shall not exceed 4 inches (100 mm). Hand-activated door opening hardware, handles, pulls, latches, locks, and other operating devices on accessible doors shall have a shape that is easy to grasp with one hand and does not require tight grasping, tight pinching or twisting of the wrist to operate. Hardware shall be 34 inches minimum and 48 inches maximum above the finish floor or ground.</p>	Maintenance restroom door - 26" width, knob hardware	For all doors along the public circulation route, replace doors with doors having 80" overhead clearance and 32" clear width For all doors along the public circulation route, replace hardware with lever hardware or hardware operable without a tight pinch or grasp	2010 ADAS Section: 404.2.3, 404.2.7, 404.2.4, 404.2.11, 404.2.11 Exception

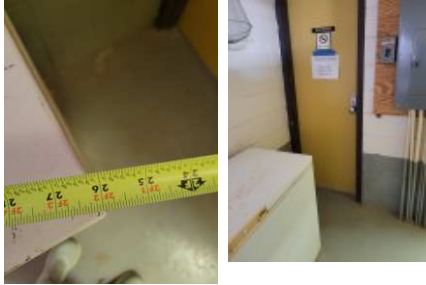
Finding Number	Area Description	Lat/Long	Finding	As Built	Recommendation	Citation	Photos	Figure
128	Buildings: Maintenance	[32.31572, -100.9417]	Employee Work Areas. Common use circulation paths within employee work areas shall comply with 402. EXCEPTIONS: 1. Common use circulation paths located within employee work areas that are less than 1000 square feet (93 m2) and defined by permanently installed partitions, counters, casework, or furnishings shall not be required to comply with 402. 2. Common use circulation paths located within employee work areas that are an integral component of work area equipment shall not be required to comply with 402. 3. Common use circulation paths located within exterior employee work areas that are fully exposed to the weather shall not be required to comply with 402.	26" pass through to restroom due to freezer	Make corrections for compliant circulation path.	<p>2015 ABAAS Section: F206.2.8, F206.2.8.1, F206.2.8.2</p> <p>2012 TAS Section: 206.2.8, 206.2.8 Exception 1, 206.2.8 Exception 2, 206.2.8 Exception 3, 206.2.8 Advisory 1, 206.2.8 Advisory 2</p> <p>2010 ADAS Section: 206.2.8, 206.2.8 Exception 1, 206.2.8 Exception 2, 206.2.8 Exception 3</p>

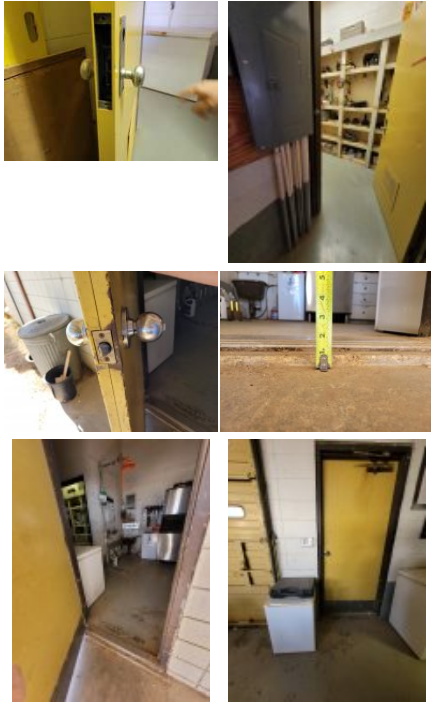
Finding Number	Area Description	Lat/Long	Finding	As Built	Recommendation	Citation	Photos	Figure
129	Buildings: Maintenance	[32.31572, -100.9417]	Spaces and elements within employee work areas shall only be required to comply with 206.2.8, 207.1, and 215.3 and shall be designed and constructed so that individuals with disabilities can approach, enter, and exit the employee work area. Employee work areas, or portions of employee work areas, other than raised courtroom stations, that are less than 300 square feet (28 m2) and elevated 7 inches (180 mm) or more above the finish floor or ground where the elevation is essential to the function of the space shall not be required to comply with these requirements or to be on an accessible route.	Closet by restroom - knob hardware, lacks clearance on push due to wall. Door by freezer - knob, 1.5" change in level, clearance on push reduced by mini fridge	For employee spaces, relocate storage, furniture, and other obstacles at doorways to provide approach, enter and exit at the employee space. Provide required maneuvering clearance on push and pull side of doors. Repair, bevel, or ramp CILs at door entries to max .25". Replace hardware with lever hardware or hardware operable without a tight pinch or grasp.	2015 ABAAS Section: F203.9 2012 TAS Section: 203.9 2010 ADAS Section: 203.9

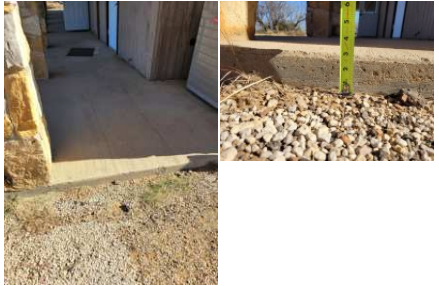
Finding Number	Area Description	Lat/Long	Finding	As Built	Recommendation	Citation	Photos	Figure
131	Buildings: Recreation Hall	[32.3214276 , -100.9317 678]	The walkway contains abrupt vertical edges and/or variations over a 1/4 inch. 1/4 inch is the maximum vertical rise. Changes in level between 1/4 inch and 1/2 inch must be beveled at 1:2 or less. Changes in level greater than 1/2 inch must be by way of a ramp.	3" change in level (CIL) up to recreation hall	Repair, bevel or ramp CIL along AR.	2012 TAS Section: 303.2, 303.3 2010 ADAS Section: 303.2, 303.3
