Access Audit Site Report

Lake Colorado City State Park

Accessibility Evaluation

Inspection Date: 12/13/2021

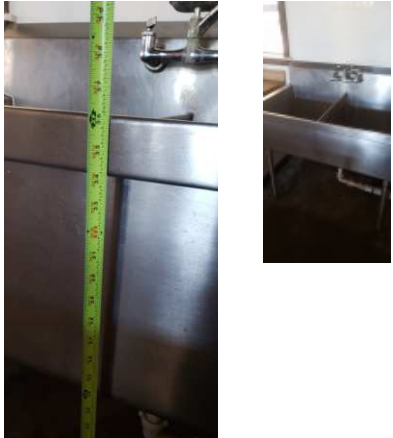
Finding Number	Area Description	Lat/Long	Finding	As Built	Recommendation	Citation	Photos	Figure
133	Buildings: Recreation Hall	[32.31572, -100.9417]	<p>The sink is not accessible. A clear floor space at least 30 inches by 48 shall be provided in front of a sink to allow forward approach. -The clear floor space shall be on an accessible route and shall extend a maximum of 19 inches underneath the sink.</p> <p>-Sinks shall be mounted with the counter or rim no higher than 34 inches above the finish floor. -Knee clearance at least 27 inches high, 30 inches wide and 19 inches deep shall be provided. -Hot water and drain pipes exposed under sinks shall be insulated or otherwise configured so as to protect against contact. There shall be no sharp or abrasive surfaces under sinks.</p> <p>-Faucet controls not require tight grasping, pinching or twisting of the wrist. -The force required to activate controls shall be not greater than 5 lb. Lever-operated, push-type and electronically controlled mechanisms are examples of acceptable designs. -Self-closing valves are allowed if the faucet remains open for at least 10 seconds.</p>	Kitchen - 36" to top of sink rim and no knee clearance	Replace sink with a shallower model and mount to max 34" aff to front of rim	<p>2015 ABAAS Section: 606.2, 606.2 EXCEPTION S: 1, 606.2 EXCEPTIONS: 4, 606.2 EXCEPTIONS: 5, 606.2 EXCEPTIONS: 6, 606.2 EXCEPTIONS: 7, 606.3, 606.4, 606.5</p> <p>2012 TAS Section: 606.2, 606.2 Exception 1, 606.2 Exception 4, 606.2 Exception 5, 606.2 Exception 6, 606.2 Exception 7, 606.3, 606.4, 606.5</p> <p>2010 ADAS Section: 606.2, 606.2 Exception 1, 606.2 Exception 4, 606.2 Exception 5, 606.2 Exception 6, 606.2 Exception 7, 606.3, 606.4, 606.5</p>

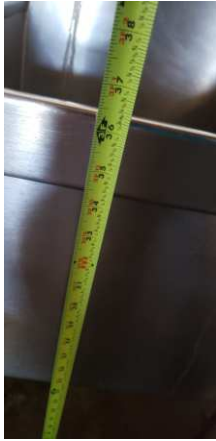
Finding Number	Area Description	Lat/Long	Finding	As Built	Recommendation	Citation	Photos	Figure
134	Buildings: Recreation Hall	[32.31572, -100.9417]	The top rim of the sink is too high. All lavatories/sinks that are designated to be accessible shall be a minimum 17 inches in horizontal depth and mounted with the rim or counter edge no higher than 34 inches above the finished floor.	Kitchen - 36" to sink rim height	Lower sinks to max 34" aff to front of rim. See previous finding for recommendation.	2015 ABAAS Section: 606.3 2012 TAS Section: 606.3 2010 ADAS Section: 606.3

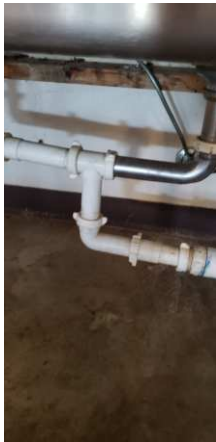
135	Buildings: Recreation Hall	[32.31572, -100.9417]	The water and drain pipes under the lavatory are not adequately insulated. Water supply and drain pipes under lavatories and sinks shall be insulated or otherwise configured to protect against contact. There shall be no sharp or abrasive surfaces under lavatories and sinks.	Kitchen - sink pipes lack insulation	Insulate exposed pipes under sink	2015 ABAAS Section: 606.5 2012 TAS Section: 606.5 2010 ADAS Section: 606.5

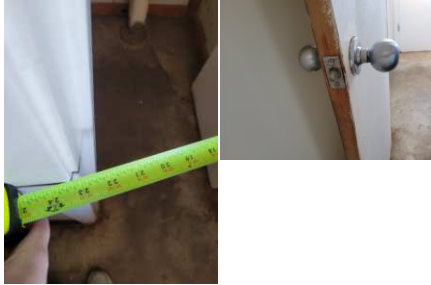
Finding Number	Area Description	Lat/Long	Finding	As Built	Recommendation	Citation	Photos	Figure
139	Buildings: Recreation Hall	[32.31572, -100.9417]	Door openings shall provide a clear width of 32 inches (815 mm) minimum. Clear openings of doorways with swinging doors shall be measured between the face of the door and the stop, with the door open 90 degrees. Openings more than 24 inches (610 mm) deep shall provide a clear opening of 36 inches (915 mm) minimum. There shall be no projections into the required clear opening width lower than 34 inches (865 mm) above the finish floor or ground. Projections into the clear opening width between 34 inches (865 mm) and 80 inches (2030 mm) above the finish floor or ground shall not exceed 4 inches (100 mm). Hand-activated door opening hardware, handles, pulls, latches, locks, and other operating devices on accessible doors shall have a shape that is easy to grasp with one hand and does not require tight grasping, tight pinching or twisting of the wrist to operate. Hardware shall be 34 inches minimum and 48 inches maximum above the finish floor or ground.	Restroom door - 22.5" width, knob	For all doors along the public circulation route, replace doors with doors having 80" overhead clearance and 32" clear width For all doors along the public circulation route, replace hardware with lever hardware or hardware operable without a tight pinch or grasp	2010 ADAS Section: 404.2.3, 404.2.7, 404.2.4, 404.2.11, 404.2.11 Exception

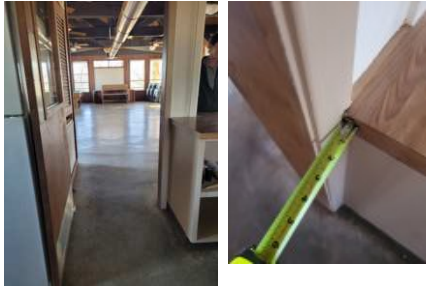
140	Buildings: Recreation Hall	[32.31572, -100.9417]	Minimum maneuvering clearances at doors and gates shall comply with 404.2.4. Maneuvering clearances shall extend the full width of the doorway and the required latch side or hinge side clearance.	Door between hall and kitchen - no clearance on either side due to wall	For all doors along the public circulation route, provide required maneuvering clearance on push and pull side of doors	2010 ADAS Section: 404.2.3, 404.2.7, 404.2.4, 404.2.11, 404.2.11 Exception

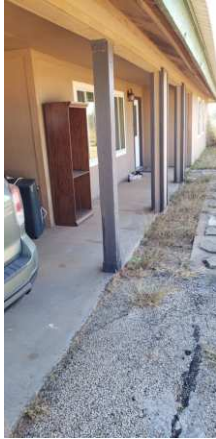
Finding Number	Area Description	Lat/Long	Finding	As Built	Recommendation	Citation	Photos	Figure
141	Buildings: Residence	[32.31572, -100.9417]	Element meets all standards and requirements	residence 2 has a compliant route to entry	None	2010 ADAS Section: N/A

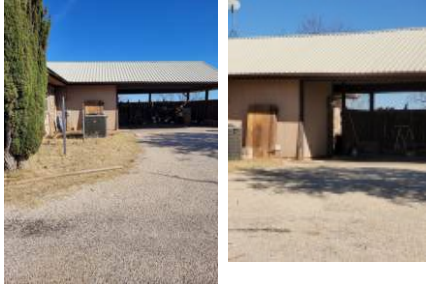
142	Buildings: Residence	[32.31572, -100.9417]	Element meets all standards and requirements	residence 1 has a compliant route to entry	None	2010 ADAS Section: N/A

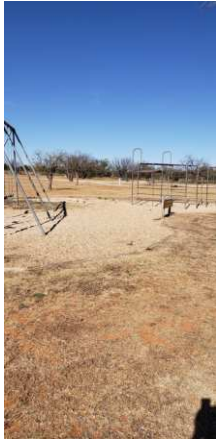
Finding Number	Area Description	Lat/Long	Finding	As Built	Recommendation	Citation	Photos	Figure
143	Play Area: Mesquite Circle - Playground	[32.3226665 , -100.9313 268]	There is no accessible route to the play area. Accessible routes serving play areas shall comply with Chapter 4 and 1008.2 and shall be permitted to use the exceptions in 1008.2.1 through 1008.2.3. Where accessible routes serve ground level play components, the vertical clearance shall be 80 inches high (2030 mm) minimum.	no accesible route to play area with ground level play components	Create an AR to the play area within the site.	2015 ABAAS Section: F206.2.2 2012 TAS Section: 1008.2 2010 ADAS Section: 206.2.2

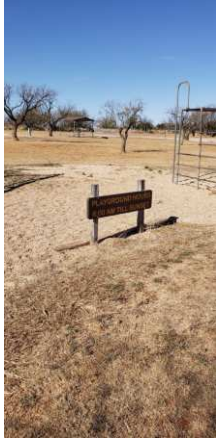
144	Play Area: Mesquite Circle - Playground	[32.322647, -100.93131 45]	Play area shall have signage listing designated ages of intended users	no designated age sign	Acquire and install intended user signage and mount at designated entry as a smart practice.	2015 ABAAS Section: F240.1 2012 TAS Section: 240.1 2010 ADAS Section: 240.1

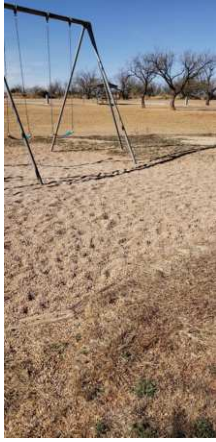
Finding Number	Area Description	Lat/Long	Finding	As Built	Recommendation	Citation	Photos	Figure
145	Play Area: Mesquite Circle - Playground	[32.322647, -100.93133 59]	Compliance with ASTM F 1951 for accessibility for ground surfaces on accessible routes, clear floor or ground spaces, and turning spaces has not been determined. Ground surfaces shall comply with ASTM F 1951. Ground surfaces shall be inspected and maintained regularly and frequently to ensure continued compliance with ASTM F 1951.	surface is gravel	Replace existing surface with an accessible surface such as EWF, PIP or tiles, with compliant slopes and changes in level.	2012 TAS Section: 1008.2.6.1 2010 ADAS Section: 1008.2.6.1

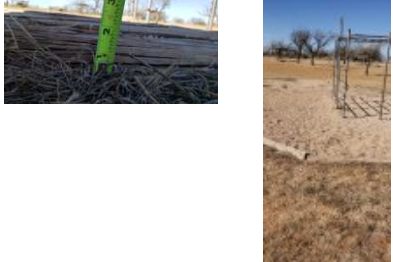
146	Play Area: Mesquite Circle - Playground	[32.3226651, -100.9313 359]	The walkway contains abrupt vertical edges and/or variations over a 1/4 inch. 1/4 inch is the maximum vertical rise. Changes in level between 1/4 inch and 1/2 inch must be beveled at 1:2 or less. Changes in level greater than 1/2 inch must be by way of a ramp.	2" change in level at border around play area	Create a designate entry by removing a 60" wide portion of the border and connecting it to a route.	2012 TAS Section: 303.2, 303.3 2010 ADAS Section: 303.2, 303.3

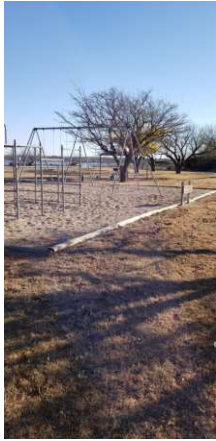
Finding Number	Area Description	Lat/Long	Finding	As Built	Recommendation	Citation	Photos	Figure
147	Play Area: Boat Launch Playground	[32.3385243 , -100.92847]	There is no accessible route to the play area. Accessible routes serving play areas shall comply with Chapter 4 and 1008.2 and shall be permitted to use the exceptions in 1008.2.1 through 1008.2.3. Where accessible routes serve ground level play components, the vertical clearance shall be 80 inches high (2030 mm) minimum.	no accesible route to play area with ground level play components	Create an AR to the play area within the site.	2015 ABAAS Section: F206.2.2 2012 TAS Section: 1008.2 2010 ADAS Section: 206.2.2

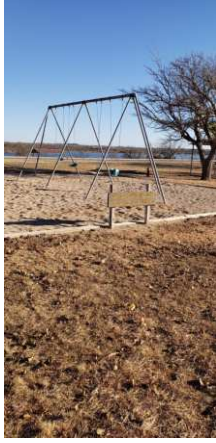
148	Play Area: Boat Launch Playground	[32.3385209 , -100.9284982]	Play area shall have signage listing designated ages of intended users	lacks signage that lists the designated age of intended users	Acquire and install intended user signage and mount at designated entry as a smart practice	2015 ABAAS Section: F240.1 2012 TAS Section: 240.1 2010 ADAS Section: 240.1

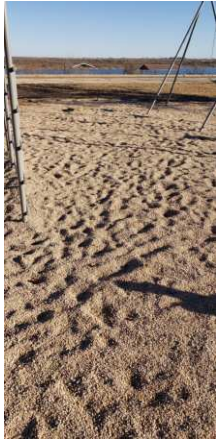
Finding Number	Area Description	Lat/Long	Finding	As Built	Recommendation	Citation	Photos	Figure
149	Play Area: Boat Launch Playground	[32.3385254, -100.9285143]	Compliance with ASTM F 1951 for accessibility for ground surfaces on accessible routes, clear floor or ground spaces, and turning spaces has not been determined. Ground surfaces shall comply with ASTM F 1951. Ground surfaces shall be inspected and maintained regularly and frequently to ensure continued compliance with ASTM F 1951.	surface is gravel	Replace existing surface with an accessible surface such as EWF, PIP or tiles, with compliant slopes and changes in level.	2012 TAS Section: 1008.2.6.1 2010 ADAS Section: 1008.2.6.1

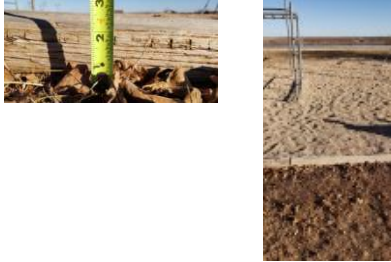
150	Play Area: Boat Launch Playground	[32.3385254, -100.9284928]	The walkway contains abrupt vertical edges and/or variations over a 1/4 inch. 1/4 inch is the maximum vertical rise. Changes in level between 1/4 inch and 1/2 inch must be beveled at 1:2 or less. Changes in level greater than 1/2 inch must be by way of a ramp.	2" change in level around play area due to border	Create a designated entry by removing a 60" portion of the border and connecting it to a route.	2012 TAS Section: 303.2, 303.3 2010 ADAS Section: 303.2, 303.3

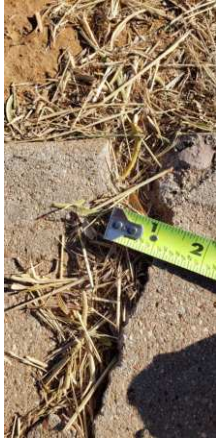
Finding Number	Area Description	Lat/Long	Finding	As Built	Recommendation	Citation	Photos	Figure
151	Cabins: Exterior Accessible Route	[32.3308268, -100.9309846]	There is a gap spaced greater than a 1/2 inch. Openings in floor or ground surfaces shall not allow passage of a sphere more than 1/2 inch diameter. Elongated openings shall be placed so that the long dimension is perpendicular to the dominant direction of travel.	Restroom 4/ cabin restroom - Slab is cracked with 1" gap	Correct or fill gaps to be max .5"	2015 ABAAS Section: 302.3 2012 TAS Section: 302.3 2010 ADAS Section: 302.3

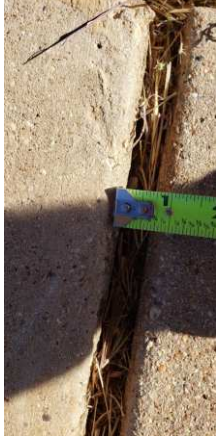
152	Cabins: Exterior Accessible Route	[32.3308245, -100.9308639]	The concrete expansion joint is spaced greater than a 1/2 inch. Openings in floor or ground surfaces shall not allow passage of a sphere more than 1/2 inch diameter. Elongated openings shall be placed so that the long dimension is perpendicular to the dominant direction of travel.	Restroom 4/ cabin restroom - expansion joint gaps - 0.75", 0.75"	Correct or fill gaps to be max .5"	2015 ABAAS Section: 302.3 2012 TAS Section: 302.3 2010 ADAS Section: 302.3

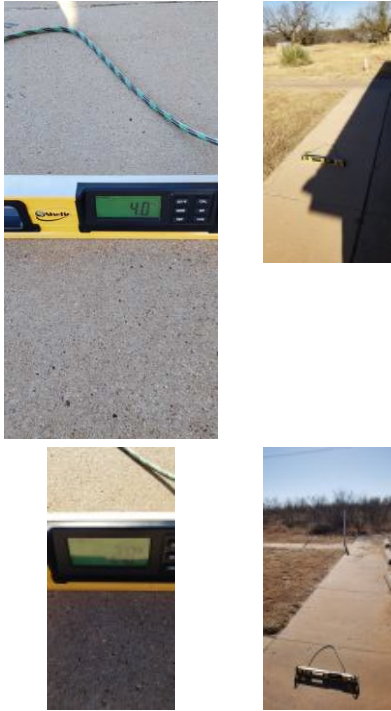
Finding Number	Area Description	Lat/Long	Finding	As Built	Recommendation	Citation	Photos	Figure
153	Cabins: Exterior Accessible Route	[32.3307917, -100.9309108]	The accessible route of travel on the accessible route contains cross slopes greater than 2%. Cross slopes shall not exceed one unit vertical in 48 units horizontal (2-percent slope).	Restroom 4/ cabin restroom - 4.0% slope, 2.8% slope	Correct or repair cross slope along AR to max 2.08%.	2015 ABAAS Section: 403.3 2012 TAS Section: 403.3 2010 ADAS Section: 403.3

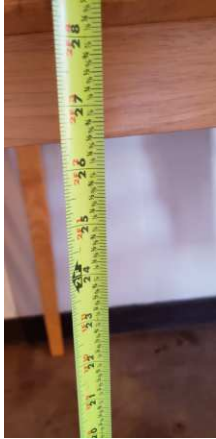
Finding Number	Area Description	Lat/Long	Finding	As Built	Recommendation	Citation	Photos	Figure
155	Cabins: Accessible Cabins	[32.3313481 , -100.9307 459]	The top of the work surface is not within a compliant height range. The tops of tables and counters shall be 28 inches to 34 inches from the floor or ground.	Cabin 3 - 26.5" knee clearance oat table	Provide tables and work surfaces at 28" to 34" aff with required knee and toe clearances.	2015 ABAAS Section: 902.3 2012 TAS Section: 902.3 2010 ADAS Section: 902.3

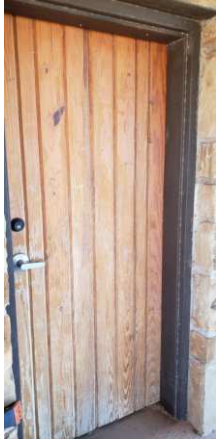
156	Cabins: Accessible Cabins	[32.31572, -100.9417]	Element meets all standards and requirements	Cabin 3 Door is compliant	None	2010 ADAS Section: N/A

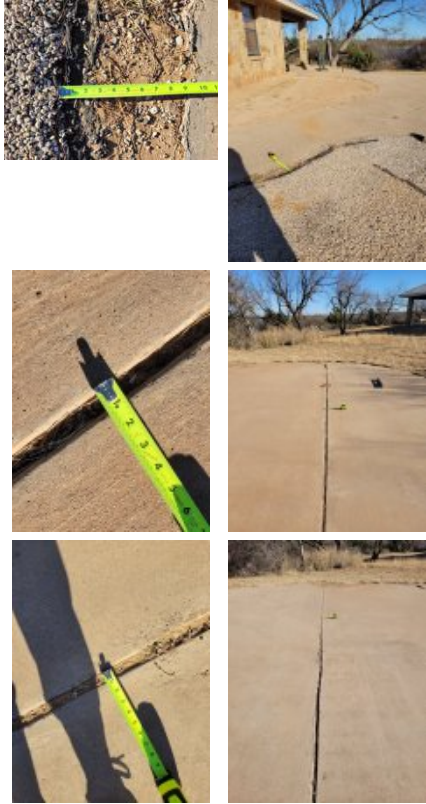
Finding Number	Area Description	Lat/Long	Finding	As Built	Recommendation	Citation	Photos	Figure
157	Cabins: Accessible Cabins	[32.331373, -100.93074 32]	An accessible access route is not provided between elements, spaces and the facilities provided within the accessible camping unit. At least one outdoor recreation access route shall connect accessible elements, spaces and facilities provided within camping units with mobility features.	Cabin 3 - 9" gap on left side of parking space, two 1" gaps along cement slab	Create AR with crushed and compacted stone or similar outdoor material to camp sites and one of each type of amenity.	2015 ABAAS Section: F244.5.1

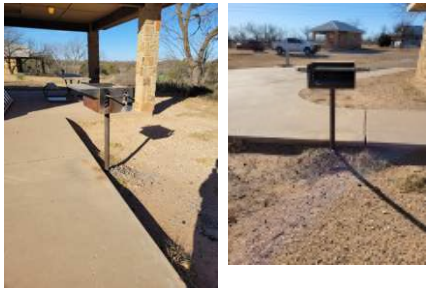
160	Cabins: Accessible Cabins	[32.3313911 , -100.9307 351]	There are not enough outdoor constructed features with mobility features located in the common uses and public use areas. Where provided in common use and public use areas that serve picnic units with mobility features, at least 20 percent, but not less than one, of each type of outdoor constructed feature must be provided at each location.	not facing route	rotate grill to face the existing route.	2015 ABAAS Section: F245.3

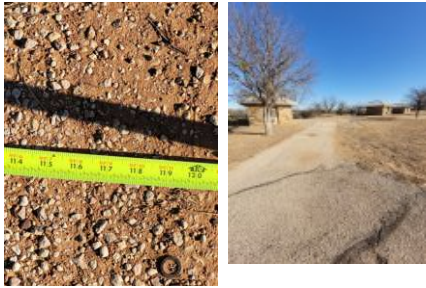
161	Cabins: Accessible Cabins	[32.31572, -100.9417]	Camping facilities shall provide camping units with mobility features complying with F244.2 in accordance with Table F244.2. Where a camping facility provides different types of camping units, Table F244.2 shall apply to each type of camping unit provided. Total Number of Camping Units Provided in Camping Facility Minimum Number of Camping Units with Mobility Features Required 1 1 2 to 25 2 26 to 50 3 51 to 75 4 76 to 100 5 101 to 150 7 151 to 200 8 201 and over 8, plus 2 percent of the number over 200	none are "deemed" ADA, all except 1 could be	Create the required number of accessible camp sites per table F244.2 as a smart practice	2015 ABAAS Section: F244.2		
162	Cabins: Accessible Cabins	[32.3312619 , -100.9307 405]	Parking spaces and pull-up spaces for recreational vehicles shall be 20 feet (6100 mm) wide minimum. EXCEPTION: Where two adjacent parking spaces are provided for recreational vehicles, one parking space shall be permitted to be 16 feet (4880 mm) wide minimum.	cabin 3 - 9'9" width	Create an accessible parking stall at accessible cabins.	2015 ABAAS Section: 1012.2, 1012.2 EXCEPTION

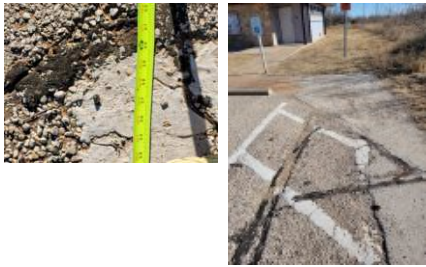
Finding Number	Area Description	Lat/Long	Finding	As Built	Recommendation	Citation	Photos	Figure																				
163	Cabins: Restroom 4 Parking	[32.31572, -100.9417]	Element meets all standards and requirements	Cabin 4 - lot complies with scoping - 3 standard stalls, 1 accessible	None	2010 ADAS Section: N/A																						
164	Cabins: Restroom 4 Parking	[32.3312733, -100.9303516]	The access aisle is not a minimum 5 feet wide. A car accessible parking stall's access aisle must be a minimum of 5 feet wide measured from centerline to centerline. Where the access aisle is not adjacent to another parking space or access aisle, measurements shall be permitted to include the full width of the line defining the access aisle.	Cabin 4 - access aisle 57" wide	Repaint access aisles to be 5' each.	2015 ABAAS Section: 502.3.1 2012 TAS Section: 502.3.1 2010 ADAS Section: 502.3.1

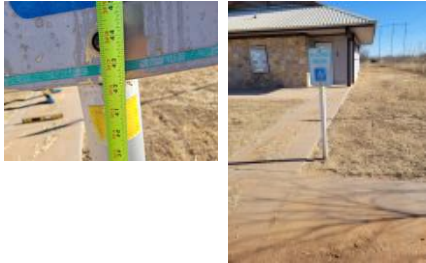
Finding Number	Area Description	Lat/Long	Finding	As Built	Recommendation	Citation	Photos	Figure
167	Cabins: Restroom 4 Parking	[32.3312925, -100.9303596]	The parking sign is mounted too low. Parking space identification signs shall include the International Symbol of Accessibility complying with. Signs identifying van parking spaces shall contain the designation "van accessible." Signs shall be 60 inches minimum above the finish floor or ground surface measured to the bottom of the sign.	Cabin 4 - sign mounted at 42.5" agl	Raise existing accessible parking signs so lowest end of bottom sign is min 60" aff.	2015 ABAAS Section: 502.6 2012 TAS Section: 502.6 2010 ADAS Section: 502.6

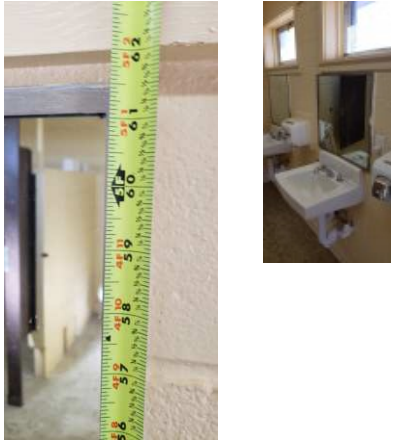
168	Cabins: Restroom Building 4 Cabin Restroom - Men's	[32.31572, -100.9417]	The mirror is mounted too high. Mirrors must have the bottom edge of the reflecting surface a maximum of 40 inches above the floor if above a sink or counter. Mirrors not located above lavatories or countertops shall be installed with the bottom edge of the reflecting surface 35 inches maximum above the finish floor or ground.	Men's Restroom - top of mirror 61"	Replace mirror mount to max 35" AFF to the bottom reflective surface and 74" to the top.	2015 ABAAS Section: 603.3 2012 TAS Section: 603.3 2010 ADAS Section: 603.3

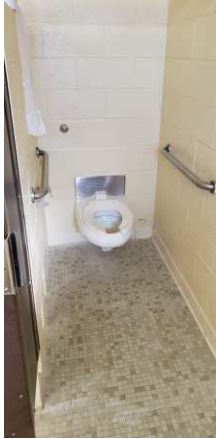
Finding Number	Area Description	Lat/Long	Finding	As Built	Recommendation	Citation	Photos	Figure
169	Cabins: Restroom Building 4 Cabin Restroom - Men's	[32.31572, -100.9417]	There are not enough accessible toilet compartments. The room contains toilet compartments. A minimum of 1 must be wheelchair accessible .	Men's Restroom - no accessible stall, ambulatory only	Create a wheelchair accessible stall with grab bars and fixtures mounted in correct locations and at correct heights.	2015 ABAAS Section: F213.3.1 2012 TAS Section: 213.3.1 2010 ADAS Section: 213.3.1

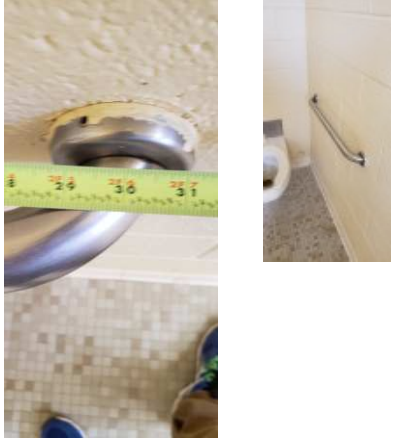
170	Cabins: Restroom Building 4 Cabin Restroom - Men's	[32.31572, -100.9417]	Grab bars shall comply with 609. A side-wall grab bar complying with 604.5.1 shall be provided on both sides of the compartment. The space between the wall and the grab bar shall be 1½ inches (38 mm). The space between the grab bar and projecting objects below and at the ends shall be 1½ inches (38 mm) minimum. The space between the grab bar and projecting objects above shall be 12 inches (305 mm) minimum. Grab bars shall be installed in a horizontal position, 33 inches (840 mm) minimum and 36 inches (915 mm) maximum above the finish floor measured to the top of the gripping surface, except that at water closets for children's use complying with 604.9, grab bars shall be installed in a horizontal position 18 inches (455 mm) minimum and 27 inches (685 mm) max	Men's Restroom - 30" bar	Replace or add side grab bars with a 42" long grab bar, mounted max 12" from the rear wall at the close end and min 54" on the far end and 33" to 36" aff, or the correct grab bars for an accessible stall.	2015 ABAAS Section: 604.8.2.3, 609.3, 609.4 2012 TAS Section: 609.4, 609.3, 604.8.2.3 2010 ADAS Section: 609.3, 609.4, 604.8.2.3

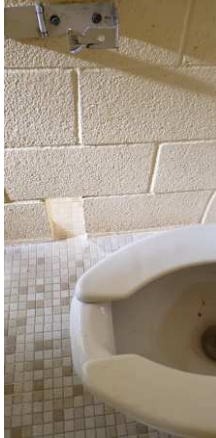
172	Cabins: Restroom Building 4 Cabin Restroom - Men's	[32.31572, -100.9417]	The toilet paper is not installed within the compliant range in front of the toilet. Toilet paper dispensers shall be 7 inches minimum and 9 inches maximum in front of the water closet measured to the centerline of the dispenser. The outlet of the dispenser shall be 15 inches minimum and 48 inches maximum above the finish floor and shall not be located behind grab bars. Dispensers shall not be of a type that controls delivery or that does not allow continuous paper flow. There shall be a clearance of 1 1/2 inches minimum below the grab bar.	Men's Restroom - toilet paper is too close to the toilet	Remount toilet paper dispenser max 7" to 9" from front of toilet, 15" to 48" aff and min 12" above or 1.5" below grab bar	2015 ABAAS Section: 604.7 2012 TAS Section: 604.7 2010 ADAS Section: 604.7

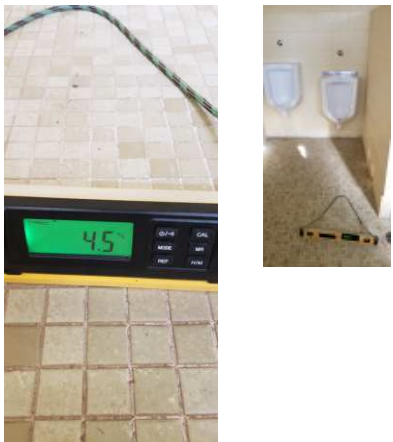
Finding Number	Area Description	Lat/Long	Finding	As Built	Recommendation	Citation	Photos	Figure
173	Cabins: Restroom Building 4 Cabin Restroom - Men's	[32.31572, -100.9417]	The accessible route contains running slopes greater than 5 percent and cross slopes greater than 2 percent across the width of the walk and has not been constructed as a ramp (i.e. handrails, wheel guides, etc.). When the slope in the direction of travel of any walk exceeds 1 unit vertical in 20 units horizontal (5-percent slope), it must be constructed as ramp. Surface cross slopes must not exceed one unit vertical in 48 units. Horizontal (2-percent slope).	Men's Restroom - 4.5% cross slope at urinal	Correct or repair slope to max 2.08%.	2015 ABAAS Section: 403.3 2012 TAS Section: 403.3 2010 ADAS Section: 403.3

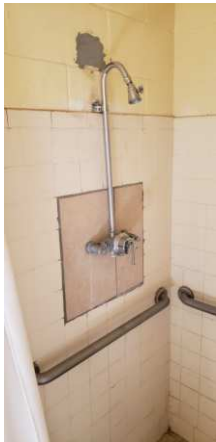
174	Cabins: Restroom Building 4 Cabin Restroom - Men's	[32.31572, -100.9417]	There is no hand held sprayer unit. The sprayer unit must have a 59 inches hose and be mounted 48 inches maximum to the top of mounting bracket off the floor. The shower spray unit shall have an on/off control with a non-positive shutoff. If an adjustable-height shower head on a vertical bar is used, the bar shall be installed so as not to obstruct the use of grab bars.	Men's Restroom - no hose or fixed 48" shower head	Replace shower control with a compliant lever control with a shower head on a 59" hose and usable as hand held or add a fixed shower head at 48" AFF.	2015 ABAAS Section: 608.6 2012 TAS Section: 608.6 2010 ADAS Section: 608.6

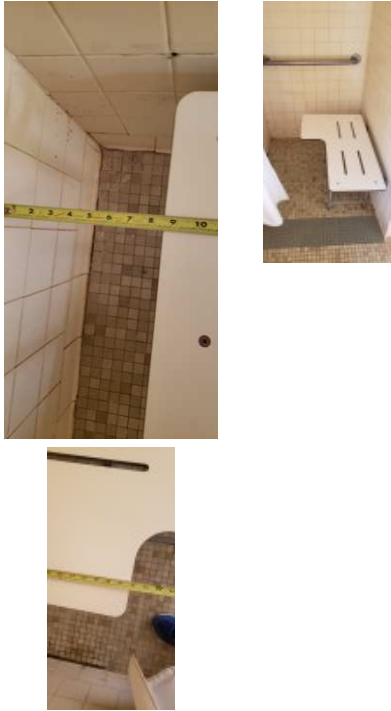
Finding Number	Area Description	Lat/Long	Finding	As Built	Recommendation	Citation	Photos	Figure
175	Cabins: Restroom Building 4 Cabin Restroom - Men's	[32.31572, -100.9417]	The shower seat does not have a compliant space between it and the wall. The folding seat must be mounted 17-19 inches above the floor, and have a maximum space of 1-1/2 inches between the edge of the seat and the side wall and 2-1/2 inches maximum to the seat wall.	Men's Restroom - 8.5" from side wall	Remount shower seat to the correct location and height in the shower.	2015 ABAAS Section: 610.3.2 2012 TAS Section: 610.3.2 2010 ADAS Section: 610.3.2

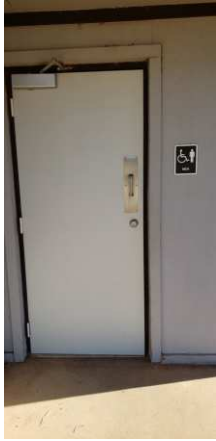
176	Cabins: Restroom Building 4 Cabin Restroom - Men's	[32.33084, -100.9308]	It is recommended that exterior doors be maintained so that the operating pressure does not exceed 8.5 lb. force to open.	Men's Restroom Door - 20# push	For all doors along the public circulation route, inspect, adjust, and maintain 8.5 lbf to open exterior doors as a smart practice.	2012 TAS Section: 404.2.9, 404.2.9 Advisory, 404.2.8.1 2010 ADAS Section: 404.2.9, 404.2.8.1

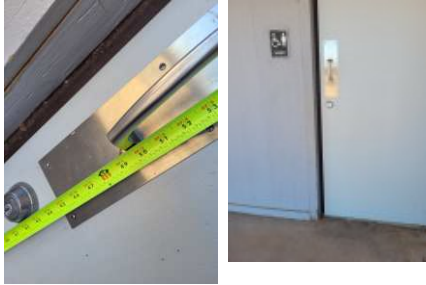
Finding Number	Area Description	Lat/Long	Finding	As Built	Recommendation	Citation	Photos	Figure
177	Cabins: Restroom Building 4 Cabin Restroom - Women's	[32.31572, -100.9417]	Exterior doors are recommended to be maintained at 8.5 lbf as a smart practice. Force is to be measured at the operating hardware or 30 inches from the hinges, whichever is greater. Hand-activated door opening hardware, handles, pulls, latches, locks, and other operating devices on accessible doors shall have a shape that is easy to grasp with one hand and does not require tight grasping, tight pinching or twisting of the wrist to operate. Hardware shall be 34 inches minimum and 48 inches maximum above the finish floor or ground.	Women's restroom - 23 lbf, 50" to handle	For all doors along the public circulation route, inspect, adjust, and maintain 8.5 lbf to open exterior doors as a smart practice For all doors along the public circulation route, mount hardware to 34" to 48" AFF.	2010 ADAS Section: 404.2.3, 404.2.7, 404.2.4, 404.2.11, 404.2.11 Exception

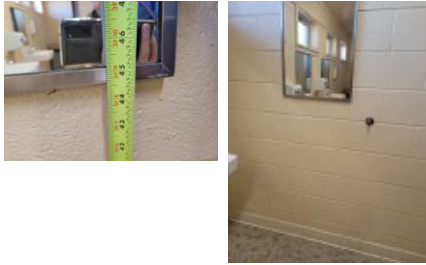
178	Cabins: Restroom Building 4 Cabin Restroom - Women's	[32.31572, -100.9417]	The mirror is mounted too high. Mirrors not located above lavatories or countertops shall be installed with the bottom edge of the reflecting surface 35 inches maximum above the finish floor or ground.	Women's Restroom - mirror 45" aff	Lower mirror not over a sink or counter to max 35" aff to the reflective surface.	2015 ABAAS Section: 603.3 2012 TAS Section: 603.3 2010 ADAS Section: 603.3

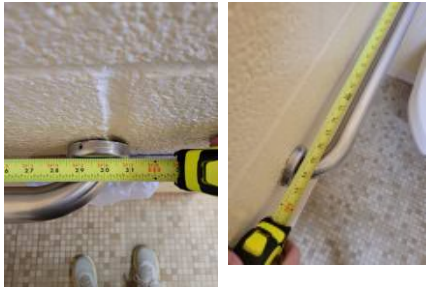
181	Cabins: Restroom Building 4 Cabin Restroom - Women's	[32.31572, -100.9417]	Grab bars shall comply with 609. A side-wall grab bar complying with 604.5.1 shall be provided on both sides of the compartment. The space between the wall and the grab bar shall be 1½ inches (38 mm). The space between the grab bar and projecting objects below and at the ends shall be 1½ inches (38 mm) minimum. The space between the grab bar and projecting objects above shall be 12 inches (305 mm) minimum. Grab bars shall be installed in a horizontal position, 33 inches (840 mm) minimum and 36 inches (915 mm) maximum above the finish floor measured to the top of the gripping surface, except that at water closets for children's use complying with 604.9, grab bars shall be installed in a horizontal position 18 inches (455 mm) minimum and 27 inches (685 mm) max	Women's Restroom - 30" in length	Replace or add side grab bars with a 42" long grab bar, mounted max 12" from the rear wall at the close end and min 54" on the far end and 33" to 36" aff or the correct type for the new wheelchair accessible stall.	2015 ABAAS Section: 604.8.2.3, 609.3, 609.4 2012 TAS Section: 609.4, 609.3, 604.8.2.3 2010 ADAS Section: 609.3, 609.4, 604.8.2.3

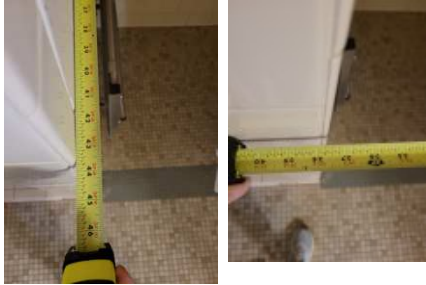
Finding Number	Area Description	Lat/Long	Finding	As Built	Recommendation	Citation	Photos	Figure
188	Cabins: Restroom Building 4 Cabin Restroom - Women's	[32.31572, -100.9417]	Transfer type shower compartments shall be 36 inches (915 mm) by 36 inches (915 mm) clear inside dimensions measured at the center points of opposing sides and shall have a 36 inch (915 mm) wide minimum entry on the face of the shower compartment. Clearance of 36 inches (915 mm) wide minimum by 48 inches (1220 mm) long minimum measured from the control wall shall be provided.	Women's Restroom - transfer shower 44" depth, 38" width	Reconfigure transfer shower to compliant 36" by 36" clear inside dimension	2015 ABAAS Section: 608.2.1 2012 TAS Section: 608.2.1 2010 ADAS Section: 608.2.1

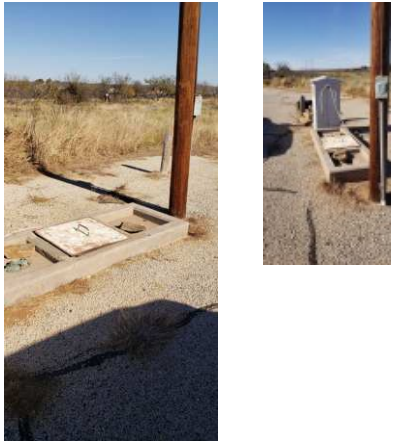
189	Cabins: Dump Station	[32.3301491, -100.9317289]	72 inches (1830 mm) by 48 inches (1220 mm) with the long side of the space adjoining or overlapping an outdoor recreation access route or trail, as applicable, or another clear ground space. Locate the space so that the water spout is 11 inches (280 mm) minimum and 12 inches (305 mm) maximum from the rear center of the long side of the space.	Cabin Dump station - asphalt is loose but faucet was in reach range	Provide required clear ground space at water hydrant and dump stations as a smart practice	2015 ABAAS Section: 1011.2

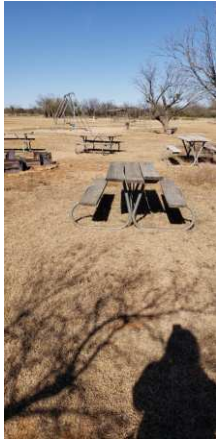
Finding Number	Area Description	Lat/Long	Finding	As Built	Recommendation	Citation	Photos	Figure
190	Campsites: Exterior Accessible Route	[32.32249, -100.931164 6]	There is no accessible route to the picnic tables. At least one accessible route shall connect accessible buildings, accessible facilities, accessible elements, and accessible spaces that are on the same site.	No accessible route to picnic area in Mesquite loop. 0 of 4 tables accessible	Create an accessible route with crushed stone or other outdoor material from parking or walkway to the picnic tables and replace one with one of an accessible design as a smart practice.	2015 ABAAS Section: F206.2.2 2012 TAS Section: 206.2.2 2010 ADAS Section: 206.2.2

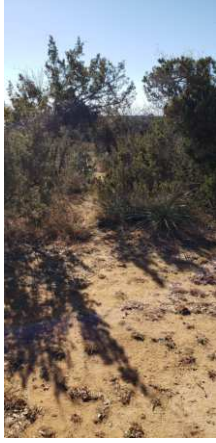
191	Campsites: Exterior Accessible Route	[32.3306721, -100.9275275]	There is no accessible route to the camping area. At least one accessible route shall connect accessible buildings, accessible facilities, accessible elements, and accessible spaces that are on the same site.	No accessible route to Lakeview camping area	Create an accessible route with crushed stone or other outdoor material from parking or walkway to camping area as a smart practice.	2015 ABAAS Section: F206.2.2 2012 TAS Section: 206.2.2 2010 ADAS Section: 206.2.2

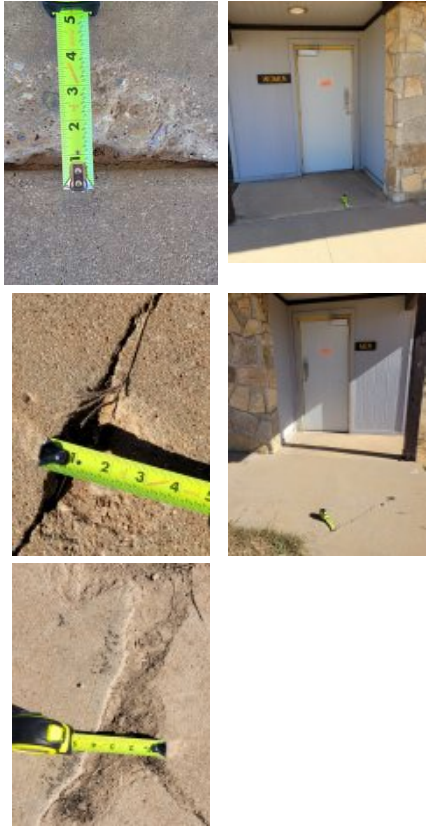
Finding Number	Area Description	Lat/Long	Finding	As Built	Recommendation	Citation	Photos	Figure
192	Campsites: Exterior Accessible Route	[32.3252105 , -100.9318 965]	There is a gap spaced greater than a 1/2 inch. Openings in floor or ground surfaces shall not allow passage of a sphere more than 1/2 inch diameter. Elongated openings shall be placed so that the long dimension is perpendicular to the dominant direction of travel.	restroom 1/ Rolling Hills loop - 1.5" gap at entry to women's restroom, 3" gap on men's side, 4" gap on path along lot	Correct or fill gaps to be max .5"	2015 ABAAS Section: 302.3 2012 TAS Section: 302.3 2010 ADAS Section: 302.3

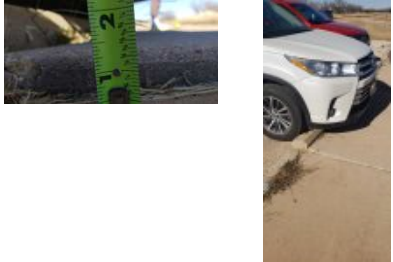
Finding Number	Area Description	Lat/Long	Finding	As Built	Recommendation	Citation	Photos	Figure
194	Campsites: Exterior Accessible Route	[32.31572, -100.9417]	The walkway contains abrupt vertical edges and/or variations over a 1/4 inch. 1/4 inch is the maximum vertical rise. Changes in level between 1/4 inch and 1/2 inch must be beveled at 1:2 or less. Changes in level greater than 1/2 inch must be by way of a ramp.	1" change in level on route to restroom building	Grind or bevel change in level to max .25"	2012 TAS Section: 303.2, 303.3 2010 ADAS Section: 303.2, 303.3

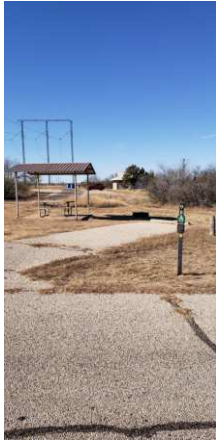
195	Campsites: Campsites	[32.3315112 , -100.9276 291]	Camping facilities shall provide camping units with mobility features complying with F244.2 in accordance with Table F244.2. Where a camping facility provides different types of camping units, Table F244.2 shall apply to each type of camping unit provided. Total Number of Camping Units Provided in Camping Facility Minimum Number of Camping Units with Mobility Features Required 1 1 2 to 25 2 26 to 50 3 51 to 75 4 76 to 100 5 101 to 150 7 151 to 200 8 201 and over 8, plus 2 percent of the number over 200	Lakeview campsite area has no accessible campsites: Site 98 is marked as representative for the area; no accessible route to restroom, table, or firepit. Picnic table not of accessible design	Create the required number of accessible camp sites per table F244.2 as a smart practice.	2015 ABAAS Section: F244.2

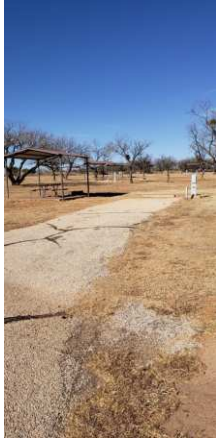
Finding Number	Area Description	Lat/Long	Finding	As Built	Recommendation	Citation	Photos	Figure
196	Campsites: Campsites	[32.3222798 , -100.9315 398]	Camping facilities shall provide camping units with mobility features complying with F244.2 in accordance with Table F244.2. Where a camping facility provides different types of camping units, Table F244.2 shall apply to each type of camping unit provided. Total Number of Camping Units Provided in Camping Facility Minimum Number of Camping Units with Mobility Features Required 1 1 2 to 25 2 26 to 50 3 51 to 75 4 76 to 100 5 101 to 150 7 151 to 200 8 201 and over 8, plus 2 percent of the number over 200	Mesquite Circle campsite area has no accessible campsites, 0 of 34; Site 10 is designated as representative for the area, no accessible route to restroom, table, or fire pit. The picnic table is not of accessible design	Create the required number of accessible camp sites per table F244.2 as a smart practice	2015 ABAAS Section: F244.2

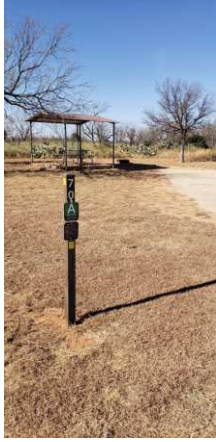
197	Campsites: Campsites	[32.3254031 , -100.93226 4]	Camping facilities shall provide camping units with mobility features complying with F244.2 in accordance with Table F244.2. Where a camping facility provides different types of camping units, Table F244.2 shall apply to each type of camping unit provided. Total Number of Camping Units Provided in Camping Facility Minimum Number of Camping Units with Mobility Features Required 1 1 2 to 25 2 26 to 50 3 51 to 75 4 76 to 100 5 101 to 150 7 151 to 200 8 201 and over 8, plus 2 percent of the number over 200	Rolling Hills campsite area has no accessible campsites: 0 of 43; Site 70 is marked as representative for the area, no accessible route to restroom, table, or fire pit, picnic table is not of accessible design	Create the required number of accessible camp sites per table F244.2 as a smart practice.	2015 ABAAS Section: F244.2

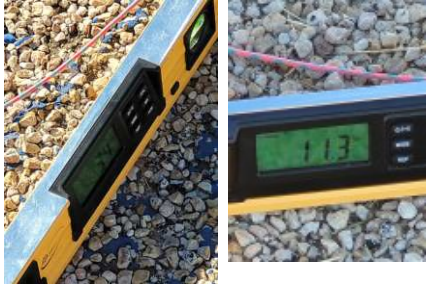
Finding Number	Area Description	Lat/Long	Finding	As Built	Recommendation	Citation	Photos	Figure
200	Campsites: Restroom Parking 1	[32.32516, -100.9319705]	The cross slopes (narrow dimension) and/or running slopes (long dimension) of the access aisle exceeds 2%. The running slope and the cross slope in an accessible parking stall and the access aisle must not exceed 2%.	Parking at restroom building by site 72 - stall has 3.4% slope, access aisle - 11.3%	Repair or correct slope of parking space and access aisle to max 2.08% in any direction	2015 ABAAS Section: 502.4 2012 TAS Section: 502.4 2010 ADAS Section: 502.4

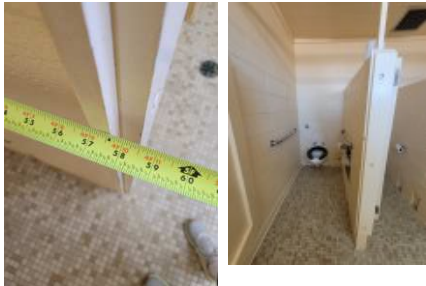
209	Campsites: Restroom Building 1 Rolling Hills - Women's	[32.31572, -100.9417]	The ambulatory stall is not between 35" to 37" wide and 60" deep.	Women's Restroom - ambulatory stall 57" depth	Correct ambulatory stall to be 35" to 37" wide and minimum 60" deep or use existing stall to create required wheelchair stall.	2015 ABAAS Section: 604.8.2.1 2012 TAS Section: 604.8.2.1 2010 ADAS Section: 604.8.2.1

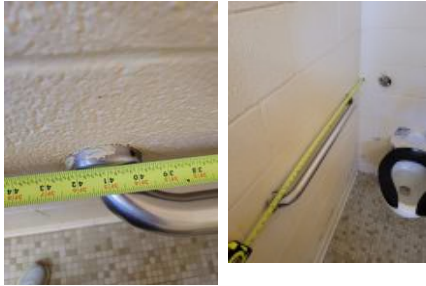
Finding Number	Area Description	Lat/Long	Finding	As Built	Recommendation	Citation	Photos	Figure
212	Campsites: Restroom Building 1 Rolling Hills - Women's	[32.31572, -100.9417]	The side grab bars are not in the correct location. Grab bars on the side wall must be installed so that the end closest to the rear wall is maximum 12" from the rear wall. The end furthest from the rear wall must be mounted minimum 54" from the rear wall.	Women's Restroom - both grab bars are 41" from rear wall	Remount side grab bar to max 12" from the rear wall at the close end and min 54" on the far end, and 33" to 36" aff and rear grab bar in new wheelchair stall to correct location behind toilet. See previous finding for cost.	2015 ABAAS Section: 604.5.1 2012 TAS Section: 604.5.1 2010 ADAS Section: 604.5.1

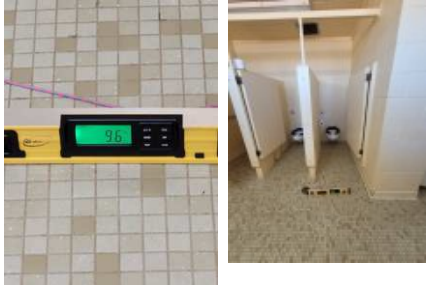
214	Campsites: Restroom Building 1 Rolling Hills - Women's	[32.31572, -100.9417]	The accessible route contains running slopes greater than 5 percent and cross slopes greater than 2 percent across the width of the walk and has not been constructed as a ramp (i.e. handrails, wheel guides, etc.). When the slope in the direction of travel of any walk exceeds 1 unit vertical in 20 units horizontal (5-percent slope), it must be constructed as ramp. Surface cross slopes must not exceed one unit vertical in 48 units. Horizontal (2-percent slope).	9.6% cross slope at entry to first standard stall	Correct or repair slope to max 2.08% cross	2015 ABAAS Section: 403.3 2012 TAS Section: 403.3 2010 ADAS Section: 403.3

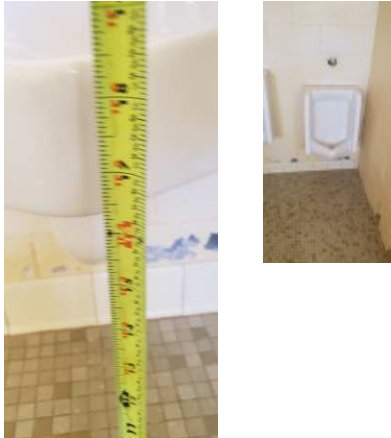
220	Campsites: Restroom Building 1 Rolling Hills - Men's	[32.31572, -100.9417]	There are not enough accessible toilet compartments. The room contains toilet compartments. A minimum of 1 must be wheelchair accessible .	Men's Restroom - lacks accessible stall, ambulatory only	Create a wheelchair accessible stall with grab bars and fixtures mounted in correct locations and at correct heights.	2015 ABAAS Section: F213.3.1 2012 TAS Section: 213.3.1 2010 ADAS Section: 213.3.1

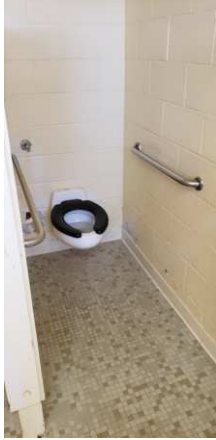
Finding Number	Area Description	Lat/Long	Finding	As Built	Recommendation	Citation	Photos	Figure
221	Campsites: Restroom Building 1 Rolling Hills - Men's	[32.31572, -100.9417]	The ambulatory stall is not between 35" to 37" wide and 60" deep.	Men's Restroom - 56" deep	Correct ambulatory stall to be 35" to 37" wide and minimum 60" deep, or use existing stall to create the required wheelchair accessible stall.	2015 ABAAS Section: 604.8.2.1 2012 TAS Section: 604.8.2.1 2010 ADAS Section: 604.8.2.1

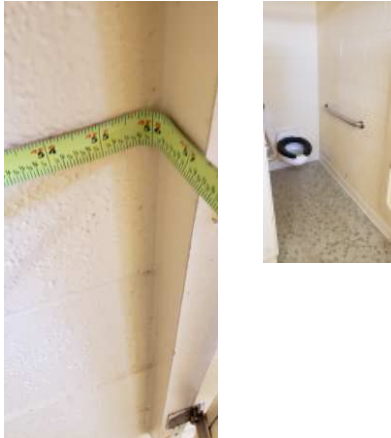
222	Campsites: Restroom Building 1 Rolling Hills - Men's	[32.31572, -100.9417]	The stall door fails to comply with all of the door requirements. The stall door must be a minimum of 32" wide and have compliant hardware on both sides. The stall door must be self-closing.	Men's Restroom - not self closing, no hardware	Adjust stall door to be self-closing Replace stall hardware with hardware operable without a tight pinch or grasp on both sides of the stall door	2015 ABAAS Section: 404.2.3, 404.2.7, 604.8.2.2 2012 TAS Section: 404.2.3, 404.2.7, 604.8.2.2 2010 ADAS Section: 404.2.3, 404.2.7, 604.8.2.2

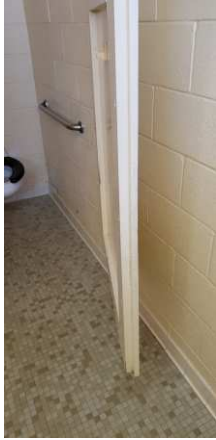
Finding Number	Area Description	Lat/Long	Finding	As Built	Recommendation	Citation	Photos	Figure
223	Campsites: Restroom Building 1 Rolling Hills - Men's	[32.31572, -100.9417]	Grab bars shall comply with 609. A side-wall grab bar complying with 604.5.1 shall be provided on both sides of the compartment. The space between the wall and the grab bar shall be 1½ inches (38 mm). The space between the grab bar and projecting objects below and at the ends shall be 1½ inches (38 mm) minimum. The space between the grab bar and projecting objects above shall be 12 inches (305 mm) minimum. Grab bars shall be installed in a horizontal position, 33 inches (840 mm) minimum and 36 inches (915 mm) maximum above the finish floor measured to the top of the gripping surface, except that at water closets for children's use complying with 604.9, grab bars shall be installed in a horizontal position 18 inches (455 mm) minimum and 27 inches (685 mm) max	Men's Restroom - right bar 30"	Replace or add side grab bars with a 42" long grab bar, mounted max 12" from the rear wall at the close end and min 54" on the far end and 33" to 36" aff	2015 ABAAS Section: 604.8.2.3, 609.3, 609.4 2012 TAS Section: 609.4, 609.3, 604.8.2.3 2010 ADAS Section: 609.3, 609.4, 604.8.2.3

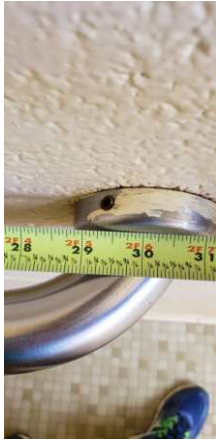
224	Campsites: Restroom Building 1 Rolling Hills - Men's	[32.31572, -100.9417]	The side grab bars are not in the correct location. Grab bars on the side wall must be installed so that the end closest to the rear wall is maximum 12" from the rear wall. The end furthest from the rear wall must be mounted minimum 54" from the rear wall.	Men's Restroom - 41" from rear wall	Remount side grab bar to max 12" from the rear wall at the close end and min 54" on the far end, and 33" to 36" aff. See previous finding for cost.	2015 ABAAS Section: 604.5.1 2012 TAS Section: 604.5.1 2010 ADAS Section: 604.5.1

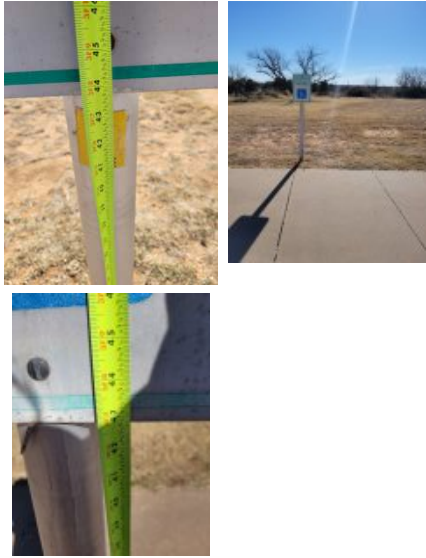
229	Campsites: Restroom 2 Parking	[32.3221461 , -100.9309 068]	The accessible parking is not located on the shortest accessible route to the building. Accessible parking spaces serving a particular building or facility entrance shall be located on the shortest accessible route of travel from the parking to an accessible entrance.	Mesquite loop - accessible stall is farthest from restroom building	Relocate stalls to be on the shortest AR to the building entry or park features	2015 ABAAS Section: F208.3.1 2012 TAS Section: 208.3.1 2010 ADAS Section: 208.3.1

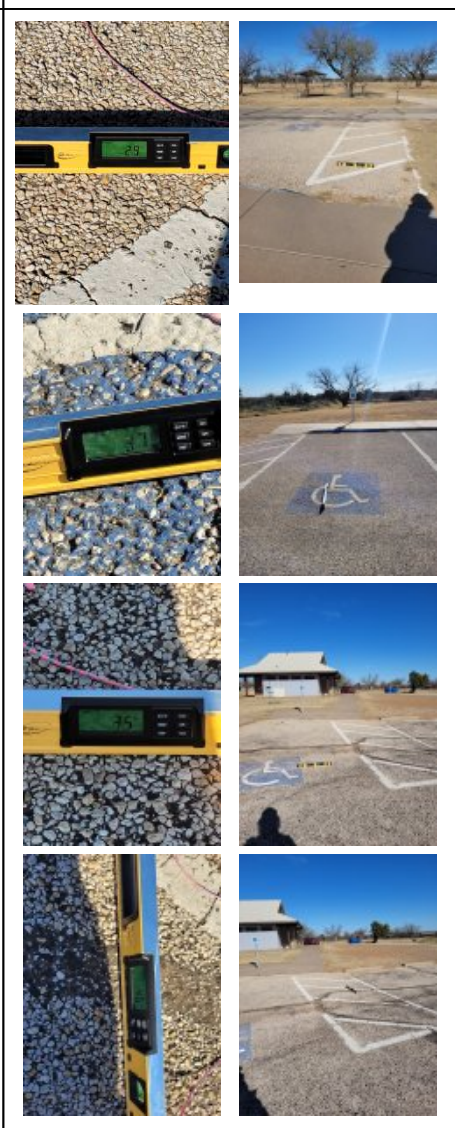
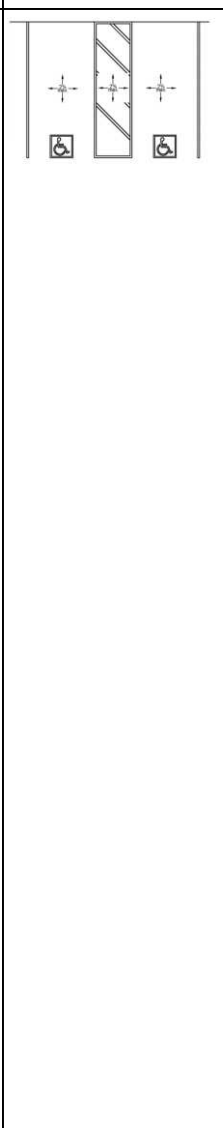
Finding Number	Area Description	Lat/Long	Finding	As Built	Recommendation	Citation	Photos	Figure
231	Campsites: Restroom 2 Parking	[32.3221381 , -100.9309 242]	The cross slopes (narrow dimension) and/or running slopes (long dimension) of the access aisle exceeds 2%. The running slope and the cross slope in an accessible parking stall and the access aisle must not exceed 2%.	Mesquite loop - 2.9% slope access aisle, stall - 3.7% slope; Recreation side - 3.5% slope in stall, access aisle - 4.6% slope	Repair or correct slope of parking space and access aisle to max 2.08% in any direction	2015 ABAAS Section: 502.4 2012 TAS Section: 502.4 2010 ADAS Section: 502.4

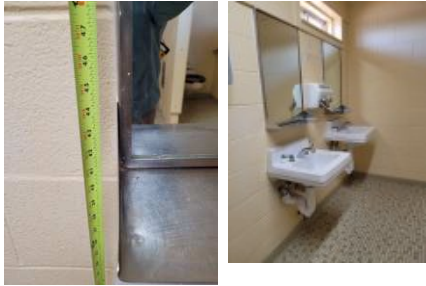
233	Campsites: Restroom Building 2 Mesquite - Women's	[32.31572, -100.9417]	Where a high forward reach is over an obstruction, the clear floor space shall extend beneath the element for a distance not less than the required reach depth over the obstruction. The high forward reach shall be 48 inches (1220 mm) maximum where the reach depth is 20 inches (510 mm) maximum. Where the reach depth exceeds 20 inches (510 mm), the high forward reach shall be 44 inches (1120 mm) maximum and the reach depth shall be 25 inches (635 mm) maximum.	Women's Restroom - hook 63" aff	Lower hook in Women's Restroom to max 48" aff to highest operable part.	2015 ABAAS Section: 308.2.1, 308.3.2 2012 TAS Section: 308.2.1, 308.3.2 2010 ADAS Section: 308.2.1, 308.3.2

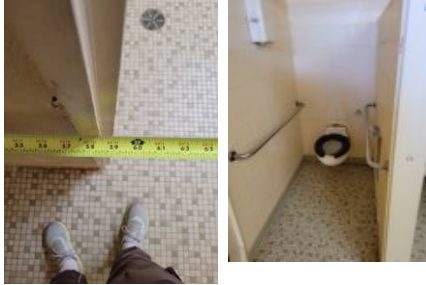
236	Campsites: Restroom Building 2 Mesquite - Women's	[32.31572, -100.9417]	The stall door fails to comply with all of the door requirements. The stall door must be a minimum of 32" wide and have compliant hardware on both sides. The stall door must be self-closing.	Women's Restroom - no hardware on pull, not self closing	Adjust stall door to be self-closing Replace stall hardware with hardware operable without a tight pinch or grasp on both sides of the stall door	2015 ABAAS Section: 404.2.3, 404.2.7, 604.8.2.2 2012 TAS Section: 404.2.3, 404.2.7, 604.8.2.2 2010 ADAS Section: 404.2.3, 404.2.7, 604.8.2.2

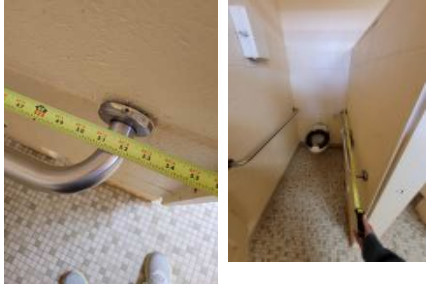
Finding Number	Area Description	Lat/Long	Finding	As Built	Recommendation	Citation	Photos	Figure
238	Campsites: Restroom Building 2 Mesquite - Women's	[32.31572, -100.9417]	The toilet paper is not installed within the compliant range in front of the toilet. Toilet paper dispensers shall be 7 inches minimum and 9 inches maximum in front of the water closet measured to the centerline of the dispenser. The outlet of the dispenser shall be 15 inches minimum and 48 inches maximum above the finish floor and shall not be located behind grab bars. Dispensers shall not be of a type that controls delivery or that does not allow continuous paper flow. There shall be a clearance of 1 1/2 inches minimum below the grab bar.	Women's Restroom - toilet paper too close to front of toilet	Remount toilet paper dispenser max 7" to 9" from front of toilet, 15" to 48" aff and min 12" above or 1.5" below grab bar.	2015 ABAAS Section: 604.7 2012 TAS Section: 604.7 2010 ADAS Section: 604.7

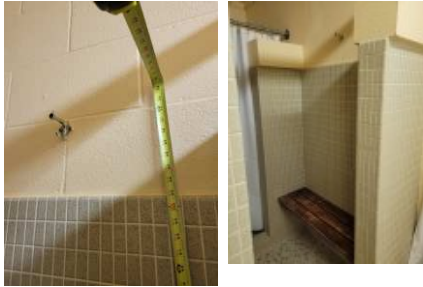
Finding Number	Area Description	Lat/Long	Finding	As Built	Recommendation	Citation	Photos	Figure
241	Campsites: Restroom Building 2 Mesquite - Women's	[32.31572, -100.9417]	The bench is not deep enough or long enough or is missing. Benches shall be provided having seats that are 42 inches long minimum and 20 inches deep minimum and 24 inches deep maximum. The bench shall provide for back support or shall be affixed to a wall. Back support shall be 42 inches (1065 mm) long minimum and shall extend from a point 2 inches (51 mm) maximum above the seat surface to a point 18 inches (455 mm) minimum above the seat surface. Back support shall be 2½ inches (64 mm) maximum from the rear edge of the seat measured horizontally. The top of the bench seat surface shall be 17 inches (430 mm) minimum and 19 inches (485 mm) maximum above the finish floor or ground. Clear floor or ground space complying with 305 shall be provided and shall be positioned at the end of the bench seat and parallel to the short axis of the bench	Women's Restroom - 12" bench depth	Replace bench in dressing area with one having a seat depth of 20" to 24" deep, 42" long, affixed to the wall or having a back and mounted 17" to 19" AFF and provide required clear floor space on the short axis of the bench. .	2012 TAS Section: 903.4, 903.2, 903.3, 903.5 2010 ADAS Section: 903.4, 903.2, 903.3, 903.5

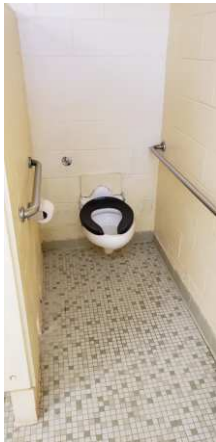
Finding Number	Area Description	Lat/Long	Finding	As Built	Recommendation	Citation	Photos	Figure
248	Campsites: Restroom Building 2 Mesquite - Men's	[32.31572, -100.9417]	The ambulatory stall is not between 35" to 37" wide and 60" deep.	Men's Restroom - ambulatory stall 58" deep	Correct ambulatory stall to be 35" to 37" wide and minimum 60" deep, in the alternative, use existing stall to create required wheelchair stall.	2015 ABAAS Section: 604.8.2.1 2012 TAS Section: 604.8.2.1 2010 ADAS Section: 604.8.2.1

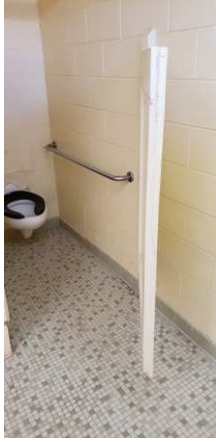
Finding Number	Area Description	Lat/Long	Finding	As Built	Recommendation	Citation	Photos	Figure
250	Campsites: Restroom Building 2 Mesquite - Men's	[32.31572, -100.9417]	The side grab bars are not in the correct location. Grab bars on the side wall must be installed so that the end closest to the rear wall is maximum 12" from the rear wall. The end furthest from the rear wall must be mounted minimum 54" from the rear wall.	Men's Restroom - 12.5" and 42.5" to rear wall	Replace grab bar with 42" long bar and mount side grab bar to max 12" from the rear wall at the close end and min 54" on the far end, and 33" to 36" aff.	2015 ABAAS Section: 604.5.1 2012 TAS Section: 604.5.1 2010 ADAS Section: 604.5.1

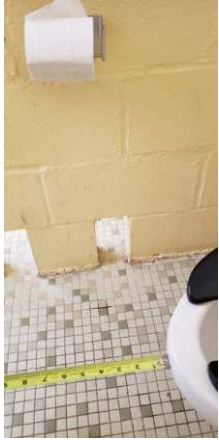
251	Campsites: Restroom Building 2 Mesquite - Men's	[32.31572, -100.9417]	The toilet paper is not installed within the compliant range in front of the toilet. Toilet paper dispensers shall be 7 inches minimum and 9 inches maximum in front of the water closet measured to the centerline of the dispenser. The outlet of the dispenser shall be 15 inches minimum and 48 inches maximum above the finish floor and shall not be located behind grab bars. Dispensers shall not be of a type that controls delivery or that does not allow continuous paper flow. There shall be a clearance of 1 1/2 inches minimum below the grab bar.	Men's Restroom - toilet paper 5" in front of toilet	Remount toilet paper dispenser max 7" to 9" from front of toilet, 15" to 48" aff and min 12" above or 1.5" below grab bar	2015 ABAAS Section: 604.7 2012 TAS Section: 604.7 2010 ADAS Section: 604.7

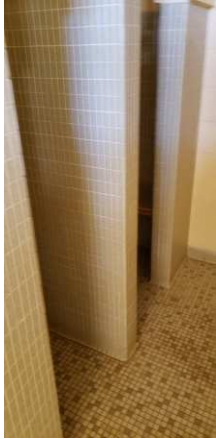
Finding Number	Area Description	Lat/Long	Finding	As Built	Recommendation	Citation	Photos	Figure
252	Campsites: Restroom Building 2 Mesquite - Men's	[32.31572, -100.9417]	There are no accessible bathing or shower facilities. Where facilities for bathing are provided for the public, clients or employees, including showers or bathtubs, at least one shower or bathtub and support facilities such as lockers, and not less than 1 percent of all facilities, shall be accessible.	Men's Restroom - no accessible showers	Create an accessible shower in locker/bathing room.	2015 ABAAS Section: F213.3.6 2012 TAS Section: 213.3.6 2010 ADAS Section: 213.3.6
