# Access Audit Site Report

Prepared By  
**WT Group**

**Lake Livingston State Park**  
**300 State Park Rd 65**  
**Livingston, TX 77351**  
**Accessibility Evaluation**  
**Inspection Date: 11/08/2021**  
**Inspectors: Tanya Scheibe**

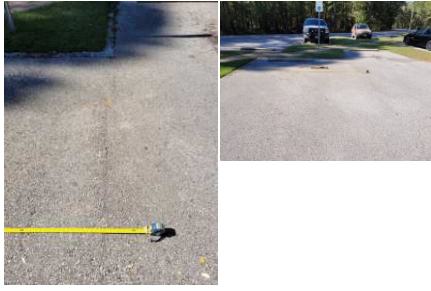
Finding Number	Area Description	Lat/Long	Finding	As Built	Recommendation	Citation	Photos	Figure
1	Headquarters: Headquarters Parking	[30.6570265 , -95.001208 3]	The access aisle is not a minimum 5 feet wide. A car accessible parking stall's access aisle must be a minimum of 5 feet wide measured from centerline to centerline. Where the access aisle is not adjacent to another parking space or access aisle, measurements shall be permitted to include the full width of the line defining the access aisle.	Lacks width requirement for access aisles	Repaint access aisles to be 5' each	2015 ABAAS Section: 502.3.1  2012 TAS Section: 502.3.1  2010 ADAS Section: 502.3.1

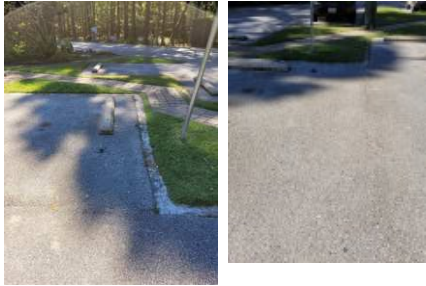
Finding Number	Area Description	Lat/Long	Finding	As Built	Recommendation	Citation	Photos	Figure
4	Headquarters: Headquarters Parking	[30.6570254 , -95.001212 3]	The access aisle is not located on an accessible route of travel to the accessible building entrance. Accessible parking spaces serving a particular building shall be located on the shortest accessible route of travel from adjacent parking to an accessible entrance. In buildings with multiple accessible entrances with adjacent parking, accessible parking spaces shall be dispersed and located closest to the accessible entrances.	Access aisle does not connect to an accessible route	Reconfigure accessible stalls to avoid requiring pedestrians to cross vehicular way, in the alternative, leave as is with striped crosswalk	2015 ABAAS Section: F208.3.1  2012 TAS Section: 208.3.1  2010 ADAS Section: 208.3.1

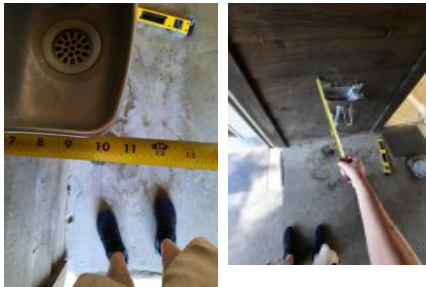
6	Headquarters: Headquarters Exterior Accessible Route	[30.65698, -95.00138]	The drinking fountain projects more than 4 inches into the circulation path. Wall-mounted objects that have leading edges between 27 inches and 80 inches from the floor must not project more than 4 inches into the circulation path. Protruding objects that extend to the floor or within 27 inches of the floor are cane detectable and are therefore not hazardous. Where it is necessary or desirable to have objects protrude from the wall, a manner of cane detection must be provided.	Drinking fountain protrudes 10.5"	Relocate protruding objects or place cane detectable warning or bollard at foot of item	2015 ABAAS Section: 307.2  2012 TAS Section: 307.2  2010 ADAS Section: 307.2

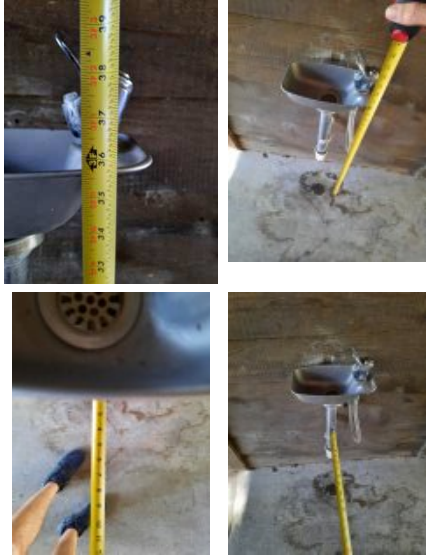
Finding Number	Area Description	Lat/Long	Finding	As Built	Recommendation	Citation	Photos	Figure
7	Headquarters: Headquarters Exterior Accessible Route	[30.65685, -95.00121]	The total number of drinking fountains are not equally divided between those that are accessible to wheelchair users and those that are available to standing persons. Where more than two are provided, 50 percent of the total number of drinking fountains provided shall be accessible to wheelchair users and 50 percent available to standing persons.	Height of spout is 37.5" AFF and is not compliant for either a low bowl or high bowl, lacks knee clearance	Replace fountain to provide 50/50 split between hi and lo bowl fountains	2015 ABAAS Section: F211.3  2012 TAS Section: 211.3  2010 ADAS Section: 211.3

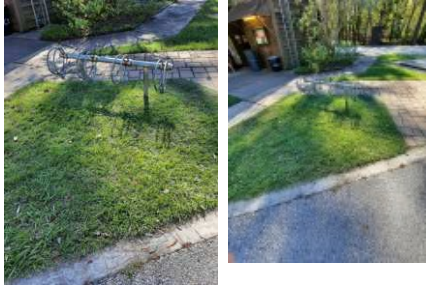
8	Headquarters: Headquarters Exterior Accessible Route	[30.65708, -95.00095]	There is no accessible route to the bike rack. At least one accessible route shall connect accessible buildings, accessible facilities, accessible elements, and accessible spaces that are on the same site.	Lacks accessible route to bike rack	Create an accessible route with crushed stone or other outdoor material from parking or walkway to bike rack.	2015 ABAAS Section: F206.2.2  2012 TAS Section: 206.2.2  2010 ADAS Section: 206.2.2

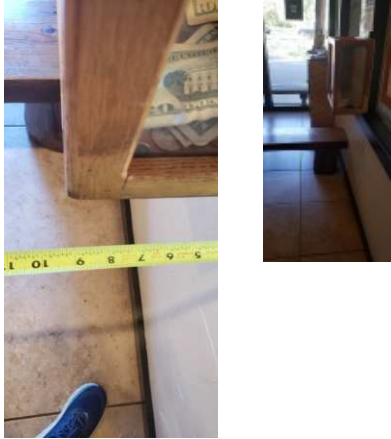
Finding Number	Area Description	Lat/Long	Finding	As Built	Recommendation	Citation	Photos	Figure
13	Headquarters: Headquarters Public Spaces	[30.65691, -95.00105]	The donation box projects more than 4 inches into the circulation path. Wall-mounted objects that have leading edges between 27 inches and 80 inches from the floor must not project more than 4 inches into the circulation path. Protruding objects that extend to the floor or within 27 inches of the floor are cane detectable and are therefore not hazardous. Where it is necessary or desirable to have objects protrude from the wall, a manner of cane detection must be provided.	Lobby - Donation box protrudes 9"	Relocate protruding objects or place cane detectable warning or bollard at foot of item	2015 ABAAS Section: 307.2  2012 TAS Section: 307.2  2010 ADAS Section: 307.2

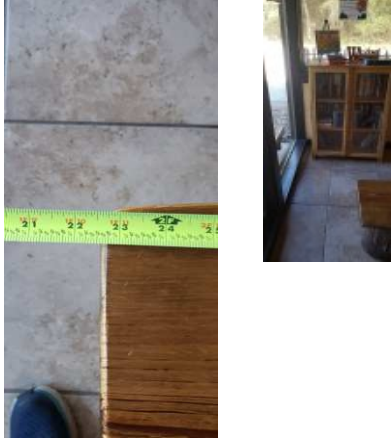
14	Headquarters: Headquarters Public Spaces	[30.65691, -95.00105]	The route of travel at this location does not provide a minimum width of 36 inches. The clear width shall be permitted to be reduced to 32 inches minimum for a length of 24 inches maximum provided that reduced width segments are separated by segments that are 48 inches long minimum and 36 inches wide minimum.	Lobby - 22.5" to bookshelf	Widen AR to compliant 36" clear width	2015 ABAAS Section: 403.5.1  2012 TAS Section: 403.5.1  2010 ADAS Section: 403.5.1

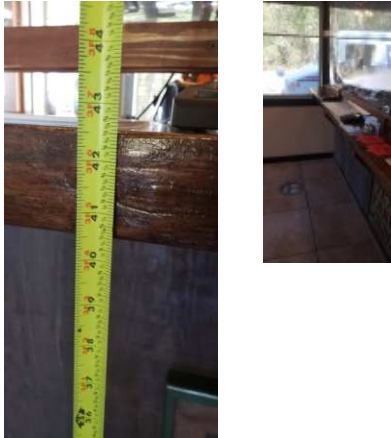
Finding Number	Area Description	Lat/Long	Finding	As Built	Recommendation	Citation	Photos	Figure
15	Headquarters: Headquarters Public Spaces	[30.65691, -95.00105]	The transaction counter provides for a parallel approach and is not within the required height range. Transaction counters shall be 36 inches high maximum and a minimum of 36 inches wide and should extend the same depth as the sales or service counter tops.	Transaction counter at 42.5"	Lower 36" wide segment of service counter to max 36" aff.	2015 ABAAS Section: 904.4.1  2012 TAS Section: 904.4.1  2010 ADAS Section: 904.4.1

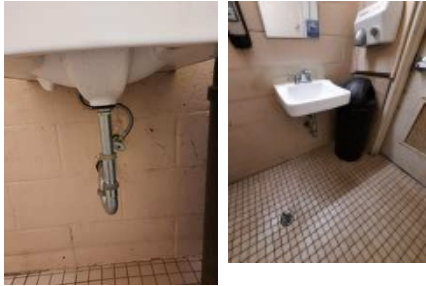
Finding Number	Area Description	Lat/Long	Finding	As Built	Recommendation	Citation	Photos	Figure
19	Headquarters: Headquarters Unisex Restroom	[30.65691, -95.00105]	The water and drain pipes under the lavatory are not adequately insulated. Water supply and drain pipes under lavatories and sinks shall be insulated or otherwise configured to protect against contact. There shall be no sharp or abrasive surfaces under lavatories and sinks.	Sink lacks insulated pipes	Insulate exposed pipes under one sink	2015 ABAAS Section: 606.5  2012 TAS Section: 606.5  2010 ADAS Section: 606.5

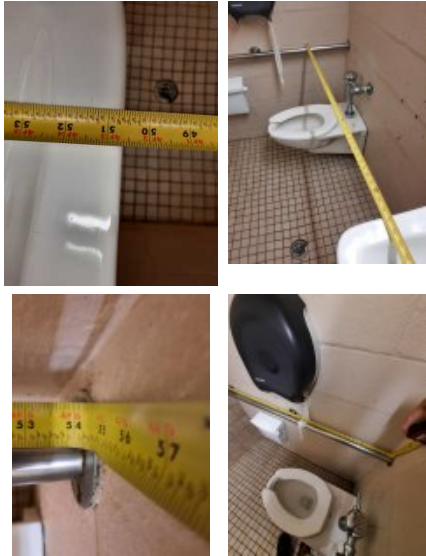
20	Headquarters: Headquarters Unisex Restroom	[30.65691, -95.00105]	The required 56 inches by 60 inches clear floor space for the water closet has been obstructed. The clear floor space around the water closet shall be 60 inches minimum measured perpendicular from the side wall and 56 inches minimum measured perpendicular from the rear wall.	Lacks 60" clear floor space around toilet - 50.75" to sink, 54.5" deep	Renovate restroom to provide 60" by 56" clearance around the toilet.	2015 ABAAS Section: 604.3.  2012 TAS Section: 604.3.1  2010 ADAS Section: 604.3.1

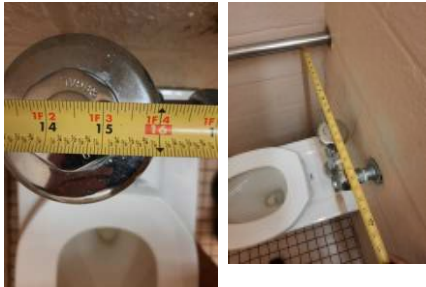
21	Headquarters: Headquarters Unisex Restroom	[30.65691, -95.00105]	The toilet is not located within the range allowed from the side wall or partition. The centerline of the toilet must be 16 to 18 inches from the side wall.	Centerline of the toilet is 14.5" from the side wall	Remount toilets to 16" to 18" from the side wall to centerline	2015 ABAAS Section: 604.2  2012 TAS Section: 604.2  2010 ADAS Section: 604.2

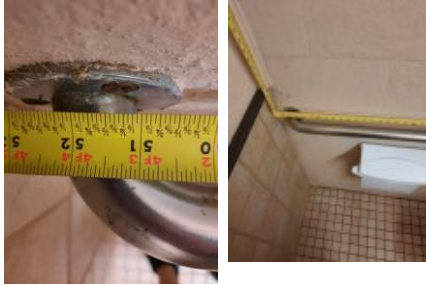
Finding Number	Area Description	Lat/Long	Finding	As Built	Recommendation	Citation	Photos	Figure
22	Headquarters: Headquarters Unisex Restroom	[30.65691, -95.00105]	The side grab bars are not in the correct location. Grab bars on the side wall must be installed so that the end closest to the rear wall is maximum 12" from the rear wall. The end furthest from the rear wall must be mounted minimum 54" from the rear wall.	Side grab bar ends 51.75" from rear wall	Remount side grab bar to max 12" from the rear wall at the close end and min 54" on the far end, and 33" to 36" aff.	2015 ABAAS Section: 604.5.1  2012 TAS Section: 604.5.1  2010 ADAS Section: 604.5.1

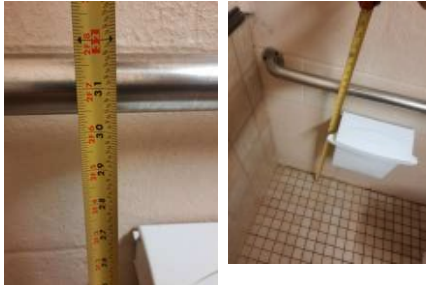
24	Headquarters: Headquarters Unisex Restroom	[30.65691, -95.00105]	The grab bar height and/or spacing fails. Grab bars must be mounted between 33" and 36" to the top of the gripping surface. There must be 1.5" of clearance between the grab bar and the wall. There must be a minimum of 1.5" of clearance below and minimum 12" above the grab bar to any dispenser or other obstruction.	Gripping surface of grab bar is 31.75" aff	Remount grab bars in accessible stall to 33" to 36" aff.	2015 ABAAS Section: 609.3, 609.4  2012 TAS Section: 609.4, 609.3  2010 ADAS Section: 609.3, 609.4

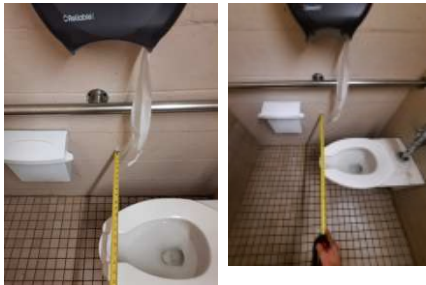
26	Headquarters: Headquarters Unisex Restroom	[30.65691, -95.00105]	The toilet paper is not installed within the compliant range in front of the toilet. Toilet paper dispensers shall be 7 inches minimum and 9 inches maximum in front of the water closet measured to the centerline of the dispenser. The outlet of the dispenser shall be 15 inches minimum and 48 inches maximum above the finish floor and shall not be located behind grab bars. Dispensers shall not be of a type that controls delivery or that does not allow continuous paper flow. There shall be a clearance of 1 1/2 inches minimum below the grab bar.	Centerline of toilet paper dispenser is 0" from the front of the toilet	Remount toilet paper dispenser max 7" to 9" from front of toilet, 15" to 48" aff and min 12" above or 1.5" below grab bar.	2015 ABAAS Section: 604.7  2012 TAS Section: 604.7  2010 ADAS Section: 604.7

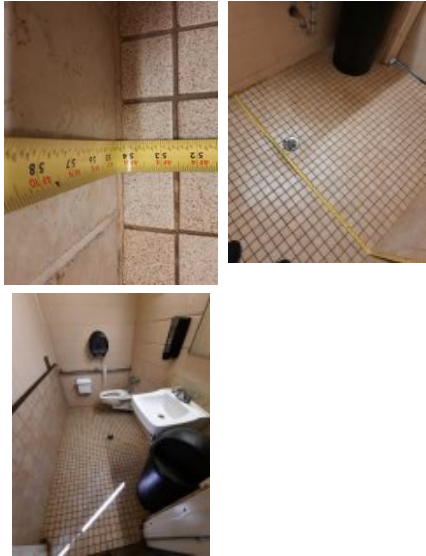
Finding Number	Area Description	Lat/Long	Finding	As Built	Recommendation	Citation	Photos	Figure
27	Headquarters: Headquarters Unisex Restroom	[30.65691, -95.00105]	There is insufficient turning space within this room or space. The space required for a wheelchair to make a 180-degree turn is a clear space of 60 inches in diameter or a T-shaped space.	Lacks sufficient turning space within this room or space	Reconfigure restroom to provide turning space if feasible. See finding 7 for cost.	2015 ABAAS Section: 304.3.1, 304.3.2  2012 TAS Section: 304.3.1, 304.3.2  2010 ADAS Section: 304.3.1, 304.3.2

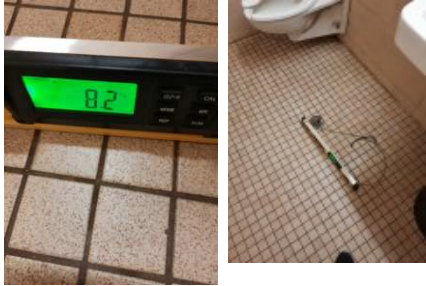
28	Headquarters: Headquarters Unisex Restroom	[30.65691, -95.00105]	The accessible route contains running slopes greater than 5 percent and cross slopes greater than 2 percent across the width of the walk and has not been constructed as a ramp (i.e. handrails, wheel guides, etc.). When the slope in the direction of travel of any walk exceeds 1 unit vertical in 20 units horizontal (5-percent slope), it must be constructed as ramp. Surface cross slopes must not exceed one unit vertical in 48 units. Horizontal (2-percent slope).	Slope of 8.2% near floor drain	Correct or repair slope to max 2.08%.	2015 ABAAS Section: 403.3  2012 TAS Section: 403.3  2010 ADAS Section: 403.3

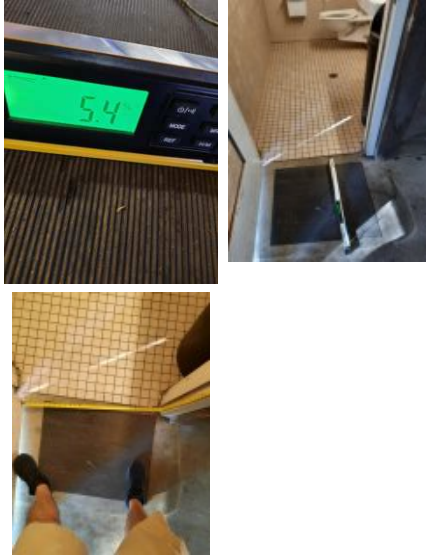
Finding Number	Area Description	Lat/Long	Finding	As Built	Recommendation	Citation	Photos	Figure
29	Headquarters: Headquarters Unisex Restroom	[30.65691, -95.00105]	Minimum maneuvering clearances at doors and gates shall comply with 404.2.4. Maneuvering clearances shall extend the full width of the doorway and the required latch side or hinge side clearance. Maneuvering clearances shall have a max slope of 2.08%. Door openings shall provide a clear width of 32 inches (815 mm) minimum. Clear openings of doorways with swinging doors shall be measured between the face of the door and the stop, with the door open 90 degrees. Openings more than 24 inches (610 mm) deep shall provide a clear opening of 36 inches (915 mm) minimum. There shall be no projections into the required clear opening width lower than 34 inches (865 mm) above the finish floor or ground. Projections into the clear opening width between 34 inches (865 mm) and 80 inches (2030 mm) above the finish floor or ground shall not exceed 4 inches (100 mm).	Slope of 5.4% at door entry, door 32" wide	For all doors along the public circulation route, provide required maneuvering clearance on push and pull side of doors. For all doors along the public circulation route, correct slope in door clearance to max 2.08%. For all doors along the public circulation route, replace doors with doors having 80" overhead clearance and 32" clear width.	2010 ADAS Section: 404.2.3, 404.2.7, 404.2.4, 404.2.11, 404.2.11 Exception

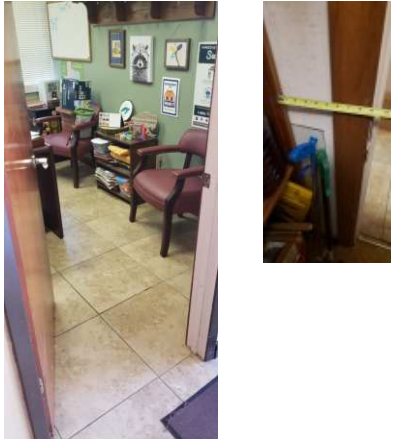
30	Headquarters: Headquarters Employee Spaces	[30.65691, -95.00105]	Spaces and elements within employee work areas shall only be required to comply with 206.2.8, 207.1, and 215.3 and shall be designed and constructed so that individuals with disabilities can approach, enter, and exit the employee work area. Employee work areas, or portions of employee work areas, other than raised courtroom stations, that are less than 300 square feet (28 m2) and elevated 7 inches (180 mm) or more above the finish floor or ground where the elevation is essential to the function of the space shall not be required to comply with these requirements or to be on an accessible route.	Entry door - chair in pull side clearance; storage closet - shelf in pull side clearance, knobs; back office door - lacks kick plate (glass), knobs ; rear door - 2" change in level (CIL), loose floor mat on pull side, knobs	For employee spaces, relocate storage, furniture, and other obstacles at doorways to provide approach, enter and exit at the employee space. Provide required maneuvering clearance on push and pull side of doors. Secure rug at door to prevent trip hazard. Repair, bevel, or ramp CILs at door entries to max .25". Replace hardware with lever hardware or hardware operable without a tight pinch or grasp. Provide kick plate on push side of door from floor to 10" AFF.	2015 ABAAS Section: F203.9  2012 TAS Section: 203.9  2010 ADAS Section: 203.9

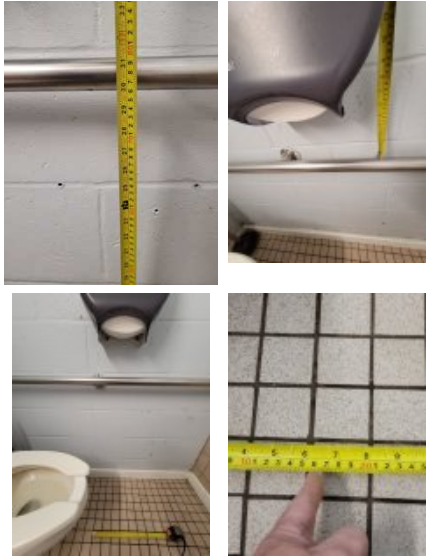
Finding Number	Area Description	Lat/Long	Finding	As Built	Recommendation	Citation	Photos	Figure
39	Headquarters: Headquarters Employee's Restroom	[30.65691, -95.00105]	The grab bar height and/or spacing fails. Grab bars must be mounted between 33" and 36" to the top of the gripping surface. There must be 1.5" of clearance between the grab bar and the wall. There must be a minimum of 1.5" of clearance below and minimum 12" above the grab bar to any dispenser or other obstruction.	Gripping surface of grab bar is 31.5" aff, and lacks 12" clearance above the bar due to toilet paper dispenser location, TP too close to toilet	Remount grab bars in accessible stall to 33" to 36" aff Remount toilet paper dispenser max 7" to 9" from front of toilet, 15" to 48" aff and min 12" above or 1.5" below grab bar	2015 ABAAS Section: 609.3, 609.4  2012 TAS Section: 609.4, 609.3  2010 ADAS Section: 609.3, 609.4

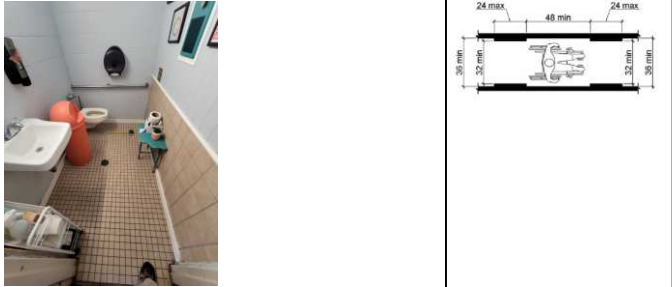
40	Headquarters: Headquarters Employee's Restroom	[30.65691, -95.00105]	The route of travel at this location does not provide a minimum width of 36 inches. The clear width shall be permitted to be reduced to 32 inches minimum for a length of 24 inches maximum provided that reduced width segments are separated by segments that are 48 inches long minimum and 36 inches wide minimum.	Lacks 36" wide route of travel	Widen AR to compliant 36" clear width by removing loose items in path of travel.	2015 ABAAS Section: 403.5.1  2012 TAS Section: 403.5.1  2010 ADAS Section: 403.5.1

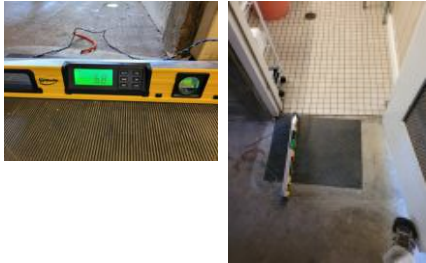
Finding Number	Area Description	Lat/Long	Finding	As Built	Recommendation	Citation	Photos	Figure
44	Headquarters: Headquarters Employee's Restroom	[30.65691, -95.00105]	<p>Minimum maneuvering clearances at doors and gates shall comply with 404.2.4. Maneuvering clearances shall extend the full width of the doorway and the required latch side or hinge side clearance. Maneuvering clearances shall have a max slope of 2.08%. Door openings shall provide a clear width of 32 inches (815 mm) minimum. Clear openings of doorways with swinging doors shall be measured between the face of the door and the stop, with the door open 90 degrees. Openings more than 24 inches (610 mm) deep shall provide a clear opening of 36 inches (915 mm) minimum. There shall be no projections into the required clear opening width lower than 34 inches (865 mm) above the finish floor or ground. Projections into the clear opening width between 34 inches (865 mm) and 80 inches (2030 mm) above the finish floor or ground shall not exceed 4 inches (100 mm). Exterior doors are recommended to be maintained at 8.5 lbf as a smart practice. Force is to be measured at the operating hardware or 30 inches from the hinges, whichever is greater.</p>	Door - Slope of 6.8% at door entry, door with 29", loose mat at door, 13# push	<p>For all doors along the public circulation route, provide required maneuvering clearance on push and pull side of doors. For all doors along the public circulation route, secure rug in door clearance to prevent trip hazard. For all doors along the public circulation route, correct slope in door clearance to max 2.08%. For all doors along the public circulation route, replace doors with doors having 80" overhead clearance and 32" clear width. For all doors along the public circulation route, inspect, adjust, and maintain 8.5 lbf to open exterior doors as a smart practice.</p>	2010 ADAS Section: 404.2.3, 404.2.7, 404.2.4, 404.2.11, 404.2.11 Exception

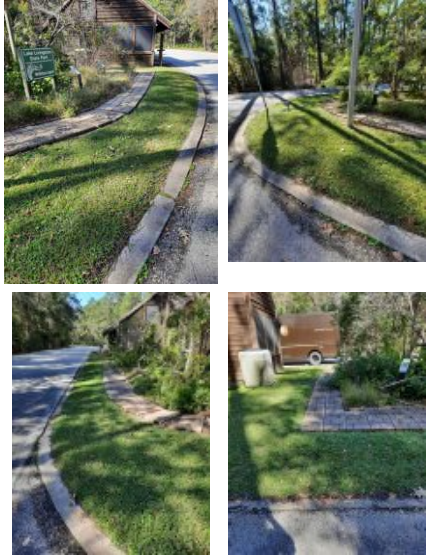
Finding Number	Area Description	Lat/Long	Finding	As Built	Recommendation	Citation	Photos	Figure
45	Headquarters: Headquarters Wildscape	[30.6568192 , -95.000951 3]	There is no accessible route to the Headquarters "Wildscape". At least one accessible route shall connect accessible buildings, accessible facilities, accessible elements, and accessible spaces that are on the same site.	Lacks accessible route to Headquarters "Wildscape"	Create an accessible route with crushed stone or other outdoor material from parking or walkway to Headquarters "Wildscape"	2015 ABAAS Section: F206.2.2  2012 TAS Section: 206.2.2  2010 ADAS Section: 206.2.2

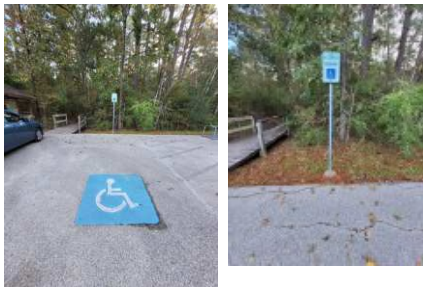
48	Trails and Trailheads: Pineywoods Boardwalk Parking	[30.6643486, -95.0051484]	The van stall is missing a sign identifying it as a van accessible stall. Parking space identification signs shall include the International Symbol of Accessibility. Signs identifying van parking spaces shall contain the designation "van accessible."	The van stall is missing a sign identifying it as a van accessible stall	Add one van parking sign to van accessible stall and ensure stall and access aisle are 11' and 5' or 8' and 8'	2015 ABAAS Section: 502.6 2012 TAS Section: 502.6 2010 ADAS Section: 502.6

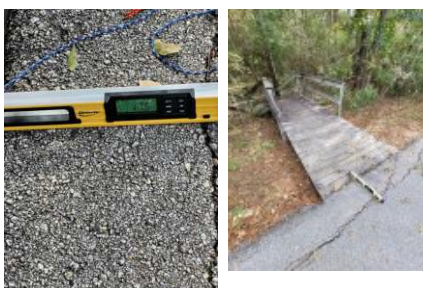
49	Trails and Trailheads: Pineywoods Boardwalk Parking	[30.664367, -95.0048695]	The running slope of walking surfaces shall not be steeper than 1:20.	Running slope of 17.5% from parking to right stairway to boardwalk	Correct running slope along the AR to max 5%	2015 ABAAS Section: 403.3 2012 TAS Section: 403.3 2010 ADAS Section: 403.3

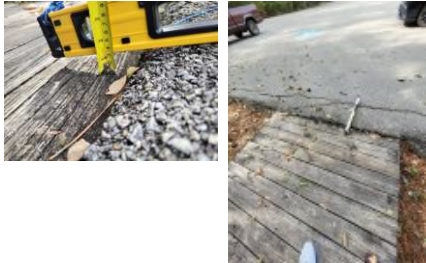
Finding Number	Area Description	Lat/Long	Finding	As Built	Recommendation	Citation	Photos	Figure
50	Trails and Trailheads: Pineywoods Boardwalk Parking	[30.6644224 , -95.004933 8]	The walkway contains abrupt vertical edges and/or variations over a 1/4 inch. 1/4 inch is the maximum vertical rise. Changes in level between 1/4 inch and 1/2 inch must be beveled at 1:2 or less. Changes in level greater than 1/2 inch must be by way of a ramp.	CIL of 1.25" from parking to boardwalk trail	Repair, bevel or ramp CIL along AR	2012 TAS Section: 303.2, 303.3  2010 ADAS Section: 303.2, 303.3

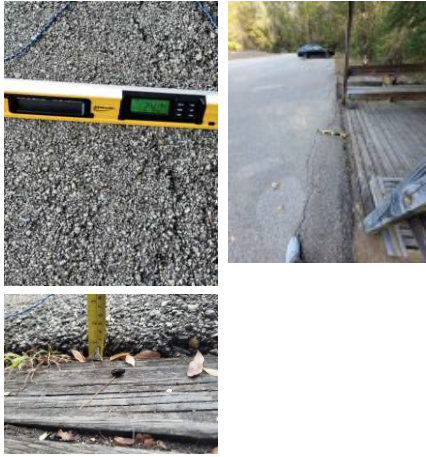
51	Trails and Trailheads: Pineywoods Boardwalk Trail	[30.6643255 , -95.004831 9]	Not more than 30 percent of the total length of a trail shall have a running slope steeper than 1:12 (8.33%). The running slope of any segment of a trail shall not be steeper than 1:8 (12%). Where the running slope of a segment of a trail is steeper than 1:20 (5%), the maximum length of the segment shall be in accordance with Table 1017.7.1, and a resting interval complying with 1017.8 shall be provided at the top and bottom of each segment.	CIL of .75" and running slope of 24% where parking asphalt meets boardwalk	Frequently maintain trail running slope to assure it does not exceed 8.33% slope for 200' max, 10% for 30' max or 12.5% for 10' with resting spaces on the trail as a smart practice	2015 ABAAS Section: 1017.7.1

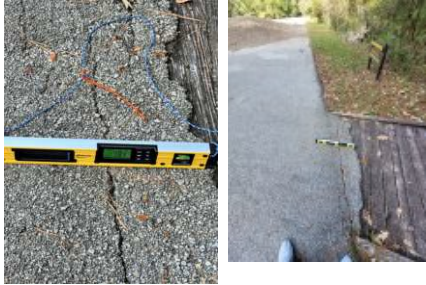
Finding Number	Area Description	Lat/Long	Finding	As Built	Recommendation	Citation	Photos	Figure
53	Trails and Trailheads: Pineywoods Boardwalk Trail	[30.66454, -95.00497]	Not more than 30 percent of the total length of a trail shall have a running slope steeper than 1:12 (8.33%). The running slope of any segment of a trail shall not be steeper than 1:8 (12%). Where the running slope of a segment of a trail is steeper than 1:20 (5%), the maximum length of the segment shall be in accordance with Table 1017.7.1, and a resting interval complying with 1017.8 shall be provided at the top and bottom of each segment.	Slope of 18.4% at boardwalk entry	Frequently maintain trail running slope to assure it does not exceed 8.33% slope for 200' max, 10% for 30' max or 12.5% for 10' with resting spaces on the trail as a smart practice	2015 ABAAS Section: 1017.7.1

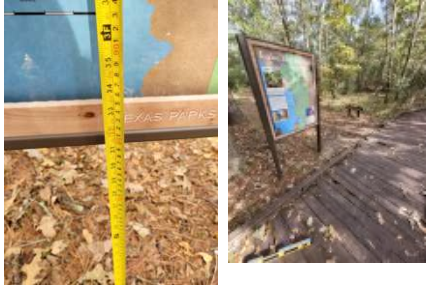
54	Trails and Trailheads: Pineywoods Boardwalk Trail	[30.6666, -95.00275]	Visual characters shall be 40 inches (1015 mm) minimum above the finish floor or ground. EXCEPTION: Visual characters indicating elevator car controls shall not be required to comply with 703.5.6.	Visual characters of informational sign at 33.5" above the ground	Remount signage to min 40" agl as a smart practice.	2015 ABAAS Section: 703.5.6, 703.5.6 EXCEPTION  2012 TAS Section: 703.5.6, 703.5.6 Exception  2010 ADAS Section: 703.5.6, 703.5.6 Exception

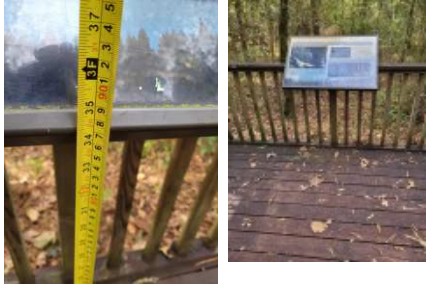
Finding Number	Area Description	Lat/Long	Finding	As Built	Recommendation	Citation	Photos	Figure
55	Trails and Trailheads: Pineywoods Boardwalk Trail	[30.66623, -95.00424]	Visual characters shall be 40 inches (1015 mm) minimum above the finish floor or ground. EXCEPTION: Visual characters indicating elevator car controls shall not be required to comply with 703.5.6.	Visual characters of informational sign at 35" above the ground	Remount signage to min 40" agl as a smart practice.	2015 ABAAS Section: 703.5.6, 703.5.6 EXCEPTION  2012 TAS Section: 703.5.6, 703.5.6 Exception  2010 ADAS Section: 703.5.6, 703.5.6 Exception

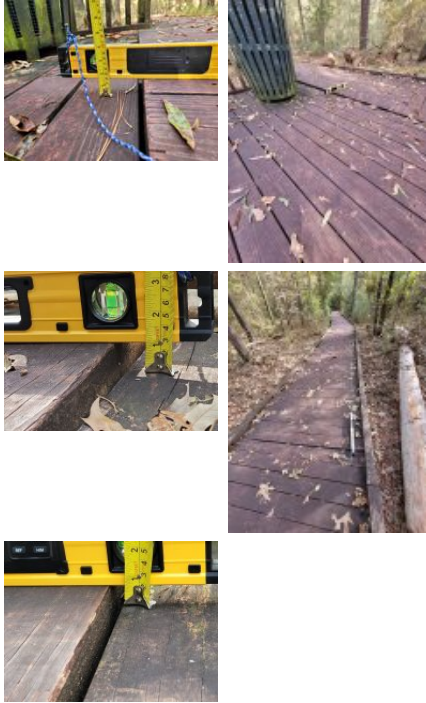
56	Trails and Trailheads: Pineywoods Boardwalk Trail	[30.66591, -95.00465]	Tread obstacles on trails, passing spaces, and resting intervals shall not exceed 1/2 inch (13 mm) in height measured vertically to the highest point. EXCEPTION: Where the surface is other than asphalt, concrete, or boards, tread obstacles shall be permitted to not exceed 2 inches (50 mm) in height measured vertically to the highest point.	Multiple CILs (5) of 1", 1", 1.25", 1", 1.5" at Night Vision Platform	Repair, bevel or ramp tread obstacle along pathway to max .5" as a smart practice.	2015 ABAAS Section: 1017.5

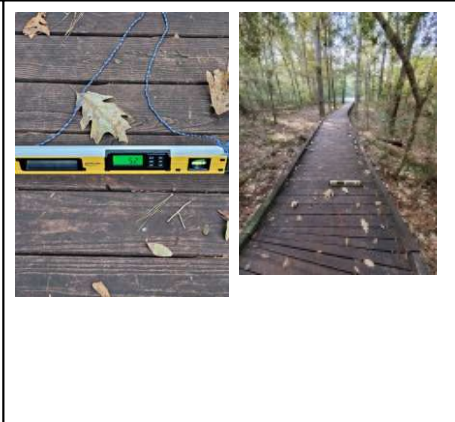
57	Trails and Trailheads: Pineywoods Boardwalk Trail	[30.66454, -95.00497]	The cross slope shall not be steeper than 1:48. EXCEPTION: Where the surface is other than concrete, asphalt, or boards, cross slopes not steeper than 1:20 shall be permitted when necessary for drainage.	Multiple cross slopes of 5.2% near boardwalk entry, 4.7%, 6.6%, 7.2% near platform, and 2.4% near Bakba Trail crossing	Correct or repair pathway cross slope to max 2.08% or 5% depending on surface as a smart practice.	2015 ABAAS Section: 1017.2

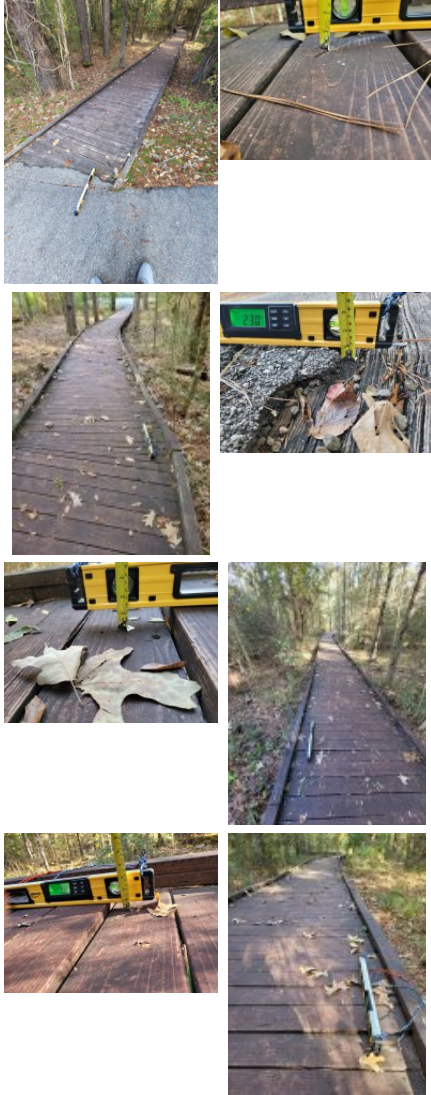
Finding Number	Area Description	Lat/Long	Finding	As Built	Recommendation	Citation	Photos	Figure
58	Trails and Trailheads: Pineywoods Boardwalk Trail	[30.6643855 , -95.004912 4]	Tread obstacles on trails, passing spaces, and resting intervals shall not exceed 1/2 inch (13 mm) in height measured vertically to the highest point. EXCEPTION: Where the surface is other than asphalt, concrete, or boards, tread obstacles shall be permitted to not exceed 2 inches (50 mm) in height measured vertically to the highest point.	Multiple CILs of .75", 1", 1.25", .75", and 1.25"	Repair, bevel or ramp tread obstacle along pathway to max .5" as a smart practice.	2015 ABAAS Section: 1017.5

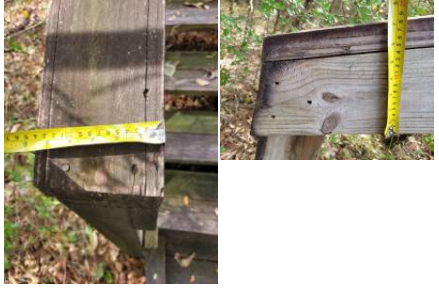
Finding Number	Area Description	Lat/Long	Finding	As Built	Recommendation	Citation	Photos	Figure
61	Trails and Trailheads: Pineywoods Boardwalk Trail	[30.664367, -95.004890 9]	The handrail gripping diameter is noncompliant. Handrail gripping surfaces with a circular cross section shall have an outside diameter of 1 1/4 inches minimum and 2 inches maximum. Handrail gripping surfaces with a non-circular cross section shall have a perimeter dimension of 4 inches minimum and 6 1/4 inches maximum, and a cross-section dimension of 2 1/4 inches maximum.	Handrails lack compliant gripping surface diameter	Replace handrails on both sides of stairway, mounted 34" to 38" aff with top and bottom extensions and having a 1.25" – 2" in diameter, or a non-circular grip that has a perimeter dimension of 4"- 6.25" max with a min gap of 1.5" between handrail and wall. Pricing in previous findings.	2015 ABAAS Section: 505.7  2012 TAS Section: 505.7  2010 ADAS Section: 505.7

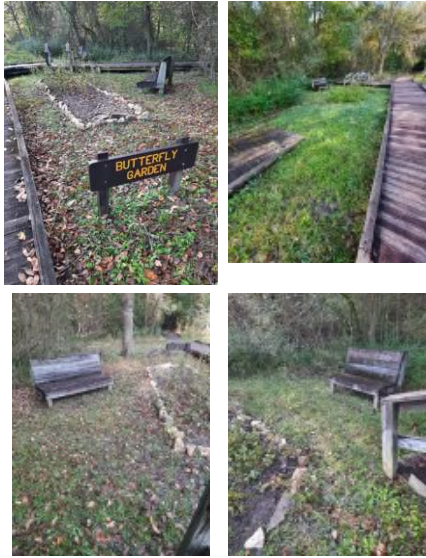
Finding Number	Area Description	Lat/Long	Finding	As Built	Recommendation	Citation	Photos	Figure
65	Trails and Trailheads: Pineywoods Boardwalk Trail	[30.66506, -95.00356]	There is no accessible route to the Butterfly Gardens (2) and benches (2). At least one accessible route shall connect accessible buildings, accessible facilities, accessible elements, and accessible spaces that are on the same site.	Lacks accessible route to two Butterfly Gardens and benches	Create an accessible route with crushed stone or other outdoor material from parking or walkway to Butterfly Gardens and benches.	2015 ABAAS Section: F206.2.2  2012 TAS Section: 206.2.2  2010 ADAS Section: 206.2.2

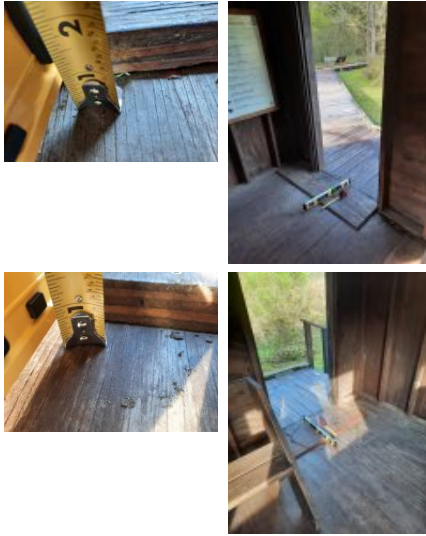
66	Trails and Trailheads: Pineywoods Boardwalk Trail	[30.6643855, -95.0049124]	There is a change in level greater than 1/4 inch. 1/4 inch is the maximum vertical rise. Changes in level between 1/4 inch and 1/2 inch must be beveled at 1:2 or less. Changes in level greater than 1/2 inch must be by way of a ramp.	CILs of .75" and .75" in doorways of Bird Blind	Repair, bevel or ramp CIL along AR to max .25"	2015 ABAAS Section: 303.3  2012 TAS Section: 303.3  2010 ADAS Section: 303.3

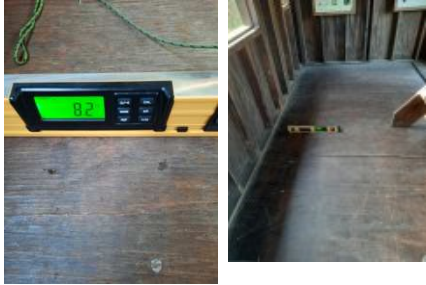
Finding Number	Area Description	Lat/Long	Finding	As Built	Recommendation	Citation	Photos	Figure
67	Trails and Trailheads: Pineywoods Boardwalk Trail	[30.65691, -95.00105]	The 30 inches minimum by 48 inches minimum clear floor space required at the operable part is not flat (2% or 1:48 maximum slope) in all directions. Changes in level are not permitted at required clear floor or ground space except that slopes not steeper than 1:48 shall be permitted.	Slope of 8.2% in Bird Blind	Correct or repair slope in CFS to max 2.08%	2015 ABAAS Section: 305.2  2012 TAS Section: 305.2  2010 ADAS Section: 305.2

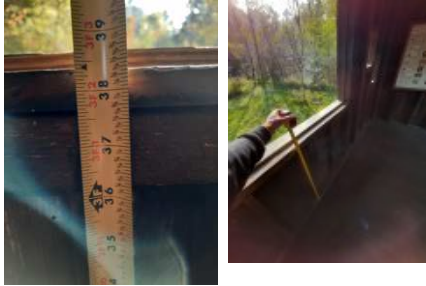
68	Trails and Trailheads: Pineywoods Boardwalk Trail	[30.6652, -95.00326]	Each distinct viewing location shall provide a viewing space adjacent to the clear ground space required by 1015.2 through which the point of interest is viewable. The viewing space shall be 32 inches (815 mm) maximum and 51 inches (1295 mm) minimum high above the ground and shall extend the full width of the clear ground space. EXCEPTION: Guards or similar safety barriers shall be permitted to obstruct the viewing space to the extent the obstruction is necessary for the guard or safety barrier to serve its intended purpose.	Bird Blind viewing window is more than 34" aff	Lower a 32" wide portion of railing to max 32" for unobstructed viewing as a smart practice.	2015 ABAAS Section: 1015.3, 1015.3 EXCEPTION

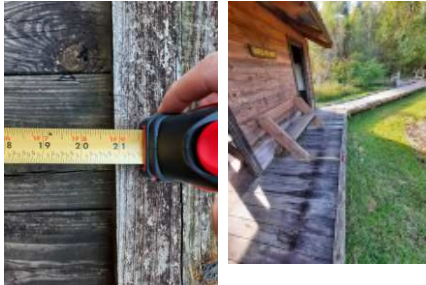
69	Trails and Trailheads: Pineywoods Boardwalk Trail	[30.6652, -95.00315]	The walking surface is obstructed. A 36 inch minimum clear walking surface is required.	Bird Blind lacks 36" wide minimum clear walking surface due to bench location	Remove obstruction for 36" clear width along the AR.	2015 ABAAS Section: 403.5.1  2012 TAS Section: 403.5.1  2010 ADAS Section: 403.5.1

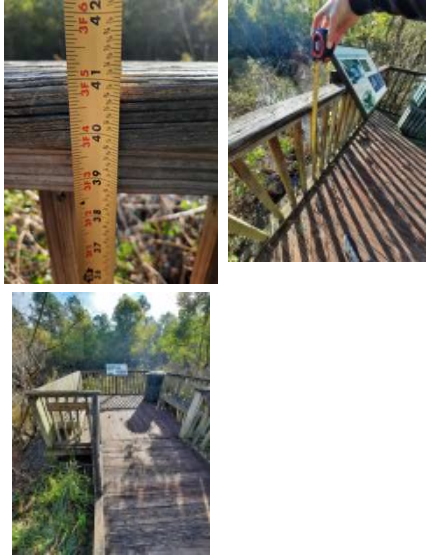
Finding Number	Area Description	Lat/Long	Finding	As Built	Recommendation	Citation	Photos	Figure
70	Trails and Trailheads: Pineywoods Boardwalk Trail	[30.6652, -95.00294]	Each distinct viewing location shall provide a viewing space adjacent to the clear ground space required by 1015.2 through which the point of interest is viewable. The viewing space shall be 32 inches (815 mm) maximum and 51 inches (1295 mm) minimum high above the ground and shall extend the full width of the clear ground space.	Duck Pond viewing area - all railings are 41" above deck surface	Lower a 36" wide portion of railing to provide an unobstructed view between 32" and 51"	2015 ABAAS Section: 1015.3

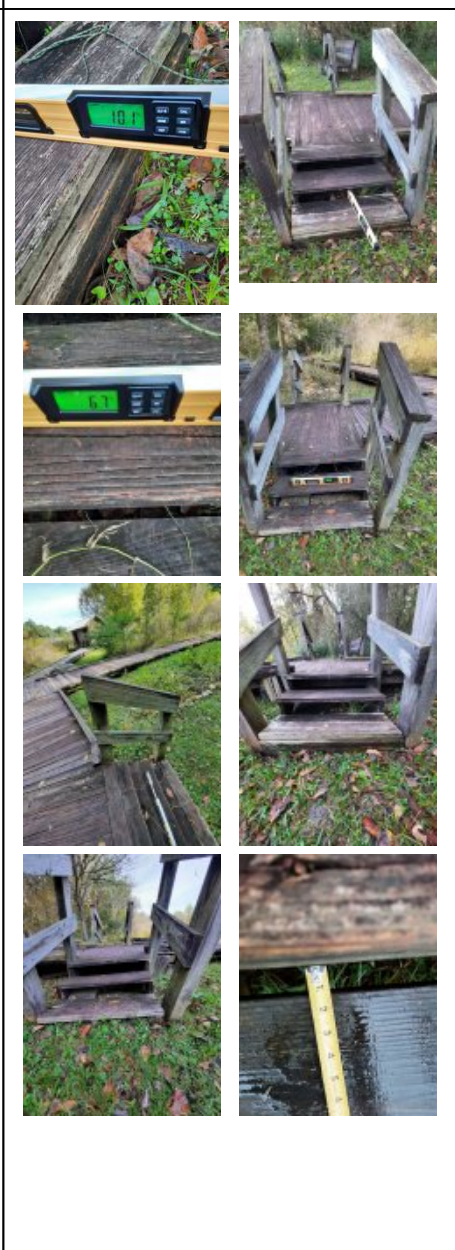
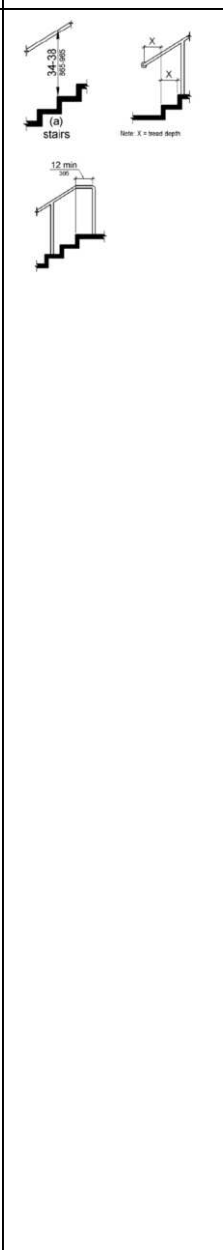
Finding Number	Area Description	Lat/Long	Finding	As Built	Recommendation	Citation	Photos	Figure
71	Trails and Trailheads: Pineywoods Boardwalk Trail	[30.6644039 , -95.004912 4]	The stairway handrails are not nearly compliant. The handrails have the following issues: - Installed at the incorrect height - The bottom handrail extensions are missing or extend incorrectly - The top handrail extensions are missing or extend incorrectly - The handrail gripping surface is not the correct size - The handrail is not located with the correct spacing from the wall or adjacent surface - The handrails are obstructed. Handrails and their extensions must be between 34 inches and 38 inches above the stair nosing or ground. The top handrails shall extend a minimum of 12 inches beyond the top nosing and shall be parallel with the floor or ground surface. At the bottom of a stair flight, handrails shall extend at the slope of the stair flight for a horizontal distance at least equal to one tread depth beyond the last riser nosing. Extension shall return to a wall, guard, or the landing surface, or shall be continuous to the handrail of an adjacent stair flight. The orientation of at least one handrail, including the extension, shall be in the direction of the run of the stair and perpendicular to the direction of the stair nosing. Handrail gripping surfaces with a circular cross section shall have an outside diameter of 1-1/4 inches minimum and 2 inches maximum. Handrail gripping surfaces with a non-circular cross section shall have a perimeter dimension of 4 inches minimum and 6 1/4 inches maximum, and a cross-section dimension of 2-1/4 inches maximum. The hand grip portion of handrails shall have a smooth surface with no sharp corners. Gripping surfaces (top or sides) shall be uninterrupted by newel posts, other construction elements or obstructions. Any wall or other surface adjacent to the handrail shall be free of sharp or abrasive elements. Handrails projecting from a wall shall have a space of 1-1/2 inches minimum between the wall and the handrail.	3 of 3 stairways - handrails do not extend past top and bottom landing or have rounded ends, open risers, gaps, slopes, gripping surface has sharp edges	Replace three stairways with compliant treads and handrails.	2015 ABAAS Section: 505.1  2012 TAS Section: 505.1  2010 ADAS Section: 505.1

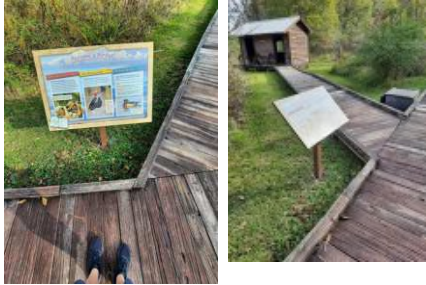
Finding Number	Area Description	Lat/Long	Finding	As Built	Recommendation	Citation	Photos	Figure
72	Trails and Trailheads: Pineywoods Boardwalk Trail	[30.66512, -95.00221]	The clear floor space for the element is obstructed. The clear floor or ground space shall be 30 inches minimum by 48 inches minimum and free of obstructions.	Lacks clear floor space at birding sign	Relocate park signage to be along AR, with level 30" by 48" CFS for viewing.	2015 ABAAS Section: 305.3  2012 TAS Section: 305.3  2010 ADAS Section: 305.3

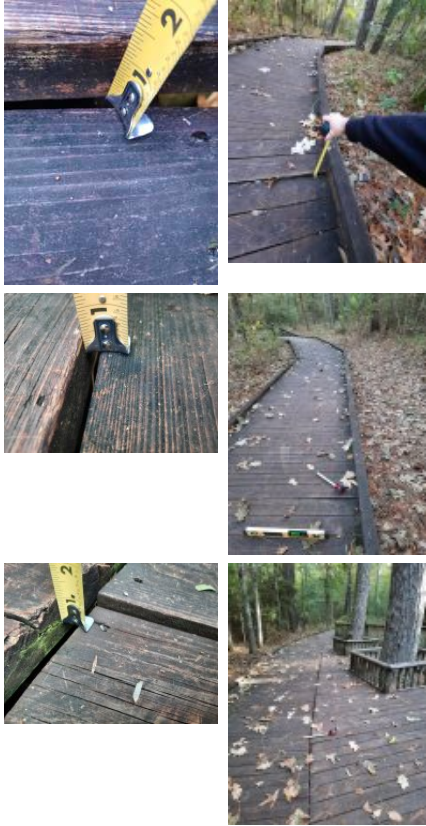
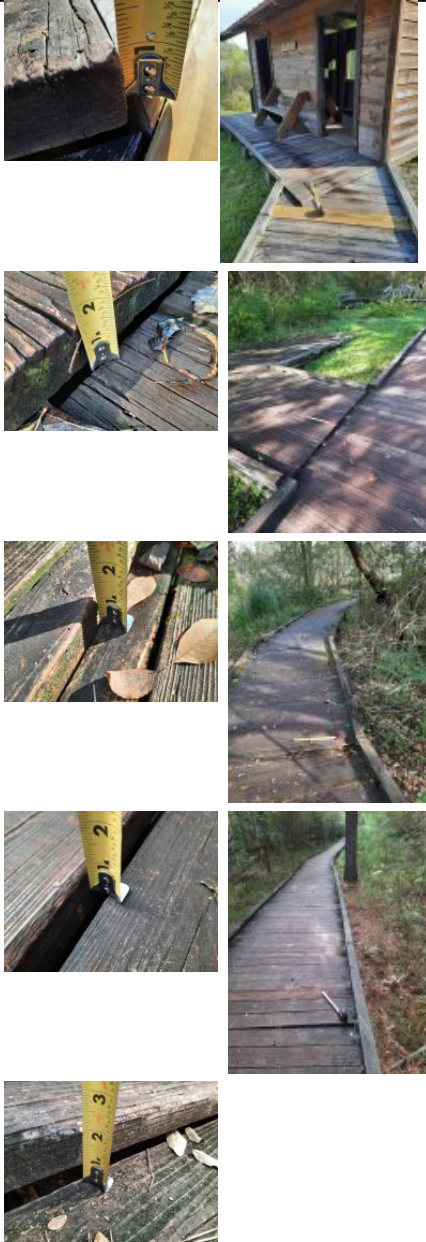
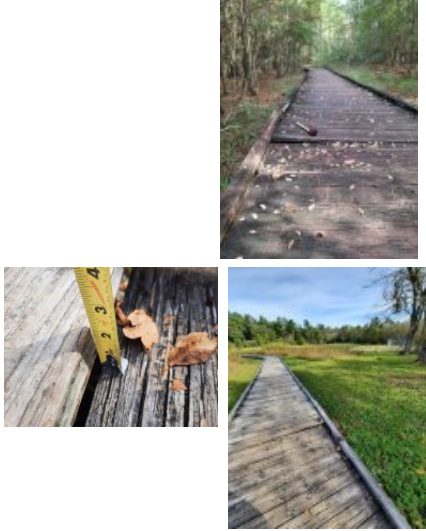
75	Trails and Trailheads: Pineywoods Boardwalk Trail	[30.66446, -95.00479]	Tread obstacles on trails, passing spaces, and resting intervals shall not exceed 1/2 inch (13 mm) in height measured vertically to the highest point. EXCEPTION: Where the surface is other than asphalt, concrete, or boards, tread obstacles shall be permitted to not exceed 2 inches (50 mm) in height measured vertically to the highest point.	Multiple CILs of 1.5", .5", 1", 1.5", 1" (at bird blind), 1.5", 1", 2", 2.25"	Repair, bevel or ramp tread obstacle along pathway to max .5" as a smart practice.	2015 ABAAS Section: 1017.5

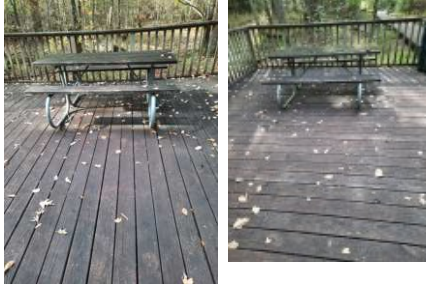
77	Trails and Trailheads: Pineywoods Boardwalk Trail	[30.6659957 , -95.000996 6]	Picnic tables shall provide at least one wheelchair space for each 24 linear feet (7320 mm) of usable table surface perimeter. Wheelchair spaces shall be 30 inches (760 mm) minimum by 48 inches (1220 mm) minimum. Wheelchair spaces shall be positioned for a forward approach to the table and provide knee and toe clearance complying with 306 under the table	Frog Pond and Picnic Area lacks picnic tables (0 of 2) of accessible design	Replace one picnic table with one of an accessible design as a smart practice	2015 ABAAS Section: 1011.4.2

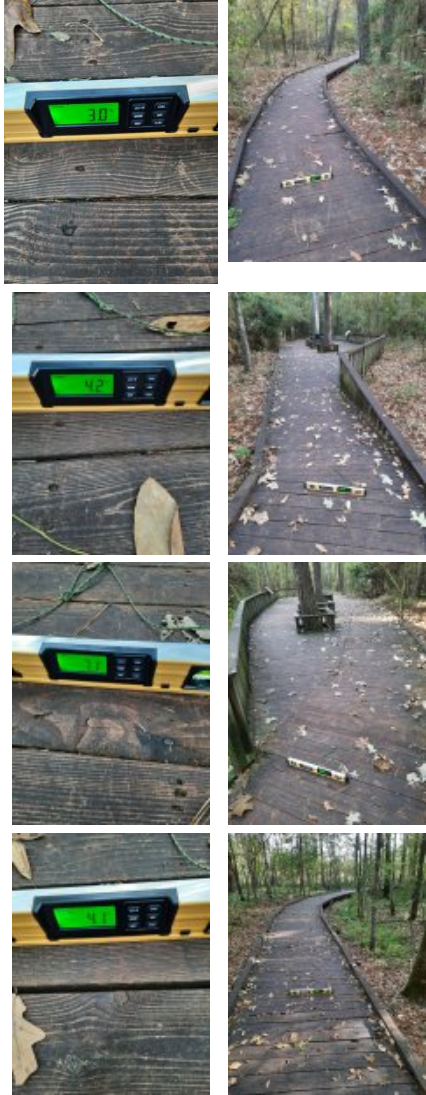
Finding Number	Area Description	Lat/Long	Finding	As Built	Recommendation	Citation	Photos	Figure
78	Trails and Trailheads: Pineywoods Boardwalk Trail	[30.66446, -95.00479]	Not more than 30 percent of the total length of a trail shall have a running slope steeper than 1:12 (8.33%). The running slope of any segment of a trail shall not be steeper than 1:8 (12%). Where the running slope of a segment of a trail is steeper than 1:20 (5%), the maximum length of the segment shall be in accordance with Table 1017.7.1, and a resting interval complying with 1017.8 shall be provided at the top and bottom of each segment.	Multiple running slopes of 15.4%, 11.2%, 14.0%, 13.2%, 17.1%, 18.6%; and multiple cross slopes of 3.0%, 4.2%, 3.1%, 4.1%, 4.9%, 8.2%, 8.0%, 10.5%, 10.5%, 5.6%	Frequently maintain trail running slope to assure it does not exceed 8.33% slope for 200' max, 10% for 30' max or 12.5% for 10' with resting spaces on the trail as a smart practice. Correct cross slopes to max 2.08%.	2015 ABAAS Section: 1017.7.1

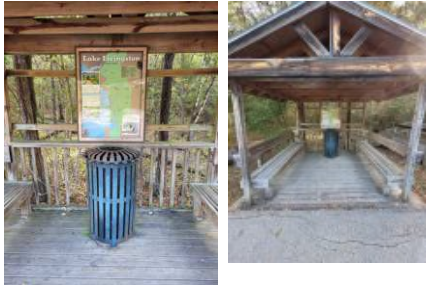
Finding Number	Area Description	Lat/Long	Finding	As Built	Recommendation	Citation	Photos	Figure
79	Trails and Trailheads: Pineywoods Boardwalk Trail	[30.6643939, -95.0049327]	Clear floor space is not provide at the informational sign. Signs containing tactile Characters shall be located so that a clear floor space of 18 inches minimum by 18 inches minimum, centered on the tactile Characters, is provided beyond the arc of any door swing between the closed position and 45 degree open position.	Informational sign lacks clear floor space due to garbage can location	Relocate objects to provide CFS for approach to sign.	2015 ABAAS Section: 703.4.2  2012 TAS Section: 703.4.2  2010 ADAS Section: 703.4.2

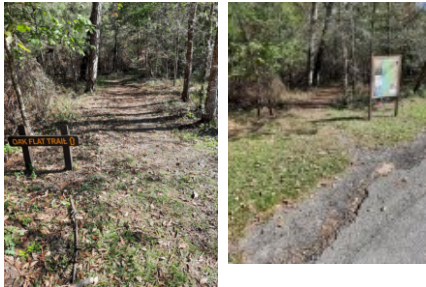
81	Trails and Trailheads: Oak Flat Interpretive Trail	[30.65708, -95.00105]	The surface of trails, passing spaces, and resting intervals shall be firm and stable	Lacks firm and stable surface	Replace surface of trail to be firm and stable as a smart practice.	2015 ABAAS Section: 1017.2

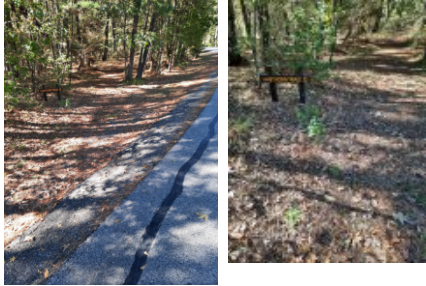
83	Trails and Trailheads: Hawthorn Trail	[30.6572, -95.00163]	An accessible access route is not provided between elements, spaces and the facilities provided within the accessible camping unit. At least one outdoor recreation access route shall connect accessible elements, spaces and facilities provided within camping units with mobility features.	Lacks accessible route to Hawthorn Trailhead	Create AR with crushed and compacted stone or similar outdoor material to camp sites and one of each type of amenity.	2015 ABAAS Section: F244.5.1

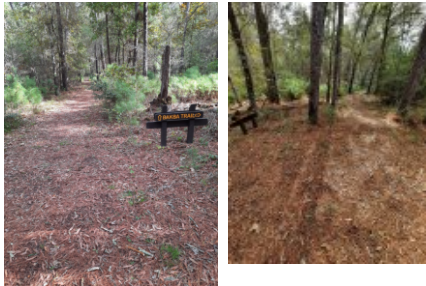
84	Trails and Trailheads: Bakba Trail	[30.66954, -95.00736]	The surface of trails, passing spaces, and resting intervals shall be firm and stable	Bakba Trail lacks firm and stable surface	Replace surface of trail to be firm and stable as a smart practice.	2015 ABAAS Section: 1017.2

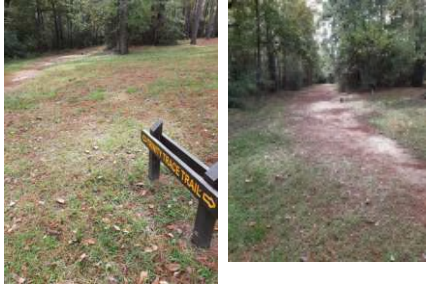
Finding Number	Area Description	Lat/Long	Finding	As Built	Recommendation	Citation	Photos	Figure
85	Trails and Trailheads: Trinity Trace Trail	[30.65693, -95.00574]	The surface of trails, passing spaces, and resting intervals shall be firm and stable	Lacks firm and stable surface	Replace surface of trail to be firm and stable as a smart practice.	2015 ABAAS Section: 1017.2

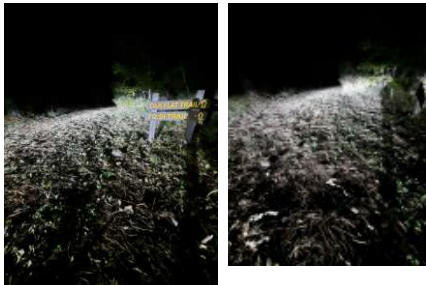
86	Trails and Trailheads: Fosi Trail	[30.65742, -95.00117]	The surface of trails, passing spaces, and resting intervals shall be firm and stable	Lacks firm and stable surface	Replace surface of trail to be firm and stable as a smart practice.	2015 ABAAS Section: 1017.2

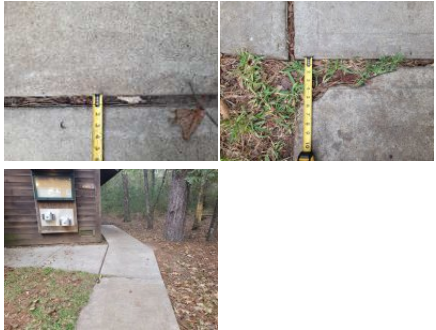
Finding Number	Area Description	Lat/Long	Finding	As Built	Recommendation	Citation	Photos	Figure
91	Hercules Club Loop: Hercules Club Loop Restroom Parking and Exterior Accessible Route	[30.6521007 , -95.003637 1]	There is a gap spaced greater than a 1/2 inch. Openings in floor or ground surfaces shall not allow passage of a sphere more than 1/2 inch diameter. Elongated openings shall be placed so that the long dimension is perpendicular to the dominant direction of travel.	Gaps of 1", 1", and 5.5" on accessible route near women's restroom	Correct or fill gaps to be max .5"	2015 ABAAS Section: 302.3 2012 TAS Section: 302.3 2010 ADAS Section: 302.3

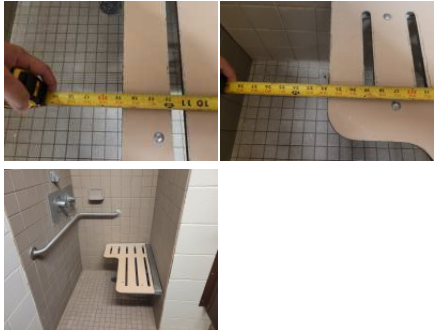
Finding Number	Area Description	Lat/Long	Finding	As Built	Recommendation	Citation	Photos	Figure
108	Hercules Club Loop: Hercules Club Loop Men's Shower	[30.6518037, -95.0034667]	The shower seat does not have a compliant space between it and the wall. The folding seat must be mounted 17-19 inches above the floor, and have a maximum space of 1-1/2 inches between the edge of the seat and the side wall and 2-1/2 inches maximum to the seat wall.	The shower seat 14.75" and 21.25" from seat wall	Remount shower seat to the correct location and height in the shower	2015 ABAAS Section: 610.3.2 2012 TAS Section: 610.3.2 2010 ADAS Section: 610.3.2

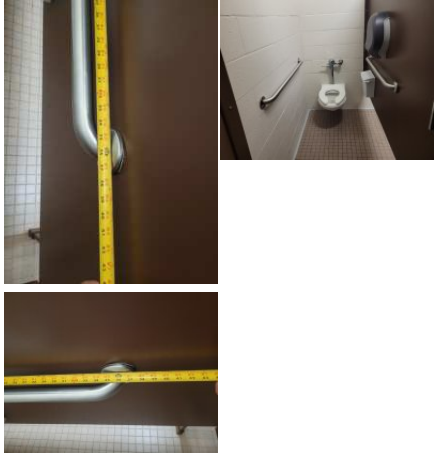
Finding Number	Area Description	Lat/Long	Finding	As Built	Recommendation	Citation	Photos	Figure
113	Hercules Club Loop: Hercules Club Loop Women's Restroom	[30.6517099 , -95.003451 7]	Grab bars shall comply with 609. A side-wall grab bar complying with 604.5.1 shall be provided on both sides of the compartment. The space between the wall and the grab bar shall be 1½ inches (38 mm). The space between the grab bar and projecting objects below and at the ends shall be 1½ inches (38 mm) minimum. The space between the grab bar and projecting objects above shall be 12 inches (305 mm) minimum. Grab bars shall be installed in a horizontal position, 33 inches (840 mm) minimum and 36 inches (915 mm) maximum above the finish floor measured to the top of the gripping surface, except that at water closets for children's use complying with 604.9, grab bars shall be installed in a horizontal position 18 inches (455 mm) minimum and 27 inches (685 mm) max	Side grab bar 36" long	Replace or add side grab bars with a 42" long grab bar, mounted max 12" from the rear wall at the close end and min 54" on the far end and 33" to 36" aff	2015 ABAAS Section: 604.8.2.3, 609.3, 609.4  2012 TAS Section: 609.4, 609.3, 604.8.2.3  2010 ADAS Section: 609.3, 609.4, 604.8.2.3

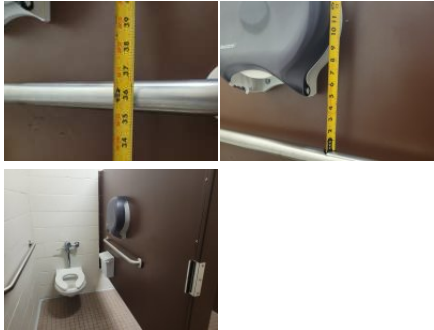
114	Hercules Club Loop: Hercules Club Loop Women's Restroom	[30.6517484 , -95.003496 2]	The grab bar height and/or spacing fails. Grab bars must be mounted between 33" and 36" to the top of the gripping surface. There must be 1.5" of clearance between the grab bar and the wall. There must be a minimum of 1.5" of clearance below and minimum 12" above the grab bar to any dispenser or other obstruction.	Gripping surface of grab bar is 36.75" aff, TP 5" above bar	Remount grab bars in accessible stall to 33" to 36" aff Remount toilet paper dispenser max 7" to 9" from front of toilet, 15" to 48" aff and min 12" above or 1.5" below grab bar	2015 ABAAS Section: 609.3, 609.4  2012 TAS Section: 609.4, 609.3  2010 ADAS Section: 609.3, 609.4
