# Access Audit Site Report

Prepared By  
**WT Group**

**Lake Livingston State Park**  
**300 State Park Rd 65**  
**Livingston, TX 77351**  
**Accessibility Evaluation**  
**Inspection Date: 11/08/2021**  
**Inspectors: Tanya Scheibe**

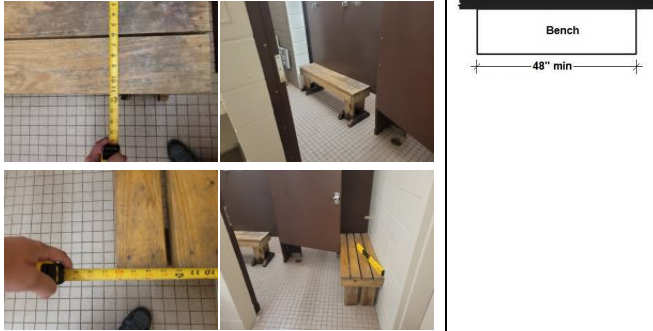
117	Hercules Club Loop: Hercules Club Loop Women's Shower	[30.6517068 , -95.003433 1]	The bench is not deep enough or long enough or is missing. Benches shall be provided having seats that are 42 inches long minimum and 20 inches deep minimum and 24 inches deep maximum. The bench shall provide for back support or shall be affixed to a wall. Back support shall be 42 inches (1065 mm) long minimum and shall extend from a point 2 inches (51 mm) maximum above the seat surface to a point 18 inches (455 mm) minimum above the seat surface. Back support shall be 2½ inches (64 mm) maximum from the rear edge of the seat measured horizontally. The top of the bench seat surface shall be 17 inches (430 mm) minimum and 19 inches (485 mm) maximum above the finish floor or ground. Clear floor or ground space complying with 305 shall be provided and shall be positioned at the end of the bench seat and parallel to the short axis of the bench	Lacks bench: one is 11.5" deep, another is 16.25" deep	Replace bench in dressing area with one having a seat depth of 20" to 24" deep, 42" long, affixed to the wall or having a back and mounted 17" to 19" AFF and provide required clear floor space on the short axis of the bench.	2012 TAS Section: 903.4, 903.2, 903.3, 903.5  2010 ADAS Section: 903.4, 903.2, 903.3, 903.5

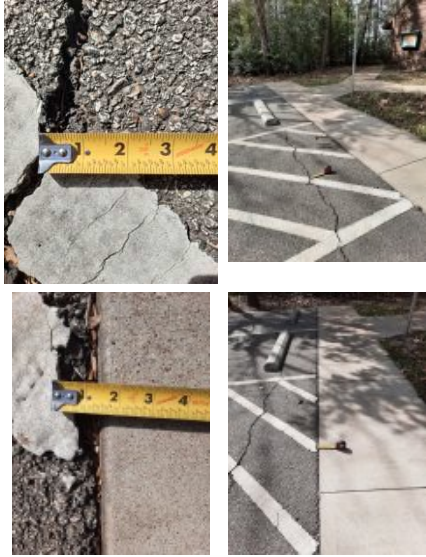
Finding Number	Area Description	Lat/Long	Finding	As Built	Recommendation	Citation	Photos	Figure
124	Piney Shores: Piney Shores Restroom Parking	[30.65691, -95.00105]	The parking stall contains abrupt edges and surface irregularities over a 1/4 inch vertical. Parking spaces and access aisles serving them shall be stable, firm, and slip resistant. Access aisles shall be at the same level as the parking spaces they serve. Changes in level are not permitted and shall not be sloped steeper than 2% in any direction.	Gaps of 1.5" and gaps of approximately 1" due to crack across head of access aisle	Resurface stalls and access aisles to eliminate gaps and cracks	2015 ABAAS Section: 502.4  2012 TAS Section: 502.4  2010 ADAS Section: 502.4

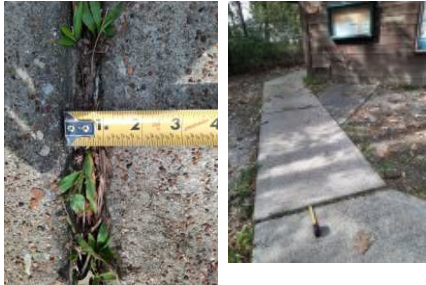
126	Piney Shores: Piney Shores Restroom Exterior Route	[30.652984, -95.006706 8]	There is a gap spaced greater than a 1/2 inch. Openings in floor or ground surfaces shall not allow passage of a sphere more than 1/2 inch diameter. Elongated openings shall be placed so that the long dimension is perpendicular to the dominant direction of travel.	Multiple gaps (11) ranging from 1" to 2.5"	Correct or fill gaps to be max .5"	2015 ABAAS Section: 302.3  2012 TAS Section: 302.3  2010 ADAS Section: 302.3

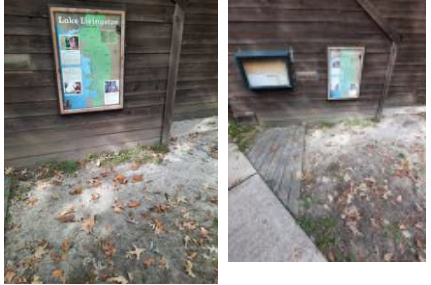
Finding Number	Area Description	Lat/Long	Finding	As Built	Recommendation	Citation	Photos	Figure
128	Piney Shores: Piney Shores Restroom Exterior Route	[30.65282, -95.00666]	There is no accessible route to the park map/informational sign. At least one accessible route shall connect accessible buildings, accessible facilities, accessible elements, and accessible spaces that are on the same site.	Lacks accessible route to park map/informational sign	Create an accessible route with crushed stone or other outdoor material from parking or walkway to park map/informational sign.	2015 ABAAS Section: F206.2.2  2012 TAS Section: 206.2.2  2010 ADAS Section: 206.2.2

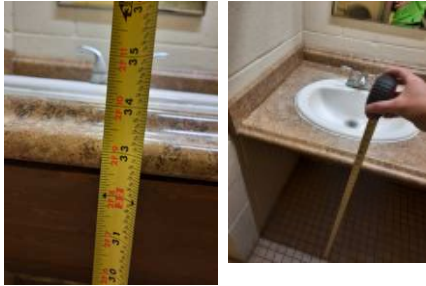
Finding Number	Area Description	Lat/Long	Finding	As Built	Recommendation	Citation	Photos	Figure
133	Piney Shores: Piney Shores Men's Restroom	[30.6529978 , -95.006681 3]	The top rim of the sink is too high. All lavatories/sinks that are designated to be accessible shall be a minimum 17 inches in horizontal depth and mounted with the rim or counter edge no higher than 34 inches above the finished floor.	The top rim of the sink is 34.25" aff	Lower sinks to max 34" aff to front of rim, in the alternative, leave as is citing construction tolerance	2015 ABAAS Section: 606.3  2012 TAS Section: 606.3  2010 ADAS Section: 606.3

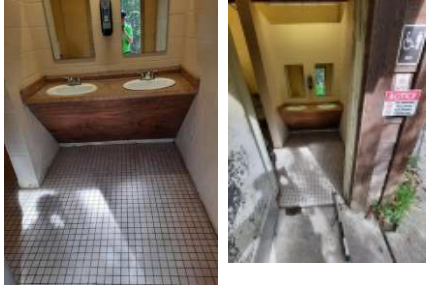
134	Piney Shores: Piney Shores Men's Restroom	[30.6529967 , -95.006689 3]	The water and drain pipes under the lavatory are not adequately insulated. Water supply and drain pipes under lavatories and sinks shall be insulated or otherwise configured to protect against contact. There shall be no sharp or abrasive surfaces under lavatories and sinks.	Wood panel to be removed for knee clearance, unknown if sink pipes are insulated	Remove wood panel to provide knee clearance and insulate exposed pipes under one sink	2015 ABAAS Section: 606.5  2012 TAS Section: 606.5  2010 ADAS Section: 606.5

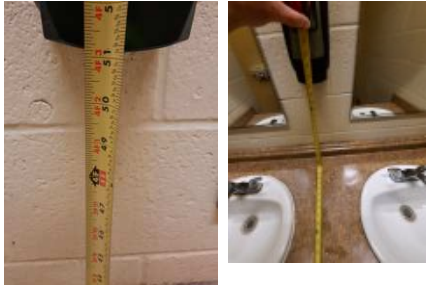
Finding Number	Area Description	Lat/Long	Finding	As Built	Recommendation	Citation	Photos	Figure
135	Piney Shores: Piney Shores Men's Restroom	[30.6529955 , -95.006693 4]	Where a high forward reach is over an obstruction, the clear floor space shall extend beneath the element for a distance not less than the required reach depth over the obstruction. The high forward reach shall be 48 inches (1220 mm) maximum where the reach depth is 20 inches (510 mm) maximum. Where the reach depth exceeds 20 inches (510 mm), the high forward reach shall be 44 inches (1120 mm) maximum and the reach depth shall be 25 inches (635 mm) maximum. Where a clear floor or ground space allows a parallel approach to an element and the high side reach is over an obstruction, the height of the obstruction shall be 34 inches (865 mm) maximum and the depth of the obstruction shall be 24 inches (610 mm) maximum. The high side reach shall be 48 inches (1220 mm) maximum for a reach depth of 10 inches (255 mm) maximum. Where the reach depth exceeds 10 inches (255 mm), the high side reach shall be 46 inches (1170 mm) maximum for a reach depth of 24 inches (610 mm) maximum.	Soap dispenser 51.25" aff over sink	Lower soap dispenser to max 44" aff for a forward reach over the sink.	2015 ABAAS Section: 308.2.1, 308.3.2  2012 TAS Section: 308.2.1, 308.3.2  2010 ADAS Section: 308.2.1, 308.3.2

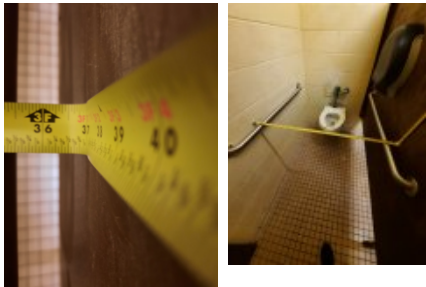
136	Piney Shores: Piney Shores Men's Restroom	[30.6529875 , -95.006709 5]	There are not enough accessible toilet compartments. The room contains several toilet compartments. A minimum of 1 must be wheelchair accessible .	Lacks wheelchair stall, ambulatory only	Create a wheelchair accessible stall with grab bars and fixtures mounted in correct locations and at correct heights.	2015 ABAAS Section: F213.3.1  2012 TAS Section: 213.3.1  2010 ADAS Section: 213.3.1

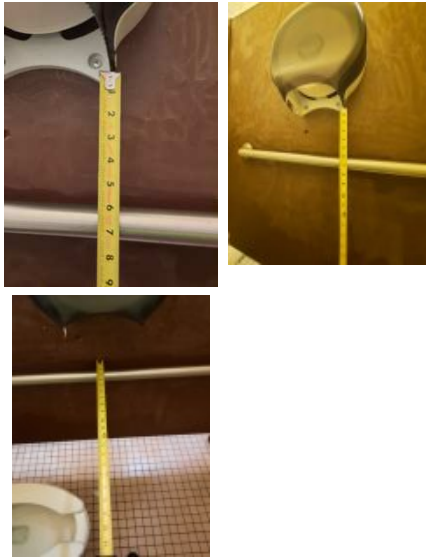
138	Piney Shores: Piney Shores Men's Restroom	[30.652984, -95.006696 1]	The grab bar height and/or spacing fails. Grab bars must be mounted between 33" and 36" to the top of the gripping surface. There must be 1.5" of clearance between the grab bar and the wall. There must be a minimum of 1.5" of clearance below and minimum 12" above the grab bar to any dispenser or other obstruction.	Toilet paper dispenser 6" above grab bar and too close to toilet	Remount toilet paper dispenser max 7" to 9" from front of toilet, 15" to 48" aff and min 12" above or 1.5" below grab bar	2015 ABAAS Section: 609.3, 609.4  2012 TAS Section: 609.4, 609.3  2010 ADAS Section: 609.3, 609.4

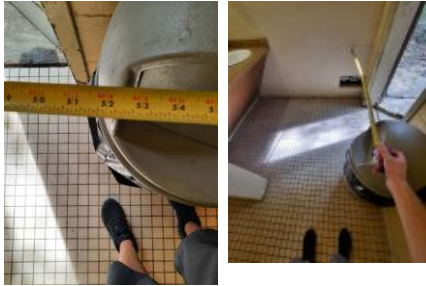
Finding Number	Area Description	Lat/Long	Finding	As Built	Recommendation	Citation	Photos	Figure
139	Piney Shores: Piney Shores Men's Restroom	[30.6529909 , -95.006700 1]	There is insufficient turning space within this room or space. The space required for a wheelchair to make a 180-degree turn is a clear space of 60 inches in diameter or a T-shaped space.	Lacks sufficient turning space within this room or space due to garbage can location	Relocate obstacles to create turning space in restroom.	2015 ABAAS Section: 304.3.1, 304.3.2  2012 TAS Section: 304.3.1, 304.3.2  2010 ADAS Section: 304.3.1, 304.3.2

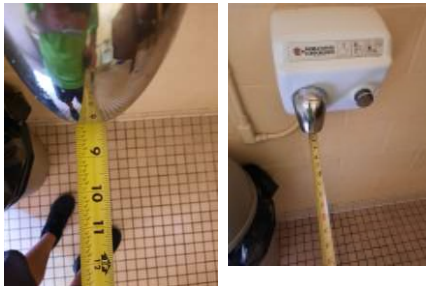
140	Piney Shores: Piney Shores Men's Restroom	[30.6529898 , -95.006690 7]	The hand dryer projects more than 4 inches into the circulation path. Wall-mounted objects that have leading edges between 27 inches and 80 inches from the floor must not project more than 4 inches into the circulation path. Protruding objects that extend to the floor or within 27 inches of the floor are cane detectable and are therefore not hazardous. Where it is necessary or desirable to have objects protrude from the wall, a manner of cane detection must be provided.	Hand dryer protrudes 8"	Relocate protruding objects or place cane detectable warning or bollard at foot of item.	2015 ABAAS Section: 307.2  2012 TAS Section: 307.2  2010 ADAS Section: 307.2

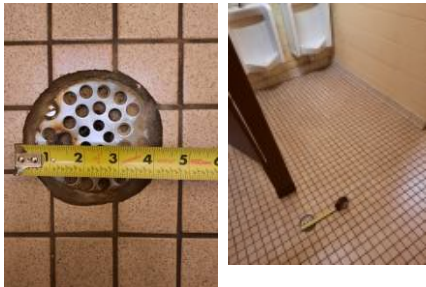
141	Piney Shores: Piney Shores Men's Restroom	[30.6529909 , -95.006712 1]	Openings in floor or ground surfaces shall not allow passage of a sphere more than 1/2 inch (13 mm) diameter except as allowed in 407.4.3, 409.4.3, 410.4, 810.5.3 and 810.10. Elongated openings shall be placed so that the long dimension is perpendicular to the dominant direction of travel.	Gap of 4.25" at floor drain	Fill and maintain gaps to max .5".	2015 ABAAS Section: 302.3  2012 TAS Section: 302.3  2010 ADAS Section: 302.3

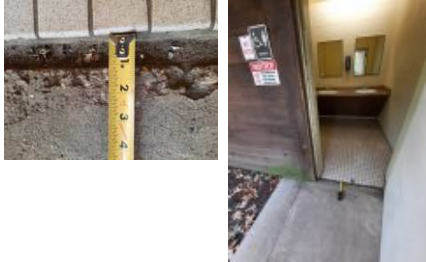
Finding Number	Area Description	Lat/Long	Finding	As Built	Recommendation	Citation	Photos	Figure
142	Piney Shores: Piney Shores Women's Restroom	[30.652999, -95.006705 4]	Minimum maneuvering clearances at doors and gates shall comply with 404.2.4. Maneuvering clearances shall extend the full width of the doorway and the required latch side or hinge side clearance. Maneuvering clearances shall have a max slope of 2.08%. Exterior doors are recommended to be maintained at 8.5 lbf as a smart practice. Force is to be measured at the operating hardware or 30 inches from the hinges, whichever is greater.	Door - Gap of 1" in doorway, 25# push	For all doors along the public circulation route, provide required maneuvering clearance on push and pull side of doors. For all doors along the public circulation route, fill gaps at door entries to max .5". For all doors along the public circulation route, inspect, adjust, and maintain 8.5 lbf to open exterior doors as a smart practice.	2010 ADAS Section: 404.2.3, 404.2.7, 404.2.4, 404.2.11, 404.2.11 Exception

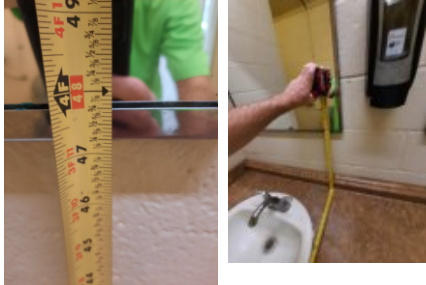
143	Piney Shores: Piney Shores Women's Restroom	[30.6529805 , -95.006688]	The mirror is mounted too high. Mirrors must have the bottom edge of the reflecting surface a maximum of 40 inches above the floor if above a sink or counter. Mirrors not located above lavatories or countertops shall be installed with the bottom edge of the reflecting surface 35 inches maximum above the finish floor or ground.	Bottom edge of reflecting surface of mirror is 47.75" aff	Lower mirror so reflective surface is max 40" aff	2015 ABAAS Section: 603.3  2012 TAS Section: 603.3  2010 ADAS Section: 603.3

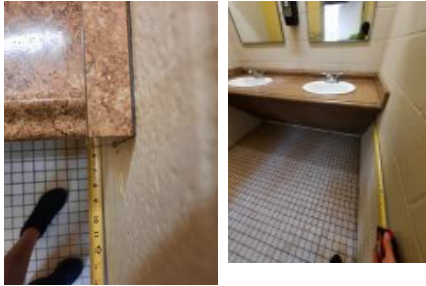
Finding Number	Area Description	Lat/Long	Finding	As Built	Recommendation	Citation	Photos	Figure
144	Piney Shores: Piney Shores Women's Restroom	[30.652999, -95.006693 4]	Knee clearance at 27 inches off the floor is not 8 inches minimum deep. The knee clearance, measured from the bottom of the apron or the outside bottom edge of the lavatory, must be 27 inches at a point located 8 inches back from the front edge and continuing to 11 inches minimum in depth at 9 inches above the floor. The top of the lavatory rim may be no higher than 34 inches.	Sink knee clearance 5.5"	Remove face board to provide 8" deep knee clearance.	2015 ABAAS Section: 306.3.1, 306.3.2, 306.3.3, 306.3.4 , 306.3.5  2012 TAS Section: 306.3.2, 306.3.3, 306.3.4, 306.3.5, 306.3.1  2010 ADAS Section: 306.3.3, 306.3.2, 306.3.4, 306.3.5, 306.3.1

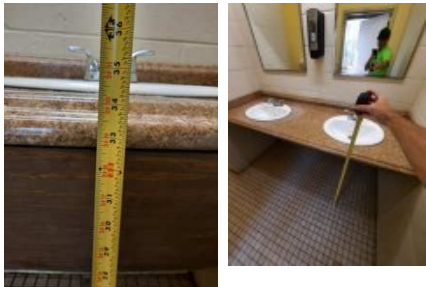
145	Piney Shores: Piney Shores Women's Restroom	[30.6529955 , -95.006710 8]	The top rim of the sink is too high. All lavatories/sinks that are designated to be accessible shall be a minimum 17 inches in horizontal depth and mounted with the rim or counter edge no higher than 34 inches above the finished floor.	The top rim of the sink is 34.5" aff	Lower sinks to max 34" aff to front of rim.	2015 ABAAS Section: 606.3  2012 TAS Section: 606.3  2010 ADAS Section: 606.3

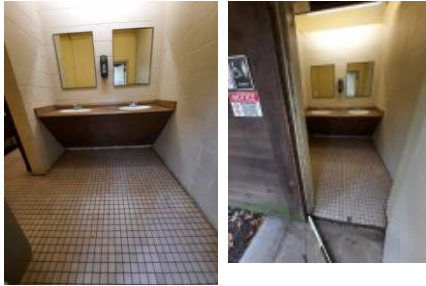
Finding Number	Area Description	Lat/Long	Finding	As Built	Recommendation	Citation	Photos	Figure
146	Piney Shores: Piney Shores Women's Restroom	[30.6529978 , -95.006694 7]	The water and drain pipes under the lavatory are not adequately insulated. Water supply and drain pipes under lavatories and sinks shall be insulated or otherwise configured to protect against contact. There shall be no sharp or abrasive surfaces under lavatories and sinks.	Wood panel to be removed for knee clearance, unknown if sin pipes are insulated	Remove wood panel to provide knee clearance and insulate exposed pipes under one sink.	2015 ABAAS Section: 606.5  2012 TAS Section: 606.5  2010 ADAS Section: 606.5

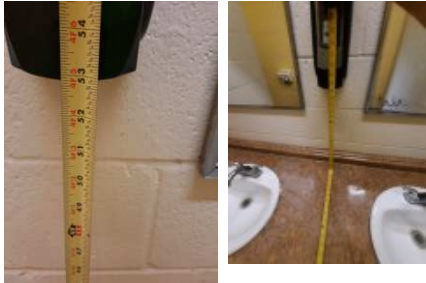
147	Piney Shores: Piney Shores Women's Restroom	[30.6529932 , -95.006698 7]	Where a high forward reach is over an obstruction, the clear floor space shall extend beneath the element for a distance not less than the required reach depth over the obstruction. The high forward reach shall be 48 inches (1220 mm) maximum where the reach depth is 20 inches (510 mm) maximum. Where the reach depth exceeds 20 inches (510 mm), the high forward reach shall be 44 inches (1120 mm) maximum and the reach depth shall be 25 inches (635 mm) maximum. Where a clear floor or ground space allows a parallel approach to an element and the high side reach is over an obstruction, the height of the obstruction shall be 34 inches (865 mm) maximum and the depth of the obstruction shall be 24 inches (610 mm) maximum. The high side reach shall be 48 inches (1220 mm) maximum for a reach depth of 10 inches (255 mm) maximum. Where the reach depth exceeds 10 inches (255 mm), the high side reach shall be 46 inches (1170 mm) maximum for a reach depth of 24 inches (610 mm) maximum.	Soap dispenser 53" aff over sink	Lower soap dispenser to max 44" aff for a forward reach over the sink.	2015 ABAAS Section: 308.2.1, 308.3.2  2012 TAS Section: 308.2.1, 308.3.2  2010 ADAS Section: 308.2.1, 308.3.2

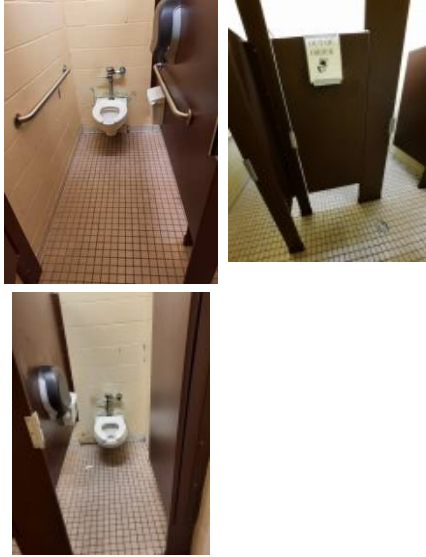
Finding Number	Area Description	Lat/Long	Finding	As Built	Recommendation	Citation	Photos	Figure
148	Piney Shores: Piney Shores Women's Restroom	[30.6529955 , -95.006700 1]	There are not enough accessible toilet compartments. The room contains several toilet compartments. A minimum of 1 must be wheelchair accessible .	Lacks wheelchair stall, ambulatory only	Create a wheelchair accessible stall with grab bars and fixtures mounted in correct locations and at correct heights.	2015 ABAAS Section: F213.3.1  2012 TAS Section: 213.3.1  2010 ADAS Section: 213.3.1

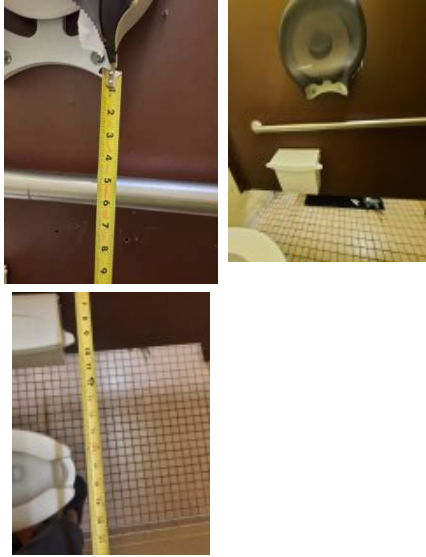
Finding Number	Area Description	Lat/Long	Finding	As Built	Recommendation	Citation	Photos	Figure
150	Piney Shores: Piney Shores Women's Restroom	[30.6529863 , -95.006689 3]	The grab bar height and/or spacing fails. Grab bars must be mounted between 33" and 36" to the top of the gripping surface. There must be 1.5" of clearance between the grab bar and the wall. There must be a minimum of 1.5" of clearance below and minimum 12" above the grab bar to any dispenser or other obstruction.	Toilet paper dispenser 5" above grab bar and too close to toilet	Remount toilet paper dispenser max 7" to 9" from front of toilet, 15" to 48" aff and min 12" above or 1.5" below grab bar	2015 ABAAS Section: 609.3, 609.4  2012 TAS Section: 609.4, 609.3  2010 ADAS Section: 609.3, 609.4

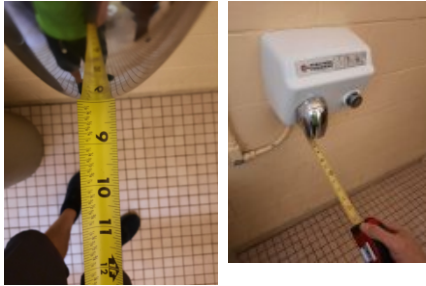
Finding Number	Area Description	Lat/Long	Finding	As Built	Recommendation	Citation	Photos	Figure
152	Piney Shores: Piney Shores Women's Restroom	[30.6530059 , -95.006689 3]	The hand dryer projects more than 4 inches into the circulation path. Wall-mounted objects that have leading edges between 27 inches and 80 inches from the floor must not project more than 4 inches into the circulation path. Protruding objects that extend to the floor or within 27 inches of the floor are cane detectable and are therefore not hazardous. Where it is necessary or desirable to have objects protrude from the wall, a manner of cane detection must be provided.	Hand dryer protrudes 8"	Relocate protruding objects or place cane detectable warning or bollard at foot of item.	2015 ABAAS Section: 307.2  2012 TAS Section: 307.2  2010 ADAS Section: 307.2

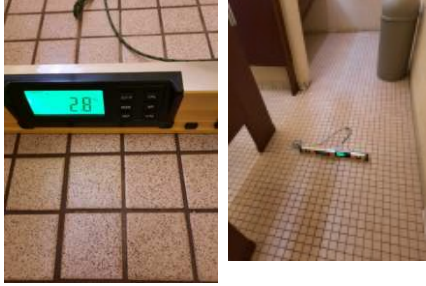
153	Piney Shores: Piney Shores Women's Restroom	[30.6530001 , -95.006697 4]	The accessible route contains running slopes greater than 5 percent and cross slopes greater than 2 percent across the width of the walk and has not been constructed as a ramp (i.e. handrails, wheel guides, etc.). When the slope in the direction of travel of any walk exceeds 1 unit vertical in 20 units horizontal (5-percent slope), it must be constructed as ramp. Surface cross slopes must not exceed one unit vertical in 48 units. Horizontal (2-percent slope).	Slope of 2.8% near floor drain	Correct or repair slope to max 2.08%.	2015 ABAAS Section: 403.3  2012 TAS Section: 403.3  2010 ADAS Section: 403.3

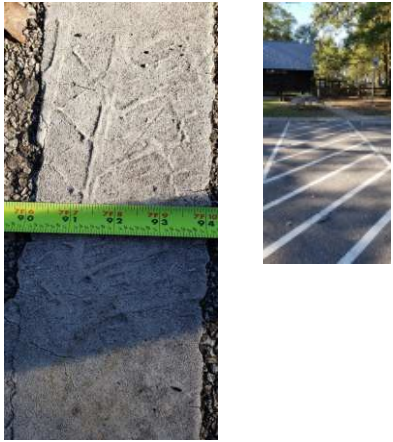
154	Piney Shores: Shelter Area Parking	[30.6525225 , -95.006962 9]	There are no van accessible parking stalls. 1 in every 6, minimum of one, required accessible stalls must be a van accessible stall. There are a total of 25 parking stalls in the parking lot that could be reasonably associated with this facility. There should be a minimum of 1 accessible stall with a minimum of 1 being designed as van accessible.	access aisle 92", too narrow for a van accessible parking space	Add van parking sign to 1 accessible stall and repaint stall and access aisle to 11' and 5' or 8' and 8'.	2015 ABAAS Section: F208.2, F208.2.4  2012 TAS Section: 208.2, 208.2.4  2010 ADAS Section: 208.2, 208.2.4

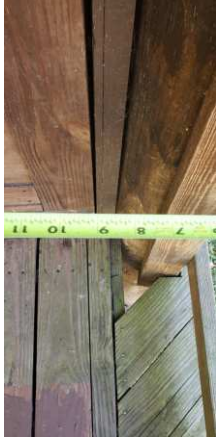
Finding Number	Area Description	Lat/Long	Finding	As Built	Recommendation	Citation	Photos	Figure
155	Piney Shores: Shelter Area Parking	[30.65691, -95.00105]	Element meets all standards and requirements	Parking lot meets scoping with 25 standard stalls and 1 accessible	None	2010 ADAS Section: N/A		
156	Piney Shores: Piney Shores Screened Shelter - 1	[30.6526021, -95.0071198]	Minimum maneuvering clearances at doors and gates shall comply with 404.2.4. Maneuvering clearances shall extend the full width of the doorway and the required latch side or hinge side clearance.	4" to railing on the pull side of the door	Provide required maneuvering clearance around pull side of door	2015 ABAAS Section: 404.2.4.1, 404.2.4.4  2012 TAS Section: 404.2.4.4, 404.2.4.1  2010 ADAS Section: 404.2.4.4, 404.2.4.1

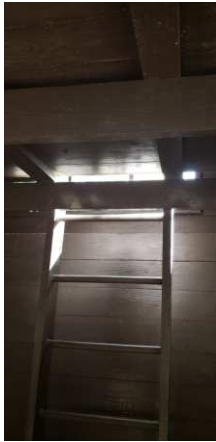
157	Piney Shores: Piney Shores Screened Shelter - 1	[30.6526067, -95.0071185]	There is no accessible route between elements in the building. An accessible route of travel must connect all elements and spaces within a building or facility.	loft is only accessed by ladder	Leave as is lack of route to loft and assure equivalent amenities are provided on the main level.	2015 ABAAS Section: F206.2.4  2012 TAS Section: 206.2.4  2010 ADAS Section: 206.2.4

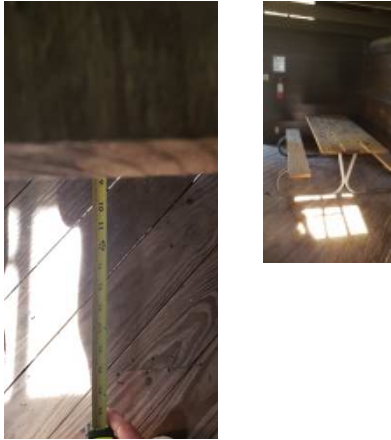
Finding Number	Area Description	Lat/Long	Finding	As Built	Recommendation	Citation	Photos	Figure
158	Piney Shores: Piney Shores Screened Shelter - 1	[30.6526021 , -95.007122 5]	Picnic tables shall provide at least one wheelchair space for each 24 linear feet (7320 mm) of usable table surface perimeter. Wheelchair spaces shall be 30 inches (760 mm) minimum by 48 inches (1220 mm) minimum. Wheelchair spaces shall be positioned for a forward approach to the table and provide knee and toe clearance complying with 306 under the table	Picnic table toe clearance only 9" deep	Replace picnic table with one of an accessible design as a smart practice	2015 ABAAS Section: 1011.4.2

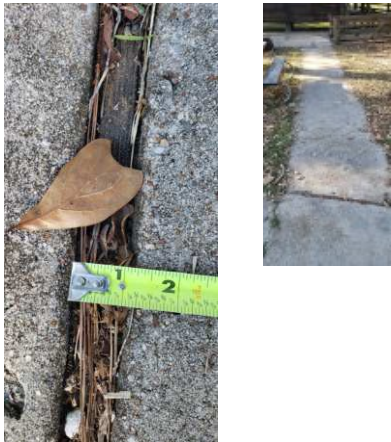
159	Piney Shores: Piney Shores Screened Shelter - 1	[30.6525813 , -95.007144]	There is a gap spaced greater than a 1/2 inch. Openings in floor or ground surfaces shall not allow passage of a sphere more than 1/2 inch diameter. Elongated openings shall be placed so that the long dimension is perpendicular to the dominant direction of travel.	Gap of 1" on route to shelter	Correct or fill gaps to be max .5"	2015 ABAAS Section: 302.3  2012 TAS Section: 302.3  2010 ADAS Section: 302.3

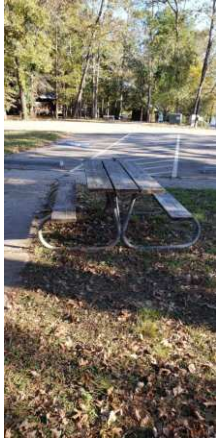
Finding Number	Area Description	Lat/Long	Finding	As Built	Recommendation	Citation	Photos	Figure
160	Piney Shores: Piney Shores Screened Shelter - 1	[30.6525652 , -95.007004 5]	An accessible access route is not provided between elements, spaces and the facilities provided within the accessible camping unit. At least one outdoor recreation access route shall connect accessible elements, spaces and facilities provided within camping units with mobility features.	Lacks route to picnic table	Create AR with crushed and compacted stone or similar outdoor material to camp sites and one of each type of amenity.	2015 ABAAS Section: F244.5.1

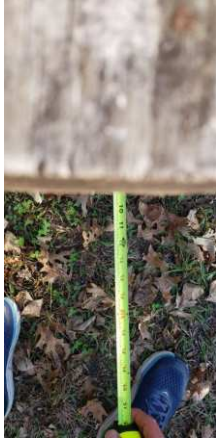
161	Piney Shores: Piney Shores Screened Shelter - 1	[30.6525675 , -95.006997 8]	Picnic tables shall provide at least one wheelchair space for each 24 linear feet (7320 mm) of usable table surface perimeter. Wheelchair spaces shall be 30 inches (760 mm) minimum by 48 inches (1220 mm) minimum. Wheelchair spaces shall be positioned for a forward approach to the table and provide knee and toe clearance complying with 306 under the table	Picnic table toe clearance only 9" deep	Replace picnic table with one of an accessible design as a smart practice	2015 ABAAS Section: 1011.4.2

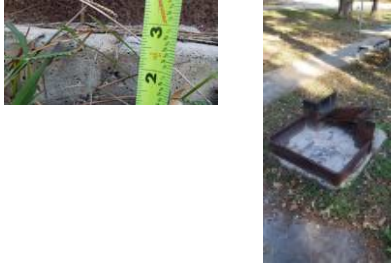
163	Piney Shores: Piney Shores Screened Shelter - 1	[30.6525952 , -95.007068 9]	Fire building surfaces shall be 9 inches (230 mm) minimum above the ground.	Fire building surface 2.5" above surrounding ground level	Correct fire building surface to be 9" min above the ground as a smart practice. In the alternative, replace fire ring with a compliant accessible fire ring.	2015 ABAAS Section: 1011.5.1

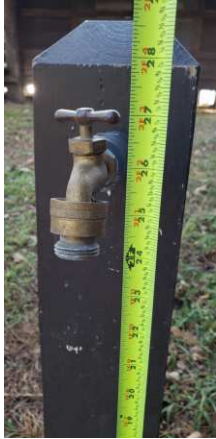
Finding Number	Area Description	Lat/Long	Finding	As Built	Recommendation	Citation	Photos	Figure
164	Piney Shores: Piney Shores Screened Shelter - 1	[30.6525975 , -95.007068 9]	Water spouts at water hydrants and water utility hook-ups shall be 28 inches (710 mm) minimum and 36 inches (915 mm) maximum above the ground	Water spout is 24" above ground level	Remount water spouts to 28" min or 36" max above the ground as a smart practice	2015 ABAAS Section: 1011.6

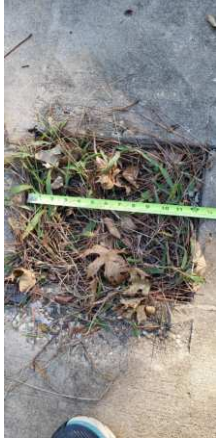
165	Piney Shores: Piney Shores Screened Shelter - 1	[30.6525929 , -95.007095 7]	The surface of the route to and into the picnic area or shelter must be firm and stable.	Lacks firm and stable surface in picnic area due to a gap of 12" and uneven concrete surface	Replace or correct surface to be firm and stable.	2015 ABAAS Section: 1016.1, 1016.1 EXCEPTION S 1, 1016.1 EXCEPTION S 2, 1016.1 EXCEPTION S 3

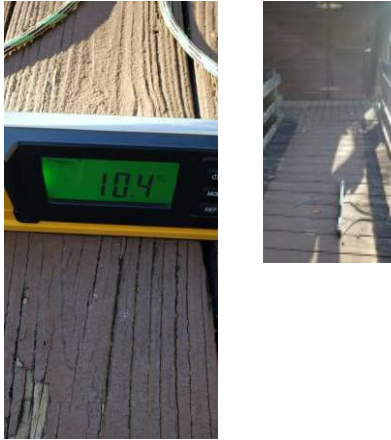
Finding Number	Area Description	Lat/Long	Finding	As Built	Recommendation	Citation	Photos	Figure
166	Piney Shores: Piney Shores Screened Shelter - 1	[30.6525767 , -95.007079 6]	The ramps slope exceeds the maximum running slope (direction of travel) allowable of 8.33%. Ramps should have the least possible slope but in no case more than 8.3% (1:12).	Entry Ramp - Slope of 10.4% on last section of ramp	Correct slope of ramp to max 8.33%	2015 ABAAS Section: 405.2  2012 TAS Section: 405.2  2010 ADAS Section: 405.2

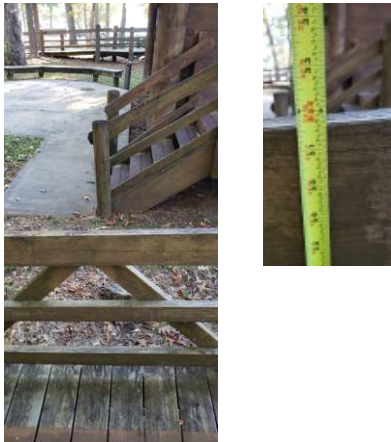
167	Piney Shores: Piney Shores Screened Shelter - 1	[30.6525987 , -95.007079 6]	The ramp does not have compliant handrails. Handrails are required on both sides of all surfaces that are sloped greater than 5 percent (1:20). Handrails must be between 34 inches and 38 inches above the ramp surface, must extend beyond the top and bottom of the ramp 12 inches and be parallel to the floor or ground surface. The diameter of the handrails must be between 1 inches and 2 inches in cross-sectional nominal dimension for circular handrails and handrail gripping surfaces with a non-circular cross section shall have a perimeter dimension of 4 inches minimum and 6 inches maximum, and a cross-section dimension of 2 inches maximum. The clear space between handrails and walls must 1-1/2 inches minimum.	Entry Ramp - lacks compliant handrails	Install handrails that are rounded and/or extend to the ground, with handrail extensions and mounted 34" to 38" aff.	2015 ABAAS Section: 505.1  2012 TAS Section: 505.1  2010 ADAS Section: 505.1

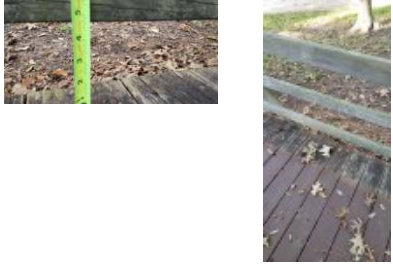
Finding Number	Area Description	Lat/Long	Finding	As Built	Recommendation	Citation	Photos	Figure
168	Piney Shores: Piney Shores Screened Shelter - 1	[30.6525906 , -95.007101 1]	The ramp run has not been provided with edge protection. The floor or ground surface of the ramp run or landing shall extend 12 inches minimum beyond the inside face of a handrail or a curb or barrier shall be provided that prevents the passage of a 4 inch diameter sphere, where any portion of the sphere is within 4 inches of the finish floor or ground surface.	edge protection at 4.5" above ramp surface	Install rail along bottom edge of ramp that prevents a 4" sphere from passing through.	2015 ABAAS Section: 405.9, 405.9.1, 405.9.2  2012 TAS Section: 405.9.1, 405.9.2, 405.9  2010 ADAS Section: 405.9.2, 405.9.1, 405.9

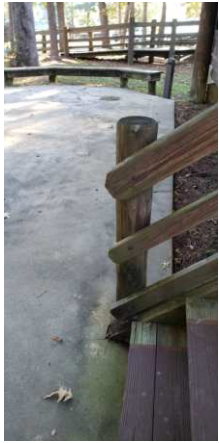
169	Piney Shores: Piney Shores Screened Shelter - 1	[30.652579, -95.007068 9]	The stairway handrails are not nearly compliant. The handrails have the following issues: - Installed at the incorrect height - The bottom handrail extensions are missing or extend incorrectly - The top handrail extensions are missing or extend incorrectly - The handrail gripping surface is not the correct size - The handrail is not located with the correct spacing from the wall or adjacent surface - The handrails are obstructed. Handrails and their extensions must be between 34 inches and 38 inches above the stair nosing or ground. The top handrails shall extend a minimum of 12 inches beyond the top nosing and shall be parallel with the floor or ground surface. At the bottom of a stair flight, handrails shall extend at the slope of the stair flight for a horizontal distance at least equal to one tread depth beyond the last riser nosing. Extension shall return to a wall, guard, or the landing surface, or shall be continuous to the handrail of an adjacent stair flight. The orientation of at least one handrail, including the extension, shall be in the direction of the run of the stair and perpendicular to the direction of the stair nosing. Handrail gripping surfaces with a	stairway lacks compliant handrails	Install handrails on both sides of stairway, mounted 34" to 38" aff with top and bottom extensions and having a 1.25" – 2" in diameter, or a non-circular grip that has a perimeter dimension of 4"- 6.25" max with a min gap of 1.5" between handrail and wall	2015 ABAAS Section: 505.1  2012 TAS Section: 505.1  2010 ADAS Section: 505.1

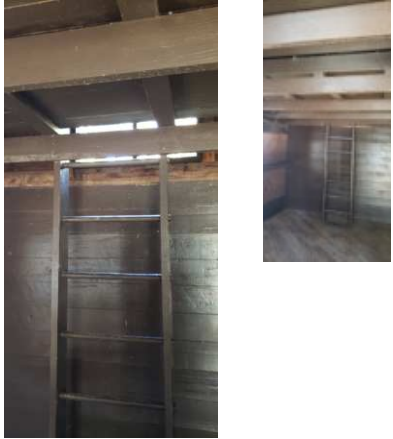
Finding Number	Area Description	Lat/Long	Finding	As Built	Recommendation	Citation	Photos	Figure
171	Piney Shores: Piney Shores Screened Shelter - 2	[30.6525467 , -95.007217 7]	There is no accessible route between elements in the building. An accessible route of travel must connect all elements and spaces within a building or facility.	Lacks accessible route to loft area (accessed via ladder)	Leave as is lack of route to loft and assure equivalent amenities are provided on the main level.	2015 ABAAS Section: F206.2.4  2012 TAS Section: 206.2.4  2010 ADAS Section: 206.2.4

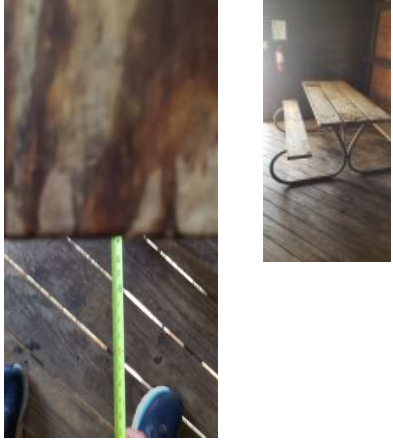
172	Piney Shores: Piney Shores Screened Shelter - 2	[30.6525514 , -95.007213 7]	Picnic tables shall provide at least one wheelchair space for each 24 linear feet (7320 mm) of usable table surface perimeter. Wheelchair spaces shall be 30 inches (760 mm) minimum by 48 inches (1220 mm) minimum. Wheelchair spaces shall be positioned for a forward approach to the table and provide knee and toe clearance complying with 306 under the table	Picnic table toe clearance only 9"	Replace picnic table with one of an accessible design as a smart practice	2015 ABAAS Section: 1011.4.2

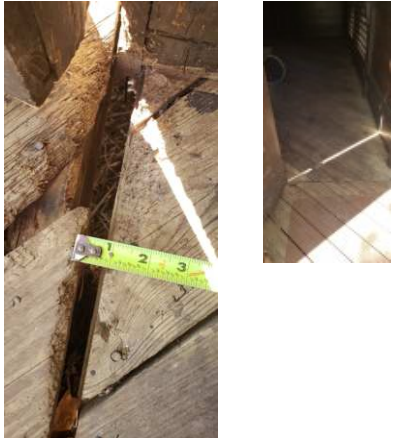
Finding Number	Area Description	Lat/Long	Finding	As Built	Recommendation	Citation	Photos	Figure
173	Piney Shores: Piney Shores Screened Shelter - 2	[30.6525237 , -95.007212 4]	Openings in floor or ground surfaces shall not allow passage of a sphere more than 1/2 inch (13 mm) diameter except as allowed in 407.4.3, 409.4.3, 410.4, 810.5.3 and 810.10. Elongated openings shall be placed so that the long dimension is perpendicular to the dominant direction of travel.	Gap of 1" at door	Fill and maintain gaps to max .5".	2015 ABAAS Section: 302.3  2012 TAS Section: 302.3  2010 ADAS Section: 302.3

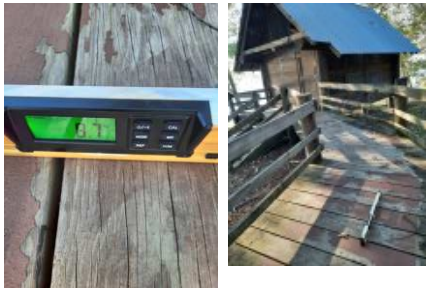
174	Piney Shores: Piney Shores Screened Shelter - 2	[30.652526, -95.007213 7]	The ramps slope exceeds the maximum running slope (direction of travel) allowable of 8.33%. Ramps should have the least possible slope but in no case more than 8.3% (1:12).	Entry Ramp - slope of 8.7%	Correct slope of ramp to max 8.33%.	2015 ABAAS Section: 405.2  2012 TAS Section: 405.2  2010 ADAS Section: 405.2

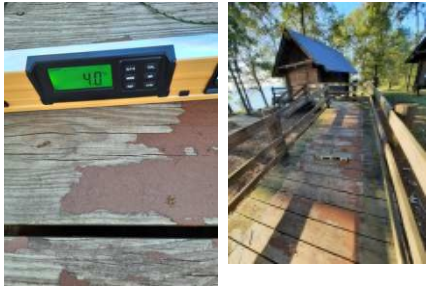
175	Piney Shores: Piney Shores Screened Shelter - 2	[30.6525271 , -95.007212 4]	The ramp on the accessible route contains cross slopes greater than 2%. Surface cross slopes shall not exceed one unit vertical in 48 units horizontal (2-percent slope).	Entry Ramp - Cross slope of 4%	Correct ramp cross slope to max 2.08%. Cost included in previous finding.	2015 ABAAS Section: 405.3  2012 TAS Section: 405.3  2010 ADAS Section: 405.3

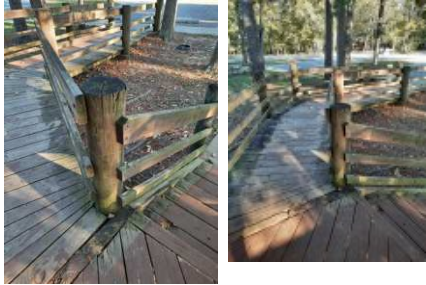
Finding Number	Area Description	Lat/Long	Finding	As Built	Recommendation	Citation	Photos	Figure
176	Piney Shores: Piney Shores Screened Shelter - 2	[30.6525098 , -95.007221 8]	The ramp does not have compliant handrails. Handrails are required on both sides of all surfaces that are sloped greater than 5 percent (1:20). Handrails must be between 34 inches and 38 inches above the ramp surface, must extend beyond the top and bottom of the ramp 12 inches and be parallel to the floor or ground surface. The diameter of the handrails must be between 1 inches and 2 inches in cross-sectional nominal dimension for circular handrails and handrail gripping surfaces with a non-circular cross section shall have a perimeter dimension of 4 inches minimum and 6 inches maximum, and a cross-section dimension of 2 inches maximum. The clear space between handrails and walls must 1-1/2 inches minimum.	Entry Ramp - lacks compliant handrails	Install handrails that are rounded and/or extend to the ground, with handrail extensions and mounted 34" to 38" aff	2015 ABAAS Section: 505.1  2012 TAS Section: 505.1  2010 ADAS Section: 505.1

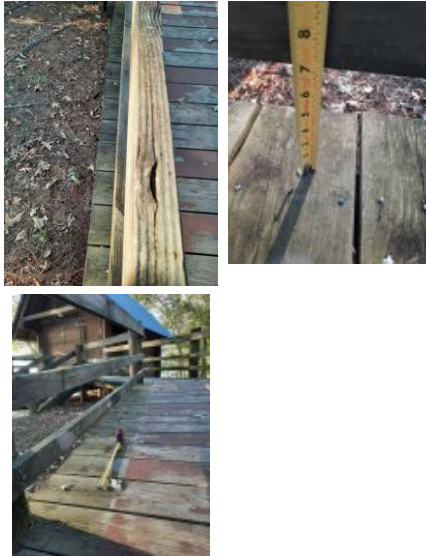
177	Piney Shores: Piney Shores Screened Shelter - 2	[30.6525294 , -95.007216 4]	The ramp run has not been provided with edge protection. The floor or ground surface of the ramp run or landing shall extend 12 inches minimum beyond the inside face of a handrail or a curb or barrier shall be provided that prevents the passage of a 4 inch diameter sphere, where any portion of the sphere is within 4 inches of the finish floor or ground surface.	Entry Ramp - lacks edge protection	Install rail along bottom edge of ramp that prevents a 4" sphere from passing through	2015 ABAAS Section: 405.9, 405.9.1, 405.9.2  2012 TAS Section: 405.9.1, 405.9.2, 405.9  2010 ADAS Section: 405.9.2, 405.9.1, 405.9

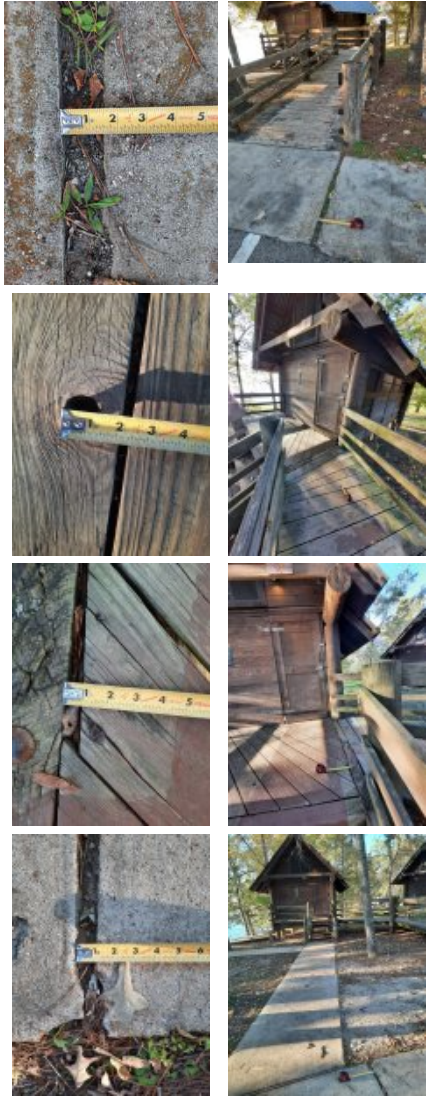
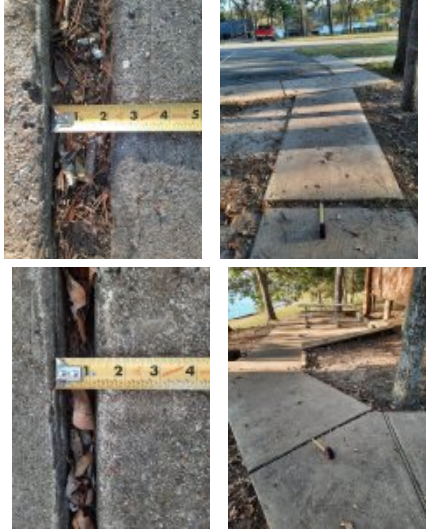
Finding Number	Area Description	Lat/Long	Finding	As Built	Recommendation	Citation	Photos	Figure
178	Piney Shores: Piney Shores Screened Shelter - 2	[30.6525415 , -95.007217 3]	There is a gap spaced greater than a 1/2 inch. Openings in floor or ground surfaces shall not allow passage of a sphere more than 1/2 inch diameter. Elongated openings shall be placed so that the long dimension is perpendicular to the dominant direction of travel.	Gaps of 1.5", 1", .75", 1", 2.25", 1.25" on route to shelter	Correct or fill gaps to be max .5"	2015 ABAAS Section: 302.3  2012 TAS Section: 302.3  2010 ADAS Section: 302.3

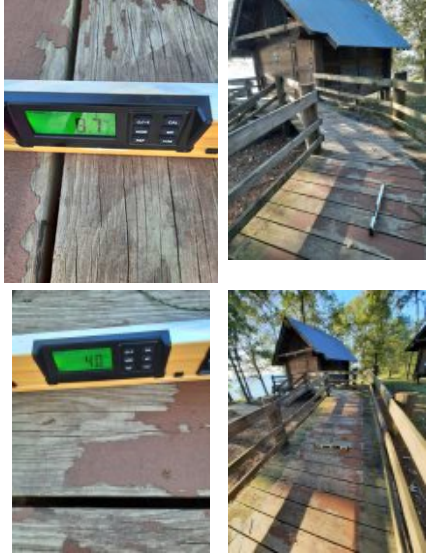
179	Piney Shores: Piney Shores Screened Shelter - 2	[30.6525398 , -95.007237 9]	The running slope of walking surfaces shall not be steeper than 1:20. The cross slope of walking surfaces shall not be steeper than 1:48.	Running slope of 8.7% and cross slope of 4.0%	Correct running slopes to max 5% and cross to max 2.08%.	2012 TAS Section: 403.3  2010 ADAS Section: 403.3

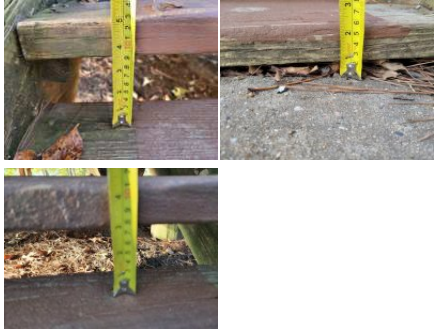
Finding Number	Area Description	Lat/Long	Finding	As Built	Recommendation	Citation	Photos	Figure
180	Piney Shores: Piney Shores Screened Shelter - 2	[30.6525306 , -95.007224 4]	The stair risers are not uniform in height. Stair riser heights shall be 7 inches maximum and 4 inches minimum. On any given flight of stairs, all steps shall have uniform riser height and uniform tread widths.	Lacks uniform height of stair risers - vary between 2.5" and 5"	Correct riser heights on stairs to consistent height between 4" to 7", leave as is if technically infeasible	2015 ABAAS Section: 504.2  2012 TAS Section: 504.2  2010 ADAS Section: 504.2

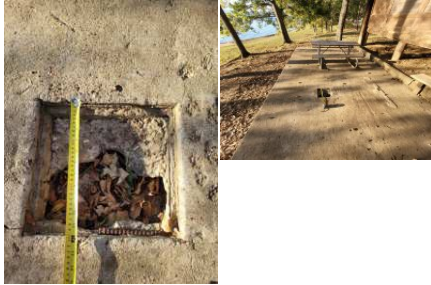
Finding Number	Area Description	Lat/Long	Finding	As Built	Recommendation	Citation	Photos	Figure
185	Piney Shores: Piney Shores Screened Shelter - 2	[30.6525421 , -95.007216 4]	The surface of the outdoor recreation access route, passing spaces, and/or resting intervals are not firm and stable. The surface of outdoor recreation access route, passing spaces, and resting intervals shall be firm and stable, having a width of 36", max gaps of .5" and tread obstacles of .5" or less.	Gap of 12" near picnic table	Correct surface of ORAR to be firm and stable, a min 36" wide and having gaps and changes in level of max .5"	2015 ABAAS Section: 1016.2

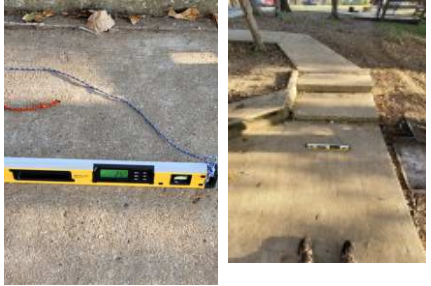
186	Piney Shores: Piney Shores Screened Shelter - 2	[30.6525444 , -95.007208 4]	The cross slope shall not be steeper than 1:48. EXCEPTION: Where the surface is other than concrete, asphalt, or boards, cross slopes not steeper than 1:20 shall be permitted when necessary for drainage.	Slope of 2.5% at bottom of stair landing	Correct or repair ORAR cross slope to max 2.08% or 5% for surfaces other than concrete, asphalt or board as a smart practices	2015 ABAAS Section: 1016.7.2, 1016.7.2 EXCEPTION

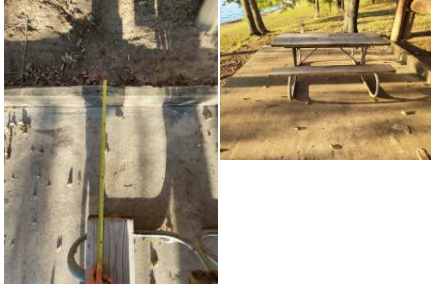
Finding Number	Area Description	Lat/Long	Finding	As Built	Recommendation	Citation	Photos	Figure
189	Piney Shores: Piney Shores Screened Shelter - 2	[30.6525514 , -95.007224 4]	Picnic tables are required to have clear ground space 36 inches (915 mm) on all usable sides of the table measured from the back edge of the benches.	Lacks 36" clear width around picnic table (32")	Provide required 36" clear ground space around all usable portions of the table as a smart practice.	2015 ABAAS Section: 1011.2.1

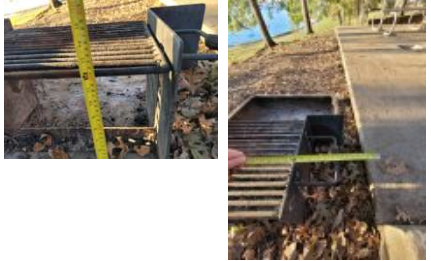
191	Piney Shores: Piney Shores Screened Shelter - 2	[30.6525467 , -95.007227 1]	Where provided, cooking surfaces shall be 15 inches (380 mm) minimum and 34 inches (865 mm) maximum above the ground.	Cooking surface of grill 12" at highest setting	Raise or lower cooking surface to be 15" min to 34" max above the ground; in the alternative, replace with a compliant surface as a smart practice.	2015 ABAAS Section: 1011.5.2

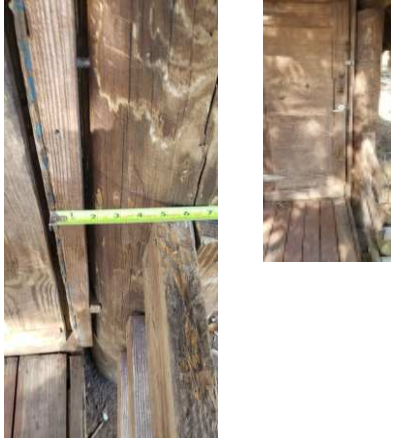
Finding Number	Area Description	Lat/Long	Finding	As Built	Recommendation	Citation	Photos	Figure
194	Piney Shores: Piney Shores Screened Shelter - 3	[30.6524152 , -95.007294 2]	Minimum maneuvering clearances at doors and gates shall comply with 404.2.4. Maneuvering clearances shall extend the full width of the doorway and the required latch side or hinge side clearance.	4.5" to railing on the pull side of the door	Provide required maneuvering clearance around pull side of door.	2015 ABAAS Section: 404.2.4.1 , 404.2.4.4  2012 TAS Section: 404.2.4.4, 404.2.4.1  2010 ADAS Section: 404.2.4.4, 404.2.4.1

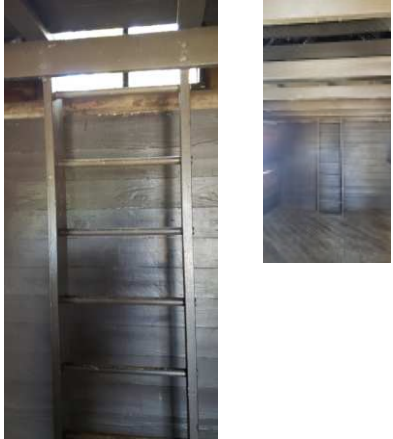
195	Piney Shores: Piney Shores Screened Shelter - 3	[30.6523852 , -95.007315 6]	There is no accessible route between elements in the building. An accessible route of travel must connect all elements and spaces within a building or facility.	loft is only accessed by ladder	Leave as is lack of route to loft and assure equivalent amenities are provided on the main level.	2015 ABAAS Section: F206.2.4  2012 TAS Section: 206.2.4  2010 ADAS Section: 206.2.4

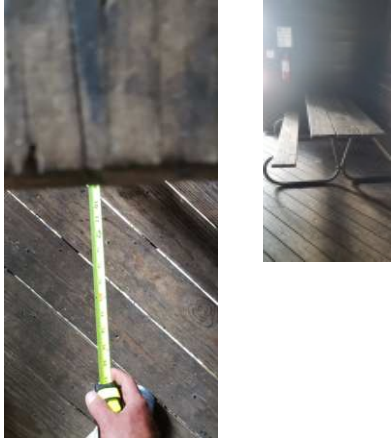
Finding Number	Area Description	Lat/Long	Finding	As Built	Recommendation	Citation	Photos	Figure
196	Piney Shores: Piney Shores Screened Shelter - 3	[30.6523852 , -95.007323 7]	Picnic tables shall provide at least one wheelchair space for each 24 linear feet (7320 mm) of usable table surface perimeter. Wheelchair spaces shall be 30 inches (760 mm) minimum by 48 inches (1220 mm) minimum. Wheelchair spaces shall be positioned for a forward approach to the table and provide knee and toe clearance complying with 306 under the table	Picnic table toe clearance 9" deep	Replace picnic table with one of an accessible design as a smart practice	2015 ABAAS Section: 1011.4.2

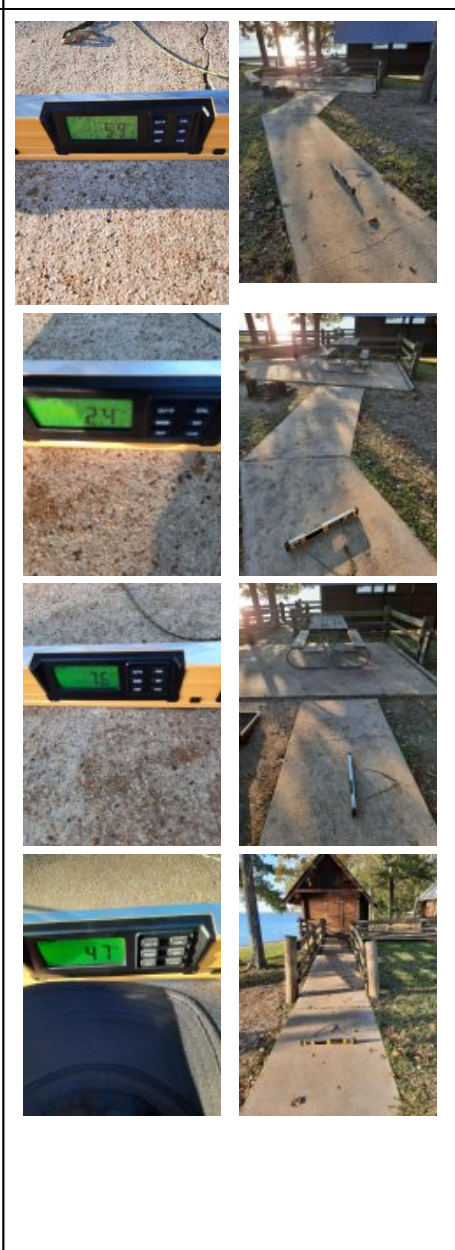
Finding Number	Area Description	Lat/Long	Finding	As Built	Recommendation	Citation	Photos	Figure
197	Piney Shores: Piney Shores Screened Shelter - 3	[30.6523831 , -95.007318 7]	The running slope of any segment of an outdoor recreation access route shall not be steeper than 1:10 (10%). Where the running slope of a segment of an outdoor recreation access route is steeper than 1:20 (5%), the maximum length of the segment shall be in accordance with Table 1016.7.1, and a resting interval complying with 1016.8 shall be provided at the top and bottom of each segment. 5% to 8.33% - max length 50' 8.33% to 10% - max length 30'	Running slopes of 5.9%, 7.6% and cross slopes of 2.4%, 4.7%, 4.3%, 2.5%, and 3.7% to picnic table	Correct or repair pathway running slope along AR to max 5% for any distance, 8.33% for 50' or 10% for 30' with level resting areas as a smart practice. Correct cross slopes to max 2.08%	2015 ABAAS Section: 1016.7, 1016.7.1

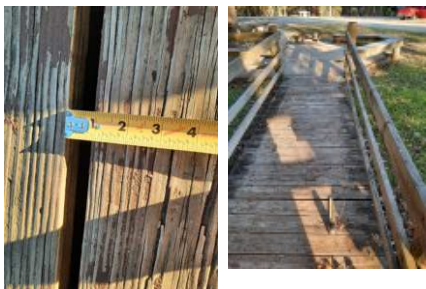
198	Piney Shores: Piney Shores Screened Shelter - 3	[30.6523968 , -95.007299 5]	There are openings in the surface of the trails, passing spaces, and resting intervals that allow the passage of a sphere more than 1/2 inch in diameter. Openings in the surface of trails, passing spaces, and resting intervals shall not allow the passage of a sphere more than 1/2 inch (13 mm) in diameter.	Gaps of .75", 1", .75", and 1" on board walk	Correct for fill gaps to max .5" as a smart practice.	2015 ABAAS Section: 1017.6

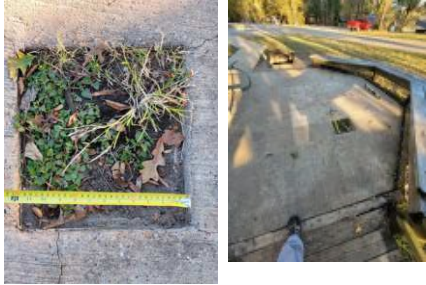
Finding Number	Area Description	Lat/Long	Finding	As Built	Recommendation	Citation	Photos	Figure
199	Piney Shores: Piney Shores Screened Shelter - 3	[30.652376, -95.007323 7]	The surface of the outdoor recreation access route, passing spaces, and/or resting intervals are not firm and stable. The surface of outdoor recreation access route, passing spaces, and resting intervals shall be firm and stable, having a width of 36", max gaps of .5" and tread obstacles of .5" or less.	Gap of 12"	Correct surface of ORAR to be firm and stable, a min 36" wide and having gaps and changes in level of max .5"	2015 ABAAS Section: 1016.2

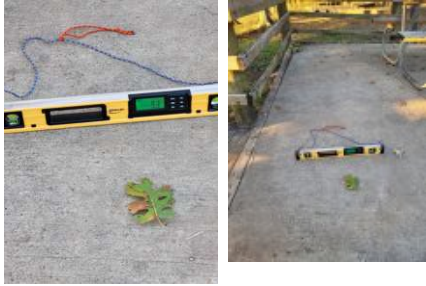
201	Piney Shores: Piney Shores Screened Shelter - 3	[30.6523991 , -95.007318 3]	The running slope of walking surfaces shall not be steeper than 1:20. The cross slope of walking surfaces shall not be steeper than 1:48.	9.3% slope at paved area to boardwalk	Correct running slopes to max 5% and cross to max 2.08%.	2012 TAS Section: 403.3  2010 ADAS Section: 403.3

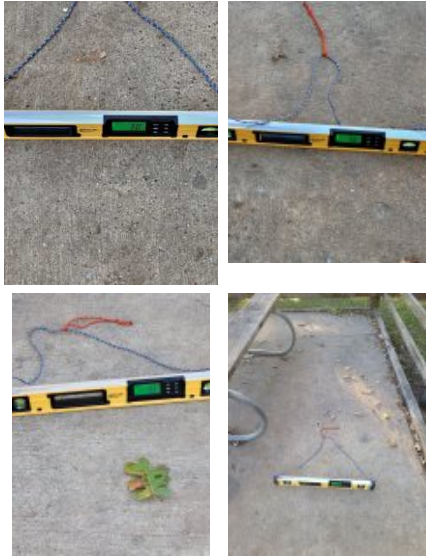
Finding Number	Area Description	Lat/Long	Finding	As Built	Recommendation	Citation	Photos	Figure
203	Piney Shores: Piney Shores Screened Shelter - 3	[30.6523818 , -95.007322 3]	The surface of the clear ground space shall be firm and stable The slope of the clear ground space surface shall not be steeper than 1:48 in any direction. EXCEPTION: Where the surface is other than asphalt, concrete, or boards, slopes not steeper than 1:20 shall be permitted when necessary for drainage	Slopes of 3.0%, 9.6%, and 9.3% around table	Correct surface at table to firm, stable and having max slope of 2.08% as a smart practice	2015 ABAAS Section: 1011.2.2, 1011.2.3, 1011.2 EXCEPTION

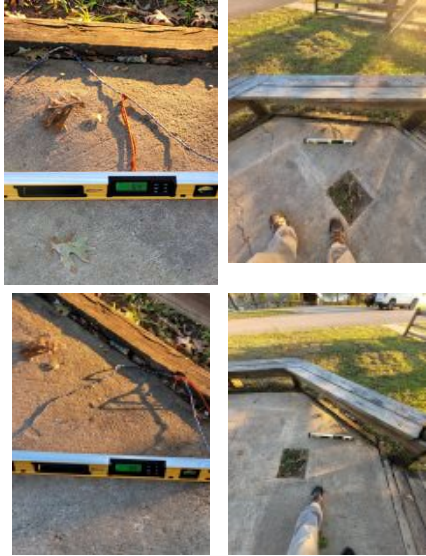
204	Piney Shores: Piney Shores Screened Shelter - 3	[30.6523806 , -95.007321]	Benches shall have a 36" by 48" clear ground space (CGS) positioned near the bench with one side of the space adjoining an outdoor recreation access route (ORAR) or trail, as applicable The CGS shall not overlap with the ORAR or trail or another CGS	Slopes of 6.4% and 8.9%	Correct slope of pads adjacent to 20% of benches to be max 2.08%, and locate along an AR as a smart practice.	2015 ABAAS Section: 1011.2.1

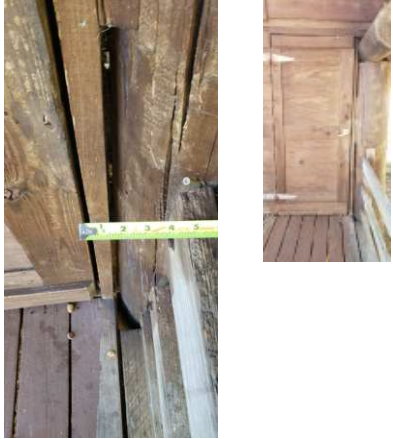
Finding Number	Area Description	Lat/Long	Finding	As Built	Recommendation	Citation	Photos	Figure
208	Piney Shores: Piney Shores Screened Shelter - 4	[30.6519491 , -95.007282 1]	Minimum maneuvering clearances at doors and gates shall comply with 404.2.4. Maneuvering clearances shall extend the full width of the doorway and the required latch side or hinge side clearance.	4" to railing on the pull side of the door	Provide required maneuvering clearance around pull side of door.	2015 ABAAS Section: 404.2.4.1 , 404.2.4.4  2012 TAS Section: 404.2.4.4, 404.2.4.1  2010 ADAS Section: 404.2.4.4, 404.2.4.1

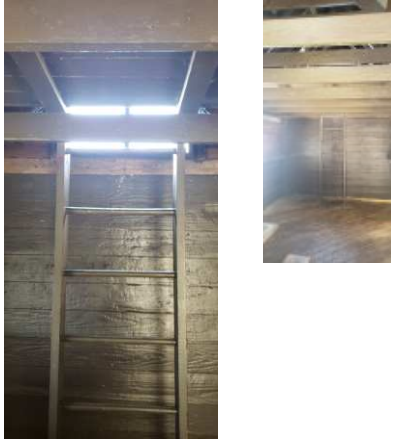
209	Piney Shores: Piney Shores Screened Shelter - 4	[30.6519399 , -95.007294 2]	There is no accessible route between elements in the building. An accessible route of travel must connect all elements and spaces within a building or facility.	loft is only accessed by ladder	Leave as is lack of route to loft and assure equivalent amenities are provided on the main level.	2015 ABAAS Section: F206.2.4  2012 TAS Section: 206.2.4  2010 ADAS Section: 206.2.4

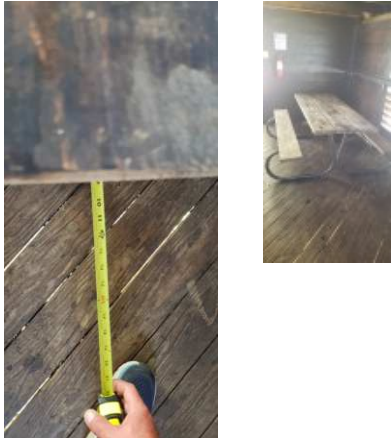
Finding Number	Area Description	Lat/Long	Finding	As Built	Recommendation	Citation	Photos	Figure
210	Piney Shores: Piney Shores Screened Shelter - 4	[30.6519353 , -95.007288 8]	Picnic tables shall provide at least one wheelchair space for each 24 linear feet (7320 mm) of usable table surface perimeter. Wheelchair spaces shall be 30 inches (760 mm) minimum by 48 inches (1220 mm) minimum. Wheelchair spaces shall be positioned for a forward approach to the table and provide knee and toe clearance complying with 306 under the table	Picnic table toe clearance 9" deep	Replace picnic table with one of an accessible design as a smart practice.	2015 ABAAS Section: 1011.4.2
