# Access Audit Site Report

Prepared By  
**WT Group**

**Lake Livingston State Park**  
**300 State Park Rd 65**  
**Livingston, TX 77351**  
**Accessibility Evaluation**  
**Inspection Date: 11/08/2021**  
**Inspectors: Tanya Scheibe**

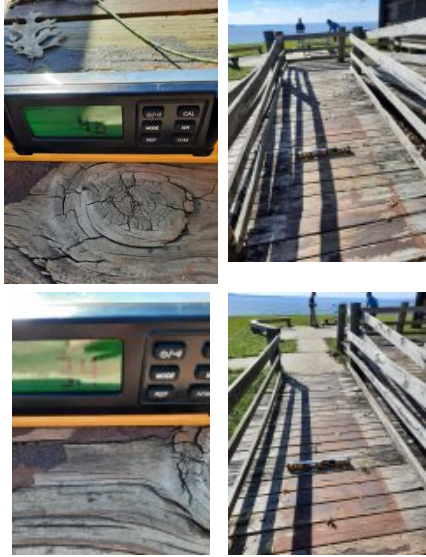
Finding Number	Area Description	Lat/Long	Finding	As Built	Recommendation	Citation	Photos	Figure
212	Piney Shores: Piney Shores Screened Shelter - 4	[30.6519306 , -95.007304 9]	The ramp on the accessible route contains cross slopes greater than 2%. Surface cross slopes shall not exceed one unit vertical in 48 units horizontal (2-percent slope).	Cross slopes of 4.6% and 3.4%	Correct ramp cross slope to max 2.08%. Cost included in previous finding.	2015 ABAAS Section: 405.3  2012 TAS Section: 405.3  2010 ADAS Section: 405.3

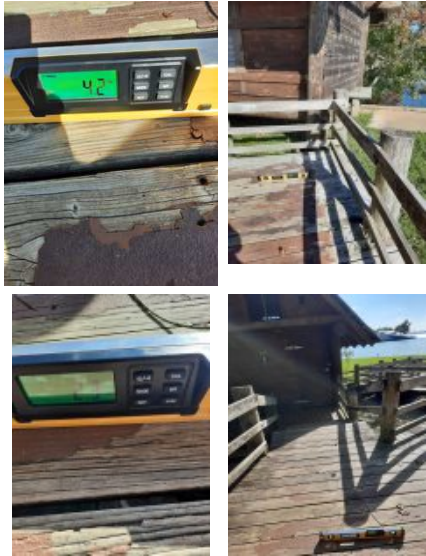
213	Piney Shores: Piney Shores Screened Shelter - 4	[30.6519445 , -95.007304 9]	The landing at the bottom of the ramp has a slope greater than 2%. Bottom landings shall have a dimension in the direction of ramp run of not less than 60 inches and have a slope of less than 2% in any direction.	Slopes of 4.2% and 2.3% at ramp run landings	Correct ramp landing slope to max 2.08%.	2015 ABAAS Section: 405.7.1, 405.7.1 EXCEPTION  2012 TAS Section: 405.7.1, 405.7.1 Exception  2010 ADAS Section: 405.7.1, 405.7.1 Exception

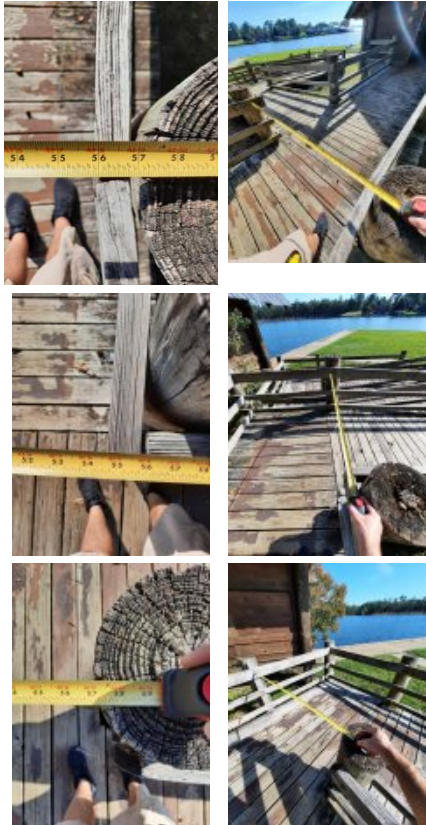
Finding Number	Area Description	Lat/Long	Finding	As Built	Recommendation	Citation	Photos	Figure
215	Piney Shores: Piney Shores Screened Shelter - 4	[30.651948, -95.007292 8]	The landing at the change of direction is not the correct size. Landings at a change of direction shall have a dimension in the direction of ramp run of not less than 60 inches by 60 inches.	4 of 4 ramp runs lack 60" by 60" landing where the ramp changes direction	Enlarge landing on ramp where directions change to 60" by 60"	2015 ABAAS Section: 405.7.4  2012 TAS Section: 405.7.4  2010 ADAS Section: 405.7.4

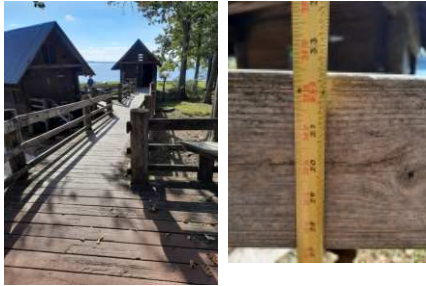
Finding Number	Area Description	Lat/Long	Finding	As Built	Recommendation	Citation	Photos	Figure
216	Piney Shores: Piney Shores Screened Shelter - 4	[30.6519353 , -95.007294 2]	The ramp does not have compliant handrails. Handrails are required on both sides of all surfaces that are sloped greater than 5 percent (1:20). Handrails must be between 34 inches and 38 inches above the ramp surface, must extend beyond the top and bottom of the ramp 12 inches and be parallel to the floor or ground surface. The diameter of the handrails must be between 1 inches and 2 inches in cross-sectional nominal dimension for circular handrails and handrail gripping surfaces with a non-circular cross section shall have a perimeter dimension of 4 inches minimum and 6 inches maximum, and a cross-section dimension of 2 inches maximum. The clear space between handrails and walls must 1-1/2 inches minimum.	Entry ramp lacks compliant handrails	Install handrails that are rounded and/or extend to the ground, with handrail extensions and mounted 34" to 38" aff	2015 ABAAS Section: 505.1  2012 TAS Section: 505.1  2010 ADAS Section: 505.1

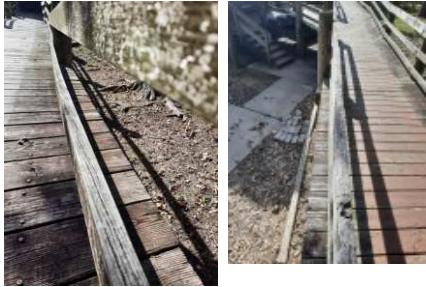
217	Piney Shores: Piney Shores Screened Shelter - 4	[30.6519422 , -95.007280 8]	The ramp run has not been provided with edge protection. The floor or ground surface of the ramp run or landing shall extend 12 inches minimum beyond the inside face of a handrail or a curb or barrier shall be provided that prevents the passage of a 4 inch diameter sphere, where any portion of the sphere is within 4 inches of the finish floor or ground surface.	Entry ramp - lacks edge protection	Install rail along bottom edge of ramp that prevents a 4" sphere from passing through	2015 ABAAS Section: 405.9, 405.9.1, 405.9.2  2012 TAS Section: 405.9.1, 405.9.2, 405.9  2010 ADAS Section: 405.9.2, 405.9.1, 405.9

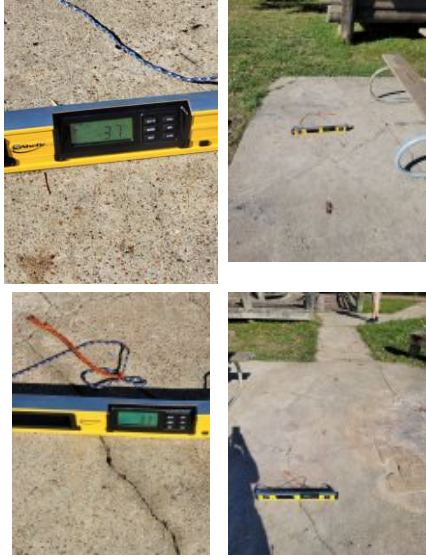
Finding Number	Area Description	Lat/Long	Finding	As Built	Recommendation	Citation	Photos	Figure
222	Piney Shores: Piney Shores Screened Shelter - 4	[30.6518764 , -95.007274 1]	The surface of the clear ground space shall be firm and stable The slope of the clear ground space surface shall not be steeper than 1:48 in any direction. EXCEPTION: Where the surface is other than asphalt, concrete, or boards, slopes not steeper than 1:20 shall be permitted when necessary for drainage	Slopes of 3.7% and 3.3% in clear floor space around picnic table	Correct surface at picnic table to be firm, stable and having max slope of 2.08% or 5% if other than concrete asphalt or boards as a smart practice	2015 ABAAS Section: 1011.2.2, 1011.2.3, 1011.2 EXCEPTION

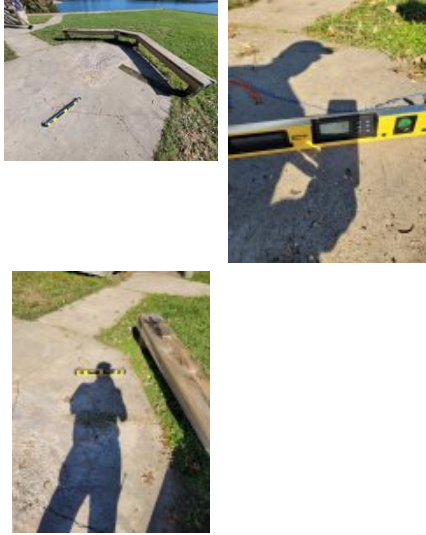
223	Piney Shores: Piney Shores Screened Shelter - 4	[30.6518776 , -95.007272 7]	36 inches (915 mm) by 48 inches (1220 mm) positioned near the bench with one side of the space adjoining an outdoor recreation access route or trail, as applicable The clear ground space shall not overlap the outdoor recreation access route or trail, or another clear ground space	Lacks clear floor space adjacent to the bench, with a slope of 6.8% and gaps in clear floor space in front of bench	Construct firm, stable, and slip resistant pads at least 36" by 48" adjacent to 20% of benches, and locate along an AR as a smart practice	2015 ABAAS Section: 1011.2, 1011.2.1

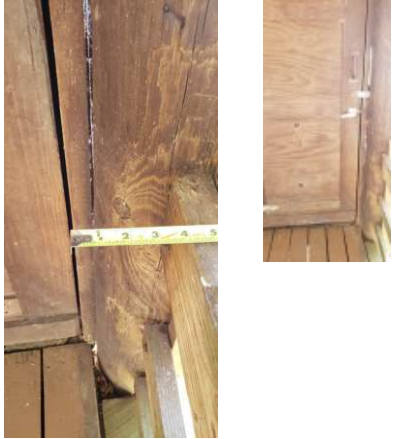
Finding Number	Area Description	Lat/Long	Finding	As Built	Recommendation	Citation	Photos	Figure
226	Piney Shores: Piney Shores Screened Shelter - 5	[30.6519583 , -95.007154 7]	Minimum maneuvering clearances at doors and gates shall comply with 404.2.4. Maneuvering clearances shall extend the full width of the doorway and the required latch side or hinge side clearance.	4" to railing on the pull side of the door	Provide required maneuvering clearance around pull side of door Relocate storage, furniture and other obstacles to create 60" maneuvering clearance around door	2015 ABAAS Section: 404.2.4.1 , 404.2.4.4  2012 TAS Section: 404.2.4.4, 404.2.4.1  2010 ADAS Section: 404.2.4.4, 404.2.4.1

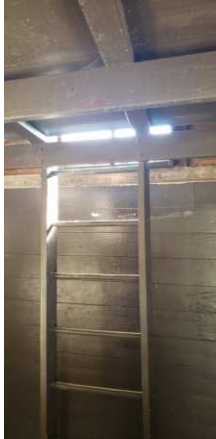
227	Piney Shores: Piney Shores Screened Shelter - 5	[30.6519353 , -95.007146 7]	There is no accessible route between elements in the building. An accessible route of travel must connect all elements and spaces within a building or facility.	loft is only accessed by ladder	Leave as is lack of route to loft and assure equivalent amenities are provided on the main level.	2015 ABAAS Section: F206.2.4  2012 TAS Section: 206.2.4  2010 ADAS Section: 206.2.4

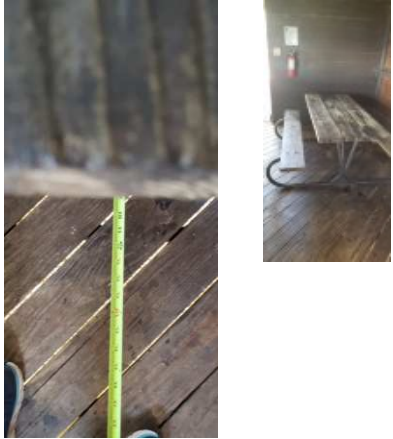
Finding Number	Area Description	Lat/Long	Finding	As Built	Recommendation	Citation	Photos	Figure
228	Piney Shores: Piney Shores Screened Shelter - 5	[30.6519537 , -95.007152]	Picnic tables shall provide at least one wheelchair space for each 24 linear feet (7320 mm) of usable table surface perimeter. Wheelchair spaces shall be 30 inches (760 mm) minimum by 48 inches (1220 mm) minimum. Wheelchair spaces shall be positioned for a forward approach to the table and provide knee and toe clearance complying with 306 under the table	Picnic table toe clearance 9" deep	Replace picnic table with one of an accessible design as a smart practice	2015 ABAAS Section: 1011.4.2

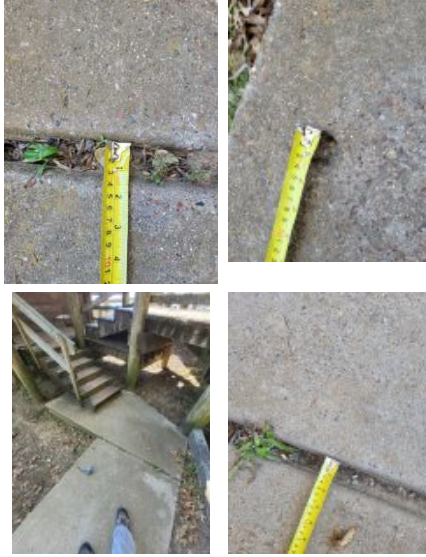
229	Piney Shores: Piney Shores Screened Shelter - 5	[30.6519468 , -95.007130 6]	The surface of the outdoor recreation access route, passing spaces, and/or resting intervals are not firm and stable. The surface of outdoor recreation access route, passing spaces, and resting intervals shall be firm and stable, having a width of 36", max gaps of .5" and tread obstacles of .5" or less.	Gaps of 1", 1.5", and gap that is 7" wide by 48" long	Correct surface of ORAR to be firm and stable, a min 36" wide and having gaps and changes in level of max .5"	2015 ABAAS Section: 1016.2

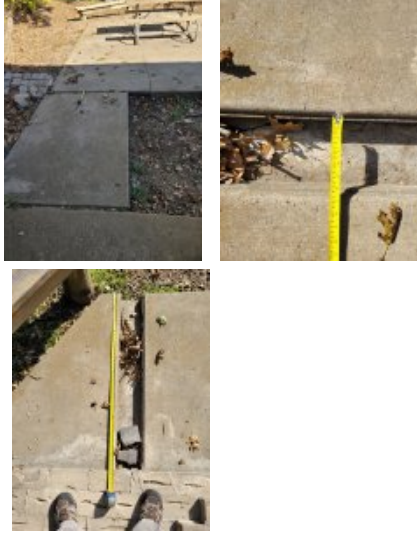
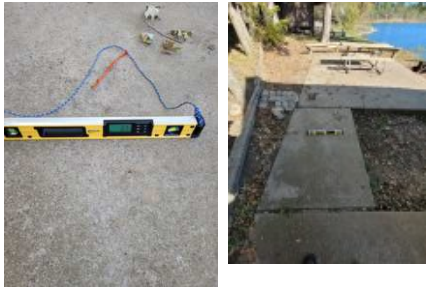
230	Piney Shores: Piney Shores Screened Shelter - 5	[30.651963, -95.007144]	The cross slope shall not be steeper than 1:48. EXCEPTION: Where the surface is other than concrete, asphalt, or boards, cross slopes not steeper than 1:20 shall be permitted when necessary for drainage.	Cross slope of 2.7% on route to shelter	Correct or repair ORAR cross slope to max 2.08% as a smart practices	2015 ABAAS Section: 1016.7.2, 1016.7.2 EXCEPTION

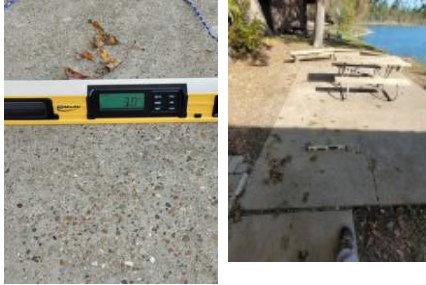
Finding Number	Area Description	Lat/Long	Finding	As Built	Recommendation	Citation	Photos	Figure
231	Piney Shores: Piney Shores Screened Shelter - 5	[30.6519491 , -95.00714]	The resting interval length shall be 60 inches (1525 mm) long minimum Where resting intervals are provided within an outdoor recreation access route, resting intervals shall be at least as wide as the widest segment of the outdoor recreation access route leading to the resting interval. Where resting intervals are provided adjacent to an outdoor recreation access route, the resting interval shall be 36 inches (915 mm) wide minimum Resting intervals shall have slopes not steeper than 1:48 in any direction. EXCEPTION: Where the surface is other than concrete, asphalt, or boards, slopes not steeper than 1:20 shall be permitted when necessary for drainage Where resting intervals are provided adjacent to an outdoor recreation access route, a turning space complying with 304.3.2 shall be provided.	Slope of 3.0% at resting interval	Correct slope in resting areas to max 2.08% along the ORAR as a smart practice.	2015 ABAAS Section: 1016.8.1, 1016.8.2, 1016.8.3, 1016.8.3 EXCEPTION, 1016.8.4

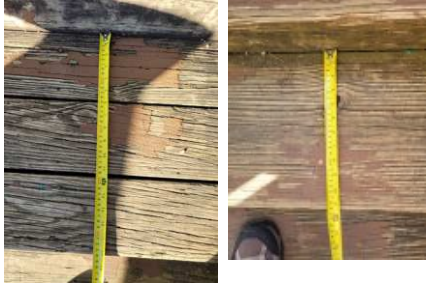
238	Piney Shores: Piney Shores Screened Shelter - 5	[30.651963, -95.007152]	Treads shall be 11 inches (280 mm) deep minimum and uniform	treads vary between 11.5" to 17" deep	Correct tread depth on stairs to 11" minimum and consistent, leave as is if technically infeasible	2015 ABAAS Section: 504.2  2012 TAS Section: 504.2  2010 ADAS Section: 504.2

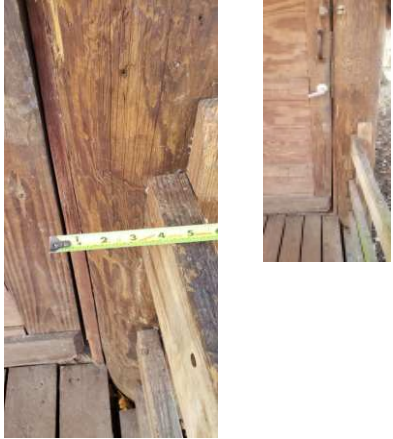
Finding Number	Area Description	Lat/Long	Finding	As Built	Recommendation	Citation	Photos	Figure
242	Piney Shores: Piney Shores Screened Shelter - 6	[30.6520403 , -95.006941 5]	Minimum maneuvering clearances at doors and gates shall comply with 404.2.4. Maneuvering clearances shall extend the full width of the doorway and the required latch side or hinge side clearance.	4" to railing on the pull side of the door	Provide required maneuvering clearance around pull side of door.	2015 ABAAS Section: 404.2.4.1 , 404.2.4.4  2012 TAS Section: 404.2.4.4, 404.2.4.1  2010 ADAS Section: 404.2.4.4, 404.2.4.1

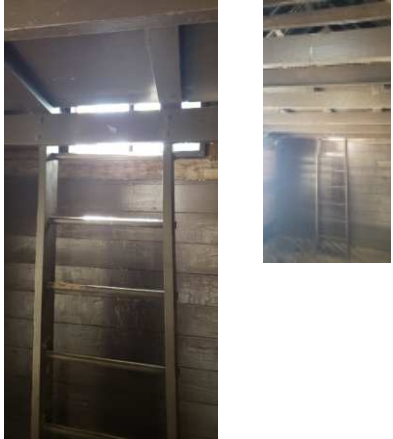
243	Piney Shores: Piney Shores Screened Shelter - 6	[30.6520553 , -95.006926 7]	There is no accessible route between elements in the building. An accessible route of travel must connect all elements and spaces within a building or facility.	loft is only accessed by ladder	Leave as is lack of route to loft and assure equivalent amenities are provided on the main level.	2015 ABAAS Section: F206.2.4  2012 TAS Section: 206.2.4  2010 ADAS Section: 206.2.4

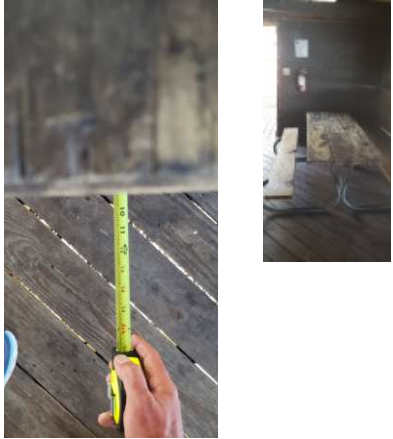
Finding Number	Area Description	Lat/Long	Finding	As Built	Recommendation	Citation	Photos	Figure
244	Piney Shores: Piney Shores Screened Shelter - 6	[30.6520622 , -95.006937 4]	Picnic tables shall provide at least one wheelchair space for each 24 linear feet (7320 mm) of usable table surface perimeter. Wheelchair spaces shall be 30 inches (760 mm) minimum by 48 inches (1220 mm) minimum. Wheelchair spaces shall be positioned for a forward approach to the table and provide knee and toe clearance complying with 306 under the table	Picnic table toe clearance 9" deep	Replace picnic table with one of an accessible design as a smart practice	2015 ABAAS Section: 1011.4.2

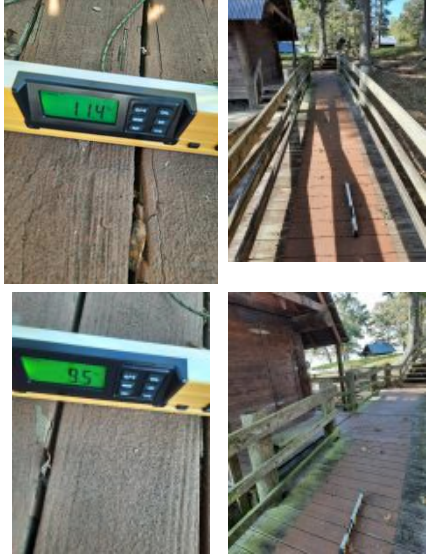
245	Piney Shores: Piney Shores Screened Shelter - 6	[30.6520564 , -95.006926 7]	The ramps slope exceeds the maximum running slope (direction of travel) allowable of 8.33%. Ramps should have the least possible slope but in no case more than 8.3% (1:12).	Entry Ramp - Slopes of 11.4% and 9.5%	Correct slope of ramp to max 8.33%	2015 ABAAS Section: 405.2  2012 TAS Section: 405.2  2010 ADAS Section: 405.2

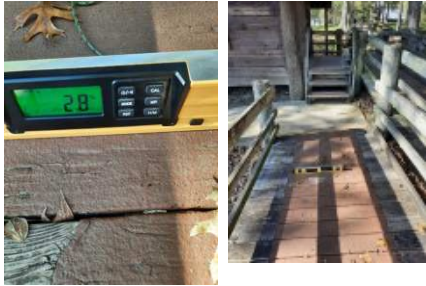
Finding Number	Area Description	Lat/Long	Finding	As Built	Recommendation	Citation	Photos	Figure
246	Piney Shores: Piney Shores Screened Shelter - 6	[30.6520472 , -95.006925 4]	The ramp on the accessible route contains cross slopes greater than 2%. Surface cross slopes shall not exceed one unit vertical in 48 units horizontal (2-percent slope).	Cross slope of 2.8%	Correct ramp cross slope to max 2.08%. Cost included in previous finding.	2015 ABAAS Section: 405.3  2012 TAS Section: 405.3  2010 ADAS Section: 405.3

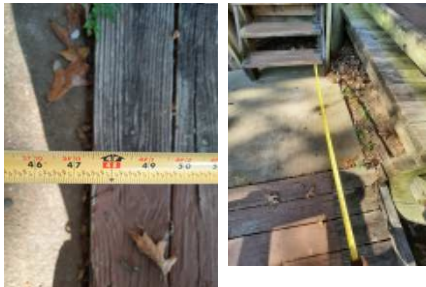
247	Piney Shores: Piney Shores Screened Shelter - 6	[30.6520679 , -95.006926 7]	The landing is not the correct length. Landings shall have a dimension in the direction of ramp run of not less than 60 inches.	Landing only 47.5" deep	Enlarge landing to be 60" deep and as wide as the ramp.	2015 ABAAS Section: 405.7.3  2012 TAS Section: 405.7.3  2010 ADAS Section: 405.7.3

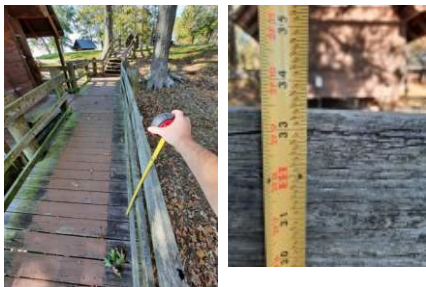
248	Piney Shores: Piney Shores Screened Shelter - 6	[30.6520599 , -95.00692]	The ramp does not have compliant handrails. Handrails are required on both sides of all surfaces that are sloped greater than 5 percent (1:20). Handrails must be between 34 inches and 38 inches above the ramp surface, must extend beyond the top and bottom of the ramp 12 inches and be parallel to the floor or ground surface. The diameter of the handrails must be between 1 inches and 2 inches in cross-sectional nominal dimension for circular handrails and handrail gripping surfaces with a non-circular cross section shall have a perimeter dimension of 4 inches minimum and 6 inches maximum, and a cross-section dimension of 2 inches maximum. The clear space between handrails and walls must 1-1/2 inches minimum.	Entry ramp - lacks compliant handrails	Install handrails that are rounded and/or extend to the ground, with handrail extensions and mounted 34" to 38" aff	2015 ABAAS Section: 505.1  2012 TAS Section: 505.1  2010 ADAS Section: 505.1

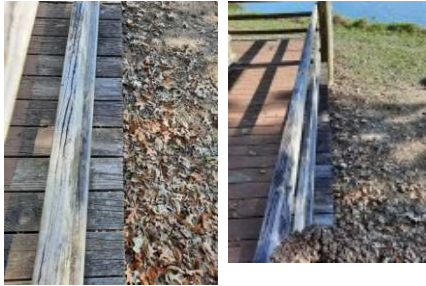
Finding Number	Area Description	Lat/Long	Finding	As Built	Recommendation	Citation	Photos	Figure
249	Piney Shores: Piney Shores Screened Shelter - 6	[30.6520645 , -95.006924]	The ramp run has not been provided with edge protection. The floor or ground surface of the ramp run or landing shall extend 12 inches minimum beyond the inside face of a handrail or a curb or barrier shall be provided that prevents the passage of a 4 inch diameter sphere, where any portion of the sphere is within 4 inches of the finish floor or ground surface.	Entry ramp - lacks edge protection	Install rail along bottom edge of ramp that prevents a 4" sphere from passing through	2015 ABAAS Section: 405.9, 405.9.1, 405.9.2  2012 TAS Section: 405.9.1, 405.9.2, 405.9  2010 ADAS Section: 405.9.2, 405.9.1, 405.9

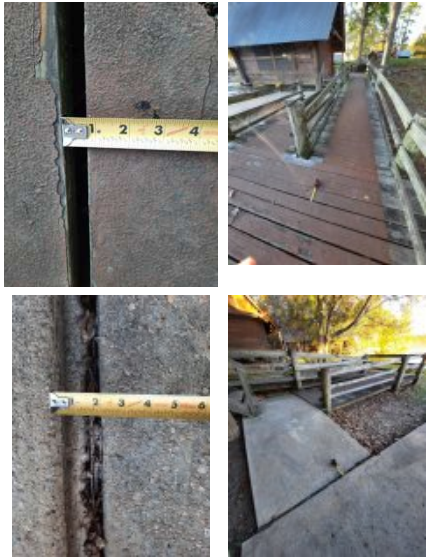
250	Piney Shores: Piney Shores Screened Shelter - 6	[30.6520541 , -95.006929 4]	There is a gap spaced greater than a 1/2 inch. Openings in floor or ground surfaces shall not allow passage of a sphere more than 1/2 inch diameter. Elongated openings shall be placed so that the long dimension is perpendicular to the dominant direction of travel.	Gaps of .75", 2", 1", and 1.5"	Correct or fill gaps to be max .5"	2015 ABAAS Section: 302.3  2012 TAS Section: 302.3  2010 ADAS Section: 302.3

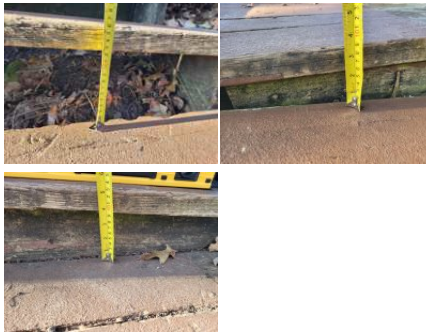
252	Piney Shores: Piney Shores Screened Shelter - 6	[30.6520553 , -95.006910 6]	The stair risers are not uniform in height. Stair riser heights shall be 7 inches maximum and 4 inches minimum. On any given flight of stairs, all steps shall have uniform riser height and uniform tread widths.	Lacks uniform height of stair risers (vary between 3.5" and 6.5")	Correct riser heights on stairs to consistent height between 4" to 7", leave as is if technically infeasible	2015 ABAAS Section: 504.2  2012 TAS Section: 504.2  2010 ADAS Section: 504.2

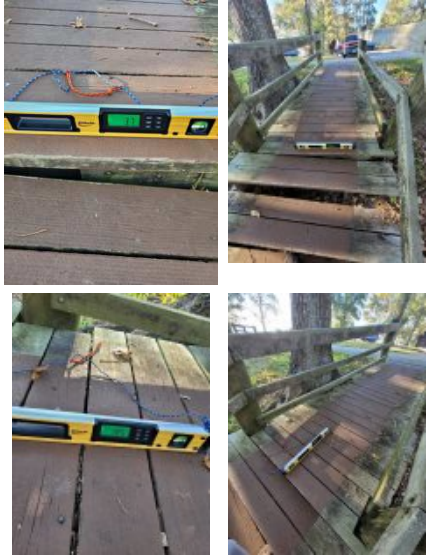
254	Piney Shores: Piney Shores Screened Shelter - 6	[30.6520576 , -95.006928 1]	The running slope of walking surfaces shall not be steeper than 1:20. The cross slope of walking surfaces shall not be steeper than 1:48.	Running slope of 18.5% running slope and cross slope of 3.5% cross slope at top of landing	Correct running slopes to max 5% and cross to max 2.08%.	2012 TAS Section: 403.3  2010 ADAS Section: 403.3

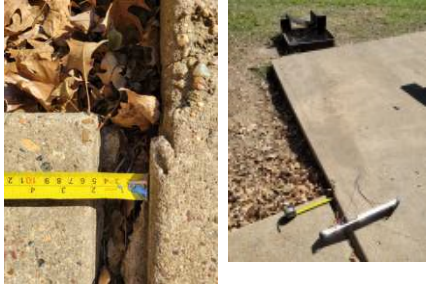
Finding Number	Area Description	Lat/Long	Finding	As Built	Recommendation	Citation	Photos	Figure
257	Piney Shores: Piney Shores Screened Shelter - 6	[30.6520553 , -95.006913 3]	Openings in the surface of outdoor recreation access routes shall not allow the passage of a sphere more than 1/2 inch (13 mm) in diameter. Advisory: Spaces between the boards in a boardwalk and drainage grates are examples of openings. Where possible, drainage grates should be located outside the minimum clear width of the outdoor recreation access route. Elongated openings should be placed so that the long dimension is perpendicular, or as close to perpendicular as possible, to the dominant direction of travel	Gap of 2"	Correct or fill gaps along the ORAR to max .5" as a smart practice.	2015 ABAAS Section: 1016.6, Advisory 1016.6

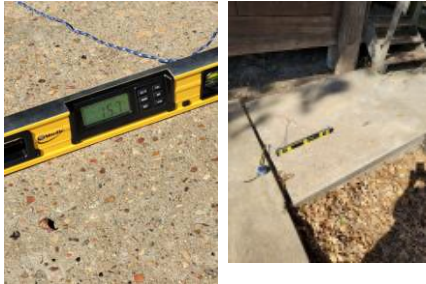
258	Piney Shores: Piney Shores Screened Shelter - 6	[30.6520564 , -95.006905 3]	The running slope of walking surfaces shall not be steeper than 1:20. The cross slope of walking surfaces shall not be steeper than 1:48.	Running slope of 15.7%	Correct running slopes to max 5% and cross to max 2.08%.	2012 TAS Section: 403.3  2010 ADAS Section: 403.3

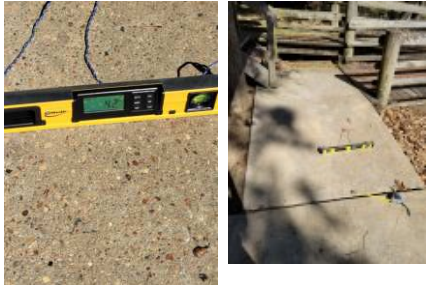
259	Piney Shores: Piney Shores Screened Shelter - 6	[30.6520529 , -95.006936 1]	The running slope of walking surfaces shall not be steeper than 1:20. The cross slope of walking surfaces shall not be steeper than 1:48.	Cross slope of 4.2%	Correct running slopes to max 5% and cross to max 2.08%.	2012 TAS Section: 403.3  2010 ADAS Section: 403.3

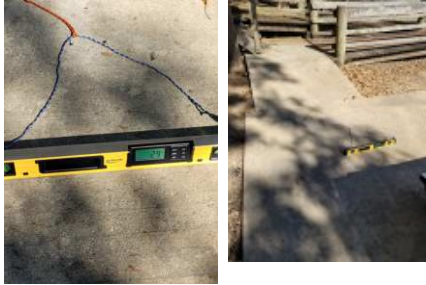
Finding Number	Area Description	Lat/Long	Finding	As Built	Recommendation	Citation	Photos	Figure
260	Piney Shores: Piney Shores Screened Shelter - 6	[30.6520529 , -95.006929 4]	The running slope of walking surfaces shall not be steeper than 1:20. The cross slope of walking surfaces shall not be steeper than 1:48.	Cross slope of 2.9%	Correct running slopes to max 5% and cross to max 2.08%.	2012 TAS Section: 403.3  2010 ADAS Section: 403.3

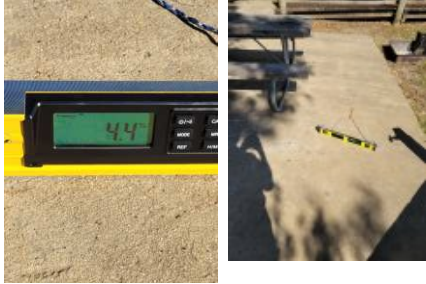
262	Piney Shores: Piney Shores Screened Shelter - 6	[30.6520276 , -95.006916]	The 30 inches minimum by 48 inches minimum clear floor space required at the operable part is not flat (2% or 1:48 maximum slope) in all directions. Changes in level are not permitted at required clear floor or ground space except that slopes not steeper than 1:48 shall be permitted.	Slope of 4.4% in clear ground space of picnic table	Correct or repair slope in CFS to max 2.08%.	2015 ABAAS Section: 305.2  2012 TAS Section: 305.2  2010 ADAS Section: 305.2

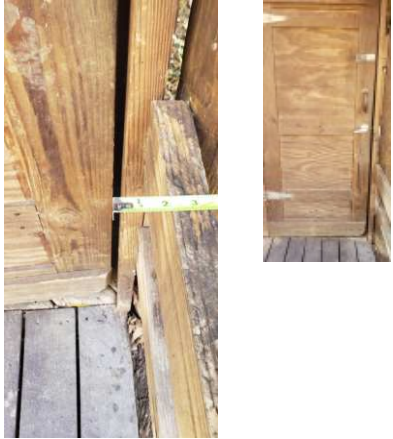
Finding Number	Area Description	Lat/Long	Finding	As Built	Recommendation	Citation	Photos	Figure
266	Piney Shores: Piney Shores Screened Shelter - 7	[30.6521372 , -95.006776 5]	Minimum maneuvering clearances at doors and gates shall comply with 404.2.4. Maneuvering clearances shall extend the full width of the doorway and the required latch side or hinge side clearance.	4" to the railing on the pull side of the door	Provide required maneuvering clearance around pull side of door	2015 ABAAS Section: 404.2.4.1 , 404.2.4.4  2012 TAS Section: 404.2.4.4, 404.2.4.1  2010 ADAS Section: 404.2.4.4, 404.2.4.1

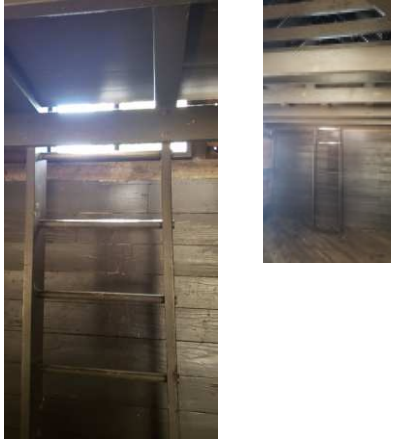
267	Piney Shores: Piney Shores Screened Shelter - 7	[30.652136, -95.006765 8]	There is no accessible route between elements in the building. An accessible route of travel must connect all elements and spaces within a building or facility.	loft is only accessed by ladder	Leave as is lack of route to loft and assure equivalent amenities are provided on the main level.	2015 ABAAS Section: F206.2.4  2012 TAS Section: 206.2.4  2010 ADAS Section: 206.2.4

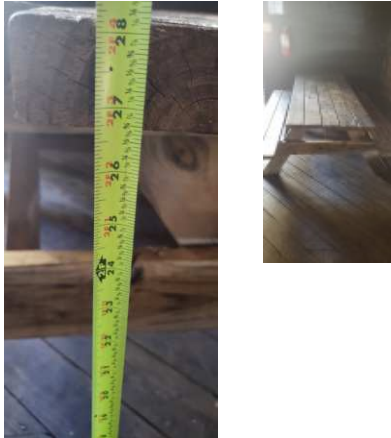
Finding Number	Area Description	Lat/Long	Finding	As Built	Recommendation	Citation	Photos	Figure
268	Piney Shores: Piney Shores Screened Shelter - 7	[30.6521475 , -95.006772 5]	Picnic tables shall provide at least one wheelchair space for each 24 linear feet (7320 mm) of usable table surface perimeter. Wheelchair spaces shall be 30 inches (760 mm) minimum by 48 inches (1220 mm) minimum. Wheelchair spaces shall be positioned for a forward approach to the table and provide knee and toe clearance complying with 306 under the table	Picnic table lacks knee clearance	Replace picnic table with one of an accessible design as a smart practice	2015 ABAAS Section: 1011.4.2

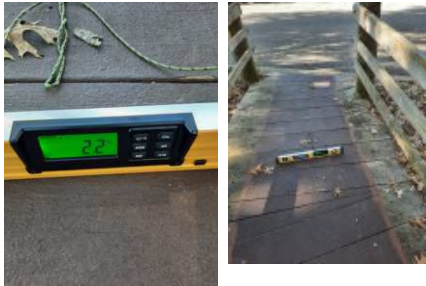
270	Piney Shores: Piney Shores Screened Shelter - 7	[30.6521452 , -95.006785 9]	The ramp on the accessible route contains cross slopes greater than 2%. Surface cross slopes shall not exceed one unit vertical in 48 units horizontal (2-percent slope).	Entry ramp - cross slopes of 2.2%, 3.2%, 9.2%, 5.9%, and 2.2%	Correct ramp cross slope to max 2.08%. Cost included in previous finding.	2015 ABAAS Section: 405.3  2012 TAS Section: 405.3  2010 ADAS Section: 405.3

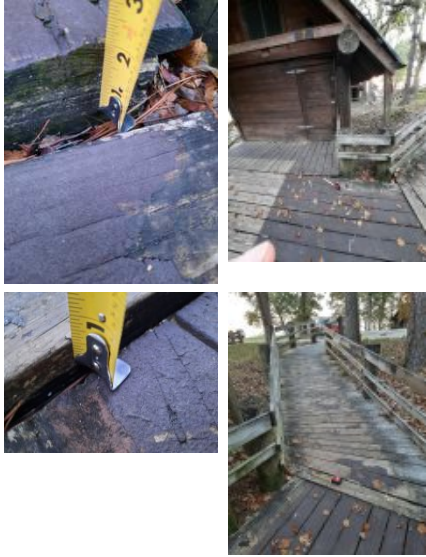
Finding Number	Area Description	Lat/Long	Finding	As Built	Recommendation	Citation	Photos	Figure
275	Piney Shores: Piney Shores Screened Shelter - 7	[30.6521406 , -95.006777 9]	The walkway contains abrupt vertical edges and/or variations over a 1/4 inch. 1/4 inch is the maximum vertical rise. Changes in level between 1/4 inch and 1/2 inch must be beveled at 1:2 or less. Changes in level greater than 1/2 inch must be by way of a ramp.	changes in level of 2" and .5"	Repair, bevel or ramp CIL along AR	2012 TAS Section: 303.2, 303.3  2010 ADAS Section: 303.2, 303.3

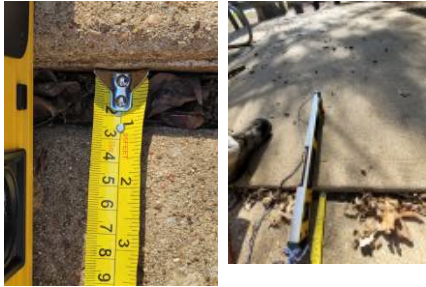
276	Piney Shores: Piney Shores Screened Shelter - 7	[30.6521314 , -95.006771 2]	There is a gap spaced greater than a 1/2 inch. Openings in floor or ground surfaces shall not allow passage of a sphere more than 1/2 inch diameter. Elongated openings shall be placed so that the long dimension is perpendicular to the dominant direction of travel.	Gap of 1"	Correct or fill gaps to be max .5"	2015 ABAAS Section: 302.3  2012 TAS Section: 302.3  2010 ADAS Section: 302.3

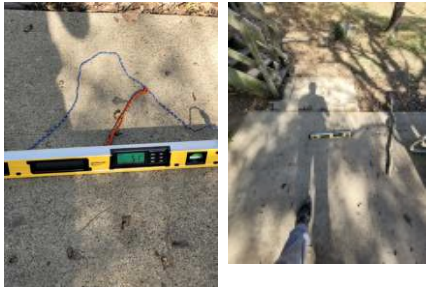
277	Piney Shores: Piney Shores Screened Shelter - 7	[30.652136, -95.006779 2]	The running slope of walking surfaces shall not be steeper than 1:20. The cross slope of walking surfaces shall not be steeper than 1:48.	Cross slope of 5.1%	Correct running slopes to max 5% and cross to max 2.08%.	2012 TAS Section: 403.3  2010 ADAS Section: 403.3

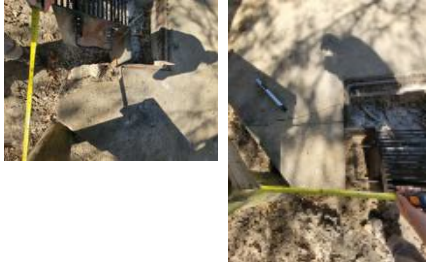
281	Piney Shores: Piney Shores Screened Shelter - 7	[30.6521406 , -95.006771 2]	Clear ground space 48 inches (1220 mm) by 48 inches (1220 mm) should be provided on all usable sides of the fire ring, grill, fireplace, and woodstove. Center the space on each usable side of the grill, fireplace, and woodstove.	Lacks 48" by 48" clear floor space on all usable sides of the fire ring	Provide required 48" clear ground space centered along usable side of fire ring, grill, fireplace, or woodstove as a smart practice.	2015 ABAAS Section: 1011.2

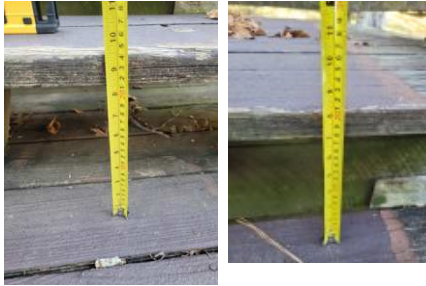
Finding Number	Area Description	Lat/Long	Finding	As Built	Recommendation	Citation	Photos	Figure
283	Piney Shores: Piney Shores Screened Shelter - 7	[30.6521314 , -95.006779 2]	The stair risers are not uniform in height. Stair riser heights shall be 7 inches maximum and 4 inches minimum. On any given flight of stairs, all steps shall have uniform riser height and uniform tread widths.	Shelter Entry Stairs - Lacks uniform height of stair risers - 8" and 9.5"	Correct riser heights on stairs to consistent height between 4" to 7"	2015 ABAAS Section: 504.2  2012 TAS Section: 504.2  2010 ADAS Section: 504.2

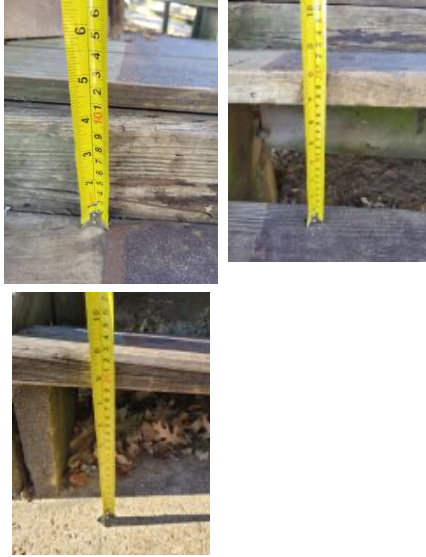
Finding Number	Area Description	Lat/Long	Finding	As Built	Recommendation	Citation	Photos	Figure
287	Piney Shores: Piney Shores Screened Shelter - 7	[30.6521314 , -95.006765 8]	The stair risers are not uniform in height. Stair riser heights shall be 7 inches maximum and 4 inches minimum. On any given flight of stairs, all steps shall have uniform riser height and uniform tread widths.	Stairs to picnic area - stair risers are not uniform - 5", 7", and 9"	Correct riser heights on stairs to consistent height between 4" to 7", leave as is if technically infeasible	2015 ABAAS Section: 504.2  2012 TAS Section: 504.2  2010 ADAS Section: 504.2

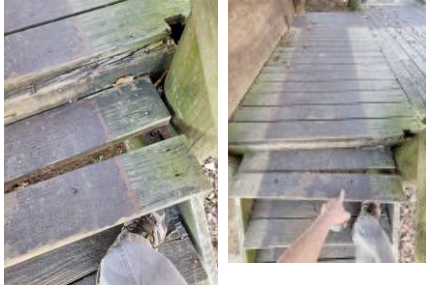
288	Piney Shores: Piney Shores Screened Shelter - 7	[30.6521452 , -95.006776 5]	Treads shall be 11 inches (280 mm) deep minimum and uniform	Stairs to picnic area - Lacks uniform depth of stair treads due to top stair tread being unsecured	Secure top tread to achieve consistent depth with remaining treads.	2015 ABAAS Section: 504.2  2012 TAS Section: 504.2  2010 ADAS Section: 504.2

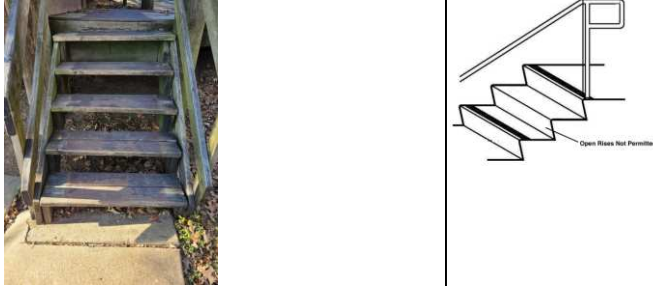
289	Piney Shores: Piney Shores Screened Shelter - 7	[30.652136, -95.006776 5]	Open risers are not permitted.	Stairs to picnic area - Lacks closed stair risers	Install kick plates on all stairs or replace with ones having closed risers	2015 ABAAS Section: 504.3  2012 TAS Section: 504.3  2010 ADAS Section: 504.3

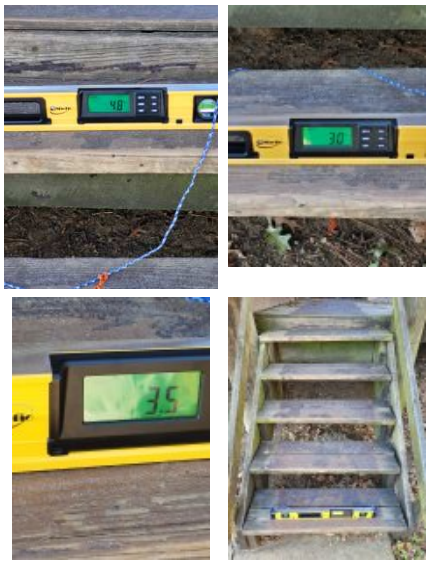
Finding Number	Area Description	Lat/Long	Finding	As Built	Recommendation	Citation	Photos	Figure
291	Piney Shores: Piney Shores Screened Shelter - 7	[30.6521291 , -95.006784 6]	The stairway treads are sloped greater than 2.08% in any direction.	Stairs to picnic area - Cross slopes range from 3% to 4.8% on treads	Correct or repair slope of tread to max 2.08% in any direction.	2015 ABAAS Section: 504.4  2012 TAS Section: 504.4  2010 ADAS Section: 403.3, 504.4

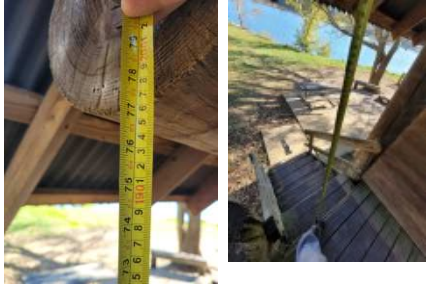
Finding Number	Area Description	Lat/Long	Finding	As Built	Recommendation	Citation	Photos	Figure
294	Piney Shores: Piney Shores Screened Shelter - 7	[30.652136, -95.006763 1]	The shelter roof extends down too close to the route of travel. Any obstruction that overhangs a route of travel must be a minimum of 80 inches above the walking surface as measured from the bottom of the obstruction.	shelter roof height 77" agl	Raise shelter roof to min 80", or pad object to prevent hazard in overhead clearance	2015 ABAAS Section: 307.3  2012 TAS Section: 307.3  2010 ADAS Section: 307.3

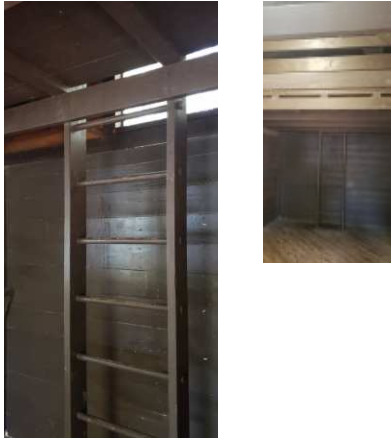
Finding Number	Area Description	Lat/Long	Finding	As Built	Recommendation	Citation	Photos	Figure
295	Piney Shores: Piney Shores Screened Shelter - 8	[30.6522456 , -95.006592 8]	There is no accessible route between elements in the building. An accessible route of travel must connect all elements and spaces within a building or facility.	loft is only accessed by ladder	Leave as is lack of route to loft and assure equivalent amenities are provided on the main level.	2015 ABAAS Section: F206.2.4  2012 TAS Section: 206.2.4  2010 ADAS Section: 206.2.4

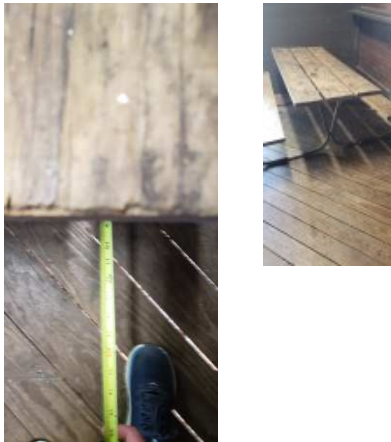
296	Piney Shores: Piney Shores Screened Shelter - 8	[30.6522629 , -95.006610 2]	Picnic tables shall provide at least one wheelchair space for each 24 linear feet (7320 mm) of usable table surface perimeter. Wheelchair spaces shall be 30 inches (760 mm) minimum by 48 inches (1220 mm) minimum. Wheelchair spaces shall be positioned for a forward approach to the table and provide knee and toe clearance complying with 306 under the table	Picnic table toe clearance 9" deep	Replace picnic table with one of an accessible design as a smart practice	2015 ABAAS Section: 1011.4.2

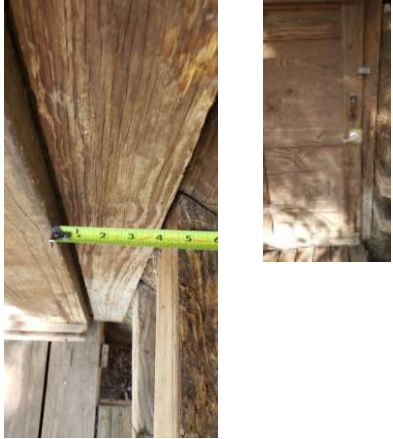
Finding Number	Area Description	Lat/Long	Finding	As Built	Recommendation	Citation	Photos	Figure
297	Piney Shores: Piney Shores Screened Shelter - 8	[30.6522814 , -95.006583 4]	Minimum maneuvering clearances at doors and gates shall comply with 404.2.4. Maneuvering clearances shall extend the full width of the doorway and the required latch side or hinge side clearance.	4" to railing on pull side of door	Provide required maneuvering clearance around pull side of door	2015 ABAAS Section: 404.2.4.1 , 404.2.4.4  2012 TAS Section: 404.2.4.4, 404.2.4.1  2010 ADAS Section: 404.2.4.4, 404.2.4.1

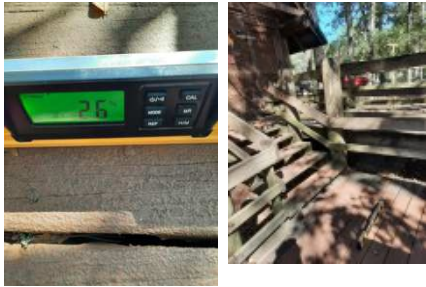
299	Piney Shores: Piney Shores Screened Shelter - 8	[30.6522906 , -95.006580 7]	The ramp on the accessible route contains cross slopes greater than 2%. Surface cross slopes shall not exceed one unit vertical in 48 units horizontal (2-percent slope).	Entry Ramp - Cross slope of 2.6%	Correct ramp cross slope to max 2.08%. Cost included in previous finding.	2015 ABAAS Section: 405.3  2012 TAS Section: 405.3  2010 ADAS Section: 405.3

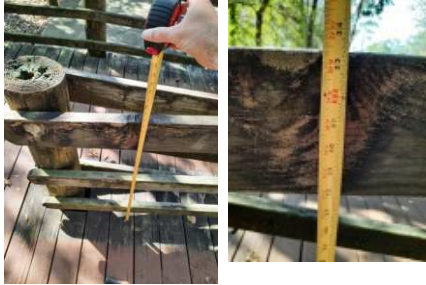
Finding Number	Area Description	Lat/Long	Finding	As Built	Recommendation	Citation	Photos	Figure
301	Piney Shores: Piney Shores Screened Shelter - 8	[30.6522756 , -95.006583 4]	The ramp does not have compliant handrails. Handrails are required on both sides of all surfaces that are sloped greater than 5 percent (1:20). Handrails must be between 34 inches and 38 inches above the ramp surface, must extend beyond the top and bottom of the ramp 12 inches and be parallel to the floor or ground surface. The diameter of the handrails must be between 1 inches and 2 inches in cross-sectional nominal dimension for circular handrails and handrail gripping surfaces with a non-circular cross section shall have a perimeter dimension of 4 inches minimum and 6 inches maximum, and a cross-section dimension of 2 inches maximum. The clear space between handrails and walls must 1-1/2 inches minimum.	Entry Ramp - lacks compliant handrails	Install handrails that are rounded and/or extend to the ground, with handrail extensions and mounted 34" to 38" aff.	2015 ABAAS Section: 505.1  2012 TAS Section: 505.1  2010 ADAS Section: 505.1

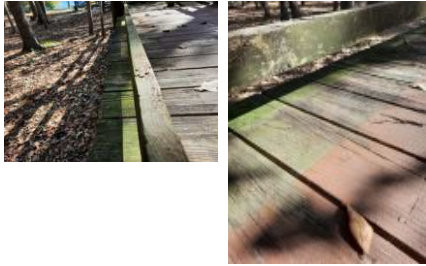
302	Piney Shores: Piney Shores Screened Shelter - 8	[30.6522883 , -95.006564 6]	The ramp run has not been provided with edge protection. The floor or ground surface of the ramp run or landing shall extend 12 inches minimum beyond the inside face of a handrail or a curb or barrier shall be provided that prevents the passage of a 4 inch diameter sphere, where any portion of the sphere is within 4 inches of the finish floor or ground surface.	Entry Ramp - Lacks edge protection	Install rail along bottom edge of ramp that prevents a 4" sphere from passing through	2015 ABAAS Section: 405.9, 405.9.1, 405.9.2  2012 TAS Section: 405.9.1, 405.9.2, 405.9  2010 ADAS Section: 405.9.2, 405.9.1, 405.9

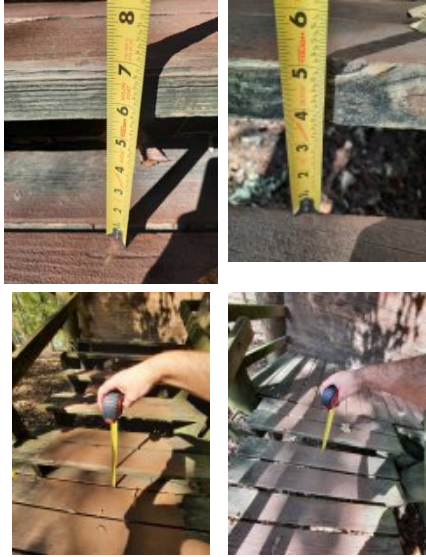
Finding Number	Area Description	Lat/Long	Finding	As Built	Recommendation	Citation	Photos	Figure
303	Piney Shores: Piney Shores Screened Shelter - 8	[30.652301, -95.006575 4]	The stair risers are not uniform in height. Stair riser heights shall be 7 inches maximum and 4 inches minimum. On any given flight of stairs, all steps shall have uniform riser height and uniform tread widths.	Two sets of stairs - lack uniform height of stair risers - vary between 5" and 7"	Correct riser heights on stairs to consistent height between 4" to 7"	2015 ABAAS Section: 504.2  2012 TAS Section: 504.2  2010 ADAS Section: 504.2

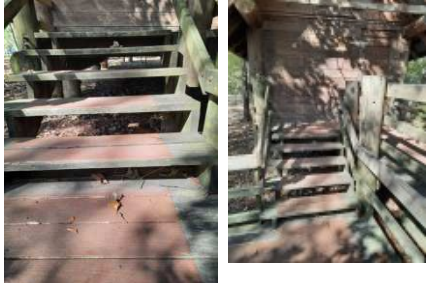
304	Piney Shores: Piney Shores Screened Shelter - 8	[30.6522883 , -95.006586 1]	Open risers are not permitted.	Two sets of stairs - lacks closed stair risers	Install kick plates on all stairs or replace with ones having closed risers	2015 ABAAS Section: 504.3  2012 TAS Section: 504.3  2010 ADAS Section: 504.3

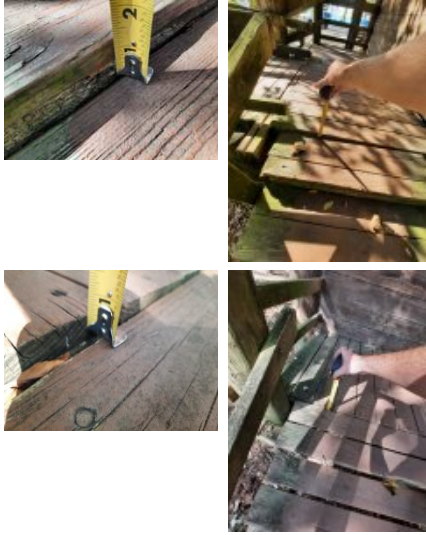
Finding Number	Area Description	Lat/Long	Finding	As Built	Recommendation	Citation	Photos	Figure
305	Piney Shores: Piney Shores Screened Shelter - 8	[30.6522906 , -95.006578]	The walkway contains abrupt vertical edges and/or variations over a 1/4 inch. 1/4 inch is the maximum vertical rise. Changes in level between 1/4 inch and 1/2 inch must be beveled at 1:2 or less. Changes in level greater than 1/2 inch must be by way of a ramp.	changes in level of between .5" and 1.5" at top of both staircases	Repair, bevel or ramp change in level along accessible route.	2012 TAS Section: 303.2, 303.3  2010 ADAS Section: 303.2, 303.3

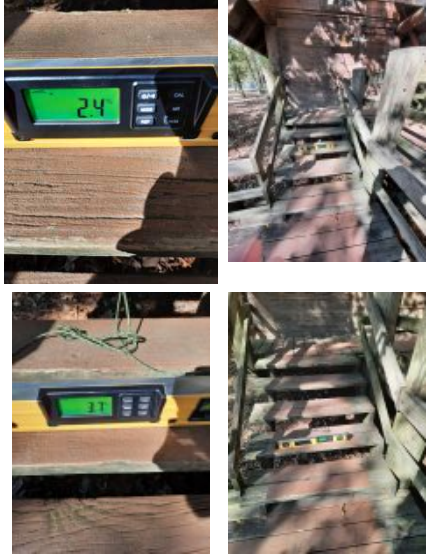
306	Piney Shores: Piney Shores Screened Shelter - 8	[30.6522883 , -95.006596 8]	The stairway treads are sloped greater than 2.08% in any direction.	Two sets of stairs - slopes of 2.4%, 3.7%, and 4.7% on stairs leading to ramp and all 6 stairs leading to woods have slopes between 4.0% and 5.2%	Correct or repair slope of tread to max 2.08% in any direction.	2015 ABAAS Section: 504.4  2012 TAS Section: 504.4  2010 ADAS Section: 403.3, 504.4

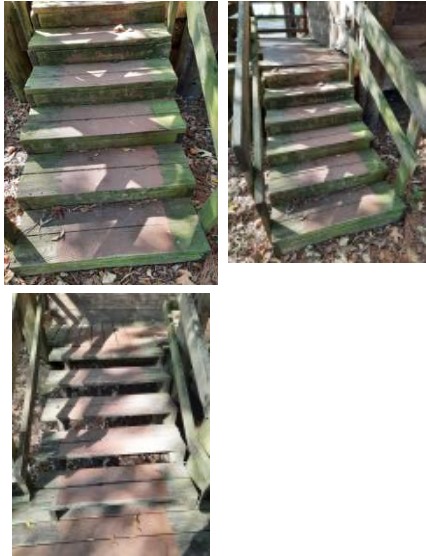
Finding Number	Area Description	Lat/Long	Finding	As Built	Recommendation	Citation	Photos	Figure
307	Piney Shores: Piney Shores Screened Shelter - 8	[30.6522871 , -95.006615 6]	The stripe on the stair tread does not contrast adequately with the stair tread. Exterior and interior stairs are recommended to have the upper approach and lower treads marked by a stripe providing clear visual contrast.	Two sets of Stairs - treadkds lack visual contrast	Install contrasting stripe along front 2" of each tread The stripe shall be a minimum of 2 inches wide to a maximum of 4 inches wide placed parallel to, and not more than 1 inch from, the nose of the step or upper approach. The stripe shall extend the full width of the step or upper approach and shall be of material that is at least as slip resistant as the other treads of the stair. A painted stripe shall be acceptable. Grooves shall not be used to satisfy this requirement.	2015 ABAAS Section: Advisory 504.4  2012 TAS Section: 504.4 Advisory  2010 ADAS Section: 504.4

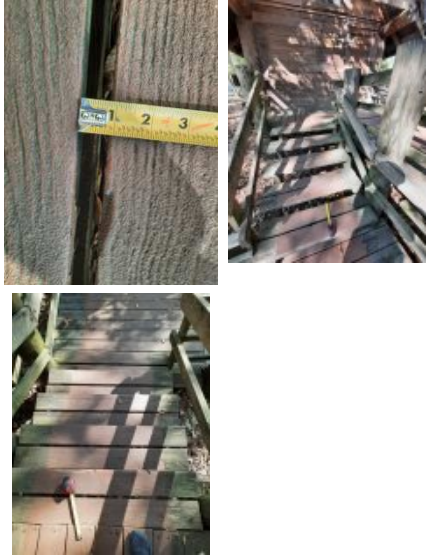
308	Piney Shores: Piney Shores Screened Shelter - 8	[30.652286, -95.006566]	Tread openings are spaced greater than 1/2 inch in the direction of travel. Openings in floor or ground surfaces shall not allow passage of a sphere more than 1/2 inch diameter. Elongated openings shall be placed so that the long dimension is perpendicular to the dominant direction of travel.	Gaps of .5" or more on 5 of 5 stairs leading to ramp	Replace tread with one having openings max .5"	2015 ABAAS Section: 302.3  2012 TAS Section: 302.3  2010 ADAS Section: 302.3

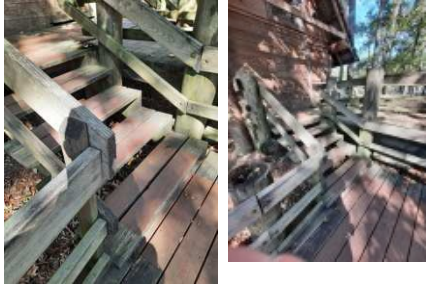
Finding Number	Area Description	Lat/Long	Finding	As Built	Recommendation	Citation	Photos	Figure
309	Piney Shores: Piney Shores Screened Shelter - 8	[30.6522871 , -95.006586 1]	Stairways must have handrails on both sides. Handrails and their extensions must be between 34 inches and 38 inches above the stair nosing or ground. The top handrails shall extend a minimum of 12 inches beyond the top nosing and shall be parallel with the floor or ground surface. At the bottom of a stair flight, handrails shall extend at the slope of the stair flight for a horizontal distance at least equal to one tread depth beyond the last riser nosing. Extension shall return to a wall, guard, or the landing surface, or shall be continuous to the handrail of an adjacent stair flight. The orientation of at least one handrail, including the extension, shall be in the direction of the run of the stair and perpendicular to the direction of the stair nosing. Handrail gripping surfaces with a circular cross section shall have an outside diameter of 1-1/4 inches minimum and 2 inches maximum. Handrail gripping surfaces with a non-circular cross section shall have a perimeter dimension of 4 inches minimum and 6 1/4 inches maximum, and a cross-section dimension of 2-1/4 inches maximum. The hand grip portion of handrails shall have a smooth surface with no sharp corners. Gripping surfaces (top or sides) shall be uninterrupted by newel posts, other construction elements or obstructions. Any wall or other surface adjacent to the handrail shall be free of sharp or abrasive elements. Handrails projecting from a wall shall have a space of 1-1/2 inches minimum between the wall and the handrail.	Two sets of Stairs - both lack compliant handrails	Install handrails on both sides of stairway, mounted 34" to 38" aff with top and bottom extensions and having a 1.25" – 2" in diameter, or a non-circular grip that has a perimeter dimension of 4"- 6.25" max with a min gap of 1.5" between handrail and wall	2015 ABAAS Section: 505.2  2012 TAS Section: 505.2  2010 ADAS Section: 505.2

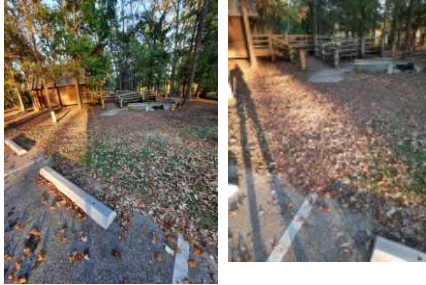
Finding Number	Area Description	Lat/Long	Finding	As Built	Recommendation	Citation	Photos	Figure
310	Piney Shores: Piney Shores Screened Shelter - 8	[30.6522958 , -95.006600 6]	An accessible access route is not provided between elements, spaces and the facilities provided within the accessible camping unit. At least one outdoor recreation access route shall connect accessible elements, spaces and facilities provided within camping units with mobility features.	Lacks accessible route to Shelter 8	Create AR with crushed and compacted stone or similar outdoor material to camp shelter.	2015 ABAAS Section: F244.5.1

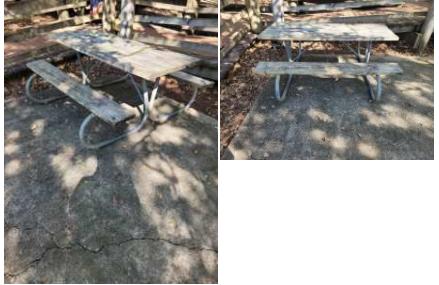
Finding Number	Area Description	Lat/Long	Finding	As Built	Recommendation	Citation	Photos	Figure
312	Piney Shores: Piney Shores Screened Shelter - 8	[30.6522941 , -95.006592 8]	Picnic tables shall provide at least one wheelchair space for each 24 linear feet (7320 mm) of usable table surface perimeter. Wheelchair spaces shall be 30 inches (760 mm) minimum by 48 inches (1220 mm) minimum. Wheelchair spaces shall be positioned for a forward approach to the table and provide knee and toe clearance complying with 306 under the table	Lacks picnic table of accessible design	Replace picnic table with one of an accessible design as a smart practice	2015 ABAAS Section: 1011.4.2

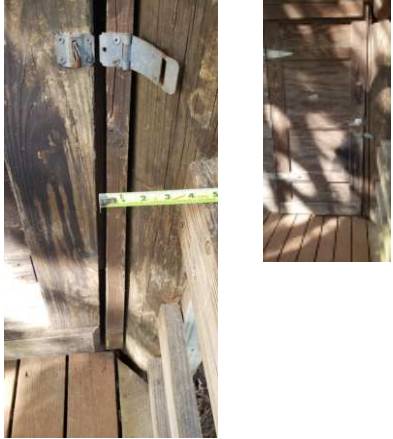
Finding Number	Area Description	Lat/Long	Finding	As Built	Recommendation	Citation	Photos	Figure
317	Piney Shores: Piney Shores Screened Shelter - 9	[30.6521718 , -95.006395 6]	Minimum maneuvering clearances at doors and gates shall comply with 404.2.4. Maneuvering clearances shall extend the full width of the doorway and the required latch side or hinge side clearance.	4" to railing on pull side of door	Provide required maneuvering clearance around pull side of door.	2015 ABAAS Section: 404.2.4.1 , 404.2.4.4  2012 TAS Section: 404.2.4.4, 404.2.4.1  2010 ADAS Section: 404.2.4.4, 404.2.4.1

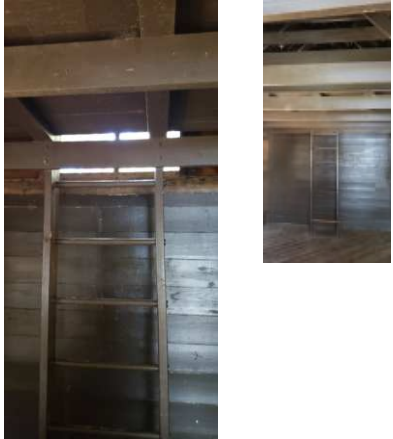
318	Piney Shores: Piney Shores Screened Shelter - 9	[30.6521522 , -95.006405]	There is no accessible route between elements in the building. An accessible route of travel must connect all elements and spaces within a building or facility.	loft is only accessed by ladder	Leave as is lack of route to loft and assure equivalent amenities are provided on the main level.	2015 ABAAS Section: F206.2.4  2012 TAS Section: 206.2.4  2010 ADAS Section: 206.2.4

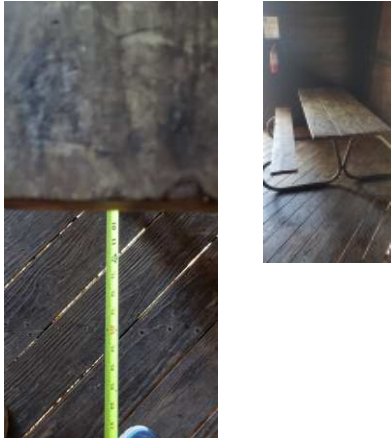
Finding Number	Area Description	Lat/Long	Finding	As Built	Recommendation	Citation	Photos	Figure
319	Piney Shores: Piney Shores Screened Shelter - 9	[30.6521522 , -95.006398 3]	Picnic tables shall provide at least one wheelchair space for each 24 linear feet (7320 mm) of usable table surface perimeter. Wheelchair spaces shall be 30 inches (760 mm) minimum by 48 inches (1220 mm) minimum. Wheelchair spaces shall be positioned for a forward approach to the table and provide knee and toe clearance complying with 306 under the table	Picnic table toe clearance 9" deep	Replace picnic table with one of an accessible design as a smart practice	2015 ABAAS Section: 1011.4.2

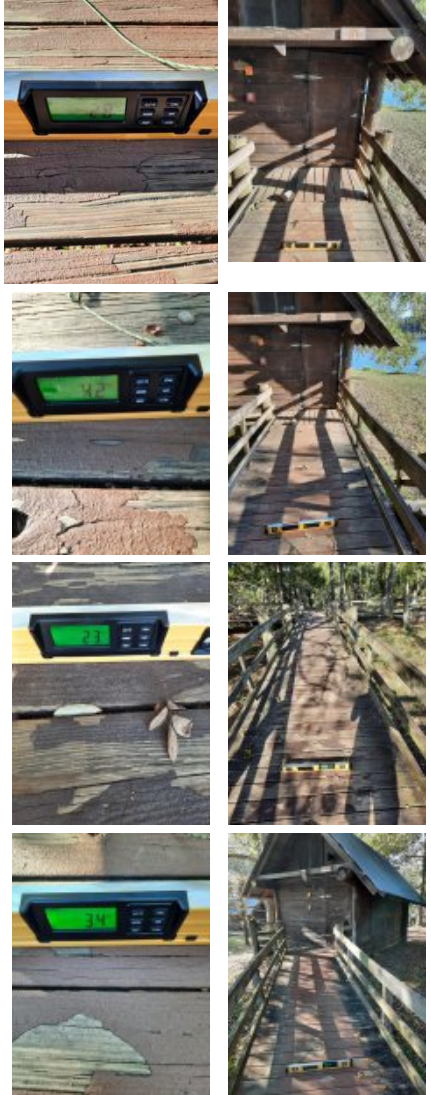
Finding Number	Area Description	Lat/Long	Finding	As Built	Recommendation	Citation	Photos	Figure
321	Piney Shores: Piney Shores Screened Shelter - 9	[30.6521672 , -95.006405]	The ramp on the accessible route contains cross slopes greater than 2%. Surface cross slopes shall not exceed one unit vertical in 48 units horizontal (2-percent slope).	Entry Ramp - cross slopes of 2.8%, 4.2%, 2.3%, 3.4%, 9.0%, and 4.9%	Correct ramp cross slope to max 2.08%. Cost included in previous finding.	2015 ABAAS Section: 405.3  2012 TAS Section: 405.3  2010 ADAS Section: 405.3
