# Access Audit Site Report

Prepared By  
**WT Group**

**Lake Livingston State Park**  
**300 State Park Rd 65**  
**Livingston, TX 77351**  
**Accessibility Evaluation**  
**Inspection Date: 11/08/2021**  
**Inspectors: Tanya Scheibe**

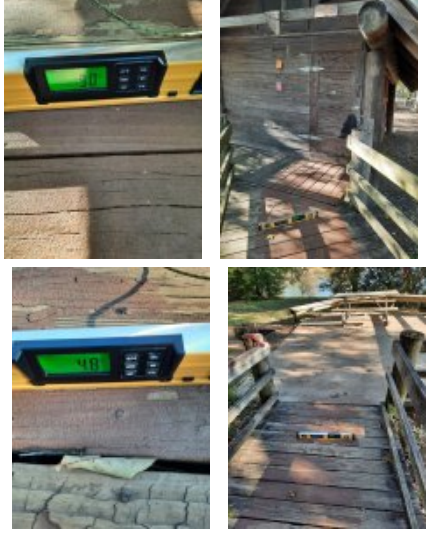
322	Piney Shores: Piney Shores Screened Shelter - 9	[30.6521672 , -95.0064037]	The landing at the bottom of the ramp has a slope greater than 2%. Bottom landings shall have a dimension in the direction of ramp run of not less than 60 inches and have a slope of less than 2% in any direction.	Entry Ramp - 4 ramp landings have slopes of 3.0%, 4.7%, 3.1%, 2.1%	Correct ramp landing slope to max 2.08%.	<p>2015 ABAAS Section: 405.7.1, 405.7.1 EXCEPTION</p> <p>2012 TAS Section: 405.7.1, 405.7.1 Exception</p> <p>2010 ADAS Section: 405.7.1, 405.7.1 Exception</p>

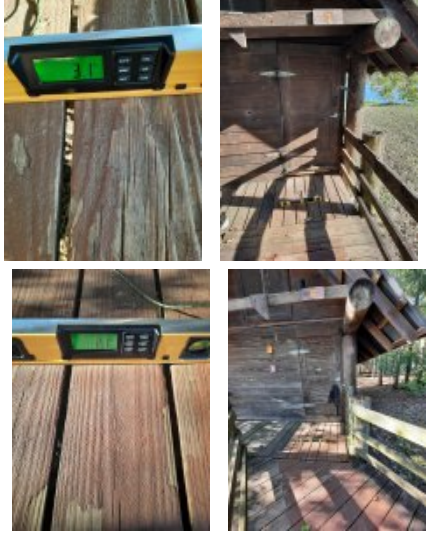
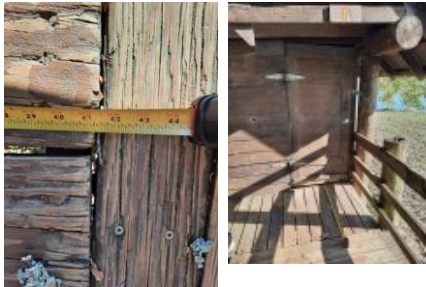
323	Piney Shores: Piney Shores Screened Shelter - 9	[30.6521683 , -95.006411 7]	The landing is not the correct length. Landings shall have a dimension in the direction of ramp run of not less than 60 inches.	Entry Ramp - Ramp leading to Shelter 10 lacks a bottom landing that is 60" deep and as wide as the ramp	Enlarge landing to be 60" deep and as wide as the ramp.	2015 ABAAS Section: 405.7.3  2012 TAS Section: 405.7.3  2010 ADAS Section: 405.7.3

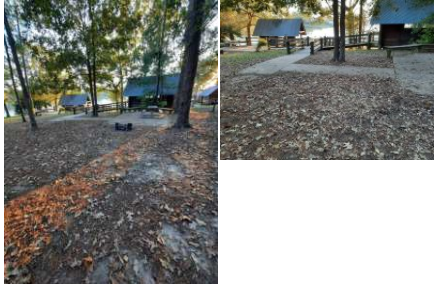
Finding Number	Area Description	Lat/Long	Finding	As Built	Recommendation	Citation	Photos	Figure
326	Piney Shores: Piney Shores Screened Shelter - 9	[30.6521712 , -95.006409 9]	An accessible access route is not provided between elements, spaces and the facilities provided within the accessible camping unit. At least one outdoor recreation access route shall connect accessible elements, spaces and facilities provided within camping units with mobility features.	Lacks accessible route to Shelter 9	Create AR with crushed and compacted stone or similar outdoor material to camp shelter as a smart practice.	2015 ABAAS Section: F244.5.1

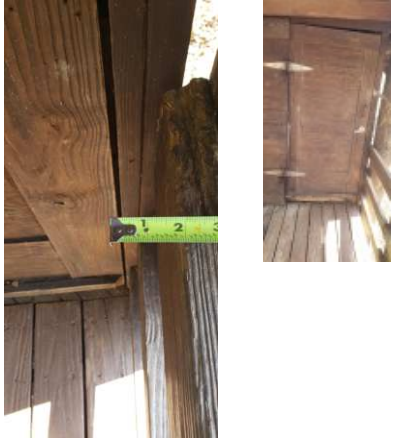
Finding Number	Area Description	Lat/Long	Finding	As Built	Recommendation	Citation	Photos	Figure
329	Piney Shores: Piney Shores Screened Shelter - 10	[30.6520183 , -95.006456]	Minimum maneuvering clearances at doors and gates shall comply with 404.2.4. Maneuvering clearances shall extend the full width of the doorway and the required latch side or hinge side clearance.	3" to railing on pull side of door	Provide required maneuvering clearance around pull side of door	2015 ABAAS Section: 404.2.4.1 , 404.2.4.4  2012 TAS Section: 404.2.4.4, 404.2.4.1  2010 ADAS Section: 404.2.4.4, 404.2.4.1

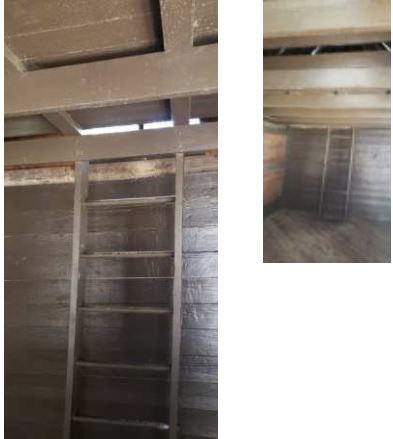
330	Piney Shores: Piney Shores Screened Shelter - 10	[30.6520137 , -95.006445 3]	There is no accessible route between elements in the building. An accessible route of travel must connect all elements and spaces within a building or facility.	loft is only accessed by ladder	Leave as is lack of route to loft and assure equivalent amenities are provided on the main level.	2015 ABAAS Section: F206.2.4  2012 TAS Section: 206.2.4  2010 ADAS Section: 206.2.4

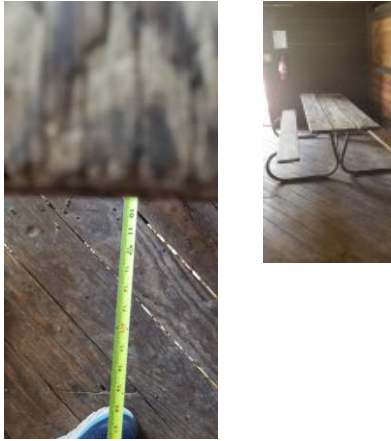
Finding Number	Area Description	Lat/Long	Finding	As Built	Recommendation	Citation	Photos	Figure
331	Piney Shores: Piney Shores Screened Shelter - 10	[30.6520183 , -95.006441 2]	Picnic tables shall provide at least one wheelchair space for each 24 linear feet (7320 mm) of usable table surface perimeter. Wheelchair spaces shall be 30 inches (760 mm) minimum by 48 inches (1220 mm) minimum. Wheelchair spaces shall be positioned for a forward approach to the table and provide knee and toe clearance complying with 306 under the table	Picnic table toe clearance 9" deep	Replace picnic table with one of an accessible design as a smart practice	2015 ABAAS Section: 1011.4.2

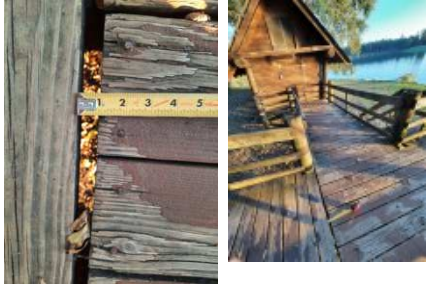
333	Piney Shores: Piney Shores Screened Shelter - 10	[30.6520206 , -95.006452]	There is a gap spaced greater than a 1/2 inch. Openings in floor or ground surfaces shall not allow passage of a sphere more than 1/2 inch diameter. Elongated openings shall be placed so that the long dimension is perpendicular to the dominant direction of travel.	Gaps of 1", 5.5", 1", 2", and 1.25"	Correct or fill gaps to be max .5"	2015 ABAAS Section: 302.3  2012 TAS Section: 302.3  2010 ADAS Section: 302.3

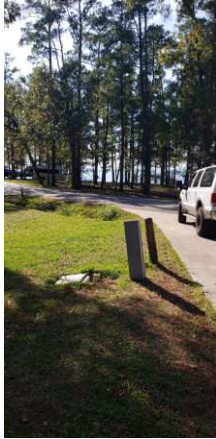
Finding Number	Area Description	Lat/Long	Finding	As Built	Recommendation	Citation	Photos	Figure
334	Piney Shores: Site 55	[30.6548611 , -95.006642 4]	An accessible access route is not provided between elements, spaces and the facilities provided within the accessible camping unit. At least one outdoor recreation access route shall connect accessible elements, spaces and facilities provided within camping units with mobility features.	Lacks route to restrooms	Create AR with crushed and compacted stone or similar outdoor material to camp sites and one of each type of amenity.	2015 ABAAS Section: F244.5.1

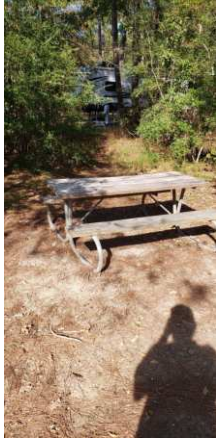
335	Piney Shores: Site 55	[30.654898, -95.006543 2]	Picnic tables shall provide at least one wheelchair space for each 24 linear feet (7320 mm) of usable table surface perimeter. Wheelchair spaces shall be 30 inches (760 mm) minimum by 48 inches (1220 mm) minimum. Wheelchair spaces shall be positioned for a forward approach to the table and provide knee and toe clearance complying with 306 under the table	Lacks picnic table of accessible design	Replace picnic table with one of an accessible design as a smart practice	2015 ABAAS Section: 1011.4.2

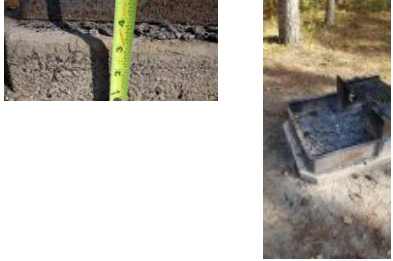
336	Piney Shores: Site 55	[30.6549014 , -95.006559 3]	Fire building surfaces shall be 9 inches (230 mm) minimum above the ground.	Fire building surface lacks 3" above surrounding ground level	Correct fire building surface to be 9" min above the ground as a smart practice. In the alternative, replace fire ring with a compliant accessible fire ring.	2015 ABAAS Section: 1011.5.1

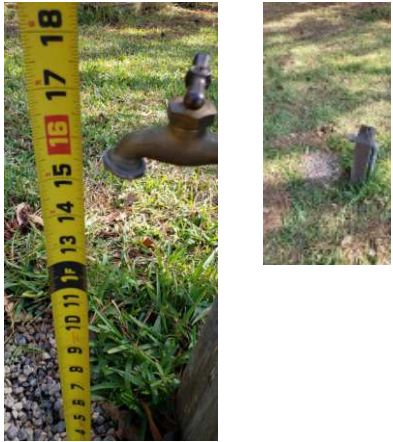
338	Piney Shores: Site 55	[30.6548888, -95.006586 1]	Water spouts at water hydrants and water utility hook-ups shall be 28 inches (710 mm) minimum and 36 inches (915 mm) maximum above the ground	Water spout is 15" above ground level	Remount water spouts to 28" min or 36" max above the ground as a smart practice	2015 ABAAS Section: 1011.6

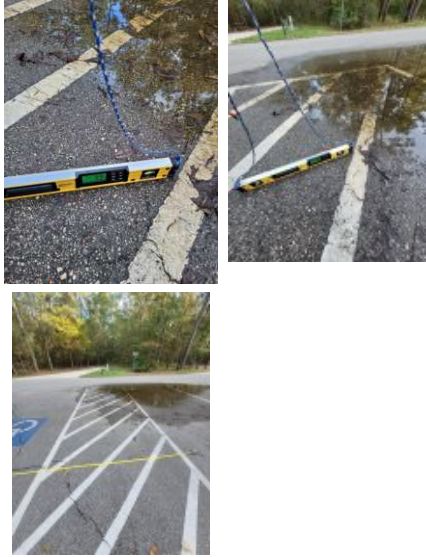
Finding Number	Area Description	Lat/Long	Finding	As Built	Recommendation	Citation	Photos	Figure
339	Red Oak: Red Oak Restroom Parking	[30.6543223 , -95.006072 4]	The cross slopes (narrow dimension) and/or running slopes (long dimension) of the access aisle exceeds 2%. The running slope and the cross slope in an accessible parking stall and the access aisle must not exceed 2%.	Slope of 3% in access aisle	Repair or correct slope of parking space and access aisle to max 2.08% in any direction	2015 ABAAS Section: 502.4  2012 TAS Section: 502.4  2010 ADAS Section: 502.4

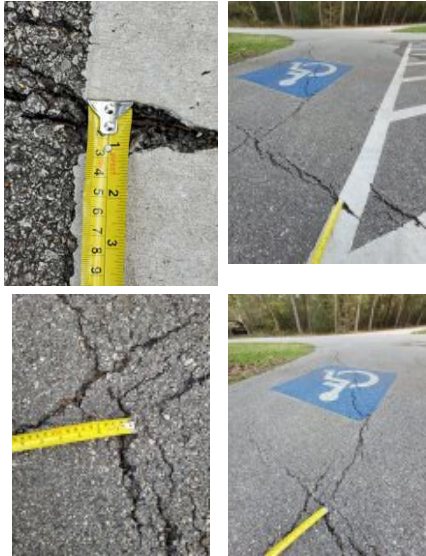
340	Red Oak: Red Oak Restroom Parking	[30.6543269 , -95.006063]	The parking stall contains abrupt edges and surface irregularities over a 1/4 inch vertical. Parking spaces and access aisles serving them shall be stable, firm, and slip resistant. Access aisles shall be at the same level as the parking spaces they serve. Changes in level are not permitted and shall not be sloped steeper than 2% in any direction.	Multiple gaps of 1" in stall and access aisle	Resurface stalls and access aisles to eliminate gaps and cracks	2015 ABAAS Section: 502.4  2012 TAS Section: 502.4  2010 ADAS Section: 502.4

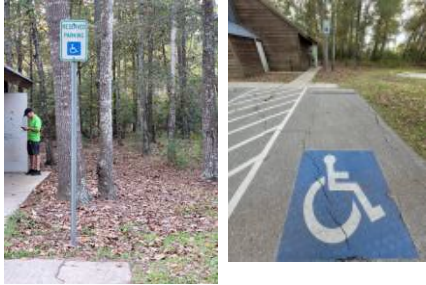
Finding Number	Area Description	Lat/Long	Finding	As Built	Recommendation	Citation	Photos	Figure
341	Red Oak: Red Oak Restroom Parking	[30.6543223, -95.0060698]	The van stall is missing a sign identifying it as a van accessible stall. Parking space identification signs shall include the International Symbol of Accessibility. Signs identifying van parking spaces shall contain the designation "van accessible."	The van stall is missing a sign identifying it as a van accessible stall	Add one van parking sign to van accessible stall and ensure stall and access aisle are 11' and 5' or 8' and 8'	2015 ABAAS Section: 502.6 2012 TAA Section: 502.6 2010 ADA Section: 502.6

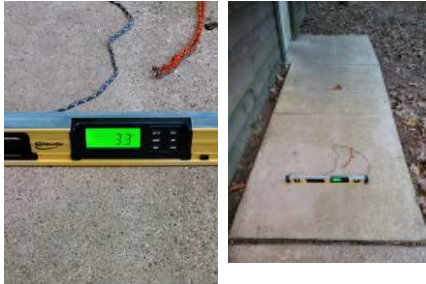
342	Red Oak: Red Oak Restroom Exterior Accessible Route	[30.65421, -95.00616]	The accessible route contains cross slopes greater than 2%. Cross slopes shall not exceed one unit vertical in 48 units horizontal (2-percent slope).	Cross slope of 3.3% slope at women's restroom entry and 4.2% near drinking fountain	Correct or repair cross slope along AR to max 2.08%	2015 ABAAS Section: 403.3 2012 TAA Section: 403.3 2010 ADA Section: 403.3

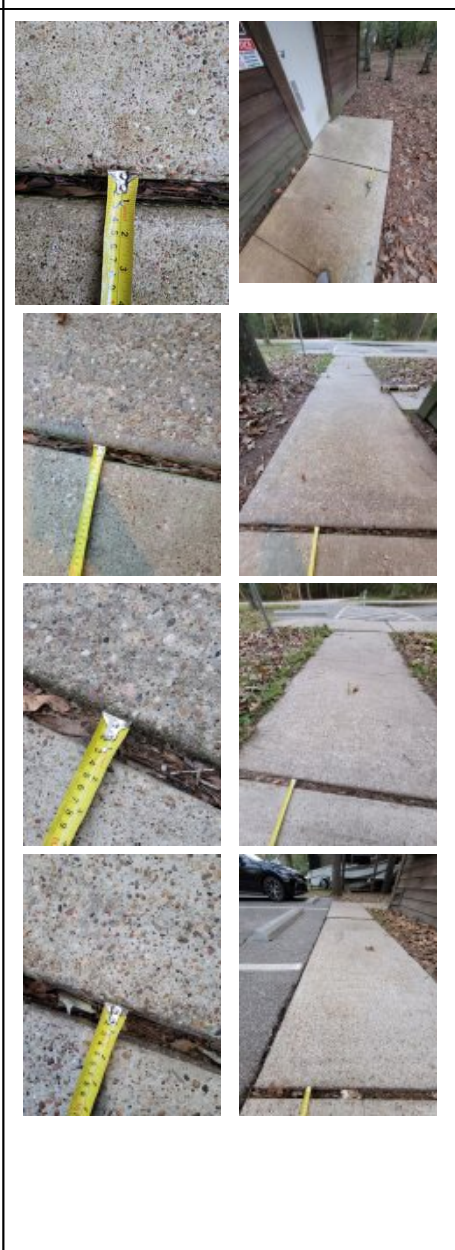
Finding Number	Area Description	Lat/Long	Finding	As Built	Recommendation	Citation	Photos	Figure
343	Red Oak: Red Oak Restroom Exterior Accessible Route	[30.65421, -95.00616]	There is a gap spaced greater than a 1/2 inch. Openings in floor or ground surfaces shall not allow passage of a sphere more than 1/2 inch diameter. Elongated openings shall be placed so that the long dimension is perpendicular to the dominant direction of travel.	Multiple gaps (6) of 1"	Correct or fill gaps to be max .5"	2015 ABAAS Section: 302.3 2012 TAS Section: 302.3 2010 ADAS Section: 302.3

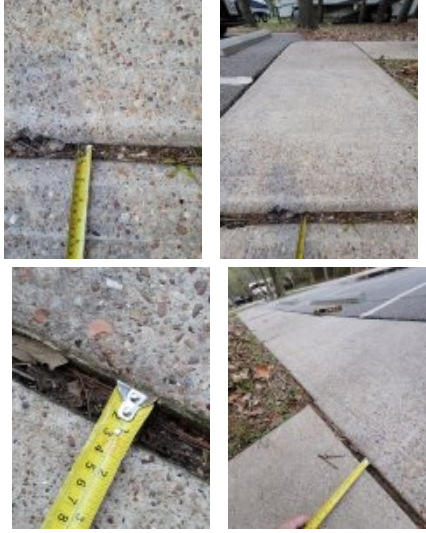
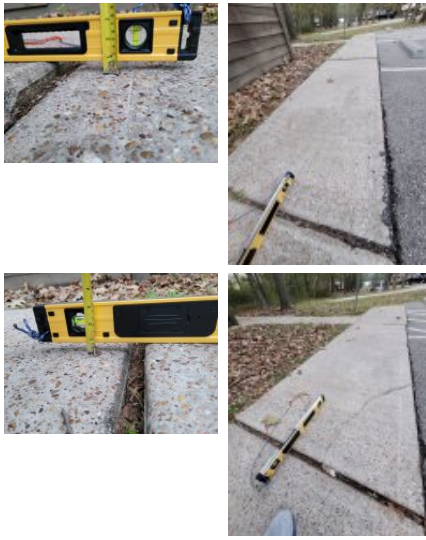
344	Red Oak: Red Oak Restroom Exterior Accessible Route	[30.6542181, -95.0061627]	The walkway contains abrupt vertical edges and/or variations over a 1/4 inch. 1/4 inch is the maximum vertical rise. Changes in level between 1/4 inch and 1/2 inch must be beveled at 1:2 or less. Changes in level greater than 1/2 inch must be by way of a ramp.	Multiple CILs (2) of .75" on accessible route and 1" near drinking fountain	Repair, bevel or ramp CIL along AR	2012 TAS Section: 303.2, 303.3  2010 ADAS Section: 303.2, 303.3

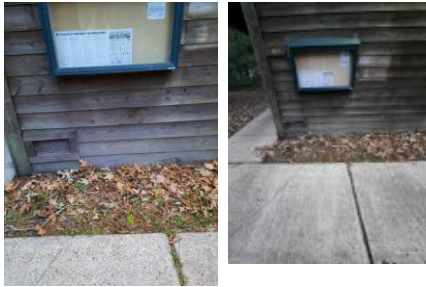
346	Red Oak: Red Oak Restroom Exterior Accessible Route	[30.6543207, -95.0062109]	There is no accessible route to the informational sign. At least one accessible route shall connect accessible buildings, accessible facilities, accessible elements, and accessible spaces that are on the same site.	Lacks accessible route to informational sign	Create an accessible route with crushed stone or other outdoor material from parking or walkway to informational sign	2015 ABAAS Section: F206.2.2  2012 TAS Section: 206.2.2  2010 ADAS Section: 206.2.2

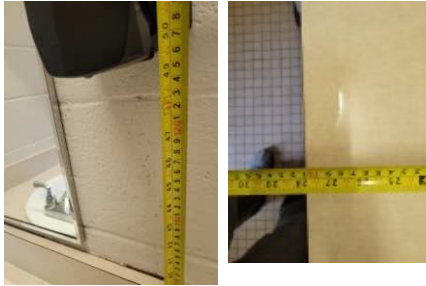
Finding Number	Area Description	Lat/Long	Finding	As Built	Recommendation	Citation	Photos	Figure
351	Red Oak: Red Oak Men's Restroom	[30.6542992 , -95.0062468]	Where a high forward reach is over an obstruction, the clear floor space shall extend beneath the element for a distance not less than the required reach depth over the obstruction. The high forward reach shall be 48 inches (1220 mm) maximum where the reach depth is 20 inches (510 mm) maximum. Where the reach depth exceeds 20 inches (510 mm), the high forward reach shall be 44 inches (1120 mm) maximum and the reach depth shall be 25 inches (635 mm) maximum. Where a clear floor or ground space allows a parallel approach to an element and the high side reach is over an obstruction, the height of the obstruction shall be 34 inches (865 mm) maximum and the depth of the obstruction shall be 24 inches (610 mm) maximum. The high side reach shall be 48 inches (1220 mm) maximum for a reach depth of 10 inches (255 mm) maximum. Where the reach depth exceeds 10 inches (255 mm), the high side reach shall be 46 inches (1170 mm) maximum for a reach depth of 24 inches (610 mm) maximum.	Soap dispenser at 49.5" aff and is obstructed by a 28" deep sink counter	Lower soap to max 44" above the finished floor (AFF) for a forward reach over counter.	2015 ABAAS Section: 308.2.1, 308.3.2  2012 TAS Section: 308.2.1, 308.3.2  2010 ADAS Section: 308.2.1, 308.3.2

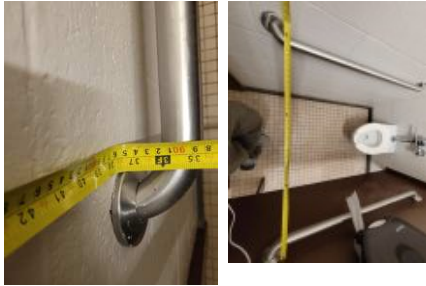
Finding Number	Area Description	Lat/Long	Finding	As Built	Recommendation	Citation	Photos	Figure
353	Red Oak: Red Oak Men's Restroom	[30.6543096 , -95.006225 3]	The ambulatory stall is not between 35" to 37" wide and 60" deep.	Ambulatory stall 37.5" wide	Correct ambulatory stall to be 35" to 37" wide and minimum 60" deep, or leave as is and use to create required wheelchair stall.	2015 ABAAS Section: 604.8.2.1  2012 TAS Section: 604.8.2.1  2010 ADAS Section: 604.8.2.1

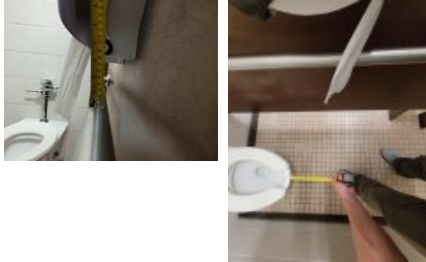
355	Red Oak: Red Oak Men's Restroom	[30.6543315 , -95.006253 5]	The grab bar height and/or spacing fails. Grab bars must be mounted between 33" and 36" to the top of the gripping surface. There must be 1.5" of clearance between the grab bar and the wall. There must be a minimum of 1.5" of clearance below and minimum 12" above the grab bar to any dispenser or other obstruction.	TP 3" above side grab bar and too far from toilet	Remount toilet paper dispenser max 7" to 9" from front of toilet, 15" to 48" aff and min 12" above or 1.5" below grab bar	2015 ABAAS Section: 609.3, 609.4  2012 TAS Section: 609.4, 609.3  2010 ADAS Section: 609.3, 609.4

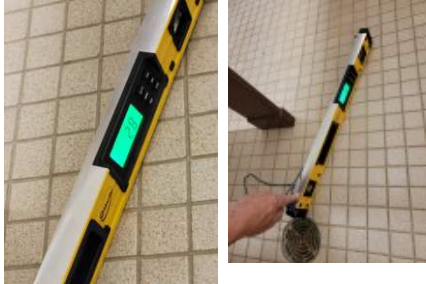
357	Red Oak: Red Oak Men's Restroom	[30.6543154 , -95.006245 4]	The accessible route contains running slopes greater than 5 percent and cross slopes greater than 2 percent across the width of the walk and has not been constructed as a ramp (i.e. handrails, wheel guides, etc.). When the slope in the direction of travel of any walk exceeds 1 unit vertical in 20 units horizontal (5-percent slope), it must be constructed as ramp. Surface cross slopes must not exceed one unit vertical in 48 units. Horizontal (2-percent slope).	Slope of 2.8% near floor drain	Correct or repair slope to max 5% running and 2.08% cross	2015 ABAAS Section: 403.3 2012 TAS Section: 403.3 2010 ADAS Section: 403.3

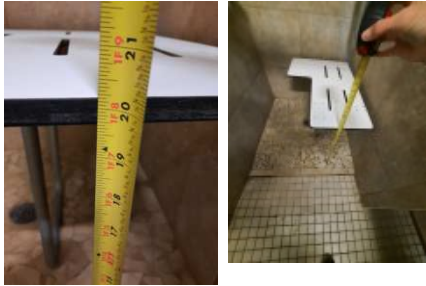
Finding Number	Area Description	Lat/Long	Finding	As Built	Recommendation	Citation	Photos	Figure
363	Red Oak: Red Oak Men's Shower	[30.6543258 , -95.0062508]	The shower seat height is noncompliant. A seat in a standard roll-in shower compartment shall be a folding type, shall be installed on the side wall adjacent to the controls, and shall extend from the back wall to a point within 3 inches of the compartment entry. A seat in an alternate roll-in type shower compartment shall be a folding type, shall be installed on the front wall opposite the back wall, and shall extend from the adjacent side wall to a point within 3 inches of the compartment entry. The top of the seat shall be 17 inches minimum and 19 inches maximum above the bathroom finish floor.	The shower seat mounted at 20.25" aff	Remount shower seat to b 17" to 19" aff.	2015 ABAAS Section: 610.3 2012 TAS Section: 610.3 2010 ADAS Section: 610.3

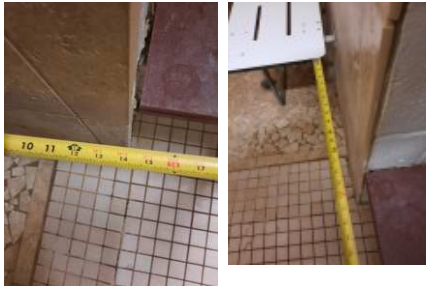
364	Red Oak: Red Oak Men's Shower	[30.6543304 , -95.0062521]	The shower seat height is noncompliant. A seat in a standard roll-in shower compartment shall be a folding type, shall be installed on the side wall adjacent to the controls, and shall extend from the back wall to a point within 3 inches of the compartment entry. A seat in an alternate roll-in type shower compartment shall be a folding type, shall be installed on the front wall opposite the back wall, and shall extend from the adjacent side wall to a point within 3 inches of the compartment entry. The top of the seat shall be 17 inches minimum and 19 inches maximum above the bathroom finish floor.	The shower seat 14" from compartment entry	Remount shower bench so that the front edge is within 3" of the opening.	2015 ABAAS Section: 610.3 2012 TAS Section: 610.3 2010 ADAS Section: 610.3

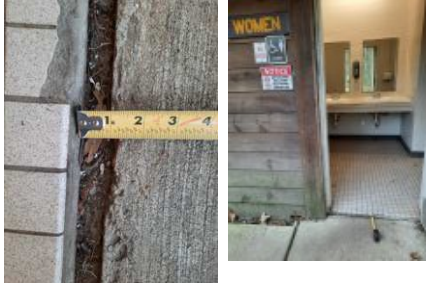
365	Red Oak: Red Oak Women's Restroom	[30.6543338 , -95.0062602]	The threshold has a gap greater than 1/2 inch wide. Exterior doors are recommended to be maintained at 8.5 lbf as a smart practice. Force is to be measured at the operating hardware or 30 inches from the hinges, whichever is greater.	Door - gap of 1" at the doorway, 10# push	For all doors along the public circulation route, fill gaps at door entries to max .5". For all doors along the public circulation route, inspect, adjust, and maintain 8.5 lbf to open exterior doors as a smart practice.	2010 ADAS Section: 404.2.3, 404.2.7, 404.2.4, 404.2.11, 404.2.11 Exception

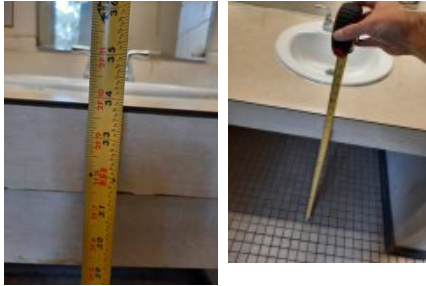
Finding Number	Area Description	Lat/Long	Finding	As Built	Recommendation	Citation	Photos	Figure
366	Red Oak: Red Oak Women's Restroom	[30.6543211 , -95.006252 1]	The top rim of the sink is too high. All lavatories/sinks that are designated to be accessible shall be a minimum 17 inches in horizontal depth and mounted with the rim or counter edge no higher than 34 inches above the finished floor.	The top rim of the sink is 34.25" aff	Lower sinks to max 34" aff to front of rim, in the alternative, leave as is citing construction tolerance.	2015 ABAAS Section: 606.3  2012 TAS Section: 606.3  2010 ADAS Section: 606.3

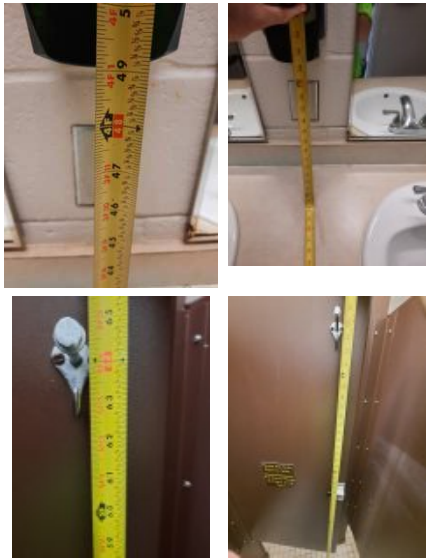
367	Red Oak: Red Oak Women's Restroom	[30.6543131 , -95.006237 4]	Where a high forward reach is over an obstruction, the clear floor space shall extend beneath the element for a distance not less than the required reach depth over the obstruction. The high forward reach shall be 48 inches (1220 mm) maximum where the reach depth is 20 inches (510 mm) maximum. Where the reach depth exceeds 20 inches (510 mm), the high forward reach shall be 44 inches (1120 mm) maximum and the reach depth shall be 25 inches (635 mm) maximum. Where a clear floor or ground space allows a parallel approach to an element and the high side reach is over an obstruction, the height of the obstruction shall be 34 inches (865 mm) maximum and the depth of the obstruction shall be 24 inches (610 mm) maximum. The high side reach shall be 48 inches (1220 mm) maximum for a reach depth of 10 inches (255 mm) maximum. Where the reach depth exceeds 10 inches (255 mm), the high side reach shall be 46 inches (1170 mm) maximum for a reach depth of 24 inches (610 mm) maximum.	Soap dispenser 49" aff and coat hook 63.25"	Lower hook to max 48" above the finished floor (AFF) to highest operable part. Lower soap to max 44" above the finished floor (AFF) for a forward reach over counter.	2015 ABAAS Section: 308.2.1, 308.3.2  2012 TAS Section: 308.2.1, 308.3.2  2010 ADAS Section: 308.2.1, 308.3.2

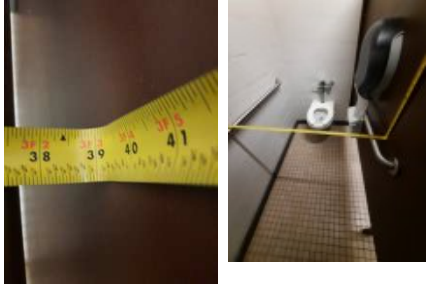
Finding Number	Area Description	Lat/Long	Finding	As Built	Recommendation	Citation	Photos	Figure
368	Red Oak: Red Oak Women's Restroom	[30.6543281 , -95.006244 1]	There are not enough accessible toilet compartments. The room contains 2 toilet compartments. A minimum of 1 must be wheelchair accessible .	Lacks wheelchair accessible stall, ambulatory only	Create a wheelchair accessible stall with grab bars and fixtures mounted in correct locations and at correct heights.	2015 ABAAS Section: F213.3.1  2012 TAS Section: 213.3.1  2010 ADAS Section: 213.3.1

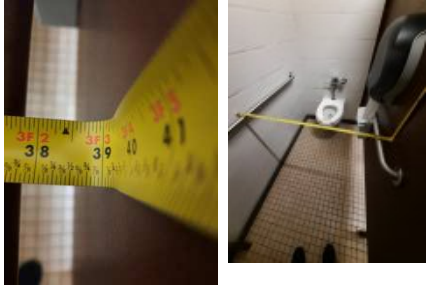
369	Red Oak: Red Oak Women's Restroom	[30.6543154 , -95.006252 1]	The ambulatory stall is not between 35" to 37" wide and 60" deep.	ambulatory stall 39" wide	Correct ambulatory stall to be 35" to 37" wide and minimum 60" deep, in the alternative, use existing stall to create required wheelchair stall.	2015 ABAAS Section: 604.8.2.1  2012 TAS Section: 604.8.2.1  2010 ADAS Section: 604.8.2.1

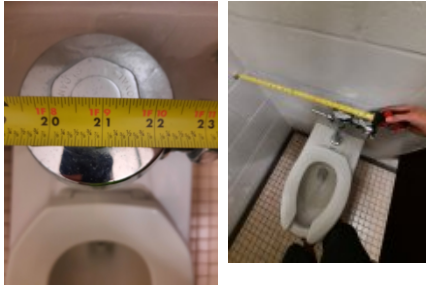
Finding Number	Area Description	Lat/Long	Finding	As Built	Recommendation	Citation	Photos	Figure
370	Red Oak: Red Oak Women's Restroom	[30.65432, -95.006241 4]	The toilet is not located within the range to the side wall or partition. The centerline of the toilet shall be 17 inches minimum and 19 inches maximum side wall or partition in the ambulatory accessible toilet compartment.	Centerline of the toilet is 21" from the side wall	Remount toilet to 17" to 19" from the side wall to center line in ambulatory stalls or 16" to 18" in new wheelchair stall.	2015 ABAAS Section: 604.9.1  2012 TAS Section: 604.9.1  2010 ADAS Section: 604.9.1

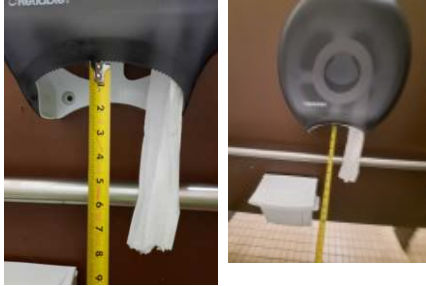
371	Red Oak: Red Oak Women's Restroom	[30.6543165, -95.006245 4]	The grab bar height and/or spacing fails. Grab bars must be mounted between 33" and 36" to the top of the gripping surface. There must be 1.5" of clearance between the grab bar and the wall. There must be a minimum of 1.5" of clearance below and minimum 12" above the grab bar to any dispenser or other obstruction.	TP 5" above grab bar	Remount toilet paper dispenser max 7" to 9" from front of toilet, 15" to 48" aff and min 12" above or 1.5" below grab bar.	2015 ABAAS Section: 609.3, 609.4  2012 TAS Section: 609.4, 609.3  2010 ADAS Section: 609.3, 609.4

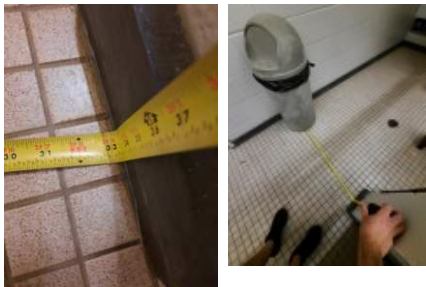
372	Red Oak: Red Oak Women's Restroom	[30.65432, -95.006241 4]	The route of travel at this location does not provide a minimum width of 36 inches. The clear width shall be permitted to be reduced to 32 inches minimum for a length of 24 inches maximum provided that reduced width segments are separated by segments that are 48 inches long minimum and 36 inches wide minimum.	33.25" between garbage can and wall	Relocate obstacles to create AR through restroom.	2015 ABAAS Section: 403.5.1  2012 TAS Section: 403.5.1  2010 ADAS Section: 403.5.1

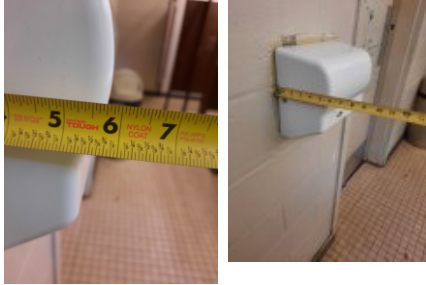
Finding Number	Area Description	Lat/Long	Finding	As Built	Recommendation	Citation	Photos	Figure
373	Red Oak: Red Oak Women's Restroom	[30.6543165 , -95.006234 7]	The hand dryer projects more than 4 inches into the circulation path. Wall-mounted objects that have leading edges between 27 inches and 80 inches from the floor must not project more than 4 inches into the circulation path. Protruding objects that extend to the floor or within 27 inches of the floor are cane detectable and are therefore not hazardous. Where it is necessary or desirable to have objects protrude from the wall, a manner of cane detection must be provided.	Hand dryer protrudes 5.75"	Relocate protruding objects or place cane detectable warning or bollard at foot of item.	2015 ABAAS Section: 307.2  2012 TAS Section: 307.2  2010 ADAS Section: 307.2

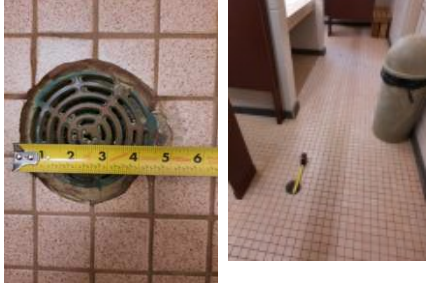
374	Red Oak: Red Oak Women's Restroom	[30.6543338 , -95.006242 8]	Openings in floor or ground surfaces shall not allow passage of a sphere more than 1/2 inch (13 mm) diameter except as allowed in 407.4.3, 409.4.3, 410.4, 810.5.3 and 810.10. Elongated openings shall be placed so that the long dimension is perpendicular to the dominant direction of travel.	Gap of 5" at floor drain	Fill and maintain gaps to max .5"	2015 ABAAS Section: 302.3  2012 TAS Section: 302.3  2010 ADAS Section: 302.3

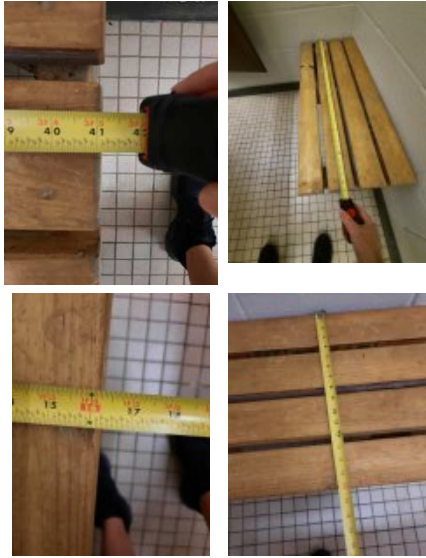
Finding Number	Area Description	Lat/Long	Finding	As Built	Recommendation	Citation	Photos	Figure
375	Red Oak: Red Oak Women's Shower	[30.6543361, -95.0062374]	The bench is not deep enough or long enough or is missing. Benches shall be provided having seats that are 42 inches long minimum and 20 inches deep minimum and 24 inches deep maximum. The bench shall provide for back support or shall be affixed to a wall. Back support shall be 42 inches (1065 mm) long minimum and shall extend from a point 2 inches (51 mm) maximum above the seat surface to a point 18 inches (455 mm) minimum above the seat surface. Back support shall be 2½ inches (64 mm) maximum from the rear edge of the seat measured horizontally. The top of the bench seat surface shall be 17 inches (430 mm) minimum and 19 inches (485 mm) maximum above the finish floor or ground. Clear floor or ground space complying with 305 shall be provided and shall be positioned at the end of the bench seat and parallel to the short axis of the bench	bench dimensions fail - 41" long x 16.25" deep and is not affixed to the wall	Replace bench in dressing area with one having a seat depth of 20" to 24" deep, 42" long, affixed to the wall or having a back and mounted 17" to 19" AFF and provide required clear floor space on the short axis of the bench.	2012 TAS Section: 903.4, 903.2, 903.3, 903.5  2010 ADAS Section: 903.4, 903.2, 903.3, 903.5

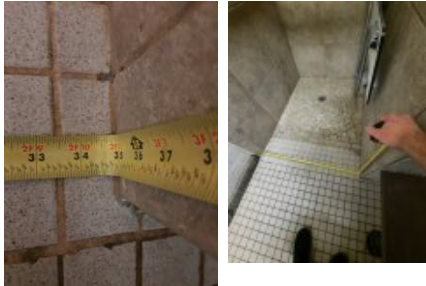
376	Red Oak: Red Oak Women's Shower	[30.6543177, -95.0062481]	Transfer type shower compartments shall be 36 inches (915 mm) by 36 inches (915 mm) clear inside dimensions measured at the center points of opposing sides and shall have a 36 inch (915 mm) wide minimum entry on the face of the shower compartment. Clearance of 36 inches (915 mm) wide minimum by 48 inches (1220 mm) long minimum measured from the control wall shall be provided.	Transfer shower 34.75" wide	Enlarge transfer shower to compliant 36" by 36" clear inside dimension.	2015 ABAAS Section: 608.2.1  2012 TAS Section: 608.2.1  2010 ADAS Section: 608.2.1

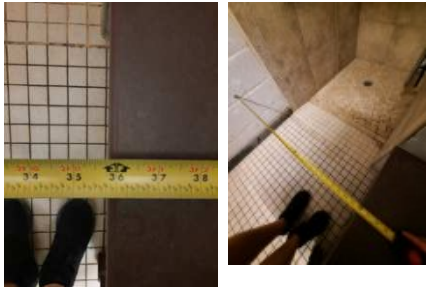
<small>Note: Transfer shower dimensions are measured at the center points of opposing sides.</small>
377	Red Oak: Red Oak Women's Shower	[30.6543258, -95.0062267]	Transfer type shower compartments shall be 36 inches (915 mm) by 36 inches (915 mm) clear inside dimensions measured at the center points of opposing sides and shall have a 36 inch (915 mm) wide minimum entry on the face of the shower compartment. Clearance of 36 inches (915 mm) wide minimum by 48 inches (1220 mm) long minimum measured from the control wall shall be provided.	Lacks clear floor space on the exterior of the transfer shower due to bench location	Remove bench to provide appropriate CFS on the exterior of the transfer shower	2015 ABAAS Section: 608.2.1  2012 TAS Section: 608.2.1  2010 ADAS Section: 608.2.1

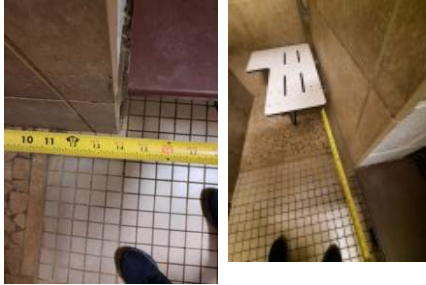
Finding Number	Area Description	Lat/Long	Finding	As Built	Recommendation	Citation	Photos	Figure
381	Red Oak: Red Oak Women's Shower	[30.6543269, -95.0062347]	The shower seat height is noncompliant. A seat in a standard roll-in shower compartment shall be a folding type, shall be installed on the side wall adjacent to the controls, and shall extend from the back wall to a point within 3 inches of the compartment entry. A seat in an alternate roll-in type shower compartment shall be a folding type, shall be installed on the front wall opposite the back wall, and shall extend from the adjacent side wall to a point within 3 inches of the compartment entry. The top of the seat shall be 17 inches minimum and 19 inches maximum above the bathroom finish floor.	The shower seat 14" from compartment entry	Remount shower bench so that the front edge is within 3" of the opening.	2015 ABAAS Section: 610.3 2012 TAS Section: 610.3 2010 ADAS Section: 610.3

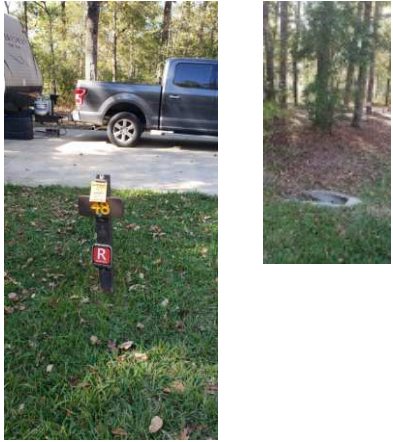
382	Red Oak: Site 48	[30.65691, -95.00105]	Site occupied, unable to audit	occupied at time of audit, appears to have similar issues to site 55	Assure site meets camping standards as a smart practice.	Capture Section: 1

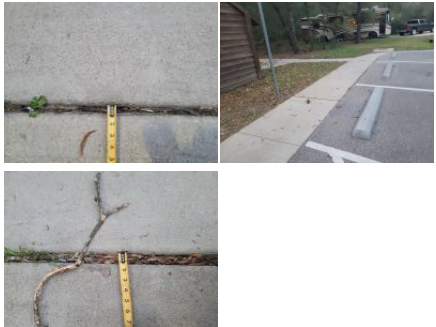
385	Yaupon Loop: Yaupon Loop Restroom Parking and Exterior Accessible Route	[30.6546166, -95.0044211]	There is a gap spaced greater than a 1/2 inch. Openings in floor or ground surfaces shall not allow passage of a sphere more than 1/2 inch diameter. Elongated openings shall be placed so that the long dimension is perpendicular to the dominant direction of travel.	Gaps of .75" and 1.25"	Correct or fill gaps to be max .5"	2015 ABAAS Section: 302.3  2012 TAS Section: 302.3  2010 ADAS Section: 302.3

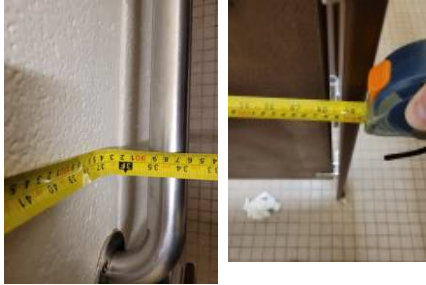
Finding Number	Area Description	Lat/Long	Finding	As Built	Recommendation	Citation	Photos	Figure
394	Yaupon Loop: Yaupon Loop Men's Restroom	[30.6547515 , -95.004518 1]	The ambulatory stall is not between 35" to 37" wide and 60" deep.	Stall dimensions fail - stall is 37.5" wide x 58.5" deep	Correct ambulatory stall to be 35" to 37" wide and minimum 60" deep. In the alternative, use existing stall to create required wheelchair stall.	2015 ABAAS Section: 604.8.2.1  2012 TAS Section: 604.8.2.1  2010 ADAS Section: 604.8.2.1

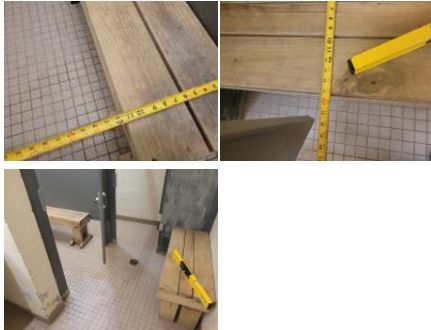
Finding Number	Area Description	Lat/Long	Finding	As Built	Recommendation	Citation	Photos	Figure
400	Yaupon Loop: Yaupon Loop Men's Shower	[30.654748, -95.004522 1]	The bench is not deep enough or long enough or is missing. Benches shall be provided having seats that are 42 inches long minimum and 20 inches deep minimum and 24 inches deep maximum. The bench shall provide for back support or shall be affixed to a wall. Back support shall be 42 inches (1065 mm) long minimum and shall extend from a point 2 inches (51 mm) maximum above the seat surface to a point 18 inches (455 mm) minimum above the seat surface. Back support shall be 2½ inches (64 mm) maximum from the rear edge of the seat measured horizontally. The top of the bench seat surface shall be 17 inches (430 mm) minimum and 19 inches (485 mm) maximum above the finish floor or ground. Clear floor or ground space complying with 305 shall be provided and shall be positioned at the end of the bench seat and parallel to the short axis of the bench	Bench dimensions fail - one is 11.5" deep and the other 15" deep	Replace bench in dressing area with one having a seat depth of 20" to 24" deep, 42" long, affixed to the wall or having a back and mounted 17" to 19" AFF and provide required clear floor space on the short axis of the bench.	2012 TAS Section: 903.4, 903.2, 903.3, 903.5  2010 ADAS Section: 903.4, 903.2, 903.3, 903.5

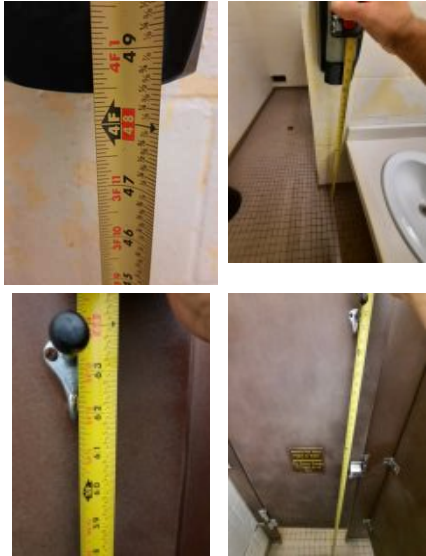
Finding Number	Area Description	Lat/Long	Finding	As Built	Recommendation	Citation	Photos	Figure
405	Yaupon Loop: Yaupon Loop Women's Restroom	[30.6547503 , -95.004527 5]	Where a high forward reach is over an obstruction, the clear floor space shall extend beneath the element for a distance not less than the required reach depth over the obstruction. The high forward reach shall be 48 inches (1220 mm) maximum where the reach depth is 20 inches (510 mm) maximum. Where the reach depth exceeds 20 inches (510 mm), the high forward reach shall be 44 inches (1120 mm) maximum and the reach depth shall be 25 inches (635 mm) maximum. Where a clear floor or ground space allows a parallel approach to an element and the high side reach is over an obstruction, the height of the obstruction shall be 34 inches (865 mm) maximum and the depth of the obstruction shall be 24 inches (610 mm) maximum. The high side reach shall be 48 inches (1220 mm) maximum for a reach depth of 10 inches (255 mm) maximum. Where the reach depth exceeds 10 inches (255 mm), the high side reach shall be 46 inches (1170 mm) maximum for a reach depth of 24 inches (610 mm) maximum.	Soap dispenser 48.5" aff and coat hook at 62.5"	Lower soap dispenser and coat hook to max 48" aff to highest operable part.	2015 ABAAS Section: 308.2.1, 308.3.2  2012 TAS Section: 308.2.1, 308.3.2  2010 ADAS Section: 308.2.1, 308.3.2

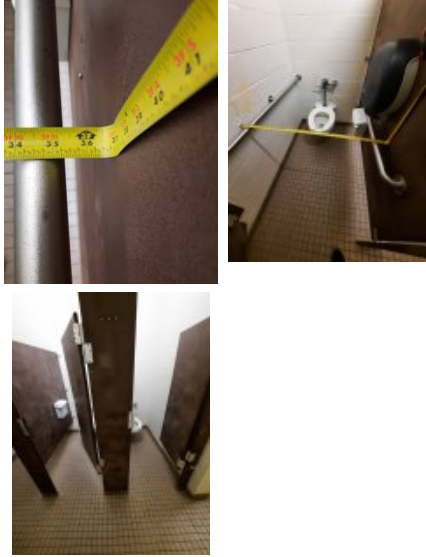
Finding Number	Area Description	Lat/Long	Finding	As Built	Recommendation	Citation	Photos	Figure
406	Yaupon Loop: Yaupon Loop Women's Restroom	[30.6547503 , -95.004520 8]	There are not enough accessible toilet compartments. The room contains 2 toilet compartments. A minimum of 1 must be wheelchair accessible .	Lacks wheelchair accessible stall - ambulatory only	Create a wheelchair accessible stall with grab bars and fixtures mounted in correct locations and at correct heights.	2015 ABAAS Section: F213.3.1  2012 TAS Section: 213.3.1  2010 ADAS Section: 213.3.1

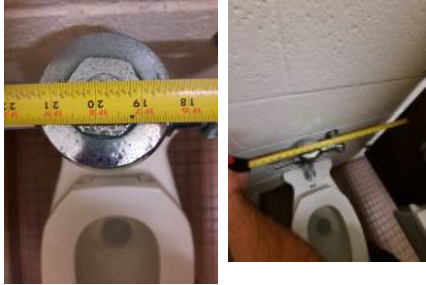
Finding Number	Area Description	Lat/Long	Finding	As Built	Recommendation	Citation	Photos	Figure
408	Yaupon Loop: Yaupon Loop Women's Restroom	[30.6547457 , -95.004520 8]	The toilet is not located within the range to the side wall or partition. The centerline of the toilet shall be 17 inches minimum and 19 inches maximum side wall or partition in the ambulatory accessible toilet compartment.	Centerline of the toilet is 19.75" from the partition	Remount toilet to 17" to 19" from the side wall to center line in ambulatory stalls or 16" to 18" in new wheelchair stall.	2015 ABAAS Section: 604.9.1  2012 TAS Section: 604.9.1  2010 ADAS Section: 604.9.1

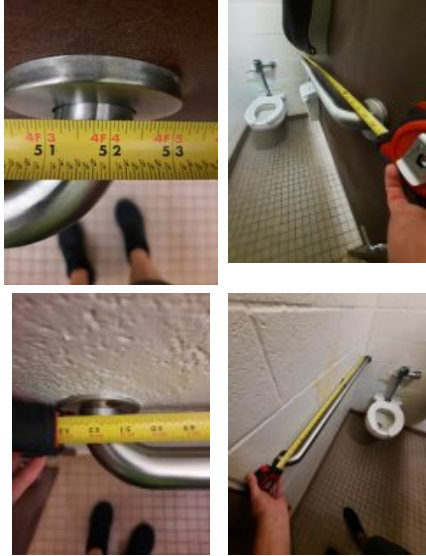
409	Yaupon Loop: Yaupon Loop Women's Restroom	[30.6547492 , -95.004519 4]	The side grab bars are not in the correct location. Grab bars on the side wall must be installed so that the end closest to the rear wall is maximum 12" from the rear wall. The end furthest from the rear wall must be mounted minimum 54" from the rear wall.	Side grab bar ends 51.75" from rear wall	Remount side grab bar to max 12" from the rear wall at the close end and min 54" on the far end, and 33" to 36" aff	2015 ABAAS Section: 604.5.1  2012 TAS Section: 604.5.1  2010 ADAS Section: 604.5.1

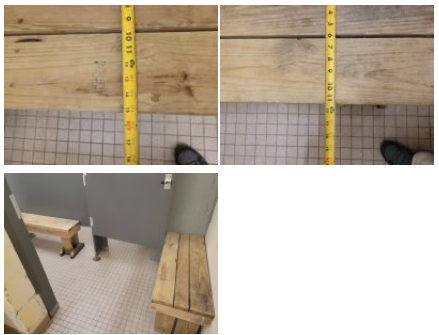
Finding Number	Area Description	Lat/Long	Finding	As Built	Recommendation	Citation	Photos	Figure
416	Yaupon Loop: Yaupon Loop Women's Shower	[30.6547492 , -95.004515 4]	The bench is not deep enough or long enough or is missing. Benches shall be provided having seats that are 42 inches long minimum and 20 inches deep minimum and 24 inches deep maximum. The bench shall provide for back support or shall be affixed to a wall. Back support shall be 42 inches (1065 mm) long minimum and shall extend from a point 2 inches (51 mm) maximum above the seat surface to a point 18 inches (455 mm) minimum above the seat surface. Back support shall be 2½ inches (64 mm) maximum from the rear edge of the seat measured horizontally. The top of the bench seat surface shall be 17 inches (430 mm) minimum and 19 inches (485 mm) maximum above the finish floor or ground. Clear floor or ground space complying with 305 shall be provided and shall be positioned at the end of the bench seat and parallel to the short axis of the bench	Bench dimensions fail - one is 15" deep and the other 11.5" deep	Replace bench in dressing area with one having a seat depth of 20" to 24" deep, 42" long, affixed to the wall or having a back and mounted 17" to 19" AFF and provide required clear floor space on the short axis of the bench.	2012 TAS Section: 903.4, 903.2, 903.3, 903.5  2010 ADAS Section: 903.4, 903.2, 903.3, 903.5

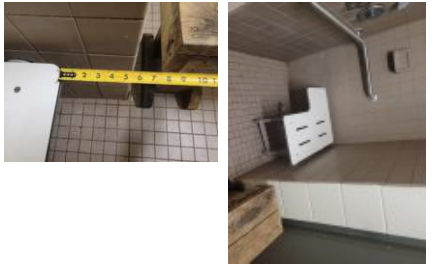
418	Yaupon Loop: Yaupon Loop Women's Shower	[30.6547549 , -95.004526 1]	The shower seat is located too far from the opening to the shower. A seat in an alternate roll-in type shower compartment shall be a folding type, shall be installed on the front wall opposite the back wall, and shall extend from the adjacent side wall to a point within 3 inches of the compartment entry. The top of the seat shall be 17 inches minimum and 19 inches maximum above the bathroom finish floor.	The shower seat is 5.5" from compartment entry	Remount shower bench so that the front edge is within 3" of the opening.	2015 ABAAS Section: 610.3  2012 TAS Section: 610.3  2010 ADAS Section: 610.3

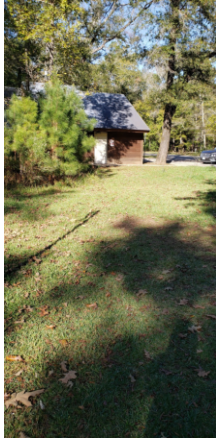
Finding Number	Area Description	Lat/Long	Finding	As Built	Recommendation	Citation	Photos	Figure
421	Yaupon Loop: Site 35	[30.654485, -95.004691 1]	An accessible access route is not provided between elements, spaces and the facilities provided within the accessible camping unit. At least one outdoor recreation access route shall connect accessible elements, spaces and facilities provided within camping units with mobility features.	Lacks accessible route to restrooms	Create AR with crushed and compacted stone or similar outdoor material to camp sites and one of each type of amenity.	2015 ABAAS Section: F244.5.1

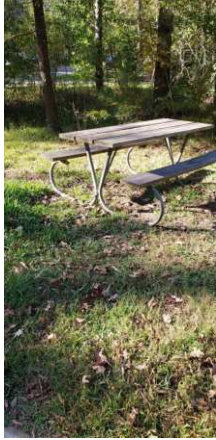
422	Yaupon Loop: Site 35	[30.6545057, -95.004672 3]	Picnic tables shall provide at least one wheelchair space for each 24 linear feet (7320 mm) of usable table surface perimeter. Wheelchair spaces shall be 30 inches (760 mm) minimum by 48 inches (1220 mm) minimum. Wheelchair spaces shall be positioned for a forward approach to the table and provide knee and toe clearance complying with 306 under the table	Lacks picnic table of accessible design	Replace picnic table with one of an accessible design as a smart practice	2015 ABAAS Section: 1011.4.2

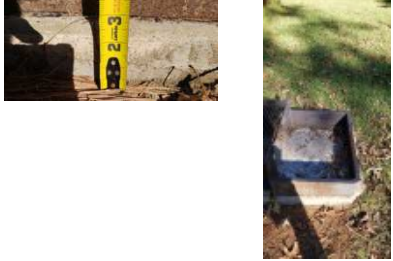
423	Yaupon Loop: Site 35	[30.654493, -95.004695 1]	Fire building surfaces shall be 9 inches (230 mm) minimum above the ground.	Fire building surface 2" above surrounding ground level	Correct fire building surface to be 9" min above the ground as a smart practice. In the alternative, replace fire ring with a compliant accessible fire ring.	2015 ABAAS Section: 1011.5.1

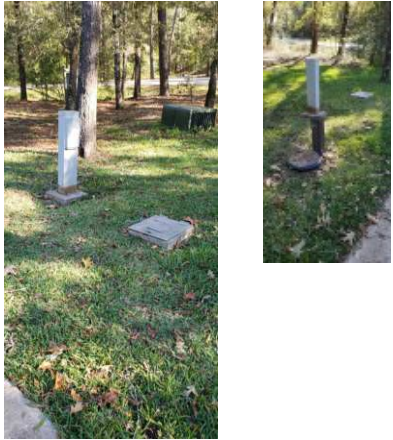
Finding Number	Area Description	Lat/Long	Finding	As Built	Recommendation	Citation	Photos	Figure
424	Yaupon Loop: Site 35	[30.6544965 , -95.004684 4]	There is no accessible route to the campsite utility (water, electricity, and sewer) hook ups. At least one accessible route shall connect accessible buildings, accessible facilities, accessible elements, and accessible spaces that are on the same site.	Lacks accessible route to campsite water, electricity, and sewer	Create an accessible route with crushed stone or other outdoor material from parking or walkway to the campsite water, electricity, and sewer hook ups	2015 ABAAS Section: F206.2.2  2012 TAS Section: 206.2.2  2010 ADAS Section: 206.2.2

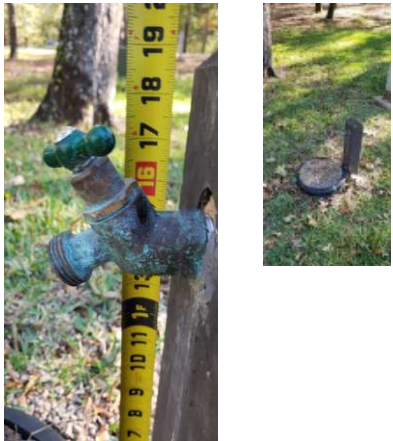
425	Yaupon Loop: Site 35	[30.6544907 , -95.004689 8]	Water spouts at water hydrants and water utility hook-ups shall be 28 inches (710 mm) minimum and 36 inches (915 mm) maximum above the ground	Water spout is 12" above ground level	Remount water spouts to 28" min or 36" max above the ground as a smart practice	2015 ABAAS Section: 1011.6

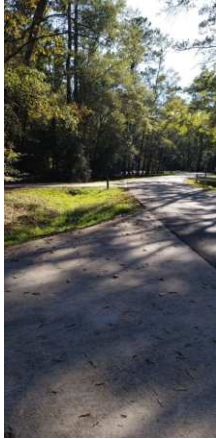
Finding Number	Area Description	Lat/Long	Finding	As Built	Recommendation	Citation	Photos	Figure
426	Yaupon Loop: Site 21	[30.6559282 , -95.004675]	An accessible access route is not provided between elements, spaces and the facilities provided within the accessible camping unit. At least one outdoor recreation access route shall connect accessible elements, spaces and facilities provided within camping units with mobility features.	Lacks accessible route to restrooms	Create AR with crushed and compacted stone or similar outdoor material to camp sites and one of each type of amenity.	2015 ABAAS Section: F244.5.1

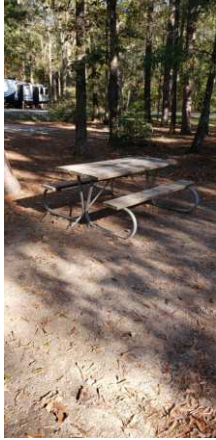
427	Yaupon Loop: Site 21	[30.6559248 , -95.004701 8]	Picnic tables shall provide at least one wheelchair space for each 24 linear feet (7320 mm) of usable table surface perimeter. Wheelchair spaces shall be 30 inches (760 mm) minimum by 48 inches (1220 mm) minimum. Wheelchair spaces shall be positioned for a forward approach to the table and provide knee and toe clearance complying with 306 under the table	Lacks picnic table of accessible design	Replace picnic table with one of an accessible design as a smart practice	2015 ABAAS Section: 1011.4.2

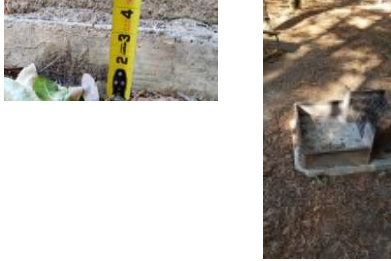
428	Yaupon Loop: Site 21	[30.6559305 , -95.004723 3]	Fire building surfaces shall be 9 inches (230 mm) minimum above the ground.	Fire building surface lacks 3" above surrounding ground level	Correct fire building surface to be 9" min above the ground as a smart practice. In the alternative, replace fire ring with a compliant accessible fire ring.	2015 ABAAS Section: 1011.5.1

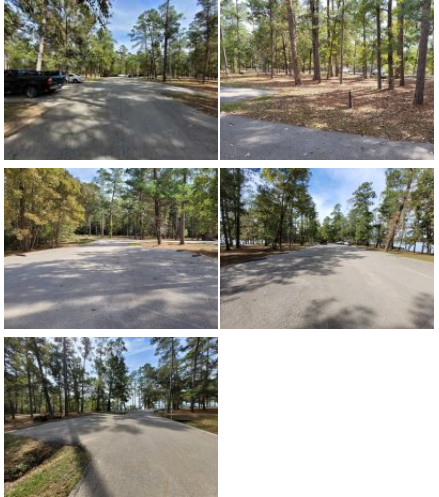
Finding Number	Area Description	Lat/Long	Finding	As Built	Recommendation	Citation	Photos	Figure
431	Picnic Area/Day Use - South: Picnic Area/Day Use South - South Playground Parking and Exterior Accessible Route	[30.6570346, -95.0066974]	There are no accessible parking stalls. Each lot where parking is provided for the public as clients, guests or employees, shall provide accessible parking and shall be located on the shortest accessible route of travel from adjacent parking to an accessible entrance. There are a total of 55 parking stalls in the parking lot that could be reasonably associated with this facility. There should be a minimum of 3 accessible stalls with a minimum of 1 being designed as van accessible.	Lacks accessible parking stalls - 55 standard, 0 accessible	Create one or more 8' accessible parking stalls, with one 5' adjacent access aisle, with proper signage and striping based on the total number of stalls	2015 ABAAS Section: F208.2  2012 TAS Section: 208.2  2010 ADAS Section: 208.2

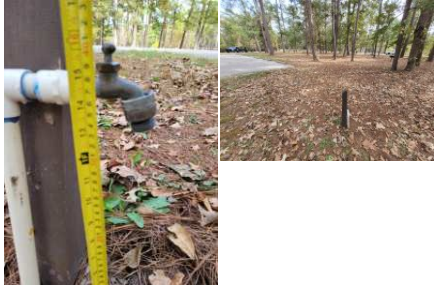
432	Picnic Area/Day Use - South: Picnic Area/Day Use South - South Playground Parking and Exterior Accessible Route	[30.65689, -95.00674]	There is no accessible route to the water spout. At least one accessible route shall connect accessible buildings, accessible facilities, accessible elements, and accessible spaces that are on the same site. Water spouts at water hydrants and water utility hook-ups shall be 28 inches (710 mm) minimum and 36 inches (915 mm) maximum above the ground	Lacks accessible route to the water spout and water spout is 13" above ground level	Create an accessible route with crushed stone or other outdoor material from parking or walkway to the water spout Remount water spouts to 28" min or 36" max above the ground as a smart practice	2015 ABAAS Section: F206.2.2  2012 TAS Section: 206.2.2  2010 ADAS Section: 206.2.2

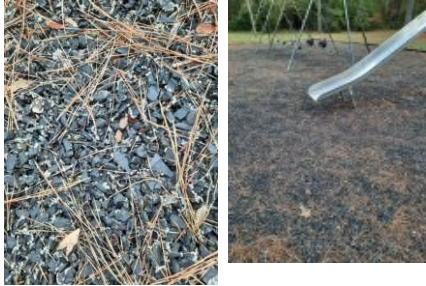
436	Picnic Area/Day Use - South: Picnic Area/Day Use - South Playground	[30.6567669 , -95.006057 7]	Compliance with ASTM F 1951 for accessibility for ground surfaces on accessible routes, clear floor or ground spaces, and turning spaces has not been determined. Ground surfaces shall comply with ASTM F 1951. Ground surfaces shall be inspected and maintained regularly and frequently to ensure continued compliance with ASTM F 1951.	Playground surface assumed to be shredded rubber	Replace existing surface with an accessible surface such as EWF, PIP or tiles.	2012 TAS Section: 1008.2.6.1  2010 ADAS Section: 1008.2.6.1

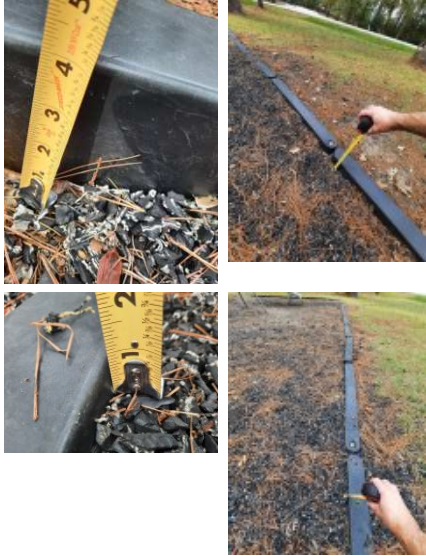
437	Picnic Area/Day Use - South: Picnic Area/Day Use - South Playground	[30.6567716 , -95.005985 3]	Play area lacks designated entry. As a smart practice, play area should have a minimum 60" wide entry, free of changes in level, gaps, and slope.	lacks designated entry - continuous plastic playground border	Create designated entry by removing 60" portion of play area boundary as a smart practice.	2015 ABAAS Section: F206.1  2012 TAS Section: 206.1  2010 ADAS Section: 206.1

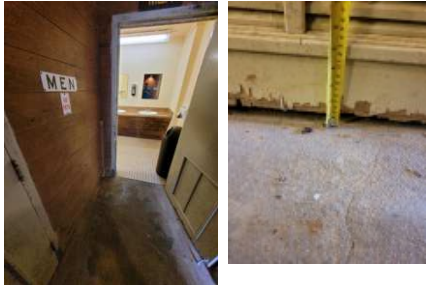
439	Picnic Area/Day Use - South: Picnic Area/Day Use - South Men's Restroom	[30.6575549 , -95.0079393]	Minimum maneuvering clearances at doors and gates shall comply with 404.2.4. Maneuvering clearances shall extend the full width of the doorway and the required latch side or hinge side clearance. Maneuvering clearances shall have a max slope of 2.08%. The sweep period for doors with closers shall be adjusted so that from an open position of 70 degrees, the door will take at least 3 seconds to move to a point 3 inches from the latch, measured to the leading edge of the door. Exterior doors are recommended to be maintained at 8.5 lbf as a smart practice. Force is to be measured at the operating hardware or 30 inches from the hinges, whichever is greater. The bottom 10 inches on the push side must be smooth and free of obstructions (hold open devices). Opening hardware must be mounted between 30 and 44 inches above the floor or ground.	Restroom Door - wall in maneuvering clearance on the pull side of the door, 9.5# push, fast close, lacks push plate	For all doors along the public circulation route, provide required maneuvering clearance on push and pull side of doors. For all doors along the public circulation route, inspect, adjust, and maintain closing speed on door closers. For all doors along the public circulation route, inspect, adjust, and maintain 8.5 lbf to open exterior doors as a smart practice. For all doors along the public circulation route, provide kick plate on push side of door from floor to 10" AFF.	2010 ADAS Section: 404.2.3, 404.2.7, 404.2.4, 404.2.11, 404.2.11 Exception
