# Access Audit Site Report

Prepared By  
**WT Group**

**Lake Livingston State Park**  
**300 State Park Rd 65**  
**Livingston, TX 77351**  
**Accessibility Evaluation**  
**Inspection Date: 11/08/2021**  
**Inspectors: Tanya Scheibe**

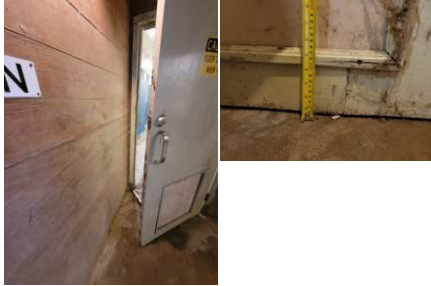
444	Picnic Area/Day Use - South: Picnic Area/Day Use - South Men's Restroom	[30.657593, -95.007943]	Minimum maneuvering clearances at doors and gates shall comply with 404.2.4. Maneuvering clearances shall extend the full width of the doorway and the required latch side or hinge side clearance. Maneuvering clearances shall have a max slope of 2.08%. Door openings shall provide a clear width of 32 inches (815 mm) minimum. Clear openings of doorways with swinging doors shall be measured between the face of the door and the stop, with the door open 90 degrees. Openings more than 24 inches (610 mm) deep shall provide a clear opening of 36 inches (915 mm) minimum. There shall be no projections into the required clear opening width lower than 34 inches (865 mm) above the finish floor or ground. Projections into the clear opening width between 34 inches (865 mm) and 80 inches (2030 mm) above the finish floor or ground shall not exceed 4 inches (100 mm). The threshold has a vertical change greater than 1/4 inch high. The threshold has a gap greater than 1/2 inch wide. The threshold at a doorway shall be no higher than 1/2 inch. Changes in level between 1/4 inch and 1/2 inch must be beveled at 1:2 or less. 1/4 inch is the maximum vertical rise. All interior doors must be maintained so that the operating pressure does not exceed 5 lbf to open. The sweep period for doors with closers shall be adjusted so that from an open position of 70 degrees, the door will take at least 3 seconds to move to a point 3	Main locker/dressing room door - wall in maneuvering clearance on the pull side of the door, 10# push, rough surface on push side	For all doors along the public circulation route, provide required maneuvering clearance on push and pull side of doors. For all doors along the public circulation route, secure rug in door clearance to prevent trip hazard. For all doors along the public circulation route, correct slope in door clearance to max 2.08%. For all doors along the public circulation route, replace doors with doors having 80" overhead clearance and 32" clear width. For all doors along the public circulation route, repair, bevel, or ramp CILs at door entries to max .25". For all doors along the public circulation route, fill gaps at door entries to max .5". For all doors along the public circulation route, provide beveled threshold. For all doors along the public circulation route, inspect, adjust, and maintain 5 lbf to open interior doors. For all doors along the public circulation route, inspect, adjust, and maintain closing speed on door closers. For all doors along the public circulation route, inspect, adjust, and maintain 8.5 lbf to open exterior doors as a smart practice. For all doors along the public circulation route, replace hardware with lever hardware or hardware operable without a tight pinch or grasp. For all doors along the public circulation route, replace hardware with lever hardware or hardware operable without a tight pinch or grasp and having a max profile of 4". For all doors along the public circulation route, provide kick plate on	2010 ADAS Section: 404.2.3, 404.2.7, 404.2.4, 404.2.11, 404.2.11 Exception

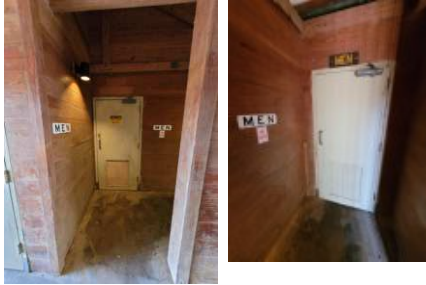
Finding Number	Area Description	Lat/Long	Finding	As Built	Recommendation	Citation	Photos	Figure
446	Picnic Area/Day Use - South: Picnic Area/Day Use - South Men's Restroom	[30.6575514 , -95.007943 3]	The restroom sign does not comply with one or more applicable requirements for the location, height, and properties of the sign.	Lacks braille lettering and raised characters on restroom signage, lacks symbol of access	Replace sign with one of contrasting colors that includes Braille, raised characters, and the symbol of accessibility and mount on the wall, latch side of the door, 48" to the baseline of the lowest character and 60" to the baseline of the highest character	2015 ABAAS Section: F216.2, 703.1, 703.2, 703.5, 703.6  2012 TAS Section: 216.2, 703.1, 703.2, 703.5, 703.6  2010 ADAS Section: 216.2, 703.1, 703.2, 703.5, 703.6

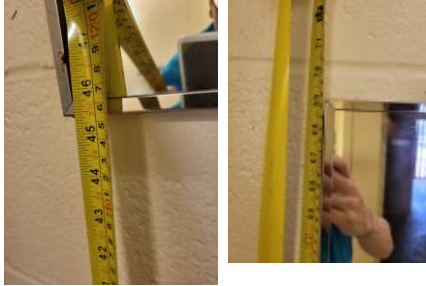
447	Picnic Area/Day Use - South: Picnic Area/Day Use - South Men's Restroom	[30.6575653 , -95.007932 5]	The mirror is mounted too high. Mirrors must have the bottom edge of the reflecting surface a maximum of 40 inches above the floor if above a sink or counter. Mirrors not located above lavatories or countertops shall be installed with the bottom edge of the reflecting surface 35 inches maximum above the finish floor or ground.	Bottom edge of reflecting surface of mirror is 45.5" aff and top edge of reflecting surface is 68.5" aff	Replace mirror mount to max 40" AFF to the bottom reflective surface and 74" to the top.	2015 ABAAS Section: 603.3  2012 TAS Section: 603.3  2010 ADAS Section: 603.3

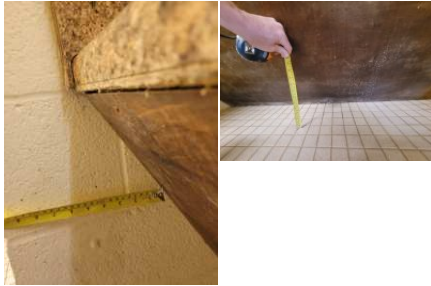
Finding Number	Area Description	Lat/Long	Finding	As Built	Recommendation	Citation	Photos	Figure
448	Picnic Area/Day Use - South: Picnic Area/Day Use - South Men's Restroom	[30.6575676 , -95.007924 5]	Knee clearance at 27 inches off the floor is not 8 inches minimum deep. The knee clearance, measured from the bottom of the apron or the outside bottom edge of the lavatory, must be 27 inches at a point located 8 inches back from the front edge and continuing to 11 inches minimum in depth at 9 inches above the floor. The top of the lavatory rim may be no higher than 34 inches.	Sink lacks 8" deep knee clearance due to wood panel under sink	Remove face board to provide 8" deep knee clearance.	2015 ABAAS Section: 306.3.1, 306.3.2, 306.3.3, 306.3.4 , 306.3.5  2012 TAS Section: 306.3.2, 306.3.3, 306.3.4, 306.3.5, 306.3.1  2010 ADAS Section: 306.3.3, 306.3.2, 306.3.4, 306.3.5, 306.3.1

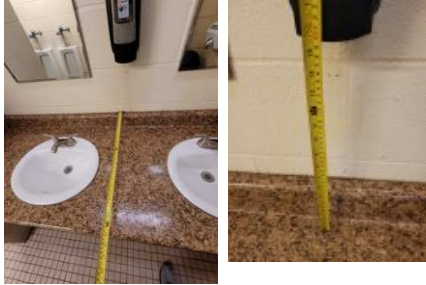
Finding Number	Area Description	Lat/Long	Finding	As Built	Recommendation	Citation	Photos	Figure
450	Picnic Area/Day Use - South: Picnic Area/Day Use - South Men's Restroom	[30.6575676 , -95.007927 2]	Where a high forward reach is over an obstruction, the clear floor space shall extend beneath the element for a distance not less than the required reach depth over the obstruction. The high forward reach shall be 48 inches (1220 mm) maximum where the reach depth is 20 inches (510 mm) maximum. Where the reach depth exceeds 20 inches (510 mm), the high forward reach shall be 44 inches (1120 mm) maximum and the reach depth shall be 25 inches (635 mm) maximum. Where a clear floor or ground space allows a parallel approach to an element and the high side reach is over an obstruction, the height of the obstruction shall be 34 inches (865 mm) maximum and the depth of the obstruction shall be 24 inches (610 mm) maximum. The high side reach shall be 48 inches (1220 mm) maximum for a reach depth of 10 inches (255 mm) maximum. Where the reach depth exceeds 10 inches (255 mm), the high side reach shall be 46 inches (1170 mm) maximum for a reach depth of 24 inches (610 mm) maximum.	Soap dispenser 50" aff over sink	Lower soap dispenser to max 44" aff for a forward reach over counter	2015 ABAAS Section: 308.2.1, 308.3.2  2012 TAS Section: 308.2.1, 308.3.2  2010 ADAS Section: 308.2.1, 308.3.2

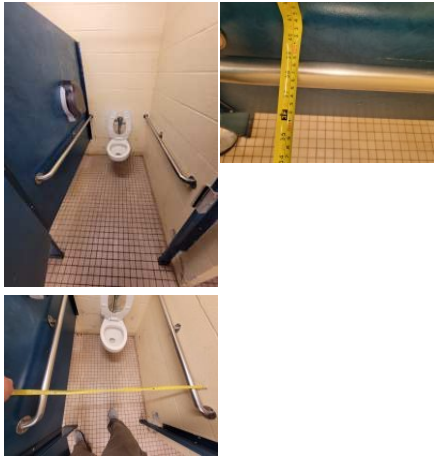
453	Picnic Area/Day Use - South: Picnic Area/Day Use - South Men's Restroom	[30.6575768, -95.0079352]	The ambulatory stall is not between 35" to 37" wide and 60" deep.	ambulatory stall 40" wide	Correct ambulatory stall to be 35" to 37" wide and minimum 60" deep. In the alternative, use existing stall to create required wheelchair stall.	2015 ABAAS Section: 604.8.2.1 2012 TAS Section: 604.8.2.1 2010 ADAS Section: 604.8.2.1

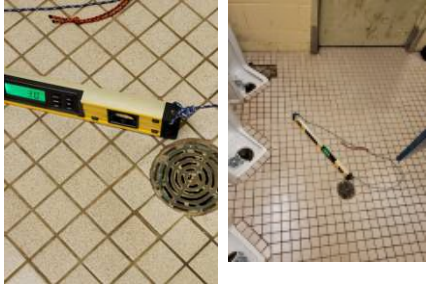
Finding Number	Area Description	Lat/Long	Finding	As Built	Recommendation	Citation	Photos	Figure
455	Picnic Area/Day Use - South: Picnic Area/Day Use - South Men's Restroom	[30.6575837, -95.0079808]	The accessible route contains running slopes greater than 5 percent and cross slopes greater than 2 percent across the width of the walk and has not been constructed as a ramp (i.e. handrails, wheel guides, etc.). When the slope in the direction of travel of any walk exceeds 1 unit vertical in 20 units horizontal (5-percent slope), it must be constructed as ramp. Surface cross slopes must not exceed one unit vertical in 48 units. Horizontal (2-percent slope).	Slope of 3% near floor drain	Correct or repair slope to max 5% running and 2.08% cross	2015 ABAAS Section: 403.3  2012 TAS Section: 403.3  2010 ADAS Section: 403.3

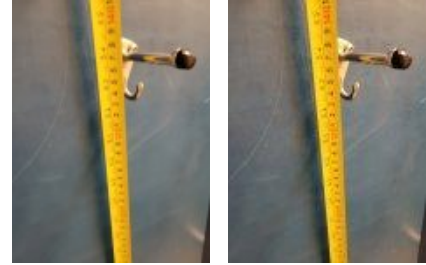
456	Picnic Area/Day Use - South: Picnic Area/Day Use - South Men's Restroom	[30.6575537, -95.0079352]	The coat hook is installed greater than 48 inches above the finished floor. Where a forward reach is unobstructed, the high forward reach shall be 48 inches maximum above the finished floor.	Coat hook 50" aff	Lower hooks in locker area to max 48" aff	2015 ABAAS Section: 308.2.1  2012 TAS Section: 308.2.1  2010 ADAS Section: 308.2.1

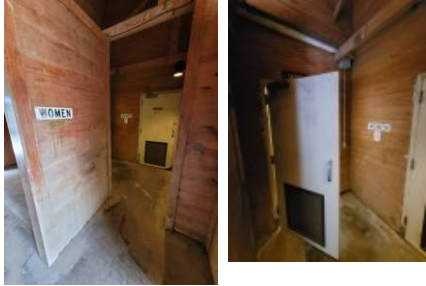
457	Picnic Area/Day Use - South: Picnic Area/Day Use - South Women's Restroom	[30.6575976, -95.0079325]	The restroom sign does not comply with one or more applicable requirements for the location, height, and properties of the sign.	Lacks braille lettering and raised characters on restroom signage, lacks Symbol of access	Replace sign with one of contrasting colors that includes Braille, raised characters, and the symbol of accessibility and mount on the wall, latch side of the door, 48" to the baseline of the lowest character and 60" to the baseline of the highest character	2015 ABAAS Section: F216.2, 703.1, 703.2, 703.5, 703.6  2012 TAS Section: 216.2, 703.1, 703.2, 703.5, 703.6  2010 ADAS Section: 216.2, 703.1, 703.2, 703.5, 703.6

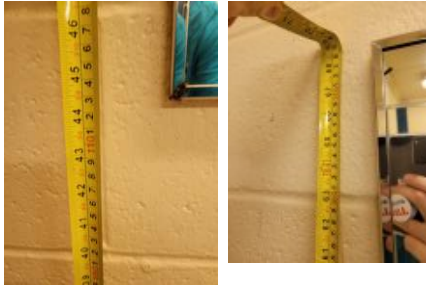
Finding Number	Area Description	Lat/Long	Finding	As Built	Recommendation	Citation	Photos	Figure
458	Picnic Area/Day Use - South: Picnic Area/Day Use - South Women's Restroom	[30.6575791 , -95.007943 3]	The mirror is mounted too high. Mirrors must have the bottom edge of the reflecting surface a maximum of 40 inches above the floor if above a sink or counter. Mirrors not located above lavatories or countertops shall be installed with the bottom edge of the reflecting surface 35 inches maximum above the finish floor or ground.	Bottom edge of reflecting surface of mirror is 44.5" aff and top edge of reflecting surface is 68.5" aff	Replace mirror mount to max 40" AFF to the bottom reflective surface and 74" to the top.	2015 ABAAS Section: 603.3  2012 TAS Section: 603.3  2010 ADAS Section: 603.3

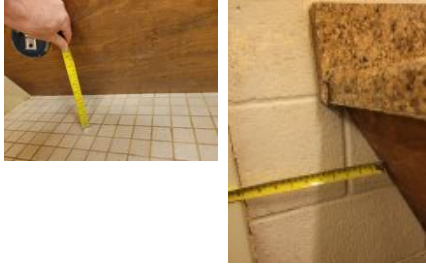
459	Picnic Area/Day Use - South: Picnic Area/Day Use - South Women's Restroom	[30.6575745 , -95.007921 8]	Knee clearance at 27 inches off the floor is not 8 inches minimum deep. The knee clearance, measured from the bottom of the apron or the outside bottom edge of the lavatory, must be 27 inches at a point located 8 inches back from the front edge and continuing to 11 inches minimum in depth at 9 inches above the floor. The top of the lavatory rim may be no higher than 34 inches.	Sink lacks 8" deep toe and knee clearance, remove wood panel under sink	Remove face board to provide 8" deep knee clearance.	2015 ABAAS Section: 306.3.1, 306.3.2, 306.3.3, 306.3.4 , 306.3.5  2012 TAS Section: 306.3.2, 306.3.3, 306.3.4, 306.3.5, 306.3.1  2010 ADAS Section: 306.3.3, 306.3.2, 306.3.4, 306.3.5, 306.3.1

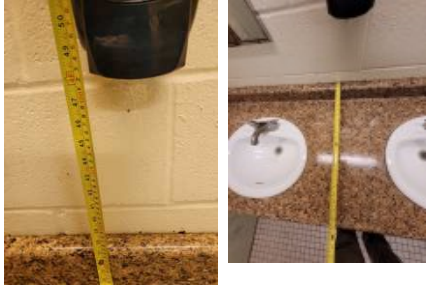
461	Picnic Area/Day Use - South: Picnic Area/Day Use - South Women's Restroom	[30.657563, -95.0079486]	Where a high forward reach is over an obstruction, the clear floor space shall extend beneath the element for a distance not less than the required reach depth over the obstruction. The high forward reach shall be 48 inches (1220 mm) maximum where the reach depth is 20 inches (510 mm) maximum. Where the reach depth exceeds 20 inches (510 mm), the high forward reach shall be 44 inches (1120 mm) maximum and the reach depth shall be 25 inches (635 mm) maximum. Where a clear floor or ground space allows a parallel approach to an element and the high side reach is over an obstruction, the height of the obstruction shall be 34 inches (865 mm) maximum and the depth of the obstruction shall be 24 inches (610 mm) maximum. The high side reach shall be 48 inches (1220 mm) maximum for a reach depth of 10 inches (255 mm) maximum. Where the reach depth exceeds 10 inches (255 mm), the high side reach shall be 46 inches (1170 mm) maximum for a reach depth of 24 inches (610 mm) maximum.	Soap dispenser 48" aff over 23" deep sink counter	Lower soap dispenser to max 44" aff for a forward reach over counter.	2015 ABAAS Section: 308.2.1, 308.3.2  2012 TAS Section: 308.2.1, 308.3.2  2010 ADAS Section: 308.2.1, 308.3.2

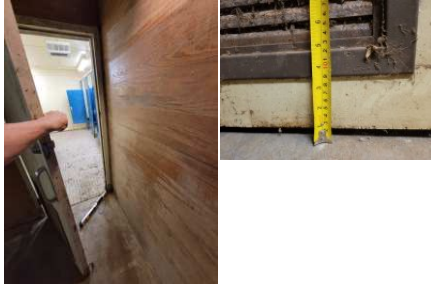
Finding Number	Area Description	Lat/Long	Finding	As Built	Recommendation	Citation	Photos	Figure
470	Picnic Area/Day Use - South: Picnic Area/Day Use - South Women's Restroom	[30.6575837 , -95.007937 9]	Minimum maneuvering clearances at doors and gates shall comply with 404.2.4. Maneuvering clearances shall extend the full width of the doorway and the required latch side or hinge side clearance. Maneuvering clearances shall have a max slope of 2.08%. Exterior doors are recommended to be maintained at 8.5 lbf as a smart practice. Force is to be measured at the operating hardware or 30 inches from the hinges, whichever is greater. The bottom 10 inches on the push side must be smooth and free of obstructions (hold open devices). Opening hardware must be mounted between 30 and 44 inches above the floor or ground.	Locker Room door - wall in maneuvering clearance on the pull side of the door, 12# push, lacks kick plate	For all doors along the public circulation route, provide required maneuvering clearance on push and pull side of doors. For all doors along the public circulation route, inspect, adjust, and maintain 8.5 lbf to open exterior doors as a smart practice. For all doors along the public circulation route, provide kick plate on push side of door from floor to 10" AFF.	2010 ADAS Section: 404.2.3, 404.2.7, 404.2.4, 404.2.11, 404.2.11 Exception

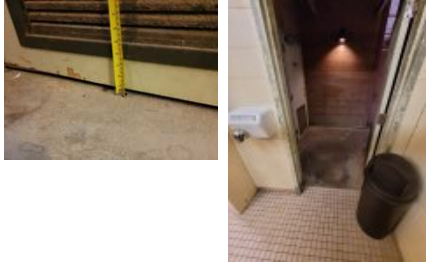
471	Picnic Area/Day Use - South: Picnic Area/Day Use - South Women's Restroom	[30.6575837 , -95.007937 9]	Minimum maneuvering clearances at doors and gates shall comply with 404.2.4. Maneuvering clearances shall extend the full width of the doorway and the required latch side or hinge side clearance. Maneuvering clearances shall have a max slope of 2.08%. The sweep period for doors with closers shall be adjusted so that from an open position of 70 degrees, the door will take at least 3 seconds to move to a point 3 inches from the latch, measured to the leading edge of the door. Exterior doors are recommended to be maintained at 8.5 lbf as a smart practice. Force is to be measured at the operating hardware or 30 inches from the hinges, whichever is greater. The bottom 10 inches on the push side must be smooth and free of obstructions (hold open devices). Opening hardware must be mounted between 30 and 44 inches above the floor or ground.	Restroom door - Lacks smooth surface within 10" of the floor on the push side, garbage and hand dryer in push side clearance, 10# push, fast close	For all doors along the public circulation route, provide required maneuvering clearance on push and pull side of doors. For all doors along the public circulation route, inspect, adjust, and maintain closing speed on door closers. For all doors along the public circulation route, inspect, adjust, and maintain 8.5 lbf to open exterior doors as a smart practice. For all doors along the public circulation route, provide kick plate on push side of door from floor to 10" AFF.	2010 ADAS Section: 404.2.3, 404.2.7, 404.2.4, 404.2.11, 404.2.11 Exception

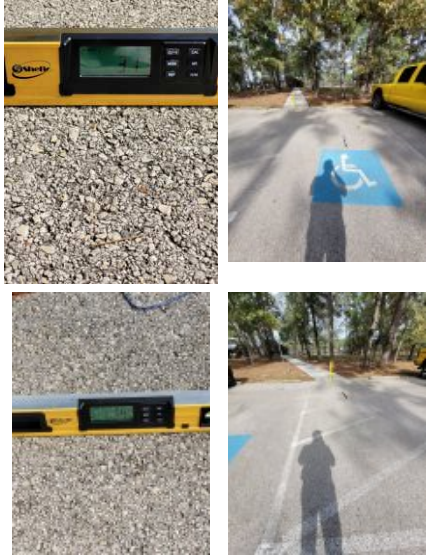
Finding Number	Area Description	Lat/Long	Finding	As Built	Recommendation	Citation	Photos	Figure
477	Picnic Area/Day Use - South: Picnic Area/Day Use - South Recreation Hall Parking and Exterior Accessible Route	[30.6569008 , -95.007798 4]	The cross slopes (narrow dimension) and/or running slopes (long dimension) of the access aisle exceeds 2%. The running slope and the cross slope in an accessible parking stall and the access aisle must not exceed 2%.	Slope of 3.1% in right stall and 3.4 % in access aisle	Repair or correct slope of parking space and access aisle to max 2.08% in any direction	2015 ABAAS Section: 502.4  2012 TAS Section: 502.4  2010 ADAS Section: 502.4

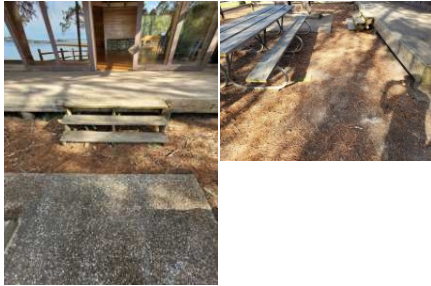
Finding Number	Area Description	Lat/Long	Finding	As Built	Recommendation	Citation	Photos	Figure
479	Picnic Area/Day Use - South: Picnic Area/Day Use - South Recreation Hall	[30.65739, -95.00809]	There is no accessible route to the picnic and grill area. At least one accessible route shall connect accessible buildings, accessible facilities, accessible elements, and accessible spaces that are on the same site.	Lacks accessible route to picnic and grill area	Create an accessible route with crushed stone or other outdoor material from parking or walkway to picnic area.	2015 ABAAS Section: F206.2.2  2012 TAS Section: 206.2.2  2010 ADAS Section: 206.2.2

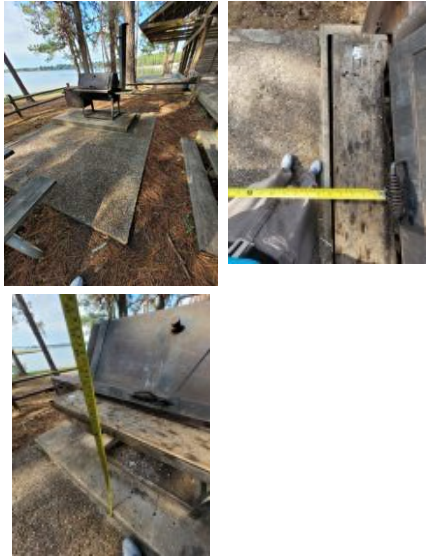
480	Picnic Area/Day Use - South: Picnic Area/Day Use - South Recreation Hall	[30.65751, -95.00809]	An accessible access route is not provided between elements, spaces and the facilities provided within the accessible camping unit. At least one outdoor recreation access route shall connect accessible elements, spaces and facilities provided within camping units with mobility features.	Grill at Recreation Hall - lacks route to cement pad with grill, cooking surface at 42"	Create AR with crushed and compacted stone or similar outdoor material to grill and replace with a compliant grill having cooking surface at 34" max.	2015 ABAAS Section: F244.5.1

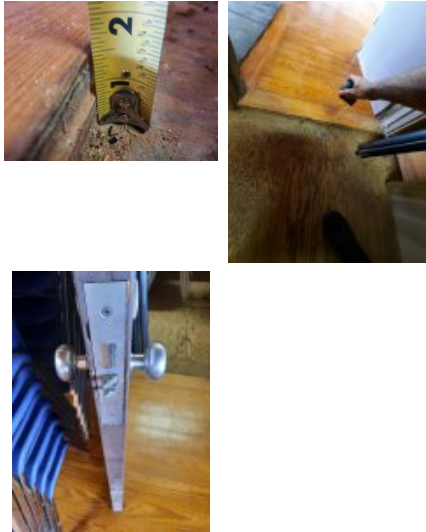
Finding Number	Area Description	Lat/Long	Finding	As Built	Recommendation	Citation	Photos	Figure
485	Picnic Area/Day Use - South: Picnic Area/Day Use - South Recreation Hall	[30.6574107 , -95.008029 1]	Minimum maneuvering clearances at doors and gates shall comply with 404.2.4. Maneuvering clearances shall extend the full width of the doorway and the required latch side or hinge side clearance. Maneuvering clearances shall have a max slope of 2.08%. Hand-activated door opening hardware, handles, pulls, latches, locks, and other operating devices on accessible doors shall have a shape that is easy to grasp with one hand and does not require tight grasping, tight pinching or twisting of the wrist to operate. Hardware shall be 34 inches minimum and 48 inches maximum above the finish floor or ground.	Inner storage - change in level of 1.5" at storage room doorway, door has knob	For all doors along the public circulation route, repair, bevel, or ramp CILs at door entries to max .25". For all doors along the public circulation route, replace hardware with lever hardware or hardware operable without a tight pinch or grasp.	2010 ADAS Section: 404.2.3, 404.2.7, 404.2.4, 404.2.11, 404.2.11 Exception

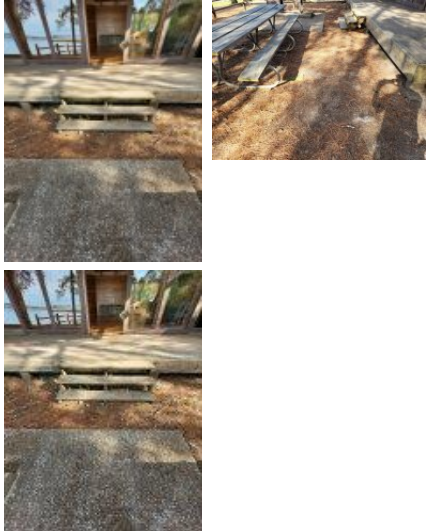
Finding Number	Area Description	Lat/Long	Finding	As Built	Recommendation	Citation	Photos	Figure
487	Picnic Area/Day Use - South: Picnic Area/Day Use - South Recreation Hall	[30.6575053 , -95.008085 4]	Stairways must have handrails on both sides. Handrails and their extensions must be between 34 inches and 38 inches above the stair nosing or ground. The top handrails shall extend a minimum of 12 inches beyond the top nosing and shall be parallel with the floor or ground surface. At the bottom of a stair flight, handrails shall extend at the slope of the stair flight for a horizontal distance at least equal to one tread depth beyond the last riser nosing. Extension shall return to a wall, guard, or the landing surface, or shall be continuous to the handrail of an adjacent stair flight. The orientation of at least one handrail, including the extension, shall be in the direction of the run of the stair and perpendicular to the direction of the stair nosing. Handrail gripping surfaces with a circular cross section shall have an outside diameter of 1-1/4 inches minimum and 2 inches maximum. Handrail gripping surfaces with a non-circular cross section shall have a perimeter dimension of 4 inches minimum and 6 1/4 inches maximum, and a cross-section dimension of 2-1/4 inches maximum. The hand grip portion of handrails shall have a smooth surface with no sharp corners. Gripping surfaces (top or sides) shall be uninterrupted by newel posts, other construction elements or obstructions. Any wall or other surface adjacent to the handrail shall be free of sharp or abrasive elements. Handrails projecting from a wall shall have a space of 1-1/2 inches minimum between the wall and the handrail. Treads shall be 11 inches (280 mm) deep minimum and uniform. Open risers are not permitted.	Non-egress stairway to grill patio in rear of Rec Hall - Lacks handrails on both sides of stairway, lacks closed risers, and lacks 11" minimum tread depth (9.5" deep)	Install handrails on both sides of stairway, mounted 34" to 38" aff with top and bottom extensions and having a 1.25" – 2" in diameter, or a non-circular grip that has a perimeter dimension of 4"- 6.25" max with a min gap of 1.5" between handrail and wall. Replace treads to be max 11" deep and uniform. Install to be a uniform height of 4"-7".	2015 ABAAS Section: 505.2  2012 TAS Section: 505.2  2010 ADAS Section: 505.2

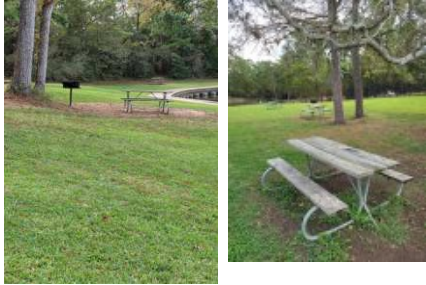
Finding Number	Area Description	Lat/Long	Finding	As Built	Recommendation	Citation	Photos	Figure
488	Picnic Area/Day Use - South: Picnic Area/Day Use - South Watercraft Rental	[30.6574091 , -95.0069707]	An accessible access route is not provided between elements, spaces and the facilities provided within the accessible camping unit. At least one outdoor recreation access route shall connect accessible elements, spaces and facilities provided within camping units with mobility features.	Watercraft area: lacks accessible route to features - 17 picnic tables/15 grills	Create AR with crushed and compacted stone or similar outdoor material to 20% of the tables and grills and replace with ones of an accessible design.	2015 ABAAS Section: F244.5.1

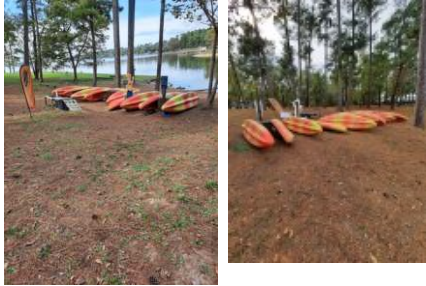
489	Picnic Area/Day Use - South: Picnic Area/Day Use - South Watercraft Rental	[30.6574, -95.0069676]	There is no accessible route to the watercraft rental area. At least one accessible route shall connect accessible buildings, accessible facilities, accessible elements, and accessible spaces that are on the same site.	Lacks accessible route to watercraft rental area	Create an accessible route with crushed stone or other outdoor material from parking or walkway to the watercraft rental area.	2015 ABAAS Section: F206.2.2  2012 TAS Section: 206.2.2  2010 ADAS Section: 206.2.2

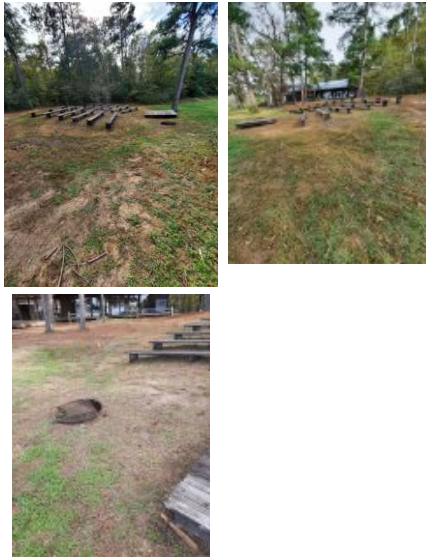
490	Picnic Area/Day Use - South: Picnic Area/Day Use - Old Amphitheater	[30.6574799 , -95.0082893]	There is no accessible route to the Old Amphitheater and associated fire pit. At least one accessible route shall connect accessible buildings, accessible facilities, accessible elements, and accessible spaces that are on the same site.	Lacks accessible to Old Amphitheater and associated fire pit	Create an accessible route with crushed stone or other outdoor material from parking or walkway to the Old Amphitheater and associated fire pit	2015 ABAAS Section: F206.2.2  2012 TAS Section: 206.2.2  2010 ADAS Section: 206.2.2

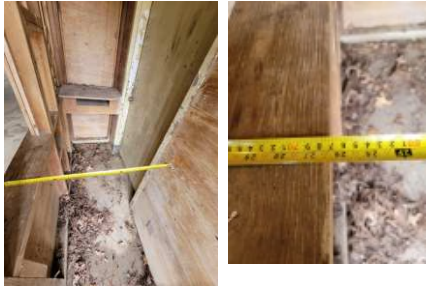
492	Picnic Area/Day Use - South: Picnic Area/Day Use - South - Employee Spaces	[30.6575676 , -95.007946]	Employee Work Areas. Common use circulation paths within employee work areas shall comply with 402. EXCEPTIONS: 1. Common use circulation paths located within employee work areas that are less than 1000 square feet (93 m2) and defined by permanently installed partitions, counters, casework, or furnishings shall not be required to comply with 402. 2. Common use circulation paths located within employee work areas that are an integral component of work area equipment shall not be required to comply with 402. 3. Common use circulation paths located within exterior employee work areas that are fully exposed to the weather shall not be required to comply with 402.	Electrical room behind former concessions counter - 26" clear width of approach	Make corrections for compliant circulation path. Widen route to compliant 36" clear width.	2015 ABAAS Section: F206.2.8, F206.2.8.1, F206.2.8.2  2012 TAS Section: 206.2.8, 206.2.8 Exception 1, 206.2.8 Exception 2, 206.2.8 Exception 3, 206.2.8 Advisory 1, 206.2.8 Advisory 2  2010 ADAS Section: 206.2.8, 206.2.8 Exception 1, 206.2.8 Exception 2, 206.2.8 Exception 3

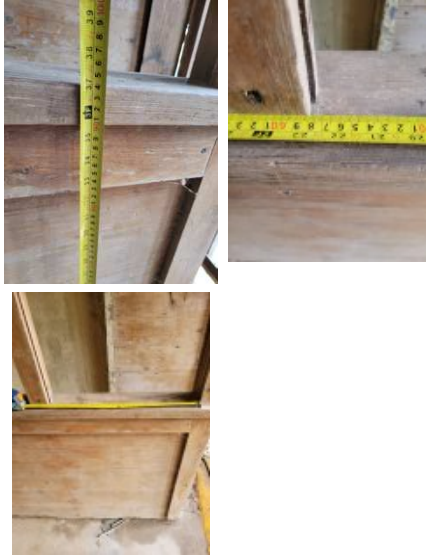
Finding Number	Area Description	Lat/Long	Finding	As Built	Recommendation	Citation	Photos	Figure
493	Picnic Area/Day Use - South: Picnic Area/Day Use - South - Employee Spaces	[30.6575791 , -95.007937 9]	The transaction counter provides for a parallel approach and is not within the required height range. Transaction counters shall be 36 inches high maximum and a minimum of 36 inches wide and should extend the same depth as the sales or service counter tops.	Former concession counter -37" aff and 23" wide	Lower 36" wide segment of service counter to max 36" aff if intended for use as a service counter.	2015 ABAAS Section: 904.4.1  2012 TAS Section: 904.4.1  2010 ADAS Section: 904.4.1

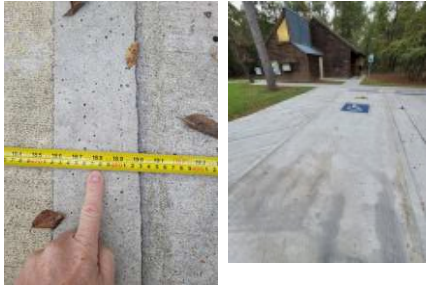
Finding Number	Area Description	Lat/Long	Finding	As Built	Recommendation	Citation	Photos	Figure
495	Pin Oak Loop: Restroom Parking and Exterior Accessible Route	[30.6697679, -95.0088955]	There are no van accessible parking stalls. 1 in every 6, minimum of one, required accessible stalls must be a van accessible stall. There are a total of 4 parking stalls in the parking lot that could be reasonably associated with this facility. There should be a minimum of 1 accessible stalls with a minimum of 1 being designed as van accessible.	Lacks total required width of stall and access aisle (188") for a van accessible parking space	Add van parking sign to 1 accessible stall and repaint stall and access aisle to 11' and 5' or 8' and 8' per the table	2015 ABAAS Section: F208.2, F208.2.4  2012 TAS Section: 208.2, 208.2.4  2010 ADAS Section: 208.2, 208.2.4

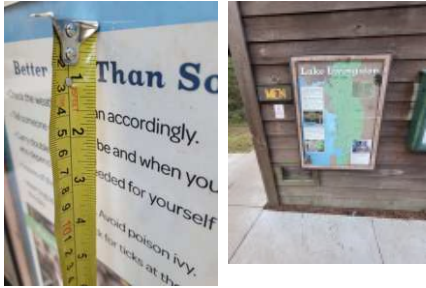
497	Pin Oak Loop: Restroom Parking and Exterior Accessible Route	[30.65691, -95.00105]	Element meets all standards and requirements	Parking lot complies with scoping - 4 standard stalls, 1 accessible	None	2010 ADAS Section: N/A		
498	Pin Oak Loop: Restroom Parking and Exterior Accessible Route	[30.6697577, -95.0089117]	Minimum character height shall comply with Table 703.5.5. Viewing distance shall be measured as the horizontal distance between the character and an obstruction preventing further approach towards the sign. Character height shall be based on the uppercase letter "I".	Lacks required character height on informational sign	Replace signage with compliant signage	2015 ABAAS Section: 703.5.5  2012 TAS Section: 703.5.5  2010 ADAS Section: 703.5.5

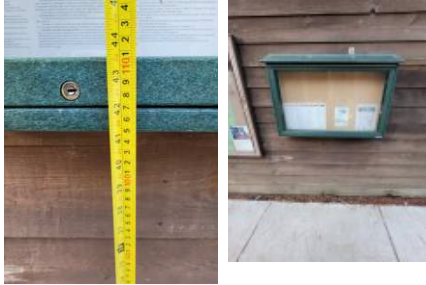
Finding Number	Area Description	Lat/Long	Finding	As Built	Recommendation	Citation	Photos	Figure
499	Pin Oak Loop: Pin Oak Loop Restroom Parking and Exterior Accessible Route	[30.6697024 , -95.009018 9]	Element meets all standards and requirements	Height of information sign and display box complies	None	2010 ADAS Section: N/A

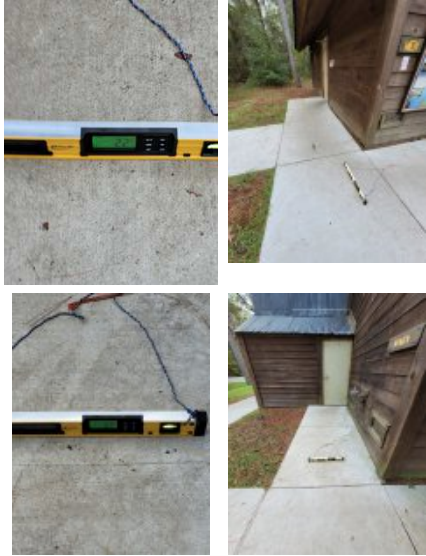
500	Pin Oak Loop: Pin Oak Loop Restroom Parking and Exterior Accessible Route	[30.6697247 , -95.008897 9]	The running slope of walking surfaces shall not be steeper than 1:20. The cross slope of walking surfaces shall not be steeper than 1:48.	Slope of 2.2% slope near men's restroom and 2.7% at maintenance room	Correct running slopes to max 5% and cross to max 2.08%.	2012 TAS Section: 403.3  2010 ADAS Section: 403.3

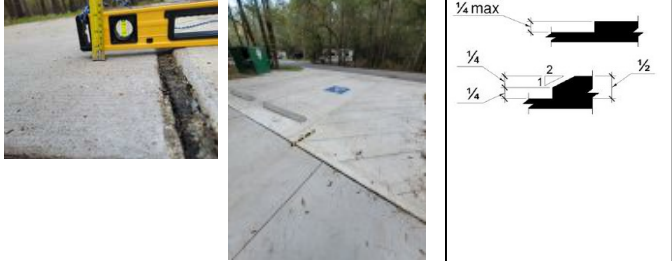
501	Pin Oak Loop: Pin Oak Loop Restroom Parking and Exterior Accessible Route	[30.6697275 , -95.008902 2]	The walkway contains abrupt vertical edges and/or variations over a 1/4 inch. 1/4 inch is the maximum vertical rise. Changes in level between 1/4 inch and 1/2 inch must be beveled at 1:2 or less. Changes in level greater than 1/2 inch must be by way of a ramp.	change in level of .75" at access aisle, 1" near dumpster, .75" at women's restroom, .75" at parking, and .75" at sidewalk	Repair, bevel or ramp change in level along accessible route.	2012 TAS Section: 303.2, 303.3  2010 ADAS Section: 303.2, 303.3

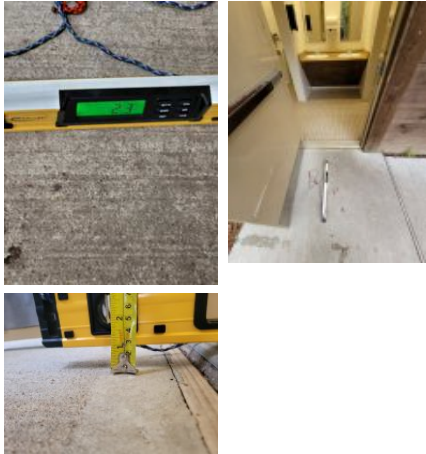
Finding Number	Area Description	Lat/Long	Finding	As Built	Recommendation	Citation	Photos	Figure
503	Pin Oak Loop: Pin Oak Loop Men's Restroom	[30.6697356 , -95.008900 8]	Minimum maneuvering clearances at doors and gates shall comply with 404.2.4. Maneuvering clearances shall extend the full width of the doorway and the required latch side or hinge side clearance. Maneuvering clearances shall have a max slope of 2.08%. The threshold has a vertical change greater than 1/4 inch high. Exterior doors are recommended to be maintained at 8.5 lbf as a smart practice. Force is to be measured at the operating hardware or 30 inches from the hinges, whichever is greater.	Door - slope of 2.3% on pull side landing, 1" at threshold, 12# push	For all doors along the public circulation route, provide required maneuvering clearance on push and pull side of doors. For all doors along the public circulation route, correct slope in door clearance to max 2.08%. For all doors along the public circulation route, repair, bevel, or ramp CILs at door entries to max .25". For all doors along the public circulation route, inspect, adjust, and maintain 8.5 lbf to open exterior doors as a smart practice.	2010 ADAS Section: 404.2.3, 404.2.7, 404.2.4, 404.2.11, 404.2.11 Exception

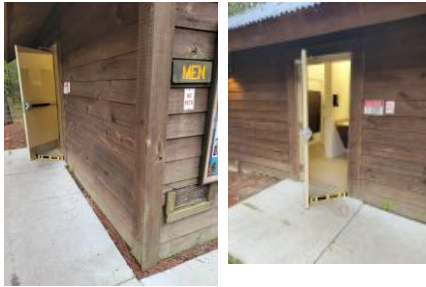
504	Pin Oak Loop: Pin Oak Loop Men's Restroom	[30.6697264 , -95.008898 1]	The restroom sign does not comply with one or more applicable requirements for the location, height, and properties of the sign.	Lacks Braille lettering and raised characters on restroom signage, no symbol of access	Replace sign with one of contrasting colors that includes Braille, raised characters, and the symbol of accessibility and mount on the wall, latch side of the door, 48" to the baseline of the lowest character and 60" to the baseline of the highest character.	2015 ABAAS Section: F216.2, 703.1, 703.2, 703.5, 703.6  2012 TAS Section: 216.2, 703.1, 703.2, 703.5, 703.6  2010 ADAS Section: 216.2, 703.1, 703.2, 703.5, 703.6

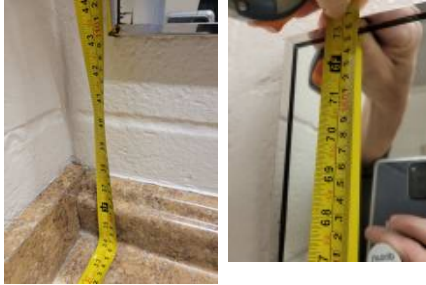
Finding Number	Area Description	Lat/Long	Finding	As Built	Recommendation	Citation	Photos	Figure
505	Pin Oak Loop: Pin Oak Loop Men's Restroom	[30.6697322 , -95.008890 1]	The mirror is mounted too high. Mirrors must have the bottom edge of the reflecting surface a maximum of 40 inches above the floor if above a sink or counter. Mirrors not located above lavatories or countertops shall be installed with the bottom edge of the reflecting surface 35 inches maximum above the finish floor or ground.	Bottom edge of reflecting surface of mirror is 43.5" aff and top edge of reflecting surface is 73" aff	Replace mirror mount to max 40" AFF to the bottom reflective surface and 74" to the top.	2015 ABAAS Section: 603.3  2012 TAS Section: 603.3  2010 ADAS Section: 603.3

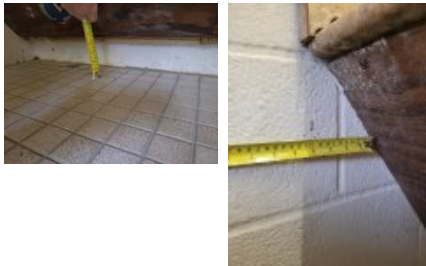
506	Pin Oak Loop: Pin Oak Loop Men's Restroom	[30.6697195 , -95.008898 1]	Knee clearance at 27 inches off the floor is not 8 inches minimum deep. The knee clearance, measured from the bottom of the apron or the outside bottom edge of the lavatory, must be 27 inches at a point located 8 inches back from the front edge and continuing to 11 inches minimum in depth at 9 inches above the floor. The top of the lavatory rim may be no higher than 34 inches.	Sink lacks 8" deep knee and toe clearance due to wood panel under sink	Remove face board to provide 8" deep knee clearance.	2015 ABAAS Section: 306.3.1, 306.3.2, 306.3.3, 306.3.4 , 306.3.5  2012 TAS Section: 306.3.2, 306.3.3, 306.3.4, 306.3.5, 306.3.1  2010 ADAS Section: 306.3.3, 306.3.2, 306.3.4, 306.3.5, 306.3.1

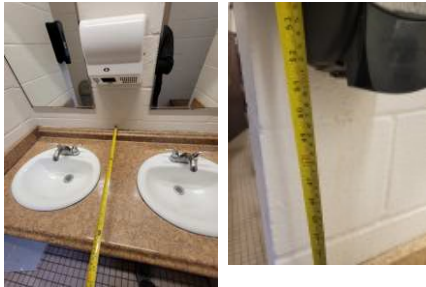
508	Pin Oak Loop: Pin Oak Loop Men's Restroom	[30.6697333 , -95.008903 5]	Where a high forward reach is over an obstruction, the clear floor space shall extend beneath the element for a distance not less than the required reach depth over the obstruction. The high forward reach shall be 48 inches (1220 mm) maximum where the reach depth is 20 inches (510 mm) maximum. Where the reach depth exceeds 20 inches (510 mm), the high forward reach shall be 44 inches (1120 mm) maximum and the reach depth shall be 25 inches (635 mm) maximum. Where a clear floor or ground space allows a parallel approach to an element and the high side reach is over an obstruction, the height of the obstruction shall be 34 inches (865 mm) maximum and the depth of the obstruction shall be 24 inches (610 mm) maximum. The high side reach shall be 48 inches (1220 mm) maximum for a reach depth of 10 inches (255 mm) maximum. Where the reach depth exceeds 10 inches (255 mm), the high side reach shall be 46 inches (1170 mm) maximum for a reach depth of 24 inches (610 mm) maximum.	Soap dispenser 51" aff	Lower soap dispenser to max 44" aff for a forward reach over counter.	2015 ABAAS Section: 308.2.1, 308.3.2  2012 TAS Section: 308.2.1, 308.3.2  2010 ADAS Section: 308.2.1, 308.3.2

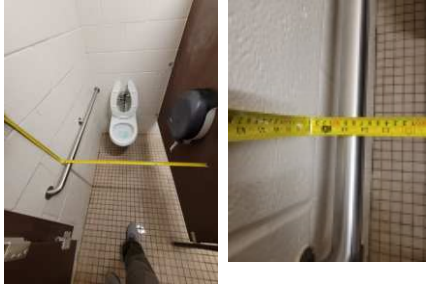
Finding Number	Area Description	Lat/Long	Finding	As Built	Recommendation	Citation	Photos	Figure
509	Pin Oak Loop: Pin Oak Loop Men's Restroom	[30.6697195 , -95.008895 5]	There are not enough accessible toilet compartments. The room contains several toilet compartments. A minimum of 1 must be wheelchair accessible .	Lacks wheelchair accessible stall - ambulatory only	Create a wheelchair accessible stall with grab bars and fixtures mounted in correct locations and at correct heights.	2015 ABAAS Section: F213.3.1  2012 TAS Section: 213.3.1  2010 ADAS Section: 213.3.1

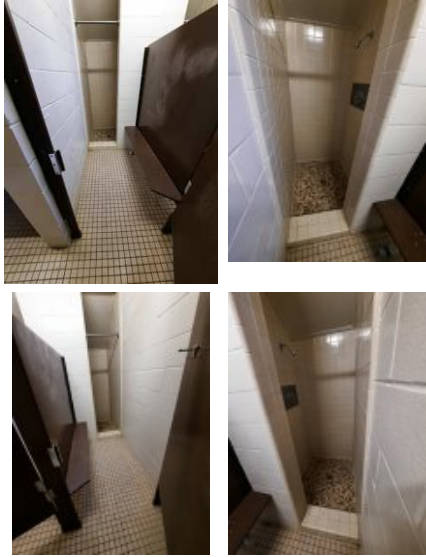
Finding Number	Area Description	Lat/Long	Finding	As Built	Recommendation	Citation	Photos	Figure
513	Pin Oak Loop: Pin Oak Loop Men's Shower	[30.6697402 , -95.008895 5]	There are no accessible bathing or shower facilities. Where facilities for bathing are provided for the public, clients or employees, including showers or bathtubs, at least one shower or bathtub and support facilities such as lockers, and not less than 1 percent of all facilities, shall be accessible.	Lacks accessible bathing or shower facilities	Create an accessible shower in locker/bathing room.	2015 ABAAS Section: F213.3.6  2012 TAS Section: 213.3.6  2010 ADAS Section: 213.3.6

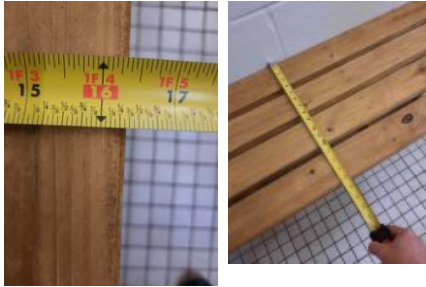
514	Pin Oak Loop: Pin Oak Loop Men's Shower	[30.6697241 , -95.008892 8]	The bench is not deep enough or long enough or is missing. Benches shall be provided having seats that are 42 inches long minimum and 20 inches deep minimum and 24 inches deep maximum. The bench shall provide for back support or shall be affixed to a wall. Back support shall be 42 inches (1065 mm) long minimum and shall extend from a point 2 inches (51 mm) maximum above the seat surface to a point 18 inches (455 mm) minimum above the seat surface. Back support shall be 2½ inches (64 mm) maximum from the rear edge of the seat measured horizontally. The top of the bench seat surface shall be 17 inches (430 mm) minimum and 19 inches (485 mm) maximum above the finish floor or ground. Clear floor or ground space complying with 305 shall be provided and shall be positioned at the end of the bench seat and parallel to the short axis of the bench	Bench lacks required dimensions - 16.25" deep and is not affixed to the wall	Replace bench in dressing area with one having a seat depth of 20" to 24" deep, 42" long, affixed to the wall or having a back and mounted 17" to 19" AFF and provide required clear floor space on the short axis of the bench.	2012 TAS Section: 903.4, 903.2, 903.3, 903.5  2010 ADAS Section: 903.4, 903.2, 903.3, 903.5

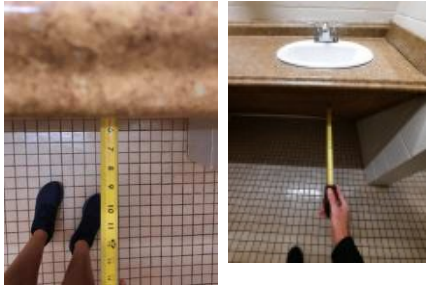
Finding Number	Area Description	Lat/Long	Finding	As Built	Recommendation	Citation	Photos	Figure
517	Pin Oak Loop: Pin Oak Loop Women's Restroom	[30.6697114 , -95.008895 5]	Knee clearance at 27 inches off the floor is not 8 inches minimum deep. The knee clearance, measured from the bottom of the apron or the outside bottom edge of the lavatory, must be 27 inches at a point located 8 inches back from the front edge and continuing to 11 inches minimum in depth at 9 inches above the floor. The top of the lavatory rim may be no higher than 34 inches.	Sink lacks 8" deep knee clearance due to wood panel	Remove face board to provide 8" deep knee clearance.	2015 ABAAS Section: 306.3.1, 306.3.2, 306.3.3, 306.3.4 , 306.3.5  2012 TAS Section: 306.3.2, 306.3.3, 306.3.4, 306.3.5, 306.3.1  2010 ADAS Section: 306.3.3, 306.3.2, 306.3.4, 306.3.5, 306.3.1

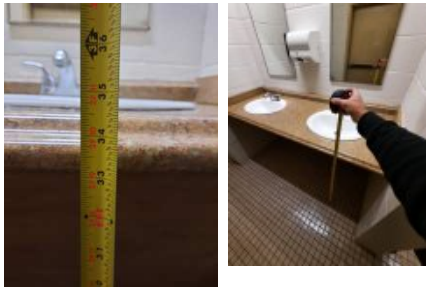
518	Pin Oak Loop: Pin Oak Loop Women's Restroom	[30.6697125 , -95.008887 4]	The top rim of the sink is too high. All lavatories/sinks that are designated to be accessible shall be a minimum 17 inches in horizontal depth and mounted with the rim or counter edge no higher than 34 inches above the finished floor.	The top rim of the sink is 34.75" aff	Lower sinks to max 34" aff to front of rim.	2015 ABAAS Section: 606.3  2012 TAS Section: 606.3  2010 ADAS Section: 606.3

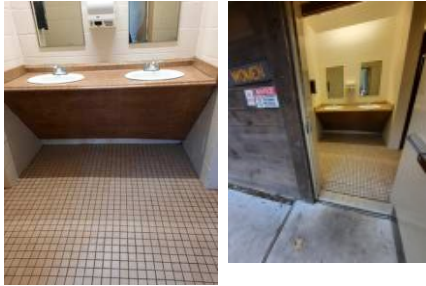
Finding Number	Area Description	Lat/Long	Finding	As Built	Recommendation	Citation	Photos	Figure
519	Pin Oak Loop: Pin Oak Loop Women's Restroom	[30.6697183 , -95.008882 1]	The water and drain pipes under the lavatory are not adequately insulated. Water supply and drain pipes under lavatories and sinks shall be insulated or otherwise configured to protect against contact. There shall be no sharp or abrasive surfaces under lavatories and sinks.	Wood panel covers pipes, unknown if pipes are insulated	Remove wood panel and insulate exposed pipes under one sink.	2015 ABAAS Section: 606.5  2012 TAS Section: 606.5  2010 ADAS Section: 606.5

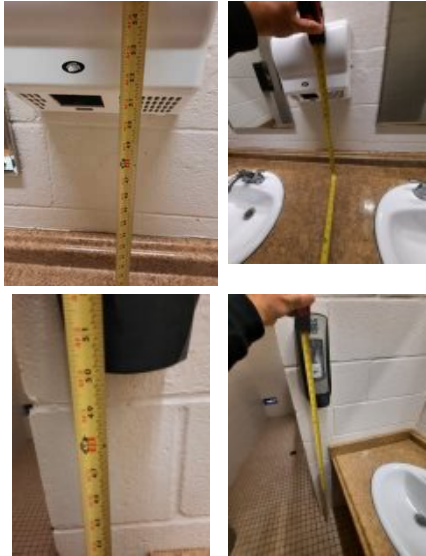
520	Pin Oak Loop: Pin Oak Loop Women's Restroom	[30.6697218 , -95.008882 1]	Where a high forward reach is over an obstruction, the clear floor space shall extend beneath the element for a distance not less than the required reach depth over the obstruction. The high forward reach shall be 48 inches (1220 mm) maximum where the reach depth is 20 inches (510 mm) maximum. Where the reach depth exceeds 20 inches (510 mm), the high forward reach shall be 44 inches (1120 mm) maximum and the reach depth shall be 25 inches (635 mm) maximum. Where a clear floor or ground space allows a parallel approach to an element and the high side reach is over an obstruction, the height of the obstruction shall be 34 inches (865 mm) maximum and the depth of the obstruction shall be 24 inches (610 mm) maximum. The high side reach shall be 48 inches (1220 mm) maximum for a reach depth of 10 inches (255 mm) maximum. Where the reach depth exceeds 10 inches (255 mm), the high side reach shall be 46 inches (1170 mm) maximum for a reach depth of 24 inches (610 mm) maximum.	Hand dryer 51" aff and soap dispenser 50" aff exceed reach range	Lower hand dryer to max 44" aff for a forward reach over counter. Lower soap dispenser to max 48" aff.	2015 ABAAS Section: 308.2.1, 308.3.2  2012 TAS Section: 308.2.1, 308.3.2  2010 ADAS Section: 308.2.1, 308.3.2

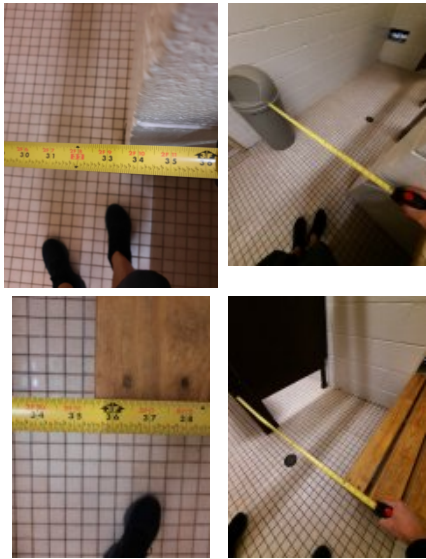
522	Pin Oak Loop: Pin Oak Loop Women's Restroom	[30.6697264 , -95.008890 1]	The route of travel at this location does not provide a minimum width of 36 inches. The clear width shall be permitted to be reduced to 32 inches minimum for a length of 24 inches maximum provided that reduced width segments are separated by segments that are 48 inches long minimum and 36 inches wide minimum.	Lacks 36" wide route of travel - 33.75" between garbage can and wall, 35.5" between partition and bench	Relocate obstacles such as garbage cans or benches to create AR through indicated rooms.	2015 ABAAS Section: 403.5.1  2012 TAS Section: 403.5.1  2010 ADAS Section: 403.5.1

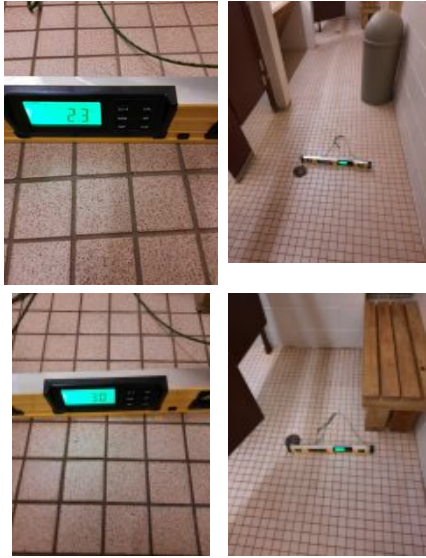
Finding Number	Area Description	Lat/Long	Finding	As Built	Recommendation	Citation	Photos	Figure
523	Pin Oak Loop: Pin Oak Loop Women's Restroom	[30.6697195 , -95.008892 8]	The accessible route contains running slopes greater than 5 percent and cross slopes greater than 2 percent across the width of the walk and has not been constructed as a ramp (i.e. handrails, wheel guides, etc.). When the slope in the direction of travel of any walk exceeds 1 unit vertical in 20 units horizontal (5-percent slope), it must be constructed as ramp. Surface cross slopes must not exceed one unit vertical in 48 units. Horizontal (2-percent slope).	Cross slopes of 2.3% and 3.0% near floor drains	Correct or repair slope to max 2.08%.	2015 ABAAS Section: 403.3  2012 TAS Section: 403.3  2010 ADAS Section: 403.3

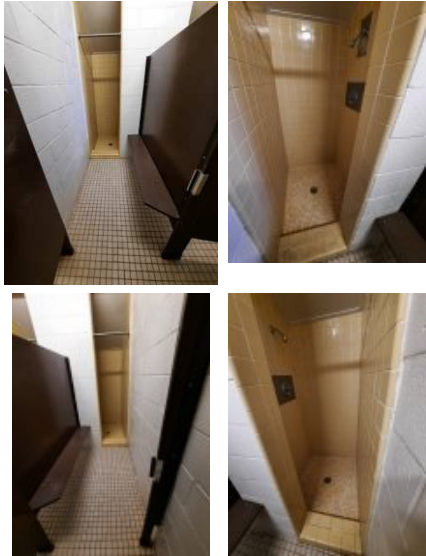
Finding Number	Area Description	Lat/Long	Finding	As Built	Recommendation	Citation	Photos	Figure
525	Pin Oak Loop: Pin Oak Loop Women's Shower	[30.6697471 , -95.008855 2]	There are no accessible bathing or shower facilities. Where facilities for bathing are provided for the public, clients or employees, including showers or bathtubs, at least one shower or bathtub and support facilities such as lockers, and not less than 1 percent of all facilities, shall be accessible.	Lacks accessible bathing or shower facilities	Create an accessible shower in locker/bathing room	2015 ABAAS Section: F213.3.6  2012 TAS Section: 213.3.6  2010 ADAS Section: 213.3.6

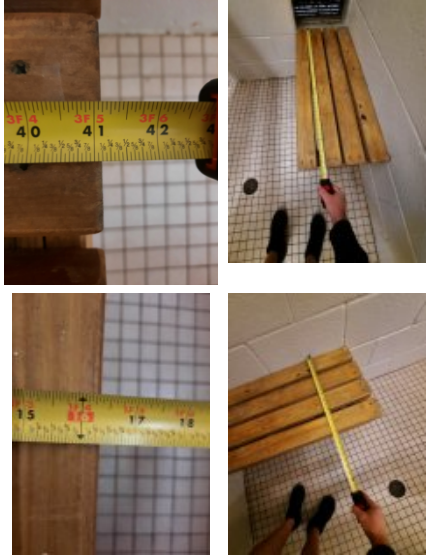
526	Pin Oak Loop: Pin Oak Loop Women's Shower	[30.6697195 , -95.008898 1]	The bench is not deep enough or long enough or is missing. Benches shall be provided having seats that are 42 inches long minimum and 20 inches deep minimum and 24 inches deep maximum. The bench shall provide for back support or shall be affixed to a wall. Back support shall be 42 inches (1065 mm) long minimum and shall extend from a point 2 inches (51 mm) maximum above the seat surface to a point 18 inches (455 mm) minimum above the seat surface. Back support shall be 2½ inches (64 mm) maximum from the rear edge of the seat measured horizontally. The top of the bench seat surface shall be 17 inches (430 mm) minimum and 19 inches (485 mm) maximum above the finish floor or ground. Clear floor or ground space complying with 305 shall be provided and shall be positioned at the end of the bench seat and parallel to the short axis of the bench	Lacks bench with required dimensions - 41" long x 16.25" deep and is not affixed to the wall	Replace bench in dressing area with one having a seat depth of 20" to 24" deep, 42" long, affixed to the wall or having a back and mounted 17" to 19" AFF and provide required clear floor space on the short axis of the bench.	2012 TAS Section: 903.4, 903.2, 903.3, 903.5  2010 ADAS Section: 903.4, 903.2, 903.3, 903.5

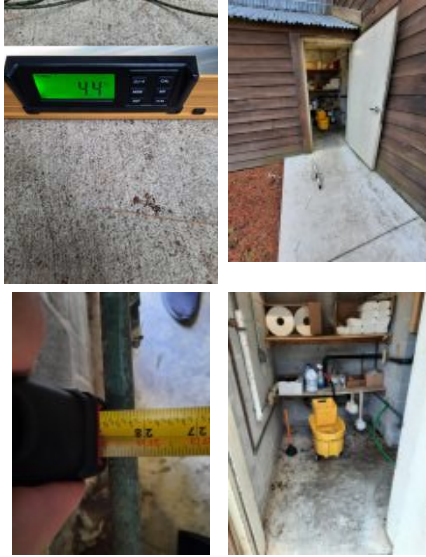
Finding Number	Area Description	Lat/Long	Finding	As Built	Recommendation	Citation	Photos	Figure
527	Pin Oak Loop: Pin Oak Loop Restroom Maintenance Room	[30.6697241 , -95.008951 8]	Spaces and elements within employee work areas shall only be required to comply with 206.2.8, 207.1, and 215.3 and shall be designed and constructed so that individuals with disabilities can approach, enter, and exit the employee work area. Employee work areas, or portions of employee work areas, other than raised courtroom stations, that are less than 300 square feet (28 m2) and elevated 7 inches (180 mm) or more above the finish floor or ground where the elevation is essential to the function of the space shall not be required to comply with these requirements or to be on an accessible route.	Door - Slope of 4.4% in pull side clearance, lacks clearance on push side due to storage and small space	For employee spaces, relocate storage, furniture, and other obstacles at doorways to provide approach, enter and exit at the employee space. Provide required maneuvering clearance on push and pull side of doors. Correct slope in door clearance to max 2.08%.	2015 ABAAS Section: F203.9  2012 TAS Section: 203.9  2010 ADAS Section: 203.9

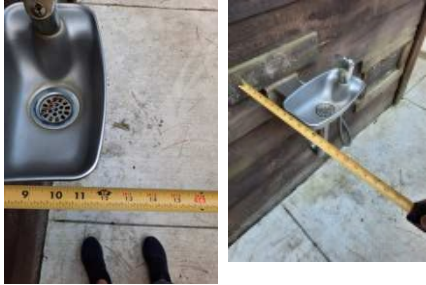
Finding Number	Area Description	Lat/Long	Finding	As Built	Recommendation	Citation	Photos	Figure
530	Pin Oak Loop: Pin Oak Loop Restroom Maintenance Room	[30.6697287 , -95.008903 5]	The drinking fountain projects more than 4 inches into the circulation path. Wall-mounted objects that have leading edges between 27 inches and 80 inches from the floor must not project more than 4 inches into the circulation path. Protruding objects that extend to the floor or within 27 inches of the floor are cane detectable and are therefore not hazardous. Where it is necessary or desirable to have objects protrude from the wall, a manner of cane detection must be provided.	Drinking fountain protrudes 12"	Relocate protruding objects or place cane detectable warning or bollard at foot of item.	2015 ABAAS Section: 307.2 2012 TAS Section: 307.2 2010 ADAS Section: 307.2

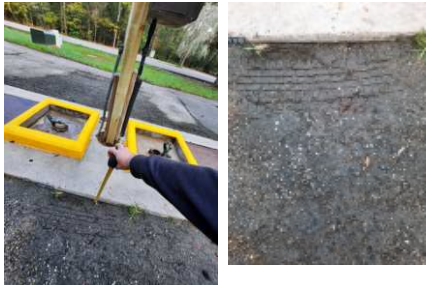
531	Pin Oak Loop: Pin Oak Loop Dump Station	[30.6697102 , -95.008160 5]	The clear floor space required at the dump station has a change in elevation. Changes in level are not permitted at required clear floor or ground space except that slopes not steeper than 1:48 shall be permitted.	Lacks clear floor space due to 2" change in level and asphalt, mud, loose rock surface	Provide 30" by 48" clear floor space at dump station operable parts	2015 ABAAS Section: 305.2 2012 TAS Section: 305.2 2010 ADAS Section: 305.2

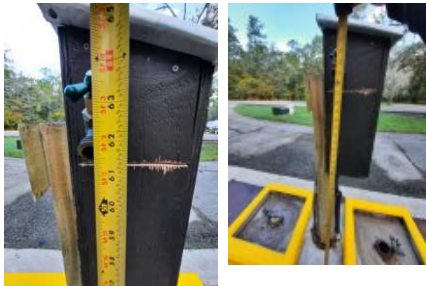
532	Pin Oak Loop: Pin Oak Loop Dump Station	[30.6697218 , -95.008172 6]	Water spouts at water hydrants and water utility hook-ups shall be 28 inches (710 mm) minimum and 36 inches (915 mm) maximum above the ground.	Water spout at 63.25" agl	Remount water spouts to 28" min or 36" max above the ground as a smart practice.	2015 ABAAS Section: 1011.6

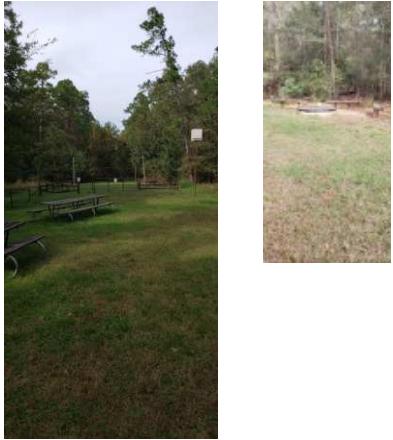
Finding Number	Area Description	Lat/Long	Finding	As Built	Recommendation	Citation	Photos	Figure
534	Pin Oak Loop: Pin Oak Loop Archery Range	[30.6702778 , -95.007779 7]	There is no accessible route to the archery range, fire pit, benches, and picnic tables. At least one accessible route shall connect accessible buildings, accessible facilities, accessible elements, and accessible spaces that are on the same site.	Lacks accessible route to archery area building, archery range, fire pit, benches, and picnic tables	Create an accessible route with crushed stone or other outdoor material from parking or walkway to the archery range, fire pit, benches, and picnic tables	2015 ABAAS Section: F206.2.2  2012 TAS Section: 206.2.2  2010 ADAS Section: 206.2.2

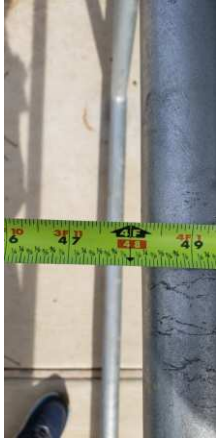
Finding Number	Area Description	Lat/Long	Finding	As Built	Recommendation	Citation	Photos	Figure																										
535	Picnic Area/Day Use - North: Picnic Area/Day Use - North Fishing Pier	[30.6603444 , -95.006578]	The landing at the change of direction is not the correct size. Landings at a change of direction shall have a dimension in the direction of ramp run of not less than 60 inches by 60 inches.	Lacks 60" by 60" landing where the ramp changes direction	Enlarge landing on ramp where directions change to 60" by 60".	2015 ABAAS Section: 405.7.4  2012 TAS Section: 405.7.4  2010 ADAS Section: 405.7.4

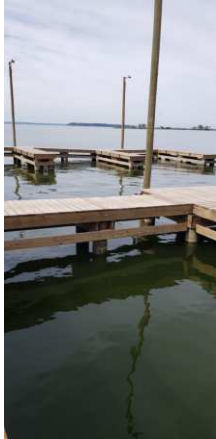
536	Picnic Area/Day Use - North: Picnic Area/Day Use - North Fishing Pier	[30.6600479 , -95.0069723]	The minimum number of boat slips is not provided. Where the number of boat slips is not identified, each 40 feet of boat slip edge provided along the perimeter of the pier shall be counted as one boat slip.	8 slips have 48" wide gangway to slips. 38" between cleats, 3% slope max on pier, there is 1 slip that appears to be accessible	Provide the required number of boat slips based on the total provided, or for every 40' of boat slip edge.	2015 ABAAS Section: F235.2  2010 ADAS Section: 235.2

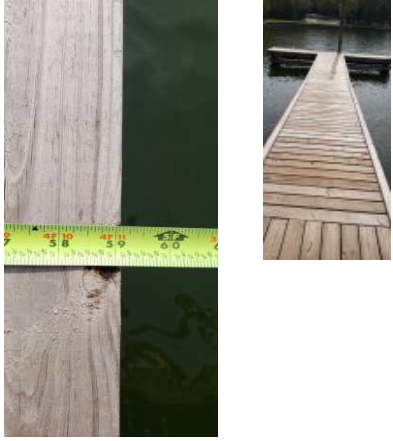
537	Picnic Area/Day Use - North: Picnic Area/Day Use - North Fishing Pier	[30.6600295 , -95.007015 2]	The boat slip segments are not wide enough. Boat slips shall provide clear pier space 60 inches wide minimum and at least as long as the boat slips. Each 10 feet maximum of linear pier edge serving boat slips shall contain at least one continuous clear opening 60 inches wide minimum. The clear width shall be permitted to be reduced to 36 inches minimum for a length of 24 inches maximum provided that reduced width segments are separated by segments that are 60 inches long minimum and 60 inches wide minimum.	pier is 59" wide with 3.5" wide edge protection on both sides, slip area is over 60" wide with 3.5" edge protection on both sides	Provide 60" clear pier space for the entire length of pier.	2015 ABAAS Section: 1003.3.1, 1003.3.1 EXCEPTIONS: 1  2012 TAS Section: 1003.3.1, 1003.3.1 Exceptions (3)  2010 ADAS Section: 1003.3.1, 1003.3.1 Exception 1
