# Access Audit Site Report

Prepared By  
**WT Group**

**Lake Livingston State Park**  
**300 State Park Rd 65**  
**Livingston, TX 77351**  
**Accessibility Evaluation**  
**Inspection Date: 11/08/2021**  
**Inspectors: Tanya Scheibe**

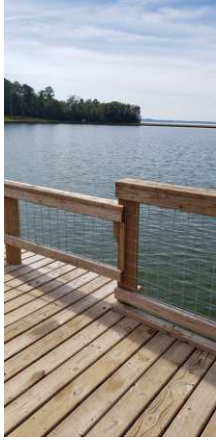
538	Picnic Area/Day Use - North: Picnic Area/Day Use - North Fishing Pier	[30.6600664 , -95.006977 7]	Element meets all standards and requirements	Pier complies with lowered railings = approximately 1000' over 34" agl and 250' at 34"	None	2010 ADAS Section: N/A

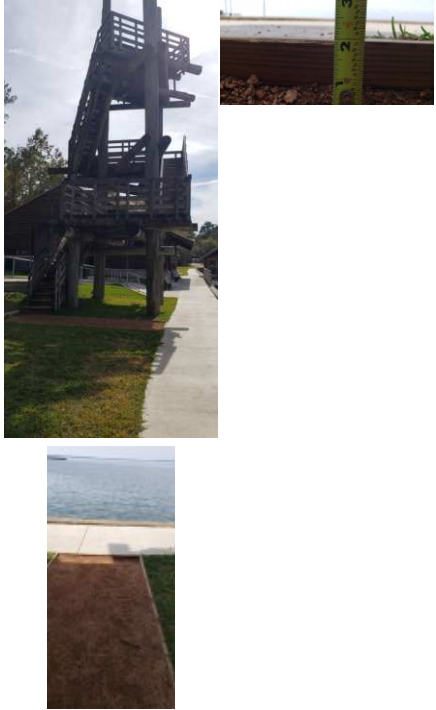
Finding Number	Area Description	Lat/Long	Finding	As Built	Recommendation	Citation	Photos	Figure
539	Picnic Area/Day Use - North: Picnic Area/Day Use - North Fishing Pier	[30.6603363 , -95.006784 6]	There is no accessible route to the lookout tower. At least one accessible route shall connect accessible buildings, accessible facilities, accessible elements, and accessible spaces that are on the same site.	Lacks accessible route to lookout tower - CIL of 2" where paved walkway connects to crushed granite path (displaces easily) to lookout tower stairs	Create an accessible route with crushed stone or other outdoor material from parking or walkway to the lookout tower. Provide an alternate method of viewing the surrounding area due to lack of access to the top.	2015 ABAAS Section: F206.2.2  2012 TAS Section: 206.2.2  2010 ADAS Section: 206.2.2

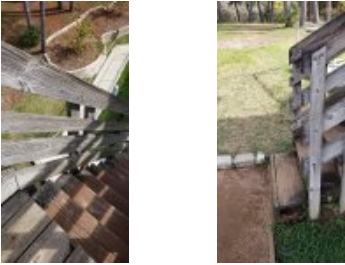
Finding Number	Area Description	Lat/Long	Finding	As Built	Recommendation	Citation	Photos	Figure
540	Picnic Area/Day Use - North: Picnic Area/Day Use - North Fishing Pier	[30.6603502 , -95.006767 1]	Stairways must have handrails on both sides. Handrails and their extensions must be between 34 inches and 38 inches above the stair nosing or ground. The top handrails shall extend a minimum of 12 inches beyond the top nosing and shall be parallel with the floor or ground surface. At the bottom of a stair flight, handrails shall extend at the slope of the stair flight for a horizontal distance at least equal to one tread depth beyond the last riser nosing. Extension shall return to a wall, guard, or the landing surface, or shall be continuous to the handrail of an adjacent stair flight. The orientation of at least one handrail, including the extension, shall be in the direction of the run of the stair and perpendicular to the direction of the stair nosing. Handrail gripping surfaces with a circular cross section shall have an outside diameter of 1-1/4 inches minimum and 2 inches maximum. Handrail gripping surfaces with a non-circular cross section shall have a perimeter dimension of 4 inches minimum and 6 1/4 inches maximum, and a cross-section dimension of 2-1/4 inches maximum. The hand grip portion of handrails shall have a smooth surface with no sharp corners. Gripping surfaces (top or sides) shall be uninterrupted by newel posts, other construction elements or obstructions. Any wall or other surface adjacent to the handrail shall be free of sharp or abrasive elements. Handrails projecting from a wall shall have a space of 1-1/2 inches minimum between the wall and the handrail.	Lookout tower lack compliant handrails	Install handrails on both sides of stairway, mounted 34" to 38" aff with top and bottom extensions and having a 1.25" – 2" in diameter, or a non-circular grip that has a perimeter dimension of 4"- 6.25" max with a min gap of 1.5" between handrail and wall	2015 ABAAS Section: 505.2  2012 TAS Section: 505.2  2010 ADAS Section: 505.2

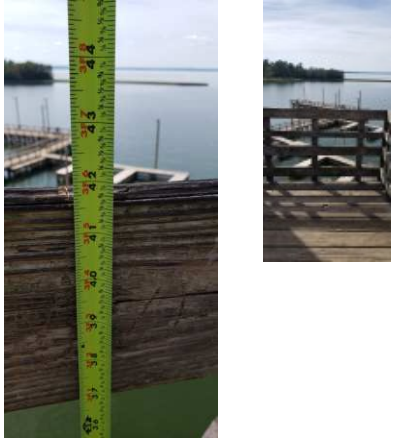
Finding Number	Area Description	Lat/Long	Finding	As Built	Recommendation	Citation	Photos	Figure
541	Picnic Area/Day Use - North: Picnic Area/Day Use - North Fishing Pier	[30.6603594 , -95.0067604]	Each distinct viewing location shall provide a viewing space adjacent to the clear ground space required by 1015.2 through which the point of interest is viewable. The viewing space shall be 32 inches (815 mm) maximum and 51 inches (1295 mm) minimum high above the ground and shall extend the full width of the clear ground space.	Lookout tower lacks accessible viewing areas (all railings are 42" aff)	Leave as is lack of lowered railings and provide an alternate method of viewing the surrounding area such as plexiglass windows, or video feed.	2015 ABAAS Section: 1015.3

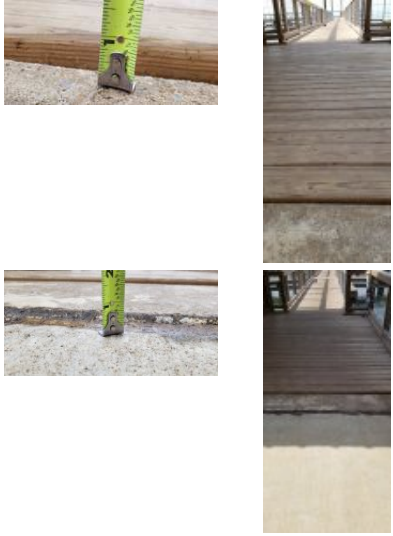
542	Picnic Area/Day Use - North: Picnic Area/Day Use - North Fishing Pier	[30.6600837 , -95.0067095]	The walkway contains abrupt vertical edges and/or variations over a 1/4 inch. 1/4 inch is the maximum vertical rise. Changes in level between 1/4 inch and 1/2 inch must be beveled at 1:2 or less. Changes in level greater than 1/2 inch must be by way of a ramp.	changes in level of 1" and .75" at fishing pier entry	Repair, bevel or ramp CIL along route.	2012 TAS Section: 303.2, 303.3  2010 ADAS Section: 303.2, 303.3

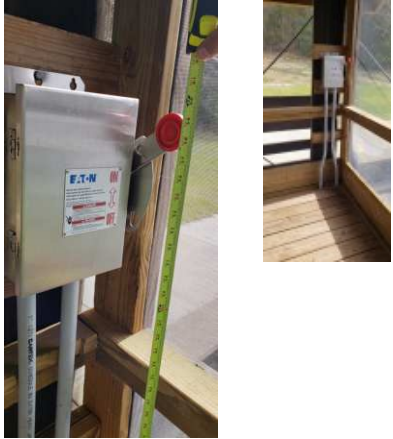
Finding Number	Area Description	Lat/Long	Finding	As Built	Recommendation	Citation	Photos	Figure
543	Picnic Area/Day Use - North: Picnic Area/Day Use - North Fish Cleaning Station	[30.660056, -95.006700 1]	The main power switch is positioned too high for either a side or front approach. Where a clear floor or ground space allows a parallel approach to an element and the side reach is unobstructed, the high side reach shall be 48 inches maximum and the low side reach shall be 15 inches minimum above the finish floor or ground. Where a forward reach is unobstructed, the high forward reach shall be 48 inches maximum and the low forward reach shall be 15 inches minimum above the finish floor or ground.	Main power switch 58" aff	Remount operable parts to be in reach range of 15" min to 48" max.	2015 ABAAS Section: 308.1  2012 TAS Section: 308.1  2010 ADAS Section: 308.1

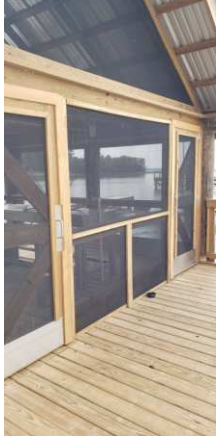
544	Picnic Area/Day Use - North: Picnic Area/Day Use - North Fish Cleaning Station	[30.6600572, -95.006688]	Element meets all standards and requirements	Fish cleaning station doors comply	None	2010 ADAS Section: N/A

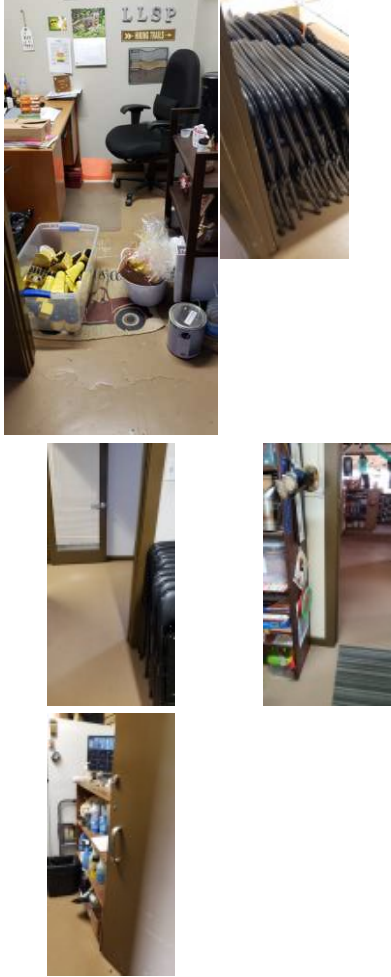
545	Picnic Area/Day Use - North: Picnic Area/Day Use - North Park Store	[30.6602256, -95.006618 3]	Spaces and elements within employee work areas shall only be required to comply with 206.2.8, 207.1, and 215.3 and shall be designed and constructed so that individuals with disabilities can approach, enter, and exit the employee work area. Employee work areas, or portions of employee work areas, other than raised courtroom stations, that are less than 300	Office 1 - storage in push side clearance; Classroom storage door - chairs in pull side clearance; Office 2 - bookshelf in pull side clearance, loose floor mat; Storage closet - bookshelf in	For employee spaces, relocate storage, furniture, and other obstacles at doorways to provide approach, enter and exit at the employee space. Provide required maneuvering clearance on push and pull side of doors. Secure rug at door to prevent trip hazard.	2015 ABAAS Section: F203.9  2012 TAS Section: 203.9  2010 ADAS

Finding Number	Area Description	Lat/Long	Finding	As Built	Recommendation	Citation	Photos	Figure
			square feet (28 m2) and elevated 7 inches (180 mm) or more above the finish floor or ground where the elevation is essential to the function of the space shall not be required to comply with these requirements or to be on an accessible route.	clearance		Section: 203.9

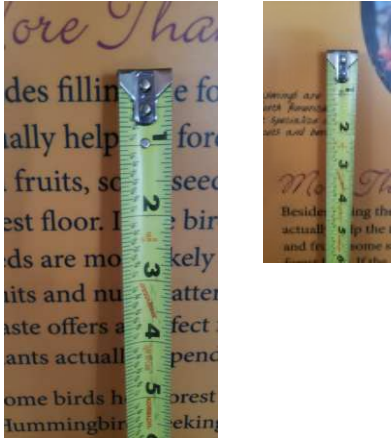
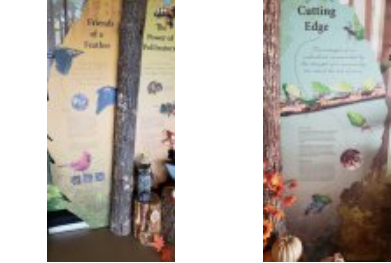
Finding Number	Area Description	Lat/Long	Finding	As Built	Recommendation	Citation	Photos	Figure																					
546	Picnic Area/Day Use - North: Picnic Area/Day Use - North Park Store	[30.6602463 , -95.006626 3]	Minimum character height shall comply with Table 703.5.5. Viewing distance shall be measured as the horizontal distance between the character and an obstruction preventing further approach towards the sign. Character height shall be based on the uppercase letter "I".	Lacks required character height on informational sign	Replace signage with compliant signage having the appropriate font size for viewing distance.	2015 ABAAS Section: 703.5.5  2012 TAS Section: 703.5.5  2010 ADAS Section: 703.5.5

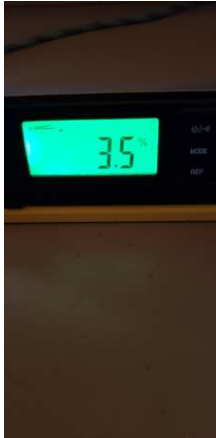
Finding Number	Area Description	Lat/Long	Finding	As Built	Recommendation	Citation	Photos	Figure
548	Picnic Area/Day Use - North: Picnic Area/Day Use - North Park Store	[30.6602348 , -95.0066236]	The accessible route contains running slopes greater than 5 percent and cross slopes greater than 2 percent across the width of the walk and has not been constructed as a ramp (i.e. handrails, wheel guides, etc.). When the slope in the direction of travel of any walk exceeds 1 unit vertical in 20 units horizontal (5-percent slope), it must be constructed as ramp. Surface cross slopes must not exceed one unit vertical in 48 units. Horizontal (2-percent slope).	Slope of 3.5%	Correct or repair slope to max 5% running and 2.08% cross	2015 ABAAS Section: 403.3  2012 TAS Section: 403.3  2010 ADAS Section: 403.3

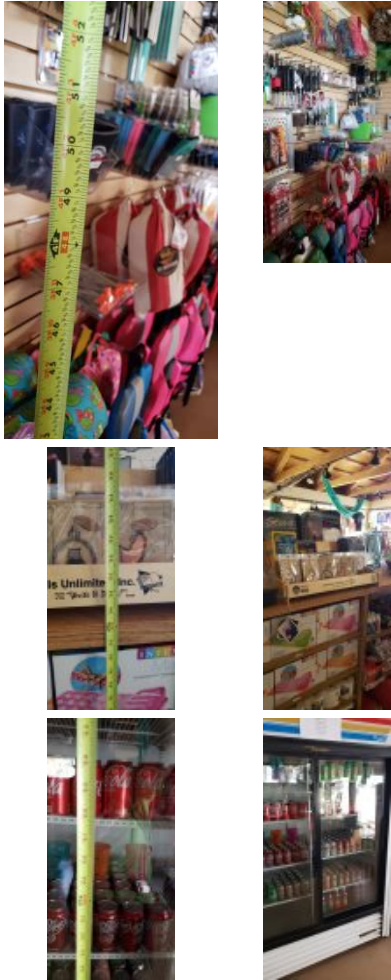
Finding Number	Area Description	Lat/Long	Finding	As Built	Recommendation	Citation	Photos	Figure
549	Picnic Area/Day Use - North: Picnic Area/Day Use - North Park Store	[30.6602579 , -95.006637]	The store merchandise is positioned too high for either a side or front approach. Where a clear floor or ground space allows a parallel approach to an element and the side reach is unobstructed, the high side reach shall be 48 inches maximum and the low side reach shall be 15 inches minimum above the finish floor or ground. Where a forward reach is unobstructed, the high forward reach shall be 48 inches maximum and the low forward reach shall be 15 inches minimum above the finish floor or ground.	Some park store merchandise items exceed reach range	Relocate merchandise to be in reach range of 15" min to 48" max.	2015 ABAAS Section: 308.1  2012 TAS Section: 308.1  2010 ADAS Section: 308.1

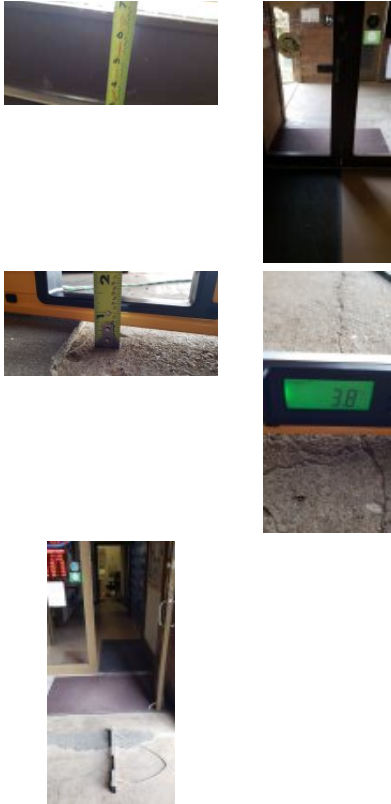
Finding Number	Area Description	Lat/Long	Finding	As Built	Recommendation	Citation	Photos	Figure
550	Picnic Area/Day Use - North: Picnic Area/Day Use - North Park Store	[30.6602463 , -95.006618 3]	Minimum maneuvering clearances at doors and gates shall comply with 404.2.4. Maneuvering clearances shall extend the full width of the doorway and the required latch side or hinge side clearance. Maneuvering clearances shall have a max slope of 2.08%. The threshold has a vertical change greater than 1/4 inch high. The sweep period for doors with closers shall be adjusted so that from an open position of 70 degrees, the door will take at least 3 seconds to move to a point 3 inches from the latch, measured to the leading edge of the door. Exterior doors are recommended to be maintained at 8.5 lbf as a smart practice. Force is to be measured at the operating hardware or 30 inches from the hinges, whichever is greater. The bottom 10 inches on the push side must be smooth and free of obstructions (hold open devices). Opening hardware must be mounted between 30 and 44 inches above the floor or ground.	Double entry doors - Lack smooth surface within 10" of the floor on the push side, 20# push, fast close, change in level of 1", slope of 3.8% on pull side landing, and loose floor mats on pull and push side landings	For all doors along the public circulation route, provide required maneuvering clearance on push and pull side of doors. For all doors along the public circulation route, secure rug in door clearance to prevent trip hazard. For all doors along the public circulation route, correct slope in door clearance to max 2.08%. For all doors along the public circulation route, repair, bevel, or ramp CILs at door entries to max .25". For all doors along the public circulation route, inspect, adjust, and maintain closing speed on door closers. For all doors along the public circulation route, inspect, adjust, and maintain 8.5 lbf to open exterior doors as a smart practice. For all doors along the public circulation route, provide kick plate on push side of door from floor to 10" AFF.	2010 ADAS Section: 404.2.3, 404.2.7, 404.2.4, 404.2.11, 404.2.11 Exception

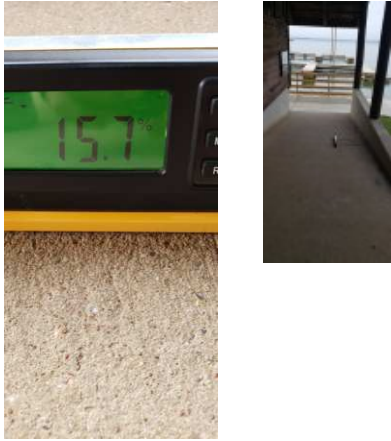
Finding Number	Area Description	Lat/Long	Finding	As Built	Recommendation	Citation	Photos	Figure
551	Picnic Area/Day Use - North: Picnic Area/Day Use - North Park Store	[30.660244, -95.0066209]	The running slope of walking surfaces shall not be steeper than 1:20.	Slope of 15.7% on accessible route from park store to pier	Correct running slope along the route to max 5%.	2015 ABAAS Section: 403.3  2012 TAS Section: 403.3  2010 ADAS Section: 403.3

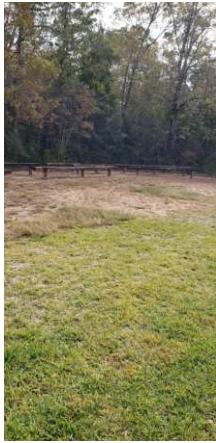
552	Picnic Area/Day Use - North: Picnic Area/Day Use - North Amphitheater	[30.6596718, -95.0064171]	There is no accessible route to the amphitheater. At least one accessible route shall connect accessible buildings, accessible facilities, accessible elements, and accessible spaces that are on the same site.	Lacks accessible route to amphitheater	Create an accessible route with crushed stone or other outdoor material from parking or walkway to amphitheater.	2015 ABAAS Section: F206.2.2  2012 TAS Section: 206.2.2  2010 ADAS Section: 206.2.2

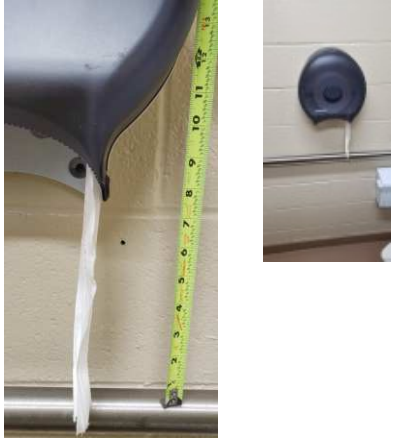
Finding Number	Area Description	Lat/Long	Finding	As Built	Recommendation	Citation	Photos	Figure
555	Picnic Area/Day Use - North: Picnic Area/Day Use - North Park Store Womens Restroom	[30.6602187 , -95.0066129]	The grab bar height and/or spacing fails. Grab bars must be mounted between 33" and 36" to the top of the gripping surface. There must be 1.5" of clearance between the grab bar and the wall. There must be a minimum of 1.5" of clearance below and minimum 12" above the grab bar to any dispenser or other obstruction.	TP dispenser is 7.5" above grab bar	Remount toilet paper dispenser max 7" to 9" from front of toilet, 15" to 48" aff and min 12" above or 1.5" below grab bar.	2015 ABAAS Section: 609.3, 609.4  2012 TAS Section: 609.4, 609.3  2010 ADAS Section: 609.3, 609.4

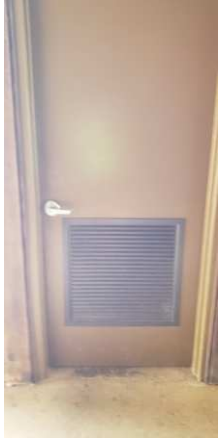
556	Picnic Area/Day Use - North: Picnic Area/Day Use - North Park Store Womens Restroom	[30.6602233 , -95.006629]	It is recommended that exterior doors be maintained so that the operating pressure does not exceed 8.5 lb. force to open. The sweep period for doors with closers shall be adjusted so that from an open position of 70 degrees, the door will take at least 3 seconds to move to a point 7 inches from the latch, measured to the leading edge of the door.	Exterior door - 20# push, fast close	For all doors along the public circulation route, inspect, adjust, and maintain 8.5 lbf to open exterior doors as a smart practice For all doors along the public circulation route, inspect, adjust, and maintain closing speed on door closers	2012 TAS Section: 404.2.9, 404.2.9 Advisory, 404.2.8.1  2010 ADAS Section: 404.2.9, 404.2.8.1

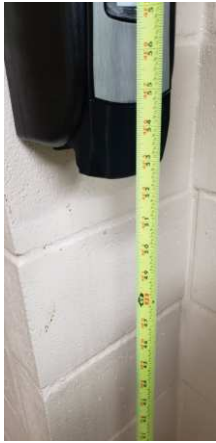
558	Picnic Area/Day Use - North: Picnic Area/Day Use - North Park Store Mens Restroom	[30.6602417 , -95.006596 8]	Where a high forward reach is over an obstruction, the clear floor space shall extend beneath the element for a distance not less than the required reach depth over the obstruction. The high forward reach shall be 48 inches (1220 mm) maximum where the reach depth is 20 inches (510 mm) maximum. Where the reach depth exceeds 20 inches (510 mm), the high forward reach shall be 44 inches (1120 mm) maximum and the reach depth shall be 25 inches (635 mm) maximum. Where a clear floor or ground space allows a parallel approach to an element and the high side reach is over an obstruction, the height of the obstruction shall be 34 inches (865 mm) maximum and the depth of the obstruction shall be 24 inches (610 mm) maximum. The high side reach shall be 48 inches (1220 mm) maximum for a reach depth of 10 inches (255 mm) maximum. Where the reach depth exceeds 10 inches (255 mm), the high side reach shall be 46 inches (1170 mm) maximum for a reach depth of 24 inches (610 mm) maximum.	Soap dispenser at 53" aff	Lower soap dispenser to max 48" aff.	2015 ABAAS Section: 308.2.1, 308.3.2  2012 TAS Section: 308.2.1, 308.3.2  2010 ADAS Section: 308.2.1, 308.3.2

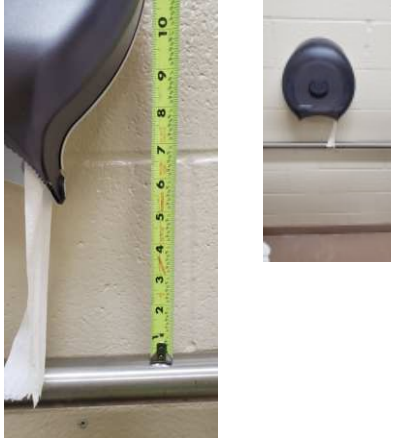
Finding Number	Area Description	Lat/Long	Finding	As Built	Recommendation	Citation	Photos	Figure																																																																														
559	Picnic Area/Day Use - North: Picnic Area/Day Use - North Park Store Mens Restroom	[30.6602348 , -95.0066263]	The grab bar height and/or spacing fails. Grab bars must be mounted between 33" and 36" to the top of the gripping surface. There must be 1.5" of clearance between the grab bar and the wall. There must be a minimum of 1.5" of clearance below and minimum 12" above the grab bar to any dispenser or other obstruction.	TP dispenser is 5" above grab bar	Remount toilet paper dispenser max 7" to 9" from front of toilet, 15" to 48" aff and min 12" above or 1.5" below grab bar.	2015 ABAAS Section: 609.3, 609.4  2012 TAS Section: 609.4, 609.3  2010 ADAS Section: 609.3, 609.4

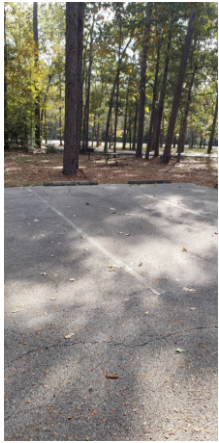
560	Picnic Area/Day Use - North: Picnic Area/Day Use North - Parking at Picnic Area	[30.66101, -95.0052691]	There are no accessible parking stalls. Each lot where parking is provided for the public as clients, guests or employees, shall provide accessible parking and shall be located on the shortest accessible route of travel from adjacent parking to an accessible entrance. There are a total of 28 parking stalls in the parking lot that could be reasonably associated with this facility. There should be a minimum of 2 accessible stalls with a minimum of 1 being designed as van accessible.	Lacks accessible parking stalls - 28 standard, 0 accessible	Create one or more 8' accessible parking stalls, with one 5' adjacent access aisle, with proper signage and striping based on the total number of stalls	2015 ABAAS Section: F208.2  2012 TAS Section: 208.2  2010 ADAS Section: 208.2

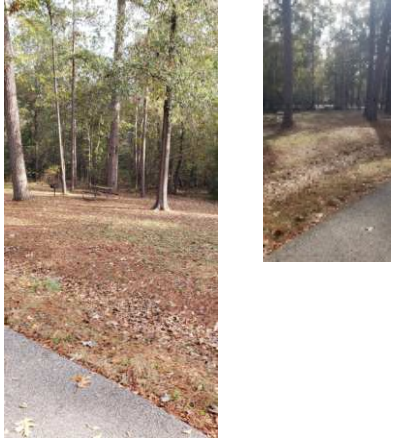
Finding Number	Area Description	Lat/Long	Finding	As Built	Recommendation	Citation	Photos	Figure
561	Picnic Area/Day Use - North: Picnic Area/Day Use North - Parking at Picnic Area	[30.6615061 , -95.006414 4]	An accessible access route is not provided between elements, spaces and the facilities provided within the accessible camping unit. At least one outdoor recreation access route shall connect accessible elements, spaces and facilities provided within camping units with mobility features.	Lacks route to 28 picnic tables and grills.	Create AR with crushed and compacted stone or similar outdoor material 20% of the tables and grills and replace with ones of an accessible design as a smart practice.	2015 ABAAS Section: F244.5.1

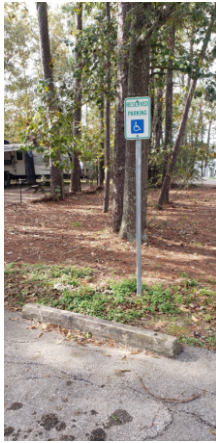
562	Picnic Area/Day Use - North: Picnic Area/Day Use North - Parking at Park Store/Pier/Boat Ramp	[30.6606247 , -95.006167 7]	The van stall is missing a sign identifying it as a van accessible stall. Parking space identification signs shall include the International Symbol of Accessibility. Signs identifying van parking spaces shall contain the designation "van accessible."	The van stall is missing a sign identifying it as a van accessible stall	Add one van parking sign to van accessible stall and ensure stall and access aisle are 11' and 5' or 8' and 8'	2015 ABAAS Section: 502.6 2012 TAS Section: 502.6 2010 ADAS Section: 502.6

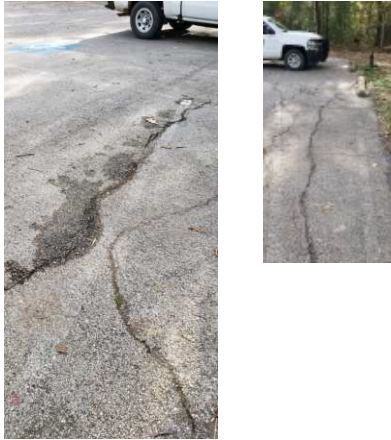
Finding Number	Area Description	Lat/Long	Finding	As Built	Recommendation	Citation	Photos	Figure
563	Picnic Area/Day Use - North: Picnic Area/Day Use North-Parking at Park Store/Pier/Boat Ramp	[30.6605786 , -95.006114]	The parking stall contains abrupt edges and surface irregularities over a 1/4 inch vertical. Parking spaces and access aisles serving them shall be stable, firm, and slip resistant. Access aisles shall be at the same level as the parking spaces they serve. Changes in level are not permitted and shall not be sloped steeper than 2% in any direction.	Multiple gaps and changes in level (CIL) due to deterioration of parking surface	Resurface stalls and access aisles to eliminate gaps and cracks	2015 ABAAS Section: 502.4  2012 TAS Section: 502.4  2010 ADAS Section: 502.4

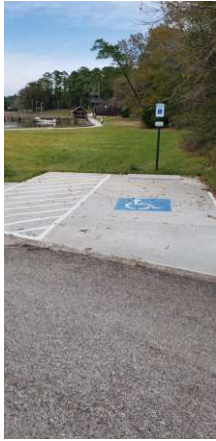
Finding Number	Area Description	Lat/Long	Finding	As Built	Recommendation	Citation	Photos	Figure
566	Picnic Area/ Day Use - Central: Picnic Area/ Day Use - Central Boat Ramp Parking	[30.6589727 , -95.006248 1]	There are no accessible parking stalls. Each lot where parking is provided for the public as clients, guests or employees, shall provide accessible parking and shall be located on the shortest accessible route of travel from adjacent parking to an accessible entrance. There are a total of 35 parking stalls in the parking lot that could be reasonably associated with this facility. There should be a minimum of 2 accessible stalls with a minimum of 1 being designed as van accessible.	Lacks required number of accessible parking stalls (35 standard, 1 accessible)	Create one or more 8' accessible parking stalls, with one 5' adjacent access aisle, with proper signage and striping based on the total number of stalls	2015 ABAAS Section: F208.2  2012 TAS Section: 208.2  2010 ADAS Section: 208.2

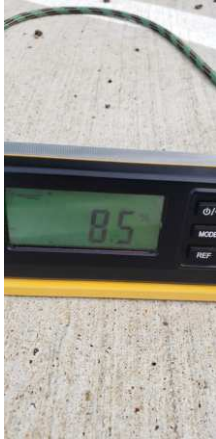
567	Picnic Area/ Day Use - Central: Picnic Area/ Day Use - Central Boat Ramp Parking	[30.6589012 , -95.006312 5]	The cross slopes (narrow dimension) and/or running slopes (long dimension) of the access aisle exceeds 2%. The running slope and the cross slope in an accessible parking stall and the access aisle must not exceed 2%.	Slope of 8.5% in aisle aisle	Repair or correct slope of parking space and access aisle to max 2.08% in any direction	2015 ABAAS Section: 502.4  2012 TAS Section: 502.4  2010 ADAS Section: 502.4

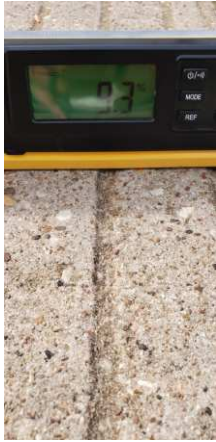
569	Picnic Area/ Day Use - Central: Picnic Area/ Day Use - Central Boat Ramp	[30.6589993 , -95.006439 9]	There is no accessible route to/on the boating facility. Accessible routes serving recreational boating facilities, including gangways and floating piers, shall comply with accessible route requirements except as modified by section Recreational Boating Facilities - Accessible Routes.	Cross slope of 9.3% on accessible route from parking to the boarding pier	Correct slope along route to pier to be max 2.08% cross and 5% running.	2015 ABAAS Section: 1005.1, 1005.1 EXCEPTIONS: 1, 1005.1 EXCEPTIONS: 2  2010 ADAS Section: 1005.1, 1005.1 Exception 1, 1005.1 Exception 2

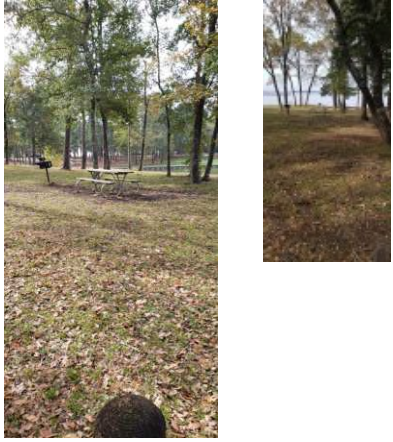
Finding Number	Area Description	Lat/Long	Finding	As Built	Recommendation	Citation	Photos	Figure
570	Picnic Area/ Day Use - Central: Picnic Area/ Day Use - Central Picnic	[30.6582575 , -95.0063822]	An accessible access route is not provided between elements, spaces and the facilities provided within the accessible camping unit. At least one outdoor recreation access route shall connect accessible elements, spaces and facilities provided within camping units with mobility features.	Lacks route to 9 picnic tables and grills.	Create AR with crushed and compacted stone or similar outdoor material to two tables and grills and replace with ones of an accessible design.	2015 ABAAS Section: F244.5.1

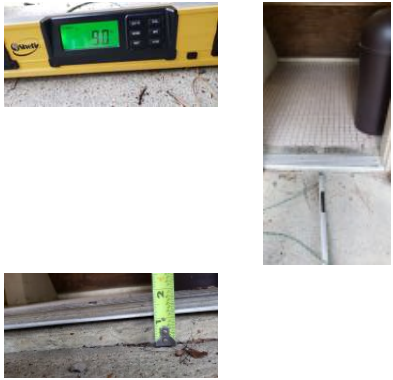
571	Picnic Area/ Day Use - Central: Picnic Area/ Day Use - Central Mens Restroom	[30.6591089 , -95.0057117]	Minimum maneuvering clearances at doors and gates shall comply with 404.2.4. Maneuvering clearances shall extend the full width of the doorway and the required latch side or hinge side clearance. The threshold has a vertical change greater than 1/4 inch high. The sweep period for doors with closers shall be adjusted so that from an open position of 70 degrees, the door will take at least 3 seconds to move to a point 3 inches from the latch, measured to the leading edge of the door. Exterior doors are recommended to be maintained at 8.5 lbf as a smart practice. Force is to be measured at the operating hardware or 30 inches from the hinges, whichever is greater.	Door - garbage can in door maneuvering clearance due to garbage can location, 30# push, fast close, change in level (CIL) of 2", slope of 9% on landing	For all doors along the public circulation route, provide required maneuvering clearance on push and pull side of doors For all doors along the public circulation route, repair, bevel, or ramp CILs at door entries to max .25" For all doors along the public circulation route, inspect, adjust, and maintain closing speed on door closers For all doors along the public circulation route, inspect, adjust, and maintain 8.5 lbf to open exterior doors as a smart practice For all doors along the public circulation route, correct or repair slope at doorway landing to max 2.08% in any direction for level CFS	2010 ADAS Section: 404.2.3, 404.2.7, 404.2.4, 404.2.11, 404.2.11 Exception

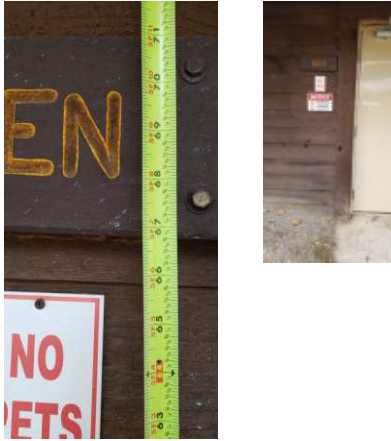
Finding Number	Area Description	Lat/Long	Finding	As Built	Recommendation	Citation	Photos	Figure
572	Picnic Area/ Day Use - Central: Picnic Area/ Day Use - Central Mens Restroom	[30.6591008 , -95.005722 4]	The restroom sign does not comply with one or more applicable requirements for the location, height, and properties of the sign.	Non compliant sign, mounted to 68" aff, lacks symbol of access	Acquire and mount signage, including Braille, raised lettering and access symbol mounted on wall, latch side of door, 48" to baseline of lowest character and 60" to baseline of highest character	2015 ABAAS Section: F216.2, 703.1, 703.2, 703.5, 703.6  2012 TAS Section: 216.2, 703.1, 703.2, 703.5, 703.6  2010 ADAS Section: 216.2, 703.1, 703.2, 703.5, 703.6

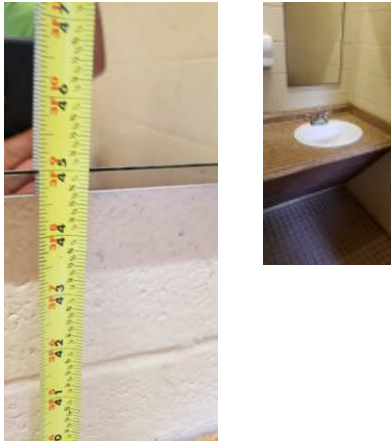
573	Picnic Area/ Day Use - Central: Picnic Area/ Day Use - Central Mens Restroom	[30.6590881 , -95.005729 1]	The mirror is mounted too high. Mirrors must have the bottom edge of the reflecting surface a maximum of 40 inches above the floor if above a sink or counter. Mirrors not located above lavatories or countertops shall be installed with the bottom edge of the reflecting surface 35 inches maximum above the finish floor or ground.	Bottom edge of reflecting surface of mirror is 45" aff	Lower mirror so reflective surface is max 40" aff	2015 ABAAS Section: 603.3  2012 TAS Section: 603.3  2010 ADAS Section: 603.3

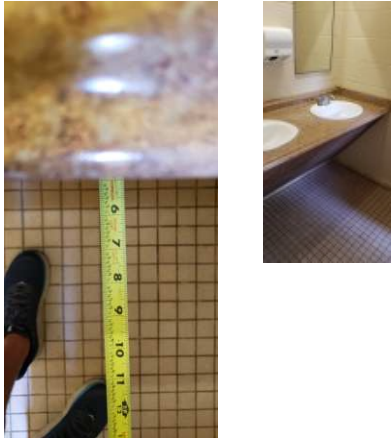
Finding Number	Area Description	Lat/Long	Finding	As Built	Recommendation	Citation	Photos	Figure
574	Picnic Area/ Day Use - Central: Picnic Area/ Day Use - Central Mens Restroom	[30.6591066 , -95.005730 5]	Knee clearance at 27 inches off the floor is not 8 inches minimum deep. The knee clearance, measured from the bottom of the apron or the outside bottom edge of the lavatory, must be 27 inches at a point located 8 inches back from the front edge and continuing to 11 inches minimum in depth at 9 inches above the floor. The top of the lavatory rim may be no higher than 34 inches.	Sink lacks 8" deep knee clearance due to wood panel	Remove face board to provide 8" deep knee clearance	2015 ABAAS Section: 306.3.1, 306.3.2, 306.3.3, 306.3.4 , 306.3.5  2012 TAS Section: 306.3.2, 306.3.3, 306.3.4, 306.3.5, 306.3.1  2010 ADAS Section: 306.3.3, 306.3.2, 306.3.4, 306.3.5, 306.3.1

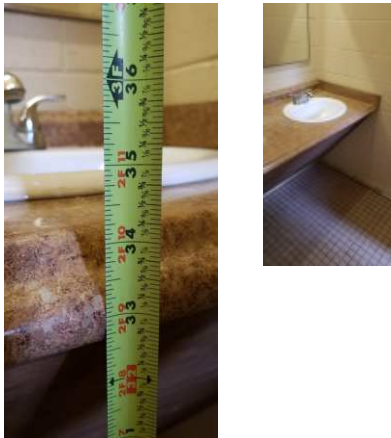
575	Picnic Area/ Day Use - Central: Picnic Area/ Day Use - Central Mens Restroom	[30.6590973 , -95.005730 5]	The top rim of the sink is too high. All lavatories/sinks that are designated to be accessible shall be a minimum 17 inches in horizontal depth and mounted with the rim or counter edge no higher than 34 inches above the finished floor.	The top rim of the sink is 35" aff	Lower sinks to max 34" aff to front of rim	2015 ABAAS Section: 606.3  2012 TAS Section: 606.3  2010 ADAS Section: 606.3

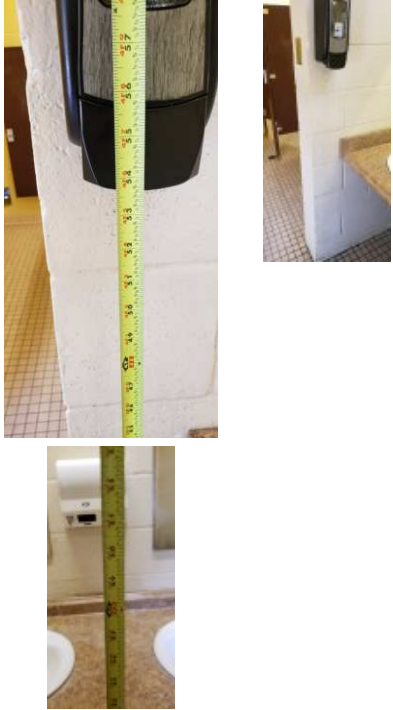
Finding Number	Area Description	Lat/Long	Finding	As Built	Recommendation	Citation	Photos	Figure
576	Picnic Area/ Day Use - Central: Picnic Area/ Day Use - Central Mens Restroom	[30.659095, -95.005741 2]	Where a high forward reach is over an obstruction, the clear floor space shall extend beneath the element for a distance not less than the required reach depth over the obstruction. The high forward reach shall be 48 inches (1220 mm) maximum where the reach depth is 20 inches (510 mm) maximum. Where the reach depth exceeds 20 inches (510 mm), the high forward reach shall be 44 inches (1120 mm) maximum and the reach depth shall be 25 inches (635 mm) maximum. Where a clear floor or ground space allows a parallel approach to an element and the high side reach is over an obstruction, the height of the obstruction shall be 34 inches (865 mm) maximum and the depth of the obstruction shall be 24 inches (610 mm) maximum. The high side reach shall be 48 inches (1220 mm) maximum for a reach depth of 10 inches (255 mm) maximum. Where the reach depth exceeds 10 inches (255 mm), the high side reach shall be 46 inches (1170 mm) maximum for a reach depth of 24 inches (610 mm) maximum.	Soap dispenser at 53.75" aff and hand dryer 52"	Lower soap dispenser to max 48" aff to highest operable part Lower hand dryer to max 44" aff for a forward reach over sink.	2015 ABAAS Section: 308.2.1, 308.3.2  2012 TAS Section: 308.2.1, 308.3.2  2010 ADAS Section: 308.2.1, 308.3.2

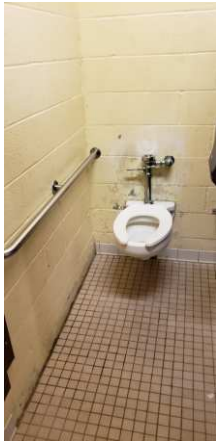
577	Picnic Area/ Day Use - Central: Picnic Area/ Day Use - Central Mens Restroom	[30.659095, -95.005717]	There are not enough accessible toilet compartments. The room contains several toilet compartments. A minimum of 1 must be wheelchair accessible .	Lacks wheelchair accessible stall, ambulatory only	Create a wheelchair accessible stall with grab bars and fixtures mounted in correct locations and at correct heights.	2015 ABAAS Section: F213.3.1  2012 TAS Section: 213.3.1  2010 ADAS Section: 213.3.1

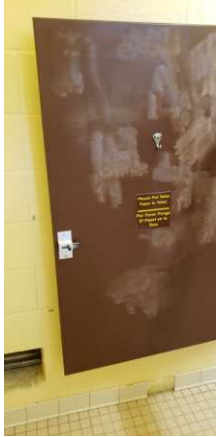
Finding Number	Area Description	Lat/Long	Finding	As Built	Recommendation	Citation	Photos	Figure
578	Picnic Area/ Day Use - Central: Picnic Area/ Day Use - Central Mens Restroom	[30.6591089 , -95.005717]	The stall door fails to comply with all of the door requirements. The stall door must be a minimum of 32" wide and have compliant hardware on both sides. The stall door must be self-closing.	Lacks self-closing door	Adjust stall door to be self-closing.	2015 ABAAS Section: 404.2.3, 404.2.7, 604.8.2.2  2012 TAS Section: 404.2.3, 404.2.7, 604.8.2.2  2010 ADAS Section: 404.2.3, 404.2.7, 604.8.2.2

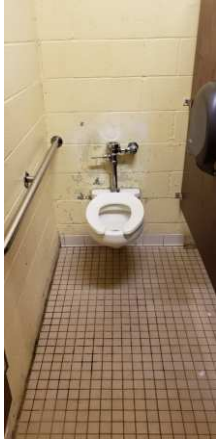
579	Picnic Area/ Day Use - Central: Picnic Area/ Day Use - Central Mens Restroom	[30.659095, -95.005722 4]	Grab bars shall comply with 609. A side-wall grab bar complying with 604.5.1 shall be provided on both sides of the compartment. The space between the wall and the grab bar shall be 1½ inches (38 mm). The space between the grab bar and projecting objects below and at the ends shall be 1½ inches (38 mm) minimum. The space between the grab bar and projecting objects above shall be 12 inches (305 mm) minimum. Grab bars shall be installed in a horizontal position, 33 inches (840 mm) minimum and 36 inches (915 mm) maximum above the finish floor measured to the top of the gripping surface, except that at water closets for children's use complying with 604.9, grab bars shall be installed in a horizontal position 18 inches (455 mm) minimum and 27 inches (685 mm) max	Lacks grab bars on both sides of ambulatory stall	Replace or add side grab bars with a 42" long grab bar, mounted max 12" from the rear wall at the close end and min 54" on the far end and 33" to 36" aff. In the alternative, use existing stall to create required wheelchair stall.	2015 ABAAS Section: 604.8.2.3, 609.3, 609.4  2012 TAS Section: 609.4, 609.3, 604.8.2.3  2010 ADAS Section: 609.3, 609.4, 604.8.2.3

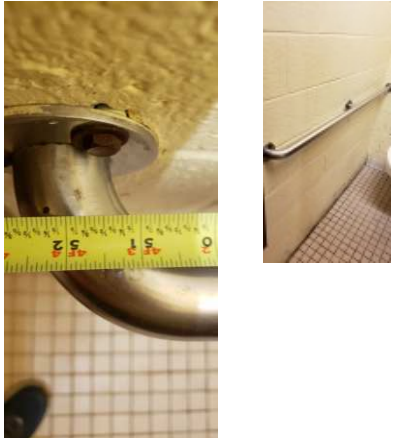
Finding Number	Area Description	Lat/Long	Finding	As Built	Recommendation	Citation	Photos	Figure
580	Picnic Area/ Day Use - Central: Picnic Area/ Day Use - Central Mens Restroom	[30.6590939 , -95.005726 4]	The side grab bars are not in the correct location. Grab bars on the side wall must be installed so that the end closest to the rear wall is maximum 12" from the rear wall. The end furthest from the rear wall must be mounted minimum 54" from the rear wall.	Side grab bar ends 52" from rear wall	Remount side grab bar to max 12" from the rear wall at the close end and min 54" on the far end, and 33" to 36" aff.	2015 ABAAS Section: 604.5.1  2012 TAS Section: 604.5.1  2010 ADAS Section: 604.5.1

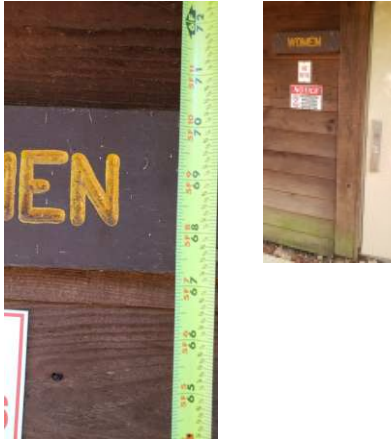
Finding Number	Area Description	Lat/Long	Finding	As Built	Recommendation	Citation	Photos	Figure
582	Picnic Area/ Day Use - Central: Picnic Area/ Day Use - Central Womens Restroom	[30.6590973 , -95.005706 3]	The restroom sign does not comply with one or more applicable requirements for the location, height, and properties of the sign.	signage fails, lacks Braille, raised lettering, symbol of access and mounted to 68" aff	Acquire and mount signage, including Braille, raised lettering and access symbol mounted on wall, latch side of door, 48" to baseline of lowest character and 60" to baseline of highest character	2015 ABAAS Section: F216.2, 703.1, 703.2, 703.5, 703.6  2012 TAS Section: 216.2, 703.1, 703.2, 703.5, 703.6  2010 ADAS Section: 216.2, 703.1, 703.2, 703.5, 703.6

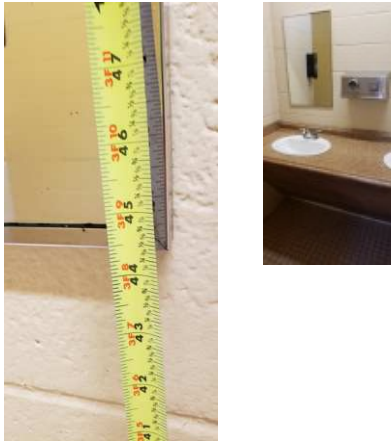
583	Picnic Area/ Day Use - Central: Picnic Area/ Day Use - Central Womens Restroom	[30.6590904 , -95.005738 5]	The mirror is mounted too high. Mirrors must have the bottom edge of the reflecting surface a maximum of 40 inches above the floor if above a sink or counter. Mirrors not located above lavatories or countertops shall be installed with the bottom edge of the reflecting surface 35 inches maximum above the finish floor or ground.	Bottom edge of reflecting surface of mirror is 45" aff	Lower mirror so reflective surface is max 40" aff	2015 ABAAS Section: 603.3  2012 TAS Section: 603.3  2010 ADAS Section: 603.3

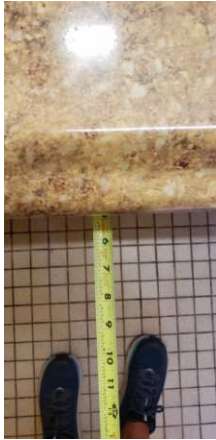
Finding Number	Area Description	Lat/Long	Finding	As Built	Recommendation	Citation	Photos	Figure
584	Picnic Area/ Day Use - Central: Picnic Area/ Day Use - Central Womens Restroom	[30.6590996, -95.0057291]	Knee clearance at 27 inches off the floor is not 8 inches minimum deep. The knee clearance, measured from the bottom of the apron or the outside bottom edge of the lavatory, must be 27 inches at a point located 8 inches back from the front edge and continuing to 11 inches minimum in depth at 9 inches above the floor. The top of the lavatory rim may be no higher than 34 inches.	Sink knee clearance 5" deep	Remove face board to provide 8" deep knee clearance	2015 ABAAS Section: 306.3.1, 306.3.2, 306.3.3, 306.3.4, 306.3.5  2012 TAS Section: 306.3.2, 306.3.3, 306.3.4, 306.3.5, 306.3.1  2010 ADAS Section: 306.3.3, 306.3.2, 306.3.4, 306.3.5, 306.3.1

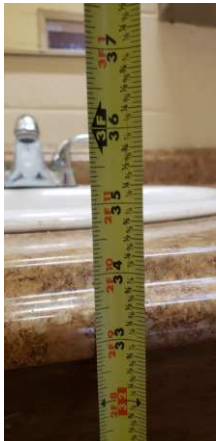
585	Picnic Area/ Day Use - Central: Picnic Area/ Day Use - Central Womens Restroom	[30.659095, -95.0057305]	The top rim of the sink is too high. All lavatories/sinks that are designated to be accessible shall be a minimum 17 inches in horizontal depth and mounted with the rim or counter edge no higher than 34 inches above the finished floor.	The top rim of the sink is 35" aff	Lower sinks to max 34" aff to front of rim	2015 ABAAS Section: 606.3  2012 TAS Section: 606.3  2010 ADAS Section: 606.3

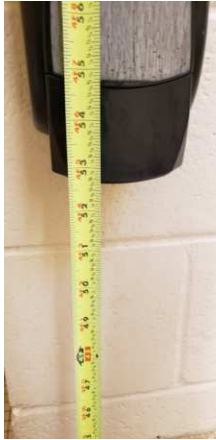
Finding Number	Area Description	Lat/Long	Finding	As Built	Recommendation	Citation	Photos	Figure
586	Picnic Area/ Day Use - Central: Picnic Area/ Day Use - Central Womens Restroom	[30.659095, -95.005717]	Where a high forward reach is over an obstruction, the clear floor space shall extend beneath the element for a distance not less than the required reach depth over the obstruction. The high forward reach shall be 48 inches (1220 mm) maximum where the reach depth is 20 inches (510 mm) maximum. Where the reach depth exceeds 20 inches (510 mm), the high forward reach shall be 44 inches (1120 mm) maximum and the reach depth shall be 25 inches (635 mm) maximum. Where a clear floor or ground space allows a parallel approach to an element and the high side reach is over an obstruction, the height of the obstruction shall be 34 inches (865 mm) maximum and the depth of the obstruction shall be 24 inches (610 mm) maximum. The high side reach shall be 48 inches (1220 mm) maximum for a reach depth of 10 inches (255 mm) maximum. Where the reach depth exceeds 10 inches (255 mm), the high side reach shall be 46 inches (1170 mm) maximum for a reach depth of 24 inches (610 mm) maximum.	Soap dispenser 52.75" aff and hand dryer 54"aff	Lower soap dispenser to max 48" aff to highest operable part Lower hand dryer to max 44" aff for a forward reach over counter	2015 ABAAS Section: 308.2.1, 308.3.2  2012 TAS Section: 308.2.1, 308.3.2  2010 ADAS Section: 308.2.1, 308.3.2

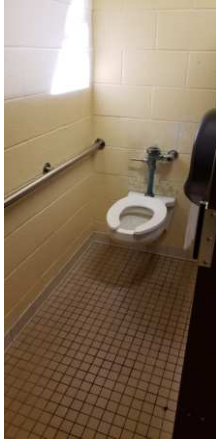
587	Picnic Area/ Day Use - Central: Picnic Area/ Day Use - Central Womens Restroom	[30.6590881, -95.0057251]	There are not enough accessible toilet compartments. The room contains several toilet compartments. A minimum of 1 must be wheelchair accessible .	Lacks wheelchair accessible stall, ambulatory only	Create a wheelchair accessible stall with grab bars and fixtures mounted in correct locations and at correct heights	2015 ABAAS Section: F213.3.1  2012 TAS Section: 213.3.1  2010 ADAS Section: 213.3.1

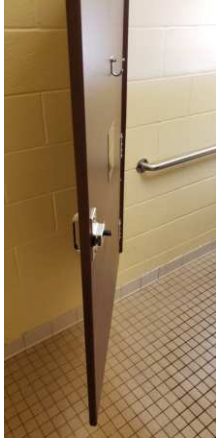
Finding Number	Area Description	Lat/Long	Finding	As Built	Recommendation	Citation	Photos	Figure
588	Picnic Area/ Day Use - Central: Picnic Area/ Day Use - Central Womens Restroom	[30.6590893 , -95.005717]	The stall door fails to comply with all of the door requirements. The stall door must be a minimum of 32" wide and have compliant hardware on both sides. The stall door must be self-closing.	Lacks self-closing door	Adjust stall door to be self-closing	2015 ABAAS Section: 404.2.3, 404.2.7, 604.8.2.2  2012 TAS Section: 404.2.3, 404.2.7, 604.8.2.2  2010 ADAS Section: 404.2.3, 404.2.7, 604.8.2.2

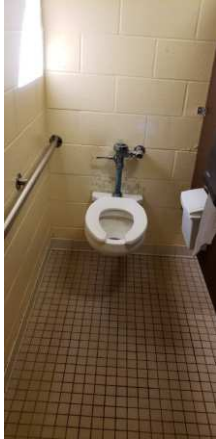
589	Picnic Area/ Day Use - Central: Picnic Area/ Day Use - Central Womens Restroom	[30.6590881 , -95.0057345]	Grab bars shall comply with 609. A side-wall grab bar complying with 604.5.1 shall be provided on both sides of the compartment. The space between the wall and the grab bar shall be 1½ inches (38 mm). The space between the grab bar and projecting objects below and at the ends shall be 1½ inches (38 mm) minimum. The space between the grab bar and projecting objects above shall be 12 inches (305 mm) minimum. Grab bars shall be installed in a horizontal position, 33 inches (840 mm) minimum and 36 inches (915 mm) maximum above the finish floor measured to the top of the gripping surface, except that at water closets for children's use complying with 604.9, grab bars shall be installed in a horizontal position 18 inches (455 mm) minimum and 27 inches (685 mm) max	Lacks grab bars on both sides of ambulatory stall	Replace or add side grab bars with a 42" long grab bar, mounted max 12" from the rear wall at the close end and min 54" on the far end and 33" to 36" aff. In the alternative, use existing stall to create required wheelchair stall.	2015 ABAAS Section: 604.8.2.3, 609.3, 609.4  2012 TAS Section: 609.4, 609.3, 604.8.2.3  2010 ADAS Section: 609.3, 609.4, 604.8.2.3

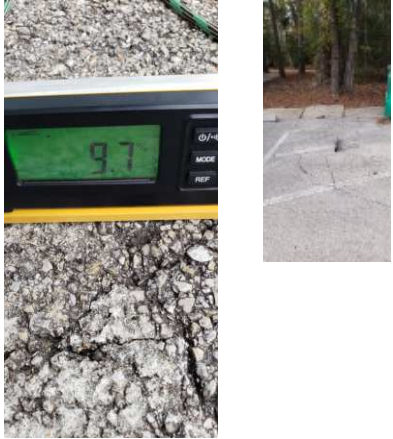
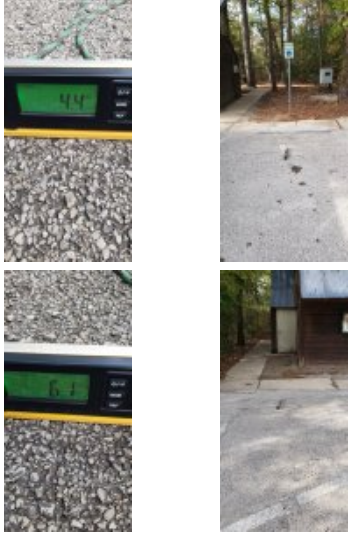
Finding Number	Area Description	Lat/Long	Finding	As Built	Recommendation	Citation	Photos	Figure
591	Picnic Area/ Day Use - Central: Picnic Area/ Day Use - Central Restroom Parking	[30.6590535 , -95.005676 8]	The cross slopes (narrow dimension) and/or running slopes (long dimension) of the access aisle exceeds 2%. The running slope and the cross slope in an accessible parking stall and the access aisle must not exceed 2%.	Slope of 9.7% in right access aisle, 4.4% in right stall and 6.1% in left access aisle, 6.3% in left stall	Repair or correct slope of parking space and access aisle to max 2.08% in any direction	2015 ABAAS Section: 502.4  2012 TAS Section: 502.4  2010 ADAS Section: 502.4

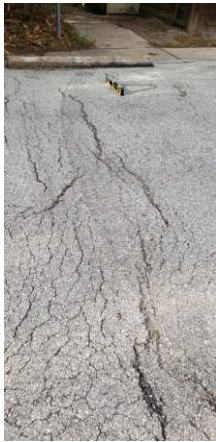
592	Picnic Area/ Day Use - Central: Picnic Area/ Day Use - Central Restroom Parking	[30.6590569 , -95.005663 4]	The parking stall contains abrupt edges and surface irregularities over a 1/4 inch vertical. Parking spaces and access aisles serving them shall be stable, firm, and slip resistant. Access aisles shall be at the same level as the parking spaces they serve. Changes in level are not permitted and shall not be sloped steeper than 2% in any direction.	Multiple gaps and changes in level (CIL) due to deterioration of parking surface	Resurface stalls and access aisles to eliminate gaps and cracks. Cost included in previous finding.	2015 ABAAS Section: 502.4 2012 TAS Section: 502.4 2010 ADAS Section: 502.4

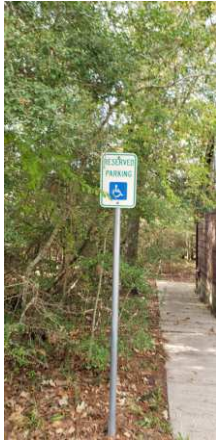
593	Picnic Area/ Day Use - Central: Picnic Area/ Day Use - Central Restroom Parking	[30.6590569 , -95.005644 6]	The van stall is missing a sign identifying it as a van accessible stall. Parking space identification signs shall include the International Symbol of Accessibility. Signs identifying van parking spaces shall contain the designation "van accessible."	The van stall is missing a sign identifying it as a van accessible stall	Add one van parking sign to van accessible stall and ensure stall and access aisle are 11' and 5' or 8' and 8'	2015 ABAAS Section: 502.6 2012 TAS Section: 502.6 2010 ADAS Section: 502.6

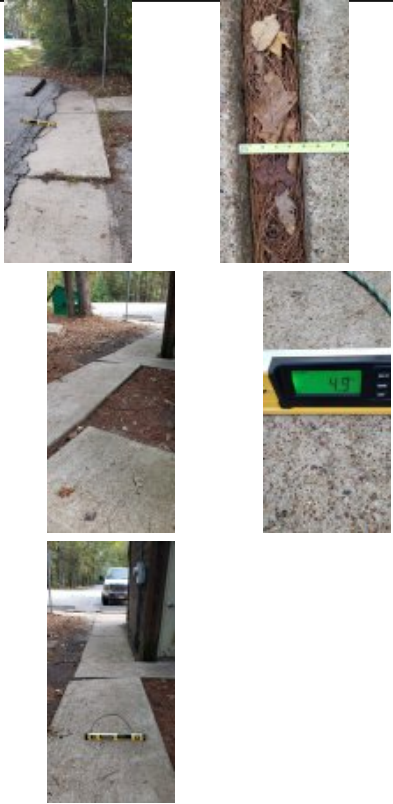
Finding Number	Area Description	Lat/Long	Finding	As Built	Recommendation	Citation	Photos	Figure
594	Picnic Area/ Day Use - Central: Picnic Area/ Day Use - Central Restroom Parking	[30.6590858 , -95.005671 4]	The path of contains multiple issues and is not accessible. The path of travel exceeds the maximum allowable cross and running slope requirements. It also contains changes in level and/or gaps that exceed the allowable maximum requirements. The path of travel does not meet the minimum width requirements for clearances, turning spaces, and/or passing spaces. The floor or ground surface is not firm, stable, and slip resistant.	Accessible route from parking lot to both restrooms has multiple CILs, cross slopes over 2%, gaps over 1"	Resurface route from parking to restrooms to be free of gaps, changes in level and having correct slopes.	2015 ABAAS Section: 403.1  2010 ADAS Section: 403.1

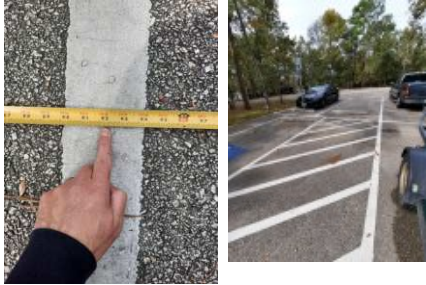
Finding Number	Area Description	Lat/Long	Finding	As Built	Recommendation	Citation	Photos	Figure																																				
595	Red Oak/Piney Shores Boat Ramp: Red Oak/Piney Shores Boat Ramp Parking	[30.6525398, -95.0060966]	There are no van accessible parking stalls. 1 in every 6, minimum of one, required accessible stalls must be a van accessible stall. There are a total of 24 parking stalls in the parking lot that could be reasonably associated with this facility. There should be a minimum of 1 accessible stalls with a minimum of 1 being designed as van accessible.	Lacks required width of access aisle (92") for a van accessible parking space	Add van parking sign to 1 accessible stall and repaint stall and access aisle to 11' and 5' or 8' and 8'.	2015 ABAAS Section: F208.2, F208.2.4  2012 TAS Section: 208.2, 208.2.4  2010 ADAS Section: 208.2, 208.2.4

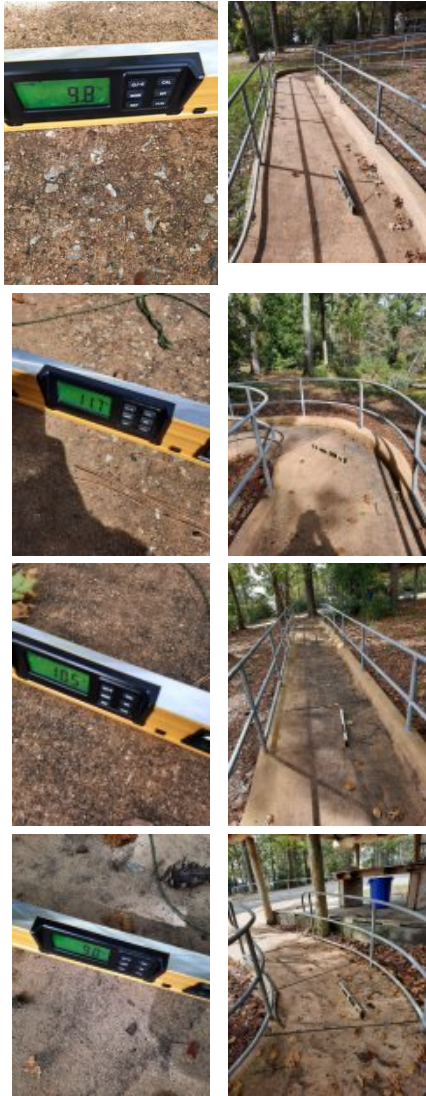
Finding Number	Area Description	Lat/Long	Finding	As Built	Recommendation	Citation	Photos	Figure
597	Red Oak/Piney Shores Boat Ramp: Red Oak/Piney Shores Boat Ramp	[30.6524406 , -95.0058458]	The ramps slope exceeds the maximum running slope (direction of travel) allowable of 8.33%. Ramps should have the least possible slope but in no case more than 8.3% (1:12).	Ramp to piers - slopes of 9.8%, 11.7%, 10.5%, and 9.0%	Correct slope of ramp to max 8.33%	2015 ABAAS Section: 405.2 2012 TAS Section: 405.2 2010 ADAS Section: 405.2

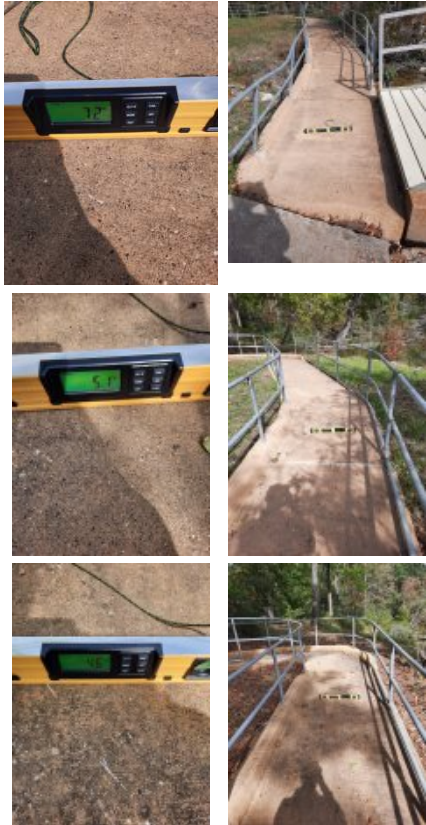
Finding Number	Area Description	Lat/Long	Finding	As Built	Recommendation	Citation	Photos	Figure
598	Red Oak/Piney Shores Boat Ramp: Red Oak/Piney Shores Boat Ramp	[30.6524429 , -95.0058324]	The ramp on the accessible route contains cross slopes greater than 2%. Surface cross slopes shall not exceed one unit vertical in 48 units horizontal (2-percent slope).	Ramp to piers - Cross slopes of 7.2%, 5.1%, and 4.6%	Correct ramp cross slope to max 2.08%. Cost included in previous finding.	2015 ABAAS Section: 405.3 2012 TAS Section: 405.3 2010 ADAS Section: 405.3

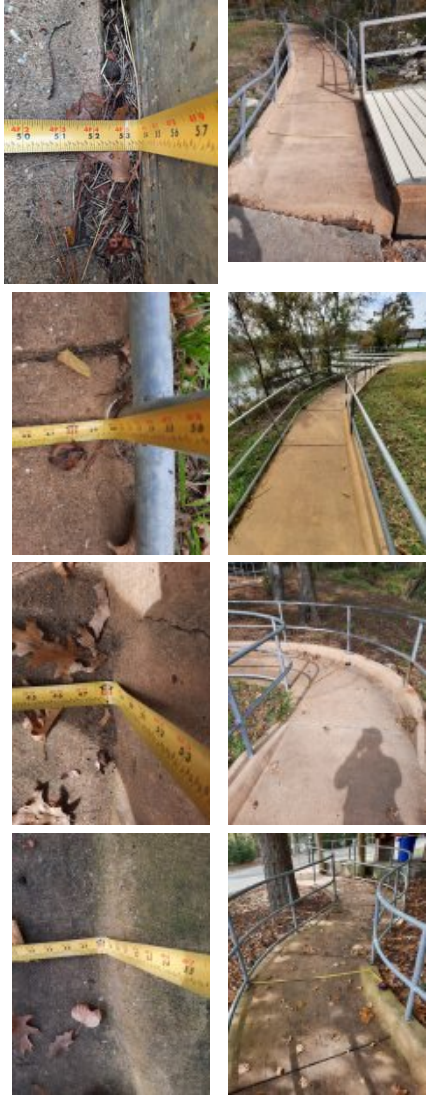
Finding Number	Area Description	Lat/Long	Finding	As Built	Recommendation	Citation	Photos	Figure
600	Red Oak/Piney Shores Boat Ramp: Red Oak/Piney Shores Boat Ramp	[30.6524094 , -95.0057305]	The landing at the change of direction is not the correct size. Landings at a change of direction shall have a dimension in the direction of ramp run of not less than 60 inches by 60 inches.	Ramp to piers - 6 of 6 ramp runs lack 60" by 60" landing where the ramp changes direction	Enlarge landing on ramp where directions change to 60" by 60".	2015 ABAAS Section: 405.7.4 2012 TAS Section: 405.7.4 2010 ADAS Section: 405.7.4

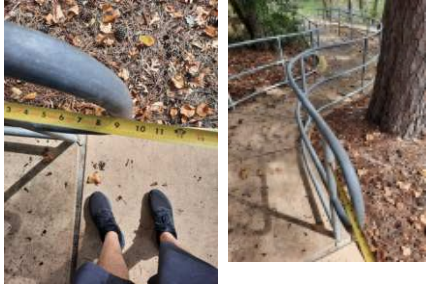
Finding Number	Area Description	Lat/Long	Finding	As Built	Recommendation	Citation	Photos	Figure
601	Red Oak/Piney Shores Boat Ramp: Red Oak/Piney Shores Boat Ramp	[30.6523956 , -95.005644 6]	The handrail does not extend past the ramp. Handrails must be between 34 inches and 38 inches above the ramp surface, must extend beyond the top and bottom of the ramp 12 inches horizontally, be parallel to the floor or ground surface and be in the same direction as the ramp runs. The 12 inches must be level and does not include the radius at the top of round handrails. Extensions shall return to a wall, guard, or the landing surface, or shall be continuous to the handrail of an adjacent ramp run.	Ramp to piers - The handrails do not extend past the bottom of the ramp	Provide handrail extensions that project 12" onto the ramp landing.	2015 ABAAS Section: 505.10.1  2012 TAS Section: 505.10.1  2010 ADAS Section: 505.10.1
