# Access Audit Site Report

Prepared By  
**WT Group**

**Lake Livingston State Park**  
**300 State Park Rd 65**  
**Livingston, TX 77351**  
**Accessibility Evaluation**  
**Inspection Date: 11/08/2021**  
**Inspectors: Tanya Scheibe**

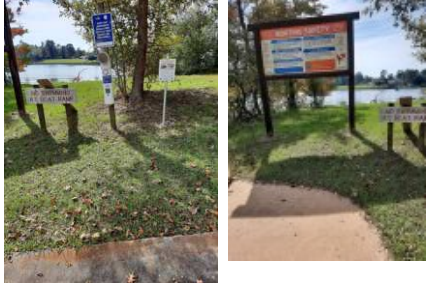
602	Red Oak/Piney Shores Boat Ramp: Red Oak/Piney Shores Boat Ramp	[30.6521845 , -95.005758 6]	There is no accessible route to the informational signs and monofilament recycling station. At least one accessible route shall connect accessible buildings, accessible facilities, accessible elements, and accessible spaces that are on the same site.	Lacks accessible route to the informational signs and monofilament recycling station	Create an accessible route with crushed stone or other outdoor material from parking or walkway to the informational signs and monofilament recycling station	2015 ABAAS Section: F206.2.2  2012 TAS Section: 206.2.2  2010 ADAS Section: 206.2.2

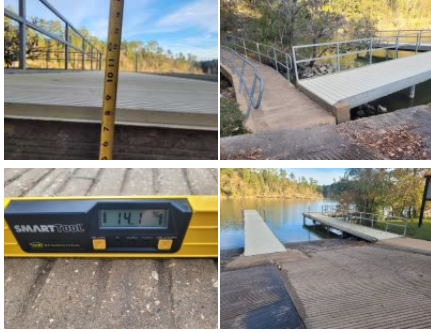
604	Red Oak/Piney Shores Boat Ramp: Red Oak/Piney Shores Boat Ramp	[30.6522352 , -95.005698 3]	There is no accessible route to/on the boating facility. Accessible routes serving recreational boating facilities, including gangways and floating piers, shall comply with accessible route requirements except as modified by section Recreational Boating Facilities - Accessible Routes.	8.25" step and excessive slope of the boat ramp surface	Create an outdoor accessible route to the boat pier or make corrections for a compliant route.	2015 ABAAS Section: 1003.2  2010 ADAS Section: 1003.2

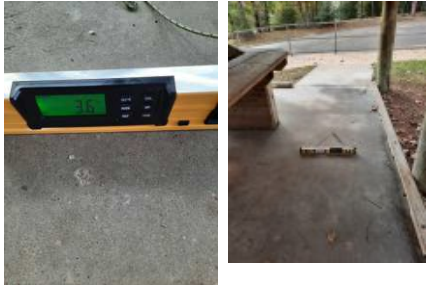
Finding Number	Area Description	Lat/Long	Finding	As Built	Recommendation	Citation	Photos	Figure
605	Red Oak/Piney Shores Boat Ramp: Red Oak/Piney Shores Boat Ramp Fish Cleaning Station	[30.652496, -95.005935 6]	The accessible route contains running slopes greater than 5 percent and cross slopes greater than 2 percent across the width of the walk and has not been constructed as a ramp (i.e. handrails, wheel guides, etc.). When the slope in the direction of travel of any walk exceeds 1 unit vertical in 20 units horizontal (5-percent slope), it must be constructed as ramp. Surface cross slopes must not exceed one unit vertical in 48 units. Horizontal (2-percent slope).	Cross slope of 3.6%	Correct or repair slope to max 5% running and 2.08% cross	2015 ABAAS Section: 403.3 2012 TAS Section: 403.3 2010 ADAS Section: 403.3

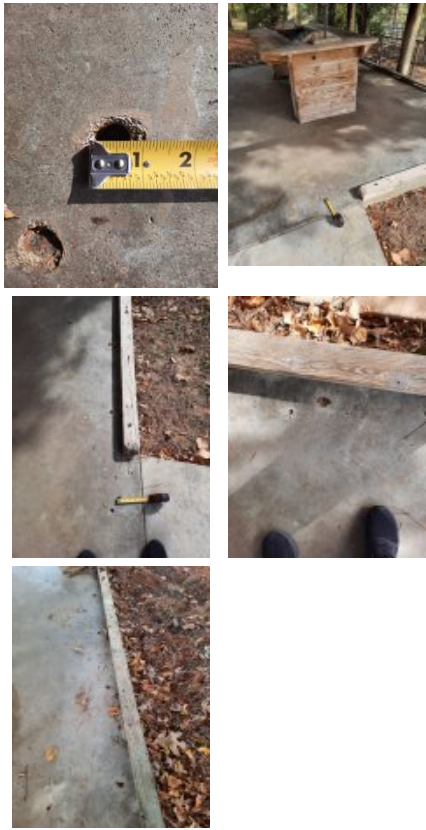
606	Red Oak/Piney Shores Boat Ramp: Red Oak/Piney Shores Boat Ramp Fish Cleaning Station	[30.6524371, -95.005950 4]	Openings in floor or ground surfaces shall not allow passage of a sphere more than 1/2 inch (13 mm) diameter except as allowed in 407.4.3, 409.4.3, 410.4, 810.5.3 and 810.10. Elongated openings shall be placed so that the long dimension is perpendicular to the dominant direction of travel.	Nine gaps of .75"	Fill and maintain gaps to max .5".	2015 ABAAS Section: 302.3 2012 TAS Section: 302.3 2010 ADAS Section: 302.3

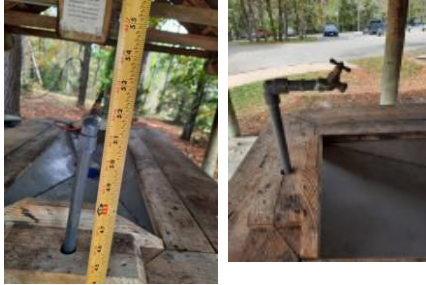
Finding Number	Area Description	Lat/Long	Finding	As Built	Recommendation	Citation	Photos	Figure
607	Red Oak/Piney Shores Boat Ramp: Red Oak/Piney Shores Boat Ramp Fish Cleaning Station	[30.6524625 , -95.005939 7]	The water spouts are positioned too high for either a side or front approach. Where a clear floor or ground space allows a parallel approach to an element and the side reach is unobstructed, the high side reach shall be 48 inches maximum and the low side reach shall be 15 inches minimum above the finish floor or ground. Where a forward reach is unobstructed, the high forward reach shall be 48 inches maximum and the low forward reach shall be 15 inches minimum above the finish floor or ground.	2 of 2 water spouts at 52.5" aff	Remount operable parts to be in reach range of 15" min to 48" max	2015 ABAAS Section: 308.1  2012 TAS Section: 308.1  2010 ADAS Section: 308.1

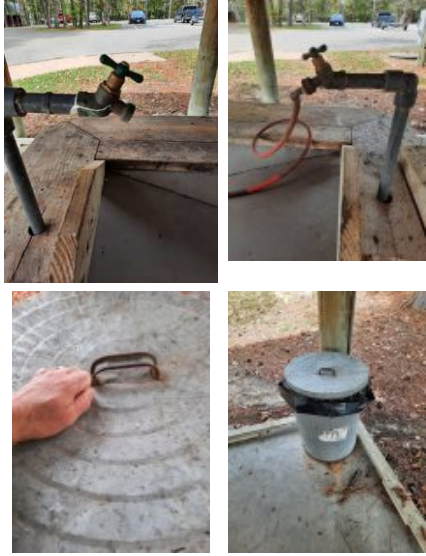
608	Red Oak/Piney Shores Boat Ramp: Red Oak/Piney Shores Boat Ramp Fish Cleaning Station	[30.6524637 , -95.005946 4]	The water spouts (2) and garbage can lid are not accessible because they require tight grasping, pinching or twisting of the wrist.	Two water spouts and garbage can lid require a tight pinch or grasp	Replace water spout handle and garbage can lid with an operable part usable without a tight pinch or grasp	2015 ABAAS Section: 309.4  2012 TAS Section: 309.4  2010 ADAS Section: 309.4

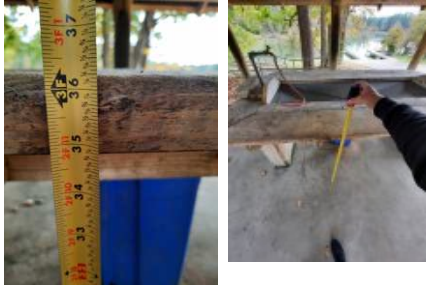
609	Red Oak/Piney Shores Boat Ramp: Red Oak/Piney Shores Boat Ramp Fish Cleaning Station	[30.6524302 , -95.005945]	The top of the work surface is not within a compliant height range. The tops of tables and counters shall be 28 inches to 34 inches from the floor or ground.	Fish cleaning table work surface at 36.25" aff	Provide tables and work surfaces at 28" to 34" aff.	2015 ABAAS Section: 902.3  2012 TAS Section: 902.3  2010 ADAS Section: 902.3

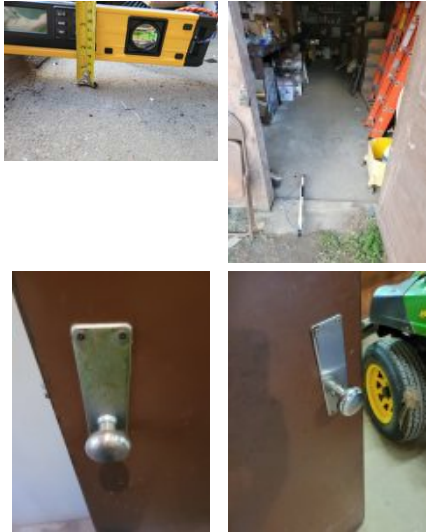
Finding Number	Area Description	Lat/Long	Finding	As Built	Recommendation	Citation	Photos	Figure
612	Employee Spaces: Maintenance	[30.6563136 , -95.0019298]	Spaces and elements within employee work areas shall only be required to comply with 206.2.8, 207.1, and 215.3 and shall be designed and constructed so that individuals with disabilities can approach, enter, and exit the employee work area. Employee work areas, or portions of employee work areas, other than raised courtroom stations, that are less than 300 square feet (28 m2) and elevated 7 inches (180 mm) or more above the finish floor or ground where the elevation is essential to the function of the space shall not be required to comply with these requirements or to be on an accessible route.	Storage area - Change in level (CIL) of 1.5" at storage area door, knob hardware	Repair, bevel, or ramp CILs at door entries to max .25". Replace hardware with lever hardware or hardware operable without a tight pinch or grasp.	2015 ABAAS Section: F203.9 2012 TAS Section: 203.9 2010 ADAS Section: 203.9

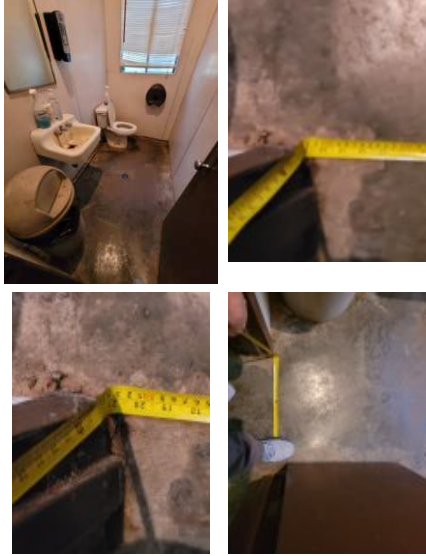
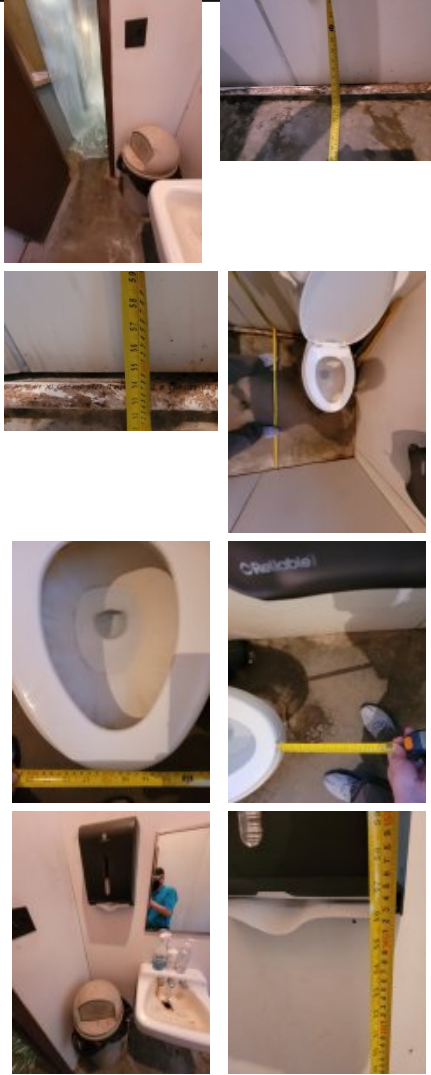
613	Employee Spaces: Maintenance	[30.6563228 , -95.001852]	The restroom is not compliant. The restroom does not have the required minimum clear floor space or maneuvering clearances for the toilet. The restroom does not have the required minimum clear floor space or maneuvering clearances for the lavatory. The entry door does not contain the required minimum maneuvering spaces on the pull/push sides. The entry door encroach into the required clear floor space for fixtures. Grab bars are missing and/or incorrectly installed. Accessories, such as toilet seat covers, paper towel holders, garbage cans, hand dryers, and mirrors are either too high or without clear floor space or both.	Bathroom not accessible	Create a compliant wheelchair accessible restroom and correct all features to be accessible if feasible.	2015 ABAAS Section: 603.1 2012 TAS Section: 603.1 2010 ADAS Section: 603.1

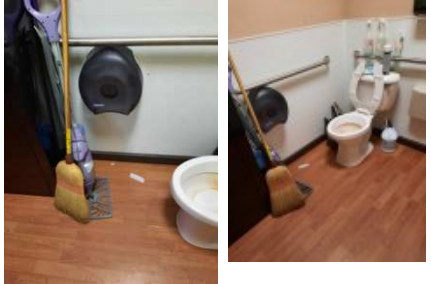
617	Employee Spaces: Maintenance Admin Building	[30.6562686 , -95.001865 4]	The required 56 inches by 60 inches clear floor space for the water closet has been obstructed. The clear floor space around the water closet shall be 60 inches minimum measured perpendicular from the side wall and 56 inches minimum measured perpendicular from the rear wall.	Admin Restroom - lacks 56" by 60" clear floor space for the toilet due to storage	Relocate storage to provide required 60" clearance around toilet.	2015 ABAAS Section: 604.3.  2012 TAS Section: 604.3.1  2010 ADAS Section: 604.3.1

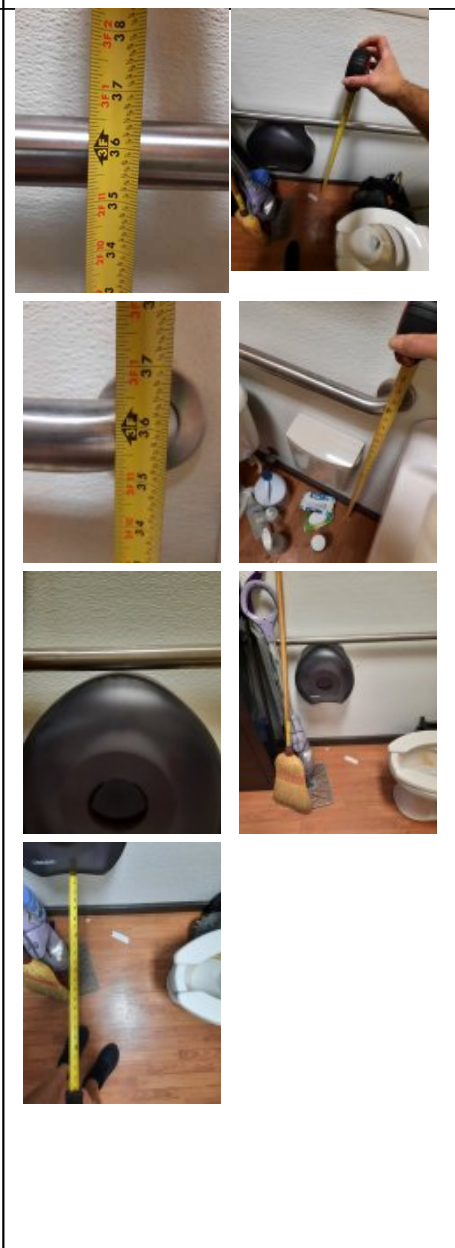
618	Employee Spaces: Maintenance Admin Building	[30.6562697 , -95.001852]	The grab bar height and/or spacing fails. Grab bars must be mounted between 33" and 36" to the top of the gripping surface. There must be 1.5" of clearance between the grab bar and the wall. There must be a	Admin Restroom - side and rear grab bars are 36.5" aff and toilet paper dispenser is mounted less than	Remount grab bars in accessible stall to 33" to 36" aff. Remount toilet paper dispenser max 7" to 9" from front of toilet, 15" to 48" aff and min 12" above or 1.5" below grab bar	2015 ABAAS Section: 609.3, 609.4  2012 TAS

Finding Number	Area Description	Lat/Long	Finding	As Built	Recommendation	Citation	Photos	Figure
			minimum of 1.5" of clearance below and minimum 12" above the grab bar to any dispenser or other obstruction.	1.5" below grab bar and too far from toilet		Section: 609.4, 609.3  2010 ADAS Section: 609.3, 609.4

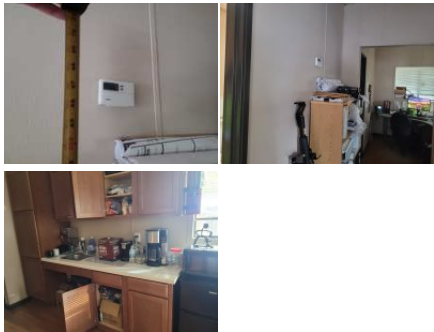
621	Employee Spaces: Maintenance Admin Building	[30.6563055 , -95.001865 4]	The thermostat is positioned too high for either a side or front approach. The cabinet shelves are positioned too low or too high for either a side or front approach. Where a clear floor or ground space allows a parallel approach to an element and the side reach is unobstructed, the high side reach shall be 48 inches maximum and the low side reach shall be 15 inches minimum above the finish floor or ground. Where a forward reach is unobstructed, the high forward reach shall be 48 inches maximum and the low forward reach shall be 15 inches minimum above the finish floor or ground.	Break room - thermostat high, lacks cabinet shelf storage in reach range	Remount operable parts to be in reach range of 15" min to 48" max.	2015 ABAAS Section: 308.1  2012 TAS Section: 308.1  2010 ADAS Section: 308.1

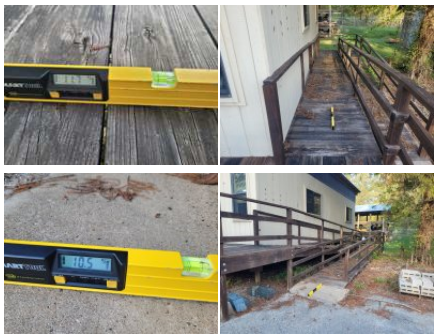
624	Employee Spaces: Maintenance Admin Building	[30.6563009 , -95.001983 4]	The ramps slope exceeds the maximum running slope (direction of travel) allowable of 8.33%. Ramps should have the least possible slope but in no case more than 8.3% (1:12).	Entry ramp - slope of 11.7% on upper ramp run and 10.5% at transition	Correct slope of ramp to max 8.33%	2015 ABAAS Section: 405.2  2012 TAS Section: 405.2  2010 ADAS Section: 405.2
