Access Audit Site Report

Lake Mineral Wells State Park and Trailway

Accessibility Evaluation

Inspection Date: 07/12/2021

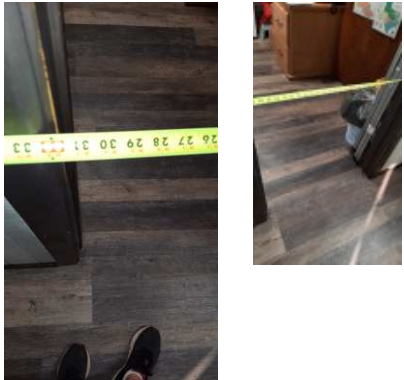
2	Headquarters : Headquarters	[32.8126, -98.04362]	Employee Work Areas. Common use circulation paths within employee work areas shall comply with 402. EXCEPTIONS: 1. Common use circulation paths located within employee work areas that are less than 1000 square feet (93 m2) and defined by permanently installed partitions, counters, casework, or furnishings shall not be required to comply with 402. 2. Common use circulation paths located within employee work areas that are an integral component of work area equipment shall not be required to comply with 402. 3. Common use circulation paths located within exterior employee work areas that are fully exposed to the weather shall not be required to comply with 402.	doorway to break area - 31" wide	Make corrections for compliant circulation path. For deficit, leave as is, employee work area pursuant to 2010 Standards 106.5 Defined Terms, until an employee with a disability works here	2015 ABAAS Section: F206.2.8, F206.2.8.1, F206.2.8.2 2012 TAS Section: 206.2.8, 206.2.8 Exception 1, 206.2.8 Exception 2, 206.2.8 Exception 3, 206.2.8 Advisory 1, 206.2.8 Advisory 2 2010 ADAS Section: 206.2.8, 206.2.8 Exception 1, 206.2.8 Exception 2, 206.2.8 Exception 3

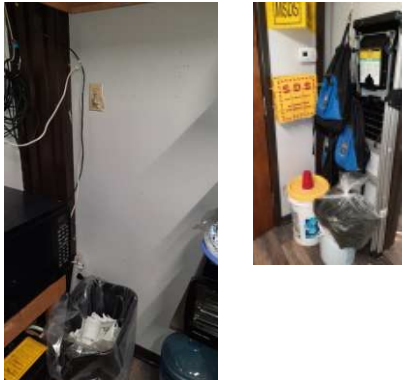
10	Headquarters : Headquarters	[32.8126, -98.04362]	The operable part is not accessible because there is not adequate clear floor space for either a forward or side approach. The clear floor or ground space shall be 30 inches minimum by 48 inches minimum.	Break area - lacks clear floor space (CFS) at switch and thermostat	Remove, or relocate storage in CFS at fixtures and operable parts along the AR	2015 ABAAS Section: 305.3 2012 TAS Section: 305.3 2010 ADAS Section: 305.3

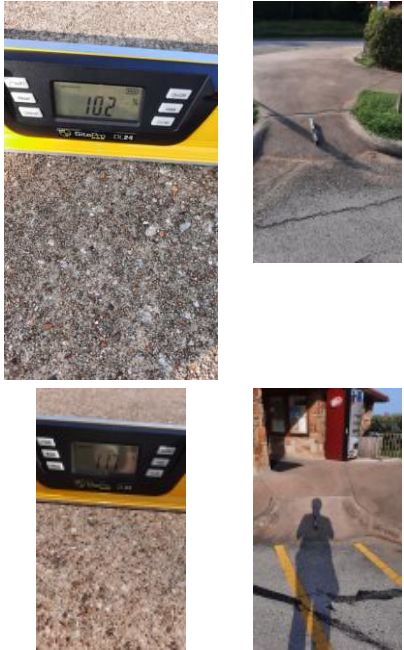
14	Headquarters : Headquarters	[32.8126, -98.04362]	The curb ramp slope exceeds the maximum running slope (Parallel to the direction of travel) allowable of 8.33%. Curb ramps should have the least possible slope but in no case more than 8.3% (1:12).	Outbound side: 10.2% slope, inbound side: 11.7%	Correct curb ramp running slope to max 8.33%	2015 ABAAS Section: 406.1 2012 TAS Section: 406.1 2010 ADAS Section: 406.1

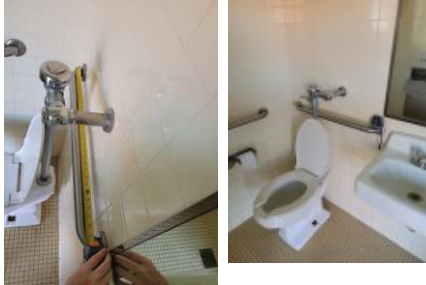
19	Headquarters : Headquarters Restroom - Left	[32.81283, -98.04368]	The rear grab bar is not 36" long or is not mounted in the correct location. The rear grab bar must be a minimum of 36" long and extend from the toilet centerline a minimum 12" towards the wall side and a minimum 24" towards the open side of the toilet. Grab bars shall be installed in a horizontal position, 33 inches minimum and 36 inches maximum above the finish floor measured to the top of the gripping surface and the space between the grab bar and the top of the tank shall be 1-1/2 inches minimum.	30" grab bar, obstructed by flush	Replace rear grab bar with one 36" long, mounted behind the toilet, 12" to one side of center and 24" to the other and 33" to 36" aff	2015 ABAAS Section: 604.5.2 2012 TAS Section: 604.5.2 2010 ADAS Section: 604.5.2

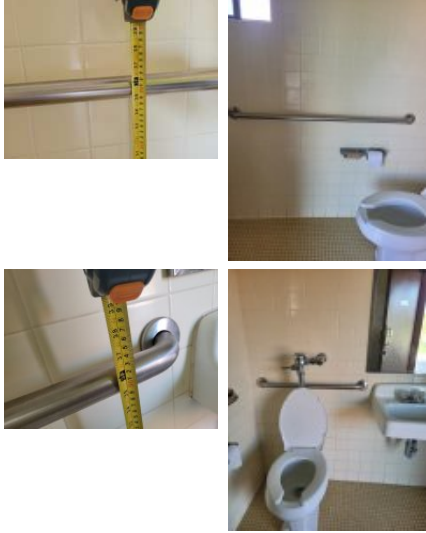
20	Headquarters : Headquarters Restroom - Left	[32.81283, -98.04368]	The grab bar height and/or spacing fails. Grab bars must be mounted between 33" and 36" to the top of the gripping surface. There must be 1.5" of clearance between the grab bar and the wall. There must be a minimum of 1.5" of clearance below and minimum 12" above the grab bar to any dispenser or other obstruction.	grab bars at 36.5" aff	Remount grab bars in accessible stall to 33" to 36" aff	2015 ABAAS Section: 609.3, 609.4 2012 TAS Section: 609.4, 609.3 2010 ADAS Section: 609.3, 609.4

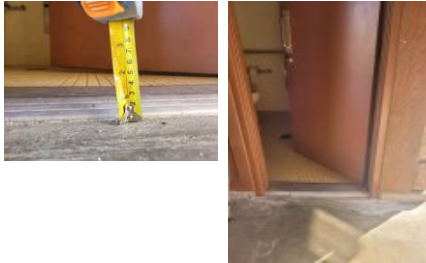
Finding Number	Area Description	Lat/Long	Finding	As Built	Recommendation	Citation	Photos	Figure
24	Headquarters : Headquarters Restroom - Right	[32.81278, -98.0433]	The threshold is greater than 1/2 inch high. The threshold at a doorway shall be no higher than 1/2 inch. Changes in level between 1/4 inch and 1/2 inch must be beveled at 1:2 or less. 1/4 inch is the maximum vertical rise.	right restroom- 1.25" threshold, 23#, closes fast	For all doors along the public circulation route, replace thresholds at exterior doors with ADA thresholds	2015 ABAAS Section: 404.2.5 2012 TAS Section: 404.2.5 2010 ADAS Section: 404.2.5

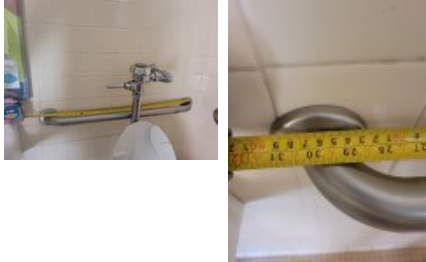
Finding Number	Area Description	Lat/Long	Finding	As Built	Recommendation	Citation	Photos	Figure
27	Headquarters : Headquarters Restroom - Right	[32.81287, -98.04313]	The rear grab bar is not 36" long or is not mounted in the correct location. The rear grab bar must be a minimum of 36" long and extend from the toilet centerline a minimum 12" towards the wall side and a minimum 24" towards the open side of the toilet. Grab bars shall be installed in a horizontal position, 33 inches minimum and 36 inches maximum above the finish floor measured to the top of the gripping surface and the space between the grab bar and the top of the tank shall be 1-1/2 inches minimum.	30" rear grab bar	Replace rear grab bar with one 36" long, mounted behind the toilet, 12" to one side of center and 24" to the other and 33" to 36" aff	2015 ABAAS Section: 604.5.2 2012 TAS Section: 604.5.2 2010 ADAS Section: 604.5.2

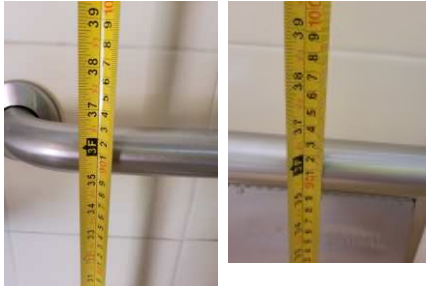
28	Headquarters : Headquarters Restroom - Right	[32.81287, -98.04313]	The grab bar height and/or spacing fails. Grab bars must be mounted between 33" and 36" to the top of the gripping surface. There must be 1.5" of clearance between the grab bar and the wall. There must be a minimum of 1.5" of clearance below and minimum 12" above the grab bar to any dispenser or other obstruction.	bars at 36.5" aff	Remount grab bars in accessible stall to 33" to 36" aff	2015 ABAAS Section: 609.3, 609.4 2012 TAS Section: 609.4, 609.3 2010 ADAS Section: 609.3, 609.4

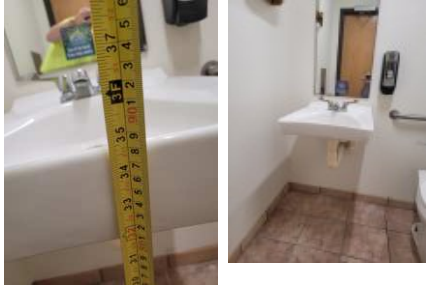
40	Administration Training Center: Administration - Men's Restroom	[32.81268, -98.0435]	The top rim of the sink is too high. All lavatories/sinks that are designated to be accessible shall be a minimum 17 inches in horizontal depth and mounted with the rim or counter edge no higher than 34 inches above the finished floor.	sink 34.75" aff	Lower sinks to max 34" aff to front of rim	2015 ABAAS Section: 606.3 2012 TAS Section: 606.3 2010 ADAS Section: 606.3

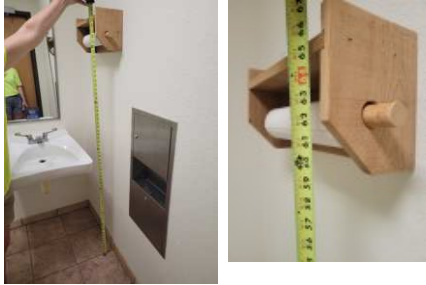
Finding Number	Area Description	Lat/Long	Finding	As Built	Recommendation	Citation	Photos	Figure
46	Administration Training Center: Administration - Women's Restroom	[32.8126, -98.04362]	Where a high forward reach is over an obstruction, the clear floor space shall extend beneath the element for a distance not less than the required reach depth over the obstruction. The high forward reach shall be 48 inches (1220 mm) maximum where the reach depth is 20 inches (510 mm) maximum. Where the reach depth exceeds 20 inches (510 mm), the high forward reach shall be 44 inches (1120 mm) maximum and the reach depth shall be 25 inches (635 mm) maximum. Where a clear floor or ground space allows a parallel approach to an element and the high side reach is over an obstruction, the height of the obstruction shall be 34 inches (865 mm) maximum and the depth of the obstruction shall be 24 inches (610 mm) maximum. The high side reach shall be 48 inches (1220 mm) maximum for a reach depth of 10 inches (255 mm) maximum. Where the reach depth exceeds 10 inches (255 mm), the high side reach shall be 46 inches (1170 mm) maximum for a reach depth of 24 inches (610 mm) maximum.	61.5" reach to paper towel	Lower paper towels to max 44" aff for a forward reach over obstruction	2015 ABAAS Section: 308.2.1, 308.3.2 2012 TAS Section: 308.2.1, 308.3.2 2010 ADAS Section: 308.2.1, 308.3.2

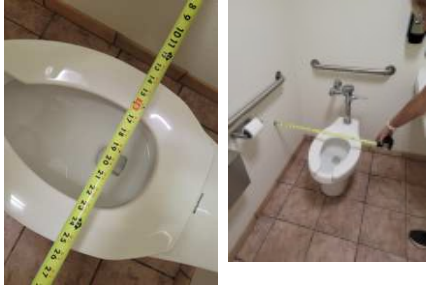
47	Administration Training Center: Administration - Women's Restroom	[32.8126, -98.04362]	The toilet is not located within the range allowed from the side wall or partition. The centerline of the toilet must be 16 to 18 inches from the side wall.	centerline at 19"	Remount toilets to 16" to 18" from the side wall to centerline	2015 ABAAS Section: 604.2 2012 TAS Section: 604.2 2010 ADAS Section: 604.2

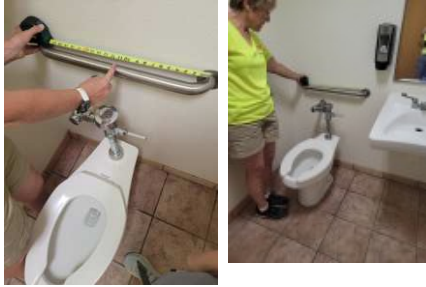
49	Administration Training Center: Administration - Women's Restroom	[32.8126, -98.04362]	The rear grab bar is not 36" long or is not mounted in the correct location. The rear grab bar must be a minimum of 36" long and extend from the toilet centerline a minimum 12" towards the wall side and a minimum 24" towards the open side of the toilet. Grab bars shall be installed in a horizontal position, 33 inches minimum and 36 inches maximum above the finish floor measured to the top of the gripping surface and the space between the grab bar and the top of the tank shall be 1-1/2 inches minimum.	24" bar meets exception but not correct centerline	Replace rear grab bar with one 36" long, mounted behind the toilet, 12" to one side of center and 24" to the other and 33" to 36" aff If a 36" bar will not fit here due to the sink placement, mount a 24" rear grab bar centered on the toilet centerline	2015 ABAAS Section: 604.5.2 2012 TAS Section: 604.5.2 2010 ADAS Section: 604.5.2

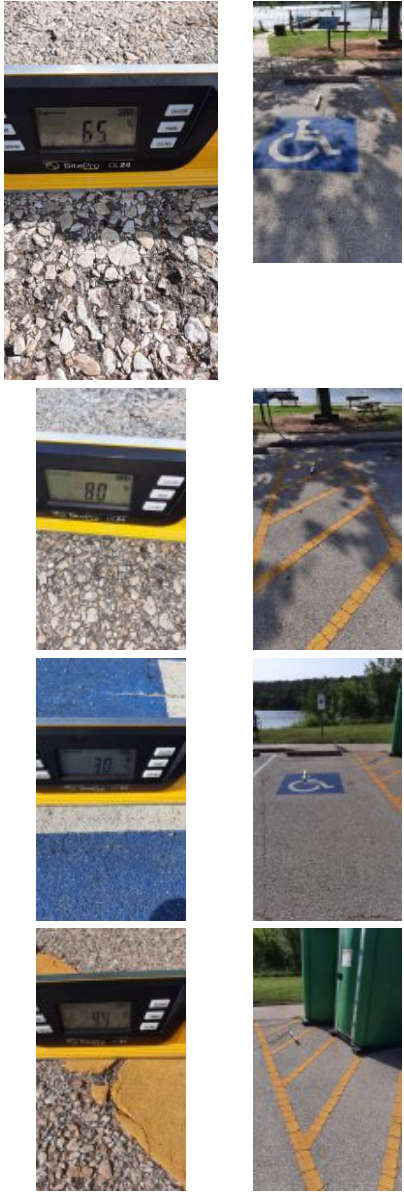
Finding Number	Area Description	Lat/Long	Finding	As Built	Recommendation	Citation	Photos	Figure
54	Day Use Area: Swimming/Boat Ramp/Concession Area	[32.8145465 , -98.0386807]	The cross slopes (narrow dimension) and/or running slopes (long dimension) of the access aisle exceeds 2%. The running slope and the cross slope in an accessible parking stall and the access aisle must not exceed 2%.	Store: stall 6.5%, AA 8%, Restroom- stall 3%, 4.4% in AA	Repair or correct slope of parking space and access aisle to max 2.08% in any direction	2015 ABAAS Section: 502.4 2012 TAS Section: 502.4 2010 ADAS Section: 502.4

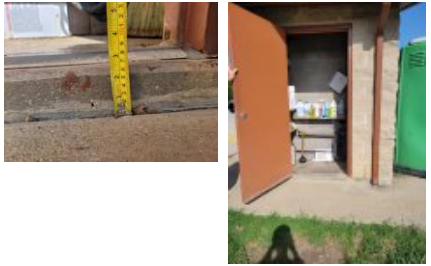
57	Day Use Area: Swimming/Boat Ramp/Concession Area	[32.8142445, -98.038796]	Spaces and elements within employee work areas shall only be required to comply with 206.2.8, 207.1, and 215.3 and shall be designed and constructed so that individuals with disabilities can approach, enter, and exit the employee work area. Employee work areas, or portions of employee work areas, other than raised courtroom stations, that are less than 300 square feet (28 m2) and elevated 7 inches (180 mm) or more above the finish floor or ground where the elevation is essential to the function of the space shall not be required to comply with these requirements or to be on an accessible route.	closet at bathroom-change in level at 3"	Repair, bevel, or ramp CILs at door entries to max .25".	2015 ABAAS Section: F203.9 2012 TAS Section: 203.9 2010 ADAS Section: 203.9

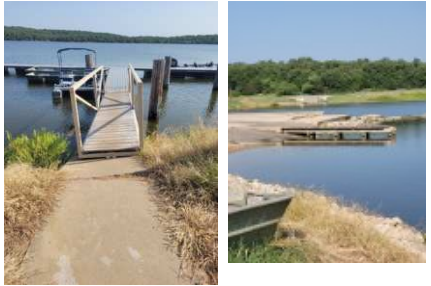
Finding Number	Area Description	Lat/Long	Finding	As Built	Recommendation	Citation	Photos	Figure
58	Day Use Area: Swimming/Boat Ramp/Concession Area	[32.8150796 , -98.038668 6]	The minimum number of boarding piers are not accessible. Where boarding piers are provided at boat launch ramps, at least 5 percent, but no fewer than one, of the boarding piers be accessible.	boat pier lacks accessible boarding areas	Provide 5%, but not less than one accessible boarding pier at boat launches.	2015 ABAAS Section: F235.3 2010 ADAS Section: 235.3

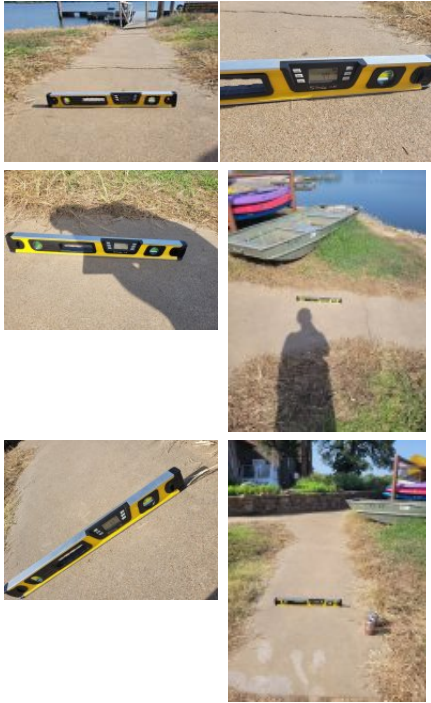
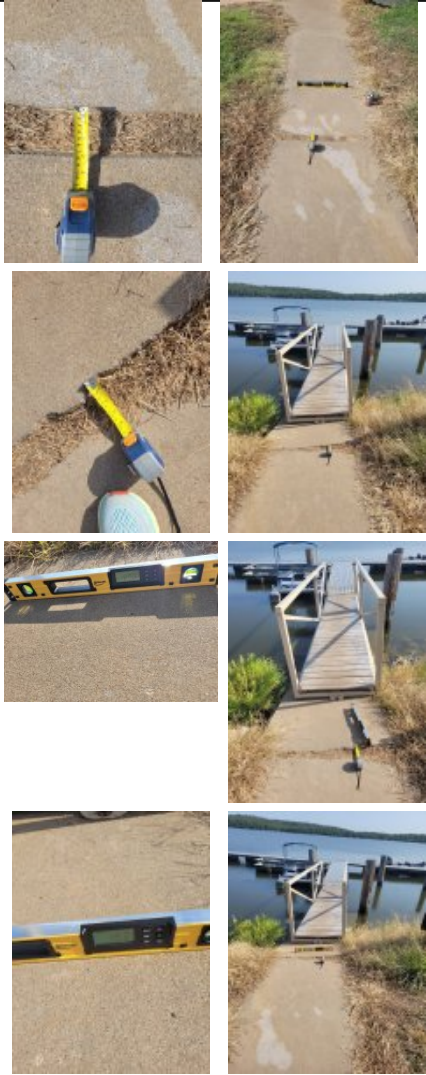
59	Day Use Area: Swimming/Boat Ramp/Concession Area	[32.8149951 , -98.03869 01], [32.8149083 , -98.038683 4]	There is no accessible route to/on the boating facility. Accessible routes serving recreational boating facilities, including gangways and floating piers, shall comply with accessible route requirements except as modified by section Recreational Boating Facilities - Accessible Routes.	route to pier - 4.4% cross at top slope, 7.3% running at top, 7.9% running at middle, 3.7% cross at middle, 3" gap in middle, 4" gap at bottom, 29% running at bottom, 10.3% cross at bottom , 7" change in level	Create an outdoor accessible route to the boat pier or make corrections for a compliant route.	2015 ABAAS Section: 1003.2 2010 ADAS Section: 1003.2

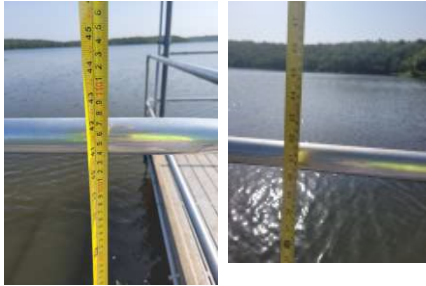
Finding Number	Area Description	Lat/Long	Finding	As Built	Recommendation	Citation	Photos	Figure
60	Day Use Area: Swimming/Boat Ramp/Concession Area	[32.8150763 , -98.038668 6]	Not enough of the railings, guards, or handrails are at the allowable height. At least 25 percent of the railings, guards, or handrails shall be 34 inches maximum above the ground or deck surface.	fishing pier- all railings at 42"	Lower 25% of the railing; dispersed through pier, to max 34".	2015 ABAAS Section: 1005.2.1 2010 ADAS Section: 1005.2.1

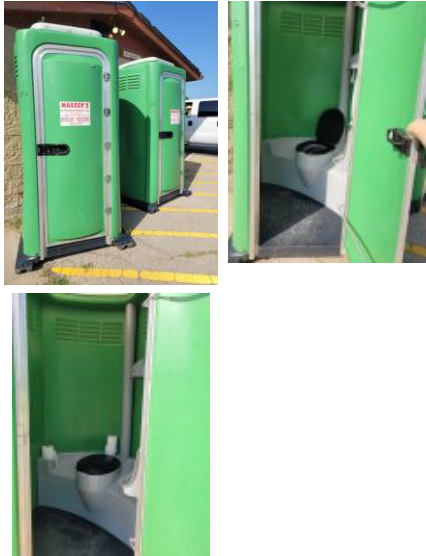
Finding Number	Area Description	Lat/Long	Finding	As Built	Recommendation	Citation	Photos	Figure
69	Day Use Area: Swimming/Boat Ramp/Concession Area	[32.8145093 , -98.038667 3]	The portable public restroom is not compliant. 5% of portable toilets must be accessible, minimum of 1. If sanitary facilities are provided, they must be made accessible to persons with disabilities. If public restrooms are desired, It is recommended that the portable unit be replaced with a permanent built in compliant restroom. The utilization of an accessible portable unit may be a temporary solution and is not recommended as a permanent solution.	temp porta potties do not comply	Ensure that 5% of portable toilets provided for permanent or temporary purposes are compliant models and place along AR	2015 ABAAS Section: F213.1 2012 TAS Section: 213.1 2010 ADAS Section: 213.1, 213.2 Exception 3

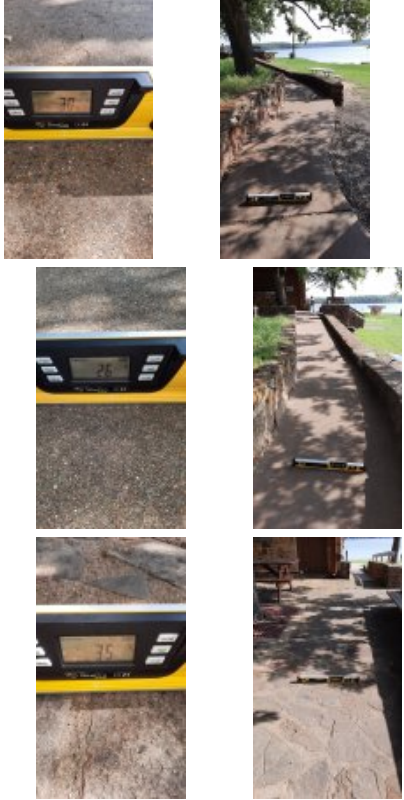
71	Day Use Area: Swimming/Boat Ramp/Concession Area	[32.8145657 , -98.0386284]	The accessible route of travel on the accessible route contains cross slopes greater than 2%. Cross slopes shall not exceed one unit vertical in 48 units horizontal (2-percent slope).	3% cross to fishing pier, 3%, 2.6% from parking to building, 3.5% on paver patio	Correct or repair cross slope along AR to max 2.08%	2015 ABAAS Section: 403.3 2012 TAS Section: 403.3 2010 ADAS Section: 403.3

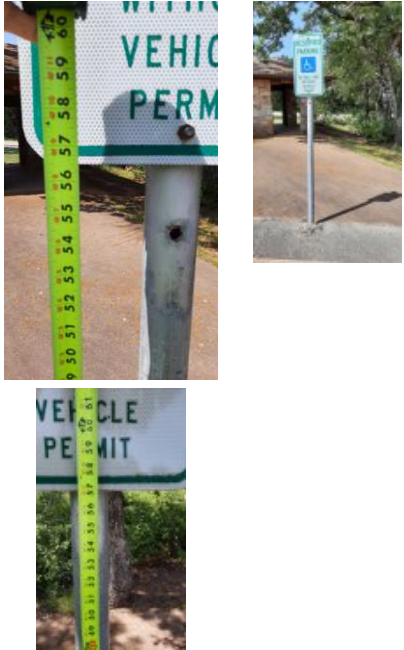
Finding Number	Area Description	Lat/Long	Finding	As Built	Recommendation	Citation	Photos	Figure
81	Day Use Area: Day Use	[32.8153051 , -98.032585 4]	The parking sign is mounted too low. Parking space identification signs shall include the International Symbol of Accessibility complying with. Signs identifying van parking spaces shall contain the designation "van accessible." Signs shall be 60 inches minimum above the finish floor or ground surface measured to the bottom of the sign.	Day Use 2 - 56.75", day Use 1 - 57"	Raise existing accessible parking signs so lowest end of bottom sign is min 60" aff	2015 ABAAS Section: 502.6 2012 TAS Section: 502.6 2010 ADAS Section: 502.6

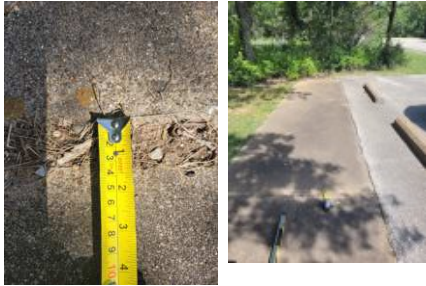
Finding Number	Area Description	Lat/Long	Finding	As Built	Recommendation	Citation	Photos	Figure
83	Day Use Area: Day Use	[32.8146918 , -98.031482 2]	There is a gap spaced greater than a 1/2 inch. Openings in floor or ground surfaces shall not allow passage of a sphere more than 1/2 inch diameter. Elongated openings shall be placed so that the long dimension is perpendicular to the dominant direction of travel.	1.5" gap	Correct or fill gaps to be max .5"	2015 ABAAS Section: 302.3 2012 TAS Section: 302.3 2010 ADAS Section: 302.3

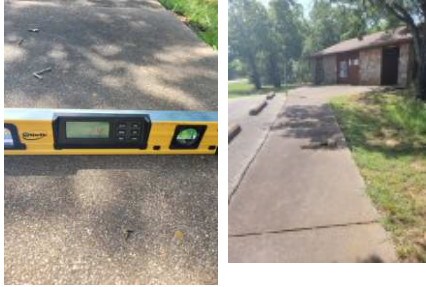
84	Day Use Area: Day Use	[32.8146941 , -98.031475 5]	The accessible path of travel between the building entrance and the accessible parking contains cross slopes greater than 2%. Surface cross slopes shall not exceed one unit vertical in 48 units horizontal (2-percent slope). When the slope in the direction of travel of any walk exceeds 1 unit vertical in 20 units horizontal (5-percent slope), it must be constructed as ramp.	2.9% cross slope	Correct or repair sidewalk cross slope along AR to max 2.08%	2015 ABAAS Section: 403.3 2012 TAS Section: 403.3 2010 ADAS Section: 403.3

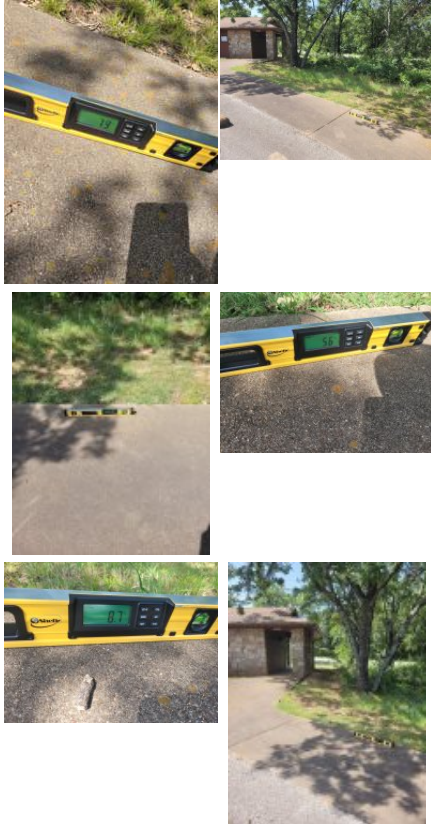
Finding Number	Area Description	Lat/Long	Finding	As Built	Recommendation	Citation	Photos	Figure
85	Day Use Area: Day Use	[32.8147076 , -98.031501]	The running slope of walking surfaces shall not be steeper than 1:20.	7.9% running at bottom, 5.6% at middle, 8.7% at top	Correct running slope along the AR to max 5%	2015 ABAAS Section: 403.3 2012 TAS Section: 403.3 2010 ADAS Section: 403.3

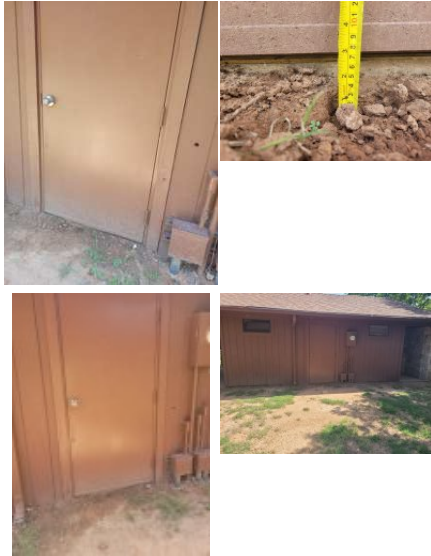
87	Day Use Area: Day Use	[32.8146119 , -98.031488 4]	Spaces and elements within employee work areas shall only be required to comply with 206.2.8, 207.1, and 215.3 and shall be designed and constructed so that individuals with disabilities can approach, enter, and exit the employee work area. Employee work areas, or portions of employee work areas, other than raised courtroom stations, that are less than 300 square feet (28 m2) and elevated 7 inches (180 mm) or more above the finish floor or ground where the elevation is essential to the function of the space shall not be required to comply with these requirements or to be on an accessible route.	day use 2 pipe chase-knob entry, change in level at 3", lacks AR	Repair, bevel, or ramp CILs at door entries to max .25". Replace hardware with lever hardware or hardware operable without a tight pinch or grasp. Provide an AR to employee only room.	2015 ABAAS Section: F203.9 2012 TAS Section: 203.9 2010 ADAS Section: 203.9

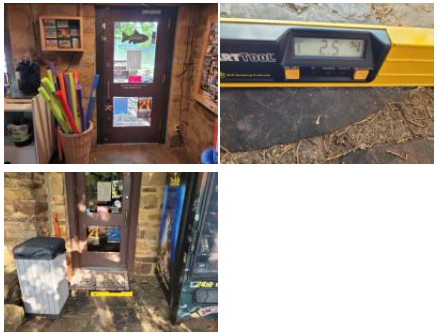
89	Day Use Area: Park Store	[32.8147229 , -98.038651]	Minimum maneuvering clearances at doors and gates shall comply with 404.2.4. Maneuvering clearances shall extend the full width of the doorway and the required latch side or hinge side clearance. Maneuvering clearances shall have a max slope of 2.08%. Exterior doors are recommended to be maintained at 8.5 lbf as a smart practice. Force is to be measured at the operating hardware or 30 inches from the hinges, whichever is greater.	store entry at lake side- 15#, basket pull side, 2.5%, stones uneven	For all doors along the public circulation route, provide required maneuvering clearance on push and pull side of doors. For all doors along the public circulation route, correct slope in door clearance to max 2.08%. For all doors along the public circulation route, inspect, adjust, and maintain 8.5 lbf to open exterior doors as a smart practice.	2010 ADAS Section: 404.2.3, 404.2.7, 404.2.4, 404.2.11, 404.2.11 Exception

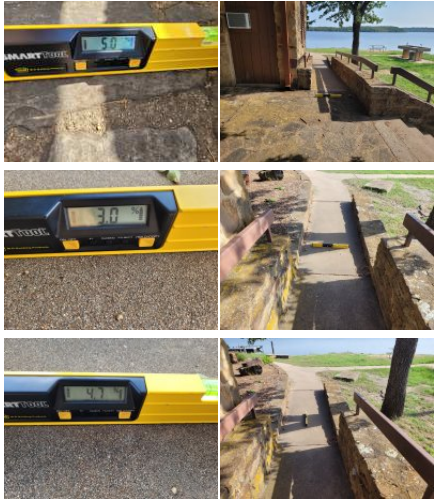
93	Day Use Area: Park Store	[32.8146649 , -98.038716 9]	The landing at the bottom of the ramp has a slope greater than 2%. Bottom landings shall have a dimension in the direction of ramp run of not less than 60 inches and have a slope of less than 2% in any direction.	park store ramp- 5% at top landing, 3% cross and 4.7% run at bottom landing	Correct ramp landing slope to max 2.08%	2015 ABAAS Section: 405.7.1, 405.7.1 EXCEPTION 2012 TAS Section: 405.7.1, 405.7.1 Exception 2010 ADAS Section: 405.7.1, 405.7.1 Exception

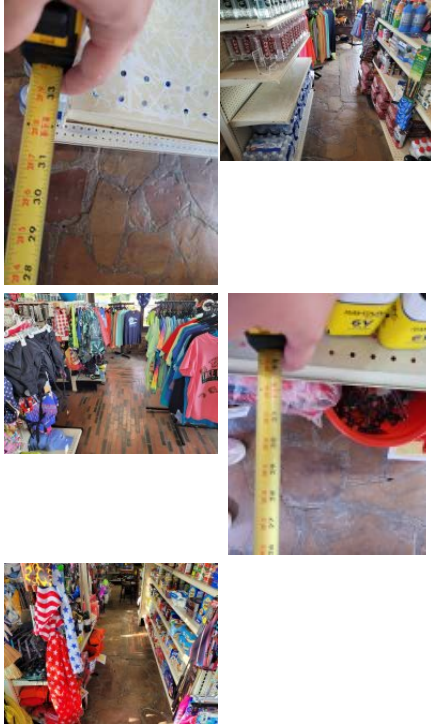
99	Day Use Area: Park Store	[32.814719, -98.038653 9]	The route of travel at this location does not provide a minimum width of 36 inches. The clear width shall be permitted to be reduced to 32 inches minimum for a length of 24 inches maximum provided that reduced width segments are separated by segments that are 48 inches long minimum and 36 inches wide minimum.	park store- reduces at displays and shelves	Widen AR to compliant 36" clear width	2015 ABAAS Section: 403.5.1 2012 TAS Section: 403.5.1 2010 ADAS Section: 403.5.1

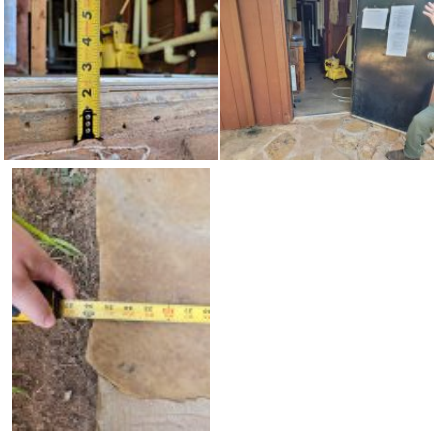
Finding Number	Area Description	Lat/Long	Finding	As Built	Recommendation	Citation	Photos	Figure
114	Day Use Area: Day Use 1 - Men's Restroom	[32.8126, -98.04362]	Spaces and elements within employee work areas shall only be required to comply with 206.2.8, 207.1, and 215.3 and shall be designed and constructed so that individuals with disabilities can approach, enter, and exit the employee work area. Employee work areas, or portions of employee work areas, other than raised courtroom stations, that are less than 300 square feet (28 m2) and elevated 7 inches (180 mm) or more above the finish floor or ground where the elevation is essential to the function of the space shall not be required to comply with these requirements or to be on an accessible route.	pipe chase- 2" CIL, knob, 36" back from door	Provide required maneuvering clearance on push and pull side of doors. Repair, bevel, or ramp CILs at door entries to max .25". Replace hardware with lever hardware or hardware operable without a tight pinch or grasp.	2015 ABAAS Section: F203.9 2012 TAS Section: 203.9 2010 ADAS Section: 203.9

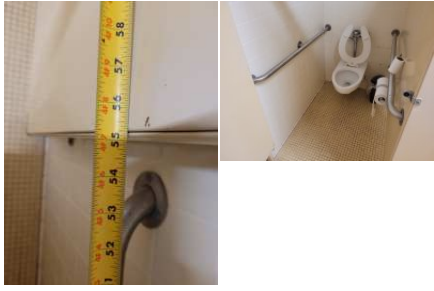
Finding Number	Area Description	Lat/Long	Finding	As Built	Recommendation	Citation	Photos	Figure
121	Day Use Area: Day Use 1 - Women's Restroom	[32.81528, -98.03297]	The ambulatory stall is not between 35" to 37" wide and 60" deep.	ambulatory stall 55" deep	Correct ambulatory stall to be 35" to 37" wide and minimum 60" deep	2015 ABAAS Section: 604.8.2.1 2012 TAS Section: 604.8.2.1 2010 ADAS Section: 604.8.2.1

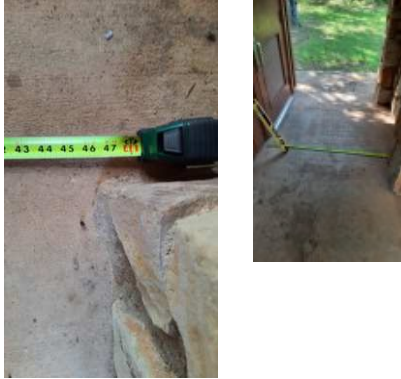
125	Day Use Area: Day Use 1 - Women's Restroom	[32.8126, -98.04362]	Minimum maneuvering clearances at doors and gates shall comply with 404.2.4. Maneuvering clearances shall extend the full width of the doorway and the required latch side or hinge side clearance.	Women's Restroom - 47" on pull side, move garbage on push	Provide required maneuvering clearance around pull side of door Relocate storage, furniture and other obstacles to create 60" maneuvering clearance around door	2015 ABAAS Section: 404.2.4.1 , 404.2.4.4 2012 TAS Section: 404.2.4.4, 404.2.4.1 2010 ADAS Section: 404.2.4.4, 404.2.4.1

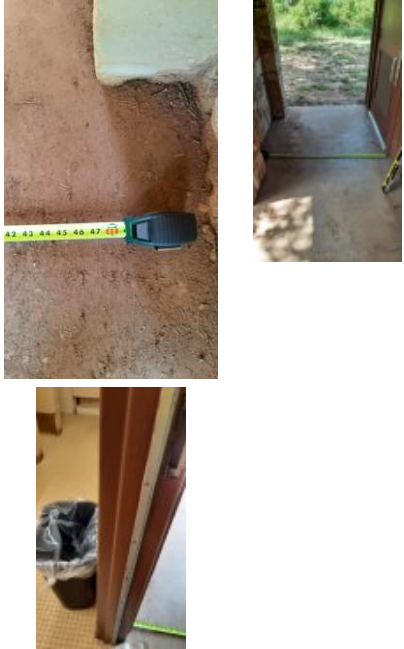
Finding Number	Area Description	Lat/Long	Finding	As Built	Recommendation	Citation	Photos	Figure
126	Day Use Area: Day Use - Men's Restroom 2	[32.8126, -98.04362]	Minimum maneuvering clearances at doors and gates shall comply with 404.2.4. Maneuvering clearances shall extend the full width of the doorway and the required latch side or hinge side clearance.	Men's Restroom 2 - 47" on pull side, move garbage on push	Provide required maneuvering clearance around pull side of door Relocate storage, furniture and other obstacles to create 60" maneuvering clearance around door	2015 ABAAS Section: 404.2.4.1 , 404.2.4.4 2012 TAS Section: 404.2.4.4, 404.2.4.1 2010 ADAS Section: 404.2.4.4, 404.2.4.1

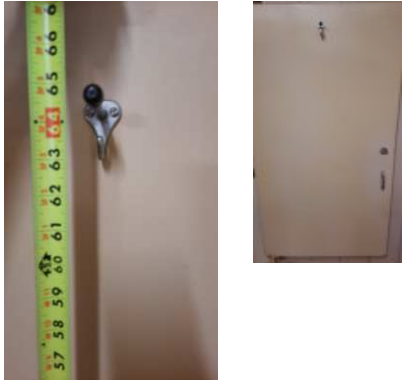
Finding Number	Area Description	Lat/Long	Finding	As Built	Recommendation	Citation	Photos	Figure
131	Day Use Area: Day Use - Men's Restroom 2	[32.8126, -98.04362]	Where a high forward reach is over an obstruction, the clear floor space shall extend beneath the element for a distance not less than the required reach depth over the obstruction. The high forward reach shall be 48 inches (1220 mm) maximum where the reach depth is 20 inches (510 mm) maximum. Where the reach depth exceeds 20 inches (510 mm), the high forward reach shall be 44 inches (1120 mm) maximum and the reach depth shall be 25 inches (635 mm) maximum. Where a clear floor or ground space allows a parallel approach to an element and the high side reach is over an obstruction, the height of the obstruction shall be 34 inches (865 mm) maximum and the depth of the obstruction shall be 24 inches (610 mm) maximum. The high side reach shall be 48 inches (1220 mm) maximum for a reach depth of 10 inches (255 mm) maximum. Where the reach depth exceeds 10 inches (255 mm), the high side reach shall be 46 inches (1170 mm) maximum for a reach depth of 24 inches (610 mm) maximum.	Men's 2 - hook in stall at 63.5"	Lower operating mechanisms to max 48" above the finished floor (AFF) to highest operable part.	2015 ABAAS Section: 308.2.1, 308.3.2 2012 TAS Section: 308.2.1, 308.3.2 2010 ADAS Section: 308.2.1, 308.3.2

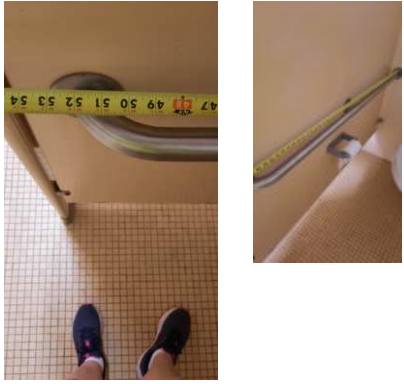
Finding Number	Area Description	Lat/Long	Finding	As Built	Recommendation	Citation	Photos	Figure
135	Day Use Area: Day Use - Men's Restroom 2	[32.8126, -98.04362]	The side grab bars are not in the correct location. Grab bars on the side wall must be installed so that the end closest to the rear wall is maximum 12" from the rear wall. The end furthest from the rear wall must be mounted minimum 54" from the rear wall.	Men's 2- both extend to 51.5"	Remount side grab bar to max 12" from the rear wall at the close end and min 54" on the far end, and 33" to 36" aff.	2015 ABAAS Section: 604.5.1 2012 TAS Section: 604.5.1 2010 ADAS Section: 604.5.1

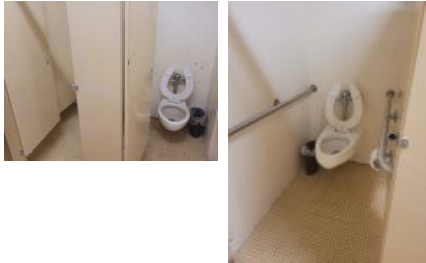
Finding Number	Area Description	Lat/Long	Finding	As Built	Recommendation	Citation	Photos	Figure
141	Day Use Area: Day Use - Women's Restroom 2	[32.81471, -98.03155]	There are not enough accessible toilet compartments. The room contains 3 toilet compartments. A minimum of 1 must be wheelchair accessible .	2 standard, 1 ambulatory	Create a wheelchair accessible stall with grab bars and fixtures mounted in correct locations and at correct heights	2015 ABAAS Section: F213.3.1 2012 TAS Section: 213.3.1 2010 ADAS Section: 213.3.1

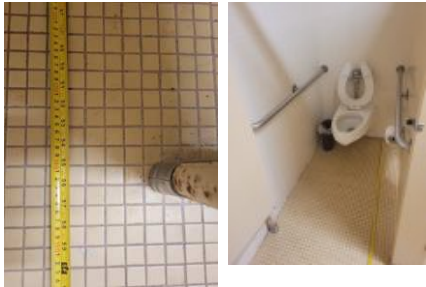
142	Day Use Area: Day Use - Women's Restroom 2	[32.81471, -98.03155]	The ambulatory stall is not between 35" to 37" wide and 60" deep.	57" depth	Correct ambulatory stall to be 35" to 37" wide and minimum 60" deep	2015 ABAAS Section: 604.8.2.1 2012 TAS Section: 604.8.2.1 2010 ADAS Section: 604.8.2.1

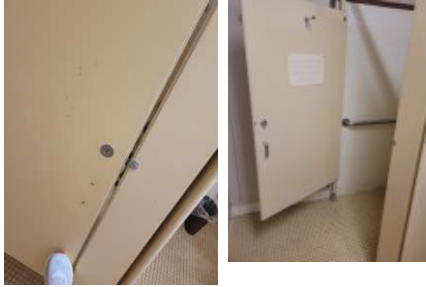
143	Day Use Area: Day Use - Women's Restroom 2	[32.81471, -98.03155]	The stall door fails to comply with all of the door requirements. The stall door must be a minimum of 32" wide and have compliant hardware on both sides. The stall door must be self-closing.	no hardware on pull, not self closing	Adjust stall door to be self-closing Replace stall hardware with hardware operable without a tight pinch or grasp on both sides of the stall door	2015 ABAAS Section: 404.2.3, 404.2.7, 604.8.2.2 2012 TAS Section: 404.2.3, 404.2.7, 604.8.2.2 2010 ADAS Section: 404.2.3, 404.2.7, 604.8.2.2

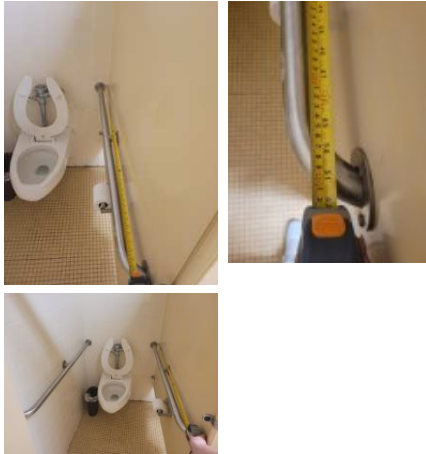
Finding Number	Area Description	Lat/Long	Finding	As Built	Recommendation	Citation	Photos	Figure
144	Day Use Area: Day Use - Women's Restroom 2	[32.81471, -98.03155]	The side grab bars are not in the correct location. Grab bars on the side wall must be installed so that the end closest to the rear wall is maximum 12" from the rear wall. The end furthest from the rear wall must be mounted minimum 54" from the rear wall.	both grab bars at 51"	Remount side grab bar to max 12" from the rear wall at the close end and min 54" on the far end, and 33" to 36" aff	2015 ABAAS Section: 604.5.1 2012 TAS Section: 604.5.1 2010 ADAS Section: 604.5.1

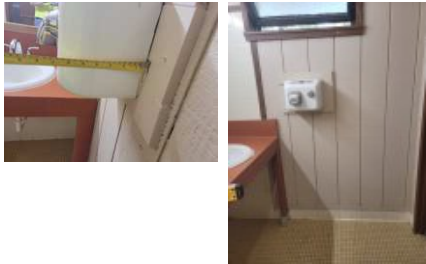
145	Day Use Area: Day Use - Women's Restroom 2	[32.81471, -98.03155]	The paper towel dispenser projects more than 4 inches into the circulation path. Wall-mounted objects that have leading edges between 27 inches and 80 inches from the floor must not project more than 4 inches into the circulation path. Protruding objects that extend to the floor or within 27 inches of the floor are cane detectable and are therefore not hazardous. Where it is necessary or desirable to have objects protrude from the wall, a manner of cane detection must be provided.	paper towel dispenser protrudes 7"	Relocate protruding objects or place cane detectable warning or bollard at foot of item	2015 ABAAS Section: 307.2 2012 TAS Section: 307.2 2010 ADAS Section: 307.2

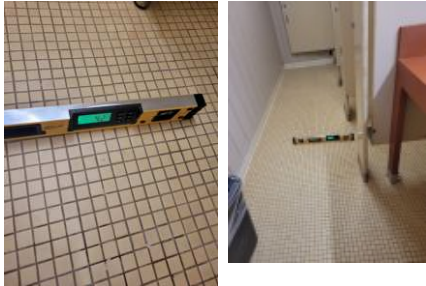
146	Day Use Area: Day Use - Women's Restroom 2	[32.81471, -98.03155]	The accessible route contains running slopes greater than 5 percent and cross slopes greater than 2 percent across the width of the walk and has not been constructed as a ramp (i.e. handrails, wheel guides, etc.). When the slope in the direction of travel of any walk exceeds 1 unit vertical in 20 units horizontal (5-percent slope), it must be constructed as ramp. Surface cross slopes must not exceed one unit vertical in 48 units. Horizontal (2-percent slope).	4.2% cross slope	Correct or repair slope to max 5% running and 2.08% cross	2015 ABAAS Section: 403.3 2012 TAS Section: 403.3 2010 ADAS Section: 403.3

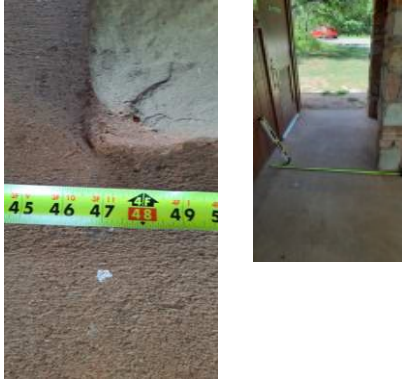
Finding Number	Area Description	Lat/Long	Finding	As Built	Recommendation	Citation	Photos	Figure
147	Day Use Area: Day Use - Women's Restroom 2	[32.8126, -98.04362]	Minimum maneuvering clearances at doors and gates shall comply with 404.2.4. Maneuvering clearances shall extend the full width of the doorway and the required latch side or hinge side clearance.	Women's Restroom 2 - 47" on pull side, move garbage on push	Provide required maneuvering clearance around pull side of door Relocate storage, furniture and other obstacles to create 60" maneuvering clearance around door	2015 ABAAS Section: 404.2.4.1 , 404.2.4.4 2012 TAS Section: 404.2.4.4, 404.2.4.1 2010 ADAS Section: 404.2.4.4, 404.2.4.1

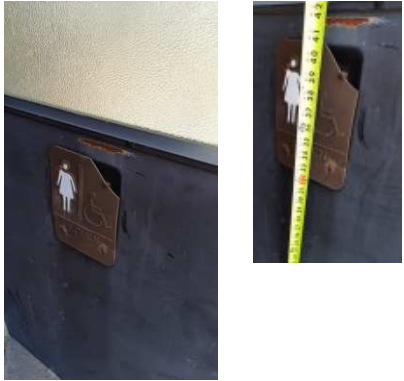
Finding Number	Area Description	Lat/Long	Finding	As Built	Recommendation	Citation	Photos	Figure
152	Trails: Weatherford Trailhead	[32.7832436 , -97.827704 9]	The restroom sign does not comply with one or more applicable requirements for the location, height, and properties of the sign.	Women's- sign on pull side of door, too low, damaged	Replace sign with one of contrasting colors that includes Braille, raised characters, and the symbol of accessibility and mount on the wall, latch side of the door, 48" to the baseline of the lowest character and 60" to the baseline of the highest character	2015 ABAAS Section: F216.2, 703.1, 703.2, 703.5, 703.6 2012 TAS Section: 216.2, 703.1, 703.2, 703.5, 703.6 2010 ADAS Section: 216.2, 703.1, 703.2, 703.5, 703.6

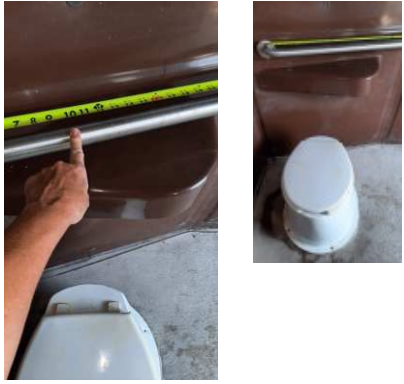
Finding Number	Area Description	Lat/Long	Finding	As Built	Recommendation	Citation	Photos	Figure
157	Trails: Weatherford Trailhead	[32.7832493 , -97.827706 2]	The rear grab bar is not 36" long or is not mounted in the correct location. The rear grab bar must be a minimum of 36" long and extend from the toilet centerline a minimum 12" towards the wall side and a minimum 24" towards the open side of the toilet. Grab bars shall be installed in a horizontal position, 33 inches minimum and 36 inches maximum above the finish floor measured to the top of the gripping surface and the space between the grab bar and the top of the tank shall be 1-1/2 inches minimum.	men's- rear bar 10" to center line	Remount rear grab bar to behind the toilet, 12" to one side of center and 24" to the other and 33" to 36" aff	2015 ABAAS Section: 604.5.2 2012 TAS Section: 604.5.2 2010 ADAS Section: 604.5.2

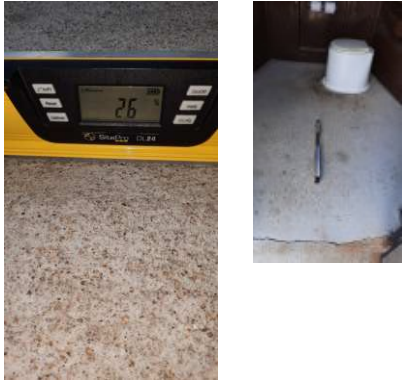
159	Trails: Weatherford Trailhead	[32.7832538 , -97.827702 2]	The accessible route contains running slopes greater than 5 percent and cross slopes greater than 2 percent across the width of the walk and has not been constructed as a ramp (i.e. handrails, wheel guides, etc.). When the slope in the direction of travel of any walk exceeds 1 unit vertical in 20 units horizontal (5-percent slope), it must be constructed as ramp. Surface cross slopes must not exceed one unit vertical in 48 units. Horizontal (2-percent slope).	men's- 2.6% slope in toilet clearance	Correct or repair slope to max 2.08% in restroom.	2015 ABAAS Section: 403.3 2012 TAS Section: 403.3 2010 ADAS Section: 403.3

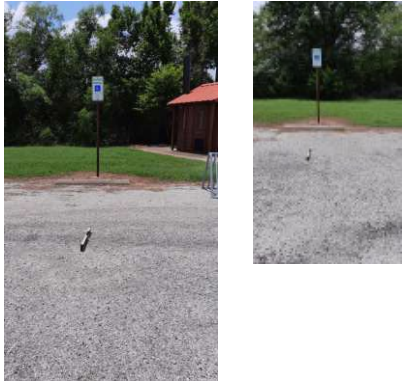
164	Trails: Weatherford Trailhead	[32.783344, -97.827637 8]	The cross slopes (narrow dimension) and/or running slopes (long dimension) of the access aisle exceeds 2%. The running slope and the cross slope in an accessible parking stall and the access aisle must not exceed 2%.	3.8% 1st stall, 2.6% last stall	Repair or correct slope of parking space and access aisle to max 2.08% in any direction	2015 ABAAS Section: 502.4 2012 TAS Section: 502.4 2010 ADAS Section: 502.4

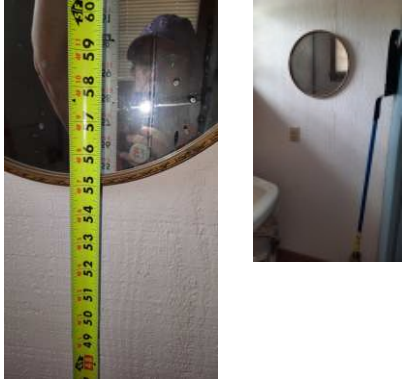
Finding Number	Area Description	Lat/Long	Finding	As Built	Recommendation	Citation	Photos	Figure
171	Trails: Weatherford Trailhead	[32.7855944 , -97.827074 5]	The mirror is mounted too high. Mirrors must have the bottom edge of the reflecting surface a maximum of 40 inches above the floor if above a sink or counter. Mirrors not located above lavatories or countertops shall be installed with the bottom edge of the reflecting surface 35 inches maximum above the finish floor or ground.	office- mirror 55.5"	Lower mirror so reflective surface is max 40" aff	2015 ABAAS Section: 603.3 2012 TAS Section: 603.3 2010 ADAS Section: 603.3

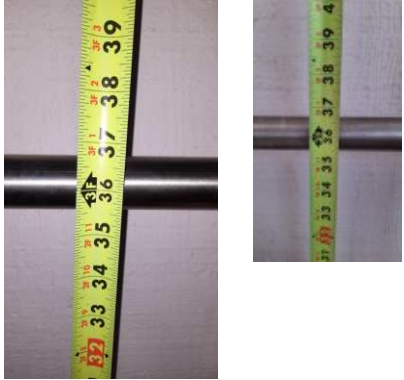
Finding Number	Area Description	Lat/Long	Finding	As Built	Recommendation	Citation	Photos	Figure
176	Trails: Weatherford Trailhead	[32.7855809 , -97.827063 8]	The grab bar height and/or spacing fails. Grab bars must be mounted between 33" and 36" to the top of the gripping surface. There must be 1.5" of clearance between the grab bar and the wall. There must be a minimum of 1.5" of clearance below and minimum 12" above the grab bar to any dispenser or other obstruction.	office- both 36.75"	Remount grab bars in accessible stall to 33" to 36" aff	2015 ABAAS Section: 609.3, 609.4 2012 TAS Section: 609.4, 609.3 2010 ADAS Section: 609.3, 609.4

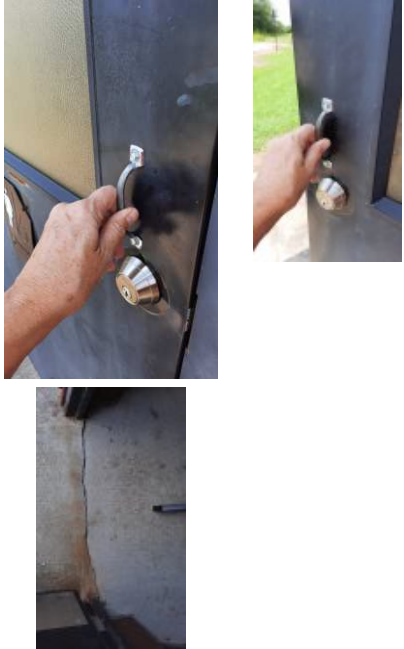
Finding Number	Area Description	Lat/Long	Finding	As Built	Recommendation	Citation	Photos	Figure
180	Trails: Weatherford Trailhead	[32.7832583 , -97.827696 8]	The threshold has a vertical change greater than 1/4 inch high. Hand-activated door opening hardware, handles, pulls, latches, locks, and other operating devices on accessible doors shall have a shape that is easy to grasp with one hand and does not require tight grasping, tight pinching or twisting of the wrist to operate. Hardware shall be 34 inches minimum and 48 inches maximum above the finish floor or ground.	RR doors have small hardware, men's has a crack/CIL	For all doors along the public circulation route, repair, bevel, or ramp CILs at door entries to max .25". For all doors along the public circulation route, fill gaps at door entries to max .5". For all doors along the public circulation route, replace hardware with lever hardware or hardware operable without a tight pinch or grasp.	2010 ADAS Section: 404.2.3, 404.2.7, 404.2.4, 404.2.11, 404.2.11 Exception

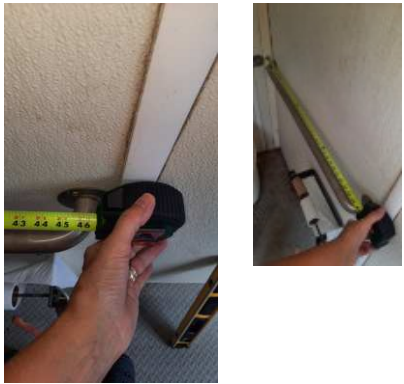
183	Trails: Cold Springs trailhead	[32.8243259, -97.8950229]	The side grab bars are not in the correct location. Grab bars on the side wall must be installed so that the end closest to the rear wall is maximum 12" from the rear wall. The end furthest from the rear wall must be mounted minimum 54" from the rear wall.	side bar extends 46" to end	Remount side grab bar to max 12" from the rear wall at the close end and min 54" on the far end, and 33" to 36" aff	2015 ABAAS Section: 604.5.1 2012 TAS Section: 604.5.1 2010 ADAS Section: 604.5.1

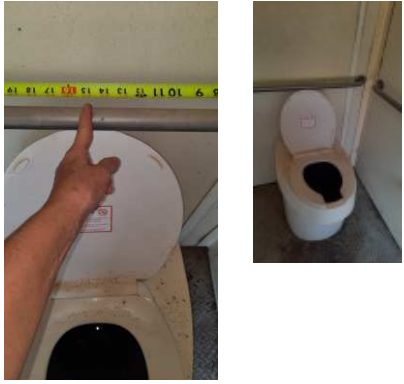
Finding Number	Area Description	Lat/Long	Finding	As Built	Recommendation	Citation	Photos	Figure
184	Trails: Cold Springs trailhead	[32.8243146 , -97.895028 3]	The rear grab bar is not 36" long or is not mounted in the correct location. The rear grab bar must be a minimum of 36" long and extend from the toilet centerline a minimum 12" towards the wall side and a minimum 24" towards the open side of the toilet. Grab bars shall be installed in a horizontal position, 33 inches minimum and 36 inches maximum above the finish floor measured to the top of the gripping surface and the space between the grab bar and the top of the tank shall be 1-1/2 inches minimum.	rear bar 15" to center line	Remount rear grab bar to behind the toilet, 12" to one side of center and 24" to the other and 33" to 36" aff	2015 ABAAS Section: 604.5.2 2012 TAS Section: 604.5.2 2010 ADAS Section: 604.5.2

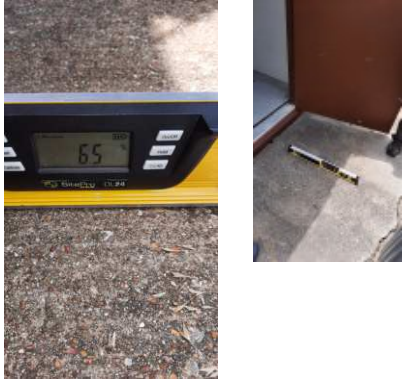
Finding Number	Area Description	Lat/Long	Finding	As Built	Recommendation	Citation	Photos	Figure
187	Trails: Cold Springs trailhead	[32.8243247 , -97.895025 6]	Minimum maneuvering clearances at doors and gates shall comply with 404.2.4. Maneuvering clearances shall extend the full width of the doorway and the required latch side or hinge side clearance. Maneuvering clearances shall have a max slope of 2.08%. The sweep period for doors with closers shall be adjusted so that from an open position of 70 degrees, the door will take at least 3 seconds to move to a point 3 inches from the latch, measured to the leading edge of the door. Exterior doors are recommended to be maintained at 8.5 lbf as a smart practice. Force is to be measured at the operating hardware or 30 inches from the hinges, whichever is greater.	RR - 6.5% slope, fast, 9# push	For all doors along the public circulation route, correct slope in door clearance to max 2.08%. For all doors along the public circulation route, inspect, adjust, and maintain closing speed on door closers. For all doors along the public circulation route, inspect, adjust, and maintain 8.5 lbf to open exterior doors as a smart practice.	2010 ADAS Section: 404.2.3, 404.2.7, 404.2.4, 404.2.11, 404.2.11 Exception

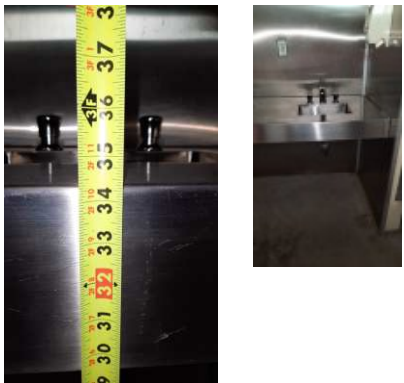
Finding Number	Area Description	Lat/Long	Finding	As Built	Recommendation	Citation	Photos	Figure
190	Trails: Mineral Wells Trailhead	[32.8062383 , -98.113994 5]	The top rim of the sink is too high. All lavatories/sinks that are designated to be accessible shall be a minimum 17 inches in horizontal depth and mounted with the rim or counter edge no higher than 34 inches above the finished floor.	women's- sink 34.25"	Lower sinks to max 34" aff to front of rim	2015 ABAAS Section: 606.3 2012 TAS Section: 606.3 2010 ADAS Section: 606.3

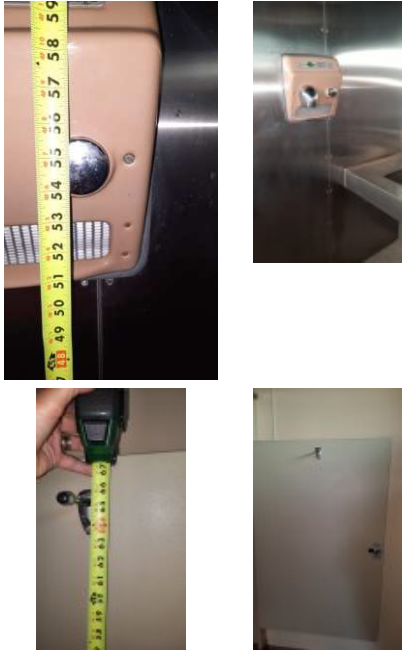
Finding Number	Area Description	Lat/Long	Finding	As Built	Recommendation	Citation	Photos	Figure
193	Trails: Mineral Wells Trailhead	[32.8062292 , -98.113985 1]	Where a high forward reach is over an obstruction, the clear floor space shall extend beneath the element for a distance not less than the required reach depth over the obstruction. The high forward reach shall be 48 inches (1220 mm) maximum where the reach depth is 20 inches (510 mm) maximum. Where the reach depth exceeds 20 inches (510 mm), the high forward reach shall be 44 inches (1120 mm) maximum and the reach depth shall be 25 inches (635 mm) maximum. Where a clear floor or ground space allows a parallel approach to an element and the high side reach is over an obstruction, the height of the obstruction shall be 34 inches (865 mm) maximum and the depth of the obstruction shall be 24 inches (610 mm) maximum. The high side reach shall be 48 inches (1220 mm) maximum for a reach depth of 10 inches (255 mm) maximum. Where the reach depth exceeds 10 inches (255 mm), the high side reach shall be 46 inches (1170 mm) maximum for a reach depth of 24 inches (610 mm) maximum.	women's- hand dryer at 54.5", hook at 64.5"	Lower operating mechanisms in restroom to max 48" aff to highest operable part	2015 ABAAS Section: 308.2.1, 308.3.2 2012 TAS Section: 308.2.1, 308.3.2 2010 ADAS Section: 308.2.1, 308.3.2

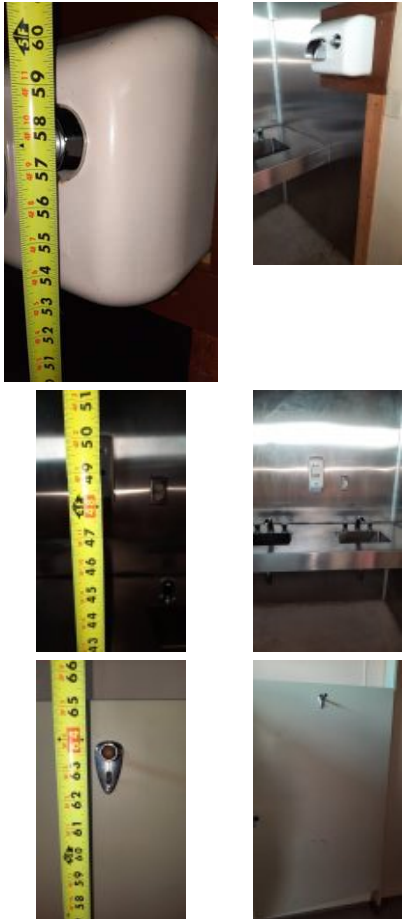
200	Trails: Mineral Wells Trailhead	[32.8062338 , -98.113979 7]	Where a high forward reach is over an obstruction, the clear floor space shall extend beneath the element for a distance not less than the required reach depth over the obstruction. The high forward reach shall be 48 inches (1220 mm) maximum where the reach depth is 20 inches (510 mm) maximum. Where the reach depth exceeds 20 inches (510 mm), the high forward reach shall be 44 inches (1120 mm) maximum and the reach depth shall be 25 inches (635 mm) maximum. Where a clear floor or ground space allows a parallel approach to an element and the high side reach is over an obstruction, the height of the obstruction shall be 34 inches (865 mm) maximum and the depth of the obstruction shall be 24 inches (610 mm) maximum. The high side reach shall be 48 inches (1220 mm) maximum for a reach depth of 10 inches (255 mm) maximum. Where the reach depth exceeds 10 inches (255 mm), the high side reach shall be 46 inches (1170 mm) maximum for a reach depth of 24 inches (610 mm) maximum.	men's- hand dryer at 57", soap at 48" over sink, hook in stall at 63"	Lower operating mechanisms in restroom to max 48" aff to highest operable part Lower soap dispenser to max 44" aff for a forward reach over sink	2015 ABAAS Section: 308.2.1, 308.3.2 2012 TAS Section: 308.2.1, 308.3.2 2010 ADAS Section: 308.2.1, 308.3.2

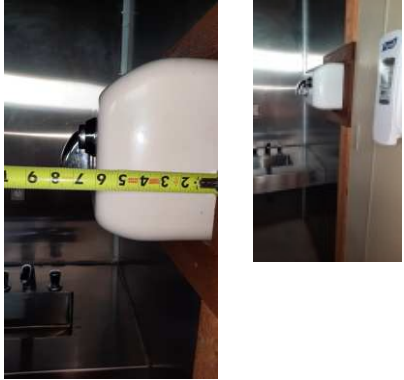
Finding Number	Area Description	Lat/Long	Finding	As Built	Recommendation	Citation	Photos	Figure
203	Trails: Mineral Wells Trailhead	[32.8062518 , -98.113979 7]	The hand dryer projects more than 4 inches into the circulation path. Wall-mounted objects that have leading edges between 27 inches and 80 inches from the floor must not project more than 4 inches into the circulation path. Protruding objects that extend to the floor or within 27 inches of the floor are cane detectable and are therefore not hazardous. Where it is necessary or desirable to have objects protrude from the wall, a manner of cane detection must be provided.	men's- hand dryer protrudes 8"	Relocate protruding objects or place cane detectable warning or bollard at foot of item	2015 ABAAS Section: 307.2 2012 TAS Section: 307.2 2010 ADAS Section: 307.2

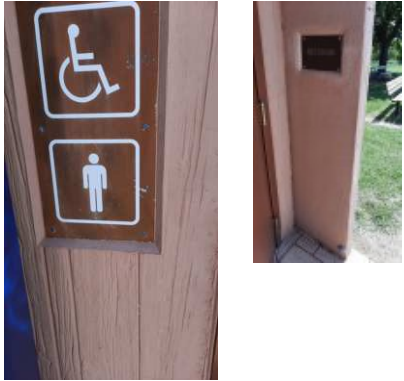
Finding Number	Area Description	Lat/Long	Finding	As Built	Recommendation	Citation	Photos	Figure
214	Trails: Amphitheater Trailhead	[32.8135986 , -98.031483]	The restroom sign does not comply with one or more applicable requirements for the location, height, and properties of the sign.	Men's Restroom - sign low, lacks Braille and raised lettering, Separate signage on hinge side	Acquire and mount signage, including Braille and access symbol mounted on wall, latch side of door, 48" to baseline of lowest character and 60" to baseline of highest character	2015 ABAAS Section: F216.2, 703.1, 703.2, 703.5, 703.6 2012 TAS Section: 216.2, 703.1, 703.2, 703.5, 703.6 2010 ADAS Section: 216.2, 703.1, 703.2, 703.5, 703.6
