Access Audit Site Report

Lake Mineral Wells State Park and Trailway

Accessibility Evaluation

Inspection Date: 07/12/2021

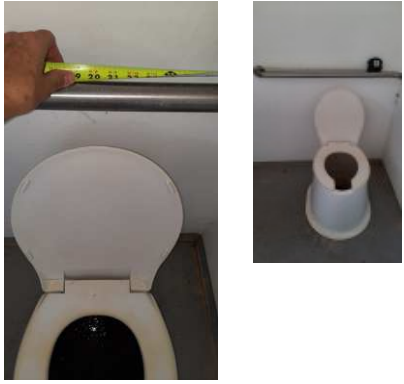
Finding Number	Area Description	Lat/Long	Finding	As Built	Recommendation	Citation	Photos	Figure
216	Trails: Amphitheater Trailhead	[32.8135975 , -98.031480 3]	The rear grab bar is not 36" long or is not mounted in the correct location. The rear grab bar must be a minimum of 36" long and extend from the toilet centerline a minimum 12" towards the wall side and a minimum 24" towards the open side of the toilet. Grab bars shall be installed in a horizontal position, 33 inches minimum and 36 inches maximum above the finish floor measured to the top of the gripping surface and the space between the grab bar and the top of the tank shall be 1-1/2 inches minimum.	Men's Restroom- rear bar 20" to open side	Remount rear grab bar to behind the toilet, 12" to one side of center and 24" to the other and 33" to 36" aff	2015 ABAAS Section: 604.5.2 2012 TAS Section: 604.5.2 2010 ADAS Section: 604.5.2

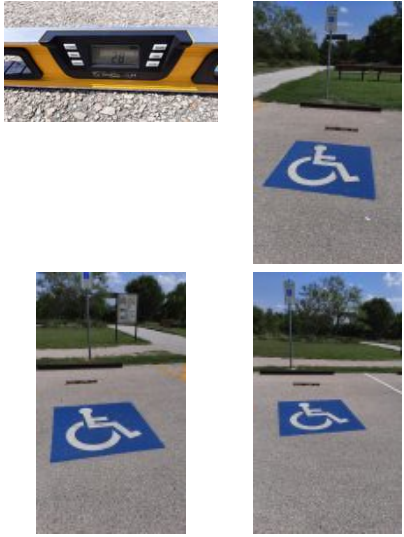
221	Trails: Amphitheater Trailhead	[32.8135885 , -98.031791 5]	The cross slopes (narrow dimension) and/or running slopes (long dimension) of the access aisle exceeds 2%. The running slope and the cross slope in an accessible parking stall and the access aisle must not exceed 2%.	1st stall on right- 2.8%, 1st stall to left- 3%, 2nd stall left - 2.4%	Repair or correct slope of parking space and access aisle to max 2.08% in any direction	2015 ABAAS Section: 502.4 2012 TAS Section: 502.4 2010 ADAS Section: 502.4

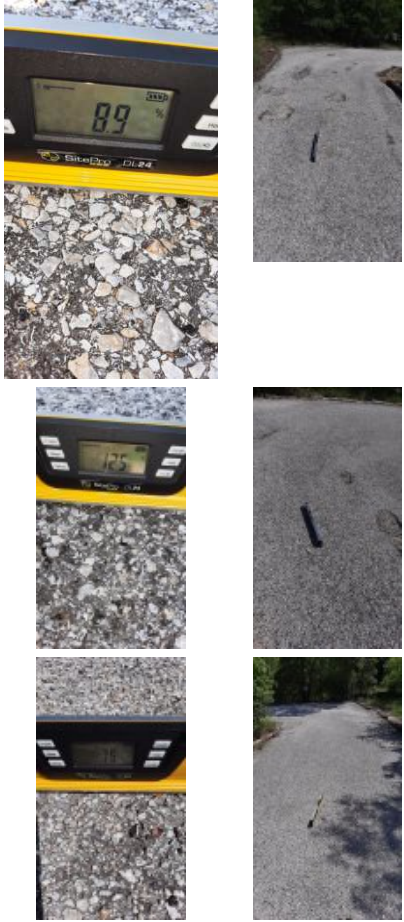
Finding Number	Area Description	Lat/Long	Finding	As Built	Recommendation	Citation	Photos	Figure
227	Trails: Amphitheater Trailhead	[32.8132718 , -98.031705 6]	The running slope of walking surfaces shall not be steeper than 1:20.	8.9%, 12.5% , 7.5% to amphitheater	Correct running slope along the AR to max 5%	2015 ABAAS Section: 403.3 2012 TAS Section: 403.3 2010 ADAS Section: 403.3

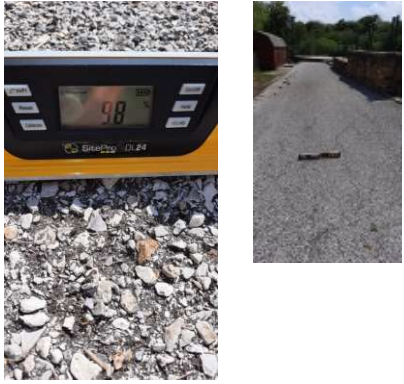
Finding Number	Area Description	Lat/Long	Finding	As Built	Recommendation	Citation	Photos	Figure
228	Trails: Amphitheater Trailhead	[32.812839, -98.031560 8]	The accessible route of travel on the accessible route contains cross slopes greater than 2%. Cross slopes shall not exceed one unit vertical in 48 units horizontal (2-percent slope).	9.8% to seating	Correct or repair cross slope along AR to max 2.08%	2015 ABAAS Section: 403.3 2012 TAS Section: 403.3 2010 ADAS Section: 403.3

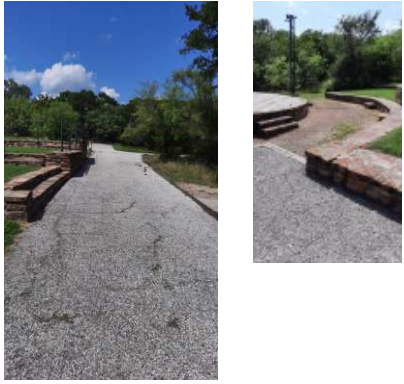
229	Trails: Amphitheater Trailhead	[32.8127229 , -98.031808 9]	Based on the number of seats provided in this area, there should be a minimum of wheelchair seating spaces. Wheelchair spaces shall be provided in assembly areas with fixed seating.	steep route to grass seating, surface in front of stage not accessible	Provide wheelchair accessible seating based on the total number of seats and extend accessible route to the accessible seating	2015 ABAAS Section: F221.2 , F221.2.1.1 2012 TAS Section: 221.2, 221.2.1.1 2010 ADAS Section: 221.2, 221.2.1.1

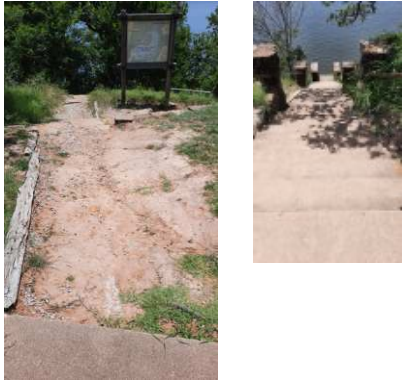
240	Camping: Shelter Camping Area	[32.8193242, -98.0419409]	There is no accessible route to the fishing area. At least one accessible route shall connect accessible buildings, accessible facilities, accessible elements, and accessible spaces that are on the same site.	inaccessible trail to fishing near dining hall	Create an accessible route with crushed stone or other outdoor material from parking or walkway to fishing area	2015 ABAAS Section: F206.2.2 2012 TAS Section: 206.2.2 2010 ADAS Section: 206.2.2

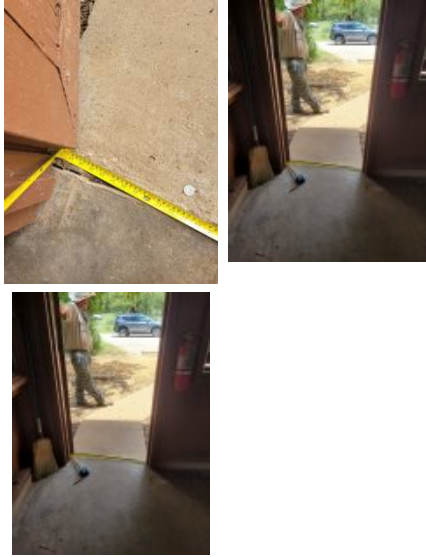
Finding Number	Area Description	Lat/Long	Finding	As Built	Recommendation	Citation	Photos	Figure
241	Camping: Shelter Camping Area	[32.81852, -98.04378]	The door opening does not provide at least 32 inches between the face of the door and the opposite stop. Door openings shall provide a clear width of 32 inches minimum. Clear openings of doorways with swinging doors shall be measured between the face of the door and the stop, with the door open 90 degrees. There shall be no projections into the required clear opening width lower than 34 inches above the finish floor or ground. Projections into the clear opening width between 34 inches and 80 inches above the finish floor or ground shall not exceed 4 inches.	shelter #4- 30.5" clear width	Replace door with one having 32" clear width	2015 ABAAS Section: 404.2.3 2012 TAS Section: 404.2.3 2010 ADAS Section: 404.2.3

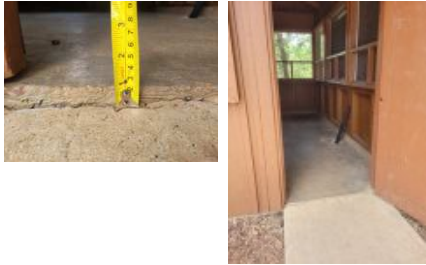
242	Camping: Shelter Camping Area	[32.81852, -98.04378]	Thresholds, if provided at doorways, shall be 1/2 inch (13 mm) high maximum. Raised thresholds and changes in level at doorways shall comply with 302 and 303. Changes in level of 1/4 inch (6.4 mm) high maximum shall be permitted to be vertical. Changes in level between 1/4 inch (6.4 mm) high minimum and 1/2 inch (13 mm) high maximum shall be beveled with a slope not steeper than 1:2. Changes in level greater than 1/2 inch (13 mm) high shall be ramped, and shall comply with 405 or 406.	shelter #4- .75 CIL	Repair, bevel or ramp CIL at doorway	2015 ABAAS Section: 303.3, 404.2.5, 303.2, 303.4 2012 TAS Section: 303.3, 404.2.5, 303.2, 303.4 2010 ADAS Section: 303.3, 404.2.5, 303.2, 303.4

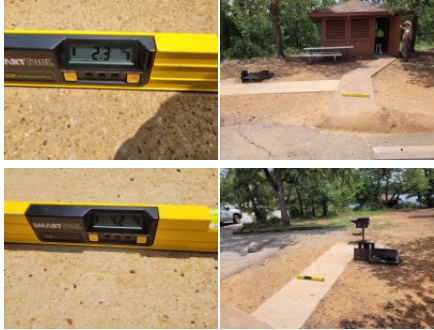
Finding Number	Area Description	Lat/Long	Finding	As Built	Recommendation	Citation	Photos	Figure
244	Camping: Shelter Camping Area	[32.81852, -98.04385]	The cross slope shall not be steeper than 1:48. EXCEPTION: Where the surface is other than concrete, asphalt, or boards, cross slopes not steeper than 1:20 shall be permitted when necessary for drainage.	shelter #4- 2.3% cross near parking, 4.2% cross to grill	Correct or repair ORAR cross slope to max 2.08% or 5% for surfaces other than concrete, asphalt or board as a smart practices	2015 ABAAS Section: 1016.7.2, 1016.7.2 EXCEPTION

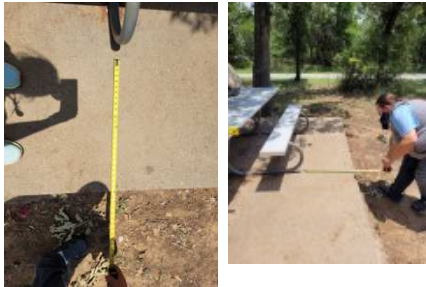
251	Camping: Post Oak Camping Area	[32.8205583, -98.0378734]	36 inches (915 mm) on all usable sides of the table measured from the back edge of the benches	site 11- 24" narrow around table	Provide required 36" clear ground space around all usable portions of the table as a smart practice	2015 ABAAS Section: 1011.2.1

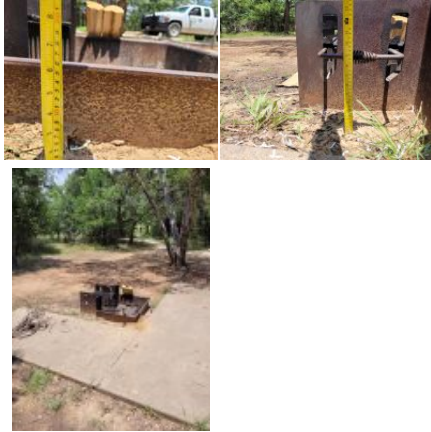
Finding Number	Area Description	Lat/Long	Finding	As Built	Recommendation	Citation	Photos	Figure
252	Camping: Post Oak Camping Area	[32.8205482 , -98.037853 3]	Fire building surfaces shall be 9 inches (230 mm) minimum above the ground	site 11- fire ring at 6.5"	Correct fire building surface to be 9" min above the ground as a smart practice.	2015 ABAAS Section: 1011.5.1

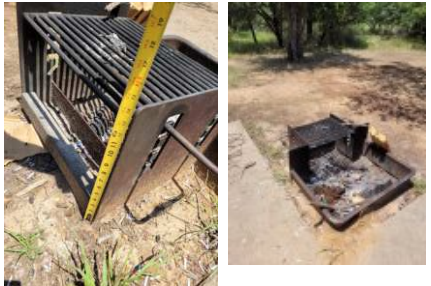
253	Camping: Post Oak Camping Area	[32.8205414 , -98.037861 3]	Where provided, cooking surfaces shall be 15 inches (380 mm) minimum and 34 inches (865 mm) maximum above the ground.	site 11- ground at 14"	Raise or lower cooking surface to be 15" min to 34" max above the ground; in the alternative, replace with a compliant surface as a smart practice.	2015 ABAAS Section: 1011.5.2

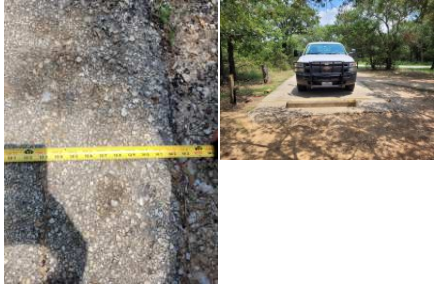
Finding Number	Area Description	Lat/Long	Finding	As Built	Recommendation	Citation	Photos	Figure
255	Camping: Post Oak Camping Area	[32.8205482 , -98.037866 7]	Parking spaces and pull-up spaces for recreational vehicles shall be 20 feet (6100 mm) wide minimum. EXCEPTION: Where two adjacent parking spaces are provided for recreational vehicles, one parking space shall be permitted to be 16 feet (4880 mm) wide minimum.	site 11- parking 12' wide	Correct RV parking space to be 20' wide minimum; or 16' for two adjacent spaces as a smart practice.	2015 ABAAS Section: 1012.2, 1012.2 EXCEPTION

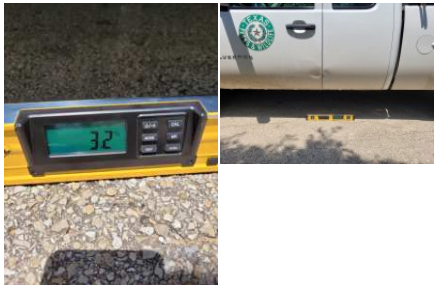
256	Camping: Post Oak Camping Area	[32.8205436 , -98.037869 3]	The surface of parking spaces and pull-up spaces shall be firm and stable. The slope of the surface of parking spaces and pull-up spaces shall not be steeper than 1:48 in any direction. EXCEPTION: Where the surface is other than asphalt, concrete, or boards, slopes not steeper than 1:20 shall be permitted when necessary for drainage.	site 11- 3.2% running slope	Correct surface of parking spaces to be firm and stable with slopes max of 2.08% or 5% for surfaces other than concrete, asphalt or boards as a smart practice.	2015 ABAAS Section: 1012.4, 1012.5, 1012.5 EXCEPTION

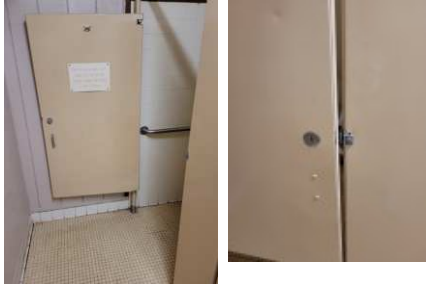
Finding Number	Area Description	Lat/Long	Finding	As Built	Recommendation	Citation	Photos	Figure
264	Camping: Post Oak Camping Area	[32.8208029 , -98.0379123]	The stall door fails to comply with all of the door requirements. The stall door must be a minimum of 32" wide and have compliant hardware on both sides. The stall door must be self-closing.	women's- no hardware on push, not self closing	Adjust stall door to be self-closing Replace stall hardware with hardware operable without a tight pinch or grasp on both sides of the stall door	2015 ABAAS Section: 404.2.3, 404.2.7, 604.8.2.2 2012 TAS Section: 404.2.3, 404.2.7, 604.8.2.2 2010 ADAS Section: 404.2.3, 404.2.7, 604.8.2.2

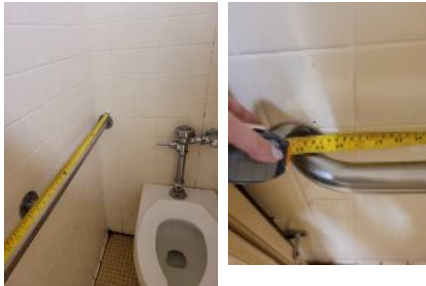
265	Camping: Post Oak Camping Area	[32.8205594 , -98.0378747]	The side grab bars are not in the correct location. Grab bars on the side wall must be installed so that the end closest to the rear wall is maximum 12" from the rear wall. The end furthest from the rear wall must be mounted minimum 54" from the rear wall.	women's- grab bars connected to wall at 51"	Remount side grab bar to max 12" from the rear wall at the close end and min 54" on the far end, and 33" to 36" aff	2015 ABAAS Section: 604.5.1 2012 TAS Section: 604.5.1 2010 ADAS Section: 604.5.1

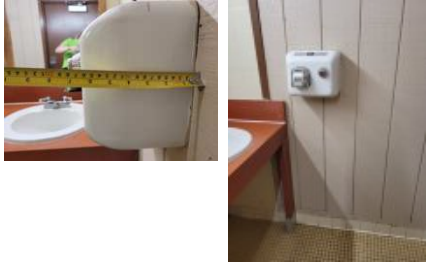
266	Camping: Post Oak Camping Area	[32.8208006 , -98.0378988]	The hand dryer projects more than 4 inches into the circulation path. Wall-mounted objects that have leading edges between 27 inches and 80 inches from the floor must not project more than 4 inches into the circulation path. Protruding objects that extend to the floor or within 27 inches of the floor are cane detectable and are therefore not hazardous. Where it is necessary or desirable to have objects protrude from the wall, a manner of cane detection must be provided.	women's- hand dryer at 7"	Relocate protruding objects or place cane detectable warning or bollard at foot of item	2015 ABAAS Section: 307.2 2012 TAS Section: 307.2 2010 ADAS Section: 307.2

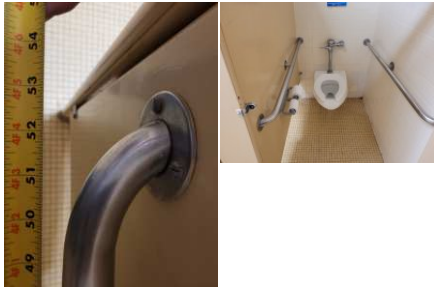
278	Camping: Post Oak Camping Area	[32.8208119 , -98.037914 9]	The side grab bars are not in the correct location. Grab bars on the side wall must be installed so that the end closest to the rear wall is maximum 12" from the rear wall. The end furthest from the rear wall must be mounted minimum 54" from the rear wall.	men's- grab bars extend 51.5"	Remount side grab bar to max 12" from the rear wall at the close end and min 54" on the far end, and 33" to 36" aff	2015 ABAAS Section: 604.5.1 2012 TAS Section: 604.5.1 2010 ADAS Section: 604.5.1

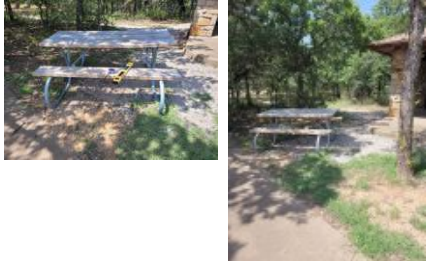
282	Camping: Post Oak Camping Area	[32.8208243 , -98.0378385]	Picnic tables shall provide at least one wheelchair space for each 24 linear feet (7320 mm) of usable table surface perimeter. Wheelchair spaces shall be 30 inches (760 mm) minimum by 48 inches (1220 mm) minimum. Wheelchair spaces shall be positioned for a forward approach to the table and provide knee and toe clearance complying with 306 under the table	picnic table at restroom building not accessible, lacks AR	Replace picnic table with one of an accessible design and locate along an accessible route as a smart practice	2015 ABAAS Section: 1011.4.2

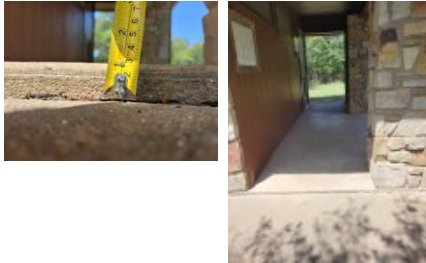
Finding Number	Area Description	Lat/Long	Finding	As Built	Recommendation	Citation	Photos	Figure
283	Camping: Post Oak Camping Area	[32.8208288 , -98.0378908]	The walkway contains abrupt vertical edges and/or variations over a 1/4 inch. 1/4 inch is the maximum vertical rise. Changes in level between 1/4 inch and 1/2 inch must be beveled at 1:2 or less. Changes in level greater than 1/2 inch must be by way of a ramp.	1" CIL to women's restroom	Repair, bevel or ramp CIL along AR	2012 TAS Section: 303.2, 303.3 2010 ADAS Section: 303.2, 303.3

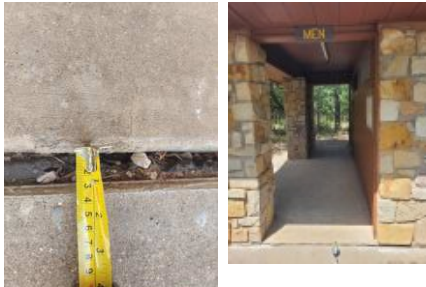
284	Camping: Post Oak Camping Area	[32.8208085 , -98.0378854]	There is a gap spaced greater than a 1/2 inch. Openings in floor or ground surfaces shall not allow passage of a sphere more than 1/2 inch diameter. Elongated openings shall be placed so that the long dimension is perpendicular to the dominant direction of travel.	1" gap to men's room	Correct or fill gaps to be max .5"	2015 ABAAS Section: 302.3 2012 TAS Section: 302.3 2010 ADAS Section: 302.3

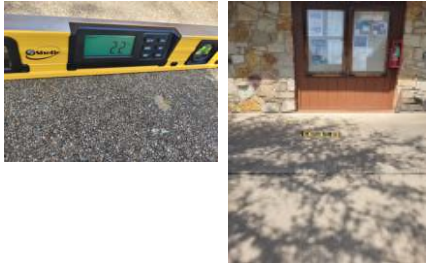
285	Camping: Post Oak Camping Area	[32.8208231 , -98.0378264]	The accessible path of travel between the building entrance and the accessible parking contains cross slopes greater than 2%. Surface cross slopes shall not exceed one unit vertical in 48 units horizontal (2-percent slope). When the slope in the direction of travel of any walk exceeds 1 unit vertical in 20 units horizontal (5-percent slope), it must be constructed as ramp.	2.2% cross in center of path to restroom building	Correct or repair sidewalk cross slope along AR to max 2.08%	2015 ABAAS Section: 403.3 2012 TAS Section: 403.3 2010 ADAS Section: 403.3

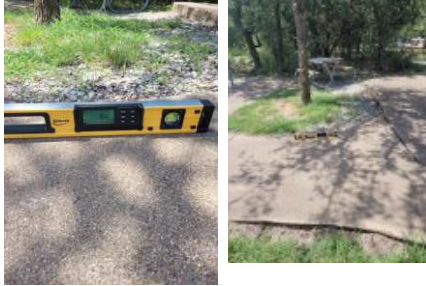
286	Camping: Post Oak Camping Area	[32.8207972 , -98.0378358]	The running slope of walking surfaces shall not be steeper than 1:20.	9.4% slope in center walk way	Correct running slope along the AR to max 5%	2015 ABAAS Section: 403.3 2012 TAS Section: 403.3 2010 ADAS Section: 403.3

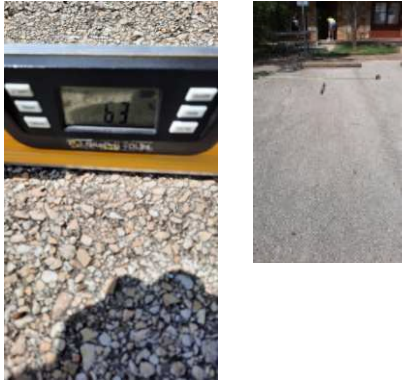
Finding Number	Area Description	Lat/Long	Finding	As Built	Recommendation	Citation	Photos	Figure
290	Camping: Post Oak Camping Area	[32.8207826 , -98.037746]	The cross slopes (narrow dimension) and/or running slopes (long dimension) of the access aisle exceeds 2%. The running slope and the cross slope in an accessible parking stall and the access aisle must not exceed 2%.	6.1% slope	Repair or correct slope of parking space and access aisle to max 2.08% in any direction	2015 ABAAS Section: 502.4 2012 TAS Section: 502.4 2010 ADAS Section: 502.4

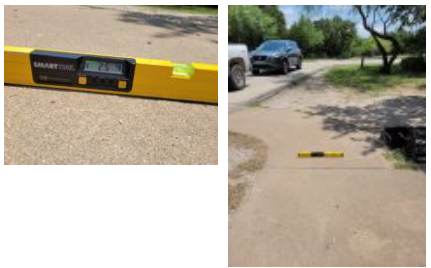
291	Camping: Live Oak Camping Area	[32.8204929 , -98.0349216]	The cross slope shall not be steeper than 1:48. EXCEPTION: Where the surface is other than concrete, asphalt, or boards, cross slopes not steeper than 1:20 shall be permitted when necessary for drainage.	site 54- 2.5% cross slope	Correct or repair ORAR cross slope to max 2.08% or 5% for surfaces other than concrete, asphalt or board as a smart practices	2015 ABAAS Section: 1016.7.2, 1016.7.2 EXCEPTION

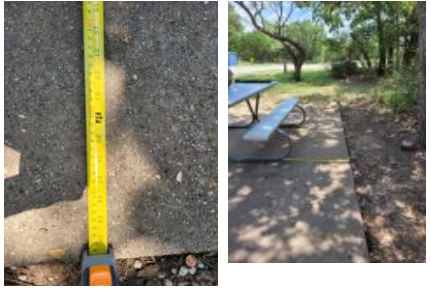
292	Camping: Live Oak Camping Area	[32.8204895 , -98.0349672]	36 inches (915 mm) on all usable sides of the table measured from the back edge of the benches	site 54- AR around table 30" in some places	Provide required 36" clear ground space around all usable portions of the table as a smart practice	2015 ABAAS Section: 1011.2.1

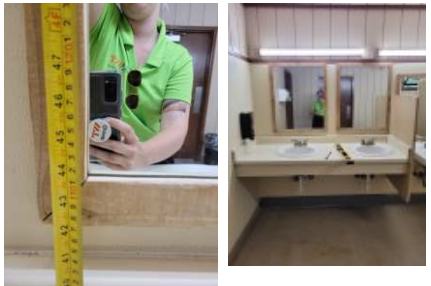
297	Camping: Live Oak Camping Area	[32.8126, -98.04362]	The mirror is mounted too high. Mirrors must have the bottom edge of the reflecting surface a maximum of 40 inches above the floor if above a sink or counter. Mirrors not located above lavatories or countertops shall be installed with the bottom edge of the reflecting surface 35 inches maximum above the finish floor or ground.	big oak women's restroom- mirror 44" aff	Lower mirror so reflective surface is max 40" aff	2015 ABAAS Section: 603.3 2012 TAS Section: 603.3 2010 ADAS Section: 603.3

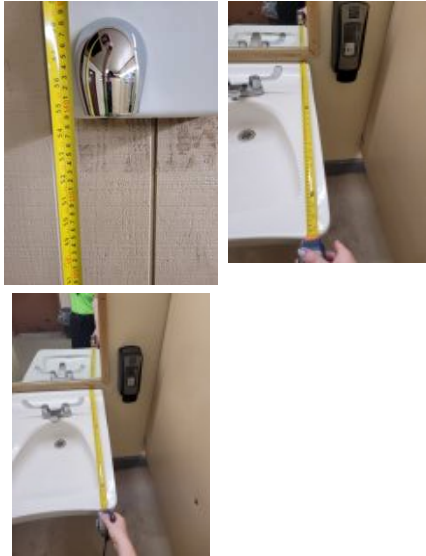
Finding Number	Area Description	Lat/Long	Finding	As Built	Recommendation	Citation	Photos	Figure
300	Camping: Live Oak Camping Area	[32.8126, -98.04362]	Where a high forward reach is over an obstruction, the clear floor space shall extend beneath the element for a distance not less than the required reach depth over the obstruction. The high forward reach shall be 48 inches (1220 mm) maximum where the reach depth is 20 inches (510 mm) maximum. Where the reach depth exceeds 20 inches (510 mm), the high forward reach shall be 44 inches (1120 mm) maximum and the reach depth shall be 25 inches (635 mm) maximum. Where a clear floor or ground space allows a parallel approach to an element and the high side reach is over an obstruction, the height of the obstruction shall be 34 inches (865 mm) maximum and the depth of the obstruction shall be 24 inches (610 mm) maximum. The high side reach shall be 48 inches (1220 mm) maximum for a reach depth of 10 inches (255 mm) maximum. Where the reach depth exceeds 10 inches (255 mm), the high side reach shall be 46 inches (1170 mm) maximum for a reach depth of 24 inches (610 mm) maximum.	big oak women's restroom- automatic dryer at 52", reach to soap 27"	Lower operating mechanisms in restroom to max 48" aff to highest operable part Relocate soap dispenser to max 44" aff for a forward reach of max 25" over counter	2015 ABAAS Section: 308.2.1, 308.3.2 2012 TAS Section: 308.2.1, 308.3.2 2010 ADAS Section: 308.2.1, 308.3.2

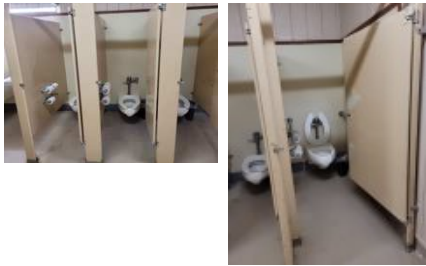
301	Camping: Live Oak Camping Area	[32.8126, -98.04362]	There are not enough accessible toilet compartments. A minimum of 1 must be wheelchair accessible .	big oak women's restroom- lacks wheelchair compartment	Create a wheelchair accessible stall with grab bars and fixtures mounted in correct locations and at correct heights	2015 ABAAS Section: F213.3.1 2012 TAS Section: 213.3.1 2010 ADAS Section: 213.3.1

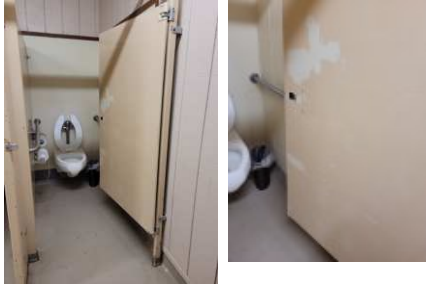
Finding Number	Area Description	Lat/Long	Finding	As Built	Recommendation	Citation	Photos	Figure
302	Camping: Live Oak Camping Area	[32.8126, -98.04362]	The stall door fails to comply with all of the door requirements. The stall door must be a minimum of 32" wide and have compliant hardware on both sides. The stall door must be self-closing.	big oak women's restroom- not self closing, no hardware on push	Adjust stall door to be self-closing Replace stall hardware with hardware operable without a tight pinch or grasp on both sides of the stall door	2015 ABAAS Section: 404.2.3, 404.2.7, 604.8.2.2 2012 TAS Section: 404.2.3, 404.2.7, 604.8.2.2 2010 ADAS Section: 404.2.3, 404.2.7, 604.8.2.2

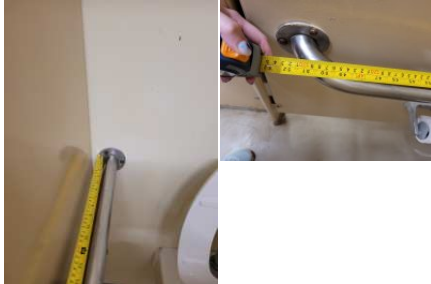
304	Camping: Live Oak Camping Area	[32.8126, -98.04362]	The side grab bars are not in the correct location. Grab bars on the side wall must be installed so that the end closest to the rear wall is maximum 12" from the rear wall. The end furthest from the rear wall must be mounted minimum 54" from the rear wall.	big oak women's restroom- grab bars 51" long. connected to rear wall	Remount side grab bar to max 12" from the rear wall at the close end and min 54" on the far end, and 33" to 36" aff	2015 ABAAS Section: 604.5.1 2012 TAS Section: 604.5.1 2010 ADAS Section: 604.5.1

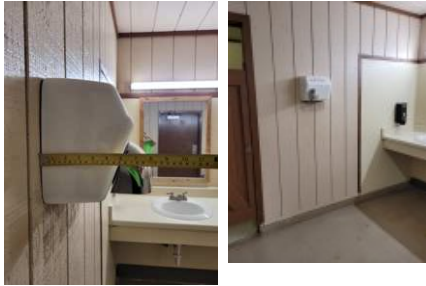
Finding Number	Area Description	Lat/Long	Finding	As Built	Recommendation	Citation	Photos	Figure
305	Camping: Live Oak Camping Area	[32.8126, -98.04362]	The hand dryer projects more than 4 inches into the circulation path. Wall-mounted objects that have leading edges between 27 inches and 80 inches from the floor must not project more than 4 inches into the circulation path. Protruding objects that extend to the floor or within 27 inches of the floor are cane detectable and are therefore not hazardous. Where it is necessary or desirable to have objects protrude from the wall, a manner of cane detection must be provided.	big oak women's restroom- hand dryer at 7"	Relocate protruding objects or place cane detectable warning or bollard at foot of item	2015 ABAAS Section: 307.2 2012 TAS Section: 307.2 2010 ADAS Section: 307.2

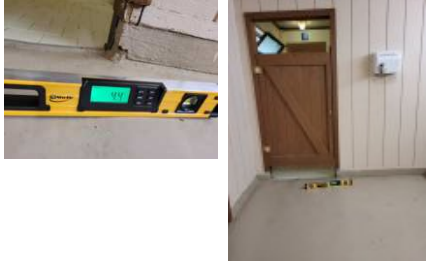
306	Camping: Live Oak Camping Area	[32.8126, -98.04362]	The accessible route contains running slopes greater than 5 percent and cross slopes greater than 2 percent across the width of the walk and has not been constructed as a ramp (i.e. handrails, wheel guides, etc.). When the slope in the direction of travel of any walk exceeds 1 unit vertical in 20 units horizontal (5-percent slope), it must be constructed as ramp. Surface cross slopes must not exceed one unit vertical in 48 units. Horizontal (2-percent slope).	big oak women's restroom- 4.4% cross slope by shower room	Correct or repair slope to max 5% running and 2.08% cross	2015 ABAAS Section: 403.3 2012 TAS Section: 403.3 2010 ADAS Section: 403.3

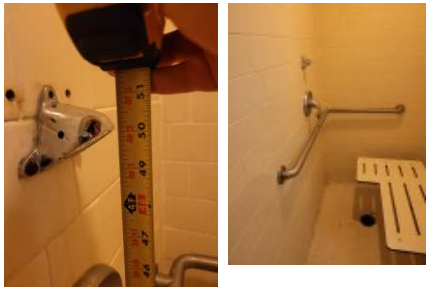
307	Camping: Live Oak Camping Area	[32.8126, -98.04362]	There is no hand held sprayer unit. The sprayer unit must have a 59 inches hose and be mounted 48 inches maximum to the top of mounting bracket off the floor. The shower spray unit shall have an on/off control with a non-positive shutoff. If an adjustable-height shower head on a vertical bar is used, the bar shall be installed so as not to obstruct the use of grab bars.	big oak women's restroom- fixed shower head 50" aff	Replace shower control with a compliant lever control with a shower head on a 59" hose and usable as hand held; in the alternative, lower fixed shower head to max 48" aff	2015 ABAAS Section: 608.6 2012 TAS Section: 608.6 2010 ADAS Section: 608.6

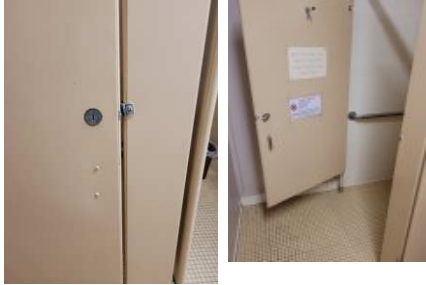
Finding Number	Area Description	Lat/Long	Finding	As Built	Recommendation	Citation	Photos	Figure
315	Camping: Live Oak Camping Area	[32.8126, -98.04362]	The stall door fails to comply with all of the door requirements. The stall door must be a minimum of 32" wide and have compliant hardware on both sides. The stall door must be self-closing.	little oak women's restroom- no hardware on pull, not self closing	Adjust stall door to be self-closing Replace stall hardware with hardware operable without a tight pinch or grasp on both sides of the stall door	2015 ABAAS Section: 404.2.3, 404.2.7, 604.8.2.2 2012 TAS Section: 404.2.3, 404.2.7, 604.8.2.2 2010 ADAS Section: 404.2.3, 404.2.7, 604.8.2.2

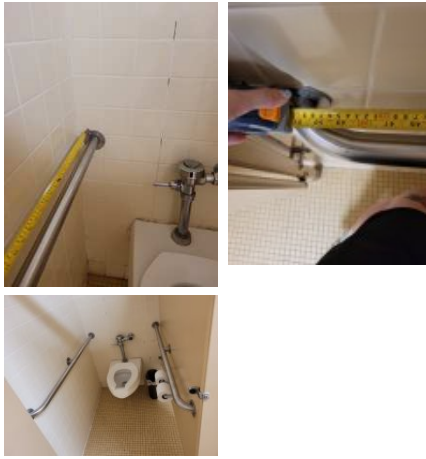
316	Camping: Live Oak Camping Area	[32.8126, -98.04362]	The side grab bars are not in the correct location. Grab bars on the side wall must be installed so that the end closest to the rear wall is maximum 12" from the rear wall. The end furthest from the rear wall must be mounted minimum 54" from the rear wall.	little oak women's restroom- connected to wall at 51"	Remount side grab bar to max 12" from the rear wall at the close end and min 54" on the far end, and 33" to 36" aff	2015 ABAAS Section: 604.5.1 2012 TAS Section: 604.5.1 2010 ADAS Section: 604.5.1

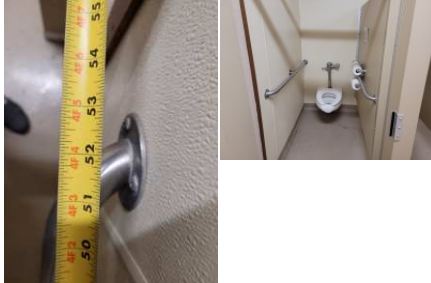
326	Camping: Live Oak Camping Area	[32.8126, -98.04362]	The side grab bars are not in the correct location. Grab bars on the side wall must be installed so that the end closest to the rear wall is maximum 12" from the rear wall. The end furthest from the rear wall must be mounted minimum 54" from the rear wall.	big oak men's- grab bars extend 52"	Remount side grab bar to max 12" from the rear wall at the close end and min 54" on the far end, and 33" to 36" aff	2015 ABAAS Section: 604.5.1 2012 TAS Section: 604.5.1 2010 ADAS Section: 604.5.1

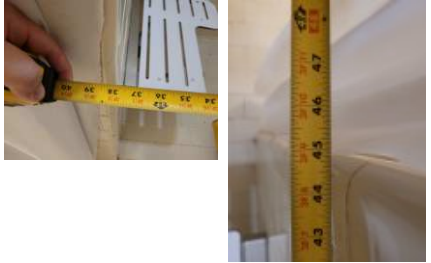
329	Camping: Live Oak Camping Area	[32.8126, -98.04362]	Transfer type shower compartments shall be 36 inches (915 mm) by 36 inches (915 mm) clear inside dimensions measured at the center points of opposing sides and shall have a 36 inch (915 mm) wide minimum entry on the face of the shower compartment. Clearance of 36 inches (915 mm) wide minimum by 48 inches (1220 mm) long minimum measured from the control wall shall be provided.	big oak men's- transfer shower 38" x 45"	Correct transfer shower to compliant 36" by 36" clear inside dimension	2015 ABAAS Section: 608.2.1 2012 TAS Section: 608.2.1 2010 ADAS Section: 608.2.1

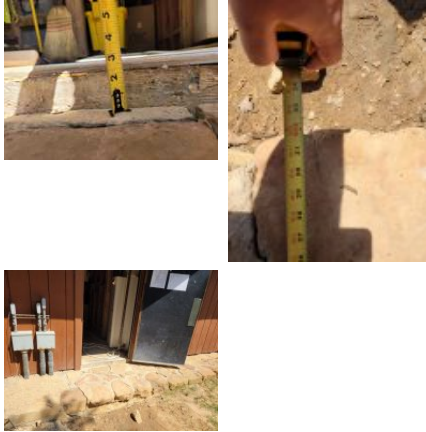
Finding Number	Area Description	Lat/Long	Finding	As Built	Recommendation	Citation	Photos	Figure
333	Camping: Live Oak Camping Area	[32.8126, -98.04362]	Spaces and elements within employee work areas shall only be required to comply with 206.2.8, 207.1, and 215.3 and shall be designed and constructed so that individuals with disabilities can approach, enter, and exit the employee work area. Employee work areas, or portions of employee work areas, other than raised courtroom stations, that are less than 300 square feet (28 m2) and elevated 7 inches (180 mm) or more above the finish floor or ground where the elevation is essential to the function of the space shall not be required to comply with these requirements or to be on an accessible route.	big live oak restroom pipe chase- CIL, 32" back from door pull side, equipment push side	For employee spaces, relocate storage, furniture, and other obstacles at doorways to provide approach, enter and exit at the employee space. Provide required maneuvering clearance on push and pull side of doors. Repair, bevel, or ramp CILs at door entries to max .25".	2015 ABAAS Section: F203.9 2012 TAS Section: 203.9 2010 ADAS Section: 203.9

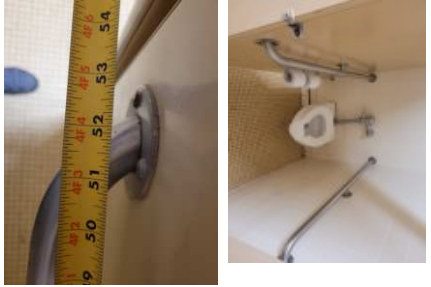
342	Camping: Live Oak Camping Area	[32.8126, -98.04362]	The side grab bars are not in the correct location. Grab bars on the side wall must be installed so that the end closest to the rear wall is maximum 12" from the rear wall. The end furthest from the rear wall must be mounted minimum 54" from the rear wall.	little oak men's- grab bar extends 52"	Remount side grab bar to max 12" from the rear wall at the close end and min 54" on the far end, and 33" to 36" aff	2015 ABAAS Section: 604.5.1 2012 TAS Section: 604.5.1 2010 ADAS Section: 604.5.1

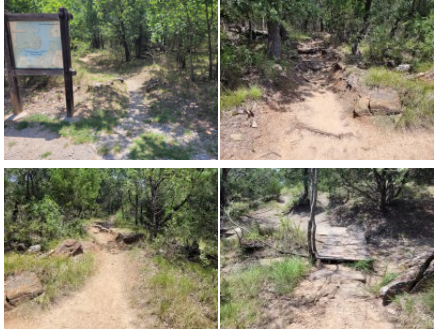
Finding Number	Area Description	Lat/Long	Finding	As Built	Recommendation	Citation	Photos	Figure
346	Camping: Live Oak Camping Area	[32.8221, -98.03332]	The surface of outdoor recreation access routes, passing spaces, and resting intervals shall be firm and stable	narrow, natural surface path to fishing piers	Repair surface or ORAR to be firm and stable as a smart practice.	2015 ABAAS Section: 1016.2

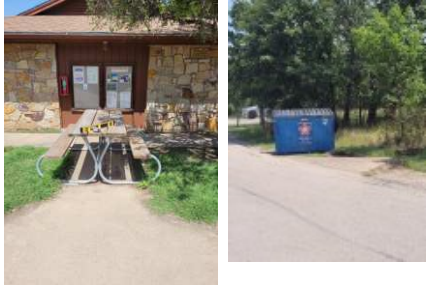
351	Camping: Live Oak Camping Area	[32.8203182, -98.0352569]	The picnic table and garbage can are not accessible or not located along the accessible route. At least one of each type of element provided at a building site must be accessible and located along an accessible route.	big oak restroom-table: on AR, not of accessible design, garbage: no AR	Replace one picnic table with one with knee and toe clearance, 9" deep at 27" high and 25" deep at 9" high, with a 36" AR around table Relocate 20% of garbage cans to be along AR	2015 ABAAS Section: F206.2.2 2012 TAS Section: 206.2.2 2010 ADAS Section: 206.2.2

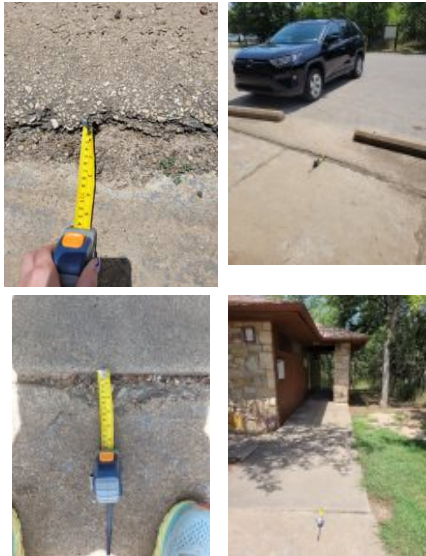
354	Camping: Live Oak Camping Area	[32.8203701 , -98.0351885]	There is a gap spaced greater than a 1/2 inch. Openings in floor or ground surfaces shall not allow passage of a sphere more than 1/2 inch diameter. Elongated openings shall be placed so that the long dimension is perpendicular to the dominant direction of travel.	big oak restroom- 3" gap facing parking, 2" by men's restroom, 1.5" close to men's restroom door, 2" at corner of men's restroom, 1" by picnic table in center	Correct or fill gaps to be max .5"	2015 ABAAS Section: 302.3 2012 TAS Section: 302.3 2010 ADAS Section: 302.3

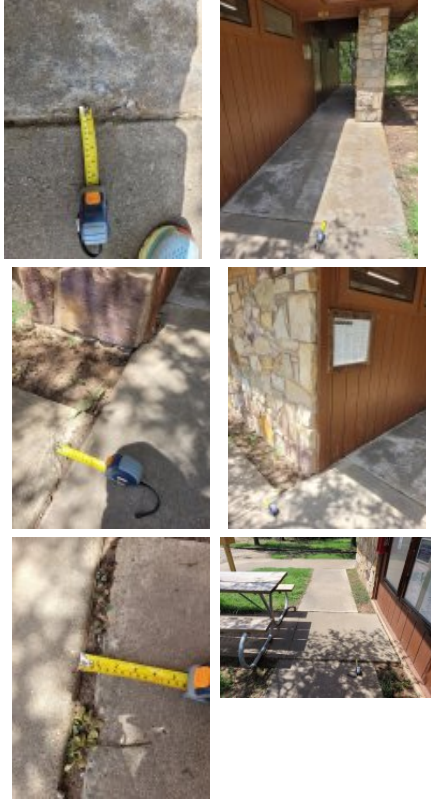
355	Camping: Live Oak Camping Area	[32.8204061, -98.0351912]	The accessible path of travel between the building entrance and the accessible parking contains cross slopes greater than 2%. Surface cross slopes shall not exceed one unit vertical in 48 units horizontal (2-percent slope). When the slope in the direction of travel of any walk exceeds 1 unit vertical in 20 units horizontal (5-percent slope), it must be constructed as ramp.	big oak restroom- 2.2% by women's restroom	Correct or repair sidewalk cross slope along AR to max 2.08%	2015 ABAAS Section: 403.3 2012 TAS Section: 403.3 2010 ADAS Section: 403.3

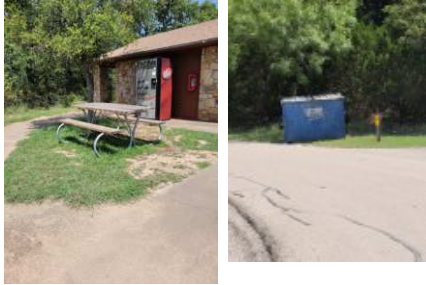
Finding Number	Area Description	Lat/Long	Finding	As Built	Recommendation	Citation	Photos	Figure
356	Camping: Live Oak Camping Area	[32.822126, -98.033524 2]	The garbage can and picnic table are not accessible or are not located along the accessible route. At least one of each type of element provided at a building site must be accessible and located along an accessible route.	little oak restroom- no AR to garbage or table	Replace one picnic table with one with knee and toe clearance, 9" deep at 27" high and 25" deep at 9" high, with a 36" AR around table Relocate 20% of garbage cans to be along AR	2015 ABAAS Section: F206.2.2 2012 TAS Section: 206.2.2 2010 ADAS Section: 206.2.2

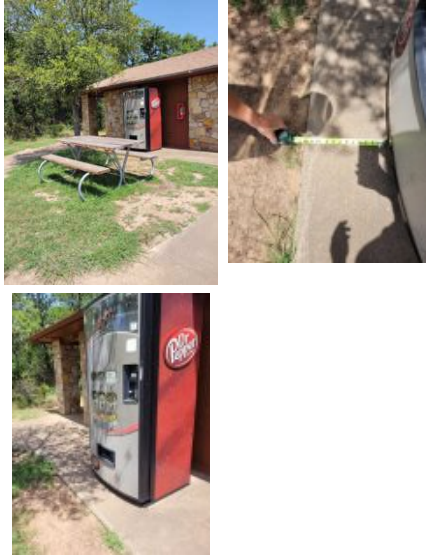
357	Camping: Live Oak Camping Area	[32.822135, -98.033567 1]	The operable part is not accessible because there is not adequate clear floor space for either a forward or side approach. The clear floor or ground space shall be 30 inches minimum by 48 inches minimum.	little oak restroom- vending machine lacks CFS	Provide required 30" by 48" CFS at operable parts	2015 ABAAS Section: 305.3 2012 TAS Section: 305.3 2010 ADAS Section: 305.3

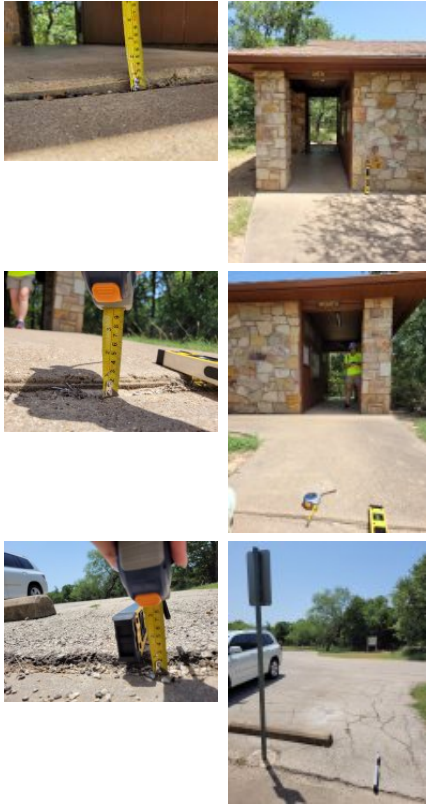
Finding Number	Area Description	Lat/Long	Finding	As Built	Recommendation	Citation	Photos	Figure
359	Camping: Live Oak Camping Area	[32.8221034, -98.0335268]	The walkway contains abrupt vertical edges and/or variations over a 1/4 inch. 1/4 inch is the maximum vertical rise. Changes in level between 1/4 inch and 1/2 inch must be beveled at 1:2 or less. Changes in level greater than 1/2 inch must be by way of a ramp.	little oak - 1" CIL by men's restroom, 1" CIL by women's, .75" by accessible stall	Repair, bevel or ramp CIL along AR	2012 TAS Section: 303.2, 303.3 2010 ADAS Section: 303.2, 303.3

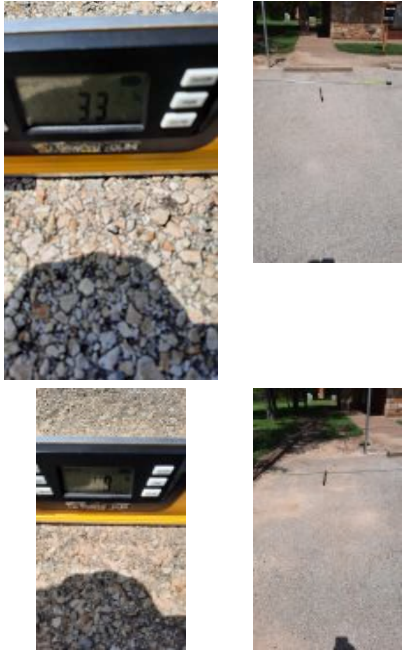
Finding Number	Area Description	Lat/Long	Finding	As Built	Recommendation	Citation	Photos	Figure
364	Camping: Live Oak Camping Area	[32.8203092 , -98.035214]	The cross slopes (narrow dimension) and/or running slopes (long dimension) of the access aisle exceeds 2%. The running slope and the cross slope in an accessible parking stall and the access aisle must not exceed 2%.	Big Oak - 3.3%, 4%	Repair or correct slope of parking space and access aisle to max 2.08% in any direction	2015 ABAAS Section: 502.4 2012 TAS Section: 502.4 2010 ADAS Section: 502.4

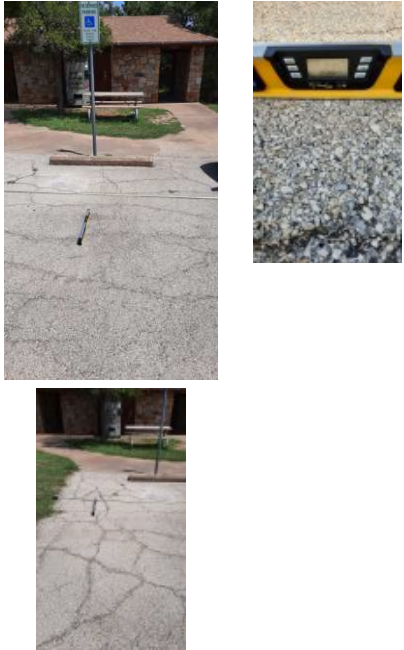
Finding Number	Area Description	Lat/Long	Finding	As Built	Recommendation	Citation	Photos	Figure
371	Camping: Live Oak Camping Area	[32.8220674 , -98.0334638]	The cross slopes (narrow dimension) and/or running slopes (long dimension) of the access aisle exceeds 2%. The running slope and the cross slope in an accessible parking stall and the access aisle must not exceed 2%.	Little Oak - 3.8%, 5.6%	Repair or correct slope of parking space and access aisle to max 2.08% in any direction	2015 ABAAS Section: 502.4 2012 TAS Section: 502.4 2010 ADAS Section: 502.4

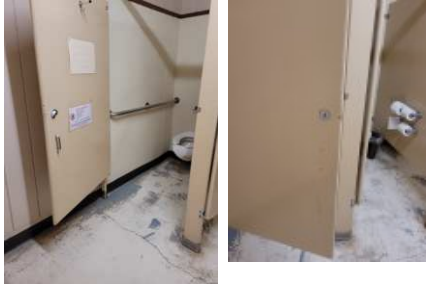
Finding Number	Area Description	Lat/Long	Finding	As Built	Recommendation	Citation	Photos	Figure
385	Camping: Cross Timbers Camping Area	[32.8126, -98.04362]	The stall door fails to comply with all of the door requirements. The stall door must be a minimum of 32" wide and have compliant hardware on both sides. The stall door must be self-closing.	women's- not self closing no hardware on pull	Adjust stall door to be self-closing Replace stall hardware with hardware operable without a tight pinch or grasp on both sides of the stall door	2015 ABAAS Section: 404.2.3, 404.2.7, 604.8.2.2 2012 TAS Section: 404.2.3, 404.2.7, 604.8.2.2 2010 ADAS Section: 404.2.3, 404.2.7, 604.8.2.2

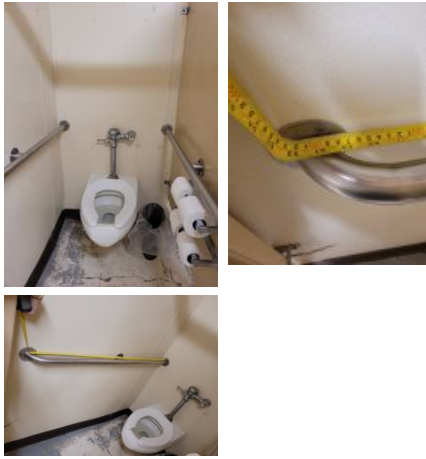
386	Camping: Cross Timbers Camping Area	[32.8126, -98.04362]	The side grab bars are not in the correct location. Grab bars on the side wall must be installed so that the end closest to the rear wall is maximum 12" from the rear wall. The end furthest from the rear wall must be mounted minimum 54" from the rear wall.	women's- grab bars connected to wall, length is 51"	Remount side grab bar to max 12" from the rear wall at the close end and min 54" on the far end, and 33" to 36" aff	2015 ABAAS Section: 604.5.1 2012 TAS Section: 604.5.1 2010 ADAS Section: 604.5.1

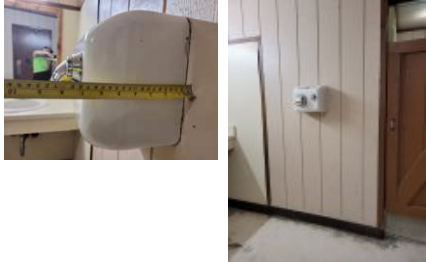
Finding Number	Area Description	Lat/Long	Finding	As Built	Recommendation	Citation	Photos	Figure
387	Camping: Cross Timbers Camping Area	[32.8126, -98.04362]	The hand dryer projects more than 4 inches into the circulation path. Wall-mounted objects that have leading edges between 27 inches and 80 inches from the floor must not project more than 4 inches into the circulation path. Protruding objects that extend to the floor or within 27 inches of the floor are cane detectable and are therefore not hazardous. Where it is necessary or desirable to have objects protrude from the wall, a manner of cane detection must be provided.	women's- hand dryer protrudes 8"	Relocate protruding objects or place cane detectable warning or bollard at foot of item	2015 ABAAS Section: 307.2 2012 TAS Section: 307.2 2010 ADAS Section: 307.2

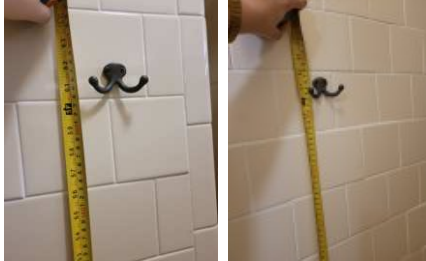
388	Camping: Cross Timbers Camping Area	[32.8126, -98.04362]	Coat hooks provided within the room shall be located within one of the reach ranges specified in 308. Shelves shall be 40 inches (1015 mm) minimum and 48 inches (1220 mm) maximum above the finish floor or ground. Where coat hooks or shelves are provided in dressing, fitting or locker rooms without individual compartments, at least one of each type shall comply with 803.5. Where coat hooks or shelves are provided in individual compartments at least one of each type complying with 803.5 shall be provided in individual compartments in dressing, fitting, or locker rooms required to comply with 222.1.	women's- hooks at 61"	Remount at least one hook to max 48" aff and shelves to 40" - 48" aff	2015 ABAAS Section: 308.2.1, 308.1, F222.2, 803.5 2012 TAS Section: 308.2.1, 308.1, 222.2, 803.5 2010 ADAS Section: 308.2.1, 308.1, 222.2, 803.5

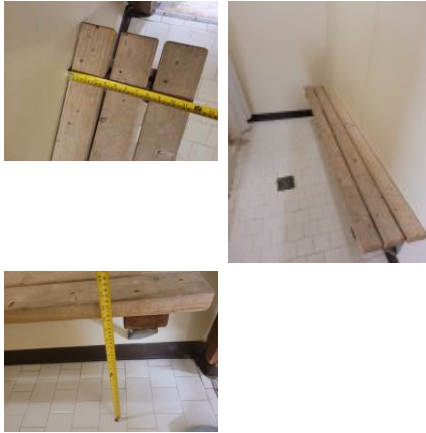
Finding Number	Area Description	Lat/Long	Finding	As Built	Recommendation	Citation	Photos	Figure
389	Camping: Cross Timbers Camping Area	[32.8126, -98.04362]	The bench is not deep enough or long enough or is missing. Benches shall be provided having seats that are 42 inches long minimum and 20 inches deep minimum and 24 inches deep maximum. The bench shall provide for back support or shall be affixed to a wall. Back support shall be 42 inches (1065 mm) long minimum and shall extend from a point 2 inches (51 mm) maximum above the seat surface to a point 18 inches (455 mm) minimum above the seat surface. Back support shall be 2½ inches (64 mm) maximum from the rear edge of the seat measured horizontally. The top of the bench seat surface shall be 17 inches (430 mm) minimum and 19 inches (485 mm) maximum above the finish floor or ground.	women's- 11" deep bench, 20" height	Replace bench in dressing area with one having a seat depth of 20" to 24" deep, 42" long, affixed to the wall or having a back and mounted 17" to 19" aff	2012 TAS Section: 903.4, 903.2, 903.3, 903.5 2010 ADAS Section: 903.4, 903.2, 903.3, 903.5

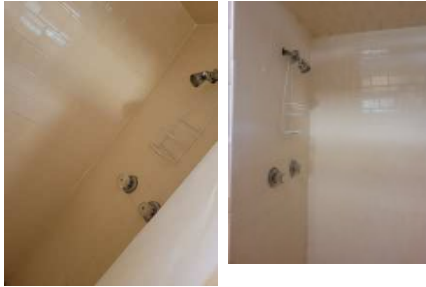
390	Camping: Cross Timbers Camping Area	[32.8126, -98.04362]	There are no accessible bathing or shower facilities. Where facilities for bathing are provided for the public, clients or employees, including showers or bathtubs, at least one shower or bathtub and support facilities such as lockers, and not less than 1 percent of all facilities, shall be accessible.	women's- no accessible shower	Create an accessible shower in locker/bathing room	2015 ABAAS Section: F213.3.6 2012 TAS Section: 213.3.6 2010 ADAS Section: 213.3.6

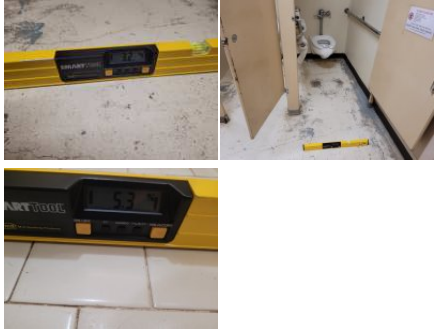
Finding Number	Area Description	Lat/Long	Finding	As Built	Recommendation	Citation	Photos	Figure
403	Camping: Cross Timbers Camping Area	[32.8126, -98.04362]	The accessible route contains running slopes greater than 5 percent and cross slopes greater than 2 percent across the width of the walk and has not been constructed as a ramp (i.e. handrails, wheel guides, etc.). When the slope in the direction of travel of any walk exceeds 1 unit vertical in 20 units horizontal (5-percent slope), it must be constructed as ramp. Surface cross slopes must not exceed one unit vertical in 48 units. Horizontal (2-percent slope).	men's- 3.2% at ambulatory stall, 5.3% at drain	Correct or repair slope to max 5% running and 2.08% cross	2015 ABAAS Section: 403.3 2012 TAS Section: 403.3 2010 ADAS Section: 403.3

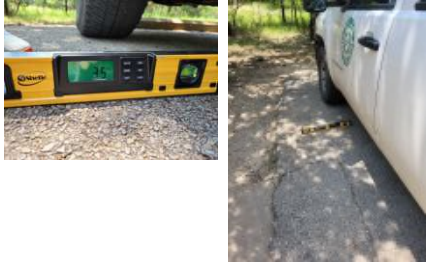
Finding Number	Area Description	Lat/Long	Finding	As Built	Recommendation	Citation	Photos	Figure
426	Camping: Plateau Camping Area	[32.8259487, -98.0345756]	The surface of parking spaces and pull-up spaces shall be firm and stable. The slope of the surface of parking spaces and pull-up spaces shall not be steeper than 1:48 in any direction. EXCEPTION: Where the surface is other than asphalt, concrete, or boards, slopes not steeper than 1:20 shall be permitted when necessary for drainage.	site 86- 3.5% cross slope	Correct surface of parking spaces to be firm and stable with slopes max of 2.08% or 5% for surfaces other than concrete, asphalt or boards as a smart practice.	2015 ABAAS Section: 1012.4, 1012.5, 1012.5 EXCEPTION

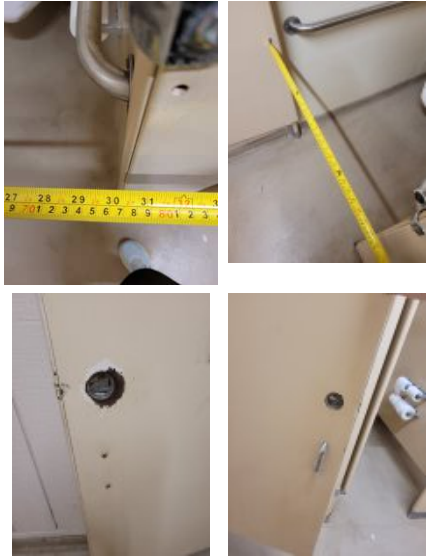
Finding Number	Area Description	Lat/Long	Finding	As Built	Recommendation	Citation	Photos	Figure
436	Camping: Plateau Camping Area	[32.8126, -98.04362]	The stall door fails to comply with all of the door requirements. The stall door must be a minimum of 32" wide and have compliant hardware on both sides. The stall door must be self-closing.	women's- 32" opening, not self closing, no hardware on push	Widen stall doors to 32" when opened to 90 degrees Adjust stall door to be self-closing Replace stall hardware with hardware operable without a tight pinch or grasp on both sides of the stall door	2015 ABAAS Section: 404.2.3, 404.2.7, 604.8.2.2 2012 TAS Section: 404.2.3, 404.2.7, 604.8.2.2 2010 ADAS Section: 404.2.3, 404.2.7, 604.8.2.2

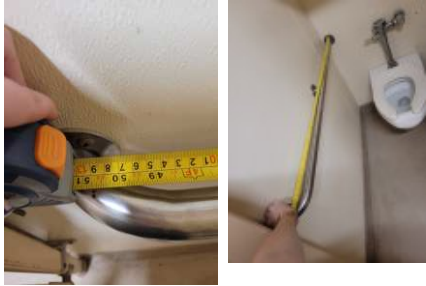
437	Camping: Plateau Camping Area	[32.8126, -98.04362]	The side grab bars are not in the correct location. Grab bars on the side wall must be installed so that the end closest to the rear wall is maximum 12" from the rear wall. The end furthest from the rear wall must be mounted minimum 54" from the rear wall.	women's- grab bars extend 51" on both sides	Remount side grab bar to max 12" from the rear wall at the close end and min 54" on the far end, and 33" to 36" aff	2015 ABAAS Section: 604.5.1 2012 TAS Section: 604.5.1 2010 ADAS Section: 604.5.1

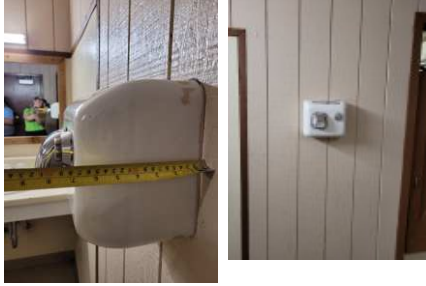
438	Camping: Plateau Camping Area	[32.8126, -98.04362]	The hand dryer projects more than 4 inches into the circulation path. Wall-mounted objects that have leading edges between 27 inches and 80 inches from the floor must not project more than 4 inches into the circulation path. Protruding objects that extend to the floor or within 27 inches of the floor are cane detectable and are therefore not hazardous. Where it is necessary or desirable to have objects protrude from the wall, a manner of cane detection must be provided.	women's- 7" hand dryer	Relocate protruding objects or place cane detectable warning or bollard at foot of item	2015 ABAAS Section: 307.2 2012 TAS Section: 307.2 2010 ADAS Section: 307.2

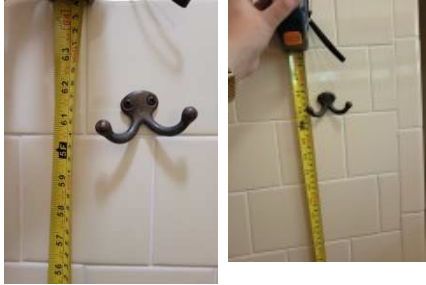
Finding Number	Area Description	Lat/Long	Finding	As Built	Recommendation	Citation	Photos	Figure
439	Camping: Plateau Camping Area	[32.8126, -98.04362]	Coat hooks provided within the room shall be located within one of the reach ranges specified in 308. Shelves shall be 40 inches (1015 mm) minimum and 48 inches (1220 mm) maximum above the finish floor or ground. Where coat hooks or shelves are provided in dressing, fitting or locker rooms without individual compartments, at least one of each type shall comply with 803.5. Where coat hooks or shelves are provided in individual compartments at least one of each type complying with 803.5 shall be provided in individual compartments in dressing, fitting, or locker rooms required to comply with 222.1.	women's- hooks at 62"	Remount at least one hook to max 48" aff and shelves to 40" - 48" aff	2015 ABAAS Section: 308.2.1, 308.1, F222.2, 803.5 2012 TAS Section: 308.2.1, 308.1, 222.2, 803.5 2010 ADAS Section: 308.2.1, 308.1, 222.2, 803.5

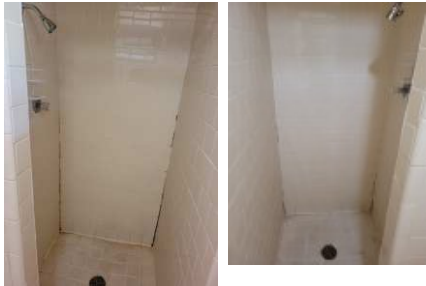
440	Camping: Plateau Camping Area	[32.8126, -98.04362]	There are no accessible bathing or shower facilities. Where facilities for bathing are provided for the public, clients or employees, including showers or bathtubs, at least one shower or bathtub and support facilities such as lockers, and not less than 1 percent of all facilities, shall be accessible.	women's- lacks accessible shower	Create an accessible shower in locker/bathing room	2015 ABAAS Section: F213.3.6 2012 TAS Section: 213.3.6 2010 ADAS Section: 213.3.6

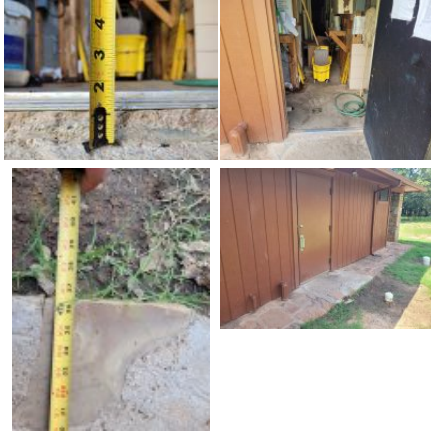
Finding Number	Area Description	Lat/Long	Finding	As Built	Recommendation	Citation	Photos	Figure																																	
457	Camping: Plateau Camping Area	[32.8126, -98.04362]	Spaces and elements within employee work areas shall only be required to comply with 206.2.8, 207.1, and 215.3 and shall be designed and constructed so that individuals with disabilities can approach, enter, and exit the employee work area. Employee work areas, or portions of employee work areas, other than raised courtroom stations, that are less than 300 square feet (28 m2) and elevated 7 inches (180 mm) or more above the finish floor or ground where the elevation is essential to the function of the space shall not be required to comply with these requirements or to be on an accessible route.	pipe chase- 1" CIL, 36" back pull side, storage push side	For employee spaces, relocate storage, furniture, and other obstacles at doorways to provide approach, enter and exit at the employee space. Provide required maneuvering clearance on push and pull side of doors. Repair, bevel, or ramp CILs at door entries to max .25".	2015 ABAAS Section: F203.9 2012 TAS Section: 203.9 2010 ADAS Section: 203.9

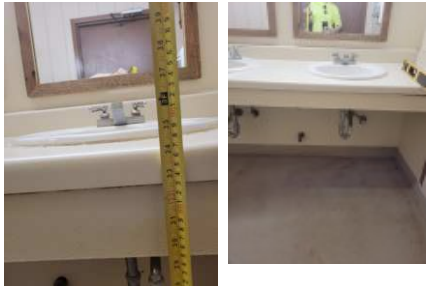
485	Penitentiary Hollow: PH - Women's Restroom	[32.81952, -98.0279]	The top rim of the sink is too high. All lavatories/sinks that are designated to be accessible shall be a minimum 17 inches in horizontal depth and mounted with the rim or counter edge no higher than 34 inches above the finished floor.	women's- sink 35" aff	Lower sinks to max 34" aff to front of rim	2015 ABAAS Section: 606.3 2012 TAS Section: 606.3 2010 ADAS Section: 606.3

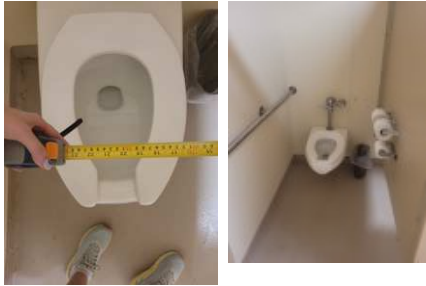
Finding Number	Area Description	Lat/Long	Finding	As Built	Recommendation	Citation	Photos	Figure
489	Penitentiary Hollow: PH - Women's Restroom	[32.81952, -98.0279]	The toilet is not located within the range to the side wall or partition. The centerline of the toilet shall be 17 inches minimum and 19 inches maximum side wall or partition in the ambulatory accessible toilet compartment.	women's- centerline 20.5" from right side wall	Remount toilet to 17" to 19" from the side wall to center line in ambulatory stalls	2015 ABAAS Section: 604.9.1 2012 TAS Section: 604.9.1 2010 ADAS Section: 604.9.1

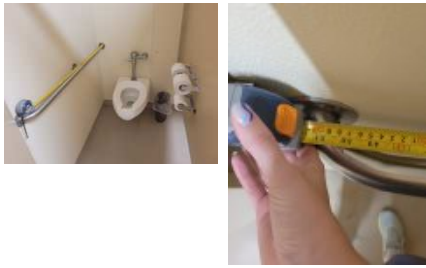
491	Penitentiary Hollow: PH - Women's Restroom	[32.81952, -98.0279]	The side grab bars are not in the correct location. Grab bars on the side wall must be installed so that the end closest to the rear wall is maximum 12" from the rear wall. The end furthest from the rear wall must be mounted minimum 54" from the rear wall.	women's- only 1 grab bar, extends to 51"	Remount side grab bar to max 12" from the rear wall at the close end and min 54" on the far end, and 33" to 36" aff	2015 ABAAS Section: 604.5.1 2012 TAS Section: 604.5.1 2010 ADAS Section: 604.5.1
