Access Audit Site Report

Lake Mineral Wells State Park and Trailway

Accessibility Evaluation

Inspection Date: 07/12/2021

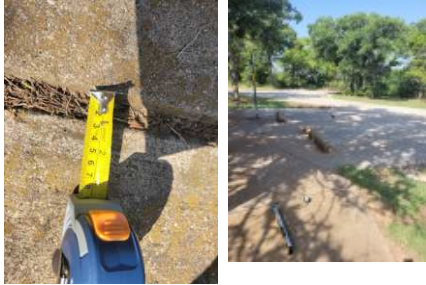
Finding Number	Area Description	Lat/Long	Finding	As Built	Recommendation	Citation	Photos	Figure
506	Penitentiary Hollow: PH - Exterior Accessible Route	[32.81953, -98.0277046]	There is a gap spaced greater than a 1/2 inch. Openings in floor or ground surfaces shall not allow passage of a sphere more than 1/2 inch diameter. Elongated openings shall be placed so that the long dimension is perpendicular to the dominant direction of travel.	1" gap at beginning of path to restroom building	Correct or fill gaps to be max .5"	2015 ABAAS Section: 302.3 2012 TAS Section: 302.3 2010 ADAS Section: 302.3

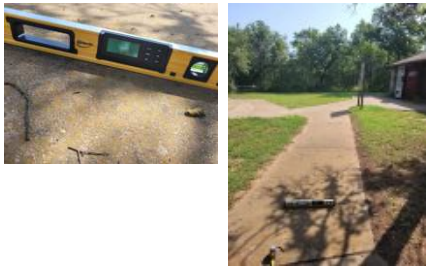
507	Penitentiary Hollow: PH - Exterior Accessible Route	[32.81953, -98.02771]	The accessible path of travel between the building entrance and the accessible parking contains cross slopes greater than 2%. Surface cross slopes shall not exceed one unit vertical in 48 units horizontal (2-percent slope). When the slope in the direction of travel of any walk exceeds 1 unit vertical in 20 units horizontal (5-percent slope), it must be constructed as ramp.	2.4% by parking at restroom	Correct or repair sidewalk cross slope along AR to max 2.08%	2015 ABAAS Section: 403.3 2012 TAS Section: 403.3 2010 ADAS Section: 403.3

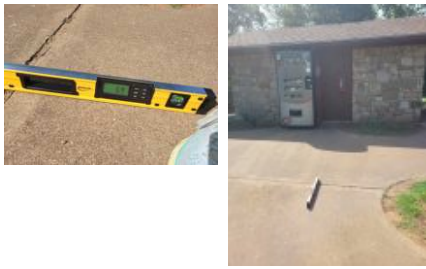
508	Penitentiary Hollow: PH - Exterior Accessible Route	[32.81953, -98.02771]	The running slope of walking surfaces shall not be steeper than 1:20.	6.9% by vending by restroom	Correct running slope along the AR to max 5%	2015 ABAAS Section: 403.3 2012 TAS Section: 403.3 2010 ADAS Section: 403.3

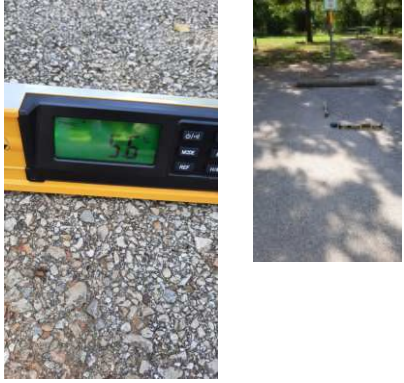
Finding Number	Area Description	Lat/Long	Finding	As Built	Recommendation	Citation	Photos	Figure
512	Penitentiary Hollow: PH - Parking	[32.8195203, -98.0277547]	The cross slopes (narrow dimension) and/or running slopes (long dimension) of the access aisle exceeds 2%. The running slope and the cross slope in an accessible parking stall and the access aisle must not exceed 2%.	5.6% slope	Repair or correct slope of parking space and access aisle to max 2.08% in any direction	2015 ABAAS Section: 502.4 2012 TAS Section: 502.4 2010 ADAS Section: 502.4

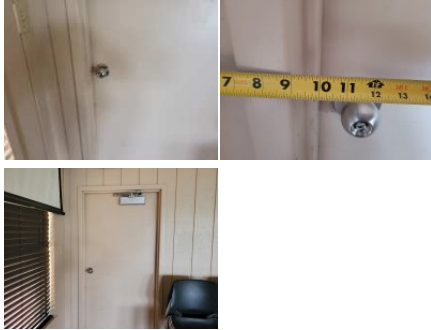
Finding Number	Area Description	Lat/Long	Finding	As Built	Recommendation	Citation	Photos	Figure																		
521	Group Hall: Group Hall	[32.81934, -98.04173]	Minimum maneuvering clearances at doors and gates shall comply with 404.2.4. Maneuvering clearances shall extend the full width of the doorway and the required latch side or hinge side clearance. Exterior doors are recommended to be maintained at 8.5 lbf as a smart practice. Force is to be measured at the operating hardware or 30 inches from the hinges, whichever is greater. Hand-activated door opening hardware, handles, pulls, latches, locks, and other operating devices on accessible doors shall have a shape that is easy to grasp with one hand and does not require tight grasping, tight pinching or twisting of the wrist to operate. Hardware shall be 34 inches minimum and 48 inches maximum above the finish floor or ground.	exit by mens- knob, wall 10" push side, 10#	For all doors along the public circulation route, provide required maneuvering clearance on push and pull side of doors For all doors along the public circulation route, inspect, adjust, and maintain 8.5 lbf to open exterior doors as a smart practice For all doors along the public circulation route, replace hardware with lever hardware or hardware operable without a tight pinch or grasp	2010 ADAS Section: 404.2.3, 404.2.7, 404.2.4, 404.2.11, 404.2.11 Exception

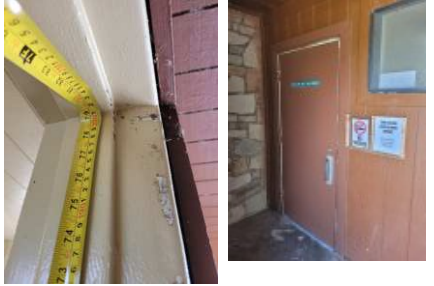
526	Group Hall: Group Hall	[32.81938, -98.04172]	Door openings shall provide a clear width of 32 inches (815 mm) minimum. Clear openings of doorways with swinging doors shall be measured between the face of the door and the stop, with the door open 90 degrees. Openings more than 24 inches (610 mm) deep shall provide a clear opening of 36 inches (915 mm) minimum. There shall be no projections into the required clear opening width lower than 34 inches (865 mm) above the finish floor or ground. Projections into the clear opening width between 34 inches (865 mm) and 80 inches (2030 mm) above the finish floor or ground shall not exceed 4 inches (100 mm). Exterior doors are recommended to be maintained at 8.5 lbf as a smart practice. Force is to be measured at the operating hardware or 30 inches from the hinges, whichever is greater.	dining hall at women's restroom- 79" clearance, 14#	For all doors along the public circulation route, replace doors with doors having 80" overhead clearance and 32" clear width. For all doors along the public circulation route, inspect, adjust, and maintain 8.5 lbf to open exterior doors as a smart practice.	2010 ADAS Section: 404.2.3, 404.2.7, 404.2.4, 404.2.11, 404.2.11 Exception

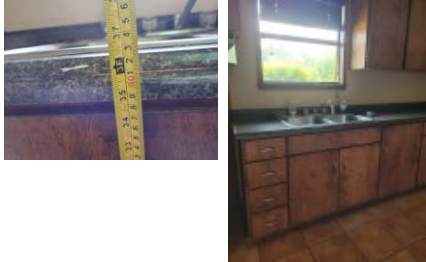
Finding Number	Area Description	Lat/Long	Finding	As Built	Recommendation	Citation	Photos	Figure
528	Group Hall: Group Hall	[32.81929, -98.04151]	The sink is not accessible. A clear floor space at least 30 inches by 48 shall be provided in front of a sink to allow forward approach. -The clear floor space shall be on an accessible route and shall extend a maximum of 19 inches underneath the sink. -Sinks shall be mounted with the counter or rim no higher than 34 inches above the finish floor. -Knee clearance at least 27 inches high, 30 inches wide and 19 inches deep shall be provided. -Hot water and drain pipes exposed under sinks shall be insulated or otherwise configured so as to protect against contact. There shall be no sharp or abrasive surfaces under sinks. -Faucet controls not require tight grasping, pinching or twisting of the wrist. -The force required to activate controls shall be not greater than 5 lb. Lever-operated, push-type and electronically controlled mechanisms are examples of acceptable designs. -Self-closing valves are allowed if the faucet remains open for at least 10 seconds.	kitchen- single sink height 36.5", no knee clearance	Lower sinks to max 34" aff to front of rim Remove cabinets to provide knee and toe clearance	2015 ABAAS Section: 606.2, 606.2 EXCEPTION S: 1, 606.2 E XCEPTIONS: 4, 606.2 EXC EPTIONS: 5, 606.2 EXCEP TIONS: 6, 606.2 EXCEP TIONS: 7, 606.3, 606.4, 606.5 2012 TAS Section: 606.2, 606.2 Exception 1, 606.2 Exception 4, 606.2 Exception 5, 606.2 Exception 6, 606.2 Exception 7, 606.3, 606.4, 606.5 2010 ADAS Section: 606.2, 606.2 Exception 1, 606.2 Exception 4, 606.2 Exception 5, 606.2 Exception 6, 606.2 Exception 7, 606.3, 606.4, 606.5

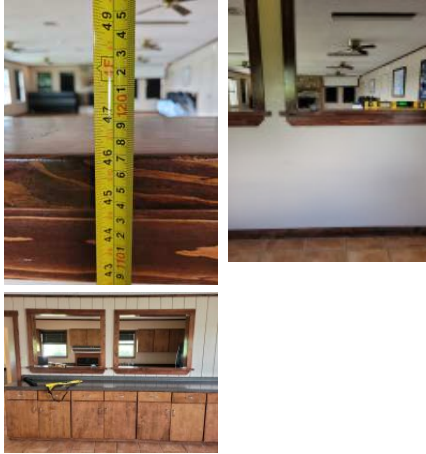
531	Group Hall: Group Hall	[32.81929, -98.04151]	The transaction counter is too high. A portion of the counter surface that is 36 inches long minimum and 36 inches high maximum above the finish floor shall be provided. Knee and toe space must be provided for a forward approach. A 30 inch by 48 inch clear floor space on an accessible route must be provided for either a forward or parallel approach.	kitchen- window at 46" aff	Lower 36" wide segment of service counter to max 36" aff	2015 ABAAS Section: 904.4.2, 904.4.1 2012 TAS Section: 904.4.1, 904.4.2 2010 ADAS Section: 904.4.2, 904.4.1

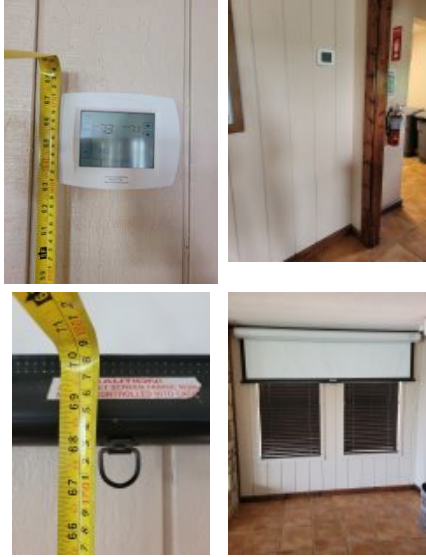
Finding Number	Area Description	Lat/Long	Finding	As Built	Recommendation	Citation	Photos	Figure
532	Group Hall: Group Hall	[32.8193, -98.0416]	The operable part is positioned too high for either a side or front approach. Where a clear floor or ground space allows a parallel approach to an element and the side reach is unobstructed, the high side reach shall be 48 inches maximum and the low side reach shall be 15 inches minimum above the finish floor or ground. Where a forward reach is unobstructed, the high forward reach shall be 48 inches maximum and the low forward reach shall be 15 inches minimum above the finish floor or ground.	dining hall- thermostat at 67", screen at 67"	Remount operable parts to be in reach range of 15" min to 48" max	2015 ABAAS Section: 308.1 2012 TAS Section: 308.1 2010 ADAS Section: 308.1

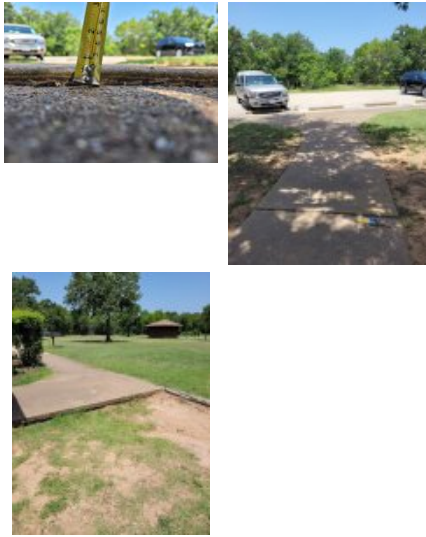
535	Group Hall: Group Hall	[32.81958, -98.04192]	The walkway contains abrupt vertical edges and/or variations over a 1/4 inch. 1/4 inch is the maximum vertical rise. Changes in level between 1/4 inch and 1/2 inch must be beveled at 1:2 or less. Changes in level greater than 1/2 inch must be by way of a ramp.	.75" CIL by parking, CIL to pier	Repair, bevel or ramp CIL along AR.	2012 TAS Section: 303.2, 303.3 2010 ADAS Section: 303.2, 303.3

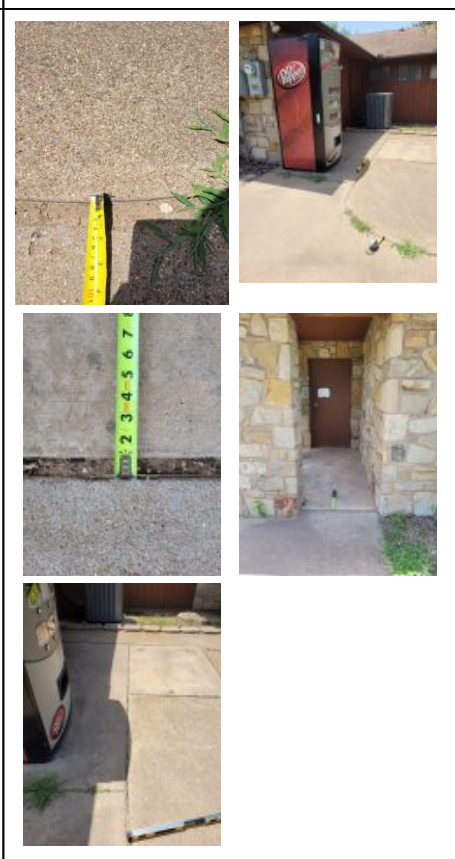
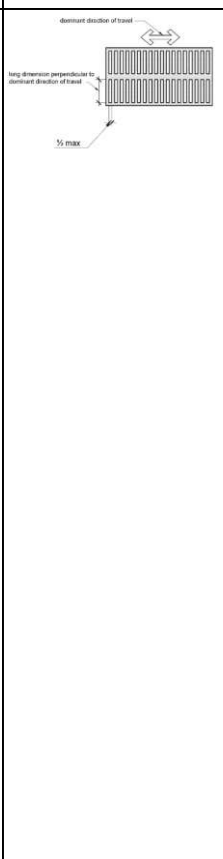
Finding Number	Area Description	Lat/Long	Finding	As Built	Recommendation	Citation	Photos	Figure
536	Group Hall: Group Hall	[32.81958, -98.04192]	There is a gap spaced greater than a 1/2 inch. Openings in floor or ground surfaces shall not allow passage of a sphere more than 1/2 inch diameter. Elongated openings shall be placed so that the long dimension is perpendicular to the dominant direction of travel.	2" gap by vending machine, 1" by back door	Correct or fill gaps to be max .5"	2015 ABAAS Section: 302.3 2012 TAS Section: 302.3 2010 ADAS Section: 302.3

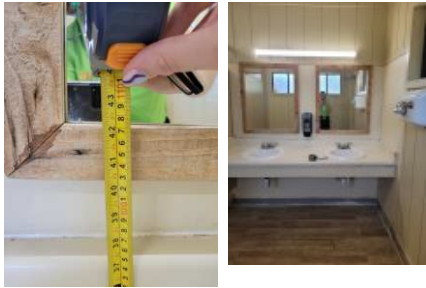
538	Group Hall: Group Hall - Women's Restroom	[32.81941, -98.04166]	The mirror is mounted too high. Mirrors must have the bottom edge of the reflecting surface a maximum of 40 inches above the floor if above a sink or counter. Mirrors not located above lavatories or countertops shall be installed with the bottom edge of the reflecting surface 35 inches maximum above the finish floor or ground.	mirrors at 42"	Lower mirror so bottom reflective surface is max 40" AFF and 74" at the top.	2015 ABAAS Section: 603.3 2012 TAS Section: 603.3 2010 ADAS Section: 603.3

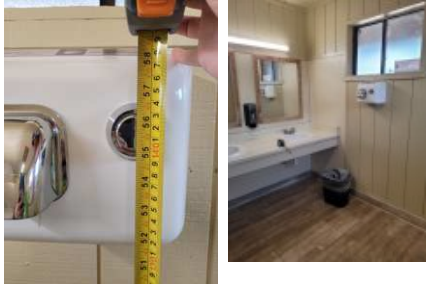
Finding Number	Area Description	Lat/Long	Finding	As Built	Recommendation	Citation	Photos	Figure
539	Group Hall: Group Hall - Women's Restroom	[32.81941, -98.04166]	Where a high forward reach is over an obstruction, the clear floor space shall extend beneath the element for a distance not less than the required reach depth over the obstruction. The high forward reach shall be 48 inches (1220 mm) maximum where the reach depth is 20 inches (510 mm) maximum. Where the reach depth exceeds 20 inches (510 mm), the high forward reach shall be 44 inches (1120 mm) maximum and the reach depth shall be 25 inches (635 mm) maximum. Where a clear floor or ground space allows a parallel approach to an element and the high side reach is over an obstruction, the height of the obstruction shall be 34 inches (865 mm) maximum and the depth of the obstruction shall be 24 inches (610 mm) maximum. The high side reach shall be 48 inches (1220 mm) maximum for a reach depth of 10 inches (255 mm) maximum. Where the reach depth exceeds 10 inches (255 mm), the high side reach shall be 46 inches (1170 mm) maximum for a reach depth of 24 inches (610 mm) maximum.	hand dryer at 55"	Lower operating mechanisms to max 48" above the finished floor (AFF) to highest operable part.	2015 ABAAS Section: 308.2.1, 308.3.2 2012 TAS Section: 308.2.1, 308.3.2 2010 ADAS Section: 308.2.1, 308.3.2

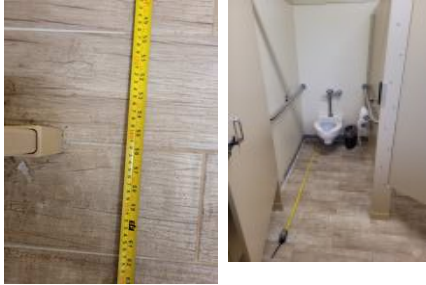
Finding Number	Area Description	Lat/Long	Finding	As Built	Recommendation	Citation	Photos	Figure
541	Group Hall: Group Hall - Women's Restroom	[32.81941, -98.04166]	The ambulatory stall is not between 35" to 37" wide and 60" deep.	ambulatory stall 56" deep	Correct ambulatory stall to be 35" to 37" wide and minimum 60" deep	2015 ABAAS Section: 604.8.2.1 2012 TAS Section: 604.8.2.1 2010 ADAS Section: 604.8.2.1

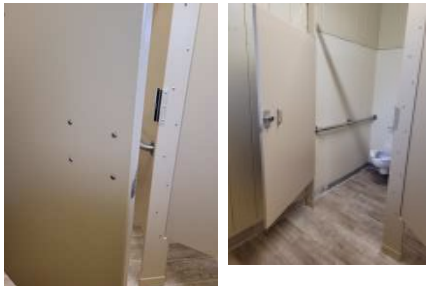
543	Group Hall: Group Hall - Women's Restroom	[32.81941, -98.04166]	The stall door fails to comply with all of the door requirements. The stall door must be a minimum of 32" wide and have compliant hardware on both sides. The stall door must be self-closing.	no hardware on pull, not self closing	Adjust stall door to be self-closing Replace stall hardware with hardware operable without a tight pinch or grasp on both sides of the stall door	2015 ABAAS Section: 404.2.3, 404.2.7, 604.8.2.2 2012 TAS Section: 404.2.3, 404.2.7, 604.8.2.2 2010 ADAS Section: 404.2.3, 404.2.7, 604.8.2.2

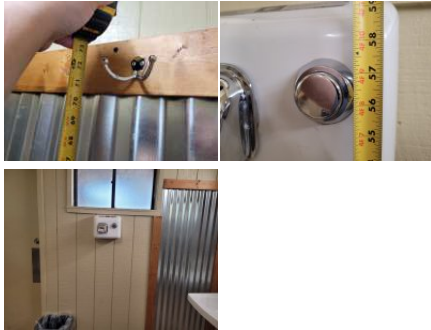
Finding Number	Area Description	Lat/Long	Finding	As Built	Recommendation	Citation	Photos	Figure
553	Group Hall: Group Hall - Men's Restroom	[32.81942, -98.04173]	Where a high forward reach is over an obstruction, the clear floor space shall extend beneath the element for a distance not less than the required reach depth over the obstruction. The high forward reach shall be 48 inches (1220 mm) maximum where the reach depth is 20 inches (510 mm) maximum. Where the reach depth exceeds 20 inches (510 mm), the high forward reach shall be 44 inches (1120 mm) maximum and the reach depth shall be 25 inches (635 mm) maximum. Where a clear floor or ground space allows a parallel approach to an element and the high side reach is over an obstruction, the height of the obstruction shall be 34 inches (865 mm) maximum and the depth of the obstruction shall be 24 inches (610 mm) maximum. The high side reach shall be 48 inches (1220 mm) maximum for a reach depth of 10 inches (255 mm) maximum. Where the reach depth exceeds 10 inches (255 mm), the high side reach shall be 46 inches (1170 mm) maximum for a reach depth of 24 inches (610 mm) maximum.	hook 72", hand dryer 57"	Lower operating mechanisms to max 48" above the finished floor (AFF) to highest operable part.	2015 ABAAS Section: 308.2.1, 308.3.2 2012 TAS Section: 308.2.1, 308.3.2 2010 ADAS Section: 308.2.1, 308.3.2

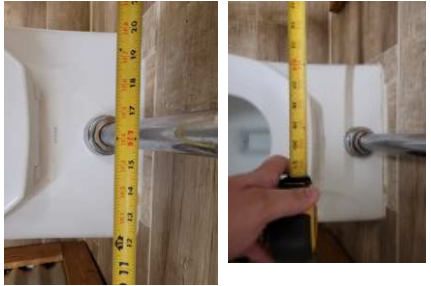
Finding Number	Area Description	Lat/Long	Finding	As Built	Recommendation	Citation	Photos	Figure
555	Group Hall: Group Hall - Men's Restroom	[32.81942, -98.04173]	The toilet is not located within the range to the side wall or partition. The centerline of the toilet shall be 17 inches minimum and 19 inches maximum side wall or partition in the ambulatory accessible toilet compartment.	toilet centerline 16" and 20"	Remount toilet to 17" to 19" from the side wall to center line in ambulatory stalls	2015 ABAAS Section: 604.9.1 2012 TAS Section: 604.9.1 2010 ADAS Section: 604.9.1

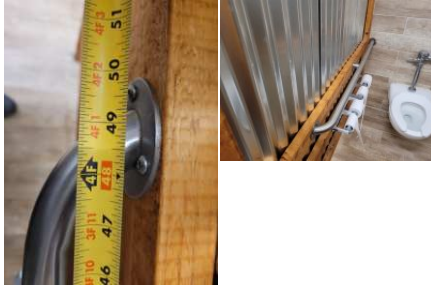
556	Group Hall: Group Hall - Men's Restroom	[32.81942, -98.04173]	The side grab bars are not in the correct location. Grab bars on the side wall must be installed so that the end closest to the rear wall is maximum 12" from the rear wall. The end furthest from the rear wall must be mounted minimum 54" from the rear wall.	grab bars extend 48"	Remount side grab bar to max 12" from the rear wall at the close end and min 54" on the far end, and 33" to 36" aff.	2015 ABAAS Section: 604.5.1 2012 TAS Section: 604.5.1 2010 ADAS Section: 604.5.1

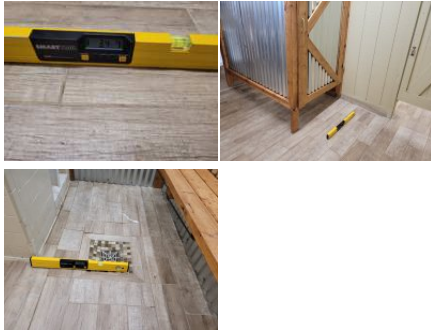
Finding Number	Area Description	Lat/Long	Finding	As Built	Recommendation	Citation	Photos	Figure
558	Group Hall: Group Hall - Men's Restroom	[32.81942, -98.04173]	The accessible route contains running slopes greater than 5 percent and cross slopes greater than 2 percent across the width of the walk and has not been constructed as a ramp (i.e. handrails, wheel guides, etc.). When the slope in the direction of travel of any walk exceeds 1 unit vertical in 20 units horizontal (5-percent slope), it must be constructed as ramp. Surface cross slopes must not exceed one unit vertical in 48 units. Horizontal (2-percent slope).	3.5% at stall, 6% and sunken at shower	Correct or repair slope to max 2.08% in restroom.	2015 ABAAS Section: 403.3 2012 TAS Section: 403.3 2010 ADAS Section: 403.3

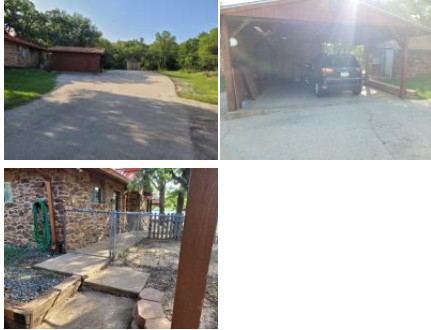
Finding Number	Area Description	Lat/Long	Finding	As Built	Recommendation	Citation	Photos	Figure
564	Employee Areas: Residences	[32.81355, -98.039]	There is no accessible route to the residence. At least one accessible route shall connect accessible buildings, accessible facilities, accessible elements, and accessible spaces that are on the same site.	east residence- asphalt drive, carport, steps to enter residence	Provide a ramp to access residence entry	2015 ABAAS Section: F206.2.2 2012 TAS Section: 206.2.2 2010 ADAS Section: 206.2.2

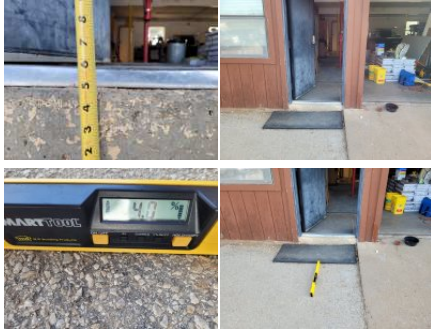
565	Employee Areas: Residences	[32.8206203, -98.0418028]	Exterior of residence has accessible features	asphalt parking, access through carport, path to front door	Make changes to the residence as needed for employees that may need modifications	Capture Section: 1		
566	Employee Areas: Maintenance	[32.83172, -98.04137]	Minimum maneuvering clearances at doors and gates shall comply with 404.2.4. Maneuvering clearances shall extend the full width of the doorway and the required latch side or hinge side clearance. Maneuvering clearances shall have a max slope of 2.08%. The threshold has a vertical change greater than 1/4 inch high.	entry- CIL, 4%	For all doors along the public circulation route, correct slope in door clearance to max 2.08%. For all doors along the public circulation route, repair, bevel, or ramp CILs at door entries to max .25".	2010 ADAS Section: 404.2.3, 404.2.7, 404.2.4, 404.2.11, 404.2.11 Exception

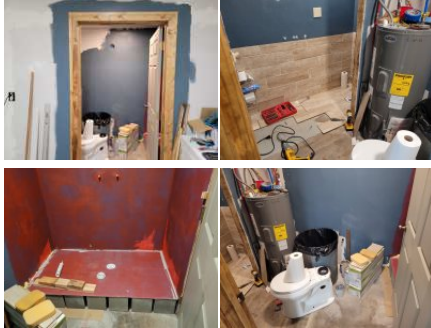
571	Employee Areas: Maintenance	[32.8126, -98.04362]	This restroom is not accessible. Where existing toilet rooms or bathing rooms do not comply, directional signs indicating the location of the nearest accessible toilet room or bathing room within the facility shall be provided. Signs shall include the International Symbol of Accessibility. Where existing toilet rooms or bathing rooms do comply, the accessible toilet rooms or bathing rooms shall be identified by the International Symbol of Where clustered single user toilet rooms or bathing facilities are permitted, accessible toilet rooms or bathing facilities shall be identified by the International Symbol of Accessibility unless all toilet rooms and bathing facilities are accessible.	restroom under construction, not large enough for compliant restroom	Restroom not accessible, acquire and mount signage directing users to accessible restroom	2015 ABAAS Section: F216.8 2012 TAS Section: 216.8 2010 ADAS Section: 216.8

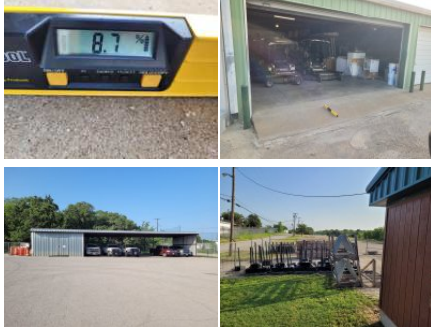
573	Employee Areas: Maintenance	[32.8299651, -98.0404228]	Spaces and elements within employee work areas shall only be required to comply with 206.2.8, 207.1, and 215.3 and shall be designed and constructed so that individuals with disabilities can approach, enter, and exit the employee work area. Employee work areas, or portions of employee work areas, other than raised courtroom stations, that are less than 300 square feet (28 m2) and elevated 7 inches (180 mm) or more above the finish floor or ground where the elevation is essential to the function of the space shall not be required to comply with these requirements or to be on an accessible route.	equipment garage, vehicle and chemical storage- no man doors, 8.7% slope at equipment, building out back to be removed	Correct slope in door clearance to max 2.08%.	2015 ABAAS Section: F203.9 2012 TAS Section: 203.9 2010 ADAS Section: 203.9

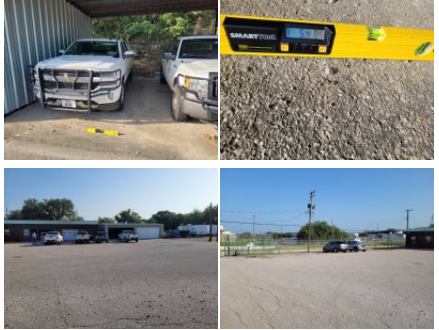
Finding Number	Area Description	Lat/Long	Finding	As Built	Recommendation	Citation	Photos	Figure																																																												
575	Employee Areas: Maintenance	[32.8298749 , -98.040658 8]	There are no or not enough accessible parking stalls. Each lot where parking is provided for the public as clients, guests or employees, shall provide accessible parking and shall be located on the shortest accessible route of travel from adjacent parking to an accessible entrance.	no marked parking, one space has access sign, 5.4% slope	Create one or more 8' accessible parking stalls, with one 5' adjacent access aisle, with proper signage and striping based on the total number of stalls.	2015 ABAAS Section: F208.2 2012 TAS Section: 208.2 2010 ADAS Section: 208.2
