# Access Audit Site Report

## Lake Somerville State Park & Trailway

Accessibility Evaluation

Inspection Date: 08/24/2021

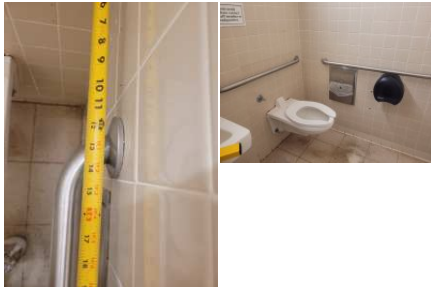
24	Nails Creek - Headquarters: (NC)Headquarters - Women's Restroom	[30.2907184 , -96.6671924]	The side grab bars are not in the correct location. Grab bars on the side wall must be installed so that the end closest to the rear wall is maximum 12" from the rear wall. The end furthest from the rear wall must be mounted minimum 54" from the rear wall.	Side grab bar starts 12.5" from rear wall	Remount side grab bar to max 12" from the rear wall at the close end and min 54" on the far end, and 33" to 36" aff	2015 ABAAS Section: 604.5.1 2012 TAS Section: 604.5.1 2010 ADAS Section: 604.5.1

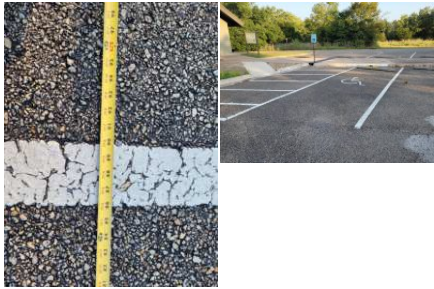
28	Nails Creek - Headquarters: (NC)Headquarters - Parking	[30.2907682 , -96.667067 6]	The accessible parking stall is not wide enough. Each parking space must be at least 8' feet wide and shall be marked to define the width. The measurements of parking spaces and access aisles shall be made from the centerline of the markings. Where the parking space is not adjacent to another parking space or access aisle, the measurement shall be permitted to include the full width of the line defining the parking space.	stall 88" wide, access aisle is 108" wide (room to repaint stall)	Repaint stalls to be 8' wide each	2015 ABAAS Section: 502.2 2012 TAS Section: 502.2 2010 ADAS Section: 502.2

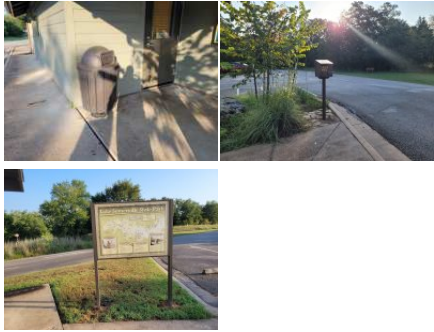
37	Nails Creek - Headquarters: (NC)Headquarters - EAR	[30.2907492 , -96.6671367]	Element meets all standards and requirements	Garbage can, map sign, and self pay box meet all standards and requirements	None	2010 ADAS Section: N/A

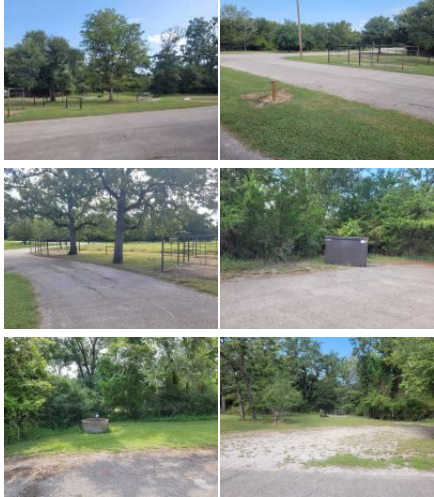
Finding Number	Area Description	Lat/Long	Finding	As Built	Recommendation	Citation	Photos	Figure
49	Nails Creek - Equestrian Area: (NC) Equestrian Area Camping	[30.2918812 , -96.666693 9]	Camping facilities shall provide camping units with mobility features complying with F244.2 in accordance with Table F244.2. Where a camping facility provides different types of camping units, Table F244.2 shall apply to each type of camping unit provided. Total Number of Camping Units Provided in Camping Facility Minimum Number of Camping Units with Mobility Features Required 1 1 2 to 25 2 26 to 50 3 51 to 75 4 76 to 100 5 101 to 150 7 151 to 200 8 201 and over 8, plus 2 percent of the number over 200	Lacks camping units with mobility features (10 standard, 0 accessible campsites) - picnic table(s), fire pit, water hook up, corrals, horse posts, dumpster, horse trough	Create the required number of accessible camp sites per table F244.2 as a smart practice	2015 ABAAS Section: F244.2

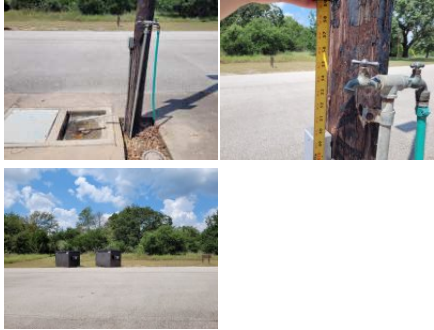
Finding Number	Area Description	Lat/Long	Finding	As Built	Recommendation	Citation	Photos	Figure
50	Nails Creek - Bent Tree Camping Area: (NC) Bent Tree-Dump Station	[30.2921362 , -96.66383 79], [30.2920575 , -96.663965 3]	The water spout handle and dumpsters are positioned too high for either a side or front approach. Where a clear floor or ground space allows a parallel approach to an element and the side reach is unobstructed, the high side reach shall be 48 inches maximum and the low side reach shall be 15 inches minimum above the finish floor or ground. Where a forward reach is unobstructed, the high forward reach shall be 48 inches maximum and the low forward reach shall be 15 inches minimum above the finish floor or ground.	Water spout handle and dumpsters exceed reach range	Remount operable parts to be in reach range of 15" min to 48" max	2015 ABAAS Section: 308.1  2012 TAS Section: 308.1  2010 ADAS Section: 308.1

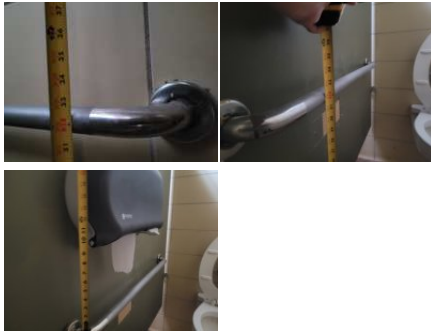
89	Nails Creek - Bent Tree Camping Area: (NC) Bent Tree-Women's Restroom	[30.2900236 , -96.664478]	The grab bar height and/or spacing fails. Grab bars must be mounted between 33" and 36" to the top of the gripping surface. There must be 1.5" of clearance between the grab bar and the wall. There must be a minimum of 1.5" of clearance below and minimum 12" above the grab bar to any dispenser or other obstruction.	Gripping surface of both grab bars is 32.75" aff, and lacks 12" clearance above the bar due to toilet paper dispenser location	Remount grab bars in accessible stall to 33" to 36" aff Remount toilet paper dispenser max 7" to 9" from front of toilet, 15" to 48" aff and min 12" above or 1.5" below grab bar	2015 ABAAS Section: 609.3, 609.4  2012 TAS Section: 609.4, 609.3  2010 ADAS Section: 609.3, 609.4

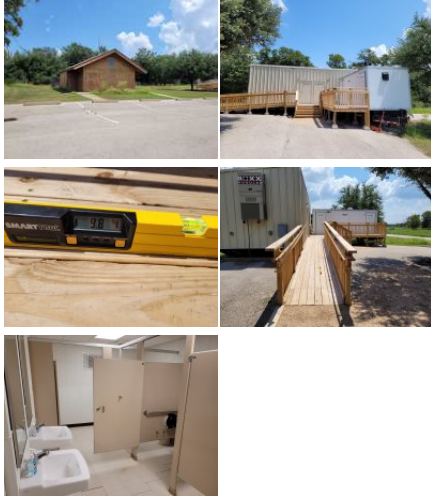
97	Nails Creek - Cedar Creek Camping Area: (NC) Cedar Creek- Restrooms	[30.286971, -96.662824 7]	Existing restroom building to be demolished.	restroom building to be demolished, temporary trailer restrooms and showers, steep ramp, restrooms include wheelchair and ambulatory stalls	Make corrections to restrooms being renovated at other places on site and if new restrooms are constructed ensure they are compliant.	Capture Section: 1

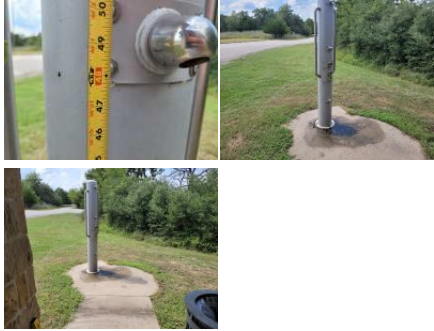
Finding Number	Area Description	Lat/Long	Finding	As Built	Recommendation	Citation	Photos	Figure
113	Nails Creek - Amenities: (NC) Boat Ramp- Restrooms Exterior Accessible Route	[30.2939446 , -96.664655]	Outdoor rinsing showers shall provide at least one hand-held shower spray unit with a hose 59 inches (1500 mm) long minimum. The hand-held shower spray unit shall have at least one fixed position located 15 inches minimum (380 mm) and 48 inches (1220 mm) maximum above the ground. EXCEPTION: Where vandalism is a consideration, a fixed shower head located at 48 in (1220 mm) above the ground shall be permitted in place of a hand-held shower spray unit.	Lacks 59" flexible hose and fixed shower head 48.25" aff	Remount or replace shower head with one that is hand held and mounted with one fixed position 15" to 48" above the ground; in the alternative, mount a fixed shower head at 48" above the ground as a smart practice.	2015 ABAAS Section: 1011.7, 1011.7 EXCEPTION

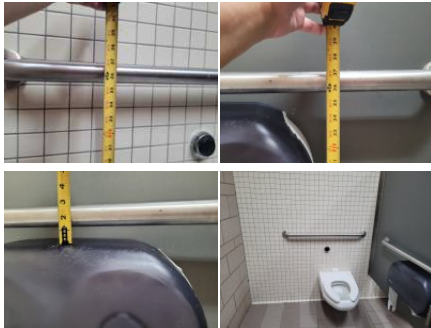
118	Nails Creek - Amenities: (NC) Boat Ramp-Men's Restroom	[30.2940442, -96.664714]	The grab bar height and/or spacing fails. Grab bars must be mounted between 33" and 36" to the top of the gripping surface. There must be 1.5" of clearance between the grab bar and the wall. There must be a minimum of 1.5" of clearance below and minimum 12" above the grab bar to any dispenser or other obstruction.	Gripping surfaces of the grab bars are 37" aff and 37.25" aff, and lacks 1.5" clearance below the bar due to toilet paper dispenser location	Remount grab bars in accessible stall to 33" to 36" aff Remount toilet paper dispenser max 7" to 9" from front of toilet, 15" to 48" aff and min 12" above or 1.5" below grab bar	2015 ABAAS Section: 609.3, 609.4  2012 TAS Section: 609.4, 609.3  2010 ADAS Section: 609.3, 609.4

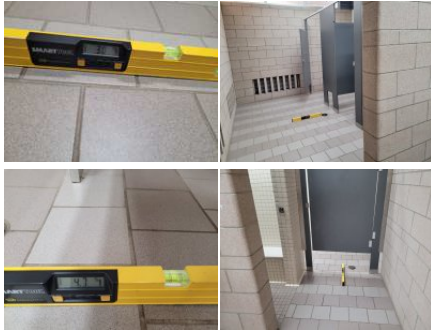
121	Nails Creek - Amenities: (NC) Boat Ramp-Men's Restroom	[30.2940349, -96.6646925]	The accessible route contains running slopes greater than 5 percent and cross slopes greater than 2 percent across the width of the walk and has not been constructed as a ramp (i.e. handrails, wheel guides, etc.). When the slope in the direction of travel of any walk exceeds 1 unit vertical in 20 units horizontal (5-percent slope), it must be constructed as ramp. Surface cross slopes must not exceed one unit vertical in 48 units. Horizontal (2-percent slope).	Slopes of 3% near restroom floor drain and 4.6% near shower door drain	Correct or repair slope to max 5% running and 2.08% cross	2015 ABAAS Section: 403.3  2012 TAS Section: 403.3  2010 ADAS Section: 403.3

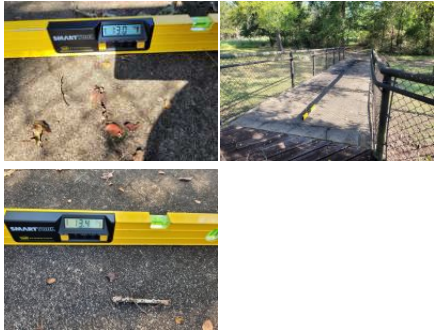
146	Nails Creek - Amenities: (NC) Nails Creek Spur-Pavilion	[30.2925898 , -96.665339]	The ramps slope exceeds the maximum running slope (direction of travel) allowable of 8.33%. Ramps should have the least possible slope but in no case more than 8.3% (1:12).	Slopes of 13% (back ramp upper run) and 13.4% (back ramp lower run)	Correct slope of ramp to max 8.33%	2015 ABAAS Section: 405.2  2012 TAS Section: 405.2  2010 ADAS Section: 405.2

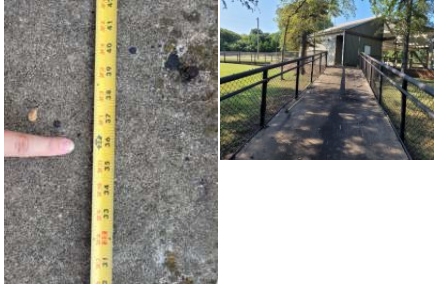
147	Nails Creek - Amenities: (NC) Nails Creek Spur-Pavilion	[30.2925921 , -96.665339]	The landing is not the correct length. Landings shall have a dimension in the direction of ramp run of not less than 60 inches.	middle landing is approximately 36" long	Enlarge landing to be 60" deep and as wide as the ramp	2015 ABAAS Section: 405.7.3  2012 TAS Section: 405.7.3  2010 ADAS Section: 405.7.3

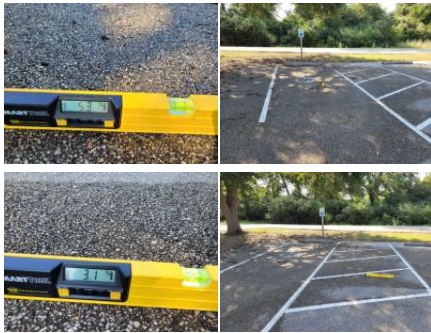
153	Nails Creek - Amenities: (NC) Nails Creek Spur-Pavilion	[30.292364, -96.6649983]	The cross slopes (narrow dimension) and/or running slopes (long dimension) of the access aisle exceeds 2%. The running slope and the cross slope in an accessible parking stall and the access aisle must not exceed 2%.	Slopes of 5.3% in stall and 3.1% in access aisle	Repair or correct slope of parking space and access aisle to max 2.08% in any direction	2015 ABAAS Section: 502.4  2012 TAS Section: 502.4  2010 ADAS Section: 502.4

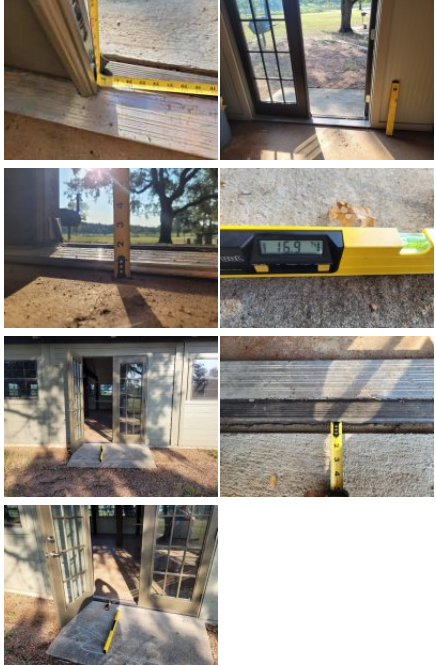
160	Nails Creek - Amenities: (NC) Group Pavilion At Boat Ramp	[30.2954622, -96.6650746]	Minimum maneuvering clearances at doors and gates shall comply with 404.2.4. Maneuvering clearances shall extend the full width of the doorway and the required latch side or hinge side clearance. Floor or ground surface within required maneuvering clearances shall comply with 302. EXCEPTIONS: 1. Slopes not steeper than 1:48 shall be permitted. Openings in floor or ground surfaces shall not allow passage of a sphere more than 1/2 inch (13 mm) diameter except as allowed in 407.4.3, 409.4.3, 410.4, 810.5.3 and 810.10. Elongated openings shall be placed so that the long dimension is perpendicular to the dominant direction of travel. Door openings shall provide a clear width of 32 inches (815 mm) minimum. Clear openings of doorways with swinging doors shall be measured between the face of the door and the stop, with the door open 90 degrees. Openings more than 24 inches (610 mm) deep shall provide a clear opening of 36 inches (915 mm) minimum. There shall be no projections into the required clear opening width lower than 34 inches (865 mm) above the finish floor or ground. Projections into the clear opening width between 34 inches (865 mm) and 80 inches (2030 mm) above the finish floor or ground shall not exceed 4 inches (100 mm). The threshold has a vertical change greater than 1/4 inch high.	Door to grill area - slope of 16.9% and lacks firm and stable surface outside, gap of 1", 26.5" wide, and .75" threshold	For all doors along the public circulation route, provide required maneuvering clearance on push and pull side of doors For all doors along the public circulation route, correct or repair slope at doorway landing to max 2.08% in any direction for level CFS For all doors along the public circulation route, fill and maintain gaps at doorways to max .5" For all doors along the public circulation route, replace doors with doors having 80" overhead clearance and 32" clear width For all doors along the public circulation route, repair, bevel, or ramp CILs at door entries to max .25" For all doors along the public circulation route, repair, provide beveled threshold	2010 ADAS Section: 404.2.3, 404.2.7, 404.2.4, 404.2.11, 404.2.11 Exception

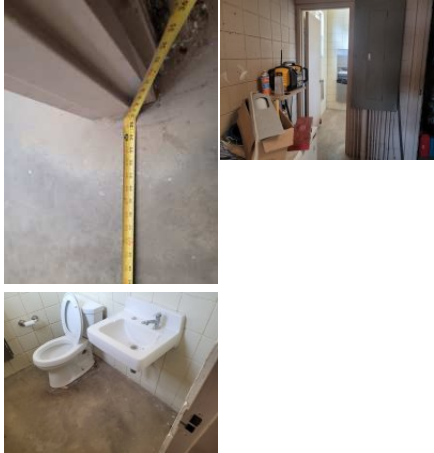
Finding Number	Area Description	Lat/Long	Finding	As Built	Recommendation	Citation	Photos	Figure
172	Nails Creek - Employee Other: (NC) Maintenance Area	[30.2911608 , -96.664751 5]	<p>Minimum maneuvering clearances at doors and gates shall comply with 404.2.4. Maneuvering clearances shall extend the full width of the doorway and the required latch side or hinge side clearance. Door openings shall provide a clear width of 32 inches (815 mm) minimum. Clear openings of doorways with swinging doors shall be measured between the face of the door and the stop, with the door open 90 degrees. Openings more than 24 inches (610 mm) deep shall provide a clear opening of 36 inches (915 mm) minimum. There shall be no projections into the required clear opening width lower than 34 inches (865 mm) above the finish floor or ground. Projections into the clear opening width between 34 inches (865 mm) and 80 inches (2030 mm) above the finish floor or ground shall not exceed 4 inches (100 mm). Hand-activated door opening hardware, handles, pulls, latches, locks, and other operating devices on accessible doors shall have a shape that is easy to grasp with one hand and does not require tight grasping, tight pinching or twisting of the wrist to operate. Hardware shall be 34 inches minimum and 48 inches maximum above the finish floor or ground.</p>	Restroom door - sink pull side, 25.5" wide, knobs	For all doors along the public circulation route, provide required maneuvering clearance on push and pull side of doors For all doors along the public circulation route, replace doors with doors having 80" overhead clearance and 32" clear width For all doors along the public circulation route, replace hardware with lever hardware or hardware operable without a tight pinch or grasp	2010 ADAS Section: 404.2.3, 404.2.7, 404.2.4, 404.2.11, 404.2.11 Exception

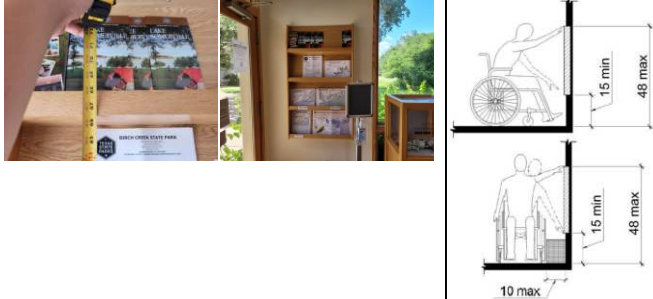
190	Birch Creek - Headquarters: (BC) Headquarters-Public Areas	[30.3086081 , -96.6347054]	The top shelf of the brochure rack is positioned too high for either a side or front approach. Where a clear floor or ground space allows a parallel approach to an element and the side reach is unobstructed, the high side reach shall be 48 inches maximum and the low side reach shall be 15 inches minimum above the finish floor or ground. Where a forward reach is unobstructed, the high forward reach shall be 48 inches maximum and the low forward reach shall be 15 inches minimum above the finish floor or ground.	Top shelf of brochure rack exceeds reach range	Remount operable parts to be in reach range of 15" min to 48" max	2015 ABAAS Section: 308.1 2012 TAS Section: 308.1 2010 ADAS Section: 308.1

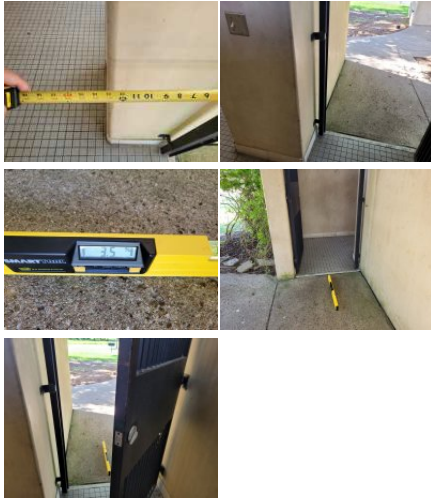
193	Birch Creek - Headquarters: (BC) Headquarters-Restrooms	[30.3086062 , -96.634983 8]	Minimum maneuvering clearances at doors and gates shall comply with 404.2.4. Maneuvering clearances shall extend the full width of the doorway and the required latch side or hinge side clearance. Maneuvering clearances shall have a max slope of 2.08%. Hand-activated door opening hardware, handles, pulls, latches, locks, and other operating devices on accessible doors shall have a shape that is easy to grasp with one hand and does not require tight grasping, tight pinching or twisting of the wrist to operate. Hardware shall be 34 inches minimum and 48 inches maximum above the finish floor or ground.	Men's restroom door - recessed 13" pull side, 3.5% slope push side, lock only on pull side	For all doors along the public circulation route, provide required maneuvering clearance on push and pull side of doors For all doors along the public circulation route, correct slope in door clearance to max 2.08% For all doors along the public circulation route, replace hardware with lever hardware or hardware operable without a tight pinch or grasp	2010 ADAS Section: 404.2.3, 404.2.7, 404.2.4, 404.2.11, 404.2.11 Exception

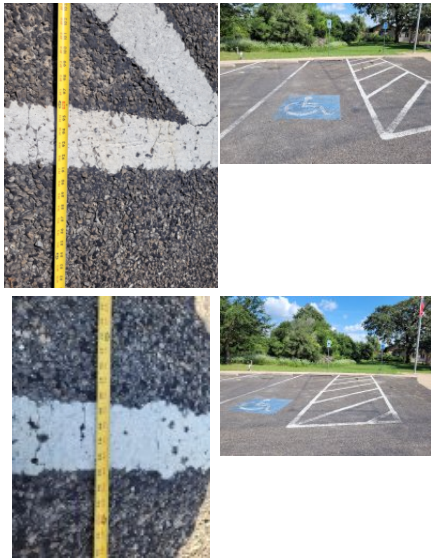
202	Birch Creek - Headquarters: (BC) Headquarters-Parking	[30.3089068 , -96.634945 5]	The accessible parking stall is not wide enough. Each parking space must be at least 8' feet wide and shall be marked to define the width. The measurements of parking spaces and access aisles shall be made from the centerline of the markings. Where the parking space is not adjacent to another parking space or access aisle, the measurement shall be permitted to include the full width of the line defining the parking space.	stall 93.5" wide, van designated access aisle is 91" wide	Repaint stalls to be 8' wide each with minimum 8' aisle for van stall	2015 ABAAS Section: 502.2 2012 TAS Section: 502.2 2010 ADAS Section: 502.2

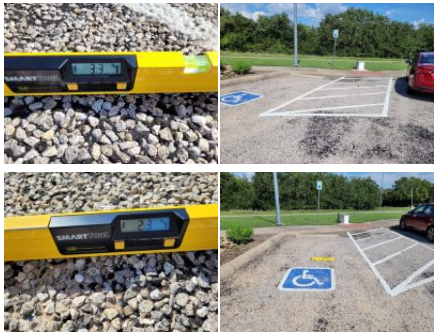
204	Birch Creek - Headquarters: (BC) Headquarters-Parking	[30.3089068 , -96.634938 8]	The cross slopes (narrow dimension) and/or running slopes (long dimension) of the access aisle exceeds 2%. The running slope and the cross slope in an accessible parking stall and the access aisle must not exceed 2%.	Slopes of 3.3% in access aisle and 2.3% in stall	Repair or correct slope of parking space and access aisle to max 2.08% in any direction	2015 ABAAS Section: 502.4  2012 TAS Section: 502.4  2010 ADAS Section: 502.4

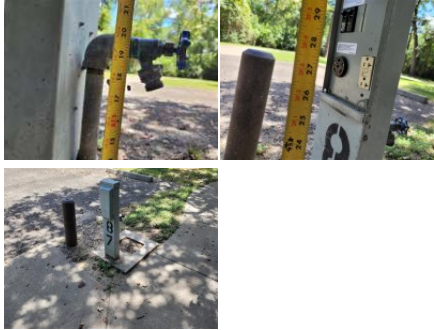
Finding Number	Area Description	Lat/Long	Finding	As Built	Recommendation	Citation	Photos	Figure
220	Birch Creek - Old Hickory Camping Area: (BC) Old Hickory-Campsites	[30.3054938 , -96.637749 3]	Water spouts at water hydrants and water utility hook-ups shall be 28 inches (710 mm) minimum and 36 inches (915 mm) maximum above the ground	site 87- water spout is 20" above ground level, and outlets are 27" agl	Remount water spouts and outlets to 28" min or 36" max above the ground as a smart practice	2015 ABAAS Section: 1011.6

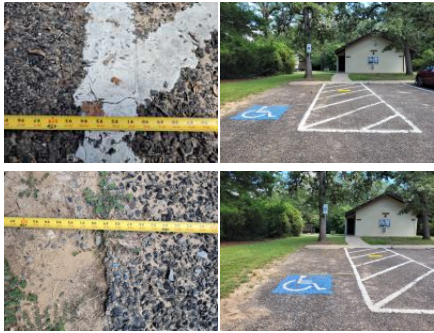
230	Birch Creek - Old Hickory Camping Area: (BC) Old Hickory-Restrooms 1 Parking	[30.3070995 , -96.637342 1]	The accessible parking stall is not wide enough. Each parking space must be at least 8' feet wide and shall be marked to define the width. The measurements of parking spaces and access aisles shall be made from the centerline of the markings. Where the parking space is not adjacent to another parking space or access aisle, the measurement shall be permitted to include the full width of the line defining the parking space.	total width 182.5" for the parking space identified as van accessible	Repaint stalls and access aisles to be 8' and 8' each	2015 ABAAS Section: 502.2  2012 TAS Section: 502.2  2010 ADAS Section: 502.2

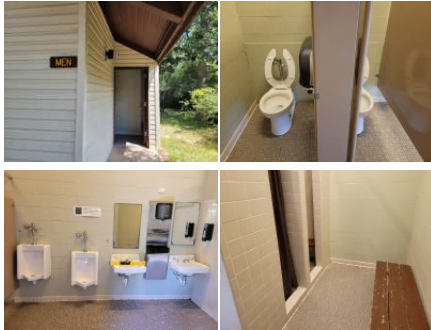
234	Birch Creek - Old Hickory Camping Area: (BC) Old Hickory Restrooms 1 - Men's Restroom	[30.3070335 , -96.637166 4]	This restroom is not accessible. Where existing toilet rooms or bathing rooms do not comply, directional signs indicating the location of the nearest accessible toilet room or bathing room within the facility shall be provided. Signs shall include the International Symbol of Accessibility. Where existing toilet rooms or bathing rooms do comply), the accessible toilet rooms or bathing rooms shall be identified by the International Symbol of Where clustered single user toilet rooms or bathing facilities are permitted, accessible toilet rooms or bathing facilities shall be identified by the International Symbol of Accessibility unless all toilet rooms and bathing facilities are accessible.	Lacks signage directing patrons to an accessible restroom	Restroom not accessible, acquire and mount signage directing patrons to accessible restroom	2015 ABAAS Section: F216.8 2012 TAS Section: 216.8 2010 ADAS Section: 216.8

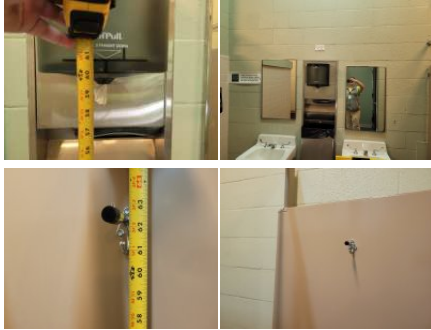
Finding Number	Area Description	Lat/Long	Finding	As Built	Recommendation	Citation	Photos	Figure
240	Birch Creek - Old Hickory Camping Area: (BC) Old Hickory Restrooms 1 - Women's Restroom	[30.3070312 , -96.637151 6]	Where a high forward reach is over an obstruction, the clear floor space shall extend beneath the element for a distance not less than the required reach depth over the obstruction. The high forward reach shall be 48 inches (1220 mm) maximum where the reach depth is 20 inches (510 mm) maximum. Where the reach depth exceeds 20 inches (510 mm), the high forward reach shall be 44 inches (1120 mm) maximum and the reach depth shall be 25 inches (635 mm) maximum. Where a clear floor or ground space allows a parallel approach to an element and the high side reach is over an obstruction, the height of the obstruction shall be 34 inches (865 mm) maximum and the depth of the obstruction shall be 24 inches (610 mm) maximum. The high side reach shall be 48 inches (1220 mm) maximum for a reach depth of 10 inches (255 mm) maximum. Where the reach depth exceeds 10 inches (255 mm), the high side reach shall be 46 inches (1170 mm) maximum for a reach depth of 24 inches (610 mm) maximum.	Paper towel dispenser 59" aff, coat hook 61.25" aff, outlet high	Lower coat hook to max 48" aff Lower paper towel dispenser and outlet to max 44" aff for a forward reach over counter; leave as is outlet if employee only operated	2015 ABAAS Section: 308.2.1, 308.3.2  2012 TAS Section: 308.2.1, 308.3.2  2010 ADAS Section: 308.2.1, 308.3.2

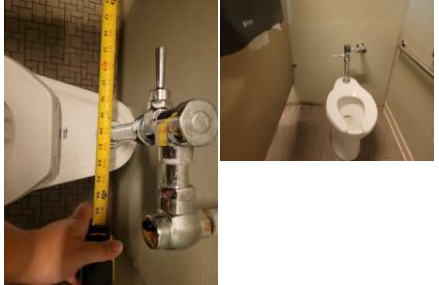
243	Birch Creek - Old Hickory Camping Area: (BC) Old Hickory Restrooms 1 - Women's Restroom	[30.3070404, -96.6371623]	The toilet is not located within the range to the side wall or partition. The centerline of the toilet shall be 17 inches minimum and 19 inches maximum side wall or partition in the ambulatory accessible toilet compartment.	Centerline of the toilet is 20" from the partition	Remount toilet to 17" to 19" from the side wall to center line in ambulatory stalls	2015 ABAAS Section: 604.9.1  2012 TAS Section: 604.9.1  2010 ADAS Section: 604.9.1

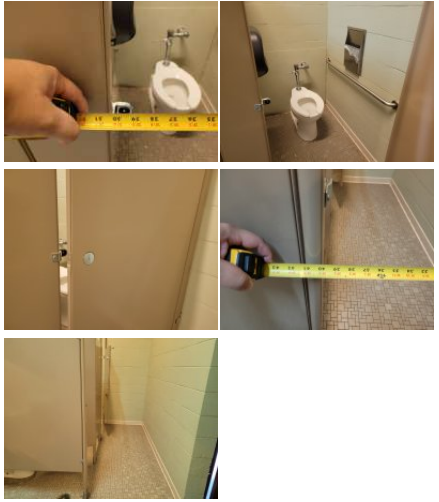
244	Birch Creek - Old Hickory Camping Area: (BC) Old Hickory Restrooms 1 - Women's Restroom	[30.3070312, -96.6371784]	The stall door fails to comply with all of the door requirements. The stall door must be a minimum of 32" wide and have compliant hardware on both sides. The stall door must be self-closing. The door to the compartment has a latch side approach and there is not enough clearance to obstructions. When the approach is to the latch side of the compartment door, clearance between the door side of the compartment and any obstruction shall be 42 inches minimum.	Stall door 30.5" wide, lacks compliant hardware on exterior side, and approach is only 40"	Widen stall doors to 32" when opened to 90 degrees Replace stall hardware with hardware operable without a tight pinch or grasp on both sides of the stall door Widen AR to stalls to min 42" for maneuvering clearance at stall door	2015 ABAAS Section: 404.2.3, 404.2.7, 604.8.2.2  2012 TAS Section: 404.2.3, 404.2.7, 604.8.2.2  2010 ADAS Section: 404.2.3, 404.2.7, 604.8.2.2

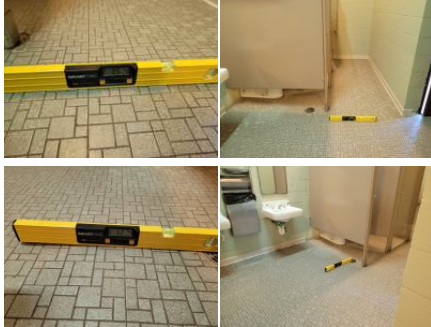
249	Birch Creek - Old Hickory Camping Area: (BC) Old Hickory Restrooms 1 - Women's Restroom	[30.3070242 , -96.637157]	The accessible route contains running slopes greater than 5 percent and cross slopes greater than 2 percent across the width of the walk and has not been constructed as a ramp (i.e. handrails, wheel guides, etc.). When the slope in the direction of travel of any walk exceeds 1 unit vertical in 20 units horizontal (5-percent slope), it must be constructed as ramp. Surface cross slopes must not exceed one unit vertical in 48 units. Horizontal (2-percent slope).	Slopes of 2.5% and 6.2% near floor drain	Correct or repair slope to max 5% running and 2.08% cross	2015 ABAAS Section: 403.3 2012 TAS Section: 403.3 2010 ADAS Section: 403.3

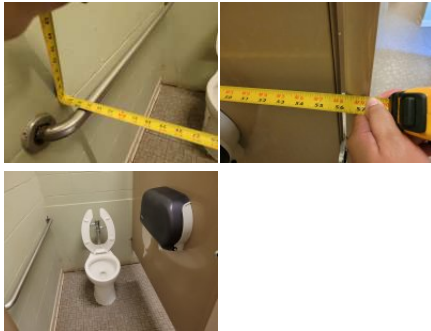
264	Birch Creek - Old Hickory Camping Area: (BC) Old Hickory Restrooms 2 - Men's Restroom	[30.3054727 , -96.638187]	The ambulatory stall is not between 35" to 37" wide and 60" deep.	ambulatory stall 38" wide and 56.75" deep	Correct ambulatory stall to be 35" to 37" wide and minimum 60" deep	2015 ABAAS Section: 604.8.2.1 2012 TAS Section: 604.8.2.1 2010 ADAS Section: 604.8.2.1

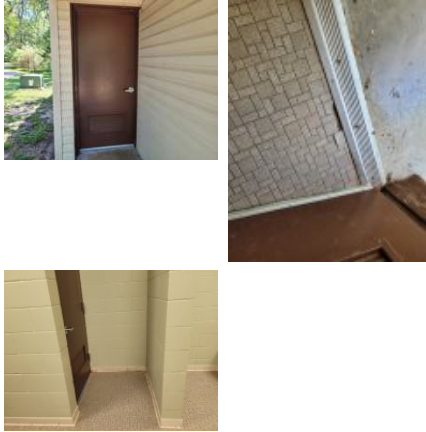
Finding Number	Area Description	Lat/Long	Finding	As Built	Recommendation	Citation	Photos	Figure
271	Birch Creek - Old Hickory Camping Area: (BC) Old Hickory Restrooms 2 - Women's Restroom	[30.3054825 , -96.638167 4]	Minimum maneuvering clearances at doors and gates shall comply with 404.2.4. Maneuvering clearances shall extend the full width of the doorway and the required latch side or hinge side clearance. The threshold has a gap greater than 1/2 inch wide.	Women's restroom door - wall push side, wall back pull side, gap where tile missing	For all doors along the public circulation route, provide required maneuvering clearance on push and pull side of doors For all doors along the public circulation fill gaps at door entries to max .5".	2010 ADAS Section: 404.2.3, 404.2.7, 404.2.4, 404.2.11, 404.2.11 Exception

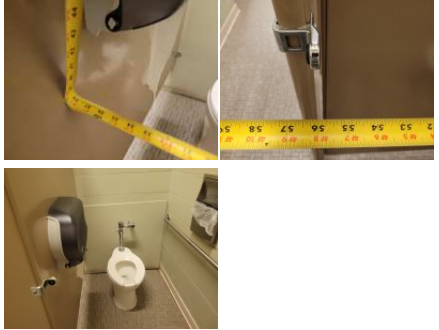
Finding Number	Area Description	Lat/Long	Finding	As Built	Recommendation	Citation	Photos	Figure
277	Birch Creek - Old Hickory Camping Area: (BC) Old Hickory Restrooms 2 - Women's Restroom	[30.3054646 , -96.638191]	The ambulatory stall is not between 35" to 37" wide and 60" deep.	ambulatory stall 38" wide and 56" deep	Correct ambulatory stall to be 35" to 37" wide and minimum 60" deep	2015 ABAAS Section: 604.8.2.1  2012 TAS Section: 604.8.2.1  2010 ADAS Section: 604.8.2.1

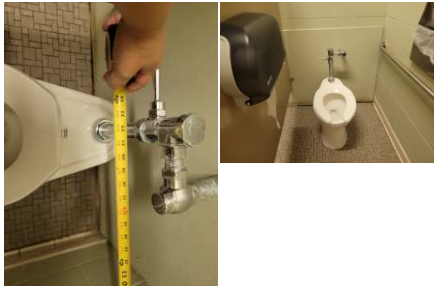
278	Birch Creek - Old Hickory Camping Area: (BC) Old Hickory Restrooms 2 - Women's Restroom	[30.3054751 , -96.638195]	The toilet is not located within the range to the side wall or partition. The centerline of the toilet shall be 17 inches minimum and 19 inches maximum side wall or partition in the ambulatory accessible toilet compartment.	Centerline of the toilet is 21.5" from the side wall	Remount toilet to 17" to 19" from the side wall to center line in ambulatory stalls	2015 ABAAS Section: 604.9.1  2012 TAS Section: 604.9.1  2010 ADAS Section: 604.9.1

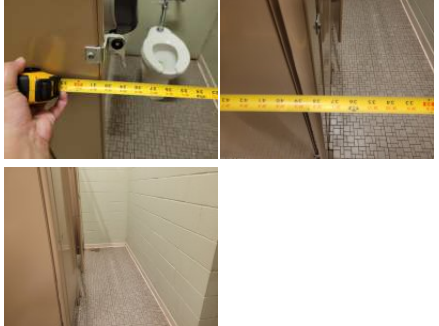
279	Birch Creek - Old Hickory Camping Area: (BC) Old Hickory Restrooms 2 - Women's Restroom	[30.3054658 , -96.6381896]	The stall door fails to comply with all of the door requirements. The stall door must be a minimum of 32" wide and have compliant hardware on both sides. The stall door must be self-closing. The door to the compartment has a latch side approach and there is not enough clearance to obstructions. When the approach is to the latch side of the compartment door, clearance between the door side of the compartment and any obstruction shall be 42 inches minimum.	Stall door 30.5" wide and 38" wide approach	Widen stall doors to 32" when opened to 90 degrees Widen AR to stalls to min 42" for maneuvering clearance at stall door	2015 ABAAS Section: 404.2.3, 404.2.7, 604.8.2.2  2012 TAS Section: 404.2.3, 404.2.7, 604.8.2.2  2010 ADAS Section: 404.2.3, 404.2.7, 604.8.2.2

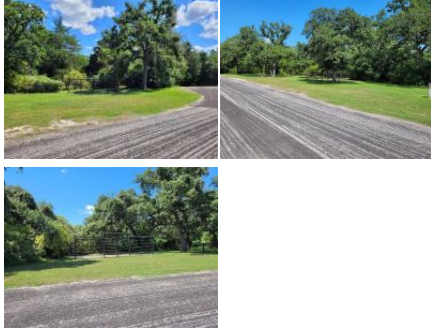
287	Birch Creek - Equestrian Area: (BC) Equestrian Area	[30.3073322 , -96.639089 5]	At least one accessible route shall connect accessible buildings, accessible facilities, accessible elements, and accessible spaces that are on the same site. For areas of sport activity, an accessible route is required to connect to the boundary of each area of sport activity. The size of an area of sport activity includes only the space needed to play. Where multiple sports fields or courts are provided, an accessible route is required to each field or area of sport activity.	Lacks route to horse corrals	Provide an accessible route (AR) to each element within the site.	2010 ADAS Section: 206.2.2, 206.2

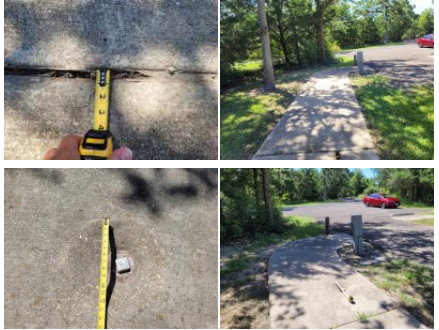
Finding Number	Area Description	Lat/Long	Finding	As Built	Recommendation	Citation	Photos	Figure
295	Birch Creek - Post Oak Camping Area: (BC) Post Oak Campsites	[30.3119703 , -96.626066]	The surface of the outdoor recreation access route, passing spaces, and/or resting intervals are not firm and stable. The surface of outdoor recreation access route, passing spaces, and resting intervals shall be firm and stable, having a width of 36", max gaps of .5" and tread obstacles of .5" or less.	campsite 32- gaps of .75" and 12" at utility	Correct surface of ORAR to be firm and stable, a min 36" wide and having gaps and changes in level of max .5"	2015 ABAAS Section: 1016.2

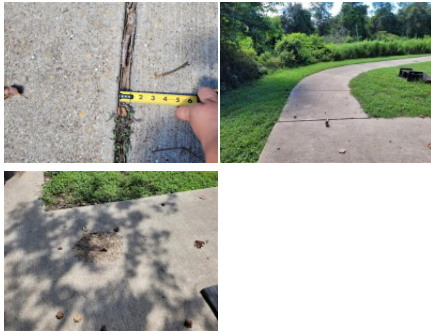
307	Birch Creek - Post Oak Camping Area: (BC) Post Oak Campsites	[30.30995, -96.626397 3]	The surface of the outdoor recreation access route, passing spaces, and/or resting intervals are not firm and stable. The surface of outdoor recreation access route, passing spaces, and resting intervals shall be firm and stable, having a width of 36", max gaps of .5" and tread obstacles of .5" or less.	campsite 46- gap of 1" gap and depression due to surface deterioration	Correct surface of ORAR to be firm and stable, a min 36" wide and having gaps and changes in level of max .5"	2015 ABAAS Section: 1016.2

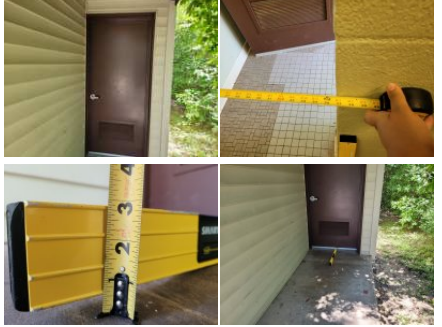
323	Birch Creek - Post Oak Camping Area: (BC) Post Oak-Restrooms Parking	[30.3108832 , -96.625757 6]	Element meets all standards and requirements	Post Oak Restroom parking meets scoping requirements - 6 standard, 1 accessible	None	2010 ADAS Section: N/A		
324	Birch Creek - Post Oak Camping Area: (BC) Post Oak-Men's Restroom	[30.3109219 , -96.625643 8]	Minimum maneuvering clearances at doors and gates shall comply with 404.2.4. Maneuvering clearances shall extend the full width of the doorway and the required latch side or hinge side clearance. The threshold has a vertical change greater than 1/4 inch high.	Men's restroom door - wall both sides, .5" CIL	For all doors along the public circulation route, provide required maneuvering clearance on push and pull side of doors For all doors along the public circulation route, repair, bevel, or ramp CILs at door entries to max .25"	2010 ADAS Section: 404.2.3, 404.2.7, 404.2.4, 404.2.11, 404.2.11 Exception

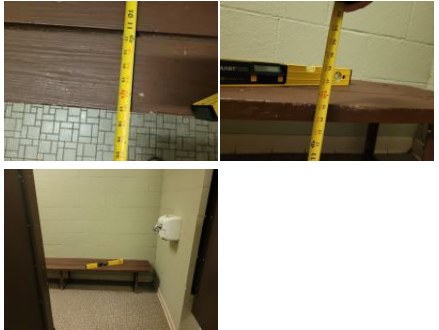
Finding Number	Area Description	Lat/Long	Finding	As Built	Recommendation	Citation	Photos	Figure
337	Birch Creek - Post Oak Camping Area: (BC) Post Oak-Men's Restroom	[30.3109214 , -96.625638 2]	The bench is not deep enough or long enough or is missing. Benches shall be provided having seats that are 42 inches long minimum and 20 inches deep minimum and 24 inches deep maximum. The bench shall provide for back support or shall be affixed to a wall. Back support shall be 42 inches (1065 mm) long minimum and shall extend from a point 2 inches (51 mm) maximum above the seat surface to a point 18 inches (455 mm) minimum above the seat surface. Back support shall be 2½ inches (64 mm) maximum from the rear edge of the seat measured horizontally. The top of the bench seat surface shall be 17 inches (430 mm) minimum and 19 inches (485 mm) maximum above the finish floor or ground.	bench 15" aff and 17" deep	Replace bench in dressing area with one having a seat depth of 20" to 24" deep, 42" long, affixed to the wall or having a back and mounted 17" to 19" aff	2012 TAS Section: 903.4, 903.2, 903.3, 903.5  2010 ADAS Section: 903.4, 903.2, 903.3, 903.5

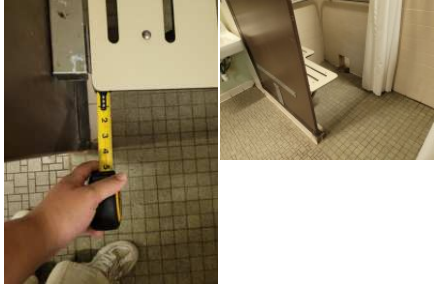
341	Birch Creek - Post Oak Camping Area: (BC) Post Oak-Men's Restroom	[30.310933, -96.6256396]	Where a seat is provided in a standard roll-in shower compartment, it shall be a folding type, shall be installed on the side wall adjacent to the controls, and shall extend from the back wall to a point within 3 inches (75 mm) of the compartment entry. Where a seat is provided in an alternate roll-in type shower compartment, it shall be a folding type, shall be installed on the front wall opposite the back wall, and shall extend from the adjacent side wall to a point within 3 inches (75 mm) of the compartment entry. In transfer-type showers, the seat shall extend from the back wall to a point within 3 inches (75 mm) of the compartment entry. The top of the seat shall be 17 inches (430 mm) minimum and 19 inches (485 mm) maximum above the bathroom finish floor. Seats shall comply with 610.3.1 or 610.3.2.	seat 3.75" from compartment entry	Remount shower seat to within 3" from the compartment entry	2015 ABAAS Section: 610.3  2012 TAS Section: 610.3  2010 ADAS Section: 610.3

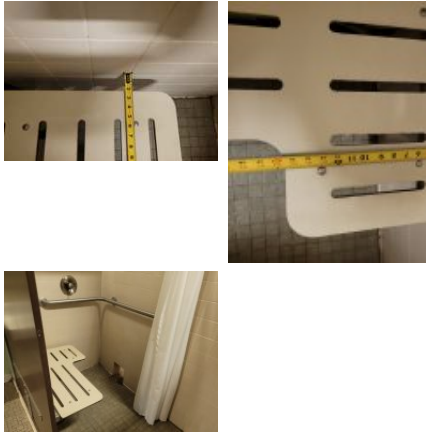
Finding Number	Area Description	Lat/Long	Finding	As Built	Recommendation	Citation	Photos	Figure
342	Birch Creek - Post Oak Camping Area: (BC) Post Oak-Men's Restroom	[30.3109191, -96.6256235]	The shower seat does not have a compliant space between it and the wall. The folding seat must be mounted 17-19 inches above the floor, and have a maximum space of 1-1/2 inches between the edge of the seat and the side wall and 2-1/2 inches maximum to the seat wall.	seat dimensions fail	Remount shower seat to the correct location and height in the shower	2015 ABAAS Section: 610.3.2  2012 TAS Section: 610.3.2  2010 ADAS Section: 610.3.2

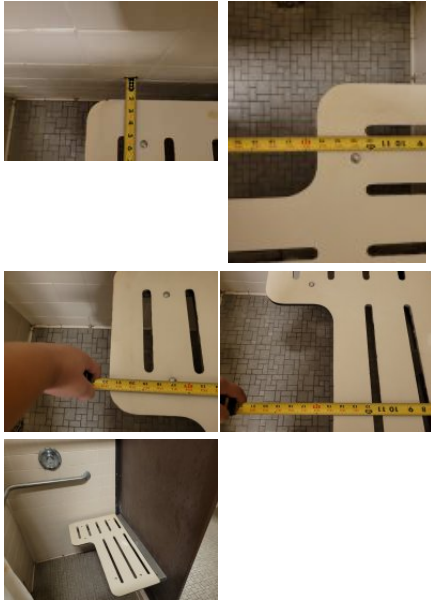
Finding Number	Area Description	Lat/Long	Finding	As Built	Recommendation	Citation	Photos	Figure
357	Birch Creek - Post Oak Camping Area: (BC) Post Oak-Women's Restroom	[30.310926, -96.625639 6]	The shower seat does not have a compliant space between it and the wall. The folding seat must be mounted 17-19 inches above the floor, and have a maximum space of 1-1/2 inches between the edge of the seat and the side wall and 2-1/2 inches maximum to the seat wall.	seat dimensions fail	Remount shower seat to the correct location and height in the shower	2015 ABAAS Section: 610.3.2  2012 TAS Section: 610.3.2  2010 ADAS Section: 610.3.2

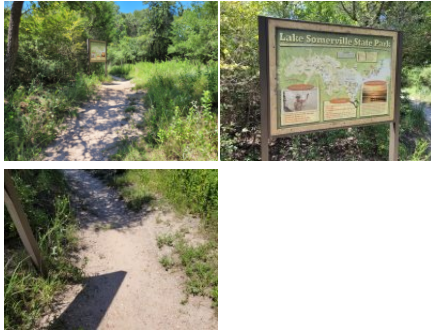
358	Birch Creek - Post Oak Camping Area: (BC) Family Fishing Pond	[30.3123849, -96.626655 8]	The accessible route contains surface materials that do not provide for a stable, firm slip resistant surface. Floor and ground surfaces shall be stable, firm, and slip resistant.	Lacks firm and stable surface on trail to pond (sand and dirt)	Resurface AR to fishing pond with one that is firm and stable	2015 ABAAS Section: 302.1  2012 TAS Section: 302.1  2010 ADAS Section: 302.1

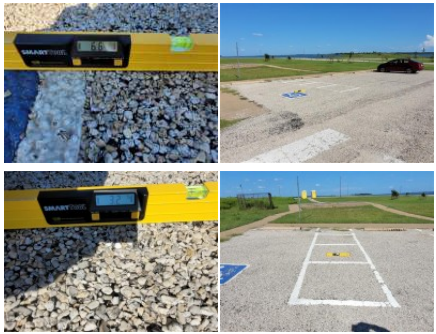
Finding Number	Area Description	Lat/Long	Finding	As Built	Recommendation	Citation	Photos	Figure
360	Birch Creek - Boat Ramp: (BC) Boat Ramp - Parking	[30.3095135 , -96.6201759]	Element meets all standards and requirements	old restroom- 5 standard, 1 accessible	None	2010 ADAS Section: N/A		
361	Birch Creek - Boat Ramp: (BC) Boat Ramp - Parking	[30.3094915 , -96.6201773]	The cross slopes (narrow dimension) and/or running slopes (long dimension) of the access aisle exceeds 2%. The running slope and the cross slope in an accessible parking stall and the access aisle must not exceed 2%.	old restroom- 6.6% stall, 3.2% aisle	Repair or correct slope of parking space and access aisle to max 2.08% in any direction.	2015 ABAAS Section: 502.4  2012 TAS Section: 502.4  2010 ADAS Section: 502.4

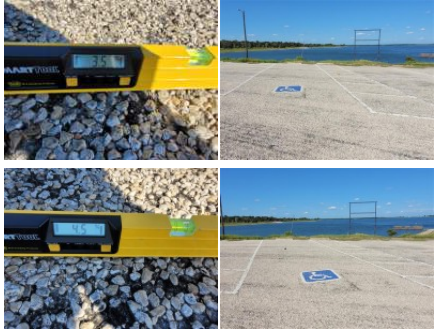
367	Birch Creek - Boat Ramp: (BC) Boat Ramp - Parking	[30.3098284 , -96.619432 9]	The cross slopes (narrow dimension) and/or running slopes (long dimension) of the access aisle exceeds 2%. The running slope and the cross slope in an accessible parking stall and the access aisle must not exceed 2%.	trailer stalls- 3.5% far passenger aisle; 4.5% far stall	Repair or correct slope of parking space and access aisle to max 2.08% in any direction.	2015 ABAAS Section: 502.4 2012 TAS Section: 502.4 2010 ADAS Section: 502.4

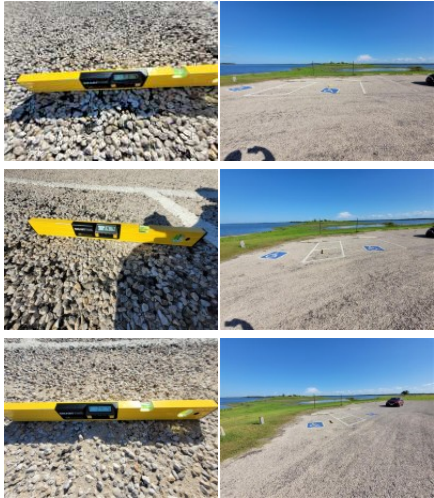
Finding Number	Area Description	Lat/Long	Finding	As Built	Recommendation	Citation	Photos	Figure
371	Birch Creek - Boat Ramp: (BC) Boat Ramp - Parking	[30.3091118 , -96.619215 7]	The cross slopes (narrow dimension) and/or running slopes (long dimension) of the access aisle exceeds 2%. The running slope and the cross slope in an accessible parking stall and the access aisle must not exceed 2%.	boat ramp- 3.1% right stall, 2.4% aisle, 2.4% left stall	Repair or correct slope of parking space and access aisle to max 2.08% in any direction.	2015 ABAAS Section: 502.4 2012 TAS Section: 502.4 2010 ADAS Section: 502.4

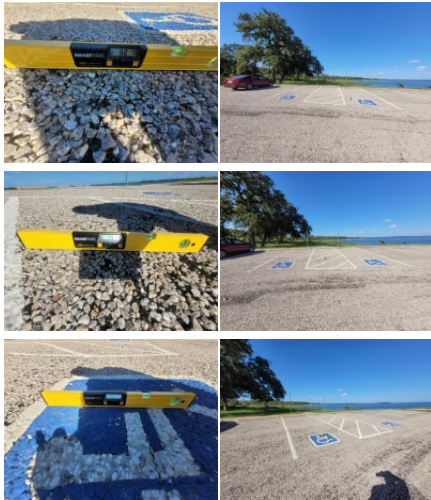
375	Birch Creek - Boat Ramp: (BC) Boat Ramp - Parking	[30.3101931, -96.619984 1]	The cross slopes (narrow dimension) and/or running slopes (long dimension) of the access aisle exceeds 2%. The running slope and the cross slope in an accessible parking stall and the access aisle must not exceed 2%.	trail stalls- 8% right stall, 7.4% aisle, 5.3% left stall	Repair or correct slope of parking space and access aisle to max 2.08% in any direction.	2015 ABAAS Section: 502.4  2012 TAS Section: 502.4  2010 ADAS Section: 502.4

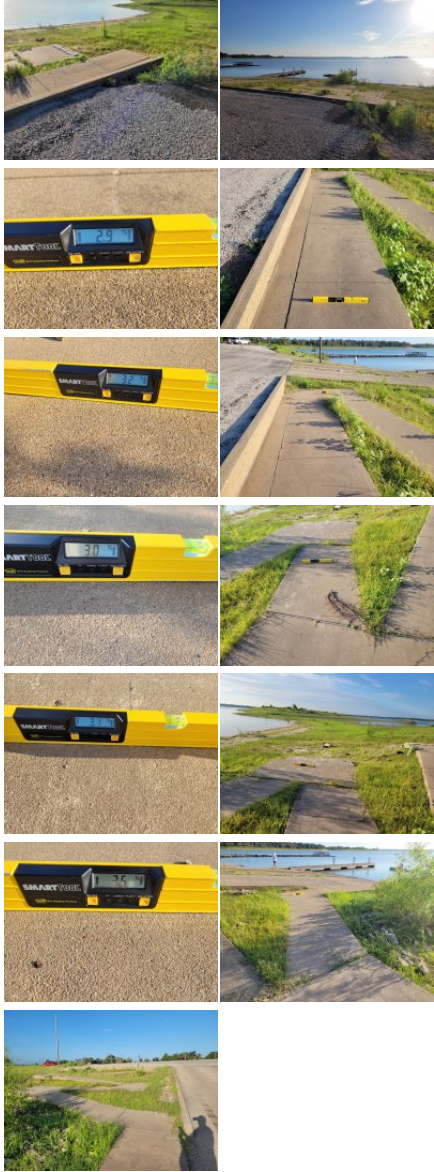
Finding Number	Area Description	Lat/Long	Finding	As Built	Recommendation	Citation	Photos	Figure
383	Birch Creek - Boat Ramp: (BC) Boat Ramp	[30.3093213 , -96.618975 6]	There is no accessible route to/on the boating facility. Accessible routes serving recreational boating facilities, including gangways and floating piers, shall comply with accessible route requirements except as modified by section Recreational Boating Facilities - Accessible Routes.	Lacks accessible route to boat ramp boarding pier due to multiple CILs and slopes - CIL/curb to enter ramp to pier, cross and running slopes of 2.9% (at top), 3.2% (on landing), running slopes exceeding 5%, 3% (at 2nd run from bottom), 3.1% (at landing), 3.5% (at bottom landing), bottom landing is not 60", gaps of 1", plant overgrowth, one landing damaged, and lacks handrails on ramp	Create an outdoor accessible route to the boat pier or make corrections for a compliant route.	2015 ABAAS Section: 1003.2  2010 ADAS Section: 1003.2

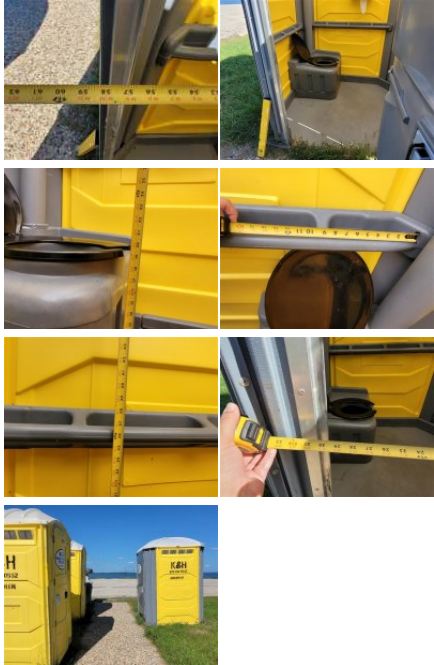
Finding Number	Area Description	Lat/Long	Finding	As Built	Recommendation	Citation	Photos	Figure
389	Birch Creek - Boat Ramp: (BC) Boat Ramp - Restrooms	[30.3096802 , -96.619736]	The portable public restroom is not compliant. 5% of portable toilets must be accessible, minimum of 1. If sanitary facilities are provided, they must be made accessible to persons with disabilities. If public restrooms are desired, It is recommended that the portable unit be replaced with a permanent built in compliant restroom. The utilization of an accessible portable unit may be a temporary solution and is not recommended as a permanent solution.	56" wide, seat height 19.5", rear bar fails, grab bar heights fail, lacks signage, door narrow	Replace 5% of portable toilets with compliant models and place along AR	2015 ABAAS Section: F213.1  2012 TAS Section: 213.1  2010 ADAS Section: 213.1, 213.2 Exception 3

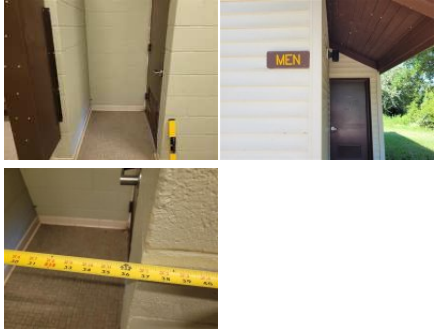
Finding Number	Area Description	Lat/Long	Finding	As Built	Recommendation	Citation	Photos	Figure
400	Birch Creek - Yaupon Camping Area: (BC) Yaupon-Men's Restroom	[30.3182313 , -96.614541 9]	Minimum maneuvering clearances at doors and gates shall comply with 404.2.4. Maneuvering clearances shall extend the full width of the doorway and the required latch side or hinge side clearance. Maneuvering clearances shall have a max slope of 2.08%. The sweep period for doors with closers shall be adjusted so that from an open position of 70 degrees, the door will take at least 3 seconds to move to a point 3 inches from the latch, measured to the leading edge of the door. Exterior doors are recommended to be maintained at 8.5 lbf as a smart practice. Force is to be measured at the operating hardware or 30 inches from the hinges, whichever is greater.	men's restroom- wall push side, wall back 37.5" pull side, closes fast, 15#	For all doors along the public circulation route, provide required maneuvering clearance on push and pull side of doors. For all doors along the public circulation route, inspect, adjust, and maintain closing speed on door closers. For all doors along the public circulation route, inspect, adjust, and maintain 8.5 lbf to open exterior doors as a smart practice.	2010 ADAS Section: 404.2.3, 404.2.7, 404.2.4, 404.2.11, 404.2.11 Exception

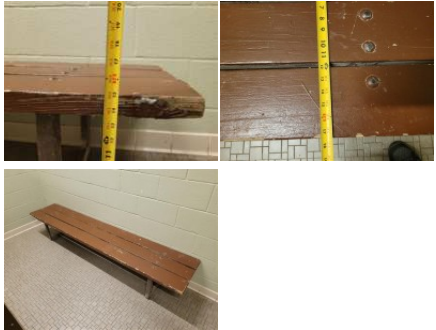
Finding Number	Area Description	Lat/Long	Finding	As Built	Recommendation	Citation	Photos	Figure
410	Birch Creek - Yaupon Camping Area: (BC) Yaupon-Men's Restroom	[30.3182243 , -96.614543 3]	The bench is not deep enough or long enough or is missing. Benches shall be provided having seats that are 42 inches long minimum and 20 inches deep minimum and 24 inches deep maximum. The bench shall provide for back support or shall be affixed to a wall. Back support shall be 42 inches (1065 mm) long minimum and shall extend from a point 2 inches (51 mm) maximum above the seat surface to a point 18 inches (455 mm) minimum above the seat surface. Back support shall be 2½ inches (64 mm) maximum from the rear edge of the seat measured horizontally. The top of the bench seat surface shall be 17 inches (430 mm) minimum and 19 inches (485 mm) maximum above the finish floor or ground. Clear floor or ground space complying with 305 shall be provided and shall be positioned at the end of the bench seat and parallel to the short axis of the bench	bench 17.5" deep, 15" aff	Replace bench in dressing area with one having a seat depth of 20" to 24" deep, 42" long, affixed to the wall or having a back and mounted 17" to 19" AFF and provide required clear floor space on the short axis of the bench.	2012 TAS Section: 903.4, 903.2, 903.3, 903.5  2010 ADAS Section: 903.4, 903.2, 903.3, 903.5

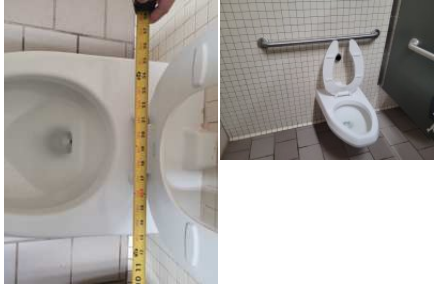
442	Birch Creek - Cedar Elm Day Use Area : (BC) Cedar Elm-Men's Restroom	[30.3062346, -96.622217 1]	The toilet is not located within the range allowed from the side wall or partition. The centerline of the toilet must be 16 to 18 inches from the side wall.	Centerline of the toilet is 19" from the partition	Remount toilets to 16" to 18" from the side wall to centerline	2015 ABAAS Section: 604.2  2012 TAS Section: 604.2  2010 ADAS Section: 604.2

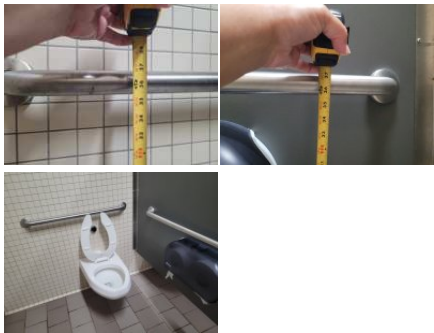
443	Birch Creek - Cedar Elm Day Use Area : (BC) Cedar Elm-Men's Restroom	[30.3062184, -96.622222 4]	The grab bar height and/or spacing fails. Grab bars must be mounted between 33" and 36" to the top of the gripping surface. There must be 1.5" of clearance between the grab bar and the wall. There must be a minimum of 1.5" of clearance below and minimum 12" above the grab bar to any dispenser or other obstruction.	Side grab bar is 36.75" aff, rear grab bar is 37" aff	Remount grab bars in accessible stall to 33" to 36" aff	2015 ABAAS Section: 609.3, 609.4  2012 TAS Section: 609.4, 609.3  2010 ADAS Section: 609.3, 609.4

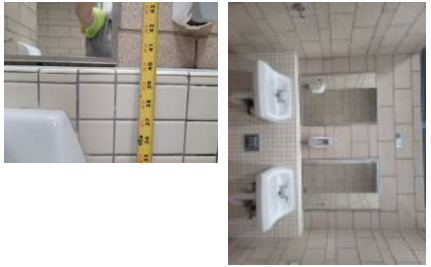
Finding Number	Area Description	Lat/Long	Finding	As Built	Recommendation	Citation	Photos	Figure
453	Birch Creek - Cedar Elm Day Use Area : (BC) Cedar Elm-Women's Restroom	[30.3062158 , -96.622239 7]	Exterior doors exceed 8.5 lbs of force to open; fire doors shall have a minimum opening force allowable by the appropriate administrative authority	Women's restroom door - 10# push	Inspect, adjust, and maintain 8.5 lbf to open exterior doors as a smart practice	2010 ADAS Section: 404.2.9		
454	Birch Creek - Cedar Elm Day Use Area : (BC) Cedar Elm-Women's Restroom	[30.3062161 , -96.622217 1]	The mirror is mounted too high. Mirrors must have the bottom edge of the reflecting surface a maximum of 40 inches above the floor if above a sink or counter. Mirrors not located above lavatories or countertops shall be installed with the bottom edge of the reflecting surface 35 inches maximum above the finish floor or ground.	Bottom edge of reflecting surface of mirror is 40.25" aff	Lower mirror so reflective surface is max 40" aff	2015 ABAAS Section: 603.3  2012 TAS Section: 603.3  2010 ADAS Section: 603.3

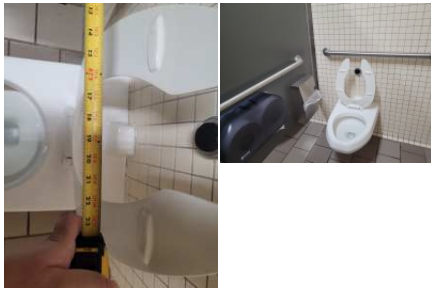
455	Birch Creek - Cedar Elm Day Use Area : (BC) Cedar Elm-Women's Restroom	[30.3062161 , -96.622222 4]	The toilet is not located within the range allowed from the side wall or partition. The centerline of the toilet must be 16 to 18 inches from the side wall.	Centerline of the toilet is 19" from the partition	Remount toilets to 16" to 18" from the side wall to centerline	2015 ABAAS Section: 604.2  2012 TAS Section: 604.2  2010 ADAS Section: 604.2

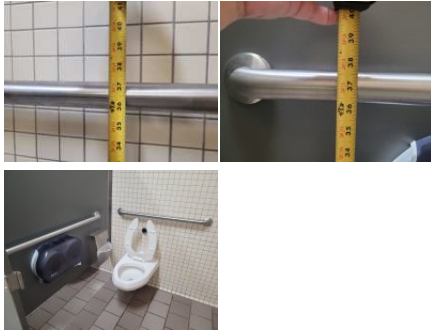
456	Birch Creek - Cedar Elm Day Use Area : (BC) Cedar Elm-Women's Restroom	[30.3062219 , -96.622210 4]	The grab bar height and/or spacing fails. Grab bars must be mounted between 33" and 36" to the top of the gripping surface. There must be 1.5" of clearance between the grab bar and the wall. There must be a minimum of 1.5" of clearance below and minimum 12" above the grab bar to any dispenser or other obstruction.	Side grab bar is 37.75" aff, rear grab bar is 37.25" aff	Remount grab bars in accessible stall to 33" to 36" aff	2015 ABAAS Section: 609.3, 609.4  2012 TAS Section: 609.4, 609.3  2010 ADAS Section: 609.3, 609.4

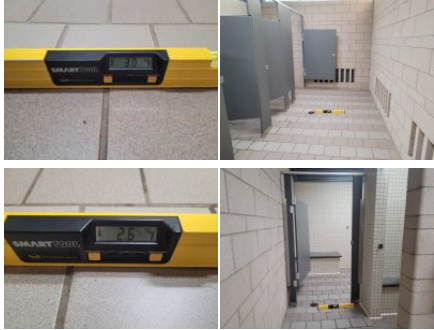
Finding Number	Area Description	Lat/Long	Finding	As Built	Recommendation	Citation	Photos	Figure
460	Birch Creek - Cedar Elm Day Use Area : (BC) Cedar Elm-Women's Restroom	[30.306223, -96.622209]	The accessible route contains running slopes greater than 5 percent and cross slopes greater than 2 percent across the width of the walk and has not been constructed as a ramp (i.e. handrails, wheel guides, etc.). When the slope in the direction of travel of any walk exceeds 1 unit vertical in 20 units horizontal (5-percent slope), it must be constructed as ramp. Surface cross slopes must not exceed one unit vertical in 48 units. Horizontal (2-percent slope).	Slopes of 3% near floor drain and 2.6% at floor drain by shower	Correct or repair slope to max 5% running and 2.08% cross	2015 ABAAS Section: 403.3  2012 TAS Section: 403.3  2010 ADAS Section: 403.3

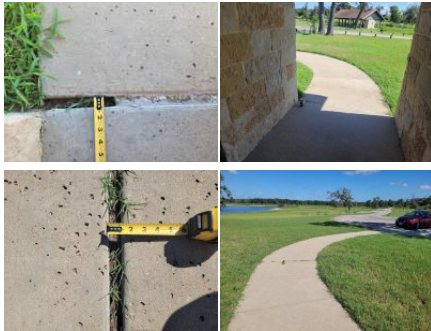
463	Birch Creek - Cedar Elm Day Use Area : (BC) Cedar Elm-Women's Restroom	[30.3063635 , -96.62225 63], [30.3061608 , -96.622291 2]	There is a gap spaced greater than a 1/2 inch. Openings in floor or ground surfaces shall not allow passage of a sphere more than 1/2 inch diameter. Elongated openings shall be placed so that the long dimension is perpendicular to the dominant direction of travel.	Multiple gaps of 1"	Correct or fill gaps to be max .5"	2015 ABAAS Section: 302.3  2012 TAS Section: 302.3  2010 ADAS Section: 302.3
