# Access Audit Site Report

## Lake Somerville State Park & Trailway

Accessibility Evaluation

Inspection Date: 08/24/2021

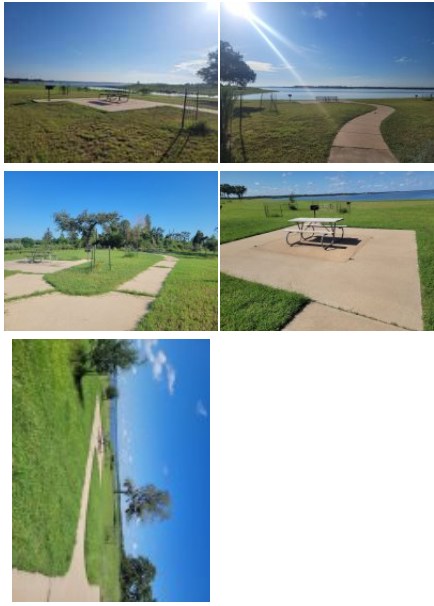
473	Birch Creek - Cedar Elm Day Use Area : (BC) Cedar Elm-Picnic Area	[30.3077143 , -96.622568 4]	Picnic tables shall provide at least one wheelchair space for each 24 linear feet (7320 mm) of usable table surface perimeter. Wheelchair spaces shall be 30 inches (760 mm) minimum by 48 inches (1220 mm) minimum. Wheelchair spaces shall be positioned for a forward approach to the table and provide knee and toe clearance complying with 306 under the table	Lacks any picnic tables of an accessible design	Replace 20% of picnic tables with ones with knee and toe clearance, 19" deep at 27" high and 24" deep at 9" high, with a 36" AR around table	2015 ABAAS Section: 1011.4.2

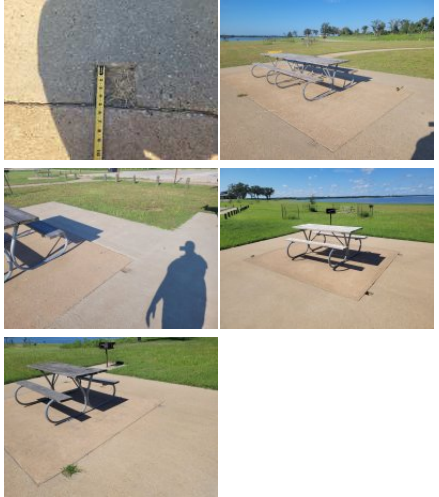
Finding Number	Area Description	Lat/Long	Finding	As Built	Recommendation	Citation	Photos	Figure
474	Birch Creek - Cedar Elm Day Use Area : (BC) Cedar Elm-Picnic Area	[30.3077027 , -96.622565 8]	Openings in floor or ground surfaces shall not allow passage of a sphere more than 1/2 inch (13 mm) diameter except as allowed in 407.4.3, 409.4.3, 410.4, 810.5.3 and 810.10. Elongated openings shall be placed so that the long dimension is perpendicular to the dominant direction of travel. Floor or ground surface within required maneuvering clearances shall comply with 302. Changes in level are not permitted.	Multiple gaps of 5" where posts were removed	Correct or fill gap in doorway to max .5"	2010 ADAS Section: 302.3, 404.2.4.4

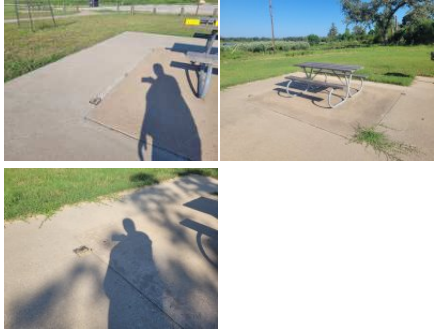
475	Birch Creek - Cedar Elm Day Use Area : (BC) Cedar Elm-Picnic Area	[30.3077143 , -96.622568 4]	The walkway contains abrupt vertical edges and/or variations over a 1/4 inch. 1/4 inch is the maximum vertical rise. Changes in level between 1/4 inch and 1/2 inch must be beveled at 1:2 or less. Changes in level greater than 1/2 inch must be by way of a ramp.	Multiple CILs where posts were removed	Repair, bevel or ramp CIL along AR	2012 TAS Section: 303.2, 303.3  2010 ADAS Section: 303.2, 303.3

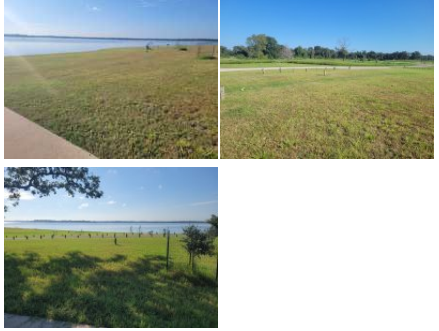
476	Birch Creek - Cedar Elm Day Use Area : (BC) Cedar Elm-Picnic Area	[30.3076078 , -96.623408]	At least one outdoor recreation access route shall connect accessible elements, spaces, and facilities provided within picnic units with mobility features	Lacks accessible route to swimming signs and water spigots	Extend an AR to features and elements in the shelter or picnic area as a smart practice.	2015 ABAAS Section: F245.4.1

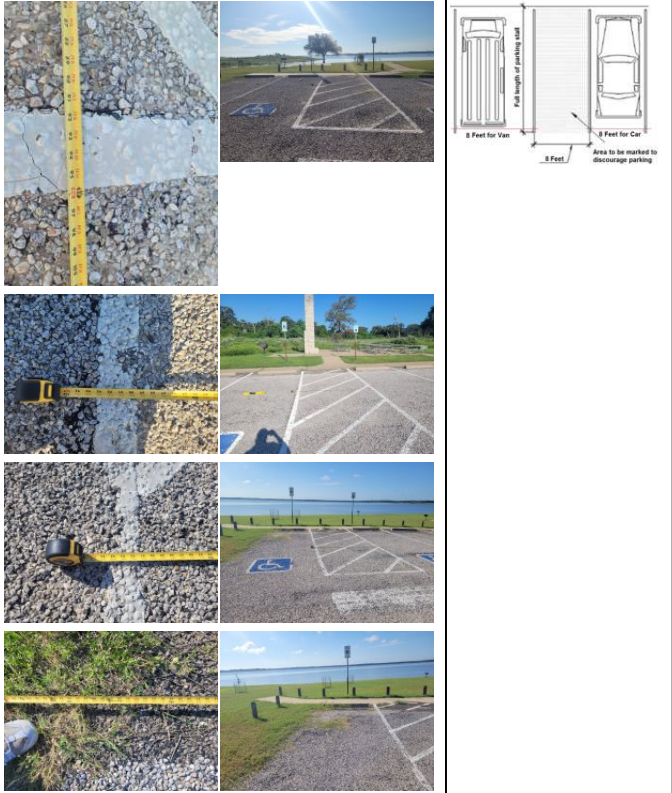
486	Birch Creek - Cedar Elm Day Use Area : (BC) Cedar Elm Picnic Parking	[30.3078301, -96.6204522], [30.3064592, -96.6213105]	The accessible parking stall is not wide enough. Each parking space must be at least 8' feet wide and shall be marked to define the width. The measurements of parking spaces and access aisles shall be made from the centerline of the markings. Where the parking space is not adjacent to another parking space or access aisle, the measurement shall be permitted to include the full width of the line defining the parking space.	group 1 picnic and open picnic at lake-access aisle 94" at van stall, 91.5" at other van stall, 93" at van stall near group picnic 2, narrows to about 64" left stall near group picnic 2 due to plant growth space	Repaint stalls and access aisles to be 8' and 8' each	2015 ABAAS Section: 502.2 2012 TAS Section: 502.2 2010 ADAS Section: 502.2

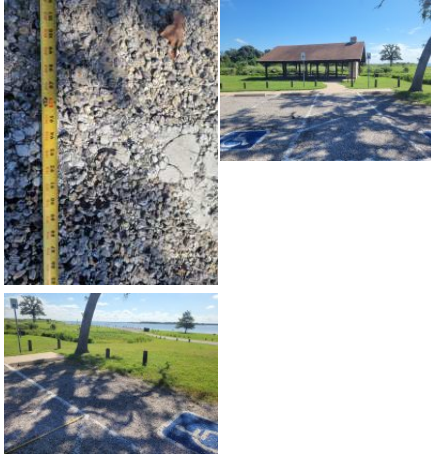
492	Birch Creek - Cedar Elm Day Use Area : (BC) Cedar Elm Picnic Parking	[30.3065646 , -96.6221044]	The accessible parking stall is not wide enough. Each parking space must be at least 8' feet wide and shall be marked to define the width. The measurements of parking spaces and access aisles shall be made from the centerline of the markings. Where the parking space is not adjacent to another parking space or access aisle, the measurement shall be permitted to include the full width of the line defining the parking space.	group picnic 2 and restroom building- access aisle of van stall 93" at shelter, and right stall narrows due to plant overgrowth	Repaint stalls and access aisles to be 8' and 8' each and establish protocols for regular and frequent inspection and maintenance of accessible parking surfaces	2015 ABAAS Section: 502.2  2012 TAS Section: 502.2  2010 ADAS Section: 502.2

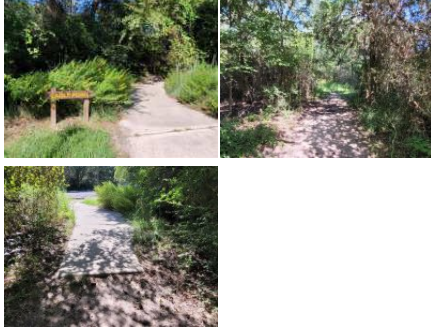
510	Birch Creek - Amenities: (BC) Amenities-Trailhead	[30.3180484, -96.6167239]	The surface of trails, passing spaces, and resting intervals shall be firm and stable	Eagle Point- trail starts as concrete but becomes natural surface	Replace surface of trail with one that is firm and stable as a smart practice.	2015 ABAAS Section: 1017.2

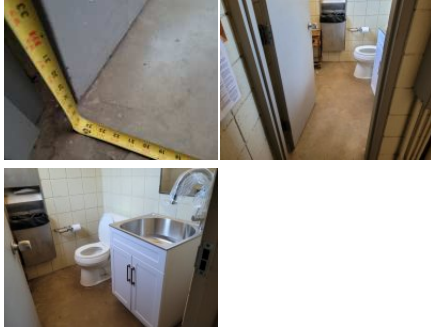
513	Birch Creek Employee Other: (BC) Employee Other-Maintenance	[30.3077261 , -96.6354713]	Minimum maneuvering clearances at doors and gates shall comply with 404.2.4. Maneuvering clearances shall extend the full width of the doorway and the required latch side or hinge side clearance. Door openings shall provide a clear width of 32 inches (815 mm) minimum. Clear openings of doorways with swinging doors shall be measured between the face of the door and the stop, with the door open 90 degrees. Openings more than 24 inches (610 mm) deep shall provide a clear opening of 36 inches (915 mm) minimum. There shall be no projections into the required clear opening width lower than 34 inches (865 mm) above the finish floor or ground. Projections into the clear opening width between 34 inches (865 mm) and 80 inches (2030 mm) above the finish floor or ground shall not exceed 4 inches (100 mm). Hand-activated door opening hardware, handles, pulls, latches, locks, and other operating devices on accessible doors shall have a shape that is easy to grasp with one hand and does not require tight grasping, tight pinching or twisting of the wrist to operate. Hardware shall be 34 inches minimum and 48 inches maximum above the finish floor or ground.	Restroom door - sink pull side, 25" wide, knob	For all doors along the public circulation route, provide required maneuvering clearance on push and pull side of doors For all doors along the public circulation route, replace doors with doors having 80" overhead clearance and 32" clear width For all doors along the public circulation route, replace hardware with lever hardware or hardware operable without a tight pinch or grasp	2010 ADAS Section: 404.2.3, 404.2.7, 404.2.4, 404.2.11, 404.2.11 Exception

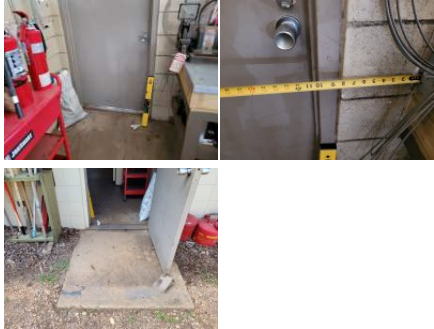
Finding Number	Area Description	Lat/Long	Finding	As Built	Recommendation	Citation	Photos	Figure
518	Birch Creek Employee Other: (BC) Employee Other-Maintenance	[30.3076361 , -96.6355225]	Minimum maneuvering clearances at doors and gates shall comply with 404.2.4. Maneuvering clearances shall extend the full width of the doorway and the required latch side or hinge side clearance. Exterior doors are recommended to be maintained at 8.5 lbf as a smart practice. Force is to be measured at the operating hardware or 30 inches from the hinges, whichever is greater. Hand-activated door opening hardware, handles, pulls, latches, locks, and other operating devices on accessible doors shall have a shape that is easy to grasp with one hand and does not require tight grasping, tight pinching or twisting of the wrist to operate. Hardware shall be 34 inches minimum and 48 inches maximum above the finish floor or ground.	Back door - workbench push side, narrow pad pull side, 12#, knob	For all doors along the public circulation route, provide required maneuvering clearance on push and pull side of doors For all doors along the public circulation route, inspect, adjust, and maintain 8.5 lbf to open exterior doors as a smart practice For all doors along the public circulation route, replace hardware with lever hardware or hardware operable without a tight pinch or grasp	2010 ADAS Section: 404.2.3, 404.2.7, 404.2.4, 404.2.11, 404.2.11 Exception

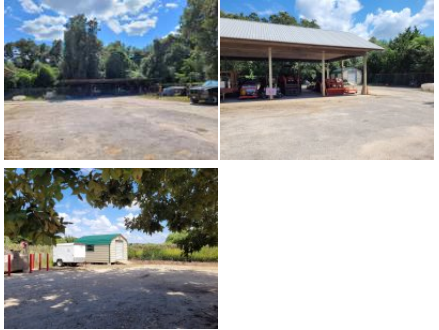
Finding Number	Area Description	Lat/Long	Finding	As Built	Recommendation	Citation	Photos	Figure
519	Birch Creek Employee Other: (BC) Employee Other-Maintenance	[30.3075946, -96.6357736], [30.3074754, -96.6354665]	The building entrance is not located on an accessible route. When a building, or portion of a building, is required to be accessible, an accessible route of travel shall be provided to all portions of the building, to accessible building entrances and between the building and the public way. All walks, halls, corridors, aisles, skywalks, tunnels, and other spaces that are part of an accessible route must comply. An accessible route of travel must not pass through kitchens, storage rooms, restrooms, closets or other spaces used for similar purposes. At least one accessible route within the boundary of the site must be provided from public transportation stops, accessible parking and accessible passenger loading zones and public streets or sidewalks to the accessible building entrance they serve. The accessible route shall, to the maximum extent feasible, coincide with the route for the general public. At least one accessible route shall connect accessible buildings, facilities, elements and spaces that are on the same site. At least one accessible route shall connect accessible building or facility entrances with all accessible spaces and elements.	Multiple buildings and elements in maintenance area lack a compliant accessible route	Create AR with crushed and compacted stone or similar outdoor material from parking or sidewalk to building entrance	2015 ABAAS Section: F206.2.1  2012 TAS Section: 206.2.1  2010 ADAS Section: 206.2.1

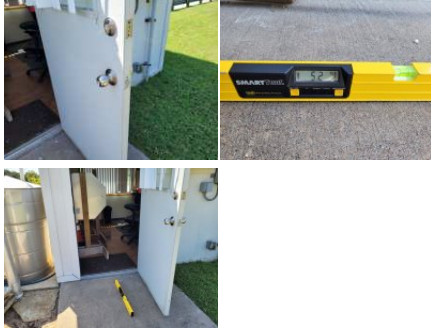
522	Birch Creek Employee Other: (BC) Entry Booth	[30.3101924 , -96.635705 5]	Minimum maneuvering clearances at doors and gates shall comply with 404.2.4. Maneuvering clearances shall extend the full width of the doorway and the required latch side or hinge side clearance. Maneuvering clearances shall have a max slope of 2.08%. Hand-activated door opening hardware, handles, pulls, latches, locks, and other operating devices on accessible doors shall have a shape that is easy to grasp with one hand and does not require tight grasping, tight pinching or twisting of the wrist to operate. Hardware shall be 34 inches minimum and 48 inches maximum above the finish floor or ground.	Entry booth door - 5.1% slope, knob	For all doors along the public circulation route, provide required maneuvering clearance on push and pull side of doors. For all doors along the public circulation route, correct slope in door clearance to max 2.08%. For all doors along the public circulation route, replace hardware with lever hardware or hardware operable without a tight pinch or grasp	2010 ADAS Section: 404.2.3, 404.2.7, 404.2.4, 404.2.11, 404.2.11 Exception

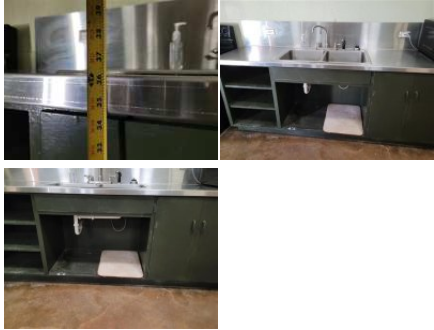
Finding Number	Area Description	Lat/Long	Finding	As Built	Recommendation	Citation	Photos	Figure
528	Birch Creek - Group Camping Area: (BC) Group Camp - Dining Hall	[30.3092866 , -96.628311 1]	The sink is not accessible. A clear floor space at least 30 inches by 48 shall be provided in front of a sink to allow forward approach. -The clear floor space shall be on an accessible route and shall extend a maximum of 19 inches underneath the sink. -Sinks shall be mounted with the counter or rim no higher than 34 inches above the finish floor. -Knee clearance at least 27 inches high, 30 inches wide and 19 inches deep shall be provided. -Hot water and drain pipes exposed under sinks shall be insulated or otherwise configured so as to protect against contact. There shall be no sharp or abrasive surfaces under sinks.	sink 36", lacks insulation on pipes, lacks knee clearance	Lower sinks to max 34" aff to front of rim Insulate exposed pipes under one sink Remove cabinetry to provide knee and toe clearance	<p>2015 ABAAS Section: 606.2, 606.2 EXCEPTION S: 1, 606.2 EXCEPTIONS: 4, 606.2 EXCEPTIONS: 5, 606.2 EXCEPTIONS: 6, 606.2 EXCEPTIONS: 7, 606.3, 606.4, 606.5</p> <p>2012 TAS Section: 606.2, 606.2 Exception 1, 606.2 Exception 4, 606.2 Exception 5, 606.2 Exception 6, 606.2 Exception 7, 606.3, 606.4, 606.5</p> <p>2010 ADAS Section: 606.2, 606.2 Exception 1, 606.2 Exception 4, 606.2 Exception 5, 606.2 Exception 6, 606.2 Exception 7, 606.3, 606.4, 606.5</p>

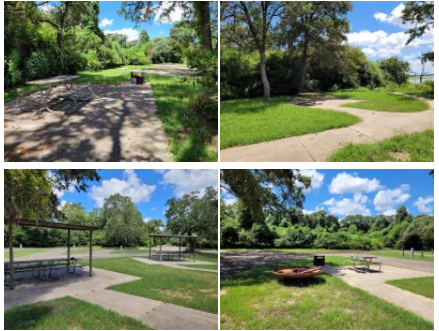
533	Birch Creek - Group Camping Area: (BC) Group Camp - Campsites	[30.3092426 , -96.628197 1]	Picnic tables shall provide at least one wheelchair space for each 24 linear feet (7320 mm) of usable table surface perimeter. Wheelchair spaces shall be 30 inches (760 mm) minimum by 48 inches (1220 mm) minimum. Wheelchair spaces shall be positioned for a forward approach to the table and provide knee and toe clearance complying with 306 under the table	0 of 2 tables at each of the 4 shelters, lacks accessible table at the open campsites	Replace picnic table with one of an accessible design as a smart practice	2015 ABAAS Section: 1011.4.2

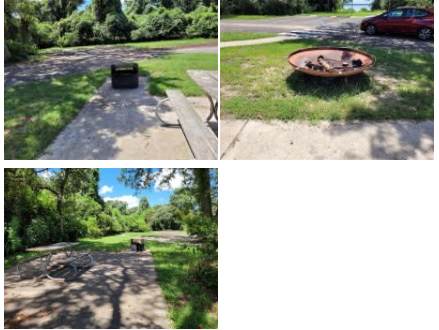
Finding Number	Area Description	Lat/Long	Finding	As Built	Recommendation	Citation	Photos	Figure
534	Birch Creek - Group Camping Area: (BC) Group Camp - Campsites	[30.3089925 , -96.628244]	Clear ground space 48 inches (1220 mm) by 48 inches (1220 mm) should be provided on all usable sides of the fire ring, grill, fireplace, and woodstove. Center the space on each usable side of the grill, fireplace, and woodstove.	fire pits lack 48" clear space around all sides	Provide required 48" clear ground space centered along usable side of fire ring, grill, fireplace, or woodstove as a smart practice.	2015 ABAAS Section: 1011.2

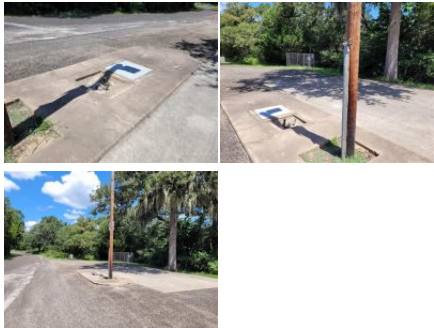
539	Birch Creek - Group Camping Area: (BC) Group Camp - Campsites	[30.3101422 , -96.628455 9]	Operable parts shall comply with 309.3 and 309.4. EXCEPTIONS: 1. Fire rings, grills, fireplaces, wood stoves, water hydrants, and water utility hookups shall comply with 309.4 to the extent practicable. 2. Trash and recycling receptacles with hinged lids and controls to keep out large animals shall comply with 309.4 to the extent practicable. 3. Dumpster type trash and recycling receptacles shall not be required to comply with 309.3 and 309.4. 4. Sewage hatches shall not be required to comply with 309.3 and 309.4.	RV dump station water spout high	Remount water spout to be between 28" and 36" as a smart practice.	2015 ABAAS Section: 1011.3, 1011.3 EXCEPTIONS: 1, 1011.3 EXCEPTIONS: 2, 1011.3 EXCEPTIONS: 3, 1011.3 EXCEPTIONS: 4

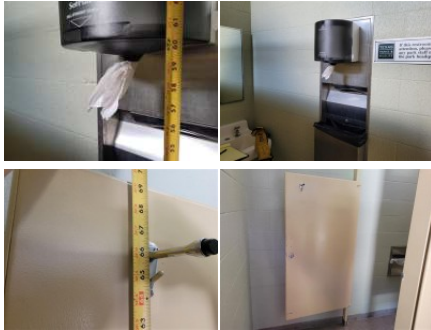
Finding Number	Area Description	Lat/Long	Finding	As Built	Recommendation	Citation	Photos	Figure
550	Birch Creek - Group Camping Area: (BC) Group Camp - Women's Restroom	[30.3092519 , -96.6283218]	Where a high forward reach is over an obstruction, the clear floor space shall extend beneath the element for a distance not less than the required reach depth over the obstruction. The high forward reach shall be 48 inches (1220 mm) maximum where the reach depth is 20 inches (510 mm) maximum. Where the reach depth exceeds 20 inches (510 mm), the high forward reach shall be 44 inches (1120 mm) maximum and the reach depth shall be 25 inches (635 mm) maximum. Where a clear floor or ground space allows a parallel approach to an element and the high side reach is over an obstruction, the height of the obstruction shall be 34 inches (865 mm) maximum and the depth of the obstruction shall be 24 inches (610 mm) maximum. The high side reach shall be 48 inches (1220 mm) maximum for a reach depth of 10 inches (255 mm) maximum. Where the reach depth exceeds 10 inches (255 mm), the high side reach shall be 46 inches (1170 mm) maximum for a reach depth of 24 inches (610 mm) maximum.	paper towels and hook high	Lower operating mechanisms to max 48" above the finished floor (AFF) to highest operable part.	2015 ABAAS Section: 308.2.1, 308.3.2  2012 TAS Section: 308.2.1, 308.3.2  2010 ADAS Section: 308.2.1, 308.3.2
