Access Audit Site Report

Lake Whitney State Park

Accessibility Evaluation

Inspection Date: 01/20/2022

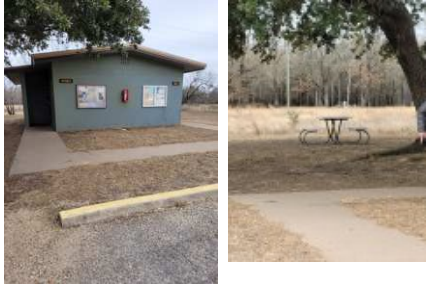
Finding Number	Area Description	Lat/Long	Finding	As Built	Recommendation	Citation	Photos	Figure
1	Exterior: Exterior Accessible Route	[31.9284559 , -97.3652129]	There is no accessible route to the restroom or picnic table. At least one accessible route shall connect accessible buildings, accessible facilities, accessible elements, and accessible spaces that are on the same site.	Horseshoe Camp Loop - lacks accessible route to restroom building or picnic table	Create an accessible route with crushed stone or other outdoor material from parking or walkway to restroom or picnic table.	2015 ABAAS Section: F206.2.2 2012 TAS Section: 206.2.2 2010 ADAS Section: 206.2.2

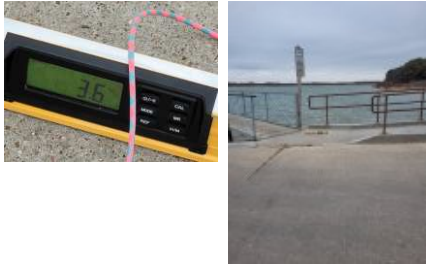
2	Exterior: Exterior Accessible Route	[31.9243173 , -97.3700999]	Element meets all standards and requirements	double sided ramps at dining hall comply	None	2010 ADAS Section: N/A		
3	Exterior: Exterior Accessible Route	[31.9235501 , -97.3731335]	The landing at the bottom of the ramp has a slope greater than 2%. Bottom landings shall have a dimension in the direction of ramp run of not less than 60 inches and have a slope of less than 2% in any direction.	Boat ramp - 3.6% slope at bottom landing	Correct ramp landing slope to max 2.08%	2015 ABAAS Section: 405.7.1, 405.7.1 EXCEPTION 2012 TAS Section: 405.7.1, 405.7.1 Exception 2010 ADAS Section: 405.7.1, 405.7.1 Exception

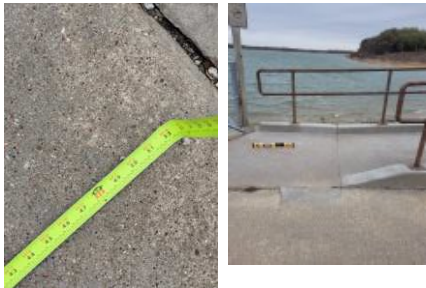
4	Exterior: Exterior Accessible Route	[31.923475, -97.3730665]	The landing is not the correct length. Landings shall have a dimension in the direction of ramp run of not less than 60 inches.	Boat ramp - 48" at bottom of pedestrian ramp	Enlarge landing to be 60" deep and as wide as the ramp	2015 ABAAS Section: 405.7.3 2012 TAS Section: 405.7.3 2010 ADAS Section: 405.7.3

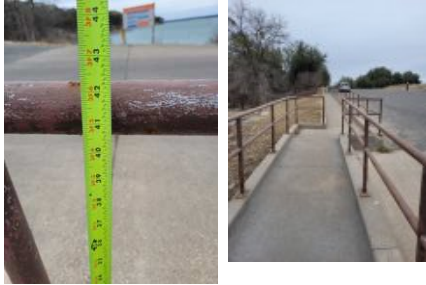
Finding Number	Area Description	Lat/Long	Finding	As Built	Recommendation	Citation	Photos	Figure
5	Exterior: Exterior Accessible Route	[31.9235296 , -97.373082 5]	The handrail is mounted incorrectly. Handrails are measured at the top and must be between 34 inches and 38 inches above the ramp surface. Handrails must extend horizontally beyond the top and bottom of the ramp 12 inches minimum.	Boat ramp - both handrails on pedestrian ramp installed 42.25" above ground	Remount handrails to 34" to 38" aff	2015 ABAAS Section: 505.4 2012 TAS Section: 505.4 2010 ADAS Section: 505.4

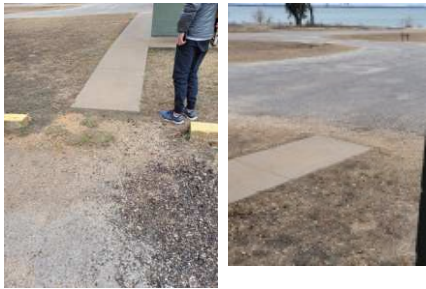
6	Exterior: Exterior Accessible Route	[31.9201785 , -97.372760 7]	The building entrance is not located on an accessible route. When a building, or portion of a building, is required to be accessible, an accessible route of travel shall be provided to all portions of the building, to accessible building entrances and between the building and the public way. All walks, halls, corridors, aisles, skywalks, tunnels, and other spaces that are part of an accessible route must comply. An accessible route of travel must not pass through kitchens, storage rooms, restrooms, closets or other spaces used for similar purposes. At least one accessible route within the boundary of the site must be provided from public transportation stops, accessible parking and accessible passenger loading zones and public streets or sidewalks to the accessible building entrance they serve. The accessible route shall, to the maximum extent feasible, coincide with the route for the general public. At least one accessible route shall connect accessible buildings, facilities, elements and spaces that are on the same site. At least one accessible route shall connect accessible building or facility entrances with all accessible spaces and elements.	no accessible route to restroom building from circle drop off and parking side	Create AR with crushed and compacted stone or similar outdoor material from parking or sidewalk to building entrance	2015 ABAAS Section: F206.2.1 2012 TAS Section: 206.2.1 2010 ADAS Section: 206.2.1

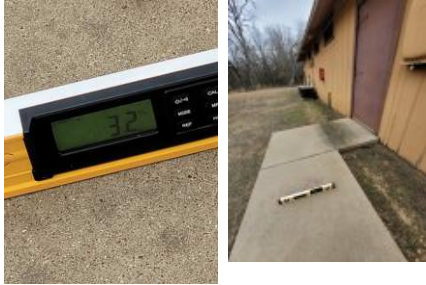
Finding Number	Area Description	Lat/Long	Finding	As Built	Recommendation	Citation	Photos	Figure
7	Exterior: Exterior Accessible Route	[31.9244812 , -97.370199 2]	The accessible route of travel on the accessible route contains cross slopes greater than 2%. Cross slopes shall not exceed one unit vertical in 48 units horizontal (2-percent slope).	Rear path at dining hall - 3.2% at back beginning of path	Correct or repair cross slope along AR to max 2.08%	2015 ABAAS Section: 403.3 2012 TAS Section: 403.3 2010 ADAS Section: 403.3

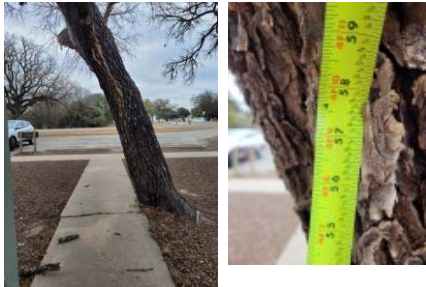
10	Exterior: Exterior Accessible Route	[31.9201239 , -97.368833 9]	The tree extends down too close to the route of travel. Any obstruction that overhangs a route of travel must be a minimum of 80 inches above the walking surface as measured from the bottom of the obstruction.	White Tail restroom building - accessible route to women's restroom obstructed overhead by tree	Maintain overhead clearance of min. 80"; in the alternative, ensure an alternate accessible route can be provided to women's restroom and provide signage directing patrons to accessible route	2015 ABAAS Section: 307.3 2012 TAS Section: 307.3 2010 ADAS Section: 307.3

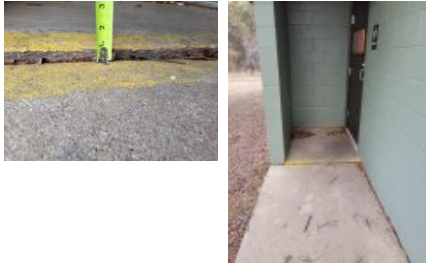
Finding Number	Area Description	Lat/Long	Finding	As Built	Recommendation	Citation	Photos	Figure
11	Exterior: Exterior Accessible Route	[31.9201762 , -97.368879 5]	The walkway contains abrupt vertical edges and/or variations over a 1/4 inch. 1/4 inch is the maximum vertical rise. Changes in level between 1/4 inch and 1/2 inch must be beveled at 1:2 or less. Changes in level greater than 1/2 inch must be by way of a ramp.	White Tail women's restroom - 1" change in elevation at entry	Repair, bevel or ramp CIL along AR	2012 TAS Section: 303.2, 303.3 2010 ADAS Section: 303.2, 303.3

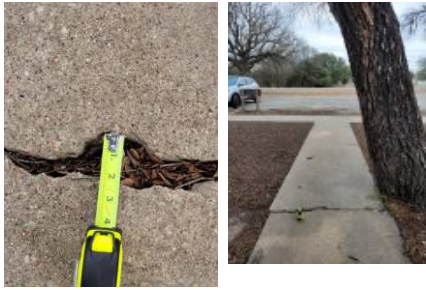
12	Exterior: Exterior Accessible Route	[31.9201717 , -97.368898 3]	There is a gap spaced greater than a 1/2 inch. Openings in floor or ground surfaces shall not allow passage of a sphere more than 1/2 inch diameter. Elongated openings shall be placed so that the long dimension is perpendicular to the dominant direction of travel.	White Tail women's restroom - 2" on path entry	Correct or fill gaps to be max .5"	2015 ABAAS Section: 302.3 2012 TAS Section: 302.3 2010 ADAS Section: 302.3

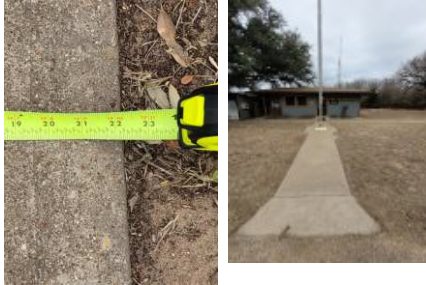
13	Exterior: Exterior Accessible Route	[31.9312445 , -97.356887 4]	The route of travel at this location does not provide the required minimum width. The minimum clear width for sidewalks and walks is 36 inches.	Headquarters - center path width 22.25" at flag pole	Widen EAR to min 36" clear width	2015 ABAAS Section: 403.5.1 2012 TAS Section: 403.5.1 2010 ADAS Section: 403.5.1

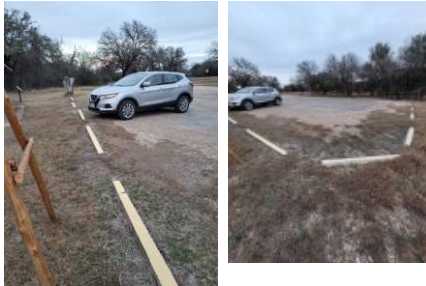
27	Exterior: Parking	[31.9191643, -97.370349 4]	There are no accessible parking stalls. Each lot where parking is provided for the public as clients, guests or employees, shall provide accessible parking and shall be located on the shortest accessible route of travel from adjacent parking to an accessible entrance. There are a total of (10-12) parking stalls in the parking lot that could be reasonably associated with this facility. There should be a minimum of (1) accessible stalls with a minimum of (1) being designed as van accessible.	White Tail fish cleaning parking - 10-12 unmarked parking stalls, no accessible parking	Create one or more 8' accessible parking stalls, with one 5' adjacent access aisle, with proper signage and striping based on the total number of stalls	2015 ABAAS Section: F208.2 2012 TAS Section: 208.2 2010 ADAS Section: 208.2

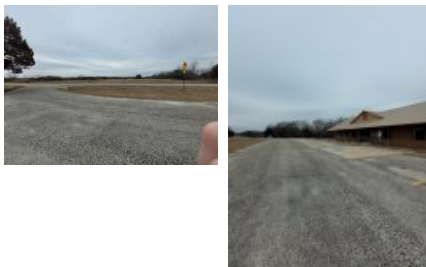
Finding Number	Area Description	Lat/Long	Finding	As Built	Recommendation	Citation	Photos	Figure
29	Exterior: Parking	[31.9243959 , -97.3700074]	There are no accessible parking stalls. Each lot where parking is provided for the public as clients, guests or employees, shall provide accessible parking and shall be located on the shortest accessible route of travel from adjacent parking to an accessible entrance. There are a total of (58) parking stalls in the parking lot that could be reasonably associated with this facility. There should be a minimum of (3) accessible stalls with a minimum of (1) being designed as van accessible.	Group recreation hall - estimated 58 standard parking stalls, 1 accessible stall	Create two or more 8' accessible parking stalls, with one 5' adjacent access aisle, with proper signage and striping based on the total number of stalls	2015 ABAAS Section: F208.2 2012 TAS Section: 208.2 2010 ADAS Section: 208.2

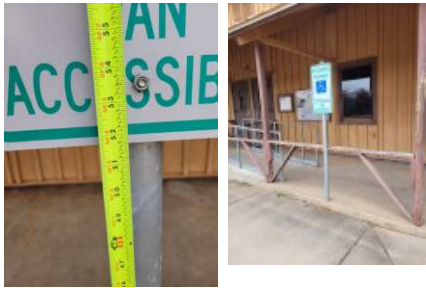
31	Exterior: Parking	[31.9243731 , -97.369998]	The parking sign is mounted too low. Parking space identification signs shall include the International Symbol of Accessibility complying with. Signs identifying van parking spaces shall contain the designation "van accessible." Signs shall be 60 inches minimum above the finish floor or ground surface measured to the bottom of the sign.	Group recreation hall - 51.75" above ground surface	Raise existing accessible parking signs so lowest end of bottom sign is min 60" aff	2015 ABAAS Section: 502.6 2012 TAS Section: 502.6 2010 ADAS Section: 502.6

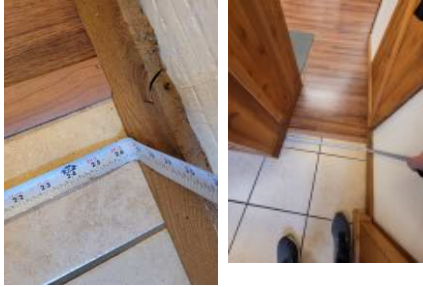
42	Headquarters Building: HQ - Employee Spaces	[31.9313232 , -97.356918 7]	The route of travel at this location does not provide a minimum width of 36 inches. The clear width shall be permitted to be reduced to 32 inches minimum for a length of 24 inches maximum provided that reduced width segments are separated by segments that are 48 inches long minimum and 36 inches wide minimum.	26.5" width	Widen AR to compliant 36" clear width For deficit, leave as is, employee work area pursuant to 2010 Standards 106.5 Defined Terms, until an employee with a disability works here	2015 ABAAS Section: 403.5.1 2012 TAS Section: 403.5.1 2010 ADAS Section: 403.5.1

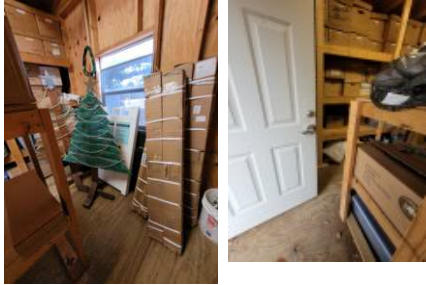
Finding Number	Area Description	Lat/Long	Finding	As Built	Recommendation	Citation	Photos	Figure
47	Headquarters Building: HQ - Employee Spaces	[31.9312878 , -97.356892 7]	Employee Work Areas. Common use circulation paths within employee work areas shall comply with 402. EXCEPTIONS: 1. Common use circulation paths located within employee work areas that are less than 1000 square feet (93 m2) and defined by permanently installed partitions, counters, casework, or furnishings shall not be required to comply with 402. 2. Common use circulation paths located within employee work areas that are an integral component of work area equipment shall not be required to comply with 402. 3. Common use circulation paths located within exterior employee work areas that are fully exposed to the weather shall not be required to comply with 402.	Storage in circulation path	Make corrections for compliant circulation path.	2015 ABAAS Section: F206.2.8, F206.2.8.1, F206.2.8.2 2012 TAS Section: 206.2.8, 206.2.8 Exception 1, 206.2.8 Exception 2, 206.2.8 Exception 3, 206.2.8 Advisory 1, 206.2.8 Advisory 2 2010 ADAS Section: 206.2.8, 206.2.8 Exception 1, 206.2.8 Exception 2, 206.2.8 Exception 3

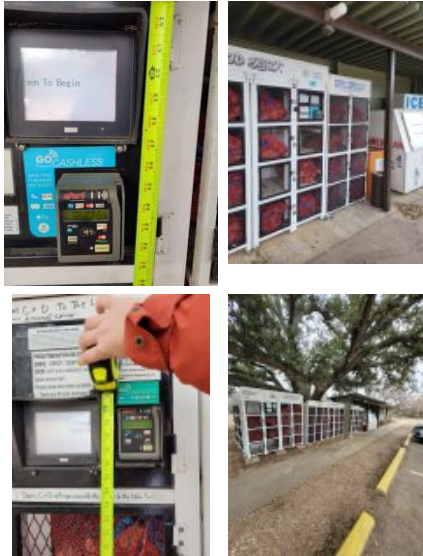
52	Headquarters Building: HQ - Public Spaces	[31.931183, -97.3570537]	The operable part is positioned too high for either a side or front approach. Where a clear floor or ground space allows a parallel approach to an element and the side reach is unobstructed, the high side reach shall be 48 inches maximum and the low side reach shall be 15 inches minimum above the finish floor or ground. Where a forward reach is unobstructed, the high forward reach shall be 48 inches maximum and the low forward reach shall be 15 inches minimum above the finish floor or ground.	Lacks accessible wood bundle storage lockers; payment for firewood 59" above ground surface	Remount operable parts to be in reach range of 15" min to 48" max	2015 ABAAS Section: 308.1 2012 TAS Section: 308.1 2010 ADAS Section: 308.1

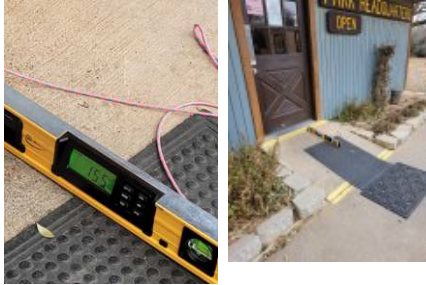
Finding Number	Area Description	Lat/Long	Finding	As Built	Recommendation	Citation	Photos	Figure
54	Headquarters Building: HQ - Public Spaces	[31.931265, -97.356919 6]	Minimum maneuvering clearances at doors and gates shall comply with 404.2.4. Maneuvering clearances shall extend the full width of the doorway and the required latch side or hinge side clearance. Maneuvering clearances shall have a max slope of 2.08%. Secure carpet at doorway entry/exit.	Center entry door - 15.5% on push side, carpet not secure on push side	For all doors along the public circulation route, correct slope in door clearance to max 2.08%. Secure carpet at doorway entry/exit.	2010 ADAS Section: 404.2.3, 404.2.7, 404.2.4, 404.2.11, 404.2.11 Exception

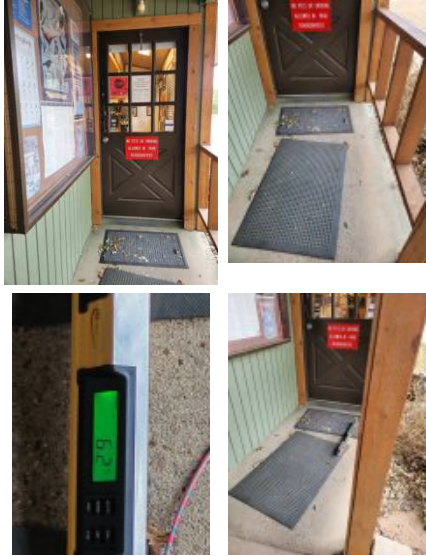
55	Headquarters Building: HQ - Public Spaces	[31.9312559, -97.356957 1]	Minimum maneuvering clearances at doors and gates shall comply with 404.2.4. Maneuvering clearances shall extend the full width of the doorway and the required latch side or hinge side clearance. Maneuvering clearances shall have a max slope of 2.08%. Secure carpet at door entry/exit.	Side door from lobby - maneuvering clearance lacks on push side due to wall, 2 of 2 carpet not secure, 6.2% in maneuvering clearance	For all doors along the public circulation route, provide required maneuvering clearance on push and pull side of doors. For all doors along the public circulation route, correct slope in door clearance to max 2.08%. Secure carpet at door entry/exit.	2010 ADAS Section: 404.2.3, 404.2.7, 404.2.4, 404.2.11, 404.2.11 Exception

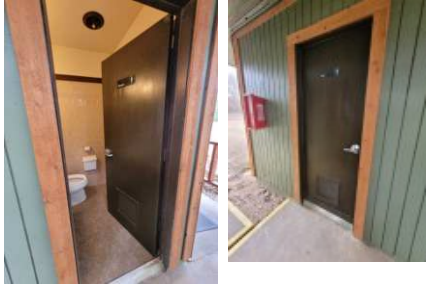
Finding Number	Area Description	Lat/Long	Finding	As Built	Recommendation	Citation	Photos	Figure
56	Headquarters Building: HQ - Restroom	[31.9312878 , -97.3569517]	This restroom is not accessible. Where existing toilet rooms or bathing rooms do not comply, directional signs indicating the location of the nearest accessible toilet room or bathing room within the facility shall be provided. Signs shall include the International Symbol of Accessibility. Where existing toilet rooms or bathing rooms do comply), the accessible toilet rooms or bathing rooms shall be identified by the International Symbol of Where clustered single user toilet rooms or bathing facilities are permitted, accessible toilet rooms or bathing facilities shall be identified by the International Symbol of Accessibility unless all toilet rooms and bathing facilities are accessible.	Lacks directional signage	Restroom not accessible, acquire and mount signage directing patrons to accessible restroom	2015 ABAAS Section: F216.8 2012 TAS Section: 216.8 2010 ADAS Section: 216.8

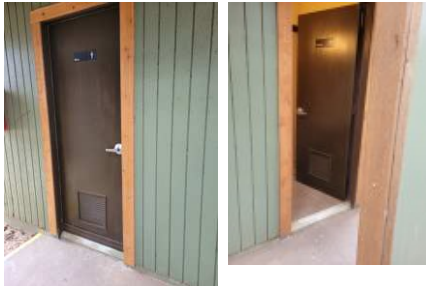
57	Headquarters Building: HQ - Restroom	[31.93213, -97.35435]	The restroom sign does not comply with one or more applicable requirements for the location, height, and properties of the sign.	Sign is mounted to high on door, lacks Braille and raised characters	Acquire and mount signage, including Braille and raised lettering, mounted on wall, latch side of door, 48" to baseline of lowest character and 60" to baseline of highest character	2015 ABAAS Section: F216.2, 703.1, 703.2, 703.5, 703.6 2012 TAS Section: 216.2, 703.1, 703.2, 703.5, 703.6 2010 ADAS Section: 216.2, 703.1, 703.2, 703.5, 703.6

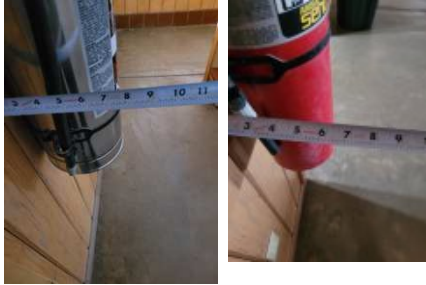
Finding Number	Area Description	Lat/Long	Finding	As Built	Recommendation	Citation	Photos	Figure
60	Dining Hall: Dining Hall	[31.9244141 , -97.370157 6]	An item or items project more than 4 inches into the circulation path. Wall-mounted objects that have leading edges between 27 inches and 80 inches from the floor must not project more than 4 inches into the circulation path. Protruding objects that extend to the floor or within 27 inches of the floor are cane detectable and are therefore not hazardous. Where it is necessary or desirable to have objects protrude from the wall, a manner of cane detection must be provided.	1st - fire extinguisher 7.5", 2nd - fire extinguisher 6.5" project into circulation path	Relocate protruding objects or place cane detectable warning or bollard at foot of item	2015 ABAAS Section: 307.2 2012 TAS Section: 307.2 2010 ADAS Section: 307.2

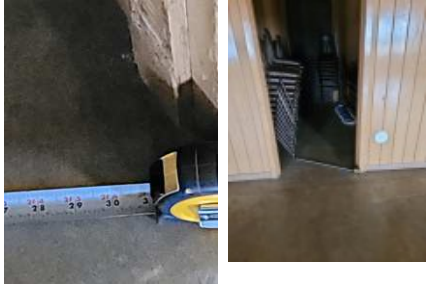
Finding Number	Area Description	Lat/Long	Finding	As Built	Recommendation	Citation	Photos	Figure
63	Dining Hall: Dining Hall	[31.9244364 , -97.370112 4]	The route of travel at this location does not provide a minimum width of 36 inches. The clear width shall be permitted to be reduced to 32 inches minimum for a length of 24 inches maximum provided that reduced width segments are separated by segments that are 48 inches long minimum and 36 inches wide minimum.	Storage space adjacent to main room - reduced to 30" due to storage	Widen AR to compliant 36" clear width For deficit, leave as is, employee work area pursuant to 2010 Standards 106.5 Defined Terms, until an employee with a disability works here	2015 ABAAS Section: 403.5.1 2012 TAS Section: 403.5.1 2010 ADAS Section: 403.5.1

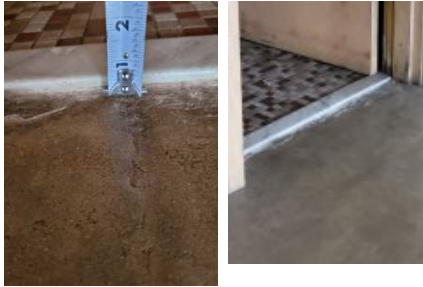
67	Dining Hall: Dining Hall	[31.9244175 , -97.370126 8]	Thresholds, if provided at doorways, shall be 1/2 inch (13 mm) high maximum. Raised thresholds and changes in level at doorways shall comply with 302 and 303. Changes in level of 1/4 inch (6.4 mm) high maximum shall be permitted to be vertical. Changes in level between 1/4 inch (6.4 mm) high minimum and 1/2 inch (13 mm) high maximum shall be beveled with a slope not steeper than 1:2. Changes in level greater than 1/2 inch (13 mm) high shall be ramped, and shall comply with 405 or 406.	.5" change in elevation at 2 of 2 restroom door entries	Repair, bevel or ramp CIL at doorway	2015 ABAAS Section: 303.3, 404.2.5, 303.2, 303.4 2012 TAS Section: 303.3, 404.2.5, 303.2, 303.4 2010 ADAS Section: 303.3, 404.2.5, 303.2, 303.4

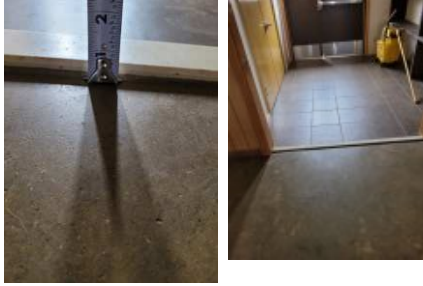
68	Dining Hall: Dining Hall	[31.9244175 , -97.370132 1]	There is a change in level greater than 1/4 inch. 1/4 inch is the maximum vertical rise. Changes in level between 1/4 inch and 1/2 inch must be beveled at 1:2 or less. Changes in level greater than 1/2 inch must be by way of a ramp.	.5" change in elevation approaching back door	Repair, bevel or ramp CIL along AR to max .25"	2015 ABAAS Section: 303.3 2012 TAS Section: 303.3 2010 ADAS Section: 303.3

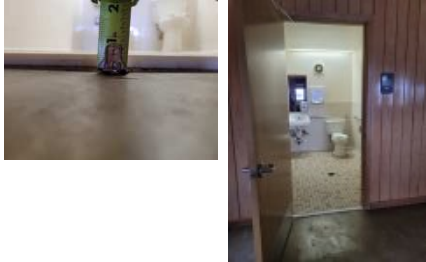
Finding Number	Area Description	Lat/Long	Finding	As Built	Recommendation	Citation	Photos	Figure
73	Dining Hall: Dining Hall - Mens Single Use Restroom	[31.9244994, -97.3700892]	Thresholds, if provided at doorways, shall be 1/2 inch (13 mm) high maximum. Raised thresholds and changes in level at doorways shall comply with 302 and 303. Changes in level of 1/4 inch (6.4 mm) high maximum shall be permitted to be vertical. Changes in level between 1/4 inch (6.4 mm) high minimum and 1/2 inch (13 mm) high maximum shall be beveled with a slope not steeper than 1:2. Changes in level greater than 1/2 inch (13 mm) high shall be ramped, and shall comply with 405 or 406.	.5" change in elevation at men's restroom	Repair, bevel or ramp CIL at doorway	2015 ABAAS Section: 303.3, 404.2.5, 303.2, 303.4 2012 TAS Section: 303.3, 404.2.5, 303.2, 303.4 2010 ADAS Section: 303.3, 404.2.5, 303.2, 303.4

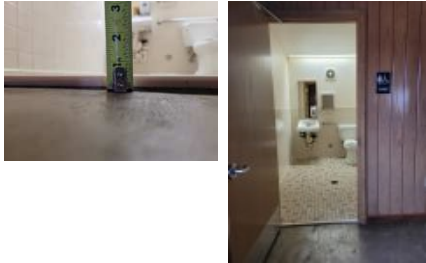
Finding Number	Area Description	Lat/Long	Finding	As Built	Recommendation	Citation	Photos	Figure
75	Dining Hall: Dining Hall - Women's Single Use Restroom	[31.9244903 , -97.370065 1]	Thresholds, if provided at doorways, shall be 1/2 inch (13 mm) high maximum. Raised thresholds and changes in level at doorways shall comply with 302 and 303. Changes in level of 1/4 inch (6.4 mm) high maximum shall be permitted to be vertical. Changes in level between 1/4 inch (6.4 mm) high minimum and 1/2 inch (13 mm) high maximum shall be beveled with a slope not steeper than 1:2. Changes in level greater than 1/2 inch (13 mm) high shall be ramped, and shall comply with 405 or 406.	.5" change in elevation at women's restroom	Repair, bevel or ramp CIL at doorway	2015 ABAAS Section: 303.3, 404.2.5, 303.2, 303.4 2012 TAS Section: 303.3, 404.2.5, 303.2, 303.4 2010 ADAS Section: 303.3, 404.2.5, 303.2, 303.4

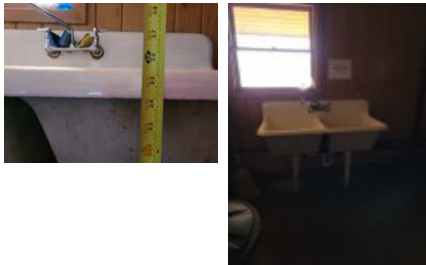
76	Dining Hall: Dining Hall - Kitchen	[31.9243947 , -97.370164 3]	The top rim of the sink is too high. All lavatories/sinks that are designated to be accessible shall be a minimum 17 inches in horizontal depth and mounted with the rim or counter edge no higher than 34 inches above the finished floor.	Sink installed 35.5" AFF	Lower sinks to max 34" AFF to front of rim.	2015 ABAAS Section: 606.3 2012 TAS Section: 606.3 2010 ADAS Section: 606.3

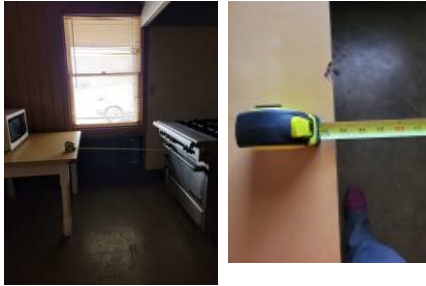
Finding Number	Area Description	Lat/Long	Finding	As Built	Recommendation	Citation	Photos	Figure
78	Dining Hall: Dining Hall - Kitchen	[31.924397, -97.370158 9]	The route of travel at this location does not provide a minimum width of 36 inches. The clear width shall be permitted to be reduced to 32 inches minimum for a length of 24 inches maximum provided that reduced width segments are separated by segments that are 48 inches long minimum and 36 inches wide minimum.	35.5" between table with microwave and oven	Widen AR to compliant 36" clear width	2015 ABAAS Section: 403.5.1 2012 TAS Section: 403.5.1 2010 ADAS Section: 403.5.1

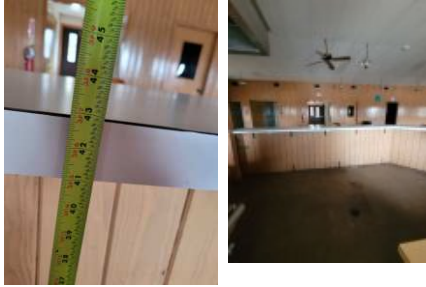
79	Dining Hall: Dining Hall - Kitchen	[31.9243856 , -97.370185 8]	The transaction counter is too high. A portion of the counter surface that is 36 inches long minimum and 36 inches high maximum above the finish floor shall be provided. Knee and toe space must be provided for a forward approach. A 30 inch by 48 inch clear floor space on an accessible route must be provided for either a forward or parallel approach.	Service counter installed 43" above finished floor	Lower 36" wide segment of service counter to max 36" aff	2015 ABAAS Section: 904.4.2, 904.4.1 2012 TAS Section: 904.4.1, 904.4.2 2010 ADAS Section: 904.4.2, 904.4.1

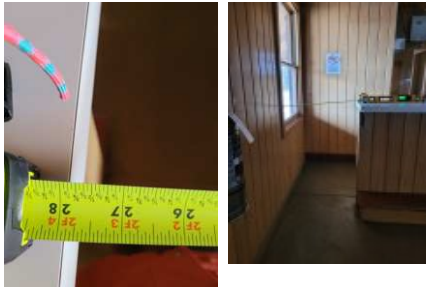
80	Dining Hall: Dining Hall - Kitchen	[31.9243993 , -97.370175]	The route of travel at this location does not provide a minimum width of 36 inches. The clear width shall be permitted to be reduced to 32 inches minimum for a length of 24 inches maximum provided that reduced width segments are separated by segments that are 48 inches long minimum and 36 inches wide minimum.	28" width to entry to kitchen by front door	Widen AR to compliant 36" clear width	2015 ABAAS Section: 403.5.1 2012 TAS Section: 403.5.1 2010 ADAS Section: 403.5.1

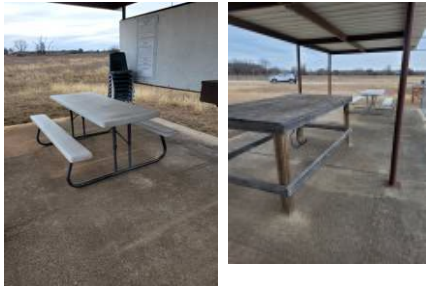
88	Park Site: Air Strip	[31.927081, -97.3610072]	Picnic tables shall provide at least one wheelchair space for each 24 linear feet (7320 mm) of usable table surface perimeter. Wheelchair spaces shall be 30 inches (760 mm) minimum by 48 inches (1220 mm) minimum. Wheelchair spaces shall be positioned for a forward approach to the table and provide knee and toe clearance complying with 306 under the table	Covered area - 0 of 3 picnic tables are of accessible design	Replace picnic table with one of an accessible design as a smart practice	2015 ABAAS Section: 1011.4.2

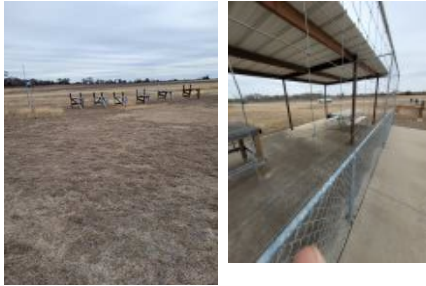
Finding Number	Area Description	Lat/Long	Finding	As Built	Recommendation	Citation	Photos	Figure
93	Park Site: Air Strip	[31.9272228 , -97.360965]	There is no accessible route to the model plane work stations, viewing and picnic area. At least one accessible route shall connect accessible buildings, accessible facilities, accessible elements, and accessible spaces that are on the same site.	Lacks accessible route to 6 of 6 model plane work stations, viewing and picnic area	Create an accessible route with crushed stone or other outdoor material from parking or walkway to model plane work stations, viewing and picnic area.	2015 ABAAS Section: F206.2.2 2012 TAS Section: 206.2.2 2010 ADAS Section: 206.2.2

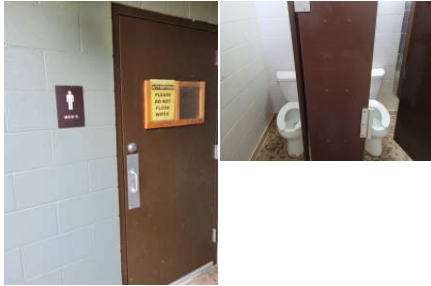
Finding Number	Area Description	Lat/Long	Finding	As Built	Recommendation	Citation	Photos	Figure
98	Horseshoe Camping Loop: Horseshoe - Men's Restroom	[31.9284981, -97.3652746]	The restroom is not compliant. The restroom does not have the required minimum clear floor space or maneuvering clearances for the toilet. The restroom does not have the required minimum clear floor space or maneuvering clearances for the lavatory. The entry door does not contain the required minimum maneuvering spaces on the pull/push sides. The entry door encroach into the required clear floor space for fixtures. Grab bars are missing and/or incorrectly installed. Accessories, such as toilet seat covers, paper towel holders, garbage cans, hand dryers, and mirrors are either too high or without clear floor space or both.	Men's restroom is not accessible	Create a compliant wheelchair accessible restroom and correct all features to be accessible if feasible.	2015 ABAAS Section: 603.1 2012 TAS Section: 603.1 2010 ADAS Section: 603.1

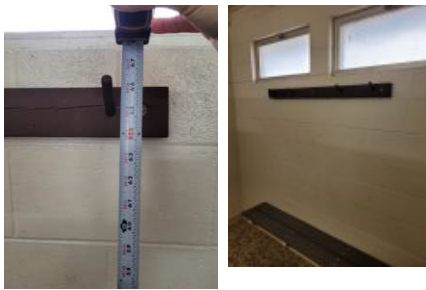
Finding Number	Area Description	Lat/Long	Finding	As Built	Recommendation	Citation	Photos	Figure
100	Horseshoe Camping Loop: Horseshoe - Men's Restroom	[31.9284981, -97.3652787]	Coat hooks provided within the room shall be located within one of the reach ranges specified in 308. Shelves shall be 40 inches (1015 mm) minimum and 48 inches (1220 mm) maximum above the finish floor or ground. Where coat hooks or shelves are provided in dressing, fitting or locker rooms without individual compartments, at least one of each type shall comply with 803.5. Where coat hooks or shelves are provided in individual compartments at least one of each type complying with 803.5 shall be provided in individual compartments in dressing, fitting, or locker rooms required to comply with 222.1.	Hooks installed 66.5" AFF	Remount at least one hook to max 48" AFF and shelves to 40" - 48" AFF.	2015 ABAAS Section: 308.2.1, 308.1, F222.2, 803.5 2012 TAS Section: 308.2.1, 308.1, 222.2, 803.5 2010 ADAS Section: 308.2.1, 308.1, 222.2, 803.5

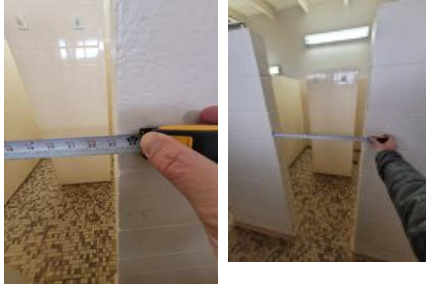
Finding Number	Area Description	Lat/Long	Finding	As Built	Recommendation	Citation	Photos	Figure
102	Horseshoe Camping Loop: Horseshoe - Men's Restroom	[31.9285128 , -97.3652706]	There are no accessible bathing or shower facilities. Where facilities for bathing are provided for the public, clients or employees, including showers or bathtubs, at least one shower or bathtub and support facilities such as lockers, and not less than 1 percent of all facilities, shall be accessible.	23" entry width to showers, showers are not accessible	Create an accessible shower in locker/bathing room	2015 ABAAS Section: F213.3.6 2012 TAS Section: 213.3.6 2010 ADAS Section: 213.3.6

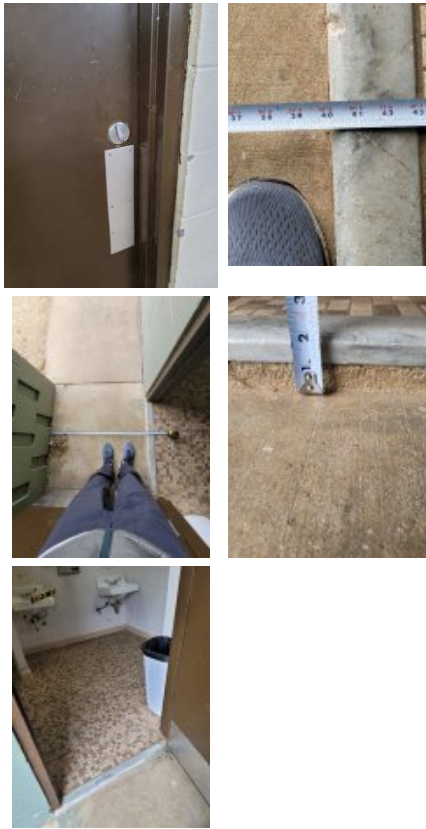
103	Horseshoe Camping Loop: Horseshoe - Men's Restroom	[31.9285089 , -97.3652799]	Minimum maneuvering clearances at doors and gates shall comply with 404.2.4. Maneuvering clearances shall extend the full width of the doorway and the required latch side or hinge side clearance. The threshold has a vertical change greater than 1/4 inch high. The threshold at a doorway shall be no higher than 1/2 inch. Changes in level between 1/4 inch and 1/2 inch must be beveled at 1:2 or less. 1/4 inch is the maximum vertical rise. The sweep period for doors with closers shall be adjusted so that from an open position of 70 degrees, the door will take at least 3 seconds to move to a point 3 inches from the latch, measured to the leading edge of the door. Hand-activated door opening hardware, handles, pulls, latches, locks, and other operating devices on accessible doors shall have a shape that is easy to grasp with one hand and does not require tight grasping, tight pinching or twisting of the wrist to operate. Hardware shall be 34 inches minimum and 48 inches maximum above the finish floor or ground.	Pinch hardware, maneuvering clearance reduced to 40", 1.75" change in elevation, fast closing	For all doors along the public circulation route, provide required maneuvering clearance on push and pull side of doors For all doors along the public circulation route, repair, bevel, or ramp CILs at door entries to max .25" For all doors along the public circulation route, inspect, adjust, and maintain closing speed on door closers For all doors along the public circulation route, replace hardware with lever hardware or hardware operable without a tight pinch or grasp	2010 ADAS Section: 404.2.3, 404.2.7, 404.2.4, 404.2.11, 404.2.11 Exception

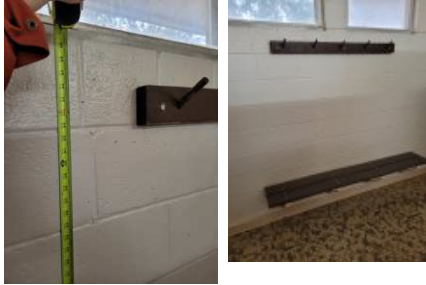
Finding Number	Area Description	Lat/Long	Finding	As Built	Recommendation	Citation	Photos	Figure
104	Horseshoe Camping Loop: Horseshoe - Women's Restroom	[31.9285265 , -97.365253 2]	Coat hooks provided within the room shall be located within one of the reach ranges specified in 308. Shelves shall be 40 inches (1015 mm) minimum and 48 inches (1220 mm) maximum above the finish floor or ground. Where coat hooks or shelves are provided in dressing, fitting or locker rooms without individual compartments, at least one of each type shall comply with 803.5. Where coat hooks or shelves are provided in individual compartments at least one of each type complying with 803.5 shall be provided in individual compartments in dressing, fitting, or locker rooms required to comply with 222.1.	Hooks installed 65" above finished floor	Remount at least one hook to max 48" aff and shelves to 40" - 48" AFF.	2015 ABAAS Section: 308.2.1, 308.1, F222.2, 803.5 2012 TAS Section: 308.2.1, 308.1, 222.2, 803.5 2010 ADAS Section: 308.2.1, 308.1, 222.2, 803.5

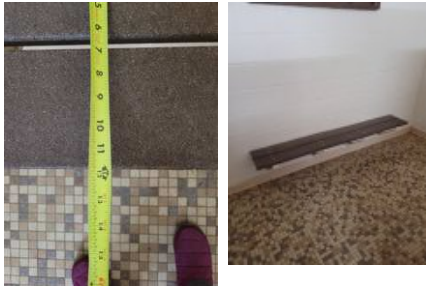
105	Horseshoe Camping Loop: Horseshoe - Women's Restroom	[31.9285197 , -97.365243 8]	The bench is not deep enough or long enough or is missing. Benches shall be provided having seats that are 42 inches long minimum and 20 inches deep minimum and 24 inches deep maximum. The bench shall provide for back support or shall be affixed to a wall. Back support shall be 42 inches (1065 mm) long minimum and shall extend from a point 2 inches (51 mm) maximum above the seat surface to a point 18 inches (455 mm) minimum above the seat surface. Back support shall be 2½ inches (64 mm) maximum from the rear edge of the seat measured horizontally. The top of the bench seat surface shall be 17 inches (430 mm) minimum and 19 inches (485 mm) maximum above the finish floor or ground.	Bench 12" seat depth	Replace bench in dressing area with one having a seat depth of 20" to 24" deep, 42" long, affixed to the wall or having a back and mounted 17" to 19" aff	2012 TAS Section: 903.4, 903.2, 903.3, 903.5 2010 ADAS Section: 903.4, 903.2, 903.3, 903.5

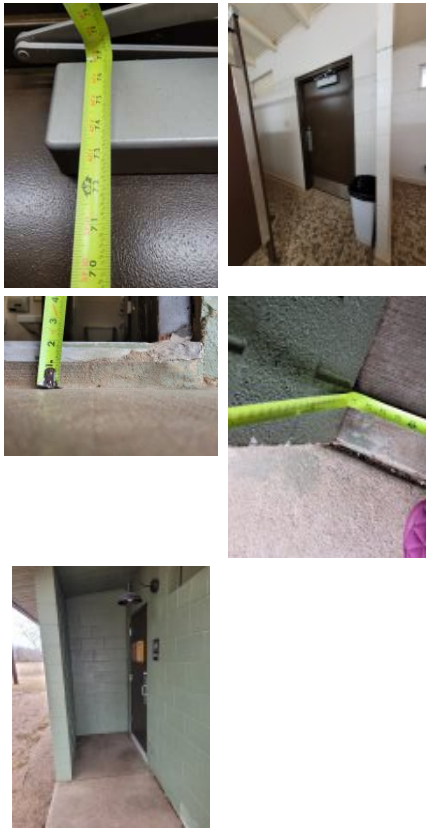
107	Horseshoe Camping Loop: Horseshoe - Women's Restroom	[31.9285231, -97.3652518]	Minimum maneuvering clearances at doors and gates shall comply with 404.2.4. Maneuvering clearances shall extend the full width of the doorway and the required latch side or hinge side clearance. Door openings shall provide a clear width of 32 inches (815 mm) minimum. Clear openings of doorways with swinging doors shall be measured between the face of the door and the stop, with the door open 90 degrees. Openings more than 24 inches (610 mm) deep shall provide a clear opening of 36 inches (915 mm) minimum. There shall be no projections into the required clear opening width lower than 34 inches (865 mm) above the finish floor or ground. Projections into the clear opening width between 34 inches (865 mm) and 80 inches (2030 mm) above the finish floor or ground shall not exceed 4 inches (100 mm). The threshold has a vertical change greater than 1/4 inch high.	77.5" overhead at closer, 2" change in level, maneuvering clearance reduced to 40", 22 lbf	For all doors along the public circulation route, provide required maneuvering clearance on push and pull side of doors For all doors along the public circulation route, replace doors with doors having 80" overhead clearance and 32" clear width For all doors along the public circulation route, repair, bevel, or ramp CILs at door entries to max .25"	2010 ADAS Section: 404.2.3, 404.2.7, 404.2.4, 404.2.11, 404.2.11 Exception

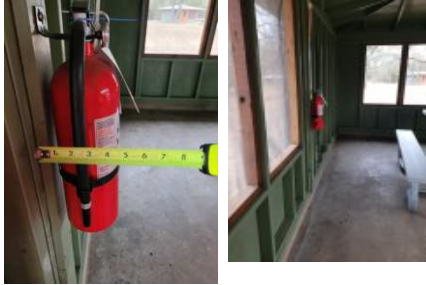
Finding Number	Area Description	Lat/Long	Finding	As Built	Recommendation	Citation	Photos	Figure
111	Towash Shelter Loop: Towash - Screened Shelters	[31.9201307 , -97.373407 1]	Objects project more than 4 inches into the circulation path. Wall-mounted objects that have leading edges between 27 inches and 80 inches from the floor must not project more than 4 inches into the circulation path. Protruding objects that extend to the floor or within 27 inches of the floor are cane detectable and are therefore not hazardous. Where it is necessary or desirable to have objects protrude from the wall, a manner of cane detection must be provided.	Shelter 1 - fire extinguisher 5" into circulation path	Relocate object to not protrude into the circulation path	2015 ABAAS Section: 307.2 2012 TAS Section: 307.2 2010 ADAS Section: 307.2

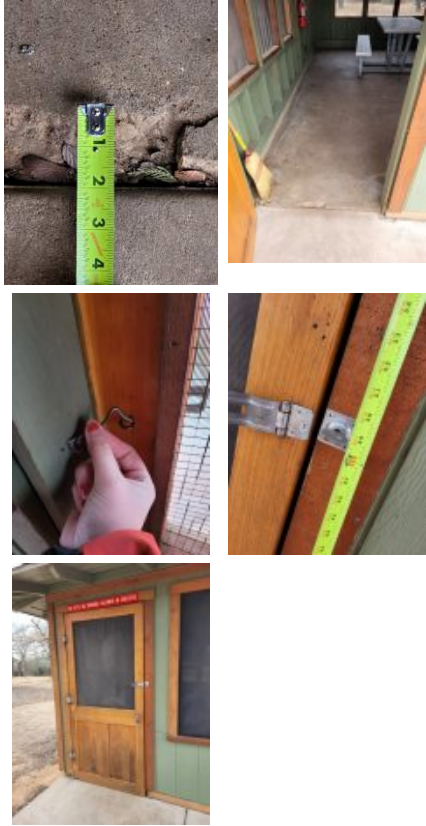
112	Towash Shelter Loop: Towash - Screened Shelters	[31.9201649 , -97.373377 6]	The threshold has a vertical change greater than 1/4 inch high. The threshold at a doorway shall be no higher than 1/2 inch. Changes in level between 1/4 inch and 1/2 inch must be beveled at 1:2 or less. 1/4 inch is the maximum vertical rise. Hand-activated door opening hardware, handles, pulls, latches, locks, and other operating devices on accessible doors shall have a shape that is easy to grasp with one hand and does not require tight grasping, tight pinching or twisting of the wrist to operate. Hardware shall be 34 inches minimum and 48 inches maximum above the finish floor or ground.	Shelter 1 - 2" change in elevation, hardware requires pinch and latch 49" above ground surface on exterior pull side	For all doors along the public circulation route, repair, bevel, or ramp CILs at door entries to max .25" For all doors along the public circulation route, replace hardware with lever hardware or hardware operable without a tight pinch or grasp and mount between 34" and 48" aff	2010 ADAS Section: 404.2.3, 404.2.7, 404.2.4, 404.2.11, 404.2.11 Exception

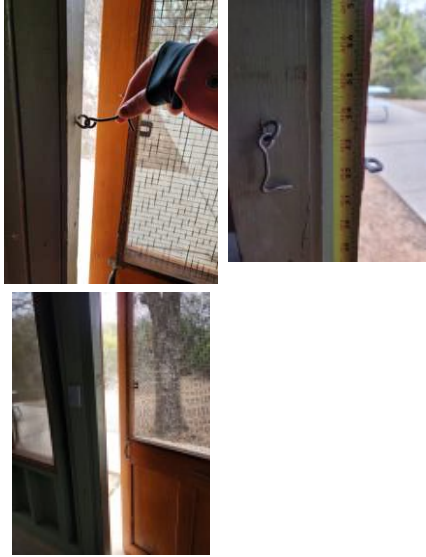
Finding Number	Area Description	Lat/Long	Finding	As Built	Recommendation	Citation	Photos	Figure
116	Towash Shelter Loop: Towash - Screened Shelters	[31.9204688 , -97.373852 3]	Hand-activated door opening hardware, handles, pulls, latches, locks, and other operating devices on accessible doors shall have a shape that is easy to grasp with one hand and does not require tight grasping, tight pinching or twisting of the wrist to operate. Hardware shall be 34 inches minimum and 48 inches maximum above the finish floor or ground.	Shelter 2 - hardware requires pinch, installed 53" above finished floor	For all doors along the public circulation route, replace hardware with lever hardware or hardware operable without a tight pinch or grasp and mount between 34" and 48" aff	2010 ADAS Section: 404.2.3, 404.2.7, 404.2.4, 404.2.11, 404.2.11 Exception

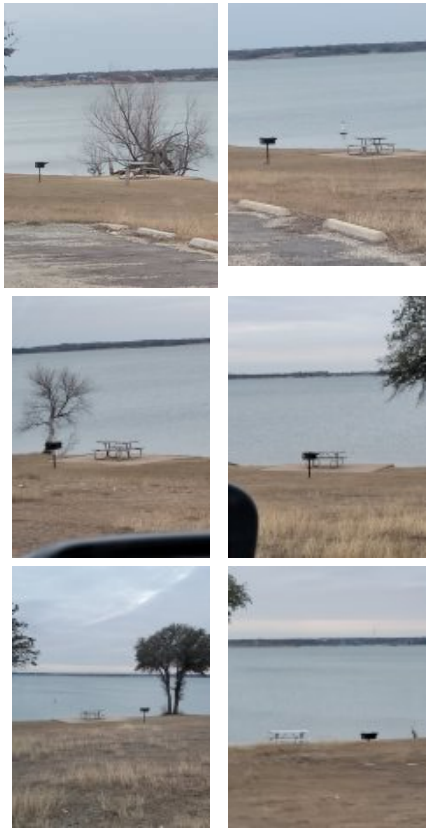
123	Towash Shelter Loop: Towash - Day Use Picnic Area	[31.9184642 , -97.372868]	There is no accessible route to the picnic tables, grills or beach. At least one accessible route shall connect accessible buildings, accessible facilities, accessible elements, and accessible spaces that are on the same site.	Towash day use area - 0 of 17 picnic tables of accessible design or on accessible route, 0 out of 16 grills on accessible route, no accessible route to beach access	Replace at least two picnic tables with ones of an accessible design and create an accessible route with crushed stone or other outdoor material from parking or walkway to the picnic tables, grills or beach.	2015 ABAAS Section: F206.2.2 2012 TAS Section: 206.2.2 2010 ADAS Section: 206.2.2

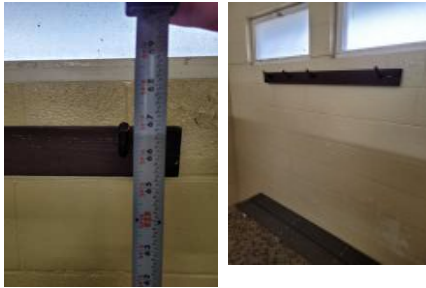
126	Towash Shelter Loop: Towash - Men's Restroom	[31.9201284 , -97.372760 7]	Coat hooks provided within the room shall be located within one of the reach ranges specified in 308. Shelves shall be 40 inches (1015 mm) minimum and 48 inches (1220 mm) maximum above the finish floor or ground. Where coat hooks or shelves are provided in dressing, fitting or locker rooms without individual compartments, at least one of each type shall comply with 803.5. Where coat hooks or shelves are provided in individual compartments at least one of each type complying with 803.5 shall be provided in individual compartments in dressing, fitting, or locker rooms required to comply with 222.1.	Hooks installed 67" above finished floor	Remount at least one hook to max 48" aff and shelves to 40" - 48" AFF.	2015 ABAAS Section: 308.2.1, 308.1, F222.2, 803.5 2012 TAS Section: 308.2.1, 308.1, 222.2, 803.5 2010 ADAS Section: 308.2.1, 308.1, 222.2, 803.5

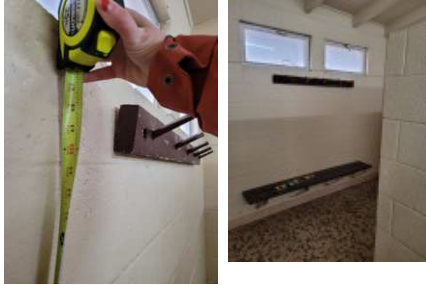
Finding Number	Area Description	Lat/Long	Finding	As Built	Recommendation	Citation	Photos	Figure
132	Towash Shelter Loop: Towash - Women's Restroom	[31.9201318 , -97.372771 4]	Coat hooks provided within the room shall be located within one of the reach ranges specified in 308. Shelves shall be 40 inches (1015 mm) minimum and 48 inches (1220 mm) maximum above the finish floor or ground. Where coat hooks or shelves are provided in dressing, fitting or locker rooms without individual compartments, at least one of each type shall comply with 803.5. Where coat hooks or shelves are provided in individual compartments at least one of each type complying with 803.5 shall be provided in individual compartments in dressing, fitting, or locker rooms required to comply with 222.1.	Hooks mounted 65" above finished floor	Remount at least one hook to max 48" aff and shelves to 40" - 48" AFF.	2015 ABAAS Section: 308.2.1, 308.1, F222.2, 803.5 2012 TAS Section: 308.2.1, 308.1, 222.2, 803.5 2010 ADAS Section: 308.2.1, 308.1, 222.2, 803.5

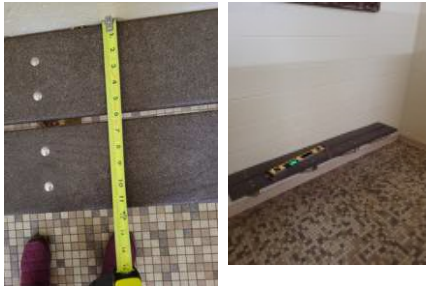
133	Towash Shelter Loop: Towash - Women's Restroom	[31.9201307 , -97.372774 1]	The bench is not deep enough or long enough or is missing. Benches shall be provided having seats that are 42 inches long minimum and 20 inches deep minimum and 24 inches deep maximum. The bench shall provide for back support or shall be affixed to a wall. Back support shall be 42 inches (1065 mm) long minimum and shall extend from a point 2 inches (51 mm) maximum above the seat surface to a point 18 inches (455 mm) minimum above the seat surface. Back support shall be 2½ inches (64 mm) maximum from the rear edge of the seat measured horizontally. The top of the bench seat surface shall be 17 inches (430 mm) minimum and 19 inches (485 mm) maximum above the finish floor or ground.	Bench 11.5" seat depth	Replace bench in dressing area with one having a seat depth of 20" to 24" deep, 42" long, affixed to the wall or having a back and mounted 17" to 19" aff	2012 TAS Section: 903.4, 903.2, 903.3, 903.5 2010 ADAS Section: 903.4, 903.2, 903.3, 903.5

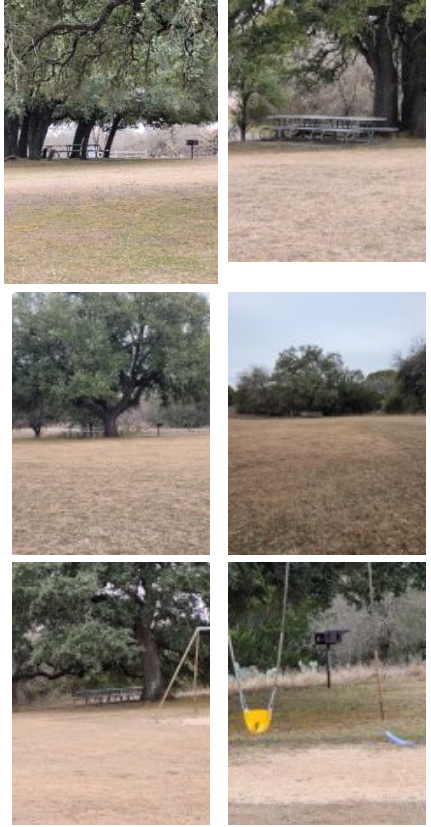
Finding Number	Area Description	Lat/Long	Finding	As Built	Recommendation	Citation	Photos	Figure
137	Towash Shelter Loop: Towash - Boat ramp	[31.9228239 , -97.372331 5]	There is no accessible route to the picnic areas. At least one accessible route shall connect accessible buildings, accessible facilities, accessible elements, and accessible spaces that are on the same site.	Day use area near boat ramp - 0 of 7 picnic tables and 0 of 2 grills have accessible route; picnic area near swings - 0 of 5 picnic tables and 0 of 2 grills have accessible route	Provide at least two accessible picnic tables in each picnic area and create an accessible route with crushed stone or other outdoor material from parking or walkway to tables and one grill at each picnic area as a smart practice	2015 ABAAS Section: F206.2.2 2012 TAS Section: 206.2.2 2010 ADAS Section: 206.2.2

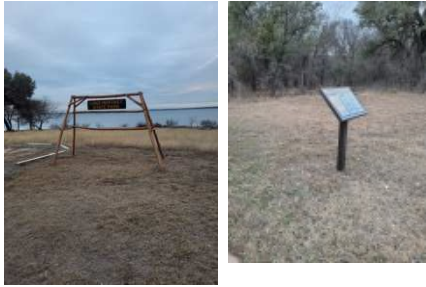
141	White Tail Camping Loop: White Tail - Fishing Point	[31.9191142 , -97.3704272]	There is no accessible route. At least one accessible route shall connect accessible buildings, accessible facilities, accessible elements, and accessible spaces that are on the same site.	Lacks accessible route to fish hanging station or signage	Create an accessible route with crushed stone or other outdoor material from parking or walkway.	2015 ABAAS Section: F206.2.2 2012 TAS Section: 206.2.2 2010 ADAS Section: 206.2.2

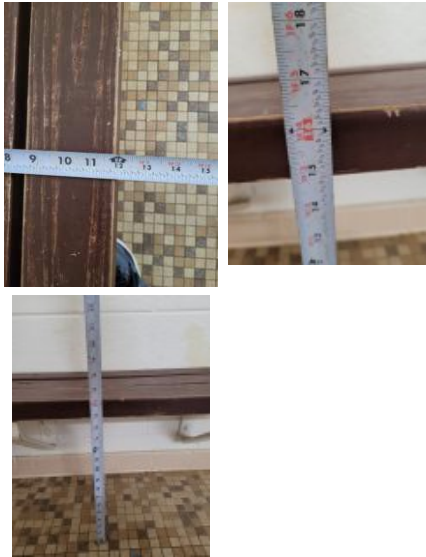
143	White Tail Camping Loop: White Tail - Men's Restroom	[31.9201876 , -97.368911 7]	The bench is not deep enough or long enough or is missing. Benches shall be provided having seats that are 42 inches long minimum and 20 inches deep minimum and 24 inches deep maximum. The bench shall provide for back support or shall be affixed to a wall. Back support shall be 42 inches (1065 mm) long minimum and shall extend from a point 2 inches (51 mm) maximum above the seat surface to a point 18 inches (455 mm) minimum above the seat surface. Back support shall be 2½ inches (64 mm) maximum from the rear edge of the seat measured horizontally. The top of the bench seat surface shall be 17 inches (430 mm) minimum and 19 inches (485 mm) maximum above the finish floor or ground.	Bench 16.25" above finished floor, 12" seat depth	Replace bench in dressing area with one having a seat depth of 20" to 24" deep, 42" long, affixed to the wall or having a back and mounted 17" to 19" aff	2012 TAS Section: 903.4, 903.2, 903.3, 903.5 2010 ADAS Section: 903.4, 903.2, 903.3, 903.5

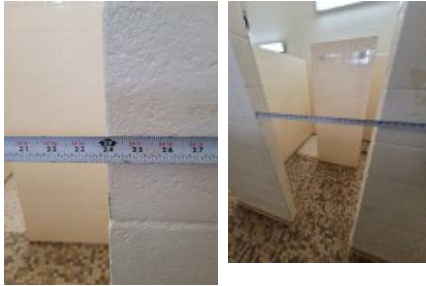
Finding Number	Area Description	Lat/Long	Finding	As Built	Recommendation	Citation	Photos	Figure
144	White Tail Camping Loop: White Tail - Men's Restroom	[31.9201831, -97.3689063]	There are no accessible bathing or shower facilities. Where facilities for bathing are provided for the public, clients or employees, including showers or bathtubs, at least one shower or bathtub and support facilities such as lockers, and not less than 1 percent of all facilities, shall be accessible.	24" width entry to shower, 2 of 2 stalls not accessible	Create an accessible shower in locker/bathing room	2015 ABAAS Section: F213.3.6 2012 TAS Section: 213.3.6 2010 ADAS Section: 213.3.6

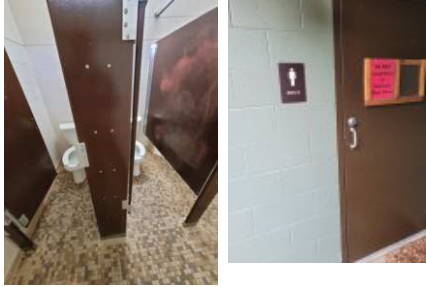
145	White Tail Camping Loop: White Tail - Men's Restroom	[31.9201876, -97.368901]	The restroom is not compliant. The restroom does not have the required minimum clear floor space or maneuvering clearances for the toilet. The restroom does not have the required minimum clear floor space or maneuvering clearances for the lavatory. The entry door does not contain the required minimum maneuvering spaces on the pull/push sides. The entry door encroach into the required clear floor space for fixtures. Grab bars are missing and/or incorrectly installed. Accessories, such as toilet seat covers, paper towel holders, garbage cans, hand dryers, and mirrors are either too high or without clear floor space or both.	Restroom lacks accessible features	Create a compliant wheelchair accessible restroom and correct all features to be accessible if feasible.	2015 ABAAS Section: 603.1 2012 TAS Section: 603.1 2010 ADAS Section: 603.1

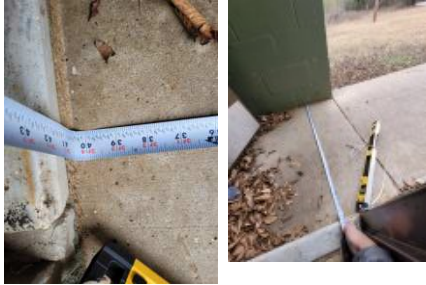
Finding Number	Area Description	Lat/Long	Finding	As Built	Recommendation	Citation	Photos	Figure
147	White Tail Camping Loop: White Tail - Men's Restroom	[31.9201933 , -97.368892 9]	Minimum maneuvering clearances at doors and gates shall comply with 404.2.4. Maneuvering clearances shall extend the full width of the doorway and the required latch side or hinge side clearance.	Maneuvering clearance reduced to 40" depth	Provide required maneuvering clearance around pull side of door	2015 ABAAS Section: 404.2.4.1 , 404.2.4.4 2012 TAS Section: 404.2.4.4, 404.2.4.1 2010 ADAS Section: 404.2.4.4, 404.2.4.1

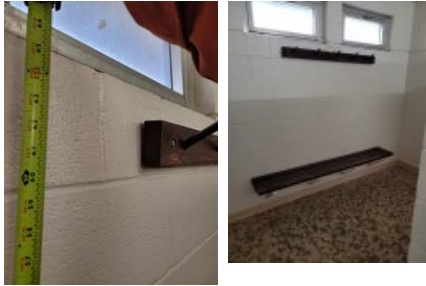
Finding Number	Area Description	Lat/Long	Finding	As Built	Recommendation	Citation	Photos	Figure
150	White Tail Camping Loop: White Tail - Women's Restroom	[31.9201945 , -97.368898 3]	Coat hooks provided within the room shall be located within one of the reach ranges specified in 308. Shelves shall be 40 inches (1015 mm) minimum and 48 inches (1220 mm) maximum above the finish floor or ground. Where coat hooks or shelves are provided in dressing, fitting or locker rooms without individual compartments, at least one of each type shall comply with 803.5. Where coat hooks or shelves are provided in individual compartments at least one of each type complying with 803.5 shall be provided in individual compartments in dressing, fitting, or locker rooms required to comply with 222.1.	Hooks mounted 62" above finished floor	Remount at least one hook to max 48" AFF and shelves to 40" - 48" AFF.	2015 ABAAS Section: 308.2.1, 308.1, F222.2, 803.5 2012 TAS Section: 308.2.1, 308.1, 222.2, 803.5 2010 ADAS Section: 308.2.1, 308.1, 222.2, 803.5

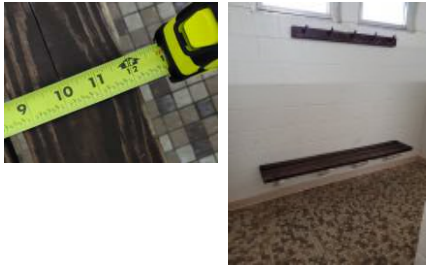
151	White Tail Camping Loop: White Tail - Women's Restroom	[31.9202013 , -97.368891 6]	The bench is not deep enough or long enough or is missing. Benches shall be provided having seats that are 42 inches long minimum and 20 inches deep minimum and 24 inches deep maximum. The bench shall provide for back support or shall be affixed to a wall. Back support shall be 42 inches (1065 mm) long minimum and shall extend from a point 2 inches (51 mm) maximum above the seat surface to a point 18 inches (455 mm) minimum above the seat surface. Back support shall be 2½ inches (64 mm) maximum from the rear edge of the seat measured horizontally. The top of the bench seat surface shall be 17 inches (430 mm) minimum and 19 inches (485 mm) maximum above the finish floor or ground.	Bench 12" seat depth	Replace bench in dressing area with one having a seat depth of 20" to 24" deep, 42" long, affixed to the wall or having a back and mounted 17" to 19" aff	2012 TAS Section: 903.4, 903.2, 903.3, 903.5 2010 ADAS Section: 903.4, 903.2, 903.3, 903.5

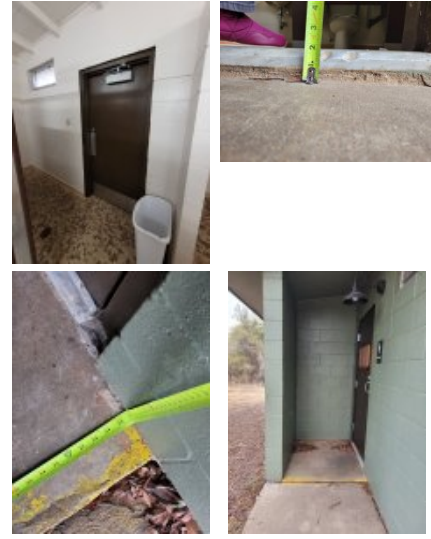
153	White Tail Camping Loop: White Tail - Women's Restroom	[31.9201945, -97.368888 9]	Minimum maneuvering clearances at doors and gates shall comply with 404.2.4. Maneuvering clearances shall extend the full width of the doorway and the required latch side or hinge side clearance. The threshold has a vertical change greater than 1/4 inch high. Exterior doors are recommended to be maintained at 8.5 lbf as a smart practice. Force is to be measured at the operating hardware or 30 inches from the hinges, whichever is greater.	17 lbf, 2" change in elevation, 40" entry depth	For all doors along the public circulation route, provide required maneuvering clearance on push and pull side of doors For all doors along the public circulation route, repair, bevel, or ramp CILs at door entries to max .25" For all doors along the public circulation route, inspect, adjust, and maintain 8.5 lbf to open exterior doors as a smart practice	2010 ADAS Section: 404.2.3, 404.2.7, 404.2.4, 404.2.11, 404.2.11 Exception

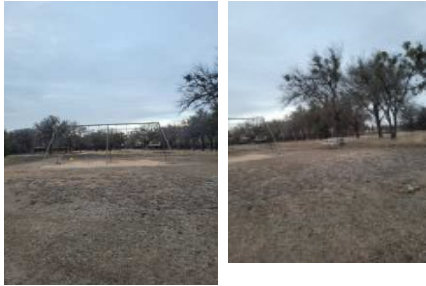
Finding Number	Area Description	Lat/Long	Finding	As Built	Recommendation	Citation	Photos	Figure
154	Post Oak Shelter Loop: Post Oak - Playground	[31.9211233 , -97.3661705]	There is no accessible route to the play area. Accessible routes serving play areas shall comply with Chapter 4 and 1008.2 and shall be permitted to use the exceptions in 1008.2.1 through 1008.2.3. Where accessible routes serve ground level play components, the vertical clearance shall be 80 inches high (2030 mm) minimum.	Lacks accessible route to play area and picnic table	Create an AR to the play area within the site	2015 ABAAS Section: F206.2.2 2012 TAS Section: 1008.2 2010 ADAS Section: 206.2.2

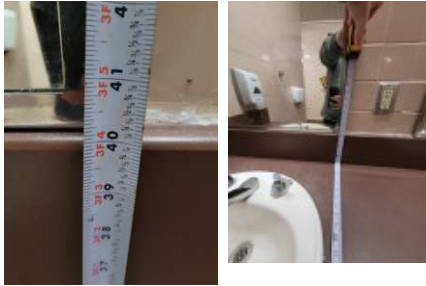
Finding Number	Area Description	Lat/Long	Finding	As Built	Recommendation	Citation	Photos	Figure
157	Post Oak Shelter Loop: Post Oak - Men's Restroom	[31.9219861 , -97.364799 9]	The mirror is mounted too high. Mirrors must have the bottom edge of the reflecting surface a maximum of 40 inches above the floor if above a sink or counter. Mirrors not located above lavatories or countertops shall be installed with the bottom edge of the reflecting surface 35 inches maximum above the finish floor or ground.	Mirror 41" above finished floor	Lower mirror so reflective surface is max 40" AFF.	2015 ABAAS Section: 603.3 2012 TAS Section: 603.3 2010 ADAS Section: 603.3
