Access Audit Site Report

Lake Whitney State Park

Accessibility Evaluation

Inspection Date: 01/20/2022

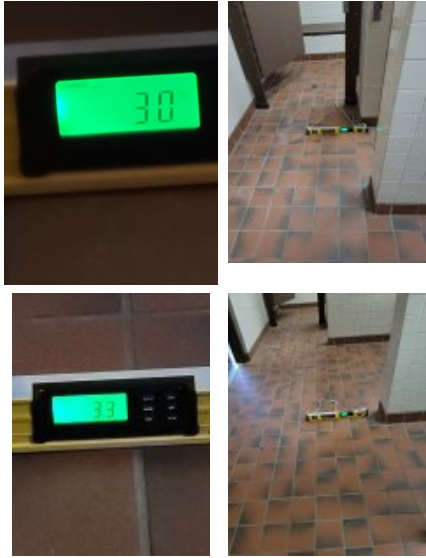
Finding Number	Area Description	Lat/Long	Finding	As Built	Recommendation	Citation	Photos	Figure
159	Post Oak Shelter Loop: Post Oak - Men's Restroom	[31.9219975 , -97.3648213]	The accessible route contains running slopes greater than 5 percent and cross slopes greater than 2 percent across the width of the walk and has not been constructed as a ramp (i.e. handrails, wheel guides, etc.). When the slope in the direction of travel of any walk exceeds 1 unit vertical in 20 units horizontal (5-percent slope), it must be constructed as ramp. Surface cross slopes must not exceed one unit vertical in 48 units. Horizontal (2-percent slope).	3% near stall, 3.3% near urinal	Correct or repair slope to max 5% running and 2.08% cross	2015 ABAAS Section: 403.3 2012 TAS Section: 403.3 2010 ADAS Section: 403.3

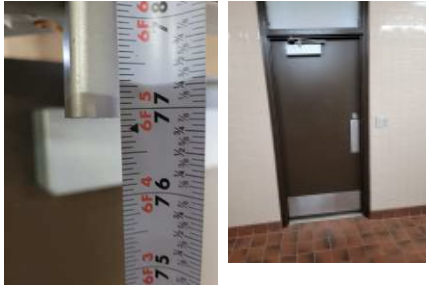
Finding Number	Area Description	Lat/Long	Finding	As Built	Recommendation	Citation	Photos	Figure
161	Post Oak Shelter Loop: Post Oak - Men's Restroom	[31.9219907 , -97.364816]	Vertical clearance shall be 80 inches (2030 mm) high minimum. Guardrails or other barriers shall be provided where the vertical clearance is less than 80 inches (2030 mm) high. The leading edge of such guardrail or barrier shall be located 27 inches (685 mm) maximum above the finish floor or ground. EXCEPTION: Door closers and door stops shall be permitted to be 78 inches (1980 mm) minimum above the finish floor or ground.	Closer 77" AFF	Replace or remount closer min 78" aff	2015 ABAAS Section: 307.4, 307.4 EXCEPTION 2012 TAS Section: 307.4, 307.4 Exception 2010 ADAS Section: 307.4, 307.4 Exception

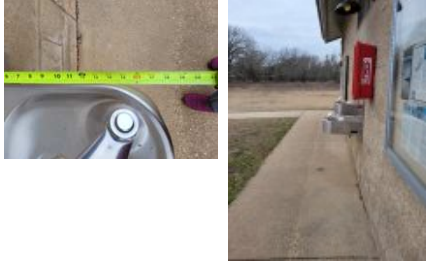
163	Post Oak Shelter Loop: Post Oak - Women's Restroom	[31.9219952 , -97.364813 3]	An item or items project more than 4 inches into the circulation path. Wall-mounted objects that have leading edges between 27 inches and 80 inches from the floor must not project more than 4 inches into the circulation path. Protruding objects that extend to the floor or within 27 inches of the floor are cane detectable and are therefore not hazardous. Where it is necessary or desirable to have objects protrude from the wall, a manner of cane detection must be provided.	Post Oak Restroom - drinking fountain projects 18" into circulation path	Relocate protruding objects or place cane detectable warning or bollard at foot of item	2015 ABAAS Section: 307.2 2012 TAS Section: 307.2 2010 ADAS Section: 307.2

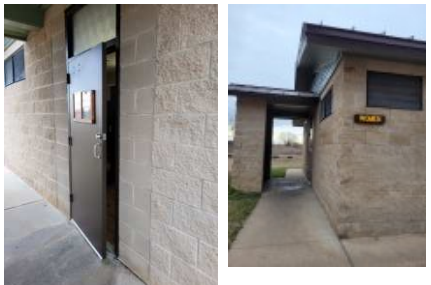
165	Post Oak Shelter Loop: Post Oak - Women's Restroom	[31.9220021 , -97.3648133]	The restroom sign does not comply with one or more applicable requirements for the location, height, and properties of the sign.	Not compliant - location, lacks symbol of accessibility and Braille	Acquire and mount signage, including Braille, raised lettering and access symbol mounted on wall, latch side of door, 48" to baseline of lowest character and 60" to baseline of highest character	2015 ABAAS Section: F216.2, 703.1, 703.2, 703.5, 703.6 2012 TAS Section: 216.2, 703.1, 703.2, 703.5, 703.6 2010 ADAS Section: 216.2, 703.1, 703.2, 703.5, 703.6

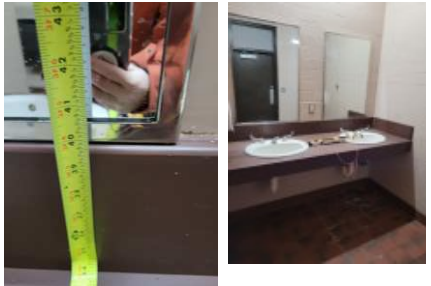
166	Post Oak Shelter Loop: Post Oak - Women's Restroom	[31.9220044 , -97.3648133]	The mirror is mounted too high. Mirrors must have the bottom edge of the reflecting surface a maximum of 40 inches above the floor if above a sink or counter. Mirrors not located above lavatories or countertops shall be installed with the bottom edge of the reflecting surface 35 inches maximum above the finish floor or ground.	Mirror 41" above finished floor	Lower mirror so reflective surface is max 40" AFF.	2015 ABAAS Section: 603.3 2012 TAS Section: 603.3 2010 ADAS Section: 603.3

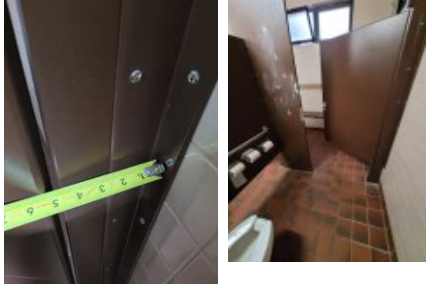
Finding Number	Area Description	Lat/Long	Finding	As Built	Recommendation	Citation	Photos	Figure
170	Post Oak Shelter Loop: Post Oak - Women's Restroom	[31.9219679 , -97.3648066]	The compartment door is located too far from the partition or wall. The door shall be located in front of the clear space and diagonal to the water closet. Where located in the front partition, the door opening shall be 4 inches maximum from the side wall or partition farthest from the water closet. Where located in the side wall or partition, the door opening shall be 4 inches maximum from the front partition. Toilet compartment doors shall not swing into the minimum required compartment area.	4.75" from wall	Rehang stall door to be max 4" from adjacent stall partition and on the stall wall farthest from the toilet	2015 ABAAS Section: 604.8.1.2 2012 TAS Section: 604.8.1.2 2010 ADAS Section: 604.8.1.2

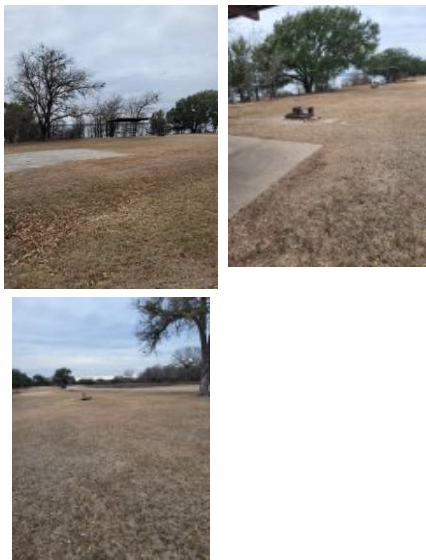
Finding Number	Area Description	Lat/Long	Finding	As Built	Recommendation	Citation	Photos	Figure
171	Lake View Camping Loop: Lake View - Campsite	[31.9169821 , -97.3569115]	An accessible access route is not provided between elements, spaces and the facilities provided within the accessible camping unit. At least one outdoor recreation access route shall connect accessible elements, spaces and facilities provided within camping units with mobility features.	Lakeview campsite 122 - lacks accessible route to site amenities; from parking 85' to water spout, 40' to picnic area, firepit 15' from picnic area	Create AR with crushed and compacted stone or similar outdoor material to camp sites and one of each type of amenity.	2015 ABAAS Section: F244.5.1

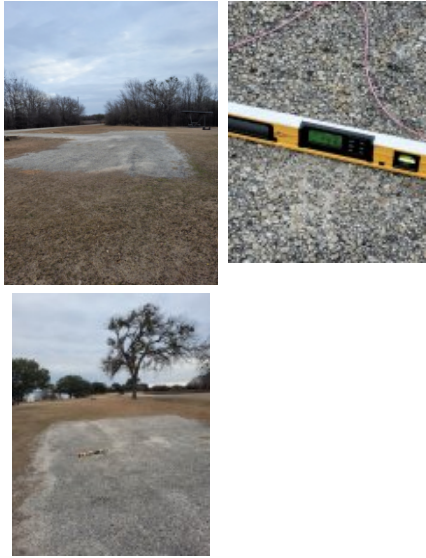
Finding Number	Area Description	Lat/Long	Finding	As Built	Recommendation	Citation	Photos	Figure
176	Lake View Camping Loop: Lake View - Campsite	[31.9170595 , -97.356737 2]	The surface of parking spaces and pull-up spaces shall be firm and stable. The slope of the surface of parking spaces and pull-up spaces shall not be steeper than 1:48 in any direction. EXCEPTION: Where the surface is other than asphalt, concrete, or boards, slopes not steeper than 1:20 shall be permitted when necessary for drainage.	Lakeview campsite 122 - parking is loose gravel, 3.3% slope	Correct surface of parking spaces to be firm and stable with slopes max of 2.08% or 5% for surfaces other than concrete, asphalt or boards as a smart practice. Resurface to eliminate gaps, cracks and change in elevation.	2015 ABAAS Section: 1012.4, 1012.5, 1012.5 EXCEPTION

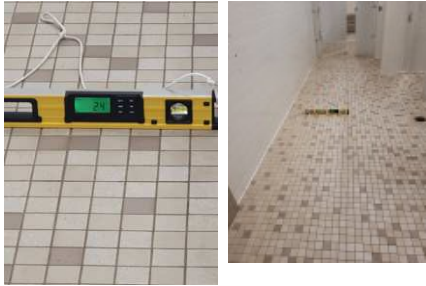
Finding Number	Area Description	Lat/Long	Finding	As Built	Recommendation	Citation	Photos	Figure
178	Lake View Camping Loop: Lake View - Men's Restroom	[31.9175342 , -97.3570161]	The accessible route contains running slopes greater than 5 percent and cross slopes greater than 2 percent across the width of the walk and has not been constructed as a ramp (i.e. handrails, wheel guides, etc.). When the slope in the direction of travel of any walk exceeds 1 unit vertical in 20 units horizontal (5-percent slope), it must be constructed as ramp. Surface cross slopes must not exceed one unit vertical in 48 units. Horizontal (2-percent slope).	2.4% near floor drain	Correct or repair slope to max 5% running and 2.08% cross	2015 ABAAS Section: 403.3 2012 TAS Section: 403.3 2010 ADAS Section: 403.3

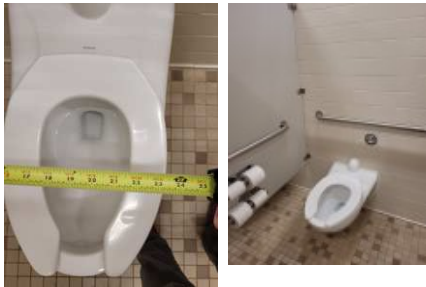
180	Lake View Camping Loop: Lake View - Women's Restroom	[31.9175057 , -97.3570429]	The toilet is not located within the range allowed from the side wall or partition. The centerline of the toilet must be 16 to 18 inches from the side wall.	20" to centerline from wall	Remount toilets to 16" to 18" from the side wall to centerline	2015 ABAAS Section: 604.2 2012 TAS Section: 604.2 2010 ADAS Section: 604.2

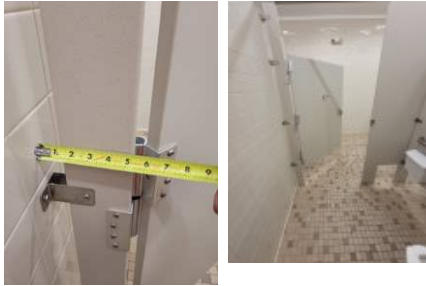
Finding Number	Area Description	Lat/Long	Finding	As Built	Recommendation	Citation	Photos	Figure
181	Lake View Camping Loop: Lake View - Women's Restroom	[31.9175376 , -97.357020 1]	The compartment door is located too far from the partition or wall. The door shall be located in front of the clear space and diagonal to the water closet. Where located in the front partition, the door opening shall be 4 inches maximum from the side wall or partition farthest from the water closet. Where located in the side wall or partition, the door opening shall be 4 inches maximum from the front partition. Toilet compartment doors shall not swing into the minimum required compartment area.	Stall door is 5" from wall	Rehang stall door to be max 4" from adjacent stall partition and on the stall wall farthest from the toilet	2015 ABAAS Section: 604.8.1.2 2012 TAS Section: 604.8.1.2 2010 ADAS Section: 604.8.1.2

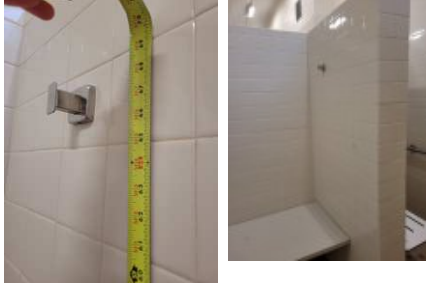
182	Lake View Camping Loop: Lake View - Women's Restroom	[31.9175319 , -97.357013 4]	Coat hooks provided within the room shall be located within one of the reach ranges specified in 308. Shelves shall be 40 inches (1015 mm) minimum and 48 inches (1220 mm) maximum above the finish floor or ground. Where coat hooks or shelves are provided in dressing, fitting or locker rooms without individual compartments, at least one of each type shall comply with 803.5. Where coat hooks or shelves are provided in individual compartments at least one of each type complying with 803.5 shall be provided in individual compartments in dressing, fitting, or locker rooms required to comply with 222.1.	Hooks installed 67" above bench	Remount at least one hook to max 48" AFF.	2015 ABAAS Section: 308.2.1, 308.1, F222.2, 803.5 2012 TAS Section: 308.2.1, 308.1, 222.2, 803.5 2010 ADAS Section: 308.2.1, 308.1, 222.2, 803.5

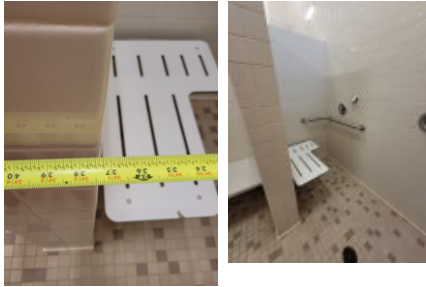
183	Lake View Camping Loop: Lake View - Women's Restroom	[31.9175353 , -97.357005 4]	Transfer type shower compartments shall be 36 inches (915 mm) by 36 inches (915 mm) clear inside dimensions measured at the center points of opposing sides and shall have a 36 inch (915 mm) wide minimum entry on the face of the shower compartment. Clearance of 36 inches (915 mm) wide minimum by 48 inches (1220 mm) long minimum measured from the control wall shall be provided.	37.5" stall width	Correct transfer shower to compliant 36" by 36" clear inside dimension.	2015 ABAAS Section: 608.2.1 2012 TAS Section: 608.2.1 2010 ADAS Section: 608.2.1

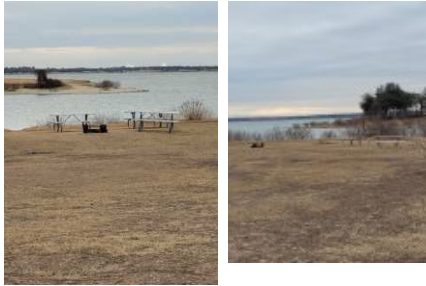
Finding Number	Area Description	Lat/Long	Finding	As Built	Recommendation	Citation	Photos	Figure
189	Washita Day Use Area: Washita - Picnic Area	[31.9197095 , -97.360787 3]	There is no accessible route to the picnic elements. At least one accessible route shall connect accessible buildings, accessible facilities, accessible elements, and accessible spaces that are on the same site.	0 of 5 picnic tables accessible, no AR, no AR to both grills	Replace at least two picnic tables with ones of an accessible design and create an accessible route with crushed stone or other outdoor material from parking or walkway to tables and one grill as a smart practice	2015 ABAAS Section: F206.2.2 2012 TAS Section: 206.2.2 2010 ADAS Section: 206.2.2

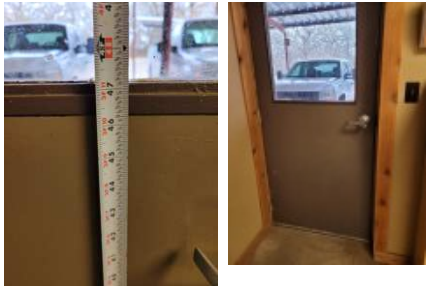
199	Employee Spaces: Maintenance - Employee Spaces	[31.9289818 , -97.3565199]	The vision light panels (glazing/window) are mounted too high. Doors, gates, and side lights adjacent to doors or gates, containing one or more glazing panels that permit viewing through the panels shall have the bottom of at least one glazed panel located 43 inches maximum above the finish floor.	Main entry to office - vision light 47.25" above finished floor	Replace doors with ones having sidelight viewing windows max 43" AFF.	2015 ABAAS Section: 404.2.11 2012 TAS Section: 404.2.11 2010 ADAS Section: 404.2.11

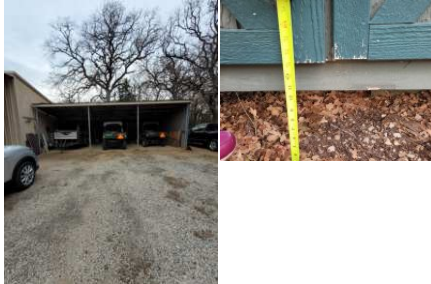
200	Employee Spaces: Maintenance - Employee Spaces	[31.9289613 , -97.3565172]	Spaces and elements within employee work areas shall only be required to comply with 206.2.8, 207.1, and 215.3 and shall be designed and constructed so that individuals with disabilities can approach, enter, and exit the employee work area. Employee work areas, or portions of employee work areas, other than raised courtroom stations, that are less than 300 square feet (28 m2) and elevated 7 inches (180 mm) or more above the finish floor or ground where the elevation is essential to the function of the space shall not be required to comply with these requirements or to be on an accessible route.	Lacks AR to car port, green shed has 12" CIL, pinch, no AR to antler building, pinch on antler, 13" CIL, no AR to flammable or herbicide storage	For employee spaces, relocate storage, furniture, and other obstacles at doorways to provide approach, enter and exit at the employee space. Create an accessible route that connects to each building at maintenance area. Repair, bevel, or ramp CIL at entry doors to max .5"	2015 ABAAS Section: F203.9 2012 TAS Section: 203.9 2010 ADAS Section: 203.9
