Access Audit Site Report

Longhorn Cavern State Park

Accessibility Evaluation

Inspection Date: 08/24/2021

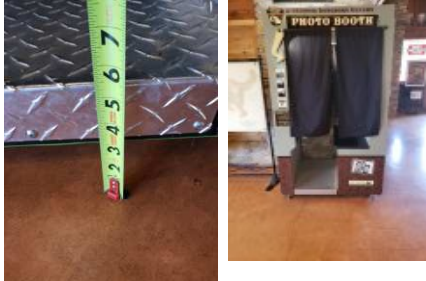
15	Visitor Center: Visitor Center Public Spaces	[30.68462, -98.35115]	Exterior doors are recommended to be maintained at 8.5 lbf as a smart practice. Force is to be measured at the operating hardware or 30 inches from the hinges, whichever is greater. The doormat is not secured in place at the entry door. If carpet or carpet tile is used on a ground or floor surface, then it shall be securely attached; have a firm cushion, pad or backing or no cushion or pad; and have a level loop, textured loop, level-cut pile or level-cut/uncut pile texture. The maximum pile height shall be 1/2 inch. Exposed edges of carpet shall be fastened to floor surfaces and have trim along the entire length of the exposed edge. Recessed doormats shall be adequately anchored to prevent interference with wheelchair traffic.	Rear double doors -18#, floor mat not secured	For all doors along the public circulation route, inspect, adjust, and maintain 8.5 lbf to open exterior doors as a smart practice 3" aff Remove or secure mat at door to prevent trip hazard	2010 ADAS Section: 404.2.3, 404.2.7, 404.2.4, 404.2.11, 404.2.11 Exception
