Access Audit Site Report

Lyndon B Johnson State Park and Historic Site

**199 Park Road 52
Stonewall, TX 78671**

**Inspection Date: 09/27/2022
Inspectors: Tanya Scheibe**

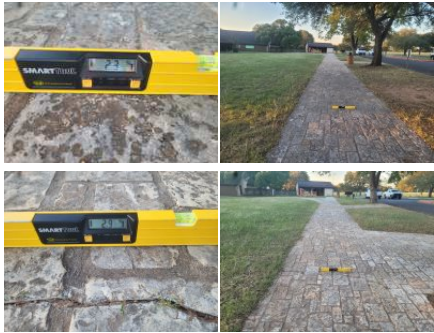
6	Visitor Center Complex: Visitor Center - Exterior Accessible Route	[30.2378976, -98.626638 4]	The running slope of walking surfaces shall not be steeper than 1:20. The cross slope of walking surfaces shall not be steeper than 1:48.	2.3% along parking, 2.9% near garbage can	Correct running slopes to max 5% and cross to max 2.08%.	2012 TAS Section: 403.3 2010 ADAS Section: 403.3

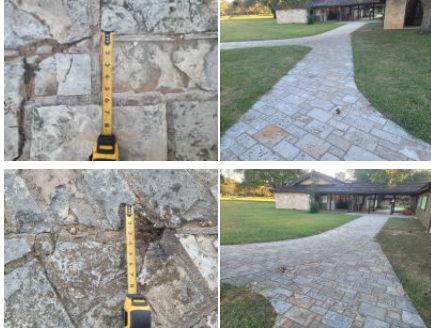
9	Visitor Center Complex: Visitor Center - Exterior Accessible Route	[30.2375248 , -98.6264943]	There is a gap spaced greater than a 1/2 inch. Openings in floor or ground surfaces shall not allow passage of a sphere more than 1/2 inch diameter. Elongated openings shall be placed so that the long dimension is perpendicular to the dominant direction of travel.	5" gap at damaged paver, 5" gap at joint	Correct or fill gaps to be max .5".	2015 ABAAS Section: 302.3 2012 TAS Section: 302.3 2010 ADAS Section: 302.3

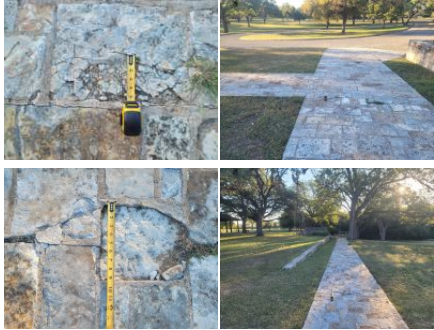
Finding Number	Area Description	Lat/Long	Finding	As Built	Recommendation	Citation	Photos	Figure
15	Visitor Center Complex: Visitor Center - Exterior Accessible Route	[30.23738, -98.62601]	There is a gap spaced greater than a 1/2 inch. Openings in floor or ground surfaces shall not allow passage of a sphere more than 1/2 inch diameter. Elongated openings shall be placed so that the long dimension is perpendicular to the dominant direction of travel.	5" gap at damaged pavers near drop off loop, 9" at sunken paver	Correct or fill gaps to be max .5".	2015 ABAAS Section: 302.3 2012 TAS Section: 302.3 2010 ADAS Section: 302.3

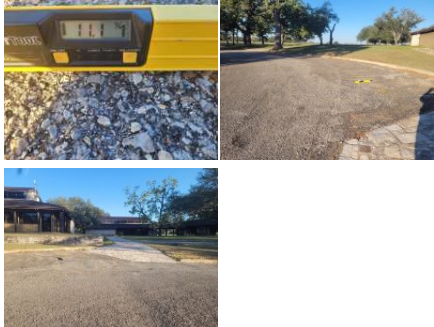
17	Visitor Center Complex: Visitor Center - Exterior Accessible Route	[30.2373093, -98.6260558]	The cross slope (narrow dimension) of the access aisle serving the pull-up space exceeds 2%. Vehicle pull-up spaces and access aisles serving them shall comply with 302. Access aisles shall be at the same level as the vehicle pull-up space they serve. Changes in level are not permitted. EXCEPTION: Slopes not steeper than 1:48 shall be permitted.	11.1% slope at area with faded striping adjacent to curb ramp at back of Visitor Center	Correct running slopes to max 5% and cross to max 2.08%.	2015 ABAAS Section: 503.4 2010 ADAS Section: 503.4, 503.4 Exception

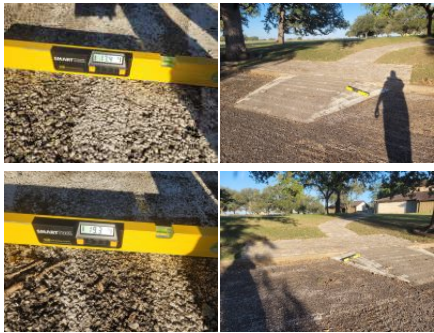
21	Visitor Center Complex: Visitor Center - Exterior Accessible Route	[30.2370887 , -98.626228]	The curb ramp does not have a compliant top landing and the side flares are too steep. In alterations, where there is no landing at the top of Curb Ramps, Curb Ramp flares shall be provided and shall not be steeper than 1:12.	Right flare - 17.4%, left flare - 19.3% at built up ramp	Correct slope of side flares to max 8.33%.	2015 ABAAS Section: 406.4 EXCEPTION 2012 TAS Section: 406.4 Exception 2010 ADAS Section: 406.4 Exception

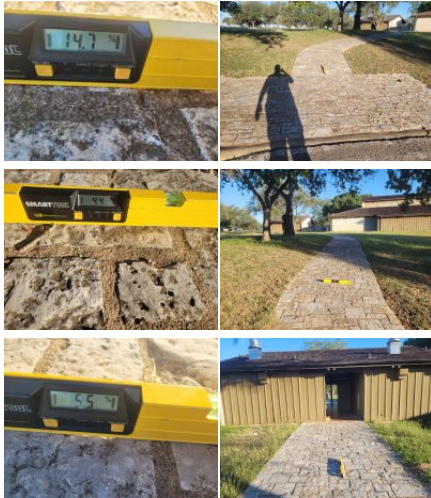
24	Visitor Center Complex: Visitor Center - Exterior Accessible Route	[30.237089, -98.6262234], [30.2373439, -98.6265614]	The running slope of walking surfaces shall not be steeper than 1:20. The cross slope of walking surfaces shall not be steeper than 1:48.	14.8% running slope, 4.4% cross, 5.5% at restroom	Correct running slopes to max 5% and cross to max 2.08%.	2012 TAS Section: 403.3 2010 ADAS Section: 403.3

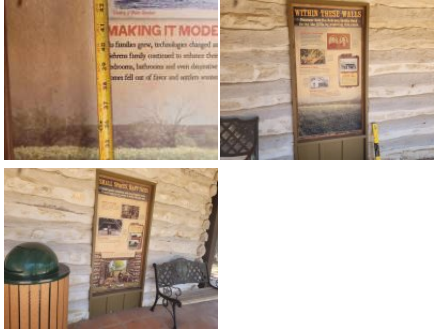
Finding Number	Area Description	Lat/Long	Finding	As Built	Recommendation	Citation	Photos	Figure
38	Visitor Center Complex: Visitor Center - Public Spaces	[30.2376966, -98.6258109]	Visual characters shall be 40 inches (1015 mm) minimum above the finish floor or ground. EXCEPTION: Visual characters indicating elevator car controls shall not be required to comply with 703.5.6.	Some Behren's cabin interpretive signs text lower than 40"	Remount signage to min 40" AFF.	2015 ABAAS Section: 703.5.6, 703.5.6 EXCEPTION 2012 TAS Section: 703.5.6, 703.5.6 Exception 2010 ADAS Section: 703.5.6, 703.5.6 Exception

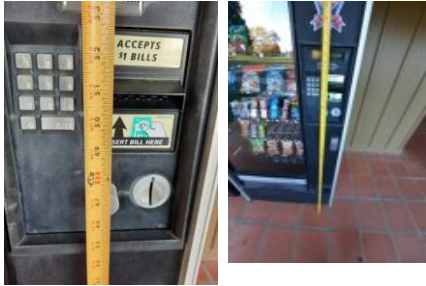
Finding Number	Area Description	Lat/Long	Finding	As Built	Recommendation	Citation	Photos	Figure
44	Visitor Center Complex: Visitor Center - Public Spaces	[30.2374036 , -98.626576 3]	The operable part is positioned too high for either a side or front approach. Where a clear floor or ground space allows a parallel approach to an element and the side reach is unobstructed, the high side reach shall be 48 inches maximum and the low side reach shall be 15 inches minimum above the finish floor or ground. Where a forward reach is unobstructed, the high forward reach shall be 48 inches maximum and the low forward reach shall be 15 inches minimum above the finish floor or ground.	Old vending machine has selection buttons and money slot at 51.75" AFF	Replace vending machine with one that has operable parts in reach between 15" and 48" aff.	2015 ABAAS Section: 308.1 2012 TAS Section: 308.1 2010 ADAS Section: 308.1

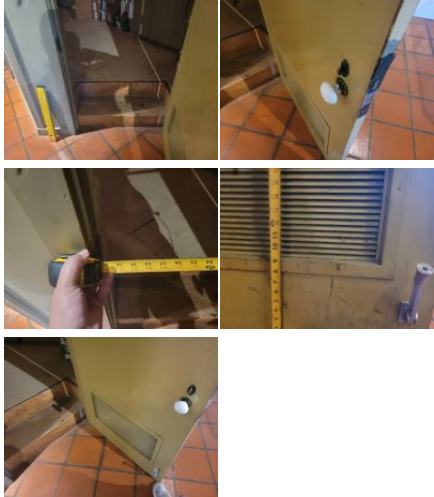
Finding Number	Area Description	Lat/Long	Finding	As Built	Recommendation	Citation	Photos	Figure
47	Visitor Center Complex: Visitor Center - Employee Spaces	[30.237451, -98.626277 2]	Spaces and elements within employee work areas shall only be required to comply with 206.2.8, 207.1, and 215.3 and shall be designed and constructed so that individuals with disabilities can approach, enter, and exit the employee work area. Employee work areas, or portions of employee work areas, other than raised courtroom stations, that are less than 300 square feet (28 m2) and elevated 7 inches (180 mm) or more above the finish floor or ground where the elevation is essential to the function of the space shall not be required to comply with these requirements or to be on an accessible route.	Theater booth - steps push side, knob, 31" wide, closes fast, grate in bottom 9" on push side, door stopper push side	For employee spaces, relocate storage, furniture, and other obstacles at doorways to provide approach, enter and exit at the employee space. Replace doors with doors having 80" overhead clearance and 32" clear width. Repair, bevel, or ramp CILs at door entries to max .25". Inspect, adjust, and maintain closing speed on door closers. Replace hardware with lever hardware or hardware operable without a tight pinch or grasp. Provide kick plate on push side of door from floor to 10" AFF. Remove door holder to provide a smooth surface on the push side of door from floor to 10" AFF.	2015 ABAAS Section: F203.9 2012 TAS Section: 203.9 2010 ADAS Section: 203.9

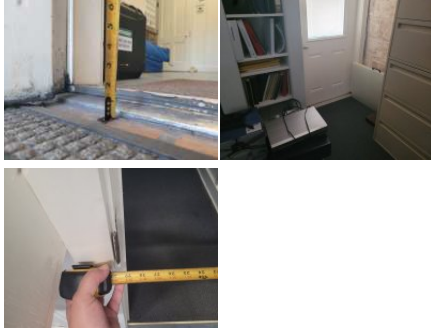
50	Visitor Center Complex: Visitor Center - Employee Spaces	[30.2376636 , -98.626318]	Spaces and elements within employee work areas shall only be required to comply with 206.2.8, 207.1, and 215.3 and shall be designed and constructed so that individuals with disabilities can approach, enter, and exit the employee work area. Employee work areas, or portions of employee work areas, other than raised courtroom stations, that are less than 300 square feet (28 m2) and elevated 7 inches (180 mm) or more above the finish floor or ground where the elevation is essential to the function of the space shall not be required to comply with these requirements or to be on an accessible route.	Admin/office entry - 1.5" threshold; Superintendent office exterior door - file cabinet back in pull side clearance; Superintendent office interior - knob, shelf in pull side clearance, 29" wide	For employee spaces, relocate storage, furniture, and other obstacles at doorways to provide approach, enter and exit at the employee space. Replace doors with doors having 80" overhead clearance and 32" clear width. Repair, provide beveled threshold. Replace hardware with lever hardware or hardware operable without a tight pinch or grasp.	2015 ABAAS Section: F203.9 2012 TAS Section: 203.9 2010 ADAS Section: 203.9

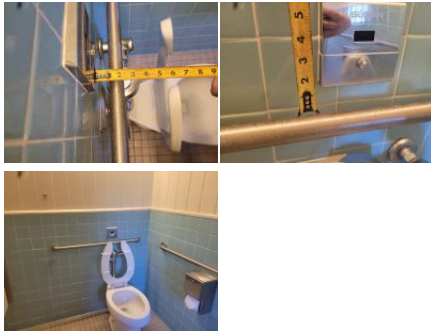
64	Visitor Center Complex: Visitor Center - Restroom Building Men's Restroom	[30.2373846, -98.6266032]	The grab bar height and/or spacing fails. Grab bars must be mounted between 33" and 36" to the top of the gripping surface. There must be 1.5" of clearance between the grab bar and the wall. There must be a minimum of 1.5" of clearance below and minimum 12" above the grab bar to any dispenser or other obstruction.	Auto flush panel reduces space between wall and rear grab bar to 1"	Remount grab bars in accessible stall to 33" to 36" above the finished floor (AFF) with 1.5" clearance between grab bar and wall.	2015 ABAAS Section: 609.3, 609.4 2012 TAS Section: 609.4, 609.3 2010 ADAS Section: 609.3, 609.4

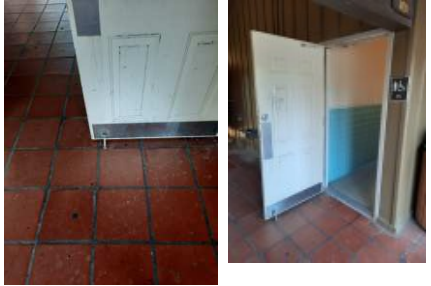
68	Visitor Center Complex: Visitor Center - Restroom Building Men's Restroom	[30.2373974 , -98.626590 8]	The bottom 10 inches on the push side must be smooth and free of obstructions (hold open devices). Opening hardware must be mounted between 30 and 44 inches above the floor or ground.	Visitor Center - Restroom Building Men's Restroom door - hold open device on push side	For all doors along the public circulation route, remove door holder to provide a smooth surface on the push side of door from floor to 10" AFF.	2010 ADAS Section: 404.2.3, 404.2.7, 404.2.4, 404.2.11, 404.2.11 Exception

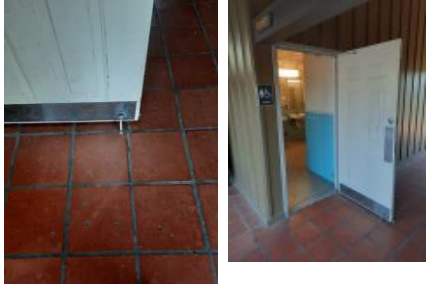
Finding Number	Area Description	Lat/Long	Finding	As Built	Recommendation	Citation	Photos	Figure
69	Visitor Center Complex: Visitor Center - Restroom Building Women's Restroom	[30.237409, -98.626566 6]	The sweep period for doors with closers shall be adjusted so that from an open position of 70 degrees, the door will take at least 3 seconds to move to a point 3 inches from the latch, measured to the leading edge of the door. The bottom 10 inches on the push side must be smooth and free of obstructions (hold open devices). Opening hardware must be mounted between 30 and 44 inches above the floor or ground.	Visitors Center - Restroom Building Women's Restroom door - fast close, hold open device on push side	For all doors along the public circulation route, inspect, adjust, and maintain closing speed on door closers. For all doors along the public circulation route, remove door holder to provide a smooth surface on the push side of door from floor to 10" AFF.	2010 ADAS Section: 404.2.3, 404.2.7, 404.2.4, 404.2.11, 404.2.11 Exception

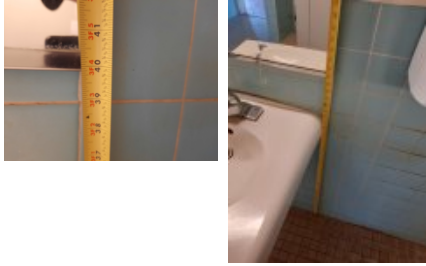
70	Visitor Center Complex: Visitor Center - Restroom Building Women's Restroom	[30.2374005, -98.626578 2]	The mirror is mounted too high. Mirrors must have the bottom edge of the reflecting surface a maximum of 40 inches above the floor if above a sink or counter. Mirrors not located above lavatories or countertops shall be installed with the bottom edge of the reflecting surface 35 inches maximum above the finish floor or ground.	Lowest mirror in restroom at 40.5" AFF	Lower mirror so bottom reflective surface is max 40" AFF and 74" at the top.	2015 ABAAS Section: 603.3 2012 TAS Section: 603.3 2010 ADAS Section: 603.3

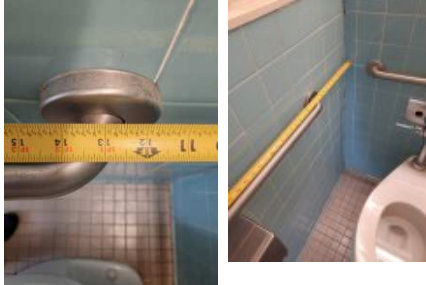
71	Visitor Center Complex: Visitor Center - Restroom Building Women's Restroom	[30.2373958, -98.626592 9]	The side grab bars are not in the correct location. Grab bars on the side wall must be installed so that the end closest to the rear wall is maximum 12" from the rear wall. The end furthest from the rear wall must be mounted minimum 54" from the rear wall.	Side grab bar starts 13" from rear wall	Remount side grab bar to max 12" from the rear wall at the close end and min 54" on the far end, and 33" to 36" AFF.	2015 ABAAS Section: 604.5.1 2012 TAS Section: 604.5.1 2010 ADAS Section: 604.5.1

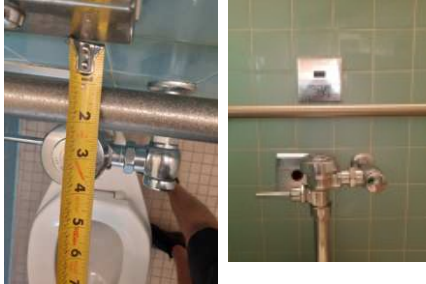
72	Visitor Center Complex: Visitor Center - Restroom Building Women's Restroom	[30.2373958, -98.626579 5]	The grab bar height and/or spacing fails. Grab bars must be mounted between 33" and 36" to the top of the gripping surface. There must be 1.5" of clearance between the grab bar and the wall. There must be a minimum of 1.5" of clearance below and minimum 12" above the grab bar to any dispenser or other obstruction.	Auto flush wall unit with button is above rear grab bar and reduces space to 1" between it and bar	Remove inactive auto flush sensor to provide required grab bar clearance.	2015 ABAAS Section: 609.3, 609.4 2012 TAS Section: 609.4, 609.3 2010 ADAS Section: 609.3, 609.4

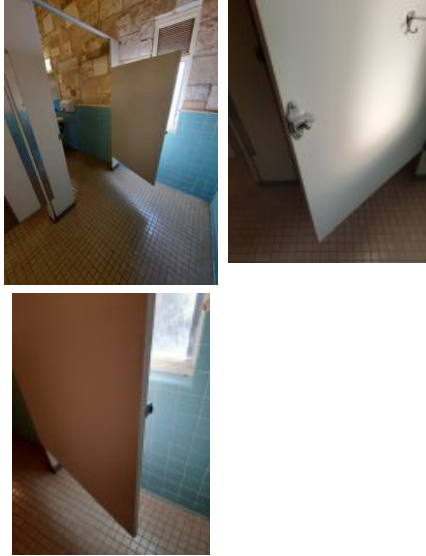
74	Visitor Center Complex: Visitor Center - Restroom Building Women's Restroom	[30.2374074 , -98.626582 2]	The stall door fails to comply with all of the door requirements. The stall door must be a minimum of 32" wide and have compliant hardware on both sides. The stall door must be self-closing.	Stall lacks self-closing door, exterior hardware, and interior hardware other than locking mechanism	Adjust stall door to be self-closing. Replace stall hardware with hardware operable without a tight pinch or grasp on both sides of the stall door.	2015 ABAAS Section: 404.2.3, 404.2.7, 604.8.2.2 2012 TAS Section: 404.2.3, 404.2.7, 604.8.2.2 2010 ADAS Section: 404.2.3, 404.2.7, 604.8.2.2

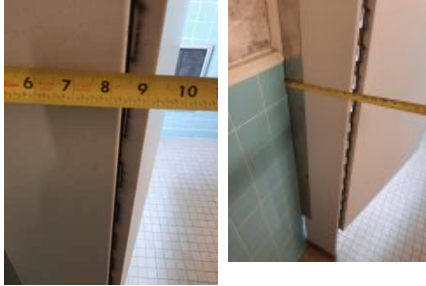
75	Visitor Center Complex: Visitor Center - Restroom Building Women's Restroom	[30.2374028 , -98.626594 3]	The compartment door is located too far from the partition or wall. The door shall be located in front of the clear space and diagonal to the water closet. Where located in the front partition, the door opening shall be 4 inches maximum from the side wall or partition farthest from the water closet. Where located in the side wall or partition, the door opening shall be 4 inches maximum from the front partition. Toilet compartment doors shall not swing into the minimum required compartment area.	stall door 8.25" from wall	Rehang stall door to be max 4" from adjacent stall partition and on the stall wall farthest from the toilet.	2015 ABAAS Section: 604.8.1.2 2012 TAS Section: 604.8.1.2 2010 ADAS Section: 604.8.1.2

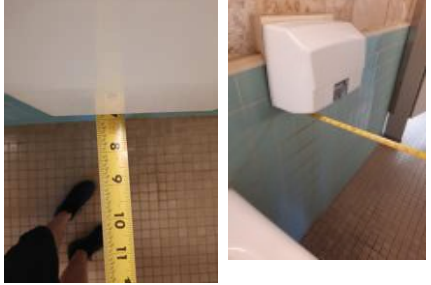
77	Visitor Center Complex: Visitor Center - Restroom Building Women's Restroom	[30.2373982 , -98.626584 9]	An item or items project more than 4 inches into the circulation path. Wall-mounted objects that have leading edges between 27 inches and 80 inches from the floor must not project more than 4 inches into the circulation path. Protruding objects that extend to the floor or within 27 inches of the floor are cane detectable and are therefore not hazardous. Where it is necessary or desirable to have objects protrude from the wall, a manner of cane detection must be provided.	Hand dryer protrudes 7"	Relocate protruding objects or place cane detectable warning or bollard at foot of item.	2015 ABAAS Section: 307.2 2012 TAS Section: 307.2 2010 ADAS Section: 307.2

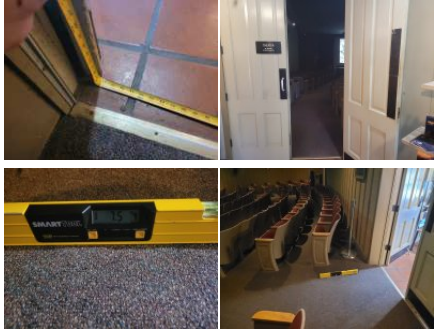
Finding Number	Area Description	Lat/Long	Finding	As Built	Recommendation	Citation	Photos	Figure
82	Visitor Center Complex: Visitor Center - Auditorium and Amphitheater	[30.2374673 , -98.626275 1]	<p>Minimum maneuvering clearances at doors and gates shall comply with 404.2.4. Maneuvering clearances shall extend the full width of the doorway and the required latch side or hinge side clearance. Maneuvering clearances shall have a max slope of 2.08%. Door openings shall provide a clear width of 32 inches (815 mm) minimum. Clear openings of doorways with swinging doors shall be measured between the face of the door and the stop, with the door open 90 degrees. Openings more than 24 inches (610 mm) deep shall provide a clear opening of 36 inches (915 mm) minimum. There shall be no projections into the required clear opening width lower than 34 inches (865 mm) above the finish floor or ground. Projections into the clear opening width between 34 inches (865 mm) and 80 inches (2030 mm) above the finish floor or ground shall not exceed 4 inches (100 mm). All interior doors must be maintained so that the operating pressure does not exceed 5 lbf to open. The sweep period for doors with closers shall be adjusted so that from an open position of 70 degrees, the door will take at least 3 seconds to move to a point 3 inches from the latch, measured to the leading edge of the door. The bottom 10 inches on the push side must be smooth and free of obstructions (hold open devices). Opening hardware must be mounted between 30 and 44 inches above the floor or ground.</p>	Theater entry (store side) - 7.5% slope in interior clearance, 29" wide, door stopper on push side, 10#, closes fast	For all doors along the public circulation route, correct slope in door clearance to max 2.08%. For all doors along the public circulation route, replace doors with doors having 80" overhead clearance and 32" clear width. For all doors along the public circulation route, inspect, adjust, and maintain 5 lbf to open interior doors. For all doors along the public circulation route, inspect, adjust, and maintain closing speed on door closers. For all doors along the public circulation route, remove door holder to provide a smooth surface on the push side of door from floor to 10" AFF.	2010 ADAS Section: 404.2.3, 404.2.7, 404.2.4, 404.2.11, 404.2.11 Exception

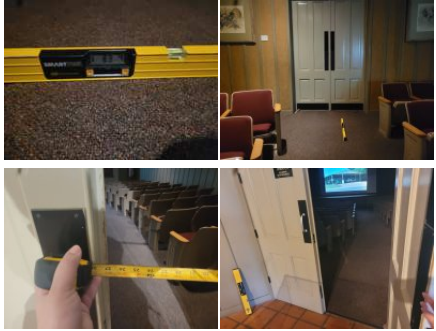
Finding Number	Area Description	Lat/Long	Finding	As Built	Recommendation	Citation	Photos	Figure
83	Visitor Center Complex: Visitor Center - Auditorium and Amphitheater	[30.2374807 , -98.6262678]	Minimum maneuvering clearances at doors and gates shall comply with 404.2.4. Maneuvering clearances shall extend the full width of the doorway and the required latch side or hinge side clearance. Maneuvering clearances shall have a max slope of 2.08%. Door openings shall provide a clear width of 32 inches (815 mm) minimum. Clear openings of doorways with swinging doors shall be measured between the face of the door and the stop, with the door open 90 degrees. Openings more than 24 inches (610 mm) deep shall provide a clear opening of 36 inches (915 mm) minimum. There shall be no projections into the required clear opening width lower than 34 inches (865 mm) above the finish floor or ground. Projections into the clear opening width between 34 inches (865 mm) and 80 inches (2030 mm) above the finish floor or ground shall not exceed 4 inches (100 mm). All interior doors must be maintained so that the operating pressure does not exceed 5 lbf to open. The sweep period for doors with closers shall be adjusted so that from an open position of 70 degrees, the door will take at least 3 seconds to move to a point 3 inches from the latch, measured to the leading edge of the door.	Theater entry (exhibit side) door - 8.9% slope in interior clearance, 27" wide, 9#, closes fast	For all doors along the public circulation route, correct slope in door clearance to max 2.08%. For all doors along the public circulation route, replace doors with doors having 80" overhead clearance and 32" clear width. For all doors along the public circulation route, inspect, adjust, and maintain 5 lbf to open interior doors. For all doors along the public circulation route, inspect, adjust, and maintain closing speed on door closers.	2010 ADAS Section: 404.2.3, 404.2.7, 404.2.4, 404.2.11, 404.2.11 Exception

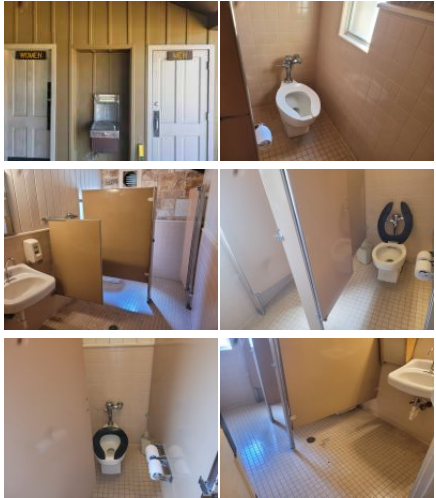
Finding Number	Area Description	Lat/Long	Finding	As Built	Recommendation	Citation	Photos	Figure
84	Visitor Center Complex: Visitor Center - Exhibit Restrooms	[30.237801, -98.626095 2]	This restroom is not accessible. Where existing toilet rooms or bathing rooms do not comply, directional signs indicating the location of the nearest accessible toilet room or bathing room within the facility shall be provided. Signs shall include the International Symbol of Accessibility. Where existing toilet rooms or bathing rooms do comply), the accessible toilet rooms or bathing rooms shall be identified by the International Symbol of Where clustered single user toilet rooms or bathing facilities are permitted, accessible toilet rooms or bathing facilities shall be identified by the International Symbol of Accessibility unless all toilet rooms and bathing facilities are accessible.	Restrooms are not accessible - lacks signage to nearest accessible restroom	Restroom not accessible, acquire and mount signage directing patrons to accessible restroom	2015 ABAAS Section: F216.8 2012 TAS Section: 216.8 2010 ADAS Section: 216.8

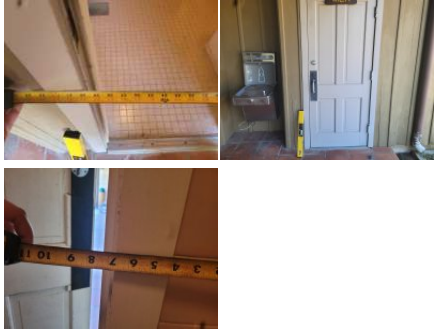
Finding Number	Area Description	Lat/Long	Finding	As Built	Recommendation	Citation	Photos	Figure
86	Visitor Center Complex: Visitor Center - Exhibit Restrooms	[30.2377973 , -98.626064 9]	<p>Minimum maneuvering clearances at doors and gates shall comply with 404.2.4. Maneuvering clearances shall extend the full width of the doorway and the required latch side or hinge side clearance. Door openings shall provide a clear width of 32 inches (815 mm) minimum. Clear openings of doorways with swinging doors shall be measured between the face of the door and the stop, with the door open 90 degrees. Openings more than 24 inches (610 mm) deep shall provide a clear opening of 36 inches (915 mm) minimum. There shall be no projections into the required clear opening width lower than 34 inches (865 mm) above the finish floor or ground. Projections into the clear opening width between 34 inches (865 mm) and 80 inches (2030 mm) above the finish floor or ground shall not exceed 4 inches (100 mm). The sweep period for doors with closers shall be adjusted so that from an open position of 70 degrees, the door will take at least 3 seconds to move to a point 3 inches from the latch, measured to the leading edge of the door.</p>	Visitor Center Exhibit Hall Restrooms Men's Restroom door - wall in pull side clearance, 29" wide, closes fast	<p>For all doors along the public circulation route, provide required maneuvering clearance on push and pull side of doors. For all doors along the public circulation route, replace doors with doors having 80" overhead clearance and 32" clear width. For all doors along the public circulation route, inspect, adjust, and maintain closing speed on door closers.</p>	2010 ADAS Section: 404.2.3, 404.2.7, 404.2.4, 404.2.11, 404.2.11 Exception

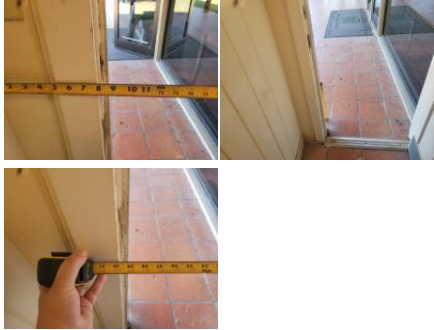
Finding Number	Area Description	Lat/Long	Finding	As Built	Recommendation	Citation	Photos	Figure
87	Visitor Center Complex: Visitor Center - Exhibit Restrooms	[30.2377878 , -98.626101]	<p>Minimum maneuvering clearances at doors and gates shall comply with 404.2.4. Maneuvering clearances shall extend the full width of the doorway and the required latch side or hinge side clearance. Door openings shall provide a clear width of 32 inches (815 mm) minimum. Clear openings of doorways with swinging doors shall be measured between the face of the door and the stop, with the door open 90 degrees. Openings more than 24 inches (610 mm) deep shall provide a clear opening of 36 inches (915 mm) minimum. There shall be no projections into the required clear opening width lower than 34 inches (865 mm) above the finish floor or ground. Projections into the clear opening width between 34 inches (865 mm) and 80 inches (2030 mm) above the finish floor or ground shall not exceed 4 inches (100 mm). The sweep period for doors with closers shall be adjusted so that from an open position of 70 degrees, the door will take at least 3 seconds to move to a point 3 inches from the latch, measured to the leading edge of the door. Exterior doors are recommended to be maintained at 8.5 lbf as a smart practice. Force is to be measured at the operating hardware or 30 inches from the hinges, whichever is greater.</p>	<p>Visitor Center Exhibit Hall Restrooms Women's Restroom exterior door - wall in pull side clearance, 29" wide, 14#, closes fast</p>	<p>For all doors along the public circulation route, provide required maneuvering clearance on push and pull side of doors. For all doors along the public circulation route, replace doors with doors having 80" overhead clearance and 32" clear width. For all doors along the public circulation route, inspect, adjust, and maintain closing speed on door closers. For all doors along the public circulation route, inspect, adjust, and maintain 8.5 lbf to open exterior doors as a smart practice.</p>	<p>2010 ADAS Section: 404.2.3, 404.2.7, 404.2.4, 404.2.11, 404.2.11 Exception</p>

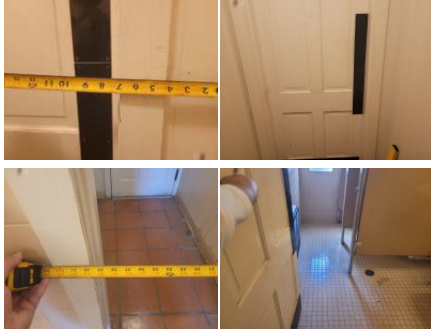
Finding Number	Area Description	Lat/Long	Finding	As Built	Recommendation	Citation	Photos	Figure
88	Visitor Center Complex: Visitor Center - Exhibit Restrooms	[30.2377827, -98.6260944]	Minimum maneuvering clearances at doors and gates shall comply with 404.2.4. Maneuvering clearances shall extend the full width of the doorway and the required latch side or hinge side clearance. Door openings shall provide a clear width of 32 inches (815 mm) minimum. Clear openings of doorways with swinging doors shall be measured between the face of the door and the stop, with the door open 90 degrees. Openings more than 24 inches (610 mm) deep shall provide a clear opening of 36 inches (915 mm) minimum. There shall be no projections into the required clear opening width lower than 34 inches (865 mm) above the finish floor or ground. Projections into the clear opening width between 34 inches (865 mm) and 80 inches (2030 mm) above the finish floor or ground shall not exceed 4 inches (100 mm). All interior doors must be maintained so that the operating pressure does not exceed 5 lbf to open. The sweep period for doors with closers shall be adjusted so that from an open position of 70 degrees, the door will take at least 3 seconds to move to a point 3 inches from the latch, measured to the leading edge of the door.	Visitor Center Exhibit Hall Restrooms Women's Restroom interior door - wall in push side clearance, stalls back in pull side clearance, 29" wide, 10#, closes fast	For all doors along the public circulation route, provide required maneuvering clearance on push and pull side of doors. For all doors along the public circulation route, replace doors with doors having 80" overhead clearance and 32" clear width. For all doors along the public circulation route, inspect, adjust, and maintain 5 lbf to open interior doors. For all doors along the public circulation route, inspect, adjust, and maintain closing speed on door closers.	2010 ADAS Section: 404.2.3, 404.2.7, 404.2.4, 404.2.11, 404.2.11 Exception

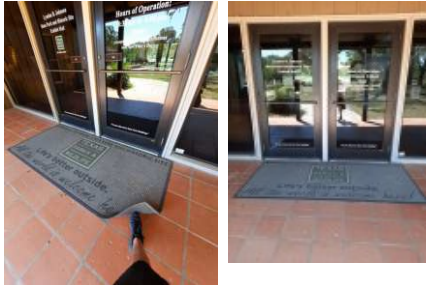
89	Visitor Center Complex: Visitor Center - Exhibit Hall	[30.237705, -98.6260166]	Minimum maneuvering clearances at doors and gates shall comply with 404.2.4. Maneuvering clearances shall extend the full width of the doorway and the required latch side or hinge side clearance. The bottom 10 inches on the push side must be smooth and free of obstructions (hold open devices). Opening hardware must be mounted between 30 and 44 inches above the floor or ground.	South entry doors - loose floor mat on pull side, hold open devices on both doors, both doors - glass starts 8.5" agl	For all doors along the public circulation route, secure rug in door clearance to prevent trip hazard. For all doors along the public circulation route, provide kick plate on push side of door from floor to 10" AFF. For all doors along the public circulation route, remove door holder to provide a smooth surface on the push side of door from floor to 10" AFF.	2010 ADAS Section: 404.2.3, 404.2.7, 404.2.4, 404.2.11, 404.2.11 Exception

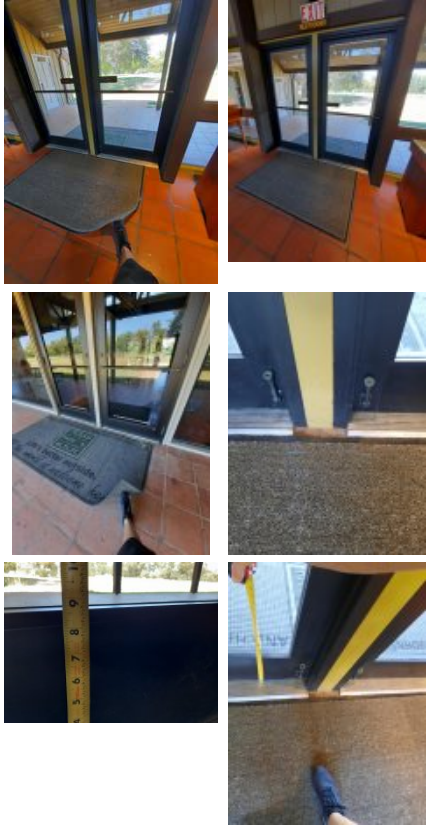
Finding Number	Area Description	Lat/Long	Finding	As Built	Recommendation	Citation	Photos	Figure
90	Visitor Center Complex: Visitor Center - Exhibit Hall	[30.2378277 , -98.6260614]	Minimum maneuvering clearances at doors and gates shall comply with 404.2.4. Maneuvering clearances shall extend the full width of the doorway and the required latch side or hinge side clearance. Exterior doors are recommended to be maintained at 8.5 lbf as a smart practice. Force is to be measured at the operating hardware or 30 inches from the hinges, whichever is greater. The bottom 10 inches on the push side must be smooth and free of obstructions (hold open devices). Opening hardware must be mounted between 30 and 44 inches above the floor or ground.	North entry doors (to access restrooms) - loose floor mat on pull side, hold open devices on both doors, both doors - glass starts 8.5" agl on push side, both doors - 10# push	For all doors along the public circulation route, secure rug in door clearance to prevent trip hazard. For all doors along the public circulation route, inspect, adjust, and maintain 8.5 lbf to open exterior doors as a smart practice. For all doors along the public circulation route, provide kick plate on push side of door from floor to 10" AFF. For all doors along the public circulation route, remove door holder to provide a smooth surface on the push side of door from floor to 10" AFF.	2010 ADAS Section: 404.2.3, 404.2.7, 404.2.4, 404.2.11, 404.2.11 Exception

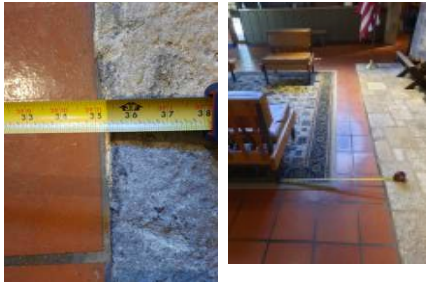
91	Visitor Center Complex: Visitor Center - Exhibit Hall	[30.2377519 , -98.6260175]	The route of travel at this location does not provide a minimum width of 36 inches. The clear width shall be permitted to be reduced to 32 inches minimum for a length of 24 inches maximum provided that reduced width segments are separated by segments that are 48 inches long minimum and 36 inches wide minimum.	Chairs in front of fireplace reduce route to 35" - move chairs	Remove or reposition chairs to widen AR to compliant 36" clear width.	2015 ABAAS Section: 403.5.1 2012 TAS Section: 403.5.1 2010 ADAS Section: 403.5.1

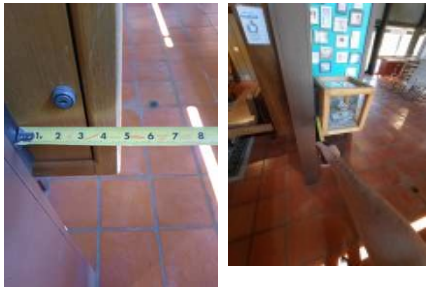
93	Visitor Center Complex: Visitor Center - Exhibit Hall	[30.2377798 , -98.6260456]	An item or items project more than 4 inches into the circulation path. Wall-mounted objects that have leading edges between 27 inches and 80 inches from the floor must not project more than 4 inches into the circulation path. Protruding objects that extend to the floor or within 27 inches of the floor are cane detectable and are therefore not hazardous. Where it is necessary or desirable to have objects protrude from the wall, a manner of cane detection must be provided.	Donation box protrudes 4.5"	Relocate protruding objects or place cane detectable warning or bollard at foot of item.	2015 ABAAS Section: 307.2 2012 TAS Section: 307.2 2010 ADAS Section: 307.2

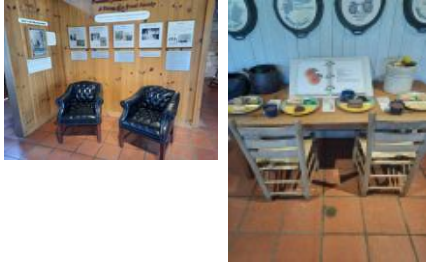
Finding Number	Area Description	Lat/Long	Finding	As Built	Recommendation	Citation	Photos	Figure
95	Visitor Center Complex: Visitor Center - Exhibit Hall	[30.2377658, -98.626051]	The operable part is not accessible because there is not adequate clear floor space for either a forward or side approach. The clear floor or ground space shall be 30 inches minimum by 48 inches minimum.	Lacks CFS in front of "President Johnson's Legacy" signage and recipe binder	Remove, or relocate storage in CFS at fixtures and operable parts along the AR.	2015 ABAAS Section: 305.3 2012 TAS Section: 305.3 2010 ADAS Section: 305.3

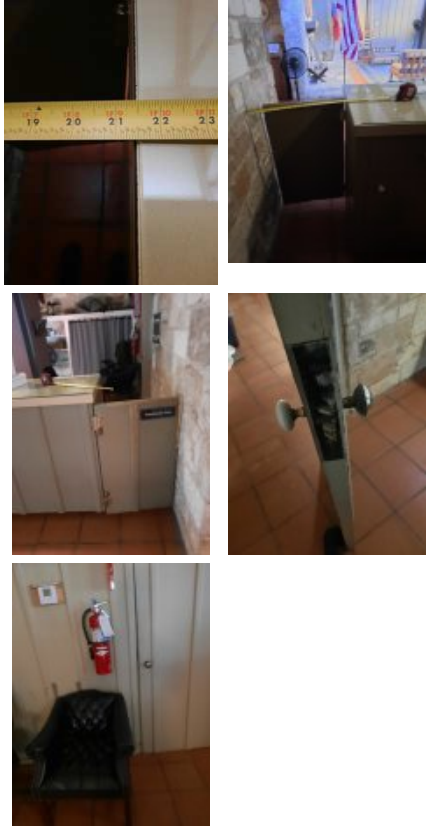
96	Visitor Center Complex: Visitor Center - Exhibit Hall	[30.237789, -98.6260527]	Spaces and elements within employee work areas shall only be required to comply with 206.2.8, 207.1, and 215.3 and shall be designed and constructed so that individuals with disabilities can approach, enter, and exit the employee work area. Employee work areas, or portions of employee work areas, other than raised courtroom stations, that are less than 300 square feet (28 m2) and elevated 7 inches (180 mm) or more above the finish floor or ground where the elevation is essential to the function of the space shall not be required to comply with these requirements or to be on an accessible route.	Information counter and employee space behind it - Front entry gate at information counter is 21.5" wide; side door to space - knobs, fast close, chair and fire extinguisher in pull side clearance, 20# push	For employee spaces, relocate storage, furniture, and other obstacles at doorways to provide approach, enter and exit at the employee space. Provide required maneuvering clearance on push and pull side of doors. Replace doors with doors having 80" overhead clearance and 32" clear width. Inspect, adjust, and maintain 5 lbf to open interior doors. Inspect, adjust, and maintain closing speed on door closers. Replace hardware with lever hardware or hardware operable without a tight pinch or grasp.	2015 ABAAS Section: F203.9 2012 TAS Section: 203.9 2010 ADAS Section: 203.9

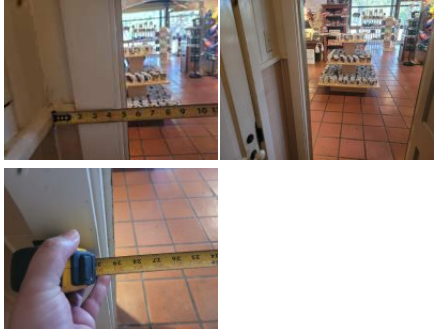
Finding Number	Area Description	Lat/Long	Finding	As Built	Recommendation	Citation	Photos	Figure
102	Visitor Center Complex: Visitor Center - Men's Restroom In Visitor Center	[30.2375, -98.62624]	Minimum maneuvering clearances at doors and gates shall comply with 404.2.4. Maneuvering clearances shall extend the full width of the doorway and the required latch side or hinge side clearance. Door openings shall provide a clear width of 32 inches (815 mm) minimum. Clear openings of doorways with swinging doors shall be measured between the face of the door and the stop, with the door open 90 degrees. Openings more than 24 inches (610 mm) deep shall provide a clear opening of 36 inches (915 mm) minimum. There shall be no projections into the required clear opening width lower than 34 inches (865 mm) above the finish floor or ground. Projections into the clear opening width between 34 inches (865 mm) and 80 inches (2030 mm) above the finish floor or ground shall not exceed 4 inches (100 mm). All interior doors must be maintained so that the operating pressure does not exceed 5 lbf to open. The sweep period for doors with closers shall be adjusted so that from an open position of 70 degrees, the door will take at least 3 seconds to move to a point 3 inches from the latch, measured to the leading edge of the door.	Men's restroom in Visitor Center door - 11#, closes fast, 7" to wall in pull side clearance, 29" wide	For all doors along the public circulation route, provide required maneuvering clearance on push and pull side of doors. For all doors along the public circulation route, replace doors with doors having 80" overhead clearance and 32" clear width. For all doors along the public circulation route, inspect, adjust, and maintain 5 lbf to open interior doors. For all doors along the public circulation route, inspect, adjust, and maintain closing speed on door closers.	2010 ADAS Section: 404.2.3, 404.2.7, 404.2.4, 404.2.11, 404.2.11 Exception

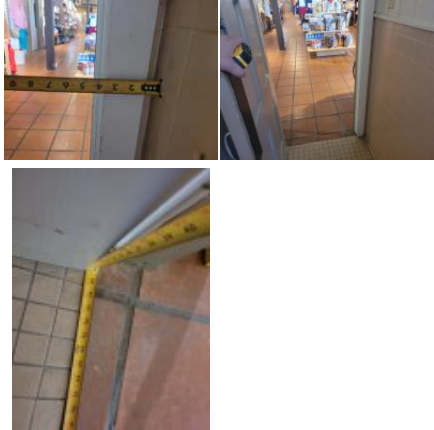
117	Visitor Center Complex: Visitor Center - Women's Restroom In Visitor Center	[30.23745, -98.62628]	Minimum maneuvering clearances at doors and gates shall comply with 404.2.4. Maneuvering clearances shall extend the full width of the doorway and the required latch side or hinge side clearance. Door openings shall provide a clear width of 32 inches (815 mm) minimum. Clear openings of doorways with swinging doors shall be measured between the face of the door and the stop, with the door open 90 degrees. Openings more than 24 inches (610 mm) deep shall provide a clear opening of 36 inches (915 mm) minimum. There shall be no projections into the required clear opening width lower than 34 inches (865 mm) above the finish floor or ground. Projections into the clear opening width between 34 inches (865 mm) and 80 inches (2030 mm) above the finish floor or ground shall not exceed 4 inches (100 mm). All interior doors must be maintained so that the operating pressure does not exceed 5 lbf to open. The sweep period for doors with closers shall be adjusted so that from an open position of 70 degrees, the door will take at least 3 seconds to move to a point 3 inches from the latch, measured to the leading edge of the door.	Women's restroom in Visitor Center door - 10#, closes fast, 4" to wall in pull side clearance, 29.5" wide	For all doors along the public circulation route, provide required maneuvering clearance on push and pull side of doors. For all doors along the public circulation route, replace doors with doors having 80" overhead clearance and 32" clear width. For all doors along the public circulation route, inspect, adjust, and maintain 5 lbf to open interior doors. For all doors along the public circulation route, inspect, adjust, and maintain closing speed on door closers.	2010 ADAS Section: 404.2.3, 404.2.7, 404.2.4, 404.2.11, 404.2.11 Exception

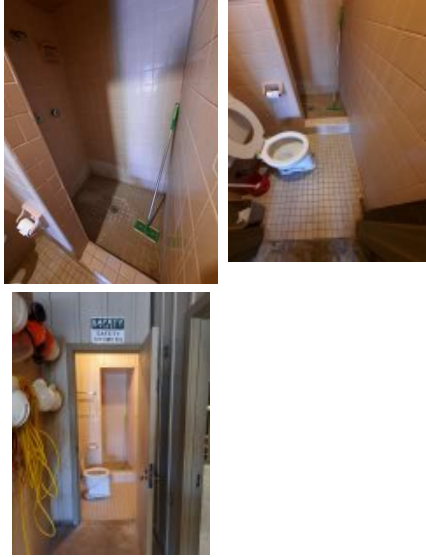
Finding Number	Area Description	Lat/Long	Finding	As Built	Recommendation	Citation	Photos	Figure
129	Employee Areas: Maintenance	[30.2368944, -98.6423803]	There are no accessible bathing or shower facilities. Where facilities for bathing are provided for the public, clients or employees, including showers or bathtubs, at least one shower or bathtub and support facilities such as lockers, and not less than 1 percent of all facilities, shall be accessible.	"Safety Shower" in non-compliant single user restroom in maintenance building is not compliant	Create an accessible shower in locker/bathing room.	2015 ABAAS Section: F213.3.6 2012 TAS Section: 213.3.6 2010 ADAS Section: 213.3.6

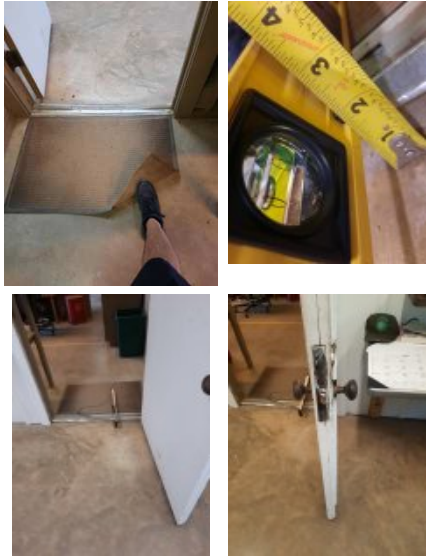
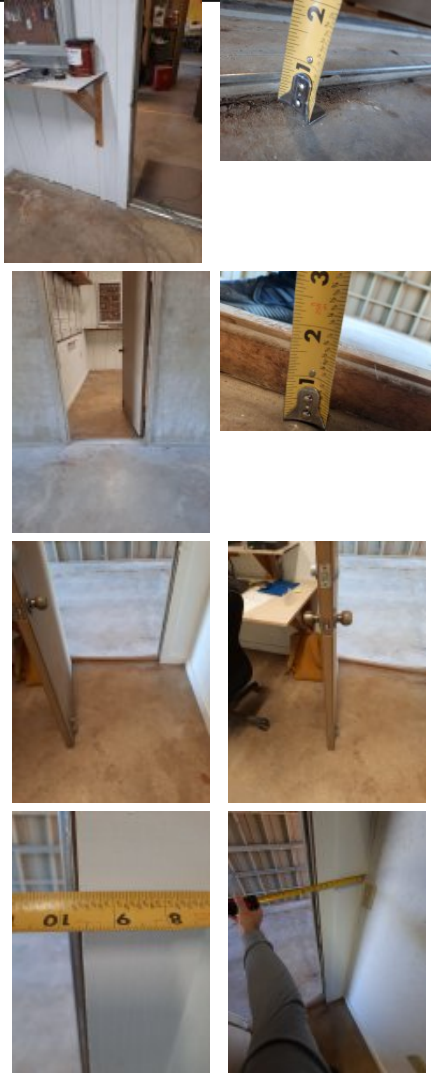
130	Employee Areas: Maintenance	[30.23689, -98.6423236]	Spaces and elements within employee work areas shall only be required to comply with 206.2.8, 207.1, and 215.3 and shall be designed and constructed so that individuals with disabilities can approach, enter, and exit the employee work area. Employee work areas, or portions of employee work areas, other than raised courtroom stations, that are less than 300 square feet (28 m2) and elevated 7 inches (180 mm) or more above the finish floor or ground where the elevation is essential to the function of the space shall not be required to comply with these requirements or to be on an accessible route.	Door from tool room - loose floor mat on push side, 1.25" CIL on push side, 1.25" CIL on pull side of threshold, knobs, shelf in pull side clearance; door from east vehicle bay - .5" CIL on threshold, 1.75" CIL on pull side, knobs, lacks pull side clearance - 9.75" to wall	For employee spaces, relocate storage, furniture, and other obstacles at doorways to provide approach, enter and exit at the employee space. Provide required maneuvering clearance on push and pull side of doors. Secure rug at door to prevent trip hazard. Repair, bevel, or ramp CILs at door entries to max .25". Repair, provide beveled threshold. Replace hardware with lever hardware or hardware operable without a tight pinch or grasp.	2015 ABAAS Section: F203.9 2012 TAS Section: 203.9 2010 ADAS Section: 203.9

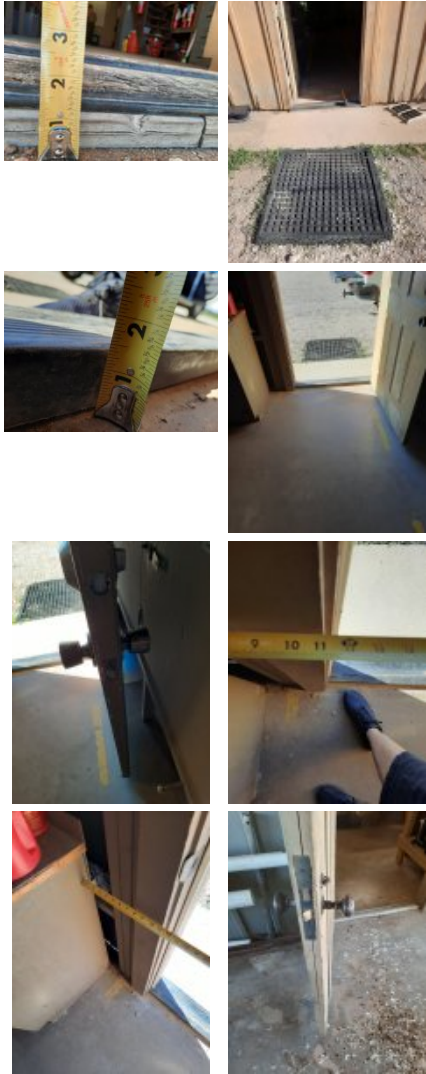
Finding Number	Area Description	Lat/Long	Finding	As Built	Recommendation	Citation	Photos	Figure
132	Employee Areas: Maintenance	[30.2368289 , -98.6423436]	Spaces and elements within employee work areas shall only be required to comply with 206.2.8, 207.1, and 215.3 and shall be designed and constructed so that individuals with disabilities can approach, enter, and exit the employee work area. Employee work areas, or portions of employee work areas, other than raised courtroom stations, that are less than 300 square feet (28 m2) and elevated 7 inches (180 mm) or more above the finish floor or ground where the elevation is essential to the function of the space shall not be required to comply with these requirements or to be on an accessible route.	Main maintenance building - Lacks clearance on push side due to narrow cement pad, CIL of 2" on exterior side, 1.5" CIL on interior side of threshold, knobs, lacks clearance on pull side - 11.25" to cabinet, fast close, 10# push; door to west vehicle bay - 1.75" threshold	For employee spaces, relocate storage, furniture, and other obstacles at doorways to provide approach, enter and exit at the employee space. Provide required maneuvering clearance on push and pull side of doors. Repair, bevel, or ramp CILs at door entries to max .25". Repair, provide beveled threshold. Inspect, adjust, and maintain closing speed on door closers. Inspect, adjust, and maintain 8.5 lbf to open exterior doors as a smart practice. Replace hardware with lever hardware or hardware operable without a tight pinch or grasp.	2015 ABAAS Section: F203.9 2012 TAS Section: 203.9 2010 ADAS Section: 203.9

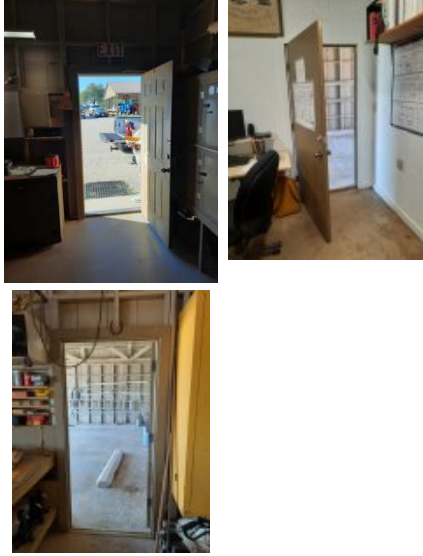
133	Employee Areas: Maintenance	[30.2368744, -98.6423786]	The tactile EXIT sign is missing at the door. Wall signs identifying exits shall have characters raised 1/32 inch minimum and shall be uppercase characters a minimum of 5/8 inch and a maximum of 2 inches high. Braille shall be placed directly below the tactile characters; flush left or centered. Signs shall be located a minimum of 48 inches above the floor, measured from the baseline of the lowest tactile characters and 60 inches maximum above the finish floor or ground surface, measured from the baseline of the highest tactile characters. Where a tactile sign is provided at a door, the sign shall be located on the latch side. Where a tactile sign is provided at double doors the sign shall be located to the right of the right-hand door. Where there is no wall space at the latch side of a single door or at the right side of double doors, signs shall be located on the nearest adjacent wall.	3 of 3 egress doors lack tactile exit signs	Mount compliant signage at all doors along the egress route	2015 ABAAS Section: F216.4.1 2012 TAS Section: 216.4.1 2010 ADAS Section: 216.4.1

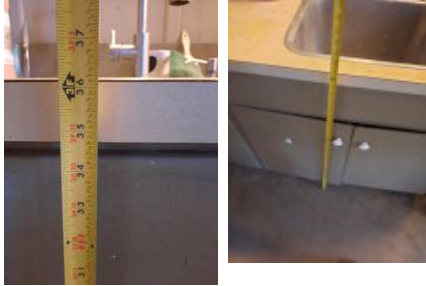
136	Employee Areas: Maintenance	[30.23691, -98.64244]	The top rim of the sink is too high. All lavatories/sinks that are designated to be accessible shall be a minimum 17 inches in horizontal depth and mounted with the rim or counter edge no higher than 34 inches above the finished floor.	Sink rim at 36" above the finished floor (AFF)	Lower sinks to max 34" above the finished floor (AFF) to front of rim.	2015 ABAAS Section: 606.3 2012 TAS Section: 606.3 2010 ADAS Section: 606.3

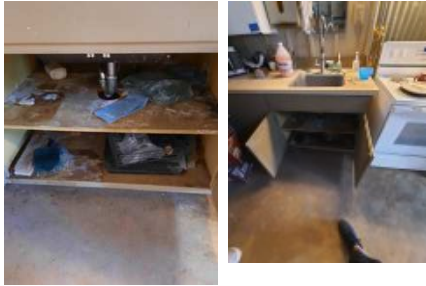
Finding Number	Area Description	Lat/Long	Finding	As Built	Recommendation	Citation	Photos	Figure
138	Employee Areas: Maintenance	[30.23691, -98.64244]	Knee and toe space has not been provided at the sink. Kitchen sinks must be provided with a clear floor space positioned for a forward approach including knee and toe clearance.	Sink lacks knee clearance due to cabinets under sink	Remove base cabinet and lower sink height to max 34" AFF.	2015 ABAAS Section: 606.2, 804.4 2012 TAS Section: 606.2, 804.4 2010 ADAS Section: 606.2, 804.4

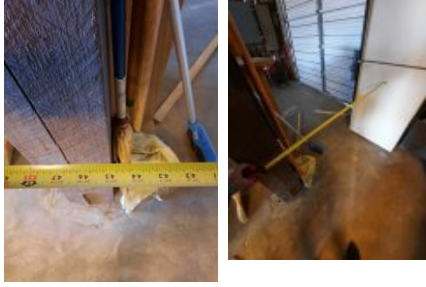
140	Employee Areas: Maintenance	[30.23691, -98.64244]	Combination refrigerators and freezers shall have at least 50 percent of the freezer space 54 inches (1370 mm) maximum above the finish floor or ground. The clear floor or ground space shall be positioned for a parallel approach to the space dedicated to a refrigerator/freezer with the centerline of the clear floor or ground space offset 24 inches (610 mm) maximum from the centerline of the dedicated space.	Refrigerator lacks clear floor space (CFS) due to column 45" from fridge	Relocate refrigerator to provided required CFS.	2015 ABAAS Section: 804.6.6 2012 TAS Section: 804.6.6 2010 ADAS Section: 804.6.6

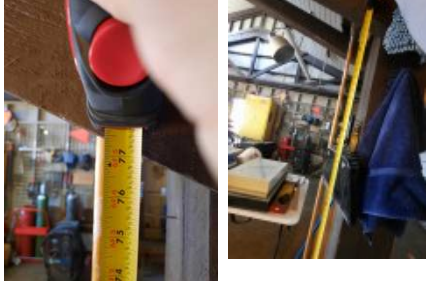
141	Employee Areas: Maintenance	[30.23691, -98.64244]	The angled support beams extend down too close to the route of travel. Any obstruction that overhangs a route of travel must be a minimum of 80 inches above the walking surface as measured from the bottom of the obstruction.	Angled support beams at vertical support column at 77" AFF	Raise angled support beams to min 80", or pad object to prevent hazard in overhead clearance along AR	2015 ABAAS Section: 307.4 2012 TAS Section: 307.4 2010 ADAS Section: 307.4

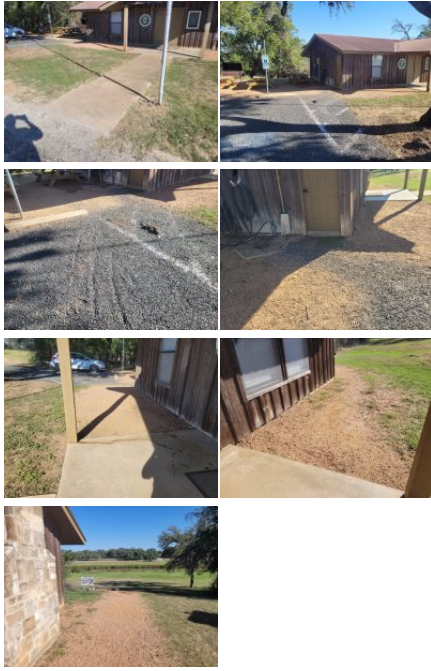
150	Resource Education Center: Resource Ed Ctr - Exterior Accessible Route	[30.2375578 , -98.641742 7]	The accessible route contains loose gravel and/or surface materials that do not provide for a stable, firm slip resistant surface. Floor and ground surfaces shall be stable, firm, and slip resistant.	Steps on path to front door, intended accessible route from parking to kitchen is loose stone, other paths loose stone and steps	Replace existing surface with an accessible surface such as EWF, boardwalk, crushed stone, or asphalt with compliant slopes and CILs.	2015 ABAAS Section: 302.1 2012 TAS Section: 302.1 2010 ADAS Section: 302.1

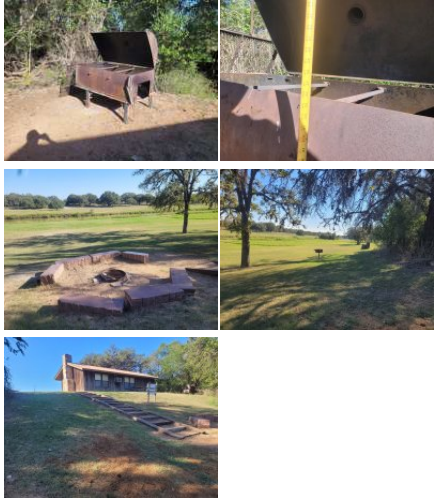
153	Resource Education Center: Resource Ed Ctr - Public Spaces	[30.2377318 , -98.641642 5]	Where provided, cooking surfaces shall be 15 inches (380 mm) minimum and 34 inches (865 mm) maximum above the ground. There is no accessible route to the the large grill, fire pit, and grill in grass. At least one accessible route shall connect accessible buildings, accessible facilities, accessible elements, and accessible spaces that are on the same site.	Large grill on loose surface, 36" to cooking surface; fire pit grill low and lacks AR; grill in grass lacks AR	Raise or lower cooking surface to be 15" min to 34" max above the ground; in the alternative, replace with a compliant surface as a smart practice. Create an accessible route with crushed stone or other outdoor material from parking or walkway to the large grill, fire pit, and grill in grass.	2015 ABAAS Section: 1011.5.2

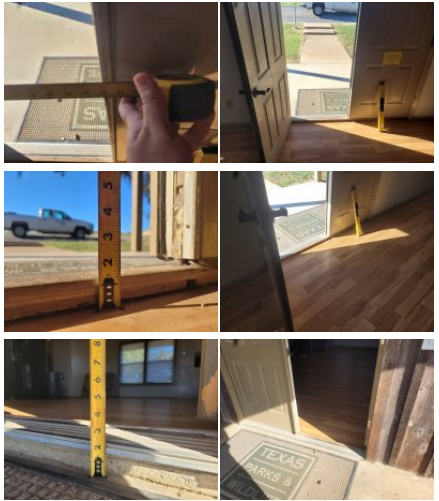
155	Resource Education Center: Resource Ed Ctr - Public Spaces	[30.23753, -98.64171]	Door openings shall provide a clear width of 32 inches (815 mm) minimum. Clear openings of doorways with swinging doors shall be measured between the face of the door and the stop, with the door open 90 degrees. Openings more than 24 inches (610 mm) deep shall provide a clear opening of 36 inches (915 mm) minimum. There shall be no projections into the required clear opening width lower than 34 inches (865 mm) above the finish floor or ground. Projections into the clear opening width between 34 inches (865 mm) and 80 inches (2030 mm) above the finish floor or ground shall not exceed 4 inches (100 mm). The threshold has a vertical change greater than 1/4 inch high. The threshold at a doorway shall be no higher than 1/2 inch. Changes in level between 1/4 inch and 1/2 inch must be beveled at 1:2 or less. 1/4 inch is the maximum vertical rise.	Resource Ed Center entry door - 30" wide, 1.25" CIL, and 2" threshold	For all doors along the public circulation route, replace doors with doors having 80" overhead clearance and 32" clear width. For all doors along the public circulation route, repair, bevel, or ramp CILs at door entries to max .25". For all doors along the public circulation route, provide beveled threshold.	2010 ADAS Section: 404.2.3, 404.2.7, 404.2.4, 404.2.11, 404.2.11 Exception

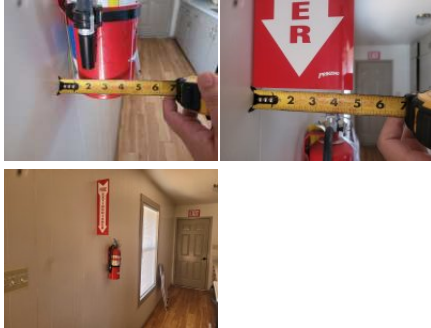
163	Resource Education Center: Resource Ed Ctr - Public Spaces	[30.2376, -98.64172]	An item or items project more than 4 inches into the circulation path. Wall-mounted objects that have leading edges between 27 inches and 80 inches from the floor must not project more than 4 inches into the circulation path. Protruding objects that extend to the floor or within 27 inches of the floor are cane detectable and are therefore not hazardous. Where it is necessary or desirable to have objects protrude from the wall, a manner of cane detection must be provided.	Fire extinguisher protrudes 4.5", sign protrudes 4.5"	Relocate protruding objects or place cane detectable warning or bollard at foot of item.	2015 ABAAS Section: 307.2 2012 TAS Section: 307.2 2010 ADAS Section: 307.2

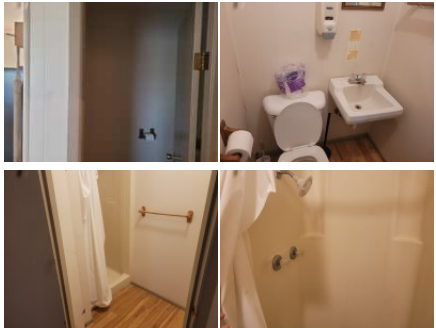
166	Resource Education Center: Resource Ed Ctr - Restroom	[30.2375718 , -98.6416604]	This restroom is not accessible. Where existing toilet rooms or bathing rooms do not comply, directional signs indicating the location of the nearest accessible toilet room or bathing room within the facility shall be provided. Signs shall include the International Symbol of Accessibility. Where existing toilet rooms or bathing rooms do comply), the accessible toilet rooms or bathing rooms shall be identified by the International Symbol of Where clustered single user toilet rooms or bathing facilities are permitted, accessible toilet rooms or bathing facilities shall be identified by the International Symbol of Accessibility unless all toilet rooms and bathing facilities are accessible.	restroom and shower not compliant, restroom too small to make accessible, no directional signage to accessible restroom, nearest is not close by	Restroom not accessible, acquire and mount signage directing patrons to accessible restroom until renovations occur.	2015 ABAAS Section: F216.8 2012 TAS Section: 216.8 2010 ADAS Section: 216.8
