Access Audit Site Report

Lyndon B Johnson State Park and Historic Site

**199 Park Road 52
Stonewall, TX 78671**

**Inspection Date: 09/27/2022
Inspectors: Tanya Scheibe**

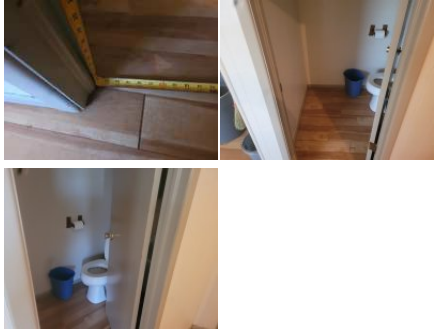
Finding Number	Area Description	Lat/Long	Finding	As Built	Recommendation	Citation	Photos	Figure
168	Resource Education Center: Resource Ed Ctr - Restroom	[30.237581, -98.641662 2]	<p>Minimum maneuvering clearances at doors and gates shall comply with 404.2.4. Maneuvering clearances shall extend the full width of the doorway and the required latch side or hinge side clearance. Door openings shall provide a clear width of 32 inches (815 mm) minimum. Clear openings of doorways with swinging doors shall be measured between the face of the door and the stop, with the door open 90 degrees. Openings more than 24 inches (610 mm) deep shall provide a clear opening of 36 inches (915 mm) minimum. There shall be no projections into the required clear opening width lower than 34 inches (865 mm) above the finish floor or ground. Projections into the clear opening width between 34 inches (865 mm) and 80 inches (2030 mm) above the finish floor or ground shall not exceed 4 inches (100 mm). Hand-activated door opening hardware, handles, pulls, latches, locks, and other operating devices on accessible doors shall have a shape that is easy to grasp with one hand and does not require tight grasping, tight pinching or twisting of the wrist to operate. Hardware shall be 34 inches minimum and 48 inches maximum above the finish floor or ground.</p>	Restroom door - wall in pull side clearance, 22" wide, knob	<p>For all doors along the public circulation route, provide required maneuvering clearance on push and pull side of doors. For all doors along the public circulation route, replace doors with doors having 80" overhead clearance and 32" clear width. For all doors along the public circulation route, replace hardware with lever hardware or hardware operable without a tight pinch or grasp.</p>	2010 ADAS Section: 404.2.3, 404.2.7, 404.2.4, 404.2.11, 404.2.11 Exception

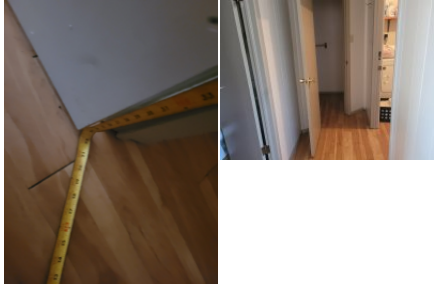
Finding Number	Area Description	Lat/Long	Finding	As Built	Recommendation	Citation	Photos	Figure
169	Resource Education Center: Resource Ed Ctr - Restroom	[30.2375753 , -98.641679 4]	<p>Minimum maneuvering clearances at doors and gates shall comply with 404.2.4. Maneuvering clearances shall extend the full width of the doorway and the required latch side or hinge side clearance. Door openings shall provide a clear width of 32 inches (815 mm) minimum. Clear openings of doorways with swinging doors shall be measured between the face of the door and the stop, with the door open 90 degrees. Openings more than 24 inches (610 mm) deep shall provide a clear opening of 36 inches (915 mm) minimum. There shall be no projections into the required clear opening width lower than 34 inches (865 mm) above the finish floor or ground. Projections into the clear opening width between 34 inches (865 mm) and 80 inches (2030 mm) above the finish floor or ground shall not exceed 4 inches (100 mm). Hand-activated door opening hardware, handles, pulls, latches, locks, and other operating devices on accessible doors shall have a shape that is easy to grasp with one hand and does not require tight grasping, tight pinching or twisting of the wrist to operate. Hardware shall be 34 inches minimum and 48 inches maximum above the finish floor or ground.</p>	Shower door - wall in pull side clearance, 22" wide, knob	<p>For all doors along the public circulation route, provide required maneuvering clearance on push and pull side of doors. For all doors along the public circulation route, replace doors with doors having 80" overhead clearance and 32" clear width. For all doors along the public circulation route, replace hardware with lever hardware or hardware operable without a tight pinch or grasp.</p>	2010 ADAS Section: 404.2.3, 404.2.7, 404.2.4, 404.2.11, 404.2.11 Exception

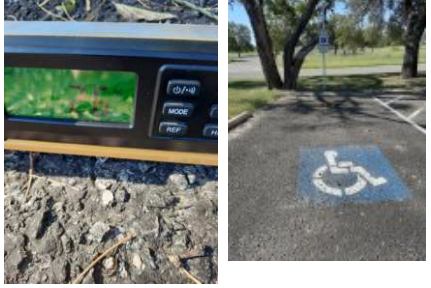
171	Group Dining Hall: Group Dining - Parking	[30.2373389, -98.6387139]	The cross slopes (narrow dimension) and/or running slopes (long dimension) of the access aisle exceeds 2%. The running slope and the cross slope in an accessible parking stall and the access aisle must not exceed 2%.	Left stall - 2.6%	Repair or correct slope of parking space and access aisle to max 2.08% in any direction.	2015 ABAAS Section: 502.4 2012 TAS Section: 502.4 2010 ADAS Section: 502.4

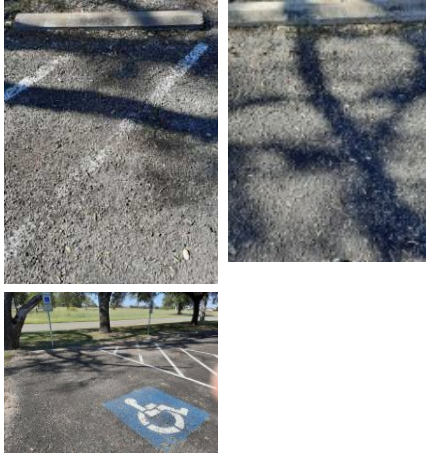
172	Group Dining Hall: Group Dining - Parking	[30.2373621, -98.638738]	The parking stall contains abrupt edges and surface irregularities over a 1/4 inch vertical. Parking spaces and access aisles serving them shall be stable, firm, and slip resistant. Access aisles shall be at the same level as the parking spaces they serve. Changes in level are not permitted and shall not be sloped steeper than 2% in any direction.	Surface is rough with loose stones and plant debris on surface	Resurface stalls and access aisles to eliminate gaps and cracks.	2015 ABAAS Section: 502.4 2012 TAS Section: 502.4 2010 ADAS Section: 502.4

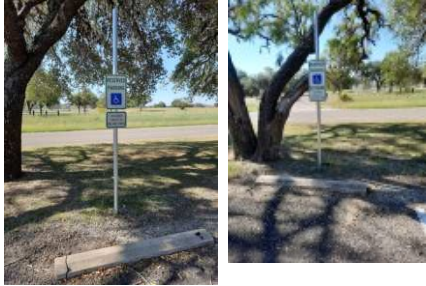
174	Group Dining Hall: Group Dining - Parking	[30.2373574 , -98.6387434]	The van stall is missing a sign identifying it as a van accessible stall. Parking space identification signs shall include the International Symbol of Accessibility. Signs identifying van parking spaces shall contain the designation "van accessible."	2 of 2 stalls meet requirements, but lacks van accessible signs	Add one van parking sign to one accessible stall and ensure stall and access aisle are 11' and 5' or 8' and 8'.	2015 ABAAS Section: 502.6 2012 TAS Section: 502.6 2010 ADAS Section: 502.6

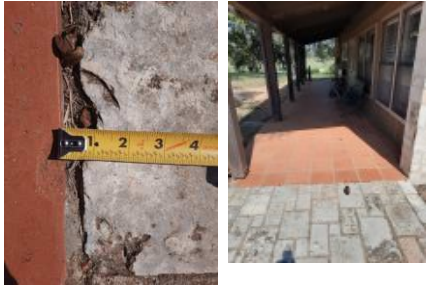
Finding Number	Area Description	Lat/Long	Finding	As Built	Recommendation	Citation	Photos	Figure
175	Group Dining Hall: Group Dining - Exterior Accessible Route	[30.2374056 , -98.6385005]	There is a gap spaced greater than a 1/2 inch. Openings in floor or ground surfaces shall not allow passage of a sphere more than 1/2 inch diameter. Elongated openings shall be placed so that the long dimension is perpendicular to the dominant direction of travel.	Gap up to 1" at transition from stone paver walkway to Group Dining Hall tiled entry	Correct or fill gaps to be max .5".	2015 ABAAS Section: 302.3 2012 TAS Section: 302.3 2010 ADAS Section: 302.3

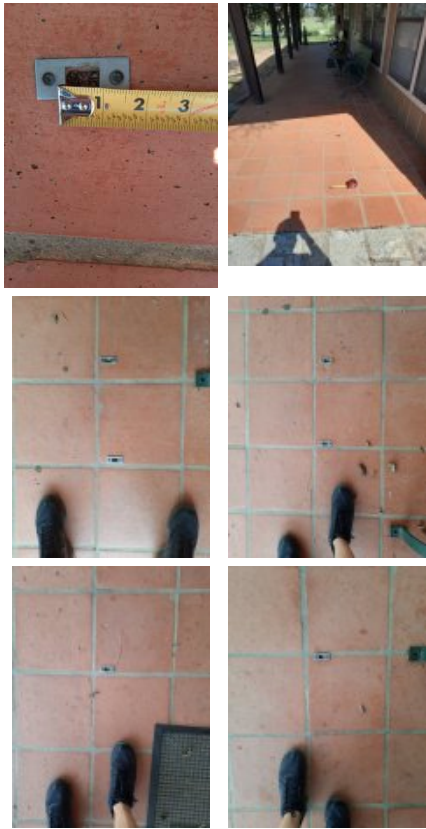
176	Group Dining Hall: Group Dining - Exterior Accessible Route	[30.2374506 , -98.6385183]	There is a gap spaced greater than a 1/2 inch. Openings in floor or ground surfaces shall not allow passage of a sphere more than 1/2 inch diameter. Elongated openings shall be placed so that the long dimension is perpendicular to the dominant direction of travel.	Seven .75" gaps caused by old brackets in floor of Group Dining Hall tiled entry	Correct or fill gaps to be max .5".	2015 ABAAS Section: 302.3 2012 TAS Section: 302.3 2010 ADAS Section: 302.3

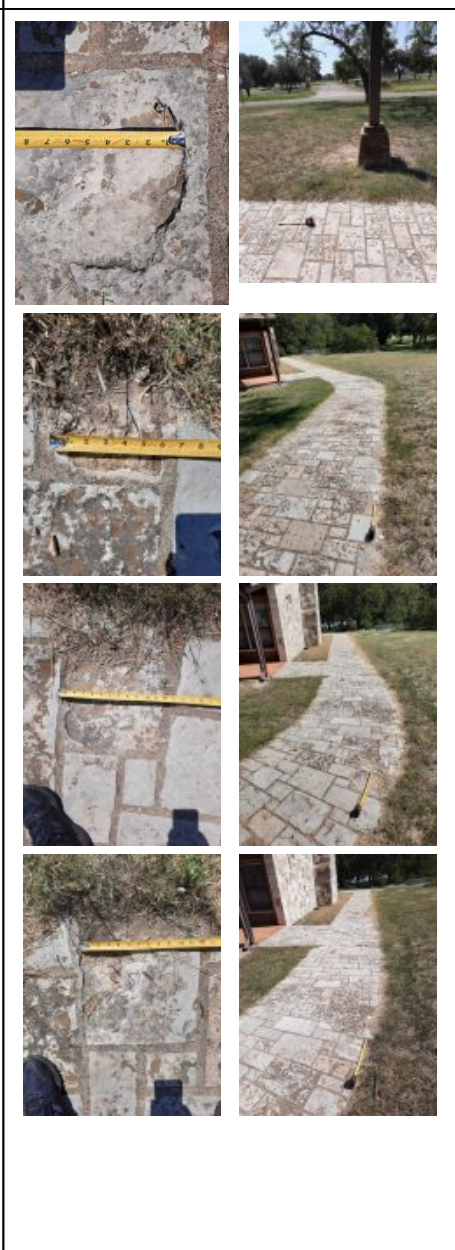
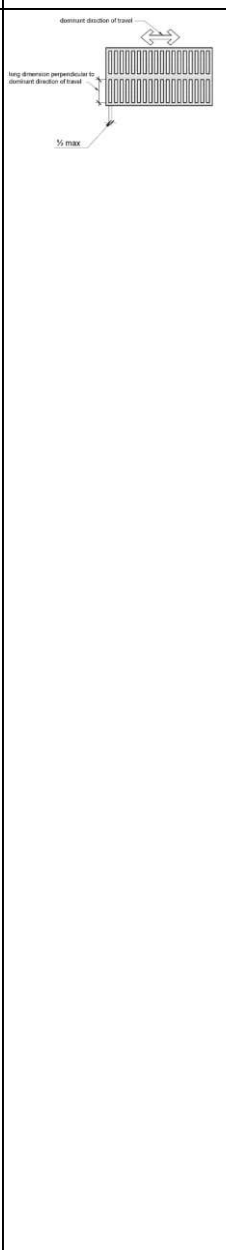
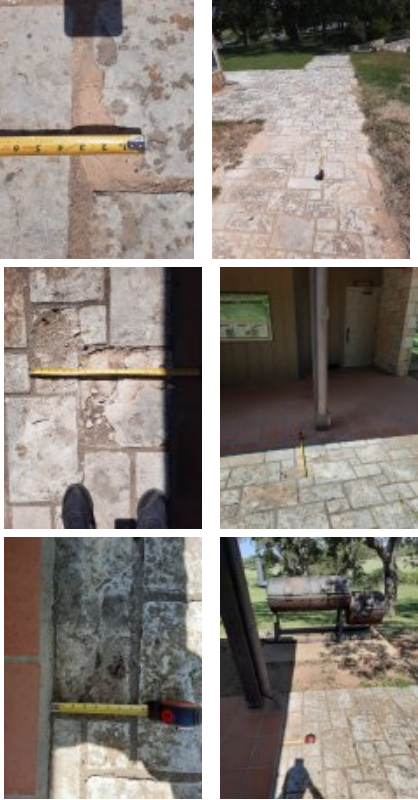
Finding Number	Area Description	Lat/Long	Finding	As Built	Recommendation	Citation	Photos	Figure
179	Group Dining Hall: Group Dining - Exterior Accessible Route	[30.2373918, -98.6386441], [30.2374636, -98.6381667]	There is a gap spaced greater than a 1/2 inch. Openings in floor or ground surfaces shall not allow passage of a sphere more than 1/2 inch diameter. Elongated openings shall be placed so that the long dimension is perpendicular to the dominant direction of travel.	Group Dining Hall - Section of route from parking lot to bridge to group picnic area - Multiple gaps (7) due to missing, broken, or deteriorated stone pavers	Correct or fill gaps to be max .5".	2015 ABAAS Section: 302.3 2012 TAS Section: 302.3 2010 ADAS Section: 302.3

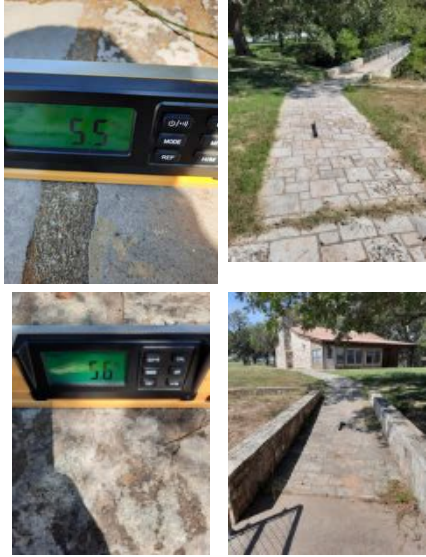
Finding Number	Area Description	Lat/Long	Finding	As Built	Recommendation	Citation	Photos	Figure
180	Group Dining Hall: Group Dining - Exterior Accessible Route	[30.2374663 , -98.6382216]	The running slope of walking surfaces shall not be steeper than 1:20.	Group Dining Hall - Section of route from parking lot to bridge to group picnic area - Running slopes of 5.5% to 5.6% (or greater) for 35'	Correct running slope along the AR to max 5%	2015 ABAAS Section: 403.3 2012 TAS Section: 403.3 2010 ADAS Section: 403.3

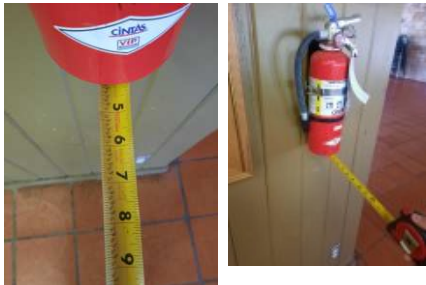
184	Group Dining Hall: Group Dining - Public Spaces	[30.23744, -98.63848]	An item or items project more than 4 inches into the circulation path. Wall-mounted objects that have leading edges between 27 inches and 80 inches from the floor must not project more than 4 inches into the circulation path. Protruding objects that extend to the floor or within 27 inches of the floor are cane detectable and are therefore not hazardous. Where it is necessary or desirable to have objects protrude from the wall, a manner of cane detection must be provided.	Fire extinguisher protrudes 4.25"	Relocate protruding objects or place cane detectable warning or bollard at foot of item.	2015 ABAAS Section: 307.2 2012 TAS Section: 307.2 2010 ADAS Section: 307.2

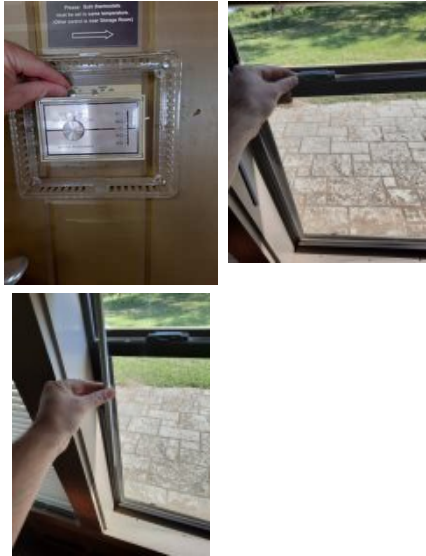
Finding Number	Area Description	Lat/Long	Finding	As Built	Recommendation	Citation	Photos	Figure
186	Group Dining Hall: Group Dining - Public Spaces	[30.23744, -98.63848]	The operable part is not accessible because it requires tight grasping, pinching or twisting of the wrist.	Thermostat controls, window locks, and blind control rod require a tight pinch	Replace operable part with one usable without a tight pinch or grasp.	2015 ABAAS Section: 309.4 2012 TAS Section: 309.4 2010 ADAS Section: 309.4

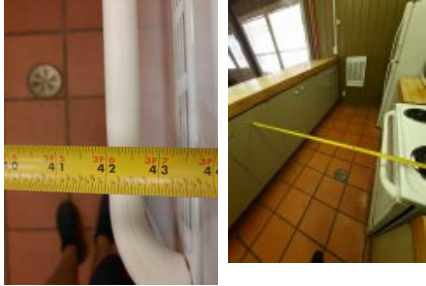
187	Group Dining Hall: Group Dining - Public Spaces	[30.2374747, -98.6384451]	The U-shaped kitchen is not wide enough. In U-shaped kitchens enclosed on three contiguous sides, clearance between all opposing base cabinets, counter tops, appliances, or walls within kitchen work areas shall be 60 inches.	Kitchen width is 43.5" at most narrow point	Renovate U shaped kitchen to provide required 60" clearance between cabinets, counter tops and appliances.	2015 ABAAS Section: 804.2.2 2012 TAS Section: 804.2.2 2010 ADAS Section: 804.2.2

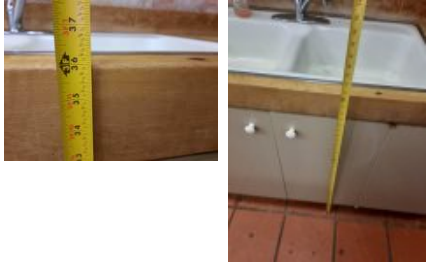
188	Group Dining Hall: Group Dining - Public Spaces	[30.237484, -98.6384532]	The top rim of the sink is too high. All lavatories/sinks that are designated to be accessible shall be a minimum 17 inches in horizontal depth and mounted with the rim or counter edge no higher than 34 inches above the finished floor.	Sink rim at 36" above the finished floor (AFF)	Lower sinks to max 34" above the finished floor (AFF) to front of rim.	2015 ABAAS Section: 606.3 2012 TAS Section: 606.3 2010 ADAS Section: 606.3

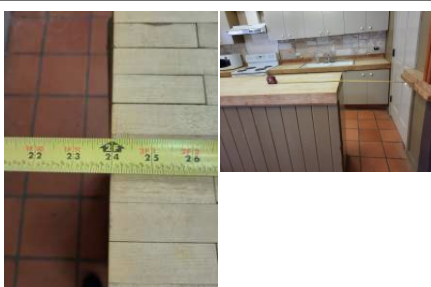
192	Group Dining Hall: Group Dining - Public Spaces	[30.2374863 , -98.638426 4]	The route of travel at this location does not provide a minimum width of 36 inches. The clear width shall be permitted to be reduced to 32 inches minimum for a length of 24 inches maximum provided that reduced width segments are separated by segments that are 48 inches long minimum and 36 inches wide minimum.	Route reduces to 24" to access kitchen	Widen AR to compliant 36" clear width.	2015 ABAAS Section: 403.5.1 2012 TAS Section: 403.5.1 2010 ADAS Section: 403.5.1

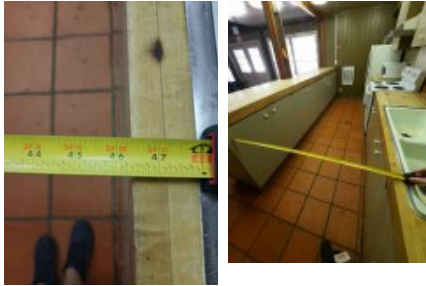
Finding Number	Area Description	Lat/Long	Finding	As Built	Recommendation	Citation	Photos	Figure
193	Group Dining Hall: Group Dining - Public Spaces	[30.2374909 , -98.638434 4]	There is insufficient turning space within this room or space. The space required for a wheelchair to make a 180-degree turn is a clear space of 60 inches in diameter or a T-shaped space.	Lacks turning space in kitchen - small space	Relocate obstacles to create turning space in kitchen	2015 ABAAS Section: 304.3.1, 304.3.2 2012 TAS Section: 304.3.1, 304.3.2 2010 ADAS Section: 304.3.1, 304.3.2

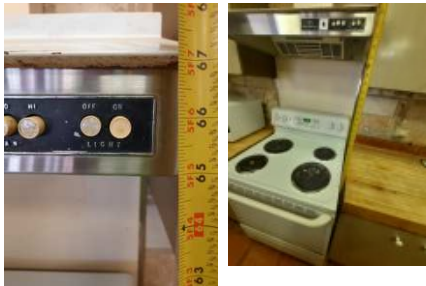
194	Group Dining Hall: Group Dining - Public Spaces	[30.2374909 , -98.638442 4]	The operable part is positioned too high for either a side or front approach. Where a clear floor or ground space allows a parallel approach to an element and the side reach is unobstructed, the high side reach shall be 48 inches maximum and the low side reach shall be 15 inches minimum above the finish floor or ground. Where a forward reach is unobstructed, the high forward reach shall be 48 inches maximum and the low forward reach shall be 15 inches minimum above the finish floor or ground.	Oven hood controls at 65.75" above the finished floor (AFF)	Remount operable parts to be in reach range of 15" min to 48" max.	2015 ABAAS Section: 308.1 2012 TAS Section: 308.1 2010 ADAS Section: 308.1

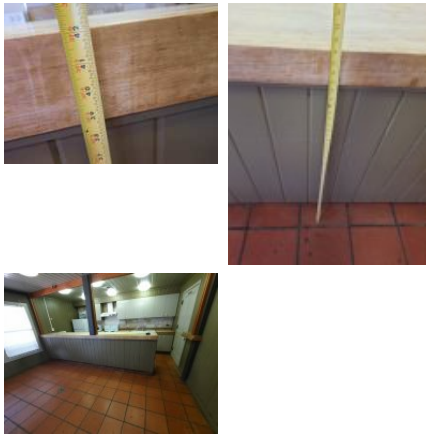
195	Group Dining Hall: Group Dining - Public Spaces	[30.2374863 , -98.638437 1]	The transaction counter is too high. A portion of the counter surface that is 36 inches long minimum and 36 inches high maximum above the finish floor shall be provided. Knee and toe space must be provided for a forward approach. A 30 inch by 48 inch clear floor space on an accessible route must be provided for either a forward or parallel approach.	Serving counter at 42" aff	Lower 36" wide segment of service counter to max 36" AFF.	2015 ABAAS Section: 904.4.2, 904.4.1 2012 TAS Section: 904.4.1, 904.4.2 2010 ADAS Section: 904.4.2, 904.4.1

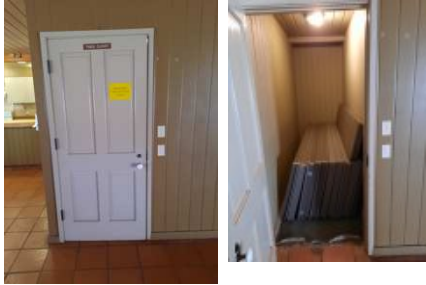
Finding Number	Area Description	Lat/Long	Finding	As Built	Recommendation	Citation	Photos	Figure
196	Group Dining Hall: Group Dining - Public Spaces	[30.2374574 , -98.6384705]	Minimum maneuvering clearances at doors and gates shall comply with 404.2.4. Maneuvering clearances shall extend the full width of the doorway and the required latch side or hinge side clearance. Hand-activated door opening hardware, handles, pulls, latches, locks, and other operating devices on accessible doors shall have a shape that is easy to grasp with one hand and does not require tight grasping, tight pinching or twisting of the wrist to operate. Hardware shall be 34 inches minimum and 48 inches maximum above the finish floor or ground.	Group Dining Hall Table Closet Door - knobs, loose floor mat/carpet on push side, lacks push side clearance due to tables and small space	For all doors along the public circulation route, provide required maneuvering clearance on push and pull side of doors. For all doors along the public circulation route, secure rug in door clearance to prevent trip hazard. For all doors along the public circulation route, replace hardware with lever hardware or hardware operable without a tight pinch or grasp.	2010 ADAS Section: 404.2.3, 404.2.7, 404.2.4, 404.2.11, 404.2.11 Exception

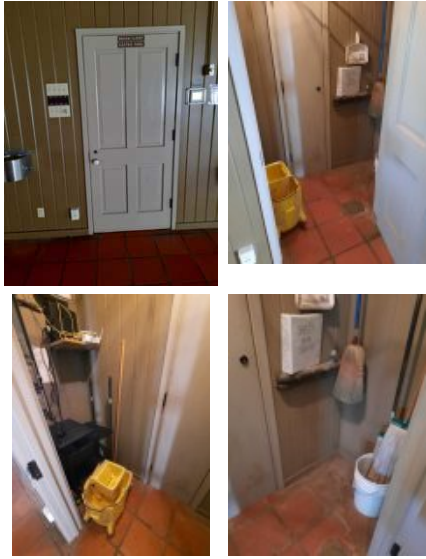
197	Group Dining Hall: Group Dining - Public Spaces	[30.2374938 , -98.638446]	Minimum maneuvering clearances at doors and gates shall comply with 404.2.4. Maneuvering clearances shall extend the full width of the doorway and the required latch side or hinge side clearance. Hand-activated door opening hardware, handles, pulls, latches, locks, and other operating devices on accessible doors shall have a shape that is easy to grasp with one hand and does not require tight grasping, tight pinching or twisting of the wrist to operate. Hardware shall be 34 inches minimum and 48 inches maximum above the finish floor or ground.	Group Dining Hall Broom Closet Door - knobs, lacks push side clearance due to small space	For all doors along the public circulation route, provide required maneuvering clearance on push and pull side of doors. For all doors along the public circulation route, replace hardware with lever hardware or hardware operable without a tight pinch or grasp.	2010 ADAS Section: 404.2.3, 404.2.7, 404.2.4, 404.2.11, 404.2.11 Exception

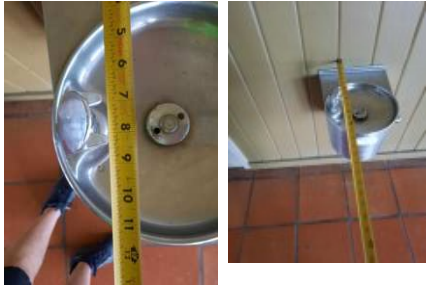
Finding Number	Area Description	Lat/Long	Finding	As Built	Recommendation	Citation	Photos	Figure
198	Group Dining Hall: Group Dining - Public Spaces	[30.2374696 , -98.638434 1]	The spout is not positioned correctly from the vertical support. The spout shall be located 15 inches minimum from the vertical support and 5 inches maximum from the front edge of the unit, including bumpers.	Drinking fountain is 7.5" from vertical support	Remount or replace fountain to provide 15" from vertical support to the spout.	2015 ABAAS Section: 602.5 2012 TAS Section: 602.5 2010 ADAS Section: 602.5

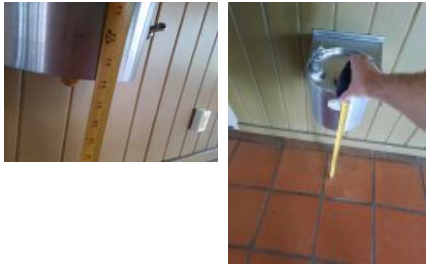
200	Group Dining Hall: Group Dining - Public Spaces	[30.2374592 , -98.638465]	There is not enough knee clearance under the drinking fountain. The drinking fountain must have a clear knee space between the bottom of the apron and the floor not less than 27 inches in height, 30 inches in width, and 8 inches in depth.	Drinking fountain - Lacks knee clearance - 22"	Raise drinking fountains to correct the height of the spout outlet.	2015 ABAAS Section: 602.2 2012 TAS Section: 602.2 2010 ADAS Section: 602.2

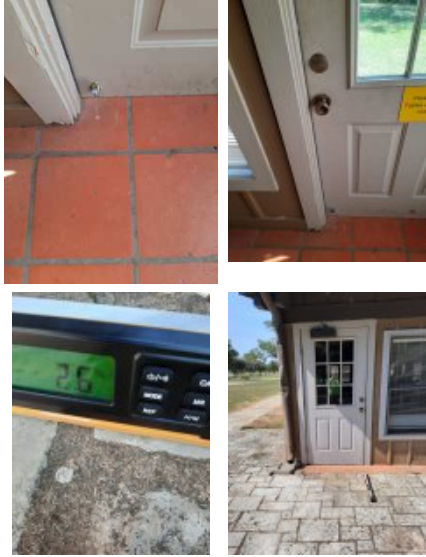
Finding Number	Area Description	Lat/Long	Finding	As Built	Recommendation	Citation	Photos	Figure
203	Group Dining Hall: Group Dining - Public Spaces	[30.2374754 , -98.638456 8]	Minimum maneuvering clearances at doors and gates shall comply with 404.2.4. Maneuvering clearances shall extend the full width of the doorway and the required latch side or hinge side clearance. Maneuvering clearances shall have a max slope of 2.08%. Exterior doors are recommended to be maintained at 8.5 lbf as a smart practice. Force is to be measured at the operating hardware or 30 inches from the hinges, whichever is greater. Hand-activated door opening hardware, handles, pulls, latches, locks, and other operating devices on accessible doors shall have a shape that is easy to grasp with one hand and does not require tight grasping, tight pinching or twisting of the wrist to operate. Hardware shall be 34 inches minimum and 48 inches maximum above the finish floor or ground. The bottom 10 inches on the push side must be smooth and free of obstructions (hold open devices). Opening hardware must be mounted between 30 and 44 inches above the floor or ground.	Group Dining Hall back door to bridge/walkways - hold open device on push side, knobs, 20# push, slope of 2.6% in pull side clearance	For all doors along the public circulation route, correct slope in door clearance to max 2.08%. For all doors along the public circulation route, inspect, adjust, and maintain 8.5 lbf to open exterior doors as a smart practice. For all doors along the public circulation route, replace hardware with lever hardware or hardware operable without a tight pinch or grasp. For all doors along the public circulation route, remove door holder to provide a smooth surface on the push side of door from floor to 10" AFF.	2010 ADAS Section: 404.2.3, 404.2.7, 404.2.4, 404.2.11, 404.2.11 Exception

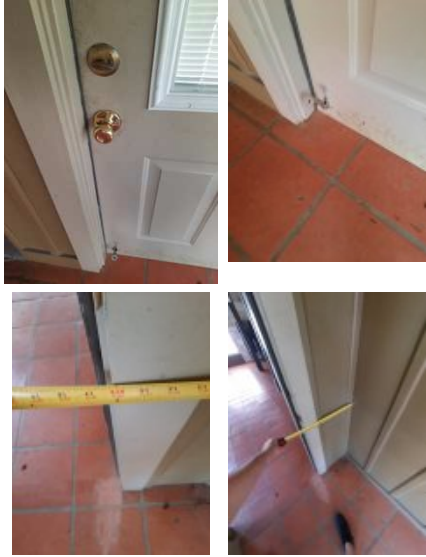
Finding Number	Area Description	Lat/Long	Finding	As Built	Recommendation	Citation	Photos	Figure
204	Group Dining Hall: Group Dining - Public Spaces	[30.2374742 , -98.638437]	Minimum maneuvering clearances at doors and gates shall comply with 404.2.4. Maneuvering clearances shall extend the full width of the doorway and the required latch side or hinge side clearance. Exterior doors are recommended to be maintained at 8.5 lbf as a smart practice. Force is to be measured at the operating hardware or 30 inches from the hinges, whichever is greater. Hand-activated door opening hardware, handles, pulls, latches, locks, and other operating devices on accessible doors shall have a shape that is easy to grasp with one hand and does not require tight grasping, tight pinching or twisting of the wrist to operate. Hardware shall be 34 inches minimum and 48 inches maximum above the finish floor or ground. The bottom 10 inches on the push side must be smooth and free of obstructions (hold open devices). Opening hardware must be mounted between 30 and 44 inches above the floor or ground.	Group Dining Hall Back Door to restrooms - knobs, hold open device on push side, 24# push (very sticky at first), 16.25" clearance to wall on pull side	For all doors along the public circulation route, provide required maneuvering clearance on push and pull side of doors. For all doors along the public circulation route, inspect, adjust, and maintain 8.5 lbf to open exterior doors as a smart practice. For all doors along the public circulation route, replace hardware with lever hardware or hardware operable without a tight pinch or grasp. For all doors along the public circulation route, remove door holder to provide a smooth surface on the push side of door from floor to 10" AFF.	2010 ADAS Section: 404.2.3, 404.2.7, 404.2.4, 404.2.11, 404.2.11 Exception

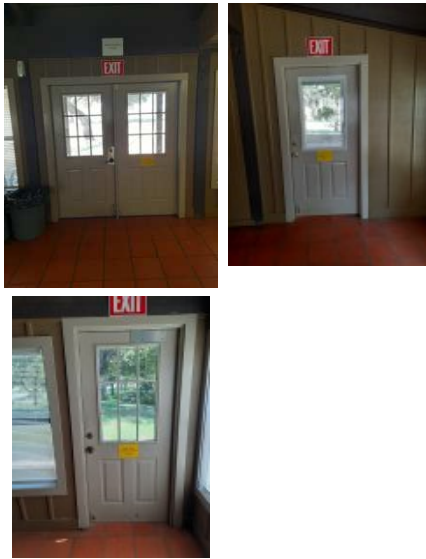
205	Group Dining Hall: Group Dining - Public Spaces	[30.2374726 , -98.638462 6]	The tactile EXIT sign is missing at the door. Wall signs identifying exits shall have characters raised 1/32 inch minimum and shall be uppercase characters a minimum of 5/8 inch and a maximum of 2 inches high. Braille shall be placed directly below the tactile characters; flush left or centered. Signs shall be located a minimum of 48 inches above the floor, measured from the baseline of the lowest tactile characters and 60 inches maximum above the finish floor or ground surface, measured from the baseline of the highest tactile characters. Where a tactile sign is provided at a door, the sign shall be located on the latch side. Where a tactile sign is provided at double doors the sign shall be located to the right of the right-hand door. Where there is no wall space at the latch side of a single door or at the right side of double doors, signs shall be located on the nearest adjacent wall.	Group Dining Hall - 3 of 3 exit doors lack tactile exit signs	Mount compliant signage at all doors along the egress route.	2015 ABAAS Section: F216.4.1 2012 TAS Section: 216.4.1 2010 ADAS Section: 216.4.1

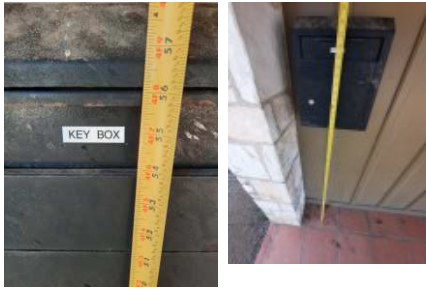
207	Group Dining Hall: Group Dining - Public Spaces	[30.2374913, -98.638502]	The operable part is positioned too high for either a side or front approach. Where a clear floor or ground space allows a parallel approach to an element and the side reach is unobstructed, the high side reach shall be 48 inches maximum and the low side reach shall be 15 inches minimum above the finish floor or ground. Where a forward reach is unobstructed, the high forward reach shall be 48 inches maximum and the low forward reach shall be 15 inches minimum above the finish floor or ground.	Group Dining Hall - Key drop box operable part at 55.75" AFF	Remount operable parts to be in reach range of 15" min to 48" max.	2015 ABAAS Section: 308.1 2012 TAS Section: 308.1 2010 ADAS Section: 308.1

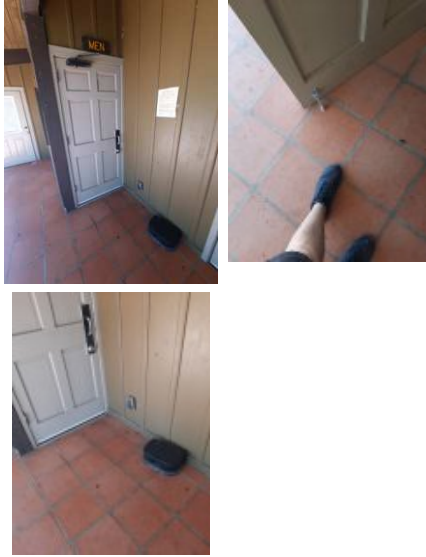
Finding Number	Area Description	Lat/Long	Finding	As Built	Recommendation	Citation	Photos	Figure
209	Group Dining Hall: Group Dining - Men's Restroom	[30.2374963 , -98.638375 5]	Minimum maneuvering clearances at doors and gates shall comply with 404.2.4. Maneuvering clearances shall extend the full width of the doorway and the required latch side or hinge side clearance. The sweep period for doors with closers shall be adjusted so that from an open position of 70 degrees, the door will take at least 3 seconds to move to a point 3 inches from the latch, measured to the leading edge of the door. The bottom 10 inches on the push side must be smooth and free of obstructions (hold open devices). Opening hardware must be mounted between 30 and 44 inches above the floor or ground.	Group Hall men's restroom door - lacks pull side clearance, fast close, hold open device on push side, storage in pull side clearance	For all doors along the public circulation route, provide required maneuvering clearance on push and pull side of doors. For all doors along the public circulation route, inspect, adjust, and maintain closing speed on door closers. For all doors along the public circulation route, remove door holder to provide a smooth surface on the push side of door from floor to 10" AFF.	2010 ADAS Section: 404.2.3, 404.2.7, 404.2.4, 404.2.11, 404.2.11 Exception

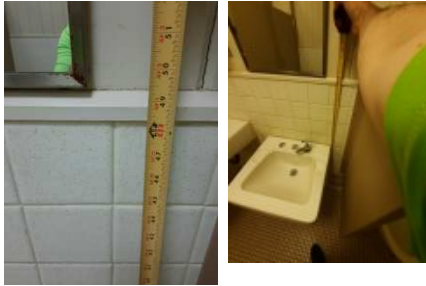
Finding Number	Area Description	Lat/Long	Finding	As Built	Recommendation	Citation	Photos	Figure
211	Group Dining Hall: Group Dining - Men's Restroom	[30.2375068 , -98.6383705]	The mirror is mounted too high. Mirrors must have the bottom edge of the reflecting surface a maximum of 40 inches above the floor if above a sink or counter. Mirrors not located above lavatories or countertops shall be installed with the bottom edge of the reflecting surface 35 inches maximum above the finish floor or ground.	Bottom edge of mirror at 49.75" above the finished floor (AFF)	Lower mirror so bottom reflective surface is max 40" AFF and 74" at the top.	2015 ABAAS Section: 603.3 2012 TAS Section: 603.3 2010 ADAS Section: 603.3

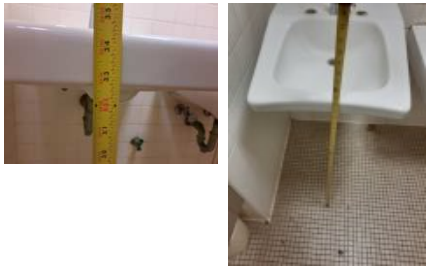
212	Group Dining Hall: Group Dining - Men's Restroom	[30.2375138 , -98.6383624]	The top rim of the sink is too high. All lavatories/sinks that are designated to be accessible shall be a minimum 17 inches in horizontal depth and mounted with the rim or counter edge no higher than 34 inches above the finished floor.	Sink rim of higher sink with knee clearance is 34.5" AFF	Lower sinks to max 34" above the finished floor (AFF) to front of rim.	2015 ABAAS Section: 606.3 2012 TAS Section: 606.3 2010 ADAS Section: 606.3

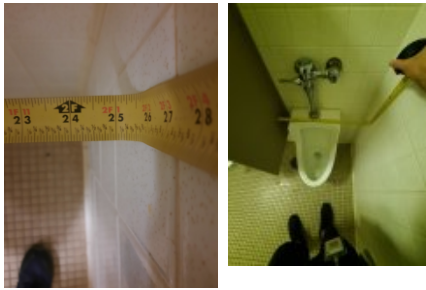
214	Group Dining Hall: Group Dining - Men's Restroom	[30.2374813 , -98.6384348]	The urinal is located in an area that does not provide the required clear floor space for a front approach. The surrounding elements of a urinal must provide a minimum of 30 by 48 inches of clear floor space for a front approach.	Accessible urinal lacks 30" wide clear floor space (CFS) - 25"	Relocate privacy wall at urinal to provide 30" CFS.	2015 ABAAS Section: 605.2 2012 TAS Section: 605.2 2010 ADAS Section: 605.2

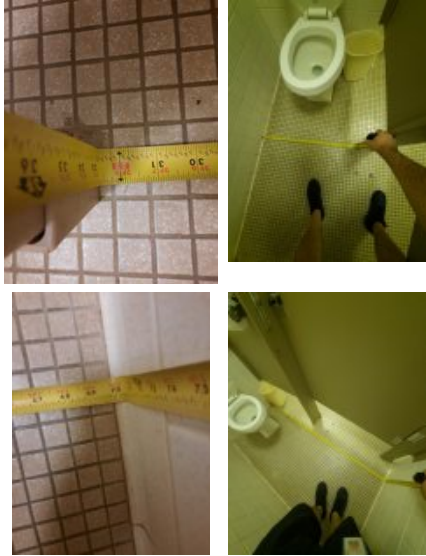
Finding Number	Area Description	Lat/Long	Finding	As Built	Recommendation	Citation	Photos	Figure
216	Group Dining Hall: Group Dining - Men's Restroom	[30.2375045 , -98.6383678]	There are not enough accessible toilet compartments. The room contains toilet compartments. A minimum of 1 must be wheelchair accessible .	Lacks accessible toilet compartment - dimensions fail - 32.5" by 70"	Create a wheelchair accessible stall with grab bars and fixtures mounted in correct locations and at correct heights.	2015 ABAAS Section: F213.3.1 2012 TAS Section: 213.3.1 2010 ADAS Section: 213.3.1

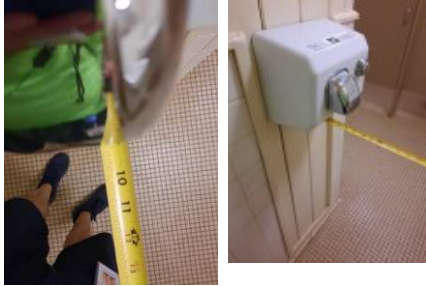
217	Group Dining Hall: Group Dining - Men's Restroom	[30.2375114 , -98.6383705]	An item or items project more than 4 inches into the circulation path. Wall-mounted objects that have leading edges between 27 inches and 80 inches from the floor must not project more than 4 inches into the circulation path. Protruding objects that extend to the floor or within 27 inches of the floor are cane detectable and are therefore not hazardous. Where it is necessary or desirable to have objects protrude from the wall, a manner of cane detection must be provided.	Hand dryer protrudes 9"	Relocate protruding objects or place cane detectable warning or bollard at foot of item.	2015 ABAAS Section: 307.2 2012 TAS Section: 307.2 2010 ADAS Section: 307.2

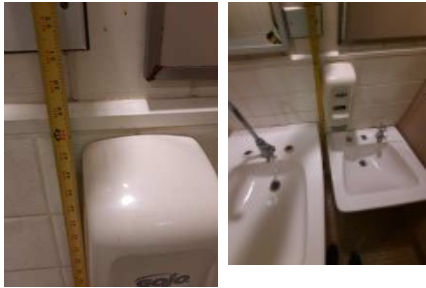
219	Group Dining Hall: Group Dining - Women's Restroom	[30.237518, -98.6383728]	The mirror is mounted too high. Mirrors must have the bottom edge of the reflecting surface a maximum of 40 inches above the floor if above a sink or counter. Mirrors not located above lavatories or countertops shall be installed with the bottom edge of the reflecting surface 35 inches maximum above the finish floor or ground.	Bottom edge of mirror at 50.5"	Lower mirror so bottom reflective surface is max 40" AFF and 74" at the top.	2015 ABAAS Section: 603.3 2012 TAS Section: 603.3 2010 ADAS Section: 603.3

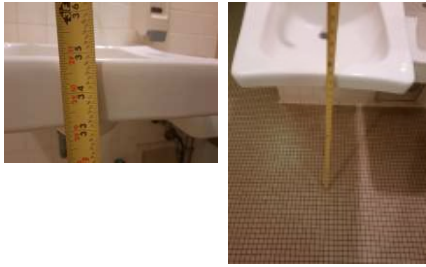
220	Group Dining Hall: Group Dining - Women's Restroom	[30.2375191 , -98.6383607]	The top rim of the sink is too high. All lavatories/sinks that are designated to be accessible shall be a minimum 17 inches in horizontal depth and mounted with the rim or counter edge no higher than 34 inches above the finished floor.	Sink rim of higher sink with knee clearance at 35" above the finished floor (AFF)	Lower sinks to max 34" above the finished floor (AFF) to front of rim.	2015 ABAAS Section: 606.3 2012 TAS Section: 606.3 2010 ADAS Section: 606.3

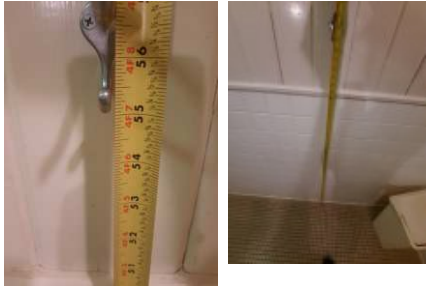
222	Group Dining Hall: Group Dining - Women's Restroom	[30.2375122 , -98.638366 1]	Where a high forward reach is over an obstruction, the clear floor space shall extend beneath the element for a distance not less than the required reach depth over the obstruction. The high forward reach shall be 48 inches (1220 mm) maximum where the reach depth is 20 inches (510 mm) maximum. Where the reach depth exceeds 20 inches (510 mm), the high forward reach shall be 44 inches (1120 mm) maximum and the reach depth shall be 25 inches (635 mm) maximum. Where a clear floor or ground space allows a parallel approach to an element and the high side reach is over an obstruction, the height of the obstruction shall be 34 inches (865 mm) maximum and the depth of the obstruction shall be 24 inches (610 mm) maximum. The high side reach shall be 48 inches (1220 mm) maximum for a reach depth of 10 inches (255 mm) maximum. Where the reach depth exceeds 10 inches (255 mm), the high side reach shall be 46 inches (1170 mm) maximum for a reach depth of 24 inches (610 mm) maximum.	Coat hook at 55.5"	Lower coat hook to max 48" above the finished floor (AFF) to highest operable part.	2015 ABAAS Section: 308.2.1, 308.3.2 2012 TAS Section: 308.2.1, 308.3.2 2010 ADAS Section: 308.2.1, 308.3.2

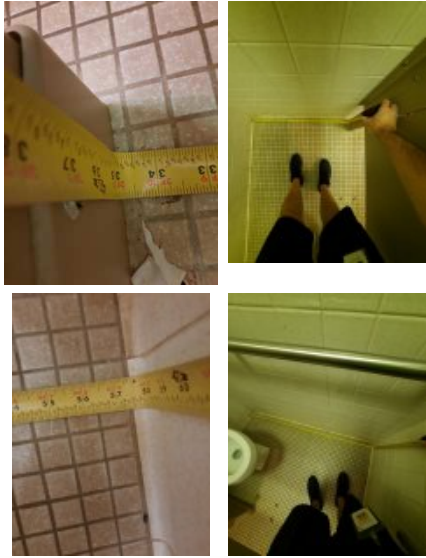
Finding Number	Area Description	Lat/Long	Finding	As Built	Recommendation	Citation	Photos	Figure
223	Group Dining Hall: Group Dining - Women's Restroom	[30.2375215 , -98.638368 8]	There are not enough accessible toilet compartments. The room contains toilet compartments. A minimum of 1 must be wheelchair accessible .	Lacks accessible toilet compartments - dimensions fail - 34.75" by 57.5"	Create a wheelchair accessible stall with grab bars and fixtures mounted in correct locations and at correct heights.	2015 ABAAS Section: F213.3.1 2012 TAS Section: 213.3.1 2010 ADAS Section: 213.3.1

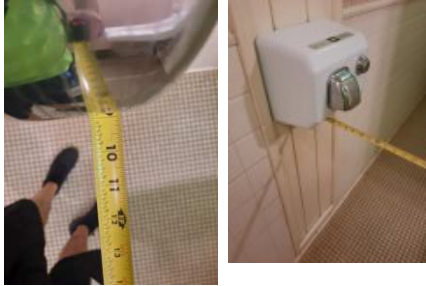
224	Group Dining Hall: Group Dining - Women's Restroom	[30.2375145 , -98.638366 1]	An item or items project more than 4 inches into the circulation path. Wall-mounted objects that have leading edges between 27 inches and 80 inches from the floor must not project more than 4 inches into the circulation path. Protruding objects that extend to the floor or within 27 inches of the floor are cane detectable and are therefore not hazardous. Where it is necessary or desirable to have objects protrude from the wall, a manner of cane detection must be provided.	Hand dryer protrudes 9"	Relocate protruding objects or place cane detectable warning or bollard at foot of item.	2015 ABAAS Section: 307.2 2012 TAS Section: 307.2 2010 ADAS Section: 307.2

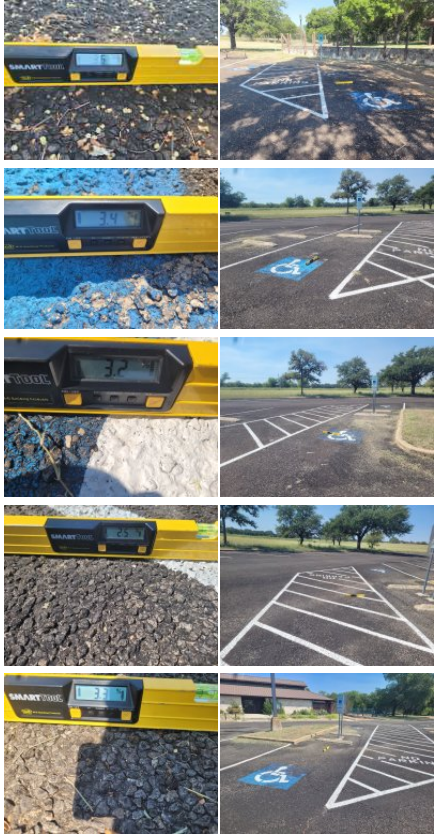
Finding Number	Area Description	Lat/Long	Finding	As Built	Recommendation	Citation	Photos	Figure
228	Aquatic Complex: Aquatic - Parking	[30.2357762 , -98.6377564]	The cross slopes (narrow dimension) and/or running slopes (long dimension) of the access aisle exceeds 2%. The running slope and the cross slope in an accessible parking stall and the access aisle must not exceed 2%.	West stalls: right stall - 3.6%; East stalls: left front stall - 3.4%, right front stall - 3.2%, back aisle - 2.5%, back stall - 3.3%	Repair or correct slope of parking space and access aisle to max 2.08% in any direction.	2015 ABAAS Section: 502.4 2012 TAS Section: 502.4 2010 ADAS Section: 502.4

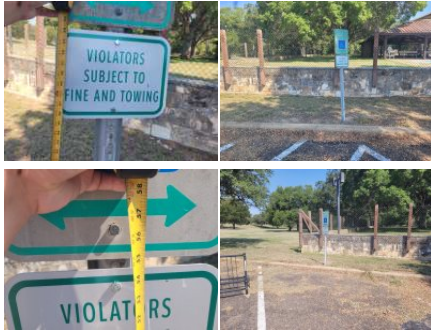
Finding Number	Area Description	Lat/Long	Finding	As Built	Recommendation	Citation	Photos	Figure
230	Aquatic Complex: Aquatic - Parking	[30.2357716 , -98.637751]	The parking sign is mounted too low. Parking space identification signs shall include the International Symbol of Accessibility complying with. Signs identifying van parking spaces shall contain the designation "van accessible." Signs shall be 60 inches minimum above the finish floor or ground surface measured to the bottom of the sign.	All 5 violation signs below 60"; west stalls- both stalls parking sign 55"	Raise existing accessible parking related signs so lowest end of bottom sign is min 60" above ground level (AGL) measured from the surface of the stall.	2015 ABAAS Section: 502.6 2012 TAS Section: 502.6 2010 ADAS Section: 502.6

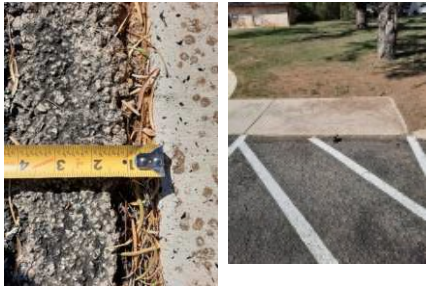
232	Aquatic Complex: Aquatic - Parking	[30.2361661 , -98.621295 6]	The parking stall contains abrupt edges and surface irregularities over a 1/4 inch vertical. Parking spaces and access aisles serving them shall be stable, firm, and slip resistant. Access aisles shall be at the same level as the parking spaces they serve. Changes in level are not permitted and shall not be sloped steeper than 2% in any direction.	East picnic Area restroom parking - Gap of 1.5" at head of access aisle	Correct or fill 1" gap in parking surface.	2015 ABAAS Section: 502.4 2012 TAS Section: 502.4 2010 ADAS Section: 502.4

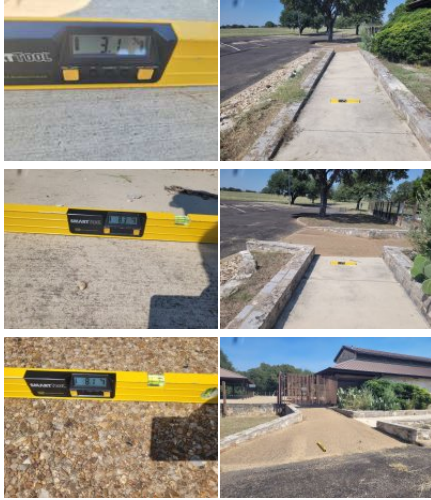
235	Aquatic Complex: Aquatic - Exterior Accessible Route	[30.2358991 , -98.637715 1]	The running slope of walking surfaces shall not be steeper than 1:20. The cross slope of walking surfaces shall not be steeper than 1:48.	3% and 8.3% towards west parking stalls, 8.1% at parking lot on west entry	Correct running slopes to max 5% and cross to max 2.08%.	2012 TAS Section: 403.3 2010 ADAS Section: 403.3

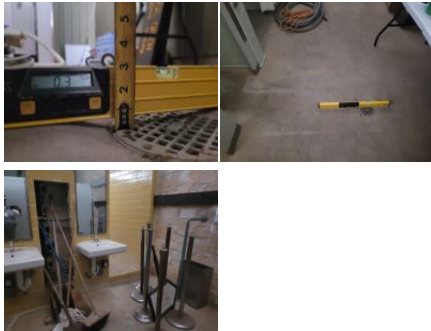
257	Aquatic Complex: Aquatic - Women's Locker Room	[30.23594, -98.63746]	There is a change in level greater than 1/4 inch. 1/4 inch is the maximum vertical rise. Changes in level between 1/4 inch and 1/2 inch must be beveled at 1:2 or less. Changes in level greater than 1/2 inch must be by way of a ramp.	.5" drop to drain; CIL to enter shower area, but accessible shower provided outside this area	Repair, bevel or ramp CIL along accessible route (AR) to max .25".	2015 ABAAS Section: 303.3 2012 TAS Section: 303.3 2010 ADAS Section: 303.3

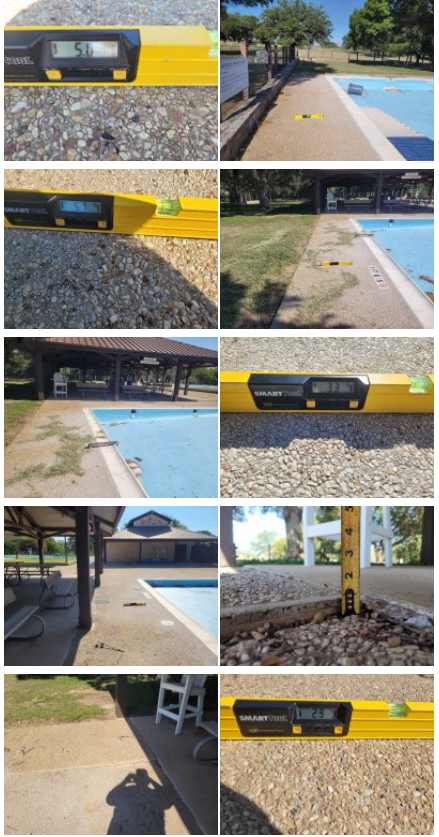
267	Aquatic Complex: Aquatic - Swimming Pool	[30.23611, -98.63741]	An accessible route on the deck shall be maintained for access to all areas of the pool accessed by the public.	4% and 5.7% around kiddie pool, CIL at pipe, 3.3% by drain at kiddie pool, 1" CIL by shelter, 2.9% by diving board, 4.2% near diving well, 2.9% near 5ft, 3% east side, 5.3% at drain, 3.1% near drinking fountain	Maintain an accessible route along the pool deck that is min 36" clear width and having 80" overhead clearance and turning spaces and free of gaps and CIL.	2010 ADAS Section: 403.5.1, 304.3.1, 307.4, 206.2.2

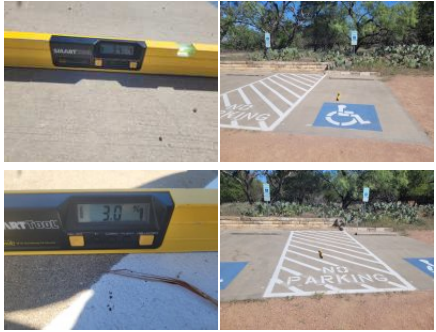
Finding Number	Area Description	Lat/Long	Finding	As Built	Recommendation	Citation	Photos	Figure
272	Sauer-Beckmann Living History Farm: Farm - Parking	[30.2352669 , -98.624131]	Element meets all standards and requirements	Farm parking lot meets scoping requirements -10 standard, 2 accessible	None	2010 ADAS Section: N/A		
273	Sauer-Beckmann Living History Farm: Farm - Parking	[30.2352229 , -98.6241068]	The cross slopes (narrow dimension) and/or running slopes (long dimension) of the access aisle exceeds 2%. The running slope and the cross slope in an accessible parking stall and the access aisle must not exceed 2%.	3.4% slope in right stall, 3% in access aisle	Repair or correct slope of parking space and access aisle to max 2.08% in any direction.	2015 ABAAS Section: 502.4 2012 TAS Section: 502.4 2010 ADAS Section: 502.4

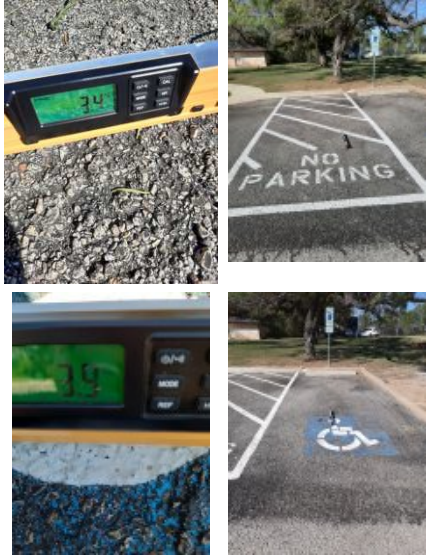
Finding Number	Area Description	Lat/Long	Finding	As Built	Recommendation	Citation	Photos	Figure
276	Sauer-Beckmann Living History Farm: Farm - Parking	[30.236173, -98.6213037]	The cross slopes (narrow dimension) and/or running slopes (long dimension) of the access aisle exceeds 2%. The running slope and the cross slope in an accessible parking stall and the access aisle must not exceed 2%.	East picnic Area restroom parking - access aisle (AA) - 3.4%, stall - 3.9%	Repair or correct slope of parking space and access aisle to max 2.08% in any direction.	2015 ABAAS Section: 502.4 2012 TAS Section: 502.4 2010 ADAS Section: 502.4

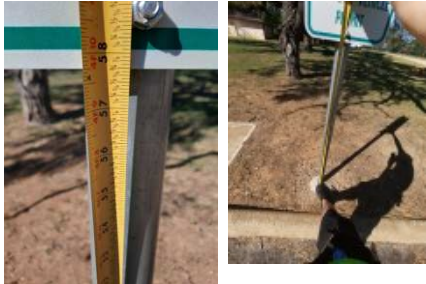
277	Sauer-Beckmann Living History Farm: Farm - Parking	[30.2361777, -98.6212997]	The parking sign is mounted too low. Parking space identification signs shall include the International Symbol of Accessibility complying with. Signs identifying van parking spaces shall contain the designation "van accessible." Signs shall be 60 inches minimum above the finish floor or ground surface measured to the bottom of the sign.	Fine sign at 57.75" above ground level (AGL)	Raise existing accessible parking signs so lowest end of bottom sign is min 60" above ground level (AGL) measured from the surface of the stall.	2015 ABAAS Section: 502.6 2012 TAS Section: 502.6 2010 ADAS Section: 502.6

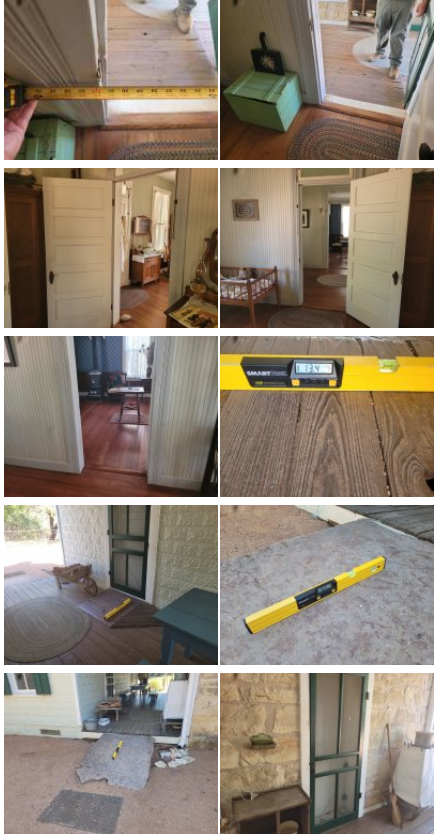
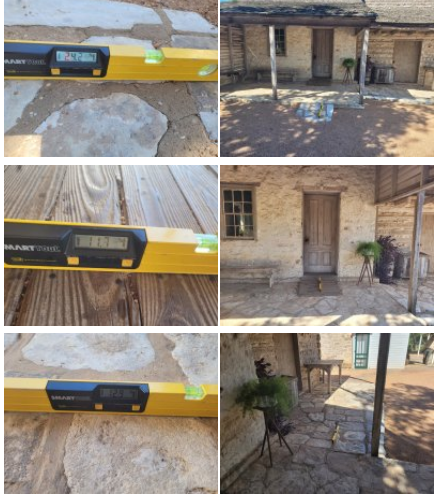
286	Sauer-Beckmann Living History Farm: Farm - Main House	[30.236325, -98.6232918]	Minimum maneuvering clearances at doors and gates shall comply with 404.2.4. Maneuvering clearances shall extend the full width of the doorway and the required latch side or hinge side clearance. Maneuvering clearances shall have a max slope of 2.08%. Door openings shall provide a clear width of 32 inches (815 mm) minimum. Clear openings of doorways with swinging doors shall be measured between the face of the door and the stop, with the door open 90 degrees. Openings more than 24 inches (610 mm) deep shall provide a clear opening of 36 inches (915 mm) minimum. There shall be no projections into the required clear opening width lower than 34 inches (865 mm) above the finish floor or ground. Projections into the clear opening width between 34 inches (865 mm) and 80 inches (2030 mm) above the finish floor or ground shall not exceed 4 inches (100 mm).	Doors narrow - approximately 31", small ramps with high slopes	For all doors along the public circulation route, provide required maneuvering clearance on push and pull side of doors. For all doors along the public circulation route, correct slope in door clearance to max 2.08%. For all doors along the public circulation route, replace doors with doors having 80" overhead clearance and 32" clear width.	2010 ADAS Section: 404.2.3, 404.2.7, 404.2.4, 404.2.11, 404.2.11 Exception

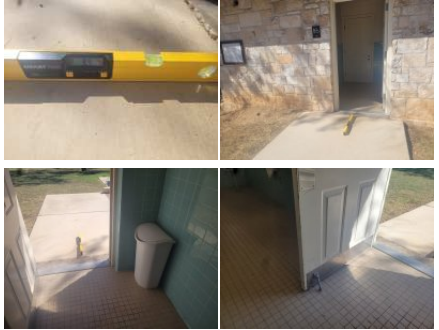
Finding Number	Area Description	Lat/Long	Finding	As Built	Recommendation	Citation	Photos	Figure
297	Sauer-Beckmann Living History Farm: East End Men's Restroom	[30.2364885, -98.6213864]	Minimum maneuvering clearances at doors and gates shall comply with 404.2.4. Maneuvering clearances shall extend the full width of the doorway and the required latch side or hinge side clearance. Maneuvering clearances shall have a max slope of 2.08%. The sweep period for doors with closers shall be adjusted so that from an open position of 70 degrees, the door will take at least 3 seconds to move to a point 3 inches from the latch, measured to the leading edge of the door. Exterior doors are recommended to be maintained at 8.5 lbf as a smart practice. Force is to be measured at the operating hardware or 30 inches from the hinges, whichever is greater. The bottom 10 inches on the push side must be smooth and free of obstructions (hold open devices). Opening hardware must be mounted between 30 and 44 inches above the floor or ground. Egress doors shall provide a continuous and unobstructed way of egress travel from any point in a building or facility that provides an accessible route to an area of refuge, a horizontal exit, or a public way.	Men's restroom door - 3.4% slope in clearance, garbage can in pull side clearance, door stop on push side, 10# push, fast close	For all doors along the public circulation route, provide required maneuvering clearance on push and pull side of doors. For all doors along the public circulation route, correct slope in door clearance to max 2.08%. For all doors along the public circulation route, inspect, adjust, and maintain closing speed on door closers. For all doors along the public circulation route, inspect, adjust, and maintain 8.5 lbf to open exterior doors as a smart practice. For all doors along the public circulation route, remove door holder to provide a smooth surface on the push side of door from floor to 10" AFF.	2010 ADAS Section: 404.2.3, 404.2.7, 404.2.4, 404.2.11, 404.2.11 Exception

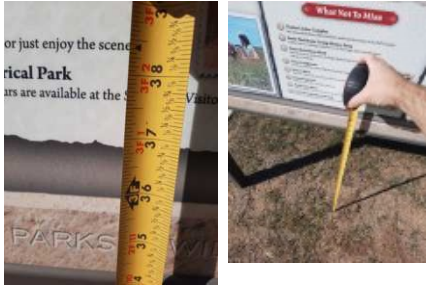
Finding Number	Area Description	Lat/Long	Finding	As Built	Recommendation	Citation	Photos	Figure
300	Sauer-Beckmann Living History Farm: East End Men's Restroom	[30.2364091 , -98.621459 5]	Visual characters shall be 40 inches (1015 mm) minimum above the finish floor or ground. EXCEPTION: Visual characters indicating elevator car controls shall not be required to comply with 703.5.6.	Map/info sign at restrooms near picnic area - text starts at 37.5" above ground level (AGL)	Remount signage to min 40" AFF.	2015 ABAAS Section: 703.5.6, 703.5.6 EXCEPTION 2012 TAS Section: 703.5.6, 703.5.6 Exception 2010 ADAS Section: 703.5.6, 703.5.6 Exception

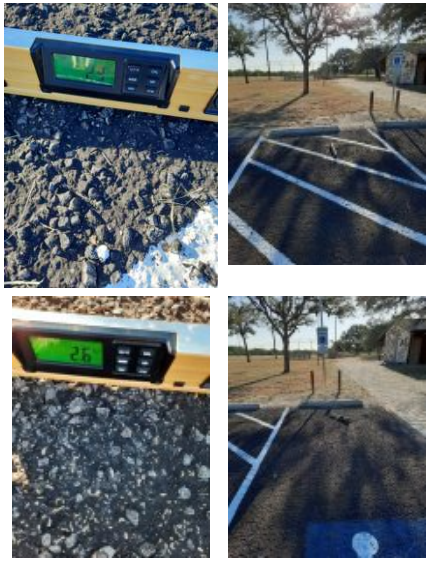
309	Park Elements: Ball Field Parking	[30.235514, -98.642408]	The cross slopes (narrow dimension) and/or running slopes (long dimension) of the access aisle exceeds 2%. The running slope and the cross slope in an accessible parking stall and the access aisle must not exceed 2%.	Shared access aisle (AA) - 2.9%, right stall - 2.6%	Repair or correct slope of parking space and access aisle to max 2.08% in any direction.	2015 ABAAS Section: 502.4 2012 TAS Section: 502.4 2010 ADAS Section: 502.4

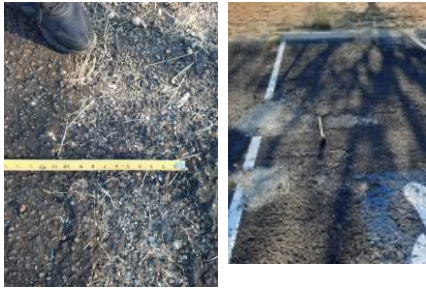
310	Park Elements: Ball Field Parking	[30.2355174, -98.6424107]	The parking stall contains abrupt edges and surface irregularities over a 1/4 inch vertical. Parking spaces and access aisles serving them shall be stable, firm, and slip resistant. Access aisles shall be at the same level as the parking spaces they serve. Changes in level are not permitted and shall not be sloped steeper than 2% in any direction.	Severe deterioration of surface causing CILs and gaps, surface is rough causing CILs, CILs along right side of right stall where stall meets paver route	Resurface stalls and access aisles to eliminate gaps and cracks.	2015 ABAAS Section: 502.4 2012 TAS Section: 502.4 2010 ADAS Section: 502.4

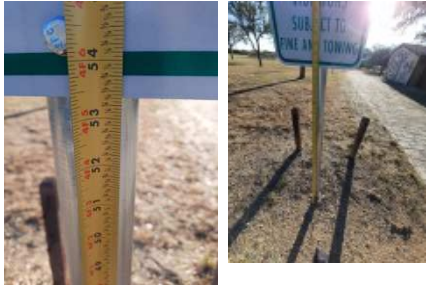
Finding Number	Area Description	Lat/Long	Finding	As Built	Recommendation	Citation	Photos	Figure
311	Park Elements: Ball Field Parking	[30.2355116 , -98.6424094]	The parking sign is mounted too low. Parking space identification signs shall include the International Symbol of Accessibility complying with. Signs identifying van parking spaces shall contain the designation "van accessible." Signs shall be 60 inches minimum above the finish floor or ground surface measured to the bottom of the sign.	"Violators Subject To Fine And Towing signs at 53.5" AGL, R7-8 signs comply	Raise existing accessible parking related signs so lowest end of bottom sign is min 60" above ground level (AGL) measured from the surface of the stall.	2015 ABAAS Section: 502.6 2012 TAS Section: 502.6 2010 ADAS Section: 502.6
