Access Audit Site Report

Lyndon B Johnson State Park and Historic Site

**199 Park Road 52
Stonewall, TX 78671**

**Inspection Date: 09/27/2022
Inspectors: Tanya Scheibe**

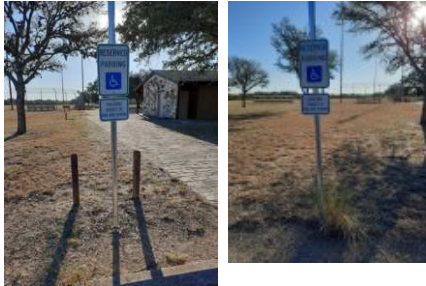
312	Park Elements: Ball Field Parking	[30.2355116 , -98.6424027]	The van stall is missing a sign identifying it as a van accessible stall. Parking space identification signs shall include the International Symbol of Accessibility. Signs identifying van parking spaces shall contain the designation "van accessible."	2 of 2 accessible parking spaces meet requirements for van accessible spaces, but both lack signs	Add one van parking sign to one accessible stall and ensure stall and access aisle are 11' and 5' or 8' and 8'.	2015 ABAAS Section: 502.6 2012 TAS Section: 502.6 2010 ADAS Section: 502.6

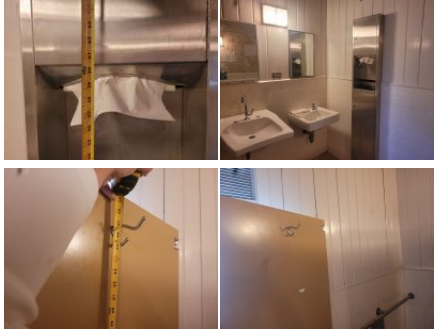
Finding Number	Area Description	Lat/Long	Finding	As Built	Recommendation	Citation	Photos	Figure
319	Park Elements: Ball Field	[30.2353749 , -98.642193 3]	The operable part is positioned too high for either a side or front approach. Where a clear floor or ground space allows a parallel approach to an element and the side reach is unobstructed, the high side reach shall be 48 inches maximum and the low side reach shall be 15 inches minimum above the finish floor or ground. Where a forward reach is unobstructed, the high forward reach shall be 48 inches maximum and the low forward reach shall be 15 inches minimum above the finish floor or ground.	Women's ballfield restroom - paper towels at 59", hook at 65"	Remount operable parts to be in reach range of 15" min to 48" max.	2015 ABAAS Section: 308.1 2012 TAS Section: 308.1 2010 ADAS Section: 308.1

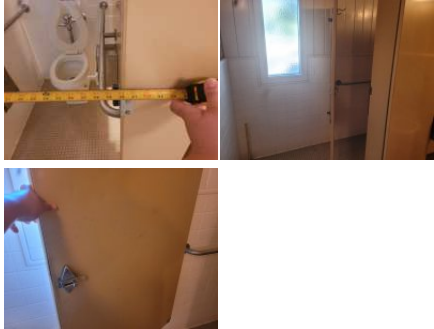
Finding Number	Area Description	Lat/Long	Finding	As Built	Recommendation	Citation	Photos	Figure
322	Park Elements: Ball Field	[30.235376, -98.642187 9]	The stall door fails to comply with all of the door requirements. The stall door must be a minimum of 32" wide and have compliant hardware on both sides. The stall door must be self-closing.	Women's ballfield restroom - 30" wide door, lacks interior handle, not self-closing	Widen stall doors to 32" when opened to 90 degrees. Adjust stall door to be self-closing. Replace stall hardware with hardware operable without a tight pinch or grasp on both sides of the stall door.	2015 ABAAS Section: 404.2.3, 404.2.7, 604.8.2.2 2012 TAS Section: 404.2.3, 404.2.7, 604.8.2.2 2010 ADAS Section: 404.2.3, 404.2.7, 604.8.2.2

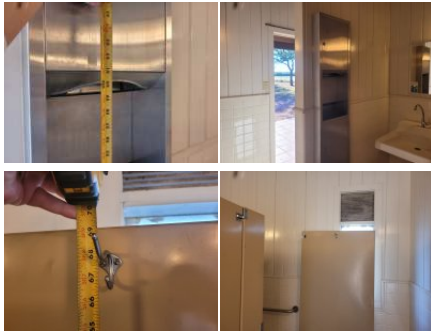
331	Park Elements: Ball Field	[30.2353695, -98.642177 3]	The operable part is positioned too high for either a side or front approach. Where a clear floor or ground space allows a parallel approach to an element and the side reach is unobstructed, the high side reach shall be 48 inches maximum and the low side reach shall be 15 inches minimum above the finish floor or ground. Where a forward reach is unobstructed, the high forward reach shall be 48 inches maximum and the low forward reach shall be 15 inches minimum above the finish floor or ground.	Men's ballfield restroom - paper towels at 60", hook at 67"	Remount operable parts to be in reach range of 15" min to 48" max.	2015 ABAAS Section: 308.1 2012 TAS Section: 308.1 2010 ADAS Section: 308.1

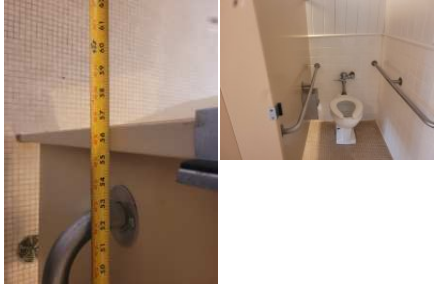
Finding Number	Area Description	Lat/Long	Finding	As Built	Recommendation	Citation	Photos	Figure
333	Park Elements: Ball Field	[30.2353672 , -98.642196 1]	The ambulatory stall is not between 35" to 37" wide and 60" deep.	Men's ballfield restroom - ambulatory stall is 55.5" deep	Correct ambulatory stall to be 35" to 37" wide and minimum 60" deep.	2015 ABAAS Section: 604.8.2.1 2012 TAS Section: 604.8.2.1 2010 ADAS Section: 604.8.2.1

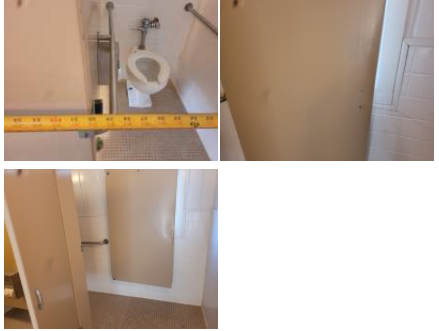
334	Park Elements: Ball Field	[30.2353788 , -98.642198 8]	The stall door fails to comply with all of the door requirements. The stall door must be a minimum of 32" wide and have compliant hardware on both sides. The stall door must be self-closing.	Men's ballfield restroom - 30", lacks interior handle, not self-closing	Widen stall doors to 32" when opened to 90 degrees. Adjust stall door to be self-closing. Replace stall hardware with hardware operable without a tight pinch or grasp on both sides of the stall door.	2015 ABAAS Section: 404.2.3, 404.2.7, 604.8.2.2 2012 TAS Section: 404.2.3, 404.2.7, 604.8.2.2 2010 ADAS Section: 404.2.3, 404.2.7, 604.8.2.2

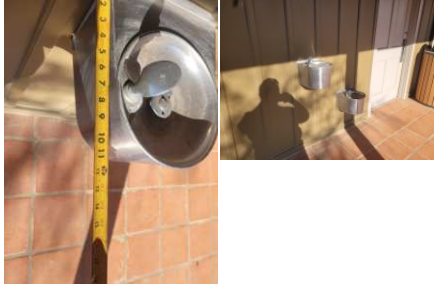
Finding Number	Area Description	Lat/Long	Finding	As Built	Recommendation	Citation	Photos	Figure
339	Park Elements: Ball Field	[30.2353917 , -98.642192 9]	An item or items project more than 4 inches into the circulation path. Wall-mounted objects that have leading edges between 27 inches and 80 inches from the floor must not project more than 4 inches into the circulation path. Protruding objects that extend to the floor or within 27 inches of the floor are cane detectable and are therefore not hazardous. Where it is necessary or desirable to have objects protrude from the wall, a manner of cane detection must be provided.	Ballfield restroom drinking fountain - protrudes 12"	Relocate protruding objects or place cane detectable warning or bollard at foot of item.	2015 ABAAS Section: 307.2 2012 TAS Section: 307.2 2010 ADAS Section: 307.2

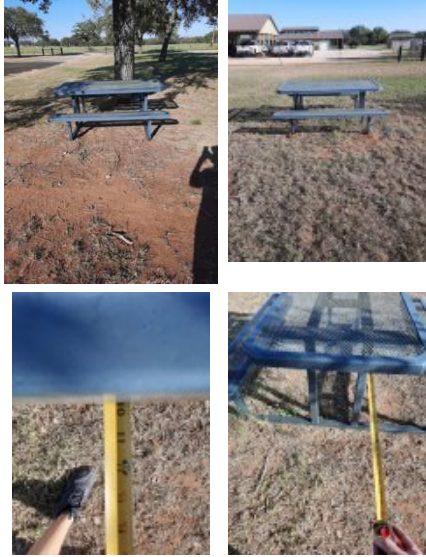
Finding Number	Area Description	Lat/Long	Finding	As Built	Recommendation	Citation	Photos	Figure
345	Park Elements: Ball Field	[30.2362704 , -98.64236]	Picnic tables shall provide at least one wheelchair space for each 24 linear feet (7320 mm) of usable table surface perimeter. Wheelchair spaces shall be 30 inches (760 mm) minimum by 48 inches (1220 mm) minimum. Wheelchair spaces shall be positioned for a forward approach to the table and provide knee and toe clearance complying with 306 under the table	2 of 2 picnic tables between ballfield and maintenance are not of an accessible design	Replace picnic tables with ones of an accessible design as a smart practice.	2015 ABAAS Section: 1011.4.2

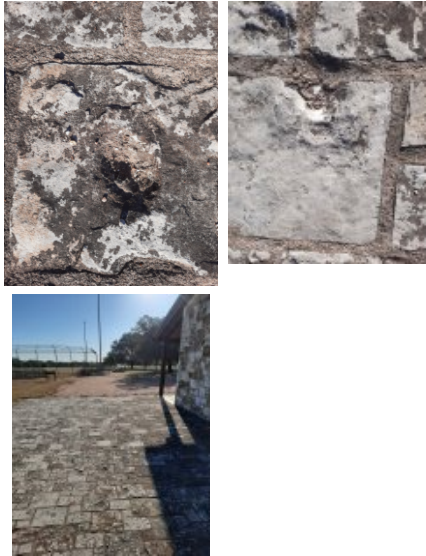
346	Park Elements: Ball Field	[30.2354623 , -98.6423707]	The accessible route contains loose gravel and/or surfaces that do not provide for a stable, firm slip resistant surface.	Ballfield Area - Section of route from parking lot to restroom building - surface is cut stone pavers with natural surface irregularities causing gaps and CILs	Resurface AR where deterioration occurs.	2015 ABAAS Section: 302.1 2012 TAS Section: 302.1 2010 ADAS Section: 302.1

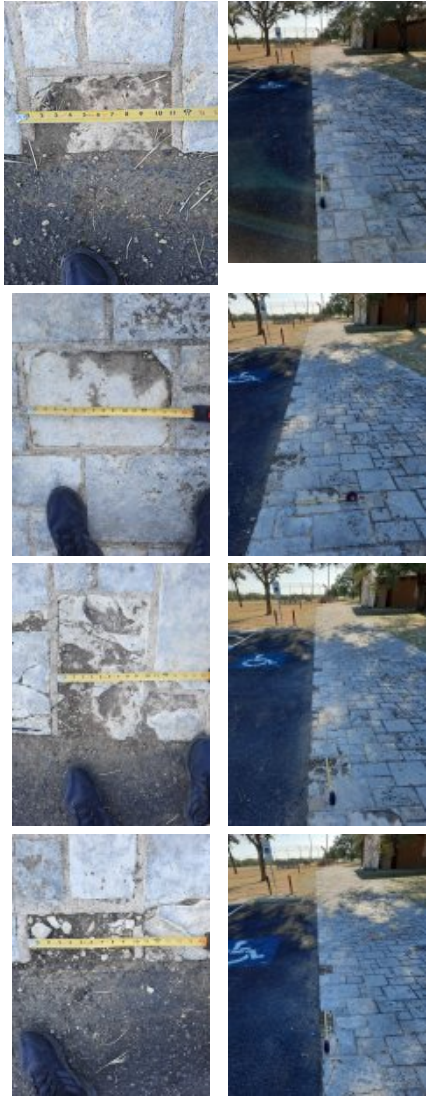
Finding Number	Area Description	Lat/Long	Finding	As Built	Recommendation	Citation	Photos	Figure
347	Park Elements: Ball Field	[30.23546, -98.64225]	The accessible route contains loose gravel and/or surfaces that do not provide for a stable, firm slip resistant surface.	Ballfield Area - Section of route from parking lot to restroom building - multiple gaps (20) due to broken, deteriorated, or missing pavers	Correct or fill 1" gap along AR.	2015 ABAAS Section: 302.1 2012 TAS Section: 302.1 2010 ADAS Section: 302.1

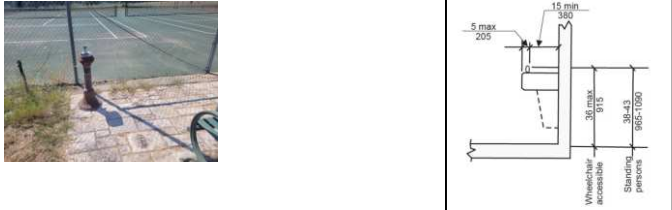
348	Park Elements: Tennis Courts	[30.2366071 , -98.639034 3]	The required types of drinking fountains are not provided. Where drinking fountains are provided, a minimum of one must be designed for wheelchair users and one must be designed for standing persons unless a single fountain meets the requirements for both.	Lacks hi-lo fountain at tennis courts	Replace drinking fountain with a hi-lo bowl fountain.	2015 ABAAS Section: F211.2 2012 TAS Section: 211.2 2010 ADAS Section: 211.2

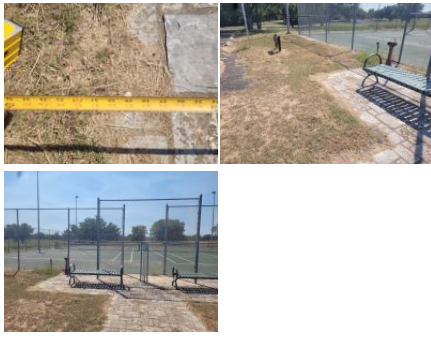
350	Park Elements: Tennis Courts	[30.236608, -98.6390368]	The route of travel at this location does not provide the required minimum width. The minimum clear width for sidewalks and walks is 36 inches.	Route reduces to 30" around bench to access tennis courts	Relocate or reposition bench to widen EAR to min 36" clear width.	2015 ABAAS Section: 403.5.1 2012 TAS Section: 403.5.1 2010 ADAS Section: 403.5.1

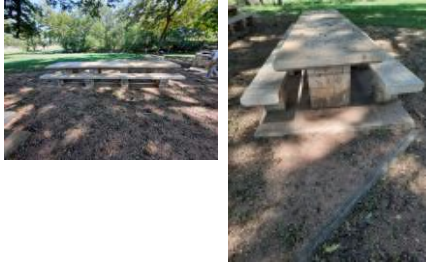
Finding Number	Area Description	Lat/Long	Finding	As Built	Recommendation	Citation	Photos	Figure
360	Park Elements: Group Picnic Area	[30.2372806 , -98.637461]	Picnic tables shall provide at least one wheelchair space for each 24 linear feet (7320 mm) of usable table surface perimeter. Wheelchair spaces shall be 30 inches (760 mm) minimum by 48 inches (1220 mm) minimum. Wheelchair spaces shall be positioned for a forward approach to the table and provide knee and toe clearance complying with 306 under the table	Group Picnic Area - 10 of 10 Picnic tables are not of an accessible design	Replace two picnic tables with ones of an accessible design as a smart practice.	2015 ABAAS Section: 1011.4.2

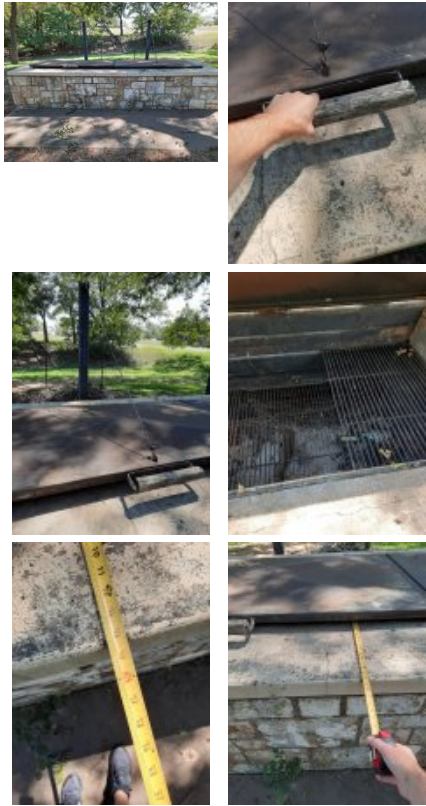
361	Park Elements: Group Picnic Area	[30.237256, -98.637301 2]	Operable parts shall comply with 309.3 and 309.4. EXCEPTIONS: 1. Fire rings, grills, fireplaces, wood stoves, water hydrants, and water utility hookups shall comply with 309.4 to the extent practicable. 2. Trash and recycling receptacles with hinged lids and controls to keep out large animals shall comply with 309.4 to the extent practicable. 3. Dumpster type trash and recycling receptacles shall not be required to comply with 309.3 and 309.4. 4. Sewage hatches shall not be required to comply with 309.3 and 309.4.	Group Picnic Area - 2 large grills require tight grasp and excessive force to open, recessed/low cooking surface requires reach across 14.25" edge	Replace operable parts with ones usable without a tight pinch or grasp, mounted within reach range of 15" to 48" above the ground as a smart practice.	2015 ABAAS Section: 1011.3, 1011.3 EXCEPTIONS: 1, 1011.3 EXCEPTIONS: 2, 1011.3 EXCEPTIONS: 3, 1011.3 EXCEPTIONS: 4

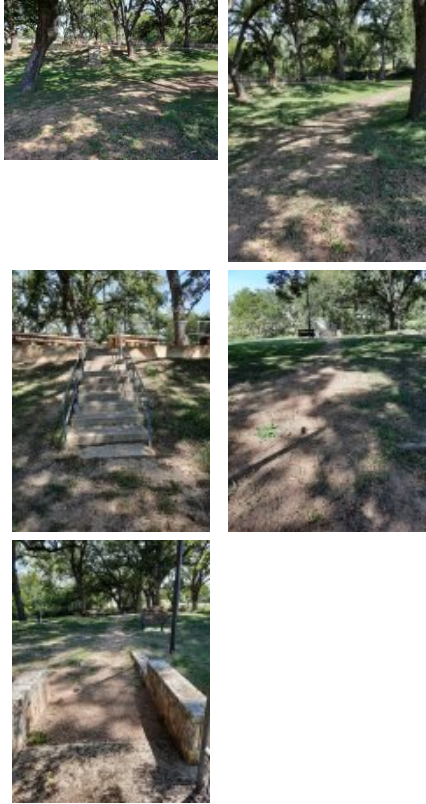
Finding Number	Area Description	Lat/Long	Finding	As Built	Recommendation	Citation	Photos	Figure
362	Park Elements: Group Picnic Area	[30.2373007 , -98.637482 9]	An accessible access route is not provided between elements, spaces and the facilities provided within the accessible camping unit. At least one outdoor recreation access route shall connect accessible elements, spaces and facilities provided within camping units with mobility features.	Lacks ORAR to Group Picnic Area including 1 drinking fountain, 10 picnic tables, 1 garbage can, grills	Create AR with crushed and compacted stone or similar outdoor material to camp sites and one of each type of amenity.	2015 ABAAS Section: F244.5.1

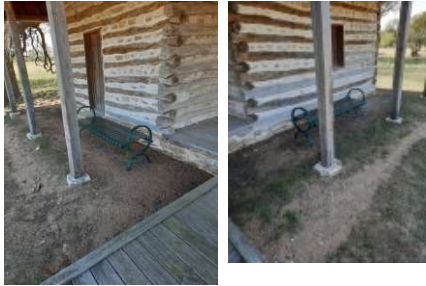
Finding Number	Area Description	Lat/Long	Finding	As Built	Recommendation	Citation	Photos	Figure																				
369	Park Elements: Danz Cabins	[30.2357745 , -98.635235 7]	Benches shall have a 36" by 48" clear ground space (CGS) positioned near the bench with one side of the space adjoining an outdoor recreation access route (ORAR) or trail, as applicable. The CGS shall not overlap with the ORAR or trail or another CGS.	2 of 2 benches at Danz Cabin have space adjacent, but are not on a compliant surface	Construct firm, stable, and slip resistant pads at least 36" by 48" adjacent to 20% of benches, and locate along an AR as a smart practice.	2015 ABAAS Section: 1011.2.1

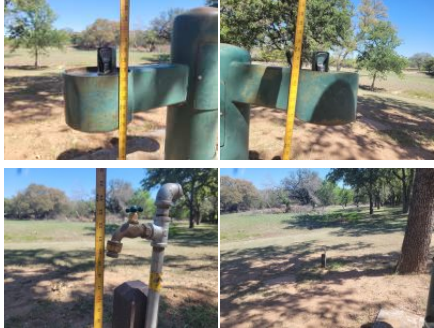
375	Park Elements: Bus Loop Picnic Area	[30.23589, -98.62605]	Where provided, at least one of each type of outdoor constructed feature shall comply with 1011. Where more than one of the same type of outdoor constructed feature is provided, at least two of the same type of outdoor constructed feature shall comply with 1011.	Drinking fountain will not meet requirements, water spout 20"	Replace existing amenities with ones of an accessible design and provide required clear ground space.	2015 ABAAS Section: F245.2.5.1

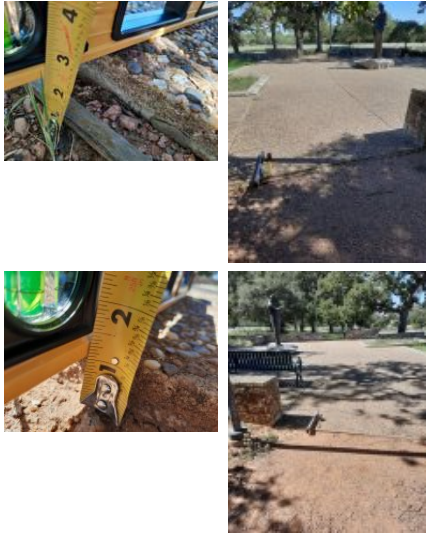
Finding Number	Area Description	Lat/Long	Finding	As Built	Recommendation	Citation	Photos	Figure
379	Park Elements: LBJ Statue	[30.2386923, -98.6257031], [30.2385927, -98.625556]	The walkway contains abrupt vertical edges and/or variations over a 1/4 inch. 1/4 inch is the maximum vertical rise. Changes in level between 1/4 inch and 1/2 inch must be beveled at 1:2 or less. Changes in level greater than 1/2 inch must be by way of a ramp.	CILs of 2.25" and 1" at entry points of LBJ statue from nature trail	Repair, bevel or ramp CIL along AR.	2012 TAS Section: 303.2, 303.3 2010 ADAS Section: 303.2, 303.3

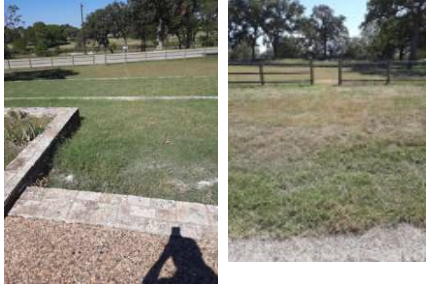
380	Park Elements: LBJ Statue	[30.2386203, -98.6256492]	There is no accessible route to the LBJ statue. At least one accessible route shall connect accessible buildings, accessible facilities, accessible elements, and accessible spaces that are on the same site.	Lacks route to LBJ statue - access to statue is either from the Nature Trail which has non-compliant surface or roadway, which has no route to it along with terraced steps/CILs - 120' needed from roadway	Create an accessible route with crushed stone or other outdoor material from parking or walkway to LBJ statue.	2015 ABAAS Section: F206.2.2 2012 TAS Section: 206.2.2 2010 ADAS Section: 206.2.2

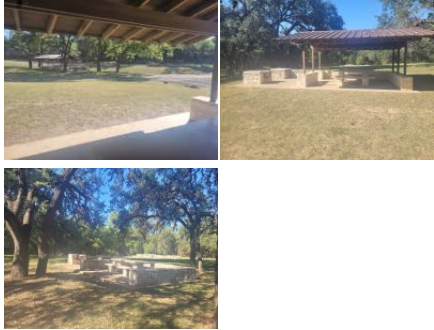
Finding Number	Area Description	Lat/Long	Finding	As Built	Recommendation	Citation	Photos	Figure
381	Park Elements: Picnic Area Near Farm	[30.2362853 , -98.6218513]	Picnic facilities shall provide outdoor recreation access routes complying with 1016 in accordance with F245.4 and 245.4 of IAC	Lacks route (ORAR) to all picnic areas and shelters	Create ORAR with crushed and compacted stone or similar outdoor material from parking or sidewalk to 2 shelters or picnic areas.	2015 ABAAS Section: F245.4

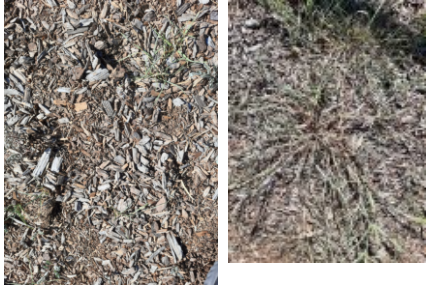
386	Park Elements: Play Areas	[30.2348911 , -98.620452 9]	Compliance with ASTM F 1951 for accessibility for ground surfaces on accessible routes, clear floor or ground spaces, and turning spaces has not been determined. Ground surfaces shall comply with ASTM F 1951. Ground surfaces shall be inspected and maintained regularly and frequently to ensure continued compliance with ASTM F 1951.	Play area at East Picnic Area - appears to be woodchips	Replace existing surface with an accessible surface such as EWF, PIP or tiles, with compliant slopes and CILs.	2012 TAS Section: 1008.2.6.1 2010 ADAS Section: 1008.2.6.1

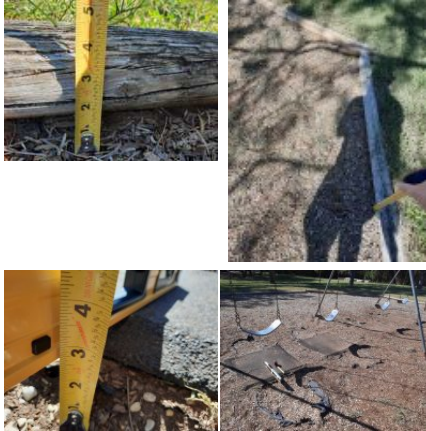
387	Park Elements: Play Areas	[30.234854, -98.620479 8]	The walkway contains abrupt vertical edges and/or variations over a 1/4 inch. 1/4 inch is the maximum vertical rise. Changes in level between 1/4 inch and 1/2 inch must be beveled at 1:2 or less. Changes in level greater than 1/2 inch must be by way of a ramp.	Play area at East Picnic Area - Up to 4.5" CIL at border, up to 2.5" CILs at rubber pads under swings	Frequently inspect and regularly maintain accessible portions of play area surface that are comprised of loose fill such as EWF so that surface is level with other surfaces.	2012 TAS Section: 303.2, 303.3 2010 ADAS Section: 303.2, 303.3

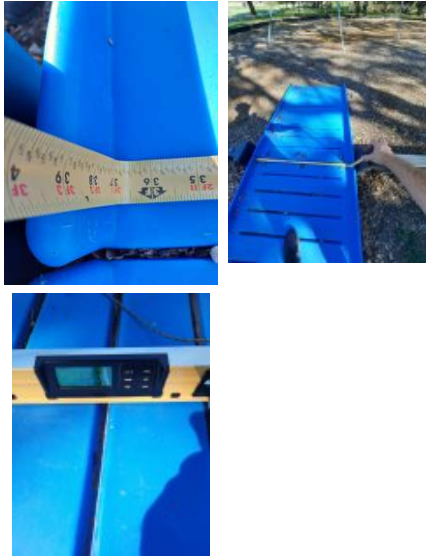
Finding Number	Area Description	Lat/Long	Finding	As Built	Recommendation	Citation	Photos	Figure
391	Park Elements: Play Areas	[30.2348473 , -98.620484 2]	As a smart practice, play area should have a minimum 60" wide entry, free of changes in level, gaps, and slope.	Swings at East Picnic Area - designated entry is 36.5" wide, slope of 12.3%	Widen the designated entry to 60" width as a smart practice. Correct slope of designated entry ramp to max 8.33%.	2015 ABAAS Section: F206.1 2012 TAS Section: 206.1 2010 ADAS Section: 206.1

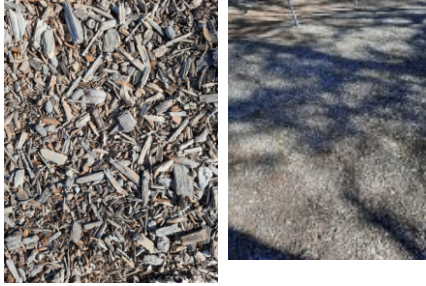
393	Park Elements: Play Areas	[30.2348751 , -98.620452]	Compliance with ASTM F 1951 for accessibility for ground surfaces on accessible routes, clear floor or ground spaces, and turning spaces has not been determined. Ground surfaces shall comply with ASTM F 1951. Ground surfaces shall be inspected and maintained regularly and frequently to ensure continued compliance with ASTM F 1951.	Swings at East Picnic Area - Surface appears to be woodchips	Replace existing surface with an accessible surface such as EWF, PIP or tiles, with compliant slopes and CILs.	2012 TAS Section: 1008.2.6.1 2010 ADAS Section: 1008.2.6.1

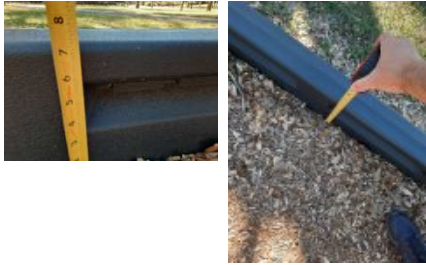
Finding Number	Area Description	Lat/Long	Finding	As Built	Recommendation	Citation	Photos	Figure
394	Park Elements: Play Areas	[30.2348797, -98.6204467]	The walkway contains abrupt vertical edges and/or variations over a 1/4 inch. 1/4 inch is the maximum vertical rise. Changes in level between 1/4 inch and 1/2 inch must be beveled at 1:2 or less. Changes in level greater than 1/2 inch must be by way of a ramp.	Swings at East Picnic Area - CIL at border due to low fill	Frequently inspect and regularly maintain accessible portions of play area surface that are comprised of loose fill such as EWF so that surface is level with other surfaces.	2012 TAS Section: 303.2, 303.3 2010 ADAS Section: 303.2, 303.3

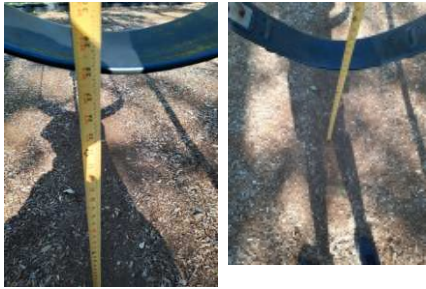
396	Park Elements: Play Areas	[30.234889, -98.6204359]	The entry point or seat is not within the compliant range above the ground. The height of entry points and seats shall be 11 inches minimum and 24 inches maximum measured to the top of the surface from the ground or floor surface.	Swings area at East Picnic Area - Lowest of 4 swings at 28" above ground level (AGL)	Lower or adjust entry point to play component to 11" to 24" AFF.	2012 TAS Section: 1008.4.4 2010 ADAS Section: 1008.4.4

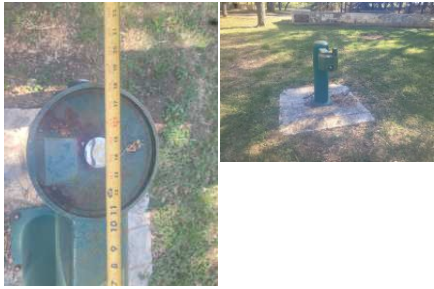
399	Park Elements: Southeast Picnic Area	[30.23496, -98.62059]	The spout is not positioned correctly from the vertical support. The spout shall be located 15 inches minimum from the vertical support and 5 inches maximum from the front edge of the unit, including bumpers.	Spout 14" from vertical support	Remount or replace fountain to provide 15" from vertical support to the spout.	2015 ABAAS Section: 602.5 2012 TAS Section: 602.5 2010 ADAS Section: 602.5

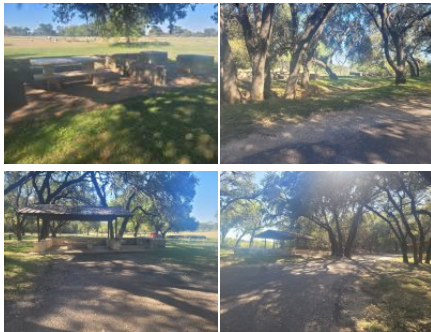
402	Park Elements: Southeast Picnic Area	[30.23507, -98.62099]	Picnic facilities shall provide outdoor recreation access routes complying with 1016 in accordance with F245.4 and 245.4 of IAC.	Lacks route (ORAR) to all 4 picnic areas and 3 shelters	Create ORAR with crushed and compacted stone or similar outdoor material from parking or sidewalk to shelter or picnic area.	2015 ABAAS Section: F245.4

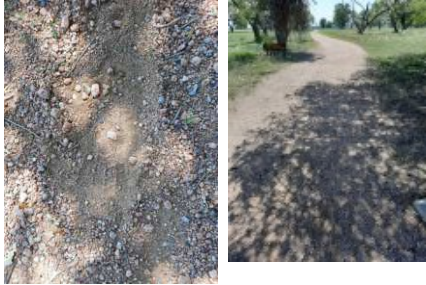
Finding Number	Area Description	Lat/Long	Finding	As Built	Recommendation	Citation	Photos	Figure
405	Trails: Trail Surface	[30.2369496, -98.635749]	The surface of trails, passing spaces, and resting intervals shall be firm and stable	Danz Cabin Interpretive Trail - lacks firm and stable surface (crushed granite) that displaces easily	Replace surface of trail with one that is firm and stable as a smart practice.	2015 ABAAS Section: 1017.2

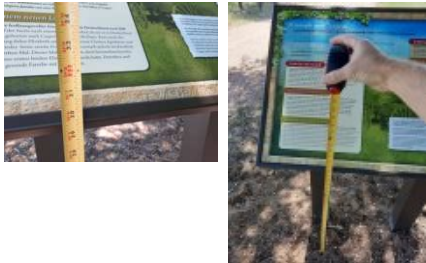
407	Trails: Trail Features	[30.23715, -98.63578]	Visual characters shall be 40 inches (1015 mm) minimum above the finish floor or ground. EXCEPTION: Visual characters indicating elevator car controls shall not be required to comply with 703.5.6.	"Triumph Over Tragedy" sign at Trailhead parking is low - text starts 32.25" above ground level (AGL)	Remount signage to min 40" AGL.	2015 ABAAS Section: 703.5.6, 703.5.6 EXCEPTION 2012 TAS Section: 703.5.6, 703.5.6 Exception 2010 ADAS Section: 703.5.6, 703.5.6 Exception

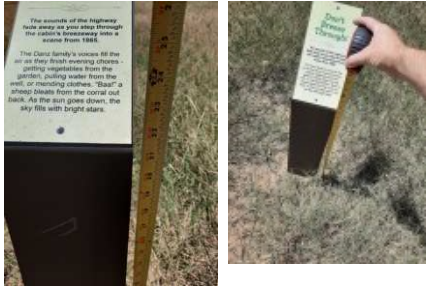
409	Trails: Trail Features	[30.2360609 , -98.635597 6]	Visual characters shall be 40 inches (1015 mm) minimum above the finish floor or ground. EXCEPTION: Visual characters indicating elevator car controls shall not be required to comply with 703.5.6.	"Don't Breeze Through" sign is low - text starts 22.5" above ground level (AGL)	Remount signage to min 40" AFF.	2015 ABAAS Section: 703.5.6, 703.5.6 EXCEPTION 2012 TAS Section: 703.5.6, 703.5.6 Exception 2010 ADAS Section: 703.5.6, 703.5.6 Exception

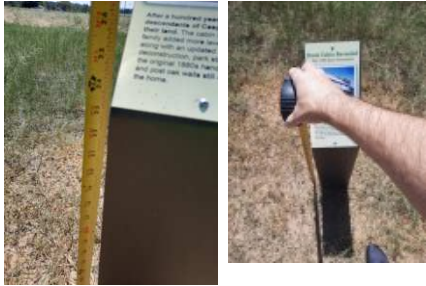
Finding Number	Area Description	Lat/Long	Finding	As Built	Recommendation	Citation	Photos	Figure
411	Trails: Trail Features	[30.2359185 , -98.635239 2]	Visual characters shall be 40 inches (1015 mm) minimum above the finish floor or ground. EXCEPTION: Visual characters indicating elevator car controls shall not be required to comply with 703.5.6.	"Danz Cabin Revealed" sign is low - text starts 24" above ground level (AGL)	Remount signage to min 40" AGL.	2015 ABAAS Section: 703.5.6, 703.5.6 EXCEPTION 2012 TAS Section: 703.5.6, 703.5.6 Exception 2010 ADAS Section: 703.5.6, 703.5.6 Exception

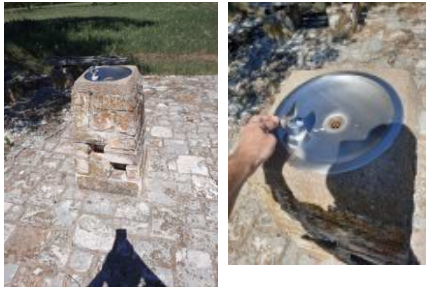
412	Trails: Trail Features	[30.2358023 , -98.634016 3]	The drinking fountain has multiple violations. Drinking fountains must be on an accessible route that provides a 30 inch by 48 inch clear floor space centered on the low unit, allowing a forward approach. Spout outlets shall be 36 inches maximum above the finish floor or ground. Spout outlets of drinking fountains for standing persons shall be 38 inches minimum and 43 inches maximum above the finish floor or ground. The spout shall be located 15 inches minimum from the vertical support and 5 inches maximum from the front edge of the unit, including bumpers. The spout shall provide a flow of water 4 inches high minimum and shall be located 5 inches maximum from the front of the unit. The angle of the water stream shall be measured horizontally relative to the front face of the unit. Where spouts are located less than 3 inches of the front of the unit, the angle of the water stream shall be 30 degrees maximum. Where spouts are located between 3 inches and 5 inches maximum from the front of the unit, the angle of the water stream shall be 15 degrees maximum. Operable parts shall comply with applicable standards.	Drinking fountain near 2 benches along Danz Cabin Interpretive Trail is not compliant and is inoperable	Replace drinking fountain with a hi-lo bowl fountain.	2015 ABAAS Section: 403.5.1 , 602.1 2012 TAS Section: 403.5.1, 602.1 2010 ADAS Section: 403.5.1, 602.1

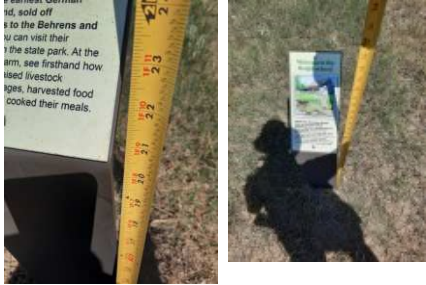
Finding Number	Area Description	Lat/Long	Finding	As Built	Recommendation	Citation	Photos	Figure
417	Trails: Trail Features	[30.2355727 , -98.6304826]	Visual characters shall be 40 inches (1015 mm) minimum above the finish floor or ground. EXCEPTION: Visual characters indicating elevator car controls shall not be required to comply with 703.5.6.	"Welcome to The Neighborhood" sign is low - text starts 22" above ground level (AGL)	Remount signage to min 40" AFF.	2015 ABAAS Section: 703.5.6, 703.5.6 EXCEPTION 2012 TAS Section: 703.5.6, 703.5.6 Exception 2010 ADAS Section: 703.5.6, 703.5.6 Exception

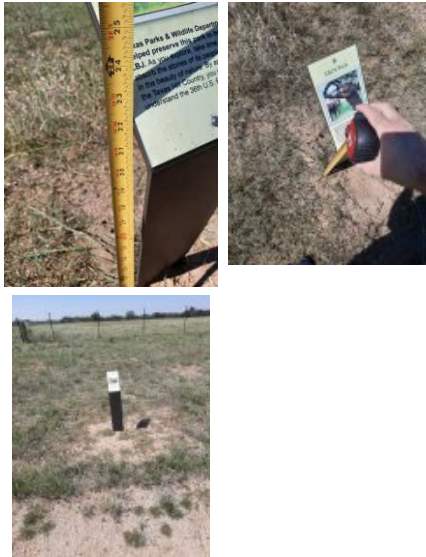
418	Trails: Trail Features	[30.2355399 , -98.632513]	An accessible access route is not provided between elements, spaces and the facilities provided within the accessible camping unit. At least one outdoor recreation access route shall connect accessible elements, spaces and facilities provided within camping units with mobility features.	Lacks ORAR to "LBJs Park" sign	Create AR with crushed and compacted stone or similar outdoor material to camp sites and one of each type of amenity.	2015 ABAAS Section: F244.5.1

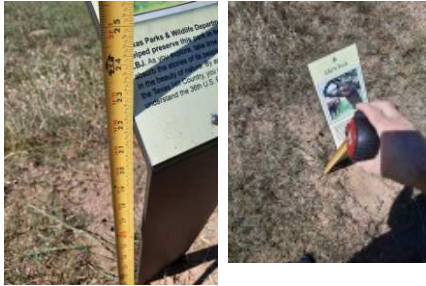
Finding Number	Area Description	Lat/Long	Finding	As Built	Recommendation	Citation	Photos	Figure
419	Trails: Trail Features	[30.2355514, -98.6325827]	Visual characters shall be 40 inches (1015 mm) minimum above the finish floor or ground. EXCEPTION: Visual characters indicating elevator car controls shall not be required to comply with 703.5.6.	"LBJs Park" sign is low - text starts 22.5" above ground level (AGL)	Remount signage to min 40" AGL.	2015 ABAAS Section: 703.5.6, 703.5.6 EXCEPTION 2012 TAS Section: 703.5.6, 703.5.6 Exception 2010 ADAS Section: 703.5.6, 703.5.6 Exception

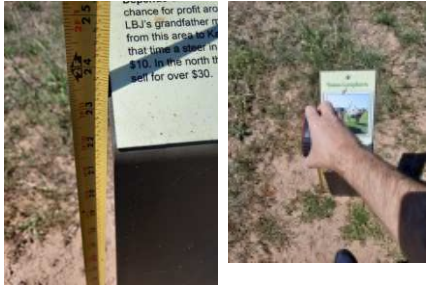
Finding Number	Area Description	Lat/Long	Finding	As Built	Recommendation	Citation	Photos	Figure
421	Trails: Trail Features	[30.23731, -98.62957]	Visual characters shall be 40 inches (1015 mm) minimum above the finish floor or ground. EXCEPTION: Visual characters indicating elevator car controls shall not be required to comply with 703.5.6.	"Texas Longhorn" sign is low - text starts 23.75" above ground level (AGL)	Remount signage to min 40" AGL.	2015 ABAAS Section: 703.5.6, 703.5.6 EXCEPTION 2012 TAS Section: 703.5.6, 703.5.6 Exception 2010 ADAS Section: 703.5.6, 703.5.6 Exception

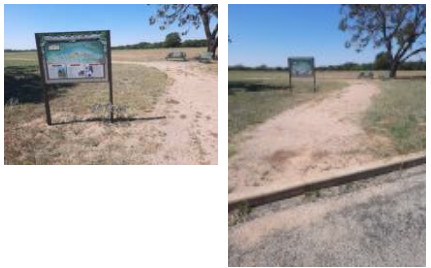
423	Trails: Trail Features	[30.23779, -98.62887]	An accessible route is not provided between elements, spaces and the facilities provided within the accessible camping unit. At least one outdoor recreation access route shall connect accessible elements, spaces and facilities provided within camping units with mobility features.	Lacks ORAR to map/info sign at Danz Trail access point	Create AR with crushed and compacted stone or similar outdoor material to camp sites and one of each type of amenity.	2015 ABAAS Section: F244.5.1

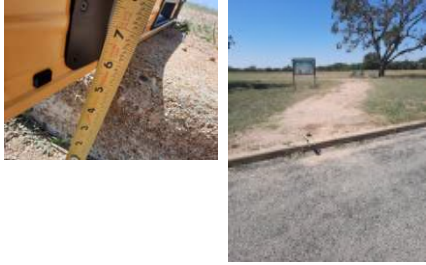
Finding Number	Area Description	Lat/Long	Finding	As Built	Recommendation	Citation	Photos	Figure
424	Trails: Trail Features	[30.237752, -98.628777]	Tread obstacles on trails, passing spaces, and resting intervals shall not exceed 1/2 inch (13 mm) in height measured vertically to the highest point. EXCEPTION: Where the surface is other than asphalt, concrete, or boards, tread obstacles shall be permitted to not exceed 2 inches (50 mm) in height measured vertically to the highest point.	5.5" curb/CIL to access trail to Danz Cabin from Visitors Center parking lot	Create a curb ramp to be max running slope 8.33%, max cross slope 2.08%, having a top landing as wide as the ramp and 36" deep and side flares with a max slope 10%.	2015 ABAAS Section: 1017.5

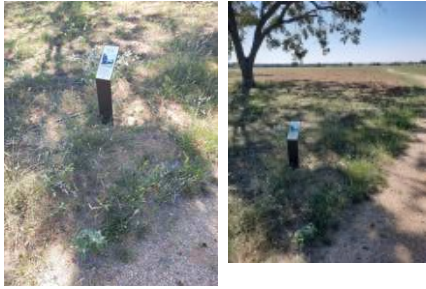
425	Trails: Trail Features	[30.23874, -98.62889]	An accessible access route is not provided between elements, spaces and the facilities provided within the accessible camping unit. At least one outdoor recreation access route shall connect accessible elements, spaces and facilities provided within camping units with mobility features.	Lacks ORAR to "Trail To Danz Cabin" sign	Create AR with crushed and compacted stone or similar outdoor material to camp sites and one of each type of amenity.	2015 ABAAS Section: F244.5.1

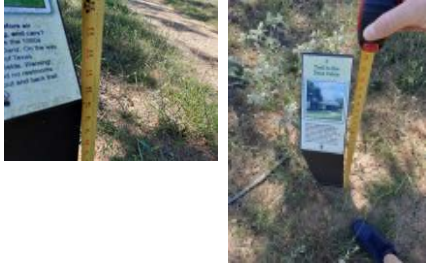
426	Trails: Trail Features	[30.23874, -98.62889]	Visual characters shall be 40 inches (1015 mm) minimum above the finish floor or ground. EXCEPTION: Visual characters indicating elevator car controls shall not be required to comply with 703.5.6.	"Trail To Danz Cabin" sign is low - text starts 21" above ground level (AGL)	Remount signage to min 40" AGL.	2015 ABAAS Section: 703.5.6, 703.5.6 EXCEPTION 2012 TAS Section: 703.5.6, 703.5.6 Exception 2010 ADAS Section: 703.5.6, 703.5.6 Exception

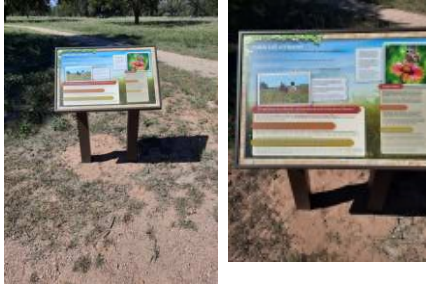
Finding Number	Area Description	Lat/Long	Finding	As Built	Recommendation	Citation	Photos	Figure
430	Trails: Trail Features	[30.23827, -98.62619]	An accessible access route is not provided between elements, spaces and the facilities provided within the accessible camping unit. At least one outdoor recreation access route shall connect accessible elements, spaces and facilities provided within camping units with mobility features.	Nature Trail - Lacks ORAR to "Fields Full of Flowers" sign	Create AR with crushed and compacted stone or similar outdoor material to camp sites and one of each type of amenity.	2015 ABAAS Section: F244.5.1

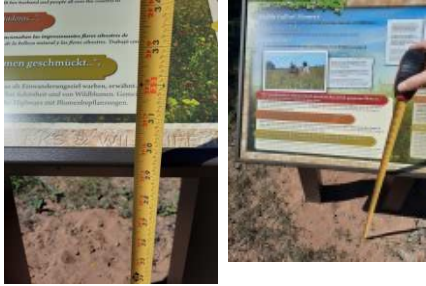
432	Trails: Trail Features	[30.23827, -98.62619]	Visual characters shall be 40 inches (1015 mm) minimum above the finish floor or ground. EXCEPTION: Visual characters indicating elevator car controls shall not be required to comply with 703.5.6.	Nature Trail - "Fields Full of Flowers" sign is low - text starts 31.5" above ground level (AGL)	Remount signage to min 40" AGL.	2015 ABAAS Section: 703.5.6, 703.5.6 EXCEPTION 2012 TAS Section: 703.5.6, 703.5.6 Exception 2010 ADAS Section: 703.5.6, 703.5.6 Exception

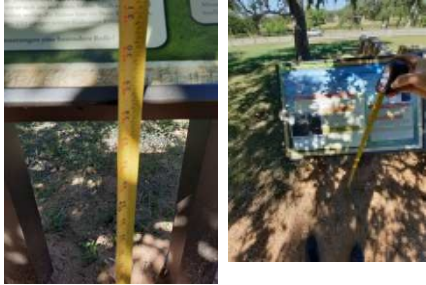
Finding Number	Area Description	Lat/Long	Finding	As Built	Recommendation	Citation	Photos	Figure
433	Trails: Trail Features	[30.23888, -98.62562]	Visual characters shall be 40 inches (1015 mm) minimum above the finish floor or ground. EXCEPTION: Visual characters indicating elevator car controls shall not be required to comply with 703.5.6.	Nature Trail - "A Man, A Friend, His Land" sign is low - text starts 30.5" above ground level (AGL)	Remount signage to min 40" AGL.	2015 ABAAS Section: 703.5.6, 703.5.6 EXCEPTION 2012 TAS Section: 703.5.6, 703.5.6 Exception 2010 ADAS Section: 703.5.6, 703.5.6 Exception

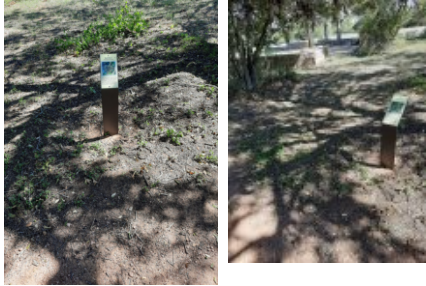
434	Trails: Trail Features	[30.2387, -98.62578]	An accessible access route is not provided between elements, spaces and the facilities provided within the accessible camping unit. At least one outdoor recreation access route shall connect accessible elements, spaces and facilities provided within camping units with mobility features.	Nature Trail - Lacks ORAR to "Ball Moss" sign	Create AR with crushed and compacted stone or similar outdoor material to camp sites and one of each type of amenity.	2015 ABAAS Section: F244.5.1

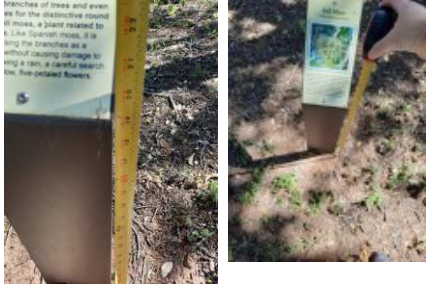
Finding Number	Area Description	Lat/Long	Finding	As Built	Recommendation	Citation	Photos	Figure
435	Trails: Trail Features	[30.2387, -98.62578]	Visual characters shall be 40 inches (1015 mm) minimum above the finish floor or ground. EXCEPTION: Visual characters indicating elevator car controls shall not be required to comply with 703.5.6.	Nature Trail - "Ball Moss" sign is low - text starts 20.5" above ground level (AGL)	Remount signage to min 40" AGL.	2015 ABAAS Section: 703.5.6, 703.5.6 EXCEPTION 2012 TAS Section: 703.5.6, 703.5.6 Exception 2010 ADAS Section: 703.5.6, 703.5.6 Exception

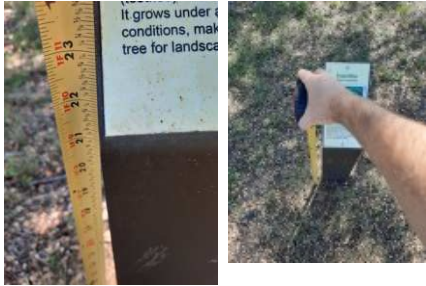
Finding Number	Area Description	Lat/Long	Finding	As Built	Recommendation	Citation	Photos	Figure
437	Trails: Trail Features	[30.23836, -98.625317 1]	Visual characters shall be 40 inches (1015 mm) minimum above the finish floor or ground. EXCEPTION: Visual characters indicating elevator car controls shall not be required to comply with 703.5.6.	Nature Trail - "Ball Moss" sign is low - text starts 23" above ground level (AGL)	Remount signage to min 40" AGL.	2015 ABAAS Section: 703.5.6, 703.5.6 EXCEPTION 2012 TAS Section: 703.5.6, 703.5.6 Exception 2010 ADAS Section: 703.5.6, 703.5.6 Exception

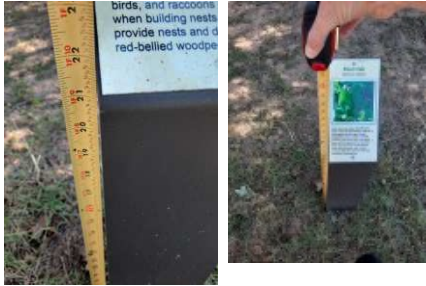
Finding Number	Area Description	Lat/Long	Finding	As Built	Recommendation	Citation	Photos	Figure
439	Trails: Trail Features	[30.2381436, -98.6251116]	Visual characters shall be 40 inches (1015 mm) minimum above the finish floor or ground. EXCEPTION: Visual characters indicating elevator car controls shall not be required to comply with 703.5.6.	Nature Trail - "Post Oak" sign is low - text starts 22.25" above ground level (AGL)	Remount signage to min 40" AGL.	2015 ABAAS Section: 703.5.6, 703.5.6 EXCEPTION 2012 TAS Section: 703.5.6, 703.5.6 Exception 2010 ADAS Section: 703.5.6, 703.5.6 Exception

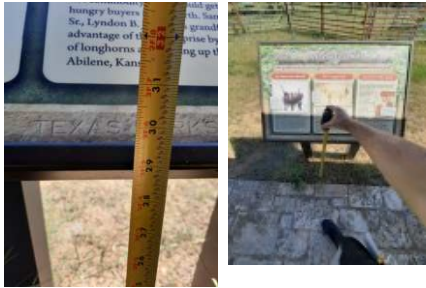
440	Trails: Trail Features	[30.2379581, -98.624325]	Visual characters shall be 40 inches (1015 mm) minimum above the finish floor or ground. EXCEPTION: Visual characters indicating elevator car controls shall not be required to comply with 703.5.6.	Nature Trail - "A Texas Legend" sign (at deer yard shelter) is low - text starts 31" above ground level (AGL)	Remount signage to min 40" AGL.	2015 ABAAS Section: 703.5.6, 703.5.6 EXCEPTION 2012 TAS Section: 703.5.6, 703.5.6 Exception 2010 ADAS Section: 703.5.6, 703.5.6 Exception

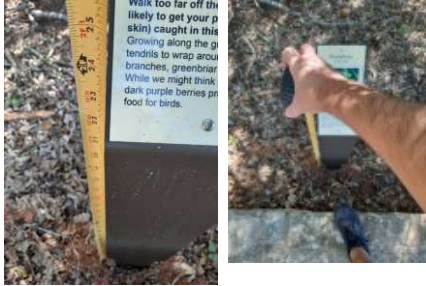
443	Trails: Trail Features	[30.2377644 , -98.624649 7]	Visual characters shall be 40 inches (1015 mm) minimum above the finish floor or ground. EXCEPTION: Visual characters indicating elevator car controls shall not be required to comply with 703.5.6.	Nature Trail - "Greenbriar" sign is low - text starts 23" above ground level (AGL)	Remount signage to min 40" AFF.	2015 ABAAS Section: 703.5.6, 703.5.6 EXCEPTION 2012 TAS Section: 703.5.6, 703.5.6 Exception 2010 ADAS Section: 703.5.6, 703.5.6 Exception

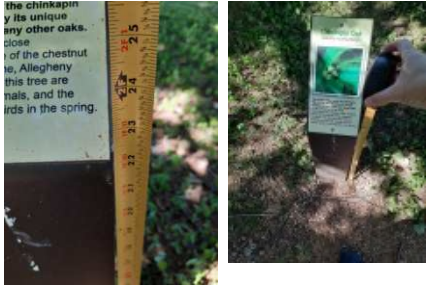
Finding Number	Area Description	Lat/Long	Finding	As Built	Recommendation	Citation	Photos	Figure
445	Trails: Trail Features	[30.2377207, -98.6244453]	Visual characters shall be 40 inches (1015 mm) minimum above the finish floor or ground. EXCEPTION: Visual characters indicating elevator car controls shall not be required to comply with 703.5.6.	Nature Trail - "Chinkapin Oak" sign is low - text starts 23.5" above ground level (AGL)	Remount signage to min 40" AGL.	2015 ABAAS Section: 703.5.6, 703.5.6 EXCEPTION 2012 TAS Section: 703.5.6, 703.5.6 Exception 2010 ADAS Section: 703.5.6, 703.5.6 Exception

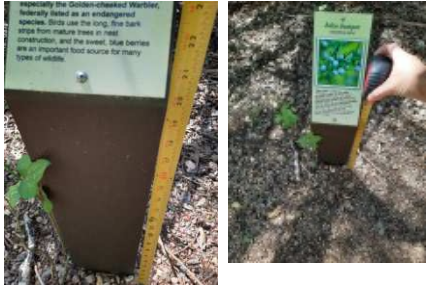
Finding Number	Area Description	Lat/Long	Finding	As Built	Recommendation	Citation	Photos	Figure
447	Trails: Trail Features	[30.2370991, -98.6240196]	Visual characters shall be 40 inches (1015 mm) minimum above the finish floor or ground. EXCEPTION: Visual characters indicating elevator car controls shall not be required to comply with 703.5.6.	Nature Trail - "Ashe Juniper" sign is low - text starts 21.5" above ground level (AGL)	Remount signage to min 40" AFF.	2015 ABAAS Section: 703.5.6, 703.5.6 EXCEPTION 2012 TAS Section: 703.5.6, 703.5.6 Exception 2010 ADAS Section: 703.5.6, 703.5.6 Exception

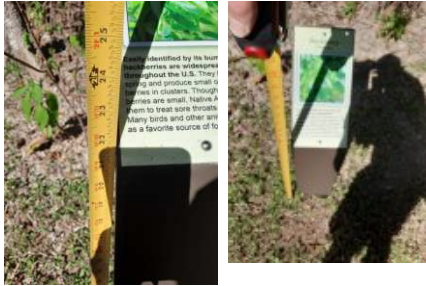
Finding Number	Area Description	Lat/Long	Finding	As Built	Recommendation	Citation	Photos	Figure
450	Trails: Trail Features	[30.23783, -98.62498]	Visual characters shall be 40 inches (1015 mm) minimum above the finish floor or ground. EXCEPTION: Visual characters indicating elevator car controls shall not be required to comply with 703.5.6.	Nature Trail -"Hackberry" sign is low - text starts 22" above ground level (AGL)	Remount signage to min 40" AGL.	2015 ABAAS Section: 703.5.6, 703.5.6 EXCEPTION 2012 TAS Section: 703.5.6, 703.5.6 Exception 2010 ADAS Section: 703.5.6, 703.5.6 Exception

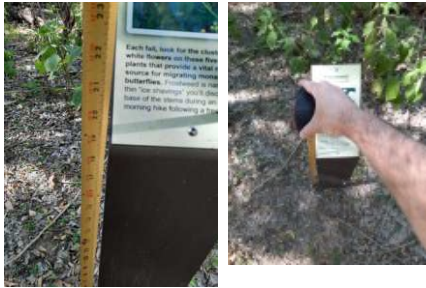
451	Trails: Trail Features	[30.2379, -98.62494]	Visual characters shall be 40 inches (1015 mm) minimum above the finish floor or ground. EXCEPTION: Visual characters indicating elevator car controls shall not be required to comply with 703.5.6.	Nature Trail -"Frostweed" sign is low - text starts 20" above ground level (AGL)	Remount signage to min 40" AGL.	2015 ABAAS Section: 703.5.6, 703.5.6 EXCEPTION 2012 TAS Section: 703.5.6, 703.5.6 Exception 2010 ADAS Section: 703.5.6, 703.5.6 Exception

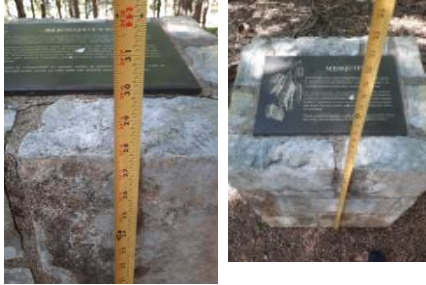
Finding Number	Area Description	Lat/Long	Finding	As Built	Recommendation	Citation	Photos	Figure
452	Trails: Trail Features	[30.2370232 , -98.623306 6]	Visual characters shall be 40 inches (1015 mm) minimum above the finish floor or ground. EXCEPTION: Visual characters indicating elevator car controls shall not be required to comply with 703.5.6.	Nature Trail - " Mesquite" sign is low - text starts 30.5" above ground level (AGL)	Remount signage to min 40" AGL.	2015 ABAAS Section: 703.5.6, 703.5.6 EXCEPTION 2012 TAS Section: 703.5.6, 703.5.6 Exception 2010 ADAS Section: 703.5.6, 703.5.6 Exception

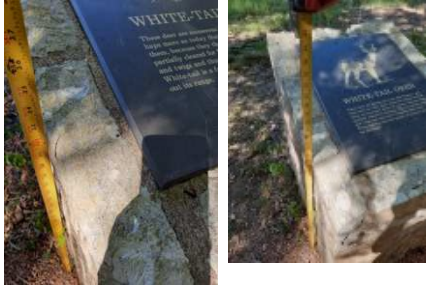
453	Trails: Trail Features	[30.2373268 , -98.622544 8]	Visual characters shall be 40 inches (1015 mm) minimum above the finish floor or ground. EXCEPTION: Visual characters indicating elevator car controls shall not be required to comply with 703.5.6.	Nature Trail - " White-tailed Deer" sign is low - text starts 33.5" above ground level (AGL)	Remount signage to min 40" AFF.	2015 ABAAS Section: 703.5.6, 703.5.6 EXCEPTION 2012 TAS Section: 703.5.6, 703.5.6 Exception 2010 ADAS Section: 703.5.6, 703.5.6 Exception

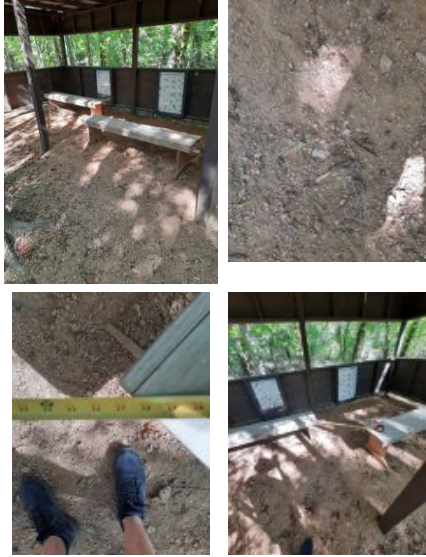
Finding Number	Area Description	Lat/Long	Finding	As Built	Recommendation	Citation	Photos	Figure
454	Trails: Trail Features	[30.23738, -98.62209]	The surface of the route to and into the picnic area or shelter must be firm and stable. The clear floor space for the element is obstructed. The clear floor or ground space shall be 30 inches minimum by 48 inches minimum and free of obstructions.	Birding shelter at trail junction to Pedernales River lacks accessible surface, has 2 benches that lack clear ground space (CGS) due to surface, benches obstruct clear ground space of birding signs	Replace or correct surface to be firm and stable. Relocate benches to provide CGS at birding signs.	2015 ABAAS Section: 1016.1, 1016.1 EXCEPTION S 1, 1016.1 EXCEPTION S 2, 1016.1 EXCEPTION S 3

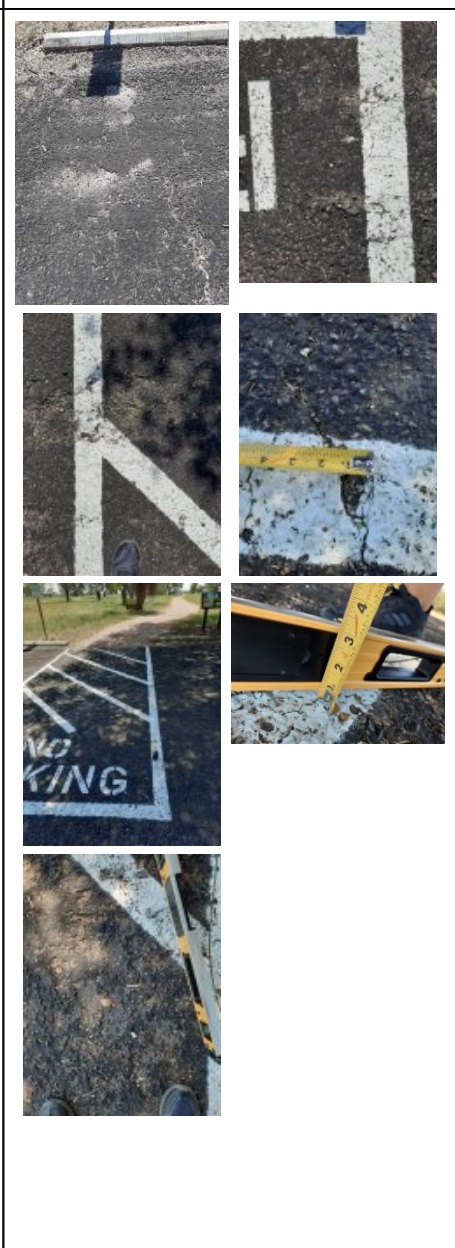
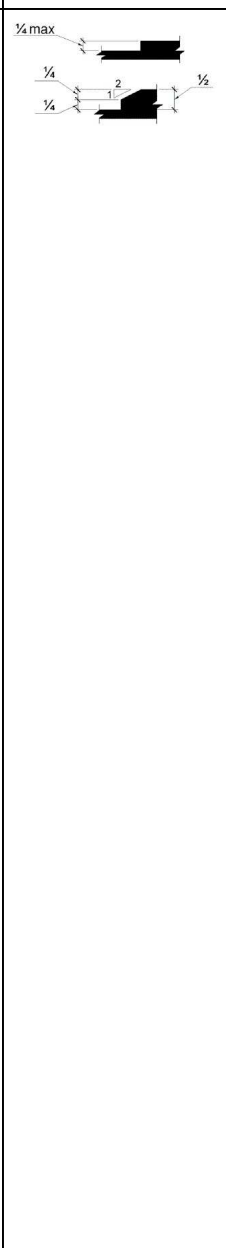
Finding Number	Area Description	Lat/Long	Finding	As Built	Recommendation	Citation	Photos	Figure
462	Trails: Trailhead Parking	[30.23711, -98.63589]	The parking stall contains abrupt edges and surface irregularities over a 1/4 inch vertical. Parking spaces and access aisles serving them shall be stable, firm, and slip resistant. Access aisles shall be at the same level as the parking spaces they serve. Changes in level are not permitted and shall not be sloped steeper than 2% in any direction.	Danz Trail trailhead parking - Large areas of deterioration and loose rock/sand on very rough surface	Resurface accessible stalls and access aisles with a firm, stable, and slip resistant material.	2015 ABAAS Section: 502.4 2012 TAS Section: 502.4 2010 ADAS Section: 502.4
