Access Audit Site Report

Prepared By
WT Group

Martin Dies Jr. State Park
634 Park Road 48 South
Jasper, TX 75951
Accessibility Evaluation
Inspection Date: 11/10/2021
Inspectors: Tanya Scheibe

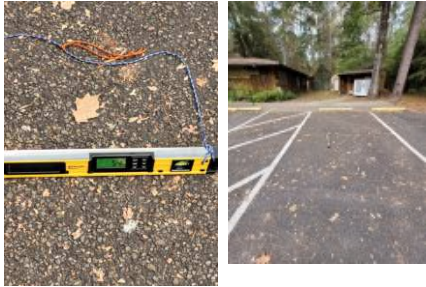
Finding Number	Area Description	Lat/Long	Finding	As Built	Recommendation	Citation	Photos	Figure
1	Headquarters: Headquarters Parking	[30.85182, -94.21043]	Element meets all standards and requirements	Lot complies with scoping - 7 standard stalls, 1 accessible.	None	2010 ADAS Section: N/A		
2	Headquarters: Headquarters Parking	[30.8465652, -94.1656881]	The cross slopes (narrow dimension) and/or running slopes (long dimension) of the access aisle exceeds 2%. The running slope and the cross slope in an accessible parking stall and the access aisle must not exceed 2%.	Slope of 5.4% in stall	Repair or correct slope of parking space and access aisle to max 2.08% in any direction	2015 ABAAS Section: 502.4 2012 TAS Section: 502.4 2010 ADAS Section: 502.4

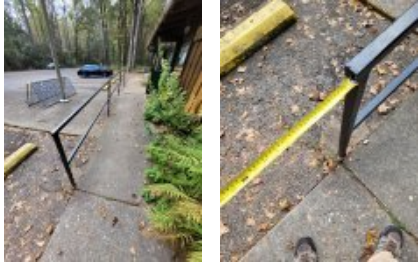
Finding Number	Area Description	Lat/Long	Finding	As Built	Recommendation	Citation	Photos	Figure
5	Headquarters: Headquarters Exterior Accessible Route	[30.8464961 , -94.165816 8]	The handrail extension does not terminate properly. Extensions shall return to a wall, guard, or the landing surface, or shall be continuous to the handrail of an adjacent ramp run.	Ramp - handrail extension does not terminate properly	Replace handrails with ones that are rounded and/or extend to the ground	2015 ABAAS Section: 505.10.1 2012 TAS Section: 505.10.1 2010 ADAS Section: 505.10.1

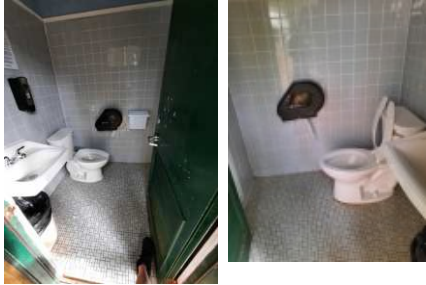
Finding Number	Area Description	Lat/Long	Finding	As Built	Recommendation	Citation	Photos	Figure
12	Headquarters: Headquarters Men's Restroom	[30.8465025 , -94.165808 9]	50% of the single accommodation restrooms provided in this grouping are not nearly compliant. The restrooms do not have the required minimum clear floor space or maneuvering clearances for the toilet. The restrooms do not have the required minimum clear floor space or maneuvering clearances for the lavatory, The entry doors do not contain the required minimum maneuvering spaces on the pull/push sides, The entry doors encroach into the required clear floor space for fixtures, Grab bars are missing and/or incorrectly installed, Accessories, such as toilet seat covers, paper towel holders, garbage cans, hand dryers, and mirrors are either too high or without clear floor space or both, The restrooms contain floor level changes greater than a 1/2 inch, the showers are too small and missing numerous accessible elements.	Lacks single accommodation restroom with required dimensions to be wheelchair accessible	Create compliant wheelchair accessible restrooms and correct all features to be accessible if feasible to meet 50% compliant restrooms in this location.	2015 ABAAS Section: 603.1 2012 TAS Section: 603.1 2010 ADAS Section: 603.1

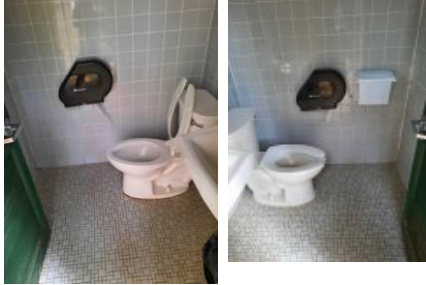
13	Headquarters: Headquarters Men's Restroom	[30.8464898 , -94.165808 9]	The restroom is not compliant. The restroom does not have the required minimum clear floor space or maneuvering clearances for the toilet. The restroom does not have the required minimum clear floor space or maneuvering clearances for the lavatory. The entry door does not contain the required minimum maneuvering spaces on the pull/push sides. The entry door encroach into the required clear floor space for fixtures. Grab bars are missing and/or incorrectly installed. Accessories, such as toilet seat covers, paper towel holders, garbage cans, hand dryers, and mirrors are either too high or without clear floor space or both.	Lacks single accommodation restroom with required dimensions to be wheelchair accessible	Create a compliant wheelchair accessible restroom and correct all features to be accessible if feasible.	2015 ABAAS Section: 603.1 2012 TAS Section: 603.1 2010 ADAS Section: 603.1

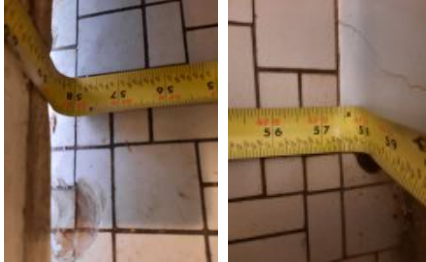
Finding Number	Area Description	Lat/Long	Finding	As Built	Recommendation	Citation	Photos	Figure
14	Headquarters: Headquarters Men's Restroom	[30.8465071 , -94.165804 9]	This restroom is not accessible. Where existing toilet rooms or bathing rooms do not comply, directional signs indicating the location of the nearest accessible toilet room or bathing room within the facility shall be provided. Signs shall include the International Symbol of Accessibility. Where existing toilet rooms or bathing rooms do comply), the accessible toilet rooms or bathing rooms shall be identified by the International Symbol of Where clustered single user toilet rooms or bathing facilities are permitted, accessible toilet rooms or bathing facilities shall be identified by the International Symbol of Accessibility unless all toilet rooms and bathing facilities are accessible.	Restroom is not accessible and lacks signage directing patrons to an accessible restroom	Restroom not accessible, acquire and mount signage directing patrons to accessible restroom	2015 ABAAS Section: F216.8 2012 TAS Section: 216.8 2010 ADAS Section: 216.8

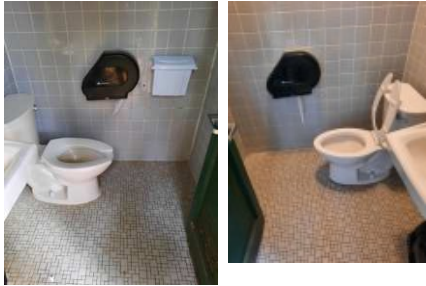
Finding Number	Area Description	Lat/Long	Finding	As Built	Recommendation	Citation	Photos	Figure
17	Headquarters: Headquarters Women's Restroom	[30.8464991 , -94.165800 9]	50% of the single accommodation restrooms provided in this grouping are not nearly compliant. The restrooms do not have the required minimum clear floor space or maneuvering clearances for the toilet, The restrooms do not have the required minimum clear floor space or maneuvering clearances for the lavatory, The entry doors do not contain the required minimum maneuvering spaces on the pull/push sides, The entry doors encroach into the required clear floor space for fixtures, Grab bars are missing and/or incorrectly installed, Accessories, such as toilet seat covers, paper towel holders, garbage cans, hand dryers, and mirrors are either too high or without clear floor space or both, The restrooms contain floor level changes greater than a 1/2 inch, the showers are too small and missing numerous accessible elements.	Lacks single accommodation restroom with required dimensions to be wheelchair accessible	Create compliant wheelchair accessible restrooms and correct all features to be accessible if feasible to meet 50% compliant restrooms in this location.	2015 ABAAS Section: 603.1 2012 TAS Section: 603.1 2010 ADAS Section: 603.1

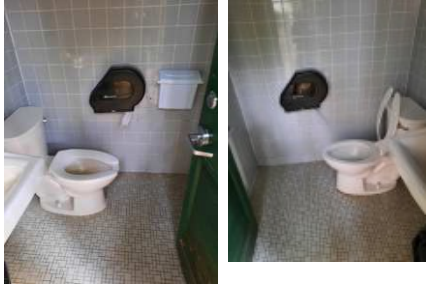
18	Headquarters: Headquarters Women's Restroom	[30.8465037 , -94.165799 5]	The restroom is not compliant. The restroom does not have the required minimum clear floor space or maneuvering clearances for the toilet. The restroom does not have the required minimum clear floor space or maneuvering clearances for the lavatory. The entry door does not contain the required minimum maneuvering spaces on the pull/push sides. The entry door encroach into the required clear floor space for fixtures. Grab bars are missing and/or incorrectly installed. Accessories, such as toilet seat covers, paper towel holders, garbage cans, hand dryers, and mirrors are either too high or without clear floor space or both.	Lacks single accommodation restroom with required dimensions to be wheelchair accessible	Create a compliant wheelchair accessible restroom and correct all features to be accessible if feasible.	2015 ABAAS Section: 603.1 2012 TAS Section: 603.1 2010 ADAS Section: 603.1

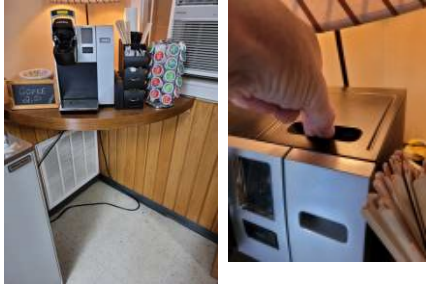
Finding Number	Area Description	Lat/Long	Finding	As Built	Recommendation	Citation	Photos	Figure
23	Headquarters: Headquarters State Parks Store	[30.8465099 , -94.165795 4]	The coffee maker is not accessible because it requires tight grasping, pinching or twisting of the wrist.	Tight pinch at coffee water filler Coffee maker water tank requires tight grasping, pinching, or twisting of the wrist	Replace coffee maker with an operable part usable without a tight pinch or grasp	2015 ABAAS Section: 309.4 2012 TAS Section: 309.4 2010 ADAS Section: 309.4

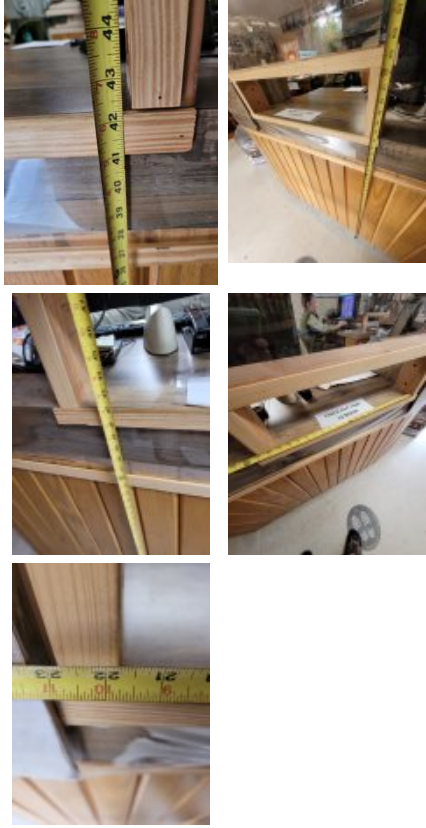
24	Headquarters: Headquarters State Parks Store	[30.8465007 , -94.165798]	The transaction counter is too high. The counter height shall be 36 inches maximum. For parallel approaches a portion of the counter surface that is 36 inches long minimum and 36 inches high maximum above the finish floor shall be provided. For a forward approaches a portion of the counter surface that is 30 inches long minimum and 36 inches high maximum.	Transaction counter exceeds 36" height maximum (42.25") and lacks required width (22")	Lower the height of a 36" wide segment of the service counter to max 36" aff, in the alternative, train staff to come out from around the counter to provide customer service	2015 ABAAS Section: 904.4.2, 904.4.1 2012 TAS Section: 904.4.1, 904.4.2 2010 ADAS Section: 904.4.2, 904.4.1

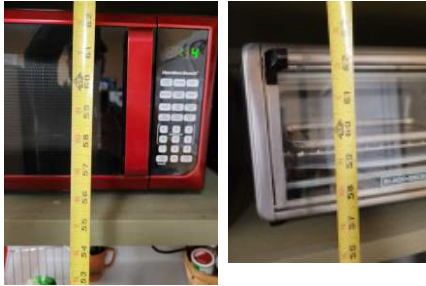
Finding Number	Area Description	Lat/Long	Finding	As Built	Recommendation	Citation	Photos	Figure
34	Headquarters: Headquarters Building	[30.8465099, -94.1658007]	The microwave and toaster oven are positioned too high for either a side or front approach. Where a clear floor or ground space allows a parallel approach to an element and the side reach is unobstructed, the high side reach shall be 48 inches maximum and the low side reach shall be 15 inches minimum above the finish floor or ground. Where a forward reach is unobstructed, the high forward reach shall be 48 inches maximum and the low forward reach shall be 15 inches minimum above the finish floor or ground.	Break room - Microwave at 59" aff and toaster oven at 62" aff	Relocate operable parts to be in reach range of 15" min to 48" max.	2015 ABAAS Section: 308.1 2012 TAS Section: 308.1 2010 ADAS Section: 308.1

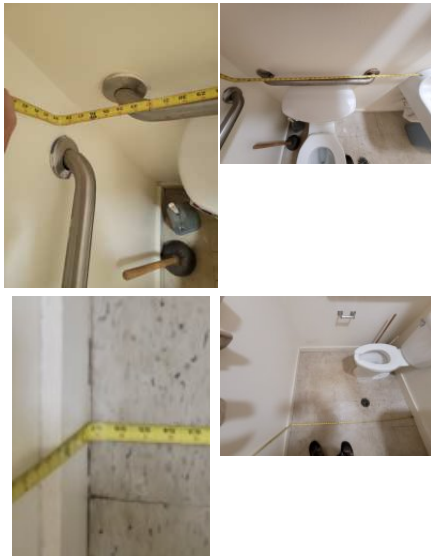
40	Headquarters: Headquarters Building	[30.8465007 , -94.165787 3]	The required 56 inches by 60 inches clear floor space for the water closet has been obstructed. The clear floor space around the water closet shall be 60 inches minimum measured perpendicular from the side wall and 56 inches minimum measured perpendicular from the rear wall.	Employee Restroom - Lacks 56" by 60" clear floor space for the toilet due to sink location and stall dimensions (39" from side wall and 57" from rear wall)	Renovate restroom to provide 60" by 56" clearance around the toilet.	2015 ABAAS Section: 604.3. 2012 TAS Section: 604.3.1 2010 ADAS Section: 604.3.1

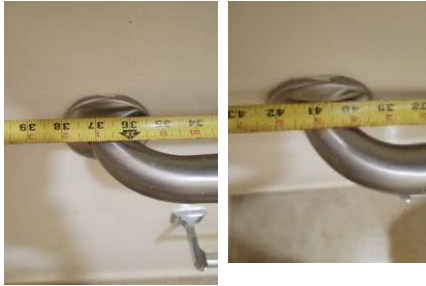
Finding Number	Area Description	Lat/Long	Finding	As Built	Recommendation	Citation	Photos	Figure
42	Headquarters: Headquarters Building	[30.8465076, -94.1658061]	The side grab bar is not long enough. The side grab bar must extend at least 54 inches minimum beyond the rear wall and start a maximum of 12 inches from the rear wall. A 42 inch grab bar installed the maximum distance from the rear wall (12 inches) will leave the leading end 54 inches from the rear wall. Grab bars shall be installed in a horizontal position, 33 inches minimum and 36 inches maximum above the finish floor measured to the top of the gripping surface.	Employee Restroom - Side grab bar 36" long and ends 41" from rear wall	Replace side grab bar with a 42" long grab bar, mounted max 12" from the rear wall at the close end and min 54" on the far end and 33" to 36" aff.	2015 ABAAS Section: 604.5.1 2012 TAS Section: 604.5.1 2010 ADAS Section: 604.5.1

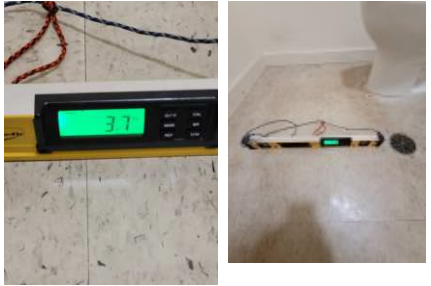
Finding Number	Area Description	Lat/Long	Finding	As Built	Recommendation	Citation	Photos	Figure
48	Headquarters: Headquarters Building	[30.8465007, -94.1658007]	The accessible route contains running slopes greater than 5 percent and cross slopes greater than 2 percent across the width of the walk and has not been constructed as a ramp (i.e. handrails, wheel guides, etc.). When the slope in the direction of travel of any walk exceeds 1 unit vertical in 20 units horizontal (5-percent slope), it must be constructed as ramp. Surface cross slopes must not exceed one unit vertical in 48 units. Horizontal (2-percent slope).	Employee Restroom - Slope of 3.7% near floor drain	Correct or repair slope to max 2.08%.	2015 ABAAS Section: 403.3 2012 TAS Section: 403.3 2010 ADAS Section: 403.3

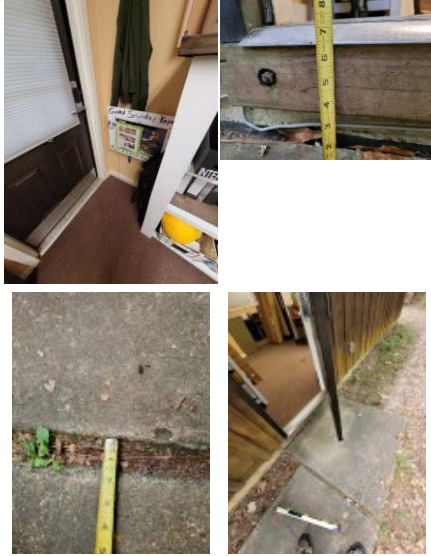
49	Headquarters: Headquarters Building	[30.8465076, -94.1658007]	Minimum maneuvering clearances at doors and gates shall comply with 404.2.4. Maneuvering clearances shall extend the full width of the doorway and the required latch side or hinge side clearance. Maneuvering clearances shall have a max slope of 2.08%. The threshold has a vertical change greater than 1/4 inch high. The threshold has a gap greater than 1/2 inch wide. The threshold at a doorway shall be no higher than 1/2 inch. Changes in level between 1/4 inch and 1/2 inch must be beveled at 1:2 or less. 1/4 inch is the maximum vertical rise. The sweep period for doors with closers shall be adjusted so that from an open position of 70 degrees, the door will take at least 3 seconds to move to a point 3 inches from the latch, measured to the leading edge of the door.	Door from employee area - Lacks maneuvering clearance on push side due to storage, gap of 1.5" at pull side landing, change in level of 6.5", fast close	For all doors along the public circulation route, provide required maneuvering clearance on push and pull side of doors. For all doors along the public circulation route, ramp CILs at door entries to max .25". For all doors along the public circulation route, fill gaps at door entries to max .5". For all doors along the public circulation route, inspect, adjust, and maintain closing speed on door closers.	2010 ADAS Section: 404.2.3, 404.2.7, 404.2.4, 404.2.11, 404.2.11 Exception

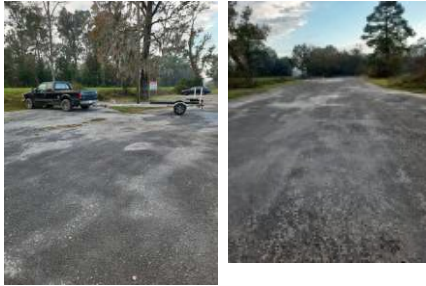
Finding Number	Area Description	Lat/Long	Finding	As Built	Recommendation	Citation	Photos	Figure
50	Cherokee Unit Day Use Area: Cherokee Unit Day Use Area "I-190" Boat Ramp Parking	[30.8543536 , -94.214088 7]	There are no accessible parking stalls. Each lot where parking is provided for the public as clients, guests or employees, shall provide accessible parking and shall be located on the shortest accessible route of travel from adjacent parking to an accessible entrance. There are a total of 20 parking stalls in the parking lot that could be reasonably associated with this facility. There should be a minimum of 1 accessible stalls with a minimum of 1 being designed as van accessible.	Lacks accessible parking stalls - approximately 20 standard, 0 accessible	Create one or more 8' accessible parking stalls, with one 5' adjacent access aisle, with proper signage and striping based on the total number of stalls	2015 ABAAS Section: F208.2 2012 TAS Section: 208.2 2010 ADAS Section: 208.2

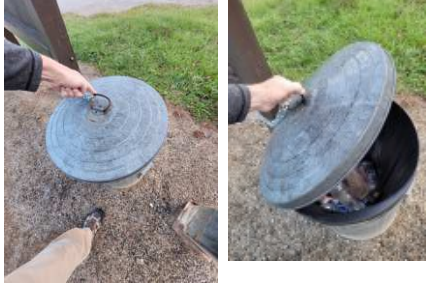
51	Cherokee Unit Day Use Area: Cherokee Unit Day Use Area "I-190" Boat Ramp Parking	[30.8542425 , -94.214744 4]	The garbage can is not accessible because it requires tight grasping, pinching or twisting of the wrist.	Garbage can lid requires tight grasping, pinching or twisting of the wrist	Replace garbage can with an operable part usable without a tight pinch or grasp	2015 ABAAS Section: 309.4 2012 TAS Section: 309.4 2010 ADAS Section: 309.4

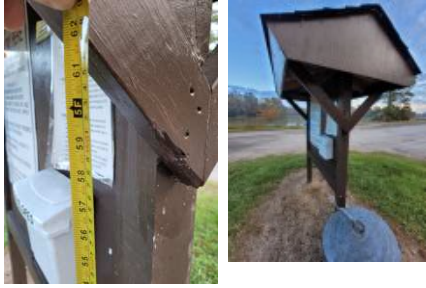
52	Cherokee Unit Day Use Area: Cherokee Unit Day Use Area "I-190" Boat Ramp Parking	[30.8542471 , -94.214744 4]	The angled roof supports on informational sign/kiosk projects more than 4 inches into the circulation path. Wall-mounted objects that have leading edges between 27 inches and 80 inches from the floor must not project more than 4 inches into the circulation path. Protruding objects that extend to the floor or within 27 inches of the floor are cane detectable and are therefore not hazardous. Where it is necessary or desirable to have objects protrude from the wall, a manner of cane detection must be provided.	Informational sign/kiosk lacks 80" overhead clearance due to angled roof supports protruding more than 4" at 62" above ground level	Raise roof supports to min 80", or pad object to prevent hazard in overhead clearance	2015 ABAAS Section: 307.2 2012 TAS Section: 307.2 2010 ADAS Section: 307.2

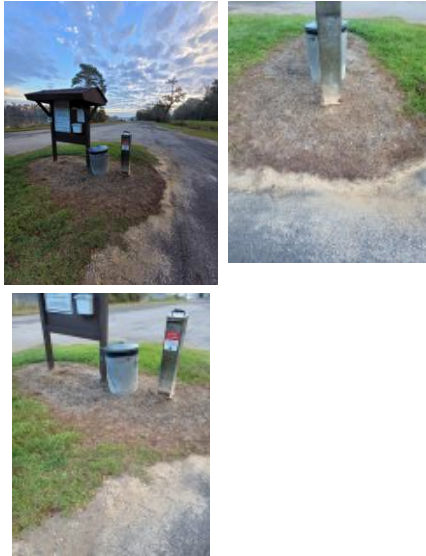
Finding Number	Area Description	Lat/Long	Finding	As Built	Recommendation	Citation	Photos	Figure
53	Cherokee Unit Day Use Area: Cherokee Unit Day Use Area "I-190" Boat Ramp Parking	[30.8542379 , -94.214744 4]	There is no accessible route to the informational sign/kiosk, garbage can, and self-pay station. At least one accessible route shall connect accessible buildings, accessible facilities, accessible elements, and accessible spaces that are on the same site.	Lacks accessible route to informational sign/kiosk, garbage can, and self-pay station	Create an accessible route with crushed stone or other outdoor material from parking or walkway to the informational sign/kiosk, garbage can, and self-pay station	2015 ABAAS Section: F206.2.2 2012 TAS Section: 206.2.2 2010 ADAS Section: 206.2.2

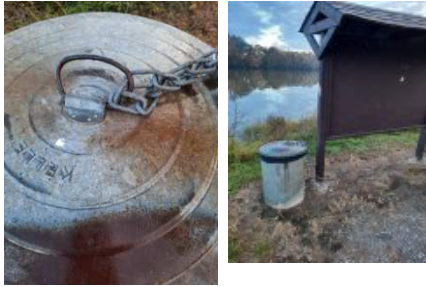
54	Cherokee Unit Day Use Area: Cherokee Unit Day Use Area "I-190" Boat Ramp	[30.8544709 , -94.213759]	The garbage can is not accessible because it requires tight grasping, pinching or twisting of the wrist.	Garbage can lid requires tight grasping, pinching or twisting of the wrist	Replace garbage can with an operable part usable without a tight pinch or grasp	2015 ABAAS Section: 309.4 2012 TAS Section: 309.4 2010 ADAS Section: 309.4

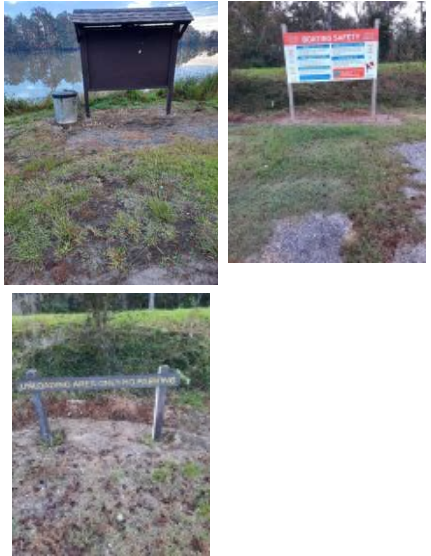
Finding Number	Area Description	Lat/Long	Finding	As Built	Recommendation	Citation	Photos	Figure
55	Cherokee Unit Day Use Area: Cherokee Unit Day Use Area "I-190" Boat Ramp	[30.854472, -94.213767 1]	There is no accessible route to the informational signs/kiosk and garbage can. At least one accessible route shall connect accessible buildings, accessible facilities, accessible elements, and accessible spaces that are on the same site.	Lacks accessible route to the informational signs/kiosk and garbage can	Create an accessible route with crushed stone or other outdoor material from parking or walkway to the informational signs/kiosk and garbage can.	2015 ABAAS Section: F206.2.2 2012 TAS Section: 206.2.2 2010 ADAS Section: 206.2.2

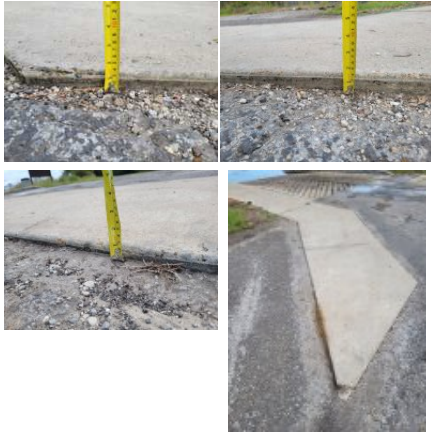
56	Cherokee Unit Day Use Area: Cherokee Unit Day Use Area "I-190" Boat Ramp	[30.85446, -94.213831]	The walkway contains abrupt vertical edges and/or variations over a 1/2 inch. 1/4 inch is the maximum vertical rise. Changes in level between 1/4 inch and 1/2 inch must be beveled at 1:2 or less. Changes in level greater than 1/2 inch must be by way of a ramp.	Three changes in level (CIL) of .75" to 1" along route to boarding pier	Repair, bevel, or ramp CIL along AR.	2015 ABAAS Section: 303.2, 303.3 2012 TAS Section: 303.3, 303.2 2010 ADAS Section: 303.3, 303.2

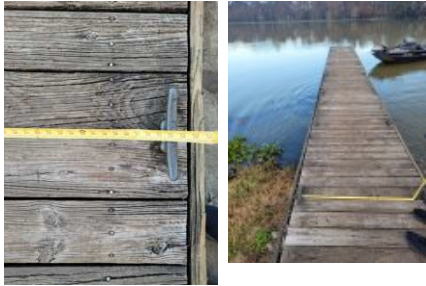
Finding Number	Area Description	Lat/Long	Finding	As Built	Recommendation	Citation	Photos	Figure
57	Cherokee Unit Day Use Area: Cherokee Unit Day Use Area "I-190" Boat Ramp	[30.8545636, -94.2138203]	The boat slip/pier is not wide enough. Boat slips and boarding piers shall provide clear pier space 60 inches wide minimum and at least as long as the boat slips/boarding pier. Each 10 feet maximum of linear pier edge serving boat slips and boarding piers shall contain at least one continuous clear opening 60 inches wide minimum. The clear width shall be permitted to be reduced to 36 inches minimum for a length of 24 inches maximum provided that reduced width segments are separated by segments that are 60 inches long minimum and 60 inches wide minimum.	Boarding pier lacks required 60" clear width (43" between cleats)	Provide 60" clear pier space for the entire length of pier.	2015 ABAAS Section: 1003.3.1 2012 TAS Section: 1003.3.1 2010 ADAS Section: 1003.3.1

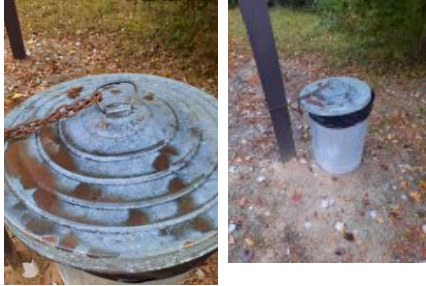
59	Cherokee Unit Day Use Area: Cherokee Unit Day Use Area "Peninsula" Boat Ramp	[30.85181, -94.21018]	The garbage can is not accessible because it requires tight grasping, pinching or twisting of the wrist.	Garbage can lid requires tight grasping, pinching or twisting of the wrist	Replace garbage can with an operable part usable without a tight pinch or grasp	2015 ABAAS Section: 309.4 2012 TAS Section: 309.4 2010 ADAS Section: 309.4

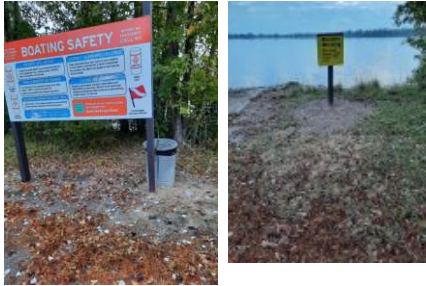
Finding Number	Area Description	Lat/Long	Finding	As Built	Recommendation	Citation	Photos	Figure
60	Cherokee Unit Day Use Area: Cherokee Unit Day Use Area "Peninsula" Boat Ramp	[30.85181, -94.21018]	There is no accessible route to the informational sign and garbage can. At least one accessible route shall connect accessible buildings, accessible facilities, accessible elements, and accessible spaces that are on the same site.	Lacks accessible route to the informational sign and garbage can	Create an accessible route with crushed stone or other outdoor material from parking or walkway to the informational sign and garbage can	2015 ABAAS Section: F206.2.2 2012 TAS Section: 206.2.2 2010 ADAS Section: 206.2.2

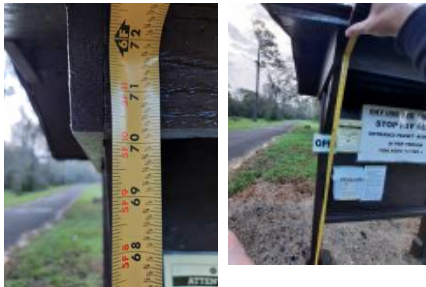
62	Cherokee Unit Day Use Area: Cherokee Unit Day Use Area Picnic Area	[30.8536613, -94.2148269]	The informational sign/kiosk extends down too close to the route of travel. Any obstruction that overhangs a route of travel must be a minimum of 80 inches above the walking surface as measured from the bottom of the obstruction.	Informational sign/kiosk lacks 80" overhead clearance	Raise informational sign/kiosk to min 80", or pad object to prevent hazard in overhead clearance	2015 ABAAS Section: 307.3 2012 TAS Section: 307.3 2010 ADAS Section: 307.3

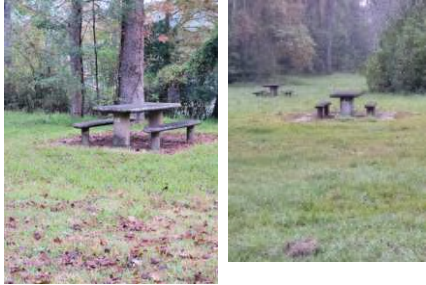
Finding Number	Area Description	Lat/Long	Finding	As Built	Recommendation	Citation	Photos	Figure
63	Cherokee Unit Day Use Area: Cherokee Unit Day Use Area Picnic Area	[30.85251, -94.21348]	There is no accessible route to the picnic tables. At least one accessible route shall connect accessible buildings, accessible facilities, accessible elements, and accessible spaces that are on the same site. Picnic tables shall provide at least one wheelchair space for each 24 linear feet (7320 mm) of usable table surface perimeter. Wheelchair spaces shall be 30 inches (760 mm) minimum by 48 inches (1220 mm) minimum. Wheelchair spaces shall be positioned for a forward approach to the table and provide knee and toe clearance complying with 306 under the table.	11 of 11 picnic tables lack accessible routes and are not of an accessible design	Create an accessible route with crushed stone or other outdoor material from parking or walkway to 3 picnic tables and replace them with ones of an accessible design as a smart practice	2015 ABAAS Section: F206.2.2 2012 TAS Section: 206.2.2 2010 ADAS Section: 206.2.2

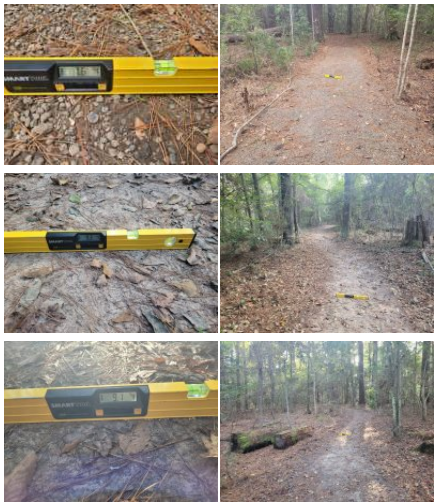
67	Trails and Trailheads: Forest Trail	[30.84929, -94.16807]	Where the surface is other than concrete, asphalt, or boards, cross slopes not steeper than 1:20 shall be permitted when necessary for drainage.	High cross slopes on gravel surface at entry near highway, slope of 9.3% near low area, and 9.1% around curves	Frequently maintain trail cross slope to assure it does not exceed 5% for surfaces other than concrete, boards or asphalt as a smart practice.	2015 ABAAS Section: 1017.7.2 EXCEPTION:

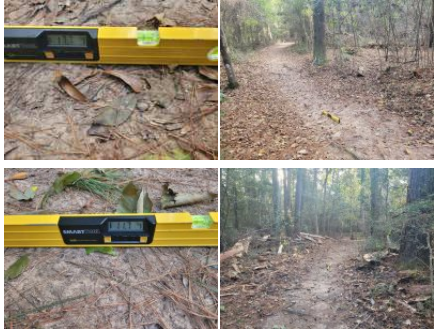
Finding Number	Area Description	Lat/Long	Finding	As Built	Recommendation	Citation	Photos	Figure
68	Trails and Trailheads: Forest Trail	[30.84929, -94.16807]	Not more than 30 percent of the total length of a trail shall have a running slope steeper than 1:12 (8.33%). The running slope of any segment of a trail shall not be steeper than 1:8 (12%). Where the running slope of a segment of a trail is steeper than 1:20 (5%), the maximum length of the segment shall be in accordance with Table 1017.7.1, and a resting interval complying with 1017.8 shall be provided at the top and bottom of each segment.	Running slope of 17.7% down into low area, and 11.7% without resting intervals near marker 8	Frequently maintain trail running slope to assure it does not exceed 8.33% slope for 200' max, 10% for 30' max or 12.5% for 10' with resting spaces on the trail as a smart practice.	2015 ABAAS Section: 1017.7.1

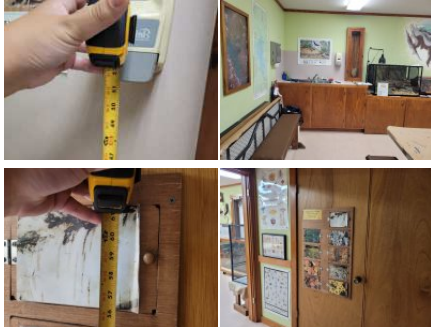
Finding Number	Area Description	Lat/Long	Finding	As Built	Recommendation	Citation	Photos	Figure
104	Wildscape Garden Education Center: Wildscape Garden Education Center Building	[30.8575841, -94.1719002]	The soap dispenser and camouflage exhibit is positioned too high for either a side or front approach. Where a clear floor or ground space allows a parallel approach to an element and the side reach is unobstructed, the high side reach shall be 48 inches maximum and the low side reach shall be 15 inches minimum above the finish floor or ground. Where a forward reach is unobstructed, the high forward reach shall be 48 inches maximum and the low forward reach shall be 15 inches minimum above the finish floor or ground.	Soap dispenser (51.5" aff) and camouflage exhibit (59" aff) exceed reach range	Remount operable parts to be in reach range of 15" min to 48" max	2015 ABAAS Section: 308.1 2012 TAS Section: 308.1 2010 ADAS Section: 308.1

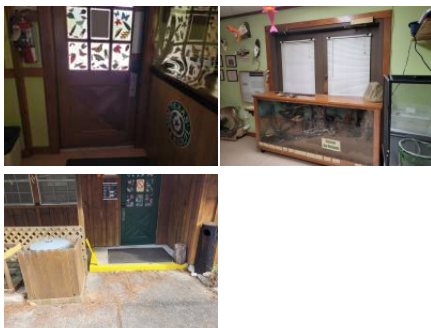
106	Wildscape Garden Education Center: Wildscape Garden Education Center Building	[30.857574, -94.1718926]	Minimum maneuvering clearances at doors and gates shall comply with 404.2.4. Maneuvering clearances shall extend the full width of the doorway and the required latch side or hinge side clearance. The threshold has a vertical change greater than 1/4 inch high. The sweep period for doors with closers shall be adjusted so that from an open position of 70 degrees, the door will take at least 3 seconds to move to a point 3 inches from the latch, measured to the leading edge of the door.	Main entry door - Lacks maneuvering clearance on pull side (counter - structural), CIL near main entrance, and lacks compliant closing speed Double door in exhibit space - Lacks maneuvering clearance and access due to alligator display obstructing door	For all doors along the public circulation route, provide required maneuvering clearance on push and pull side of doors For all doors along the public circulation route, repair, bevel, or ramp CILs at door entries to max .25" For all doors along the public circulation route, inspect, adjust, and maintain closing speed on door closers	2010 ADAS Section: 404.2.3, 404.2.7, 404.2.4, 404.2.11, 404.2.11 Exception

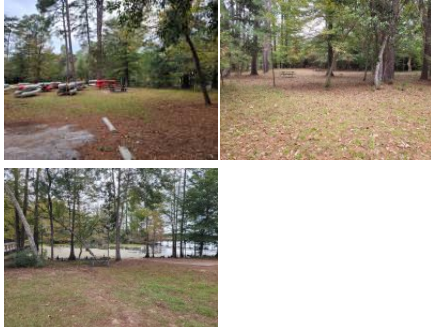
109	Walnut Slough Day Use Area: Walnut Slough Day Use Area Picnic Area	[30.86974, -94.17515]	There is no accessible route to the 6 of 6 picnic tables. At least one accessible route shall connect accessible buildings, accessible facilities, accessible elements, and accessible spaces that are on the same site. Picnic tables shall provide at least one wheelchair space for each 24 linear feet (7320 mm) of usable table surface perimeter. Wheelchair spaces shall be 30 inches (760 mm) minimum by 48 inches (1220 mm) minimum. Wheelchair spaces shall be positioned for a forward approach to the table and provide knee and toe clearance complying with 306 under the table.	6 of 6 picnic tables lack accessible routes and are not of an accessible design	Create an accessible route with crushed stone or other outdoor material from parking or walkway to 2 picnic tables and replace them with ones of an accessible design as a smart practice	2015 ABAAS Section: F206.2.2 2012 TAS Section: 206.2.2 2010 ADAS Section: 206.2.2

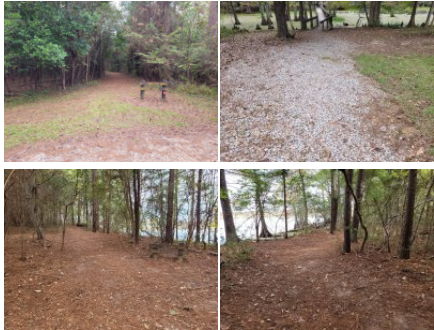
114	Walnut Slough Day Use Area: Walnut Slough Day Use Area Observation Bridge	[30.86973, -94.17592]	The surface of trails, passing spaces, and resting intervals shall be firm and stable	Shelter area trail, Wildlife trail, nature trail, and portions of nature trail lack firm and stable surfaces - dirt surface or gravel at entry to nature trail	Replace surface of at least one trail with one that is firm and stable as a smart practice.	2015 ABAAS Section: 1017.2

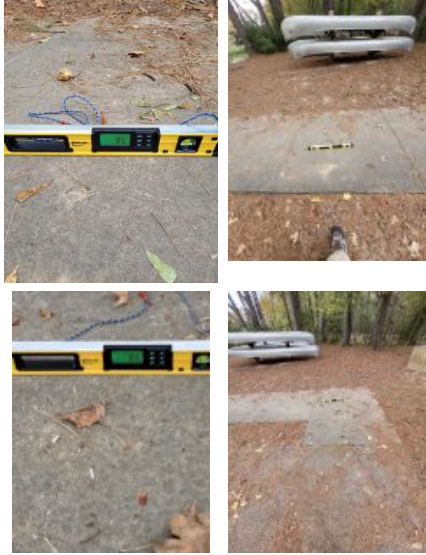
120	Hen House Ridge Unit (Sites 300-327): Hen House Ridge Unit (Sites 300-327) Canoe/Kayak Launch	[30.8436233 , -94.166722 1]	There is no accessible route to/on the boating facility. Accessible routes serving recreational boating facilities, including gangways and floating piers, shall comply with accessible route requirements except as modified by section Recreational Boating Facilities - Accessible Routes.	Slope of 9.4% slope at top landing, and multiple sections over 8.5% for approximately 30 feet	Create an accessible route to the boat pier or make corrections for a compliant route.	2015 ABAAS Section: 1003.2 2010 ADAS Section: 1003.2

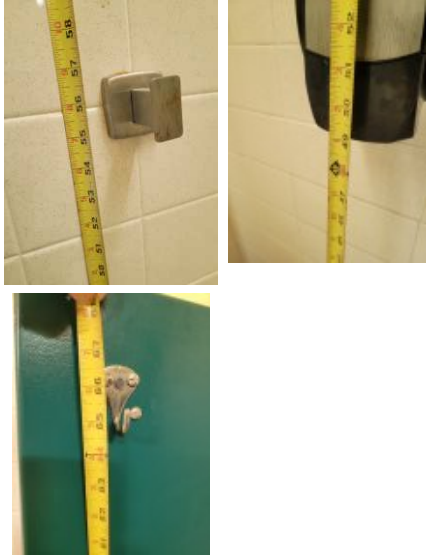
134	Hen House Ridge Unit (Sites 300-327): Hen House Ridge Unit (Sites 300-327) Men's Restroom	[30.8446239 , -94.1676005]	Where a high forward reach is over an obstruction, the clear floor space shall extend beneath the element for a distance not less than the required reach depth over the obstruction. The high forward reach shall be 48 inches (1220 mm) maximum where the reach depth is 20 inches (510 mm) maximum. Where the reach depth exceeds 20 inches (510 mm), the high forward reach shall be 44 inches (1120 mm) maximum and the reach depth shall be 25 inches (635 mm) maximum. Where a clear floor or ground space allows a parallel approach to an element and the high side reach is over an obstruction, the height of the obstruction shall be 34 inches (865 mm) maximum and the depth of the obstruction shall be 24 inches (610 mm) maximum. The high side reach shall be 48 inches (1220 mm) maximum for a reach depth of 10 inches (255 mm) maximum. Where the reach depth exceeds 10 inches (255 mm), the high side reach shall be 46 inches (1170 mm) maximum for a reach depth of 24 inches (610 mm) maximum.	Coat hooks at 56.5" aff and 65.5" aff and soap dispenser 49" aff	Lower one coat hook and soap dispenser to max 48" aff to highest operable part.	2015 ABAAS Section: 308.2.1, 308.3.2 2012 TAS Section: 308.2.1, 308.3.2 2010 ADAS Section: 308.2.1, 308.3.2

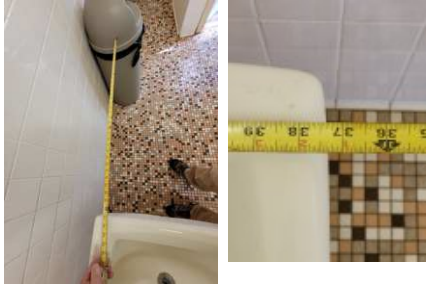
Finding Number	Area Description	Lat/Long	Finding	As Built	Recommendation	Citation	Photos	Figure
135	Hen House Ridge Unit (Sites 300-327): Hen House Ridge Unit (Sites 300-327) Men's Restroom	[30.8446147 , -94.167592 4]	The operable part is not accessible because there is not adequate clear floor space for either a forward or side approach. The clear floor or ground space shall be 30 inches minimum by 48 inches minimum.	Garbage in sink clearance	Remove, or relocate storage in CFS at fixtures and operable parts.	2015 ABAAS Section: 305.3 2012 TAS Section: 305.3 2010 ADAS Section: 305.3

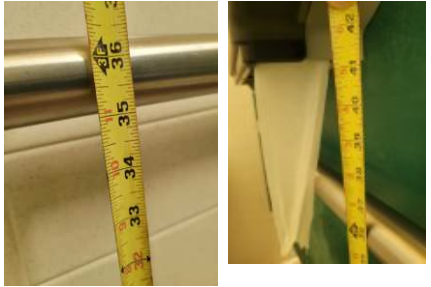
139	Hen House Ridge Unit (Sites 300-327): Hen House Ridge Unit (Sites 300-327) Men's Restroom	[30.844617, -94.1676139]	The grab bar height and/or spacing fails. Grab bars must be mounted between 33" and 36" to the top of the gripping surface. There must be 1.5" of clearance between the grab bar and the wall. There must be a minimum of 1.5" of clearance below and minimum 12" above the grab bar to any dispenser or other obstruction.	Gripping surface of grab bar is 36.5" aff, TP 4.5" above grab bar	Remount grab bars in accessible stall to 33" to 36" aff. Remount toilet paper dispenser max 7" to 9" from front of toilet, 15" to 48" aff and min 12" above or 1.5" below grab bar	2015 ABAAS Section: 609.3, 609.4 2012 TAS Section: 609.4, 609.3 2010 ADAS Section: 609.3, 609.4

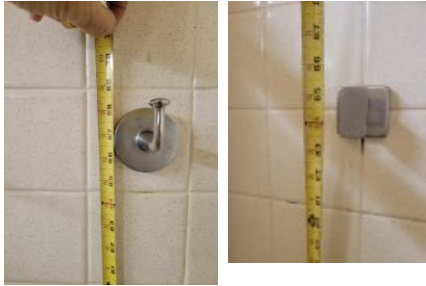
Finding Number	Area Description	Lat/Long	Finding	As Built	Recommendation	Citation	Photos	Figure
141	Hen House Ridge Unit (Sites 300-327): Hen House Ridge Unit (Sites 300-327) Men's Restroom	[30.8445963 , -94.167621 9]	Coat hooks provided within the room shall be located within one of the reach ranges specified in 308. Shelves shall be 40 inches (1015 mm) minimum and 48 inches (1220 mm) maximum above the finish floor or ground. Where coat hooks or shelves are provided in dressing, fitting or locker rooms without individual compartments, at least one of each type shall comply with 803.5. Where coat hooks or shelves are provided in individual compartments at least one of each type complying with 803.5 shall be provided in individual compartments in dressing, fitting, or locker rooms required to comply with 222.1.	Coat hooks at 65" aff and 68" aff	Remount at least one hook to max 48" aff.	2015 ABAAS Section: 308.2.1, 308.1, F222.2, 803.5 2012 TAS Section: 308.2.1, 308.1, 222.2, 803.5 2010 ADAS Section: 308.2.1, 308.1, 222.2, 803.5

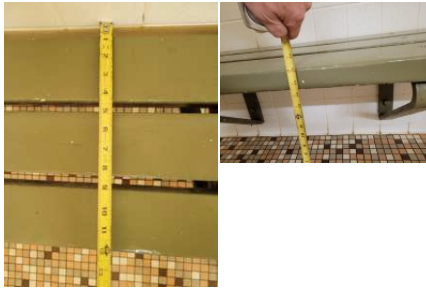
142	Hen House Ridge Unit (Sites 300-327): Hen House Ridge Unit (Sites 300-327) Men's Restroom	[30.8446181 , -94.167644 7]	The bench is not deep enough or long enough or is missing. Benches shall be provided having seats that are 42 inches long minimum and 20 inches deep minimum and 24 inches deep maximum. The bench shall provide for back support or shall be affixed to a wall. Back support shall be 42 inches (1065 mm) long minimum and shall extend from a point 2 inches (51 mm) maximum above the seat surface to a point 18 inches (455 mm) minimum above the seat surface. Back support shall be 2½ inches (64 mm) maximum from the rear edge of the seat measured horizontally. The top of the bench seat surface shall be 17 inches (430 mm) minimum and 19 inches (485 mm) maximum above the finish floor or ground. Clear floor or ground space complying with 305 shall be provided and shall be positioned at the end of the bench seat and parallel to the short axis of the bench	Bench fails required dimensions - 12" deep, 16" aff	Replace bench in dressing area with one having a seat depth of 20" to 24" deep, 42" long, affixed to the wall or having a back and mounted 17" to 19" AFF and provide required clear floor space on the short axis of the bench.	2012 TAS Section: 903.4, 903.2, 903.3, 903.5 2010 ADAS Section: 903.4, 903.2, 903.3, 903.5

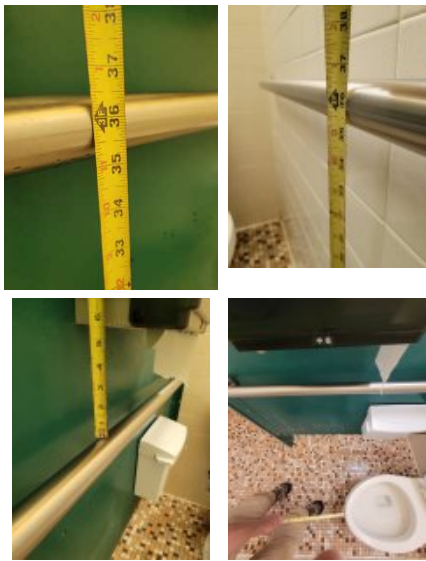
154	Hen House Ridge Unit (Sites 300-327): Hen House Ridge Unit (Sites 300-327) Women's Restroom	[30.8445963, -94.1675898]	The grab bar height and/or spacing fails. Grab bars must be mounted between 33" and 36" to the top of the gripping surface. There must be 1.5" of clearance between the grab bar and the wall. There must be a minimum of 1.5" of clearance below and minimum 12" above the grab bar to any dispenser or other obstruction.	Gripping surface of grab bar is 36.5" aff, TP 5.5" above bar and too close to toilet	Remount grab bars in accessible stall to 33" to 36" aff. Remount toilet paper dispenser max 7" to 9" from front of toilet, 15" to 48" aff and min 12" above or 1.5" below grab bar	2015 ABAAS Section: 609.3, 609.4 2012 TAS Section: 609.4, 609.3 2010 ADAS Section: 609.3, 609.4

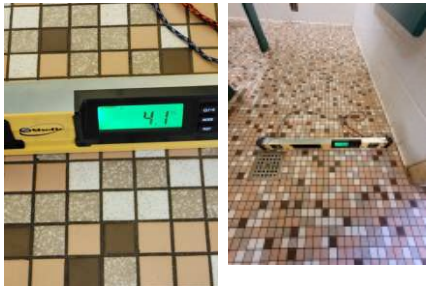
155	Hen House Ridge Unit (Sites 300-327): Hen House Ridge Unit (Sites 300-327) Women's Restroom	[30.844617, -94.1675737]	The accessible route contains running slopes greater than 5 percent and cross slopes greater than 2 percent across the width of the walk and has not been constructed as a ramp (i.e. handrails, wheel guides, etc.). When the slope in the direction of travel of any walk exceeds 1 unit vertical in 20 units horizontal (5-percent slope), it must be constructed as ramp. Surface cross slopes must not exceed one unit vertical in 48 units. Horizontal (2-percent slope).	Slope of 4.1% near floor drain	Correct or repair slope to max 5% running and 2.08% cross	2015 ABAAS Section: 403.3 2012 TAS Section: 403.3 2010 ADAS Section: 403.3

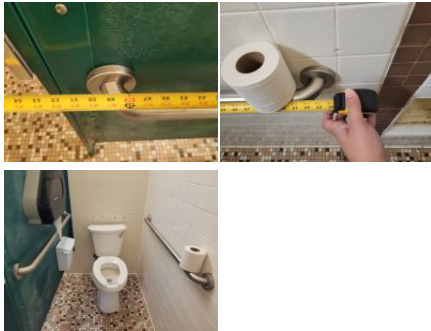
171	Hen House Ridge Unit (Shelter Sites 400-420) : Hen House Ridge Unit (Shelter Sites 400-420) Women's Restroom Bldg 4	[30.8473165 , -94.170990 9]	The side grab bars are not in the correct location. Grab bars on the side wall must be installed so that the end closest to the rear wall is maximum 12" from the rear wall. The end furthest from the rear wall must be mounted minimum 54" from the rear wall.	Side grab bars end 49" and 53" from rear wall	Remount side grab bar to max 12" from the rear wall at the close end and min 54" on the far end, and 33" to 36" aff in new wheelchair accessible stall.	2015 ABAAS Section: 604.5.1 2012 TAS Section: 604.5.1 2010 ADAS Section: 604.5.1

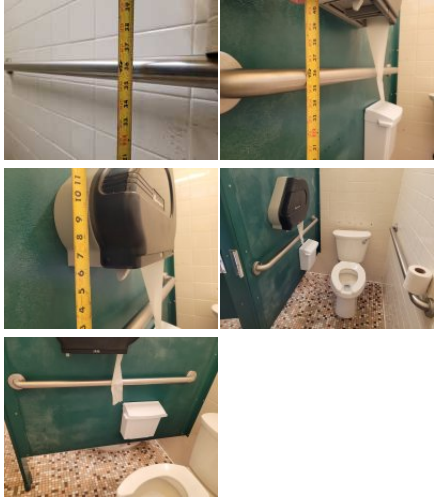
Finding Number	Area Description	Lat/Long	Finding	As Built	Recommendation	Citation	Photos	Figure
172	Hen House Ridge Unit (Shelter Sites 400-420) : Hen House Ridge Unit (Shelter Sites 400-420) Women's Restroom Bldg 4	[30.8473062 , -94.170993 6]	The grab bar height and/or spacing fails. Grab bars must be mounted between 33" and 36" to the top of the gripping surface. There must be 1.5" of clearance between the grab bar and the wall. There must be a minimum of 1.5" of clearance below and minimum 12" above the grab bar to any dispenser or other obstruction.	Gripping surface of grab bar is 36.5" aff, and TP 6" above bar and too close to toilet	Remount grab bars in accessible stall to 33" to 36" aff Remount toilet paper dispenser max 7" to 9" from front of toilet, 15" to 48" aff and min 12" above or 1.5" below grab bar	2015 ABAAS Section: 609.3, 609.4 2012 TAS Section: 609.4, 609.3 2010 ADAS Section: 609.3, 609.4

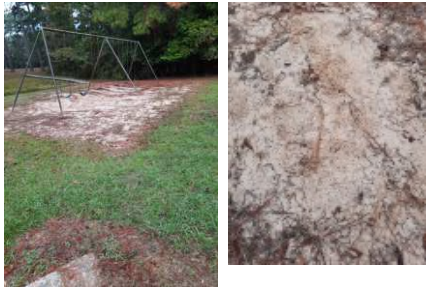
174	Hen House Ridge Unit (Shelter Sites 400-420) : Hen House Ridge Unit (Shelter Sites 400-420) Exterior Accessible Route	[30.8473338 , -94.171178 7]	At least one accessible route shall connect accessible buildings, accessible facilities, accessible elements, and accessible spaces that are on the same site. For areas of sport activity, an accessible route is required to connect to the boundary of each area of sport activity. The size of an area of sport activity includes only the space needed to play. Where multiple sports fields or courts are provided, an accessible route is required to each field or area of sport activity.	Lacks route to play area (6 swings), sand surface	Provide an accessible route to play elements and replace surface with an accessible surface.	2010 ADAS Section: 206.2.2, 206.2

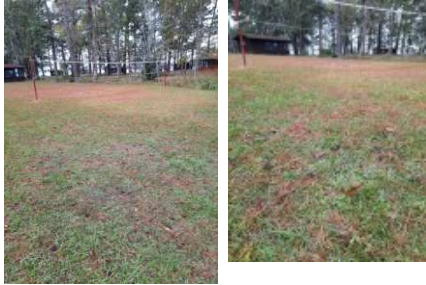
Finding Number	Area Description	Lat/Long	Finding	As Built	Recommendation	Citation	Photos	Figure
175	Hen House Ridge Unit (Shelter Sites 400-420) : Hen House Ridge Unit (Shelter Sites 400-420) Exterior Accessible Route	[30.8472244 , -94.171367 8]	At least one accessible route shall connect accessible buildings, accessible facilities, accessible elements, and accessible spaces that are on the same site. For areas of sport activity, an accessible route is required to connect to the boundary of each area of sport activity. The size of an area of sport activity includes only the space needed to play. Where multiple sports fields or courts are provided, an accessible route is required to each field or area of sport activity.	Lacks accessible route to grass volleyball court	Provide an accessible route to each element within the site.	2010 ADAS Section: 206.2.2, 206.2

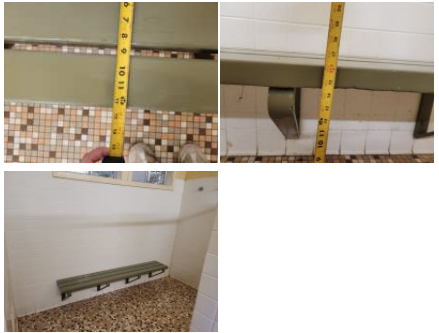
180	Hen House Ridge Unit (Shelter Sites 400-420) : Hen House Ridge Unit (Shelter Sites 400-420) Women's Shower Bldg 4	[30.8473085 , -94.1709976]	The bench is not deep enough or long enough or is missing. Benches shall be provided having seats that are 42 inches long minimum and 20 inches deep minimum and 24 inches deep maximum. The bench shall provide for back support or shall be affixed to a wall. Back support shall be 42 inches (1065 mm) long minimum and shall extend from a point 2 inches (51 mm) maximum above the seat surface to a point 18 inches (455 mm) minimum above the seat surface. Back support shall be 2½ inches (64 mm) maximum from the rear edge of the seat measured horizontally. The top of the bench seat surface shall be 17 inches (430 mm) minimum and 19 inches (485 mm) maximum above the finish floor or ground. Clear floor or ground space complying with 305 shall be provided and shall be positioned at the end of the bench seat and parallel to the short axis of the bench	Bench dimensions fail - 12.25" deep, 16.25" aff and lacks clear floor space	Replace bench in dressing area with one having a seat depth of 20" to 24" deep, 42" long, affixed to the wall or having a back and mounted 17" to 19" AFF and provide required clear floor space on the short axis of the bench.	2012 TAS Section: 903.4, 903.2, 903.3, 903.5 2010 ADAS Section: 903.4, 903.2, 903.3, 903.5

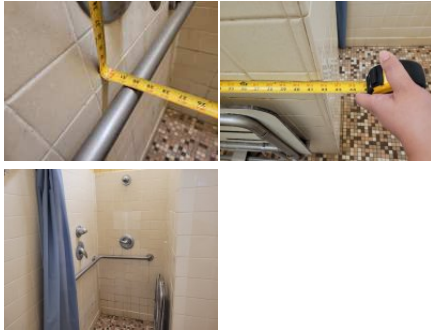
Finding Number	Area Description	Lat/Long	Finding	As Built	Recommendation	Citation	Photos	Figure
181	Hen House Ridge Unit (Shelter Sites 400-420) : Hen House Ridge Unit (Shelter Sites 400-420) Women's Shower Bldg 4	[30.8473154 , -94.170988 2]	Transfer type shower compartments shall be 36 inches (915 mm) by 36 inches (915 mm) clear inside dimensions measured at the center points of opposing sides and shall have a 36 inch (915 mm) wide minimum entry on the face of the shower compartment. Clearance of 36 inches (915 mm) wide minimum by 48 inches (1220 mm) long minimum measured from the control wall shall be provided.	Transfer shower dimensions fail 32" wide, 42" deep	Reconfigure transfer shower to compliant 36" by 36" clear inside dimension	2015 ABAAS Section: 608.2.1 2012 TAS Section: 608.2.1 2010 ADAS Section: 608.2.1

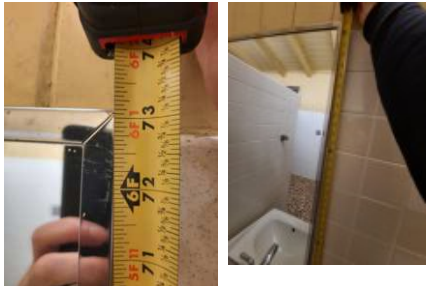
188	Hen House Ridge Unit (Shelter Sites 400-420) : Hen House Ridge Unit (Shelter Sites 400-420) Men's Restroom Bldg 4	[30.8473039 , -94.170996 3]	The mirror is mounted too high. Mirrors must have the bottom edge of the reflecting surface a maximum of 40 inches above the floor if above a sink or counter. Mirrors not located above lavatories or countertops shall be installed with the bottom edge of the reflecting surface 35 inches maximum above the finish floor or ground.	Top edge of reflecting surface is 72.5" aff	Remount or replace mirror so bottom reflective surface is max 40" AFF and 74" at the top.	2015 ABAAS Section: 603.3 2012 TAS Section: 603.3 2010 ADAS Section: 603.3

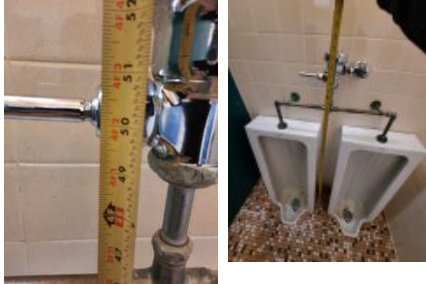
189	Hen House Ridge Unit (Shelter Sites 400-420) : Hen House Ridge Unit (Shelter Sites 400-420) Men's Restroom Bldg 4	[30.8473235 , -94.170977 5]	The urinals flush handle is mounted too high. Flush controls shall be operable with one hand and shall not require tight grasping, pinching or twisting of the wrist and shall be mounted no more than 48 inches above the floor. The force required to activate controls shall be no greater than 5 lb. Electronic automatic flushing controls are acceptable and preferable.	Urinal flush handle at 50.5" aff	Lower flush handle at urinal to max 48" AFF.	2015 ABAAS Section: 605.4 2012 TAS Section: 605.4 2010 ADAS Section: 605.4

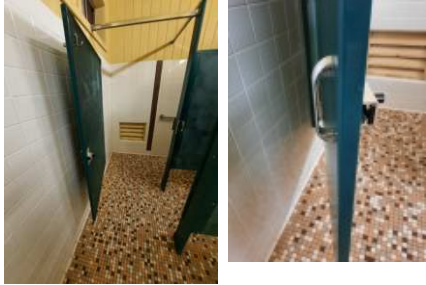
Finding Number	Area Description	Lat/Long	Finding	As Built	Recommendation	Citation	Photos	Figure
192	Hen House Ridge Unit (Shelter Sites 400-420) : Hen House Ridge Unit (Shelter Sites 400-420) Men's Restroom Bldg 4	[30.847305, -94.1710017]	The stall door fails to comply with all of the door requirements. The stall door must be a minimum of 32" wide and have compliant hardware on both sides. The stall door must be self-closing.	Stall lacks self-closing door and lacks compliant hardware	Adjust stall door to be self-closing Replace stall hardware with hardware operable without a tight pinch or grasp on both sides of the stall door	2015 ABAAS Section: 404.2.3, 404.2.7, 604.8.2.2 2012 TAS Section: 404.2.3, 404.2.7, 604.8.2.2 2010 ADAS Section: 404.2.3, 404.2.7, 604.8.2.2

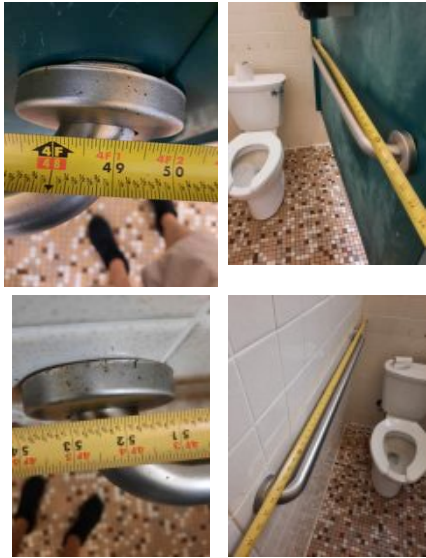
193	Hen House Ridge Unit (Shelter Sites 400-420) : Hen House Ridge Unit (Shelter Sites 400-420) Men's Restroom Bldg 4	[30.8473108, -94.1709963]	The side grab bars are not in the correct location. Grab bars on the side wall must be installed so that the end closest to the rear wall is maximum 12" from the rear wall. The end furthest from the rear wall must be mounted minimum 54" from the rear wall.	Side grab bars end 49.25" and 53" from rear wall	Remount side grab bar to max 12" from the rear wall at the close end and min 54" on the far end, and 33" to 36" aff in new wheelchair stall.	2015 ABAAS Section: 604.5.1 2012 TAS Section: 604.5.1 2010 ADAS Section: 604.5.1

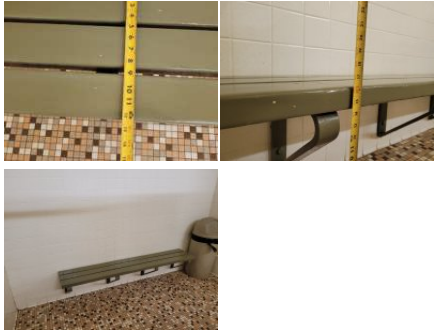
Finding Number	Area Description	Lat/Long	Finding	As Built	Recommendation	Citation	Photos	Figure
198	Hen House Ridge Unit (Shelter Sites 400-420) : Hen House Ridge Unit (Shelter Sites 400-420) Men's Shower Bldg 4	[30.8473131 , -94.170992 3]	The bench is not deep enough or long enough or is missing. Benches shall be provided having seats that are 42 inches long minimum and 20 inches deep minimum and 24 inches deep maximum. The bench shall provide for back support or shall be affixed to a wall. Back support shall be 42 inches (1065 mm) long minimum and shall extend from a point 2 inches (51 mm) maximum above the seat surface to a point 18 inches (455 mm) minimum above the seat surface. Back support shall be 2½ inches (64 mm) maximum from the rear edge of the seat measured horizontally. The top of the bench seat surface shall be 17 inches (430 mm) minimum and 19 inches (485 mm) maximum above the finish floor or ground. Clear floor or ground space complying with 305 shall be provided and shall be positioned at the end of the bench seat and parallel to the short axis of the bench	Bench dimensions fail - 12.25" deep, 16.25" aff and lacks clear floor space	Replace bench in dressing area with one having a seat depth of 20" to 24" deep, 42" long, affixed to the wall or having a back and mounted 17" to 19" AFF and provide required clear floor space on the short axis of the bench.	2012 TAS Section: 903.4, 903.2, 903.3, 903.5 2010 ADAS Section: 903.4, 903.2, 903.3, 903.5

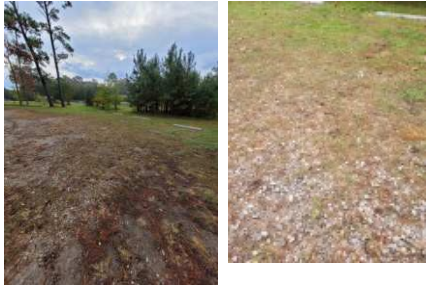
Finding Number	Area Description	Lat/Long	Finding	As Built	Recommendation	Citation	Photos	Figure
202	Hen House Ridge Unit Near I-190: Hen House Ridge Unit North Boat Ramp (near I-190) Parking	[30.8527088 , -94.172085 1]	There are no accessible parking stalls. Each lot where parking is provided for the public as clients, guests or employees, shall provide accessible parking and shall be located on the shortest accessible route of travel from adjacent parking to an accessible entrance. There are a total of 7 parking stalls in the parking lot that could be reasonably associated with this facility. There should be a minimum of 1 accessible stalls with a minimum of 1 being designed as van accessible. Floor and ground surfaces shall be stable, firm, and slip resistant	7 standard stalls, 0 accessible spaces, no accessible route, gravel & grass surface	Create one or more 8' accessible parking stalls, with one 5' adjacent access aisle, with proper signage and striping based on the total number of stalls.	2015 ABAAS Section: F208.2 2012 TAS Section: 208.2 2010 ADAS Section: 208.2

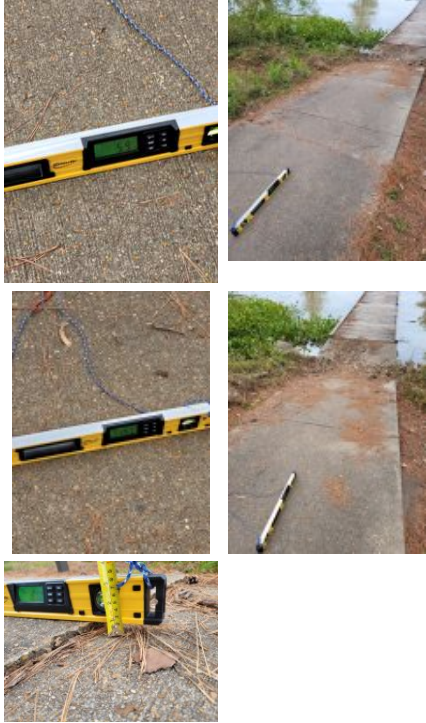
203	Hen House Ridge Unit Near I-190: Hen House Ridge Unit North Boat Ramp (near I-190) Fishing Pier	[30.8526006 , -94.173125 8]	The running slope of walking surfaces shall not be steeper than 1:20. The walkway contains abrupt vertical edges and/or variations over a 1/4 inch. 1/4 inch is the maximum vertical rise. Changes in level between 1/4 inch and 1/2 inch must be beveled at 1:2 or less. Changes in level greater than 1/2 inch must be by way of a ramp.	Running slopes of 5.9% and 14.1%, and change in level (CIL) of .75" on walkway to fishing pier	Correct running slope along the route to max 5% Repair, bevel or ramp CIL along route	2015 ABAAS Section: 403.3 2012 TAS Section: 403.3 2010 ADAS Section: 403.3

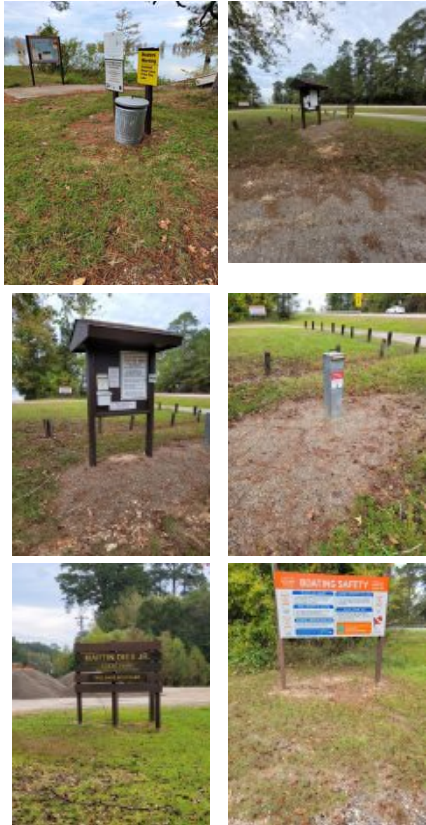
Finding Number	Area Description	Lat/Long	Finding	As Built	Recommendation	Citation	Photos	Figure
207	Hen House Ridge Unit Near I-190: Hen House Ridge Unit North Boat Ramp (near I-190)	[30.8526535 , -94.1728286]	At least one accessible route shall connect accessible buildings, accessible facilities, accessible elements, and accessible spaces that are on the same site. For areas of sport activity, an accessible route is required to connect to the boundary of each area of sport activity. The size of an area of sport activity includes only the space needed to play. Where multiple sports fields or courts are provided, an accessible route is required to each field or area of sport activity.	Tidelands Area - Lacks accessible route to trash can, informational sign, and self-pay station	Provide an accessible route to each element within the site.	2010 ADAS Section: 206.2.2, 206.2
