Access Audit Site Report

Prepared By
WT Group

Martin Dies Jr. State Park
634 Park Road 48 South
Jasper, TX 75951
Accessibility Evaluation
Inspection Date: 11/10/2021
Inspectors: Tanya Scheibe

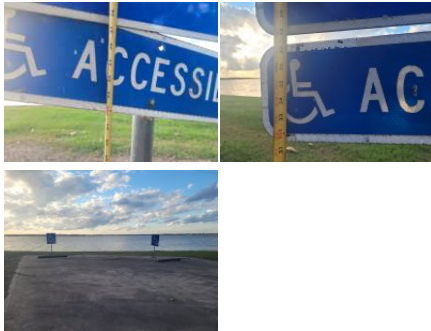
218	Hen House Ridge Unit Day Use Area: Hen House Ridge Unit Day Use Area Boat Ramp Parking	[30.842826, -94.174798 3]	The parking sign is mounted too low. Parking space identification signs shall include the International Symbol of Accessibility complying with. Signs identifying van parking spaces shall contain the designation "van accessible." Signs shall be 60 inches minimum above the finish floor or ground surface measured to the bottom of the sign.	The parking sign is mounted too low at 32" above ground level (AGL)	Raise existing accessible parking signs so lowest end of bottom sign is min 60" AGL	2015 ABAAS Section: 502.6 2012 TAS Section: 502.6 2010 ADAS Section: 502.6

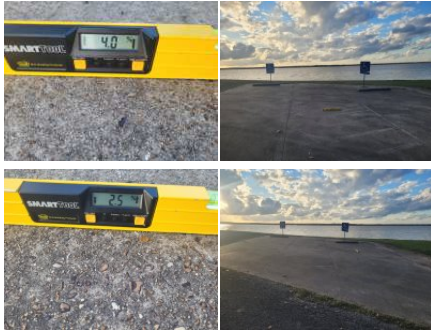
220	Hen House Ridge Unit Day Use Area: Hen House Ridge Unit Day Use Area Boat Ramp Parking	[30.8428387 , -94.174795 6]	The cross slopes (narrow dimension) and/or running slopes (long dimension) of the accessible stall exceeds 2%. The running slope and the cross slope in an accessible parking stall and the access aisle must not exceed 2%.	Slope of 4% in aisle aisle, and 2.5% in right stall	Correct or repair slope of stall to max 2.08% in any direction	2015 ABAAS Section: 502.4 2012 TAS Section: 502.4 2010 ADAS Section: 502.4

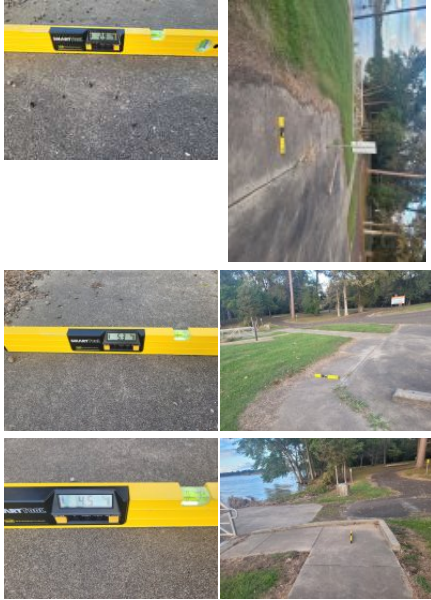
Finding Number	Area Description	Lat/Long	Finding	As Built	Recommendation	Citation	Photos	Figure
222	Hen House Ridge Unit Day Use Area: Hen House Ridge Unit Day Use Area Boat Ramp	[30.8429188 , -94.1747009]	The accessible route contains cross slopes greater than 2%. Cross slopes shall not exceed one unit vertical in 48 units horizontal (2-percent slope).	Cross slopes of 2.9% at parking, 5.3% along parking, and 4.5% at walkway turn	Correct or repair cross slope along AR to max 2.08%.	2015 ABAAS Section: 403.3 2012 TAS Section: 403.3 2010 ADAS Section: 403.3

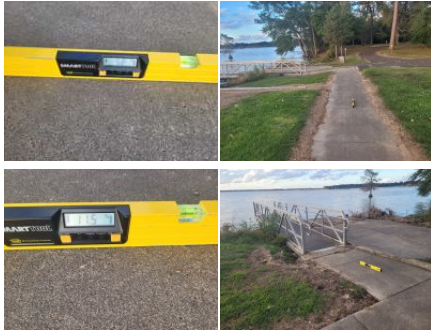
223	Hen House Ridge Unit Day Use Area: Hen House Ridge Unit Day Use Area Boat Ramp	[30.8429542 , -94.1746664]	The running slope of walking surfaces shall not be steeper than 1:20.	Running slopes of 5.2% and 11.4% on route to pier	Correct running slope along the AR to max 5%	2015 ABAAS Section: 403.3 2012 TAS Section: 403.3 2010 ADAS Section: 403.3

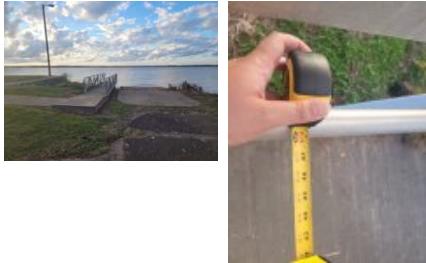
Finding Number	Area Description	Lat/Long	Finding	As Built	Recommendation	Citation	Photos	Figure
224	Hen House Ridge Unit Day Use Area: Hen House Ridge Unit Day Use Area Boat Ramp	[30.8430022 , -94.1747336]	The boat slip/pier is not wide enough. Boat slips and boarding piers shall provide clear pier space 60 inches wide minimum and at least as long as the boat slips/boarding pier. Each 10 feet maximum of linear pier edge serving boat slips and boarding piers shall contain at least one continuous clear opening 60 inches wide minimum. The clear width shall be permitted to be reduced to 36 inches minimum for a length of 24 inches maximum provided that reduced width segments are separated by segments that are 60 inches long minimum and 60 inches wide minimum.	Pier only 48" clear width (staff indicated that this fishing pier and boat ramp are scheduled to be renovated)	Provide 60" clear pier space for the entire length of pier upon renovation.	2015 ABAAS Section: 1003.3.1 2012 TAS Section: 1003.3.1 2010 ADAS Section: 1003.3.1

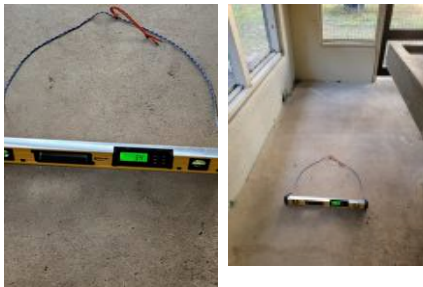
230	Hen House Ridge Unit Day Use Area: Hen House Ridge Unit Day Use Area Boat Ramp Fish Cleaning Station	[30.843408, -94.1742081]	The accessible route contains running slopes greater than 5 percent and cross slopes greater than 2 percent across the width of the walk and has not been constructed as a ramp (i.e. handrails, wheel guides, etc.). When the slope in the direction of travel of any walk exceeds 1 unit vertical in 20 units horizontal (5-percent slope), it must be constructed as ramp. Surface cross slopes must not exceed one unit vertical in 48 units. Horizontal (2-percent slope).	Slope of 3.4% on interior	Correct or repair slope to max 2.08% cross.	2015 ABAAS Section: 403.3 2012 TAS Section: 403.3 2010 ADAS Section: 403.3

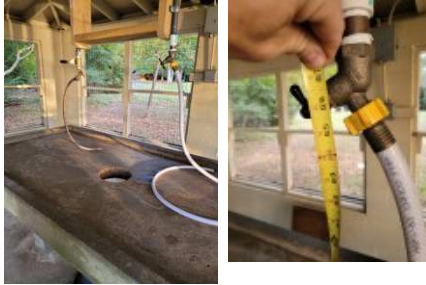
Finding Number	Area Description	Lat/Long	Finding	As Built	Recommendation	Citation	Photos	Figure
231	Hen House Ridge Unit Day Use Area: Hen House Ridge Unit Day Use Area Boat Ramp Fish Cleaning Station	[30.8434137 , -94.1742027]	The water spout handle is positioned too high for either a side or front approach. Where a clear floor or ground space allows a parallel approach to an element and the side reach is unobstructed, the high side reach shall be 48 inches maximum and the low side reach shall be 15 inches minimum above the finish floor or ground. Where a forward reach is unobstructed, the high forward reach shall be 48 inches maximum and the low forward reach shall be 15 inches minimum above the finish floor or ground.	Water spout handle at 66" aff	Remount operable parts to be in reach range of 15" min to 48" max.	2015 ABAAS Section: 308.1 2012 TAS Section: 308.1 2010 ADAS Section: 308.1

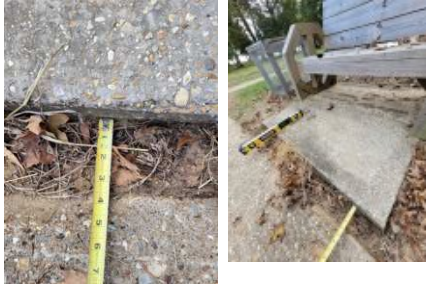
Finding Number	Area Description	Lat/Long	Finding	As Built	Recommendation	Citation	Photos	Figure
234	Hen House Ridge Unit Day Use Area: Hen House Ridge Unit Day Use Area Restroom (near site 143) Parking and Exterior Accessible Route	[30.84144, -94.16961]	There is a gap spaced greater than a 1/2 inch. Openings in floor or ground surfaces shall not allow passage of a sphere more than 1/2 inch diameter. Elongated openings shall be placed so that the long dimension is perpendicular to the dominant direction of travel.	Gap of 4" near bench	Correct or fill gaps to be max .5"	2015 ABAAS Section: 302.3 2012 TAS Section: 302.3 2010 ADAS Section: 302.3

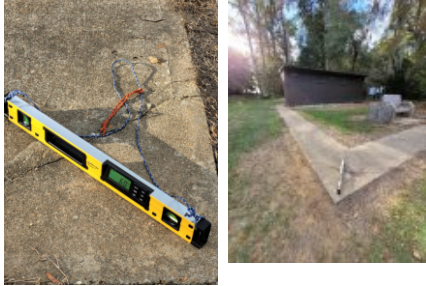
235	Hen House Ridge Unit Day Use Area: Hen House Ridge Unit Day Use Area Restroom (near site 143) Parking and Exterior Accessible Route	[30.8413214, -94.169602]	The accessible route has running slopes greater than 5% and has not been constructed as a ramp (i.e. handrails, edge protection, etc.). Cross slopes are greater than 2% across the width of the walk. When the slope in the direction of travel of any walk exceeds 1 unit vertical in 20 units horizontal (5-percent slope), it must be constructed as a ramp. Surface cross slopes must not exceed 1 unit vertical in 48 units horizontal (2-percent slope).	Cross slope of 4.3% on route to men's restroom, and 6.0% running and 4.3% cross on route to women's restroom	Correct or repair sidewalk cross slope along AR to max 2.08%. Correct or repair sidewalk running slope along AR to max 5%.	2015 ABAAS Section: 403.3 2012 TAS Section: 403.3 2010 ADAS Section: 403.3

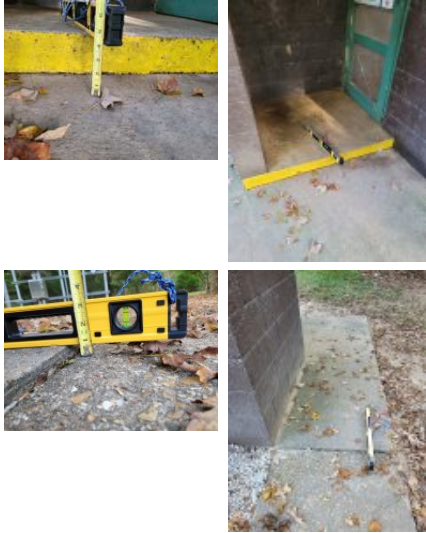
236	Hen House Ridge Unit Day Use Area: Hen House Ridge Unit Day Use Area Restroom (near site 143) Parking and Exterior Accessible Route	[30.8412972, -94.1696851]	The walkway contains abrupt vertical edges and/or variations over a 1/2 inch. 1/4 inch is the maximum vertical rise. Changes in level between 1/4 inch and 1/2 inch must be beveled at 1:2 or less. Changes in level greater than 1/2 inch must be by way of a ramp.	Changes in level (CIL) of 4" at men's restroom entry, .75" on route to men's restroom, 2.5" near bench, 1" near women's restroom, and 4.5" at women's restroom entry	Repair, bevel, or ramp CIL along the route.	2015 ABAAS Section: 303.2, 303.3 2012 TAS Section: 303.3, 303.2 2010 ADAS Section: 303.3, 303.2

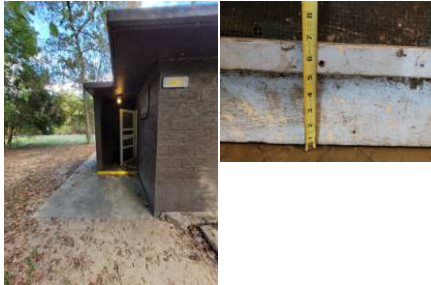
239	Hen House Ridge Unit Day Use Area: Hen House Ridge Unit Day Use Area Men's Restroom (near site 143)	[30.8413331, -94.1697114]	Minimum maneuvering clearances at doors and gates shall comply with 404.2.4. Maneuvering clearances shall extend the full width of the doorway and the required latch side or hinge side clearance. Maneuvering clearances shall have a max slope of 2.08%. The sweep period for doors with closers shall be adjusted so that from an open position of 70 degrees, the door will take at least 3 seconds to move to a point 3 inches from the latch, measured to the leading edge of the door. The bottom 10 inches on the push side must be smooth and free of obstructions (hold open devices). Opening hardware must be mounted between 30 and 44 inches above the floor or ground.	Lacks maneuvering clearance on pull side due to CIL and landing dimensions at entry, lacks smooth surface on push side, fast close	For all doors along the public circulation route, provide required maneuvering clearance on push and pull side of doors. For all doors along the public circulation route, inspect, adjust, and maintain closing speed on door closers. For all doors along the public circulation route, provide kick plate on push side of door from floor to 10" AFF.	2010 ADAS Section: 404.2.3, 404.2.7, 404.2.4, 404.2.11, 404.2.11 Exception

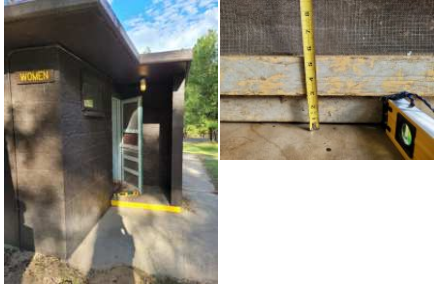
Finding Number	Area Description	Lat/Long	Finding	As Built	Recommendation	Citation	Photos	Figure
242	Hen House Ridge Unit Day Use Area: Hen House Ridge Unit Day Use Area Women's Restroom (near site 143)	[30.8413434 , -94.1697154]	Minimum maneuvering clearances at doors and gates shall comply with 404.2.4. Maneuvering clearances shall extend the full width of the doorway and the required latch side or hinge side clearance. Maneuvering clearances shall have a max slope of 2.08%. The sweep period for doors with closers shall be adjusted so that from an open position of 70 degrees, the door will take at least 3 seconds to move to a point 3 inches from the latch, measured to the leading edge of the door. The bottom 10 inches on the push side must be smooth and free of obstructions (hold open devices). Opening hardware must be mounted between 30 and 44 inches above the floor or ground.	Lacks maneuvering clearance on pull side due to CIL and landing dimensions at entry, lacks smooth surface on push side, fast close	For all doors along the public circulation route, provide required maneuvering clearance on push and pull side of doors. For all doors along the public circulation route, inspect, adjust, and maintain closing speed on door closers. For all doors along the public circulation route, provide kick plate on push side of door from floor to 10" AFF.	2010 ADAS Section: 404.2.3, 404.2.7, 404.2.4, 404.2.11, 404.2.11 Exception

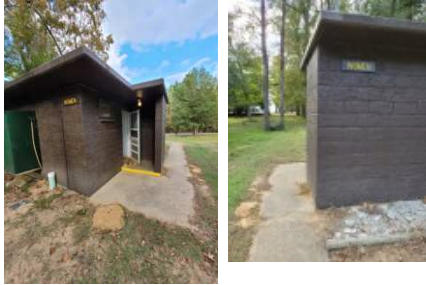
Finding Number	Area Description	Lat/Long	Finding	As Built	Recommendation	Citation	Photos	Figure
244	Hen House Ridge Unit Day Use Area: Hen House Ridge Unit Day Use Area Women's Restroom (near site 143)	[30.8413354 , -94.1697154]	The restroom sign does not comply with one or more applicable requirements for the location, height, and properties of the sign.	Lacks compliant signage	Acquire and mount signage, including Braille and raised lettering mounted on wall, latch side of door, 48" to baseline of lowest character and 60" to baseline of highest character.	2015 ABAAS Section: F216.2, 703.1, 703.2, 703.5, 703.6 2012 TAS Section: 216.2, 703.1, 703.2, 703.5, 703.6 2010 ADAS Section: 216.2, 703.1, 703.2, 703.5, 703.6

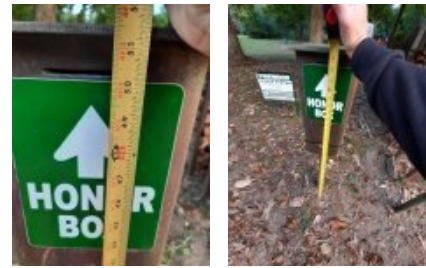
249	Hen House Ridge Unit Day Use Area: Hen House Ridge Unit Day Use Area Restroom Exterior Accessible Route (Near Site 128)	[30.8434034 , -94.173198 3]	The firewood self-pay station is positioned too high for either a side or front approach. Where a clear floor or ground space allows a parallel approach to an element and the side reach is unobstructed, the high side reach shall be 48 inches maximum and the low side reach shall be 15 inches minimum above the finish floor or ground. Where a forward reach is unobstructed, the high forward reach shall be 48 inches maximum and the low forward reach shall be 15 inches minimum above the finish floor or ground.	Firewood self-pay station mounted at 50.25" agl	Remount operable parts to be in reach range of 15" min to 48" max.	2015 ABAAS Section: 308.1 2012 TAS Section: 308.1 2010 ADAS Section: 308.1

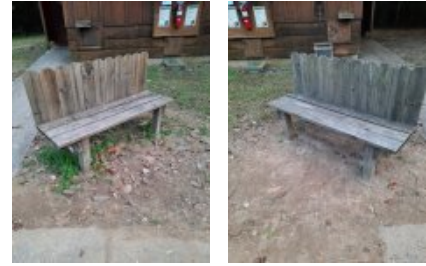
Finding Number	Area Description	Lat/Long	Finding	As Built	Recommendation	Citation	Photos	Figure
250	Hen House Ridge Unit Day Use Area: Hen House Ridge Unit Day Use Area Restroom Exterior Accessible Route (Near Site 128)	[30.8432848 , -94.1733283]	Benches shall have a 36" by 48" clear ground space (CGS) positioned near the bench with one side of the space adjoining an outdoor recreation access route (ORAR) or trail, as applicable The CGS shall not overlap with the ORAR or trail or another CGS	Lacks clear ground space adjacent to the benches	Construct firm, stable, and slip resistant pads at least 36" by 48" adjacent to 20% of benches, and locate along an AR as a smart practice	2015 ABAAS Section: 1011.2.1

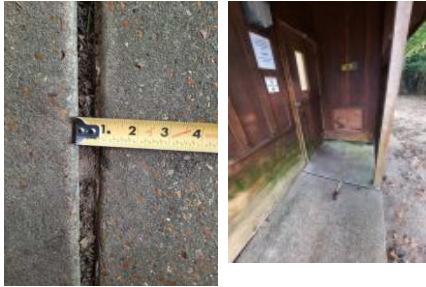
251	Hen House Ridge Unit Day Use Area: Hen House Ridge Unit Day Use Area Men's Restroom (near site 128)	[30.8432382 , -94.173303]	Minimum maneuvering clearances at doors and gates shall comply with 404.2.4. Maneuvering clearances shall extend the full width of the doorway and the required latch side or hinge side clearance. Maneuvering clearances shall have a max slope of 2.08%. Exterior doors are recommended to be maintained at 8.5 lbf as a smart practice. Force is to be measured at the operating hardware or 30 inches from the hinges, whichever is greater.	Door - gap of 1" in maneuvering clearance, 10# push	For all doors along the public circulation route, fill gaps at door entries to max .5". For all doors along the public circulation route, inspect, adjust, and maintain 8.5 lbf to open exterior doors as a smart practice.	2010 ADAS Section: 404.2.3, 404.2.7, 404.2.4, 404.2.11, 404.2.11 Exception

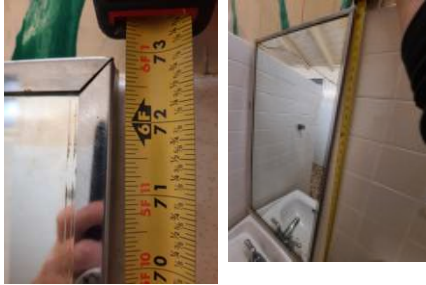
Finding Number	Area Description	Lat/Long	Finding	As Built	Recommendation	Citation	Photos	Figure
253	Hen House Ridge Unit Day Use Area: Hen House Ridge Unit Day Use Area Men's Restroom (near site 128)	[30.843229, -94.173309 7]	The mirror is mounted too high. Mirrors must have the bottom edge of the reflecting surface a maximum of 40 inches above the floor if above a sink or counter. Mirrors not located above lavatories or countertops shall be installed with the bottom edge of the reflecting surface 35 inches maximum above the finish floor or ground.	Top edge of reflecting surface is 72.5" aff	Replace mirror and mount to max 40" AFF to the bottom reflective surface and 74" to the top.	2015 ABAAS Section: 603.3 2012 TAS Section: 603.3 2010 ADAS Section: 603.3

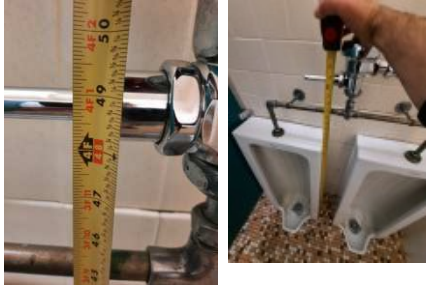
254	Hen House Ridge Unit Day Use Area: Hen House Ridge Unit Day Use Area Men's Restroom (near site 128)	[30.8432475, -94.173321 8]	The urinals flush handle is mounted too high. Flush controls shall be operable with one hand and shall not require tight grasping, pinching or twisting of the wrist and shall be mounted no more than 48 inches above the floor. The force required to activate controls shall be no greater than 5 lb. Electronic automatic flushing controls are acceptable and preferable.	Urinal flush handle at 49" aff	Lower flush handle at urinal to max 48" aff.	2015 ABAAS Section: 605.4 2012 TAS Section: 605.4 2010 ADAS Section: 605.4

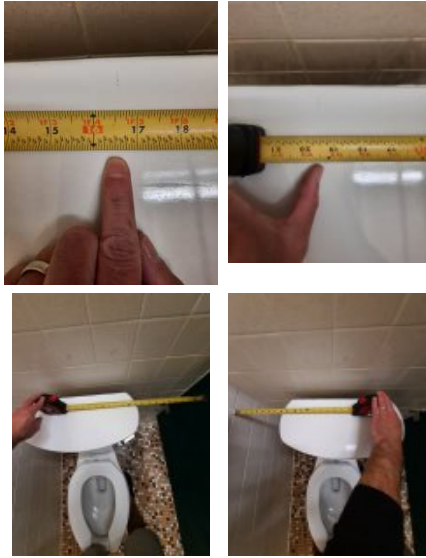
Finding Number	Area Description	Lat/Long	Finding	As Built	Recommendation	Citation	Photos	Figure
257	Hen House Ridge Unit Day Use Area: Hen House Ridge Unit Day Use Area Men's Restroom (near site 128)	[30.8432428 , -94.1733218]	The toilet is not located within the range to the side wall or partition. The centerline of the toilet shall be 17 inches minimum and 19 inches maximum side wall or partition in the ambulatory accessible toilet compartment.	Centerline of the toilet is 16.5" from the partition and 19.5" from the side wall	Remount toilet to 17" to 19" from the side wall to center line in ambulatory stalls or 16" to 18" in new wheelchair stall.	2015 ABAAS Section: 604.9.1 2012 TAS Section: 604.9.1 2010 ADAS Section: 604.9.1

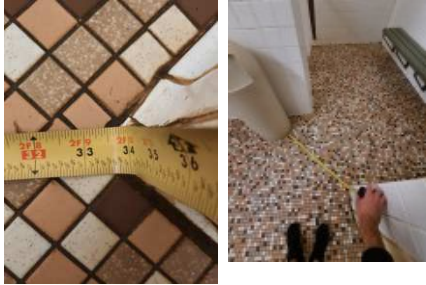
Finding Number	Area Description	Lat/Long	Finding	As Built	Recommendation	Citation	Photos	Figure
261	Hen House Ridge Unit Day Use Area: Hen House Ridge Unit Day Use Area Men's Restroom (near site 128)	[30.8432336 , -94.1733057]	The route of travel at this location does not provide a minimum width of 36 inches. The clear width shall be permitted to be reduced to 32 inches minimum for a length of 24 inches maximum provided that reduced width segments are separated by segments that are 48 inches long minimum and 36 inches wide minimum.	Lacks 36" wide route of travel - 34" between garbage can and wall	Relocate obstacles such as garbage cans to create AR through indicated rooms.	2015 ABAAS Section: 403.5.1 2012 TAS Section: 403.5.1 2010 ADAS Section: 403.5.1

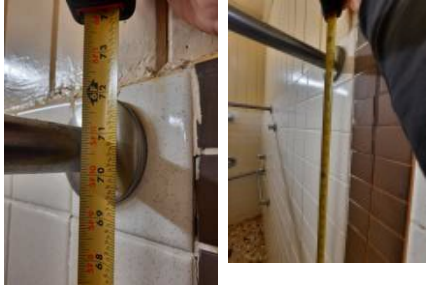
262	Hen House Ridge Unit Day Use Area: Hen House Ridge Unit Day Use Area Men's Restroom (near site 128)	[30.8432428 , -94.1733164]	The shower curtain rod extends down too close to the route of travel. Any obstruction that overhangs a route of travel must be a minimum of 80 inches above the walking surface as measured from the bottom of the obstruction.	70" to shower curtain rod	Raise the shower curtain rod to min 80".	2015 ABAAS Section: 307.4 2012 TAS Section: 307.4 2010 ADAS Section: 307.4

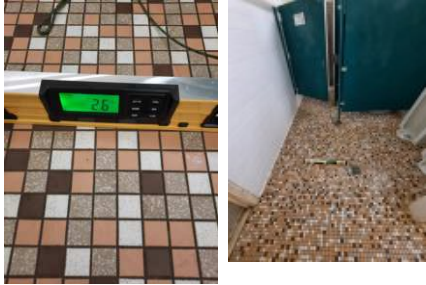
263	Hen House Ridge Unit Day Use Area: Hen House Ridge Unit Day Use Area Men's Restroom (near site 128)	[30.8432451 , -94.1733164]	The accessible route contains running slopes greater than 5 percent and cross slopes greater than 2 percent across the width of the walk and has not been constructed as a ramp (i.e. handrails, wheel guides, etc.). When the slope in the direction of travel of any walk exceeds 1 unit vertical in 20 units horizontal (5-percent slope), it must be constructed as ramp. Surface cross slopes must not exceed one unit vertical in 48 units. Horizontal (2-percent slope).	Cross slope of 2.6% near floor drain	Correct or repair slope to max 2.08%.	2015 ABAAS Section: 403.3 2012 TAS Section: 403.3 2010 ADAS Section: 403.3

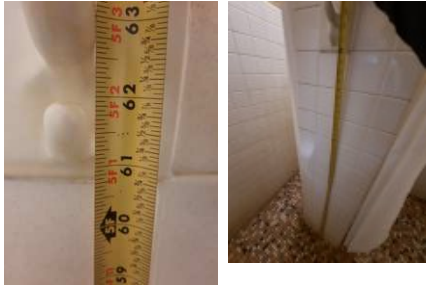
Finding Number	Area Description	Lat/Long	Finding	As Built	Recommendation	Citation	Photos	Figure
264	Hen House Ridge Unit Day Use Area: Hen House Ridge Unit Day Use Area Men's Shower (near site 128)	[30.8432336 , -94.173316 4]	Coat hooks provided within the room shall be located within one of the reach ranges specified in 308. Shelves shall be 40 inches (1015 mm) minimum and 48 inches (1220 mm) maximum above the finish floor or ground. Where coat hooks or shelves are provided in dressing, fitting or locker rooms without individual compartments, at least one of each type shall comply with 803.5. Where coat hooks or shelves are provided in individual compartments at least one of each type complying with 803.5 shall be provided in individual compartments in dressing, fitting, or locker rooms required to comply with 222.1.	7 of 7 coat hooks at 62" aff	Remount at least one hook to max 48" aff.	2015 ABAAS Section: 308.2.1, 308.1, F222.2, 803.5 2012 TAS Section: 308.2.1, 308.1, 222.2, 803.5 2010 ADAS Section: 308.2.1, 308.1, 222.2, 803.5

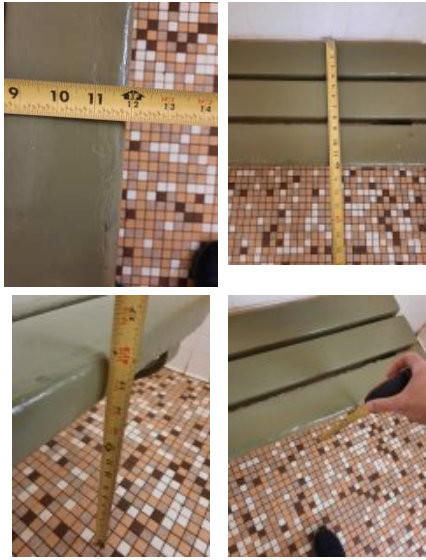
265	Hen House Ridge Unit Day Use Area: Hen House Ridge Unit Day Use Area Men's Shower (near site 128)	[30.8432267 , -94.173319 1]	The bench is not deep enough or long enough or is missing. Benches shall be provided having seats that are 42 inches long minimum and 20 inches deep minimum and 24 inches deep maximum. The bench shall provide for back support or shall be affixed to a wall. Back support shall be 42 inches (1065 mm) long minimum and shall extend from a point 2 inches (51 mm) maximum above the seat surface to a point 18 inches (455 mm) minimum above the seat surface. Back support shall be 2½ inches (64 mm) maximum from the rear edge of the seat measured horizontally. The top of the bench seat surface shall be 17 inches (430 mm) minimum and 19 inches (485 mm) maximum above the finish floor or ground. Clear floor or ground space complying with 305 shall be provided and shall be positioned at the end of the bench seat and parallel to the short axis of the bench	Bench fails dimensions - 12" deep, 16" aff	Replace bench in dressing area with one having a seat depth of 20" to 24" deep, 42" long, affixed to the wall or having a back and mounted 17" to 19" AFF and provide required clear floor space on the short axis of the bench.	2012 TAS Section: 903.4, 903.2, 903.3, 903.5 2010 ADAS Section: 903.4, 903.2, 903.3, 903.5

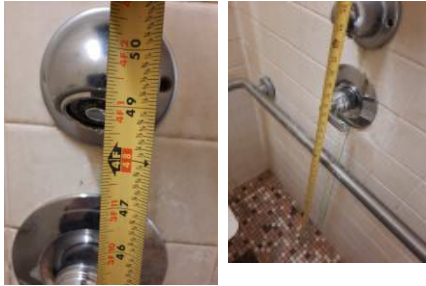
Finding Number	Area Description	Lat/Long	Finding	As Built	Recommendation	Citation	Photos	Figure
266	Hen House Ridge Unit Day Use Area: Hen House Ridge Unit Day Use Area Men's Shower (near site 128)	[30.8432405, -94.1733271]	There is no hand held sprayer unit. The sprayer unit must have a 59 inches hose and be mounted 48 inches maximum to the top of mounting bracket off the floor. The shower spray unit shall have an on/off control with a non-positive shutoff. If an adjustable-height shower head on a vertical bar is used, the bar shall be installed so as not to obstruct the use of grab bars.	Lacks 59" flexible hose and fixed shower head at 49" aff	Replace shower control with a compliant fixed lever control with a shower head on a 59" hose and usable as hand held or remount lowered shower head to 48".	2015 ABAAS Section: 608.6 2012 TAS Section: 608.6 2010 ADAS Section: 608.6

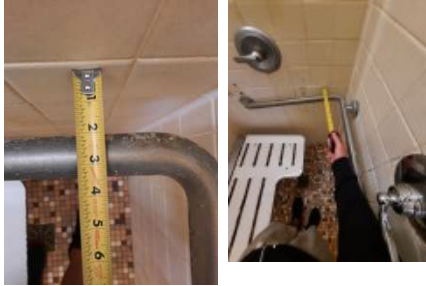
267	Hen House Ridge Unit Day Use Area: Hen House Ridge Unit Day Use Area Men's Shower (near site 128)	[30.8432428, -94.1733218]	The space between the wall and the grab bar shall be 1½ inches (38 mm). The space between the grab bar and projecting objects below and at the ends shall be 1½ inches (38 mm) minimum. The space between the grab bar and projecting objects above shall be 12 inches (305 mm) minimum. EXCEPTION: The space between the grab bars and shower controls, shower fittings, and other grab bars above shall be permitted to be 1½ inches (38 mm) minimum.	Grab bars gap between bars and walls is 2"	Replace grab bars with ones providing 1.5" gap between bar and wall and mount so no objects interfere within 1.5" below and 12" above bar.	2010 ADAS Section: 609.3, 609.3 Exception

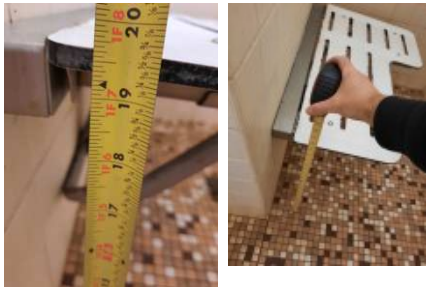
<p>1.5" min (a) projecting objects (b) recessed objects</p>
268	Hen House Ridge Unit Day Use Area: Hen House Ridge Unit Day Use Area Men's Shower (near site 128)	[30.8432428, -94.1733218]	The shower seat height is noncompliant. A seat in a standard roll-in shower compartment shall be a folding type, shall be installed on the side wall adjacent to the controls, and shall extend from the back wall to a point within 3 inches of the compartment entry. A seat in an alternate roll-in type shower compartment shall be a folding type, shall be installed on the front wall opposite the back wall, and shall extend from the adjacent side wall to a point within 3 inches of the compartment entry. The top of the seat shall be 17 inches minimum and 19 inches maximum above the bathroom finish floor.	The shower seat mounted at 19.75" aff	Remount shower seat to 17" to 19" AFF.	2015 ABAAS Section: 610.3 2012 TAS Section: 610.3 2010 ADAS Section: 610.3

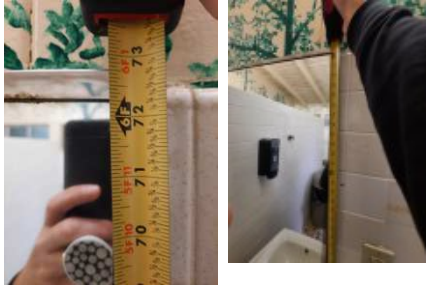
Finding Number	Area Description	Lat/Long	Finding	As Built	Recommendation	Citation	Photos	Figure
271	Hen House Ridge Unit Day Use Area: Hen House Ridge Unit Day Use Area Women's Restroom (near site 128)	[30.8432475 , -94.173303]	Exterior doors exceed 8.5 lbs of force to open; fire doors shall have a minimum opening force allowable by the appropriate administrative authority	Door - 17# push	Inspect, adjust, and maintain 8.5 lbf to open exterior doors as a smart practice.	2010 ADAS Section: 404.2.9		
272	Hen House Ridge Unit Day Use Area: Hen House Ridge Unit Day Use Area Women's Restroom (near site 128)	[30.8432371 , -94.1733177]	The mirror is mounted too high. Mirrors must have the bottom edge of the reflecting surface a maximum of 40 inches above the floor if above a sink or counter. Mirrors not located above lavatories or countertops shall be installed with the bottom edge of the reflecting surface 35 inches maximum above the finish floor or ground.	Top edge of reflecting surface is 72.25" aff	Replace mirror and mount to max 40" AFF to the bottom reflective surface and 74" to the top.	2015 ABAAS Section: 603.3 2012 TAS Section: 603.3 2010 ADAS Section: 603.3

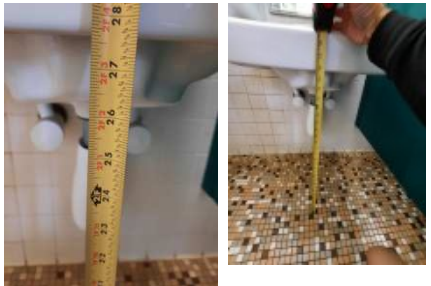
273	Hen House Ridge Unit Day Use Area: Hen House Ridge Unit Day Use Area Women's Restroom (near site 128)	[30.8432405 , -94.1733137]	Knee clearance at 27 inches off the floor is not 8 inches minimum deep. The knee clearance, measured from the bottom of the apron or the outside bottom edge of the lavatory, must be 27 inches at a point located 8 inches back from the front edge and continuing to 11 inches minimum in depth at 9 inches above the floor. The top of the lavatory rim may be no higher than 34 inches.	Sink lacks 8" deep knee clearance	Raise sink bowl to provide 27" knee clearance, in the alternative, acquire a shallower model.	2015 ABAAS Section: 306.3.1, 306.3.2, 306.3.3, 306.3.4 , 306.3.5 2012 TAS Section: 306.3.2, 306.3.3, 306.3.4, 306.3.5, 306.3.1 2010 ADAS Section: 306.3.3, 306.3.2, 306.3.4, 306.3.5, 306.3.1

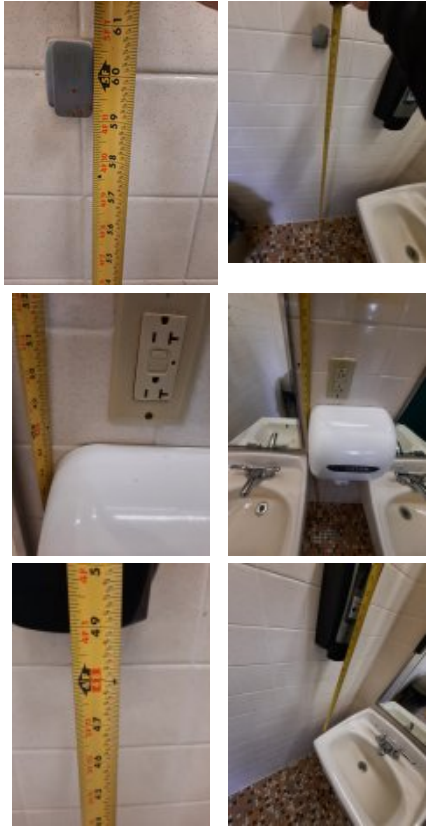
Finding Number	Area Description	Lat/Long	Finding	As Built	Recommendation	Citation	Photos	Figure
274	Hen House Ridge Unit Day Use Area: Hen House Ridge Unit Day Use Area Women's Restroom (near site 128)	[30.8432348 , -94.1733124]	Where a high forward reach is over an obstruction, the clear floor space shall extend beneath the element for a distance not less than the required reach depth over the obstruction. The high forward reach shall be 48 inches (1220 mm) maximum where the reach depth is 20 inches (510 mm) maximum. Where the reach depth exceeds 20 inches (510 mm), the high forward reach shall be 44 inches (1120 mm) maximum and the reach depth shall be 25 inches (635 mm) maximum. Where a clear floor or ground space allows a parallel approach to an element and the high side reach is over an obstruction, the height of the obstruction shall be 34 inches (865 mm) maximum and the depth of the obstruction shall be 24 inches (610 mm) maximum. The high side reach shall be 48 inches (1220 mm) maximum for a reach depth of 10 inches (255 mm) maximum. Where the reach depth exceeds 10 inches (255 mm), the high side reach shall be 46 inches (1170 mm) maximum for a reach depth of 24 inches (610 mm) maximum.	Coat hooks at 60.25" aff, outlet at 49.5" aff, and soap dispenser at 49" aff	Lower one hook, and soap dispenser to max 48" aff to highest operable part/ Remount outlet to max 44" for a forward reach over the sink.	2015 ABAAS Section: 308.2.1, 308.3.2 2012 TAS Section: 308.2.1, 308.3.2 2010 ADAS Section: 308.2.1, 308.3.2

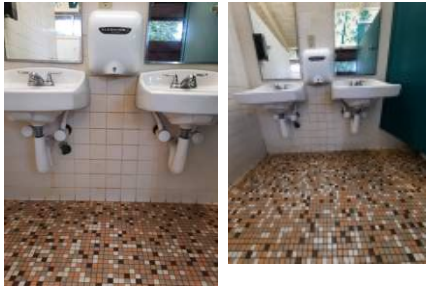
275	Hen House Ridge Unit Day Use Area: Hen House Ridge Unit Day Use Area Women's Restroom (near site 128)	[30.8432475 , -94.1733097]	The operable part is not accessible because there is not adequate clear floor space for either a forward or side approach. The clear floor or ground space shall be 30 inches minimum by 48 inches minimum.	Hand dryer lacks clear floor space	Relocate hand dryer to provide required 30" by 48" CFS at operable parts	2015 ABAAS Section: 305.3 2012 TAS Section: 305.3 2010 ADAS Section: 305.3

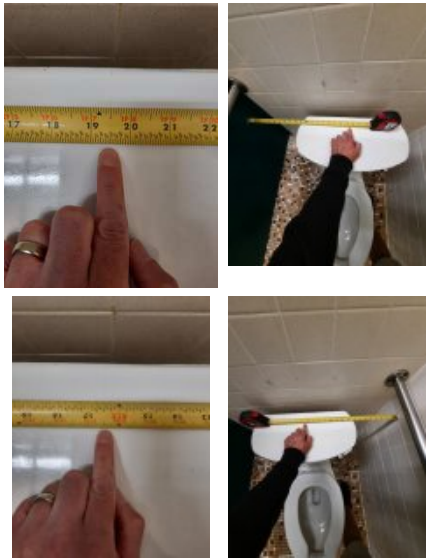
277	Hen House Ridge Unit Day Use Area: Hen House Ridge Unit Day Use Area Women's Restroom (near site 128)	[30.8432336 , -94.1733137]	The toilet is not located within the range to the side wall or partition. The centerline of the toilet shall be 17 inches minimum and 19 inches maximum side wall or partition in the ambulatory accessible toilet compartment.	Centerline of the toilet is 19.5" from the partition and 16.5" from the side wall	Remount toilet to 17" to 19" from the side wall to center line in ambulatory stalls or 16" to 18" in new wheelchair stall. May meet standard for new wheelchair stall with existing condition.	2015 ABAAS Section: 604.9.1 2012 TAS Section: 604.9.1 2010 ADAS Section: 604.9.1

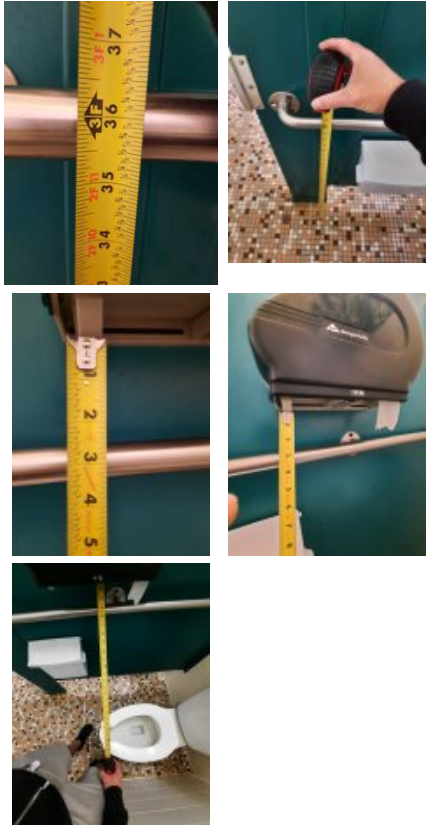
Finding Number	Area Description	Lat/Long	Finding	As Built	Recommendation	Citation	Photos	Figure
280	Hen House Ridge Unit Day Use Area: Hen House Ridge Unit Day Use Area Women's Restroom (near site 128)	[30.8432382, -94.173311]	The grab bar height and/or spacing fails. Grab bars must be mounted between 33" and 36" to the top of the gripping surface. There must be 1.5" of clearance between the grab bar and the wall. There must be a minimum of 1.5" of clearance below and minimum 12" above the grab bar to any dispenser or other obstruction.	Gripping surface of grab bar on partition is 36.35" aff, TP 2.5" above bar and too close to toilet	Remount grab bars in accessible stall to 33" to 36" aff. Remount toilet paper dispenser max 7" to 9" from front of toilet, 15" to 48" aff and min 12" above or 1.5" below grab bar.	2015 ABAAS Section: 609.3, 609.4 2012 TAS Section: 609.4, 609.3 2010 ADAS Section: 609.3, 609.4

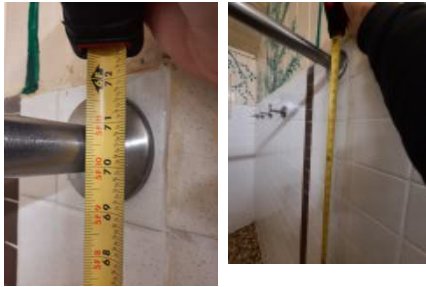
281	Hen House Ridge Unit Day Use Area: Hen House Ridge Unit Day Use Area Women's Restroom (near site 128)	[30.843244, -94.1733177]	The shower curtain rod extends down too close to the route of travel. Any obstruction that overhangs a route of travel must be a minimum of 80 inches above the walking surface as measured from the bottom of the obstruction.	Shower curtain rod height 70" aff	Raise the shower curtain rod to min 80".	2015 ABAAS Section: 307.4 2012 TAS Section: 307.4 2010 ADAS Section: 307.4

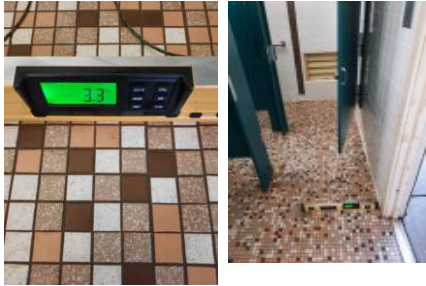
Finding Number	Area Description	Lat/Long	Finding	As Built	Recommendation	Citation	Photos	Figure
282	Hen House Ridge Unit Day Use Area: Hen House Ridge Unit Day Use Area Women's Restroom (near site 128)	[30.8432475 , -94.173319 1]	The accessible route contains running slopes greater than 5 percent and cross slopes greater than 2 percent across the width of the walk and has not been constructed as a ramp (i.e. handrails, wheel guides, etc.). When the slope in the direction of travel of any walk exceeds 1 unit vertical in 20 units horizontal (5-percent slope), it must be constructed as ramp. Surface cross slopes must not exceed one unit vertical in 48 units. Horizontal (2-percent slope).	Cross slope of 3.3% near floor drain	Correct or repair slope to max 2.08%.	2015 ABAAS Section: 403.3 2012 TAS Section: 403.3 2010 ADAS Section: 403.3

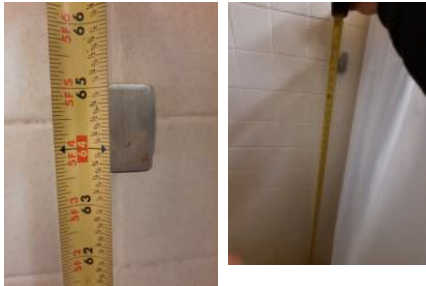
283	Hen House Ridge Unit Day Use Area: Hen House Ridge Unit Day Use Area Women's Shower (near site 128)	[30.8432405 , -94.173321 8]	Coat hooks provided within the room shall be located within one of the reach ranges specified in 308. Shelves shall be 40 inches (1015 mm) minimum and 48 inches (1220 mm) maximum above the finish floor or ground. Where coat hooks or shelves are provided in dressing, fitting or locker rooms without individual compartments, at least one of each type shall comply with 803.5. Where coat hooks or shelves are provided in individual compartments at least one of each type complying with 803.5 shall be provided in individual compartments in dressing, fitting, or locker rooms required to comply with 222.1.	6 of 6 coat hooks at 65" aff	Remount at least one hook to max 48" aff.	2015 ABAAS Section: 308.2.1, 308.1, F222.2, 803.5 2012 TAS Section: 308.2.1, 308.1, 222.2, 803.5 2010 ADAS Section: 308.2.1, 308.1, 222.2, 803.5

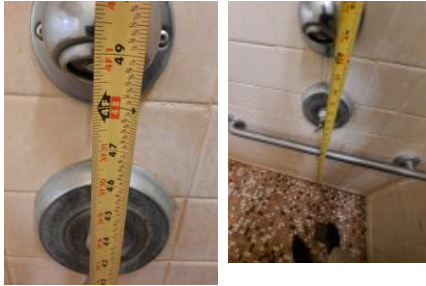
Finding Number	Area Description	Lat/Long	Finding	As Built	Recommendation	Citation	Photos	Figure
286	Hen House Ridge Unit Day Use Area: Hen House Ridge Unit Day Use Area Women's Shower (near site 128)	[30.8432451, -94.1733164]	There is no hand held sprayer unit. The sprayer unit must have a 59 inches hose and be mounted 48 inches maximum to the top of mounting bracket off the floor. The shower spray unit shall have an on/off control with a non-positive shutoff. If an adjustable-height shower head on a vertical bar is used, the bar shall be installed so as not to obstruct the use of grab bars.	Lacks 59" flexible hose and fixed shower head at 49" aff	Replace shower control with a compliant fixed lever control with a shower head on a 59" hose and usable as hand held or remount fixed shower head to max 48" AFF.	2015 ABAAS Section: 608.6 2012 TAS Section: 608.6 2010 ADAS Section: 608.6

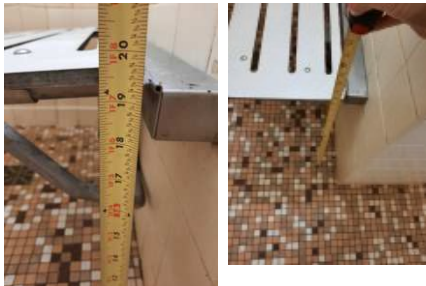
287	Hen House Ridge Unit Day Use Area: Hen House Ridge Unit Day Use Area Women's Shower (near site 128)	[30.8432405, -94.1733271]	The shower seat height is noncompliant. A seat in a standard roll-in shower compartment shall be a folding type, shall be installed on the side wall adjacent to the controls, and shall extend from the back wall to a point within 3 inches of the compartment entry. A seat in an alternate roll-in type shower compartment shall be a folding type, shall be installed on the front wall opposite the back wall, and shall extend from the adjacent side wall to a point within 3 inches of the compartment entry. The top of the seat shall be 17 inches minimum and 19 inches maximum above the bathroom finish floor.	The shower seat mounted to 19.75" aff	Remount shower seat to 17" to 19" AFF.	2015 ABAAS Section: 610.3 2012 TAS Section: 610.3 2010 ADAS Section: 610.3

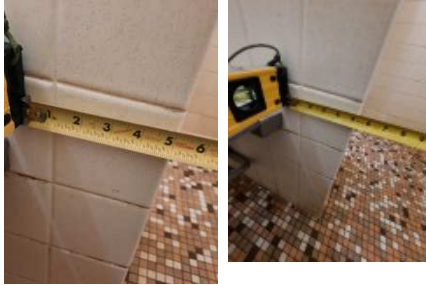
Finding Number	Area Description	Lat/Long	Finding	As Built	Recommendation	Citation	Photos	Figure
288	Hen House Ridge Unit Day Use Area: Hen House Ridge Unit Day Use Area Women's Shower (near site 128)	[30.8432544 , -94.1733164]	Where a seat is provided in a standard roll-in shower compartment, it shall be a folding type, shall be installed on the side wall adjacent to the controls, and shall extend from the back wall to a point within 3 inches (75 mm) of the compartment entry. Where a seat is provided in an alternate roll-in type shower compartment, it shall be a folding type, shall be installed on the front wall opposite the back wall, and shall extend from the adjacent side wall to a point within 3 inches (75 mm) of the compartment entry. In transfer-type showers, the seat shall extend from the back wall to a point within 3 inches (75 mm) of the compartment entry. The top of the seat shall be 17 inches (430 mm) minimum and 19 inches (485 mm) maximum above the bathroom finish floor. Seats shall comply with 610.3.1 or 610.3.2.	The shower seat 5" from compartment entry	Remount shower bench so that the front edge is within 3" of the opening	2015 ABAAS Section: 610.3 2012 TAS Section: 610.3 2010 ADAS Section: 610.3

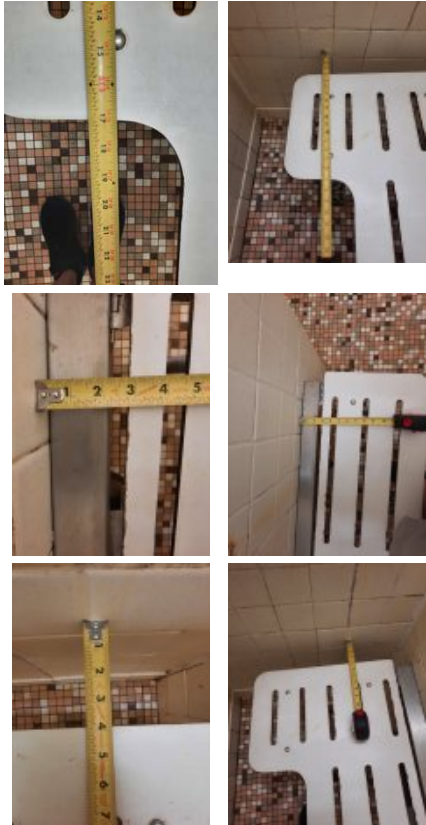
Finding Number	Area Description	Lat/Long	Finding	As Built	Recommendation	Citation	Photos	Figure
289	Hen House Ridge Unit Day Use Area: Hen House Ridge Unit Day Use Area Women's Shower (near site 128)	[30.8432325 , -94.173304 3]	The shower seat does not have a compliant space between it and the wall. The folding seat must be mounted 17-19 inches above the floor, and have a maximum space of 1-1/2 inches between the edge of the seat and the side wall and 2-1/2 inches maximum to the seat wall.	The shower seat lacks required dimensions and spacing between it and the wall	Remount shower seat to the correct location and height in the shower	2015 ABAAS Section: 610.3.2 2012 TAS Section: 610.3.2 2010 ADAS Section: 610.3.2

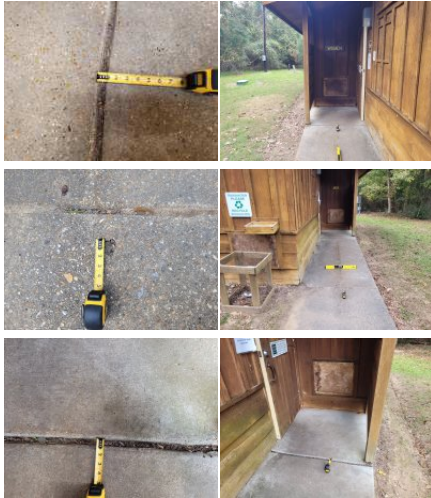
296	Walnut Ridge Unit (Sites 549-574): Walnut Ridge Unit (Sites 549-574) Restroom Parking Bldg 5B	[30.8600588 , -94.175887 3]	There is a gap spaced greater than a 1/2 inch. Openings in floor or ground surfaces shall not allow passage of a sphere more than 1/2 inch diameter. Elongated openings shall be placed so that the long dimension is perpendicular to the dominant direction of travel.	Gap of 1" at women's restroom, gap of 1" at men's restroom, and gap of 1.75"	Correct or fill gaps to be max .5".	2015 ABAAS Section: 302.3 2012 TAS Section: 302.3 2010 ADAS Section: 302.3

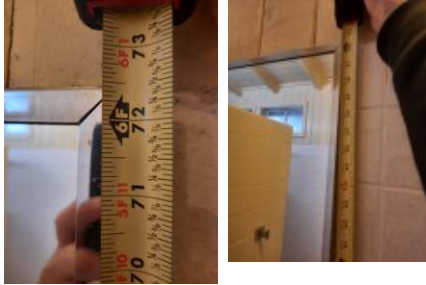
Finding Number	Area Description	Lat/Long	Finding	As Built	Recommendation	Citation	Photos	Figure
298	Walnut Ridge Unit (Sites 549-574): Walnut Ridge Unit (Sites 549-574) Men's Restroom Bldg 5B	[30.8600685 , -94.175918 1]	The mirror is mounted too high. Mirrors must have the bottom edge of the reflecting surface a maximum of 40 inches above the floor if above a sink or counter. Mirrors not located above lavatories or countertops shall be installed with the bottom edge of the reflecting surface 35 inches maximum above the finish floor or ground.	Top edge of reflecting surface is 72" aff	Replace mirror and mount to max 40" AFF to the bottom reflective surface and 74" to the top.	2015 ABAAS Section: 603.3 2012 TAS Section: 603.3 2010 ADAS Section: 603.3

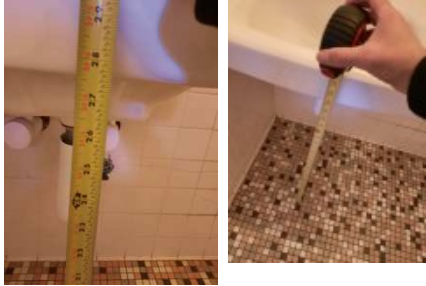
299	Walnut Ridge Unit (Sites 549-574): Walnut Ridge Unit (Sites 549-574) Men's Restroom Bldg 5B	[30.8600616 , -94.175915 5]	Knee clearance at 27 inches off the floor is not 8 inches minimum deep. The knee clearance, measured from the bottom of the apron or the outside bottom edge of the lavatory, must be 27 inches at a point located 8 inches back from the front edge and continuing to 11 inches minimum in depth at 9 inches above the floor. The top of the lavatory rim may be no higher than 34 inches.	Sink lacks 8" deep knee clearance	Raise sink bowl to provide 27" knee clearance, in the alternative, acquire a shallower model.	2015 ABAAS Section: 306.3.1, 306.3.2, 306.3.3, 306.3.4 , 306.3.5 2012 TAS Section: 306.3.2, 306.3.3, 306.3.4, 306.3.5, 306.3.1 2010 ADAS Section: 306.3.3, 306.3.2, 306.3.4, 306.3.5, 306.3.1

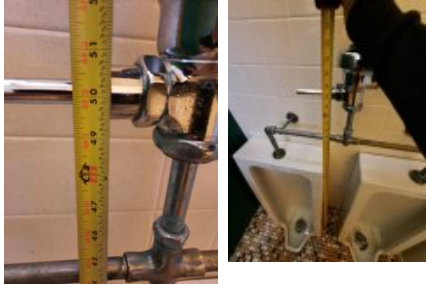
Finding Number	Area Description	Lat/Long	Finding	As Built	Recommendation	Citation	Photos	Figure
300	Walnut Ridge Unit (Sites 549-574): Walnut Ridge Unit (Sites 549-574) Men's Restroom Bldg 5B	[30.860057, -94.175923 5]	The urinals flush handle is mounted too high. Flush controls shall be operable with one hand and shall not require tight grasping, pinching or twisting of the wrist and shall be mounted no more than 48 inches above the floor. The force required to activate controls shall be no greater than 5 lb. Electronic automatic flushing controls are acceptable and preferable.	Urinal flush handle at 50.25" aff	Lower flush handle at urinal to max 48" aff.	2015 ABAAS Section: 605.4 2012 TAS Section: 605.4 2010 ADAS Section: 605.4

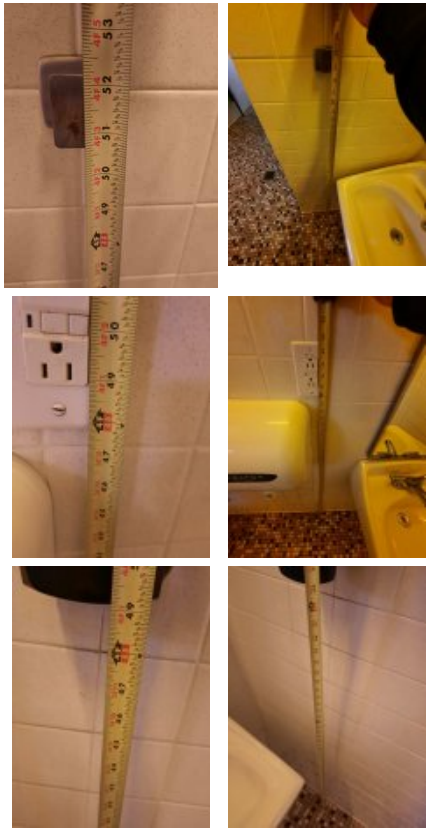
301	Walnut Ridge Unit (Sites 549-574): Walnut Ridge Unit (Sites 549-574) Men's Restroom Bldg 5B	[30.8600685, -94.175904 7]	Where a high forward reach is over an obstruction, the clear floor space shall extend beneath the element for a distance not less than the required reach depth over the obstruction. The high forward reach shall be 48 inches (1220 mm) maximum where the reach depth is 20 inches (510 mm) maximum. Where the reach depth exceeds 20 inches (510 mm), the high forward reach shall be 44 inches (1120 mm) maximum and the reach depth shall be 25 inches (635 mm) maximum. Where a clear floor or ground space allows a parallel approach to an element and the high side reach is over an obstruction, the height of the obstruction shall be 34 inches (865 mm) maximum and the depth of the obstruction shall be 24 inches (610 mm) maximum. The high side reach shall be 48 inches (1220 mm) maximum for a reach depth of 10 inches (255 mm) maximum. Where the reach depth exceeds 10 inches (255 mm), the high side reach shall be 46 inches (1170 mm) maximum for a reach depth of 24 inches (610 mm) maximum.	3 of 3 coat hooks at 52.25" aff, outlet at 49.5" aff, and soap dispenser at 49.25" aff	Lower one coat hook and soap dispenser to max 48" aff to highest operable part. Lower outlet to max 44" for a forward reach over sinks.	2015 ABAAS Section: 308.2.1, 308.3.2 2012 TAS Section: 308.2.1, 308.3.2 2010 ADAS Section: 308.2.1, 308.3.2

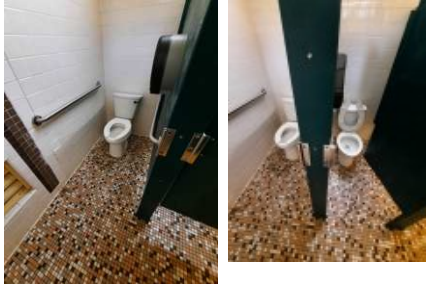
Finding Number	Area Description	Lat/Long	Finding	As Built	Recommendation	Citation	Photos	Figure
302	Walnut Ridge Unit (Sites 549-574): Walnut Ridge Unit (Sites 549-574) Men's Restroom Bldg 5B	[30.8600662 , -94.175920 8]	There are not enough accessible toilet compartments. The room contains 2 toilet compartments. A minimum of 1 must be wheelchair accessible .	Lacks wheelchair accessible stall, ambulatory only	Create a wheelchair accessible stall with grab bars and fixtures mounted in correct locations and at correct heights.	2015 ABAAS Section: F213.3.1 2012 TAS Section: 213.3.1 2010 ADAS Section: 213.3.1

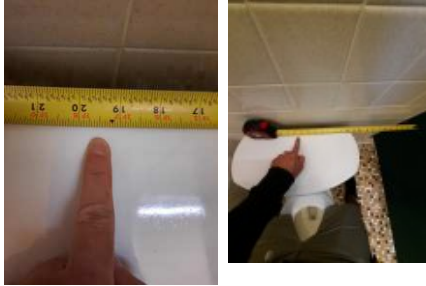
303	Walnut Ridge Unit (Sites 549-574): Walnut Ridge Unit (Sites 549-574) Men's Restroom Bldg 5B	[30.8600639 , -94.175910 1]	The toilet is not located within the range to the side wall or partition. The centerline of the toilet shall be 17 inches minimum and 19 inches maximum side wall or partition in the ambulatory accessible toilet compartment.	Centerline of the toilet is 19.5" from the partition	Remount toilet to 17" to 19" from the side wall to center line in ambulatory stalls or 16" to 18" in wheelchair stalls.	2015 ABAAS Section: 604.9.1 2012 TAS Section: 604.9.1 2010 ADAS Section: 604.9.1

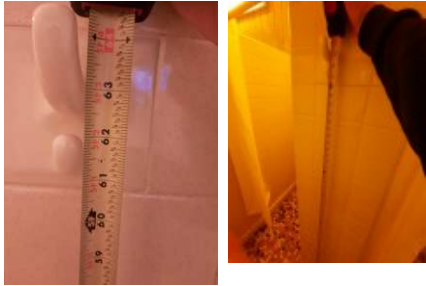
Finding Number	Area Description	Lat/Long	Finding	As Built	Recommendation	Citation	Photos	Figure
310	Walnut Ridge Unit (Sites 549-574): Walnut Ridge Unit (Sites 549-574) Men's Shower Bldg 5B	[30.8600639 , -94.175923 5]	Coat hooks provided within the room shall be located within one of the reach ranges specified in 308. Shelves shall be 40 inches (1015 mm) minimum and 48 inches (1220 mm) maximum above the finish floor or ground. Where coat hooks or shelves are provided in dressing, fitting or locker rooms without individual compartments, at least one of each type shall comply with 803.5. Where coat hooks or shelves are provided in individual compartments at least one of each type complying with 803.5 shall be provided in individual compartments in dressing, fitting, or locker rooms required to comply with 222.1.	7 of 7 coat hooks at 62" aff	Remount at least one hook to max 48" aff.	2015 ABAAS Section: 308.2.1, 308.1, F222.2, 803.5 2012 TAS Section: 308.2.1, 308.1, 222.2, 803.5 2010 ADAS Section: 308.2.1, 308.1, 222.2, 803.5

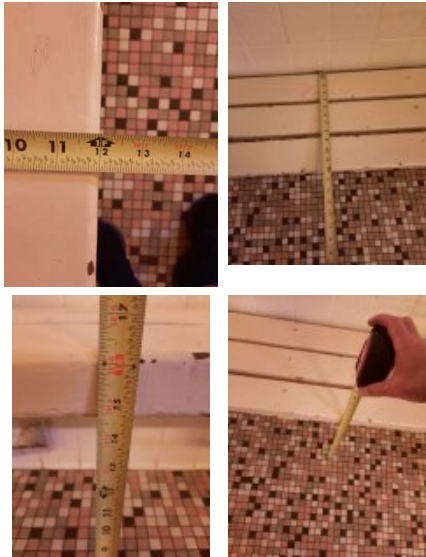
311	Walnut Ridge Unit (Sites 549-574): Walnut Ridge Unit (Sites 549-574) Men's Shower Bldg 5B	[30.8600742 , -94.175912 8]	The bench is not deep enough or long enough or is missing. Benches shall be provided having seats that are 42 inches long minimum and 20 inches deep minimum and 24 inches deep maximum. The bench shall provide for back support or shall be affixed to a wall. Back support shall be 42 inches (1065 mm) long minimum and shall extend from a point 2 inches (51 mm) maximum above the seat surface to a point 18 inches (455 mm) minimum above the seat surface. Back support shall be 2½ inches (64 mm) maximum from the rear edge of the seat measured horizontally. The top of the bench seat surface shall be 17 inches (430 mm) minimum and 19 inches (485 mm) maximum above the finish floor or ground. Clear floor or ground space complying with 305 shall be provided and shall be positioned at the end of the bench seat and parallel to the short axis of the bench	Bench lacks required dimensions - 12" deep, 16.25" aff	Replace bench in dressing area with one having a seat depth of 20" to 24" deep, 42" long, affixed to the wall or having a back and mounted 17" to 19" AFF and provide required clear floor space on the short axis of the bench.	2012 TAS Section: 903.4, 903.2, 903.3, 903.5 2010 ADAS Section: 903.4, 903.2, 903.3, 903.5

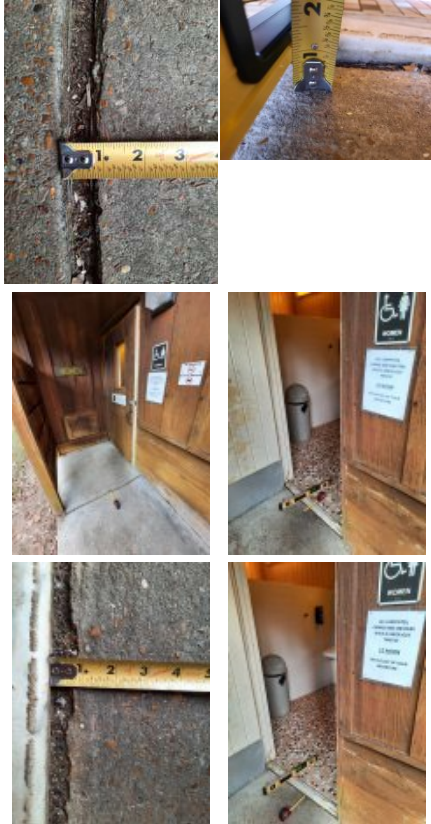
Finding Number	Area Description	Lat/Long	Finding	As Built	Recommendation	Citation	Photos	Figure
315	Walnut Ridge Unit (Sites 549-574): Walnut Ridge Unit (Sites 549-574) Women's Restroom Bldg 5B	[30.8600616 , -94.175918 1]	Minimum maneuvering clearances at doors and gates shall comply with 404.2.4. Maneuvering clearances shall extend the full width of the doorway and the required latch side or hinge side clearance. Maneuvering clearances shall have a max slope of 2.08%. The threshold has a vertical change greater than 1/4 inch high. The threshold has a gap greater than 1/2 inch wide. Exterior doors are recommended to be maintained at 8.5 lbf as a smart practice. Force is to be measured at the operating hardware or 30 inches from the hinges, whichever is greater.	Door - gap of .75" on landing, change in level of .75", gap in doorway, 10# push	For all doors along the public circulation route, provide required maneuvering clearance on push and pull side of doors. For all doors along the public circulation route, repair, bevel, or ramp CILs at door entries to max .25". For all doors along the public circulation route, fill gaps at door entries to max .5". For all doors along the public circulation route, inspect, adjust, and maintain 8.5 lbf to open exterior doors as a smart practice.	2010 ADAS Section: 404.2.3, 404.2.7, 404.2.4, 404.2.11, 404.2.11 Exception

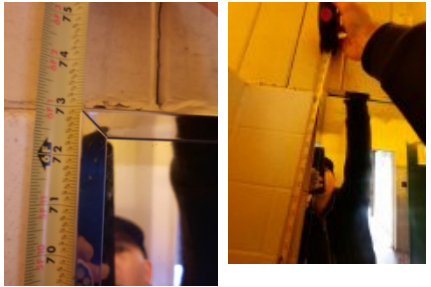
316	Walnut Ridge Unit (Sites 549-574): Walnut Ridge Unit (Sites 549-574) Women's Restroom Bldg 5B	[30.8600662 , -94.175912 8]	The mirror is mounted too high. Mirrors must have the bottom edge of the reflecting surface a maximum of 40 inches above the floor if above a sink or counter. Mirrors not located above lavatories or countertops shall be installed with the bottom edge of the reflecting surface 35 inches maximum above the finish floor or ground.	Top edge of reflecting surface is 72.25" aff	Replace mirror and mount to max 40" AFF to the bottom reflective surface and 74" to the top.	2015 ABAAS Section: 603.3 2012 TAS Section: 603.3 2010 ADAS Section: 603.3

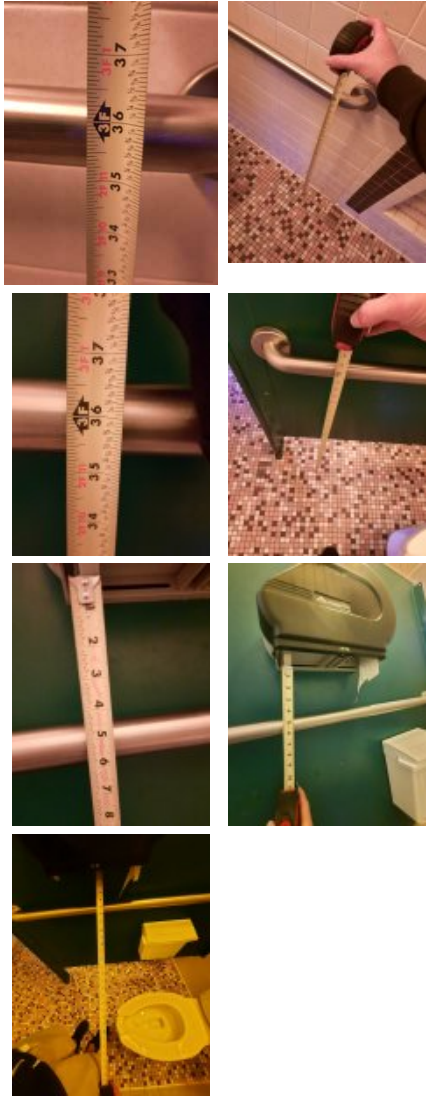
Finding Number	Area Description	Lat/Long	Finding	As Built	Recommendation	Citation	Photos	Figure
323	Walnut Ridge Unit (Sites 549-574): Walnut Ridge Unit (Sites 549-574) Women's Restroom Bldg 5B	[30.8600731 , -94.175915 5]	The grab bar height and/or spacing fails. Grab bars must be mounted between 33" and 36" to the top of the gripping surface. There must be 1.5" of clearance between the grab bar and the wall. There must be a minimum of 1.5" of clearance below and minimum 12" above the grab bar to any dispenser or other obstruction.	Gripping surface of grab bars are 36.5" aff, and TP 4.5" above bar and too close to toilet	Remount grab bars in accessible stall to 33" to 36" aff Remount toilet paper dispenser max 7" to 9" from front of toilet, 15" to 48" aff and min 12" above or 1.5" below grab bar	2015 ABAAS Section: 609.3, 609.4 2012 TAS Section: 609.4, 609.3 2010 ADAS Section: 609.3, 609.4

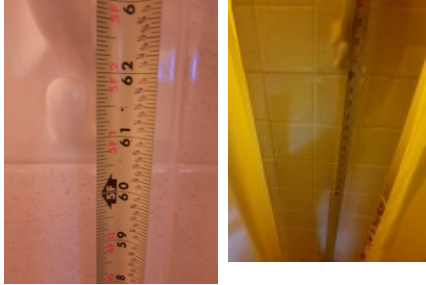
Finding Number	Area Description	Lat/Long	Finding	As Built	Recommendation	Citation	Photos	Figure
327	Walnut Ridge Unit (Sites 549-574): Walnut Ridge Unit (Sites 549-574) Women's Shower Bldg 5B	[30.8600846 , -94.175912 8]	Coat hooks provided within the room shall be located within one of the reach ranges specified in 308. Shelves shall be 40 inches (1015 mm) minimum and 48 inches (1220 mm) maximum above the finish floor or ground. Where coat hooks or shelves are provided in dressing, fitting or locker rooms without individual compartments, at least one of each type shall comply with 803.5. Where coat hooks or shelves are provided in individual compartments at least one of each type complying with 803.5 shall be provided in individual compartments in dressing, fitting, or locker rooms required to comply with 222.1.	7 of 7 coat hooks at 62" aff	Remount at least one hook to max 48" aff.	2015 ABAAS Section: 308.2.1, 308.1, F222.2, 803.5 2012 TAS Section: 308.2.1, 308.1, 222.2, 803.5 2010 ADAS Section: 308.2.1, 308.1, 222.2, 803.5
