Access Audit Site Report

Prepared By
WT Group

Martin Dies Jr. State Park
634 Park Road 48 South
Jasper, TX 75951
Accessibility Evaluation
Inspection Date: 11/10/2021
Inspectors: Tanya Scheibe

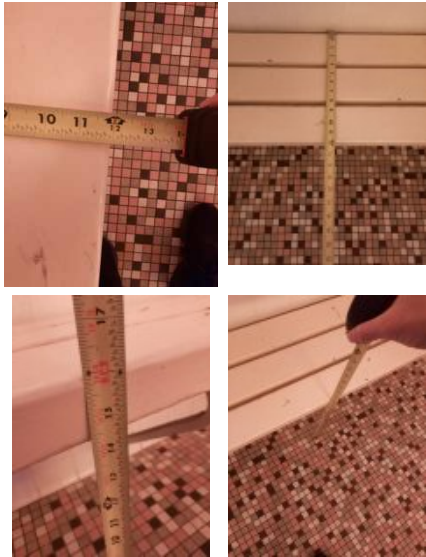
328	Walnut Ridge Unit (Sites 549-574): Walnut Ridge Unit (Sites 549-574) Women's Shower Bldg 5B	[30.8600708 , -94.175907 4]	The bench is not deep enough or long enough or is missing. Benches shall be provided having seats that are 42 inches long minimum and 20 inches deep minimum and 24 inches deep maximum. The bench shall provide for back support or shall be affixed to a wall. Back support shall be 42 inches (1065 mm) long minimum and shall extend from a point 2 inches (51 mm) maximum above the seat surface to a point 18 inches (455 mm) minimum above the seat surface. Back support shall be 2½ inches (64 mm) maximum from the rear edge of the seat measured horizontally. The top of the bench seat surface shall be 17 inches (430 mm) minimum and 19 inches (485 mm) maximum above the finish floor or ground. Clear floor or ground space complying with 305 shall be provided and shall be positioned at the end of the bench seat and parallel to the short axis of the bench	Bench lacks required dimensions - 12" deep, 16" aff	Replace bench in dressing area with one having a seat depth of 20" to 24" deep, 42" long, affixed to the wall or having a back and mounted 17" to 19" AFF and provide required clear floor space on the short axis of the bench.	2012 TAS Section: 903.4, 903.2, 903.3, 903.5 2010 ADAS Section: 903.4, 903.2, 903.3, 903.5

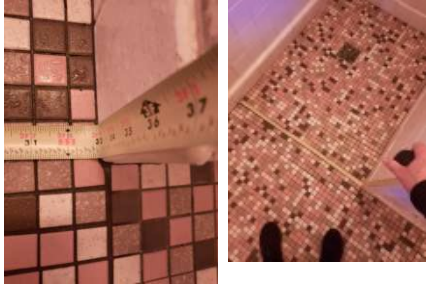
Finding Number	Area Description	Lat/Long	Finding	As Built	Recommendation	Citation	Photos	Figure
329	Walnut Ridge Unit (Sites 549-574): Walnut Ridge Unit (Sites 549-574) Women's Shower Bldg 5B	[30.8600708 , -94.175915 5]	Transfer type shower compartments shall be 36 inches (915 mm) by 36 inches (915 mm) clear inside dimensions measured at the center points of opposing sides and shall have a 36 inch (915 mm) wide minimum entry on the face of the shower compartment. Clearance of 36 inches (915 mm) wide minimum by 48 inches (1220 mm) long minimum measured from the control wall shall be provided.	Transfer shower only 32.75" wide	Enlarge transfer shower to compliant 36" by 36" clear inside dimension.	2015 ABAAS Section: 608.2.1 2012 TAS Section: 608.2.1 2010 ADAS Section: 608.2.1

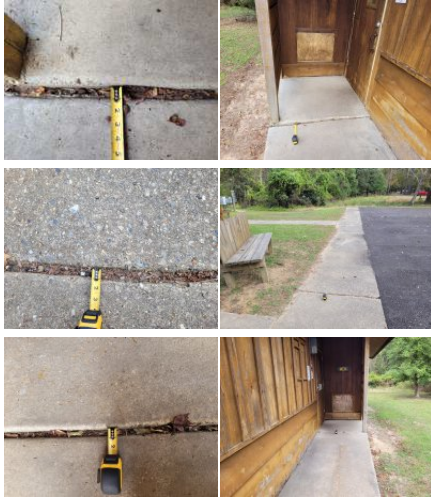
Finding Number	Area Description	Lat/Long	Finding	As Built	Recommendation	Citation	Photos	Figure
334	Walnut Ridge Unit (Sites 500-548): Walnut Ridge Unit (Sites 500-548) Restroom Parking and Exterior Accessible Route Bldg 5A	[30.8586329 , -94.179262 9]	There is a gap spaced greater than a 1/2 inch. Openings in floor or ground surfaces shall not allow passage of a sphere more than 1/2 inch diameter. Elongated openings shall be placed so that the long dimension is perpendicular to the dominant direction of travel.	Gaps of .75" gap at women's restroom, 1" along parking, and 1" at men's restroom	Correct or fill gaps to be max .5".	2015 ABAAS Section: 302.3 2012 TAS Section: 302.3 2010 ADAS Section: 302.3

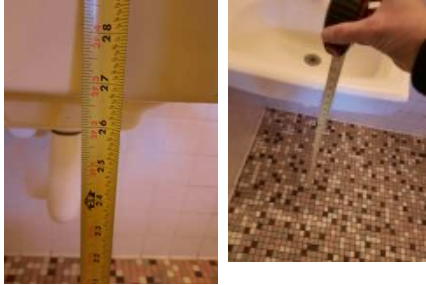
Finding Number	Area Description	Lat/Long	Finding	As Built	Recommendation	Citation	Photos	Figure
340	Walnut Ridge Unit (Sites 500-548): Walnut Ridge Unit (Sites 500-548) Men's Restroom Bldg 5A	[30.8587215 , -94.179276 3]	Knee clearance at 27 inches off the floor is not 8 inches minimum deep. The knee clearance, measured from the bottom of the apron or the outside bottom edge of the lavatory, must be 27 inches at a point located 8 inches back from the front edge and continuing to 11 inches minimum in depth at 9 inches above the floor. The top of the lavatory rim may be no higher than 34 inches.	Sink lacks 8" deep knee clearance	Raise sink bowl to provide 27" knee clearance, in the alternative, acquire a shallower model	2015 ABAAS Section: 306.3.1, 306.3.2, 306.3.3, 306.3.4 , 306.3.5 2012 TAS Section: 306.3.2, 306.3.3, 306.3.4, 306.3.5, 306.3.1 2010 ADAS Section: 306.3.3, 306.3.2, 306.3.4, 306.3.5, 306.3.1

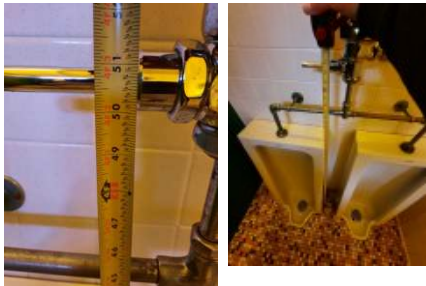
341	Walnut Ridge Unit (Sites 500-548): Walnut Ridge Unit (Sites 500-548) Men's Restroom Bldg 5A	[30.8587399 , -94.179276 3]	The urinals flush handle is mounted too high. Flush controls shall be operable with one hand and shall not require tight grasping, pinching or twisting of the wrist and shall be mounted no more than 48 inches above the floor. The force required to activate controls shall be no greater than 5 lb. Electronic automatic flushing controls are acceptable and preferable.	Urinal flush handle at 50.75" aff	Lower flush handle at urinal to max 48" aff	2015 ABAAS Section: 605.4 2012 TAS Section: 605.4 2010 ADAS Section: 605.4

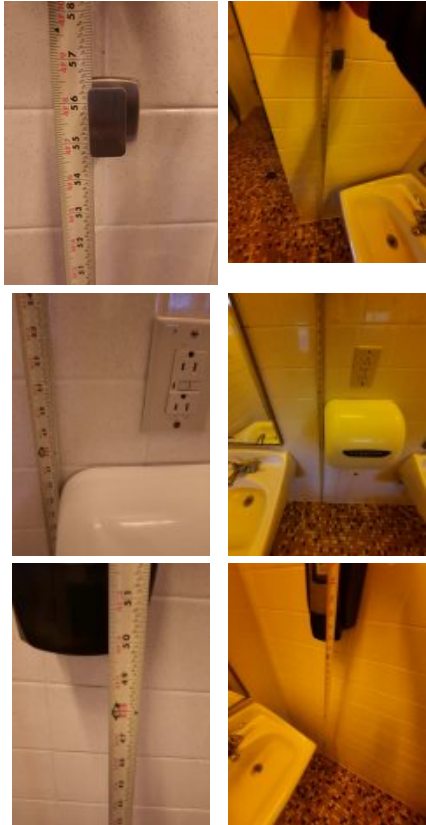
Finding Number	Area Description	Lat/Long	Finding	As Built	Recommendation	Citation	Photos	Figure
342	Walnut Ridge Unit (Sites 500-548): Walnut Ridge Unit (Sites 500-548) Men's Restroom Bldg 5A	[30.8587261, -94.1792763]	Where a high forward reach is over an obstruction, the clear floor space shall extend beneath the element for a distance not less than the required reach depth over the obstruction. The high forward reach shall be 48 inches (1220 mm) maximum where the reach depth is 20 inches (510 mm) maximum. Where the reach depth exceeds 20 inches (510 mm), the high forward reach shall be 44 inches (1120 mm) maximum and the reach depth shall be 25 inches (635 mm) maximum. Where a clear floor or ground space allows a parallel approach to an element and the high side reach is over an obstruction, the height of the obstruction shall be 34 inches (865 mm) maximum and the depth of the obstruction shall be 24 inches (610 mm) maximum. The high side reach shall be 48 inches (1220 mm) maximum for a reach depth of 10 inches (255 mm) maximum. Where the reach depth exceeds 10 inches (255 mm), the high side reach shall be 46 inches (1170 mm) maximum for a reach depth of 24 inches (610 mm) maximum.	3 of 3 coat hooks at 56" aff, outlet at 51.5" aff behind sink, and soap dispenser at 49.75" aff	Lower coat hooks and soap dispenser to max 48" aff to highest operable part. Lower outlet to max 44" for a forward reach over sink.	2015 ABAAS Section: 308.2.1, 308.3.2 2012 TAS Section: 308.2.1, 308.3.2 2010 ADAS Section: 308.2.1, 308.3.2

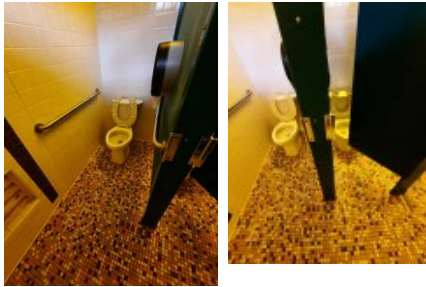
343	Walnut Ridge Unit (Sites 500-548): Walnut Ridge Unit (Sites 500-548) Men's Restroom Bldg 5A	[30.8587123, -94.179287]	There are not enough accessible toilet compartments. The room contains 2 toilet compartments. A minimum of 1 must be wheelchair accessible .	Lacks wheelchair accessible stall, ambulatory only	Create a wheelchair accessible stall with grab bars and fixtures mounted in correct locations and at correct heights	2015 ABAAS Section: F213.3.1 2012 TAS Section: 213.3.1 2010 ADAS Section: 213.3.1

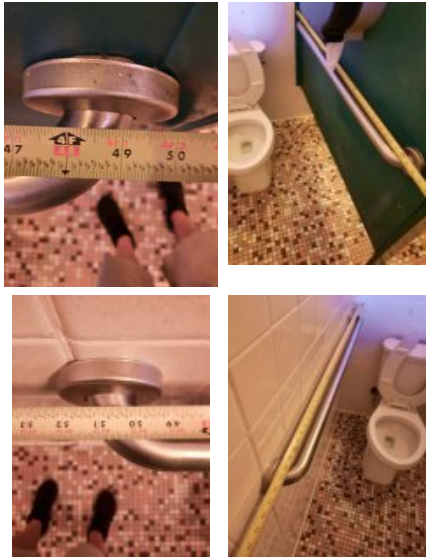
345	Walnut Ridge Unit (Sites 500-548): Walnut Ridge Unit (Sites 500-548) Men's Restroom Bldg 5A	[30.8587399 , -94.179287]	The side grab bars are not in the correct location. Grab bars on the side wall must be installed so that the end closest to the rear wall is maximum 12" from the rear wall. The end furthest from the rear wall must be mounted minimum 54" from the rear wall.	Side grab bars end at 48.5" from rear wall	Remount side grab bar to max 12" from the rear wall at the close end and min 54" on the far end, and 33" to 36" aff	2015 ABAAS Section: 604.5.1 2012 TAS Section: 604.5.1 2010 ADAS Section: 604.5.1

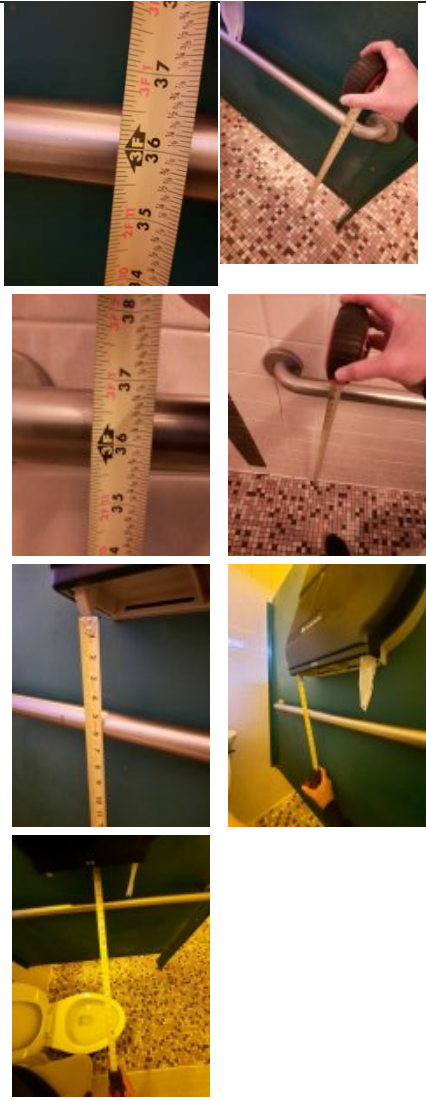
346	Walnut Ridge Unit (Sites 500-548): Walnut Ridge Unit (Sites 500-548) Men's Restroom Bldg	[30.8587399 , -94.179276 3]	The grab bar height and/or spacing fails. Grab bars must be mounted between 33" and 36" to the top of the gripping surface. There must be 1.5" of clearance between the grab bar and the wall. There must be a minimum of 1.5" of clearance below and	Gripping surfaces of grab bars are 36.5" aff and 36.75" aff, TP 4.5" above side grab bar and too close to toilet	Remount grab bars in accessible stall to 33" to 36" aff Remount toilet paper dispenser max 7" to 9" from front of toilet, 15" to 48" aff and min 12" above or 1.5" below grab bar	2015 ABAAS Section: 609.3, 609.4 2012 TAS Section:

Finding Number	Area Description	Lat/Long	Finding	As Built	Recommendation	Citation	Photos	Figure
	5A		minimum 12" above the grab bar to any dispenser or other obstruction.			609.4, 609.3 2010 ADAS Section: 609.3, 609.4

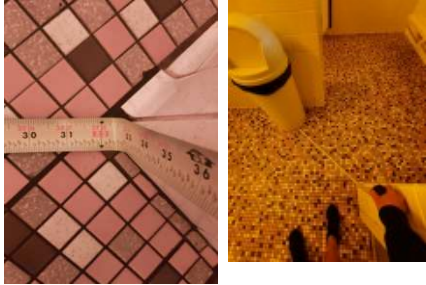
Finding Number	Area Description	Lat/Long	Finding	As Built	Recommendation	Citation	Photos	Figure
347	Walnut Ridge Unit (Sites 500-548): Walnut Ridge Unit (Sites 500-548) Men's Restroom Bldg 5A	[30.8587215 , -94.179268 2]	The route of travel at this location does not provide a minimum width of 36 inches. The clear width shall be permitted to be reduced to 32 inches minimum for a length of 24 inches maximum provided that reduced width segments are separated by segments that are 48 inches long minimum and 36 inches wide minimum.	Lacks 36" wide route of travel due to 32.5" between garbage can and wall	Relocate obstacles such as garbage cans to create AR through indicated rooms.	2015 ABAAS Section: 403.5.1 2012 TAS Section: 403.5.1 2010 ADAS Section: 403.5.1

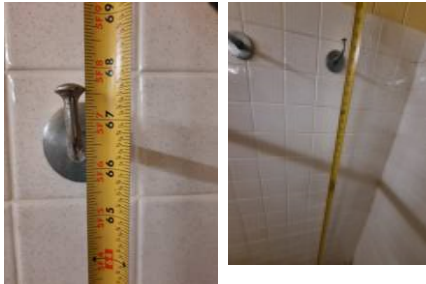
348	Walnut Ridge Unit (Sites 500-548): Walnut Ridge Unit (Sites 500-548) Men's Shower Bldg 5A	[30.8587215 , -94.179268 2]	Coat hooks provided within the room shall be located within one of the reach ranges specified in 308. Shelves shall be 40 inches (1015 mm) minimum and 48 inches (1220 mm) maximum above the finish floor or ground. Where coat hooks or shelves are provided in dressing, fitting or locker rooms without individual compartments, at least one of each type shall comply with 803.5. Where coat hooks or shelves are provided in individual compartments at least one of each type complying with 803.5 shall be provided in individual compartments in dressing, fitting, or locker rooms required to comply with 222.1.	8 of 8 coat hooks at 67.75" aff	Remount at least one hook to max 48" aff.	2015 ABAAS Section: 308.2.1, 308.1, F222.2, 803.5 2012 TAS Section: 308.2.1, 308.1, 222.2, 803.5 2010 ADAS Section: 308.2.1, 308.1, 222.2, 803.5

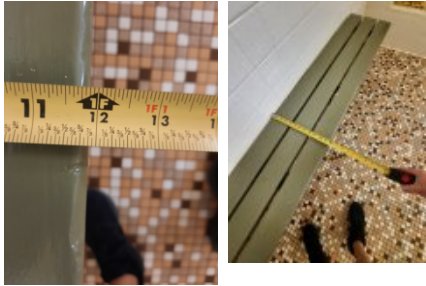
Finding Number	Area Description	Lat/Long	Finding	As Built	Recommendation	Citation	Photos	Figure
349	Walnut Ridge Unit (Sites 500-548): Walnut Ridge Unit (Sites 500-548) Men's Shower Bldg 5A	[30.8587261, -94.1792816]	The bench is not deep enough or long enough or is missing. Benches shall be provided having seats that are 42 inches long minimum and 20 inches deep minimum and 24 inches deep maximum. The bench shall provide for back support or shall be affixed to a wall. Back support shall be 42 inches (1065 mm) long minimum and shall extend from a point 2 inches (51 mm) maximum above the seat surface to a point 18 inches (455 mm) minimum above the seat surface. Back support shall be 2½ inches (64 mm) maximum from the rear edge of the seat measured horizontally. The top of the bench seat surface shall be 17 inches (430 mm) minimum and 19 inches (485 mm) maximum above the finish floor or ground. Clear floor or ground space complying with 305 shall be provided and shall be positioned at the end of the bench seat and parallel to the short axis of the bench	Bench dimensions 11.75" deep	Replace bench in dressing area with one having a seat depth of 20" to 24" deep, 42" long, affixed to the wall or having a back and mounted 17" to 19" AFF and provide required clear floor space on the short axis of the bench.	2012 TAS Section: 903.4, 903.2, 903.3, 903.5 2010 ADAS Section: 903.4, 903.2, 903.3, 903.5

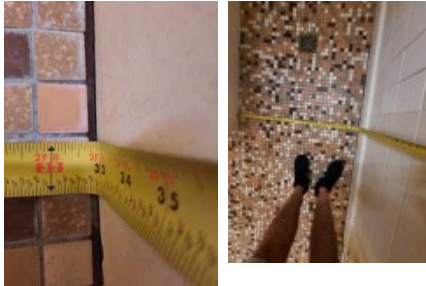
350	Walnut Ridge Unit (Sites 500-548): Walnut Ridge Unit (Sites 500-548) Men's Shower Bldg 5A	[30.8587215, -94.179279]	Transfer type shower compartments shall be 36 inches (915 mm) by 36 inches (915 mm) clear inside dimensions measured at the center points of opposing sides and shall have a 36 inch (915 mm) wide minimum entry on the face of the shower compartment. Clearance of 36 inches (915 mm) wide minimum by 48 inches (1220 mm) long minimum measured from the control wall shall be provided.	Transfer shower 32.75" wide	Enlarge transfer shower to compliant 36" by 36" clear inside dimension.	2015 ABAAS Section: 608.2.1 2012 TAS Section: 608.2.1 2010 ADAS Section: 608.2.1

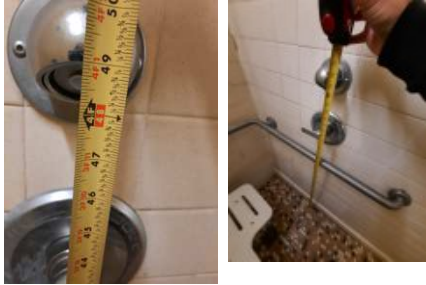
Finding Number	Area Description	Lat/Long	Finding	As Built	Recommendation	Citation	Photos	Figure
351	Walnut Ridge Unit (Sites 500-548): Walnut Ridge Unit (Sites 500-548) Men's Shower Bldg 5A	[30.8587284, -94.179279]	There is no hand held sprayer unit. The sprayer unit must have a 59 inches hose and be mounted 48 inches maximum to the top of mounting bracket off the floor. The shower spray unit shall have an on/off control with a non-positive shutoff. If an adjustable-height shower head on a vertical bar is used, the bar shall be installed so as not to obstruct the use of grab bars.	Lacks 59" flexible hose and fixed shower head at 48.5" aff	Replace shower control with a compliant lever control with a shower head on a 59" hose and usable as hand held or remount shower head to max 48". In the alternative leave as is citing construction tolerance.	2015 ABAAS Section: 608.6 2012 TAS Section: 608.6 2010 ADAS Section: 608.6

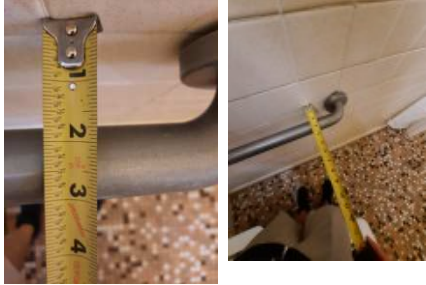
352	Walnut Ridge Unit (Sites 500-548): Walnut Ridge Unit (Sites 500-548) Men's Shower Bldg 5A	[30.8587284, -94.179279]	The space between the wall and the grab bar shall be 1½ inches (38 mm). The space between the grab bar and projecting objects below and at the ends shall be 1½ inches (38 mm) minimum. The space between the grab bar and projecting objects above shall be 12 inches (305 mm) minimum. EXCEPTION: The space between the grab bars and shower controls, shower fittings, and other grab bars above shall be permitted to be 1½ inches (38 mm) minimum.	Grab bars exceed 1.5" between bars and walls	Replace grab bar with one providing 1.5" gap between bar and wall and mount so no objects interfere within 1.5" below and 12" above bar.	2010 ADAS Section: 609.3, 609.3 Exception

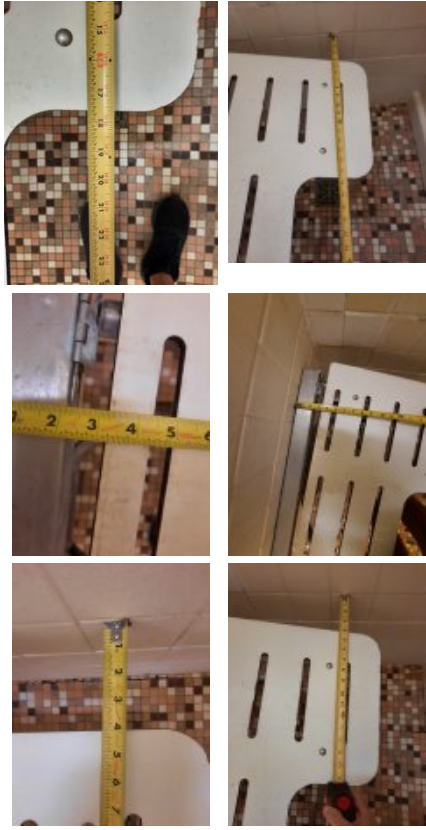
Finding Number	Area Description	Lat/Long	Finding	As Built	Recommendation	Citation	Photos	Figure
353	Walnut Ridge Unit (Sites 500-548): Walnut Ridge Unit (Sites 500-548) Men's Shower Bldg 5A	[30.8587215, -94.179279]	The shower seat does not have a compliant space between it and the wall. The folding seat must be mounted 17-19 inches above the floor, and have a maximum space of 1-1/2 inches between the edge of the seat and the side wall and 2-1/2 inches maximum to the seat wall.	The shower seat lacks required dimensions and spacing between it and the wall	Remount shower seat to the correct location and height in the shower.	2015 ABAAS Section: 610.3.2 2012 TAS Section: 610.3.2 2010 ADAS Section: 610.3.2

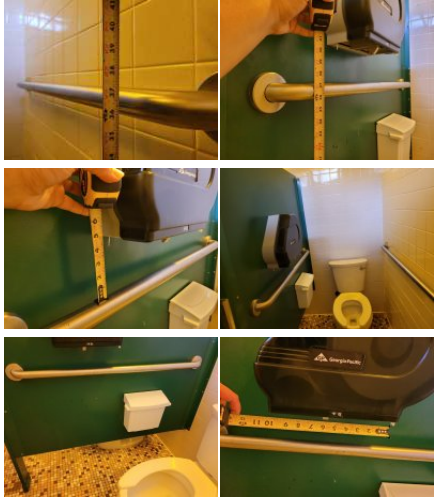
Finding Number	Area Description	Lat/Long	Finding	As Built	Recommendation	Citation	Photos	Figure
359	Walnut Ridge Unit (Sites 500-548): Walnut Ridge Unit (Sites 500-548) Women's Restroom Bldg 5A	[30.8587399 , -94.179270 9]	The grab bar height and/or spacing fails. Grab bars must be mounted between 33" and 36" to the top of the gripping surface. There must be 1.5" of clearance between the grab bar and the wall. There must be a minimum of 1.5" of clearance below and minimum 12" above the grab bar to any dispenser or other obstruction.	Gripping surfaces of grab bars are 37.25" aff, and TP 4.5" above side grab bar and too close to toilet	Remount grab bars in accessible stall to 33" to 36" aff Remount toilet paper dispenser max 7" to 9" from front of toilet, 15" to 48" aff and min 12" above or 1.5" below grab bar	2015 ABAAS Section: 609.3, 609.4 2012 TAS Section: 609.4, 609.3 2010 ADAS Section: 609.3, 609.4

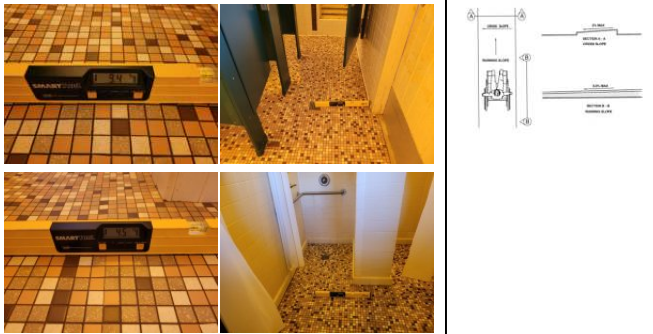
361	Walnut Ridge Unit (Sites 500-548): Walnut Ridge Unit (Sites 500-548) Women's Restroom Bldg 5A	[30.8587307 , -94.179270 9]	The accessible route contains running slopes greater than 5 percent and cross slopes greater than 2 percent across the width of the walk and has not been constructed as a ramp (i.e. handrails, wheel guides, etc.). When the slope in the direction of travel of any walk exceeds 1 unit vertical in 20 units horizontal (5-percent slope), it must be constructed as ramp. Surface cross slopes must not exceed one unit vertical in 48 units. Horizontal (2-percent slope).	Slopes of 9.4% near floor drain and 4.5% near showers	Correct or repair slope to max 5% running and 2.08% cross	2015 ABAAS Section: 403.3 2012 TAS Section: 403.3 2010 ADAS Section: 403.3

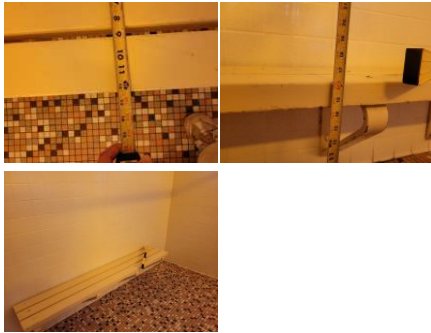
363	Walnut Ridge Unit (Sites 500-548): Walnut Ridge Unit (Sites 500-548) Women's Shower Bldg 5A	[30.8587123 , -94.179276 3]	The bench is not deep enough or long enough or is missing. Benches shall be provided having seats that are 42 inches long minimum and 20 inches deep minimum and 24 inches deep maximum. The bench shall provide for back support or shall be affixed to a wall. Back support shall be 42 inches (1065 mm) long minimum and shall extend from a point 2 inches (51 mm) maximum above the seat surface to a point 18 inches (455 mm) minimum above the seat surface. Back support shall be 2½ inches (64 mm) maximum from the rear edge of the seat measured horizontally. The top of the bench seat surface shall be 17 inches (430 mm) minimum and 19 inches (485 mm) maximum above the finish floor or ground. Clear floor or ground space complying with 305 shall be provided and shall be positioned at the end of the bench seat and parallel to the short axis of the bench	Bench lacks required dimensions - 12.5" deep, 16.25" aff and lacks clear floor space	Replace bench in dressing area with one having a seat depth of 20" to 24" deep, 42" long, affixed to the wall or having a back and mounted 17" to 19" AFF and provide required clear floor space on the short axis of the bench.	2012 TAS Section: 903.4, 903.2, 903.3, 903.5 2010 ADAS Section: 903.4, 903.2, 903.3, 903.5

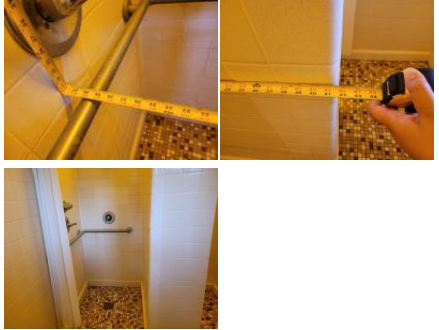
Finding Number	Area Description	Lat/Long	Finding	As Built	Recommendation	Citation	Photos	Figure
364	Walnut Ridge Unit (Sites 500-548): Walnut Ridge Unit (Sites 500-548) Women's Shower Bldg 5A	[30.8587261, -94.179279]	Transfer type shower compartments shall be 36 inches (915 mm) by 36 inches (915 mm) clear inside dimensions measured at the center points of opposing sides and shall have a 36 inch (915 mm) wide minimum entry on the face of the shower compartment. Clearance of 36 inches (915 mm) wide minimum by 48 inches (1220 mm) long minimum measured from the control wall shall be provided.	Transfer shower 32" wide	Enlarge transfer shower to compliant 36" by 36" clear inside dimension.	2015 ABAAS Section: 608.2.1 2012 TAS Section: 608.2.1 2010 ADAS Section: 608.2.1

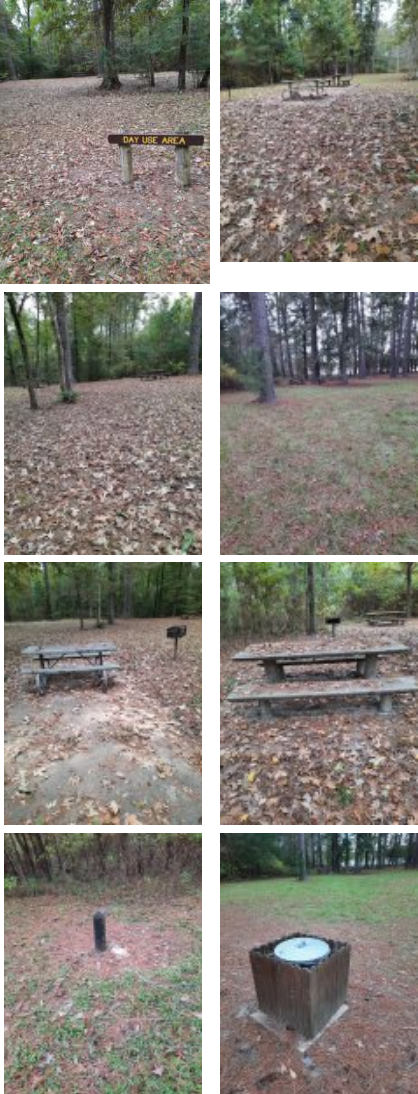
Finding Number	Area Description	Lat/Long	Finding	As Built	Recommendation	Citation	Photos	Figure
366	Walnut Ridge Unit : Walnut Ridge Unit Group Picnic Area	[30.86179, -94.18202]	There is no accessible route to 19 picnic tables, 3 grills, 2 water spouts, and 1 garbage can. At least one accessible route shall connect accessible buildings, accessible facilities, accessible elements, and accessible spaces that are on the same site.	Lacks accessible route to 19 inaccessible picnic tables, 3 grills, 2 water spouts, and 1 garbage can	Create an accessible route with crushed stone or other outdoor material from parking or walkway to four picnic tables, one grill, one water spout, and one garbage can, and replace those 4 picnic tables with ones of an accessible design as a smart practice	2015 ABAAS Section: F206.2.2 2012 TAS Section: 206.2.2 2010 ADAS Section: 206.2.2

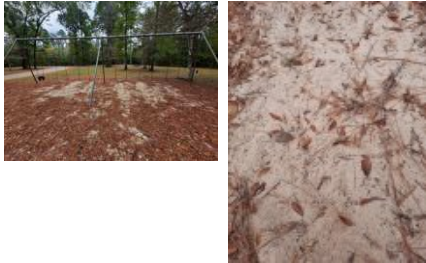
Finding Number	Area Description	Lat/Long	Finding	As Built	Recommendation	Citation	Photos	Figure																														
367	Walnut Ridge Unit : Walnut Ridge Unit Group Picnic Area Playground	[30.8612264 , -94.182023 8]	There is no accessible route to the play area. At least one accessible route shall connect accessible buildings, accessible facilities, accessible elements, and accessible spaces that are on the same site. Compliance with ASTM F 1951 for accessibility for ground surfaces on accessible routes, clear floor or ground spaces, and turning spaces has not been determined. Ground surfaces shall comply with ASTM F 1951. Ground surfaces shall be inspected and maintained regularly and frequently to ensure continued compliance with ASTM F 1951.	Lacks accessible route to 6 swings and playground surface assumed to be sand and natural debris	Create an accessible route with crushed stone or other outdoor material from parking or walkway to the play area Replace existing surface with an accessible surface such as EWF, PIP or tiles.	2015 ABAAS Section: F206.2.2 2012 TAS Section: 206.2.2 2010 ADAS Section: 206.2.2

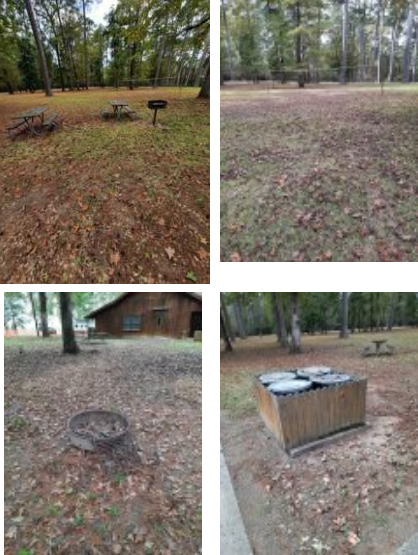
Finding Number	Area Description	Lat/Long	Finding	As Built	Recommendation	Citation	Photos	Figure
369	Walnut Ridge Unit : Walnut Ridge Unit Group Hall With Kitchen	[30.86231, -94.18199]	There is no accessible route to the 2 picnic tables, grill, volleyball court, fire pit, and garbage cans. At least one accessible route shall connect accessible buildings, accessible facilities, accessible elements, and accessible spaces that are on the same site.	Lacks accessible route to 2 inaccessible picnic tables, grill, volleyball court, fire pit, and garbage cans	Create an accessible route with crushed stone or other outdoor material from parking or walkway to two picnic tables, grill, volleyball court, fire pit, and garbage cans, and replace the picnic tables in them with ones of an accessible design as a smart practice	2015 ABAAS Section: F206.2.2 2012 TAS Section: 206.2.2 2010 ADAS Section: 206.2.2

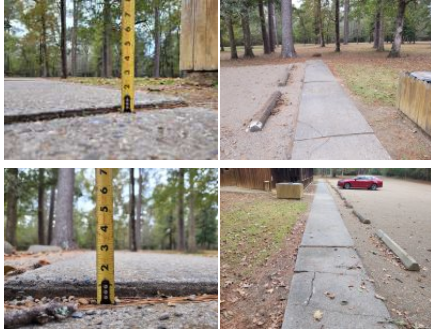
Finding Number	Area Description	Lat/Long	Finding	As Built	Recommendation	Citation	Photos	Figure
372	Walnut Ridge Unit : Walnut Ridge Unit Group Hall With Kitchen	[30.86218, -94.18185]	The walkway contains abrupt vertical edges and/or variations over a 1/4 inch. 1/4 inch is the maximum vertical rise. Changes in level between 1/4 inch and 1/2 inch must be beveled at 1:2 or less. Changes in level greater than 1/2 inch must be by way of a ramp.	Multiple changes in level (CIL) along sidewalk	Repair, bevel or ramp CIL along the route.	2012 TAS Section: 303.2, 303.3 2010 ADAS Section: 303.2, 303.3

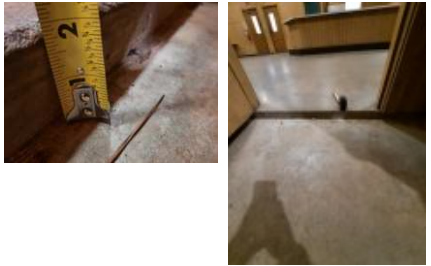
374	Walnut Ridge Unit : Walnut Ridge Unit Group Hall With Kitchen	[30.8623179, -94.1819156]	The threshold has a vertical change greater than 1/4 inch high. Hand-activated door opening hardware, handles, pulls, latches, locks, and other operating devices on accessible doors shall have a shape that is easy to grasp with one hand and does not require tight grasping, tight pinching or twisting of the wrist to operate. Hardware shall be 34 inches minimum and 48 inches maximum above the finish floor or ground.	Left Storage closet - change in level of 2" in doorway, knob hardware	For all doors along the public circulation route, repair, bevel, or ramp CILs at door entries to max .25". For all doors along the public circulation route, replace hardware with lever hardware or hardware operable without a tight pinch or grasp.	2010 ADAS Section: 404.2.3, 404.2.7, 404.2.4, 404.2.11, 404.2.11 Exception

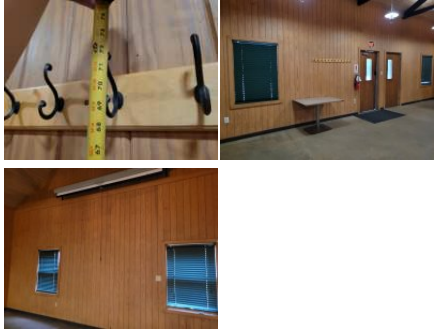
Finding Number	Area Description	Lat/Long	Finding	As Built	Recommendation	Citation	Photos	Figure
377	Walnut Ridge Unit : Walnut Ridge Unit Group Hall With Kitchen	[30.862349, -94.181942 4]	The coat hooks and projector screen pull cord are positioned too high for either a side or front approach. Where a clear floor or ground space allows a parallel approach to an element and the side reach is unobstructed, the high side reach shall be 48 inches maximum and the low side reach shall be 15 inches minimum above the finish floor or ground. Where a forward reach is unobstructed, the high forward reach shall be 48 inches maximum and the low forward reach shall be 15 inches minimum above the finish floor or ground.	Dining Hall - Coat hooks at 69.5" aff and projector screen pull cord too high	Remount operable parts to be in reach range of 15" min to 48" max.	2015 ABAAS Section: 308.1 2012 TAS Section: 308.1 2010 ADAS Section: 308.1

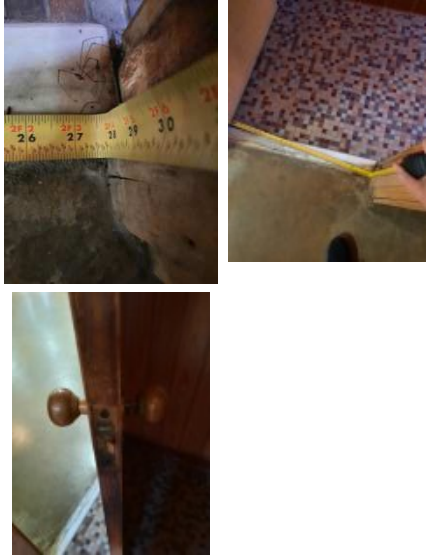
Finding Number	Area Description	Lat/Long	Finding	As Built	Recommendation	Citation	Photos	Figure
390	Walnut Ridge Unit : Walnut Ridge Unit Group Hall With Kitchen Men's Restroom	[30.8623617 , -94.181963 8]	Door openings shall provide a clear width of 32 inches (815 mm) minimum. Clear openings of doorways with swinging doors shall be measured between the face of the door and the stop, with the door open 90 degrees. Openings more than 24 inches (610 mm) deep shall provide a clear opening of 36 inches (915 mm) minimum. There shall be no projections into the required clear opening width lower than 34 inches (865 mm) above the finish floor or ground. Projections into the clear opening width between 34 inches (865 mm) and 80 inches (2030 mm) above the finish floor or ground shall not exceed 4 inches (100 mm). Hand-activated door opening hardware, handles, pulls, latches, locks, and other operating devices on accessible doors shall have a shape that is easy to grasp with one hand and does not require tight grasping, tight pinching or twisting of the wrist to operate. Hardware shall be 34 inches minimum and 48 inches maximum above the finish floor or ground.	Door - 27.75" clear width, knob	For all doors along the public circulation route, replace doors with doors having 80" overhead clearance and 32" clear width. For all doors along the public circulation route, replace hardware with lever hardware or hardware operable without a tight pinch or grasp.	2010 ADAS Section: 404.2.3, 404.2.7, 404.2.4, 404.2.11, 404.2.11 Exception

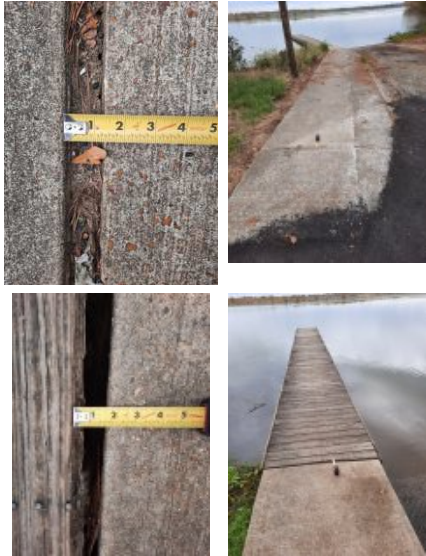
Finding Number	Area Description	Lat/Long	Finding	As Built	Recommendation	Citation	Photos	Figure
396	Walnut Ridge Unit : Walnut Ridge Unit Boat Ramp	[30.8629057 , -94.1828534]	There is a gap spaced greater than a 1/2 inch. Openings in floor or ground surfaces shall not allow passage of a sphere more than 1/2 inch diameter. Elongated openings shall be placed so that the long dimension is perpendicular to the dominant direction of travel.	Gaps of 1.25" and 1.5" on route to boat ramp pier	Correct or fill gaps to be max .5"	2015 ABAAS Section: 302.3 2012 TAS Section: 302.3 2010 ADAS Section: 302.3

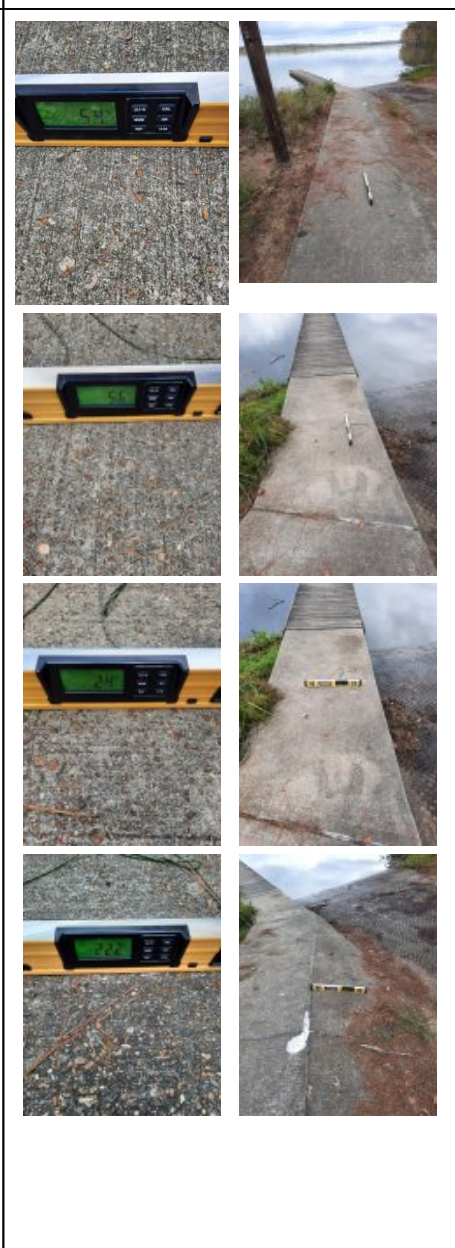
Finding Number	Area Description	Lat/Long	Finding	As Built	Recommendation	Citation	Photos	Figure
397	Walnut Ridge Unit : Walnut Ridge Unit Boat Ramp	[30.8627918 , -94.1827622]	The accessible route has running slopes greater than 5% and has not been constructed as a ramp (i.e. handrails, edge protection, etc.). Cross slopes are greater than 2% across the width of the walk. When the slope in the direction of travel of any walk exceeds 1 unit vertical in 20 units horizontal (5-percent slope), it must be constructed as a ramp. Surface cross slopes must not exceed 1 unit vertical in 48 units horizontal (2-percent slope).	Running slopes of 5.4% and 5.6%, and cross slopes of 2.4% and 22.2% on route to boat ramp pier	Correct running slopes to max 5% and cross slopes to max 2.08% along the route.	2015 ABAAS Section: 403.3 2012 TAS Section: 403.3 2010 ADAS Section: 403.3

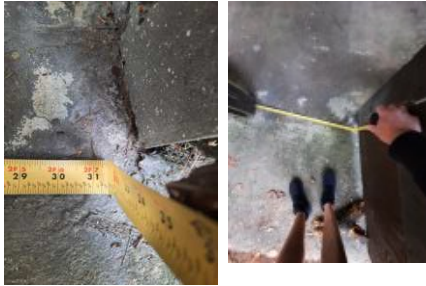
Finding Number	Area Description	Lat/Long	Finding	As Built	Recommendation	Citation	Photos	Figure
400	Walnut Ridge Unit : Walnut Ridge Unit Boat Ramp Fish Cleaning Station	[30.862996, -94.182425 2]	The door opening does not provide at least 32 inches between the face of the door and the opposite stop. Door openings shall provide a clear width of 32 inches minimum. Clear openings of doorways with swinging doors shall be measured between the face of the door and the stop, with the door open 90 degrees. There shall be no projections into the required clear opening width lower than 34 inches above the finish floor or ground. Projections into the clear opening width between 34 inches and 80 inches above the finish floor or ground shall not exceed 4 inches.	Entry Door, shelter side - 31.5" clear width	Replace door with one having 32" clear width.	2015 ABAAS Section: 404.2.3 2012 TAS Section: 404.2.3 2010 ADAS Section: 404.2.3

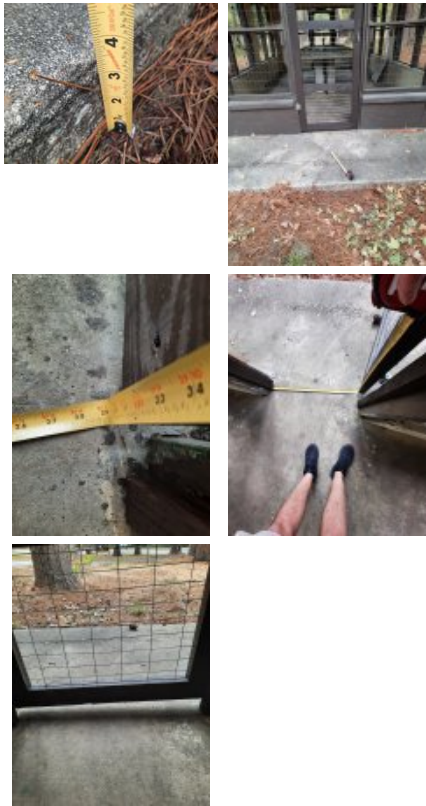
401	Walnut Ridge Unit : Walnut Ridge Unit Boat Ramp Fish Cleaning Station	[30.8629972, -94.182422 5]	Minimum maneuvering clearances at doors and gates shall comply with 404.2.4. Maneuvering clearances shall extend the full width of the doorway and the required latch side or hinge side clearance. Maneuvering clearances shall have a max slope of 2.08%. Door openings shall provide a clear width of 32 inches (815 mm) minimum. Clear openings of doorways with swinging doors shall be measured between the face of the door and the stop, with the door open 90 degrees. Openings more than 24 inches (610 mm) deep shall provide a clear opening of 36 inches (915 mm) minimum. There shall be no projections into the required clear opening width lower than 34 inches (865 mm) above the finish floor or ground. Projections into the clear opening width between 34 inches (865 mm) and 80 inches (2030 mm) above the finish floor or ground shall not exceed 4 inches (100 mm). The maneuvering clearance has a vertical change greater than 1/4 inch high. The bottom 10 inches on the push side must be smooth and free of obstructions (hold open devices). Opening hardware must be mounted between 30 and 44 inches above the floor or ground.	Entry door, boat ramp parking side - Lacks maneuvering clearance on pull side due to change in level of 3.5" at landing, 29.5" width, lacks smooth surface on push	In the alternative, leave as is an mount signage directing users to the other door. For all doors along the public circulation route, provide required maneuvering clearance on push and pull side of doors. For all doors along the public circulation route, replace doors with doors having 80" overhead clearance and 32" clear width. For all doors along the public circulation route, repair, bevel, or ramp CILs at door entries to max .25". For all doors along the public circulation route, provide kick plate on push side of door from floor to 10" AFF.	2010 ADAS Section: 404.2.3, 404.2.7, 404.2.4, 404.2.11, 404.2.11 Exception

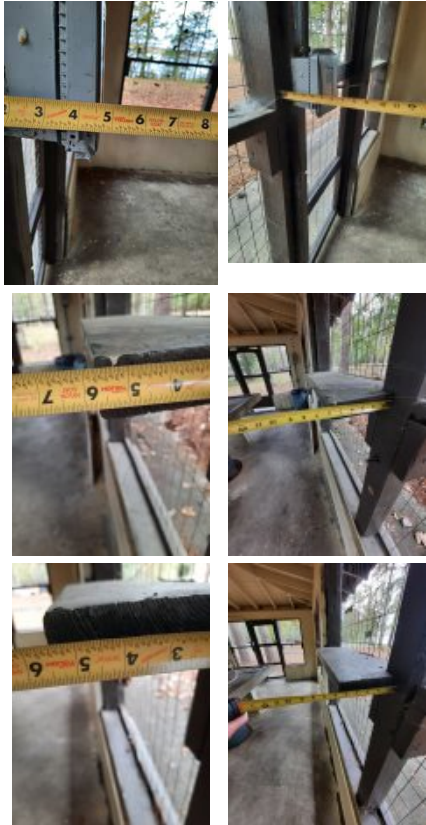
Finding Number	Area Description	Lat/Long	Finding	As Built	Recommendation	Citation	Photos	Figure
402	Walnut Ridge Unit : Walnut Ridge Unit Boat Ramp Fish Cleaning Station	[30.8630018 , -94.182417 1]	The light switch box and 2 shelves projects more than 4 inches into the circulation path. Wall-mounted objects that have leading edges between 27 inches and 80 inches from the floor must not project more than 4 inches into the circulation path. Protruding objects that extend to the floor or within 27 inches of the floor are cane detectable and are therefore not hazardous. Where it is necessary or desirable to have objects protrude from the wall, a manner of cane detection must be provided.	Light switch box protrudes 4.5" and two shelves protrude 5.75" and 5.5"	Relocate protruding objects or place cane detectable warning or bollard at foot of items.	2015 ABAAS Section: 307.2 2012 TAS Section: 307.2 2010 ADAS Section: 307.2

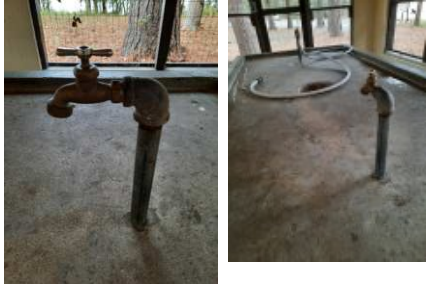
Finding Number	Area Description	Lat/Long	Finding	As Built	Recommendation	Citation	Photos	Figure
405	Walnut Ridge Unit : Walnut Ridge Unit Boat Ramp Fish Cleaning Station	[30.8630075 , -94.182417 1]	The water spout handle is not accessible because it requires tight grasping, pinching or twisting of the wrist.	Water spout handle requires tight grasping, pinching, or twisting of the wrist	Replace the water spout with an operable part usable without a tight pinch or grasp.	2015 ABAAS Section: 309.4 2012 TAS Section: 309.4 2010 ADAS Section: 309.4

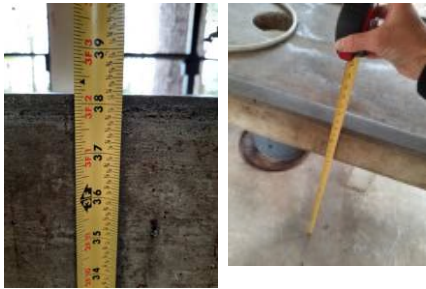
406	Walnut Ridge Unit : Walnut Ridge Unit Boat Ramp Fish Cleaning Station	[30.8630006 , -94.182414 5]	The top of the work surface is not within a compliant height range. The tops of tables and counters shall be 28 inches to 34 inches from the floor or ground.	Fish cleaning station work surface at 38.25" aff	Provide tables and work surfaces at 28" to 34" aff with required knee and toe clearances.	2015 ABAAS Section: 902.3 2012 TAS Section: 902.3 2010 ADAS Section: 902.3

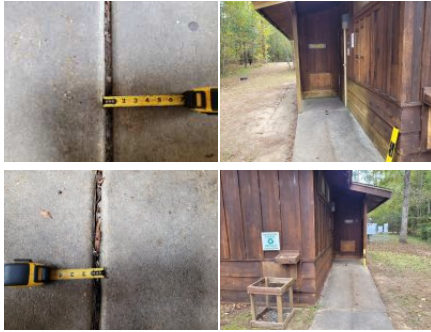
409	Walnut Ridge Unit (Shelter Sites 600-625): Walnut Ridge Unit (Shelter Sites 600-625) Restroom Parking and Exterior Accessible Route Bldg 6	[30.86535, -94.18096]	There is a gap spaced greater than a 1/2 inch. Openings in floor or ground surfaces shall not allow passage of a sphere more than 1/2 inch diameter. Elongated openings shall be placed so that the long dimension is perpendicular to the dominant direction of travel.	Gaps of 1" and 1" on routes to women's and men's restrooms	Correct or fill gaps to be max .5".	2015 ABAAS Section: 302.3 2012 TAS Section: 302.3 2010 ADAS Section: 302.3

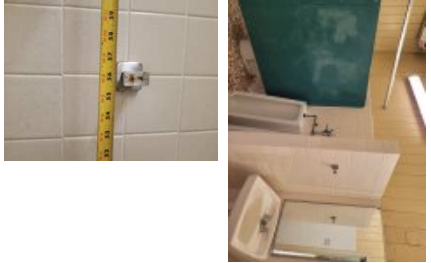
412	Walnut Ridge Unit (Shelter Sites 600-625): Walnut Ridge Unit (Shelter Sites 600-625) Men's Restroom Bldg 6	[30.8652328, -94.1810224]	The operable part is positioned too high for either a side or front approach. Where a clear floor or ground space allows a parallel approach to an element and the side reach is unobstructed, the high side reach shall be 48 inches maximum and the low side reach shall be 15 inches minimum above the finish floor or ground. Where a forward reach is unobstructed, the high forward reach shall be 48 inches maximum and the low forward reach shall be 15 inches minimum above the finish floor or ground.	Coat hook at 56.5" aff	Remount hook to 48" max.	2015 ABAAS Section: 308.1 2012 TAS Section: 308.1 2010 ADAS Section: 308.1

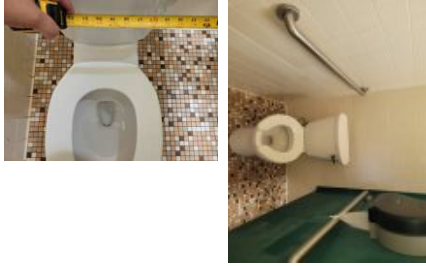
414	Walnut Ridge Unit (Shelter Sites 600-625): Walnut Ridge Unit (Shelter Sites 600-625) Men's Restroom Bldg 6	[30.8652604 , -94.181009]	The toilet is not located within the range to the side wall or partition. The centerline of the toilet shall be 17 inches minimum and 19 inches maximum side wall or partition in the ambulatory accessible toilet compartment.	Centerline of the toilet is 19.5" from the partition	Remount toilet to 17" to 19" from the side wall to center line in ambulatory stalls or 16" to 18" in new wheelchair stall.	2015 ABAAS Section: 604.9.1 2012 TAS Section: 604.9.1 2010 ADAS Section: 604.9.1

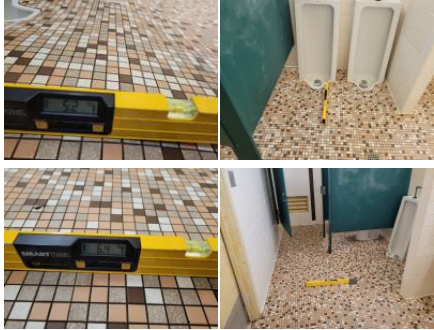
Finding Number	Area Description	Lat/Long	Finding	As Built	Recommendation	Citation	Photos	Figure
419	Walnut Ridge Unit (Shelter Sites 600-625): Walnut Ridge Unit (Shelter Sites 600-625) Men's Restroom Bldg 6	[30.865242, -94.181019 7]	The accessible route contains running slopes greater than 5 percent and cross slopes greater than 2 percent across the width of the walk and has not been constructed as a ramp (i.e. handrails, wheel guides, etc.). When the slope in the direction of travel of any walk exceeds 1 unit vertical in 20 units horizontal (5-percent slope), it must be constructed as ramp. Surface cross slopes must not exceed one unit vertical in 48 units. Horizontal (2-percent slope).	Slopes of 5.2% at urinal and 6.4% near floor drain	Correct or repair slope to max 5% running and 2.08% cross	2015 ABAAS Section: 403.3 2012 TAS Section: 403.3 2010 ADAS Section: 403.3

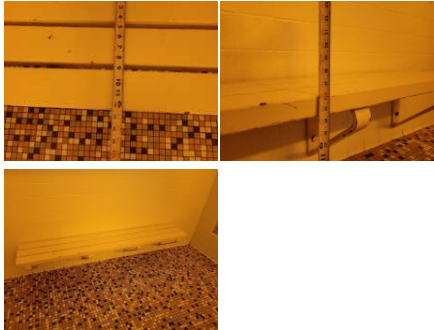
Finding Number	Area Description	Lat/Long	Finding	As Built	Recommendation	Citation	Photos	Figure
422	Walnut Ridge Unit (Shelter Sites 600-625): Walnut Ridge Unit (Shelter Sites 600-625) Men's Shower Bldg 6	[30.8652466 , -94.1810197]	The bench is not deep enough or long enough or is missing. Benches shall be provided having seats that are 42 inches long minimum and 20 inches deep minimum and 24 inches deep maximum. The bench shall provide for back support or shall be affixed to a wall. Back support shall be 42 inches (1065 mm) long minimum and shall extend from a point 2 inches (51 mm) maximum above the seat surface to a point 18 inches (455 mm) minimum above the seat surface. Back support shall be 2½ inches (64 mm) maximum from the rear edge of the seat measured horizontally. The top of the bench seat surface shall be 17 inches (430 mm) minimum and 19 inches (485 mm) maximum above the finish floor or ground. Clear floor or ground space complying with 305 shall be provided and shall be positioned at the end of the bench seat and parallel to the short axis of the bench	Bench lacks required dimensions -12.25" deep, 16" aff	Replace bench in dressing area with one having a seat depth of 20" to 24" deep, 42" long, affixed to the wall or having a back and mounted 17" to 19" AFF and provide required clear floor space on the short axis of the bench.	2012 TAS Section: 903.4, 903.2, 903.3, 903.5 2010 ADAS Section: 903.4, 903.2, 903.3, 903.5

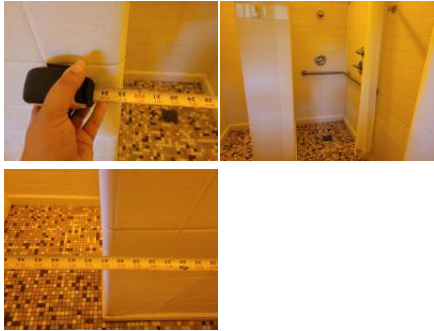
423	Walnut Ridge Unit (Shelter Sites 600-625): Walnut Ridge Unit (Shelter Sites 600-625) Men's Shower Bldg 6	[30.8652236 , -94.1810184]	Transfer type shower compartments shall be 36 inches (915 mm) by 36 inches (915 mm) clear inside dimensions measured at the center points of opposing sides and shall have a 36 inch (915 mm) wide minimum entry on the face of the shower compartment. Clearance of 36 inches (915 mm) wide minimum by 48 inches (1220 mm) long minimum measured from the control wall shall be provided.	Transfer shower 33" wide	Enlarge transfer shower to compliant 36" by 36" clear inside dimension	2015 ABAAS Section: 608.2.1 2012 TAS Section: 608.2.1 2010 ADAS Section: 608.2.1

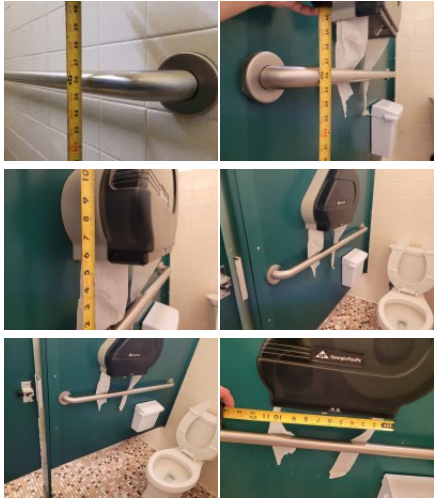
Finding Number	Area Description	Lat/Long	Finding	As Built	Recommendation	Citation	Photos	Figure
429	Walnut Ridge Unit (Shelter Sites 600-625): Walnut Ridge Unit (Shelter Sites 600-625) Women's Restroom Bldg 6	[30.8652236 , -94.181019 7]	The grab bar height and/or spacing fails. Grab bars must be mounted between 33" and 36" to the top of the gripping surface. There must be 1.5" of clearance between the grab bar and the wall. There must be a minimum of 1.5" of clearance below and minimum 12" above the grab bar to any dispenser or other obstruction.	Gripping surfaces of grab bars are 36.5" aff, TP 5.5" above side bar and too close to toilet	Remount grab bars in accessible stall to 33" to 36" aff Remount toilet paper dispenser max 7" to 9" from front of toilet, 15" to 48" aff and min 12" above or 1.5" below grab bar	2015 ABAAS Section: 609.3, 609.4 2012 TAS Section: 609.4, 609.3 2010 ADAS Section: 609.3, 609.4

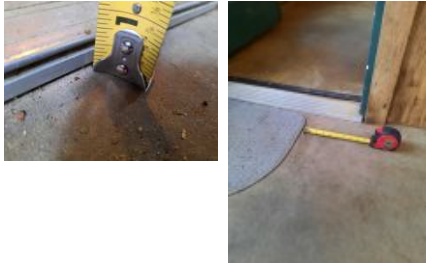
Finding Number	Area Description	Lat/Long	Finding	As Built	Recommendation	Citation	Photos	Figure
441	Walnut Ridge Unit (Shelter Sites 600-625): Walnut Ridge Unit (Shelter Sites 600-625) Shelters with Amenities	[30.84929, -94.16807]	Changes in level of ¼ inch (6.4 mm) high maximum shall be permitted to be vertical. Changes in level between ¼ inch (6.4 mm) high minimum and ½ inch (13 mm) high maximum shall be beveled with a slope not steeper than 1:2. Changes in level greater than ½ inch (13 mm) high shall be ramped, and shall comply with 405 or 406.	Shelter 619 interior door - change in level (CIL) of .5" in doorway	Repair, bevel or ramp CIL at doorway.	2015 ABAAS Section: 303.3, 404.2.5, 303.2, 303.4 2012 TAS Section: 303.3, 404.2.5, 303.2, 303.4 2010 ADAS Section: 303.3, 404.2.5, 303.2, 303.4

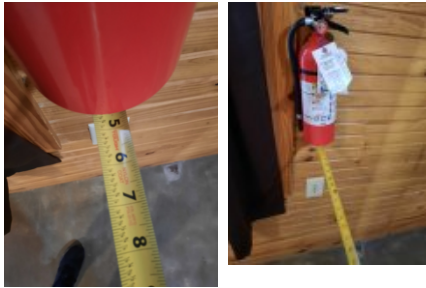
442	Walnut Ridge Unit (Shelter Sites 600-625): Walnut Ridge Unit (Shelter Sites 600-625) Shelters with Amenities	[30.84929, -94.16807]	The fire extinguisher projects more than 4 inches into the circulation path. Wall-mounted objects that have leading edges between 27 inches and 80 inches from the floor must not project more than 4 inches into the circulation path. Protruding objects that extend to the floor or within 27 inches of the floor are cane detectable and are therefore not hazardous. Where it is necessary or desirable to have objects protrude from the wall, a manner of cane detection must be provided.	Shelter 619 - Fire extinguisher protrudes 4.5"	Relocate protruding objects or place cane detectable warning or bollard at foot of item.	2015 ABAAS Section: 307.2 2012 TAS Section: 307.2 2010 ADAS Section: 307.2

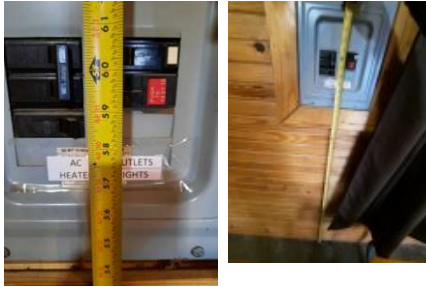
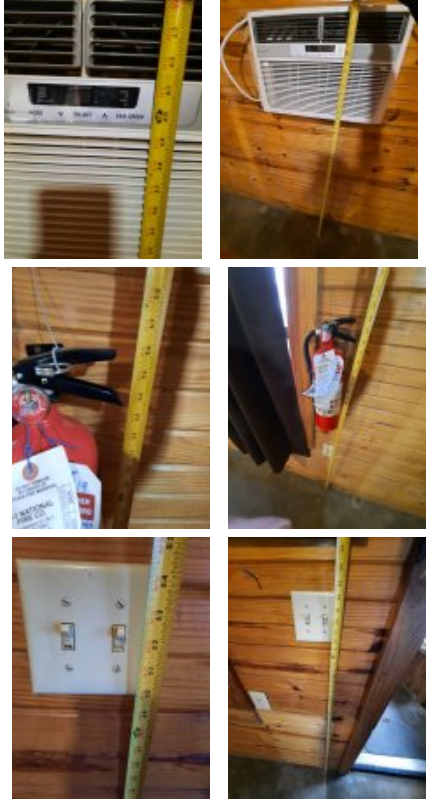
443	Walnut Ridge Unit (Shelter Sites 600-625): Walnut Ridge Unit (Shelter Sites 600-625) Shelters with Amenities	[30.84929, -94.16807]	The breaker box, AC/Heater unit, fire extinguisher, and light switches are positioned too high for either a side or front approach. Where a clear floor or ground space allows a parallel approach to an element and the side reach is unobstructed, the high side reach shall be 48 inches maximum and the low side reach shall be 15 inches minimum above the finish floor or ground. Where a forward reach is unobstructed, the high forward reach shall be 48 inches maximum and the low forward reach shall be 15 inches minimum above the finish floor or ground.	Shelter 619 - Breaker box at 59.5" aff, AC/Heater unit at 60" aff, fire extinguisher at 55" aff, and light switches at 52" aff	Remount operable parts to be in reach range of 15" min to 48" max. Leave as is light switches citing safe harbor.	2015 ABAAS Section: 308.1 2012 TAS Section: 308.1 2010 ADAS Section: 308.1

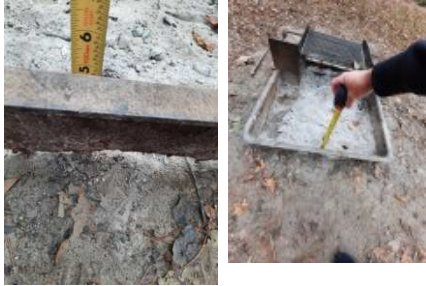
448	Walnut Ridge Unit (Shelter Sites 600-625): Walnut Ridge Unit (Shelter Sites 600-625) Shelters with Amenities	[30.8641875 , -94.182119 4]	Fire building surfaces shall be 9 inches (230 mm) minimum above the ground.	Shelter 619 - Fire building surface lacks 9" minimum above surrounding ground level	Correct fire building surface to be 9" min above the ground as a smart practice. In the alternative, replace fire ring with a compliant accessible fire ring.	2015 ABAAS Section: 1011.5.1

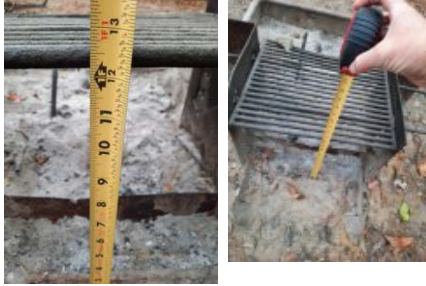
449	Walnut Ridge Unit (Shelter Sites 600-625): Walnut Ridge Unit (Shelter Sites 600-625) Shelters with Amenities	[30.8641875 , -94.182111 4]	Where provided, cooking surfaces shall be 15 inches (380 mm) minimum and 34 inches (865 mm) maximum above the ground.	Shelter 619 - Cooking surface of grill 12.75" at highest setting	Raise or lower cooking surface to be 15" min to 34" max above the ground; in the alternative, replace with a compliant surface as a smart practice.	2015 ABAAS Section: 1011.5.2

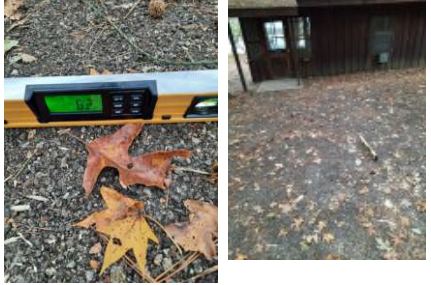
451	Walnut Ridge Unit (Shelter Sites 600-625): Walnut Ridge Unit (Shelter Sites 600-625) Shelters with Amenities	[30.8641691, -94.182114]	The surface of parking spaces and pull-up spaces shall be firm and stable. The slope of the surface of parking spaces and pull-up spaces shall not be steeper than 1:48 in any direction. EXCEPTION: Where the surface is other than asphalt, concrete, or boards, slopes not steeper than 1:20 shall be permitted when necessary for drainage.	Shelter 619 - Slope of 6.2% in "parking space"	Correct surface of parking spaces to be firm and stable with slopes max of 5% for surfaces other than concrete, asphalt or boards as a smart practice.	2015 ABAAS Section: 1012.4, 1012.5, 1012.5 EXCEPTION

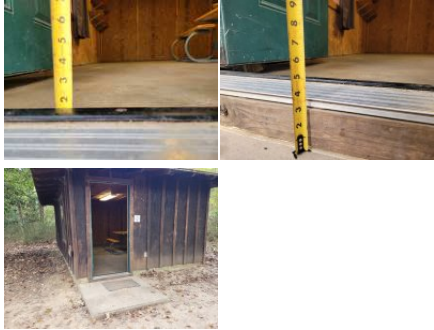
Finding Number	Area Description	Lat/Long	Finding	As Built	Recommendation	Citation	Photos	Figure
457	Walnut Ridge Unit (Shelter Sites 600-625): Walnut Ridge Unit (Shelter Sites 600-625) Shelters with Amenities	[30.86432, -94.18193]	Minimum maneuvering clearances at doors and gates shall comply with 404.2.4. Maneuvering clearances shall extend the full width of the doorway and the required latch side or hinge side clearance. The threshold has a vertical change greater than 1/4 inch high. The threshold at a doorway shall be no higher than 1/2 inch. Changes in level between 1/4 inch and 1/2 inch must be beveled at 1:2 or less. 1/4 inch is the maximum vertical rise.	Shelter 618 - change in level (CIL) of 1.5" at threshold and CIL of 3" at doorway	For all doors along the public circulation route, provide required maneuvering clearance on push and pull side of doors For all doors along the public circulation route, repair, bevel, or ramp CILs at door entries to max .25" For all doors along the public circulation route, repair, provide beveled threshold	2010 ADAS Section: 404.2.3, 404.2.7, 404.2.4, 404.2.11, 404.2.11 Exception

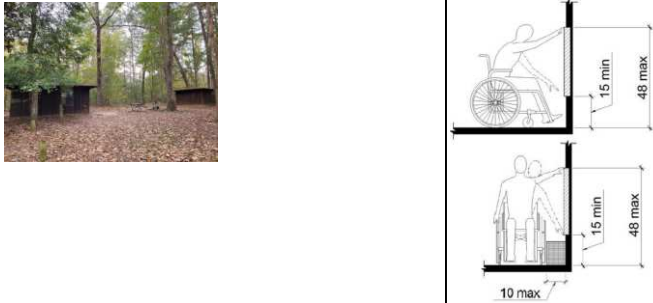
460	Walnut Ridge Unit (Shelter Sites 600-625): Walnut Ridge Unit (Shelter Sites 600-625) Shelters with Amenities	[30.8642095, -94.1818447]	The lantern hook is positioned too high for either a side or front approach. Where a clear floor or ground space allows a parallel approach to an element and the side reach is unobstructed, the high side reach shall be 48 inches maximum and the low side reach shall be 15 inches minimum above the finish floor or ground. Where a forward reach is unobstructed, the high forward reach shall be 48 inches maximum and the low forward reach shall be 15 inches minimum above the finish floor or ground.	Shelter 618 - Lantern hook exceeds reach range	Remount operable parts to be in reach range of 15" min to 48" max.	2015 ABAAS Section: 308.1 2012 TAS Section: 308.1 2010 ADAS Section: 308.1
