Access Audit Site Report

Prepared By
WT Group

Martin Dies Jr. State Park
634 Park Road 48 South
Jasper, TX 75951
Accessibility Evaluation
Inspection Date: 11/10/2021
Inspectors: Tanya Scheibe

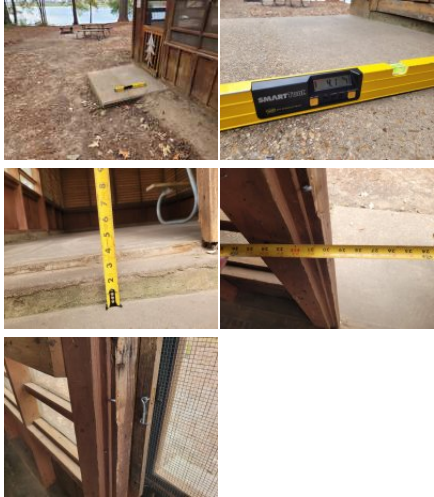
Finding Number	Area Description	Lat/Long	Finding	As Built	Recommendation	Citation	Photos	Figure
466	Walnut Ridge Unit (Shelter Sites 600-625): Walnut Ridge Unit (Shelter Sites 600-625) Shelters with Amenities	[30.86404, -94.18179]	Minimum maneuvering clearances at doors and gates shall comply with 404.2.4. Maneuvering clearances shall extend the full width of the doorway and the required latch side or hinge side clearance. Door openings shall provide a clear width of 32 inches (815 mm) minimum. Clear openings of doorways with swinging doors shall be measured between the face of the door and the stop, with the door open 90 degrees. Openings more than 24 inches (610 mm) deep shall provide a clear opening of 36 inches (915 mm) minimum. There shall be no projections into the required clear opening width lower than 34 inches (865 mm) above the finish floor or ground. Projections into the clear opening width between 34 inches (865 mm) and 80 inches (2030 mm) above the finish floor or ground shall not exceed 4 inches (100 mm). The threshold at a doorway shall be no higher than 1/2 inch. Changes in level between 1/4 inch and 1/2 inch must be beveled at 1:2 or less. 1/4 inch is the maximum vertical rise. Hand-activated door opening hardware, handles, pulls, latches, locks, and other operating devices on accessible doors shall have a shape that is easy to grasp with one hand and does not require tight grasping, tight pinching or twisting of the wrist to operate. Hardware shall be 34 inches minimum and 48 inches maximum above the finish floor or ground.	Shelter 621 - Lacks maneuvering clearance on pull side due to slope of 4.1% on landing, 30" door width, changes in level totaling 3" in doorway, and lacks compliant hardware	For all doors along the public circulation route, provide required maneuvering clearance on push and pull side of doors For all doors along the public circulation route, correct or repair slope at doorway landing to max 2.08% in any direction for level CFS For all doors along the public circulation route, replace doors with doors having 80" overhead clearance and 32" clear width For all doors along the public circulation route, repair, bevel, or ramp CILs at door entries to max .25" For all doors along the public circulation route, replace hardware with lever hardware or hardware operable without a tight pinch or grasp	2010 ADAS Section: 404.2.3, 404.2.7, 404.2.4, 404.2.11, 404.2.11 Exception

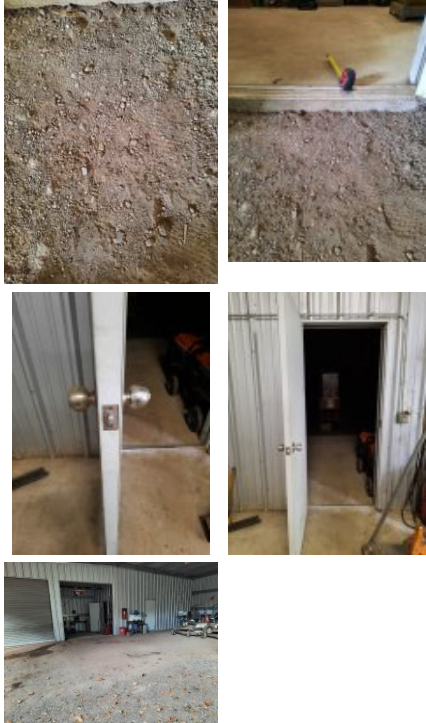
Finding Number	Area Description	Lat/Long	Finding	As Built	Recommendation	Citation	Photos	Figure
481	Employee Spaces: Maintenance	[30.8443436 , -94.165570 2]	Minimum maneuvering clearances at doors and gates shall comply with 404.2.4. Maneuvering clearances shall extend the full width of the doorway and the required latch side or hinge side clearance. The threshold at a doorway shall be no higher than 1/2 inch. Changes in level between 1/4 inch and 1/2 inch must be beveled at 1:2 or less. 1/4 inch is the maximum vertical rise. Hand-activated door opening hardware, handles, pulls, latches, locks, and other operating devices on accessible doors shall have a shape that is easy to grasp with one hand and does not require tight grasping, tight pinching or twisting of the wrist to operate. Hardware shall be 34 inches minimum and 48 inches maximum above the finish floor or ground.	Lacks maneuvering clearance on pull side due to dirt, CIL at doorway, and has knob hardware	For all doors along the public circulation route, provide required maneuvering clearance on push and pull side of doors For all doors along the public circulation route, repair, bevel, or ramp CILs at door entries to max .25" For all doors along the public circulation route, replace hardware with lever hardware or hardware operable without a tight pinch or grasp	2010 ADAS Section: 404.2.3, 404.2.7, 404.2.4, 404.2.11, 404.2.11 Exception

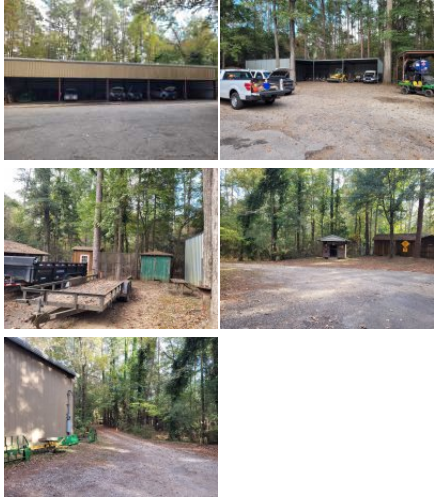
Finding Number	Area Description	Lat/Long	Finding	As Built	Recommendation	Citation	Photos	Figure
482	Employee Spaces: Maintenance	[30.8442999 , -94.165621 1]	Spaces and elements within employee work areas shall only be required to comply with 206.2.8, 207.1, and 215.3 and shall be designed and constructed so that individuals with disabilities can approach, enter, and exit the employee work area. Employee work areas, or portions of employee work areas, other than raised courtroom stations, that are less than 300 square feet (28 m2) and elevated 7 inches (180 mm) or more above the finish floor or ground where the elevation is essential to the function of the space shall not be required to comply with these requirements or to be on an accessible route.	buildings lack AR, lack accessible surfaces	Create an accessible route to each building entry	2015 ABAAS Section: F203.9 2012 TAS Section: 203.9 2010 ADAS Section: 203.9

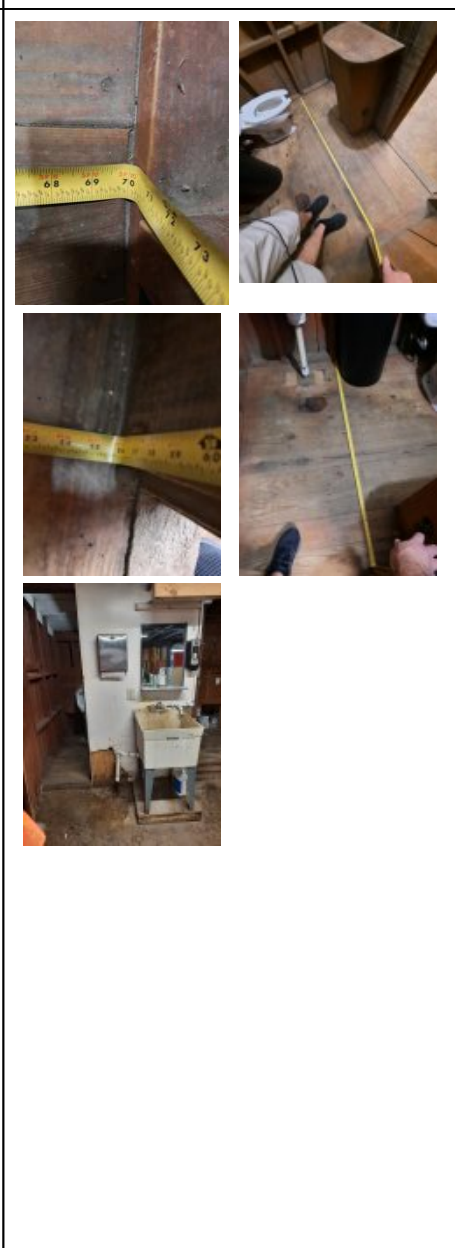
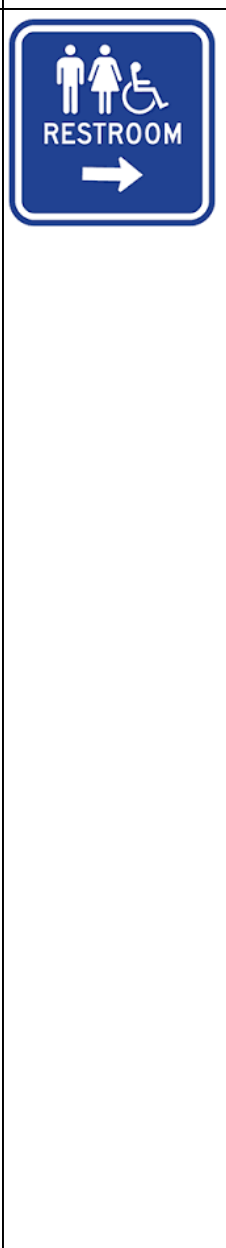
Finding Number	Area Description	Lat/Long	Finding	As Built	Recommendation	Citation	Photos	Figure
484	Employee Spaces: Maintenance Admin Building	[30.8443298 , -94.165613 1]	This restroom is not accessible. Where existing toilet rooms or bathing rooms do not comply, directional signs indicating the location of the nearest accessible toilet room or bathing room within the facility shall be provided. Signs shall include the International Symbol of Accessibility. Where existing toilet rooms or bathing rooms do comply), the accessible toilet rooms or bathing rooms shall be identified by the International Symbol of Where clustered single user toilet rooms or bathing facilities are permitted, accessible toilet rooms or bathing facilities shall be identified by the International Symbol of Accessibility unless all toilet rooms and bathing facilities are accessible.	Restroom is not accessible and lacks signage directing patrons to an accessible restroom	Restroom not accessible, acquire and mount signage directing employees to accessible restroom.	2015 ABAAS Section: F216.8 2012 TAS Section: 216.8 2010 ADAS Section: 216.8

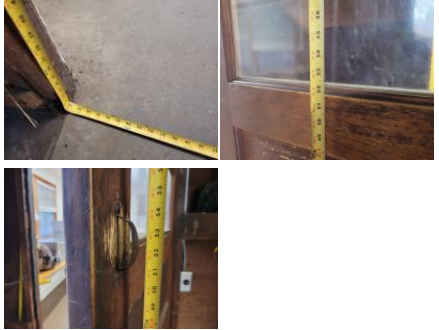
Finding Number	Area Description	Lat/Long	Finding	As Built	Recommendation	Citation	Photos	Figure
487	Employee Spaces: Maintenance Admin Building	[30.8443698 , -94.165556 4]	Door openings shall provide a clear width of 32 inches (815 mm) minimum. Clear openings of doorways with swinging doors shall be measured between the face of the door and the stop, with the door open 90 degrees. Openings more than 24 inches (610 mm) deep shall provide a clear opening of 36 inches (915 mm) minimum. There shall be no projections into the required clear opening width lower than 34 inches (865 mm) above the finish floor or ground. Projections into the clear opening width between 34 inches (865 mm) and 80 inches (2030 mm) above the finish floor or ground shall not exceed 4 inches (100 mm). Hand-activated door opening hardware, handles, pulls, latches, locks, and other operating devices on accessible doors shall have a shape that is easy to grasp with one hand and does not require tight grasping, tight pinching or twisting of the wrist to operate. Hardware shall be 34 inches minimum and 48 inches maximum above the finish floor or ground.	Break room door - 30" clear width, hardware centerline is 52.5" agl	For all doors along the public circulation route, replace doors with doors having 80" overhead clearance and 32" clear width For all doors along the public circulation route, remount hardware to be 34" to 48" aff	2010 ADAS Section: 404.2.3, 404.2.7, 404.2.4, 404.2.11, 404.2.11 Exception
