# Access Audit Site Report

**McKinney Falls State Park**  
**5808 McKinney Falls Pkwy**  
**Austin, TX 78744**  
**Accessibility Evaluation**  
**Inspection Date: 11/11/2021**  
**Inspectors: Tanya Scheibe**

Prepared By  
**WT Group**

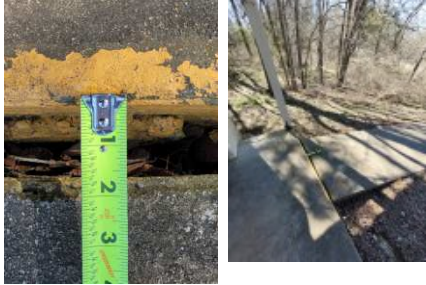
Finding Number	Area Description	Lat/Long	Finding	As Built	Recommendation	Citation	Photos	Figure
6	Exterior: Exterior Accessible Route	[30.1801042 , -97.724685 6]	There is a gap spaced greater than a 1/2 inch. Openings in floor or ground surfaces shall not allow passage of a sphere more than 1/2 inch diameter. Elongated openings shall be placed so that the long dimension is perpendicular to the dominant direction of travel.	Big oak RR building (non shower) - 1.5" gap at level landing to RR	Correct or fill gaps to be max .5"	2015 ABAAS Section: 302.3 2012 TAS Section: 302.3 2010 ADAS Section: 302.3

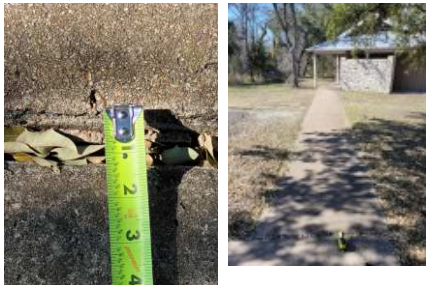
7	Exterior: Exterior Accessible Route	[30.1786724 , -97.723832 6]	There is a gap spaced greater than a 1/2 inch. Openings in floor or ground surfaces shall not allow passage of a sphere more than 1/2 inch diameter. Elongated openings shall be placed so that the long dimension is perpendicular to the dominant direction of travel.	To little oak RR building - 1.5" gap at top of path	Correct or fill gaps to be max .5"	2015 ABAAS Section: 302.3 2012 TAS Section: 302.3 2010 ADAS Section: 302.3

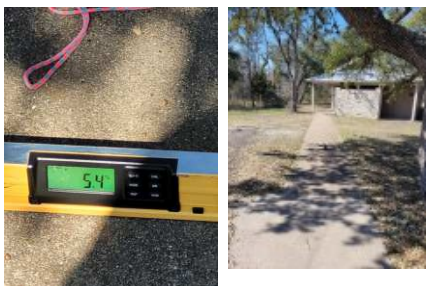
8	Exterior: Exterior Accessible Route	[30.1786844 , -97.723886 3]	The running slope of walking surfaces shall not be steeper than 1:20.	To little oak RR - 5.4% slope in middle of path	Correct running slope along the AR to max 5%	2015 ABAAS Section: 403.3 2012 TAS Section: 403.3 2010 ADAS Section: 403.3

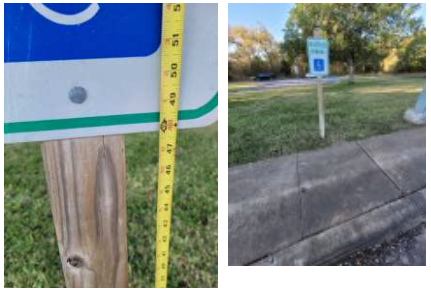
13	Exterior: Headquarters Parking	[30.1808764 , -97.7222258]	The parking sign is mounted too low. Parking space identification signs shall include the International Symbol of Accessibility complying with. Signs identifying van parking spaces shall contain the designation "van accessible." Signs shall be 60 inches minimum above the finish floor or ground surface measured to the bottom of the sign.	48 inch to bottom of sign	Raise existing accessible parking signs so lowest end of bottom sign is min 60" AFF	2015 ABAAS Section: 502.6 2012 TAS Section: 502.6 2010 ADAS Section: 502.6

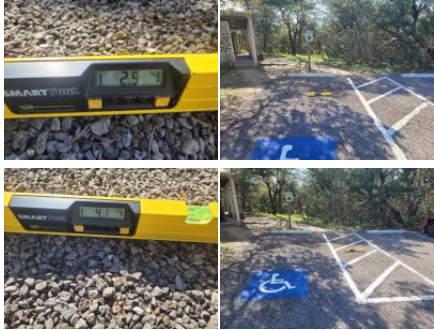
Finding Number	Area Description	Lat/Long	Finding	As Built	Recommendation	Citation	Photos	Figure
30	Exterior: Big Cedar Camping Area Restroom Parking	[30.1753821, -97.7268736]	The cross slopes (narrow dimension) and/or running slopes (long dimension) of the access aisle exceeds 2%. The running slope and the cross slope in an accessible parking stall and the access aisle must not exceed 2%.	2.9% slope at stall, 4.1% slope at aisle	Repair or correct slope of parking space and access aisle to max 2.08% in any direction	2015 ABAAS Section: 502.4 2012 TAS Section: 502.4 2010 ADAS Section: 502.4

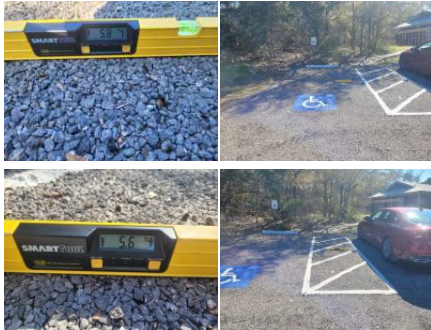
Finding Number	Area Description	Lat/Long	Finding	As Built	Recommendation	Citation	Photos	Figure
38	Exterior: Grapevine Loop Camping Area Restroom Parking	[30.1772385 , -97.726154 5]	The cross slopes (narrow dimension) and/or running slopes (long dimension) of the access aisle exceeds 2%. The running slope and the cross slope in an accessible parking stall and the access aisle must not exceed 2%.	5.8% slope at stall, 5.6% slope at aisle	Repair or correct slope of parking space and access aisle to max 2.08% in any direction	2015 ABAAS Section: 502.4  2012 TAS Section: 502.4  2010 ADAS Section: 502.4

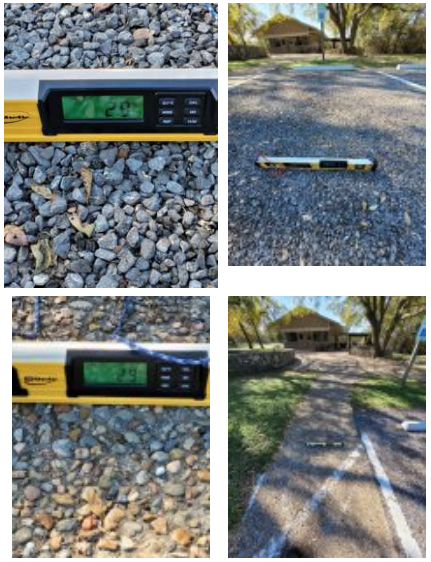
52	Exterior: Group Dining Hall Parking	[30.1800006 , -97.728654 7]	The cross slopes (narrow dimension) and/or running slopes (long dimension) of the access aisle exceeds 2%. The running slope and the cross slope in an accessible parking stall and the access aisle must not exceed 2%.	2.9% slope in two locations at Dining Hall	Repair or correct slope of parking space and access aisle to max 2.08% in any direction	2015 ABAAS Section: 502.4  2012 TAS Section: 502.4  2010 ADAS Section: 502.4

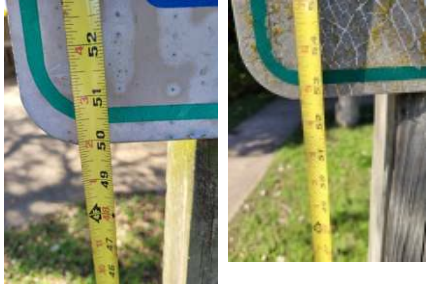
Finding Number	Area Description	Lat/Long	Finding	As Built	Recommendation	Citation	Photos	Figure
53	Exterior: Group Dining Hall Parking	[30.1800018 , -97.728706]	The parking sign is mounted too low. Parking space identification signs shall include the International Symbol of Accessibility complying with. Signs identifying van parking spaces shall contain the designation "van accessible." Signs shall be 60 inches minimum above the finish floor or ground surface measured to the bottom of the sign.	50 inch to bottom of sign at Dining Hall, 52.5 inch to bottom of sign at Amphitheater Restroom	Raise existing accessible parking signs so lowest end of bottom sign is min 60" AGL	2015 ABAAS Section: 502.6 2012 TAS Section: 502.6 2010 ADAS Section: 502.6

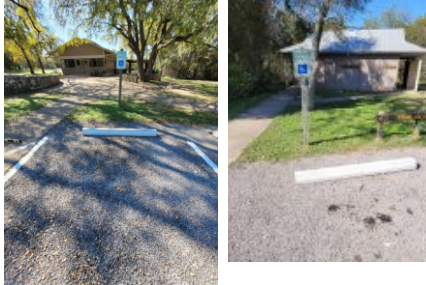
54	Exterior: Group Dining Hall Parking	[30.1799989 , -97.728668]	The van stall is missing a sign identifying it as a van accessible stall. Parking space identification signs shall include the International Symbol of Accessibility. Signs identifying van parking spaces shall contain the designation "van accessible."	Stall at Dining Hall lacks van sign	Add one van parking sign to van accessible stall and ensure stall and access aisle are 11' and 5' or 8' and 8'	2015 ABAAS Section: 502.6 2012 TAS Section: 502.6 2010 ADAS Section: 502.6

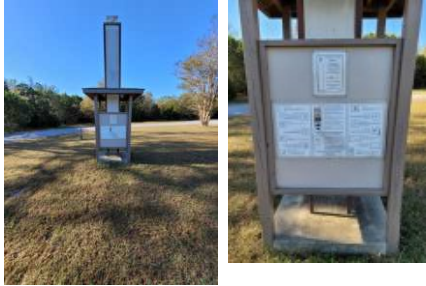
58	Exterior: Smith Visitor Center Parking	[30.1832762 , -97.724812 6]	At least one accessible route shall connect accessible buildings, accessible facilities, accessible elements, and accessible spaces that are on the same site. For areas of sport activity, an accessible route is required to connect to the boundary of each area of sport activity. The size of an area of sport activity includes only the space needed to play. Where multiple sports fields or courts are provided, an accessible route is required to each field or area of sport activity.	Lacks accessible route to Chimney Swift Tower	Provide an accessible route to each element within the site.	2010 ADAS Section: 206.2.2, 206.2

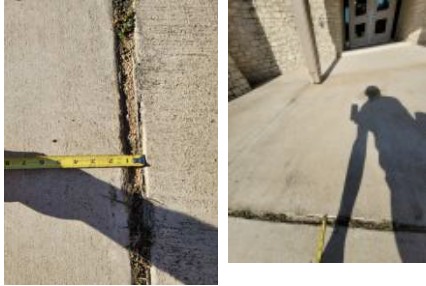
60	Exterior: Smith Visitor Center Parking	[30.183923, -97.7248427]	There is a gap spaced greater than a 1/2 inch. Openings in floor or ground surfaces shall not allow passage of a sphere more than 1/2 inch diameter. Elongated openings shall be placed so that the long dimension is perpendicular to the dominant direction of travel.	1 inch gap along route	Correct or fill gaps to be max .5"	2015 ABAAS Section: 302.3 2012 TAS Section: 302.3 2010 ADAS Section: 302.3

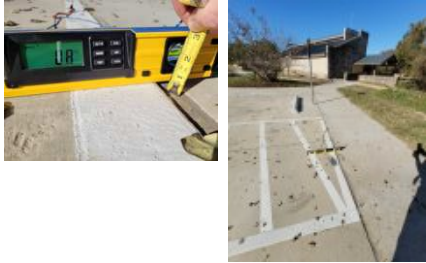
61	Exterior: Smith Visitor Center Parking	[30.1840541, -97.7246174]	The walkway contains abrupt vertical edges and/or variations over a 1/4 inch. 1/4 inch is the maximum vertical rise. Changes in level between 1/4 inch and 1/2 inch must be beveled at 1:2 or less. Changes in level greater than 1/2 inch must be by way of a ramp.	1 inch gap at access aisle to walk	Repair, bevel or ramp CIL along AR	2012 TAS Section: 303.2, 303.3 2010 ADAS Section: 303.2, 303.3

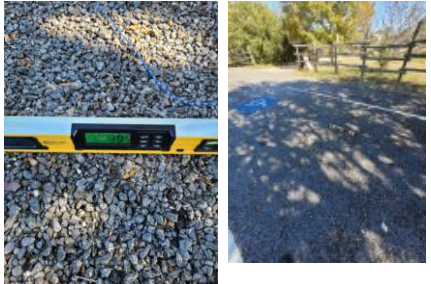
64	Exterior: Upper Falls Parking	[30.1837645 , -97.725785 3]	The cross slopes (narrow dimension) and/or running slopes (long dimension) of the access aisle exceeds 2%. The running slope and the cross slope in an accessible parking stall and the access aisle must not exceed 2%.	3% slope in parking stall	Repair or correct slope of parking space and access aisle to max 2.08% in any direction	2015 ABAAS Section: 502.4  2012 TAS Section: 502.4  2010 ADAS Section: 502.4

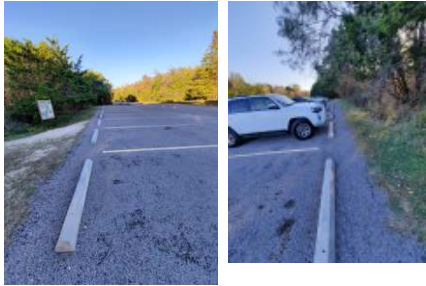
Finding Number	Area Description	Lat/Long	Finding	As Built	Recommendation	Citation	Photos	Figure																																				
70	Exterior: Picnic Trail Trailhead Parking	[30.1836988, -97.7227049]	There are no accessible parking stalls. Each lot where parking is provided for the public as clients, guests or employees, shall provide accessible parking and shall be located on the shortest accessible route of travel from adjacent parking to an accessible entrance. There are a total of (20) parking stalls in the parking lot that could be reasonably associated with this facility. There should be a minimum of (1) accessible stalls with a minimum of (1) being designed as van accessible.	20 standard, 0 accessible	Create one or more 8' accessible parking stalls, with one 5' adjacent access aisle, with proper signage and striping based on the total number of stalls	2015 ABAAS Section: F208.2  2012 TAS Section: 208.2  2010 ADAS Section: 208.2

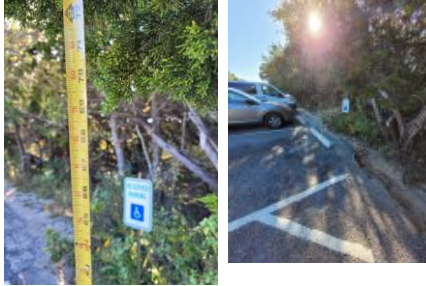
73	Exterior: Homestead Trail Trailhead Parking	[30.1859627 , -97.721558 8]	The vehicle route to the accessible parking contains vertical clearances less than 98 inches. A minimum vertical clearance of 98 inches must be provided at accessible parking spaces and along at least one vehicle access route to such spaces from site entrances and exits.	Branches at 70 inches at parking space	Raise obstructions over van stalls to provide 98" vertical clearance	2015 ABAAS Section: 502.5  2012 TAS Section: 502.5  2010 ADAS Section: 502.5

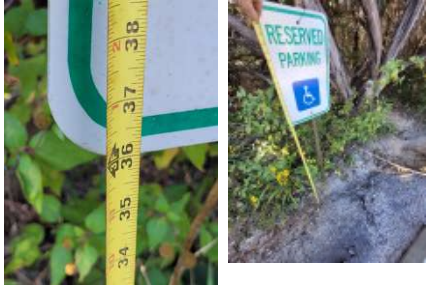
75	Exterior: Homestead Trail Trailhead Parking	[30.1859671 , -97.721567 5]	The parking sign is mounted too low. Parking space identification signs shall include the International Symbol of Accessibility complying with. Signs identifying van parking spaces shall contain the designation "van accessible." Signs shall be 60 inches minimum above the finish floor or ground surface measured to the bottom of the sign.	36 inches to bottom of sign	Raise existing accessible parking signs so lowest end of bottom sign is min 60" AGL	2015 ABAAS Section: 502.6  2012 TAS Section: 502.6  2010 ADAS Section: 502.6

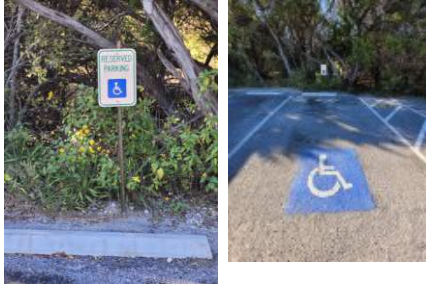
Finding Number	Area Description	Lat/Long	Finding	As Built	Recommendation	Citation	Photos	Figure
76	Exterior: Homestead Trail Trailhead Parking	[30.185966, -97.721567 5]	The van stall is missing a sign identifying it as a van accessible stall. Parking space identification signs shall include the International Symbol of Accessibility. Signs identifying van parking spaces shall contain the designation "van accessible."	Stall lacks van sign	Add one van parking sign to van accessible stall and ensure stall and access aisle are 11' and 5' or 8' and 8'	2015 ABAAS Section: 502.6  2012 TAS Section: 502.6  2010 ADAS Section: 502.6

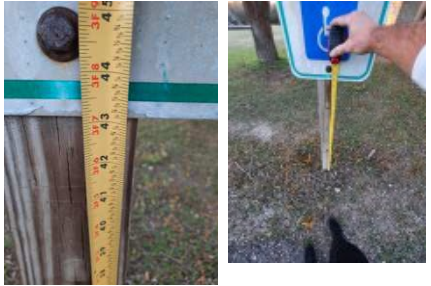
Finding Number	Area Description	Lat/Long	Finding	As Built	Recommendation	Citation	Photos	Figure
79	Exterior: Picnic Area Parking	[30.1828478 , -97.7233203]	The parking sign is mounted too low. Parking space identification signs shall include the International Symbol of Accessibility complying with. Signs identifying van parking spaces shall contain the designation "van accessible." Signs shall be 60 inches minimum above the finish floor or ground surface measured to the bottom of the sign.	Bottom edge of lowest parking sign is 43" AGL	Raise existing accessible parking signs so lowest end of bottom sign is min 60" AGL	2015 ABAAS Section: 502.6 2012 TAS Section: 502.6 2010 ADAS Section: 502.6

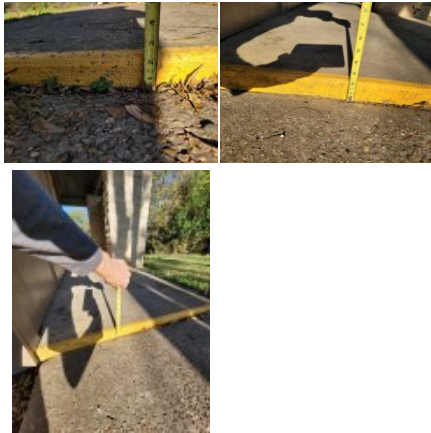
81	Exterior: Picnic Area Parking	[30.1829428 , -97.7233078]	The walkway contains abrupt vertical edges and/or variations over a 1/4 inch. 1/4 inch is the maximum vertical rise. Changes in level between 1/4 inch and 1/2 inch must be beveled at 1:2 or less. Changes in level greater than 1/2 inch must be by way of a ramp.	2" CIL toward women's and men's restroom	Repair, bevel or ramp CIL along AR.	2012 TAS Section: 303.2, 303.3 2010 ADAS Section: 303.2, 303.3

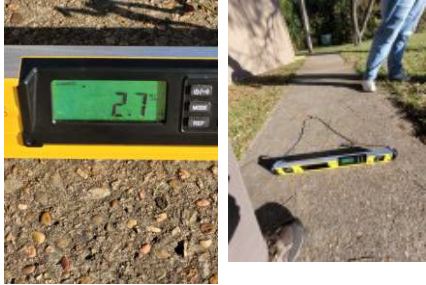
Finding Number	Area Description	Lat/Long	Finding	As Built	Recommendation	Citation	Photos	Figure
82	Exterior: Picnic Area Parking	[30.1829289 , -97.7233017]	The accessible route of travel on the accessible route contains cross slopes greater than 2%. Cross slopes shall not exceed one unit vertical in 48 units horizontal (2-percent slope).	2.7% slope along route toward men's restroom	Correct or repair cross slope along AR to max 2.08%	2015 ABAAS Section: 403.3  2012 TAS Section: 403.3  2010 ADAS Section: 403.3

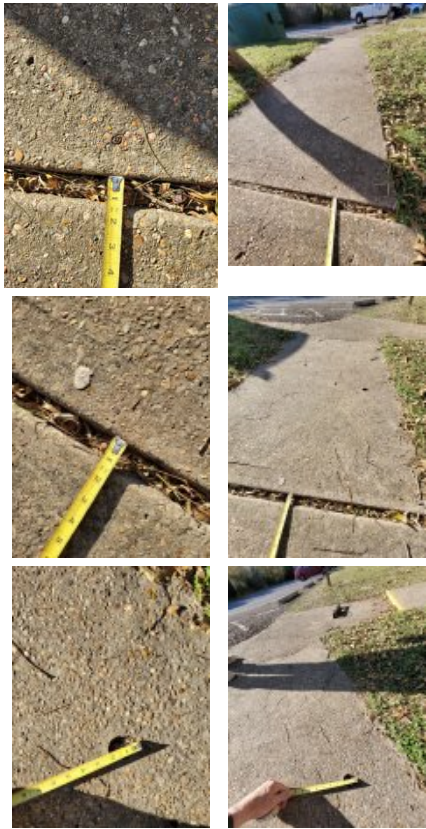
83	Exterior: Picnic Area Parking	[30.1828764 , -97.7233199], [30.1829002 , -97.7233058]	There is a gap spaced greater than a 1/2 inch. Openings in floor or ground surfaces shall not allow passage of a sphere more than 1/2 inch diameter. Elongated openings shall be placed so that the long dimension is perpendicular to the dominant direction of travel.	Two 1.25 inch gaps along route toward women's and men's restroom, 2 inch toward men's restroom	Correct or fill gaps to be max .5"	2015 ABAAS Section: 302.3  2012 TAS Section: 302.3  2010 ADAS Section: 302.3

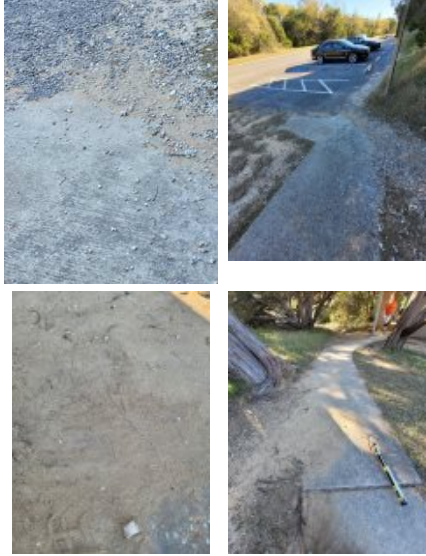
89	Exterior: Lower Falls Restroom Parking	[30.1848172, -97.7222068], [30.1851008, -97.7221733]	The accessible route contains loose gravel and/or surfaces that do not provide for a stable, firm slip resistant surface.	Loose gravel on accessible route from parking to restroom, sand on route,	Resurface AR where deterioration occurs	2015 ABAAS Section: 302.1 2012 TAS Section: 302.1 2010 ADAS Section: 302.1

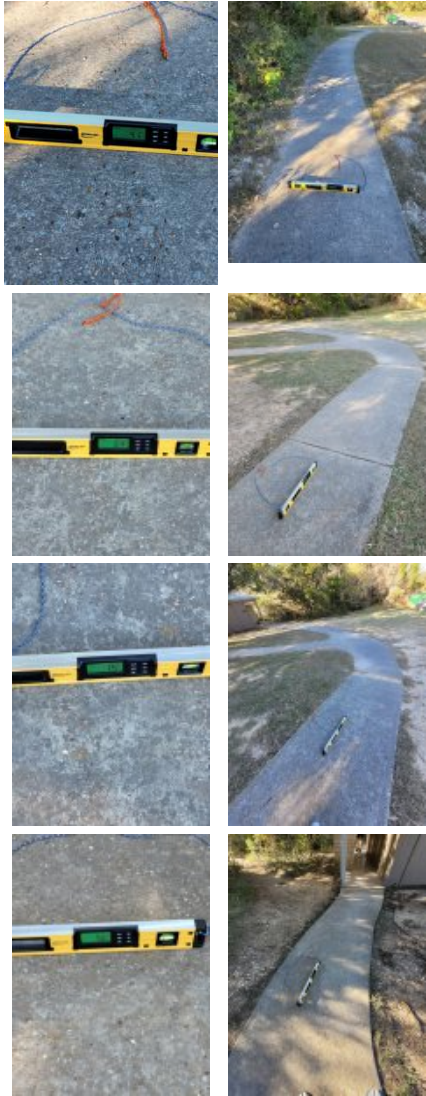
Finding Number	Area Description	Lat/Long	Finding	As Built	Recommendation	Citation	Photos	Figure
90	Exterior: Lower Falls Restroom Parking	[30.1848516, -97.7221887], [30.1851082, -97.7221914]	The accessible route of travel contains cross slopes greater than 2%. Cross slopes shall not exceed one unit vertical in 48 units horizontal (2-percent slope).	Cross slope along route: 4.1% at large rocks and green dumpster and 3% at restrooms.	Correct or repair cross slope along AR to max 2.08%.	2015 ABAAS Section: 403.3 2012 TAS Section: 403.3 2010 ADAS Section: 403.3

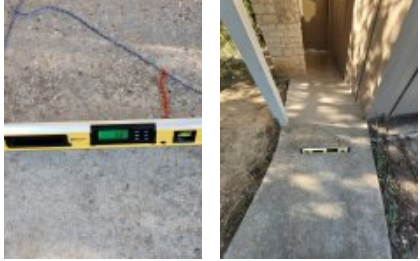
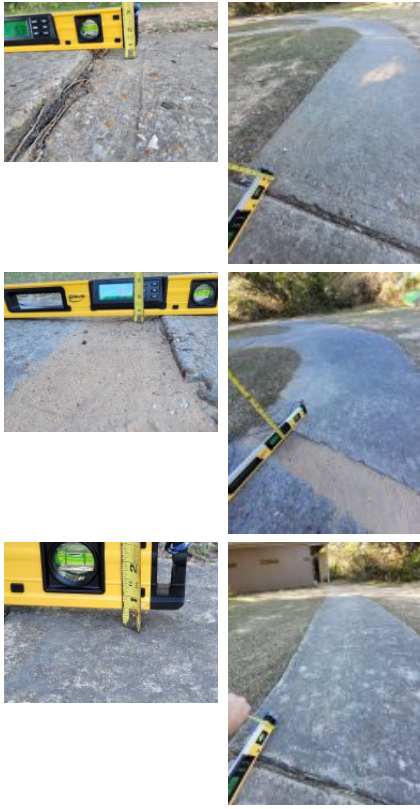
91	Exterior: Lower Falls Restroom Parking	[30.1850058, -97.7221331], [30.1851025, -97.7221941]	Changes in level greater than ½ inch (13 mm) high shall be ramped, and shall comply with 405 or 406.	Changes in Level: two at .75", two at .5", 1.5", and 1"	Repair, bevel, or ramp CIL along AR	2015 ABAAS Section: 303.4 2012 TAS Section: 303.4 2010 ADAS Section: 303.4

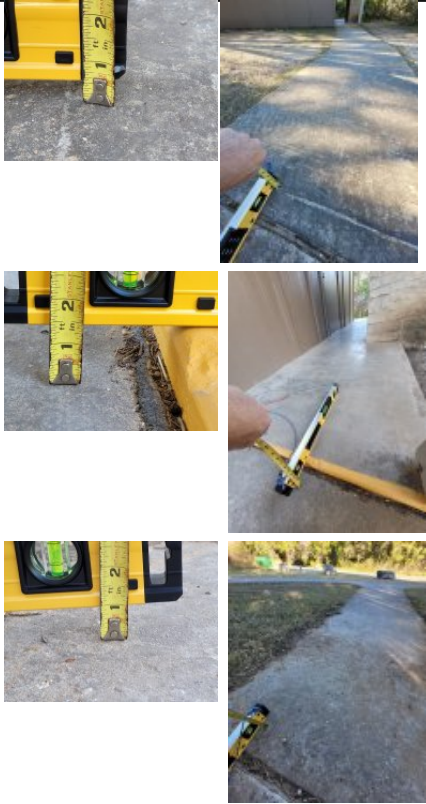
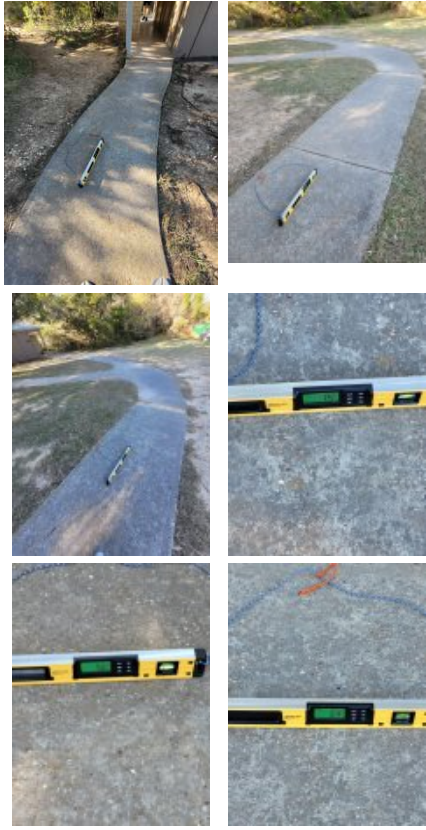
Finding Number	Area Description	Lat/Long	Finding	As Built	Recommendation	Citation	Photos	Figure
92	Exterior: Lower Falls Restroom Parking	[30.1849888, -97.7221475], [30.1851101, -97.7222038]	The running slope of walking surfaces shall not be steeper than 1:20.	Running slope along route: 6.4% and 7.5% at curve path intersection, and 5.6% approaching restrooms	Correct running slope along the AR to max 5%	2015 ABAAS Section: 403.3  2012 TAS Section: 403.3  2010 ADAS Section: 403.3

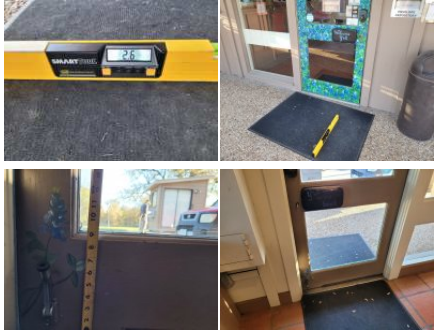
96	Headquarters: Headquarters Building	[30.18079, -97.722023 6]	Minimum maneuvering clearances at doors and gates shall comply with 404.2.4. and floor and ground surfaces shall comply with 402.4.4. Maneuvering clearances shall extend the full width of the doorway and the required latch side or hinge side clearance. The bottom 10 inches on the push side must be smooth and free of obstructions (hold open devices). Opening hardware must be mounted between 30 and 44 inches above the floor or ground.	HQ entry - 2.6% slope, glass starts at 9" AFF	For all doors along the public circulation route, provide required maneuvering clearance and floor and ground slope on push and pull side of doors For all doors along the public circulation route, provide kick plate on push side of door from floor to 10" AFF	2010 ADAS Section: 404.2.3, 404.2.7, 404.2.4, 404.2.11, 404.2.11 Exception

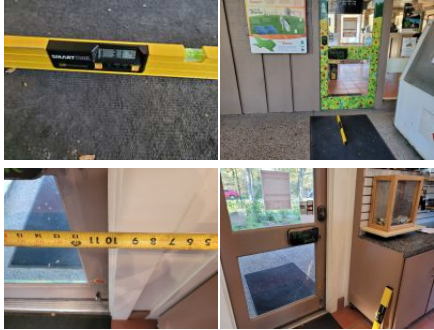
Finding Number	Area Description	Lat/Long	Finding	As Built	Recommendation	Citation	Photos	Figure
97	Headquarters: Headquarters Building	[30.1808113 , -97.7220263]	Minimum maneuvering clearances at doors and gates shall comply with 404.2.4. and floor and ground slope per 402.4.4. Maneuvering clearances and floor and ground slope shall extend the full width of the doorway and the required latch side or hinge side clearance. The sweep period for doors with closers shall be adjusted so that from an open position of 70 degrees, the door will take at least 3 seconds to move to a point 3 inches from the latch, measured to the leading edge of the door. Exterior doors are recommended to be maintained at 8.5 lbf as a smart practice. Force is to be measured at the operating hardware or 30 inches from the hinges, whichever is greater. The bottom 10 inches on the push side must be smooth and free of obstructions (hold open devices). Opening hardware must be mounted between 30 and 44 inches above the floor or ground.	Back entry- 12#, closes fast, glass starts at 9", 3.1%, counter, 10.25" push side	For all doors along the public circulation route, provide required maneuvering clearance and floor and ground slope on push and pull side of doors For all doors along the public circulation route, inspect, adjust, and maintain closing speed on door closers For all doors along the public circulation route, inspect, adjust, and maintain 8.5 lbf to open exterior doors as a smart practice For all doors along the public circulation route, provide kick plate on push side of door from floor to 10" AFF	2010 ADAS Section: 404.2.3, 404.2.7, 404.2.4, 404.2.11, 404.2.11 Exception

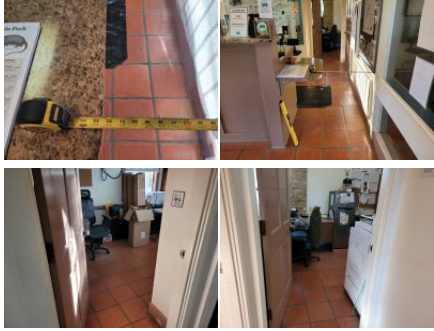
98	Headquarters: Headquarters Building	[30.1807813 , -97.7220134]	Spaces and elements within employee work areas shall only be required to comply with 206.2.8, 207.1, and 215.3 and shall be designed and constructed so that individuals with disabilities can approach, enter, and exit the employee work area. Employee work areas, or portions of employee work areas, other than raised courtroom stations, that are less than 300 square feet (28 m2) and elevated 7 inches (180 mm) or more above the finish floor or ground where the elevation is essential to the function of the space shall not be required to comply with these requirements or to be on an accessible route.	22.5" to enter, office doors (2) have knobs and lack pull side clearance	For employee spaces, relocate storage, furniture, and other obstacles at doorways to provide approach, enter and exit at the employee space. For all doors along the public circulation route, replace hardware with lever hardware where indicated Remove existing service shelf Lower 36" wide segment of service counter to max 36" AFF	2015 ABAAS Section: F203.9 2012 TAS Section: 203.9 2010 ADAS Section: 203.9

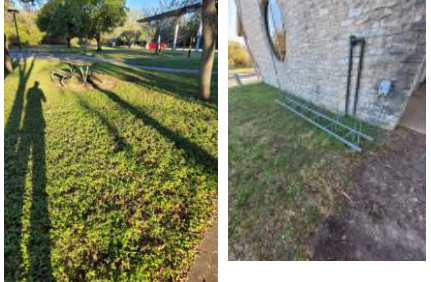
104	Headquarters: Headquarters Building	[30.1807437 , -97.7221225], [30.1808011 , -97.7220552]	At least one accessible route shall connect accessible buildings, accessible facilities, accessible elements, and accessible spaces that are on the same site. For areas of sport activity, an accessible route is required to connect to the boundary of each area of sport activity. The size of an area of sport activity includes only the space needed to play. Where multiple sports fields or courts are provided, an accessible route is required to each field or area of sport activity.	Picnic table and bike rack lack accessible route	Provide an accessible route to each element within the site.	2010 ADAS Section: 206.2.2, 206.2

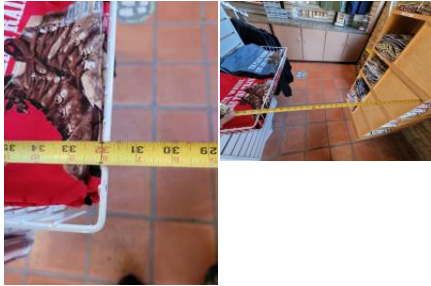
Finding Number	Area Description	Lat/Long	Finding	As Built	Recommendation	Citation	Photos	Figure
108	Headquarters: Headquarters Building	[30.1807961 , -97.722021 5]	The route of travel at this location does not provide a minimum width of 36 inches. The clear width shall be permitted to be reduced to 32 inches minimum for a length of 24 inches maximum provided that reduced width segments are separated by segments that are 48 inches long minimum and 36 inches wide minimum.	Racks reduce width to 32"	Relocate merchandise to widen AR to compliant 36" clear width	2015 ABAAS Section: 403.5.1  2012 TAS Section: 403.5.1  2010 ADAS Section: 403.5.1

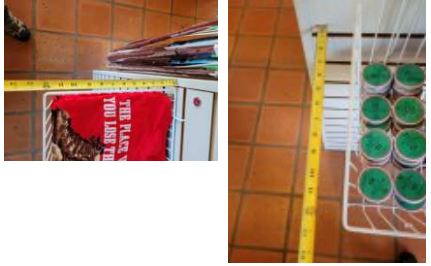
109	Headquarters: Headquarters Building	[30.1807862 , -97.722012 1]	The rack projects more than 4 inches into the circulation path. Wall-mounted objects that have leading edges between 27 inches and 80 inches from the floor must not project more than 4 inches into the circulation path. Protruding objects that extend to the floor or within 27 inches of the floor are cane detectable and are therefore not hazardous. Where it is necessary or desirable to have objects protrude from the wall, a manner of cane detection must be provided.	Two racks project 12"	Relocate protruding objects or place cane detectable warning or bollard at foot of item	2015 ABAAS Section: 307.2  2012 TAS Section: 307.2  2010 ADAS Section: 307.2

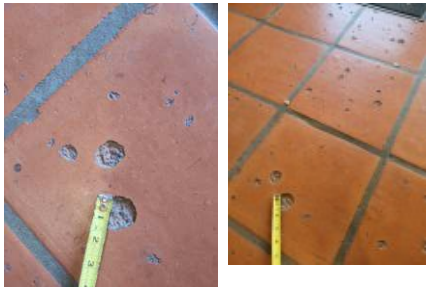
110	Headquarters: Headquarters Building	[30.1807993 , -97.722016 1]	Openings in floor or ground surfaces shall not allow passage of a sphere more than 1/2 inch (13 mm) diameter except as allowed in 407.4.3, 409.4.3, 410.4, 810.5.3 and 810.10. Elongated openings shall be placed so that the long dimension is perpendicular to the dominant direction of travel.	1" to 1.5" gaps	Fill and maintain gaps to max .5"	2015 ABAAS Section: 302.3  2012 TAS Section: 302.3  2010 ADAS Section: 302.3

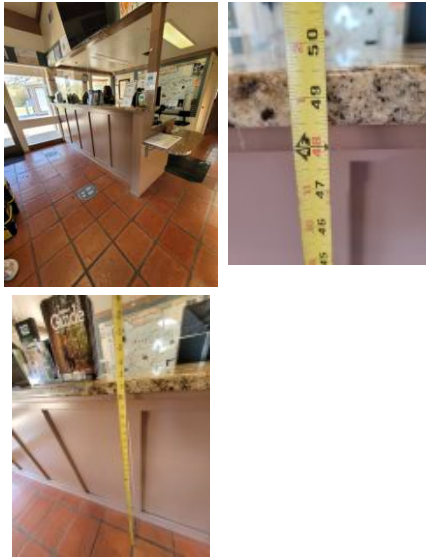
112	Headquarters: Headquarters Building	[30.1807862 , -97.7220134]	The top of the work surface is not within a compliant height range. The tops of tables and counters shall be 28 inches to 34 inches from the floor or ground.	49.5" high counter lacks knee space	Provide tables and work surfaces at 28" to 34" AFF with required knee and toe clearances. Cost included in separate finding	2015 ABAAS Section: 902.3 2012 TAS Section: 902.3 2010 ADAS Section: 902.3

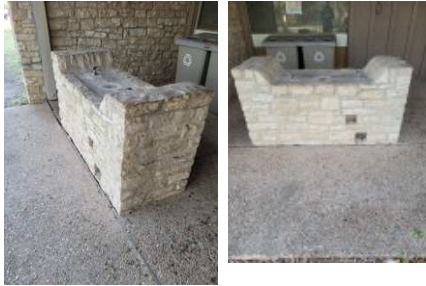
Finding Number	Area Description	Lat/Long	Finding	As Built	Recommendation	Citation	Photos	Figure
114	Headquarters: Headquarters Building	[30.1807665, -97.7220097]	There is not enough knee clearance under the drinking fountain. The drinking fountain must have a clear knee space between the bottom of the apron and the floor not less than 27 inches in height, 30 inches in width, and 8 inches in depth.	Drinking fountain does not have knee clearance	Replace drinking fountain with a hi-lo bowl fountain	2015 ABAAS Section: 602.2 2012 TAS Section: 602.2 2010 ADAS Section: 602.2

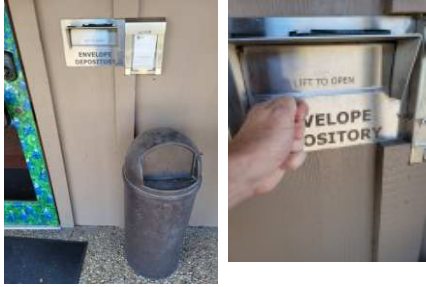
116	Headquarters: Headquarters Building	[30.1808074, -97.7220478]	The lid is not accessible because it requires tight grasping, pinching or twisting of the wrist.	Envelope depository lid requires tight pinch	Replace lid with an operable part usable without a tight pinch or grasp	2015 ABAAS Section: 309.4 2012 TAS Section: 309.4 2010 ADAS Section: 309.4

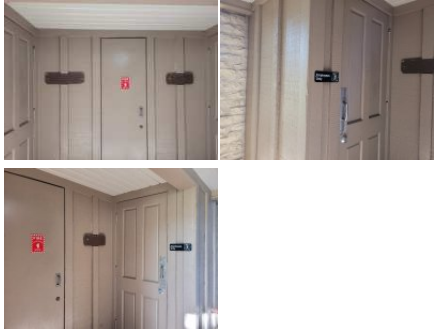
Finding Number	Area Description	Lat/Long	Finding	As Built	Recommendation	Citation	Photos	Figure
118	Headquarters: Headquarters Staff Restrooms	[30.18076, -97.722]	The restroom sign does not comply with one or more applicable requirements for the location, height, and properties of the sign.	Sign lacks Braille and raised characters	Acquire and mount signage, including Braille and access symbol mounted on wall, latch side of door, 48" to baseline of lowest character and 60" to baseline of highest character	2015 ABAAS Section: F216.2, 703.1, 703.2, 703.5, 703.6  2012 TAS Section: 216.2, 703.1, 703.2, 703.5, 703.6  2010 ADAS Section: 216.2, 703.1, 703.2, 703.5, 703.6

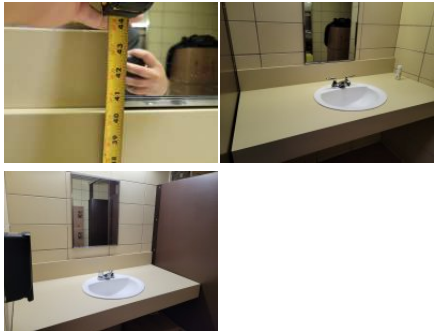
119	Headquarters: Headquarters Staff Restrooms	[30.18076, -97.722]	The mirror is mounted too high. Mirrors must have the bottom edge of the reflecting surface a maximum of 40 inches above the floor if above a sink or counter. Mirrors not located above lavatories or countertops shall be installed with the bottom edge of the reflecting surface 35 inches maximum above the finish floor or ground.	41" to bottom of mirror	Lower mirror so reflective surface is max 40" AFF	2015 ABAAS Section: 603.3  2012 TAS Section: 603.3  2010 ADAS Section: 603.3

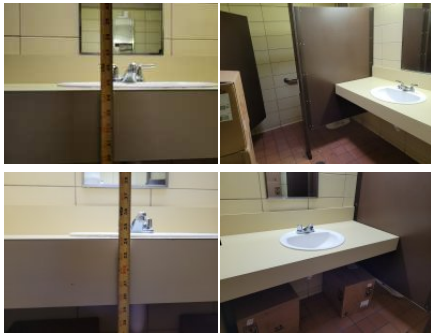
121	Headquarters: Headquarters Staff Restrooms	[30.18076, -97.722]	The top rim of the sink is too high. All lavatories/sinks that are designated to be accessible shall be a minimum 17 inches in horizontal depth and mounted with the rim or counter edge no higher than 34 inches above the finished floor.	Top of rim, 1 at 35", 1 at 34.5"	Lower sinks to max 34" AFF to front of rim	2015 ABAAS Section: 606.3  2012 TAS Section: 606.3  2010 ADAS Section: 606.3

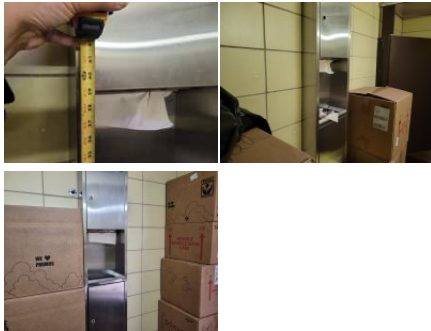
123	Headquarters: Headquarters Staff Restrooms	[30.18076, -97.722]	Where a high forward reach is over an obstruction, the clear floor space shall extend beneath the element for a distance not less than the required reach depth over the obstruction. The high forward reach shall be 48 inches (1220 mm) maximum where the reach depth is 20 inches (510 mm) maximum. Where the reach depth exceeds 20 inches (510 mm), the high forward reach shall be 44 inches (1120 mm) maximum and the reach depth shall be 25 inches (635 mm) maximum. Where a clear floor or ground space allows a parallel approach to an element and the high side reach is over an obstruction, the height of the obstruction shall be 34 inches (865 mm) maximum and the depth of the obstruction shall be 24 inches (610 mm) maximum. The high side reach shall be 48 inches (1220 mm) maximum for a reach depth of 10 inches (255 mm) maximum. Where the reach depth exceeds 10 inches (255 mm), the high side reach shall be 46 inches (1170 mm) maximum for a reach depth of 24 inches (610 mm) maximum.	Paper towels 59" AFF	Lower operating mechanisms in restroom to max 48" AFF to highest operable part.	2015 ABAAS Section: 308.2.1, 308.3.2  2012 TAS Section: 308.2.1, 308.3.2  2010 ADAS Section: 308.2.1, 308.3.2

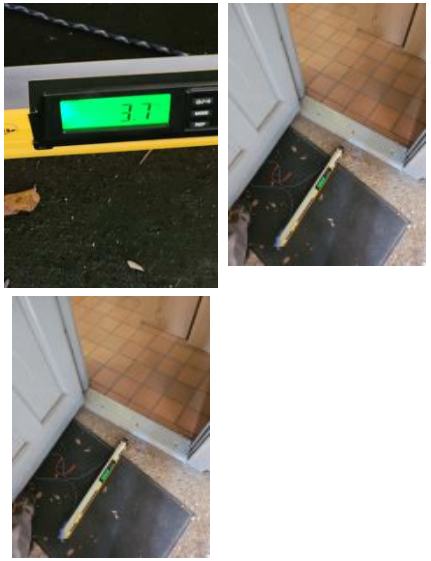
131	Headquarters: Headquarters Staff Restrooms	[30.1807707 , -97.721989 7]	The landing at the door does not have a compliant landing. Doors with an approach from the hinge side must have a landing on the pull side that is a minimum of 60 inches in depth perpendicular to the door in a close position by a minimum width dimension of 36 inches plus the door width. The additional 36 inches must extend past the door on the latch side. The entire landing must be free of obstructions and must be flat (2% max. slope is considered flat in any direction).	Right restroom- 3.7% slope at exterior side of door	Correct or repair landing slope at maneuvering clearance on pull side of door to max 2.08%	2015 ABAAS Section: 404.2.4.1  2012 TAS Section: 404.2.4.1  2010 ADAS Section: 404.2.4.1

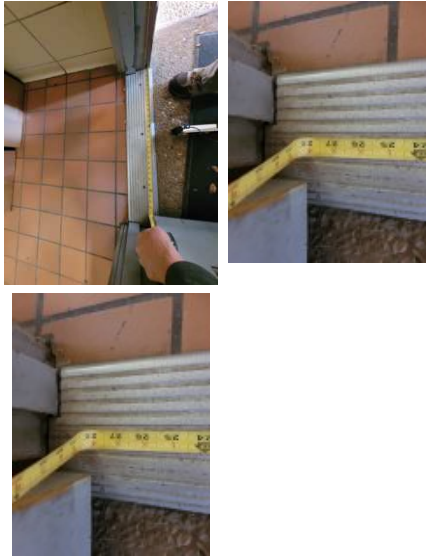
Finding Number	Area Description	Lat/Long	Finding	As Built	Recommendation	Citation	Photos	Figure
132	Headquarters: Headquarters Staff Restrooms	[30.180774, -97.722001 7]	The door opening does not provide at least 32 inches between the face of the door and the opposite stop. Door openings shall provide a clear width of 32 inches minimum. Clear openings of doorways with swinging doors shall be measured between the face of the door and the stop, with the door open 90 degrees. There shall be no projections into the required clear opening width lower than 34 inches above the finish floor or ground. Projections into the clear opening width between 34 inches and 80 inches above the finish floor or ground shall not exceed 4 inches.	Right restroom- 28" wide door	Replace door with one having 32" clear width	2015 ABAAS Section: 404.2.3  2012 TAS Section: 404.2.3  2010 ADAS Section: 404.2.3

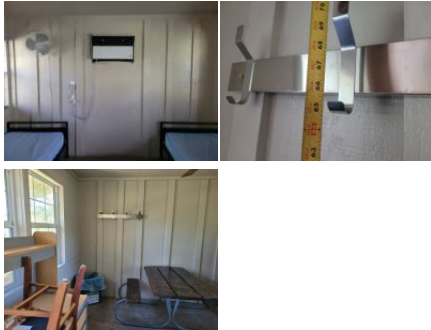
Finding Number	Area Description	Lat/Long	Finding	As Built	Recommendation	Citation	Photos	Figure
136	Cabin Area: Cabin Area - Cabin 6	[30.1787486 , -97.728670 7]	The A/C and hooks are positioned too high for either a side or front approach. Where a clear floor or ground space allows a parallel approach to an element and the side reach is unobstructed, the high side reach shall be 48 inches maximum and the low side reach shall be 15 inches minimum above the finish floor or ground. Where a forward reach is unobstructed, the high forward reach shall be 48 inches maximum and the low forward reach shall be 15 inches minimum above the finish floor or ground.	A/C high, hooks high	Remount operable parts to be in reach range of 15" min to 48" max	2015 ABAAS Section: 308.1  2012 TAS Section: 308.1  2010 ADAS Section: 308.1

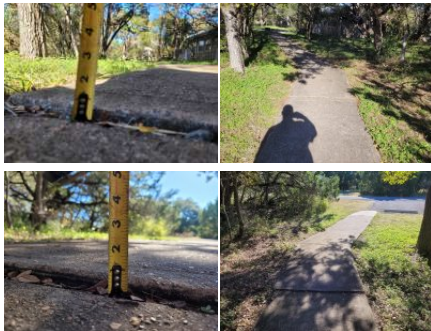
139	Cabin Area: Cabin Area - Cabin 6	[30.1786095 , -97.72888 13], [30.1786999 , -97.728714 4]	The walkway contains abrupt vertical edges and/or variations over a 1/4 inch. 1/4 inch is the maximum vertical rise. Changes in level between 1/4 inch and 1/2 inch must be beveled at 1:2 or less. Changes in level greater than 1/2 inch must be by way of a ramp.	Route has two .75" CILs between cabin and parking area	Repair, bevel or ramp change in level along accessible route.	2012 TAAS Section: 303.2, 303.3  2010 ADAS Section: 303.2, 303.3

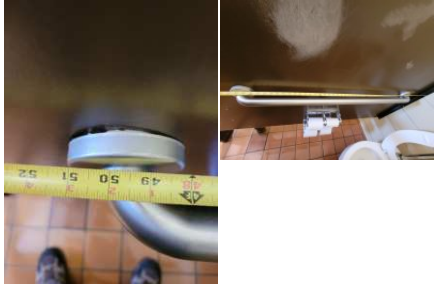
Finding Number	Area Description	Lat/Long	Finding	As Built	Recommendation	Citation	Photos	Figure
151	Cabin Area: Cabin Area Men's Restroom	[30.1783507 , -97.728971 1]	The side grab bars are not in the correct location. Grab bars on the side wall must be installed so that the end closest to the rear wall is maximum 12" from the rear wall. The end furthest from the rear wall must be mounted minimum 54" from the rear wall.	Edge of grab bar 50" to face of wall	Remount side grab bar to max 12" from the rear wall at the close end and min 54" on the far end, and 33" to 36" AFF	2015 ABAAS Section: 604.5.1  2012 TAS Section: 604.5.1  2010 ADAS Section: 604.5.1

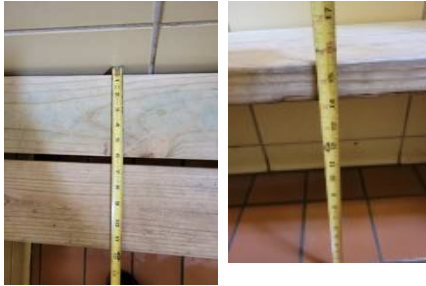
Finding Number	Area Description	Lat/Long	Finding	As Built	Recommendation	Citation	Photos	Figure
165	Cabin Area: Cabin Area Men's Shower	[30.1783422 , -97.728965 7]	The bench is not deep enough or long enough or is missing. Benches shall be provided having seats that are 42 inches long minimum and 20 inches deep minimum and 24 inches deep maximum. The bench shall provide for back support or shall be affixed to a wall. Back support shall be 42 inches (1065 mm) long minimum and shall extend from a point 2 inches (51 mm) maximum above the seat surface to a point 18 inches (455 mm) minimum above the seat surface. Back support shall be 2½ inches (64 mm) maximum from the rear edge of the seat measured horizontally. The top of the bench seat surface shall be 17 inches (430 mm) minimum and 19 inches (485 mm) maximum above the finish floor or ground.	Bench, 12" deep, 15.5" high	Replace bench in dressing area with one having a seat depth of 20" to 24" deep, 42" long, affixed to the wall or having a back and mounted 17" to 19" AFF	2012 TAS Section: 903.4, 903.2, 903.3, 903.5  2010 ADAS Section: 903.4, 903.2, 903.3, 903.5

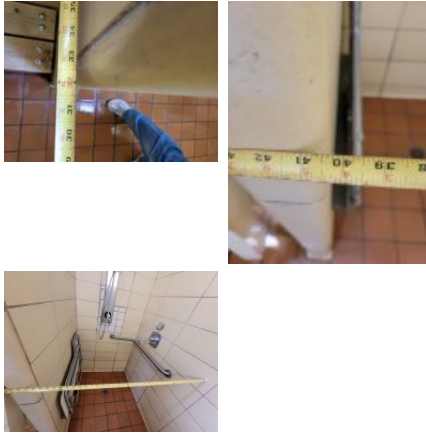
166	Cabin Area: Cabin Area Men's Shower	[30.1783556 , -97.728973 7]	Alternate roll-in type shower compartments shall be 36 inches (915 mm) wide and 60 inches (1525 mm) deep minimum clear inside dimensions measured at center points of opposing sides. A 36 inch (915 mm) wide minimum entry shall be provided at one end of the long side of the compartment.	32" wide opening, 49.5" wide compartment	Correct shower stall, if feasible, to compliant dimensions for an alternate roll in shower of 36" deep by 60" wide with a 36" opening on the long dimension	2015 ABAAS Section: 608.2.3  2012 TAS Section: 608.2.3  2010 ADAS Section: 608.2.3

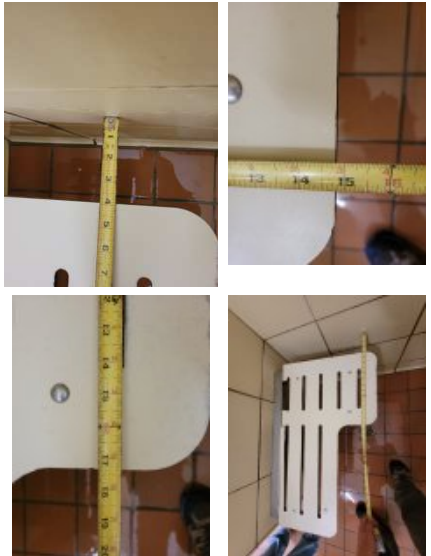
171	Cabin Area: Cabin Area Men's Shower	[30.1783465 , -97.728971 1]	The shower seat does not have a compliant space between it and the wall. The folding seat must be mounted 17-19 inches above the floor, and have a maximum space of 1-1/2 inches between the edge of the seat and the side wall and 2-1/2 inches maximum to the seat wall.	4" gap, 14.75" seat dimension, 17" dimension	Remount shower seat to the correct location and height in the shower. Cost included in previous finding	2015 ABAAS Section: 610.3.2  2012 TAS Section: 610.3.2  2010 ADAS Section: 610.3.2

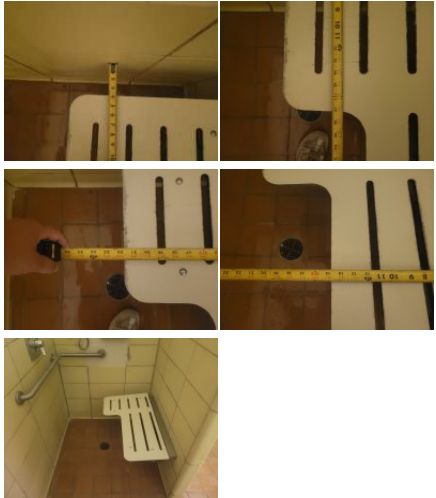
Finding Number	Area Description	Lat/Long	Finding	As Built	Recommendation	Citation	Photos	Figure
179	Cabin Area: Cabin Area Women's Shower	[30.1783433 , -97.728987 2]	The shower seat does not have a compliant space between it and the wall. The folding seat must be mounted 17-19 inches above the floor, and have a maximum space of 1-1/2 inches between the edge of the seat and the side wall and 2-1/2 inches maximum to the seat wall.	Multiple dimensions fail	Remount shower seat to the correct location and height in the shower	2015 ABAAS Section: 610.3.2  2012 TAS Section: 610.3.2  2010 ADAS Section: 610.3.2

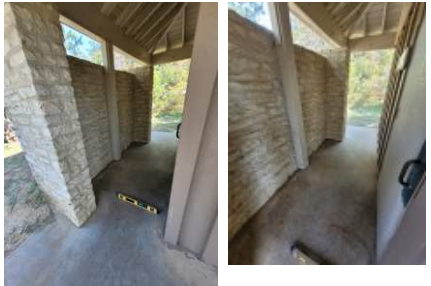
183	Big Cedar/Moss Loop Camping Areas: Big Cedar Camping Area Men's Restroom	[30.1753231 , -97.726853 5]	Minimum maneuvering clearances at doors and gates shall comply with 404.2.4. Maneuvering clearances shall extend the full width of the doorway and the required latch side or hinge side clearance.	Masonry and column restrict maneuvering clearance	Provide required maneuvering clearance around pull side of door	2015 ABAAS Section: 404.2.4.1 , 404.2.4.4  2012 TAS Section: 404.2.4.4, 404.2.4.1  2010 ADAS Section: 404.2.4.4, 404.2.4.1

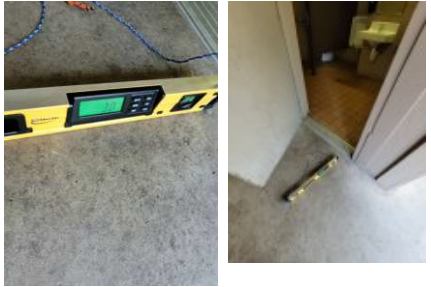
184	Big Cedar/Moss Loop Camping Areas: Big Cedar Camping Area Men's Restroom	[30.1753315 , -97.726848 1]	The landing at the door does not have a compliant landing. Doors with an approach from the hinge side must have a landing on the pull side that is a minimum of 60 inches in depth perpendicular to the door in a close position by a minimum width dimension of 36 inches plus the door width. The additional 36 inches must extend past the door on the latch side. The entire landing must be free of obstructions and must be flat (2% max. slope is considered flat in any direction).	3% slope at door CFS	For all doors along the public circulation route, correct or repair slope at doorway landing to max 2.08% in any direction for level CFS	2015 ABAAS Section: 404.2.4.1  2012 TAS Section: 404.2.4.1  2010 ADAS Section: 404.2.4.1

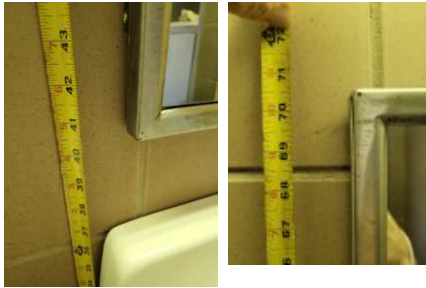
186	Big Cedar/Moss Loop Camping Areas: Big Cedar Camping Area Men's Restroom	[30.1753248 , -97.726850 8]	The mirror is mounted too high. Mirrors must have the bottom edge of the reflecting surface a maximum of 40 inches above the floor if above a sink or counter. Mirrors not located above lavatories or countertops shall be installed with the bottom edge of the reflecting surface 35 inches maximum above the finish floor or ground.	Mirror, 41" to bottom, 70" to top	Lower mirror so reflective surface is max 40" AFF	2015 ABAAS Section: 603.3  2012 TAS Section: 603.3  2010 ADAS Section: 603.3

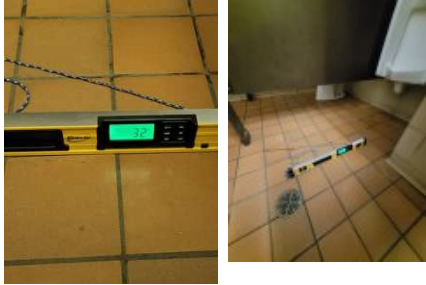
Finding Number	Area Description	Lat/Long	Finding	As Built	Recommendation	Citation	Photos	Figure
193	Big Cedar/Moss Loop Camping Areas: Big Cedar Camping Area Men's Restroom	[30.1753222 , -97.726853 5]	The accessible route contains running slopes greater than 5 percent and cross slopes greater than 2 percent across the width of the walk and has not been constructed as a ramp (i.e. handrails, wheel guides, etc.). When the slope in the direction of travel of any walk exceeds 1 unit vertical in 20 units horizontal (5-percent slope), it must be constructed as ramp. Surface cross slopes must not exceed one unit vertical in 48 units. Horizontal (2-percent slope).	3.2% slope near floor drain	Correct or repair slope to max 5% running and 2.08% cross	2015 ABAAS Section: 403.3  2012 TAS Section: 403.3  2010 ADAS Section: 403.3

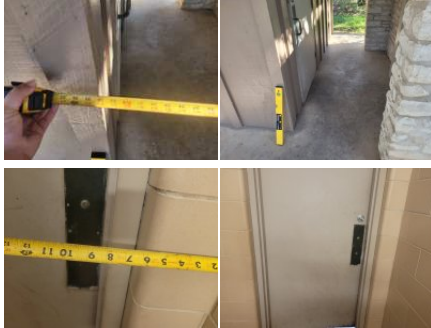
194	Big Cedar/Moss Loop Camping Areas: Big Cedar Camping Area Women's Restroom	[30.1753218 , -97.726856 1]	Minimum maneuvering clearances at doors and gates shall comply with 404.2.4. Maneuvering clearances shall extend the full width of the doorway and the required latch side or hinge side clearance. The sweep period for doors with closers shall be adjusted so that from an open position of 70 degrees, the door will take at least 3 seconds to move to a point 3 inches from the latch, measured to the leading edge of the door. Exterior doors are recommended to be maintained at 8.5 lbf as a smart practice. Force is to be measured at the operating hardware or 30 inches from the hinges, whichever is greater.	Women's RR- 34" to stone wall within latch side clearance on pull side, 8" to wall push side, 17#, closes fast	For all doors along the public circulation route, provide required maneuvering clearance on push and pull side of doors For all doors along the public circulation route, inspect, adjust, and maintain closing speed on door closers For all doors along the public circulation route, inspect, adjust, and maintain 8.5 #f to open exterior doors as a smart practice	2010 ADAS Section: 404.2.3, 404.2.7, 404.2.4, 404.2.11, 404.2.11 Exception

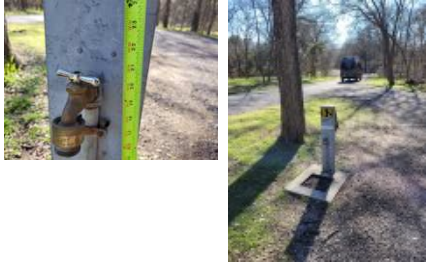
206	Big Cedar/Moss Loop Camping Areas: Big Cedar Campsite	[30.1770062 , -97.7269232]	Water spouts at water hydrants and water utility hook-ups shall be 28 inches (710 mm) minimum and 36 inches (915 mm) maximum above the ground	Spigot 21" AFF	Remount water spouts to 28" min or 36" max above the ground as a smart practice	2015 ABAAS Section: 1011.6

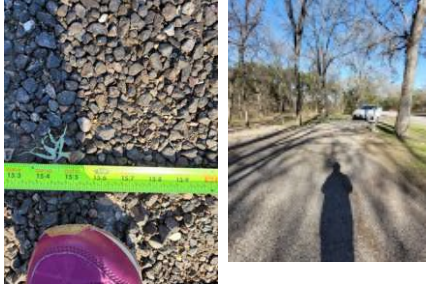
208	Big Cedar/Moss Loop Camping Areas: Big Cedar Campsite	[30.1770108 , -97.726895]	Parking spaces and pull-up spaces for recreational vehicles shall be 20 feet (6100 mm) wide minimum. EXCEPTION: Where two adjacent parking spaces are provided for recreational vehicles, one parking space shall be permitted to be 16 feet (4880 mm) wide minimum.	Site 52, RV - 13' width	Correct RV parking space to be 20' wide minimum; or 16' for two adjacent spaces as a smart practice.	2015 ABAAS Section: 1012.2, 1012.2 EXCEPTION

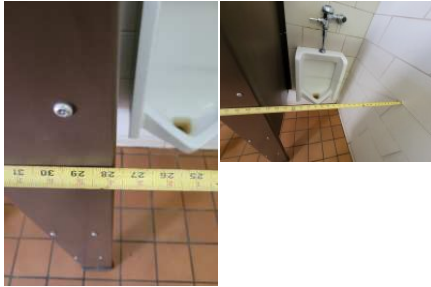
214	Grapevine Loop Camping Area: Grapevine Loop Camping Men's Restroom	[30.1770568 , -97.726243 3]	The urinal is located in an area that does not provide the required clear floor space for a front approach. The surrounding elements of a urinal must provide a minimum of 30 by 48 inches of clear floor space for a front approach.	27" width at urinal	Relocate privacy wall at urinal to provide 30" CFS	2015 ABAAS Section: 605.2  2012 TAS Section: 605.2  2010 ADAS Section: 605.2

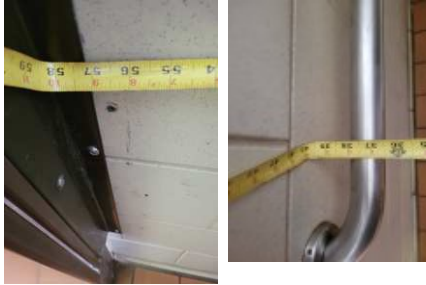
Finding Number	Area Description	Lat/Long	Finding	As Built	Recommendation	Citation	Photos	Figure
218	Grapevine Loop Camping Area: Grapevine Loop Camping Men's Restroom	[30.1770631 , -97.726224 5]	The ambulatory stall is not between 35" to 37" wide and 60" deep.	Stall 58" deep, 40" wide	Correct ambulatory stall to be 35" to 37" wide and minimum 60" deep	2015 ABAAS Section: 604.8.2.1  2012 TAS Section: 604.8.2.1  2010 ADAS Section: 604.8.2.1

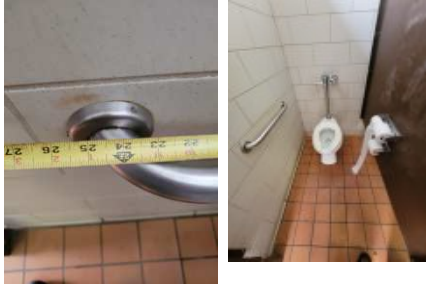
Finding Number	Area Description	Lat/Long	Finding	As Built	Recommendation	Citation	Photos	Figure
220	Grapevine Loop Camping Area: Grapevine Loop Camping Men's Restroom	[30.1770688 , -97.726239 2]	Grab bars shall comply with 609. A side-wall grab bar complying with 604.5.1 shall be provided on both sides of the compartment. The space between the wall and the grab bar shall be 1½ inches (38 mm). The space between the grab bar and projecting objects below and at the ends shall be 1½ inches (38 mm) minimum. The space between the grab bar and projecting objects above shall be 12 inches (305 mm) minimum. Grab bars shall be installed in a horizontal position, 33 inches (840 mm) minimum and 36 inches (915 mm) maximum above the finish floor measured to the top of the gripping surface, except that at water closets for children's use complying with 604.9, grab bars shall be installed in a horizontal position 18 inches (455 mm) minimum and 27 inches (685 mm) max	Only one 24" long bar provided in the stall	Replace or add side grab bars with a 42" long grab bar, mounted max 12" from the rear wall at the close end and min 54" on the far end and 33" to 36" AFF	2015 ABAAS Section: 604.8.2.3, 609.3, 609.4  2012 TAS Section: 609.4, 609.3, 604.8.2.3  2010 ADAS Section: 609.3, 609.4, 604.8.2.3

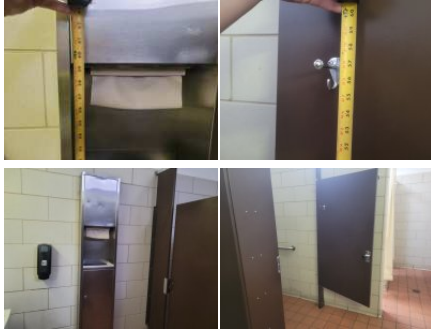
Finding Number	Area Description	Lat/Long	Finding	As Built	Recommendation	Citation	Photos	Figure
228	Grapevine Loop Camping Area: Grapevine Loop Camping Women's Restroom	[30.1770663 , -97.7262325]	Where a high forward reach is over an obstruction, the clear floor space shall extend beneath the element for a distance not less than the required reach depth over the obstruction. The high forward reach shall be 48 inches (1220 mm) maximum where the reach depth is 20 inches (510 mm) maximum. Where the reach depth exceeds 20 inches (510 mm), the high forward reach shall be 44 inches (1120 mm) maximum and the reach depth shall be 25 inches (635 mm) maximum. Where a clear floor or ground space allows a parallel approach to an element and the high side reach is over an obstruction, the height of the obstruction shall be 34 inches (865 mm) maximum and the depth of the obstruction shall be 24 inches (610 mm) maximum. The high side reach shall be 48 inches (1220 mm) maximum for a reach depth of 10 inches (255 mm) maximum. Where the reach depth exceeds 10 inches (255 mm), the high side reach shall be 46 inches (1170 mm) maximum for a reach depth of 24 inches (610 mm) maximum.	Paper towels 59", hook 56"	Lower operating mechanisms in RR to max 48" AFF to highest operable part	2015 ABAAS Section: 308.2.1, 308.3.2  2012 TAS Section: 308.2.1, 308.3.2  2010 ADAS Section: 308.2.1, 308.3.2

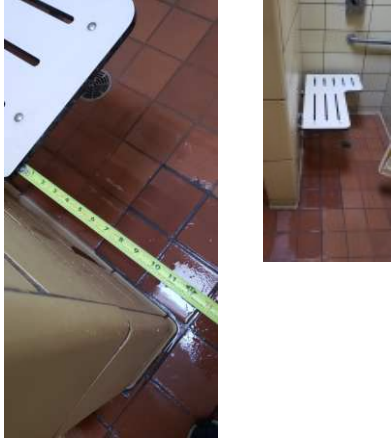
244	Little Oak Camping Area: Little Oak Camping Area Men's Restroom	[30.1787794 , -97.723971 4]	Where a seat is provided in a standard roll-in shower compartment, it shall be a folding type, shall be installed on the side wall adjacent to the controls, and shall extend from the back wall to a point within 3 inches (75 mm) of the compartment entry. Where a seat is provided in an alternate roll-in type shower compartment, it shall be a folding type, shall be installed on the front wall opposite the back wall, and shall extend from the adjacent side wall to a point within 3 inches (75 mm) of the compartment entry. In transfer-type showers, the seat shall extend from the back wall to a point within 3 inches (75 mm) of the compartment entry. The top of the seat shall be 17 inches (430 mm) minimum and 19 inches (485 mm) maximum above the bathroom finish floor. Seats shall comply with 610.3.1 or 610.3.2.	Seat 11" from edge	Provide the correct seat based on shower type.	2015 ABAAS Section: 610.3  2012 TAS Section: 610.3  2010 ADAS Section: 610.3

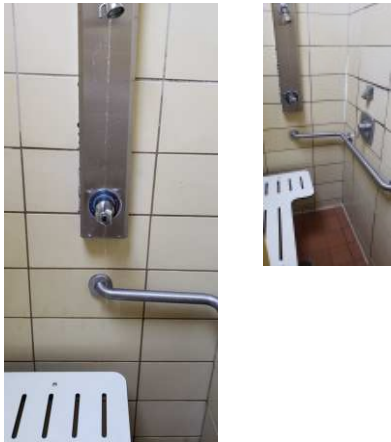
246	Little Oak Camping Area: Little Oak Camping Area Men's Restroom	[30.1787917 , -97.723973 4]	The operable part is not accessible because it requires tight grasping, pinching or twisting of the wrist.	Knob on one shower, other shower less than 5# push	Replace operable part with one usable without a tight pinch or grasp	2015 ABAAS Section: 309.4  2012 TAS Section: 309.4  2010 ADAS Section: 309.4

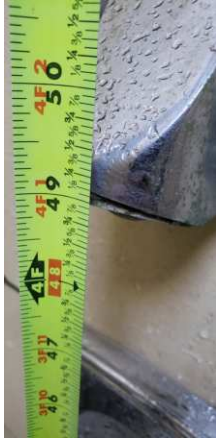
Finding Number	Area Description	Lat/Long	Finding	As Built	Recommendation	Citation	Photos	Figure
247	Little Oak Camping Area: Little Oak Camping Area Men's Restroom	[30.1787937 , -97.723966 1]	There is no hand held sprayer unit. The sprayer unit must have a 59 inches hose and be mounted 48 inches maximum to the top of mounting bracket off the floor. The shower spray unit shall have an on/off control with a non-positive shutoff. If an adjustable-height shower head on a vertical bar is used, the bar shall be installed so as not to obstruct the use of grab bars.	49" AFF to shower spray	Replace shower control with a compliant lever control with a shower head on a 59" hose and usable as hand held	2015 ABAAS Section: 608.6  2012 TAS Section: 608.6  2010 ADAS Section: 608.6
