# Access Audit Site Report

**McKinney Falls State Park**  
**5808 McKinney Falls Pkwy**  
**Austin, TX 78744**  
**Accessibility Evaluation**  
**Inspection Date: 11/11/2021**  
**Inspectors: Tanya Scheibe**

Prepared By  
**WT Group**

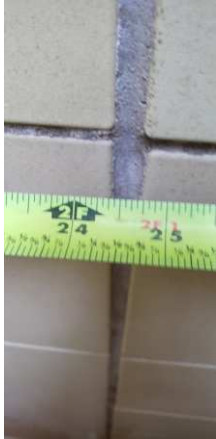
248	Little Oak Camping Area: Little Oak Camping Area Men's Restroom	[30.1787834 , -97.723971 4]	Shower controls are in the incorrect location In transfer type shower compartments, the controls, faucets, and shower spray unit shall be installed on the side wall opposite the seat 38 inches (965 mm) minimum and 48 inches (1220 mm) maximum above the shower floor and shall be located on the control wall 15 inches (380 mm) maximum from the centerline of the seat toward the shower opening.	Controls 24.5" from opening	Remount shower controls to the correct location in the transfer shower	2015 ABAAS Section: 608.5.1  2012 TAS Section: 608.5.1  2010 ADAS Section: 608.5.1

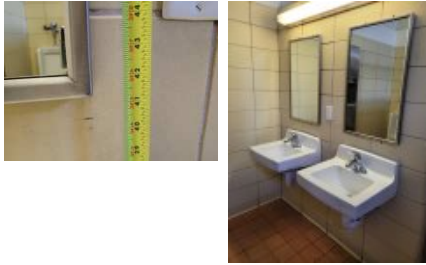
Finding Number	Area Description	Lat/Long	Finding	As Built	Recommendation	Citation	Photos	Figure
251	Little Oak Camping Area: Little Oak Camping Area Men's Restroom	[30.1787866 , -97.723968 7]	The mirror is mounted too high. Mirrors must have the bottom edge of the reflecting surface a maximum of 40 inches above the floor if above a sink or counter. Mirrors not located above lavatories or countertops shall be installed with the bottom edge of the reflecting surface 35 inches maximum above the finish floor or ground.	Mirror at 42" AFF	Lower mirror so bottom reflective surface is max 40" AFF and 74" at the top.	2015 ABAAS Section: 603.3  2012 TAS Section: 603.3  2010 ADAS Section: 603.3

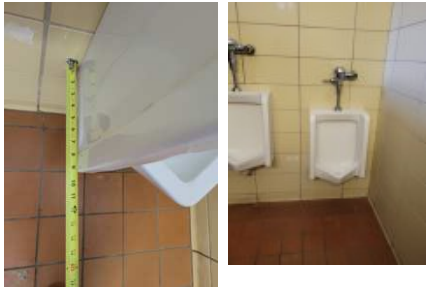
252	Little Oak Camping Area: Little Oak Camping Area Men's Restroom	[30.1787779 , -97.723968 1]	The bowl of the urinal does not extend out from the wall far enough. Wall-hung urinals must be provided with an elongated rim projecting a minimum of 13 1/2 inches from the wall and a maximum of 17 inches above the floor.	Urinal projects less than 13.5"	Replace urinal with one having a 13.5" min depth mounted at max 17" to rim with flush controls max 48" AFF.	2015 ABAAS Section: 605.2  2012 TAS Section: 605.2  2010 ADAS Section: 605.2

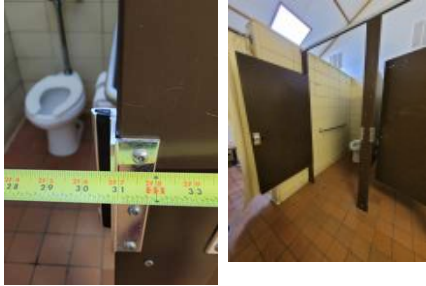
253	Little Oak Camping Area: Little Oak Camping Area Men's Restroom	[30.1787771 , -97.723974 1]	The stall door fails to comply with all of the door requirements. The stall door must be a minimum of 32" wide and have compliant hardware on both sides. The stall door must be self-closing.	Stall door is 31" wide and not self-closing	Widen stall doors to 32" when opened to 90 degrees. Adjust stall door to be self-closing.	2015 ABAAS Section: 404.2.3, 404.2.7, 604.8.2.2  2012 TAS Section: 404.2.3, 404.2.7, 604.8.2.2  2010 ADAS Section: 404.2.3, 404.2.7, 604.8.2.2

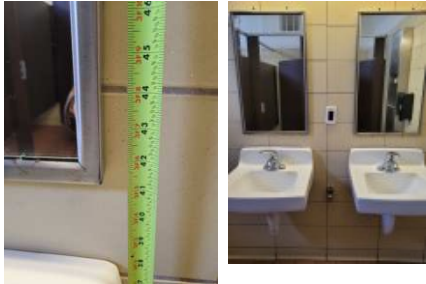
255	Little Oak Camping Area: Little Oak Camping Area Women's Restroom	[30.1787771 , -97.723983 5]	The mirror is mounted too high. Mirrors must have the bottom edge of the reflecting surface a maximum of 40 inches above the floor if above a sink or counter. Mirrors not located above lavatories or countertops shall be installed with the bottom edge of the reflecting surface 35 inches maximum above the finish floor or ground.	Mirrors 41.5" AFF to bottom	Lower mirror so reflective surface is max 40" AFF	2015 ABAAS Section: 603.3  2012 TAS Section: 603.3  2010 ADAS Section: 603.3

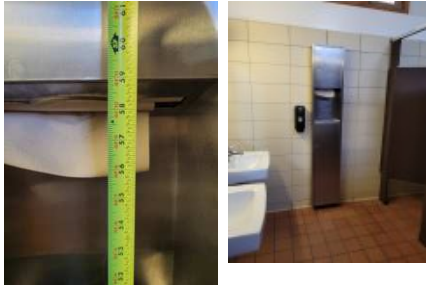
Finding Number	Area Description	Lat/Long	Finding	As Built	Recommendation	Citation	Photos	Figure
256	Little Oak Camping Area: Little Oak Camping Area Women's Restroom	[30.1787817 , -97.7239634]	Where a high forward reach is over an obstruction, the clear floor space shall extend beneath the element for a distance not less than the required reach depth over the obstruction. The high forward reach shall be 48 inches (1220 mm) maximum where the reach depth is 20 inches (510 mm) maximum. Where the reach depth exceeds 20 inches (510 mm), the high forward reach shall be 44 inches (1120 mm) maximum and the reach depth shall be 25 inches (635 mm) maximum. Where a clear floor or ground space allows a parallel approach to an element and the high side reach is over an obstruction, the height of the obstruction shall be 34 inches (865 mm) maximum and the depth of the obstruction shall be 24 inches (610 mm) maximum. The high side reach shall be 48 inches (1220 mm) maximum for a reach depth of 10 inches (255 mm) maximum. Where the reach depth exceeds 10 inches (255 mm), the high side reach shall be 46 inches (1170 mm) maximum for a reach depth of 24 inches (610 mm) maximum.	Paper towels - 56" AFF	Lower dispenser to max 46" above the finished floor (AFF) for a side reach over counter.	2015 ABAAS Section: 308.2.1, 308.3.2  2012 TAS Section: 308.2.1, 308.3.2  2010 ADAS Section: 308.2.1, 308.3.2

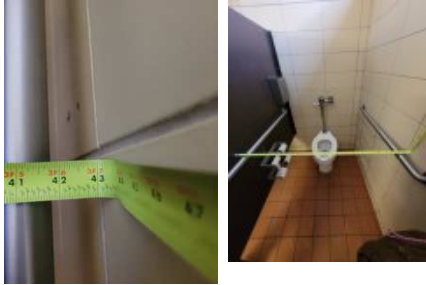
Finding Number	Area Description	Lat/Long	Finding	As Built	Recommendation	Citation	Photos	Figure
258	Little Oak Camping Area: Little Oak Camping Area Women's Restroom	[30.1787959 , -97.723974 1]	The ambulatory stall is not between 35" to 37" wide and 60" deep.	Ambulatory stall 43" wide	Correct ambulatory stall to be 35" to 37" wide and minimum 60" deep	2015 ABAAS Section: 604.8.2.1  2012 TAS Section: 604.8.2.1  2010 ADAS Section: 604.8.2.1

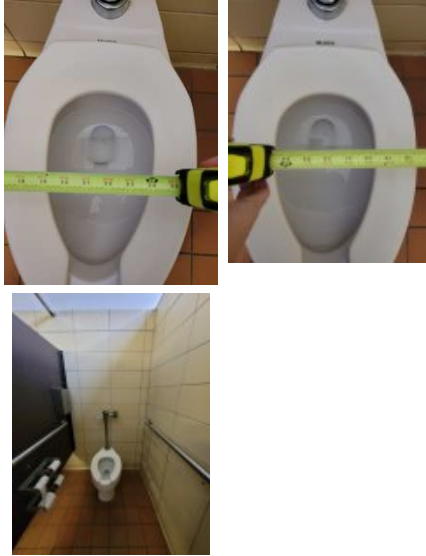
259	Little Oak Camping Area: Little Oak Camping Area Women's Restroom	[30.1787926 , -97.723972 8]	The toilet is not located within the range to the side wall or partition. The centerline of the toilet shall be 17 inches minimum and 19 inches maximum side wall or partition in the ambulatory accessible toilet compartment.	22.5" from partition wall, 22" from cement wall	Remount toilet to 17" to 19" from the side wall to center line in ambulatory stalls	2015 ABAAS Section: 604.9.1  2012 TAS Section: 604.9.1  2010 ADAS Section: 604.9.1

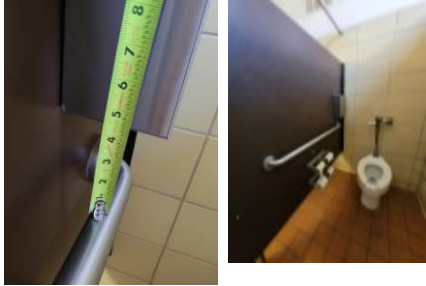
261	Little Oak Camping Area: Little Oak Camping Area Women's Restroom	[30.1787749 , -97.723966 1]	The grab bar height and/or spacing fails. Grab bars must be mounted between 33" and 36" to the top of the gripping surface. There must be 1.5" of clearance between the grab bar and the wall. There must be a minimum of 1.5" of clearance below and minimum 12" above the grab bar to any dispenser or other obstruction.	4.5" overhead spacing to grab bar on partition wall	Remount napkin disposal, 15" to 48" above the finished floor (AFF) and min 12" above or 1.5" below grab bar.	2015 ABAAS Section: 609.3, 609.4  2012 TAS Section: 609.4, 609.3  2010 ADAS Section: 609.3, 609.4

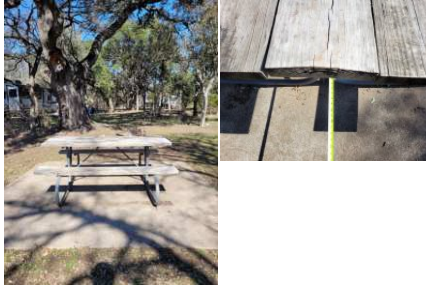
267	Little Oak Camping Area: Little Oak Campsites	[30.1784646 , -97.723679 1]	Picnic tables shall provide at least one wheelchair space for each 24 linear feet (7320 mm) of usable table surface perimeter. Wheelchair spaces shall be 30 inches (760 mm) minimum by 48 inches (1220 mm) minimum. Wheelchair spaces shall be positioned for a forward approach to the table and provide knee and toe clearance complying with 306 under the table	Picnic table lacks toe clearance	Replace picnic table with one of an accessible design as a smart practice	2015 ABAAS Section: 1011.4.2

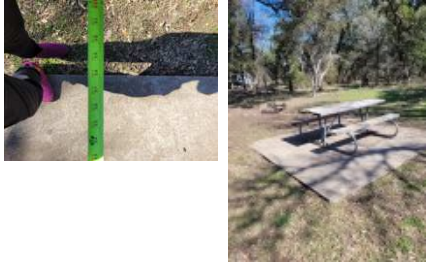
268	Little Oak Camping Area: Little Oak Campsites	[30.1784769 , -97.723689 1]	36 inches (915 mm) on all usable sides of the table measured from the back edge of the benches	28" width around usable portion	Provide required 36" clear ground space around all usable portions of the table as a smart practice	2015 ABAAS Section: 1011.2.1

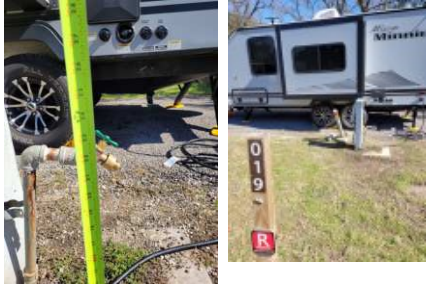
271	Little Oak Camping Area: Little Oak Campsites	[30.1784417 , -97.723734]	Water spouts at water hydrants and water utility hook-ups shall be 28 inches (710 mm) minimum and 36 inches (915 mm) maximum above the ground	Water spigot 22" AGL	Remount water spouts to 28" min or 36" max above the ground as a smart practice	2015 ABAAS Section: 1011.6

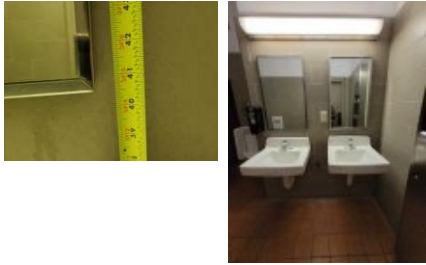
Finding Number	Area Description	Lat/Long	Finding	As Built	Recommendation	Citation	Photos	Figure
275	Big Oak Camping Area: Big Oak Camping Area Men's Restroom	[30.1801363 , -97.724661 5]	The mirror is mounted too high. Mirrors must have the bottom edge of the reflecting surface a maximum of 40 inches above the floor if above a sink or counter. Mirrors not located above lavatories or countertops shall be installed with the bottom edge of the reflecting surface 35 inches maximum above the finish floor or ground.	Mirror mounted 41" AFF	Lower mirror so reflective surface is max 40" AFF	2015 ABAAS Section: 603.3  2012 TAS Section: 603.3  2010 ADAS Section: 603.3

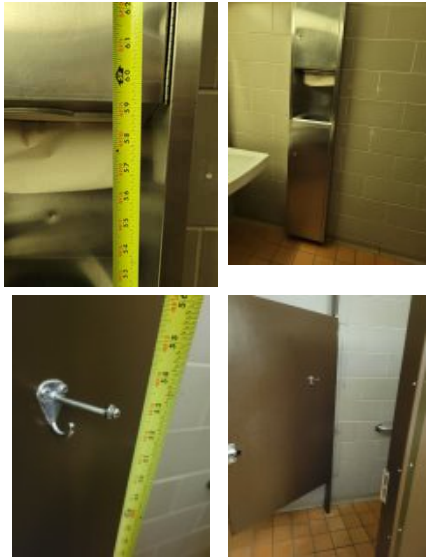
276	Big Oak Camping Area: Big Oak Camping Area Men's Restroom	[30.1801438 , -97.724674 4]	Where a high forward reach is over an obstruction, the clear floor space shall extend beneath the element for a distance not less than the required reach depth over the obstruction. The high forward reach shall be 48 inches (1220 mm) maximum where the reach depth is 20 inches (510 mm) maximum. Where the reach depth exceeds 20 inches (510 mm), the high forward reach shall be 44 inches (1120 mm) maximum and the reach depth shall be 25 inches (635 mm) maximum. Where a clear floor or ground space allows a parallel approach to an element and the high side reach is over an obstruction, the height of the obstruction shall be 34 inches (865 mm) maximum and the depth of the obstruction shall be 24 inches (610 mm) maximum. The high side reach shall be 48 inches (1220 mm) maximum for a reach depth of 10 inches (255 mm) maximum. Where the reach depth exceeds 10 inches (255 mm), the high side reach shall be 46 inches (1170 mm) maximum for a reach depth of 24 inches (610 mm) maximum.	Paper towels 56" AFF, hook in stall 52" AFF	Lower hook to max 48" above the finished floor (AFF) to highest operable part. Lower dispenser to max 46" above the finished floor (AFF) for a side reach over counter.	2015 ABAAS Section: 308.2.1, 308.3.2  2012 TAS Section: 308.2.1, 308.3.2  2010 ADAS Section: 308.2.1, 308.3.2

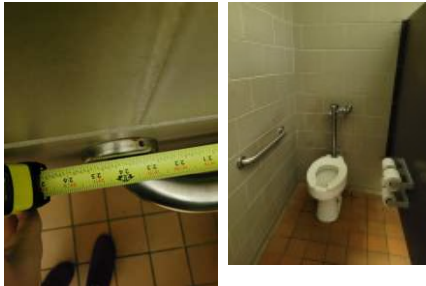
281	Big Oak Camping Area: Big Oak Camping Area Men's Restroom	[30.1801392 , -97.724674 9]	Grab bars shall comply with 609. A side-wall grab bar complying with 604.5.1 shall be provided on both sides of the compartment. The space between the wall and the grab bar shall be 1½ inches (38 mm). The space between the grab bar and projecting objects below and at the ends shall be 1½ inches (38 mm) minimum. The space between the grab bar and projecting objects above shall be 12 inches (305 mm) minimum. Grab bars shall be installed in a horizontal position, 33 inches (840 mm) minimum and 36 inches (915 mm) maximum above the finish floor measured to the top of the gripping surface, except that at water closets for children's use complying with 604.9, grab bars shall be installed in a horizontal position 18 inches (455 mm) minimum and 27 inches (685 mm) max	Cement wall grab bar 24", partition side is missing grab bar	Replace or add side grab bars with a 42" long grab bar, mounted max 12" from the rear wall at the close end and min 54" on the far end and 33" to 36" AFF	2015 ABAAS Section: 604.8.2.3, 609.3, 609.4  2012 TAS Section: 609.4, 609.3, 604.8.2.3  2010 ADAS Section: 609.3, 609.4, 604.8.2.3

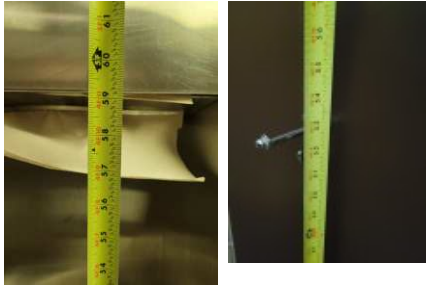
Finding Number	Area Description	Lat/Long	Finding	As Built	Recommendation	Citation	Photos	Figure
286	Big Oak Camping Area: Big Oak Camping Area Women's Restroom	[30.180134, -97.724668 3]	Where a high forward reach is over an obstruction, the clear floor space shall extend beneath the element for a distance not less than the required reach depth over the obstruction. The high forward reach shall be 48 inches (1220 mm) maximum where the reach depth is 20 inches (510 mm) maximum. Where the reach depth exceeds 20 inches (510 mm), the high forward reach shall be 44 inches (1120 mm) maximum and the reach depth shall be 25 inches (635 mm) maximum. Where a clear floor or ground space allows a parallel approach to an element and the high side reach is over an obstruction, the height of the obstruction shall be 34 inches (865 mm) maximum and the depth of the obstruction shall be 24 inches (610 mm) maximum. The high side reach shall be 48 inches (1220 mm) maximum for a reach depth of 10 inches (255 mm) maximum. Where the reach depth exceeds 10 inches (255 mm), the high side reach shall be 46 inches (1170 mm) maximum for a reach depth of 24 inches (610 mm) maximum.	Paper towels 57" AFF, hook in stall 52" AFF	Lower hook to max 48" above the finished floor (AFF) to highest operable part. Lower dispenser to max 46" above the finished floor (AFF) for a side reach over counter.	2015 ABAAS Section: 308.2.1, 308.3.2  2012 TAS Section: 308.2.1, 308.3.2  2010 ADAS Section: 308.2.1, 308.3.2

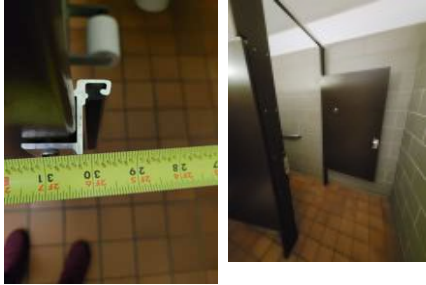
Finding Number	Area Description	Lat/Long	Finding	As Built	Recommendation	Citation	Photos	Figure
288	Big Oak Camping Area: Big Oak Camping Area Women's Restroom	[30.1801438, -97.7246621]	The stall door fails to comply with all of the door requirements. The stall door must be a minimum of 32" wide and have compliant hardware on both sides. The stall door must be self-closing.	30" wide door, not self-closing	Widen stall doors to 32" when opened to 90 degrees Adjust stall door to be self-closing	2015 ABAAS Section: 404.2.3, 404.2.7, 604.8.2.2  2012 TAS Section: 404.2.3, 404.2.7, 604.8.2.2  2010 ADAS Section: 404.2.3, 404.2.7, 604.8.2.2

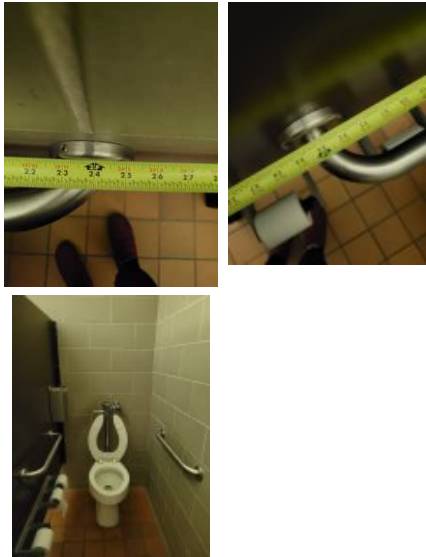
289	Big Oak Camping Area: Big Oak Camping Area Women's Restroom	[30.180134, -97.7246666]	Grab bars shall comply with 609. A side-wall grab bar complying with 604.5.1 shall be provided on both sides of the compartment. The space between the wall and the grab bar shall be 1½ inches (38 mm). The space between the grab bar and projecting objects below and at the ends shall be 1½ inches (38 mm) minimum. The space between the grab bar and projecting objects above shall be 12 inches (305 mm) minimum. Grab bars shall be installed in a horizontal position, 33 inches (840 mm) minimum and 36 inches (915 mm) maximum above the finish floor measured to the top of the gripping surface, except that at water closets for children's use complying with 604.9, grab bars shall be installed in a horizontal position 18 inches (455 mm) minimum and 27 inches (685 mm) max	24" grab bars on both sides	Replace or add side grab bars with a 42" long grab bar, mounted max 12" from the rear wall at the close end and min 54" on the far end and 33" to 36" AFF	2015 ABAAS Section: 604.8.2.3, 609.3, 609.4  2012 TAS Section: 609.4, 609.3, 604.8.2.3  2010 ADAS Section: 609.3, 609.4, 604.8.2.3

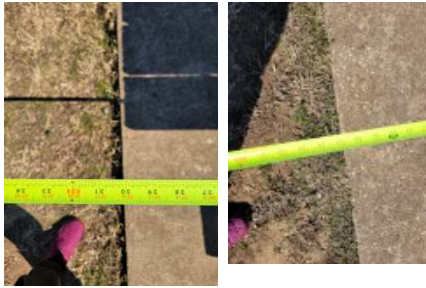
292	Big Oak Camping Area: Big Oak Campsites	[30.180432, -97.7243516]	36 inches (915 mm) on all usable sides of the table measured from the back edge of the benches	30" width, 27" width around table	Provide required 36" clear ground space around all usable portions of the table as a smart practice	2015 ABAAS Section: 1011.2.1

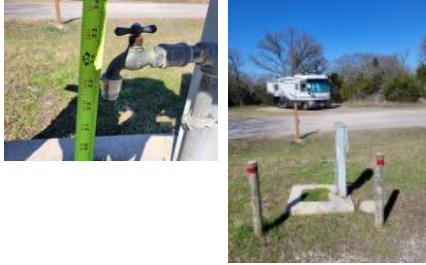
295	Big Oak Camping Area: Big Oak Campsites	[30.180576, -97.724370 4]	Water spouts at water hydrants and water utility hook-ups shall be 28 inches (710 mm) minimum and 36 inches (915 mm) maximum above the ground	Water spigot 25" AFF	Remount water spouts to 28" min or 36" max above the ground as a smart practice	2015 ABAAS Section: 1011.6

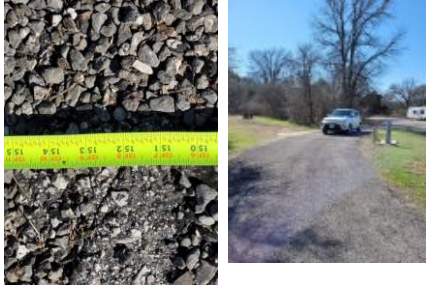
296	Big Oak Camping Area: Big Oak Campsites	[30.1805465 , -97.724366 4]	Parking spaces and pull-up spaces for recreational vehicles shall be 20 feet (6100 mm) wide minimum. EXCEPTION: Where two adjacent parking spaces are provided for recreational vehicles, one parking space shall be permitted to be 16 feet (4880 mm) wide minimum.	RV parking stall - 12' 8" width	Correct RV parking space to be 20' wide minimum; or 16' for two adjacent spaces as a smart practice.	2015 ABAAS Section: 1012.2, 1012.2 EXCEPTION

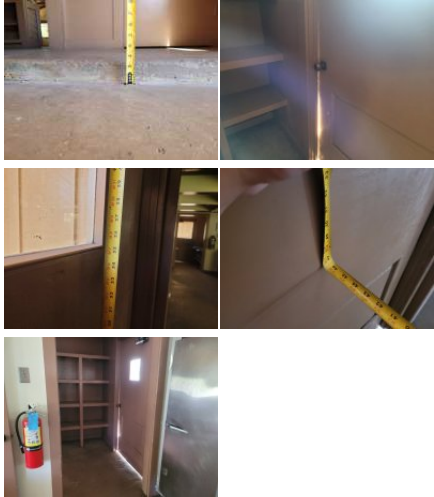
Finding Number	Area Description	Lat/Long	Finding	As Built	Recommendation	Citation	Photos	Figure
306	Group Dining Hall: Group Dining Hall Building	[30.1798121 , -97.728858 3]	<p>Minimum maneuvering clearances at doors and gates shall comply with 404.2.4. Maneuvering clearances shall extend the full width of the doorway and the required latch side or hinge side clearance. The threshold at a doorway shall be no higher than 1/2 inch. Changes in level between 1/4 inch and 1/2 inch must be beveled at 1:2 or less. 1/4 inch is the maximum vertical rise. The sweep period for doors with closers shall be adjusted so that from an open position of 70 degrees, the door will take at least 3 seconds to move to a point 3 inches from the latch, measured to the leading edge of the door. Exterior doors are recommended to be maintained at 8.5 #f as a smart practice. Force is to be measured at the operating hardware or 30 inches from the hinges, whichever is greater. Hand-activated door opening hardware, handles, pulls, latches, locks, and other operating devices on accessible doors shall have a shape that is easy to grasp with one hand and does not require tight grasping, tight pinching or twisting of the wrist to operate. Hardware shall be 34 inches minimum and 48 inches maximum above the finish floor or ground. Doors, gates, and side lights adjacent to doors or gates, containing one or more glazing panels that permit viewing through the panels shall have the bottom of at least one glazed panel located 43 inches (1090 mm) maximum above the finish floor. EXCEPTION: Vision lights with the lowest part more than 66 inches (1675 mm) from the finish floor or ground shall not be required to comply with 404.2.11.</p>	Kitchen exit- knob, 55" window, 2.5" CIL, wall back 47" push side, closes fast, 10#f	<p>For all doors along the public circulation route, provide required maneuvering clearance on push and pull side of doors. For all doors along the public circulation route, repair, bevel, or ramp CILs at door entries to max .25" For all doors along the public circulation route, inspect, adjust, and maintain closing speed on door closers. For all doors along the public circulation route, inspect, adjust, and maintain 8.5 #f to open exterior doors as a smart practice. For all doors along the public circulation route, replace hardware with lever hardware or hardware operable without a tight pinch or grasp. For all doors along the public circulation route, replace doors with ones having sidelight viewing windows max 43" AFF.</p>	2010 ADAS Section: 404.2.3, 404.2.7, 404.2.4, 404.2.11, 404.2.11 Exception

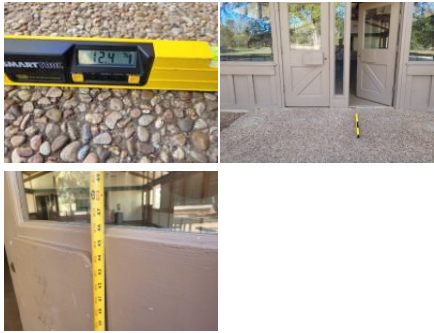
308	Group Dining Hall: Group Dining Hall Building	[30.1798272, -97.7288612]	Floor and ground surfaces shall comply with 404.2.4.4. Maneuvering clearances and floor and ground slope shall extend the full width of the doorway and the required latch side or hinge side clearance. EXCEPTION: Vision lights with the lowest part more than 66 inches (1675 mm) from the finish floor or ground shall not be required to comply with 404.2.11.	Front entry- 12.4% slope, window 46" AFF	For all doors along the public circulation route, provide required floor and ground slope on push and pull side of doors For all doors along the public circulation route, replace doors with ones having sidelight viewing windows max 43" AFF	2010 ADAS Section: 404.2.3, 404.2.7, 404.2.4, 404.2.11, 404.2.11 Exception

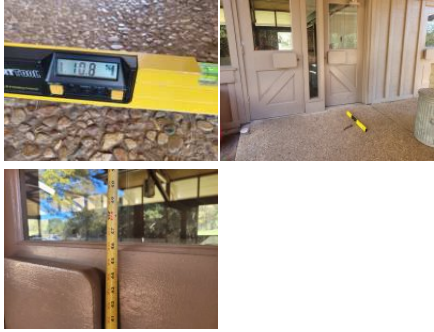
309	Group Dining Hall: Group Dining Hall Building	[30.17985, -97.72888]	Floor and ground slopes at doors and gates shall comply with 404.2.4.4. Floor and ground slopes shall extend the full width of the doorway and the required latch side or hinge side clearance. EXCEPTION: Vision lights with the lowest part more than 66 inches (1675 mm) from the finish floor or ground shall not be required to comply with 404.2.11.	Side entry- 10.8% slope, window 46.25" AFF	For all doors along the public circulation route, provide required floor and ground slopes on push and pull side of doors For all doors along the public circulation route, replace doors with ones having sidelight viewing windows max 43" AFF	2010 ADAS Section: 404.2.3, 404.2.7, 404.2.4, 404.2.11, 404.2.11 Exception

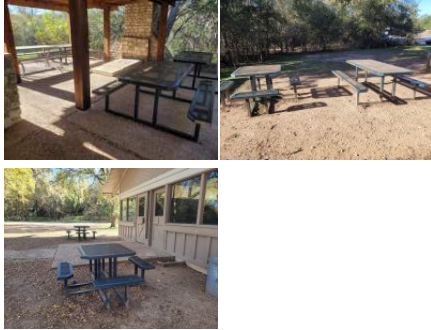
Finding Number	Area Description	Lat/Long	Finding	As Built	Recommendation	Citation	Photos	Figure
310	Group Dining Hall: Group Dining Hall Building	[30.1798281, -97.7288611]	Picnic tables shall provide at least one wheelchair space for each 24 linear feet (7320 mm) of usable table surface perimeter. Wheelchair spaces shall be 30 inches (760 mm) minimum by 48 inches (1220 mm) minimum. Wheelchair spaces shall be positioned for a forward approach to the table and provide knee and toe clearance complying with 306 under the table	0 of 8 tables accessible	Replace picnic table with one of an accessible design as a smart practice	2015 ABAAS Section: 1011.4.2

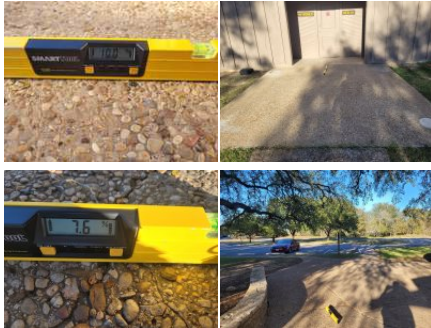
316	Group Dining Hall: Group Dining Hall Building	[30.1799712, -97.7286685], [30.1798359, -97.7287812]	The running slope of walking surfaces shall not be steeper than 1:20.	10% slope to restrooms, 7.6% slope to parking	Correct running slope along the AR to max 5%	2015 ABAAS Section: 403.3 2012 TAS Section: 403.3 2010 ADAS Section: 403.3

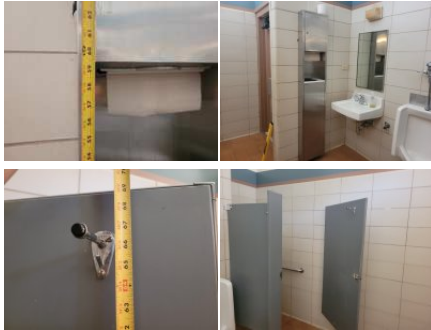
Finding Number	Area Description	Lat/Long	Finding	As Built	Recommendation	Citation	Photos	Figure
322	Group Dining Hall: Group Dining Hall Men's Restroom	[30.1798014 , -97.7288624]	Where a high forward reach is over an obstruction, the clear floor space shall extend beneath the element for a distance not less than the required reach depth over the obstruction. The high forward reach shall be 48 inches (1220 mm) maximum where the reach depth is 20 inches (510 mm) maximum. Where the reach depth exceeds 20 inches (510 mm), the high forward reach shall be 44 inches (1120 mm) maximum and the reach depth shall be 25 inches (635 mm) maximum. Where a clear floor or ground space allows a parallel approach to an element and the high side reach is over an obstruction, the height of the obstruction shall be 34 inches (865 mm) maximum and the depth of the obstruction shall be 24 inches (610 mm) maximum. The high side reach shall be 48 inches (1220 mm) maximum for a reach depth of 10 inches (255 mm) maximum. Where the reach depth exceeds 10 inches (255 mm), the high side reach shall be 46 inches (1170 mm) maximum for a reach depth of 24 inches (610 mm) maximum.	Paper towels 59" AFF, hook 65.5" AFF	Lower operating mechanisms in RR to max 48" AFF to highest operable part	2015 ABAAS Section: 308.2.1, 308.3.2  2012 TAS Section: 308.2.1, 308.3.2  2010 ADAS Section: 308.2.1, 308.3.2

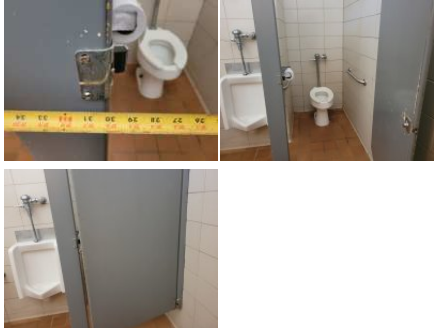
325	Group Dining Hall: Group Dining Hall Men's Restroom	[30.1798107 , -97.728858 4]	The stall door fails to comply with all of the door requirements. The stall door must be a minimum of 32" wide and have compliant hardware on both sides. The stall door must be self-closing.	30.5" opening, not self-closing, lacks exterior hardware	Widen stall doors to 32" when opened to 90 degrees Adjust or replace stall door to be self-closing Replace stall hardware with hardware operable without a tight pinch or grasp on both sides of the stall door	2015 ABAAS Section: 404.2.3, 404.2.7, 604.8.2.2  2012 TAS Section: 404.2.3, 404.2.7, 604.8.2.2  2010 ADAS Section: 404.2.3, 404.2.7, 604.8.2.2

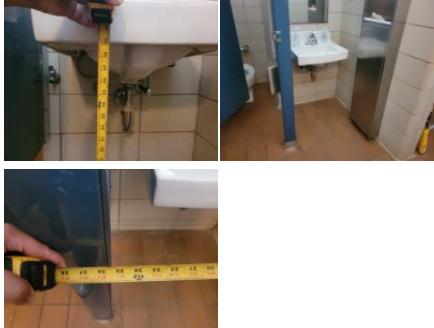
331	Group Dining Hall: Group Dining Hall Women's Restroom	[30.1798064 , -97.728871 8]	Knee clearance at 27 inches off the floor is not 8 inches minimum deep. The knee clearance, measured from the bottom of the apron or the outside bottom edge of the lavatory, must be 27 inches at a point located 8 inches back from the front edge and continuing to 11 inches minimum in depth at 9 inches above the floor. The top of the lavatory rim may be no higher than 34 inches.	Low bowl, only 25.5" wide to access	Raise sink bowl to provide minimum 27" knee clearance	2015 ABAAS Section: 306.3.1, 306.3.2, 306.3.3, 306.3.4 , 306.3.5  2012 TAS Section: 306.3.2, 306.3.3, 306.3.4, 306.3.5, 306.3.1  2010 ADAS Section: 306.3.3, 306.3.2, 306.3.4, 306.3.5, 306.3.1

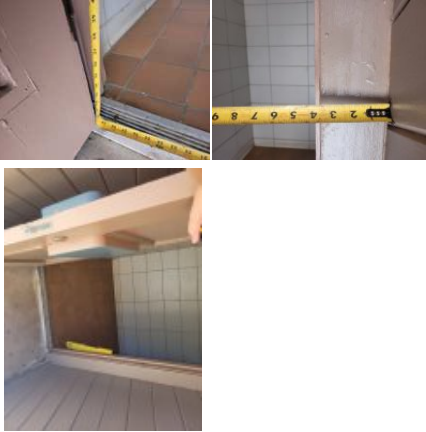
Finding Number	Area Description	Lat/Long	Finding	As Built	Recommendation	Citation	Photos	Figure
339	Group Dining Hall: Group Dining Hall Women's Restroom	[30.17977, -97.7289]	Minimum maneuvering clearances at doors and gates shall comply with 404.2.4. Maneuvering clearances shall extend the full width of the doorway and the required latch side or hinge side clearance. Door openings shall provide a clear width of 32 inches (815 mm) minimum. Clear openings of doorways with swinging doors shall be measured between the face of the door and the stop, with the door open 90 degrees. Openings more than 24 inches (610 mm) deep shall provide a clear opening of 36 inches (915 mm) minimum. There shall be no projections into the required clear opening width lower than 34 inches (865 mm) above the finish floor or ground. Projections into the clear opening width between 34 inches (865 mm) and 80 inches (2030 mm) above the finish floor or ground shall not exceed 4 inches (100 mm).	29.5" wide opening, wall pull side	For all doors along the public circulation route, provide required maneuvering clearance on push and pull side of doors For all doors along the public circulation route, replace doors with doors having 80" overhead clearance and 32" clear width	2010 ADAS Section: 404.2.3, 404.2.7, 404.2.4, 404.2.11, 404.2.11 Exception

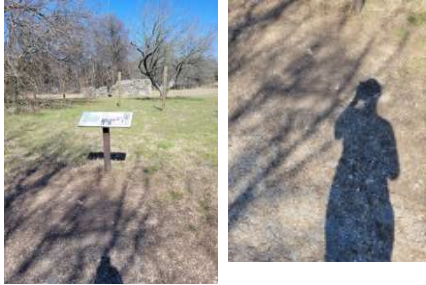
Finding Number	Area Description	Lat/Long	Finding	As Built	Recommendation	Citation	Photos	Figure
340	Park Sites: Horse Trainer's Cabin	[30.1816735 , -97.725334 3]	Clear floor space is not provide at the sign. Signs shall be located so that a clear floor space is provided at the sign.	CFS for signage is not stable, mud surface	Resurface CFS at sign to be firm and stable	2015 ABAAS Section: 703.4.2  2012 TAS Section: 703.4.2  2010 ADAS Section: 703.4.2

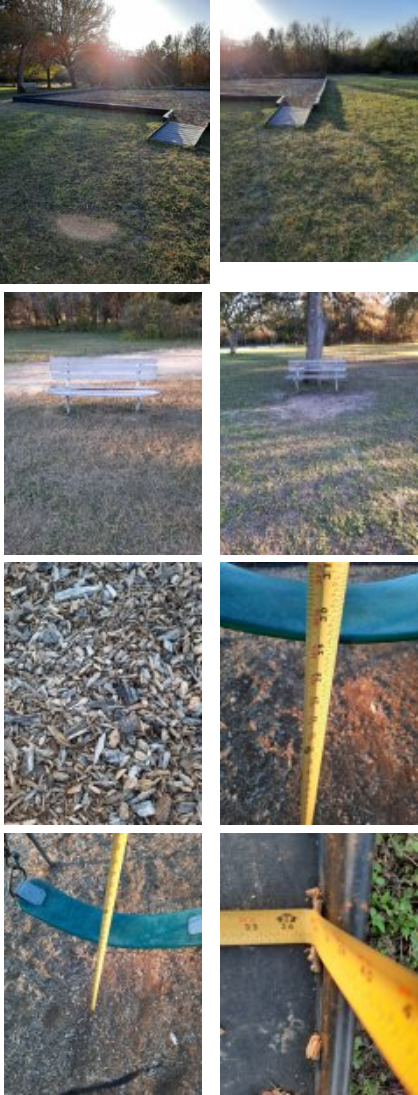
Finding Number	Area Description	Lat/Long	Finding	As Built	Recommendation	Citation	Photos	Figure
341	Park Sites: Playground	[30.1828326 , -97.7236425]	The required clear floor or ground space is not the correct size. The required accessible route is not provided Clear floor or ground space shall be 30 inches minimum by 48 inches minimum with slopes no greater than 2% (1:48) in any direction, Changes in level are not permitted. 1008.4.2 advisory - When designing play components with manipulative or interactive features, consider appropriate reach ranges for children seated in wheelchairs.	Lacks AR to playground and benches (2), surface is assumed to be woodchips, 4 of 4 swings lack entry height, designated entry (37" wide, cross slope of 8.2%, CIL of 1.75", 10 gaps of .75")	Create AR with crushed and compacted stone or similar outdoor material from building to building or parking to all site features Create 60" wide designated entry as a smart practice, correct CIL and slope Replace playground surface with an accessible surface meeting ASTM F 1951. Lower at least one swing to entry height of 11" - 24" agl	2012 TAS Section: 1008.4.2  2010 ADAS Section: 1008.4.2

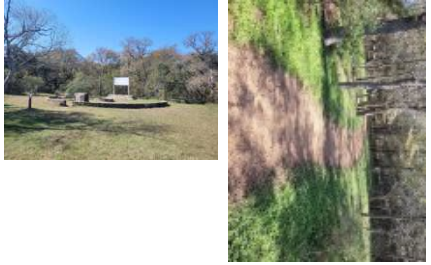
Finding Number	Area Description	Lat/Long	Finding	As Built	Recommendation	Citation	Photos	Figure
342	Park Sites: Amphitheater	[30.180066 , -97.729724 1]	At least one accessible route shall connect accessible buildings, accessible facilities, accessible elements, and accessible spaces that are on the same site. For areas of sport activity, an accessible route is required to connect to the boundary of each area of sport activity. The size of an area of sport activity includes only the space needed to play. Where multiple sports fields or courts are provided, an accessible route is required to each field or area of sport activity.	Amphitheater lacks AR, grass only close to amenity, loose crushed stone path to access	Provide an accessible route to each element within the site.	2010 ADAS Section: 206.2.2, 206.2

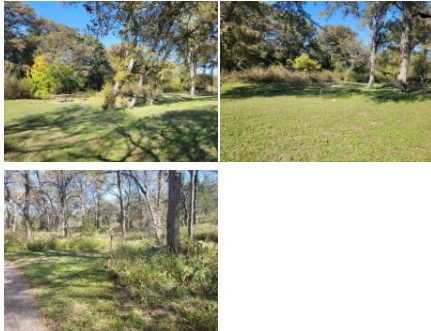
344	Park Sites: Amphitheater	[30.1818427 , -97.729297 3]	Where provided, at least one of each type of outdoor constructed feature shall comply with 1011. Where more than one of the same type of outdoor constructed feature is provided, at least two of the same type of outdoor constructed feature shall comply with 1011.	Tables and grills at each, lack AR, lacks AR to water spouts	Provide required clear ground space existing amenities	2015 ABAAS Section: F245.2.5.1

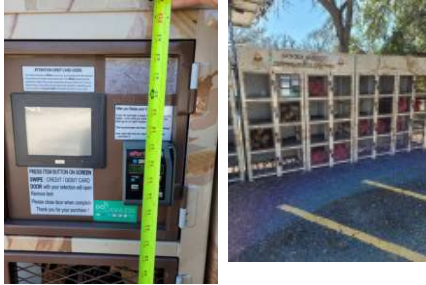
Finding Number	Area Description	Lat/Long	Finding	As Built	Recommendation	Citation	Photos	Figure
345	Park Sites: Park Elements	[30.1784894 , -97.723909 5]	The operable part is positioned too high for either a side or front approach. Where a clear floor or ground space allows a parallel approach to an element and the side reach is unobstructed, the high side reach shall be 48 inches maximum and the low side reach shall be 15 inches minimum above the finish floor or ground. Where a forward reach is unobstructed, the high forward reach shall be 48 inches maximum and the low forward reach shall be 15 inches minimum above the finish floor or ground.	Fire wood at Little Oak Campground RR - 58" AGL to swipe	Remount operable parts to be in reach range of 15" min to 48" max	2015 ABAAS Section: 308.1  2012 TAS Section: 308.1  2010 ADAS Section: 308.1

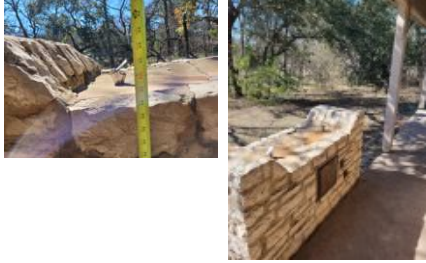
347	Park Sites: Park Elements	[30.1793503 , -97.726634 9]	There are not enough drinking fountains. When drinking fountains are provided, a minimum of one must be designed for wheelchair users and one must be designed for standing persons unless a single fountain meets the requirements for both.	2 low bowls 33" AFF	Replace drinking fountain with hi-lo bowl	2015 ABAAS Section: F211.2  2012 TAS Section: 211.2  2010 ADAS Section: 211.2

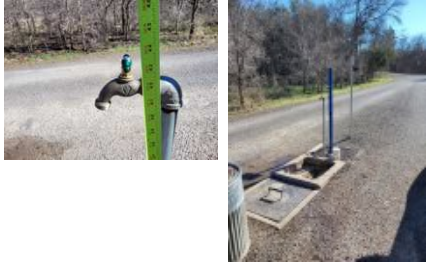
Finding Number	Area Description	Lat/Long	Finding	As Built	Recommendation	Citation	Photos	Figure
348	Park Sites: Park Elements	[30.1805175 , -97.725834 2]	Operable parts shall comply with 309.3 and 309.4. EXCEPTIONS: 1. Fire rings, grills, fireplaces, wood stoves, water hydrants, and water utility hookups shall comply with 309.4 to the extent practicable. 2. Trash and recycling receptacles with hinged lids and controls to keep out large animals shall comply with 309.4 to the extent practicable. 3. Dumpster type trash and recycling receptacles shall not be required to comply with 309.3 and 309.4. 4. Sewage hatches shall not be required to comply with 309.3 and 309.4.	Dump station at turn to big and little oak - water spigot 43" AFF	Replace operable parts with ones usable without a tight pinch or grasp, mounted within reach range of 15" to 48" above the ground as a smart practice	2015 ABAAS Section: 1011.3, 1011.3 EXCEPTIONS: 1, 1011.3 EXCEPTIONS: 2, 1011.3 EXCEPTIONS: 3, 1011.3 EXCEPTIONS: 4

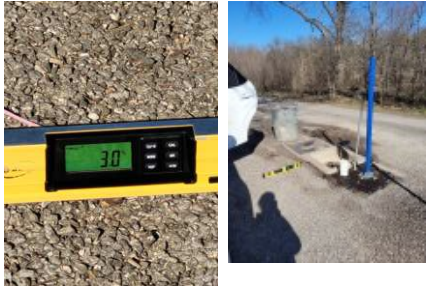
349	Park Sites: Park Elements	[30.1805315 , -97.725827 5]	The surface of the clear ground space shall be firm and stable The slope of the clear ground space surface shall not be steeper than 1:48 in any direction. EXCEPTION: Where the surface is other than asphalt, concrete, or boards, slopes not steeper than 1:20 shall be permitted when necessary for drainage	Dump station at little and big oak camping - 3% slope in CFS	Correct surface at water spigot to firm, stable and having max slope of 2.08% or 5% if other than concrete asphalt or boards as a smart practice	2015 ABAAS Section: 1011.2.2, 1011.2.3, 1011.2 EXCEPTION

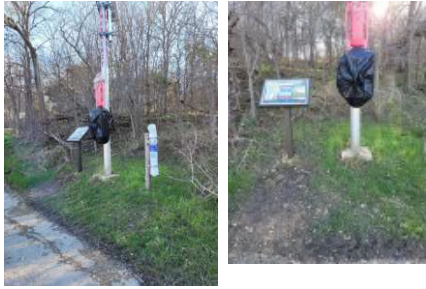
350	Park Sites: Park Elements	[30.1842888 , -97.725702 8]	There is no accessible route to the site elements At least one accessible route shall connect accessible buildings, accessible facilities, accessible elements, and accessible spaces that are on the same site.	No AR to sign, safety equipment or recycling by Upper Falls look-out	Create an accessible route with crushed stone or other outdoor material from parking or walkway to site elements	2015 ABAAS Section: F206.2.2  2012 TAS Section: 206.2.2  2010 ADAS Section: 206.2.2

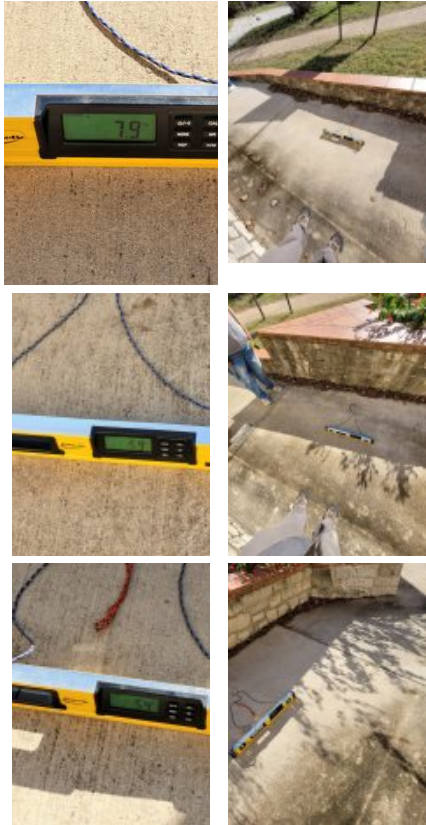
Finding Number	Area Description	Lat/Long	Finding	As Built	Recommendation	Citation	Photos	Figure
358	Smith Visitor Center: Smith Visitor Center Building	[30.1839166, -97.7248599], [30.1840543, -97.7247433]	The running slope of walking surfaces shall not be steeper than 1:20.	Slopes: 7.9%, 5.4%, and 5.9% along route near Visitors Center	Correct running slope along the AR to max 5%	2015 ABAAS Section: 403.3 2012 TAS Section: 403.3 2010 ADAS Section: 403.3

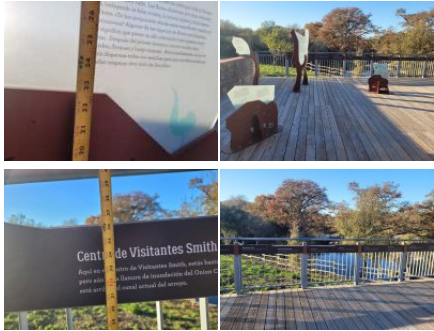
Finding Number	Area Description	Lat/Long	Finding	As Built	Recommendation	Citation	Photos	Figure
366	Smith Visitor Center: Smith Visitor Center Building	[30.1840198 , -97.7250887]	Visual characters shall be 40 inches (1015 mm) minimum above the finish floor or ground. EXCEPTION: Visual characters indicating elevator car controls shall not be required to comply with 703.5.6.	Exhibit signs on deck low	Remount signage to min 40" AFF	2015 ABAAS Section: 703.5.6, 703.5.6 EXCEPTION  2012 TAS Section: 703.5.6, 703.5.6 Exception  2010 ADAS Section: 703.5.6, 703.5.6 Exception

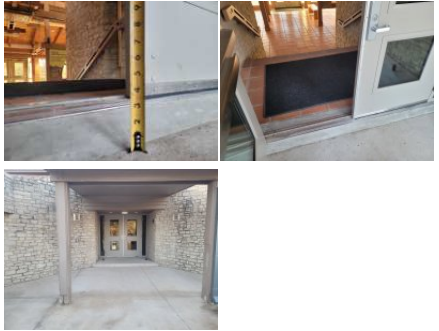
Finding Number	Area Description	Lat/Long	Finding	As Built	Recommendation	Citation	Photos	Figure
373	Smith Visitor Center: Smith Visitor Center Building	[30.1840333 , -97.7249105]	Minimum maneuvering clearances at doors and gates shall comply with 404.2.4. Maneuvering clearances shall extend the full width of the doorway and the required latch side or hinge side clearance. Door openings shall provide a clear width of 32 inches (815 mm) minimum. Clear openings of doorways with swinging doors shall be measured between the face of the door and the stop, with the door open 90 degrees. Openings more than 24 inches (610 mm) deep shall provide a clear opening of 36 inches (915 mm) minimum. There shall be no projections into the required clear opening width lower than 34 inches (865 mm) above the finish floor or ground. Projections into the clear opening width between 34 inches (865 mm) and 80 inches (2030 mm) above the finish floor or ground shall not exceed 4 inches (100 mm). The threshold has a vertical change greater than 1/4 inch high. The threshold at a doorway shall be no higher than 1/2 inch. Changes in level between 1/4 inch and 1/2 inch must be beveled at 1:2 or less. 1/4 inch is the maximum vertical rise. All interior doors must be maintained so that the operating pressure does not exceed 5 lb. force to open. The sweep period for doors with closers shall be adjusted so that from an open position of 70 degrees, the door will take at least 3 seconds to move to a point 3 inches from the latch, measured to the leading edge of the door. Exterior doors are recommended to be maintained at 8.5 lbf as a smart practice. Force is to be measured at the operating hardware or 30 inches from the hinges, whichever is greater. Hand-activated door opening hardware, handles, pulls, latches, locks, and other operating devices on accessible doors shall have a shape that is easy to grasp with one hand and does not require tight grasping, tight pinching or twisting of the wrist to operate. Hardware shall be 34 inches minimum and 48 inches maximum above the finish floor or	Main entry- 12# and 13# push, one closes fast, 3" CIL, CIL to get to door	For all doors along the public circulation route, repair, bevel, or ramp CILs at door entries to max .25" For all doors along the public circulation route, inspect, adjust, and maintain closing speed on door closers For all doors along the public circulation route, inspect, adjust, and maintain 8.5 #f to open exterior doors as a smart practice	2010 ADAS Section: 404.2.3, 404.2.7, 404.2.4, 404.2.11, 404.2.11 Exception

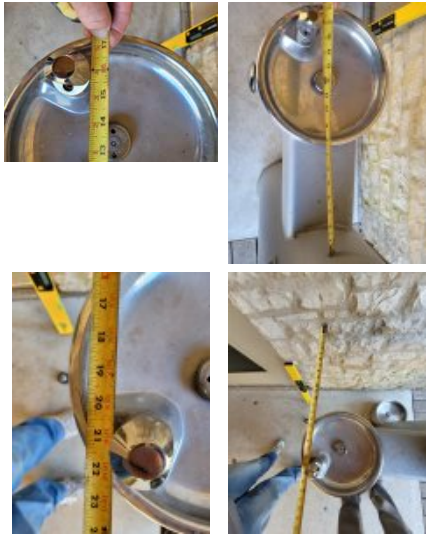
379	Smith Visitor Center: Smith Visitor Center Building	[30.1839596 , -97.7249612]	The spout is not positioned correctly from the vertical support. The spout shall be located 15 inches minimum from the vertical support and 5 inches maximum from the front edge of the unit, including bumpers.	15.5" to edge to post, 21" from post to wall	Remount or replace fountain to provide 15" from vertical support to the spout	2015 ABAAS Section: 602.5  2012 TAS Section: 602.5  2010 ADAS Section: 602.5

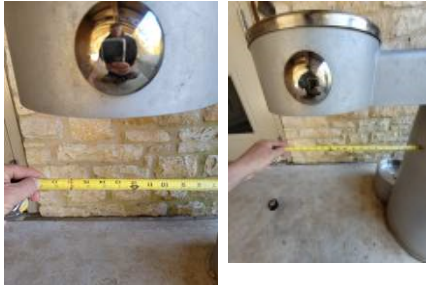
Finding Number	Area Description	Lat/Long	Finding	As Built	Recommendation	Citation	Photos	Figure
380	Smith Visitor Center: Smith Visitor Center Building	[30.1839875 , -97.724886 1]	The clear floor space required at accessible drinking fountains is not centered on the low fountain. At "hi-low" type drinking fountains, the 30 inch by 48 inch clear floor space must be centered on the "low" fountain.	13" from centerline to face of post	Remount fountain to provide centered clear floor space. Cost include in previous finding	2015 ABAAS Section: 602.2 2012 TAS Section: 602.2 2010 ADAS Section: 602.2

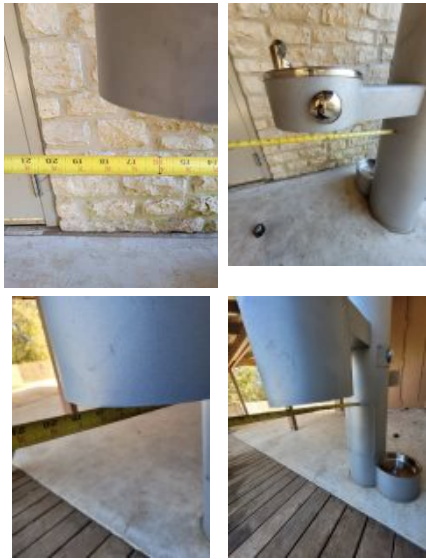
381	Smith Visitor Center: Smith Visitor Center Building	[30.1839318 , -97.724896 8]	The drinking fountain projects more than 4 inches into the circulation path. Wall-mounted objects that have leading edges between 27 inches and 80 inches from the floor must not project more than 4 inches into the circulation path. Protruding objects that extend to the floor or within 27 inches of the floor are cane detectable and are therefore not hazardous. Where it is necessary or desirable to have objects protrude from the wall, a manner of cane detection must be provided.	Hi and low bowls both project 18 inches	Relocate protruding objects or place cane detectable warning or bollard at foot of item	2015 ABAAS Section: 307.2 2012 TAS Section: 307.2 2010 ADAS Section: 307.2

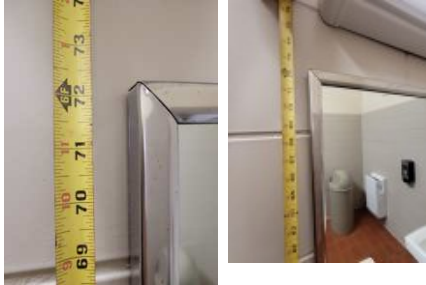
30"x48" Clear Floor Space
383	Upper Falls: Upper Falls Men's Restroom	[30.1835359 , -97.727340 3]	The mirror is mounted too high. Mirrors must have the bottom edge of the reflecting surface a maximum of 40 inches above the floor if above a sink or counter. Mirrors not located above lavatories or countertops shall be installed with the bottom edge of the reflecting surface 35 inches maximum above the finish floor or ground.	71.5" AFF to top of mirror	Raise mirror so reflective surface is max 40" AFF	2015 ABAAS Section: 603.3  2012 TAS Section: 603.3  2010 ADAS Section: 603.3

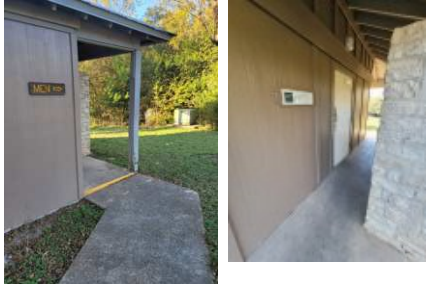
Finding Number	Area Description	Lat/Long	Finding	As Built	Recommendation	Citation	Photos	Figure
391	Picnic Area: Picnic Area Men's Restroom	[30.1829766 , -97.7233518]	The restroom sign does not comply with one or more applicable requirements for the location, height, and properties of the sign.	Sign lacks tactile characters and Braille	Replace sign with one of contrasting colors that includes Braille, raised characters, and the symbol of accessibility and mount on the wall, latch side of the door, 48" to the baseline of the lowest character and 60" to the baseline of the highest character. Cost included in separate finding	2015 ABAAS Section: F216.2, 703.1, 703.2, 703.5, 703.6  2012 TAS Section: 216.2, 703.1, 703.2, 703.5, 703.6  2010 ADAS Section: 216.2, 703.1, 703.2, 703.5, 703.6

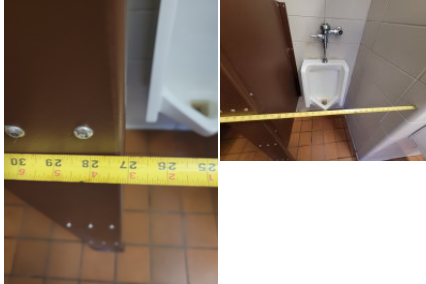
393	Picnic Area: Picnic Area Men's Restroom	[30.1829625 , -97.7233478]	The urinal is located in an area that does not provide the required clear floor space for a front approach. The surrounding elements of a urinal must provide a minimum of 30 by 48 inches of clear floor space for a front approach.	27" wide at urinal (lacks 30" clear)	Relocate privacy wall at urinal to provide 30" CFS	2015 ABAAS Section: 605.2  2012 TAS Section: 605.2  2010 ADAS Section: 605.2

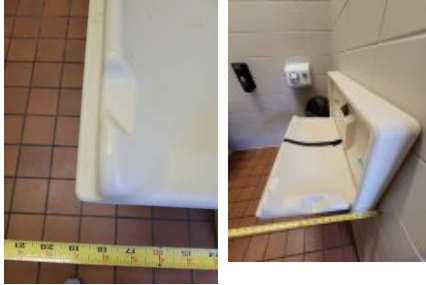
Finding Number	Area Description	Lat/Long	Finding	As Built	Recommendation	Citation	Photos	Figure
396	Picnic Area: Picnic Area Men's Restroom	[30.1829657 , -97.723351 8]	The baby changing table is not compliant. Baby changing tables are work surfaces. If fixed or built-in baby changing tables are provided, at least 5%, but not less than one, must comply with TAS 902 based TAS 226.1. Baby changing tables cannot violate the protruding object requirements in either an open or closed position since either position is a potential hazard for persons with visual impairments. Baby changing tables are not prohibited from being located in wheelchair accessible toilet compartments; however, the minimum space required for the compartment cannot be obstructed by the baby changing table in either an open or closed position. The clear floor space required for a baby changing table may overlap the water closet clearance since baby changing tables are considered convenience "fixtures" based on Advisory 604.8.1.1. The overlap is applicable only to the clear floor space and not to actual table itself. Baby changing tables must be dispersed throughout a space, however, an additional baby changing table is not required in a common use area of a toilet or bathing room when the only baby changing table is located in a toilet compartment.	Baby changing table protrudes 19" into dryer clear floor space	Relocate baby changing table to eliminate protrusion when in the open position.	2012 TAS Section: 226.1, 902.3, 604.3.2, 204.1, 226.1 Advisory, 226.2, 307.1, 604.8.1.1 Advisory, 902.1, 902.1 Advisory, 902.2

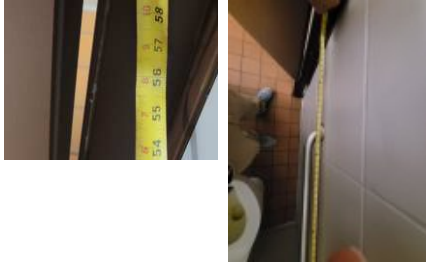
Finding Number	Area Description	Lat/Long	Finding	As Built	Recommendation	Citation	Photos	Figure
398	Picnic Area: Picnic Area Men's Restroom	[30.1829723 , -97.723353 2]	The ambulatory stall is not between 35" to 37" wide and 60" deep.	56.5" deep (lacks minimum stall depth)	Correct ambulatory stall to be 35" to 37" wide and minimum 60" deep	2015 ABAAS Section: 604.8.2.1  2012 TAS Section: 604.8.2.1  2010 ADAS Section: 604.8.2.1

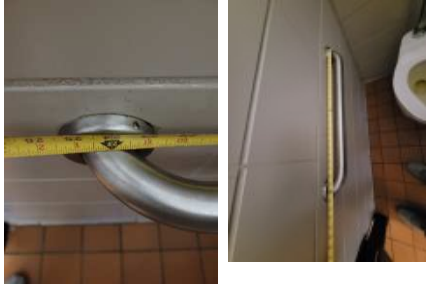
Finding Number	Area Description	Lat/Long	Finding	As Built	Recommendation	Citation	Photos	Figure
400	Picnic Area: Picnic Area Men's Restroom	[30.1829684 , -97.7233505]	Grab bars shall comply with 609. A side-wall grab bar complying with 604.5.1 shall be provided on both sides of the compartment. The space between the wall and the grab bar shall be 1½ inches (38 mm). The space between the grab bar and projecting objects below and at the ends shall be 1½ inches (38 mm) minimum. The space between the grab bar and projecting objects above shall be 12 inches (305 mm) minimum. Grab bars shall be installed in a horizontal position, 33 inches (840 mm) minimum and 36 inches (915 mm) maximum above the finish floor measured to the top of the gripping surface, except that at water closets for children's use complying with 604.9, grab bars shall be installed in a horizontal position 18 inches (455 mm) minimum and 27 inches (685 mm) max	24" long bars (lacks required grab bar length )	Replace or add side grab bars with a 42" long grab bar, mounted max 12" from the rear wall at the close end and min 54" on the far end and 33" to 36" AFF	2015 ABAAS Section: 604.8.2.3, 609.3, 609.4  2012 TAS Section: 609.4, 609.3, 604.8.2.3  2010 ADAS Section: 609.3, 609.4, 604.8.2.3

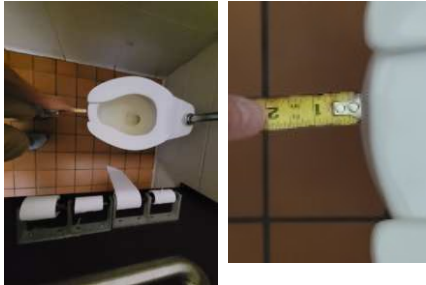
401	Picnic Area: Picnic Area Men's Restroom	[30.182979, -97.7233552]	The toilet paper is not installed within the compliant range in front of the toilet. Toilet paper dispensers shall be 7 inches minimum and 9 inches maximum in front of the water closet measured to the centerline of the dispenser. The outlet of the dispenser shall be 15 inches minimum and 48 inches maximum above the finish floor and shall not be located behind grab bars. Dispensers shall not be of a type that controls delivery or that does not allow continuous paper flow. There shall be a clearance of 1 1/2 inches minimum below the grab bar.	2" from edge of bowl to centerline of toilet paper dispenser	Remount toilet paper dispenser max 7" to 9" from front of toilet, 15" to 48" AFF and min 12" above or 1.5" below grab bar	2015 ABAAS Section: 604.7  2012 TAS Section: 604.7  2010 ADAS Section: 604.7

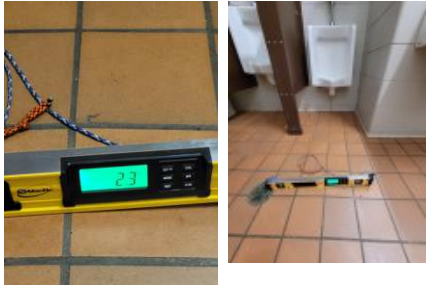
Finding Number	Area Description	Lat/Long	Finding	As Built	Recommendation	Citation	Photos	Figure
403	Picnic Area: Picnic Area Men's Restroom	[30.1829736 , -97.723356 5]	The accessible route contains running slopes greater than 5 percent and cross slopes greater than 2 percent across the width of the walk and has not been constructed as a ramp (i.e. handrails, wheel guides, etc.). When the slope in the direction of travel of any walk exceeds 1 unit vertical in 20 units horizontal (5-percent slope), it must be constructed as ramp. Surface cross slopes must not exceed one unit vertical in 48 units. Horizontal (2-percent slope).	2.3% slope at drain	Correct or repair slope to max 5% running and 2.08% cross	2015 ABAAS Section: 403.3  2012 TAS Section: 403.3  2010 ADAS Section: 403.3

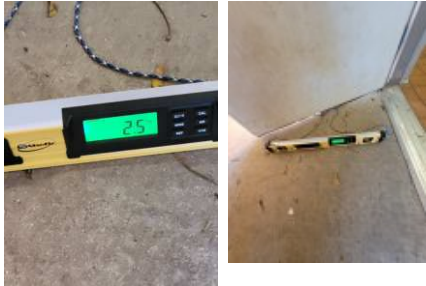
405	Picnic Area: Picnic Area Women's Restroom	[30.1829727 , -97.723349 2]	Minimum maneuvering clearances at doors and gates shall comply with 404.2.4. Maneuvering clearances shall extend the full width of the doorway and the required latch side or hinge side clearance. Maneuvering clearances shall have a max slope of 2.08%.	2.5% slope in door maneuvering clearance	For all doors along the public circulation route, correct slope in door clearance to max 2.08%.	2010 ADAS Section: 404.2.3, 404.2.7, 404.2.4, 404.2.11, 404.2.11 Exception

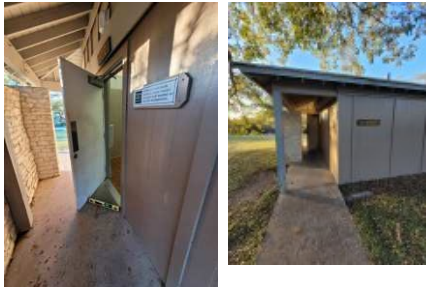
Finding Number	Area Description	Lat/Long	Finding	As Built	Recommendation	Citation	Photos	Figure
406	Picnic Area: Picnic Area Women's Restroom	[30.1829668 , -97.723363 9]	It is recommended that exterior doors be maintained so that the operating pressure does not exceed 8.5 lb. force to open. The sweep period for doors with closers shall be adjusted so that from an open position of 70 degrees, the door will take at least 3 seconds to move to a point 7 inches from the latch, measured to the leading edge of the door.	10# push	For all doors along the public circulation route, inspect, adjust, and maintain 8.5 #f to open exterior doors as a smart practice	2012 TAS Section: 404.2.9, 404.2.9 Advisory, 404.2.8.1  2010 ADAS Section: 404.2.9, 404.2.8.1		
407	Picnic Area: Picnic Area Women's Restroom	[30.1829668 , -97.723363 9]	The restroom sign does not comply with one or more applicable requirements for the location, height, and properties of the sign.	Sign lacks Braille and raised characters	Replace sign with one of contrasting colors that includes Braille, raised characters, and the symbol of accessibility and mount on the wall, latch side of the door, 48" to the baseline of the lowest character and 60" to the baseline of the highest character	2015 ABAAS Section: F216.2, 703.1, 703.2, 703.5, 703.6  2012 TAS Section: 216.2, 703.1, 703.2, 703.5, 703.6  2010 ADAS Section: 216.2, 703.1, 703.2, 703.5, 703.6

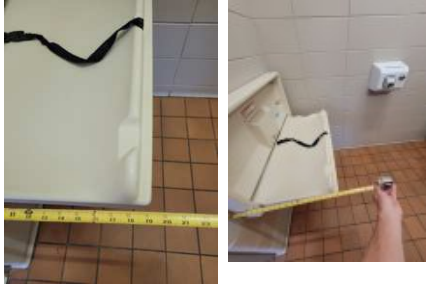
Finding Number	Area Description	Lat/Long	Finding	As Built	Recommendation	Citation	Photos	Figure
408	Picnic Area: Picnic Area Women's Restroom	[30.1829746 , -97.723347 8]	The baby changing table is not compliant. Baby changing tables are work surfaces. If fixed or built-in baby changing tables are provided, at least 5%, but not less than one, must comply with TAS 902 based TAS 226.1. Baby changing tables cannot violate the protruding object requirements in either an open or closed position since either position is a potential hazard for persons with visual impairments. Baby changing tables are not prohibited from being located in wheelchair accessible toilet compartments; however, the minimum space required for the compartment cannot be obstructed by the baby changing table in either an open or closed position. The clear floor space required for a baby changing table may overlap the water closet clearance since baby changing tables are considered convenience "fixtures" based on Advisory 604.8.1.1. The overlap is applicable only to the clear floor space and not to actual table itself. Baby changing tables must be dispersed throughout a space, however, an additional baby changing table is not required in a common use area of a toilet or bathing room when the only baby changing table is located in a toilet compartment.	Baby changing table protrudes 19" in open position	Relocate baby changing table to eliminate protrusion when in the open position.	2012 TAS Section: 226.1, 902.3, 604.3.2, 204.1, 226.1 Advisory, 226.2, 307.1, 604.8.1.1 Advisory, 902.1, 902.1 Advisory, 902.2

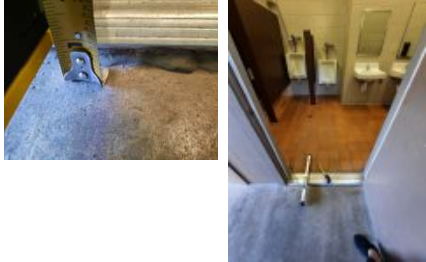
Finding Number	Area Description	Lat/Long	Finding	As Built	Recommendation	Citation	Photos	Figure
415	Homestead Trail Trailhead : Lower Falls Men's Restroom	[30.1851662 , -97.7222226]	The threshold is greater than 1/2 inch high. The threshold at a doorway shall be no higher than 1/2 inch. Changes in level between 1/4 inch and 1/2 inch must be beveled at 1:2 or less. 1/4 inch is the maximum vertical rise.	CIL of 1" at beveled threshold	For all doors along the public circulation route, replace thresholds at exterior doors with ADA thresholds	2015 ABAAS Section: 404.2.5  2012 TAS Section: 404.2.5  2010 ADAS Section: 404.2.5
