# Access Audit Site Report

**McKinney Falls State Park**  
**5808 McKinney Falls Pkwy**  
**Austin, TX 78744**  
**Accessibility Evaluation**  
**Inspection Date: 11/11/2021**  
**Inspectors: Tanya Scheibe**

Prepared By  
**WT Group**

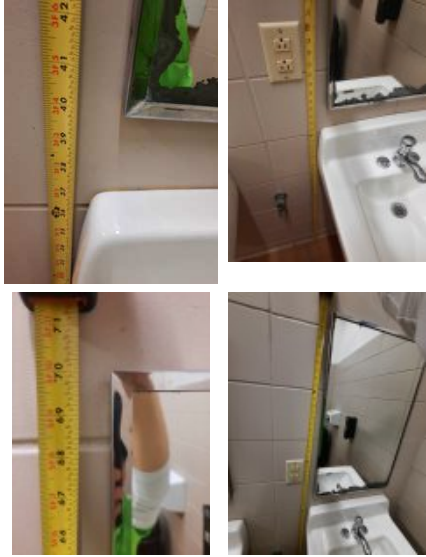
Finding Number	Area Description	Lat/Long	Finding	As Built	Recommendation	Citation	Photos	Figure
418	Homestead Trail Trailhead : Lower Falls Men's Restroom	[30.1851532 , -97.722221 3]	The mirror is mounted too high. Mirrors must have the bottom edge of the reflecting surface a maximum of 40 inches above the floor if above a sink or counter. Mirrors not located above lavatories or countertops shall be installed with the bottom edge of the reflecting surface 35 inches maximum above the finish floor or ground.	Bottom edge of reflecting surface is 40.25" AFF and top edge reflecting surface is 69.5" AFF	Replace mirror so reflective surface is max 40" and top is 74" AFF min.	2015 ABAAS Section: 603.3  2012 TAS Section: 603.3  2010 ADAS Section: 603.3

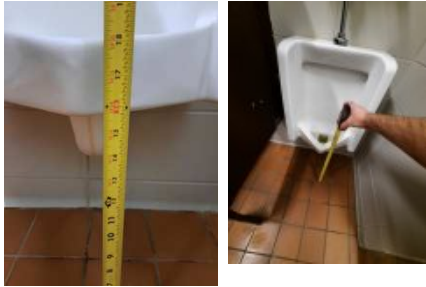
419	Homestead Trail Trailhead : Lower Falls Men's Restroom	[30.1851612 , -97.722226 6]	The rim of the urinal is too high. Wall-hung urinals must be provided with an elongated rim projecting a minimum of 13 1/2 inches from the wall and a maximum of 17 inches above the floor.	Lower of 2 urinals is mounted 18" AFF	Lower urinal so that rim height is max 17" AFF	2015 ABAAS Section: 605.2  2012 TAS Section: 605.2  2010 ADAS Section: 605.2

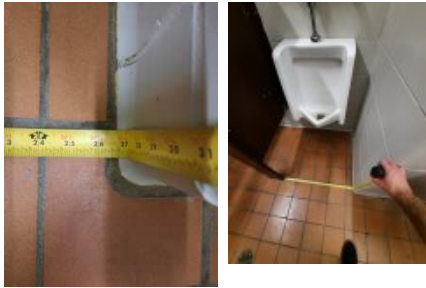
420	Homestead Trail Trailhead : Lower Falls Men's Restroom	[30.1851571 , -97.722217 3]	The urinal is located in an area that does not provide the required clear floor space for a front approach. The surrounding elements of a urinal must provide a minimum of 30 by 48 inches of clear floor space for a front approach.	Urinals lack 30" wide CFS	Relocate privacy wall at urinal to provide 30" CFS	2015 ABAAS Section: 605.2  2012 TAS Section: 605.2  2010 ADAS Section: 605.2

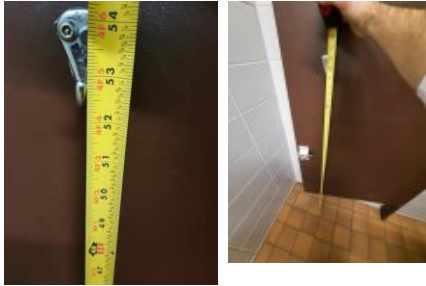
Finding Number	Area Description	Lat/Long	Finding	As Built	Recommendation	Citation	Photos	Figure
421	Homestead Trail Trailhead : Lower Falls Men's Restroom	[30.1851603 , -97.722225 3]	Where a high forward reach is over an obstruction, the clear floor space shall extend beneath the element for a distance not less than the required reach depth over the obstruction. The high forward reach shall be 48 inches (1220 mm) maximum where the reach depth is 20 inches (510 mm) maximum. Where the reach depth exceeds 20 inches (510 mm), the high forward reach shall be 44 inches (1120 mm) maximum and the reach depth shall be 25 inches (635 mm) maximum. Where a clear floor or ground space allows a parallel approach to an element and the high side reach is over an obstruction, the height of the obstruction shall be 34 inches (865 mm) maximum and the depth of the obstruction shall be 24 inches (610 mm) maximum. The high side reach shall be 48 inches (1220 mm) maximum for a reach depth of 10 inches (255 mm) maximum. Where the reach depth exceeds 10 inches (255 mm), the high side reach shall be 46 inches (1170 mm) maximum for a reach depth of 24 inches (610 mm) maximum.	2 of 2 coat hooks exceed reach range	Lower operating mechanisms in RR to max 48" AFF to highest operable part.	2015 ABAAS Section: 308.2.1, 308.3.2  2012 TAS Section: 308.2.1, 308.3.2  2010 ADAS Section: 308.2.1, 308.3.2

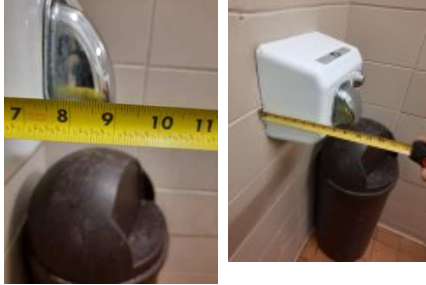
Finding Number	Area Description	Lat/Long	Finding	As Built	Recommendation	Citation	Photos	Figure
423	Homestead Trail Trailhead : Lower Falls Men's Restroom	[30.1851677 , -97.722219 9]	The dryer projects more than 4 inches into the circulation path. Wall-mounted objects that have leading edges between 27 inches and 80 inches from the floor must not project more than 4 inches into the circulation path. Protruding objects that extend to the floor or within 27 inches of the floor are cane detectable and are therefore not hazardous. Where it is necessary or desirable to have objects protrude from the wall, a manner of cane detection must be provided.	Hand dryer protrudes 9"	Relocate protruding objects or place cane detectable warning or bollard at foot of item	2015 ABAAS Section: 307.2  2012 TAS Section: 307.2  2010 ADAS Section: 307.2

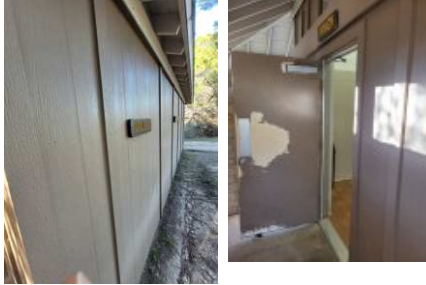
425	Homestead Trail Trailhead : Lower Falls Women's Restroom	[30.1851506 , -97.722219 9]	The restroom sign does not comply with one or more applicable requirements for the location, height, and properties of the sign. Cost included in separate finding	Sign lacks Braille and tactile characters	Replace sign with one of contrasting colors that includes Braille, raised characters, and the symbol of accessibility and mount on the wall, latch side of the door, 48" to the baseline of the lowest character and 60" to the baseline of the highest character.	2015 ABAAS Section: F216.2, 703.1, 703.2, 703.5, 703.6  2012 TAS Section: 216.2, 703.1, 703.2, 703.5, 703.6  2010 ADAS Section: 216.2, 703.1, 703.2, 703.5, 703.6

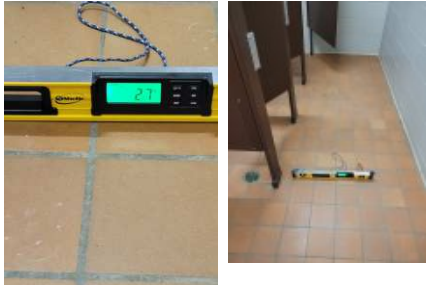
Finding Number	Area Description	Lat/Long	Finding	As Built	Recommendation	Citation	Photos	Figure
434	Homestead Trail Trailhead : Lower Falls Women's Restroom	[30.185159, -97.722226 6]	The accessible route contains running slopes greater than 5 percent and cross slopes greater than 2 percent across the width of the walk and has not been constructed as a ramp (i.e. handrails, wheel guides, etc.). When the slope in the direction of travel of any walk exceeds 1 unit vertical in 20 units horizontal (5-percent slope), it must be constructed as ramp. Surface cross slopes must not exceed one unit vertical in 48 units. Horizontal (2-percent slope).	2.7% slope at drain	Correct or repair slope to max 5% running and 2.08% cross	2015 ABAAS Section: 403.3  2012 TAS Section: 403.3  2010 ADAS Section: 403.3

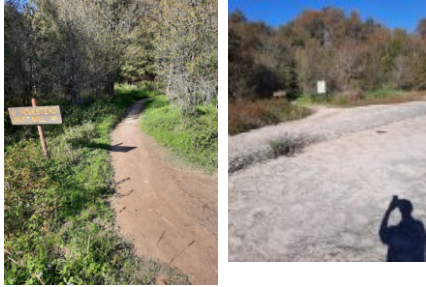
436	Homestead Trail Trailhead : Homestead Trail Trailhead	[30.1888308, -97.720417 3]	The surface of trails, passing spaces, and resting intervals shall be firm and stable	Trail lacks firm and stable surface	Replace surface of trail with one that is firm and stable as a smart practice.	2015 ABAAS Section: 1017.2

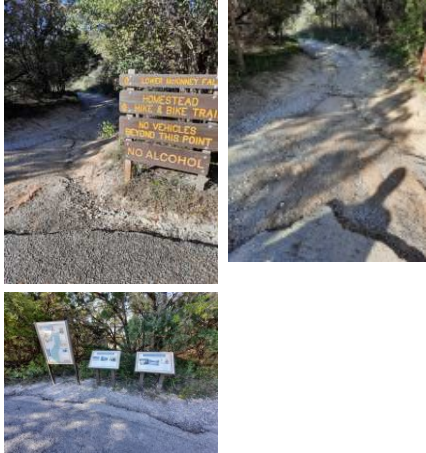
Finding Number	Area Description	Lat/Long	Finding	As Built	Recommendation	Citation	Photos	Figure
437	Homestead Trail Trailhead : Homestead Trail Trailhead	[30.186242, -97.721329]	The surface of outdoor recreation access routes, passing spaces, and resting intervals shall be firm and stable	Homestead Trail Trailhead lacks firm and stable surface, lacks AR to trailhead signs	Repair surface or ORAR to be firm and stable as a smart practice.	2015 ABAAS Section: 1016.2

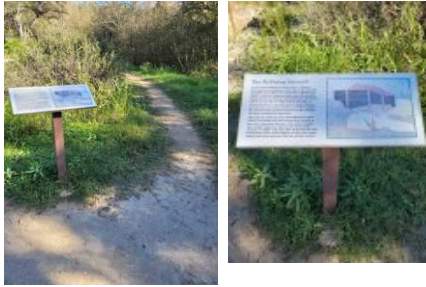
438	Homestead Trail Trailhead : Gristmill Spur Trail	[30.1887477, -97.7194968]	The surface of trails, passing spaces, and resting intervals shall be firm and stable	Trail surface inaccessible	Replace surface of trail with one that is firm and stable as a smart practice.	2015 ABAAS Section: 1017.2

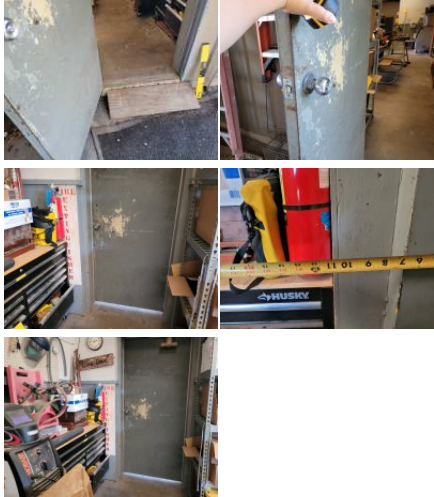
Finding Number	Area Description	Lat/Long	Finding	As Built	Recommendation	Citation	Photos	Figure
446	Employee Spaces: Maintenance	[30.184852, -97.7200109]	Minimum maneuvering clearances at doors and gates shall comply with 404.2.4. Maneuvering clearances shall extend the full width of the doorway and the required latch side or hinge side clearance. The threshold has a vertical change greater than 1/4 inch high. The threshold at a doorway shall be no higher than 1/2 inch. Changes in level between 1/4 inch and 1/2 inch must be beveled at 1:2 or less. 1/4 inch is the maximum vertical rise. The sweep period for doors with closers shall be adjusted so that from an open position of 70 degrees, the door will take at least 3 seconds to move to a point 3 inches from the latch, measured to the leading edge of the door. Exterior doors are recommended to be maintained at 8.5 #f as a smart practice. Force is to be measured at the operating hardware or 30 inches from the hinges, whichever is greater. Hand-activated door opening hardware, handles, pulls, latches, locks, and other operating devices on accessible doors shall have a shape that is easy to grasp with one hand and does not require tight grasping, tight pinching or twisting of the wrist to operate. Hardware shall be 34 inches minimum and 48 inches maximum above the finish floor or ground.	Shop side exit- large CIL, knob, toolbox push side, 15# push, closes fast, recessed 11" push side	For all doors along the public circulation route, provide required maneuvering clearance on push and pull side of doors For all doors along the public circulation route, repair, bevel, or ramp CILs at door entries to max .25" For all doors along the public circulation route, repair, provide beveled threshold For all doors along the circulation route, inspect, adjust, and maintain 8.5 #f to open exterior doors as a smart practice For all doors along the circulation route, inspect, adjust, and maintain closing speed on door closers For all doors along the circulation route, replace hardware with lever hardware or hardware operable without a tight pinch or grasp	2010 ADAS Section: 404.2.3, 404.2.7, 404.2.4, 404.2.11, 404.2.11 Exception

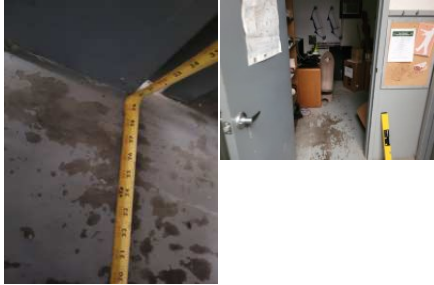
Finding Number	Area Description	Lat/Long	Finding	As Built	Recommendation	Citation	Photos	Figure
451	Employee Spaces: Maintenance	[30.1848494 , -97.720008 5]	Spaces and elements within employee work areas shall only be required to comply with 206.2.8, 207.1, and 215.3 and shall be designed and constructed so that individuals with disabilities can approach, enter, and exit the employee work area. Employee work areas, or portions of employee work areas, other than raised courtroom stations, that are less than 300 square feet (28 m2) and elevated 7 inches (180 mm) or more above the finish floor or ground where the elevation is essential to the function of the space shall not be required to comply with these requirements or to be on an accessible route.	29.5" wide door to work area	For all doors along the circulation route, replace doors with doors having 80" overhead clearance and 32" clear width	2015 ABAAS Section: F203.9  2012 TAS Section: 203.9  2010 ADAS Section: 203.9

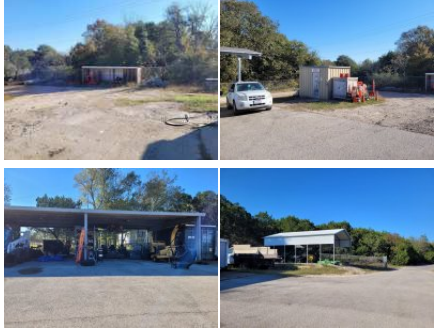
452	Employee Spaces: Maintenance	[30.1849419 , -97.720380 6]	There is no accessible route between the buildings. At least one accessible route shall connect accessible buildings, facilities, elements and spaces that are on the same site.	Outbuildings lack AR	Create AR with crushed and compacted stone or similar outdoor material from building to building within the site	2015 ABAAS Section: F206.2.2  2012 TAS Section: 206.2.2  2010 ADAS Section: 206.2.2

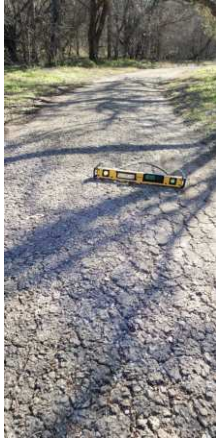
Finding Number	Area Description	Lat/Long	Finding	As Built	Recommendation	Citation	Photos	Figure
455	Trails: Trailhead	[30.1836132 , -97.728252 2]	The surface of trails, passing spaces, and resting intervals shall be firm and stable	Onion Creek Falls - surface material deteriorated on trail near woods towards picnic area	Resurface trail where deteriorated as a smart practice.	2015 ABAAS Section: 1017.2

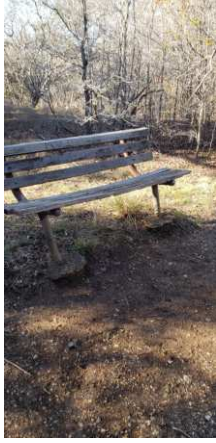
456	Trails: Trailhead	[30.1826242 , -97.728748 4]	36 inches (915 mm) by 48 inches (1220 mm) positioned near the bench with one side of the space adjoining an outdoor recreation access route or trail, as applicable The clear ground space shall not overlap the outdoor recreation access route or trail, or another clear ground space	Onion Creek Trail - No access to bench, dirt	Construct firm, stable, and slip resistant pads at least 36" by 48" adjacent to 20% of benches, and locate along an AR as a smart practice	2015 ABAAS Section: 1011.2, 1011.2.1

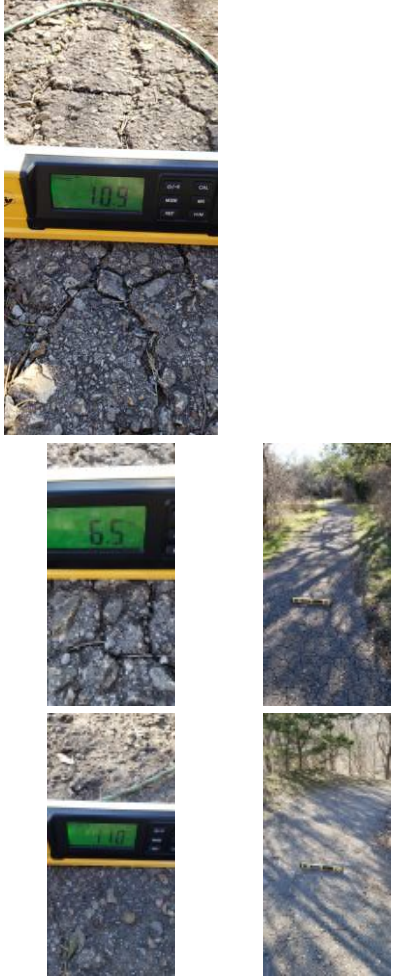
457	Trails: Trailhead	[30.1835042 , -97.72860 09], [30.1841216 , -97.727597 8]	The cross slope shall not be steeper than 1:48. EXCEPTION: Where the surface is other than concrete, asphalt, or boards, cross slopes not steeper than 1:20 shall be permitted when necessary for drainage.	Onion Creek Trail - 10.9% and 6.5% cross slope approaching woods	Correct or repair pathway cross slope to max 2.08% or 5% depending on surface as a smart practice.	2015 ABAAS Section: 1017.2

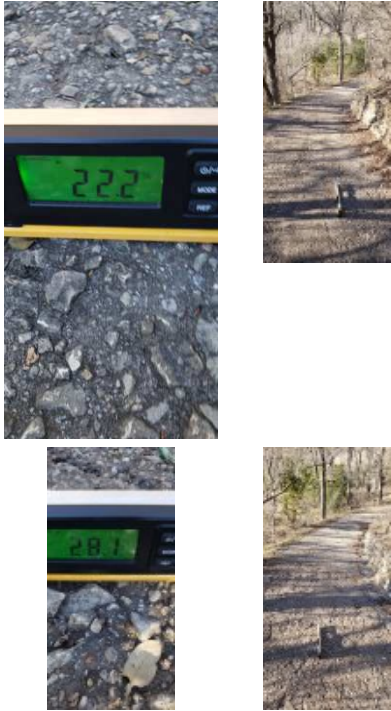
Finding Number	Area Description	Lat/Long	Finding	As Built	Recommendation	Citation	Photos	Figure
458	Trails: Trailhead	[30.177188, -97.725124 8]	Not more than 30 percent of the total length of a trail shall have a running slope steeper than 1:12 (8.33%). The running slope of any segment of a trail shall not be steeper than 1:8 (12%). Where the running slope of a segment of a trail is steeper than 1:20 (5%), the maximum length of the segment shall be in accordance with Table 1017.7.1, and a resting interval complying with 1017.8 shall be provided at the top and bottom of each segment.	Onion Creek Trail - over 20% run slope for 50'	Correct trail running slope to not exceed 8.33% slope for 200' max, 10% for 30' max or 12.5% for 10' with resting spaces on the trail as a smart practice	2015 ABAAS Section: 1017.7.1

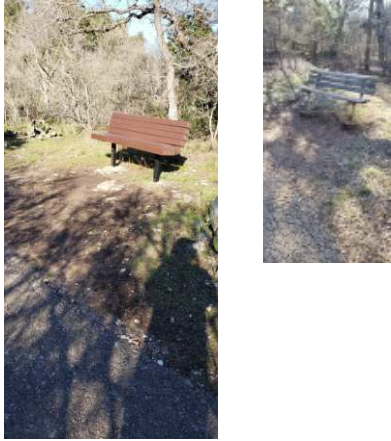
459	Trails: Trailhead	[30.1835725, -97.726149 4]	There is no accessible route to the benches. At least one accessible route shall connect accessible buildings, accessible facilities, accessible elements, and accessible spaces that are on the same site.	Onion Creek Trail - No accessible route to 2 benches on trail	Create an accessible route with crushed stone or other outdoor material from parking or walkway to the benches	2015 ABAAS Section: F206.2.2 2012 TAS Section: 206.2.2 2010 ADAS Section: 206.2.2

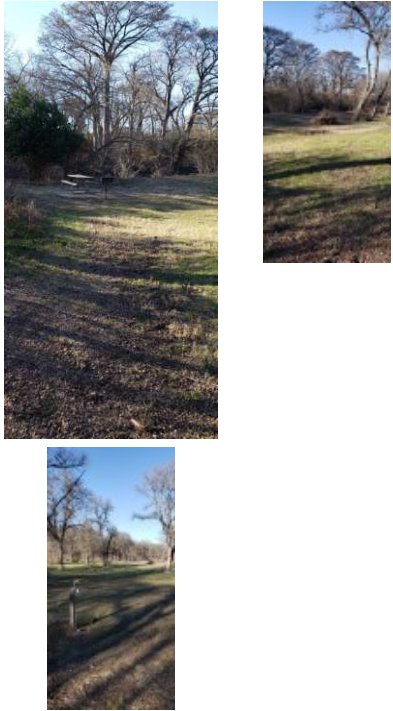
Finding Number	Area Description	Lat/Long	Finding	As Built	Recommendation	Citation	Photos	Figure
460	Trails: Trailhead	[30.1837271 , -97.727946 5]	There is no accessible route to the picnic tables At least one accessible route shall connect accessible buildings, accessible facilities, accessible elements, and accessible spaces that are on the same site.	No accessible route to picnic tables and grills - 0 of 60 picnic tables accessible	Create an accessible route with crushed stone or other outdoor material from parking or walkway to picnic tables	2015 ABAAS Section: F206.2.2  2012 TAS Section: 206.2.2  2010 ADAS Section: 206.2.2

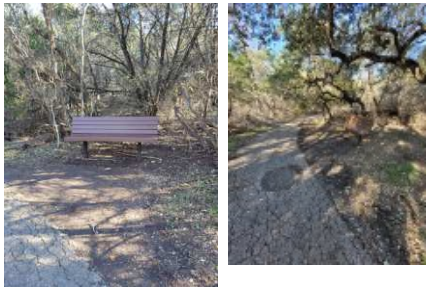
461	Trails: Trail Elements	[30.1752702 , -97.725656 6]	The element is not accessible because there is not adequate clear floor space for an approach. The clear floor or ground space shall be 30 inches minimum by 48 inches minimum.	At fork on onion creek trail - no CFS, left of fork bench same issue	Create AR with crushed and compacted stone or similar outdoor material from trail to the element	2015 ABAAS Section: 305.3  2012 TAS Section: 305.3  2010 ADAS Section: 305.3

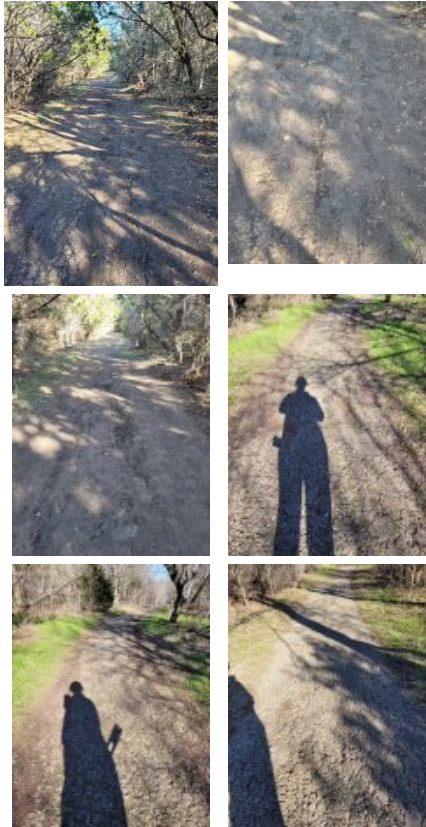
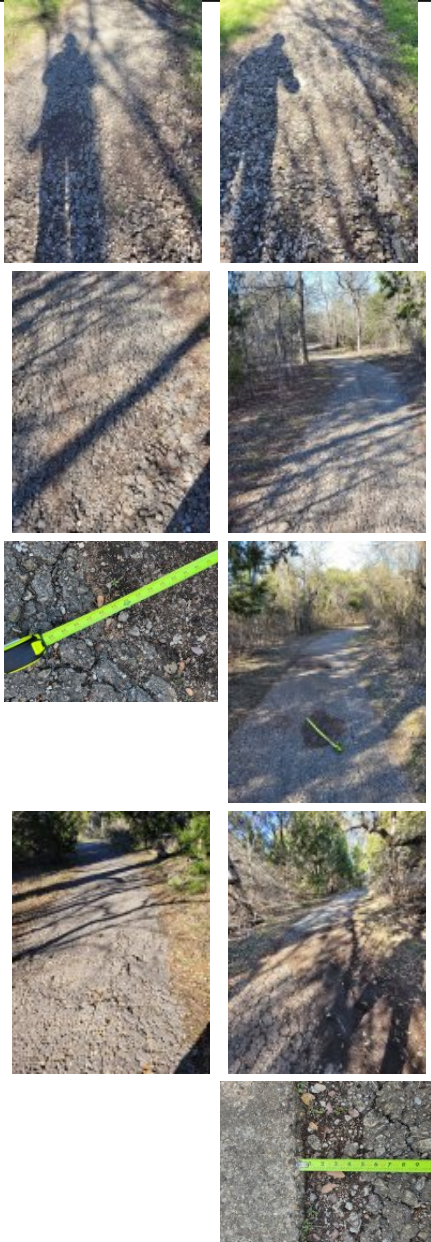
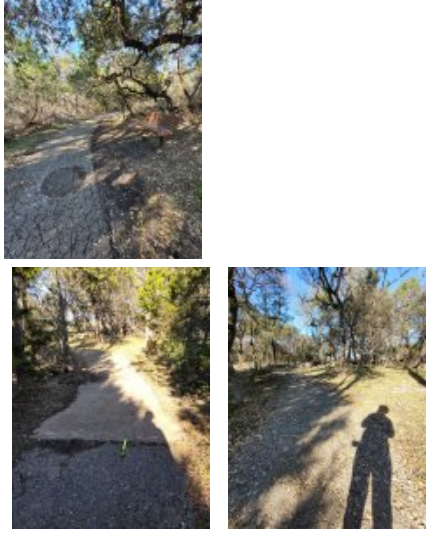
463	Trails: Trail Surface	[30.1754405 , -97.725527 1]	The surface of trails, passing spaces, and resting intervals shall be firm and stable	Onion creek, left at fork from head at site 84 - turns to Mud for est. 50 ft. directly after fork, deteriorated for most, very broken asphalt at curb, at curve parallel to site 25. 29" pothole, deterioration throughout. mud past second bench. cement creek pass before road - 5" gap before. deteriorating path after cement slab	Establish protocols for regular and frequent inspection and maintenance of accessible trail surface as a smart practice Frequently maintain trail surface in identified washout areas to assure CIL's remain 2" or less and gaps are filled as a smart practice	2015 ABAAS Section: 1017.2

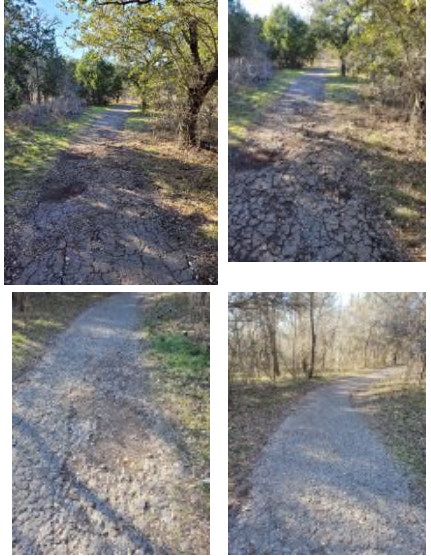
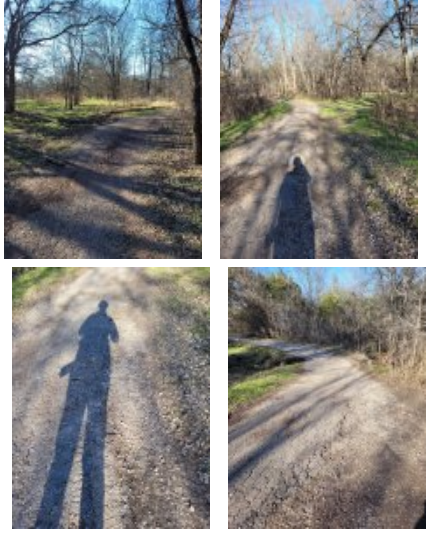
464	Trails: Trail Surface	[30.1803649 , -97.722439 9]	The surface of trails, passing spaces, and resting intervals shall be firm and stable	Onion creek, parallel to park entry - deterioration surface, deteriorated past dog bags by HQ, Mud by site 35, past stables, at electrical stuff there is deterioration, at fork - deterioration	Establish protocols for regular and frequent inspection and maintenance of accessible trail surface as a smart practice Frequently maintain trail surface in identified washout areas to assure CIL's remain 2" or less and gaps are filled as a smart practice	2015 ABAAS Section: 1017.2

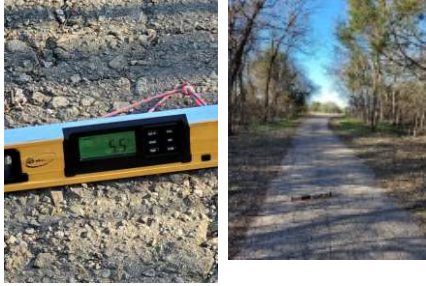
465	Trails: Trail Surface	[30.182699 , -97.72547 35], [30.1832127 , -97.725618 3]	The cross slope shall not be steeper than 1:48. EXCEPTION: Where the surface is other than concrete, asphalt, or boards, cross slopes not steeper than 1:20 shall be permitted when necessary for drainage.	After stable, past fork - 5.5% consistent until road	Correct or repair pathway cross slope to max 2.08% or 5% depending on surface as a smart practice.	2015 ABAAS Section: 1017.2

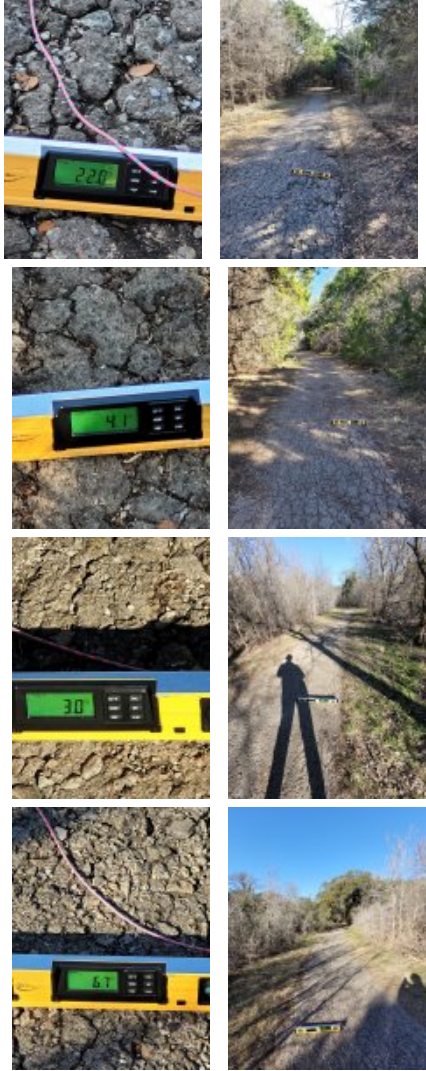
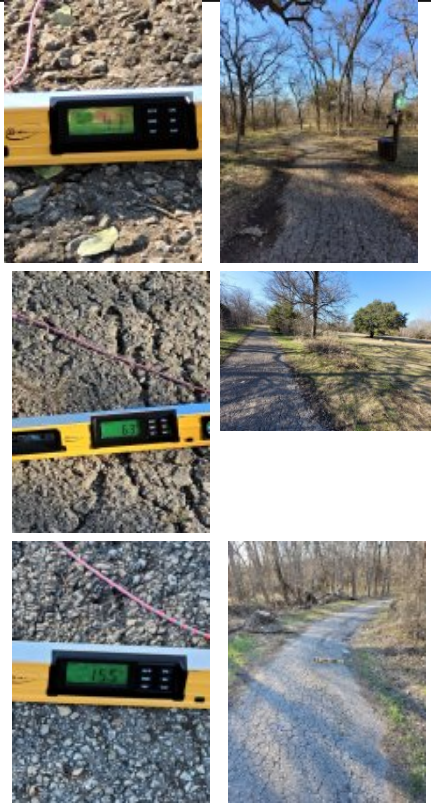
468	Trails: Trail Surface	[30.1771152 , -97.725134 8]	The cross slope shall not be steeper than 1:48. EXCEPTION: Where the surface is other than concrete, asphalt, or boards, cross slopes not steeper than 1:20 shall be permitted when necessary for drainage.	3.7% slope at entry to Onion Creek trailhead by site 84, 5.1% six yards from trailhead by 84, 22% on the path where it turns to deterioration after entry at 84. left at fork, after mud - 4.1% slope. consistent, 3% before turn in path after mud, 6.8% parallel to site 25 on map, 4.7% by dog bags near HQ, 6.3% continuously on path by yellow lid septic all the way to the road. after stable ruins - 15.5%	Correct or repair pathway cross slope to max 2.08% or 5% depending on surface as a smart practice.	2015 ABAAS Section: 1017.2

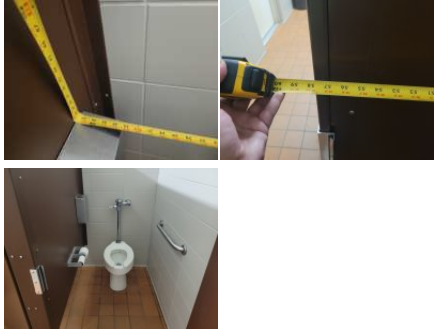
Finding Number	Area Description	Lat/Long	Finding	As Built	Recommendation	Citation	Photos	Figure
475	Amphitheater Restrooms: Amphitheater Women's Restroom	[30.1811682 , -97.728819 5]	The ambulatory stall is not between 35" to 37" wide and 60" deep.	37.5" width, 57" depth	Correct ambulatory stall to be 35" to 37" wide and minimum 60" deep	2015 ABAAS Section: 604.8.2.1  2012 TAS Section: 604.8.2.1  2010 ADAS Section: 604.8.2.1

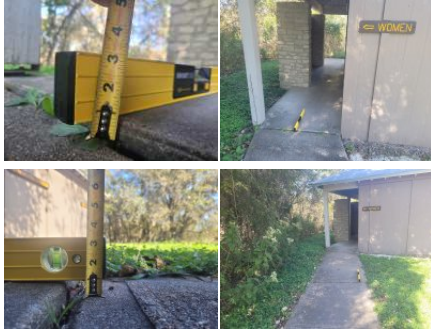
482	Amphitheater Restrooms: Amphitheater Women's Restroom	[30.181162, -97.728820 4]	The walkway contains abrupt vertical edges and/or variations over a 1/4 inch. 1/4 inch is the maximum vertical rise. Changes in level between 1/4 inch and 1/2 inch must be beveled at 1:2 or less. Changes in level greater than 1/2 inch must be by way of a ramp.	.5" CIL and 1" CIL at women's restroom	Repair or reset pavers to eliminate CIL	2012 TAS Section: 303.2, 303.3  2010 ADAS Section: 303.2, 303.3

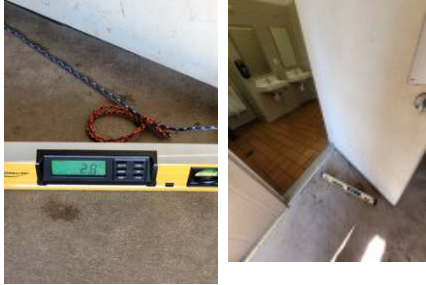
Finding Number	Area Description	Lat/Long	Finding	As Built	Recommendation	Citation	Photos	Figure
484	Amphitheater Restrooms: Amphitheater Men's Restroom	[30.1811599 , -97.728823 5]	The landing at the door does not have a compliant landing. Doors with an approach from the hinge side must have a landing on the pull side that is a minimum of 60 inches in depth perpendicular to the door in a close position by a minimum width dimension of 36 inches plus the door width. The additional 36 inches must extend past the door on the latch side. The entire landing must be free of obstructions and must be flat (2% max. slope is considered flat in any direction).	2.8% slope	For all doors along the public circulation route, correct or repair slope at doorway landing to max 2.08% in any direction for level CFS	2015 ABAAS Section: 404.2.4.1  2012 TAS Section: 404.2.4.1  2010 ADAS Section: 404.2.4.1

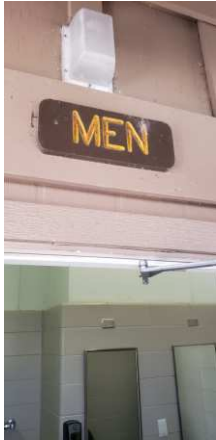
485	Amphitheater Restrooms: Amphitheater Men's Restroom	[30.1811606 , -97.728814 2]	Exterior doors exceed 8.5 lbs of force to open; fire doors shall have a minimum opening force allowable by the appropriate administrative authority	9# push	Inspect, adjust, and maintain 8.5 lbf to open exterior doors as a smart practice.	2010 ADAS Section: 404.2.9		
486	Amphitheater Restrooms: Amphitheater Men's Restroom	[30.1811547 , -97.728824 9]	The restroom sign does not comply with one or more applicable requirements for the location, height, and properties of the sign.	signage above door, lacks Braille	Replace sign with one of contrasting colors that includes Braille, raised characters, and the symbol of accessibility and mount on the wall, latch side of the door, 48" to the baseline of the lowest character and 60" to the baseline of the highest character	2015 ABAAS Section: F216.2, 703.1, 703.2, 703.5, 703.6  2012 TAS Section: 216.2, 703.1, 703.2, 703.5, 703.6  2010 ADAS Section: 216.2, 703.1, 703.2, 703.5, 703.6

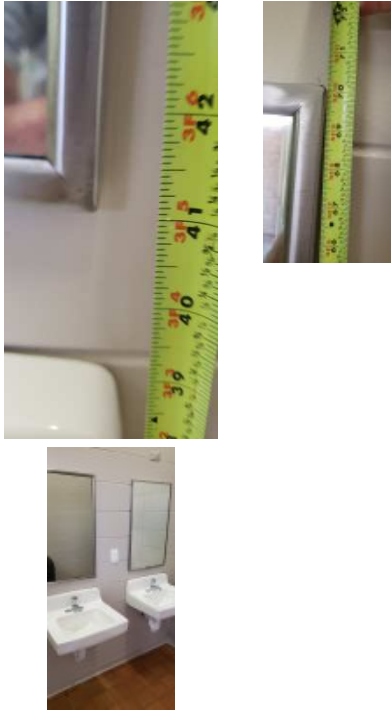
Finding Number	Area Description	Lat/Long	Finding	As Built	Recommendation	Citation	Photos	Figure
487	Amphitheater Restrooms: Amphitheater Men's Restroom	[30.1811561 , -97.7288168]	The mirror is mounted too high. Mirrors must have the bottom edge of the reflecting surface a maximum of 40 inches above the floor if above a sink or counter. Mirrors not located above lavatories or countertops shall be installed with the bottom edge of the reflecting surface 35 inches maximum above the finish floor or ground.	bottom of mirror mounted 49.5" AFF, top of mirror 69.5" AFF	Replace mirror mount to max 40" AFF to the bottom reflective surface and 74" to the top.	2015 ABAAS Section: 603.3  2012 TAS Section: 603.3  2010 ADAS Section: 603.3

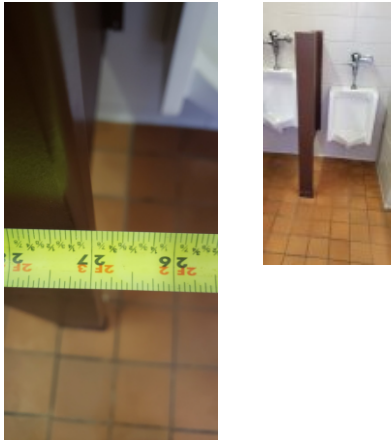
488	Amphitheater Restrooms: Amphitheater Men's Restroom	[30.1811586 , -97.7288289]	The urinal is located in an area that does not provide the required clear floor space for a front approach. The surrounding elements of a urinal must provide a minimum of 30 by 48 inches of clear floor space for a front approach.	27" width	Relocate or add a urinal in a location that provides 30" X 48" CFS for a forward approach	2015 ABAAS Section: 605.2  2012 TAS Section: 605.2  2010 ADAS Section: 605.2

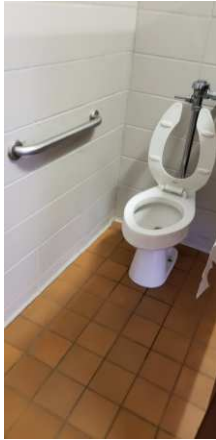
Finding Number	Area Description	Lat/Long	Finding	As Built	Recommendation	Citation	Photos	Figure
489	Amphitheater Restrooms: Amphitheater Men's Restroom	[30.1811679 , -97.728822 2]	There are not enough accessible toilet compartments. The room contains toilet compartments. A minimum of 1 must be wheelchair accessible .	lacks wheelchair accessible stall	Create a wheelchair accessible stall with grab bars and fixtures mounted in correct locations and at correct heights.	2015 ABAAS Section: F213.3.1  2012 TAS Section: 213.3.1  2010 ADAS Section: 213.3.1

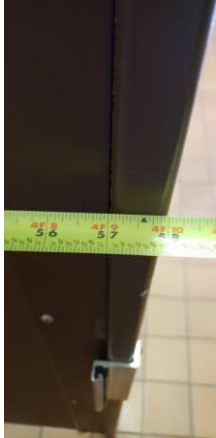
490	Amphitheater Restrooms: Amphitheater Men's Restroom	[30.1811546 , -97.728831 6]	The ambulatory stall is not between 35" to 37" wide and 60" deep.	57" depth	Correct ambulatory stall to be 35" to 37" wide and minimum 60" deep	2015 ABAAS Section: 604.8.2.1  2012 TAS Section: 604.8.2.1  2010 ADAS Section: 604.8.2.1

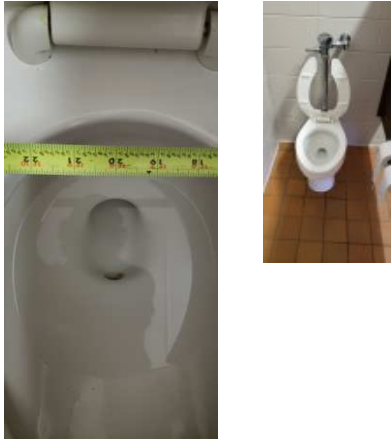
Finding Number	Area Description	Lat/Long	Finding	As Built	Recommendation	Citation	Photos	Figure
491	Amphitheater Restrooms: Amphitheater Men's Restroom	[30.1811584 , -97.728830 2]	The toilet is not located within the range to the side wall or partition. The centerline of the toilet shall be 17 inches minimum and 19 inches maximum side wall or partition in the ambulatory accessible toilet compartment.	20" from side wall to centerline	Remount toilet to 17" to 19" from the side wall to center line in ambulatory stalls	2015 ABAAS Section: 604.9.1  2012 TAS Section: 604.9.1  2010 ADAS Section: 604.9.1

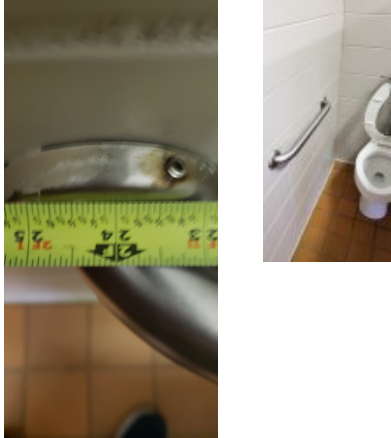
492	Amphitheater Restrooms: Amphitheater Men's Restroom	[30.1811624 , -97.728819 5]	Grab bars shall comply with 609. A side-wall grab bar complying with 604.5.1 shall be provided on both sides of the compartment. The space between the wall and the grab bar shall be 1½ inches (38 mm). The space between the grab bar and projecting objects below and at the ends shall be 1½ inches (38 mm) minimum. The space between the grab bar and projecting objects above shall be 12 inches (305 mm) minimum. Grab bars shall be installed in a horizontal position, 33 inches (840 mm) minimum and 36 inches (915 mm) maximum above the finish floor measured to the top of the gripping surface, except that at water closets for children's use complying with 604.9, grab bars shall be installed in a horizontal position 18 inches (455 mm) minimum and 27 inches (685 mm) max	grab bar 24" in length	Replace or add side grab bars with a 42" long grab bar, mounted max 12" from the rear wall at the close end and min 54" on the far end and 33" to 36" aff	2015 ABAAS Section: 604.8.2.3, 609.3, 609.4  2012 TAS Section: 609.4, 609.3, 604.8.2.3  2010 ADAS Section: 609.3, 609.4, 604.8.2.3
