Access Audit Site Report

Meridian State Park

Accessibility Evaluation

Inspection Date: 01/19/2022

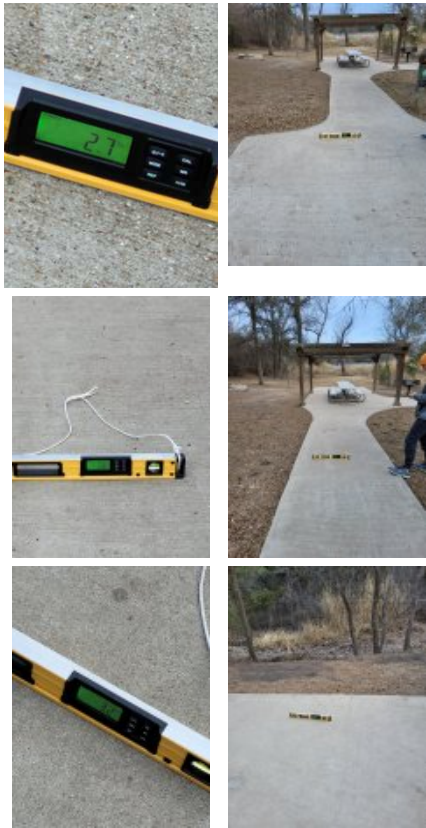
45	Cottonwood Cove Campground: Cottonwood Cove Campground (Primitive)	[31.8911195 , -97.699360 4]	The cross slope shall not be steeper than 1:48. EXCEPTION: Where the surface is other than concrete, asphalt, or boards, cross slopes not steeper than 1:20 shall be permitted when necessary for drainage.	Group camp - 2.7% at entry, 2.6% on path, 3.2% on path behind table facing creek	Correct or repair ORAR cross slope to max 2.08% or 5% for surfaces other than concrete, asphalt or board as a smart practices	2015 ABAAS Section: 1016.7.2, 1016.7.2 EXCEPTION

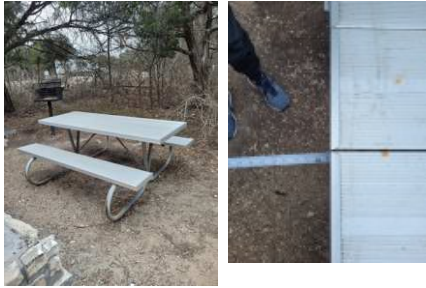
57	Crosstimbers Campground: Accessible Cabin 9	[31.8896847 , -97.699049 2]	Picnic tables shall provide at least one wheelchair space for each 24 linear feet (7320 mm) of usable table surface perimeter. Wheelchair spaces shall be 30 inches (760 mm) minimum by 48 inches (1220 mm) minimum. Wheelchair spaces shall be positioned for a forward approach to the table and provide knee and toe clearance complying with 306 under the table	11" toe clearance	Replace picnic table with one of an accessible design as a smart practice	2015 ABAAS Section: 1011.4.2

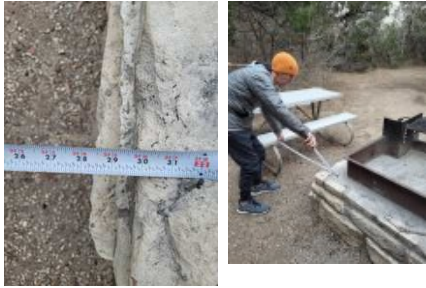
58	Crosstimbers Campground: Accessible Cabin 9	[31.889695, -97.699035 8]	36 inches (915 mm) on all usable sides of the table measured from the back edge of the benches	28.5" clearance between table and fire pit	Provide required 36" clear ground space around all usable portions of the table as a smart practice	2015 ABAAS Section: 1011.2.1

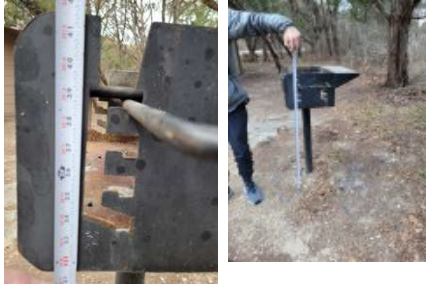
Finding Number	Area Description	Lat/Long	Finding	As Built	Recommendation	Citation	Photos	Figure
60	Crosstimbers Campground: Accessible Cabin 9	[31.8896893 , -97.6990412]	Where provided, cooking surfaces shall be 15 inches (380 mm) minimum and 34 inches (865 mm) maximum above the ground	35" to bottom level cooking surface	Raise or lower cooking surface to be 15" min to 34" max above the ground; in the alternative, replace with a compliant surface as a smart practice	2015 ABAAS Section: 1011.5.2

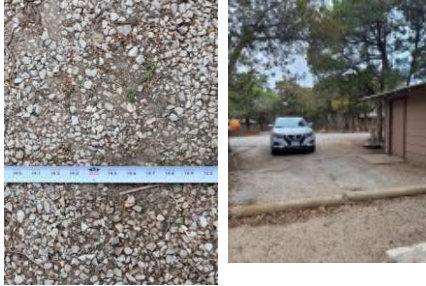
61	Crosstimbers Campground: Accessible Cabin 9	[31.8897075 , -97.6990734]	Parking spaces and pull-up spaces for recreational vehicles shall be 20 feet (6100 mm) wide minimum. EXCEPTION: Where two adjacent parking spaces are provided for recreational vehicles, one parking space shall be permitted to be 16 feet (4880 mm) wide minimum.	Cabin 9 - parking space 12' wide	Correct RV parking space to be 20' wide minimum; or 16' for two adjacent spaces as a smart practice.	2015 ABAAS Section: 1012.2, 1012.2 EXCEPTION

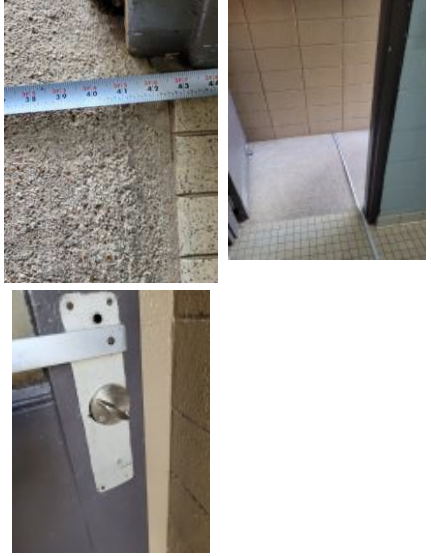
Finding Number	Area Description	Lat/Long	Finding	As Built	Recommendation	Citation	Photos	Figure
64	Crosstimbers Campground: Accessible Cabin 9	[31.8897325 , -97.699143 1]	Camping facilities shall provide camping units with mobility features complying with F244.2 in accordance with Table F244.2. Where a camping facility provides different types of camping units, Table F244.2 shall apply to each type of camping unit provided. Total Number of Camping Units Provided in Camping Facility Minimum Number of Camping Units with Mobility Features Required 1 1 2 to 25 2 26 to 50 3 51 to 75 4 76 to 100 5 101 to 150 7 151 to 200 8 201 and over 8, plus 2 percent of the number over 200	0 of 5 cabins campsites accessible	Create the required number of accessible camp sites per table F244.2 as a smart practice	2015 ABAAS Section: F244.2		
65	Crosstimbers Campground: Crosstimbers - Men's Restroom	[31.8900582 , -97.698514 1]	Minimum maneuvering clearances at doors and gates shall comply with 404.2.4. Maneuvering clearances shall extend the full width of the doorway and the required latch side or hinge side clearance. Maneuvering clearances shall have a max slope of 2.08%. Hand-activated door opening hardware, handles, pulls, latches, locks, and other operating devices on accessible doors shall have a shape that is easy to grasp with one hand and does not require tight grasping, tight pinching or twisting of the wrist to operate. Hardware shall be 34 inches minimum and 48 inches maximum above the finish floor or ground.	Men's restroom - maneuvering clearance depth reduced by rear wall to 40", hardware	For all doors along the public circulation route, provide required maneuvering clearance on push and pull side of doors. For all doors along the public circulation route, replace hardware with lever hardware or hardware operable without a tight pinch or grasp.	2010 ADAS Section: 404.2.3, 404.2.7, 404.2.4, 404.2.11, 404.2.11 Exception

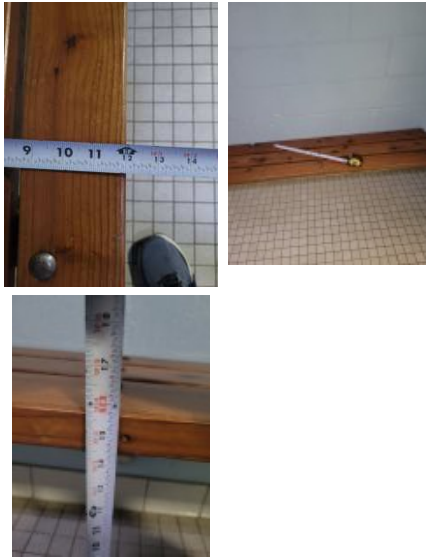
67	Crosstimbers Campground: Crosstimbers - Men's Restroom	[31.8900377 , -97.6985208]	The bench is not deep enough or long enough or is missing. Benches shall be provided having seats that are 42 inches long minimum and 20 inches deep minimum and 24 inches deep maximum. The bench shall provide for back support or shall be affixed to a wall. Back support shall be 42 inches (1065 mm) long minimum and shall extend from a point 2 inches (51 mm) maximum above the seat surface to a point 18 inches (455 mm) minimum above the seat surface. Back support shall be 2½ inches (64 mm) maximum from the rear edge of the seat measured horizontally. The top of the bench seat surface shall be 17 inches (430 mm) minimum and 19 inches (485 mm) maximum above the finish floor or ground.	Men's restroom - bench 12" seat depth, seat height 16"	Replace bench in dressing area with one having a seat depth of 20" to 24" deep, 42" long, affixed to the wall or having a back and mounted 17" to 19" aff	2012 TAS Section: 903.4, 903.2, 903.3, 903.5 2010 ADAS Section: 903.4, 903.2, 903.3, 903.5

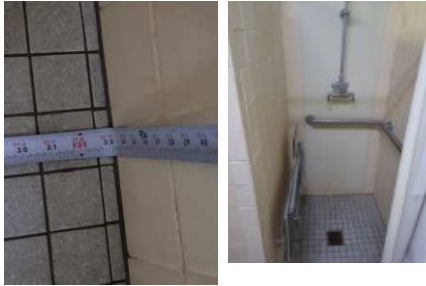
Finding Number	Area Description	Lat/Long	Finding	As Built	Recommendation	Citation	Photos	Figure
68	Crosstimbers Campground: Crosstimbers - Men's Restroom	[31.8900559 , -97.698526 2]	Transfer type shower compartments shall be 36 inches (915 mm) by 36 inches (915 mm) clear inside dimensions measured at the center points of opposing sides and shall have a 36 inch (915 mm) wide minimum entry on the face of the shower compartment. Clearance of 36 inches (915 mm) wide minimum by 48 inches (1220 mm) long minimum measured from the control wall shall be provided.	Men's restroom - shower stall 33" width	Enlarge transfer shower to compliant 36" by 36" clear inside dimension	2015 ABAAS Section: 608.2.1 2012 TAS Section: 608.2.1 2010 ADAS Section: 608.2.1

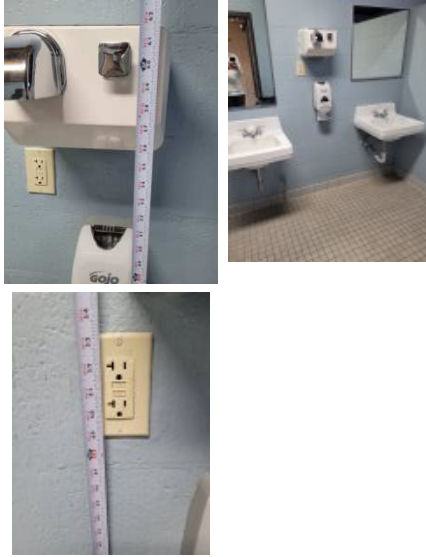
Finding Number	Area Description	Lat/Long	Finding	As Built	Recommendation	Citation	Photos	Figure
72	Crosstimbers Campground: Crosstimbers - Men's Restroom	[31.8900423 , -97.698523 5]	Where a high forward reach is over an obstruction, the clear floor space shall extend beneath the element for a distance not less than the required reach depth over the obstruction. The high forward reach shall be 48 inches (1220 mm) maximum where the reach depth is 20 inches (510 mm) maximum. Where the reach depth exceeds 20 inches (510 mm), the high forward reach shall be 44 inches (1120 mm) maximum and the reach depth shall be 25 inches (635 mm) maximum. Where a clear floor or ground space allows a parallel approach to an element and the high side reach is over an obstruction, the height of the obstruction shall be 34 inches (865 mm) maximum and the depth of the obstruction shall be 24 inches (610 mm) maximum. The high side reach shall be 48 inches (1220 mm) maximum for a reach depth of 10 inches (255 mm) maximum. Where the reach depth exceeds 10 inches (255 mm), the high side reach shall be 46 inches (1170 mm) maximum for a reach depth of 24 inches (610 mm) maximum.	Men's restroom - hand dryer 60" and outlet 50.5" above finished floor	Lower operable parts to max 44" above the finished floor (AFF) for a forward reach over counter.	2015 ABAAS Section: 308.2.1, 308.3.2 2012 TAS Section: 308.2.1, 308.3.2 2010 ADAS Section: 308.2.1, 308.3.2

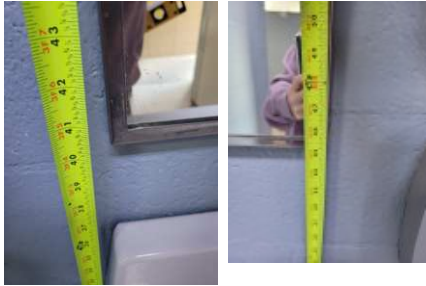
Finding Number	Area Description	Lat/Long	Finding	As Built	Recommendation	Citation	Photos	Figure
80	Crosstimbers Campground: Crosstimbers - Women's Restroom	[31.8900764 , -97.698534 2]	The mirror is mounted too high. Mirrors must have the bottom edge of the reflecting surface a maximum of 40 inches above the floor if above a sink or counter. Mirrors not located above lavatories or countertops shall be installed with the bottom edge of the reflecting surface 35 inches maximum above the finish floor or ground.	Women's restroom - mirrors mounted 40.5" and 45.5" above finished floor	Lower mirror so reflective surface is max 40" aff	2015 ABAAS Section: 603.3 2012 TAS Section: 603.3 2010 ADAS Section: 603.3

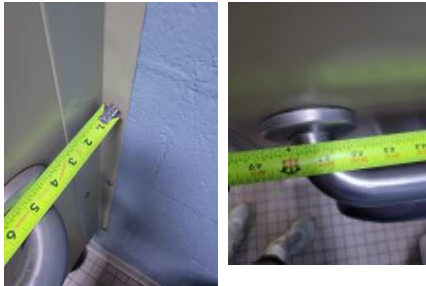
84	Crosstimbers Campground: Crosstimbers - Women's Restroom	[31.8900741 , -97.698526 2]	The side grab bars are not in the correct location. Grab bars on the side wall must be installed so that the end closest to the rear wall is maximum 12" from the rear wall. The end furthest from the rear wall must be mounted minimum 54" from the rear wall.	Women's restroom partition side grab bar - mounted 5.5" from rear wall, extends to 47.5" from rear wall	Remount side grab bar to max 12" from the rear wall at the close end and min 54" on the far end, and 33" to 36" aff	2015 ABAAS Section: 604.5.1 2012 TAS Section: 604.5.1 2010 ADAS Section: 604.5.1

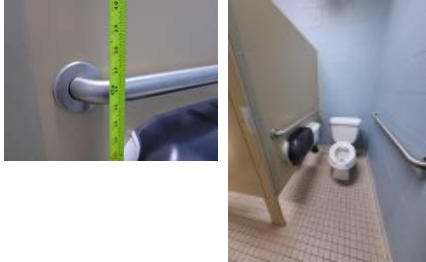
85	Crosstimbers Campground: Crosstimbers - Women's Restroom	[31.8900696 , -97.698528 9]	The grab bar height and/or spacing fails. Grab bars must be mounted between 33" and 36" to the top of the gripping surface. There must be 1.5" of clearance between the grab bar and the wall. There must be a minimum of 1.5" of clearance below and minimum 12" above the grab bar to any dispenser or other obstruction.	Women's restroom - partition side grab bar is 36.5" above finished floor	Remount grab bars in accessible stall to 33" to 36" aff	2015 ABAAS Section: 609.3, 609.4 2012 TAS Section: 609.4, 609.3 2010 ADAS Section: 609.3, 609.4

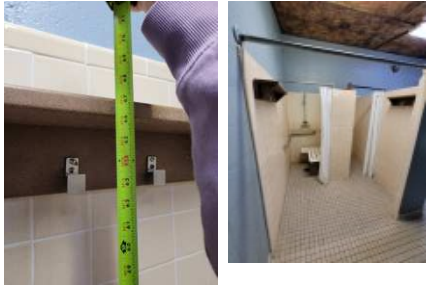
Finding Number	Area Description	Lat/Long	Finding	As Built	Recommendation	Citation	Photos	Figure
86	Crosstimbers Campground: Crosstimbers - Women's Restroom	[31.8900741 , -97.698526 2]	Coat hooks provided within the room shall be located within one of the reach ranges specified in 308. Shelves shall be 40 inches (1015 mm) minimum and 48 inches (1220 mm) maximum above the finish floor or ground. Where coat hooks or shelves are provided in dressing, fitting or locker rooms without individual compartments, at least one of each type shall comply with 803.5. Where coat hooks or shelves are provided in individual compartments at least one of each type complying with 803.5 shall be provided in individual compartments in dressing, fitting, or locker rooms required to comply with 222.1.	Women's restroom - hooks 62" and shelf 67"	Remount at least one hook to max 48" aff and shelves to 40" - 48" aff	2015 ABAAS Section: 308.2.1, 308.1, F222.2, 803.5 2012 TAS Section: 308.2.1, 308.1, 222.2, 803.5 2010 ADAS Section: 308.2.1, 308.1, 222.2, 803.5

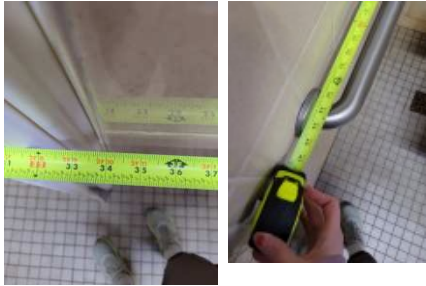
Finding Number	Area Description	Lat/Long	Finding	As Built	Recommendation	Citation	Photos	Figure
88	Crosstimbers Campground: Crosstimbers - Women's Restroom	[31.8900753, -97.6985356]	Transfer type shower compartments shall be 36 inches (915 mm) by 36 inches (915 mm) clear inside dimensions measured at the center points of opposing sides and shall have a 36 inch (915 mm) wide minimum entry on the face of the shower compartment. Clearance of 36 inches (915 mm) wide minimum by 48 inches (1220 mm) long minimum measured from the control wall shall be provided.	Women's restroom - shower stall 40" depth x 34" width	Correct transfer shower to compliant 36" by 36" clear inside dimension	2015 ABAAS Section: 608.2.1 2012 TAS Section: 608.2.1 2010 ADAS Section: 608.2.1

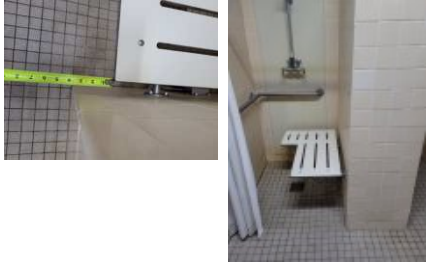
90	Crosstimbers Campground: Crosstimbers - Women's Restroom	[31.890073, -97.6985302]	Where a seat is provided in a standard roll-in shower compartment, it shall be a folding type, shall be installed on the side wall adjacent to the controls, and shall extend from the back wall to a point within 3 inches (75 mm) of the compartment entry. Where a seat is provided in an alternate roll-in type shower compartment, it shall be a folding type, shall be installed on the front wall opposite the back wall, and shall extend from the adjacent side wall to a point within 3 inches (75 mm) of the compartment entry. In transfer-type showers, the seat shall extend from the back wall to a point within 3 inches (75 mm) of the compartment entry. The top of the seat shall be 17 inches (430 mm) minimum and 19 inches (485 mm) maximum above the bathroom finish floor. Seats shall comply with 610.3.1 or 610.3.2.	Women's restroom - seat mounted 3.5" from compartment entry	Remount shower seat to within 3" of the opening	2015 ABAAS Section: 610.3 2012 TAS Section: 610.3 2010 ADAS Section: 610.3

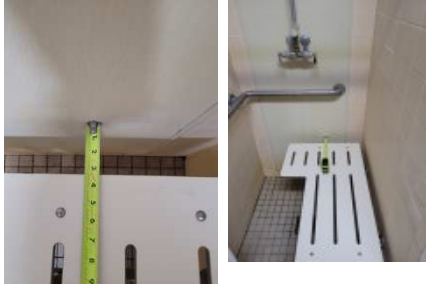
Finding Number	Area Description	Lat/Long	Finding	As Built	Recommendation	Citation	Photos	Figure
91	Crosstimbers Campground: Crosstimbers - Women's Restroom	[31.8900764 , -97.698530 2]	The shower seat does not have a compliant space between it and the wall. The folding seat must be mounted 17-19 inches above the floor, and have a maximum space of 1-1/2 inches between the edge of the seat and the side wall and 2-1/2 inches maximum to the seat wall.	Women's restroom - shower seat installed 3.25" from back wall	Remount shower seat to the correct location and height in the shower	2015 ABAAS Section: 610.3.2 2012 TAS Section: 610.3.2 2010 ADAS Section: 610.3.2

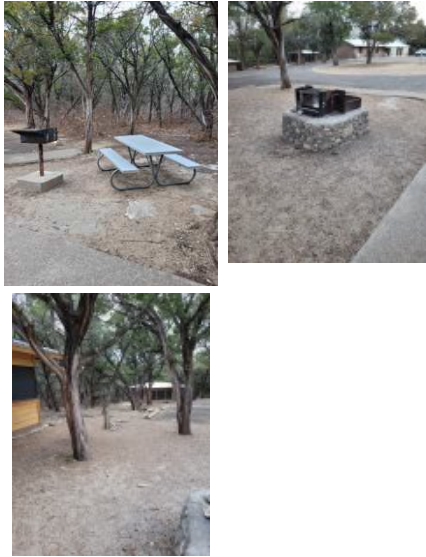
95	Juniper Ridge Campground: Accessible Shelter 18	[31.8912629 , -97.700945 5]	An accessible access route is not provided between elements, spaces and the facilities provided within the accessible camping unit. At least one outdoor recreation access route shall connect accessible elements, spaces and facilities provided within camping units with mobility features.	lacks accessible route to grill and picnic table	Create AR with crushed and compacted stone or similar outdoor material to camp sites and one of each type of amenity.	2015 ABAAS Section: F244.5.1

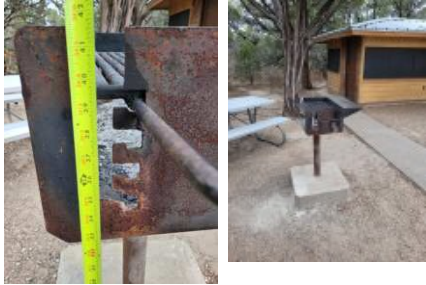
Finding Number	Area Description	Lat/Long	Finding	As Built	Recommendation	Citation	Photos	Figure
100	Juniper Ridge Campground: Accessible Shelter 18	[31.8912561, -97.7009214]	Where provided, cooking surfaces shall be 15 inches (380 mm) minimum and 34 inches (865 mm) maximum above the ground	35" to lowest level cooking surface	Raise or lower cooking surface to be 15" min to 34" max above the ground; in the alternative, replace with a compliant surface as a smart practice	2015 ABAAS Section: 1011.5.2

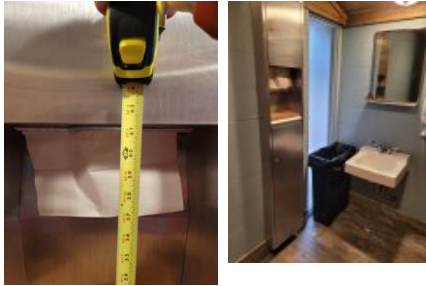
Finding Number	Area Description	Lat/Long	Finding	As Built	Recommendation	Citation	Photos	Figure
108	Juniper Ridge Campground: Juniper Ridge - Men's Restroom	[31.891231, -97.701530 3]	The operable part is positioned too high for either a side or front approach. Where a clear floor or ground space allows a parallel approach to an element and the side reach is unobstructed, the high side reach shall be 48 inches maximum and the low side reach shall be 15 inches minimum above the finish floor or ground. Where a forward reach is unobstructed, the high forward reach shall be 48 inches maximum and the low forward reach shall be 15 inches minimum above the finish floor or ground.	Men's restroom - paper towels 60" above finished floor	Remount operable parts to be in reach range of 15" min to 48" max	2015 ABAAS Section: 308.1 2012 TAS Section: 308.1 2010 ADAS Section: 308.1

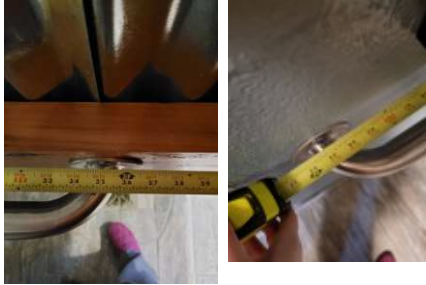
Finding Number	Area Description	Lat/Long	Finding	As Built	Recommendation	Citation	Photos	Figure
113	Juniper Ridge Campground: Juniper Ridge - Men's Restroom	[31.8912356 , -97.701530 3]	Grab bars shall comply with 609. A side-wall grab bar complying with 604.5.1 shall be provided on both sides of the compartment. The space between the wall and the grab bar shall be 1½ inches (38 mm). The space between the grab bar and projecting objects below and at the ends shall be 1½ inches (38 mm) minimum. The space between the grab bar and projecting objects above shall be 12 inches (305 mm) minimum. Grab bars shall be installed in a horizontal position, 33 inches (840 mm) minimum and 36 inches (915 mm) maximum above the finish floor measured to the top of the gripping surface, except that at water closets for children's use complying with 604.9, grab bars shall be installed in a horizontal position 18 inches (455 mm) minimum and 27 inches (685 mm) max	Men's restroom - side grab bars 35" on both sides	Replace side grab bars with a 42" long grab bar, mounted max 12" from the rear wall at the close end and min 54" on the far end and 33" to 36" aff	2015 ABAAS Section: 604.8.2.3, 609.3, 609.4 2012 TAS Section: 609.4, 609.3, 604.8.2.3 2010 ADAS Section: 609.3, 609.4, 604.8.2.3

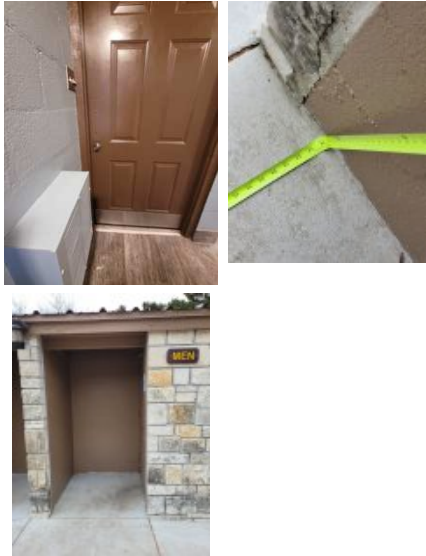
Finding Number	Area Description	Lat/Long	Finding	As Built	Recommendation	Citation	Photos	Figure
115	Juniper Ridge Campground: Juniper Ridge - Men's Restroom	[31.891231, -97.701524 9]	Minimum maneuvering clearances at doors and gates shall comply with 404.2.4. Maneuvering clearances shall extend the full width of the doorway and the required latch side or hinge side clearance.	Men's restroom - maneuvering clearance reduced by heater on push side, 44" clearance at entry path	For all doors along the public circulation route, provide required maneuvering clearance on push and pull side of doors	2010 ADAS Section: 404.2.3, 404.2.7, 404.2.4, 404.2.11, 404.2.11 Exception

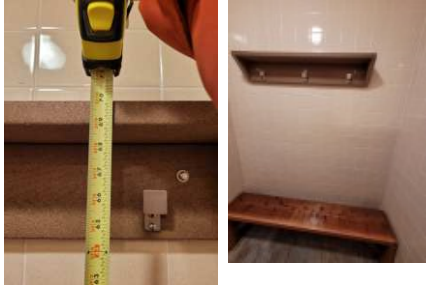
118	Juniper Ridge Campground: Juniper Ridge - Women's Restroom	[31.8912265 , -97.7015195]	Coat hooks provided within the room shall be located within one of the reach ranges specified in 308. Shelves shall be 40 inches (1015 mm) minimum and 48 inches (1220 mm) maximum above the finish floor or ground. Where coat hooks or shelves are provided in dressing, fitting or locker rooms without individual compartments, at least one of each type shall comply with 803.5. Where coat hooks or shelves are provided in individual compartments at least one of each type complying with 803.5 shall be provided in individual compartments in dressing, fitting, or locker rooms required to comply with 222.1.	Women's restroom - 66" to hook and 70" to shelf above finished floor	Remount at least one hook to max 48" aff and shelves to 40" - 48" aff	2015 ABAAS Section: 308.2.1, 308.1, F222.2, 803.5 2012 TAS Section: 308.2.1, 308.1, 222.2, 803.5 2010 ADAS Section: 308.2.1, 308.1, 222.2, 803.5

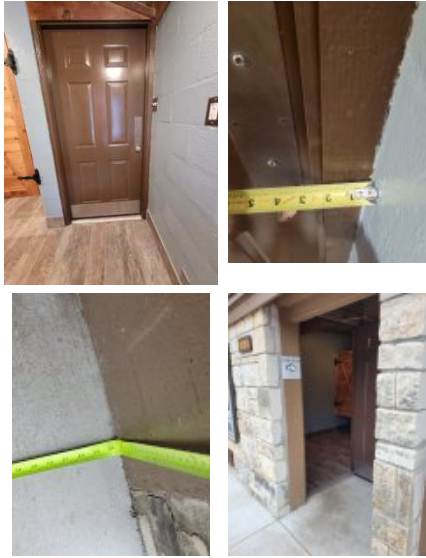
Finding Number	Area Description	Lat/Long	Finding	As Built	Recommendation	Citation	Photos	Figure
121	Juniper Ridge Campground: Juniper Ridge - Women's Restroom	[31.8912447 , -97.7015115]	Minimum maneuvering clearances at doors and gates shall comply with 404.2.4. Maneuvering clearances shall extend the full width of the doorway and the required latch side or hinge side clearance.	women's- 2.5" clearance on push, 44" width at entry	For all doors along the public circulation route, provide required maneuvering clearance on push and pull side of doors	2010 ADAS Section: 404.2.3, 404.2.7, 404.2.4, 404.2.11, 404.2.11 Exception

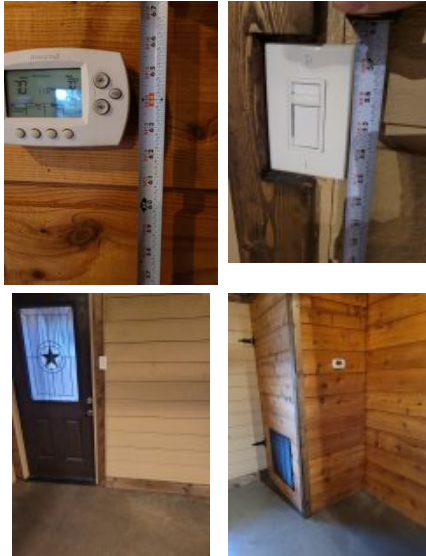
Finding Number	Area Description	Lat/Long	Finding	As Built	Recommendation	Citation	Photos	Figure
123	Juniper Ridge Campground: Juniper Ridge - Dining Hall	[31.8912219 , -97.701519 5]	The operable part is positioned too high for either a side or front approach. Where a clear floor or ground space allows a parallel approach to an element and the side reach is unobstructed, the high side reach shall be 48 inches maximum and the low side reach shall be 15 inches minimum above the finish floor or ground. Where a forward reach is unobstructed, the high forward reach shall be 48 inches maximum and the low forward reach shall be 15 inches minimum above the finish floor or ground.	hvac controls 65", light switch 56" aff	Remount operable parts to be in reach range of 15" min to 48" max	2015 ABAAS Section: 308.1 2012 TAS Section: 308.1 2010 ADAS Section: 308.1

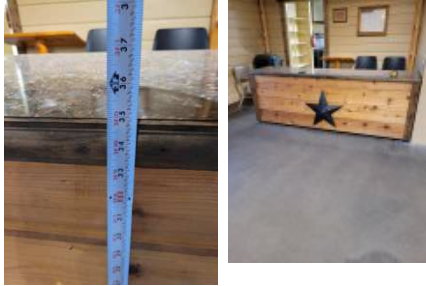
124	Juniper Ridge Campground: Juniper Ridge - Dining Hall	[31.8912379 , -97.701524 9]	The top of the work surface is not within a compliant height range. The tops of tables and counters shall be 28 inches to 34 inches from the floor or ground.	work surface 35" above finished floor	Provide tables and work surfaces at 28" to 34" aff with required knee and toe clearances	2015 ABAAS Section: 902.3 2012 TAS Section: 902.3 2010 ADAS Section: 902.3

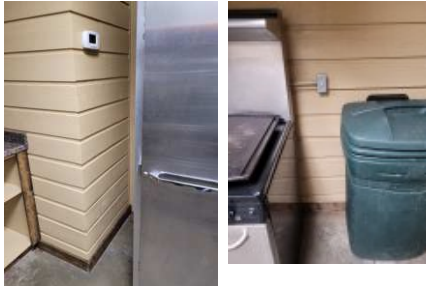
127	Juniper Ridge Campground: Juniper Ridge - Dining Hall	[31.8912356 , -97.701530 3]	The operable part is not accessible because there is not adequate clear floor space for either a forward or side approach. The clear floor or ground space shall be 30 inches minimum by 48 inches minimum.	hvac controls and light switch lack clear floor space due to refrigerator and garbage	Remove, or relocate storage in CFS at fixtures and operable parts along the AR	2015 ABAAS Section: 305.3 2012 TAS Section: 305.3 2010 ADAS Section: 305.3

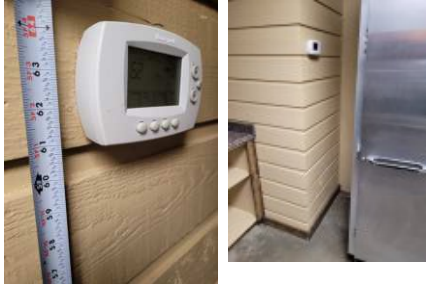
128	Juniper Ridge Campground: Juniper Ridge - Dining Hall	[31.8912356 , -97.701532 9]	The operable part is positioned too high for either a side or front approach. Where a clear floor or ground space allows a parallel approach to an element and the side reach is unobstructed, the high side reach shall be 48 inches maximum and the low side reach shall be 15 inches minimum above the finish floor or ground. Where a forward reach is unobstructed, the high forward reach shall be 48 inches maximum and the low forward reach shall be 15 inches minimum above the finish floor or ground.	hvac controls installed 63.5" above finished floor	Remount operable parts to be in reach range of 15" min to 48" max	2015 ABAAS Section: 308.1 2012 TAS Section: 308.1 2010 ADAS Section: 308.1

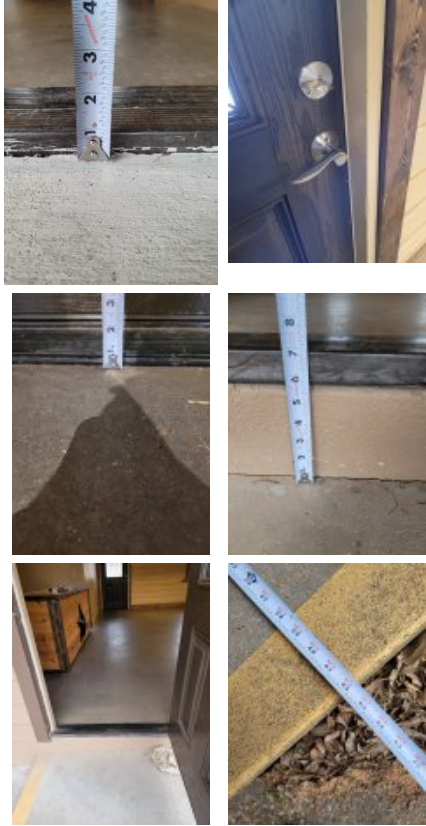
130	Juniper Ridge Campground: Juniper Ridge - Dining Hall	[31.89123, -97.70149]	Minimum maneuvering clearances at doors and gates shall comply with 404.2.4. Maneuvering clearances shall extend the full width of the doorway and the required latch side or hinge side clearance. The threshold has a vertical change greater than 1/4 inch high. The threshold at a doorway shall be no higher than 1/2 inch. Changes in level between 1/4 inch and 1/2 inch must be beveled at 1:2 or less. 1/4 inch is the maximum vertical rise. Exterior doors are recommended to be maintained at 8.5 lbf as a smart practice. Force is to be measured at the operating hardware or 30 inches from the hinges, whichever is greater. Hand-activated door opening hardware, handles, pulls, latches, locks, and other operating devices on accessible doors shall have a shape that is easy to grasp with one hand and does not require tight grasping, tight pinching or twisting of the wrist to operate. Hardware shall be 34 inches minimum and 48 inches maximum above the finish floor or ground.	front door - 1" CIL on pull side, maneuvering clearance reduced by elevated 6" landing area, and .75" CIL on push, lock hardware requires pinch, 18#; backdoor to patio - pull side 7" CIL, landing has 42" depth, maneuvering clearance reduced by elevated stoop, lock hardware requires pinch, 18#	For all doors along the public circulation route, provide required maneuvering clearance on push and pull side of doors For all doors along the public circulation route, repair, bevel, or ramp CILs at door entries to max .25" For all doors along the public circulation route, repair, provide beveled threshold For all doors along the public circulation route, inspect, adjust, and maintain 8.5 lbf to open exterior doors as a smart practice For all doors along the public circulation route, replace hardware with lever hardware or hardware operable without a tight pinch or grasp	2010 ADAS Section: 404.2.3, 404.2.7, 404.2.4, 404.2.11, 404.2.11 Exception

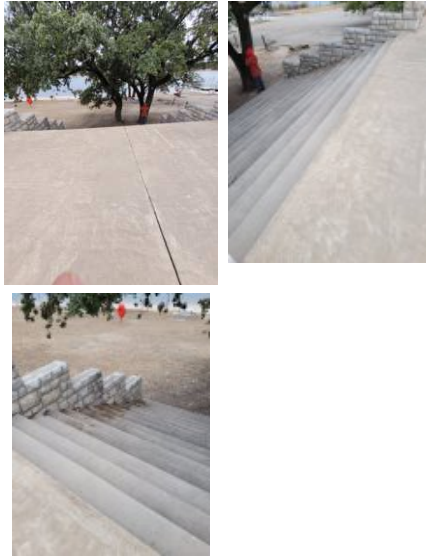
Finding Number	Area Description	Lat/Long	Finding	As Built	Recommendation	Citation	Photos	Figure
138	Lakeside Campground: Lakeside - Swimming	[31.8887442 , -97.699851 2]	Stairways must have handrails on both sides. Handrails and their extensions must be between 34 inches and 38 inches above the stair nosing or ground. The top handrails shall extend a minimum of 12 inches beyond the top nosing and shall be parallel with the floor or ground surface. At the bottom of a stair flight, handrails shall extend at the slope of the stair flight for a horizontal distance at least equal to one tread depth beyond the last riser nosing. Extension shall return to a wall, guard, or the landing surface, or shall be continuous to the handrail of an adjacent stair flight. The orientation of at least one handrail, including the extension, shall be in the direction of the run of the stair and perpendicular to the direction of the stair nosing. Handrail gripping surfaces with a circular cross section shall have an outside diameter of 1-1/4 inches minimum and 2 inches maximum. Handrail gripping surfaces with a non-circular cross section shall have a perimeter dimension of 4 inches minimum and 6 1/4 inches maximum, and a cross-section dimension of 2-1/4 inches maximum. The hand grip portion of handrails shall have a smooth surface with no sharp corners. Gripping surfaces (top or sides) shall be uninterrupted by newel posts, other construction elements or obstructions. Any wall or other surface adjacent to the handrail shall be free of sharp or abrasive elements. Handrails projecting from a wall shall have a space of 1-1/2 inches minimum between the wall and the handrail.	Stairway lacks handrails on both sides	Install handrails on both sides of stairway, mounted 34" to 38" aff with top and bottom extensions and having a 1.25" – 2" in diameter, or a non-circular grip that has a perimeter dimension of 4"- 6.25" max with a min gap of 1.5" between handrail and wall	2015 ABAAS Section: 505.2 2012 TAS Section: 505.2 2010 ADAS Section: 505.2

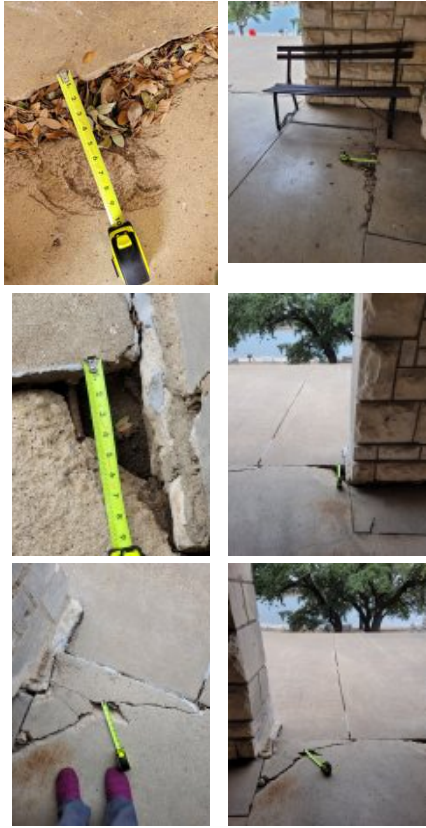
Finding Number	Area Description	Lat/Long	Finding	As Built	Recommendation	Citation	Photos	Figure
139	Lakeside Campground: Lakeside - Picnic Area	[31.8887601 , -97.699835 1]	There is a gap spaced greater than a 1/2 inch. Openings in floor or ground surfaces shall not allow passage of a sphere more than 1/2 inch diameter. Elongated openings shall be placed so that the long dimension is perpendicular to the dominant direction of travel.	Gaps - 9" on right side facing water, 7" center, 5" center	Correct or fill gaps to be max .5"	2015 ABAAS Section: 302.3 2012 TAS Section: 302.3 2010 ADAS Section: 302.3

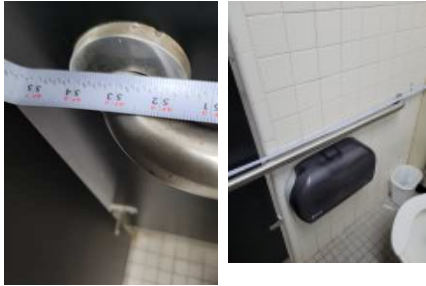
Finding Number	Area Description	Lat/Long	Finding	As Built	Recommendation	Citation	Photos	Figure
149	Lakeside Campground: Lakeside - Men's Restroom	[31.8888056 , -97.6997707]	The side grab bars are not in the correct location. Grab bars on the side wall must be installed so that the end closest to the rear wall is maximum 12" from the rear wall. The end furthest from the rear wall must be mounted minimum 54" from the rear wall.	Men's restroom - side grab bar installed 53" from back wall	Remount side grab bar to max 12" from the rear wall at the close end and min 54" on the far end, and 33" to 36" aff	2015 ABAAS Section: 604.5.1 2012 TAS Section: 604.5.1 2010 ADAS Section: 604.5.1

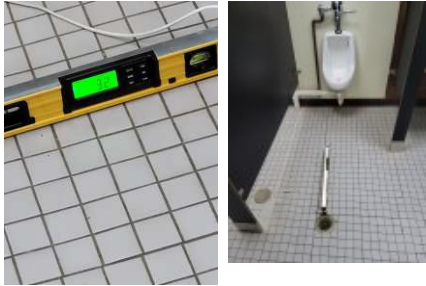
Finding Number	Area Description	Lat/Long	Finding	As Built	Recommendation	Citation	Photos	Figure
152	Lakeside Campground: Lakeside - Men's Restroom	[31.8888011 , -97.6997815]	The accessible route contains cross slopes greater than 2 percent across the width of the walk and has not been constructed as a ramp (i.e. handrails, wheel guides, etc.). When the slope in the direction of travel of any walk surface must not exceed one unit vertical in 48 units. Horizontal (2-percent slope).	Men's restroom - 3.2% near urinal and drain	Correct or repair slope to max 2.08% cross.	2015 ABAAS Section: 403.3 2012 TAS Section: 403.3 2010 ADAS Section: 403.3

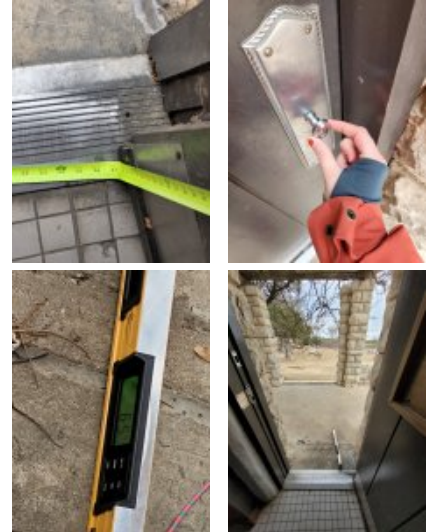
153	Lakeside Campground: Lakeside - Men's Restroom	[31.8887715 , -97.6997922]	Minimum maneuvering clearances at doors and gates shall comply with 404.2.4. Maneuvering clearances shall extend the full width of the doorway and the required latch side or hinge side clearance. Maneuvering clearances shall have a max slope of 2.08%. Door openings shall provide a clear width of 32 inches (815 mm) minimum. Clear openings of doorways with swinging doors shall be measured between the face of the door and the stop, with the door open 90 degrees. Openings more than 24 inches (610 mm) deep shall provide a clear opening of 36 inches (915 mm) minimum. There shall be no projections into the required clear opening width lower than 34 inches (865 mm) above the finish floor or ground. Projections into the clear opening width between 34 inches (865 mm) and 80 inches (2030 mm) above the finish floor or ground shall not exceed 4 inches (100 mm). Exterior doors are recommended to be maintained at 8.5 lbf as a smart practice. Force is to be measured at the operating hardware or 30 inches from the hinges, whichever is greater. Hand-activated door opening hardware, handles, pulls, latches, locks, and other operating devices on accessible doors shall have a shape that is easy to grasp with one hand and does not require tight grasping, tight pinching or twisting of the wrist to operate. Hardware shall be 34 inches minimum and 48 inches maximum above the finish floor or ground.	Men's restroom - 27" width, 11# to open, hardware requires pinch to operate, 6.5%	For all doors along the public circulation route, correct slope in door clearance to max 2.08%. For all doors along the public circulation route, replace doors with doors having 80" overhead clearance and 32" clear width. For all doors along the public circulation route, inspect, adjust, and maintain 8.5 lbf to open exterior doors as a smart practice. For all doors along the public circulation route, replace hardware with lever hardware or hardware operable without a tight pinch or grasp.	2010 ADAS Section: 404.2.3, 404.2.7, 404.2.4, 404.2.11, 404.2.11 Exception

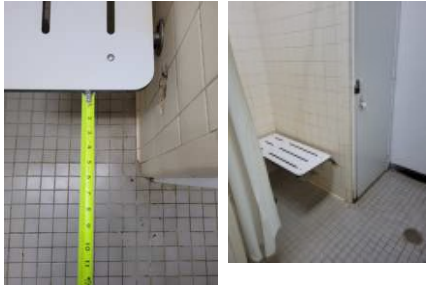
Finding Number	Area Description	Lat/Long	Finding	As Built	Recommendation	Citation	Photos	Figure
165	Lakeside Campground: Lakeside - Women's Restroom	[31.8887943 , -97.6997815]	The shower seat is located too far from the opening to the shower. A seat in a standard roll-in shower compartment shall be a folding type, shall be installed on the side wall adjacent to the controls, and shall extend from the back wall to a point within 3 inches of the compartment entry.	Women's restroom - seat installed 6" from stall entry	Remount shower bench so that the front edge is within 3" of the opening	2015 ABAAS Section: 610.3 2012 TAS Section: 610.3 2010 ADAS Section: 610.3

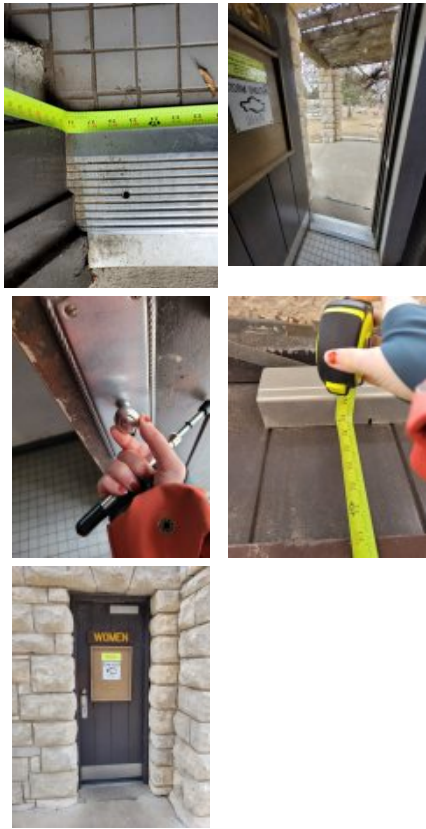
166	Lakeside Campground: Lakeside - Women's Restroom	[31.8888034 , -97.6997761]	Door openings shall provide a clear width of 32 inches (815 mm) minimum. Clear openings of doorways with swinging doors shall be measured between the face of the door and the stop, with the door open 90 degrees. Openings more than 24 inches (610 mm) deep shall provide a clear opening of 36 inches (915 mm) minimum. There shall be no projections into the required clear opening width lower than 34 inches (865 mm) above the finish floor or ground. Projections into the clear opening width between 34 inches (865 mm) and 80 inches (2030 mm) above the finish floor or ground shall not exceed 4 inches (100 mm). Exterior doors are recommended to be maintained at 8.5 lbf as a smart practice. Force is to be measured at the operating hardware or 30 inches from the hinges, whichever is greater. Hand-activated door opening hardware, handles, pulls, latches, locks, and other operating devices on accessible doors shall have a shape that is easy to grasp with one hand and does not require tight grasping, tight pinching or twisting of the wrist to operate. Hardware shall be 34 inches minimum and 48 inches maximum above the finish floor or ground.	Women's restroom - 28" width, 18#, hardware requires pinch	For all doors along the public circulation route, replace doors with doors having 80" overhead clearance and 32" clear width For all doors along the public circulation route, inspect, adjust, and maintain 8.5 lbf to open exterior doors as a smart practice For all doors along the public circulation route, replace hardware with lever hardware or hardware operable without a tight pinch or grasp	2010 ADAS Section: 404.2.3, 404.2.7, 404.2.4, 404.2.11, 404.2.11 Exception

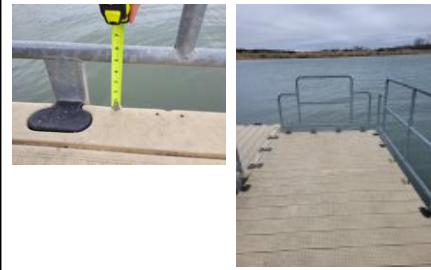
168	Lakeside Campground: Lakeside - Fishing Pier	[31.8886576 , -97.700350 1]	The required edge protection is not provided. Where compliant railings, guards, or handrails are provided, edge protection shall also be provided. Curbs or barriers shall extend 2 inches minimum above the surface of the fishing pier or platform or The ground or deck surface shall extend 12 inches minimum beyond the inside face of the railing. Toe clearance shall be provided and shall be 30 inches wide minimum and 9 inches minimum above the ground or deck surface beyond the railing.	Lacks curb or barrier along edge, railing installed 5" above ground	Provide 2" high curb or 12" extended surface beyond railing for edge protection.	2015 ABAAS Section: 1005.3.1, 1005.3.2 2010 ADAS Section: 1005.3.1, 1005.3.2

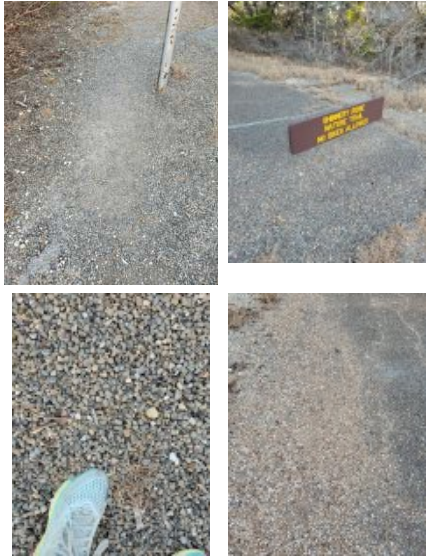
Finding Number	Area Description	Lat/Long	Finding	As Built	Recommendation	Citation	Photos	Figure
171	Trails: Trailhead	[31.8905251, -97.7050761]	The surface of trails, passing spaces, and resting intervals shall be firm and stable	Shinnery paved trailhead - loose gravel at entry, entire trail had loose gravel on top of blacktop.	Establish protocols for regular and frequent inspection and maintenance of accessible trail surface as a smart practice Frequently maintain trail surface in identified washout areas to assure CIL's remain 2" or less and gaps are filled as a smart practice	2015 ABAAS Section: 1017.2

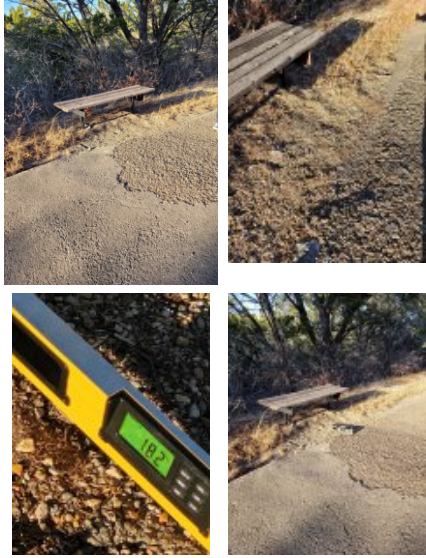
172	Trails: Trailhead	[31.890771, -97.7049742]	The 30 inches minimum by 48 inches minimum clear floor space required at the operable part is not flat (2% or 1:48 maximum slope) in all directions. Changes in level are not permitted at required clear floor or ground space except that slopes not steeper than 1:48 shall be permitted.	Shinnery paved trailhead section - bench without clear floor space and 18.2%	Correct or repair slope in CFS to max 2.08%	2015 ABAAS Section: 305.2 2012 TAS Section: 305.2 2010 ADAS Section: 305.2

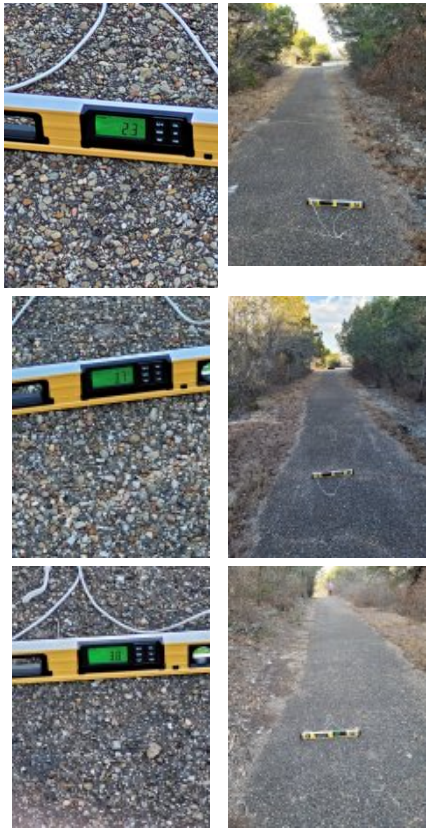
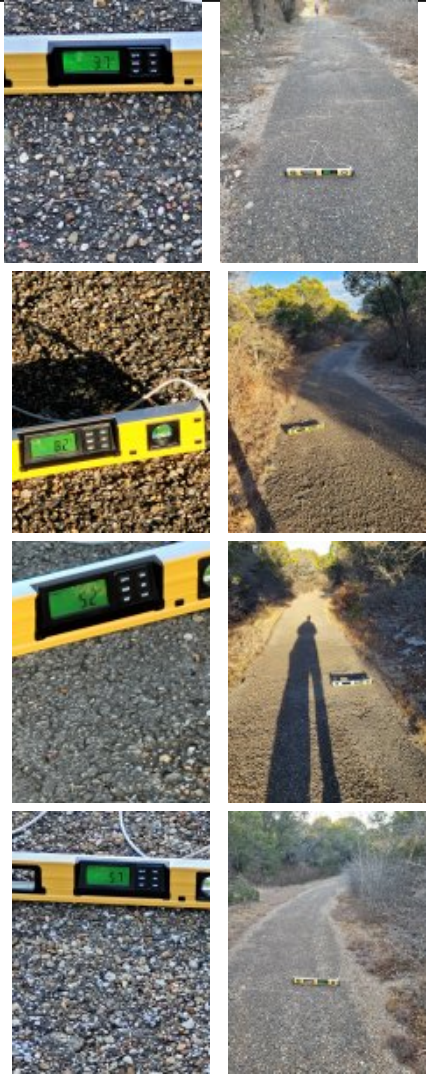
174	Trails: Trail Surface	[31.8913426 , -97.706841]	The cross slope shall not be steeper than 1:48. EXCEPTION: Where the surface is other than concrete, asphalt, or boards, cross slopes not steeper than 1:20 shall be permitted when necessary for drainage.	Shinnery Ridge Trail- 2.3%, 3.7%, 3.8%, 3.7%, 7.5%, 8.2%, 5.2%, 5.7%,	Correct or repair pathway cross slope to max 2.08% or 5% depending on surface as a smart practice.	2015 ABAAS Section: 1017.2

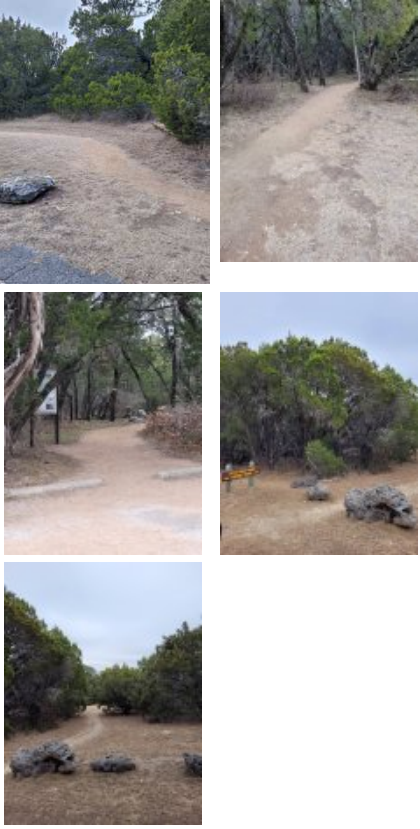
Finding Number	Area Description	Lat/Long	Finding	As Built	Recommendation	Citation	Photos	Figure
175	Trails: Trail Surface	[31.8931964 , -97.699929]	The surface of trails, passing spaces, and resting intervals shall be firm and stable	little forest junior trail and juniper ridge non compliant surface	Leave as is and designate other trails at the park accessible	2015 ABAAS Section: 1017.2
