# Access Audit Site Report

**Mission Tejas State Park**

**Accessibility Evaluation**

**Inspection Date: 09/14/2022**

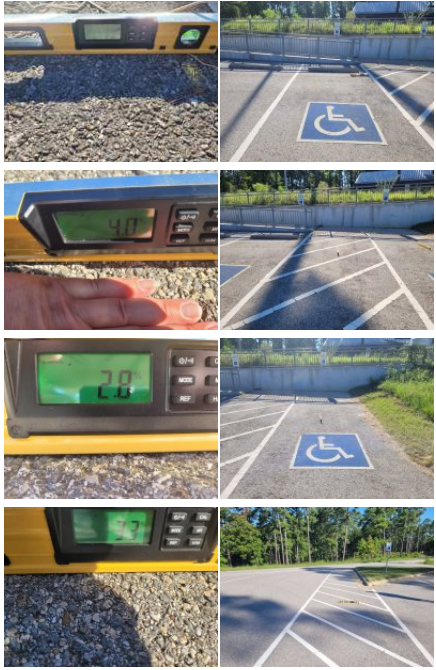
Finding Number	Area Description	Lat/Long	Finding	As Built	Recommendation	Citation	Photos	Figure
1	Headquarters Area: HQ - Parking	[31.54236, -95.23393]	Element meets all standards and requirements	Parking scoping complies - 14 total standard sized, 3 are accessible; 5 total RV stalls, 1 accessible	None	2010 ADAS Section: N/A		
2	Headquarters Area: HQ - Parking	[31.54236, -95.23393]	The cross slopes (narrow dimension) and/or running slopes (long dimension) of the access aisle exceeds 2%. The running slope and the cross slope in an accessible parking stall and the access aisle must not exceed 2%.	3.3% left stall, 4% aisle, 2.8% right stall, 3.3% RV side aisle	Repair or correct slope of parking space and access aisle to max 2.08% in any direction.	2015 ABAAS Section: 502.4 2012 TAS Section: 502.4 2010 ADAS Section: 502.4

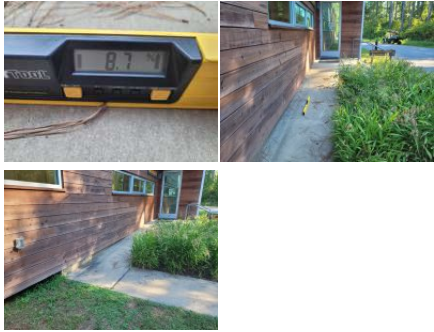
10	Headquarters Area: HQ - Exterior Accessible Route	[31.5418, -95.23337]	The accessible route of travel exceeds 5% and therefore must be considered a ramp. Where the slope is greater than one unit vertical in 20 units horizontal (5-percent slope), ramps shall be used. Ramps shall have handrails and wheel guides on both sides.	Ramp at employee entry - lacks handrails	Install handrails on both sides of the ramp and provide edge protection.	2015 ABAAS Section: 403.3 2012 TAS Section: 403.3 2010 ADAS Section: 403.3

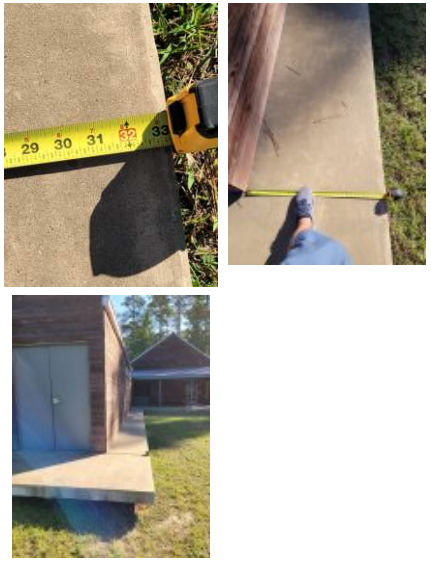
16	Headquarters Area: HQ - Exterior Accessible Route	[31.54214, -95.23386]	The route of travel at this location does not provide the required minimum width. The minimum clear width for sidewalks and walks is 36 inches.	33.25" walkway to employee areas at restroom building	Widen EAR to min 36" clear width.	2015 ABAAS Section: 403.5.1 2012 TAS Section: 403.5.1 2010 ADAS Section: 403.5.1

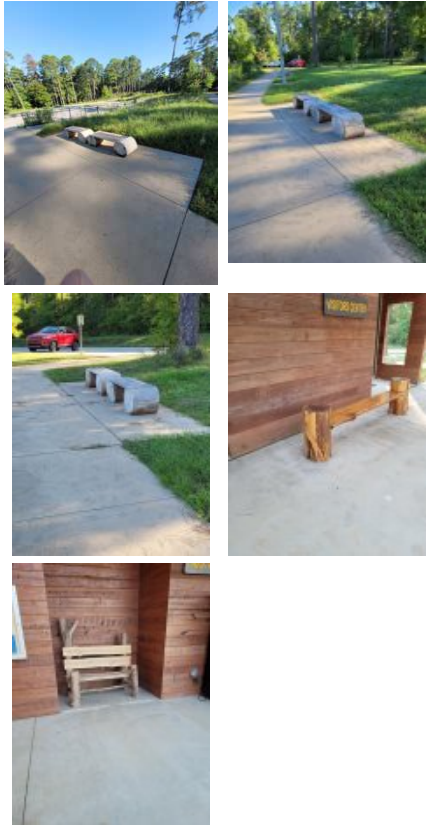
Finding Number	Area Description	Lat/Long	Finding	As Built	Recommendation	Citation	Photos	Figure
17	Headquarters Area: HQ - Exterior Accessible Route	[31.54235, -95.23391]	Element meets all standards and requirements	6 of 7 benches compliant	None	2010 ADAS Section: N/A

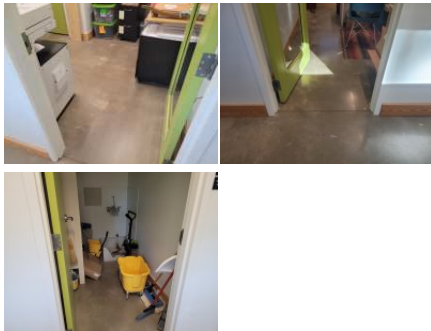
26	Headquarters Area: HQ - Employee Spaces	[31.5419563, -95.233680 7]	Spaces and elements within employee work areas shall only be required to comply with 206.2.8, 207.1, and 215.3 and shall be designed and constructed so that individuals with disabilities can approach, enter, and exit the employee work area. Employee work areas, or portions of employee work areas, other than raised courtroom stations, that are less than 300 square feet (28 m2) and elevated 7 inches (180 mm) or more above the finish floor or ground where the elevation is essential to the function of the space shall not be required to comply with these requirements or to be on an accessible route.	Office at front desk - copier and cabinet pull side; 2nd office-storage and chair pull side; janitor- wall and storage pull side	For employee spaces, relocate storage, furniture, and other obstacles at doorways to provide approach, enter and exit at the employee space. Provide required maneuvering clearance on push and pull side of doors.	2015 ABAAS Section: F203.9  2012 TAS Section: 203.9  2010 ADAS Section: 203.9

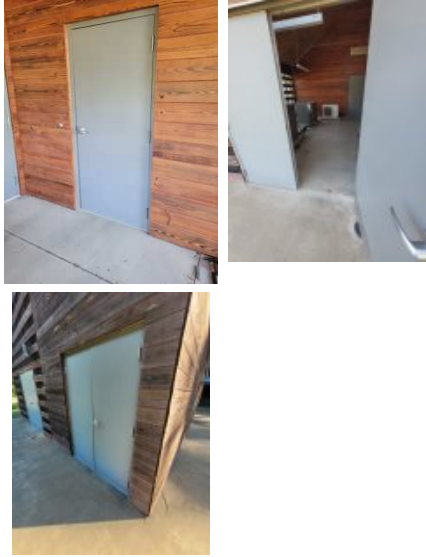
Finding Number	Area Description	Lat/Long	Finding	As Built	Recommendation	Citation	Photos	Figure
34	Headquarters Area: HQ - Employee Spaces	[31.54229, -95.2338]	Element meets all standards and requirements	Mechanical room door - complies; doors into AC unit area comply; storage room - complies	None	2010 ADAS Section: N/A

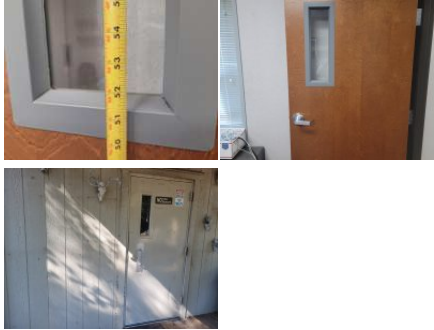
Finding Number	Area Description	Lat/Long	Finding	As Built	Recommendation	Citation	Photos	Figure
60	Employee Areas: Maintenance	[31.5425686, -95.2317238]	Spaces and elements within employee work areas shall only be required to comply with 206.2.8, 207.1, and 215.3 and shall be designed and constructed so that individuals with disabilities can approach, enter, and exit the employee work area. Employee work areas, or portions of employee work areas, other than raised courtroom stations, that are less than 300 square feet (28 m2) and elevated 7 inches (180 mm) or more above the finish floor or ground where the elevation is essential to the function of the space shall not be required to comply with these requirements or to be on an accessible route.	Breakroom - entry door: 52" window; entry- 52" window, 15 lbf	Inspect, adjust, and maintain 5 lbf to open interior doors. Inspect, adjust, and maintain 8.5 lbf to open exterior doors as a smart practice. Replace doors with ones having sidelight viewing windows max 43" AFF.	2015 ABAAS Section: F203.9 2012 TAS Section: 203.9 2010 ADAS Section: 203.9

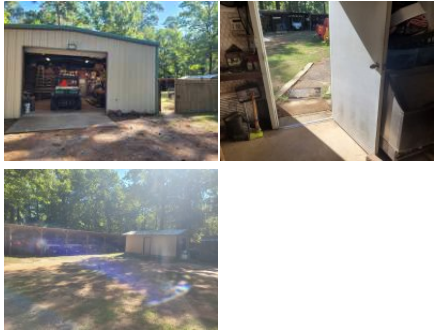
Finding Number	Area Description	Lat/Long	Finding	As Built	Recommendation	Citation	Photos	Figure
69	Employee Areas: Maintenance	[31.5425206 , -95.2320504]	The building entrance is not located on an accessible route. When a building, or portion of a building, is required to be accessible, an accessible route of travel shall be provided to all portions of the building, to accessible building entrances and between the building and the public way. All walks, halls, corridors, aisles, skywalks, tunnels, and other spaces that are part of an accessible route must comply. An accessible route of travel must not pass through kitchens, storage rooms, restrooms, closets or other spaces used for similar purposes. At least one accessible route within the boundary of the site must be provided from public transportation stops, accessible parking and accessible passenger loading zones and public streets or sidewalks to the accessible building entrance they serve. The accessible route shall, to the maximum extent feasible, coincide with the route for the general public. At least one accessible route shall connect accessible buildings, facilities, elements and spaces that are on the same site. At least one accessible route shall connect accessible building or facility entrances with all accessible spaces and elements.	Lacks accessible route to pedestrian entry, no AR to structures in the maintenance yard	Create AR with crushed and compacted stone or similar outdoor material from parking or sidewalk to building entrance	2015 ABAAS Section: F206.2.1  2012 TAS Section: 206.2.1  2010 ADAS Section: 206.2.1

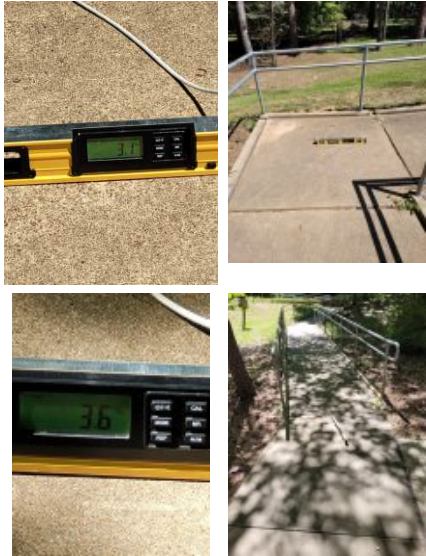
Finding Number	Area Description	Lat/Long	Finding	As Built	Recommendation	Citation	Photos	Figure
103	Day Use Area: Group Picnic Area & Pavilion	[31.54863, -95.23742]	The landing at the bottom of the ramp has a slope greater than 2%. Bottom landings shall have a dimension in the direction of ramp run of not less than 60 inches and have a slope of less than 2% in any direction.	ramp near pavilion- 3.1% on top first run; 3.6% on bottom landing	Correct ramp landing slope to max 2.08%.	2015 ABAAS Section: 405.7.1, 405.7.1 EXCEPTION  2012 TAS Section: 405.7.1, 405.7.1 Exception  2010 ADAS Section: 405.7.1, 405.7.1 Exception

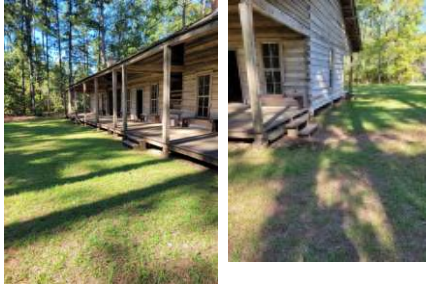
Finding Number	Area Description	Lat/Long	Finding	As Built	Recommendation	Citation	Photos	Figure
111	Day Use Area: Rice Family Log Home	[31.5427931 , -95.232983 6]	Stairways must have handrails on both sides. Handrails and their extensions must be between 34 inches and 38 inches above the stair nosing or ground. The top handrails shall extend a minimum of 12 inches beyond the top nosing and shall be parallel with the floor or ground surface. At the bottom of a stair flight, handrails shall extend at the slope of the stair flight for a horizontal distance at least equal to one tread depth beyond the last riser nosing. Extension shall return to a wall, guard, or the landing surface, or shall be continuous to the handrail of an adjacent stair flight. The orientation of at least one handrail, including the extension, shall be in the direction of the run of the stair and perpendicular to the direction of the stair nosing. Handrail gripping surfaces with a circular cross section shall have an outside diameter of 1-1/4 inches minimum and 2 inches maximum. Handrail gripping surfaces with a non-circular cross section shall have a perimeter dimension of 4 inches minimum and 6 1/4 inches maximum, and a cross-section dimension of 2-1/4 inches maximum. The hand grip portion of handrails shall have a smooth surface with no sharp corners. Gripping surfaces (top or sides) shall be uninterrupted by newel posts, other construction elements or obstructions. Any wall or other surface adjacent to the handrail shall be free of sharp or abrasive elements. Handrails projecting from a wall shall have a space of 1-1/2 inches minimum between the wall and the handrail.	4 sets of stairs lack handrails	Install handrails on both sides of stairway, mounted 34" to 38" AFF with top and bottom extensions and having a 1.25" – 2" in diameter, or a non-circular grip that has a perimeter dimension of 4"- 6.25" max with a min gap of 1.5" between handrail and wall.	2015 ABAAS Section: 505.2  2012 TAS Section: 505.2  2010 ADAS Section: 505.2

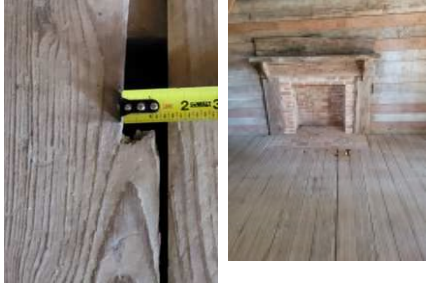
126	Day Use Area: Rice Family Log Home	[31.5428374 , -95.232966 4]	Openings in floor or ground surfaces shall not allow passage of a sphere more than 1/2 inch (13 mm) diameter except as allowed in 407.4.3, 409.4.3, 410.4, 810.5.3 and 810.10. Elongated openings shall be placed so that the long dimension is perpendicular to the dominant direction of travel.	Middle room - gap of 1.5" at fireplace	Fill and maintain gaps to max .5".	2015 ABAAS Section: 302.3  2012 TAS Section: 302.3  2010 ADAS Section: 302.3

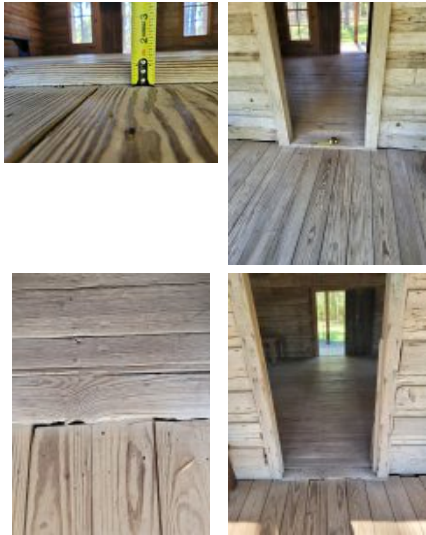
131	Day Use Area: Rice Family Log Home	[31.5427571 , -95.232990 6]	Door openings shall provide a clear width of 32 inches (815 mm) minimum. Clear openings of doorways with swinging doors shall be measured between the face of the door and the stop, with the door open 90 degrees. Openings more than 24 inches (610 mm) deep shall provide a clear opening of 36 inches (915 mm) minimum. There shall be no projections into the required clear opening width lower than 34 inches (865 mm) above the finish floor or ground. Projections into the clear opening width between 34 inches (865 mm) and 80 inches (2030 mm) above the finish floor or ground shall not exceed 4 inches (100 mm). The threshold has a gap greater than 1/2 inch wide. The threshold at a doorway shall be no higher than 1/2 inch. Changes in level between 1/4 inch and 1/2 inch must be beveled at 1:2 or less. 1/4 inch is the maximum vertical rise.	Front room - ramp side - 1" CIL at threshold, 73.25" overhead; other side - gaps at threshold, 76.5" overhead	For all doors along the public circulation route, replace doors with doors having 80" overhead clearance. For all doors along the public circulation route, fill gaps at door entries to max .5". For all doors along the public circulation route, provide beveled threshold.	2010 ADAS Section: 404.2.3, 404.2.7, 404.2.4, 404.2.11, 404.2.11 Exception

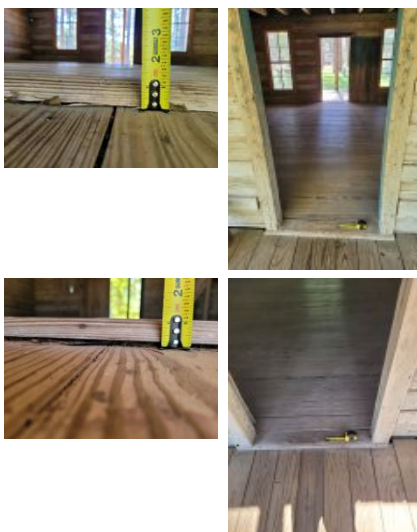
132	Day Use Area: Rice Family Log Home	[31.5427949 , -95.232971 5]	Door openings shall provide a clear width of 32 inches (815 mm) minimum. Clear openings of doorways with swinging doors shall be measured between the face of the door and the stop, with the door open 90 degrees. Openings more than 24 inches (610 mm) deep shall provide a clear opening of 36 inches (915 mm) minimum. There shall be no projections into the required clear opening width lower than 34 inches (865 mm) above the finish floor or ground. Projections into the clear opening width between 34 inches (865 mm) and 80 inches (2030 mm) above the finish floor or ground shall not exceed 4 inches (100 mm). The threshold has a gap greater than 1/2 inch wide. The threshold at a doorway shall be no higher than 1/2 inch. Changes in level between 1/4 inch and 1/2 inch must be beveled at 1:2 or less. 1/4 inch is the maximum vertical rise.	Back room - ramp side - 30.5" width, 62" overhead, 1" CIL at threshold; middle door - 29.75" width, 69.85" overhead, 1.25" CIL at threshold; other side - 71.5" overhead, 1.25" CIL and .75" gap at threshold	For all doors along the public circulation route, replace doors with doors having 80" overhead clearance and 32" clear width. For all doors along the public circulation route, fill gaps at door entries to max .5". For all doors along the public circulation route, provide beveled threshold.	2010 ADAS Section: 404.2.3, 404.2.7, 404.2.4, 404.2.11, 404.2.11 Exception

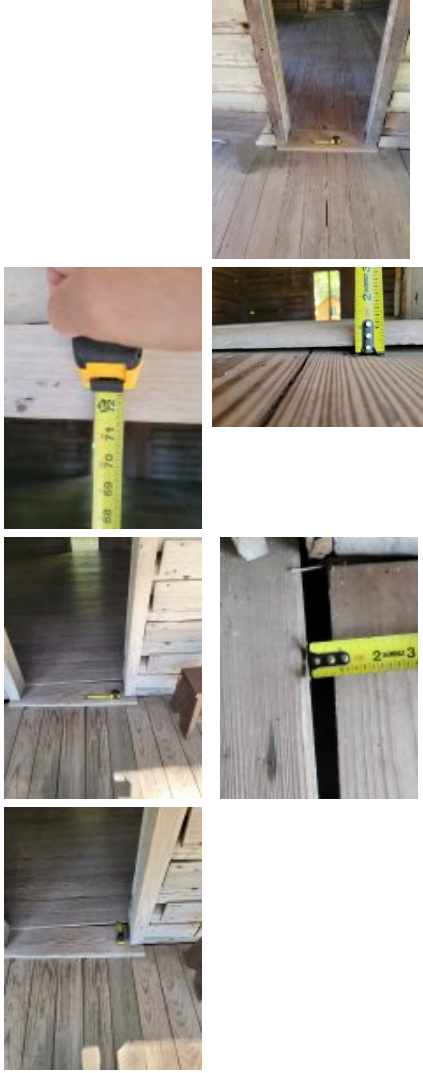
Finding Number	Area Description	Lat/Long	Finding	As Built	Recommendation	Citation	Photos	Figure
133	Day Use Area: Rice Family Log Home	[31.5427949 , -95.232980 9]	Door openings shall provide a clear width of 32 inches (815 mm) minimum. Clear openings of doorways with swinging doors shall be measured between the face of the door and the stop, with the door open 90	Back room - ramp side - 76.5" overhead, 1" CIL at threshold; other side - 76.5" overhead, 1.25" CIL	For all doors along the public circulation route, replace doors with doors having 80" overhead clearance and 32" clear width. For all doors along the public circulation route, provide beveled threshold.	2010 ADAS Section: 404.2.3, 404.2.7, 404.2.4,

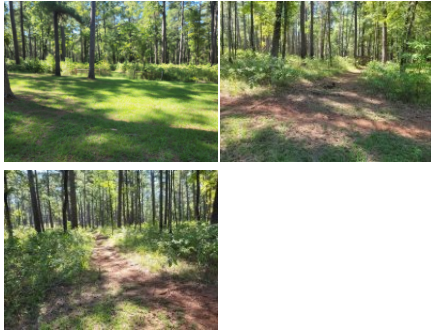
137	Day Use Area: Bird Blind	[31.5454828, -95.236811 7]	The surface of trails, passing spaces, and resting intervals shall be firm and stable	Grass trail and dirt trail connected to bird blind	Replace surface of trail with one that is firm and stable as a smart practice.	2015 ABAAS Section: 1017.2

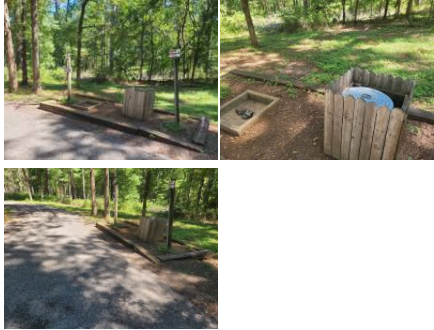
140	Day Use Area: Dump Station	[31.54729, -95.23734]	72 inches (1830 mm) by 48 inches (1220 mm) with the long side of the space adjoining or overlapping an outdoor recreation access route or trail, as applicable, or another clear ground space Locate the space so that the water spout is 11 inches (280 mm) minimum and 12 inches (305 mm) maximum from the rear center of the long side of the space	Step up, slopes and rough surface at water spouts, dump station and garbage	Assure parking space at dump station is level and relocate garbage to be closer to the parking space.	2015 ABAAS Section: 1011.2

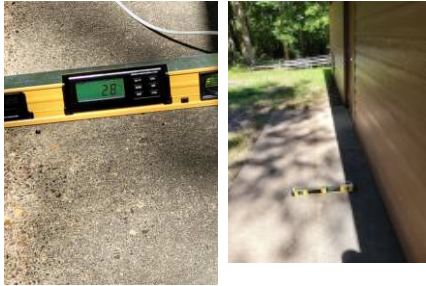
Finding Number	Area Description	Lat/Long	Finding	As Built	Recommendation	Citation	Photos	Figure
142	Day Use Area: Day Use - Men's Restroom	[31.54847, -95.23759]	The accessible route of travel contains cross slopes greater than 2%. Cross slopes shall not exceed one unit vertical in 48 units horizontal (2-percent slope).	2.8% near chase door	Correct or repair cross slope along accessible route to max 2.08%.	2015 ABAAS Section: 403.3  2012 TAS Section: 403.3  2010 ADAS Section: 403.3

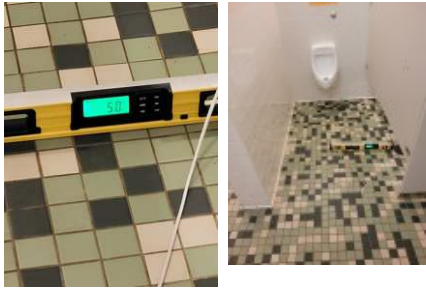
149	Day Use Area: Day Use - Men's Restroom	[31.5484023 , -95.237501 5]	The accessible route contains running slopes greater than 5 percent and cross slopes greater than 2 percent across the width of the walk and has not been constructed as a ramp (i.e. handrails, wheel guides, etc.). When the slope in the direction of travel of any walk exceeds 1 unit vertical in 20 units horizontal (5-percent slope), it must be constructed as ramp. Surface cross slopes must not exceed one unit vertical in 48 units. Horizontal (2-percent slope).	5% slope near drain	Correct or repair slope to max 2.08% in restroom.	2015 ABAAS Section: 403.3  2012 TAS Section: 403.3  2010 ADAS Section: 403.3

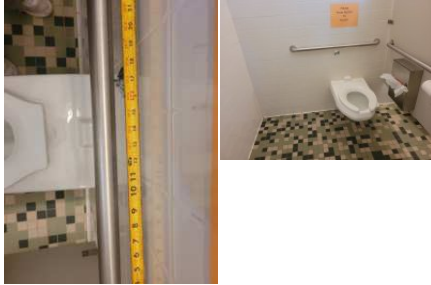
Finding Number	Area Description	Lat/Long	Finding	As Built	Recommendation	Citation	Photos	Figure
154	Day Use Area: Day Use - Women's Restroom	[31.5483551 , -95.237486]	The rear grab bar is not 36" long or is not mounted in the correct location. The rear grab bar must be a minimum of 36" long and extend from the toilet centerline a minimum 12" towards the wall side and a minimum 24" towards the open side of the toilet. Grab bars shall be installed in a horizontal position, 33 inches minimum and 36 inches maximum above the finish floor measured to the top of the gripping surface and the space between the grab bar and the top of the tank shall be 1-1/2 inches minimum.	rear grab bar - toilet center at 13", lacks 24" to open side	Remount rear grab bar to behind the toilet, 12" to the wall side of center and 24" to the open side and 33" to 36" AFF.	2015 ABAAS Section: 604.5.2  2012 TAS Section: 604.5.2  2010 ADAS Section: 604.5.2

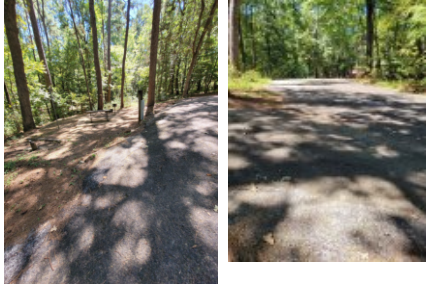
Finding Number	Area Description	Lat/Long	Finding	As Built	Recommendation	Citation	Photos	Figure
160	Main Camping Loop (Campsites 1-15): Main - Sample Campsite #15	[31.5483412 , -95.2395329]	An accessible access route is not provided between elements, spaces and the facilities provided within the accessible camping unit. At least one outdoor recreation access route shall connect accessible elements, spaces and facilities provided within camping units with mobility features.	Lacks route to elements	Create AR with crushed and compacted stone or similar outdoor material to two camp sites and one of each type of amenity.	2015 ABAAS Section: F244.5.1

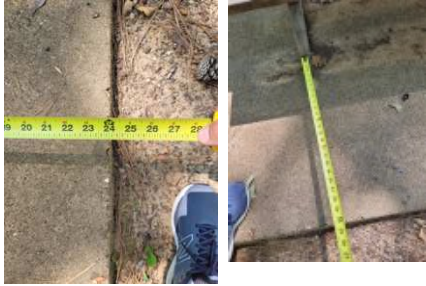
162	Main Camping Loop (Campsites 1-15): Main - Sample Campsite #15	[31.5483457 , -95.2395651]	Picnic tables are required to have clear ground space 36 inches (915 mm) on all usable sides of the table measured from the back edge of the benches.	table lacks 36" clearance around all sides - 24" clearance	Provide required 36" clear ground space around all usable portions of the table as a smart practice at two campsites.	2015 ABAAS Section: 1011.2.1

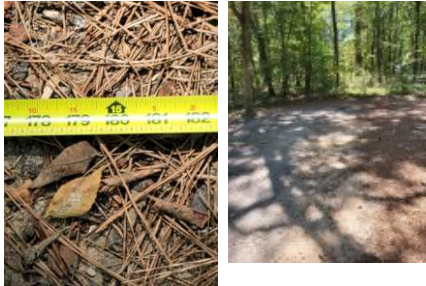
168	Main Camping Loop (Campsites 1-15): Main - Sample Campsite #15	[31.5484097 , -95.239591 9]	Parking spaces and pull-up spaces for recreational vehicles shall be 20 feet (6100 mm) wide minimum. EXCEPTION: Where two adjacent parking spaces are provided for recreational vehicles, one parking space shall be permitted to be 16 feet (4880 mm) wide minimum.	parking space - 15' width	Correct RV parking space to be 20' wide minimum; or 16' for two adjacent spaces at two campsites as a smart practice.	2015 ABAAS Section: 1012.2, 1012.2 EXCEPTION

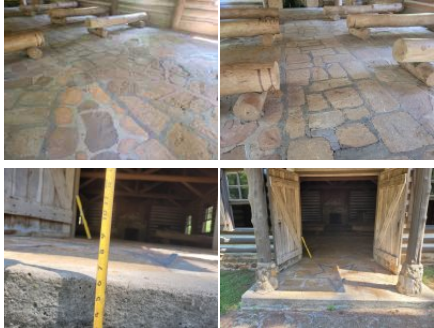
174	Main Camping Loop (Campsites 1-15): Commemorative Mission	[31.54823, -95.23997]	There is a change in level greater than 1/4 inch. 1/4 inch is the maximum vertical rise. Changes in level between 1/4 inch and 1/2 inch must be beveled at 1:2 or less. Changes in level greater than 1/2 inch must be by way of a ramp.	Stone floor has CILs and gaps	Replace stone floor or provide a smooth pathway through the building if doing so would not effect the historic significance of the building.	2015 ABAAS Section: 303.3 2012 TAS Section: 303.3 2010 ADAS Section: 303.3

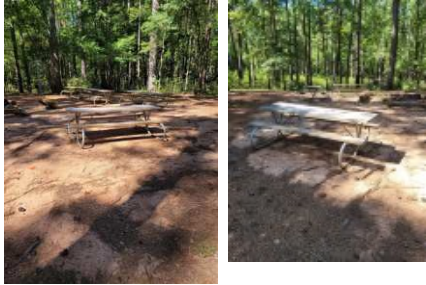
Finding Number	Area Description	Lat/Long	Finding	As Built	Recommendation	Citation	Photos	Figure
193	Small Camping Area (A &B): Sample Campsite	[31.5489878 , -95.236221 6]	Picnic tables shall provide at least one wheelchair space for each 24 linear feet (7320 mm) of usable table surface perimeter. Wheelchair spaces shall be 30 inches (760 mm) minimum by 48 inches (1220 mm) minimum. Wheelchair spaces shall be positioned for a forward approach to the table and provide knee and toe clearance complying with 306 under the table	0 of 7 lack wheelchair space	Replace two picnic tables at each campsite with ones of an accessible design as a smart practice.	2015 ABAAS Section: 1011.4.2

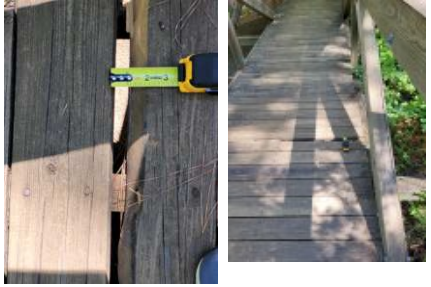
210	Trails: Trail Surface	[31.54865, -95.23611]	There is a gap spaced greater than a 1/2 inch. Openings in floor or ground surfaces shall not allow passage of a sphere more than 1/2 inch diameter. Elongated openings shall be placed so that the long dimension is perpendicular to the dominant direction of travel.	Nature trail bridge - 2" gap	Correct or fill gaps to be max .5".	2015 ABAAS Section: 302.3 2012 TAS Section: 302.3 2010 ADAS Section: 302.3
