Access Audit Site Report

Mother Neff State Park
1921 Park Road 14
Moody, TX 76557
Accessibility Evaluation
Inspection Date: 09/29/2022
Inspectors: Tanya Scheibe

Prepared By
WT Group

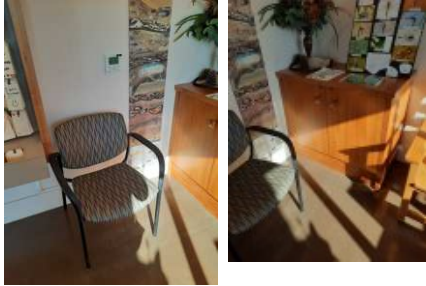
22	Headquarters Area: HQ - Public Spaces	[31.334243, -97.467869 8]	The operable part is not accessible because there is not adequate clear floor space for either a forward or side approach. The clear floor or ground space shall be 30 inches minimum by 48 inches minimum.	HQ Main Public Room - thermostat and cabinet lack clear floor space (CFS) - obstructed by chairs	Remove, or relocate storage in CFS at fixtures and operable parts along the AR.	2015 ABAAS Section: 305.3 2012 TAS Section: 305.3 2010 ADAS Section: 305.3

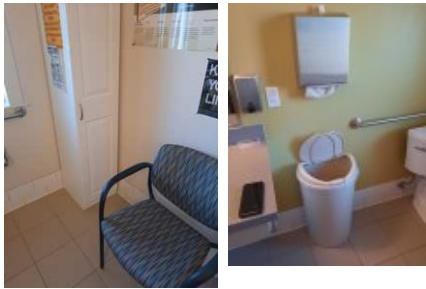
27	Headquarters Area: HQ - Employee Spaces	[31.334329, -97.467825 1]	The operable part is not accessible because there is not adequate clear floor space for either a forward or side approach. The clear floor or ground space shall be 30 inches minimum by 48 inches minimum.	HQ employee restroom - Chair in clear floor space (CFS) of cabinet, garbage can in CFS of paper towel dispenser	Remove, or relocate storage in CFS at fixtures and operable parts along the AR.	2015 ABAAS Section: 305.3 2012 TAS Section: 305.3 2010 ADAS Section: 305.3

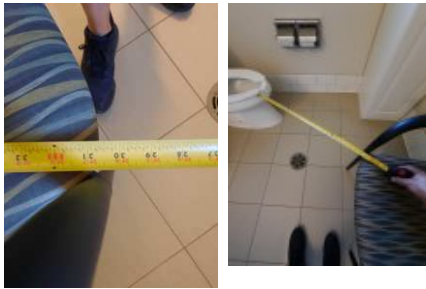
29	Headquarters Area: HQ - Employee Spaces	[31.33436, -97.467854 6]	The route of travel at this location does not provide a minimum width of 36 inches. The clear width shall be permitted to be reduced to 32 inches minimum for a length of 24 inches maximum provided that reduced width segments are separated by segments that are 48 inches long minimum and 36 inches wide minimum.	HQ employee restroom - Route reduces to 30" between chair and toilet to access cabinet	Remove chair to widen AR to compliant 36" clear width.	2015 ABAAS Section: 403.5.1 2012 TAS Section: 403.5.1 2010 ADAS Section: 403.5.1

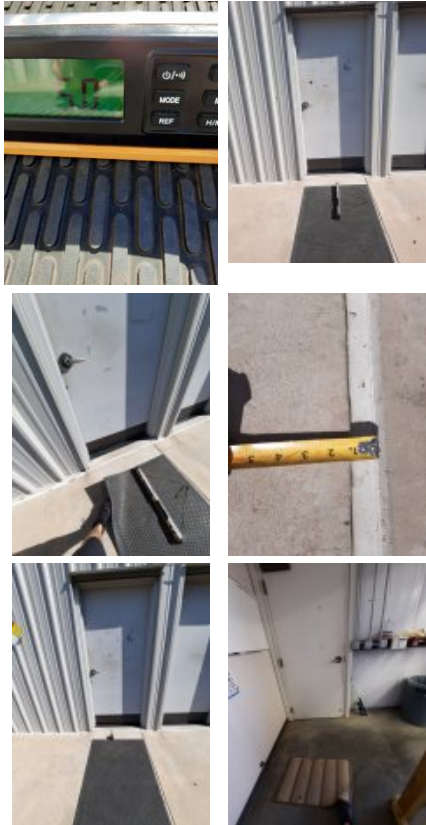
Finding Number	Area Description	Lat/Long	Finding	As Built	Recommendation	Citation	Photos	Figure
63	Employee Areas: Maintenance	[31.333752, -97.464454 1]	Minimum maneuvering clearances at doors and gates shall comply with 404.2.4. Maneuvering clearances shall extend the full width of the doorway and the required latch side or hinge side clearance. Maneuvering clearances shall have a max slope of 2.08%. The threshold has a gap greater than 1/2 inch wide. The sweep period for doors with closers shall be adjusted so that from an open position of 70 degrees, the door will take at least 3 seconds to move to a point 3 inches from the latch, measured to the leading edge of the door. Exterior doors are recommended to be maintained at 8.5 lbf as a smart practice. Force is to be measured at the operating hardware or 30 inches from the hinges, whichever is greater.	Maintenance main entry door - fast close, 15# push, slope of 5% in push side clearance, loose floor mat on push and pull sides, gap of 1" on push side	For all doors along the public circulation route, provide required maneuvering clearance on push and pull side of doors. For all doors along the public circulation route, secure rug in door clearance to prevent trip hazard. For all doors along the public circulation route, correct slope in door clearance to max 2.08%. For all doors along the public circulation route, fill gaps at door entries to max .5". For all doors along the public circulation route, inspect, adjust, and maintain closing speed on door closers. For all doors along the public circulation route, inspect, adjust, and maintain 8.5 lbf to open exterior doors as a smart practice.	2010 ADAS Section: 404.2.3, 404.2.7, 404.2.4, 404.2.11, 404.2.11 Exception

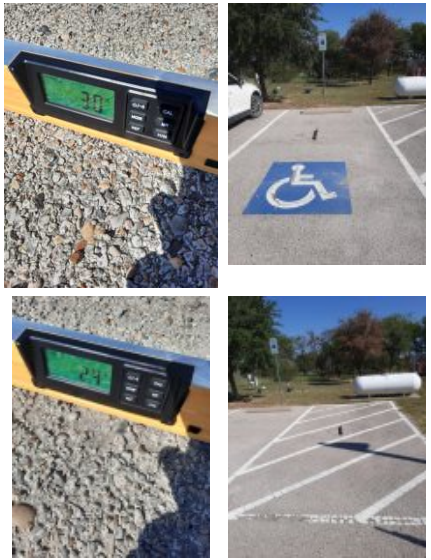
66	Employee Areas: Maintenance	[31.3336831 , -97.464736]	The cross slopes (narrow dimension) and/or running slopes (long dimension) of the access aisle exceeds 2%. The running slope and the cross slope in an accessible parking stall and the access aisle must not exceed 2%.	Maintenance parking: Stall - 3%, access aisle (AA) - 2.4%	Repair or correct slope of parking space and access aisle to max 2.08% in any direction.	2015 ABAAS Section: 502.4 2012 TAS Section: 502.4 2010 ADAS Section: 502.4

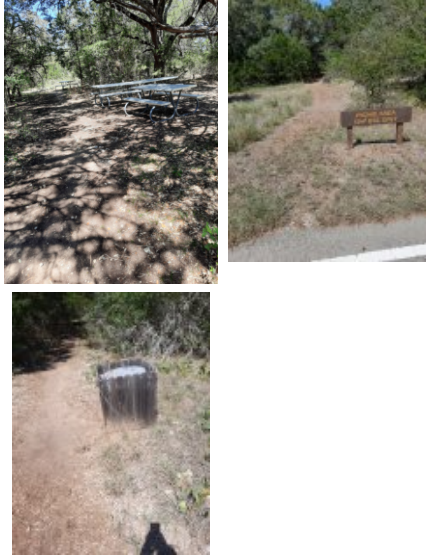
Finding Number	Area Description	Lat/Long	Finding	As Built	Recommendation	Citation	Photos	Figure
84	Park Elements: Camping Loop Picnic Areas	[31.32825, -97.46983]	An accessible access route is not provided between elements, spaces and the facilities provided within the accessible picnic unit. At least one outdoor recreation access route shall connect accessible elements, spaces and facilities provided within camping units with mobility features.	Prairie Loop Picnic Area (near playground) - lacks route to 15 picnic tables and 3 garbage cans in picnic area	Create an outdoor recreation access route with crushed and compacted stone or similar outdoor material to picnic area/shelter and one of each type of amenity.	2015 ABAAS Section: F244.5.1

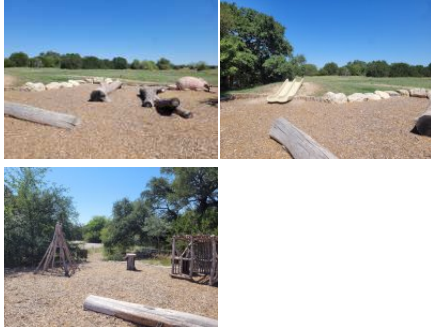
101	Park Elements: Nature Playscape	[31.3282727 , -97.469426 5]	A minimum of one of each type of ground level play components is not on an accessible route. Where ground level play components are provided, at least one of each type shall be on an accessible route and shall comply.	on AR: 3 interactive-teepee, playhouse, tic tac toe table; 5 climbers; slide lacks AR to entry side	Provide an AR to slide entry for one of each type accessible	2012 TAS Section: 240.2.1.1 2010 ADAS Section: 240.2.1.1

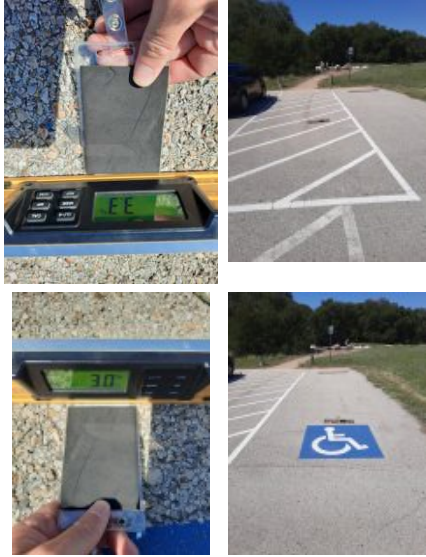
Finding Number	Area Description	Lat/Long	Finding	As Built	Recommendation	Citation	Photos	Figure
105	Park Elements: Nature Playscape	[31.3281423 , -97.469106 2]	The cross slopes (narrow dimension) and/or running slopes (long dimension) of the access aisle exceeds 2%. The running slope and the cross slope in an accessible parking stall and the access aisle must not exceed 2%.	Nature Playscape parking - access aisle (AA) - 3.3%, stall - 3%	Repair or correct slope of parking space and access aisle to max 2.08% in any direction.	2015 ABAAS Section: 502.4 2012 TAS Section: 502.4 2010 ADAS Section: 502.4

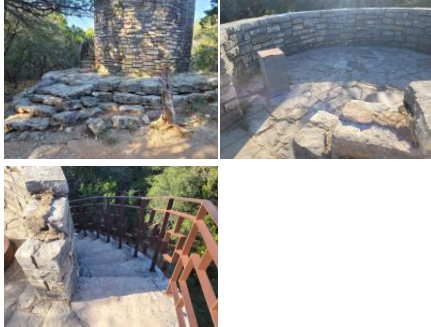
112	Park Elements: Tower Trail CCC Tower	[31.32137, -97.46951]	At least one accessible route shall connect accessible buildings, accessible facilities, accessible elements, and accessible spaces that are on the same site. For areas of sport activity, an accessible route is required to connect to the boundary of each area of sport activity. The size of an area of sport activity includes only the space needed to play. Where multiple sports fields or courts are provided, an accessible route is required to each field or area of sport activity.	steps up rock to tower, stairs to viewpoint	Provide an accessible route (AR) to each element within the site if feasible. In the alternative, provide another means to access the same view as is available from the tower, such as video feed, etc.	2010 ADAS Section: 206.2.2, 206.2

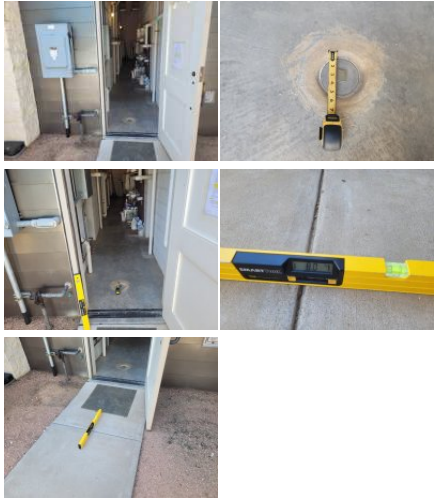
126	Full Hook-Up Campsites: Full Hook-Up - Men's Restroom	[31.3268596 , -97.468631 5]	Spaces and elements within employee work areas shall only be required to comply with 206.2.8, 207.1, and 215.3 and shall be designed and constructed so that individuals with disabilities can approach, enter, and exit the employee work area. Employee work areas, or portions of employee work areas, other than raised courtroom stations, that are less than 300 square feet (28 m2) and elevated 7 inches (180 mm) or more above the finish floor or ground where the elevation is essential to the function of the space shall not be required to comply with these requirements or to be on an accessible route.	Full Hook-Up Camping pipe chase at restrooms - sidewalk narrows at pull side entry, 6" gap, 8% slope in pull side clearance	For employee spaces, relocate storage, furniture, and other obstacles at doorways to provide approach, enter and exit at the employee space. Provide required maneuvering clearance on push and pull side of doors. Correct slope in door clearance to max 2.08%. Fill gaps at door entries to max .5".	2015 ABAAS Section: F203.9 2012 TAS Section: 203.9 2010 ADAS Section: 203.9

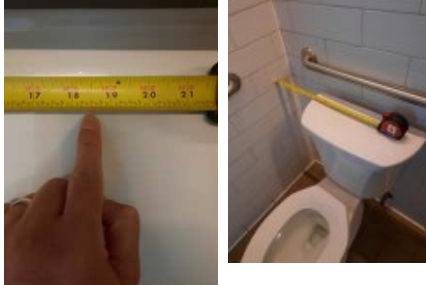
131	Full Hook-Up Campsites: Full Hook-Up - Men's Restroom	[31.3268634 , -97.468626]	The toilet is not located within the range allowed from the side wall or partition. The centerline of the toilet must be 16 to 18 inches from the side wall.	Toilet centerline is 18.5" towards wall	Remount toilets to 16" to 18" from the side wall to centerline.	2015 ABAAS Section: 604.2 2012 TAS Section: 604.2 2010 ADAS Section: 604.2

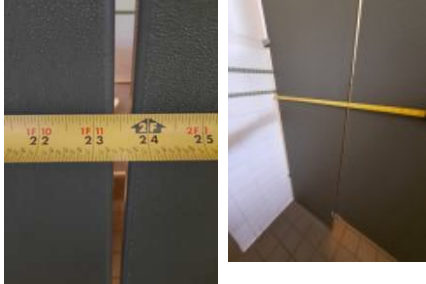
134	Full Hook-Up Campsites: Full Hook-Up - Men's Restroom	[31.3268565 , -97.4686367]	The compartment door is located too far from the partition or wall. The door shall be located in front of the clear space and diagonal to the water closet. Where located in the front partition, the door opening shall be 4 inches maximum from the side wall or partition farthest from the water closet. Where located in the side wall or partition, the door opening shall be 4 inches maximum from the front partition. Toilet compartment doors shall not swing into the minimum required compartment area.	23.5" from wall	Rehang stall door to be max 4" from adjacent stall partition and on the stall wall farthest from the toilet.	2015 ABAAS Section: 604.8.1.2 2012 TAS Section: 604.8.1.2 2010 ADAS Section: 604.8.1.2

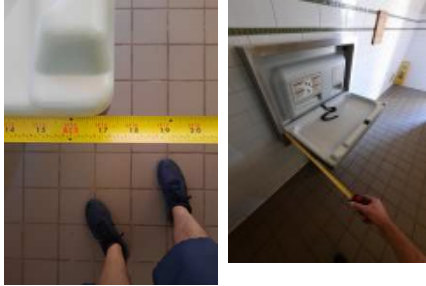
140	Full Hook-Up Campsites: Full Hook-Up - Women's Restroom	[31.3268578 , -97.468629 8]	The baby changing table is not compliant. Baby changing tables are work surfaces. If fixed or built-in baby changing tables are provided, at least 5%, but not less than one, must comply with TAS 902 based TAS 226.1. Baby changing tables cannot violate the protruding object requirements in either an open or closed position since either position is a potential hazard for persons with visual impairments. Baby changing tables are not prohibited from being located in wheelchair accessible toilet compartments; however, the minimum space required for the compartment cannot be obstructed by the baby changing table in either an open or closed position. The clear floor space required for a baby changing table may overlap the water closet clearance since baby changing tables are considered convenience "fixtures" based on Advisory 604.8.1.1. The overlap is applicable only to the clear floor space and not to actual table itself. Baby changing tables must be dispersed throughout a space, however, an additional baby changing table is not required in a common use area of a toilet or bathing room when the only baby changing table is located in a toilet compartment.	Baby changing table protrudes 17.5" when open	Relocate baby changing table to eliminate protrusion when in the open position.	2012 TAS Section: 226.1, 902.3, 604.3.2, 204.1, 226.1 Advisory, 226.2, 307.1, 604.8.1.1 Advisory, 902.1, 902.1 Advisory, 902.2

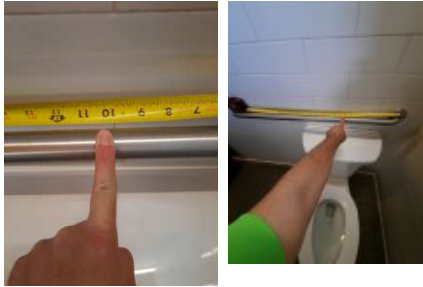
142	Full Hook-Up Campsites: Full Hook-Up - Women's Restroom	[31.3268578 , -97.468632 5]	The rear grab bar is not 36" long or is not mounted in the correct location. The rear grab bar must be a minimum of 36" long and extend from the toilet centerline a minimum 12" towards the wall side and a minimum 24" towards the open side of the toilet. Grab bars shall be installed in a horizontal position, 33 inches minimum and 36 inches maximum above the finish floor measured to the top of the gripping surface and the space between the grab bar and the top of the tank shall be 1-1/2 inches minimum.	rear grab bar mounted 10.25" towards wall	Remount rear grab bar to behind the toilet, 12" to the wall side of center and 24" to the open side and 33" to 36" AFF.	2015 ABAAS Section: 604.5.2 2012 TAS Section: 604.5.2 2010 ADAS Section: 604.5.2

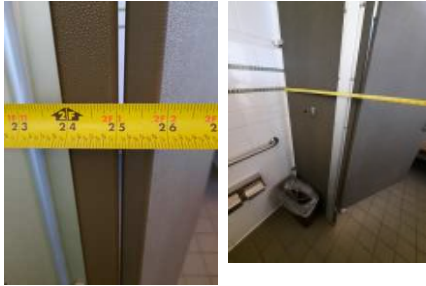
Finding Number	Area Description	Lat/Long	Finding	As Built	Recommendation	Citation	Photos	Figure
144	Full Hook-Up Campsites: Full Hook-Up - Women's Restroom	[31.3268417 , -97.468639 2]	The compartment door is located too far from the partition or wall. The door shall be located in front of the clear space and diagonal to the water closet. Where located in the front partition, the door opening shall be 4 inches maximum from the side wall or partition farthest from the water closet. Where located in the side wall or partition, the door opening shall be 4 inches maximum from the front partition. Toilet compartment doors shall not swing into the minimum required compartment area.	25" to wall	Rehang stall door to be max 4" from adjacent stall partition and on the stall wall farthest from the toilet.	2015 ABAAS Section: 604.8.1.2 2012 TAS Section: 604.8.1.2 2010 ADAS Section: 604.8.1.2

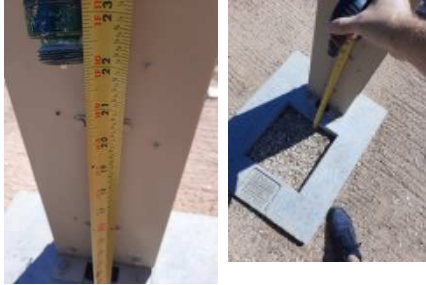
Finding Number	Area Description	Lat/Long	Finding	As Built	Recommendation	Citation	Photos	Figure
152	Full Hook-Up Campsites: Full Hook-Up - Campsite 18	[31.3274478, -97.4685631]	Water spouts at water hydrants and water utility hook-ups shall be 28 inches (710 mm) minimum and 36 inches (915 mm) maximum above the ground.	Water spout 22" above ground level (AGL)	Remount water spouts to 28" min or 36" max above the ground as a smart practice.	2015 ABAAS Section: 1011.6

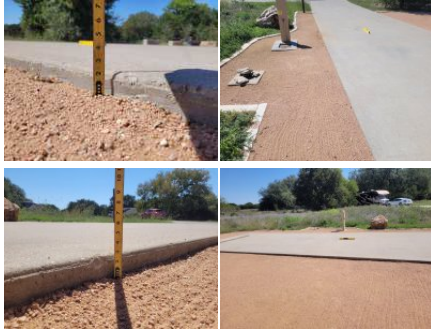
154	Full Hook-Up Campsites: Full Hook-Up - Campsite 20	[31.32768, -97.46864]	The surface of the outdoor recreation access route, passing spaces, and/or resting intervals are not firm and stable. The surface of outdoor recreation access route, passing spaces, and resting intervals shall be firm and stable, having a width of 36", max gaps of .5" and tread obstacles of .5" or less.	2" and 3" change in elevation (CIL) where decomposed granite meets paved surface	Frequently inspect and regularly maintain accessible portions of camping area surface that are comprised of loose fill such as decomposed granite so that surface is level with other surfaces.	2015 ABAAS Section: 1016.2

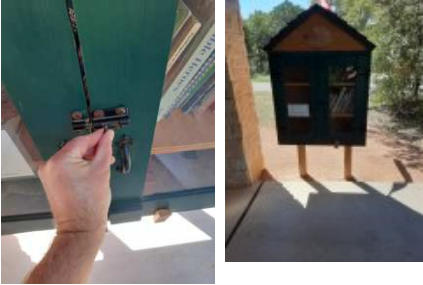
Finding Number	Area Description	Lat/Long	Finding	As Built	Recommendation	Citation	Photos	Figure
160	Full Hook-Up Campsites: Full Hook-Up - Elements	[31.3268217 , -97.468704 4]	The operable part is not accessible because it requires tight grasping, pinching or twisting of the wrist.	Bolt lock on little Free Library at restrooms in Full Hook-Up Campground requires tight pinch and sticks when opening	Replace operable part with one usable without a tight pinch or grasp.	2015 ABAAS Section: 309.4 2012 TAS Section: 309.4 2010 ADAS Section: 309.4

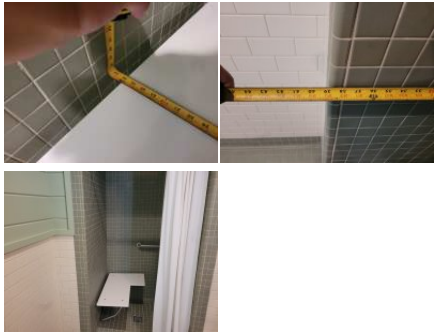
174	CCC Cabin: CCC Cabin - Cabin	[31.3213116 , -97.469172 2]	Transfer type shower compartments shall be 36 inches (915 mm) by 36 inches (915 mm) clear inside dimensions measured at the center points of opposing sides and shall have a 36 inch (915 mm) wide minimum entry on the face of the shower compartment. Clearance of 36 inches (915 mm) wide minimum by 48 inches (1220 mm) long minimum measured from the control wall shall be provided.	Restroom - Shower dimensions not compliant - 37.5" x 39"	Renovate transfer shower to compliant 36" by 36" clear inside dimension.	2015 ABAAS Section: 608.2.1 2012 TAS Section: 608.2.1 2010 ADAS Section: 608.2.1

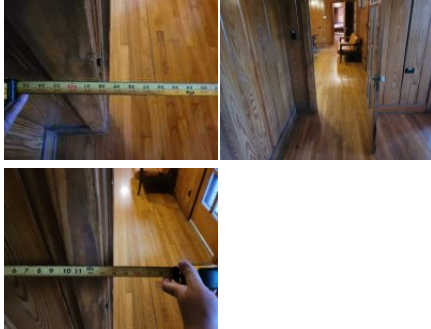
Finding Number	Area Description	Lat/Long	Finding	As Built	Recommendation	Citation	Photos	Figure
180	CCC Cabin: CCC Cabin - Cabin	[31.3212612 , -97.4691967]	Minimum maneuvering clearances at doors and gates shall comply with 404.2.4. Maneuvering clearances shall extend the full width of the doorway and the required latch side or hinge side clearance. Door openings shall provide a clear width of 32 inches (815 mm) minimum. Clear openings of doorways with swinging doors shall be measured between the face of the door and the stop, with the door open 90 degrees. Openings more than 24 inches (610 mm) deep shall provide a clear opening of 36 inches (915 mm) minimum. There shall be no projections into the required clear opening width lower than 34 inches (865 mm) above the finish floor or ground. Projections into the clear opening width between 34 inches (865 mm) and 80 inches (2030 mm) above the finish floor or ground shall not exceed 4 inches (100 mm). Hand-activated door opening hardware, handles, pulls, latches, locks, and other operating devices on accessible doors shall have a shape that is easy to grasp with one hand and does not require tight grasping, tight pinching or twisting of the wrist to operate. Hardware shall be 34 inches minimum and 48 inches maximum above the finish floor or ground.	Dining room between rooms door - 29.5" wide, knob, wall in pull side clearance	For all doors along the public circulation route, provide required maneuvering clearance on push and pull side of doors. For all doors along the public circulation route, replace doors with doors having 80" overhead clearance and 32" clear width. For all doors along the public circulation route, replace hardware with lever hardware or hardware operable without a tight pinch or grasp.	2010 ADAS Section: 404.2.3, 404.2.7, 404.2.4, 404.2.11, 404.2.11 Exception

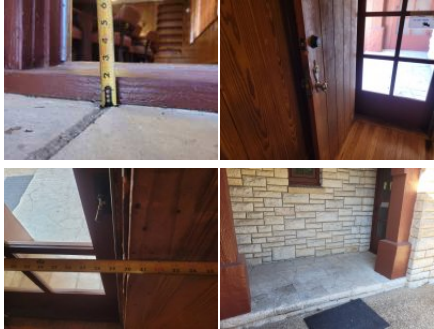
Finding Number	Area Description	Lat/Long	Finding	As Built	Recommendation	Citation	Photos	Figure
184	CCC Cabin: CCC Cabin - Cabin	[31.32119, -97.46912]	<p>Minimum maneuvering clearances at doors and gates shall comply with 404.2.4. Maneuvering clearances shall extend the full width of the doorway and the required latch side or hinge side clearance. Door openings shall provide a clear width of 32 inches (815 mm) minimum. Clear openings of doorways with swinging doors shall be measured between the face of the door and the stop, with the door open 90 degrees. Openings more than 24 inches (610 mm) deep shall provide a clear opening of 36 inches (915 mm) minimum. There shall be no projections into the required clear opening width lower than 34 inches (865 mm) above the finish floor or ground. Projections into the clear opening width between 34 inches (865 mm) and 80 inches (2030 mm) above the finish floor or ground shall not exceed 4 inches (100 mm). The threshold has a vertical change greater than 1/4 inch high. The threshold at a doorway shall be no higher than 1/2 inch. Changes in level between 1/4 inch and 1/2 inch must be beveled at 1:2 or less. 1/4 inch is the maximum vertical rise. Hand-activated door opening hardware, handles, pulls, latches, locks, and other operating devices on accessible doors shall have a shape that is easy to grasp with one hand and does not require tight grasping, tight pinching or twisting of the wrist to operate. Hardware shall be 34 inches minimum and 48 inches maximum above the finish floor or ground.</p>	Original porch doors (2) - wall in pull side clearance, knobs, thresholds high, step to access, 29" wide	<p>For all doors along the public circulation route, provide required maneuvering clearance on push and pull side of doors. For all doors along the public circulation route, replace doors with doors having 80" overhead clearance and 32" clear width. For all doors along the public circulation route, repair, bevel, or ramp CILs at door entries to max .25". For all doors along the public circulation route, provide beveled threshold. For all doors along the public circulation route, replace hardware with lever hardware or hardware operable without a tight pinch or grasp. In the alternative, leave as is and make previous recommended changes to one patio door.</p>	2010 ADAS Section: 404.2.3, 404.2.7, 404.2.4, 404.2.11, 404.2.11 Exception

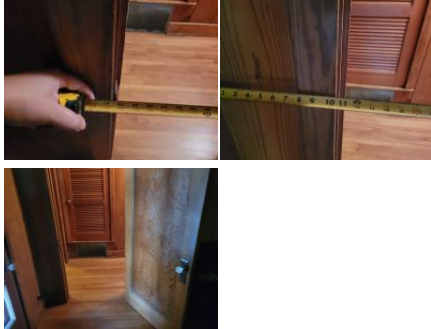
Finding Number	Area Description	Lat/Long	Finding	As Built	Recommendation	Citation	Photos	Figure
186	CCC Cabin: CCC Cabin - Cabin	[31.32123, -97.46915]	Minimum maneuvering clearances at doors and gates shall comply with 404.2.4. Maneuvering clearances shall extend the full width of the doorway and the required latch side or hinge side clearance. Door openings shall provide a clear width of 32 inches (815 mm) minimum. Clear openings of doorways with swinging doors shall be measured between the face of the door and the stop, with the door open 90 degrees. Openings more than 24 inches (610 mm) deep shall provide a clear opening of 36 inches (915 mm) minimum. There shall be no projections into the required clear opening width lower than 34 inches (865 mm) above the finish floor or ground. Projections into the clear opening width between 34 inches (865 mm) and 80 inches (2030 mm) above the finish floor or ground shall not exceed 4 inches (100 mm). Hand-activated door opening hardware, handles, pulls, latches, locks, and other operating devices on accessible doors shall have a shape that is easy to grasp with one hand and does not require tight grasping, tight pinching or twisting of the wrist to operate. Hardware shall be 34 inches minimum and 48 inches maximum above the finish floor or ground.	Double-bed bedroom door - 29" wide, knob, wall pull side	For all doors along the public circulation route, provide required maneuvering clearance on push and pull side of doors. For all doors along the public circulation route, replace doors with doors having 80" overhead clearance and 32" clear width. For all doors along the public circulation route, replace hardware with lever hardware or hardware operable without a tight pinch or grasp.	2010 ADAS Section: 404.2.3, 404.2.7, 404.2.4, 404.2.11, 404.2.11 Exception

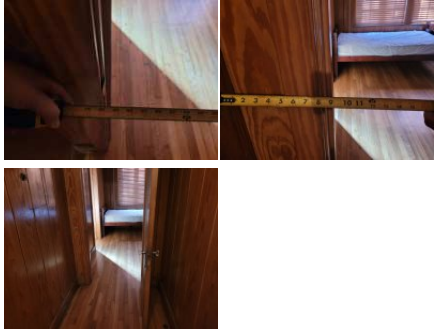
Finding Number	Area Description	Lat/Long	Finding	As Built	Recommendation	Citation	Photos	Figure
189	CCC Cabin: CCC Cabin - Cabin	[31.32122, -97.46921]	<p>Minimum maneuvering clearances at doors and gates shall comply with 404.2.4. Maneuvering clearances shall extend the full width of the doorway and the required latch side or hinge side clearance. Door openings shall provide a clear width of 32 inches (815 mm) minimum. Clear openings of doorways with swinging doors shall be measured between the face of the door and the stop, with the door open 90 degrees. Openings more than 24 inches (610 mm) deep shall provide a clear opening of 36 inches (915 mm) minimum. There shall be no projections into the required clear opening width lower than 34 inches (865 mm) above the finish floor or ground. Projections into the clear opening width between 34 inches (865 mm) and 80 inches (2030 mm) above the finish floor or ground shall not exceed 4 inches (100 mm). Hand-activated door opening hardware, handles, pulls, latches, locks, and other operating devices on accessible doors shall have a shape that is easy to grasp with one hand and does not require tight grasping, tight pinching or twisting of the wrist to operate. Hardware shall be 34 inches minimum and 48 inches maximum above the finish floor or ground.</p>	Bedroom with 2 beds door - wall in pull side clearance, 29.5" wide, knobs	<p>For all doors along the public circulation route, provide required maneuvering clearance on push and pull side of doors. For all doors along the public circulation route, replace doors with doors having 80" overhead clearance and 32" clear width. For all doors along the public circulation route, replace hardware with lever hardware or hardware operable without a tight pinch or grasp.</p>	2010 ADAS Section: 404.2.3, 404.2.7, 404.2.4, 404.2.11, 404.2.11 Exception

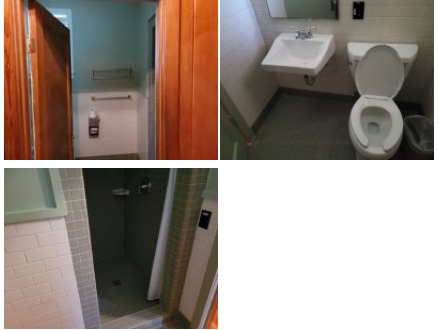
Finding Number	Area Description	Lat/Long	Finding	As Built	Recommendation	Citation	Photos	Figure
198	CCC Cabin: CCC Cabin - Cabin	[31.3212092 , -97.4691787]	This restroom is not accessible. Where existing toilet rooms or bathing rooms do not comply, directional signs indicating the location of the nearest accessible toilet room or bathing room within the facility shall be provided. Signs shall include the International Symbol of Accessibility. Where existing toilet rooms or bathing rooms do comply), the accessible toilet rooms or bathing rooms shall be identified by the International Symbol of Where clustered single user toilet rooms or bathing facilities are permitted, accessible toilet rooms or bathing facilities shall be identified by the International Symbol of Accessibility unless all toilet rooms and bathing facilities are accessible.	Hall bathroom not accessible, lacks directional signage	Restroom not accessible, acquire and mount signage directing patrons to accessible restroom.	2015 ABAAS Section: F216.8 2012 TAS Section: 216.8 2010 ADAS Section: 216.8

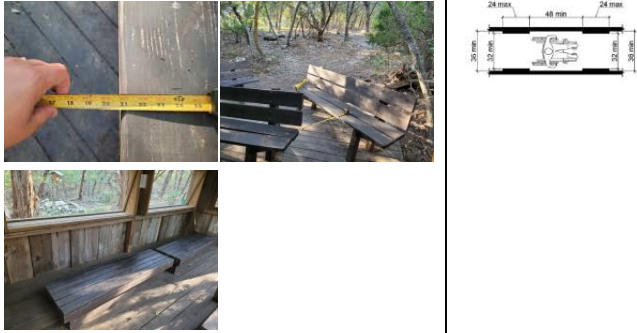
208	CCC Cabin: CCC - Tower Bird Blind	[31.3218067 , -97.4692051]	The route of travel at this location does not provide the required minimum width. The minimum clear width for sidewalks and walks is 36 inches.	Route in bird blind reduces to 21" between benches, benches obstruct windows	Reposition or remove benches to widen EAR to min 36" clear width and provide clear floor space at viewing windows.	2015 ABAAS Section: 403.5.1 2012 TAS Section: 403.5.1 2010 ADAS Section: 403.5.1

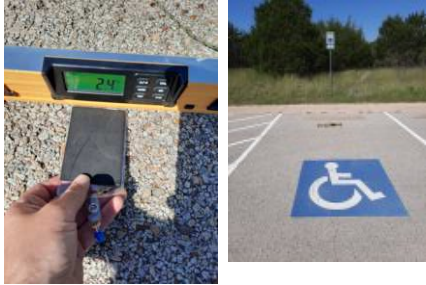
Finding Number	Area Description	Lat/Long	Finding	As Built	Recommendation	Citation	Photos	Figure
222	Trails: Trails - Prairie Loop Trail	[31.3322258 , -97.4674626]	The cross slopes (narrow dimension) and/or running slopes (long dimension) of the access aisle exceeds 2%. The running slope and the cross slope in an accessible parking stall and the access aisle must not exceed 2%.	Right stall - 2.4%	Repair or correct slope of parking space and access aisle to max 2.08% in any direction.	2015 ABAAS Section: 502.4 2012 TAS Section: 502.4 2010 ADAS Section: 502.4

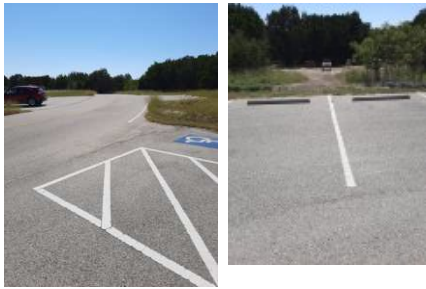
224	Trails: Trails - Prairie Loop Trail	[31.3322212 , -97.4674961]	The accessible parking is not located on the shortest accessible route to the building. Accessible parking spaces serving a particular building or facility entrance shall be located on the shortest accessible route of travel from the parking to an accessible entrance.	Accessible spaces not on shortest route to Prairie Loop Trail trailhead	Relocate stalls to be on the shortest AR to the building entry or park features.	2015 ABAAS Section: F208.3.1 2012 TAS Section: 208.3.1 2010 ADAS Section: 208.3.1

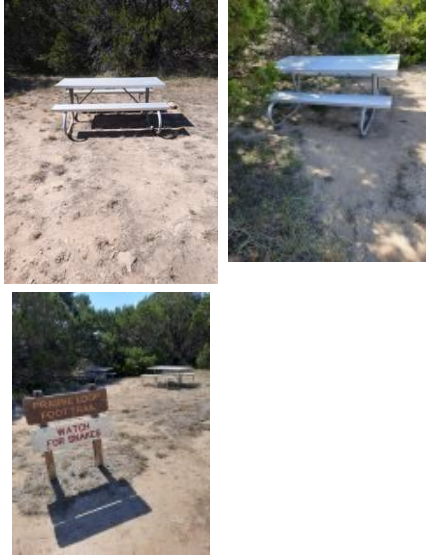
Finding Number	Area Description	Lat/Long	Finding	As Built	Recommendation	Citation	Photos	Figure
225	Trails: Trails - Prairie Loop Trail	[31.3315844 , -97.467783 6]	Picnic tables shall provide at least one wheelchair space for each 24 linear feet (7320 mm) of usable table surface perimeter. Wheelchair spaces shall be 30 inches (760 mm) minimum by 48 inches (1220 mm) minimum. Wheelchair spaces shall be positioned for a forward approach to the table and provide knee and toe clearance complying with 306 under the table	2 of 2 picnic tables at Prairie Loop Trail trailhead are not of an accessible design	Replace one picnic table with one of an accessible design as a smart practice.	2015 ABAAS Section: 1011.4.2

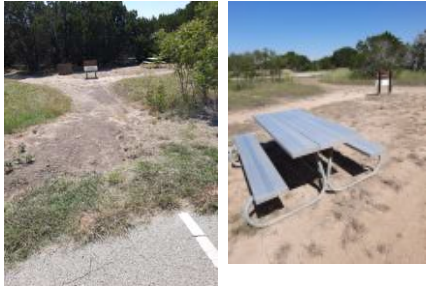
226	Trails: Trails - Prairie Loop Trail	[31.3315725 , -97.467749]	An accessible access route is not provided between elements, spaces and the facilities provided within the accessible camping unit. At least one outdoor recreation access route shall connect accessible elements, spaces and facilities provided within camping units with mobility features.	Prairie Loop Trailhead - lacks route to trail, garbage can, and 2 of 2 picnic tables	Create AR with crushed and compacted stone or similar outdoor material to trailhead and one of each type of amenity.	2015 ABAAS Section: F244.5.1

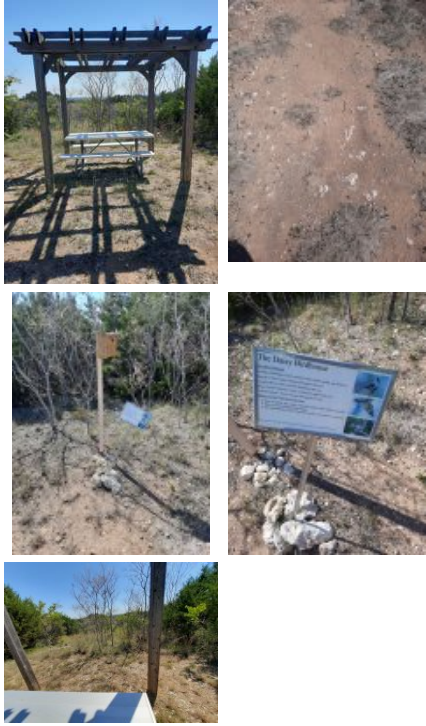
Finding Number	Area Description	Lat/Long	Finding	As Built	Recommendation	Citation	Photos	Figure
227	Trails: Trails - Prairie Loop Trail	[31.33279, -97.46861]	An accessible access route is not provided between elements, spaces and the facilities provided within the accessible camping unit. At least one outdoor recreation access route shall connect accessible elements, spaces and facilities provided within camping units with mobility features.	Prairie Loop Trail - Lacks route to Pergola, overlook (just an open area behind pergola to view landscape), "The Daisey Birdhouse" sign, and picnic table (not of an accessible design) due to non-compliant trail surface (natural surface) - 1200' from Trailhead parking	Create an outdoor recreation access route with crushed and compacted stone or similar outdoor material to trailhead and one of each type of amenity.	2015 ABAAS Section: F244.5.1
