Access Audit Site Report

Mustang Island State Park
9394 TX-361
Corpus Christi, TX 78418
Accessibility Evaluation
Inspection Date: 06/13/2022
Inspectors: Tanya Scheibe

Prepared By
WT Group

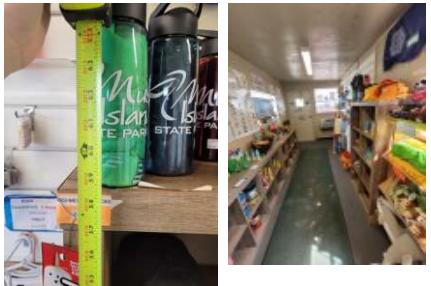
19	Headquarters (HQ) : HQ - Public Spaces	[27.6723274 , -97.175015]	The operable part is positioned too high for either a side or front approach. Where a clear floor or ground space allows a parallel approach to an element and the side reach is unobstructed, the high side reach shall be 48 inches maximum and the low side reach shall be 15 inches minimum above the finish floor or ground. Where a forward reach is unobstructed, the high forward reach shall be 48 inches maximum and the low forward reach shall be 15 inches minimum above the finish floor or ground.	Shop - merchandise 58.5" above finished floor	Remount operable parts to be in reach range of 15" min to 48" max or train staff to assist individuals with short stature or who use mobility devices.	2015 ABAAS Section: 308.1 2012 TAS Section: 308.1 2010 ADAS Section: 308.1

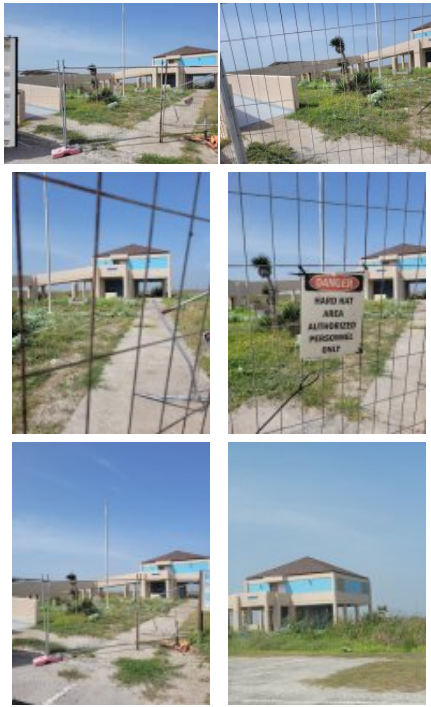
21	Headquarters (HQ) : HQ - Public Spaces	[27.6721374 , -97.1752511]	Existing building status unknown and could not be audited at this time for safety reasons.	original HQ was not open or safe to audit, construction has started but completion uncertain	Ensure all new work on this facility is accessible prior to reopening.	Capture Section: 1

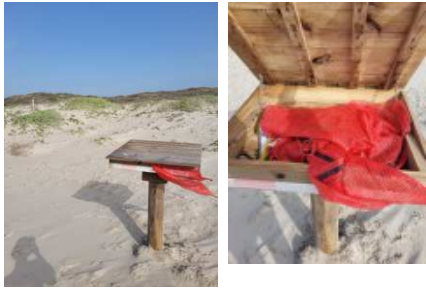
32	Park Site: Park Elements	[27.6685041 , -97.172422 7]	There is no accessible route to the wooden box. At least one accessible route shall connect accessible buildings, accessible facilities, accessible elements, and accessible spaces that are on the same site.	no route to wooden stand on beach	Create a beach access route to wooden podium if intended for use by the public.	2015 ABAAS Section: F206.2.2 2012 TAS Section: 206.2.2 2010 ADAS Section: 206.2.2

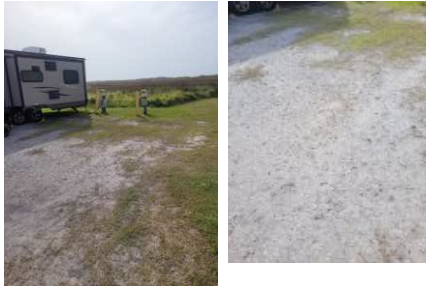
Finding Number	Area Description	Lat/Long	Finding	As Built	Recommendation	Citation	Photos	Figure
43	Park Site: Campsites	[27.6733346 , -97.1732448]	Camping facilities shall provide camping units with mobility features complying with F244.2 in accordance with Table F244.2. Where a camping facility provides different types of camping units, Table F244.2 shall apply to each type of camping unit provided. Total Number of Camping Units Provided in Camping Facility Minimum Number of Camping Units with Mobility Features Required 1 1 2 to 25 2 26 to 50 3 51 to 75 4 76 to 100 5 101 to 150 7 151 to 200 8 201 and over 8, plus 2 percent of the number over 200	0 ADA sites	Create the required number of accessible camp sites per table F244.2 as a smart practice	2015 ABAAS Section: F244.2		
44	Park Site: Campsites	[27.673135, -97.1731268]	Parking spaces and pull-up spaces for recreational vehicles shall be 20 feet (6100 mm) wide minimum. EXCEPTION: Where two adjacent parking spaces are provided for recreational vehicles, one parking space shall be permitted to be 16 feet (4880 mm) wide minimum.	sample site 25 - surface fails, gravel and grass	Correct RV parking space to be 20' wide minimum; or 16' for two adjacent spaces as a smart practice.	2015 ABAAS Section: 1012.2, 1012.2 EXCEPTION

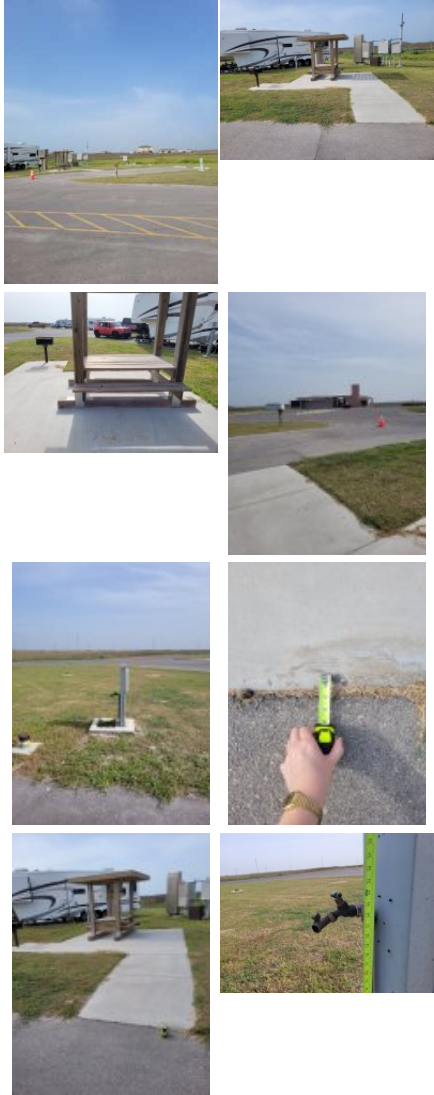
Finding Number	Area Description	Lat/Long	Finding	As Built	Recommendation	Citation	Photos	Figure
46	Park Site: Campsites	[27.672344, -97.173546 5]	Camping facilities shall provide camping units with mobility features complying with F244.2 in accordance with Table F244.2. Where a camping facility provides different types of camping units, Table F244.2 shall apply to each type of camping unit provided. Total Number of Camping Units Provided in Camping Facility Minimum Number of Camping Units with Mobility Features Required 1 1 2 to 25 2 26 to 50 3 51 to 75 4 76 to 100 5 101 to 150 7 151 to 200 8 201 and over 8, plus 2 percent of the number over 200	0 of 4 park host sites are designated accessible but each has paved surfaces and could be more easily made accessible than other campsites.	Create the required number of accessible camp sites per table F244.2 as a smart practice	2015 ABAAS Section: F244.2

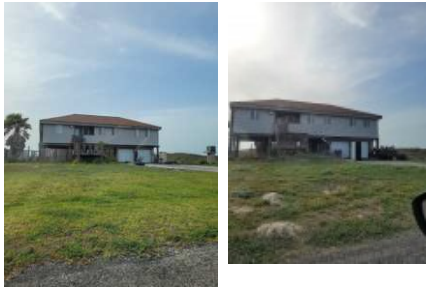
47	Park Site: Residence	[27.668978, -97.1748005]	The building entrance is not located on an accessible route. When a building, or portion of a building, is required to be accessible, an accessible route of travel shall be provided to all portions of the building, to accessible building entrances and between the building and the public way. All walks, halls, corridors, aisles, skywalks, tunnels, and other spaces that are part of an accessible route must comply. An accessible route of travel must not pass through kitchens, storage rooms, restrooms, closets or other spaces used for similar purposes. At least one accessible route within the boundary of the site must be provided from public transportation stops, accessible parking and accessible passenger loading zones and public streets or sidewalks to the accessible building entrance they serve. The accessible route shall, to the maximum extent feasible, coincide with the route for the general public. At least one accessible route shall connect accessible buildings, facilities, elements and spaces that are on the same site. At least one accessible route shall connect accessible building or facility entrances with all accessible spaces and elements.	both residence entries are on 2nd floor, no one lives in them for last 5 years due to hurricane Harvey	If residences will be used, create AR with crushed and compacted stone or similar outdoor material from parking or sidewalk to at least one residence entrance; in the alternative, provide a residence with entry at ground level.	2015 ABAAS Section: F206.2.1 2012 TAS Section: 206.2.1 2010 ADAS Section: 206.2.1

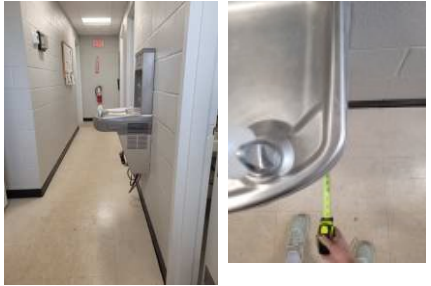
Finding Number	Area Description	Lat/Long	Finding	As Built	Recommendation	Citation	Photos	Figure
55	Park Site: Maintenance	[27.6708261 , -97.174575 2]	An item or items project more than 4 inches into the circulation path. Wall-mounted objects that have leading edges between 27 inches and 80 inches from the floor must not project more than 4 inches into the circulation path. Protruding objects that extend to the floor or within 27 inches of the floor are cane detectable and are therefore not hazardous. Where it is necessary or desirable to have objects protrude from the wall, a manner of cane detection must be provided.	2nd floor - fountain projects 15" into way	Relocate protruding objects or place cane detectable warning or bollard at foot of item.	2015 ABAAS Section: 307.2 2012 TAS Section: 307.2 2010 ADAS Section: 307.2

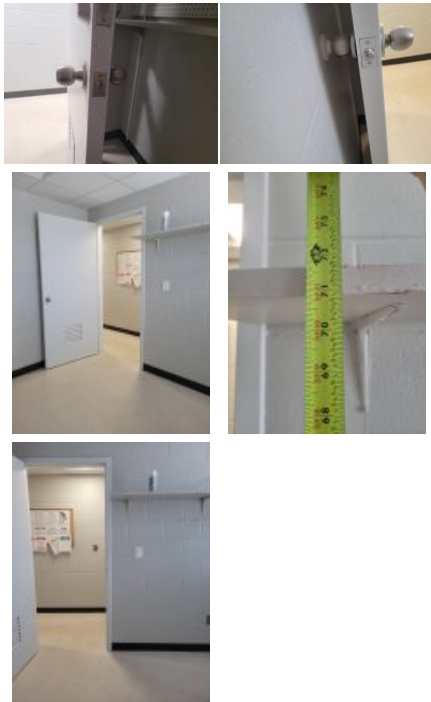
56	Park Site: Maintenance	[27.6708214 , -97.174564 4]	Spaces and elements within employee work areas shall only be required to comply with 206.2.8, 207.1, and 215.3 and shall be designed and constructed so that individuals with disabilities can approach, enter, and exit the employee work area. Employee work areas, or portions of employee work areas, other than raised courtroom stations, that are less than 300 square feet (28 m2) and elevated 7 inches (180 mm) or more above the finish floor or ground where the elevation is essential to the function of the space shall not be required to comply with these requirements or to be on an accessible route.	2nd floor - 2 of 2 empty offices have knobs, door further from fountain - shelf in pull side clearance	For employee spaces, relocate storage, furniture, and other obstacles at doorways to provide approach, enter and exit at the employee space. Provide required maneuvering clearance on push and pull side of doors. Replace hardware with lever hardware or hardware operable without a tight pinch or grasp.	2015 ABAAS Section: F203.9 2012 TAS Section: 203.9 2010 ADAS Section: 203.9

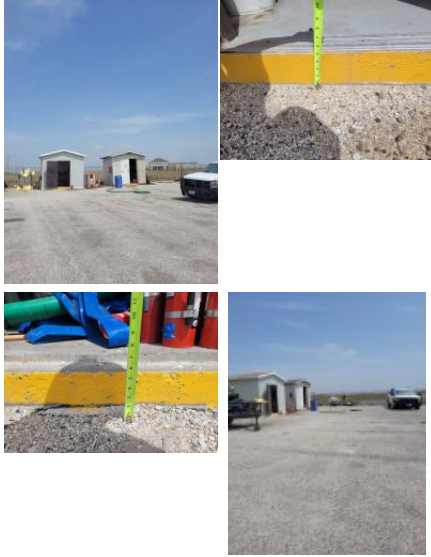
Finding Number	Area Description	Lat/Long	Finding	As Built	Recommendation	Citation	Photos	Figure
58	Park Site: Maintenance	[27.6707786 , -97.1749507]	Spaces and elements within employee work areas shall only be required to comply with 206.2.8, 207.1, and 215.3 and shall be designed and constructed so that individuals with disabilities can approach, enter, and exit the employee work area. Employee work areas, or portions of employee work areas, other than raised courtroom stations, that are less than 300 square feet (28 m2) and elevated 7 inches (180 mm) or more above the finish floor or ground where the elevation is essential to the function of the space shall not be required to comply with these requirements or to be on an accessible route.	No AR to green sheds due to 5.5" and 7" change in level, loose gravel surface	Provide ramps at door entries. Provide a firm and stable pad near entries for driver access to buildings.	2015 ABAAS Section: F203.9 2012 TAS Section: 203.9 2010 ADAS Section: 203.9

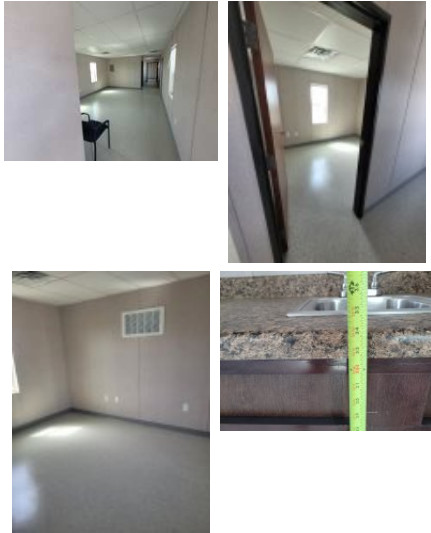
59	Park Site: Administration Building (New)	[27.6705696 , -97.174543]	Element meets all standards and requirements	empty temporary trailer common circulation path complies	None	2010 ADAS Section: N/A

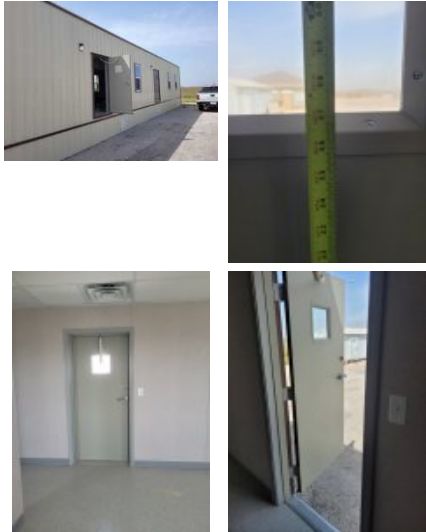
Finding Number	Area Description	Lat/Long	Finding	As Built	Recommendation	Citation	Photos	Figure
60	Park Site: Administration Building (New)	[27.6706112 , -97.1745215]	Spaces and elements within employee work areas shall only be required to comply with 206.2.8, 207.1, and 215.3 and shall be designed and constructed so that individuals with disabilities can approach, enter, and exit the employee work area. Employee work areas, or portions of employee work areas, other than raised courtroom stations, that are less than 300 square feet (28 m2) and elevated 7 inches (180 mm) or more above the finish floor or ground where the elevation is essential to the function of the space shall not be required to comply with these requirements or to be on an accessible route.	temporary building at maintenance will eventually have a ramp, no route during audit due to change in level, both doors have windows 57" above finished floor, both lacked exit signage	Repair, bevel, or ramp CILs at door entries to max .25". Replace doors with ones having sidelight viewing windows max 43" aff. Enlarge cement pad at exit to allow 18" clearance on the latch side, and extend a pathway away from the building for emergency egress.	2015 ABAAS Section: F203.9 2012 TAS Section: 203.9 2010 ADAS Section: 203.9

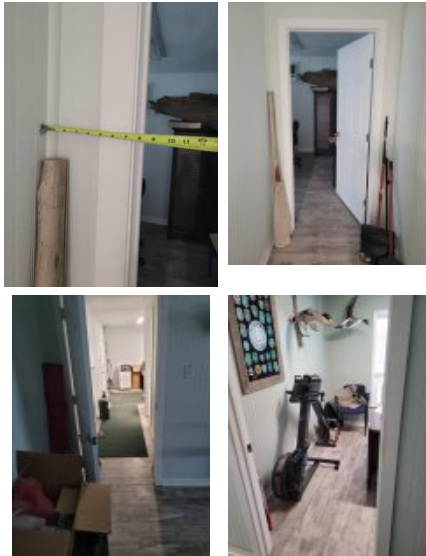
61	Park Site: Administration Building (Old)	[27.6706076 , -97.1747468]	Spaces and elements within employee work areas shall only be required to comply with 206.2.8, 207.1, and 215.3 and shall be designed and constructed so that individuals with disabilities can approach, enter, and exit the employee work area. Employee work areas, or portions of employee work areas, other than raised courtroom stations, that are less than 300 square feet (28 m2) and elevated 7 inches (180 mm) or more above the finish floor or ground where the elevation is essential to the function of the space shall not be required to comply with these requirements or to be on an accessible route.	police trailer at maintenance, end office - clearance on push reduced to 8" by wall, middle office - clearance on pull reduced by storage	For employee spaces, relocate storage, furniture, and other obstacles at doorways to provide approach, enter and exit at the employee space. Provide required maneuvering clearance on push and pull side of doors.	2015 ABAAS Section: F203.9 2012 TAS Section: 203.9 2010 ADAS Section: 203.9

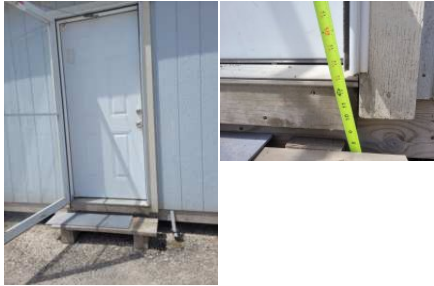
Finding Number	Area Description	Lat/Long	Finding	As Built	Recommendation	Citation	Photos	Figure
62	Park Site: Administration Building (Old)	[27.6706123 , -97.174773 6]	Spaces and elements within employee work areas shall only be required to comply with 206.2.8, 207.1, and 215.3 and shall be designed and constructed so that individuals with disabilities can approach, enter, and exit the employee work area. Employee work areas, or portions of employee work areas, other than raised courtroom stations, that are less than 300 square feet (28 m2) and elevated 7 inches (180 mm) or more above the finish floor or ground where the elevation is essential to the function of the space shall not be required to comply with these requirements or to be on an accessible route.	blue trailer/ police - knob, 13" change in level	Provide a ramp for access to building. Replace hardware with lever hardware or hardware operable without a tight pinch or grasp.	2015 ABAAS Section: F203.9 2012 TAS Section: 203.9 2010 ADAS Section: 203.9

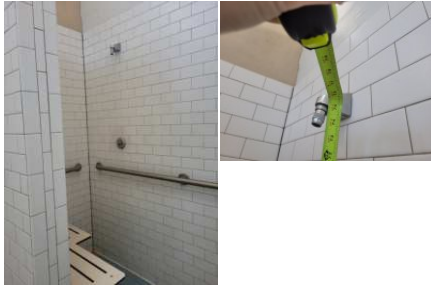
Finding Number	Area Description	Lat/Long	Finding	As Built	Recommendation	Citation	Photos	Figure
66	Restrooms: Men's Restroom	[27.672926, -97.173234 1]	There is no hand held sprayer unit. The sprayer unit must have a 59 inches hose and be mounted 48 inches maximum to the top of mounting bracket off the floor. The shower spray unit shall have an on/off control with a non-positive shutoff. If an adjustable-height shower head on a vertical bar is used, the bar shall be installed so as not to obstruct the use of grab bars.	no hose, shower head 74" above finished floor	Replace shower control with a compliant lever control with a shower head on a 59" hose and usable as hand held.	2015 ABAAS Section: 608.6 2012 TAS Section: 608.6 2010 ADAS Section: 608.6

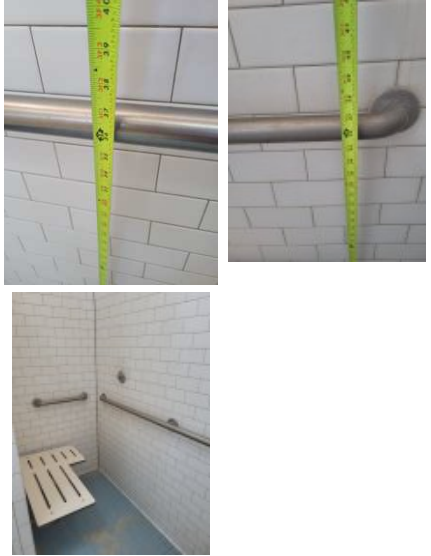
67	Restrooms: Men's Restroom	[27.672964, -97.173277]	Grab bars shall be installed in a horizontal position, 33 inches (840 mm) minimum and 36 inches (915 mm) maximum above the finish floor measured to the top of the gripping surface	37" above finished floor for both	Remount shower grab bar to 33" min. and 36" max. AFF.	2015 ABAAS Section: 609.3 Exception, 609.4 2012 TAS Section: 609.4, 609.3 Exception 2010 ADAS Section: 609.4, 609.3 Exception

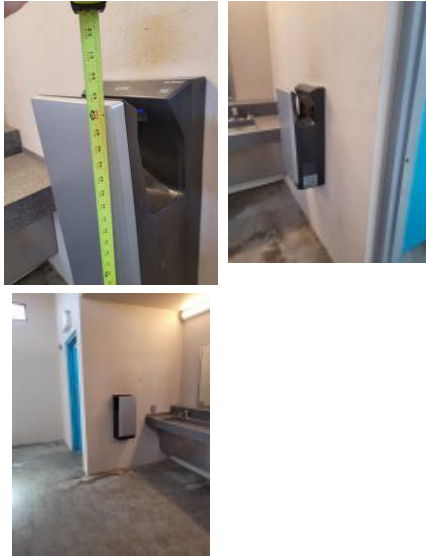
Finding Number	Area Description	Lat/Long	Finding	As Built	Recommendation	Citation	Photos	Figure
70	Restrooms: Men's Restroom	[27.672926, -97.173234 1]	Where a high forward reach is over an obstruction, the clear floor space shall extend beneath the element for a distance not less than the required reach depth over the obstruction. The high forward reach shall be 48 inches (1220 mm) maximum where the reach depth is 20 inches (510 mm) maximum. Where the reach depth exceeds 20 inches (510 mm), the high forward reach shall be 44 inches (1120 mm) maximum and the reach depth shall be 25 inches (635 mm) maximum. Where a clear floor or ground space allows a parallel approach to an element and the high side reach is over an obstruction, the height of the obstruction shall be 34 inches (865 mm) maximum and the depth of the obstruction shall be 24 inches (610 mm) maximum. The high side reach shall be 48 inches (1220 mm) maximum for a reach depth of 10 inches (255 mm) maximum. Where the reach depth exceeds 10 inches (255 mm), the high side reach shall be 46 inches (1170 mm) maximum for a reach depth of 24 inches (610 mm) maximum.	2 of 2 hand dryers 48.5" above finished floor	Lower operating mechanisms to max 48" above the finished floor (AFF) to highest operable part. In the alternative, leave as is citing construction tolerance.	2015 ABAAS Section: 308.2.1, 308.3.2 2012 TAS Section: 308.2.1, 308.3.2 2010 ADAS Section: 308.2.1, 308.3.2

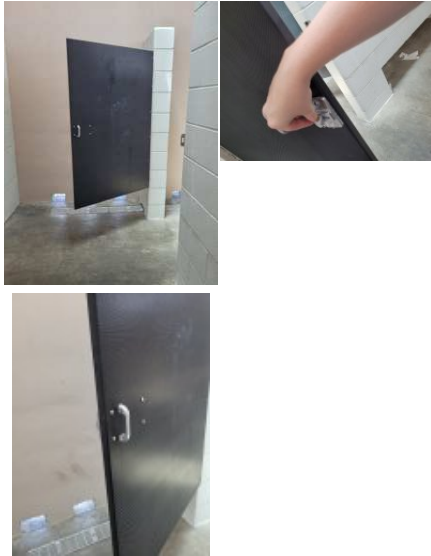
Finding Number	Area Description	Lat/Long	Finding	As Built	Recommendation	Citation	Photos	Figure
75	Restrooms: Women's Restroom	[27.6728975 , -97.173266 2]	The stall door fails to comply with all of the door requirements. The stall door must be a minimum of 32" wide and have compliant hardware on both sides. The stall door must be self-closing.	not self closing	Adjust stall door to be self-closing.	2015 ABAAS Section: 404.2.3, 404.2.7, 604.8.2.2 2012 TAS Section: 404.2.3, 404.2.7, 604.8.2.2 2010 ADAS Section: 404.2.3, 404.2.7, 604.8.2.2

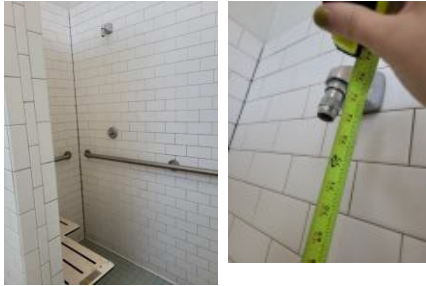
Finding Number	Area Description	Lat/Long	Finding	As Built	Recommendation	Citation	Photos	Figure
77	Restrooms: Women's Restroom	[27.672964, -97.173212 6]	There is no hand held sprayer unit. The sprayer unit must have a 59 inches hose and be mounted 48 inches maximum to the top of mounting bracket off the floor. The shower spray unit shall have an on/off control with a non-positive shutoff. If an adjustable-height shower head on a vertical bar is used, the bar shall be installed so as not to obstruct the use of grab bars.	no hose, shower head is 74" AFF	Replace shower control with a compliant lever control with a shower head on a 59" hose and usable as hand held.	2015 ABAAS Section: 608.6 2012 TAS Section: 608.6 2010 ADAS Section: 608.6

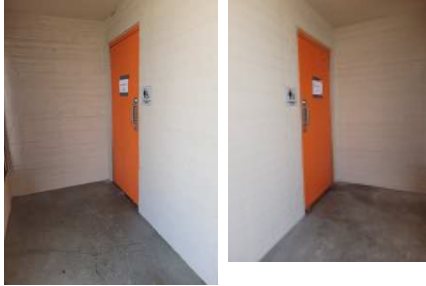
78	Restrooms: Women's Restroom	[27.672926, -97.173244 8]	Element meets all standards and requirements	both women's restroom doors comply	None	2010 ADAS Section: N/A

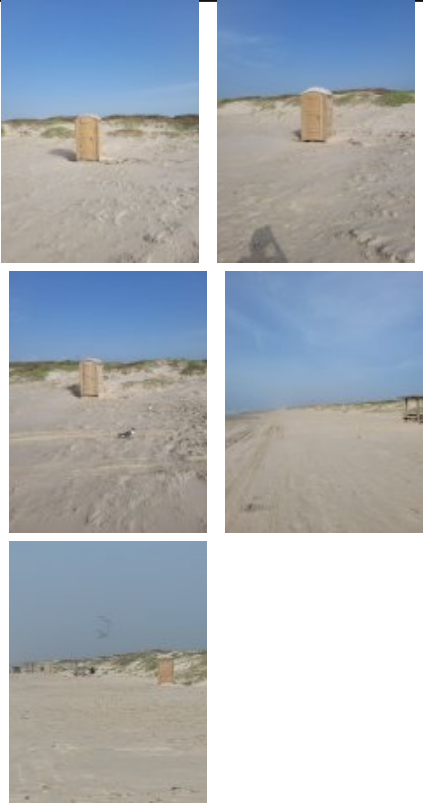
Finding Number	Area Description	Lat/Long	Finding	As Built	Recommendation	Citation	Photos	Figure
82	Restrooms: Outdoor Rinsing Showers	[27.6728761, -97.1732206]	The outdoor shower is noncompliant. The valve requires tight grasping and twisting of the wrist and must be mounted centered at 39-41 inches, there must be a flexible hand-held sprayer unit with a hose at least 59 inches long that can be used both as a fixed shower head and as a hand-held shower. The shower spray unit shall have an on/off control with a non-positive shutoff. This unit must be mounted such that the top of the mounting bracket is at a maximum height of 48 inches above the floor. A fixed shower head located at 48 inches maximum above the shower finish floor shall be permitted instead of a hand-held spray unit in facilities that are not medical care facilities, long-term care facilities, transient lodging guest rooms, or residential dwelling units.	accessible shower button is removed. clear floor space for shower is reduced by sign, hook is high	Create an accessible rinsing shower.	2015 ABAAS Section: 608.6 2012 TAS Section: 608.6 2010 ADAS Section: 608.6

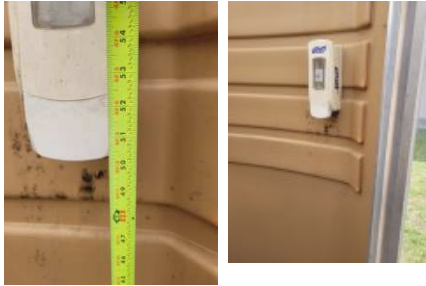
Finding Number	Area Description	Lat/Long	Finding	As Built	Recommendation	Citation	Photos	Figure
84	Restrooms: H1 - Accessible Portable Restroom	[27.6730495 , -97.1732877]	Where a high forward reach is over an obstruction, the clear floor space shall extend beneath the element for a distance not less than the required reach depth over the obstruction. The high forward reach shall be 48 inches (1220 mm) maximum where the reach depth is 20 inches (510 mm) maximum. Where the reach depth exceeds 20 inches (510 mm), the high forward reach shall be 44 inches (1120 mm) maximum and the reach depth shall be 25 inches (635 mm) maximum. Where a clear floor or ground space allows a parallel approach to an element and the high side reach is over an obstruction, the height of the obstruction shall be 34 inches (865 mm) maximum and the depth of the obstruction shall be 24 inches (610 mm) maximum. The high side reach shall be 48 inches (1220 mm) maximum for a reach depth of 10 inches (255 mm) maximum. Where the reach depth exceeds 10 inches (255 mm), the high side reach shall be 46 inches (1170 mm) maximum for a reach depth of 24 inches (610 mm) maximum.	sanitizer 50" above finished floor	Lower operating mechanisms to max 48" above the finished floor (AFF) to highest operable part.	2015 ABAAS Section: 308.2.1, 308.3.2 2012 TAS Section: 308.2.1, 308.3.2 2010 ADAS Section: 308.2.1, 308.3.2

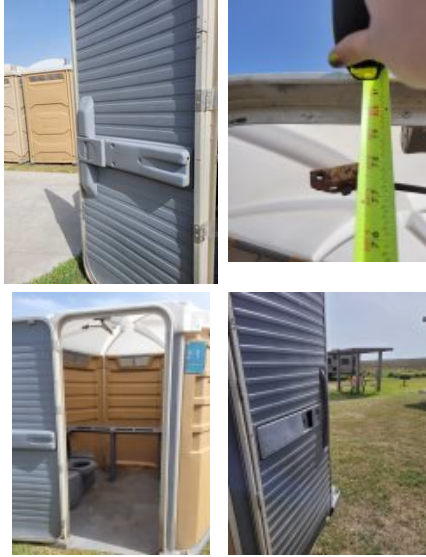
Finding Number	Area Description	Lat/Long	Finding	As Built	Recommendation	Citation	Photos	Figure
86	Restrooms: H1 - Accessible Portable Restroom	[27.6730115, -97.173277]	Door openings shall provide a clear width of 32 inches (815 mm) minimum. Clear openings of doorways with swinging doors shall be measured between the face of the door and the stop, with the door open 90 degrees. Openings more than 24 inches (610 mm) deep shall provide a clear opening of 36 inches (915 mm) minimum. There shall be no projections into the required clear opening width lower than 34 inches (865 mm) above the finish floor or ground. Projections into the clear opening width between 34 inches (865 mm) and 80 inches (2030 mm) above the finish floor or ground shall not exceed 4 inches (100 mm). Hand-activated door opening hardware, handles, pulls, latches, locks, and other operating devices on accessible doors shall have a shape that is easy to grasp with one hand and does not require tight grasping, tight pinching or twisting of the wrist to operate. Hardware shall be 34 inches minimum and 48 inches maximum above the finish floor or ground.	Door - broken closer 78" above finished floor and projects in overhead clearance, .75" CIL	For all doors along the public circulation route, replace doors with doors having 80" overhead clearance and 32" clear width. In the alternative, repair closer. Bevel change in level at doorway.	2010 ADAS Section: 404.2.3, 404.2.7, 404.2.4, 404.2.11, 404.2.11 Exception

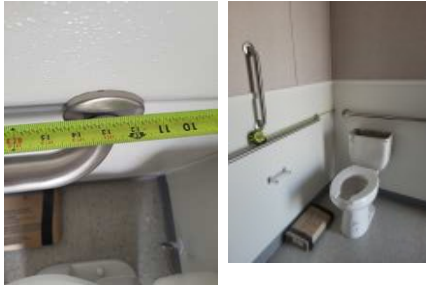
Finding Number	Area Description	Lat/Long	Finding	As Built	Recommendation	Citation	Photos	Figure
93	Restrooms: Restroom Administration Building (New)	[27.6706361 , -97.174505 4]	The side grab bars are not in the correct location. Grab bars on the side wall must be installed so that the end closest to the rear wall is maximum 12" from the rear wall. The end furthest from the rear wall must be mounted minimum 54" from the rear wall.	side grab bar mounted 13" from rear wall	Remount side grab bar to max 12" from the rear wall at the close end and min 54" on the far end, and 33" to 36" aff.	2015 ABAAS Section: 604.5.1 2012 TAS Section: 604.5.1 2010 ADAS Section: 604.5.1

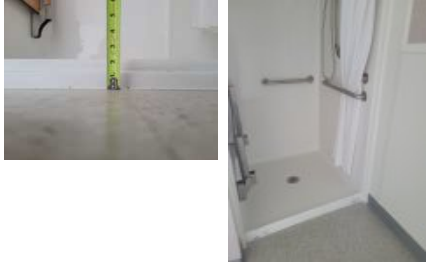
Finding Number	Area Description	Lat/Long	Finding	As Built	Recommendation	Citation	Photos	Figure
96	Restrooms: Restroom Administration Building (New)	[27.6706266 , -97.174521 5]	Thresholds in roll-in type shower compartments shall be ½ inch (13 mm) high maximum in accordance with 303. In transfer type shower compartments, thresholds ½ inch (13 mm) high maximum shall be beveled, rounded, or vertical. EXCEPTION: A threshold 2 inches (51 mm) high maximum shall be permitted in transfer type shower compartments in existing facilities where provision of a ½ inch (13 mm) high threshold would disturb the structural reinforcement of the floor slab.	2" change in level	Reduce threshold at shower to max .5" that is beveled.	2015 ABAAS Section: 303.3, 608.7, 608.7 EXCEPTION 2012 TAS Section: 303.3, 608.7, 608.7 Exception 2010 ADAS Section: 303.3, 608.7, 608.7 Exception

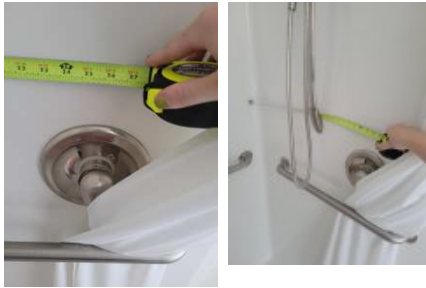
97	Restrooms: Restroom Administration Building (New)	[27.6706361 , -97.174505 4]	Shower controls are in the incorrect location In transfer type shower compartments, the controls, faucets, and shower spray unit shall be installed on the side wall opposite the seat 38 inches (965 mm) minimum and 48 inches (1220 mm) maximum above the shower floor and shall be located on the control wall 15 inches (380 mm) maximum from the centerline of the seat toward the shower opening.	shower controls 26" from side wall	Remount shower controls to the correct location in the transfer shower	2015 ABAAS Section: 608.5.1 2012 TAS Section: 608.5.1 2010 ADAS Section: 608.5.1

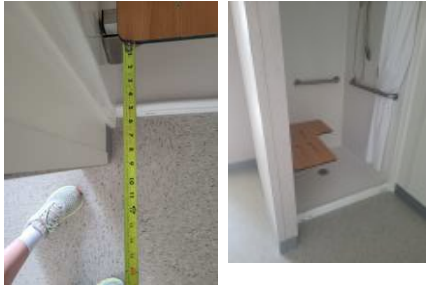
Finding Number	Area Description	Lat/Long	Finding	As Built	Recommendation	Citation	Photos	Figure
98	Restrooms: Restroom Administration Building (New)	[27.6705696 , -97.174543]	Where a seat is provided in a standard roll-in shower compartment, it shall be a folding type, shall be installed on the side wall adjacent to the controls, and shall extend from the back wall to a point within 3 inches (75 mm) of the compartment entry. Where a seat is provided in an alternate roll-in type shower compartment, it shall be a folding type, shall be installed on the front wall opposite the back wall, and shall extend from the adjacent side wall to a point within 3 inches (75 mm) of the compartment entry. In transfer-type showers, the seat shall extend from the back wall to a point within 3 inches (75 mm) of the compartment entry. The top of the seat shall be 17 inches (430 mm) minimum and 19 inches (485 mm) maximum above the bathroom finish floor. Seats shall comply with 610.3.1 or 610.3.2.	9" from entry, wall blocks 48" clear floor space	Provide the correct seat based on shower type.	2015 ABAAS Section: 610.3 2012 TAS Section: 610.3 2010 ADAS Section: 610.3

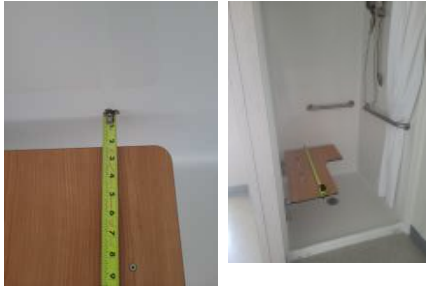
99	Restrooms: Restroom Administration Building (New)	[27.6705791 , -97.174553 7]	The shower seat does not have a compliant space between it and the wall. The folding seat must be mounted 17-19 inches above the floor, and have a maximum space of 1-1/2 inches between the edge of the seat and the side wall and 2-1/2 inches maximum to the seat wall.	mounted 2.25" from side wall	Remount shower seat to the correct location and height in the shower.	2015 ABAAS Section: 610.3.2 2012 TAS Section: 610.3.2 2010 ADAS Section: 610.3.2

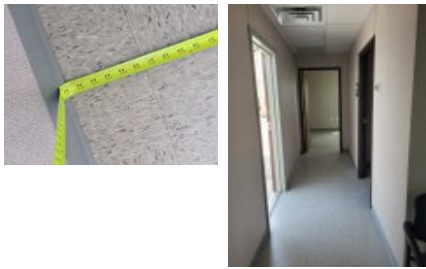
100	Restrooms: Restroom Administration Building (New)	[27.6705886 , -97.174521 5]	Minimum maneuvering clearances at doors and gates shall comply with 404.2.4. Maneuvering clearances shall extend the full width of the doorway and the required latch side or hinge side clearance.	47" back clearance on push side	Provide required maneuvering clearance on push side of door.	2015 ABAAS Section: 404.2.4.4, 404.2.4.1 2012 TAS Section: 404.2.4.4, 404.2.4.1 2010 ADAS Section: 404.2.4.4, 404.2.4.1

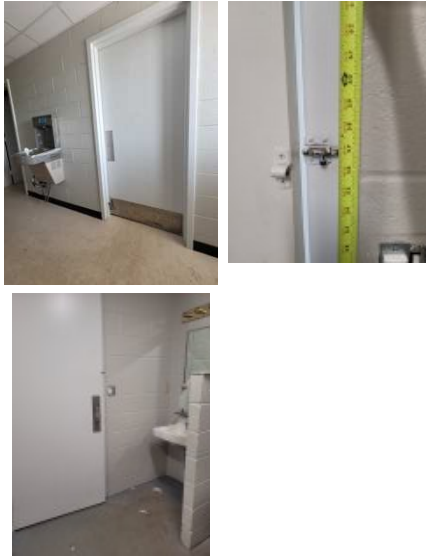
Finding Number	Area Description	Lat/Long	Finding	As Built	Recommendation	Citation	Photos	Figure
103	Restrooms: 2nd Floor Of Maintenance Building Restroom	[27.6708071 , -97.174553 7]	Hand-activated door opening hardware, handles, pulls, latches, locks, and other operating devices on accessible doors shall have a shape that is easy to grasp with one hand and does not require tight grasping, tight pinching or twisting of the wrist to operate. Hardware shall be 34 inches minimum and 48 inches maximum above the finish floor or ground. The bottom 10 inches on the push side must be smooth and free of obstructions (hold open devices). Opening hardware must be mounted between 30 and 44 inches above the floor or ground.	Restroom door - door holder in bottom 10", lock 57" AFF	For all doors along the public circulation route, replace hardware with lever hardware or hardware operable without a tight pinch or grasp mounted 34" minimum and 48" maximum above the finished floor. For all doors along the public circulation route, provide kick plate on push side of door from floor to 10" AFF.	2010 ADAS Section: 404.2.3, 404.2.7, 404.2.4, 404.2.11, 404.2.11 Exception

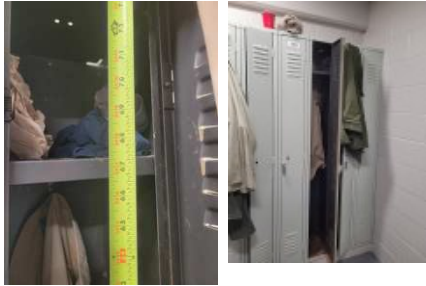
Finding Number	Area Description	Lat/Long	Finding	As Built	Recommendation	Citation	Photos	Figure
105	Restrooms: 2nd Floor Of Maintenance Building Restroom	[27.6708261, -97.1745859]	Storage elements shall comply with at least one of the reach ranges specified in 308 Where a clear floor or ground space allows a parallel approach to an element and the high side reach is over an obstruction, the height of the obstruction shall be 34 inches (865 mm) maximum and the depth of the obstruction shall be 24 inches (610 mm) maximum. The high side reach shall be 48 inches (1220 mm) maximum for a reach depth of 10 inches (255 mm) maximum. Where the reach depth exceeds 10 inches (255 mm), the high side reach shall be 46 inches (1170 mm) maximum for a reach depth of 24 inches (610 mm) maximum.	shelf 68" AFF, hook 66" AFF	Replace or remount locker to max 48" to the hooks and 15" to 48" to the storage shelves.	2015 ABAAS Section: 308.3.2, 811.3 2012 TAS Section: 308.3.2, 811.3 2010 ADAS Section: 308.3.2, 811.3

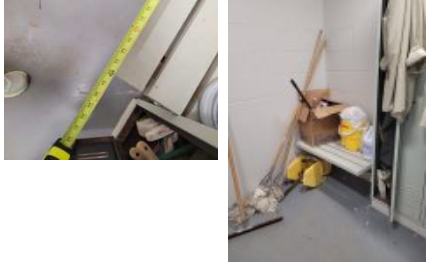
Finding Number	Area Description	Lat/Long	Finding	As Built	Recommendation	Citation	Photos	Figure
107	Restrooms: 2nd Floor Of Maintenance Building Restroom	[27.6708736 , -97.1746074]	The bench is not deep enough or long enough or is missing. Benches shall be provided having seats that are 42 inches long minimum and 20 inches deep minimum and 24 inches deep maximum. The bench shall provide for back support or shall be affixed to a wall. Back support shall be 42 inches (1065 mm) long minimum and shall extend from a point 2 inches (51 mm) maximum above the seat surface to a point 18 inches (455 mm) minimum above the seat surface. Back support shall be 2½ inches (64 mm) maximum from the rear edge of the seat measured horizontally. The top of the bench seat surface shall be 17 inches (430 mm) minimum and 19 inches (485 mm) maximum above the finish floor or ground. Clear floor or ground space complying with 305 shall be provided and shall be positioned at the end of the bench seat and parallel to the short axis of the bench	Locker area - bench has no clear floor space on side, 36" width	Replace bench in dressing area with one having a seat depth of 20" to 24" deep, 42" long, affixed to the wall or having a back and mounted 17" to 19" AFF and provide required clear floor space on the short axis of the bench.	2012 TAS Section: 903.4, 903.2, 903.3, 903.5 2010 ADAS Section: 903.4, 903.2, 903.3, 903.5

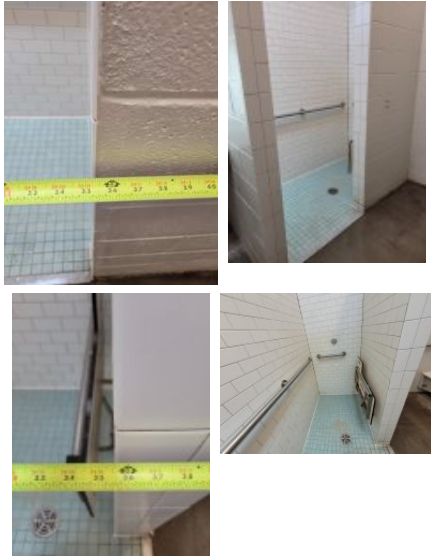
Finding Number	Area Description	Lat/Long	Finding	As Built	Recommendation	Citation	Photos	Figure
111	Restrooms: Family Restroom By Accessible Parking	[27.672926, -97.173255 5]	Alternate roll-in type shower compartments shall be 36 inches (915 mm) wide and 60 inches (1525 mm) deep minimum clear inside dimensions measured at center points of opposing sides. A 36 inch (915 mm) wide minimum entry shall be provided at one end of the long side of the compartment.	35.25" entry, 35.5" width	Enlarge shower stall, if feasible, to compliant dimensions for an alternate roll in shower of 36" deep by 60" wide with a 36" opening on the long dimension.	2015 ABAAS Section: 608.2.3 2012 TAS Section: 608.2.3 2010 ADAS Section: 608.2.3

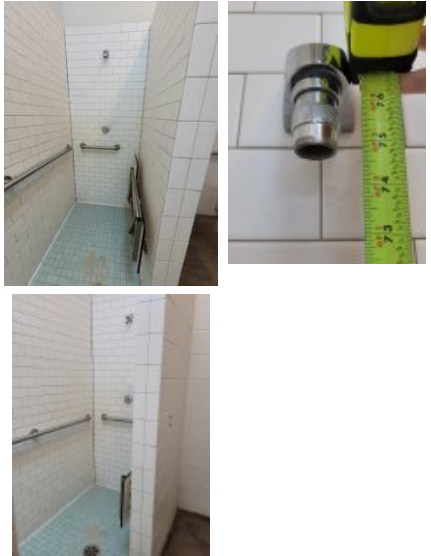
<p>Note: Inside finish; all dimensions measured at the center points of opposing sides.</p>
112	Restrooms: Family Restroom By Accessible Parking	[27.672907, -97.173234 1]	There is no hand held sprayer unit. The sprayer unit must have a 59 inches hose and be mounted 48 inches maximum to the top of mounting bracket off the floor. The shower spray unit shall have an on/off control with a non-positive shutoff. If an adjustable-height shower head on a vertical bar is used, the bar shall be installed so as not to obstruct the use of grab bars.	no hose, shower head 74.5" AFF	Replace shower control with a compliant lever control with a shower head on a 59" hose and usable as hand held.	2015 ABAAS Section: 608.6 2012 TAS Section: 608.6 2010 ADAS Section: 608.6

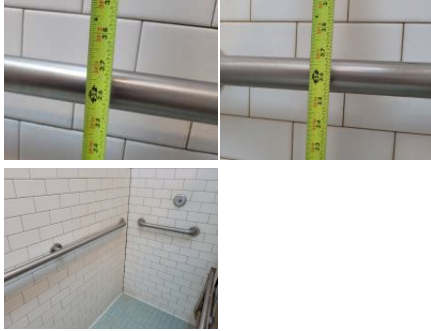
Finding Number	Area Description	Lat/Long	Finding	As Built	Recommendation	Citation	Photos	Figure
113	Restrooms: Family Restroom By Accessible Parking	[27.672926, -97.173298 4]	Grab bars shall be installed in a horizontal position, 33 inches (840 mm) minimum and 36 inches (915 mm) maximum above the finish floor measured to the top of the gripping surface	both 37" AFF	Remount shower grab bar to 33" min. and 36" max. AFF.	2015 ABAAS Section: 609.3 Exception, 609.4 2012 TAS Section: 609.4, 609.3 Exception 2010 ADAS Section: 609.4, 609.3 Exception

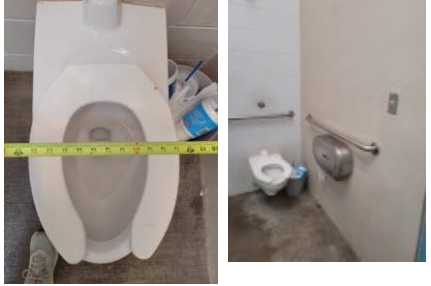
114	Restrooms: Family Restroom By Accessible Parking	[27.672926, -97.173277]	The toilet is not located within the range allowed from the side wall or partition. The centerline of the toilet must be 16 to 18 inches from the side wall.	18.5" centerline	Remount toilets to 16" to 18" from the side wall to centerline.	2015 ABAAS Section: 604.2 2012 TAS Section: 604.2 2010 ADAS Section: 604.2

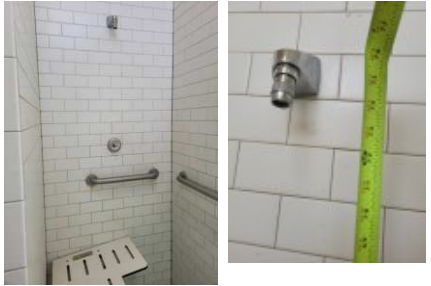
Finding Number	Area Description	Lat/Long	Finding	As Built	Recommendation	Citation	Photos	Figure
116	Restrooms: Family Restroom Beside Bike Rack	[27.6729213 , -97.173274 3]	There is no hand held sprayer unit. The sprayer unit must have a 59 inches hose and be mounted 48 inches maximum to the top of mounting bracket off the floor. The shower spray unit shall have an on/off control with a non-positive shutoff. If an adjustable-height shower head on a vertical bar is used, the bar shall be installed so as not to obstruct the use of grab bars.	no hose, shower head at 74" AFF	Replace shower control with a compliant lever control with a shower head on a 59" hose and usable as hand held.	2015 ABAAS Section: 608.6 2012 TAS Section: 608.6 2010 ADAS Section: 608.6

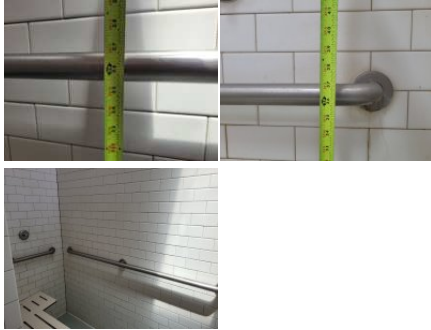
117	Restrooms: Family Restroom Beside Bike Rack	[27.6729498 , -97.173287 7]	Grab bars shall be installed in a horizontal position, 33 inches (840 mm) minimum and 36 inches (915 mm) maximum above the finish floor measured to the top of the gripping surface	both 37" AFF	Remount shower grab bar to 33" min. and 36" max. AFF.	2015 ABAAS Section: 609.3 Exception, 609.4 2012 TAS Section: 609.4, 609.3 Exception 2010 ADAS Section: 609.4, 609.3 Exception

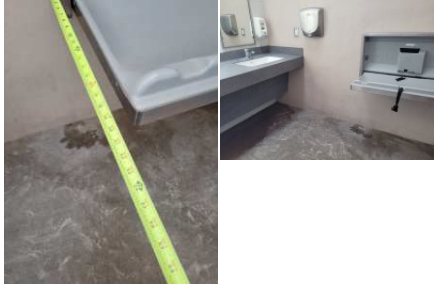
Finding Number	Area Description	Lat/Long	Finding	As Built	Recommendation	Citation	Photos	Figure
119	Restrooms: Family Restroom Beside Bike Rack	[27.6708261 , -97.174575 2]	The baby changing table is not compliant. Baby changing tables are work surfaces. If fixed or built-in baby changing tables are provided, at least 5%, but not less than one, must comply with TAS 902 based TAS 226.1. Baby changing tables cannot violate the protruding object requirements in either an open or closed position since either position is a potential hazard for persons with visual impairments. Baby changing tables are not prohibited from being located in wheelchair accessible toilet compartments; however, the minimum space required for the compartment cannot be obstructed by the baby changing table in either an open or closed position. The clear floor space required for a baby changing table may overlap the water closet clearance since baby changing tables are considered convenience "fixtures" based on Advisory 604.8.1.1. The overlap is applicable only to the clear floor space and not to actual table itself. Baby changing tables must be dispersed throughout a space, however, an additional baby changing table is not required in a common use area of a toilet or bathing room when the only baby changing table is located in a toilet compartment.	20.5" projection	Relocate baby changing table to eliminate protrusion when in the open position.	2012 TAS Section: 226.1, 902.3, 604.3.2, 204.1, 226.1 Advisory, 226.2, 307.1, 604.8.1.1 Advisory, 902.1, 902.1 Advisory, 902.2
