Access Audit Site Report

Palo Duro Canyon State Park
11450 State Hwy Park Rd 5
Canyon, TX 79015
Accessibility Evaluation
Inspection Date: 08/10/2021
Inspectors: Tanya Scheibe

Prepared By
WT Group

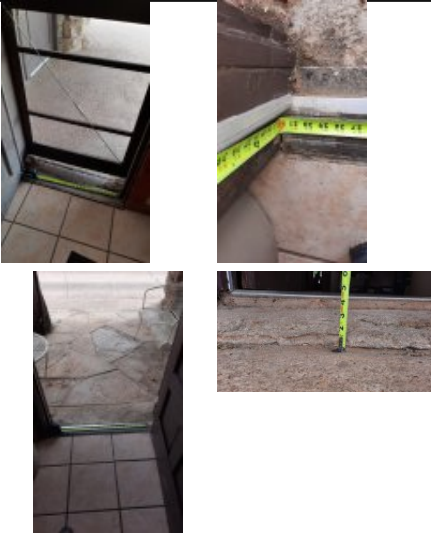
Finding Number	Area Description	Lat/Long	Finding	As Built	Recommendation	Citation	Photos	Figure
9	Headquarters: Headquarters Employee Spaces	[34.9847196 , -101.7018 471]	Employee Work Areas. Common use circulation paths within employee work areas shall comply with 402. EXCEPTIONS: 1. Common use circulation paths located within employee work areas that are less than 1000 square feet (93 m2) and defined by permanently installed partitions, counters, casework, or furnishings shall not be required to comply with 402. 2. Common use circulation paths located within employee work areas that are an integral component of work area equipment shall not be required to comply with 402. 3. Common use circulation paths located within exterior employee work areas that are fully exposed to the weather shall not be required to comply with 402.	check-in - 27.5" from front to employee area, 20.9% slope	Make corrections for compliant circulation path. Widen entry and correct slope to max 12.5%	2015 ABAAS Section: F206.2.8, F206.2.8.1, F206.2.8.2 2012 TAS Section: 206.2.8, 206.2.8 Exception 1, 206.2.8 Exception 2, 206.2.8 Exception 3, 206.2.8 Advisory 1, 206.2.8 Advisory 2 2010 ADAS Section: 206.2.8, 206.2.8 Exception 1, 206.2.8 Exception 2, 206.2.8 Exception 3

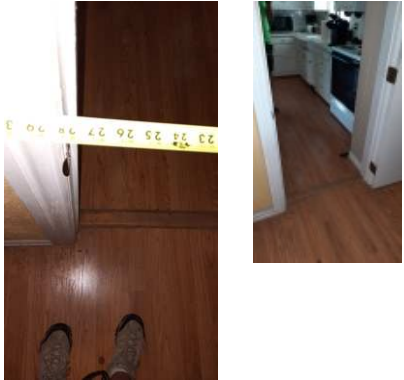
Finding Number	Area Description	Lat/Long	Finding	As Built	Recommendation	Citation	Photos	Figure
11	Headquarters: Headquarters Employee Spaces	[34.9855602 , -101.7018 444]	Employee Work Areas. Common use circulation paths within employee work areas shall comply with 402. EXCEPTIONS: 1. Common use circulation paths located within employee work areas that are less than 1000 square feet (93 m2) and defined by permanently installed partitions, counters, casework, or furnishings shall not be required to comply with 402. 2. Common use circulation paths located within employee work areas that are an integral component of work area equipment shall not be required to comply with 402. 3. Common use circulation paths located within exterior employee work areas that are fully exposed to the weather shall not be required to comply with 402.	Admin building - 27.5" wide to back office, knob hardware	Make corrections for compliant circulation path. Widen passage and replace knob with lever hardware.	2015 ABAAS Section: F206.2.8, F206.2.8.1, F206.2.8.2 2012 TAS Section: 206.2.8, 206.2.8 Exception 1, 206.2.8 Exception 2, 206.2.8 Exception 3, 206.2.8 Advisory 1, 206.2.8 Advisory 2 2010 ADAS Section: 206.2.8, 206.2.8 Exception 1, 206.2.8 Exception 2, 206.2.8 Exception 3

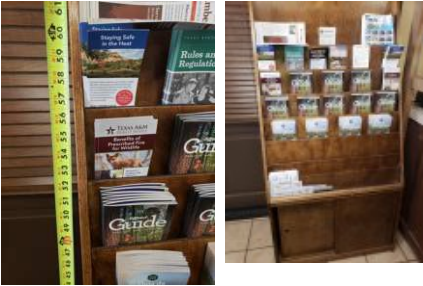
Finding Number	Area Description	Lat/Long	Finding	As Built	Recommendation	Citation	Photos	Figure
13	Headquarters: Headquarters Public Spaces	[34.9847207 , -101.7018 417]	The informational brochures are positioned too high for either a side or front approach. Where a clear floor or ground space allows a parallel approach to an element and the side reach is unobstructed, the high side reach shall be 48 inches maximum and the low side reach shall be 15 inches minimum above the finish floor or ground. Where a forward reach is unobstructed, the high forward reach shall be 48 inches maximum and the low forward reach shall be 15 inches minimum above the finish floor or ground.	not all informational brochures below 48" reach range	Remount operable parts to be in reach range of 15" min to 48" max.	2015 ABAAS Section: 308.1 2012 TAS Section: 308.1 2010 ADAS Section: 308.1

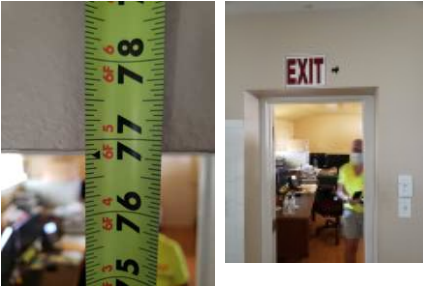
14	Headquarters: Headquarters Public Spaces	[34.9847262 , -101.7018 404]	The door way extends down too close to the route of travel. Any obstruction that overhangs a route of travel must be a minimum of 80 inches above the walking surface as measured from the bottom of the obstruction.	door way 77" above ground on route towards office	Raise doorway to min 80", or pad object to prevent hazard in overhead clearance along AR.	2015 ABAAS Section: 307.4 2012 TAS Section: 307.4 2010 ADAS Section: 307.4

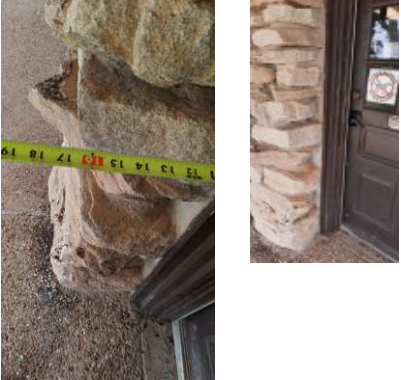
15	Headquarters: Headquarters Public Spaces	[34.9847163 , -101.7018 458]	Minimum maneuvering clearances at doors and gates shall comply with 404.2.4. Maneuvering clearances shall extend the full width of the doorway and the required latch side or hinge side clearance.	check in entry - recessed 16.5" due to rock facade	Provide required maneuvering clearance on push side of door.	2015 ABAAS Section: 404.2.4.4, 404.2.4.1 2012 TAS Section: 404.2.4.4, 404.2.4.1 2010 ADAS Section: 404.2.4.4, 404.2.4.1

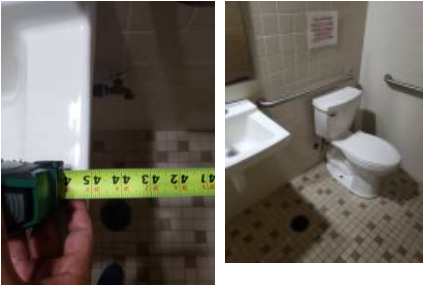
Finding Number	Area Description	Lat/Long	Finding	As Built	Recommendation	Citation	Photos	Figure
18	Headquarters: Headquarters Restrooms	[34.9848614 , -101.7015 762]	The required 56 inches by 60 inches clear floor space for the water closet has been obstructed. The clear floor space around the water closet shall be 60 inches minimum measured perpendicular from the side wall and 56 inches minimum measured perpendicular from the rear wall.	Men's RR - clear floor space reduced by sink at 45"	Relocate sink to provide required 60" clearance around toilet, in the alternative, leave as is citing safe harbor.	2015 ABAAS Section: 604.3. 2012 TAS Section: 604.3.1 2010 ADAS Section: 604.3.1

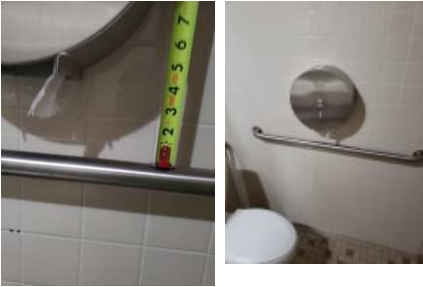
19	Headquarters: Headquarters Restrooms	[34.9848537 , -101.7015 843]	The grab bar height and/or spacing fails. Grab bars must be mounted between 33" and 36" to the top of the gripping surface. There must be 1.5" of clearance between the grab bar and the wall. There must be a minimum of 1.5" of clearance below and minimum 12" above the grab bar to any dispenser or other obstruction.	Men's RR - toilet paper dispenser mounted 1" above side grab bar and too close to toilet	Remount toilet paper dispenser max 7" to 9" from front of toilet, 15" to 48" aff and min 12" above or 1.5" below grab bar.	2015 ABAAS Section: 609.3, 609.4 2012 TAS Section: 609.4, 609.3 2010 ADAS Section: 609.3, 609.4

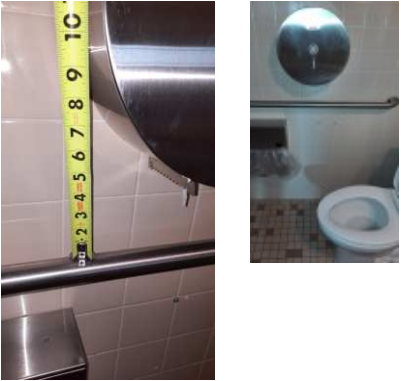
Finding Number	Area Description	Lat/Long	Finding	As Built	Recommendation	Citation	Photos	Figure
25	Headquarters: Headquarters Restrooms	[34.9848658 , -101.7015 896]	The grab bar height and/or spacing fails. Grab bars must be mounted between 33" and 36" to the top of the gripping surface. There must be 1.5" of clearance between the grab bar and the wall. There must be a minimum of 1.5" of clearance below and minimum 12" above the grab bar to any dispenser or other obstruction.	Women's restroom - toilet paper dispenser is not mounted within compliant range	Remount toilet paper dispenser max 7" to 9" from front of toilet, 15" to 48" aff and min 12" above or 1.5" below grab bar.	2015 ABAAS Section: 609.3, 609.4 2012 TAS Section: 609.4, 609.3 2010 ADAS Section: 609.3, 609.4

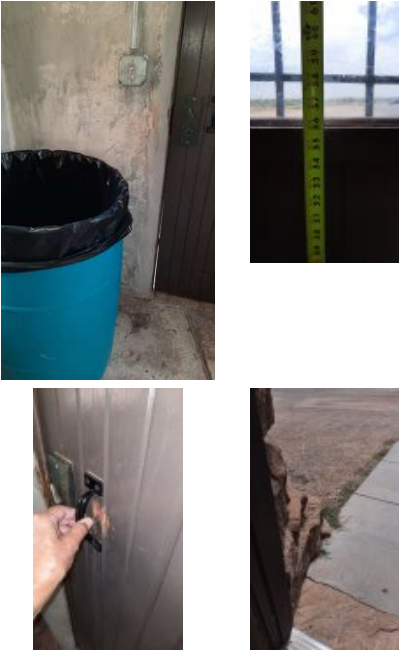
Finding Number	Area Description	Lat/Long	Finding	As Built	Recommendation	Citation	Photos	Figure
27	Headquarters: Headquarters Restrooms	[34.984857, -101.70158 29]	Minimum maneuvering clearances at doors and gates shall comply with 404.2.4. Maneuvering clearances shall extend the full width of the doorway and the required latch side or hinge side clearance. Exterior doors are recommended to be maintained at 8.5 lbf as a smart practice. Force is to be measured at the operating hardware or 30 inches from the hinges, whichever is greater. Hand-activated door opening hardware, handles, pulls, latches, locks, and other operating devices on accessible doors shall have a shape that is easy to grasp with one hand and does not require tight grasping, tight pinching or twisting of the wrist to operate. Hardware shall be 34 inches minimum and 48 inches maximum above the finish floor or ground. Doors, gates, and side lights adjacent to doors or gates, containing one or more glazing panels that permit viewing through the panels shall have the bottom of at least one glazed panel located 43 inches (1090 mm) maximum above the finish floor. EXCEPTION: Vision lights with the lowest part more than 66 inches (1675 mm) from the finish floor or ground shall not be required to comply with 404.2.11.	restroom building entry - garbage in pull side maneuvering clearance, window 56" above ground, small hardware requires a pinch, stone wall on push side maneuvering clearance, 16 lb of force to open	For all doors along the public circulation route, provide required maneuvering clearance on push and pull side of doors For all doors along the public circulation route, inspect, adjust, and maintain 8.5 lbf to open exterior doors as a smart practice For all doors along the public circulation route, replace hardware with lever hardware or hardware operable without a tight pinch or grasp For all doors along the public circulation route, replace doors with ones having sidelight viewing windows max 43" aff	2010 ADAS Section: 404.2.3, 404.2.7, 404.2.4, 404.2.11, 404.2.11 Exception

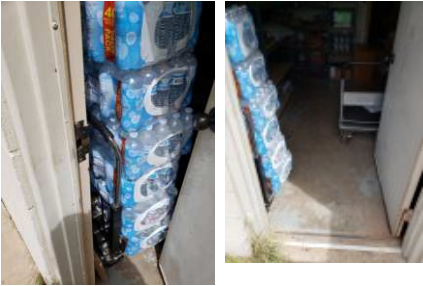
Finding Number	Area Description	Lat/Long	Finding	As Built	Recommendation	Citation	Photos	Figure
36	Visitor Center: Visitor Center Employee Spaces	[34.9792179 , -101.6915 582]	Minimum maneuvering clearances at doors and gates shall comply with 404.2.4. Maneuvering clearances shall extend the full width of the doorway and the required latch side or hinge side clearance.	rear exterior door: storage in pull side maneuvering clearance	Provide required maneuvering clearance around pull side of door Relocate storage, furniture and other obstacles to create 60" maneuvering clearance around door	2015 ABAAS Section: 404.2.4.1 , 404.2.4.4 2012 TAS Section: 404.2.4.4, 404.2.4.1 2010 ADAS Section: 404.2.4.4, 404.2.4.1

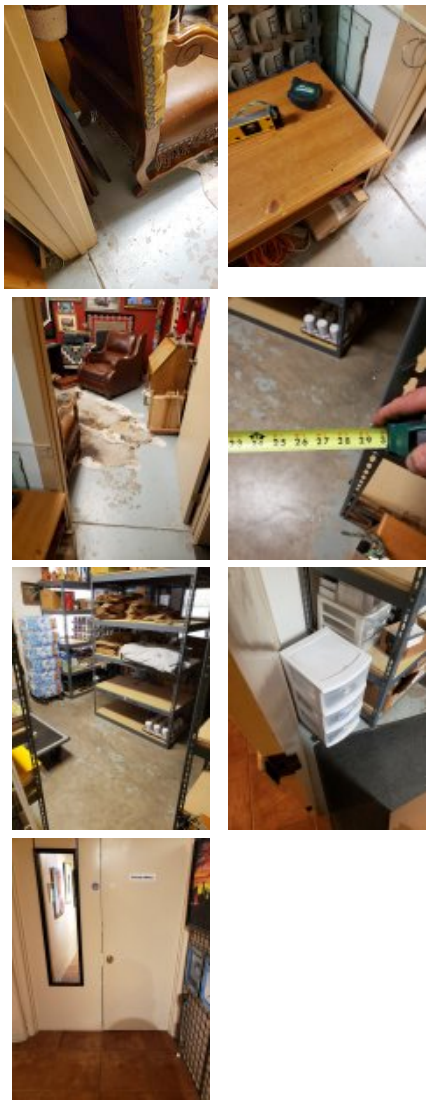
Finding Number	Area Description	Lat/Long	Finding	As Built	Recommendation	Citation	Photos	Figure
37	Visitor Center: Visitor Center Employee Spaces	[34.9792124 , -101.691538]	Spaces and elements within employee work areas shall only be required to comply with 206.2.8, 207.1, and 215.3 and shall be designed and constructed so that individuals with disabilities can approach, enter, and exit the employee work area. Employee work areas, or portions of employee work areas, other than raised courtroom stations, that are less than 300 square feet (28 m2) and elevated 7 inches (180 mm) or more above the finish floor or ground where the elevation is essential to the function of the space shall not be required to comply with these requirements or to be on an accessible route.	Offices and storage - storage in push and pull side maneuvering clearance of main office, 29" wide route to storage area; entrance door to office area: storage in pull side maneuvering clearance	For employee spaces, relocate storage, furniture, and other obstacles at doorways to provide approach, enter and exit at the employee space. Widen route to storage to min 32" clear width.	2015 ABAAS Section: F203.9 2012 TAS Section: 203.9 2010 ADAS Section: 203.9

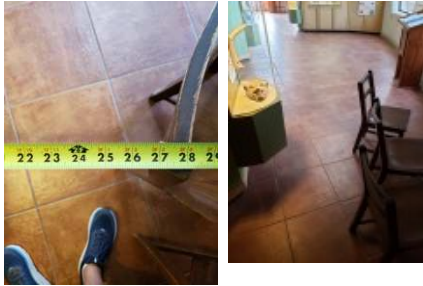
Finding Number	Area Description	Lat/Long	Finding	As Built	Recommendation	Citation	Photos	Figure
38	Visitor Center: Visitor Center Public Spaces	[34.9792113 , -101.6915 528]	The route of travel at this location does not provide a minimum width of 36 inches. The clear width shall be permitted to be reduced to 32 inches minimum for a length of 24 inches maximum provided that reduced width segments are separated by segments that are 48 inches long minimum and 36 inches wide minimum.	interpretive center/ museum - path of travel narrows to 25" for video seating area	Widen AR to compliant 36" clear width.	2015 ABAAS Section: 403.5.1 2012 TAS Section: 403.5.1 2010 ADAS Section: 403.5.1

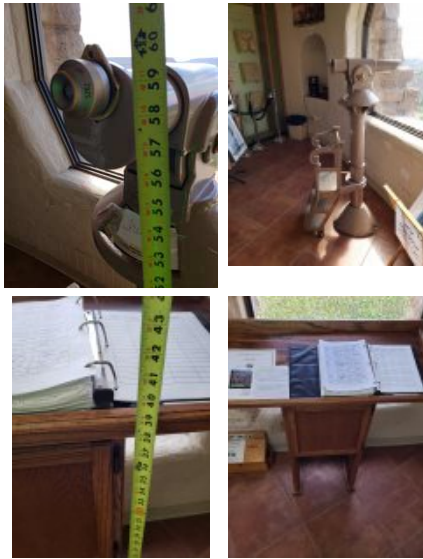
39	Visitor Center: Visitor Center Public Spaces	[34.9791212 , -101.69147 5]	The elements are positioned too high for either a side or front approach. Where a clear floor or ground space allows a parallel approach to an element and the side reach is unobstructed, the high side reach shall be 48 inches maximum and the low side reach shall be 15 inches minimum above the finish floor or ground. Where a forward reach is unobstructed, the high forward reach shall be 48 inches maximum and the low forward reach shall be 15 inches minimum above the finish floor or ground.	interpretive center/ museum - telescope 69", registration desk 59" above ground	Replace or add a telescope having an eyepiece 43" minimum and 51" maximum above the ground and having knee and toe clearances. Lower a 36" wide portion of the registration desk to max 36" AFF.	2015 ABAAS Section: 308.1 2012 TAS Section: 308.1 2010 ADAS Section: 308.1

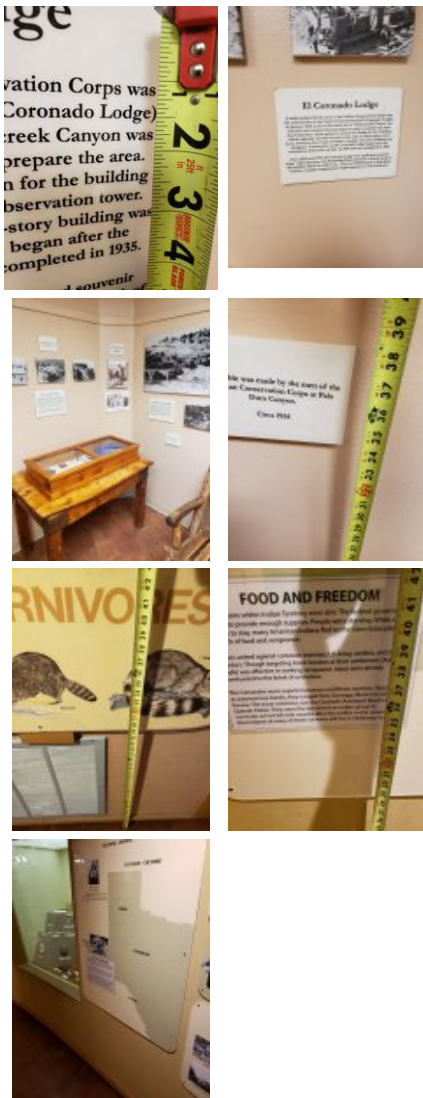
Finding Number	Area Description	Lat/Long	Finding	As Built	Recommendation	Citation	Photos	Figure														
41	Visitor Center: Visitor Center Public Spaces	[34.9791871 , -101.6915 233]	Minimum character height shall comply with Table 703.5.5. Viewing distance shall be measured as the horizontal distance between the character and an obstruction preventing further approach towards the sign. Character height shall be based on the uppercase letter "I".	most informational sign font is 1/4 inch some is below 40" above ground	Replace signage with compliant signage having larger font and mounted min 40" AFF.	2015 ABAAS Section: 703.5.5 2012 TAS Section: 703.5.5 2010 ADAS Section: 703.5.5

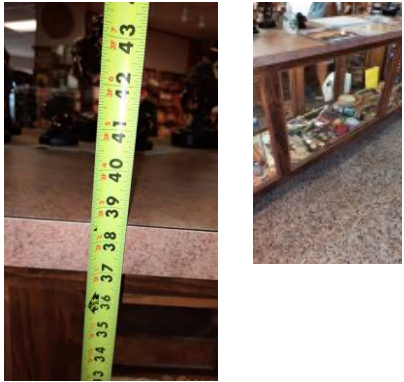
44	Visitor Center: Visitor Center Public Spaces	[34.9791739, -101.6915126]	The transaction counter is too high. A portion of the counter surface that is 36 inches long minimum and 36 inches high maximum above the finish floor shall be provided. Knee and toe space must be provided for a forward approach. A 30 inch by 48 inch clear floor space on an accessible route must be provided for either a forward or parallel approach.	shop - display cases serve as service counter, 38.5"	Lower 36" wide segment of service counter to max 36" aff, in the alternative, train staff to come out from around the counter to provide customer service	2015 ABAAS Section: 904.4.2, 904.4.1 2012 TAS Section: 904.4.1, 904.4.2 2010 ADAS Section: 904.4.2, 904.4.1

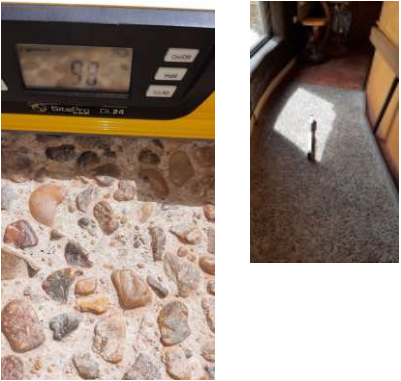
Finding Number	Area Description	Lat/Long	Finding	As Built	Recommendation	Citation	Photos	Figure
46	Visitor Center: Visitor Center Public Spaces	[34.979197, -101.6915139]	The ramps slope exceeds the maximum running slope (direction of travel) allowable of 8.33%. Ramps should have the least possible slope but in no case more than 8.3% (1:12).	Interior Ramp - 9.8% slope on ramp	Correct slope of ramp to max 8.33% if feasible.	2015 ABAAS Section: 405.2 2012 TAS Section: 405.2 2010 ADAS Section: 405.2

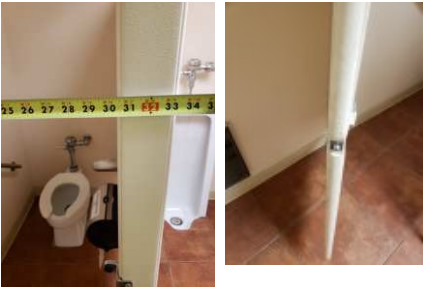
Finding Number	Area Description	Lat/Long	Finding	As Built	Recommendation	Citation	Photos	Figure
58	Visitor Center: Visitor Center Restrooms	[34.9792069 , -101.6915 528]	There are not enough accessible toilet compartments. The room contains toilet compartments. A minimum of 1 must be wheelchair accessible .	Men's RR - lacks wheelchair stall, ambulatory only.	Create a wheelchair accessible stall with grab bars and fixtures mounted in correct locations and at correct heights	2015 ABAAS Section: F213.3.1 2012 TAS Section: 213.3.1 2010 ADAS Section: 213.3.1		
59	Visitor Center: Visitor Center Restrooms	[34.9791739 , -101.6914 965]	The stall door fails to comply with all of the door requirements. The stall door must be a minimum of 32" wide and have compliant hardware on both sides. The stall door must be self-closing.	Ambulatory stall door - 30.5" wide, not self closing, no hardware	Widen stall doors to 32" when opened to 90 degrees Adjust stall door to be self-closing Replace stall hardware with hardware operable without a tight pinch or grasp on both sides of the stall door	2015 ABAAS Section: 404.2.3, 404.2.7, 604.8.2.2 2012 TAS Section: 404.2.3, 404.2.7, 604.8.2.2 2010 ADAS Section: 404.2.3, 404.2.7, 604.8.2.2

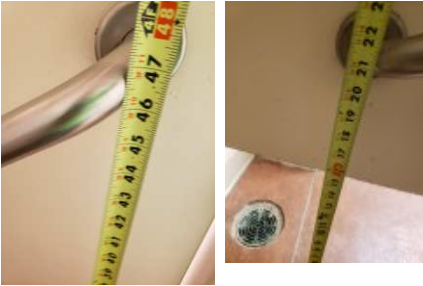
Finding Number	Area Description	Lat/Long	Finding	As Built	Recommendation	Citation	Photos	Figure
60	Visitor Center: Visitor Center Restrooms	[34.9791904 , -101.6915 219]	The grab bar height and/or spacing fails. Grab bars must be mounted between 33" and 36" to the top of the gripping surface. There must be 1.5" of clearance between the grab bar and the wall. There must be a minimum of 1.5" of clearance below and minimum 12" above the grab bar to any dispenser or other obstruction.	Ambulatory stall - grab bars mounted on a diagonal, range above finished floor - 21" to 47"	Remount grab bars in accessible stall to 33" to 36" aff.	2015 ABAAS Section: 609.3, 609.4 2012 TAS Section: 609.4, 609.3 2010 ADAS Section: 609.3, 609.4

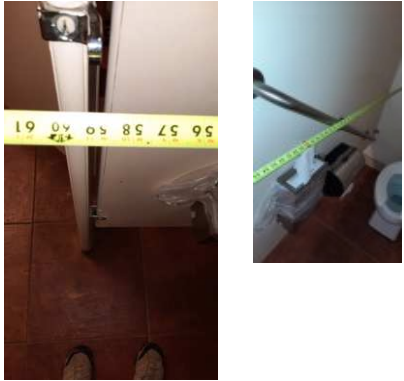
Finding Number	Area Description	Lat/Long	Finding	As Built	Recommendation	Citation	Photos	Figure
66	Visitor Center: Visitor Center Restrooms	[34.9791827 , -101.6915 126]	The ambulatory stall is not between 35" to 37" wide and 60" deep.	Women's restroom - stall is 59.25" deep	Correct ambulatory stall to be 35" to 37" wide and minimum 60" deep, in the alternative, use existing ambulatory stall to create required wheelchair stall.	2015 ABAAS Section: 604.8.2.1 2012 TAS Section: 604.8.2.1 2010 ADAS Section: 604.8.2.1

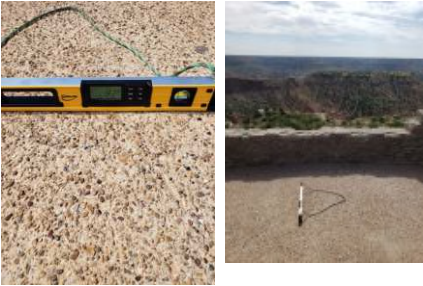
71	Visitor Center: Visitor Center Overlook	[34.9799926 , -101.6909 198]	A clear ground space shall be provided at each distinct viewing location. The clear ground space shall be 36 inches (915 mm) minimum by 48 inches (1220 mm) minimum and shall be positioned for either a forward or parallel approach to the viewing location. One full unobstructed side of the clear ground space shall adjoin or overlap an outdoor recreation access route or trail, as applicable, or another clear ground space.	slope to edge 3.2%	Provide required 36" by 48" clear ground space at each viewing area as a smart practice	2015 ABAAS Section: 1015.2

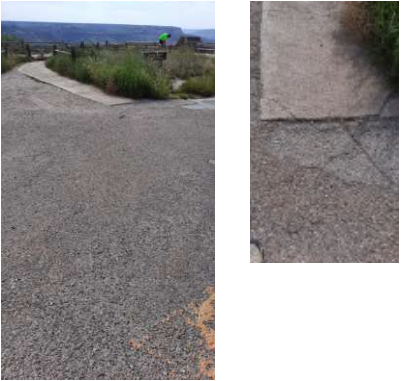
Finding Number	Area Description	Lat/Long	Finding	As Built	Recommendation	Citation	Photos	Figure
72	Visitor Center: Visitor Center Overlook	[34.9801492 , -101.6910 262]	The accessible route contains loose gravel and/or surfaces that do not provide for a stable, firm slip resistant surface.	route from parking to overlook deteriorated	Resurface AR where deterioration occurs.	2015 ABAAS Section: 302.1 2012 TAS Section: 302.1 2010 ADAS Section: 302.1

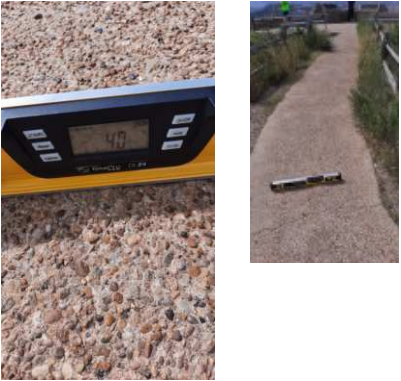
73	Visitor Center: Visitor Center Overlook	[34.9801431 , -101.6910 003]	The accessible route of travel on the accessible route contains cross slopes greater than 2%. Cross slopes shall not exceed one unit vertical in 48 units horizontal (2-percent slope).	4% cross slope approaching overlook	Correct or repair cross slope along AR to max 2.08%	2015 ABAAS Section: 403.3 2012 TAS Section: 403.3 2010 ADAS Section: 403.3

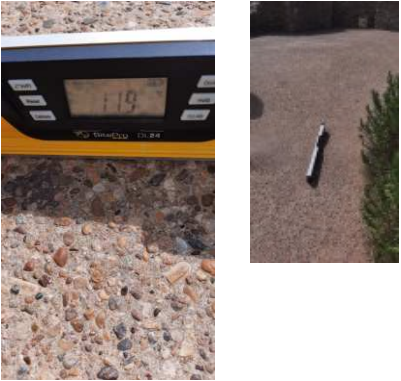
74	Visitor Center: Visitor Center Overlook	[34.9800453 , -101.6909 386]	The running slope of walking surfaces shall not be steeper than 1:20.	11.9% slope approaching overlook	Correct running slope along the AR to max 5%	2015 ABAAS Section: 403.3 2012 TAS Section: 403.3 2010 ADAS Section: 403.3

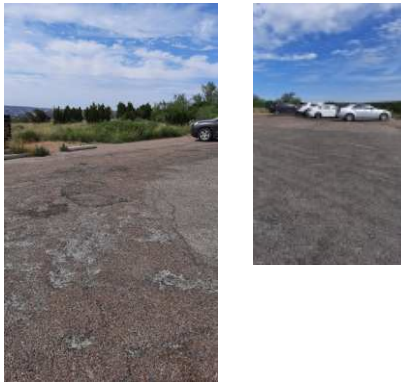
Finding Number	Area Description	Lat/Long	Finding	As Built	Recommendation	Citation	Photos	Figure																												
75	Visitor Center: Visitor Center Overlook	[34.9802156 , -101.6912 819]	There are no accessible parking stalls. Each lot where parking is provided for the public as clients, guests or employees, shall provide accessible parking and shall be located on the shortest accessible route of travel from adjacent parking to an accessible entrance. There are a total of 15 parking stalls in the parking lot that could be reasonably associated with this facility. There should be a minimum of one accessible stalls with a minimum of one being designed as van accessible.	approximately 15 parking stalls, 0 accessible parking stalls	Create one or more 8' accessible parking stalls, with one 5' adjacent access aisle, with proper signage and striping based on the total number of stalls	2015 ABAAS Section: F208.2 2012 TAS Section: 208.2 2010 ADAS Section: 208.2

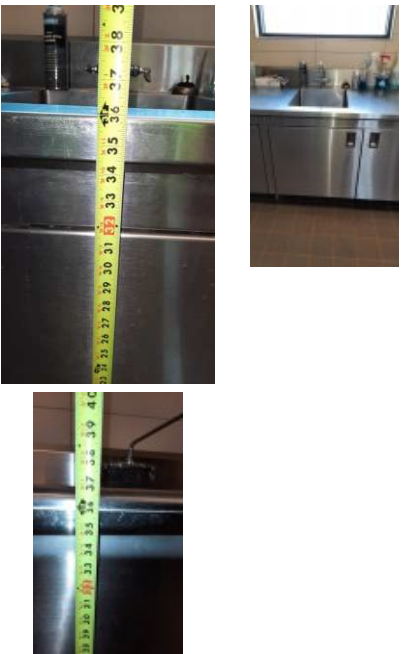
Finding Number	Area Description	Lat/Long	Finding	As Built	Recommendation	Citation	Photos	Figure
86	Mack Dick Group Pavilion: Mack Dick Group Pavilion Public Spaces	[34.9792552, -101.6789196]	The top rim of the sink is too high. All lavatories/sinks that are designated to be accessible shall be a minimum 17 inches in horizontal depth and mounted with the rim or counter edge no higher than 34 inches above the finished floor.	kitchen - prep sink at 36" AFF, triple sink at 37" AFF.	Lower sinks to max 34" aff to front of rim.	2015 ABAAS Section: 606.3 2012 TAS Section: 606.3 2010 ADAS Section: 606.3

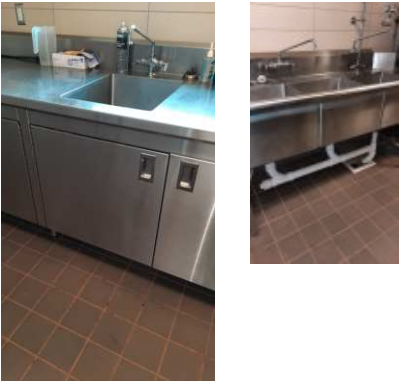
87	Mack Dick Group Pavilion: Mack Dick Group Pavilion Public Spaces	[34.9792267, -101.6789437]	Knee and toe space has not been provided at the sink. Kitchen sinks must be provided with a clear floor space positioned for a forward approach including knee and toe clearance.	kitchen - cabinet at prep, triple basin lacks knee and toe clearance	Remove base cabinet and lower sink height to max 34" aff.	2015 ABAAS Section: 606.2, 804.4 2012 TAS Section: 606.2, 804.4 2010 ADAS Section: 606.2, 804.4

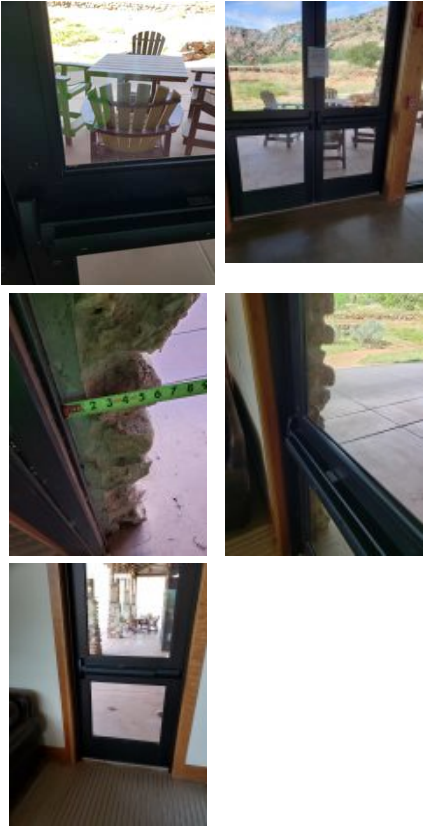
Finding Number	Area Description	Lat/Long	Finding	As Built	Recommendation	Citation	Photos	Figure
91	Mack Dick Group Pavilion: Mack Dick Group Pavilion Public Spaces	[34.9792267, -101.6789062]	Minimum maneuvering clearances at doors and gates shall comply with 404.2.4. Maneuvering clearances shall extend the full width of the doorway and the required latch side or hinge side clearance. Exterior doors are recommended to be maintained at 8.5 lbf as a smart practice. Force is to be measured at the operating hardware or 30 inches from the hinges, whichever is greater.	5 sets of double exterior double doors: all over 15lbf, all push bars stick, one set has table in pull side clearance; single exterior glass door 20lb, rock wall in pull side clearance, push bar sticks	For all doors along the public circulation route, provide required maneuvering clearance on push and pull side of doors For all doors along the public circulation route, inspect, adjust, and maintain 8.5 lbf to open exterior doors as a smart practice	2010 ADAS Section: 404.2.3, 404.2.7, 404.2.4, 404.2.11, 404.2.11 Exception

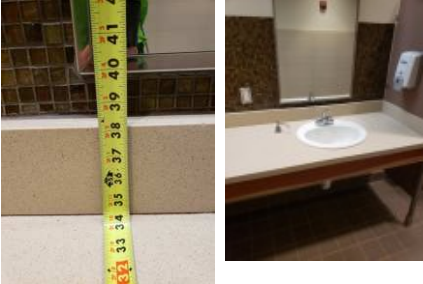
92	Mack Dick Group Pavilion: Mack Dick Group Pavilion Restrooms	[34.9792574, -101.678933]	The mirror is mounted too high. Mirrors must have the bottom edge of the reflecting surface a maximum of 40 inches above the floor if above a sink or counter. Mirrors not located above lavatories or countertops shall be installed with the bottom edge of the reflecting surface 35 inches maximum above the finish floor or ground.	Men's Restroom - reflective surface mounted 40.5" above finished floor	Lower mirror so reflective surface is max 40" aff.	2015 ABAAS Section: 603.3 2012 TAS Section: 603.3 2010 ADAS Section: 603.3

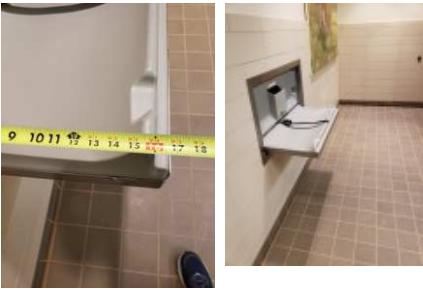
94	Mack Dick Group Pavilion: Mack Dick Group Pavilion Restrooms	[34.9792574 , -101.6789 491]	The baby changing table is not compliant. Baby changing tables are work surfaces. If fixed or built-in baby changing tables are provided, at least 5%, but not less than one, must comply with TAS 902 based TAS 226.1. Baby changing tables cannot violate the protruding object requirements in either an open or closed position since either position is a potential hazard for persons with visual impairments. Baby changing tables are not prohibited from being located in wheelchair accessible toilet compartments; however, the minimum space required for the compartment cannot be obstructed by the baby changing table in either an open or closed position. The clear floor space required for a baby changing table may overlap the water closet clearance since baby changing tables are considered convenience "fixtures" based on Advisory 604.8.1.1. The overlap is applicable only to the clear floor space and not to actual table itself. Baby changing tables must be dispersed throughout a space, however, an additional baby changing table is not required in a common use area of a toilet or bathing room when the only baby changing table is located in a toilet compartment.	Men's Restroom - changing table projects 17" when open	Relocate baby changing table to eliminate protrusion when in the open position.	2012 TAS Section: 226.1, 902.3, 604.3.2, 204.1, 226.1 Advisory, 226.2, 307.1, 604.8.1.1 Advisory, 902.1, 902.1 Advisory, 902.2

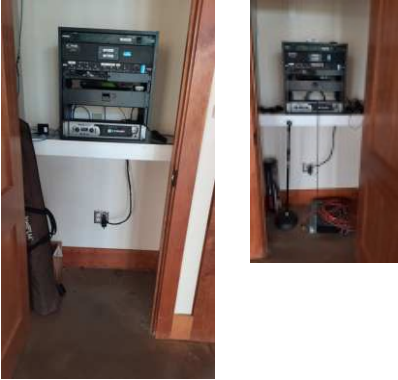
Finding Number	Area Description	Lat/Long	Finding	As Built	Recommendation	Citation	Photos	Figure
103	Mack Dick Group Pavilion: Mack Dick Group Pavilion Employee Spaces	[34.9792574 , -101.6789 518]	Element meets all standards and requirements	storage room - room and door complies	None	2010 ADAS Section: N/A		
104	Mack Dick Group Pavilion: Mack Dick Group Pavilion Employee Spaces	[34.9792728 , -101.6789 491]	Spaces and elements within employee work areas shall only be required to comply with 206.2.8, 207.1, and 215.3 and shall be designed and constructed so that individuals with disabilities can approach, enter, and exit the employee work area. Employee work areas, or portions of employee work areas, other than raised courtroom stations, that are less than 300 square feet (28 m2) and elevated 7 inches (180 mm) or more above the finish floor or ground where the elevation is essential to the function of the space shall not be required to comply with these requirements or to be on an accessible route.	main room storage (2) - no entry, too small	For employee spaces, relocate storage, furniture, and other obstacles at doorways to provide approach, enter and exit at the employee space. Leave as is, entry not intended.	2015 ABAAS Section: F203.9 2012 TAS Section: 203.9 2010 ADAS Section: 203.9

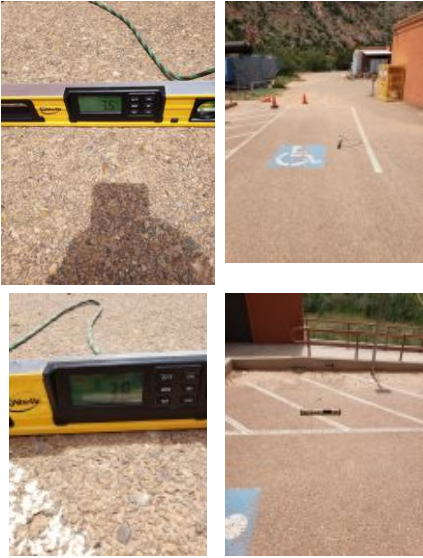
Finding Number	Area Description	Lat/Long	Finding	As Built	Recommendation	Citation	Photos	Figure
107	Pioneer Amphitheater: Pioneer Amphitheater Parking	[34.9751345 , -101.6791 047]	The cross slopes (narrow dimension) and/or running slopes (long dimension) of the access aisle exceeds 2%. The running slope and the cross slope in an accessible parking stall and the access aisle must not exceed 2%.	3.5% slope in stall, 3.9% slope in access aisle	Repair or correct slope of parking space and access aisle to max 2.08% in any direction	2015 ABAAS Section: 502.4 2012 TAS Section: 502.4 2010 ADAS Section: 502.4

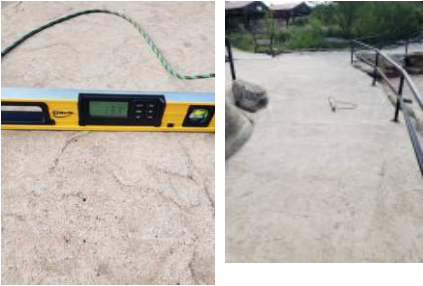
Finding Number	Area Description	Lat/Long	Finding	As Built	Recommendation	Citation	Photos	Figure
110	Pioneer Amphitheater: Pioneer Amphitheater EAR	[34.9763323 , -101.6793 635]	The ramps slope exceeds the maximum running slope (direction of travel) allowable of 8.33%. Ramps should have the least possible slope but in no case more than 8.3% (1:12).	Chow Cart Ramp -running slope over 13%	Correct slope of ramp to max 8.33%.	2015 ABAAS Section: 405.2 2012 TAS Section: 405.2 2010 ADAS Section: 405.2

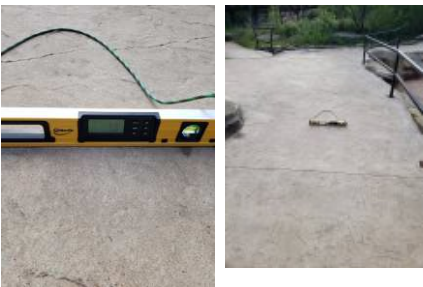
111	Pioneer Amphitheater: Pioneer Amphitheater EAR	[34.9763301 , -101.6793 514]	The ramp on the accessible route contains cross slopes greater than 2%. Surface cross slopes shall not exceed one unit vertical in 48 units horizontal (2-percent slope).	Chow Cart Ramp - cross slope 3%	Correct ramp cross slope to max 2.08%.	2015 ABAAS Section: 405.3 2012 TAS Section: 405.3 2010 ADAS Section: 405.3

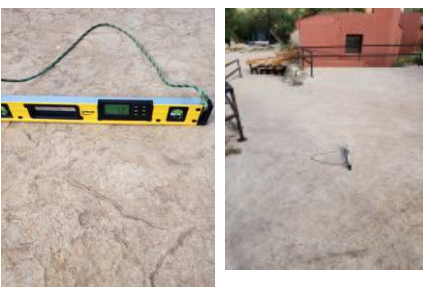
112	Pioneer Amphitheater: Pioneer Amphitheater EAR	[34.9763092 , -101.6792 777]	The landing at the top of the ramp has a slope greater than 2%. Top landings shall have a dimension in the direction of ramp run of not less than 60 inches and have a slope of less than 2% in any direction.	Chow Cart Ramp - top landing of first run of ramp 5.9 %	Correct ramp landing slope to max 2.08%.	2015 ABAAS Section: 405.7.1 EXCEPTION 2012 TAS Section: 405.7.1 2010 ADAS Section: 405.7.1, 405.7.1 Exception

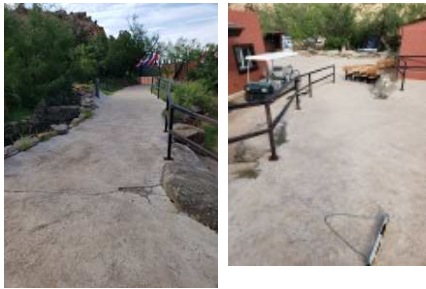
114	Pioneer Amphitheater: Pioneer Amphitheater EAR	[34.9763268 , -101.6793 501]	The ramp does not have compliant handrails. Handrails are required on both sides of all surfaces that are sloped greater than 5 percent (1:20). Handrails must be between 34 inches and 38 inches above the ramp surface, must extend beyond the top and bottom of the ramp 12 inches and be parallel to the floor or ground surface. The diameter of the handrails must be between 1 inches and 2 inches in cross-sectional nominal dimension for circular handrails and handrail gripping surfaces with a non-circular cross section shall have a perimeter dimension of 4 inches minimum and 6 inches maximum, and a cross-section dimension of 2 inches maximum. The clear space between handrails and walls must 1-1/2 inches minimum.	Chow Cart Ramp -handrails on one side of ramp	Install handrails on both sides of ramp that are rounded and/or extend to the ground, with handrail extensions and mounted 34" to 38" aff	2015 ABAAS Section: 505.1 2012 TAS Section: 505.1 2010 ADAS Section: 505.1

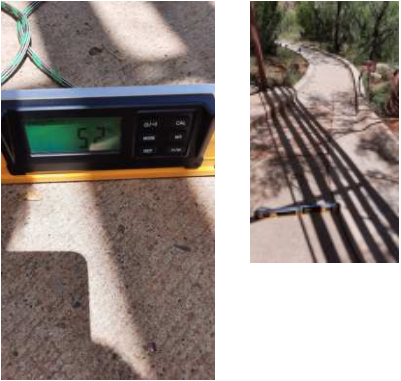
Finding Number	Area Description	Lat/Long	Finding	As Built	Recommendation	Citation	Photos	Figure
119	Pioneer Amphitheater: Pioneer Amphitheater EAR	[34.9755235 , -101.6793 863]	The accessible route of travel on the accessible route contains cross slopes greater than 2%. Cross slopes shall not exceed one unit vertical in 48 units horizontal (2-percent slope).	ramp to back stage - 5.2% cross slope	Correct or repair cross slope along AR to max 2.08%.	2015 ABAAS Section: 403.3 2012 TAS Section: 403.3 2010 ADAS Section: 403.3

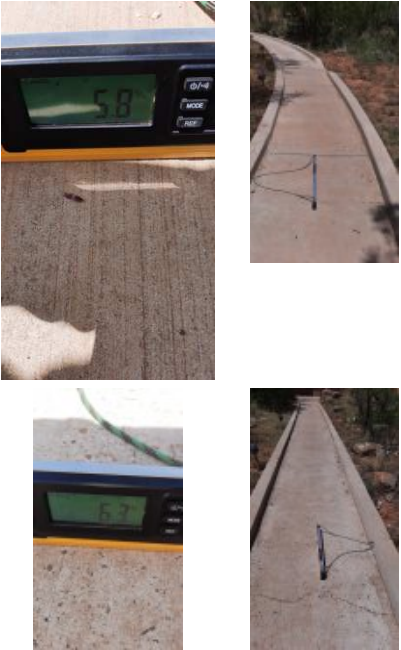
120	Pioneer Amphitheater: Pioneer Amphitheater EAR	[34.9755938 , -101.6792 441]	The running slope of walking surfaces shall not be steeper than 1:20.	slopes to back stage - 10.5%, 12%, 5.8%, 6.3%, 6.7%, 9.5%	Correct running slope along the AR to max 5%. In the alternative, create a compliant ramp with max slopes of 8.33% and handrails on both sides.	2015 ABAAS Section: 403.3 2012 TAS Section: 403.3 2010 ADAS Section: 403.3

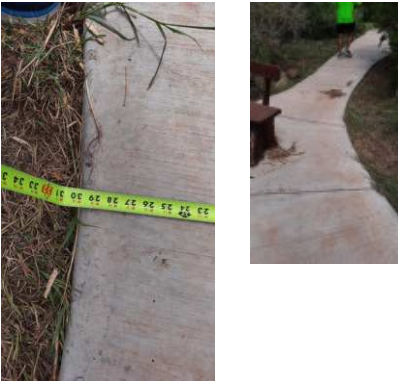
121	Pioneer Amphitheater: Pioneer Amphitheater EAR	[34.9760949 , -101.67973 1]	The route of travel at this location does not provide the required minimum width. The minimum clear width for sidewalks and walks is 36 inches.	pathway near ticket booth reduces to 30" at bench	Widen EAR to min 36" clear width.	2015 ABAAS Section: 403.5.1 2012 TAS Section: 403.5.1 2010 ADAS Section: 403.5.1

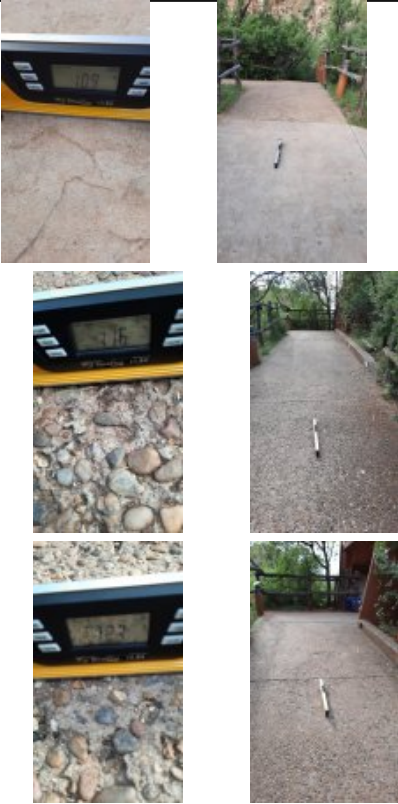
126	Pioneer Amphitheater: Pioneer Amphitheater EAR	[34.9763531, -101.679271], [34.9763927, -101.6793139]	There is a gap spaced greater than a 1/2 inch. Openings in floor or ground surfaces shall not allow passage of a sphere more than 1/2 inch diameter. Elongated openings shall be placed so that the long dimension is perpendicular to the dominant direction of travel.	route to shelters - bridges have large gaps	Correct or fill gaps to be max .5" at bridges.	2015 ABAAS Section: 302.3 2012 TAS Section: 302.3 2010 ADAS Section: 302.3

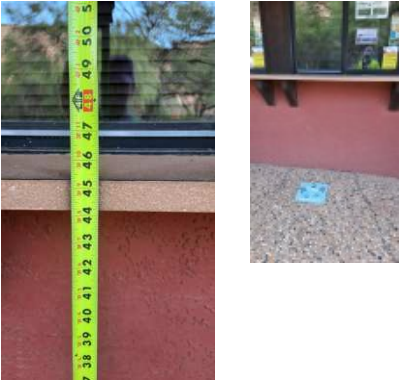
Finding Number	Area Description	Lat/Long	Finding	As Built	Recommendation	Citation	Photos	Figure
129	Pioneer Amphitheater: Pioneer Amphitheater Public Spaces	[34.9764597, -101.6794668]	The transaction counter is too high. A portion of the counter surface that is 36 inches long minimum and 36 inches high maximum above the finish floor shall be provided. Knee and toe space must be provided for a forward approach. A 30 inch by 48 inch clear floor space on an accessible route must be provided for either a forward or parallel approach.	ticket counter 45.5" above ground	Lower 36" wide segment of service counter to max 36" aff.	2015 ABAAS Section: 904.4.2, 904.4.1 2012 TAS Section: 904.4.1, 904.4.2 2010 ADAS Section: 904.4.2, 904.4.1

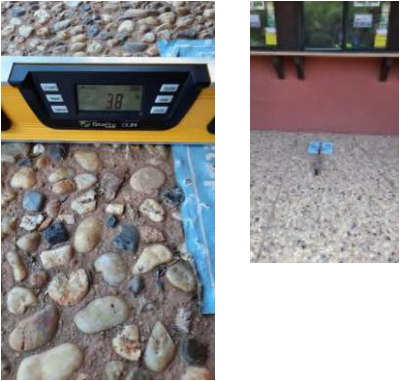
130	Pioneer Amphitheater: Pioneer Amphitheater Public Spaces	[34.9764707, -101.679503]	The 30 inches minimum by 48 inches minimum clear floor space required at the operable part is not flat (2% or 1:48 maximum slope) in all directions. Changes in level are not permitted at required clear floor or ground space except that slopes not steeper than 1:48 shall be permitted.	3.8% slope at ticket counter	Correct or repair slope in CFS to max 2.08%.	2015 ABAAS Section: 305.2 2012 TAS Section: 305.2 2010 ADAS Section: 305.2

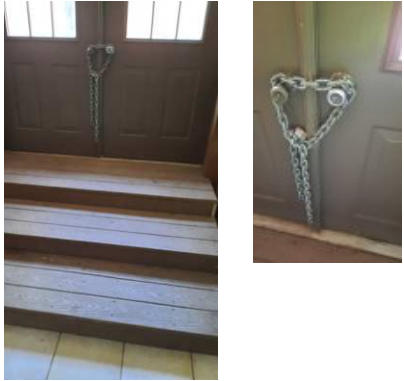
Finding Number	Area Description	Lat/Long	Finding	As Built	Recommendation	Citation	Photos	Figure
132	Pioneer Amphitheater: Pioneer Amphitheater Public Spaces	[34.9761345 , -101.6793 595]	Minimum maneuvering clearances at doors and gates shall comply with 404.2.4. Maneuvering clearances shall extend the full width of the doorway and the required latch side or hinge side clearance. Hand-activated door opening hardware, handles, pulls, latches, locks, and other operating devices on accessible doors shall have a shape that is easy to grasp with one hand and does not require tight grasping, tight pinching or twisting of the wrist to operate. Hardware shall be 34 inches minimum and 48 inches maximum above the finish floor or ground.	back exit concession - stairs on push, knob hardware	For all doors along the public circulation route, provide required maneuvering clearance on push and pull side of doors, in the alternative, mount signage directing staff to an accessible exit. For all doors along the public circulation route, replace hardware with lever hardware or hardware operable without a tight pinch or grasp	2010 ADAS Section: 404.2.3, 404.2.7, 404.2.4, 404.2.11, 404.2.11 Exception

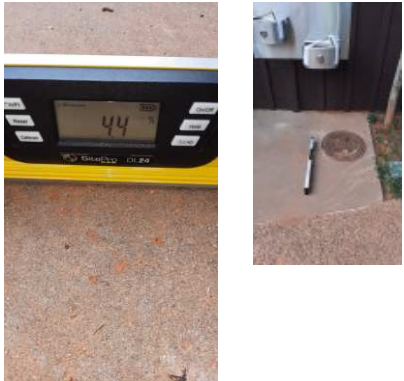
134	Pioneer Amphitheater: Pioneer Amphitheater Public Spaces	[34.9761828 , -101.6798 557]	The 30 inches minimum by 48 inches minimum clear floor space required at the operable part is not flat (2% or 1:48 maximum slope) in all directions. Changes in level are not permitted at required clear floor or ground space except that slopes not steeper than 1:48 shall be permitted.	drinking fountain near restroom - 4.4% slope in clear floor space	Correct or repair slope in CFS to max 2.08%.	2015 ABAAS Section: 305.2 2012 TAS Section: 305.2 2010 ADAS Section: 305.2

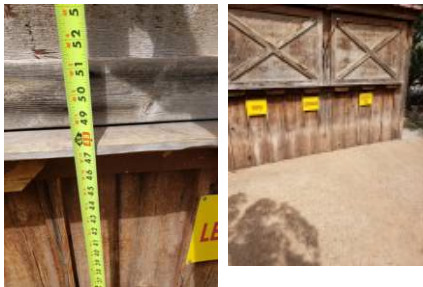
140	Pioneer Amphitheater: Pioneer Amphitheater Public Spaces	[34.9764224 , -101.6790 966]	Picnic tables shall provide at least one wheelchair space for each 24 linear feet (7320 mm) of usable table surface perimeter. Wheelchair spaces shall be 30 inches (760 mm) minimum by 48 inches (1220 mm) minimum. Wheelchair spaces shall be positioned for a forward approach to the table and provide knee and toe clearance complying with 306 under the table	3 shelters lack accessible picnic tables, red shelter on accessible route	Replace two picnic tables with ones of an accessible design in red shelter as a smart practice	2015 ABAAS Section: 1011.4.2		
141	Pioneer Amphitheater: Pioneer Amphitheater Public Spaces	[34.9767114 , -101.6790 765]	The transaction counter is too high. A portion of the counter surface that is 36 inches long minimum and 36 inches high maximum above the finish floor shall be provided. Knee and toe space must be provided for a forward approach. A 30 inch by 48 inch clear floor space on an accessible route must be provided for either a forward or parallel approach.	chow cart beverage concession counter 47" above ground	Lower 36" wide segment of service counter to max 36" aff.	2015 ABAAS Section: 904.4.2, 904.4.1 2012 TAS Section: 904.4.1, 904.4.2 2010 ADAS Section: 904.4.2, 904.4.1

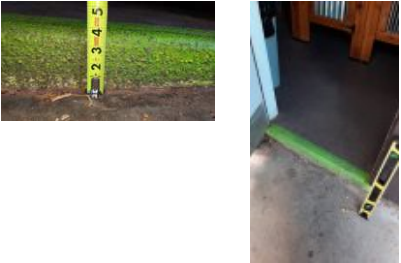
Finding Number	Area Description	Lat/Long	Finding	As Built	Recommendation	Citation	Photos	Figure
142	Pioneer Amphitheater: Pioneer Amphitheater Restrooms - Women's	[34.9761916 , -101.67974 3]	Thresholds, if provided at doorways, shall be 1/2 inch (13 mm) high maximum. Raised thresholds and changes in level at doorways shall comply with 302 and 303. Changes in level of ¼ inch (6.4 mm) high maximum shall be permitted to be vertical. Changes in level between ¼ inch (6.4 mm) high minimum and ½ inch (13 mm) high maximum shall be beveled with a slope not steeper than 1:2. Changes in level greater than ½ inch (13 mm) high shall be ramped, and shall comply with 405 or 406.	Women's restroom - 4" change in level at door	Repair, bevel or ramp CIL at doorway.	2015 ABAAS Section: 303.3, 404.2.5, 303.2, 303.4 2012 TAS Section: 303.3, 404.2.5, 303.2, 303.4 2010 ADAS Section: 303.3, 404.2.5, 303.2, 303.4

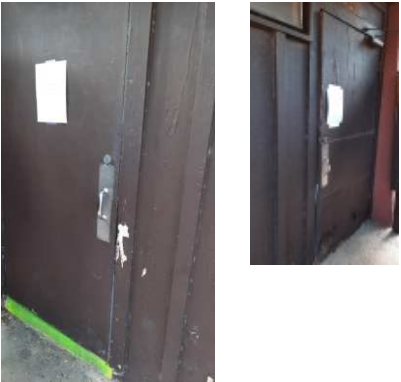
143	Pioneer Amphitheater: Pioneer Amphitheater Restrooms - Women's	[34.976207, -101.67973 77]	This restroom is not accessible. Where existing toilet rooms or bathing rooms do not comply, directional signs indicating the location of the nearest accessible toilet room or bathing room within the facility shall be provided. Signs shall include the International Symbol of Accessibility. Where existing toilet rooms or bathing rooms do comply), the accessible toilet rooms or bathing rooms shall be identified by the International Symbol of Where clustered single user toilet rooms or bathing facilities are permitted, accessible toilet rooms or bathing facilities shall be identified by the International Symbol of Accessibility unless all toilet rooms and bathing facilities are accessible.	Women's restroom, inaccessible - no directional signage	Restroom not accessible, acquire and mount signage directing patrons to accessible restroom.	2015 ABAAS Section: F216.8 2012 TAS Section: 216.8 2010 ADAS Section: 216.8

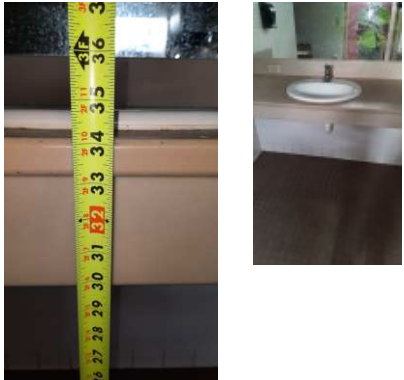
147	Pioneer Amphitheater: Pioneer Amphitheater Restrooms - Women's	[34.9761894, -101.6799066]	The top rim of the sink is too high. All lavatories/sinks that are designated to be accessible shall be a minimum 17 inches in horizontal depth and mounted with the rim or counter edge no higher than 34 inches above the finished floor.	Women's restroom accessible - 34.75" to rim from finished floor	Lower sinks to max 34" aff to front of rim.	2015 ABAAS Section: 606.3 2012 TAS Section: 606.3 2010 ADAS Section: 606.3

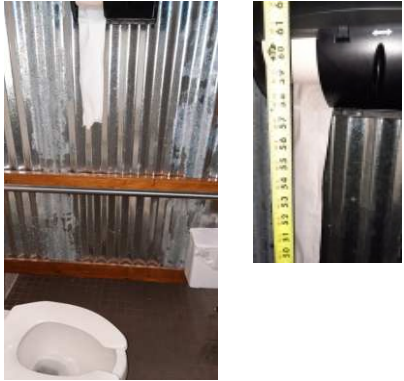
Finding Number	Area Description	Lat/Long	Finding	As Built	Recommendation	Citation	Photos	Figure
153	Pioneer Amphitheater: Pioneer Amphitheater Restrooms - Women's	[34.9761894 , -101.6798 986]	The toilet paper is not installed within the compliant range in front of the toilet. Toilet paper dispensers shall be 7 inches minimum and 9 inches maximum in front of the water closet measured to the centerline of the dispenser. The outlet of the dispenser shall be 15 inches minimum and 48 inches maximum above the finish floor and shall not be located behind grab bars. Dispensers shall not be of a type that controls delivery or that does not allow continuous paper flow. There shall be a clearance of 1 1/2 inches minimum below the grab bar.	Women's restroom accessible - toilet paper too close to toilet, and too high at 57"	Remount toilet paper dispenser max 7" to 9" from front of toilet, 15" to 48" aff and min 12" above or 1.5" below grab bar	2015 ABAAS Section: 604.7 2012 TAS Section: 604.7 2010 ADAS Section: 604.7

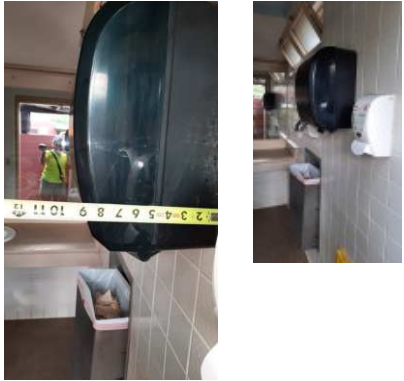
154	Pioneer Amphitheater: Pioneer Amphitheater Restrooms - Women's	[34.9761938 , -101.6798 825]	The paper towel dispenser projects more than 4 inches into the circulation path. Wall-mounted objects that have leading edges between 27 inches and 80 inches from the floor must not project more than 4 inches into the circulation path. Protruding objects that extend to the floor or within 27 inches of the floor are cane detectable and are therefore not hazardous. Where it is necessary or desirable to have objects protrude from the wall, a manner of cane detection must be provided.	Women's restroom accessible - paper towel dispenser protrudes 9" into circulation path	Relocate protruding objects or place cane detectable warning or bollard at foot of item.	2015 ABAAS Section: 307.2 2012 TAS Section: 307.2 2010 ADAS Section: 307.2

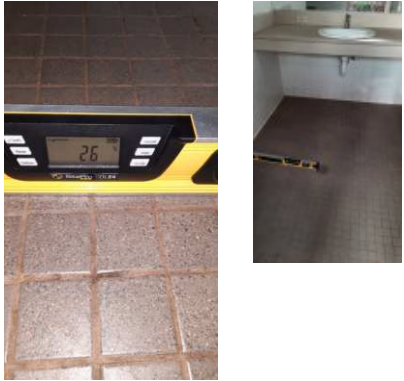
155	Pioneer Amphitheater: Pioneer Amphitheater Restrooms - Women's	[34.9762158 , -101.6798 798]	The accessible route contains running slopes greater than 5 percent and cross slopes greater than 2 percent across the width of the walk and has not been constructed as a ramp (i.e. handrails, wheel guides, etc.). When the slope in the direction of travel of any walk exceeds 1 unit vertical in 20 units horizontal (5-percent slope), it must be constructed as ramp. Surface cross slopes must not exceed one unit vertical in 48 units. Horizontal (2-percent slope).	women's restroom accessible - 2.6% slope at drain	Correct or repair slope to max 2.08%.	2015 ABAAS Section: 403.3 2012 TAS Section: 403.3 2010 ADAS Section: 403.3

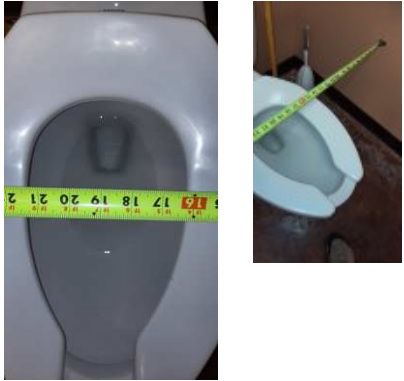
Finding Number	Area Description	Lat/Long	Finding	As Built	Recommendation	Citation	Photos	Figure
156	Pioneer Amphitheater: Pioneer Amphitheater Restrooms - Women's	[34.9750487, -101.6790738]	The toilet is not located within the range allowed from the side wall or partition for children age 9 to 12. The centerline of the toilet must be 15 to 18 inches from the side wall.	Girls dressing - 18.75" to center line	Remount toilets to 15" to 18" from the side wall to centerline for children age 9 to 12.	2015 ABAAS Section: 604.9, 604.9.1 2012 TAS Section: 604.9, 604.9.1 2010 ADAS Section: 604.9, 604.9.1

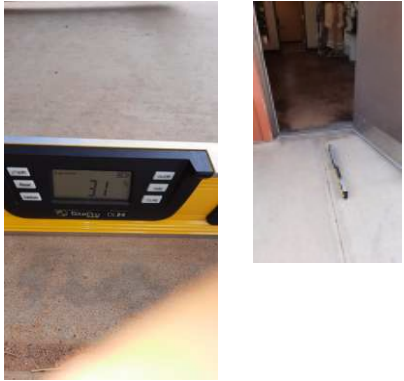
157	Pioneer Amphitheater: Pioneer Amphitheater Restrooms - Women's	[34.9750597, -101.6790859]	Minimum maneuvering clearances at doors and gates shall comply with 404.2.4. Maneuvering clearances shall extend the full width of the doorway and the required latch side or hinge side clearance.	Girls dressing - bench on pull side, 3.1% slope on pull	Provide required maneuvering clearance around pull side of door Relocate storage, furniture and other obstacles to create 60" maneuvering clearance around door Correct or repair slope at doorway landing to max 2.08% in any direction for level	2015 ABAAS Section: 404.2.4.1 , 404.2.4.4 2012 TAS Section: 404.2.4.4, 404.2.4.1 2010 ADAS Section: 404.2.4.4, 404.2.4.1

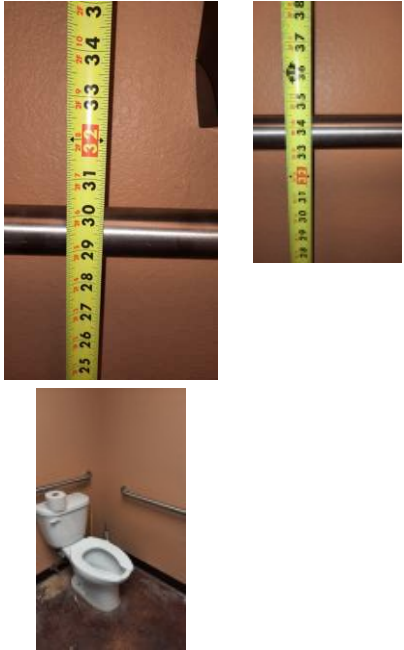
Finding Number	Area Description	Lat/Long	Finding	As Built	Recommendation	Citation	Photos	Figure
159	Pioneer Amphitheater: Pioneer Amphitheater Restrooms - Women's	[34.9750509 , -101.6790832]	The grab bar height and/or spacing fails. Grab bars for children age 9 to 12 must be mounted between 25" and 27" to the top of the gripping surface. There must be 1.5" of clearance between the grab bar and the wall. There must be a minimum of 1.5" of clearance below and minimum 12" above the grab bar to any dispenser or other obstruction.	Girls dressing room restroom - side grab bar 30.25", rear grab bar 34.5" above finished floor	Remount grab bars in accessible stall to 25" to 27" aff for children age 9 to 12.	2015 ABAAS Section: 604.5, 604.9, 604.9.4, 609.3 2012 TAS Section: 604.5, 609.3, 604.9, 604.9.4 2010 ADAS Section: 604.5, 609.3, 604.9, 604.9.4

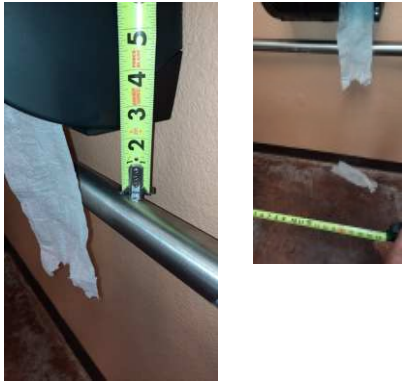
160	Pioneer Amphitheater: Pioneer Amphitheater Restrooms - Women's	[34.9750334 , -101.6790832]	The toilet paper is not installed within the compliant range in front of the toilet. Toilet paper dispensers shall be 7 inches minimum and 9 inches maximum in front of the water closet measured to the centerline of the dispenser. The outlet of the dispenser shall be 15 inches minimum and 48 inches maximum above the finish floor and shall not be located behind grab bars. Dispensers shall not be of a type that controls delivery or that does not allow continuous paper flow. There shall be a clearance of 1 1/2 inches minimum below the grab bar.	Girls dressing room restroom - too far from toilet, too close above side grab bar	Remount toilet paper dispenser max 7" to 9" from front of toilet, 15" to 48" aff and min 12" above or 1.5" below grab bar	2015 ABAAS Section: 604.7 2012 TAS Section: 604.7 2010 ADAS Section: 604.7
