Access Audit Site Report

Palo Duro Canyon State Park
11450 State Hwy Park Rd 5
Canyon, TX 79015
Accessibility Evaluation
Inspection Date: 08/10/2021
Inspectors: Tanya Scheibe

Prepared By
WT Group

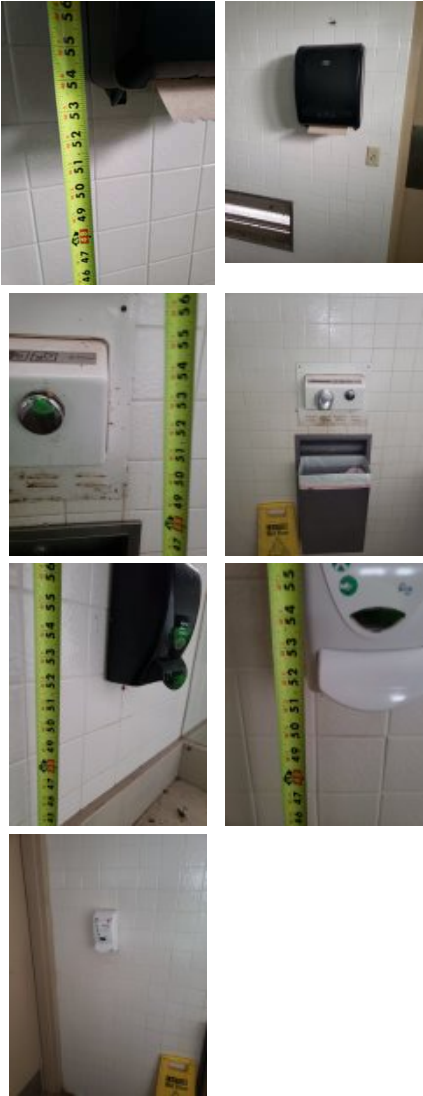
Finding Number	Area Description	Lat/Long	Finding	As Built	Recommendation	Citation	Photos	Figure
165	Pioneer Amphitheater: Pioneer Ampitheater Restrooms - Men's	[34.9762026, -101.6798879]	Where a high forward reach is over an obstruction, the clear floor space shall extend beneath the element for a distance not less than the required reach depth over the obstruction. The high forward reach shall be 48 inches (1220 mm) maximum where the reach depth is 20 inches (510 mm) maximum. Where the reach depth exceeds 20 inches (510 mm), the high forward reach shall be 44 inches (1120 mm) maximum and the reach depth shall be 25 inches (635 mm) maximum. Where a clear floor or ground space allows a parallel approach to an element and the high side reach is over an obstruction, the height of the obstruction shall be 34 inches (865 mm) maximum and the depth of the obstruction shall be 24 inches (610 mm) maximum. The high side reach shall be 48 inches (1220 mm) maximum for a reach depth of 10 inches (255 mm) maximum. Where the reach depth exceeds 10 inches (255 mm), the high side reach shall be 46 inches (1170 mm) maximum for a reach depth of 24 inches (610 mm) maximum.	Men's Accessible - paper towels, hand dryer, soap and hand sanitizer all mounted 52" - 53" above finished floor	Lower operating mechanisms to max 48" aff to highest operable part; leave as is citing safe harbor.	2015 ABAAS Section: 308.2.1, 308.3.2 2012 TAS Section: 308.2.1, 308.3.2 2010 ADAS Section: 308.2.1, 308.3.2

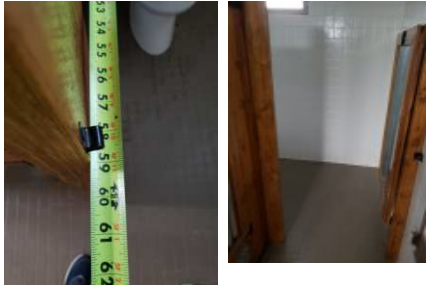
Finding Number	Area Description	Lat/Long	Finding	As Built	Recommendation	Citation	Photos	Figure
169	Pioneer Amphitheater: Pioneer Ampitheater Restrooms - Men's	[34.9762026 , -101.679904]	The door encroaches into the minimum required compartment area. Toilet compartment doors shall not swing into the minimum required compartment area. Wheelchair accessible compartments shall be 60 inches wide minimum measured perpendicular to the side wall, and 56 inches deep minimum for wall hung water closets and 59 inches deep minimum for floor mounted water closets measured perpendicular to the rear wall.	Men's Accessible - stall door opens into required compartment area, lacks extra depth	Reverse stall door to swing out due to lack of required depth for inward swinging door; in the alternative, enlarge stall to 92" depth for wall mounted toilet or 95" depth for floor mounted toilet.	2015 ABAAS Section: 604.8.1.1, 604.8.1.2 2012 TAS Section: 604.8.1.1, 604.8.1.2 2010 ADAS Section: 604.8.1.2, 604.8.1.1

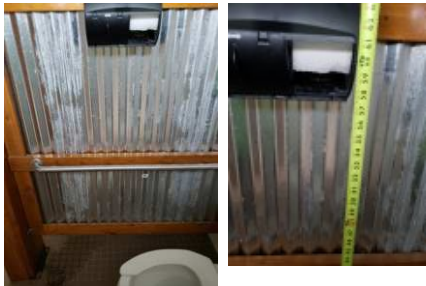
170	Pioneer Amphitheater: Pioneer Ampitheater Restrooms - Men's	[34.9761938 , -101.6799093]	The toilet paper is not installed within the compliant range in front of the toilet. Toilet paper dispensers shall be 7 inches minimum and 9 inches maximum in front of the water closet measured to the centerline of the dispenser. The outlet of the dispenser shall be 15 inches minimum and 48 inches maximum above the finish floor and shall not be located behind grab bars. Dispensers shall not be of a type that controls delivery or that does not allow continuous paper flow. There shall be a clearance of 1 1/2 inches minimum below the grab bar.	Men's Accessible - toilet paper too close to toilet and 60" AFF	Remount toilet paper dispenser max 7" to 9" from front of toilet, 15" to 48" aff and min 12" above or 1.5" below grab bar	2015 ABAAS Section: 604.7 2012 TAS Section: 604.7 2010 ADAS Section: 604.7

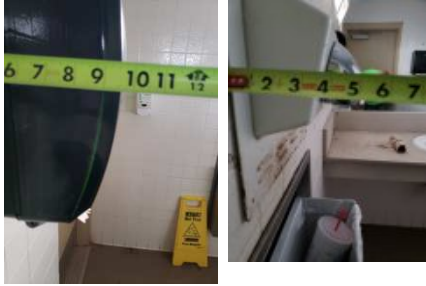
171	Pioneer Amphitheater: Pioneer Ampitheater Restrooms - Men's	[34.9762729 , -101.6798986]	The paper towel dispenser and hand dryer projects more than 4 inches into the circulation path. Wall-mounted objects that have leading edges between 27 inches and 80 inches from the floor must not project more than 4 inches into the circulation path. Protruding objects that extend to the floor or within 27 inches of the floor are cane detectable and are therefore not hazardous. Where it is necessary or desirable to have objects protrude from the wall, a manner of cane detection must be provided.	Men's Accessible - elements project into circulation path - paper towels 9.5", hand dryer 5"	Relocate protruding objects or place cane detectable warning or bollard at foot of item.	2015 ABAAS Section: 307.2 2012 TAS Section: 307.2 2010 ADAS Section: 307.2

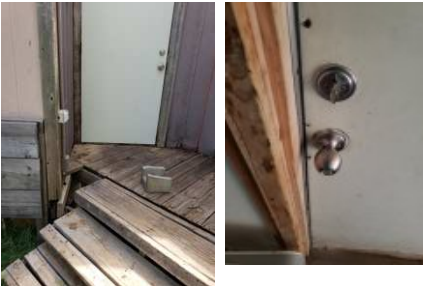
Finding Number	Area Description	Lat/Long	Finding	As Built	Recommendation	Citation	Photos	Figure
178	Pioneer Amphitheater: Pioneer Ampitheater Restrooms - Men's	[34.97193, -101.6783]	Element meets all standards and requirements	childrens dressing room boys interior door compliant	None	2010 ADAS Section: N/A		
179	Pioneer Amphitheater: Pioneer Amphitheater Employee Spaces	[34.9768355, -101.6791248]	Minimum maneuvering clearances at doors and gates shall comply with 404.2.4. Maneuvering clearances shall extend the full width of the doorway and the required latch side or hinge side clearance. The sweep period for doors with closers shall be adjusted so that from an open position of 70 degrees, the door will take at least 3 seconds to move to a point 3 inches from the latch, measured to the leading edge of the door. Exterior doors are recommended to be maintained at 8.5 lbf as a smart practice. Force is to be measured at the operating hardware or 30 inches from the hinges, whichever is greater.	chow cart beverage concession rear: 10# push to open, fast closing, only steps to access push side of door	For all doors along the public circulation route, provide required maneuvering clearance on push and pull side of doors, in the alternative, leave as is and mount signage directing staff to an accessible exit. For all doors along the public circulation route, inspect, adjust, and maintain closing speed on door closers For all doors along the public circulation route, inspect, adjust, and maintain 8.5 lbf to open exterior doors as a smart practice	2010 ADAS Section: 404.2.3, 404.2.7, 404.2.4, 404.2.11, 404.2.11 Exception

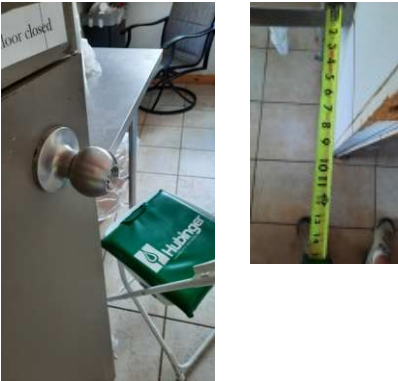
180	Pioneer Amphitheater: Pioneer Amphitheater Employee Spaces	[34.9761718, -101.6794225]	Spaces and elements within employee work areas shall only be required to comply with 206.2.8, 207.1, and 215.3 and shall be designed and constructed so that individuals with disabilities can approach, enter, and exit the employee work area. Employee work areas, or portions of employee work areas, other than raised courtroom stations, that are less than 300 square feet (28 m2) and elevated 7 inches (180 mm) or more above the finish floor or ground where the elevation is essential to the function of the space shall not be required to comply with these requirements or to be on an accessible route.	concession drink room - knob hardware, sink on pull side, ice room - knob hardware, storage on push side, 1.5" change in level	For employee spaces, relocate storage, furniture, and other obstacles at doorways to provide approach, enter and exit at the employee space. Repair change in level and replace knobs with lever hardware.	2015 ABAAS Section: F203.9 2012 TAS Section: 203.9 2010 ADAS Section: 203.9

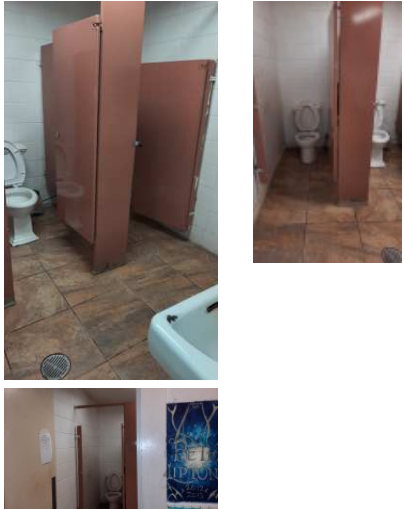
Finding Number	Area Description	Lat/Long	Finding	As Built	Recommendation	Citation	Photos	Figure
184	Pioneer Amphitheater: Pioneer Amphitheater Employee Spaces	[34.9752773 , -101.6793 031]	This restroom is not accessible. Where existing toilet rooms or bathing rooms do not comply, directional signs indicating the location of the nearest accessible toilet room or bathing room within the facility shall be provided. Signs shall include the International Symbol of Accessibility. Where existing toilet rooms or bathing rooms do comply), the accessible toilet rooms or bathing rooms shall be identified by the International Symbol of Where clustered single user toilet rooms or bathing facilities are permitted, accessible toilet rooms or bathing facilities shall be identified by the International Symbol of Accessibility unless all toilet rooms and bathing facilities are accessible.	W dressing rooms RR - restroom is not accessible, lacks signage to closest accessible restroom	Restroom not accessible, acquire and mount signage directing patrons to accessible restroom.	2015 ABAAS Section: F216.8 2012 TAS Section: 216.8 2010 ADAS Section: 216.8

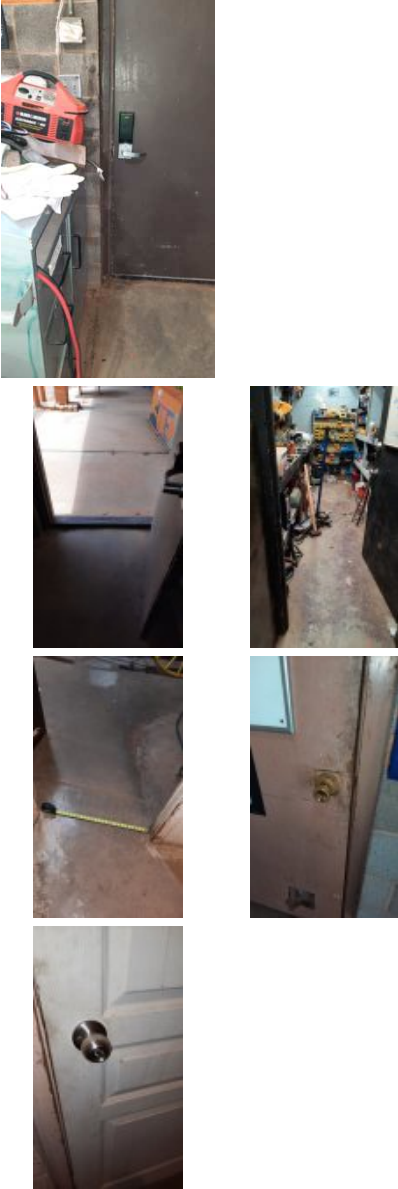
Finding Number	Area Description	Lat/Long	Finding	As Built	Recommendation	Citation	Photos	Figure
			courtroom stations, that are less than 300 square feet (28 m2) and elevated 7 inches (180 mm) or more above the finish floor or ground where the elevation is essential to the function of the space shall not be required to comply with these requirements or to be on an accessible route.	hardware, fast closing, 7 lb of force to open		2010 ADAS Section: 203.9

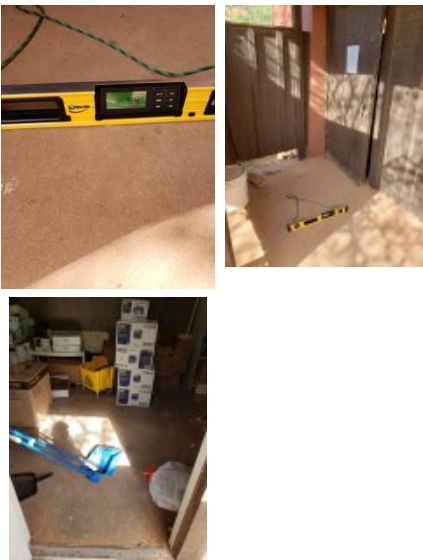
Finding Number	Area Description	Lat/Long	Finding	As Built	Recommendation	Citation	Photos	Figure
192	Pioneer Amphitheater: Pioneer Amphitheater Employee Spaces	[34.9761916, -101.6798825]	Spaces and elements within employee work areas shall only be required to comply with 206.2.8, 207.1, and 215.3 and shall be designed and constructed so that individuals with disabilities can approach, enter, and exit the employee work area. Employee work areas, or portions of employee work areas, other than raised courtroom stations, that are less than 300 square feet (28 m2) and elevated 7 inches (180 mm) or more above the finish floor or ground where the elevation is essential to the function of the space shall not be required to comply with these requirements or to be on an accessible route.	storage by men's restroom: cross slope to entry 4.9%, 22# push, fast closing, storage in push side maneuvering clearance	For employee spaces, relocate storage, furniture, and other obstacles at doorways to provide approach, enter and exit at the employee space. Correct or repair slope at doorway landing to max 2.08% in any direction for level. Adjust closer to correct speed and provide max 5 lbf to open.	2015 ABAAS Section: F203.9 2012 TAS Section: 203.9 2010 ADAS Section: 203.9

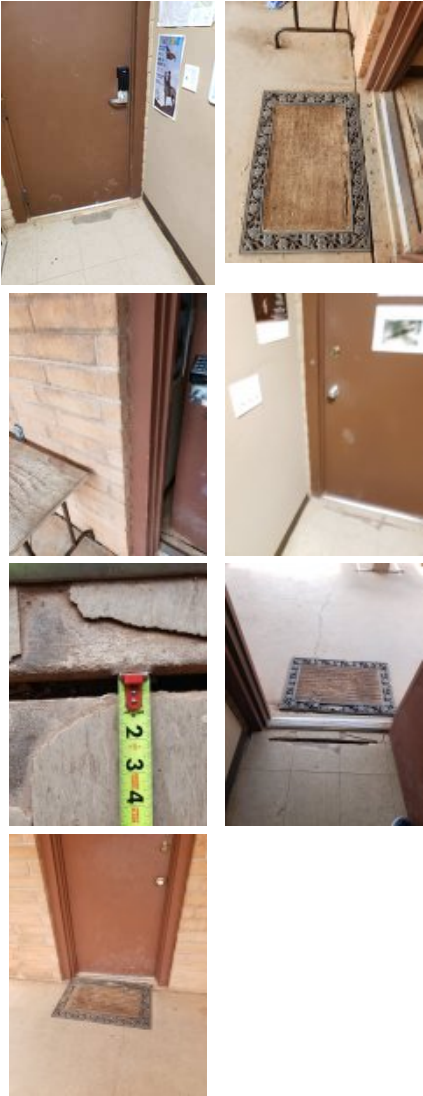
Finding Number	Area Description	Lat/Long	Finding	As Built	Recommendation	Citation	Photos	Figure
194	Pioneer Amphitheater: Pioneer Amphitheater Employee Spaces	[34.9754279, -101.6794332]	Minimum maneuvering clearances at doors and gates shall comply with 404.2.4. Maneuvering clearances shall extend the full width of the doorway and the required latch side or hinge side clearance. The sweep period for doors with closers shall be adjusted so that from an open position of 70 degrees, the door will take at least 3 seconds to move to a point 3 inches from the latch, measured to the leading edge of the door. Exterior doors are recommended to be maintained at 8.5 lbf as a smart practice. Force is to be measured at the operating hardware or 30 inches from the hinges, whichever is greater.	production office entrance crew house door: wall in pull side clearance, 20# push, fast closing, table in push side maneuvering clearance, non secured mat; Production office entrance first aid door: wall in pull side clearance, 15# push, fast closing, non secured mat	For all doors along the public circulation route, provide required maneuvering clearance on push and pull side of doors For all doors along the public circulation route, inspect, adjust, and maintain closing speed on door closers For all doors along the public circulation route, inspect, adjust, and maintain 8.5 lbf to open exterior doors as a smart practice	2010 ADAS Section: 404.2.3, 404.2.7, 404.2.4, 404.2.11, 404.2.11 Exception

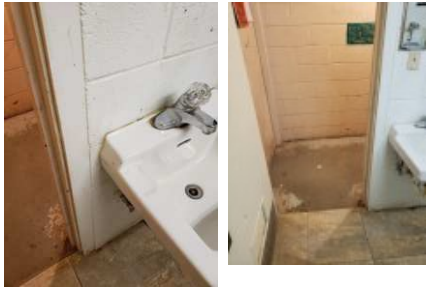
196	Pioneer Amphitheater: Pioneer Amphitheater Employee Spaces	[34.9754509 , -101.6794 802]	Minimum maneuvering clearances at doors and gates shall comply with 404.2.4. Maneuvering clearances shall extend the full width of the doorway and the required latch side or hinge side clearance. All interior doors must be maintained so that the operating pressure does not exceed 5 lb. force to open. The sweep period for doors with closers shall be adjusted so that from an open position of 70 degrees, the door will take at least 3 seconds to move to a point 3 inches from the latch, measured to the leading edge of the door.	Production Restroom - sink in pull side clearance, 8# push, fast closing	For all doors along the public circulation route, provide required maneuvering clearance on push and pull side of doors For all doors along the public circulation route, inspect, adjust, and maintain 5 lbf to open interior doors For all doors along the public circulation route, inspect, adjust, and maintain closing speed on door closers	2010 ADAS Section: 404.2.3, 404.2.7, 404.2.4, 404.2.11, 404.2.11 Exception

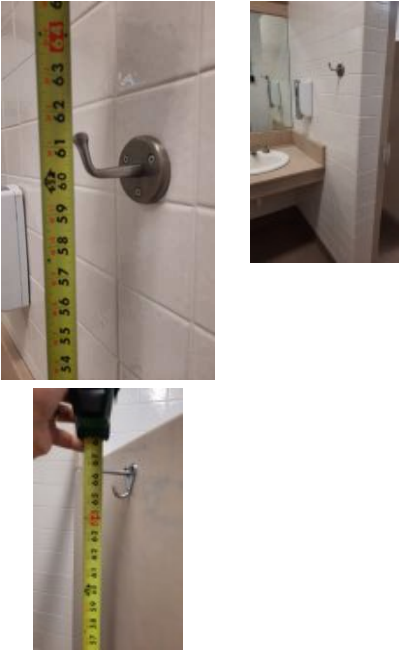
Finding Number	Area Description	Lat/Long	Finding	As Built	Recommendation	Citation	Photos	Figure
202	Sagebrush Camp Area: Sagebrush Camp Area Restrooms	[34.9769586 , -101.67628 3]	Where a high forward reach is over an obstruction, the clear floor space shall extend beneath the element for a distance not less than the required reach depth over the obstruction. The high forward reach shall be 48 inches (1220 mm) maximum where the reach depth is 20 inches (510 mm) maximum. Where the reach depth exceeds 20 inches (510 mm), the high forward reach shall be 44 inches (1120 mm) maximum and the reach depth shall be 25 inches (635 mm) maximum. Where a clear floor or ground space allows a parallel approach to an element and the high side reach is over an obstruction, the height of the obstruction shall be 34 inches (865 mm) maximum and the depth of the obstruction shall be 24 inches (610 mm) maximum. The high side reach shall be 48 inches (1220 mm) maximum for a reach depth of 10 inches (255 mm) maximum. Where the reach depth exceeds 10 inches (255 mm), the high side reach shall be 46 inches (1170 mm) maximum for a reach depth of 24 inches (610 mm) maximum.	Women's restroom - hooks mounted at 61" and 66" AFF	Lower hooks to max 48" AFF.	2015 ABAAS Section: 308.2.1, 308.3.2 2012 TAS Section: 308.2.1, 308.3.2 2010 ADAS Section: 308.2.1, 308.3.2

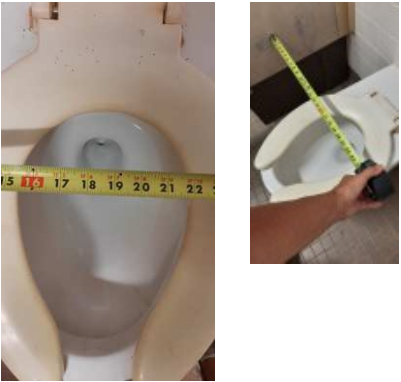
203	Sagebrush Camp Area: Sagebrush Camp Area Restrooms	[34.9769454 , -101.6762 293]	The toilet is not located within the range allowed from the side wall or partition. The centerline of the toilet must be 16 to 18 inches from the side wall.	Women's restroom - 18.5" to center line from wall	Centerline of toilet is 18.5" from wall, should not exceed 18", leave as is citing construction tolerance.	2015 ABAAS Section: 604.2 2012 TAS Section: 604.2 2010 ADAS Section: 604.2

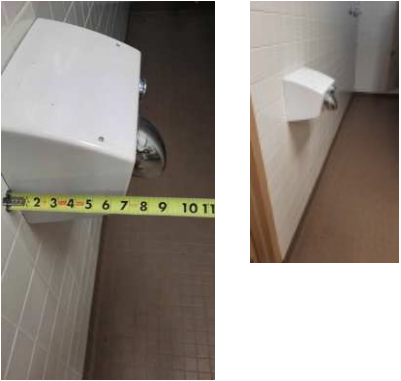
Finding Number	Area Description	Lat/Long	Finding	As Built	Recommendation	Citation	Photos	Figure
206	Sagebrush Camp Area: Sagebrush Camp Area Restrooms	[34.9769322 , -101.6762 615]	The hand dryer projects more than 4 inches into the circulation path. Wall-mounted objects that have leading edges between 27 inches and 80 inches from the floor must not project more than 4 inches into the circulation path. Protruding objects that extend to the floor or within 27 inches of the floor are cane detectable and are therefore not hazardous. Where it is necessary or desirable to have objects protrude from the wall, a manner of cane detection must be provided.	W RR - hand dryer protrudes into circulation path	Relocate protruding objects or place cane detectable warning or bollard at foot of item.	2015 ABAAS Section: 307.2 2012 TAS Section: 307.2 2010 ADAS Section: 307.2

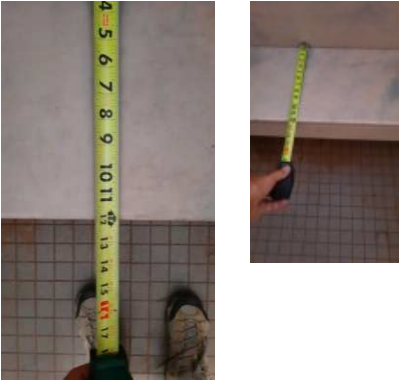
207	Sagebrush Camp Area: Sagebrush Camp Area Restrooms	[34.9769235 , -101.6762 615]	The bench is not deep enough or long enough or is missing. Benches shall be provided having seats that are 42 inches long minimum and 20 inches deep minimum and 24 inches deep maximum. The bench shall provide for back support or shall be affixed to a wall. Back support shall be 42 inches (1065 mm) long minimum and shall extend from a point 2 inches (51 mm) maximum above the seat surface to a point 18 inches (455 mm) minimum above the seat surface. Back support shall be 2½ inches (64 mm) maximum from the rear edge of the seat measured horizontally. The top of the bench seat surface shall be 17 inches (430 mm) minimum and 19 inches (485 mm) maximum above the finish floor or ground.	Women's restroom - 12" deep bench	Replace bench in dressing area with one having a seat depth of 20" to 24" deep, 42" long, affixed to the wall or having a back and mounted 17" to 19" aff	2012 TAS Section: 903.4, 903.2, 903.3, 903.5 2010 ADAS Section: 903.4, 903.2, 903.3, 903.5

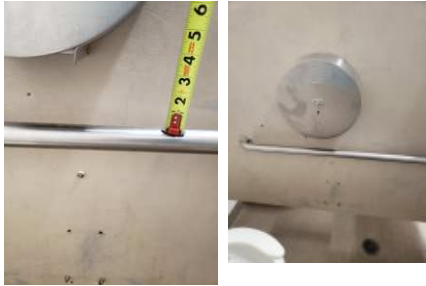
Finding Number	Area Description	Lat/Long	Finding	As Built	Recommendation	Citation	Photos	Figure
212	Sagebrush Camp Area: Sagebrush Camp Area Restrooms	[34.9769235 , -101.6762 615]	The grab bar height and/or spacing fails. Grab bars must be mounted between 33" and 36" to the top of the gripping surface. There must be 1.5" of clearance between the grab bar and the wall. There must be a minimum of 1.5" of clearance below and minimum 12" above the grab bar to any dispenser or other obstruction.	Men's Restroom - toilet paper dispenser installed 3.5" above side grab bar	Remount toilet paper dispenser max 7" to 9" from front of toilet, 15" to 48" aff and min 12" above or 1.5" below grab bar.	2015 ABAAS Section: 609.3, 609.4 2012 TAS Section: 609.4, 609.3 2010 ADAS Section: 609.3, 609.4

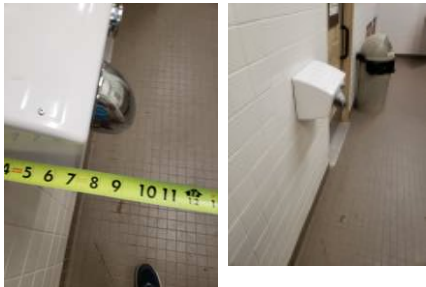
213	Sagebrush Camp Area: Sagebrush Camp Area Restrooms	[34.9769718 , -101.6762 615]	The hand dryer projects more than 4 inches into the circulation path. Wall-mounted objects that have leading edges between 27 inches and 80 inches from the floor must not project more than 4 inches into the circulation path. Protruding objects that extend to the floor or within 27 inches of the floor are cane detectable and are therefore not hazardous. Where it is necessary or desirable to have objects protrude from the wall, a manner of cane detection must be provided.	Men's Restroom - hand dryer projects 9" into circulation path	Relocate protruding objects or place cane detectable warning or bollard at foot of item.	2015 ABAAS Section: 307.2 2012 TAS Section: 307.2 2010 ADAS Section: 307.2

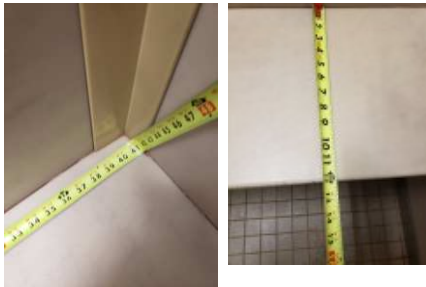
214	Sagebrush Camp Area: Sagebrush Camp Area Restrooms	[34.9769586 , -101.6762 508]	The bench is not deep enough or long enough or is missing. Benches shall be provided having seats that are 42 inches long minimum and 20 inches deep minimum and 24 inches deep maximum. The bench shall provide for back support or shall be affixed to a wall. Back support shall be 42 inches (1065 mm) long minimum and shall extend from a point 2 inches (51 mm) maximum above the seat surface to a point 18 inches (455 mm) minimum above the seat surface. Back support shall be 2½ inches (64 mm) maximum from the rear edge of the seat measured horizontally. The top of the bench seat surface shall be 17 inches (430 mm) minimum and 19 inches (485 mm) maximum above the finish floor or ground.	Men's Restroom - bench - 41" long, 12" deep	Replace bench in dressing area with one having a seat depth of 20" to 24" deep, 42" long, affixed to the wall or having a back and mounted 17" to 19" aff	2012 TAS Section: 903.4, 903.2, 903.3, 903.5 2010 ADAS Section: 903.4, 903.2, 903.3, 903.5

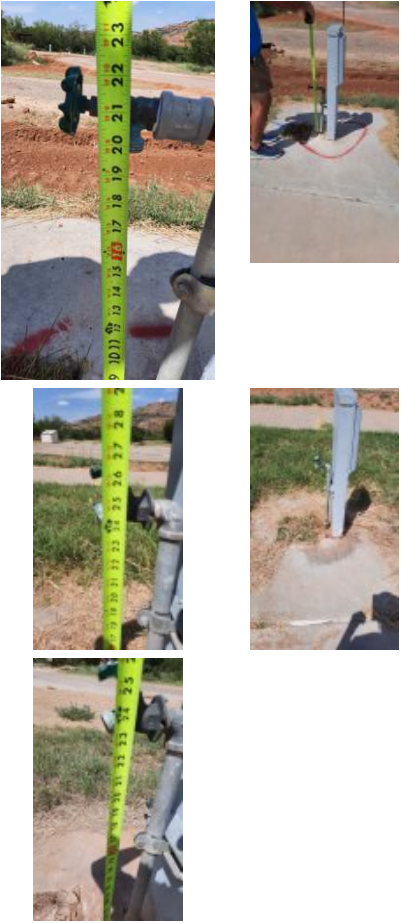
Finding Number	Area Description	Lat/Long	Finding	As Built	Recommendation	Citation	Photos	Figure
220	Sagebrush Camp Area: Sagebrush Camp Area Campsites	[34.976774, -101.676519]	Water spouts at water hydrants and water utility hook-ups shall be 28 inches (710 mm) minimum and 36 inches (915 mm) maximum above the ground	water spouts installed too low above ground at 144 - 20", 145 - 24", 146 - 23.5"	Remount water spouts to 28" min or 36" max above the ground as a smart practice.	2015 ABAAS Section: 1011.6

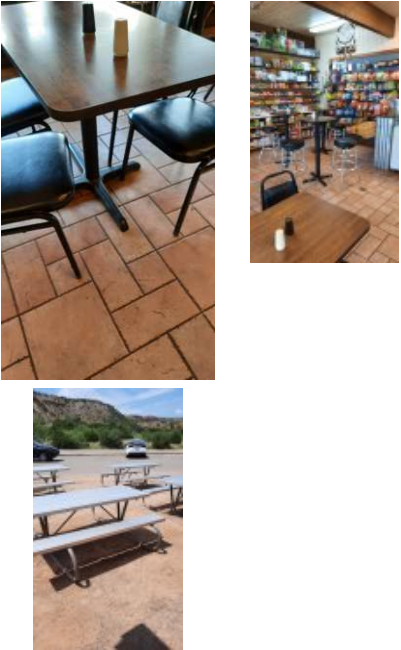
Finding Number	Area Description	Lat/Long	Finding	As Built	Recommendation	Citation	Photos	Figure
228	Trading Post / Wildlife Viewing Blind: Trading Post / WVB Public Spaces	[34.9739586 , -101.6767 014]	There are no accessible tables/seated or standing. At least 5% of each type in each functional area of dining surfaces must be accessible and must be dispersed throughout the space or facility containing dining surfaces. An accessible table must be on an accessible route (36 inches minimum) and have knee and toe spaces at least 27 inches high, 30 inches wide and 19 inches deep. The tops of tables and counters shall be 28 inches to 34 inches from the floor or ground.	5 exterior tables lack route, none are accessible, interior tables lack toe clearance, high tops not accessible, 11 inside	Replace 5% of the tables with ones providing the required knee and toe clearances in each location.	2015 ABAAS Section: F226.1 2012 TAS Section: 226.1 2010 ADAS Section: 226.1

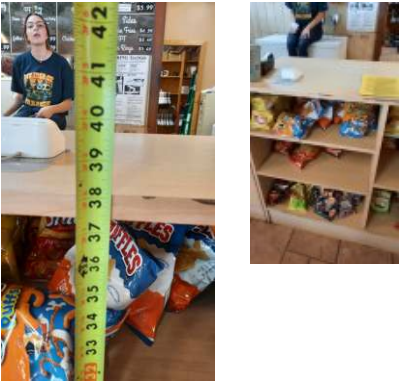
229	Trading Post / Wildlife Viewing Blind: Trading Post / WVB Public Spaces	[34.9739784 , -101.6767 336]	The sales and service counter is not a minimum 36 inches wide. A portion of the counter surface that is 36 inches long minimum and 36 inches high maximum above the finish floor shall be provided. A 30 inch by 48 inch clear floor space on an accessible route must be provided for either a forward or parallel approach.	service counter 38" above finished floor	Lower 36" wide segment of service counter to max 36" aff.	2012 TAS Section: 904.4 2010 ADAS Section: 904.4

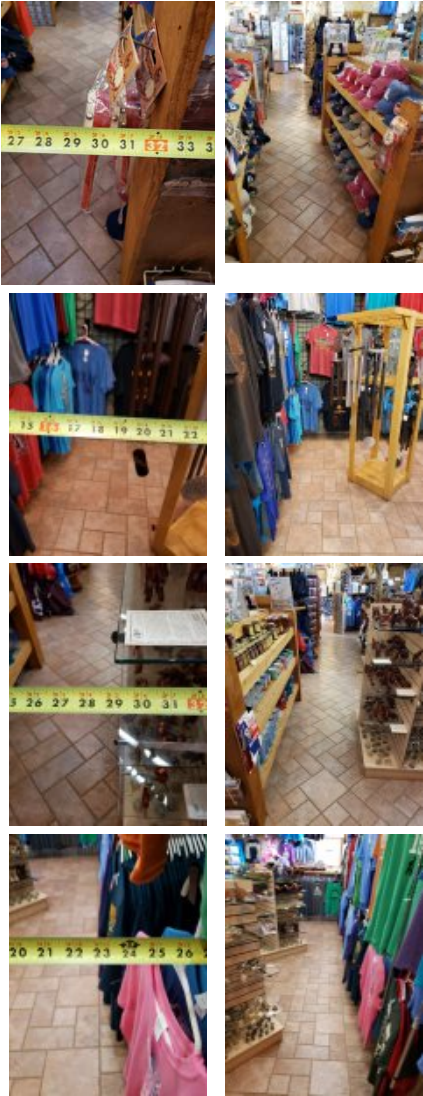
Finding Number	Area Description	Lat/Long	Finding	As Built	Recommendation	Citation	Photos	Figure
231	Trading Post / Wildlife Viewing Blind: Trading Post / WVB Public Spaces	[34.9738905 , -101.6767 229]	The route of travel at this location does not provide a minimum width of 36 inches. The clear width shall be permitted to be reduced to 32 inches minimum for a length of 24 inches maximum provided that reduced width segments are separated by segments that are 48 inches long minimum and 36 inches wide minimum.	most aisles in store are less than 30"	Widen AR to compliant 36" clear width.	2015 ABAAS Section: 403.5.1 2012 TAS Section: 403.5.1 2010 ADAS Section: 403.5.1

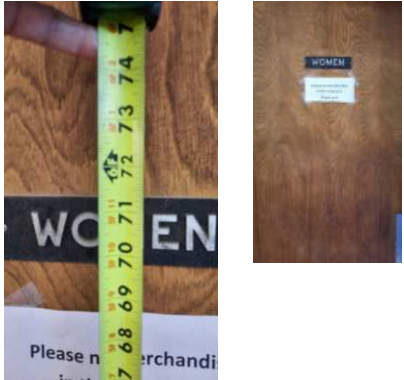
Finding Number	Area Description	Lat/Long	Finding	As Built	Recommendation	Citation	Photos	Figure
233	Trading Post / Wildlife Viewing Blind: Trading Post / WVB Restrooms	[34.9739345 , -101.6766 639]	The restroom sign does not comply with one or more applicable requirements for the location, height, and properties of the sign.	women's restroom - lacks Braille, mounted too high	Acquire and mount signage, including Braille and raised lettering mounted on wall, latch side of door, 48" to baseline of lowest character and 60" to baseline of highest character	2015 ABAAS Section: F216.2, 703.1, 703.2, 703.5, 703.6 2012 TAS Section: 216.2, 703.1, 703.2, 703.5, 703.6 2010 ADAS Section: 216.2, 703.1, 703.2, 703.5, 703.6

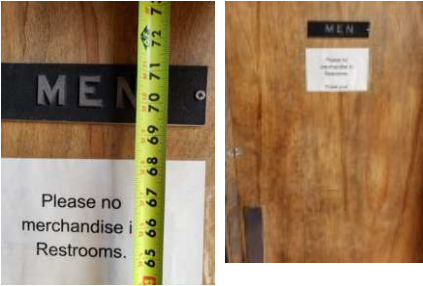
Finding Number	Area Description	Lat/Long	Finding	As Built	Recommendation	Citation	Photos	Figure
235	Trading Post / Wildlife Viewing Blind: Trading Post / WVB Restrooms	[34.9739169, -101.6767121]	The restroom sign does not comply with one or more applicable requirements for the location, height, and properties of the sign.	Men's Restroom - sign is mounted too high, lacks Braille	Acquire and mount signage, including Braille and raised lettering mounted on wall, latch side of door, 48" to baseline of lowest character and 60" to baseline of highest character.	2015 ABAAS Section: F216.2, 703.1, 703.2, 703.5, 703.6 2012 TAS Section: 216.2, 703.1, 703.2, 703.5, 703.6 2010 ADAS Section: 216.2, 703.1, 703.2, 703.5, 703.6

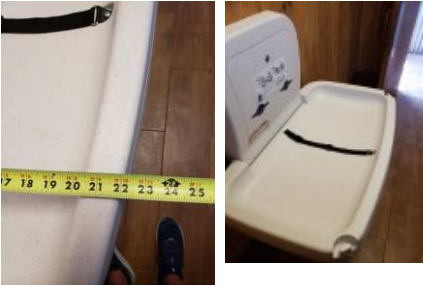
Finding Number	Area Description	Lat/Long	Finding	As Built	Recommendation	Citation	Photos	Figure
236	Trading Post / Wildlife Viewing Blind: Trading Post / WVB Restrooms	[34.9739345 , -101.6767 014]	The baby changing table is not compliant. Baby changing tables are work surfaces. If fixed or built-in baby changing tables are provided, at least 5%, but not less than one, must comply with TAS 902 based TAS 226.1. Baby changing tables cannot violate the protruding object requirements in either an open or closed position since either position is a potential hazard for persons with visual impairments. Baby changing tables are not prohibited from being located in wheelchair accessible toilet compartments; however, the minimum space required for the compartment cannot be obstructed by the baby changing table in either an open or closed position. The clear floor space required for a baby changing table may overlap the water closet clearance since baby changing tables are considered convenience “fixtures” based on Advisory 604.8.1.1. The overlap is applicable only to the clear floor space and not to actual table itself. Baby changing tables must be dispersed throughout a space, however, an additional baby changing table is not required in a common use area of a toilet or bathing room when the only baby changing table is located in a toilet compartment.	Men's Restroom - changing table protrudes 22"	Relocate baby changing table to eliminate protrusion when in the open position.	2012 TAS Section: 226.1, 902.3, 604.3.2, 204.1, 226.1 Advisory, 226.2, 307.1, 604.8.1.1 Advisory, 902.1, 902.1 Advisory, 902.2

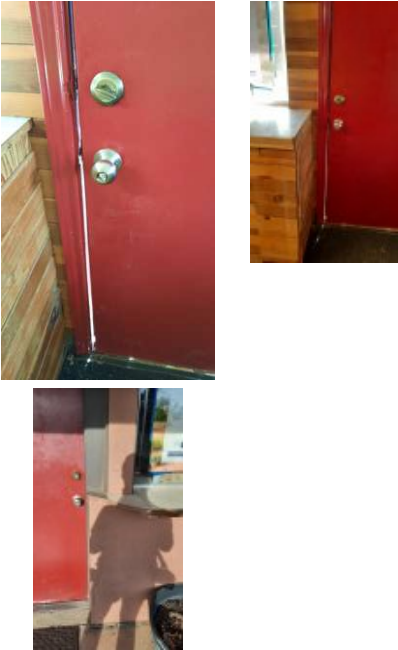
Finding Number	Area Description	Lat/Long	Finding	As Built	Recommendation	Citation	Photos	Figure
251	Old West Stables: Old West Stables Public Spaces	[34.97193, -101.6783]	Minimum maneuvering clearances at doors and gates shall comply with 404.2.4. Maneuvering clearances shall extend the full width of the doorway and the required latch side or hinge side clearance. The sweep period for doors with closers shall be adjusted so that from an open position of 70 degrees, the door will take at least 3 seconds to move to a point 3 inches from the latch, measured to the leading edge of the door. Hand-activated door opening hardware, handles, pulls, latches, locks, and other operating devices on accessible doors shall have a shape that is easy to grasp with one hand and does not require tight grasping, tight pinching or twisting of the wrist to operate. Hardware shall be 34 inches minimum and 48 inches maximum above the finish floor or ground.	Entry to shop - knob hardware, counter on pull maneuvering clearance, fast closing, counter on push maneuvering clearance	For all doors along the public circulation route, provide required maneuvering clearance on push and pull side of doors For all doors along the public circulation route, inspect, adjust, and maintain closing speed on door closers For all doors along the public circulation route, replace hardware with lever hardware or hardware operable without a tight pinch or grasp	2010 ADAS Section: 404.2.3, 404.2.7, 404.2.4, 404.2.11, 404.2.11 Exception

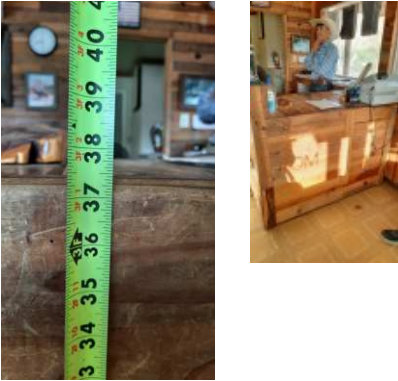
Finding Number	Area Description	Lat/Long	Finding	As Built	Recommendation	Citation	Photos	Figure
253	Old West Stables: Old West Stables Public Spaces	[34.97193, -101.6783]	The transaction counter is too high. A portion of the counter surface that is 36 inches long minimum and 36 inches high maximum above the finish floor shall be provided. Knee and toe space must be provided for a forward approach. A 30 inch by 48 inch clear floor space on an accessible route must be provided for either a forward or parallel approach.	service counter - 37.25" above finished floor	Lower 36" wide segment of service counter to max 36" aff.	2015 ABAAS Section: 904.4.2, 904.4.1 2012 TAS Section: 904.4.1, 904.4.2 2010 ADAS Section: 904.4.2, 904.4.1

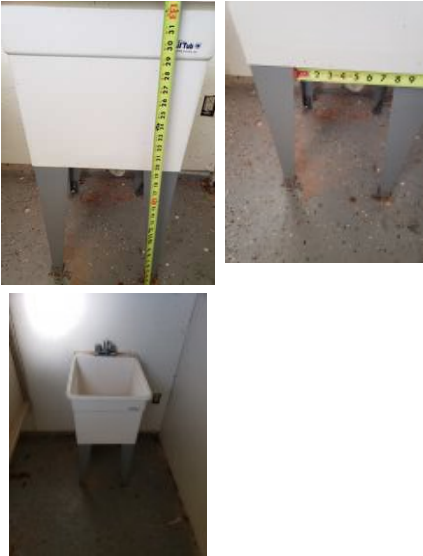
Finding Number	Area Description	Lat/Long	Finding	As Built	Recommendation	Citation	Photos	Figure
260	Old West Stables: Old West Stables Restrooms	[34.9716377 , -101.6785 816]	Knee clearance at 27 inches off the floor is not 8 inches minimum deep. The knee clearance, measured from the bottom of the apron or the outside bottom edge of the lavatory, must be 27 inches at a point located 8 inches back from the front edge and continuing to 11 inches minimum in depth at 9 inches above the floor. The top of the lavatory rim may be no higher than 34 inches.	Unisex Restroom - sink does not provide knee or toe clearance	Replace sink with one providing 27" knee clearance that is a min 8" deep	2015 ABAAS Section: 306.3.1, 306.3.2, 306.3.3, 306.3.4 , 306.3.5 2012 TAS Section: 306.3.2, 306.3.3, 306.3.4, 306.3.5, 306.3.1 2010 ADAS Section: 306.3.3, 306.3.2, 306.3.4, 306.3.5, 306.3.1

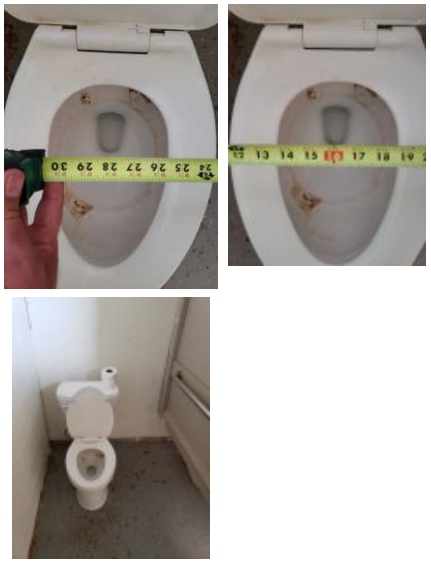
266	Old West Stables: Old West Stables Restrooms	[34.9716311 , -101.67859 5]	The toilet is not located within the range to the side wall or partition. The centerline of the toilet shall be 17 inches minimum and 19 inches maximum side wall or partition in the ambulatory accessible toilet compartment.	Unisex Restroom - center line of toilet to side walls - 16" left, 28" right	Remount toilet to 17" to 19" from the side wall to center line in ambulatory stalls, in the alternative, use existing ambulatory stall to create required wheelchair stall.	2015 ABAAS Section: 604.9.1 2012 TAS Section: 604.9.1 2010 ADAS Section: 604.9.1

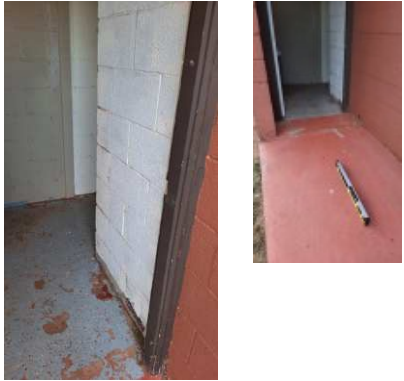
Finding Number	Area Description	Lat/Long	Finding	As Built	Recommendation	Citation	Photos	Figure
270	Old West Stables: Old West Stables Restrooms	[34.9716311 , -101.67859 5]	Minimum maneuvering clearances at doors and gates shall comply with 404.2.4. Maneuvering clearances shall extend the full width of the doorway and the required latch side or hinge side clearance.	Restroom door - wall on pull side, sloped ramp on push side landing	For all doors along the public circulation route, provide required maneuvering clearance on push and pull side of doors Correct or repair slope at doorway landing to max 2.08% in any direction for level	2010 ADAS Section: 404.2.3, 404.2.7, 404.2.4, 404.2.11, 404.2.11 Exception

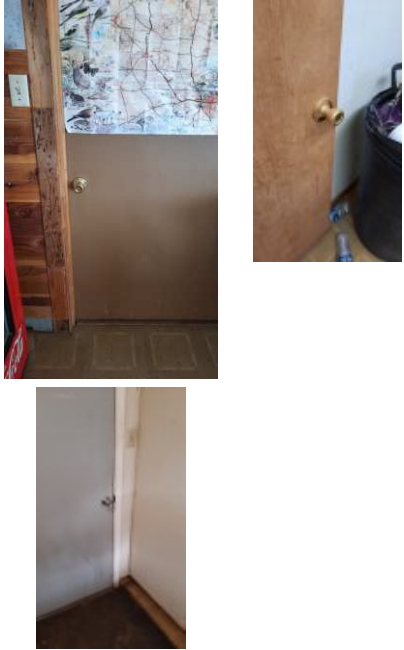
271	Old West Stables: Old West Stables Employee Spaces	[34.97193, -101.6783]	Spaces and elements within employee work areas shall only be required to comply with 206.2.8, 207.1, and 215.3 and shall be designed and constructed so that individuals with disabilities can approach, enter, and exit the employee work area. Employee work areas, or portions of employee work areas, other than raised courtroom stations, that are less than 300 square feet (28 m2) and elevated 7 inches (180 mm) or more above the finish floor or ground where the elevation is essential to the function of the space shall not be required to comply with these requirements or to be on an accessible route.	old kitchen - knob hardware, back room - knob hardware, exit - knob hardware and wall on pull side maneuvering clearance	For employee spaces, relocate storage, furniture, and other obstacles at doorways to provide approach, enter and exit at the employee space. Replace knob hardware with lever hardware.	2015 ABAAS Section: F203.9 2012 TAS Section: 203.9 2010 ADAS Section: 203.9

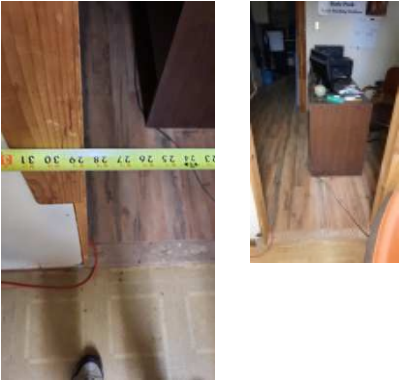
Finding Number	Area Description	Lat/Long	Finding	As Built	Recommendation	Citation	Photos	Figure
272	Old West Stables: Old West Stables Employee Spaces	[34.97193, -101.6783]	Employee Work Areas. Common use circulation paths within employee work areas shall comply with 402. EXCEPTIONS: 1. Common use circulation paths located within employee work areas that are less than 1000 square feet (93 m2) and defined by permanently installed partitions, counters, casework, or furnishings shall not be required to comply with 402. 2. Common use circulation paths located within employee work areas that are an integral component of work area equipment shall not be required to comply with 402. 3. Common use circulation paths located within exterior employee work areas that are fully exposed to the weather shall not be required to comply with 402.	circulation path reduces to 29" to back office and 31" to kitchen	Make corrections for compliant circulation path. Widen passageways to min 32" clear width	2015 ABAAS Section: F206.2.8, F206.2.8.1, F206.2.8.2 2012 TAS Section: 206.2.8, 206.2.8 Exception 1, 206.2.8 Exception 2, 206.2.8 Exception 3, 206.2.8 Advisory 1, 206.2.8 Advisory 2 2010 ADAS Section: 206.2.8, 206.2.8 Exception 1, 206.2.8 Exception 2, 206.2.8 Exception 3

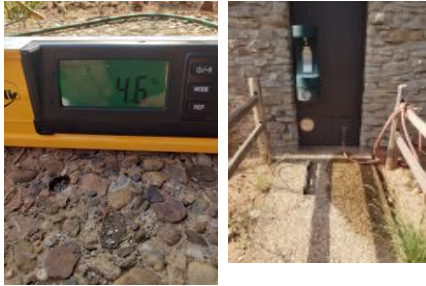
Finding Number	Area Description	Lat/Long	Finding	As Built	Recommendation	Citation	Photos	Figure
278	Hackberry Camp Area: Hackberry Camp Area - E. Restroom Parking/Exterior Route	[34.9676924 , -101.6716 106]	The 30 inches minimum by 48 inches minimum clear floor space required at the operable part is not flat (2% or 1:48 maximum slope) in all directions. Changes in level are not permitted at required clear floor or ground space except that slopes not steeper than 1:48 shall be permitted.	water filler - 4.7% slope in clear floor slope	Correct or repair slope in CFS to max 2.08%	2015 ABAAS Section: 305.2 2012 TAS Section: 305.2 2010 ADAS Section: 305.2

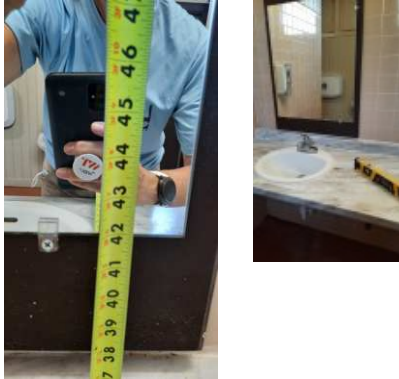
280	Hackberry Camp Area: Hackberry Camp Area Restrooms East	[34.9676308 , -101.6716 052]	The mirror is mounted too high. Mirrors must have the bottom edge of the reflecting surface a maximum of 40 inches above the floor if above a sink or counter. Mirrors not located above lavatories or countertops shall be installed with the bottom edge of the reflecting surface 35 inches maximum above the finish floor or ground.	Women's restroom -reflective surface mounted 42" above finished floor	Lower mirror so reflective surface is max 40" aff.	2015 ABAAS Section: 603.3 2012 TAS Section: 603.3 2010 ADAS Section: 603.3

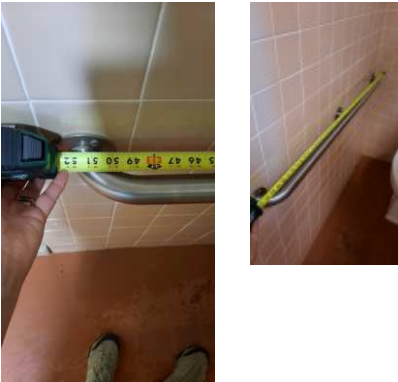
286	Hackberry Camp Area: Hackberry Camp Area Restrooms East	[34.9676748, -101.6716267]	The side grab bars are not in the correct location. Grab bars on the side wall must be installed so that the end closest to the rear wall is maximum 12" from the rear wall. The end furthest from the rear wall must be mounted minimum 54" from the rear wall.	Women's restroom - side grab bar extends to 51.5" from rear wall	Remount side grab bar to max 12" from the rear wall at the close end and min 54" on the far end, and 33" to 36" aff, in the alternative, use existing ambulatory stall to create required wheelchair stall.	2015 ABAAS Section: 604.5.1 2012 TAS Section: 604.5.1 2010 ADAS Section: 604.5.1

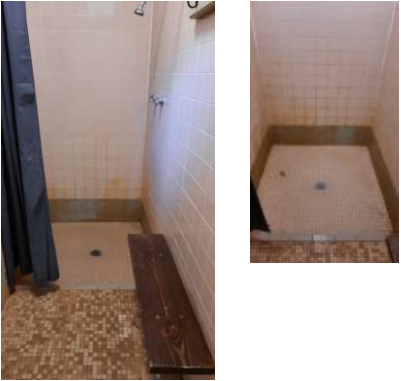
Finding Number	Area Description	Lat/Long	Finding	As Built	Recommendation	Citation	Photos	Figure
290	Hackberry Camp Area: Hackberry Camp Area Restrooms East	[34.967666, -101.6716374]	There are no accessible bathing or shower facilities. Where facilities for bathing are provided for the public, clients or employees, including showers or bathtubs, at least one shower or bathtub and support facilities such as lockers, and not less than 1 percent of all facilities, shall be accessible.	Women's restroom east - lacks accessible shower	Create an accessible shower in locker/bathing room.	2015 ABAAS Section: F213.3.6 2012 TAS Section: 213.3.6 2010 ADAS Section: 213.3.6

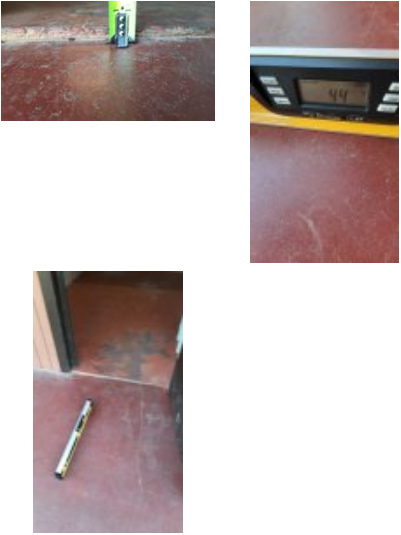
291	Hackberry Camp Area: Hackberry Camp Area Restrooms East	[34.967644, -101.6716052]	Minimum maneuvering clearances at doors and gates shall comply with 404.2.4. Maneuvering clearances shall extend the full width of the doorway and the required latch side or hinge side clearance. The threshold has a vertical change greater than 1/4 inch high. The sweep period for doors with closers shall be adjusted so that from an open position of 70 degrees, the door will take at least 3 seconds to move to a point 3 inches from the latch, measured to the leading edge of the door. Exterior doors are recommended to be maintained at 8.5 lbf as a smart practice. Force is to be measured at the operating hardware or 30 inches from the hinges, whichever is greater.	Women's restroom - 13 lb of force to open, fast closing, .5" change in elevation, 4.4% slope on pull side landing	For all doors along the public circulation route, repair, bevel, or ramp CILs at door entries to max .25" For all doors along the public circulation route, inspect, adjust, and maintain closing speed on door closers For all doors along the public circulation route, inspect, adjust, and maintain 8.5 lbf to open exterior doors as a smart practice Correct or repair slope at doorway landing to max 2.08% in any direction for level	2010 ADAS Section: 404.2.3, 404.2.7, 404.2.4, 404.2.11, 404.2.11 Exception

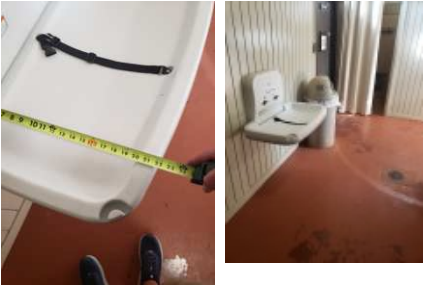
Finding Number	Area Description	Lat/Long	Finding	As Built	Recommendation	Citation	Photos	Figure
293	Hackberry Camp Area: Hackberry Camp Area Restrooms East	[34.9676572, -101.6715837]	The baby changing table is not compliant. Baby changing tables are work surfaces. If fixed or built-in baby changing tables are provided, at least 5%, but not less than one, must comply with TAS 902 based TAS 226.1. Baby changing tables cannot violate the protruding object requirements in either an open or closed position since either position is a potential hazard for persons with visual impairments. Baby changing tables are not prohibited from being located in wheelchair accessible toilet compartments; however, the minimum space required for the compartment cannot be obstructed by the baby changing table in either an open or closed position. The clear floor space required for a baby changing table may overlap the water closet clearance since baby changing tables are considered convenience “fixtures” based on Advisory 604.8.1.1. The overlap is applicable only to the clear floor space and not to actual table itself. Baby changing tables must be dispersed throughout a space, however, an additional baby changing table is not required in a common use area of a toilet or bathing room when the only baby changing table is located in a toilet compartment.	Men's Restroom - changing station extends 22 " when open in circulation path	Relocate baby changing table to eliminate protrusion when in the open position.	2012 TAS Section: 226.1, 902.3, 604.3.2, 204.1, 226.1 Advisory, 226.2, 307.1, 604.8.1.1 Advisory, 902.1, 902.1 Advisory, 902.2

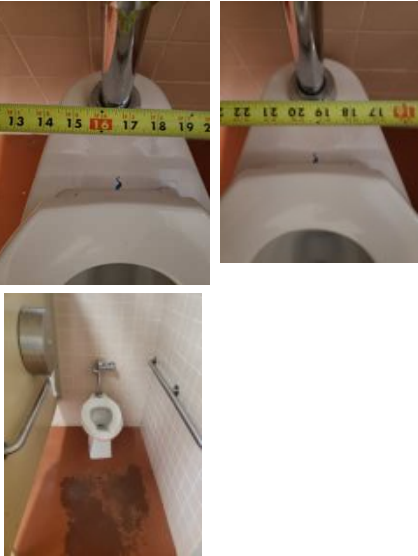
Finding Number	Area Description	Lat/Long	Finding	As Built	Recommendation	Citation	Photos	Figure
295	Hackberry Camp Area: Hackberry Camp Area Restrooms East	[34.9676572, -101.6716052]	The toilet is not located within the range to the side wall or partition. The centerline of the toilet shall be 17 inches minimum and 19 inches maximum side wall or partition in the ambulatory accessible toilet compartment.	Men's Restroom - ambulatory stall toilet center line - 19.5" one side 16.5" the other	Remount toilet to 17" to 19" from the side wall to center line in ambulatory stalls, in the alternative, use existing ambulatory stall to create required wheelchair stall.	2015 ABAAS Section: 604.9.1 2012 TAS Section: 604.9.1 2010 ADAS Section: 604.9.1

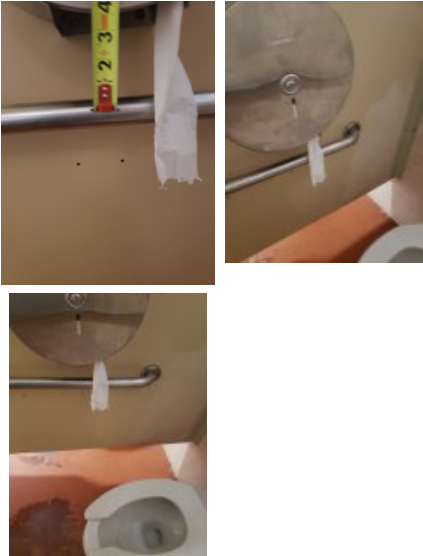
Finding Number	Area Description	Lat/Long	Finding	As Built	Recommendation	Citation	Photos	Figure
297	Hackberry Camp Area: Hackberry Camp Area Restrooms East	[34.9676616 , -101.6715 677]	The grab bar height and/or spacing fails. Grab bars must be mounted between 33" and 36" to the top of the gripping surface. There must be 1.5" of clearance between the grab bar and the wall. There must be a minimum of 1.5" of clearance below and minimum 12" above the grab bar to any dispenser or other obstruction.	Men's Restroom - toilet paper dispenser too close above grab bar and too close to front of toilet	Remount toilet paper dispenser max 7" to 9" from front of toilet, 15" to 48" aff and min 12" above or 1.5" below grab bar	2015 ABAAS Section: 609.3, 609.4 2012 TAS Section: 609.4, 609.3 2010 ADAS Section: 609.3, 609.4

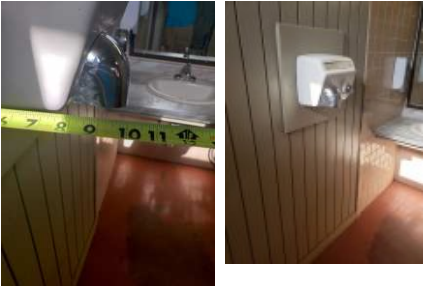
298	Hackberry Camp Area: Hackberry Camp Area Restrooms East	[34.967666, -101.67162 67]	The hand dryer projects more than 4 inches into the circulation path. Wall-mounted objects that have leading edges between 27 inches and 80 inches from the floor must not project more than 4 inches into the circulation path. Protruding objects that extend to the floor or within 27 inches of the floor are cane detectable and are therefore not hazardous. Where it is necessary or desirable to have objects protrude from the wall, a manner of cane detection must be provided.	Men's Restroom - hand dryer protrudes 10" from wall	Relocate protruding objects or place cane detectable warning or bollard at foot of item.	2015 ABAAS Section: 307.2 2012 TAS Section: 307.2 2010 ADAS Section: 307.2

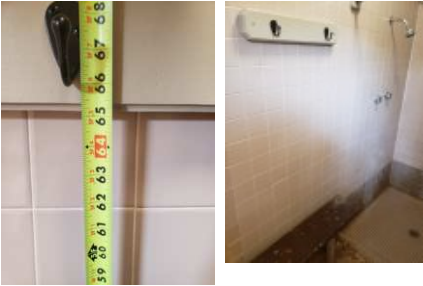
Finding Number	Area Description	Lat/Long	Finding	As Built	Recommendation	Citation	Photos	Figure
299	Hackberry Camp Area: Hackberry Camp Area Restrooms East	[34.967666, -101.6716374]	Coat hooks provided within the room shall be located within one of the reach ranges specified in 308. Shelves shall be 40 inches (1015 mm) minimum and 48 inches (1220 mm) maximum above the finish floor or ground. Where coat hooks or shelves are provided in dressing, fitting or locker rooms without individual compartments, at least one of each type shall comply with 803.5. Where coat hooks or shelves are provided in individual compartments at least one of each type complying with 803.5 shall be provided in individual compartments in dressing, fitting, or locker rooms required to comply with 222.1.	Men's Restroom - hooks mounted at 66" above finished floor	Remount at least one hook to max 48" aff and shelves to 40" - 48" aff.	2015 ABAAS Section: 308.2.1, 308.1, F222.2, 803.5 2012 TAS Section: 308.2.1, 308.1, 222.2, 803.5 2010 ADAS Section: 308.2.1, 308.1, 222.2, 803.5

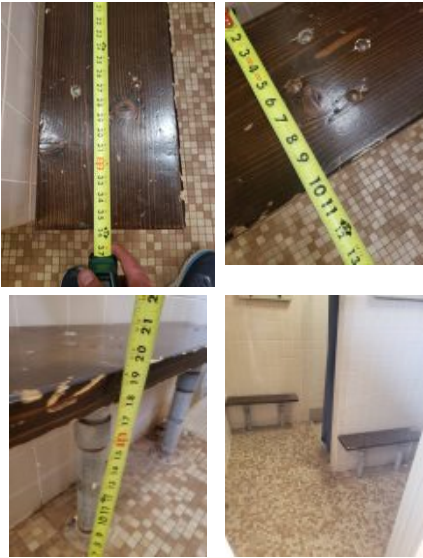
300	Hackberry Camp Area: Hackberry Camp Area Restrooms East	[34.9676396, -101.6716481]	The bench is not deep enough or long enough or is missing. Benches shall be provided having seats that are 42 inches long minimum and 20 inches deep minimum and 24 inches deep maximum. The bench shall provide for back support or shall be affixed to a wall. Back support shall be 42 inches (1065 mm) long minimum and shall extend from a point 2 inches (51 mm) maximum above the seat surface to a point 18 inches (455 mm) minimum above the seat surface. Back support shall be 2½ inches (64 mm) maximum from the rear edge of the seat measured horizontally. The top of the bench seat surface shall be 17 inches (430 mm) minimum and 19 inches (485 mm) maximum above the finish floor or ground.	Men's Restroom - 2 of 2 benches are not compliant	Replace bench in dressing area with one having a seat depth of 20" to 24" deep, 42" long, affixed to the wall or having a back and mounted 17" to 19" aff	2012 TAS Section: 903.4, 903.2, 903.3, 903.5 2010 ADAS Section: 903.4, 903.2, 903.3, 903.5

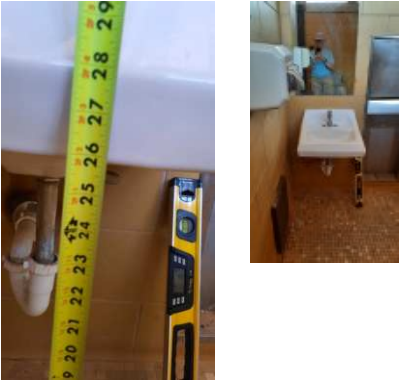
Finding Number	Area Description	Lat/Long	Finding	As Built	Recommendation	Citation	Photos	Figure
308	Hackberry Camp Area: Hackberry Camp Area Restrooms West	[34.9662592 , -101.6716 213]	Knee clearance at 27 inches off the floor is not 8 inches minimum deep. The knee clearance, measured from the bottom of the apron or the outside bottom edge of the lavatory, must be 27 inches at a point located 8 inches back from the front edge and continuing to 11 inches minimum in depth at 9 inches above the floor. The top of the lavatory rim may be no higher than 34 inches.	Women's restroom - 26" knee clearance, hand dryer in clear floor space	Raise sink to provide 27" knee clearance that is 8" deep. Relocate hand dryer to be out of sink clear floor space and in an area where it doesn't protrude into the circulation path.	2015 ABAAS Section: 306.3.1, 306.3.2, 306.3.3, 306.3.4 , 306.3.5 2012 TAS Section: 306.3.2, 306.3.3, 306.3.4, 306.3.5, 306.3.1 2010 ADAS Section: 306.3.3, 306.3.2, 306.3.4, 306.3.5, 306.3.1

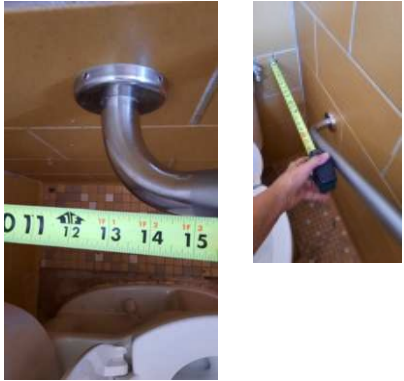
Finding Number	Area Description	Lat/Long	Finding	As Built	Recommendation	Citation	Photos	Figure
313	Hackberry Camp Area: Hackberry Camp Area Restrooms West	[34.9662461, -101.6715945]	The side grab bars are not in the correct location. Grab bars on the side wall must be installed so that the end closest to the rear wall is maximum 12" from the rear wall. The end furthest from the rear wall must be mounted minimum 54" from the rear wall.	Women's restroom - side grab bar mounted 13" from rear wall	Remount side grab bar to max 12" from the rear wall at the close end and min 54" on the far end, and 33" to 36" aff, in the alternative, use existing ambulatory stall to create required wheelchair stall.	2015 ABAAS Section: 604.5.1 2012 TAS Section: 604.5.1 2010 ADAS Section: 604.5.1

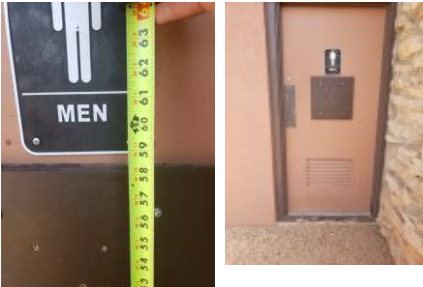
319	Hackberry Camp Area: Hackberry Camp Area Restrooms West	[34.9662856 , -101.6715 837]	The restroom sign does not comply with one or more applicable requirements for the location, height, and properties of the sign.	Men's Restroom - sign mounted 60" above ground on door, lacks symbol of access	Acquire and mount signage, including Braille, raised lettering and access symbol mounted on wall, latch side of door, 48" to baseline of lowest character and 60" to baseline of highest character	2015 ABAAS Section: F216.2, 703.1, 703.2, 703.5, 703.6 2012 TAS Section: 216.2, 703.1, 703.2, 703.5, 703.6 2010 ADAS Section: 216.2, 703.1, 703.2, 703.5, 703.6

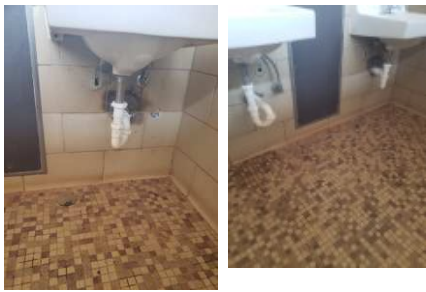
322	Hackberry Camp Area: Hackberry Camp Area Restrooms West	[34.9662417, -101.6715945]	The water and drain pipes under the lavatory are not adequately insulated. Water supply and drain pipes under lavatories and sinks shall be insulated or otherwise configured to protect against contact. There shall be no sharp or abrasive surfaces under lavatories and sinks.	Men's Restroom - 2 of 2 sinks lack insulated drain pipes	Insulate exposed pipes under one sink.	2015 ABAAS Section: 606.5 2012 TAS Section: 606.5 2010 ADAS Section: 606.5
