Access Audit Site Report

Palo Duro Canyon State Park
11450 State Hwy Park Rd 5
Canyon, TX 79015
Accessibility Evaluation
Inspection Date: 08/10/2021
Inspectors: Tanya Scheibe

Prepared By
WT Group

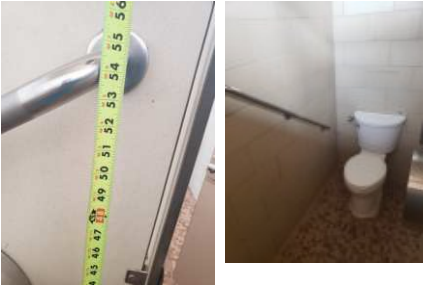
Finding Number	Area Description	Lat/Long	Finding	As Built	Recommendation	Citation	Photos	Figure
325	Hackberry Camp Area: Hackberry Camp Area Restrooms West	[34.9662505 , -101.6715 998]	The grab bar height and/or spacing fails. Grab bars must be mounted between 33" and 36" to the top of the gripping surface. There must be 1.5" of clearance between the grab bar and the wall. There must be a minimum of 1.5" of clearance below and minimum 12" above the grab bar to any dispenser or other obstruction.	Men's Restroom - side grab bar is installed diagonally	Remount grab bars in accessible stall to 33" to 36" aff, in the alternative, use stall to create required wheelchair stall.	2015 ABAAS Section: 609.3, 609.4 2012 TAS Section: 609.4, 609.3 2010 ADAS Section: 609.3, 609.4

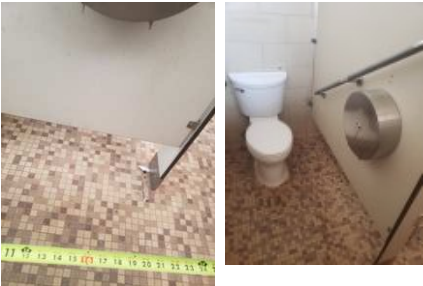
326	Hackberry Camp Area: Hackberry Camp Area Restrooms West	[34.9662856 , -101.6715 837]	The toilet paper is not installed within the compliant range in front of the toilet. Toilet paper dispensers shall be 7 inches minimum and 9 inches maximum in front of the water closet measured to the centerline of the dispenser. The outlet of the dispenser shall be 15 inches minimum and 48 inches maximum above the finish floor and shall not be located behind grab bars. Dispensers shall not be of a type that controls delivery or that does not allow continuous paper flow. There shall be a clearance of 1 1/2 inches minimum below the grab bar.	Men's Restroom - toilet paper dispenser too far from toilet	Remount toilet paper dispenser max 7" to 9" from front of toilet, 15" to 48" aff and min 12" above or 1.5" below grab bar.	2015 ABAAS Section: 604.7 2012 TAS Section: 604.7 2010 ADAS Section: 604.7

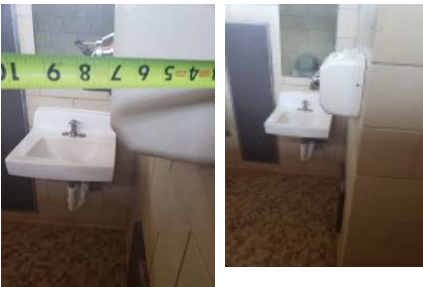
327	Hackberry Camp Area: Hackberry Camp Area Restrooms West	[34.9662395 , -101.6716 052]	The hand dryer projects more than 4 inches into the circulation path. Wall-mounted objects that have leading edges between 27 inches and 80 inches from the floor must not project more than 4 inches into the circulation path. Protruding objects that extend to the floor or within 27 inches of the floor are cane detectable and are therefore not hazardous. Where it is necessary or desirable to have objects protrude from the wall, a manner of cane detection must be provided.	Men's Restroom - hand dryer protrudes 8" from wall	Relocate protruding objects or place cane detectable warning or bollard at foot of item.	2015 ABAAS Section: 307.2 2012 TAS Section: 307.2 2010 ADAS Section: 307.2

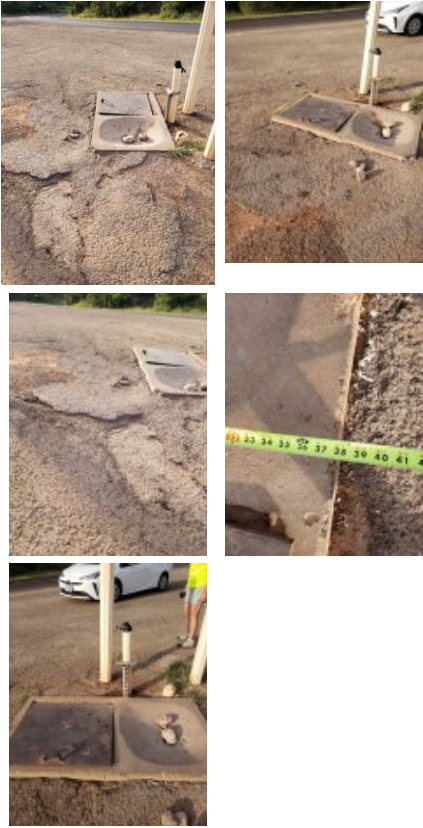
Finding Number	Area Description	Lat/Long	Finding	As Built	Recommendation	Citation	Photos	Figure
328	Hackberry Camp Area: Hackberry Camp Area Dump Station	[34.9662241, -101.6725681]	The surface of the clear ground space shall be firm and stable The slope of the clear ground space surface shall not be steeper than 1:48 in any direction. EXCEPTION: Where the surface is other than asphalt, concrete, or boards, slopes not steeper than 1:20 shall be permitted when necessary for drainage	surface around the dump station is uneven and worn out, water spout is out of reach range	Correct surface at dump station to be firm, stable and having max slope of 2.08% as a smart practice. Remount water spout to between 28" and 36" above ground level.	2015 ABAAS Section: 1011.2.2, 1011.2.3, 1011.2 EXCEPTION

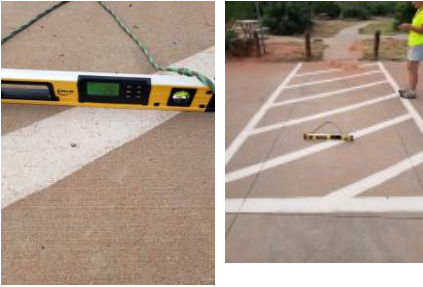
Finding Number	Area Description	Lat/Long	Finding	As Built	Recommendation	Citation	Photos	Figure
329	Soapberry Day Use Area: Soapberry Day Use Parking	[34.9618499, -101.6717527]	The cross slopes (narrow dimension) and/or running slopes (long dimension) of the access aisle exceeds 2%. The running slope and the cross slope in an accessible parking stall and the access aisle must not exceed 2%.	access aisle 2.6% slope	Repair or correct slope of parking space and access aisle to max 2.08% in any direction	2015 ABAAS Section: 502.4 2012 TAS Section: 502.4 2010 ADAS Section: 502.4

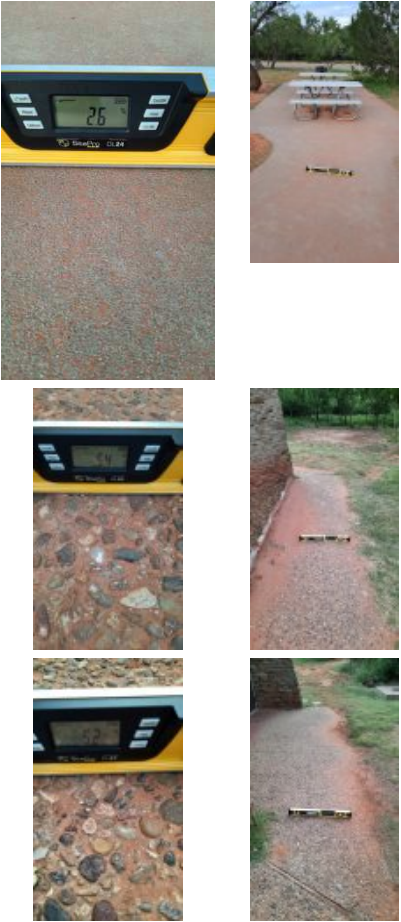
Finding Number	Area Description	Lat/Long	Finding	As Built	Recommendation	Citation	Photos	Figure
331	Soapberry Day Use Area: Soapberry Day Use EAR	[34.9616542, -101.6715972]	The accessible route of travel on the accessible route contains cross slopes greater than 2%. Cross slopes shall not exceed one unit vertical in 48 units horizontal (2-percent slope).	cross slopes on accessible route - 2.6% to double picnic table, 5.4%, 5.2% to women's restroom	Correct or repair cross slope along AR to max 2.08%	2015 ABAAS Section: 403.3 2012 TAS Section: 403.3 2010 ADAS Section: 403.3

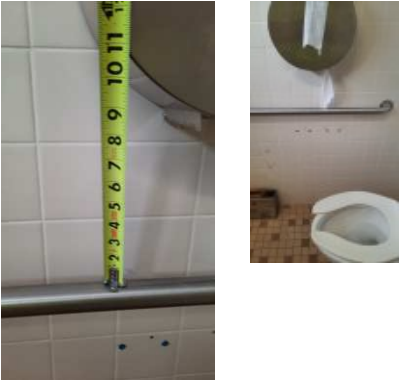
Finding Number	Area Description	Lat/Long	Finding	As Built	Recommendation	Citation	Photos	Figure
348	Soapberry Day Use Area: Soapberry Day Use Restrooms	[34.9613619 , -101.6714 765]	The grab bar height and/or spacing fails. Grab bars must be mounted between 33" and 36" to the top of the gripping surface. There must be 1.5" of clearance between the grab bar and the wall. There must be a minimum of 1.5" of clearance below and minimum 12" above the grab bar to any dispenser or other obstruction.	Women's restroom - toilet paper dispenser too close above grab bar	Remount toilet paper dispenser max 7" to 9" from front of toilet, 15" to 48" aff and min 12" above or 1.5" below grab bar	2015 ABAAS Section: 609.3, 609.4 2012 TAS Section: 609.4, 609.3 2010 ADAS Section: 609.3, 609.4

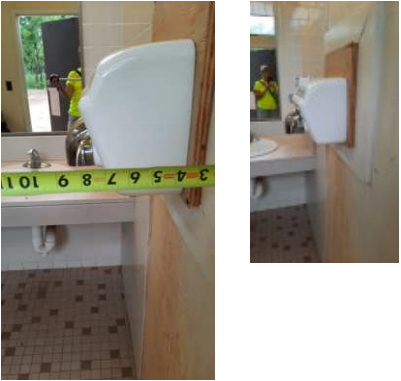
Finding Number	Area Description	Lat/Long	Finding	As Built	Recommendation	Citation	Photos	Figure
350	Soapberry Day Use Area: Soapberry Day Use Restrooms	[34.9613794 , -101.6714 979]	The hand dryer projects more than 4 inches into the circulation path. Wall-mounted objects that have leading edges between 27 inches and 80 inches from the floor must not project more than 4 inches into the circulation path. Protruding objects that extend to the floor or within 27 inches of the floor are cane detectable and are therefore not hazardous. Where it is necessary or desirable to have objects protrude from the wall, a manner of cane detection must be provided.	Women's restroom - hand dryer protrudes 8.5"	Relocate protruding objects or place cane detectable warning or bollard at foot of item.	2015 ABAAS Section: 307.2 2012 TAS Section: 307.2 2010 ADAS Section: 307.2

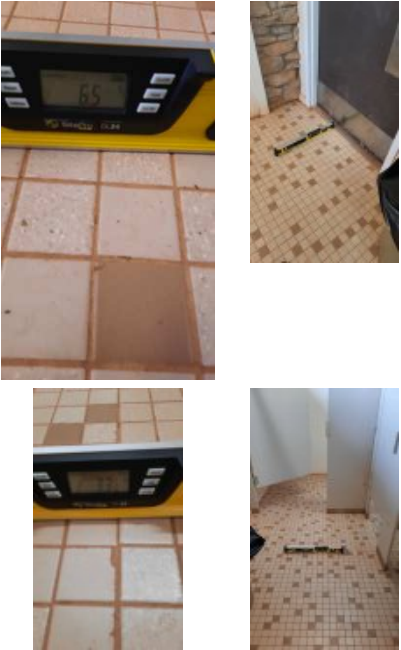
351	Soapberry Day Use Area: Soapberry Day Use Restrooms	[34.9613663 , -101.6714 872]	The accessible route contains running slopes greater than 5 percent and cross slopes greater than 2 percent across the width of the walk and has not been constructed as a ramp (i.e. handrails, wheel guides, etc.). When the slope in the direction of travel of any walk exceeds 1 unit vertical in 20 units horizontal (5-percent slope), it must be constructed as ramp. Surface cross slopes must not exceed one unit vertical in 48 units. Horizontal (2-percent slope).	Women's restroom - 6.5% slope at door, 3.3% slope at drain	Correct or repair slope to max 2.08%.	2015 ABAAS Section: 403.3 2012 TAS Section: 403.3 2010 ADAS Section: 403.3

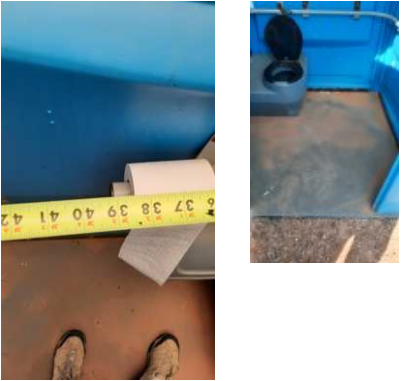
Finding Number	Area Description	Lat/Long	Finding	As Built	Recommendation	Citation	Photos	Figure
352	Fortress Cliff Camp Area: Fortress Cliff Camp Area Public Spaces	[34.9438372, -101.6604405]	The portable public restroom is not compliant. 5% of portable toilets must be accessible, minimum of 1. If sanitary facilities are provided, they must be made accessible to persons with disabilities. If public restrooms are desired, It is recommended that the portable unit be replaced with a permanent built in compliant restroom. The utilization of an accessible portable unit may be a temporary solution and is not recommended as a permanent solution.	portable restroom - 60" wide, 58" deep, grab bars fail	Replace 5% of portable toilets with compliant models and place along AR.	2015 ABAAS Section: F213.1 2012 TAS Section: 213.1 2010 ADAS Section: 213.1, 213.2 Exception 3

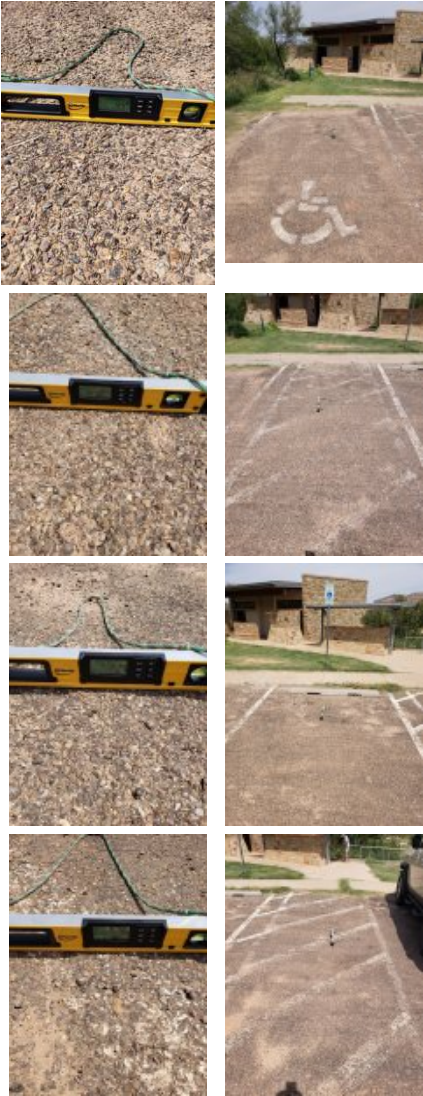
Finding Number	Area Description	Lat/Long	Finding	As Built	Recommendation	Citation	Photos	Figure
355	Juniper Camp Area: Juniper Camp Area Parking	[34.9363516, -101.6499517]	The cross slopes (narrow dimension) and/or running slopes (long dimension) of the access aisle exceeds 2%. The running slope and the cross slope in an accessible parking stall and the access aisle must not exceed 2%.	2 stalls and 2 access aisles exceed 2.08% slope	Repair or correct slope of parking space and access aisle to max 2.08% in any direction	2015 ABAAS Section: 502.4 2012 TAS Section: 502.4 2010 ADAS Section: 502.4

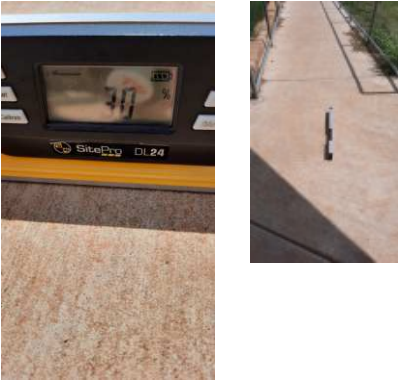
358	Juniper Camp Area: Juniper Camp Area EAR	[34.9364253 , -101.6499 799]	The landing at the bottom of the ramp has a slope greater than 2%. Bottom landings shall have a dimension in the direction of ramp run of not less than 60 inches and have a slope of less than 2% in any direction.	Ramp - top landing 3% slope	Correct ramp landing slope to max 2.08%.	2015 ABAAS Section: 405.7.1, 405.7.1 EXCEPTION 2012 TAS Section: 405.7.1, 405.7.1 Exception 2010 ADAS Section: 405.7.1, 405.7.1 Exception

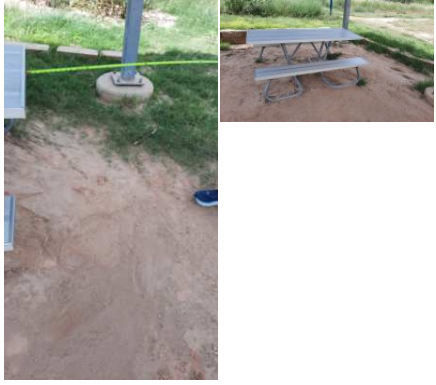
362	Juniper Camp Area: Juniper Camp Area Campsites	[34.9368749, -101.6499678]	36 inches (915 mm) on all usable sides of the table measured from the back edge of the benches	111 - 2 sides are sand and grass, 113 - dirt surface around	Provide required 36" clear ground space around all usable portions of the table as a smart practice	2015 ABAAS Section: 1011.2.1

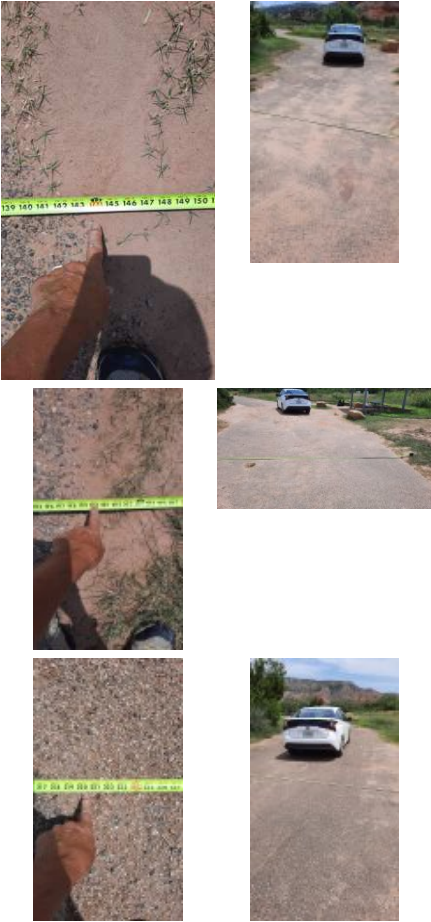
Finding Number	Area Description	Lat/Long	Finding	As Built	Recommendation	Citation	Photos	Figure
366	Juniper Camp Area: Juniper Camp Area Campsites	[34.9369013, -101.6501207]	Parking spaces and pull-up spaces for recreational vehicles shall be 20 feet (6100 mm) wide minimum. EXCEPTION: Where two adjacent parking spaces are provided for recreational vehicles, one parking space shall be permitted to be 16 feet (4880 mm) wide minimum.	parking space width - 111 - 12' at hook up, 113 - 16' 8", 115 - 18' 4"	Correct RV parking space to be 20' wide minimum as a smart practice.	2015 ABAAS Section: 1012.2, 1012.2 EXCEPTION

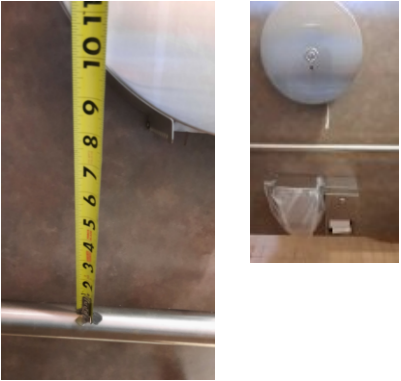
Finding Number	Area Description	Lat/Long	Finding	As Built	Recommendation	Citation	Photos	Figure
371	Juniper Camp Area: Juniper Camp Area Restrooms	[34.9364528 , -101.6500778]	The grab bar height and/or spacing fails. Grab bars must be mounted between 33" and 36" to the top of the gripping surface. There must be 1.5" of clearance between the grab bar and the wall. There must be a minimum of 1.5" of clearance below and minimum 12" above the grab bar to any dispenser or other obstruction.	Women's Restroom - toilet paper dispenser too close above grab bar	Remount toilet paper dispenser max 7" to 9" from front of toilet, 15" to 48" aff and min 12" above or 1.5" below grab bar	2015 ABAAS Section: 609.3, 609.4 2012 TAS Section: 609.4, 609.3 2010 ADAS Section: 609.3, 609.4

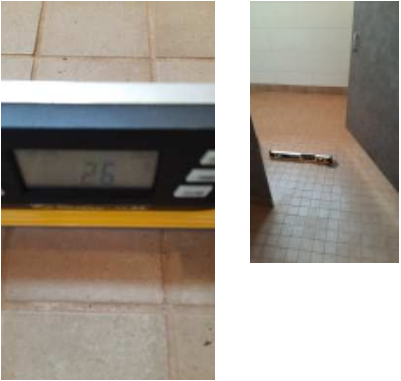
Finding Number	Area Description	Lat/Long	Finding	As Built	Recommendation	Citation	Photos	Figure
375	Juniper Camp Area: Juniper Camp Area Restrooms	[34.9364835 , -101.6501 153]	The accessible route contains running slopes greater than 5 percent and cross slopes greater than 2 percent across the width of the walk and has not been constructed as a ramp (i.e. handrails, wheel guides, etc.). When the slope in the direction of travel of any walk exceeds 1 unit vertical in 20 units horizontal (5-percent slope), it must be constructed as ramp. Surface cross slopes must not exceed one unit vertical in 48 units. Horizontal (2-percent slope).	Women's Restroom - 2.6% slope at drain in shower stall	Correct or repair slope to max 2.08%.	2015 ABAAS Section: 403.3 2012 TAS Section: 403.3 2010 ADAS Section: 403.3

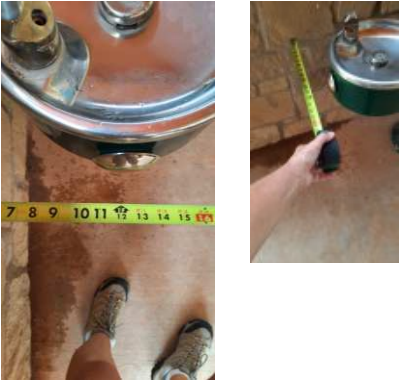
377	Juniper Camp Area: Juniper Camp Area Restrooms	[34.97193, -101.6783]	Element meets all standards and requirements	Women's Restroom - shower area and shower comply	None	2010 ADAS Section: N/A		
378	Juniper Camp Area: Juniper Camp Area Restrooms	[34.9369255 , -101.6501 636]	The clear floor space required at accessible drinking fountains is not centered on the low fountain. At "hi-low" type drinking fountains, the 30 inch by 48 inch clear floor space must be centered on the "low" fountain.	fountain at restroom - clear floor space not centered	Remount fountain to provide centered clear floor space.	2015 ABAAS Section: 602.2 2012 TAS Section: 602.2 2010 ADAS Section: 602.2

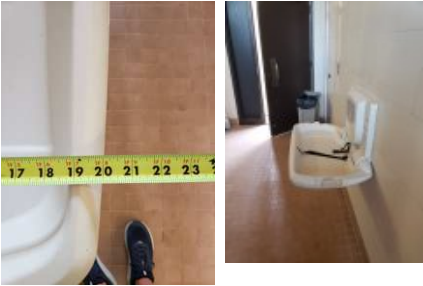
Finding Number	Area Description	Lat/Long	Finding	As Built	Recommendation	Citation	Photos	Figure
379	Juniper Camp Area: Juniper Camp Area Restrooms	[34.9364616, -101.65011]	The baby changing table is not compliant. Baby changing tables are work surfaces. If fixed or built-in baby changing tables are provided, at least 5%, but not less than one, must comply with TAS 902 based TAS 226.1. Baby changing tables cannot violate the protruding object requirements in either an open or closed position since either position is a potential hazard for persons with visual impairments. Baby changing tables are not prohibited from being located in wheelchair accessible toilet compartments; however, the minimum space required for the compartment cannot be obstructed by the baby changing table in either an open or closed position. The clear floor space required for a baby changing table may overlap the water closet clearance since baby changing tables are considered convenience “fixtures” based on Advisory 604.8.1.1. The overlap is applicable only to the clear floor space and not to actual table itself. Baby changing tables must be dispersed throughout a space, however, an additional baby changing table is not required in a common use area of a toilet or bathing room when the only baby changing table is located in a toilet compartment.	Men's Restroom - changing station protrudes 20" into circulation path when open	Relocate baby changing table to eliminate protrusion when in the open position.	2012 TAS Section: 226.1, 902.3, 604.3.2, 204.1, 226.1 Advisory, 226.2, 307.1, 604.8.1.1 Advisory, 902.1, 902.1 Advisory, 902.2

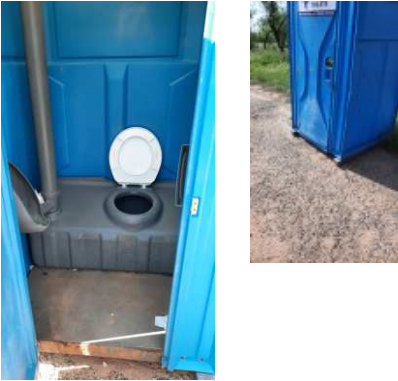
384	Cactus Camp Area: Cactus Camp Area Restrooms	[34.9386626 , -101.6409 261]	The portable public restroom is not compliant. 5% of portable toilets must be accessible, minimum of 1. If sanitary facilities are provided, they must be made accessible to persons with disabilities. If public restrooms are desired, It is recommended that the portable unit be replaced with a permanent built in compliant restroom. The utilization of an accessible portable unit may be a temporary solution and is not recommended as a permanent solution.	portable restroom is not accessible	Replace 5% of portable toilets with compliant models and place along AR	2015 ABAAS Section: F213.1 2012 TAS Section: 213.1 2010 ADAS Section: 213.1, 213.2 Exception 3

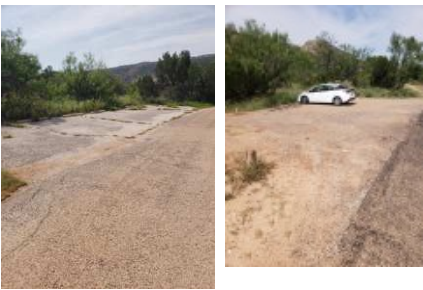
Finding Number	Area Description	Lat/Long	Finding	As Built	Recommendation	Citation	Photos	Figure
385	Cow Camp Cabins: Cow Camp Cabins Parking	[34.9361339 , -101.6387 481]	There are no accessible parking stalls. Each lot where parking is provided for the public as clients, guests or employees, shall provide accessible parking and shall be located on the shortest accessible route of travel from adjacent parking to an accessible entrance. There are a total of 7 parking stalls in the parking lot that could be reasonably associated with this facility. There should be a minimum of one accessible stalls with a minimum of one being designed as van accessible.	7 parking stalls, no accessible stalls	Create one or more 8' accessible van parking stalls, with one 8' adjacent access aisle, with proper signage and striping based on the total number of stalls.	2015 ABAAS Section: F208.2 2012 TAS Section: 208.2 2010 ADAS Section: 208.2

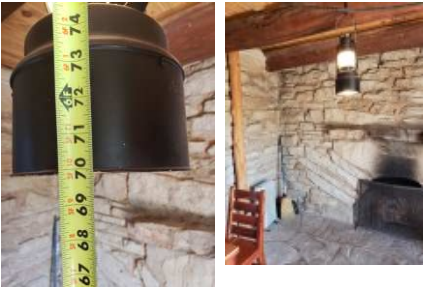
386	Cow Camp Cabins: Cow Camp Cabins: Cabin 2	[34.9358327 , -101.6381 473]	The lantern extends down too close to the route of travel. Any obstruction that overhangs a route of travel must be a minimum of 80 inches above the walking surface as measured from the bottom of the obstruction.	lantern hung with bottom 70" above the ground and reducing overhead clearance	Raise lantern to min 80", or pad object to prevent hazard in overhead clearance along AR	2015 ABAAS Section: 307.4 2012 TAS Section: 307.4 2010 ADAS Section: 307.4

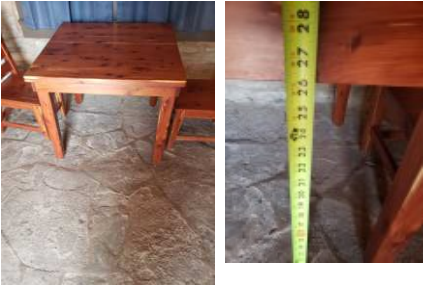
Finding Number	Area Description	Lat/Long	Finding	As Built	Recommendation	Citation	Photos	Figure
388	Cow Camp Cabins: Cow Camp Cabins: Cabin 2	[34.9358239, -101.6381098]	The top of the work surface is not within a compliant height range. The tops of tables and counters shall be 28 inches to 34 inches from the floor or ground.	no knee clearance on table	Provide tables and work surfaces at 28" to 34" aff with required knee and toe clearances	2015 ABAAS Section: 902.3 2012 TAS Section: 902.3 2010 ADAS Section: 902.3

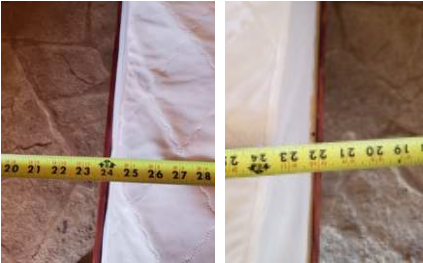
Finding Number	Area Description	Lat/Long	Finding	As Built	Recommendation	Citation	Photos	Figure
389	Cow Camp Cabins: Cow Camp Cabins: Cabin 2	[34.9358063 , -101.6381956]	State and local governments have an obligation to make their programs and services accessible to persons with disabilities. This may or may not require the alteration, addition or construction of existing facilities which predate The Americans with Disabilities Act (ADA) of 1990. Under the Code of Federal Regulations Section 35.151(b)(2) State and Local Government Title II entities may provide programmatic access where alterations to existing facilities would result in undue financial and administrative burdens. For Example, A public entity has six courtrooms in two existing buildings and determines that only three of those courtrooms and the public use and common use areas serving those courtrooms in one building are needed to be made accessible in order to satisfy its program access obligations. The entity must comply with 2010 Standards unless compliance would result in undue financial and administrative burdens and must take other actions that would not result in an undue financial burden to ensure access to persons with disabilities. This may include the scheduling of the various types of cases, hearings etc. in accessible courtrooms and relocating them where necessary to accommodate persons with disabilities. Having a defined program and effective communication process in place to ensure the public and employees can request accommodations is necessary to ensure equal access to the county's court system. Program access is not part of this evaluation and this information is being provided as an advisory only.	cabin 2 - no clear floor space on either side of the bed	Rearrange room to provide 36" clearance on either side of the bed.	2010 ADAS Section: Advisory

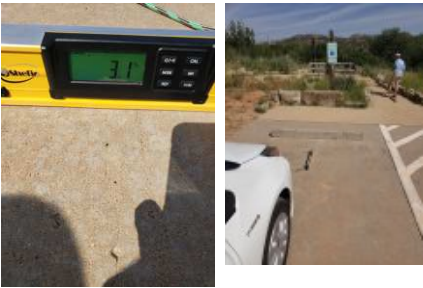
Finding Number	Area Description	Lat/Long	Finding	As Built	Recommendation	Citation	Photos	Figure
390	Cow Camp Cabins: Cow Camp Cabins: Cabin 2	[34.9357931 , -101.638083]	The cross slopes (narrow dimension) and/or running slopes (long dimension) of the access aisle exceeds 2%. The running slope and the cross slope in an accessible parking stall and the access aisle must not exceed 2%.	parking stall 3.1% slope	Repair or correct slope of parking space and access aisle to max 2.08% in any direction	2015 ABAAS Section: 502.4 2012 TAS Section: 502.4 2010 ADAS Section: 502.4

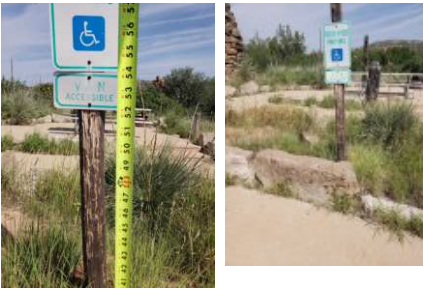
391	Cow Camp Cabins: Cow Camp Cabins: Cabin 2	[34.9358019 , -101.638083]	The parking sign is mounted too low. Parking space identification signs shall include the International Symbol of Accessibility complying with. Signs identifying van parking spaces shall contain the designation "van accessible." Signs shall be 60 inches minimum above the finish floor or ground surface measured to the bottom of the sign.	bottom of sign 52" above the ground	Raise existing accessible parking signs so lowest end of bottom sign is min 60" aff	2015 ABAAS Section: 502.6 2012 TAS Section: 502.6 2010 ADAS Section: 502.6

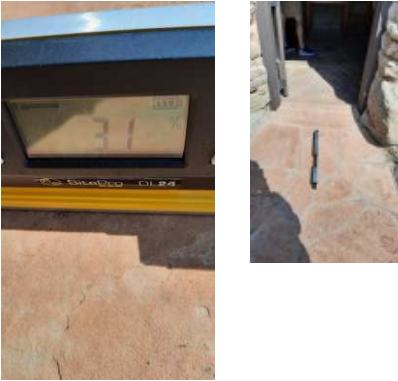
Finding Number	Area Description	Lat/Long	Finding	As Built	Recommendation	Citation	Photos	Figure
392	Cow Camp Cabins: Cow Camp Cabins: Cabin 2	[34.9358415, -101.6381527]	Floor or ground surface within required maneuvering clearances shall comply with 302. Changes in level are not permitted. EXCEPTIONS: 1. Slopes not steeper than 1:48 shall be permitted. 2. Changes in level at thresholds complying with 404.2.5 shall be permitted.	3.1% slope at entry door	Correct or repair slope at doorway landing to max 2.08% in any direction for level landing	2015 ABAAS Section: 404.2.4.4, 404.2.4.4 EX CEPTIONS: 1, 404.2.4.4 E XCEPTIONS: 2 2012 TAS Section: 404.2.4.4, 404.2.4.4 Exception 1, 404.2.4.4 Exception 2 2010 ADAS Section: 404.2.4.4, 404.2.4.4 Exception 1, 404.2.4.4 Exception 2

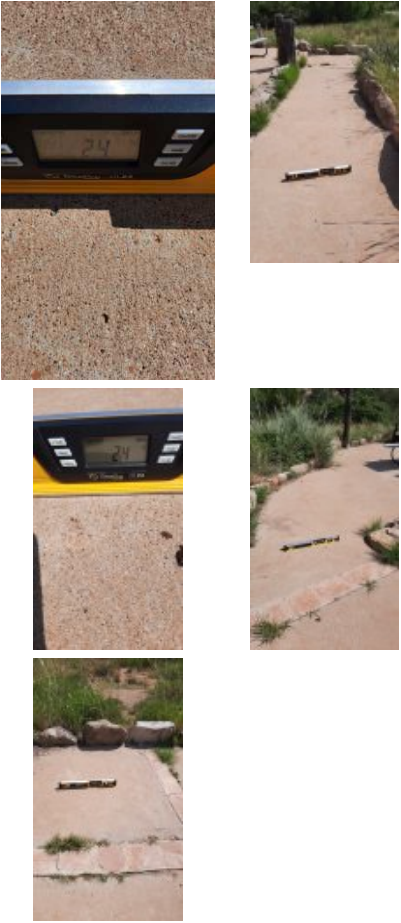
Finding Number	Area Description	Lat/Long	Finding	As Built	Recommendation	Citation	Photos	Figure
394	Cow Camp Cabins: Cow Camp Cabins: Cabin 2	[34.9358591, -101.6381849]	The accessible route of travel on the accessible route contains cross slopes greater than 2%. Cross slopes shall not exceed one unit vertical in 48 units horizontal (2-percent slope).	accessible route - 2.4% slope from parking to table, 3% slope at turn	Correct or repair cross slope along AR to max 2.08%.	2015 ABAAS Section: 403.3 2012 TAS Section: 403.3 2010 ADAS Section: 403.3

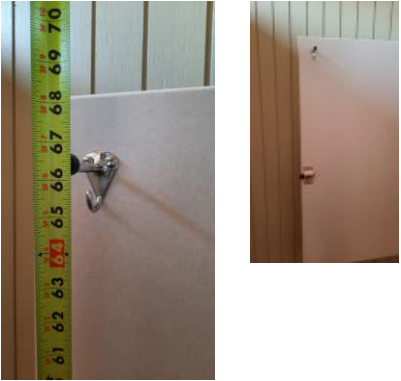
Finding Number	Area Description	Lat/Long	Finding	As Built	Recommendation	Citation	Photos	Figure
403	Mesquite Camp Area: Mesquite Camp Area Restrooms	[34.9358327, -101.6371227]	Where a high forward reach is over an obstruction, the clear floor space shall extend beneath the element for a distance not less than the required reach depth over the obstruction. The high forward reach shall be 48 inches (1220 mm) maximum where the reach depth is 20 inches (510 mm) maximum. Where the reach depth exceeds 20 inches (510 mm), the high forward reach shall be 44 inches (1120 mm) maximum and the reach depth shall be 25 inches (635 mm) maximum. Where a clear floor or ground space allows a parallel approach to an element and the high side reach is over an obstruction, the height of the obstruction shall be 34 inches (865 mm) maximum and the depth of the obstruction shall be 24 inches (610 mm) maximum. The high side reach shall be 48 inches (1220 mm) maximum for a reach depth of 10 inches (255 mm) maximum. Where the reach depth exceeds 10 inches (255 mm), the high side reach shall be 46 inches (1170 mm) maximum for a reach depth of 24 inches (610 mm) maximum.	Women's restroom - hook in stall 65.5" above ground	Lower hook to max 48" AFF.	2015 ABAAS Section: 308.2.1, 308.3.2 2012 TAS Section: 308.2.1, 308.3.2 2010 ADAS Section: 308.2.1, 308.3.2

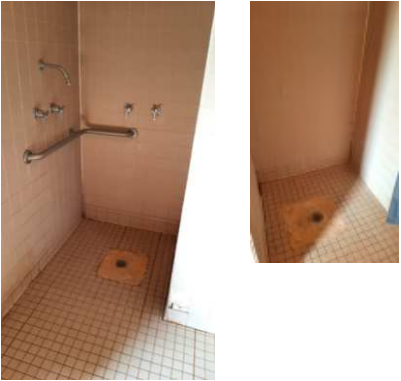
Finding Number	Area Description	Lat/Long	Finding	As Built	Recommendation	Citation	Photos	Figure
411	Mesquite Camp Area: Mesquite Camp Area Restrooms	[34.9358195 , -101.6371 388]	There are no accessible bathing or shower facilities. Where facilities for bathing are provided for the public, clients or employees, including showers or bathtubs, at least one shower or bathtub and support facilities such as lockers, and not less than 1 percent of all facilities, shall be accessible.	Women's restroom - lacks accessible shower, one was attempted, no seat	Create an accessible shower in locker/bathing room.	2015 ABAAS Section: F213.3.6 2012 TAS Section: 213.3.6 2010 ADAS Section: 213.3.6

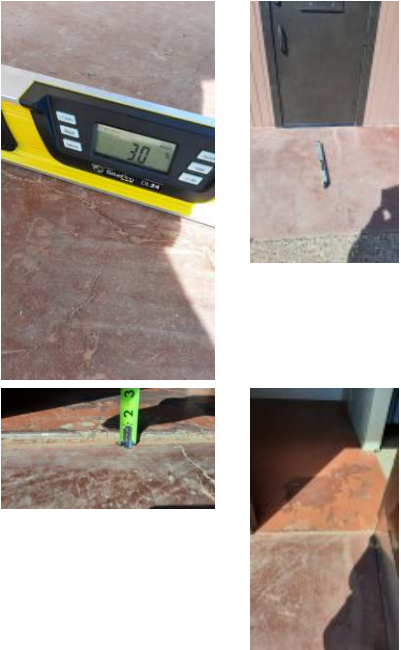
412	Mesquite Camp Area: Mesquite Camp Area Restrooms	[34.9358503 , -101.6371 656]	Floor or ground surface within required maneuvering clearances shall comply with 302. Changes in level are not permitted. EXCEPTIONS: 1. Slopes not steeper than 1:48 shall be permitted. 2. Changes in level at thresholds complying with 404.2.5 shall be permitted.	Women's restroom door - .5" change in level, 3% slope on pull side landing	Correct or repair slope at doorway landing to max 2.08% in any direction for level. For all doors along the public circulation route, repair, bevel, or ramp CILs at door entries to max .25".	2015 ABAAS Section: 404.2.4.4, 404.2.4.4 EX CEPTIONS: 1, 404.2.4.4 E XCEPTIONS: 2 2012 TAS Section: 404.2.4.4, 404.2.4.4 Exception 1, 404.2.4.4 Exception 2 2010 ADAS Section: 404.2.4.4, 404.2.4.4 Exception 1, 404.2.4.4 Exception 2

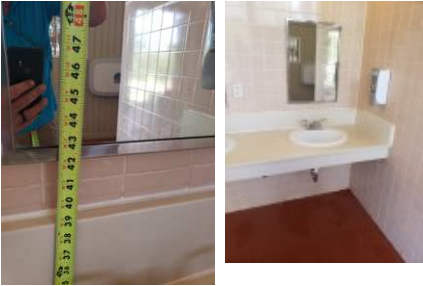
Finding Number	Area Description	Lat/Long	Finding	As Built	Recommendation	Citation	Photos	Figure
414	Mesquite Camp Area: Mesquite Camp Area Restrooms	[34.9358105 , -101.6371 303]	The mirror is mounted too high. Mirrors must have the bottom edge of the reflecting surface a maximum of 40 inches above the floor if above a sink or counter. Mirrors not located above lavatories or countertops shall be installed with the bottom edge of the reflecting surface 35 inches maximum above the finish floor or ground.	Men's Restroom - reflective surface mounted 43" above finished floor	Lower mirror so reflective surface is max 40" aff	2015 ABAAS Section: 603.3 2012 TAS Section: 603.3 2010 ADAS Section: 603.3

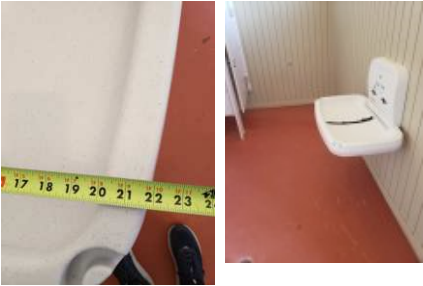
Finding Number	Area Description	Lat/Long	Finding	As Built	Recommendation	Citation	Photos	Figure
416	Mesquite Camp Area: Mesquite Camp Area Restrooms	[34.9357975 , -101.6371 656]	The baby changing table is not compliant. Baby changing tables are work surfaces. If fixed or built-in baby changing tables are provided, at least 5%, but not less than one, must comply with TAS 902 based TAS 226.1. Baby changing tables cannot violate the protruding object requirements in either an open or closed position since either position is a potential hazard for persons with visual impairments. Baby changing tables are not prohibited from being located in wheelchair accessible toilet compartments; however, the minimum space required for the compartment cannot be obstructed by the baby changing table in either an open or closed position. The clear floor space required for a baby changing table may overlap the water closet clearance since baby changing tables are considered convenience “fixtures” based on Advisory 604.8.1.1. The overlap is applicable only to the clear floor space and not to actual table itself. Baby changing tables must be dispersed throughout a space, however, an additional baby changing table is not required in a common use area of a toilet or bathing room when the only baby changing table is located in a toilet compartment.	Men's Restroom - changing table extends 22" when open in clear floor space	Relocate baby changing table to eliminate protrusion when in the open position.	2012 TAS Section: 226.1, 902.3, 604.3.2, 204.1, 226.1 Advisory, 226.2, 307.1, 604.8.1.1 Advisory, 902.1, 902.1 Advisory, 902.2

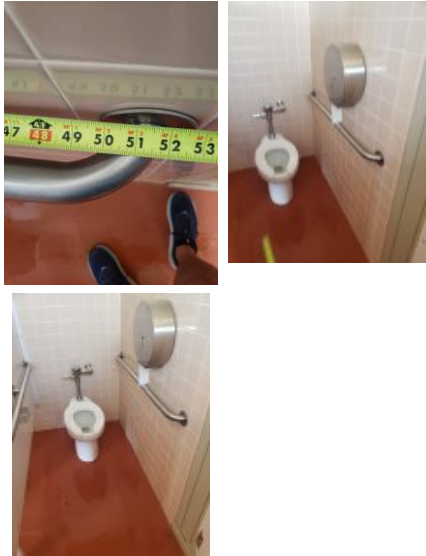
Finding Number	Area Description	Lat/Long	Finding	As Built	Recommendation	Citation	Photos	Figure
418	Mesquite Camp Area: Mesquite Camp Area Restrooms	[34.9357975, -101.6371495]	The side grab bars are not in the correct location. Grab bars on the side wall must be installed so that the end closest to the rear wall is maximum 12" from the rear wall. The end furthest from the rear wall must be mounted minimum 54" from the rear wall.	Men's Restroom - side grab bar only extend 51" from rear wall	Remount side grab bar to max 12" from the rear wall at the close end and min 54" on the far end, and 33" to 36" aff, in the alternative, use existing ambulatory stall to create required wheelchair stall.	2015 ABAAS Section: 604.5.1 2012 TAS Section: 604.5.1 2010 ADAS Section: 604.5.1

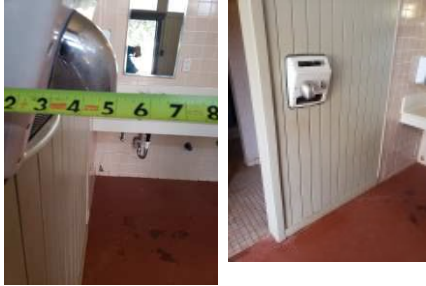
420	Mesquite Camp Area: Mesquite Camp Area Restrooms	[34.9357975, -101.637112]	The hand dryer projects more than 4 inches into the circulation path. Wall-mounted objects that have leading edges between 27 inches and 80 inches from the floor must not project more than 4 inches into the circulation path. Protruding objects that extend to the floor or within 27 inches of the floor are cane detectable and are therefore not hazardous. Where it is necessary or desirable to have objects protrude from the wall, a manner of cane detection must be provided.	Men's Restroom - hand dryer projects 5" from wall	Relocate protruding objects or place cane detectable warning or bollard at foot of item.	2015 ABAAS Section: 307.2 2012 TAS Section: 307.2 2010 ADAS Section: 307.2

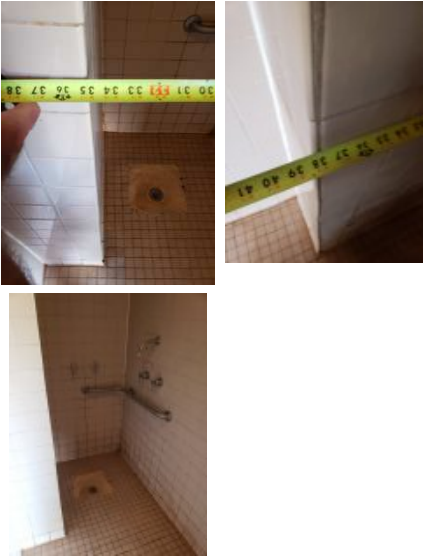
Finding Number	Area Description	Lat/Long	Finding	As Built	Recommendation	Citation	Photos	Figure
423	Mesquite Camp Area: Mesquite Camp Area Restrooms	[34.9358239 , -101.63717 1]	Transfer type shower compartments shall be 36 inches (915 mm) by 36 inches (915 mm) clear inside dimensions measured at the center points of opposing sides and shall have a 36 inch (915 mm) wide minimum entry on the face of the shower compartment. Clearance of 36 inches (915 mm) wide minimum by 48 inches (1220 mm) long minimum measured from the control wall shall be provided.	Men's Restroom - 35" by 38"	Reconfigure transfer shower to compliant 36" by 36" clear inside dimension	2015 ABAAS Section: 608.2.1 2012 TAS Section: 608.2.1 2010 ADAS Section: 608.2.1

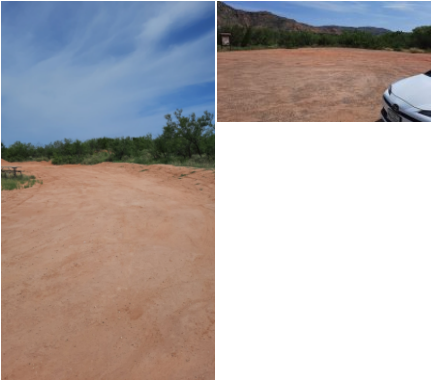
Finding Number	Area Description	Lat/Long	Finding	As Built	Recommendation	Citation	Photos	Figure
427	Equestrian Sites: Equestrian Sites Parking	[34.9319978 , -101.6346 873]	There are no accessible parking stalls. Each lot where parking is provided for the public as clients, guests or employees, shall provide accessible parking and shall be located on the shortest accessible route of travel from adjacent parking to an accessible entrance. There are an unknown number parking stalls in the parking lot that could be reasonably associated with this facility. There should be a minimum of one accessible stalls with a minimum of one being designed as van accessible.	dirt lot lacks accessible parking stalls. Day Use area lacks accessible parking stalls	Create two or more 8' accessible parking stalls, with one 5' adjacent access aisle, with proper signage and striping based on the total number of stalls. One in each lot.	2015 ABAAS Section: F208.2 2012 TAS Section: 208.2 2010 ADAS Section: 208.2

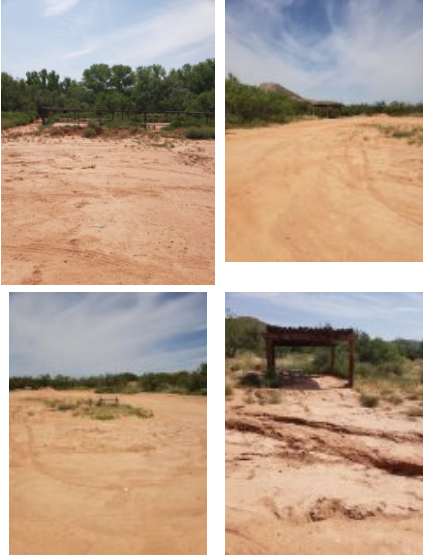
428	Equestrian Sites: Equestrian Sites EAR	[34.9319571 , -101.6342 608]	There is no accessible route to the area amenities. At least one accessible route shall connect accessible buildings, accessible facilities, accessible elements, and accessible spaces that are on the same site.	no accesible route to trails, corral or shelter	Create an accessible route with crushed stone or other outdoor material from parking to each amenity.	2015 ABAAS Section: F206.2.2 2012 TAS Section: 206.2.2 2010 ADAS Section: 206.2.2

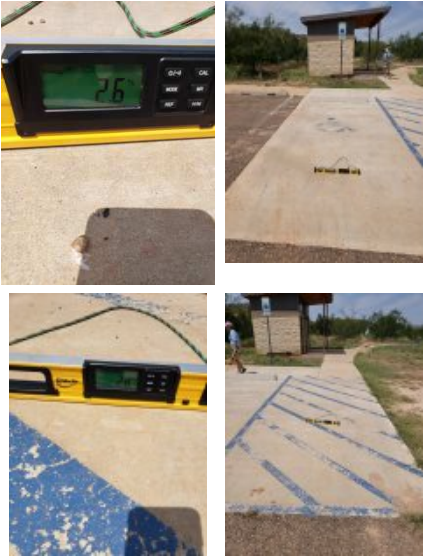
Finding Number	Area Description	Lat/Long	Finding	As Built	Recommendation	Citation	Photos	Figure
432	Wolfberry Camp Area: Wolfberry Camp Area Parking	[34.9371957 , -101.6482 862]	The cross slopes (narrow dimension) and/or running slopes (long dimension) of the access aisle exceeds 2%. The running slope and the cross slope in an accessible parking stall and the access aisle must not exceed 2%.	parking stall 2.6% slope, access aisle 2.8% slope	Repair or correct slope of parking space and access aisle to max 2.08% in any direction	2015 ABAAS Section: 502.4 2012 TAS Section: 502.4 2010 ADAS Section: 502.4

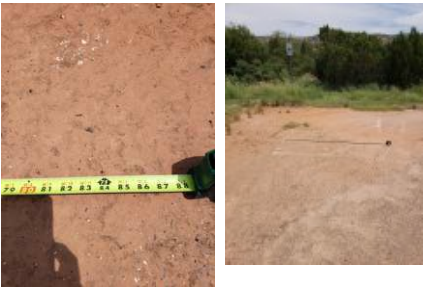
Finding Number	Area Description	Lat/Long	Finding	As Built	Recommendation	Citation	Photos	Figure
434	Wolfberry Camp Area: Wolfberry Camp Area Parking	[34.9372861 , -101.6468 216]	There are no van accessible parking stalls. 1 in every 6, minimum of one, required accessible stalls must be a van accessible stall. There are a total of 6 parking stalls in the parking lot that could be reasonably associated with this facility. There should be a minimum of 1 accessible stalls with a minimum of 1 being designed as van accessible.	Near torn down bathroom - access aisle 7', lacks signage	Add van parking sign to 1 accessible stall and repaint stall and access aisle to 11' and 5' or 8' and 8' per the table	2015 ABAAS Section: F208.2, F208.2.4 2012 TAS Section: 208.2, 208.2.4 2010 ADAS Section: 208.2, 208.2.4

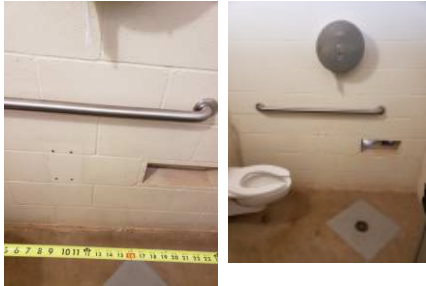
439	Wolfberry Camp Area: Wolfberry Camp Area Restrooms	[34.97193, -101.6783]	The toilet paper is not installed within the compliant range in front of the toilet. Toilet paper dispensers shall be 7 inches minimum and 9 inches maximum in front of the water closet measured to the centerline of the dispenser. The outlet of the dispenser shall be 15 inches minimum and 48 inches maximum above the finish floor and shall not be located behind grab bars. Dispensers shall not be of a type that controls delivery or that does not allow continuous paper flow. There shall be a clearance of 1 1/2 inches minimum below the grab bar.	Men's Restroom - toilet paper dispenser too far from toilet	Remount toilet paper dispenser max 7" to 9" from front of toilet, 15" to 48" aff and min 12" above or 1.5" below grab bar	2015 ABAAS Section: 604.7 2012 TAS Section: 604.7 2010 ADAS Section: 604.7

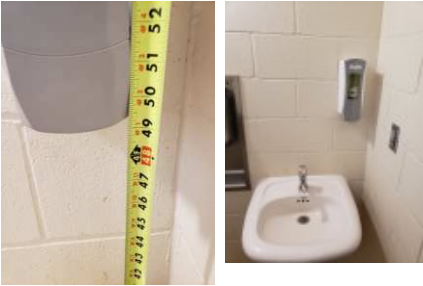
Finding Number	Area Description	Lat/Long	Finding	As Built	Recommendation	Citation	Photos	Figure
440	Wolfberry Camp Area: Wolfberry Camp Area Restrooms	[34.97193, -101.6783]	Where a high forward reach is over an obstruction, the clear floor space shall extend beneath the element for a distance not less than the required reach depth over the obstruction. The high forward reach shall be 48 inches (1220 mm) maximum where the reach depth is 20 inches (510 mm) maximum. Where the reach depth exceeds 20 inches (510 mm), the high forward reach shall be 44 inches (1120 mm) maximum and the reach depth shall be 25 inches (635 mm) maximum. Where a clear floor or ground space allows a parallel approach to an element and the high side reach is over an obstruction, the height of the obstruction shall be 34 inches (865 mm) maximum and the depth of the obstruction shall be 24 inches (610 mm) maximum. The high side reach shall be 48 inches (1220 mm) maximum for a reach depth of 10 inches (255 mm) maximum. Where the reach depth exceeds 10 inches (255 mm), the high side reach shall be 46 inches (1170 mm) maximum for a reach depth of 24 inches (610 mm) maximum.	Men's Restroom - soap dispenser mounted 49" above finished floor	Lower to max 44" aff for a forward reach over counter.	2015 ABAAS Section: 308.2.1, 308.3.2 2012 TAS Section: 308.2.1, 308.3.2 2010 ADAS Section: 308.2.1, 308.3.2

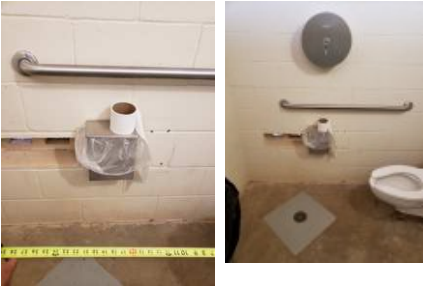
441	Wolfberry Camp Area: Wolfberry Camp Area Restrooms	[34.97193, -101.6783]	Exterior doors exceed 8.5 lbs of force to open; fire doors shall have a minimum opening force allowable by the appropriate administrative authority	Women's - 22 lb of force to open	Inspect, adjust, and maintain 8.5 lbf to open exterior doors as a smart practice	2010 ADAS Section: 404.2.9		
442	Wolfberry Camp Area: Wolfberry Camp Area Restrooms	[34.97193, -101.6783]	The toilet paper is not installed within the compliant range in front of the toilet. Toilet paper dispensers shall be 7 inches minimum and 9 inches maximum in front of the water closet measured to the centerline of the dispenser. The outlet of the dispenser shall be 15 inches minimum and 48 inches maximum above the finish floor and shall not be located behind grab bars. Dispensers shall not be of a type that controls delivery or that does not allow continuous paper flow. There shall be a clearance of 1 1/2 inches minimum below the grab bar.	Women's Restroom - toilet paper dispenser too far from toilet	Remount toilet paper dispenser max 7" to 9" from front of toilet, 15" to 48" aff and min 12" above or 1.5" below grab bar	2015 ABAAS Section: 604.7 2012 TAS Section: 604.7 2010 ADAS Section: 604.7

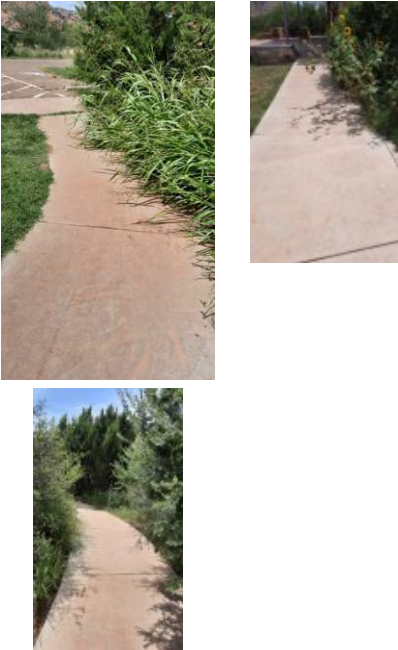
Finding Number	Area Description	Lat/Long	Finding	As Built	Recommendation	Citation	Photos	Figure
447	Tasajillo Pavilion : Exterior Accessible Route	[34.937838, -101.6487219]	The route of travel at this location does not provide the required minimum width. The minimum clear width for sidewalks and walks is 36 inches.	areas of overgrowth from parking near site 103	Widen EAR to min 36" clear width, train staff to maintain plant overgrowth.	2015 ABAAS Section: 403.5.1 2012 TAS Section: 403.5.1 2010 ADAS Section: 403.5.1

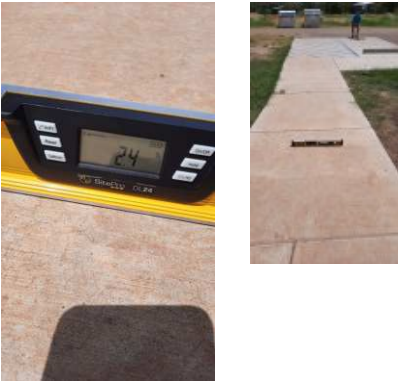
448	Tasajillo Pavilion : Exterior Accessible Route	[34.9373103, -101.6483411]	The accessible route of travel on the accessible route contains cross slopes greater than 2%. Cross slopes shall not exceed one unit vertical in 48 units horizontal (2-percent slope).	2.4% cross slope from parking to restroom	Correct or repair cross slope along AR to max 2.08%	2015 ABAAS Section: 403.3 2012 TAS Section: 403.3 2010 ADAS Section: 403.3

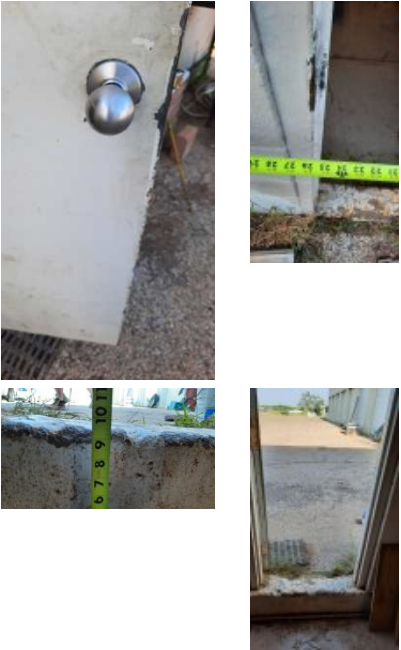
Finding Number	Area Description	Lat/Long	Finding	As Built	Recommendation	Citation	Photos	Figure
455	Water Plant: Office	[34.9856437, -101.6959919]	Spaces and elements within employee work areas shall only be required to comply with 206.2.8, 207.1, and 215.3 and shall be designed and constructed so that individuals with disabilities can approach, enter, and exit the employee work area. Employee work areas, or portions of employee work areas, other than raised courtroom stations, that are less than 300 square feet (28 m2) and elevated 7 inches (180 mm) or more above the finish floor or ground where the elevation is essential to the function of the space shall not be required to comply with these requirements or to be on an accessible route.	warehouse - knob hardware, door width 25", 9" change in level	For employee spaces, relocate storage, furniture, and other obstacles at doorways to provide approach, enter and exit at the employee space. Ramp entry and replace door with one having 32" clear width and lever hardware.	2015 ABAAS Section: F203.9 2012 TAS Section: 203.9 2010 ADAS Section: 203.9

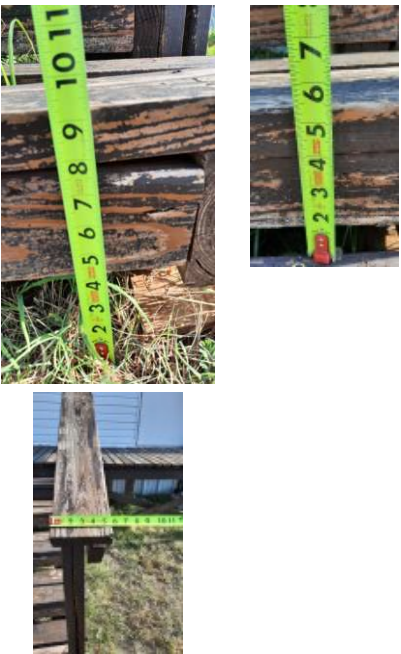
Finding Number	Area Description	Lat/Long	Finding	As Built	Recommendation	Citation	Photos	Figure
459	Water Plant: FEMA Trailer	[34.9856129 , -101.6970352]	The stair risers are not uniform in height. Stair riser heights shall be 7 inches maximum and 4 inches minimum. On any given flight of stairs, all steps shall have uniform riser height and uniform tread widths.	risers 5.5" to 9", handrails fail	Correct riser heights on stairs to consistent height between 4" to 7", leave as is if technically infeasible Install compliant handrails	2015 ABAAS Section: 504.2 2012 TAS Section: 504.2 2010 ADAS Section: 504.2

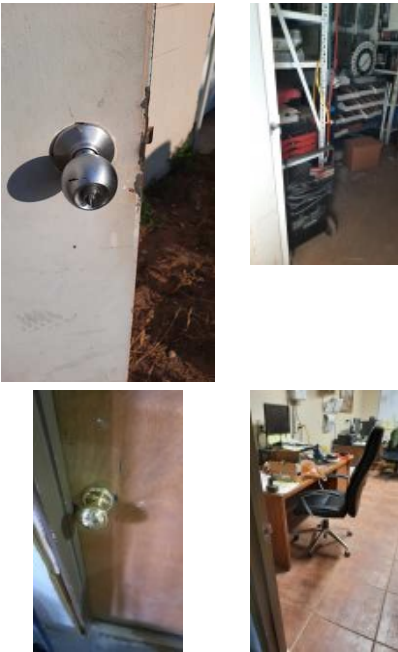
Finding Number	Area Description	Lat/Long	Finding	As Built	Recommendation	Citation	Photos	Figure
461	Maintenance Area: Employee Spaces	[34.9855931 , -101.6963 674]	Spaces and elements within employee work areas shall only be required to comply with 206.2.8, 207.1, and 215.3 and shall be designed and constructed so that individuals with disabilities can approach, enter, and exit the employee work area. Employee work areas, or portions of employee work areas, other than raised courtroom stations, that are less than 300 square feet (28 m2) and elevated 7 inches (180 mm) or more above the finish floor or ground where the elevation is essential to the function of the space shall not be required to comply with these requirements or to be on an accessible route.	Shop - knob hardware, mechanics room - storage on pull side, offices - knob hardware, chair back in maneuvering clearance	For employee spaces, relocate storage, furniture, and other obstacles at doorways to provide approach, enter and exit at the employee space. Replace door knobs with lever hardware.	2015 ABAAS Section: F203.9 2012 TAS Section: 203.9 2010 ADAS Section: 203.9

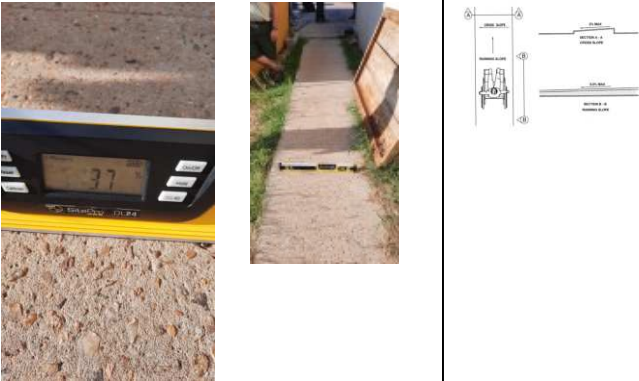
462	Maintenance Area: Employee Spaces	[34.9855909 , -101.6962 011]	The accessible route of travel on the accessible route contains cross slopes greater than 2%. Cross slopes shall not exceed one unit vertical in 48 units horizontal (2-percent slope).	shop - 3.7% slope to shop	Correct or repair cross slope along AR to max 2.08%	2015 ABAAS Section: 403.3 2012 TAS Section: 403.3 2010 ADAS Section: 403.3

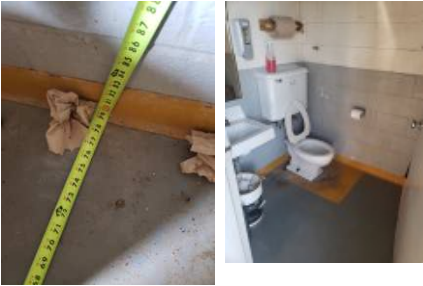
Finding Number	Area Description	Lat/Long	Finding	As Built	Recommendation	Citation	Photos	Figure
465	Maintenance Area: Maintinance Area Restrooms	[34.9856393 , -101.6962 708]	This restroom is not accessible. Where existing toilet rooms or bathing rooms do not comply, directional signs indicating the location of the nearest accessible toilet room or bathing room within the facility shall be provided. Signs shall include the International Symbol of Accessibility. Where existing toilet rooms or bathing rooms do comply), the accessible toilet rooms or bathing rooms shall be identified by the International Symbol of Where clustered single user toilet rooms or bathing facilities are permitted, accessible toilet rooms or bathing facilities shall be identified by the International Symbol of Accessibility unless all toilet rooms and bathing facilities are accessible.	60" x 78" concrete block space, no accessible features, lacks signage to accessible restroom	Restroom not accessible, acquire and mount signage directing patrons to accessible restroom.	2015 ABAAS Section: F216.8 2012 TAS Section: 216.8 2010 ADAS Section: 216.8

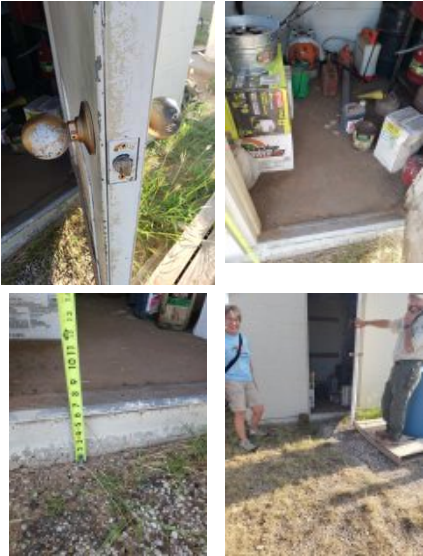
Finding Number	Area Description	Lat/Long	Finding	As Built	Recommendation	Citation	Photos	Figure
467	Maintenance Area: Maintenance Fuel Storage	[34.9855734 , -101.6962 815]	Spaces and elements within employee work areas shall only be required to comply with 206.2.8, 207.1, and 215.3 and shall be designed and constructed so that individuals with disabilities can approach, enter, and exit the employee work area. Employee work areas, or portions of employee work areas, other than raised courtroom stations, that are less than 300 square feet (28 m2) and elevated 7 inches (180 mm) or more above the finish floor or ground where the elevation is essential to the function of the space shall not be required to comply with these requirements or to be on an accessible route.	Fuel Storage - knob hardware on door, storage in push side, 7" change in level at door, gravel approach to door	For employee spaces, relocate storage, furniture, and other obstacles at doorways to provide approach, enter and exit at the employee space. Replace door knob with lever hardware and ramp CIL into building.	2015 ABAAS Section: F203.9 2012 TAS Section: 203.9 2010 ADAS Section: 203.9

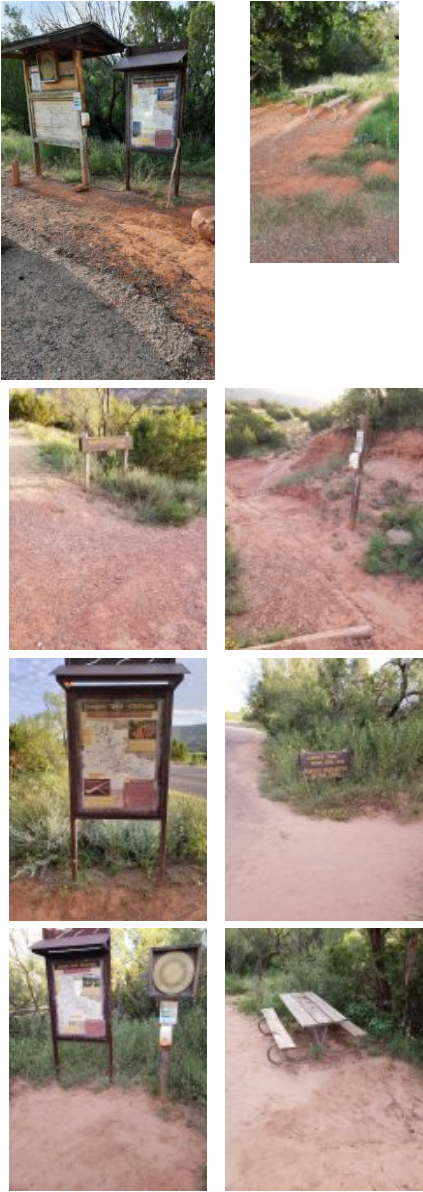
Finding Number	Area Description	Lat/Long	Finding	As Built	Recommendation	Citation	Photos	Figure
470	Trails: Trailheads	[34.95121, -101.6682]	There is no accessible route to map, dispenser, drinking fountain, shelter and benches. At least one accessible route shall connect accessible buildings, accessible facilities, accessible elements, and accessible spaces that are on the same site.	lighthouse trail and juniper/rojo grande, No accessible route to map, dispenser, drinking fountain, shelter, and benches.	Leave as an inaccessible trail and create a new accessible trail in the park.	2015 ABAAS Section: F206.2.2 2012 TAS Section: 206.2.2 2010 ADAS Section: 206.2.2
