Access Audit Site Report

Palo Duro Canyon State Park
11450 State Hwy Park Rd 5
Canyon, TX 79015
Accessibility Evaluation
Inspection Date: 08/10/2021
Inspectors: Tanya Scheibe

Prepared By
WT Group

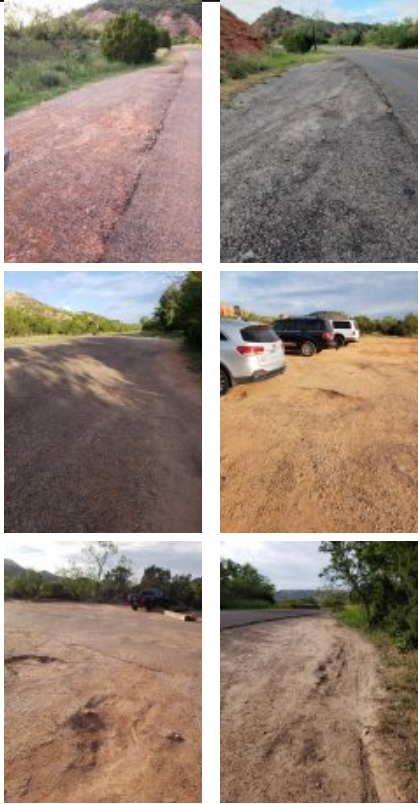
472	Trails: Trailheads	[34.96579, -101.6728]	There is no accessible route to the map and dispenser. At least one accessible route shall connect accessible buildings, accessible facilities, accessible elements, and accessible spaces that are on the same site.	No route to map and dispenser at Comanche trailhead	Create an accessible route with crushed stone or other outdoor material from parking or walkway to map and dispenser. In the alternative, leave as is inaccessible trail and create a new accessible trail in the park.	2015 ABAAS Section: F206.2.2 2012 TAS Section: 206.2.2 2010 ADAS Section: 206.2.2

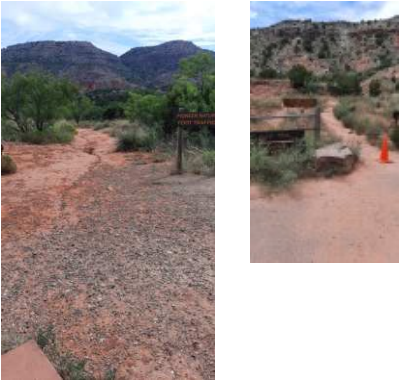
475	Trails: Trailheads	[34.9786641, -101.6780854]	The surface of the trails, passing spaces, and/or resting intervals is not firm and stable. The surface of trails, passing spaces, and resting intervals shall be firm and stable	Pioneer Nature trail - inaccessible surface, CCC trail - inaccessible surface	Leave as is inaccessible trails and create a new accessible trail in the park.	2015 ABAAS Section: 1017.2

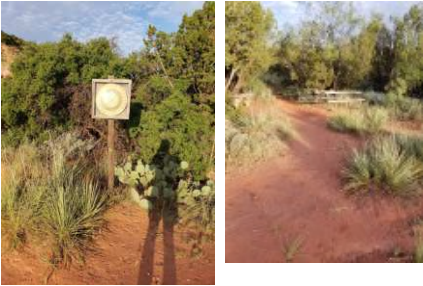
Finding Number	Area Description	Lat/Long	Finding	As Built	Recommendation	Citation	Photos	Figure
476	Trails: Trailheads	[34.94886, -101.6687]	There is no accessible route to thermometer and table. At least one accessible route shall connect accessible buildings, accessible facilities, accessible elements, and accessible spaces that are on the same site.	capitol peak - no accessible route to thermometer and table	Create an accessible route with crushed stone or other outdoor material from parking or walkway to thermometer and table. In the alternative, leave as is inaccessible trail and create a new accessible trail in the park.	2015 ABAAS Section: F206.2.2 2012 TAS Section: 206.2.2 2010 ADAS Section: 206.2.2

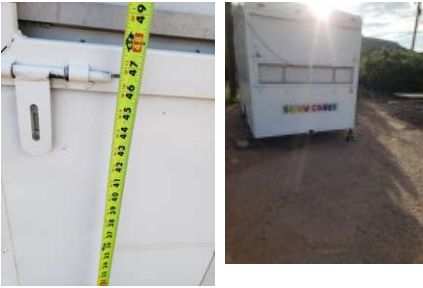
478	Trails: Trailheads	[34.951364, -101.6676677]	The transaction counter is too high. A portion of the counter surface that is 36 inches long minimum and 36 inches high maximum above the finish floor shall be provided. Knee and toe space must be provided for a forward approach. A 30 inch by 48 inch clear floor space on an accessible route must be provided for either a forward or parallel approach.	snow cone service counter 48" above the ground	Lower 36" wide segment of service counter to max 36" aff, in the alternative, train staff to come out from around the counter to provide customer service.	2015 ABAAS Section: 904.4.2, 904.4.1 2012 TAS Section: 904.4.1, 904.4.2 2010 ADAS Section: 904.4.2, 904.4.1

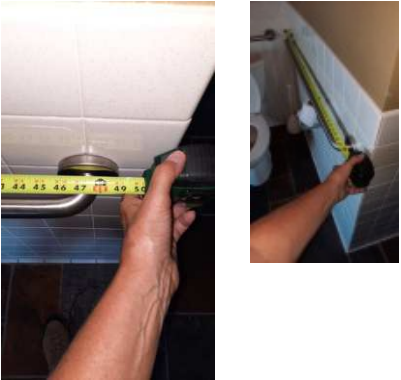
Finding Number	Area Description	Lat/Long	Finding	As Built	Recommendation	Citation	Photos	Figure
492	Canoncita: Retreat Center	[34.8801871 , -101.6576 416]	The side grab bars are not in the correct location. Grab bars on the side wall must be installed so that the end closest to the rear wall is maximum 12" from the rear wall. The end furthest from the rear wall must be mounted minimum 54" from the rear wall.	Main Building Restroom - side grab bar extends to 47.5" from rear wall	Remount side grab bar to max 12" from the rear wall at the close end and min 54" on the far end, and 33" to 36" aff	2015 ABAAS Section: 604.5.1 2012 TAS Section: 604.5.1 2010 ADAS Section: 604.5.1

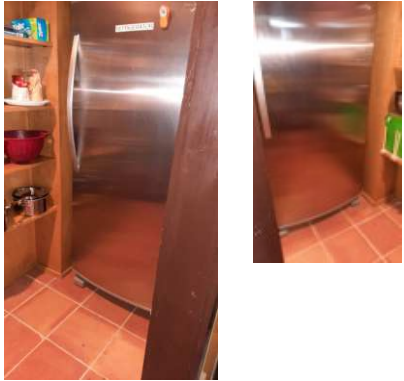
Finding Number	Area Description	Lat/Long	Finding	As Built	Recommendation	Citation	Photos	Figure
495	Canoncita: Retreat Center	[34.8801871 , -101.6576 416]	Combination refrigerators and freezers shall have at least 50 percent of the freezer space 54 inches (1370 mm) maximum above the finish floor or ground. The clear floor or ground space shall be positioned for a parallel approach to the space dedicated to a refrigerator/freezer with the centerline of the clear floor or ground space offset 24 inches (610 mm) maximum from the centerline of the dedicated space.	Dorm kitchen - fridge and freezer in alcove	Enlarge alcove for clear space at refridgerator.	2015 ABAAS Section: 804.6.6 2012 TAS Section: 804.6.6 2010 ADAS Section: 804.6.6

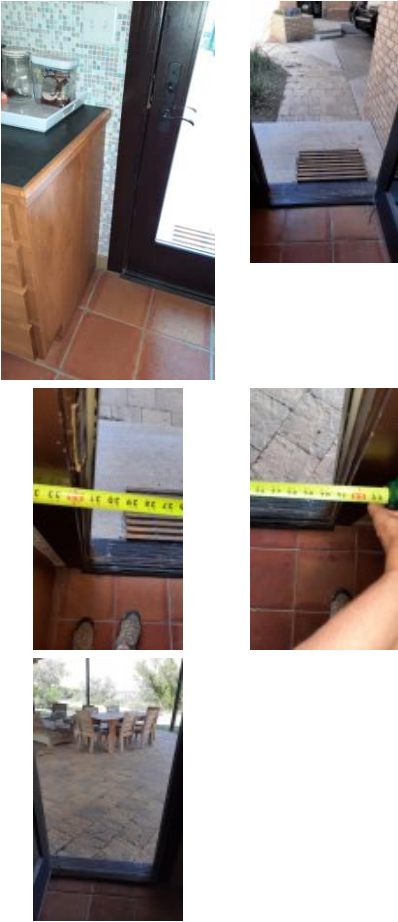
Finding Number	Area Description	Lat/Long	Finding	As Built	Recommendation	Citation	Photos	Figure
498	Canoncita: Retreat Center	[34.8801871, -101.6576416]	Minimum maneuvering clearances at doors and gates shall comply with 404.2.4. Maneuvering clearances shall extend the full width of the doorway and the required latch side or hinge side clearance. Door openings shall provide a clear width of 32 inches (815 mm) minimum. Clear openings of doorways with swinging doors shall be measured between the face of the door and the stop, with the door open 90 degrees. Openings more than 24 inches (610 mm) deep shall provide a clear opening of 36 inches (915 mm) minimum. There shall be no projections into the required clear opening width lower than 34 inches (865 mm) above the finish floor or ground. Projections into the clear opening width between 34 inches (865 mm) and 80 inches (2030 mm) above the finish floor or ground shall not exceed 4 inches (100 mm).	Kitchen entries - 30.5" wide, counter in pull side clearance	For all doors along the public circulation route, provide required maneuvering clearance on push and pull side of doors For all doors along the public circulation route, replace doors with doors having 80" overhead clearance and 32" clear width	2010 ADAS Section: 404.2.3, 404.2.7, 404.2.4, 404.2.11, 404.2.11 Exception

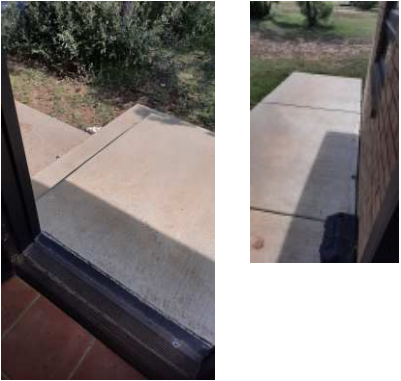
Finding Number	Area Description	Lat/Long	Finding	As Built	Recommendation	Citation	Photos	Figure
499	Canoncita: Retreat Center	[34.8801871 , -101.6576 416]	Minimum maneuvering clearances at doors and gates shall comply with 404.2.4. Maneuvering clearances shall extend the full width of the doorway and the required latch side or hinge side clearance.	Bedroom exit - door complies, but lacks connection to AR	Provide required maneuvering clearance on push side of door and ramp step for egress.	2015 ABAAS Section: 404.2.4.4, 404.2.4.1 2012 TAS Section: 404.2.4.4, 404.2.4.1 2010 ADAS Section: 404.2.4.4, 404.2.4.1

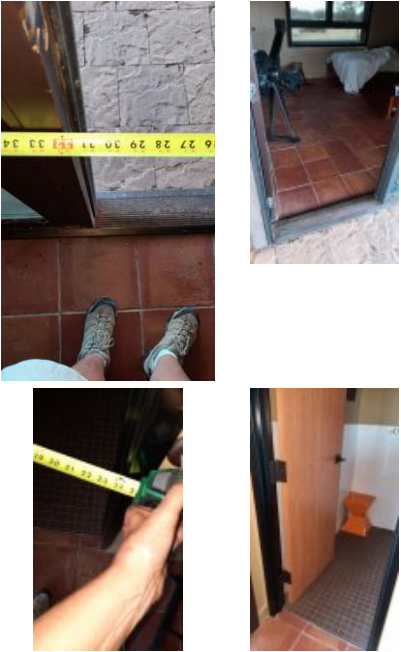
500	Canoncita: Retreat Center	[34.8801871 , -101.6576 416]	Element meets all standards and requirements	Bedroom complies, bedrooms across patio complies	None	2010 ADAS Section: N/A		
501	Canoncita: Retreat Center	[34.8801871 , -101.6576 416]	The door opening does not provide at least 32 inches between the face of the door and the opposite stop. Door openings shall provide a clear width of 32 inches minimum. Clear openings of doorways with swinging doors shall be measured between the face of the door and the stop, with the door open 90 degrees. There shall be no projections into the required clear opening width lower than 34 inches above the finish floor or ground. Projections into the clear opening width between 34 inches and 80 inches above the finish floor or ground shall not exceed 4 inches.	Right bedroom entry across patio - 31" wide, restroom - 23.5", closet - 21", left bedroom - 30.5" entry, restroom - 23.5"	Replace door with one having 32" clear width.	2015 ABAAS Section: 404.2.3 2012 TAS Section: 404.2.3 2010 ADAS Section: 404.2.3

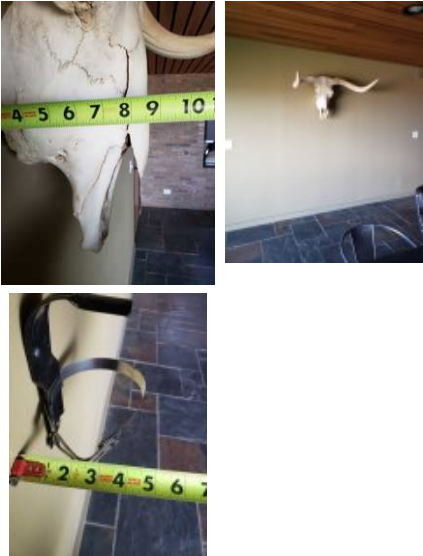
Finding Number	Area Description	Lat/Long	Finding	As Built	Recommendation	Citation	Photos	Figure
503	Canoncita: Retreat Center	[34.8801871 , -101.6576 416]	An item or items project more than 4 inches into the circulation path. Wall-mounted objects that have leading edges between 27 inches and 80 inches from the floor must not project more than 4 inches into the circulation path. Protruding objects that extend to the floor or within 27 inches of the floor are cane detectable and are therefore not hazardous. Where it is necessary or desirable to have objects protrude from the wall, a manner of cane detection must be provided.	Main Building - cow head 8" from wall, fire extinguisher 5"	Relocate protruding objects or place cane detectable warning or bollard at foot of item	2015 ABAAS Section: 307.2 2012 TAS Section: 307.2 2010 ADAS Section: 307.2

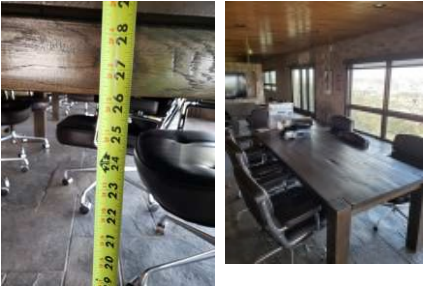
504	Canoncita: Retreat Center	[34.8801871 , -101.6576 416]	Compliant knee and toe clearance is not provided at the accessible table. When seating for persons in wheelchairs is provided at fixed tables or counters, knee spaces at least 27 inches high, 30 inches wide and 19 inches deep shall be provided.	Main building - all three conference tables 26.25" above finish floor do not provide knee clearance	Replace 5% of the tables with ones providing required knee and toe clearances	2015 ABAAS Section: 306.3.3 2012 TAS Section: 306.3.3 2010 ADAS Section: 306.3.3

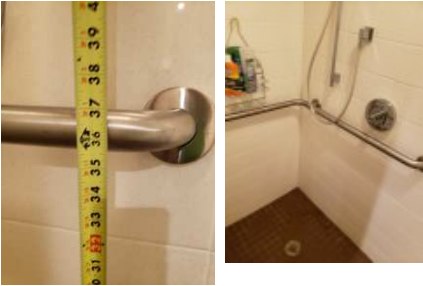
Finding Number	Area Description	Lat/Long	Finding	As Built	Recommendation	Citation	Photos	Figure
510	Canoncita: Retreat Center	[34.8801871 , -101.6576 416]	Grab bars shall be installed in a horizontal position, 33 inches (840 mm) minimum and 36 inches (915 mm) maximum above the finish floor measured to the top of the gripping surface	residence side of main building - shower side grab bar installed 37" above finished floor	Remount shower grab bar to 33" min and 36" max aff.	2015 ABAAS Section: 609.3 Exception, 609.4 2012 TAS Section: 609.4, 609.3 Exception 2010 ADAS Section: 609.4, 609.3 Exception

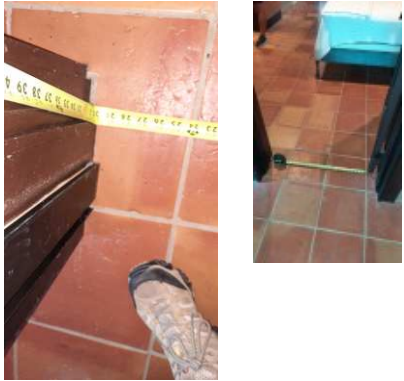
Finding Number	Area Description	Lat/Long	Finding	As Built	Recommendation	Citation	Photos	Figure
516	Canoncita: Retreat Center	[34.8801871 , -101.6576 416]	The door opening does not provide at least 32 inches between the face of the door and the opposite stop. Door openings shall provide a clear width of 32 inches minimum. Clear openings of doorways with swinging doors shall be measured between the face of the door and the stop, with the door open 90 degrees. There shall be no projections into the required clear opening width lower than 34 inches above the finish floor or ground. Projections into the clear opening width between 34 inches and 80 inches above the finish floor or ground shall not exceed 4 inches.	Screen house bedroom entry - 29" wide	Replace door with one having 32" clear width	2015 ABAAS Section: 404.2.3 2012 TAS Section: 404.2.3 2010 ADAS Section: 404.2.3

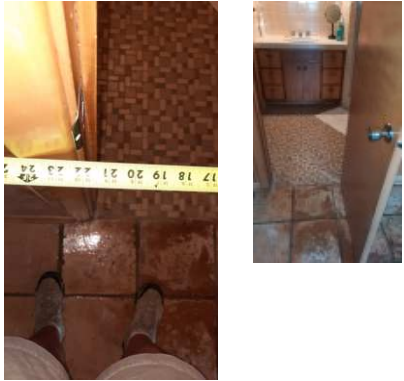
517	Canoncita: Retreat Center	[34.8801871 , -101.6576 416]	Door openings shall provide a clear width of 32 inches (815 mm) minimum. Clear openings of doorways with swinging doors shall be measured between the face of the door and the stop, with the door open 90 degrees. Openings more than 24 inches (610 mm) deep shall provide a clear opening of 36 inches (915 mm) minimum. There shall be no projections into the required clear opening width lower than 34 inches (865 mm) above the finish floor or ground. Projections into the clear opening width between 34 inches (865 mm) and 80 inches (2030 mm) above the finish floor or ground shall not exceed 4 inches (100 mm). Hand-activated door opening hardware, handles, pulls, latches, locks, and other operating devices on accessible doors shall have a shape that is easy to grasp with one hand and does not require tight grasping, tight pinching or twisting of the wrist to operate. Hardware shall be 34 inches minimum and 48 inches maximum above the finish floor or ground.	Screen room restroom - 21.5" wide, knob hardware	For all doors along the public circulation route, replace doors with doors having 80" overhead clearance and 32" clear width For all doors along the public circulation route, replace hardware with lever hardware or hardware operable without a tight pinch or grasp	2010 ADAS Section: 404.2.3, 404.2.7, 404.2.4, 404.2.11, 404.2.11 Exception

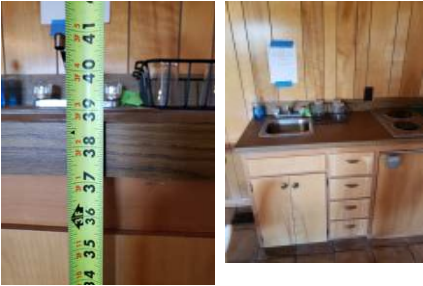
Finding Number	Area Description	Lat/Long	Finding	As Built	Recommendation	Citation	Photos	Figure
521	Canoncita: Retreat Center	[34.8801871 , -101.6576 416]	The top rim of the sink is too high. All lavatories/sinks that are designated to be accessible shall be a minimum 17 inches in horizontal depth and mounted with the rim or counter edge no higher than 34 inches above the finished floor.	sink installed 39" above finished floor	Lower sinks to max 34" aff to front of rim.	2015 ABAAS Section: 606.3 2012 TAS Section: 606.3 2010 ADAS Section: 606.3
