Access Audit Site Report

Pedernales Falls State Park
2585 Park Rd 6026
Johnson City, TX 78636
Accessibility Evaluation
Inspection Date: 02/08/2022
Inspectors: Tanya Scheibe

Prepared By
WT Group

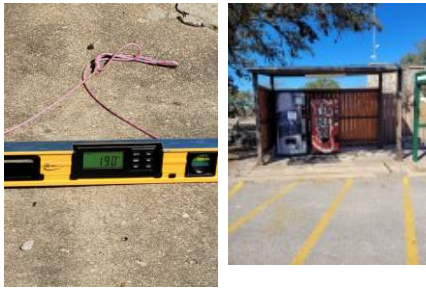
12	Headquarters (HQ) : HQ - Parking and Exterior Accessible Route	[30.30802, -98.25768]	The running slope of walking surfaces shall not be steeper than 1:20.	19% slope up to vending machine at HQ	Correct running slope along the AR to max 5%	2015 ABAAS Section: 403.3 2012 TAS Section: 403.3 2010 ADAS Section: 403.3

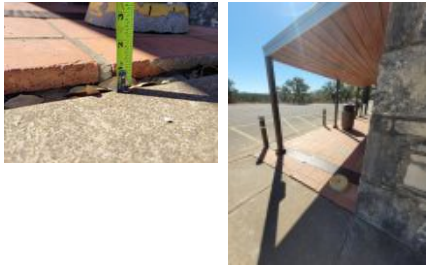
13	Headquarters (HQ) : HQ - Parking and Exterior Accessible Route	[30.30802, -98.25768]	The walkway contains abrupt vertical edges and/or variations over a 1/4 inch. 1/4 inch is the maximum vertical rise. Changes in level between 1/4 inch and 1/2 inch must be beveled at 1:2 or less. Changes in level greater than 1/2 inch must be by way of a ramp.	1.25" change in level (CIL) up to entry at HQ	Repair, bevel or ramp CIL along AR.	2012 TAS Section: 303.2, 303.3 2010 ADAS Section: 303.2, 303.3

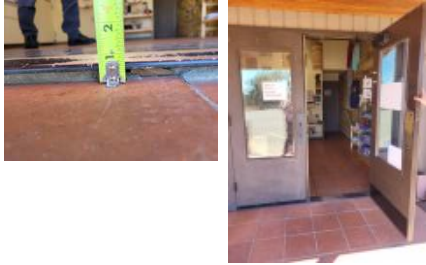
18	Headquarters (HQ) : HQ - Public Spaces	[30.30802, -98.25768]	The threshold is greater than 1/2 inch high. The threshold at a doorway shall be no higher than 1/2 inch. Changes in level between 1/4 inch and 1/2 inch must be beveled at 1:2 or less. 1/4 inch is the maximum vertical rise.	1" change in level (CIL) at entry door	For all doors along the public circulation route, replace thresholds at exterior doors with ADA thresholds	2015 ABAAS Section: 404.2.5 2012 TAS Section: 404.2.5 2010 ADAS Section: 404.2.5

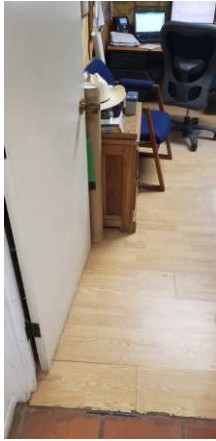
Finding Number	Area Description	Lat/Long	Finding	As Built	Recommendation	Citation	Photos	Figure
19	Headquarters (HQ) : HQ - Employee Spaces	[30.30802, -98.25768]	Spaces and elements within employee work areas shall only be required to comply with 206.2.8, 207.1, and 215.3 and shall be designed and constructed so that individuals with disabilities can approach, enter, and exit the employee work area. Employee work areas, or portions of employee work areas, other than raised courtroom stations, that are less than 300 square feet (28 m2) and elevated 7 inches (180 mm) or more above the finish floor or ground where the elevation is essential to the function of the space shall not be required to comply with these requirements or to be on an accessible route.	office door - desk in pull side maneuvering clearance (MC), knob hardware	For employee spaces, relocate storage, furniture, and other obstacles at doorways to provide approach, enter and exit at the employee space. Provide required maneuvering clearance on push and pull side of doors. Replace hardware with lever hardware or hardware operable without a tight pinch or grasp.	2015 ABAAS Section: F203.9 2012 TAS Section: 203.9 2010 ADAS Section: 203.9

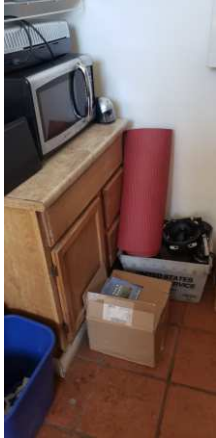
20	Headquarters (HQ) : HQ - Employee Spaces	[30.30802, -98.25768]	The operable part is not accessible because there is not adequate clear floor space for either a forward or side approach. The clear floor or ground space shall be 30 inches minimum by 48 inches minimum.	Break Room - items stored in microwave clear floor space (CFS)	Remove, or relocate storage in CFS at fixtures and operable parts along the AR	2015 ABAAS Section: 305.3 2012 TAS Section: 305.3 2010 ADAS Section: 305.3

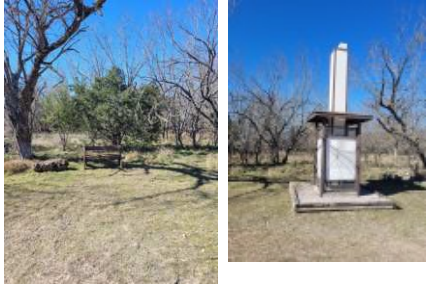
Finding Number	Area Description	Lat/Long	Finding	As Built	Recommendation	Citation	Photos	Figure
24	Park Site: Park Elements	[30.3251448 , -98.255909 7]	There is no accessible route to the bench or bird sign. At least one accessible route shall connect accessible buildings, accessible facilities, accessible elements, and accessible spaces that are on the same site.	bird blind - no route to bench, or to bird sign	Create an accessible route with crushed stone or other outdoor material from parking or walkway to bench or bird signage at bird blind entry	2015 ABAAS Section: F206.2.2 2012 TAS Section: 206.2.2 2010 ADAS Section: 206.2.2

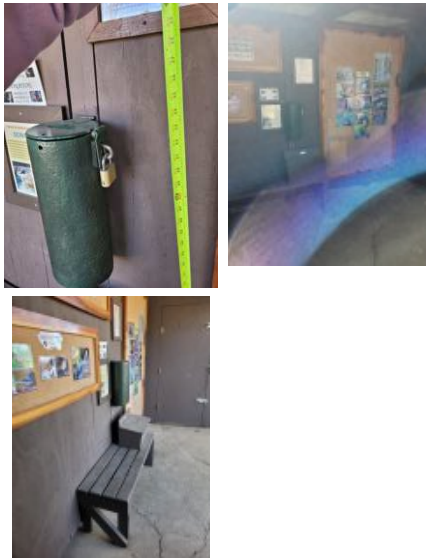
25	Park Site: Park Elements	[30.3250592 , -98.255738 1]	The operable part is positioned too high for either a side or front approach. Where a clear floor or ground space allows a parallel approach to an element and the side reach is unobstructed, the high side reach shall be 48 inches maximum and the low side reach shall be 15 inches minimum above the finish floor or ground. Where a forward reach is unobstructed, the high forward reach shall be 48 inches maximum and the low forward reach shall be 15 inches minimum above the finish floor or ground.	bird blind closer to stable - donation box 52" aff	Remount operable parts to be in reach range of 15" min to 48" max	2015 ABAAS Section: 308.1 2012 TAS Section: 308.1 2010 ADAS Section: 308.1

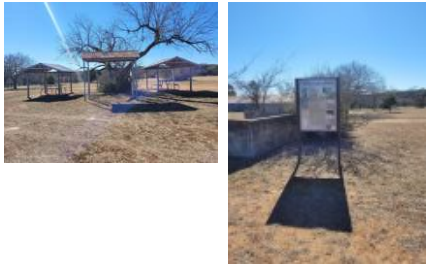
26	Park Site: Park Elements	[30.3249318 , -98.256269 2]	An accessible access route is not provided between elements, spaces and the facilities provided within the accessible camping unit. At least one outdoor recreation access route shall connect accessible elements, spaces and facilities provided within camping units with mobility features.	no route to 2 of 2 picnic tables by star theater, no route to sign	Create AR with crushed and compacted stone or similar outdoor material to table and sign. Replace one table with one of an accessible design.	2015 ABAAS Section: F244.5.1

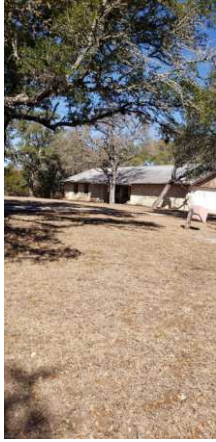
Finding Number	Area Description	Lat/Long	Finding	As Built	Recommendation	Citation	Photos	Figure
31	Park Site: Residence	[30.3083141 , -98.2545123]	Spaces and elements within employee work areas shall only be required to comply with 206.2.8, 207.1, and 215.3 and shall be designed and constructed so that individuals with disabilities can approach, enter, and exit the employee work area. Employee work areas, or portions of employee work areas, other than raised courtroom stations, that are less than 300 square feet (28 m2) and elevated 7 inches (180 mm) or more above the finish floor or ground where the elevation is essential to the function of the space shall not be required to comply with these requirements or to be on an accessible route.	no accessible route to residence door	Provide an accessible route and entry as employee residence upon request.	2015 ABAAS Section: F203.9 2012 TAS Section: 203.9 2010 ADAS Section: 203.9

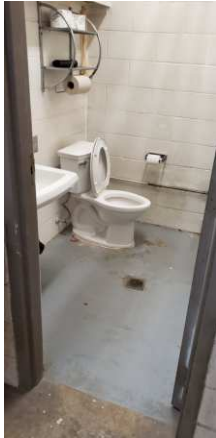
Finding Number	Area Description	Lat/Long	Finding	As Built	Recommendation	Citation	Photos	Figure
33	Park Site: Maintenance	[30.3187546 , -98.255569 1]	50% of the single accommodation restrooms provided in this grouping are not nearly compliant. The restrooms do not have the required minimum clear floor space or maneuvering clearances for the toilet, The restrooms do not have the required minimum clear floor space or maneuvering clearances for the lavatory, The entry doors do not contain the required minimum maneuvering spaces on the pull/push sides, The entry doors encroach into the required clear floor space for fixtures, Grab bars are missing and/or incorrectly installed, Accessories, such as toilet seat covers, paper towel holders, garbage cans, hand dryers, and mirrors are either too high or without clear floor space or both, The restrooms contain floor level changes greater than a 1/2 inch, the showers are too small and missing numerous accessible elements.	restroom lacks accessible features	Create compliant wheelchair accessible restrooms and correct all features to be accessible if feasible.	2015 ABAAS Section: 603.1 2012 TAS Section: 603.1 2010 ADAS Section: 603.1

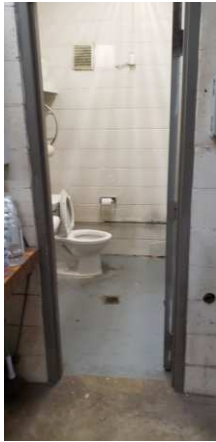
35	Park Site: Maintenance	[30.318772, -98.255524 8]	The restroom sign does not comply with one or more applicable requirements for the location, height, and properties of the sign.	restroom has no signage	Acquire and mount signage, including Braille and raised lettering mounted on wall, latch side of door, 48" to baseline of lowest character and 60" to baseline of highest character	2015 ABAAS Section: F216.2, 703.1, 703.2, 703.5, 703.6 2012 TAS Section: 216.2, 703.1, 703.2, 703.5, 703.6 2010 ADAS Section: 216.2, 703.1, 703.2, 703.5, 703.6

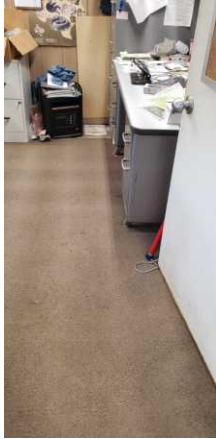
Finding Number	Area Description	Lat/Long	Finding	As Built	Recommendation	Citation	Photos	Figure
36	Park Site: Maintenance	[30.3187569 , -98.2555316]	Spaces and elements within employee work areas shall only be required to comply with 206.2.8, 207.1, and 215.3 and shall be designed and constructed so that individuals with disabilities can approach, enter, and exit the employee work area. Employee work areas, or portions of employee work areas, other than raised courtroom stations, that are less than 300 square feet (28 m2) and elevated 7 inches (180 mm) or more above the finish floor or ground where the elevation is essential to the function of the space shall not be required to comply with these requirements or to be on an accessible route.	office - desk in pull side clearance, knob hardware; restroom - sink and trash in pull side clearance, knob hardware closet - cabinet in pull side clearance	For employee spaces, relocate storage, furniture, and other obstacles at doorways to provide approach, enter and exit at the employee space. Provide required maneuvering clearance on push and pull side of doors. Replace hardware with lever hardware or hardware operable without a tight pinch or grasp.	2015 ABAAS Section: F203.9 2012 TAS Section: 203.9 2010 ADAS Section: 203.9

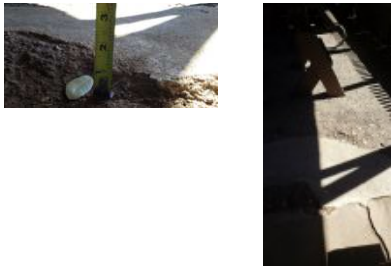
45	Park Site: Bird Blinds	[30.3251356 , -98.255802 5]	There is a change in level greater than 1/4 inch. 1/4 inch is the maximum vertical rise. Changes in level between 1/4 inch and 1/2 inch must be beveled at 1:2 or less. Changes in level greater than 1/2 inch must be by way of a ramp.	1" crack in concrete	Repair, bevel or ramp CIL along accessible route (AR) to max .25".	2015 ABAAS Section: 303.3 2012 TAS Section: 303.3 2010 ADAS Section: 303.3

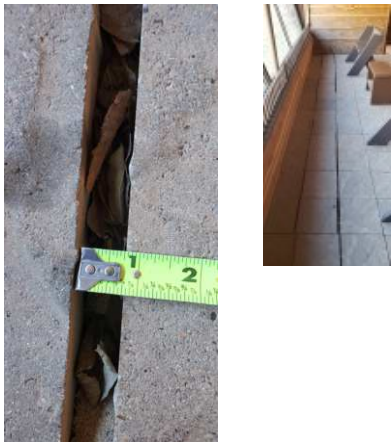
46	Park Site: Bird Blinds	[30.3251356 , -98.255850 7]	Openings in floor or ground surfaces shall not allow passage of a sphere more than 1/2 inch (13 mm) diameter except as allowed in 407.4.3, 409.4.3, 410.4, 810.5.3 and 810.10. Elongated openings shall be placed so that the long dimension is perpendicular to the dominant direction of travel.	several 0.75" gaps	Fill and maintain gaps to max .5"	2015 ABAAS Section: 302.3 2012 TAS Section: 302.3 2010 ADAS Section: 302.3

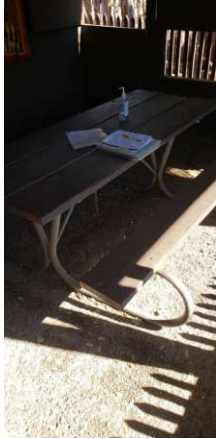
Finding Number	Area Description	Lat/Long	Finding	As Built	Recommendation	Citation	Photos	Figure
47	Park Site: Bird Blinds	[30.3250568 , -98.2557354]	The top of the work surface is not within a compliant height range. The tops of tables and counters shall be 28 inches to 34 inches from the floor or ground.	0 of 1 picnic table accessible	Provide tables and work surfaces at 28" to 34" aff with required knee and toe clearances	2015 ABAAS Section: 902.3 2012 TAS Section: 902.3 2010 ADAS Section: 902.3

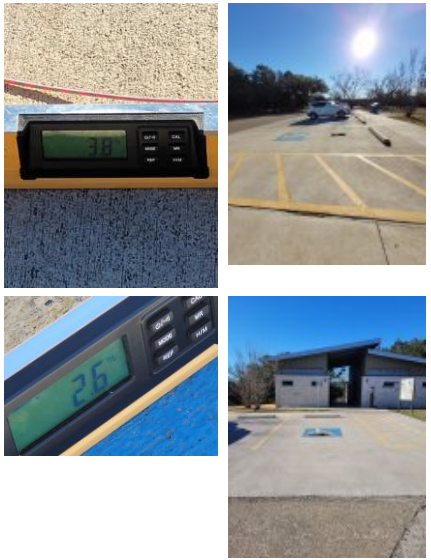
51	Camping Area - Site 63: Camping - Parking by Site 63 and Exterior Accessible Route	[30.31141, -98.2475734]	The cross slopes (narrow dimension) and/or running slopes (long dimension) of the access aisle exceeds 2%. The running slope and the cross slope in an accessible parking stall and the access aisle must not exceed 2%.	restroom building by site 63 - stall - 3.8% slope, 2.6% slope	Repair or correct slope of parking space and access aisle to max 2.08% in any direction.	2015 ABAAS Section: 502.4 2012 TAS Section: 502.4 2010 ADAS Section: 502.4

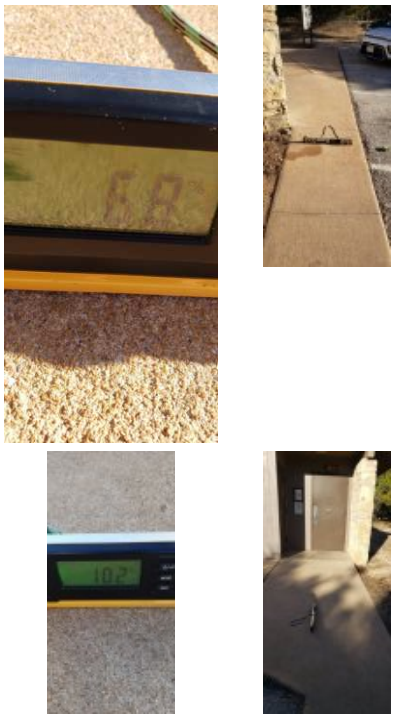
Finding Number	Area Description	Lat/Long	Finding	As Built	Recommendation	Citation	Photos	Figure
53	Camping Area - Site 63: Camping - Parking by Site 63 and Exterior Accessible Route	[30.3114285 , -98.247594 9]	The accessible route has running slopes greater than 5% and has not been constructed as a ramp (i.e. handrails, edge protection, etc.). Cross slopes are greater than 2% across the width of the walk. When the slope in the direction of travel of any walk exceeds 1 unit vertical in 20 units horizontal (5-percent slope), it must be constructed as a ramp. Surface cross slopes must not exceed 1 unit vertical in 48 units horizontal (2-percent slope).	6.8% cross slope; running slope 10.1%	Correct running slope along the AR to max 5% Correct cross slope along the AR to max 2%	2015 ABAAS Section: 403.3 2012 TAS Section: 403.3 2010 ADAS Section: 403.3

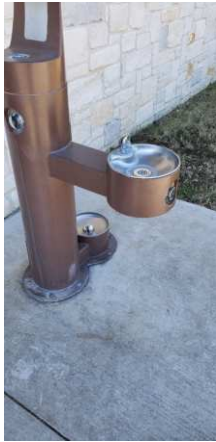
54	Camping Area - Site 63: Camping - Parking by Site 63 and Exterior Accessible Route	[30.3113915 , -98.247594 9]	There is no drinking fountain for standing persons. Spout outlets of drinking fountains for standing persons shall be 38 inches minimum and 43 inches maximum above the finish floor or ground.	lacks fountain for standing person	Add second high bowl fountain for standing persons.	2015 ABAAS Section: 602.7 2012 TAS Section: 602.7 2010 ADAS Section: 602.7, 211.2

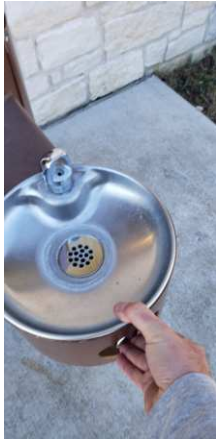
Finding Number	Area Description	Lat/Long	Finding	As Built	Recommendation	Citation	Photos	Figure
55	Camping Area - Site 63: Camping - Parking by Site 63 and Exterior Accessible Route	[30.31141, -98.247552]	The water flow from the spout is too low. The spout shall provide a flow of water 4 inches high minimum.	unable to determine current state due to water being off	Ensure spout flow height is min 4".	2015 ABAAS Section: 602.6 2012 TAS Section: 602.6 2010 ADAS Section: 602.6

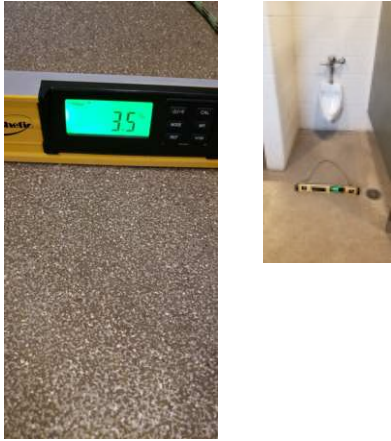
Finding Number	Area Description	Lat/Long	Finding	As Built	Recommendation	Citation	Photos	Figure
58	Camping Area - Site 63: Camping Area - Men's Restroom By 63	[30.3114146 , -98.247584 2]	The accessible route contains running slopes greater than 5 percent and cross slopes greater than 2 percent across the width of the walk and has not been constructed as a ramp (i.e. handrails, wheel guides, etc.). When the slope in the direction of travel of any walk exceeds 1 unit vertical in 20 units horizontal (5-percent slope), it must be constructed as ramp. Surface cross slopes must not exceed one unit vertical in 48 units. Horizontal (2-percent slope).	3.5% cross slope at urinal	Correct or repair slope to max 2.08% in restroom.	2015 ABAAS Section: 403.3 2012 TAS Section: 403.3 2010 ADAS Section: 403.3

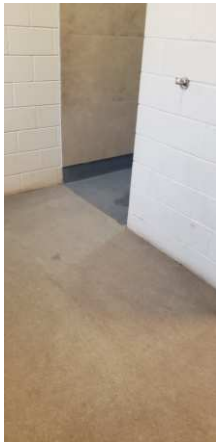
59	Camping Area - Site 63: Camping Area - Men's Restroom By 63	[30.30802, -98.25768]	The bench is not deep enough or long enough or is missing. Benches shall be provided having seats that are 42 inches long minimum and 20 inches deep minimum and 24 inches deep maximum. The bench shall provide for back support or shall be affixed to a wall. Back support shall be 42 inches (1065 mm) long minimum and shall extend from a point 2 inches (51 mm) maximum above the seat surface to a point 18 inches (455 mm) minimum above the seat surface. Back support shall be 2½ inches (64 mm) maximum from the rear edge of the seat measured horizontally. The top of the bench seat surface shall be 17 inches (430 mm) minimum and 19 inches (485 mm) maximum above the finish floor or ground. Clear floor or ground space complying with 305 shall be provided and shall be positioned at the end of the bench seat and parallel to the short axis of the bench	shower area has no bench	Acquire and install bench in dressing area having a seat depth of 20" to 24" deep, 42" long, affixed to the wall or having a back and mounted 17" to 19" AFF and provide required clear floor space on the short axis of the bench.	2012 TAS Section: 903.4, 903.2, 903.3, 903.5 2010 ADAS Section: 903.4, 903.2, 903.3, 903.5

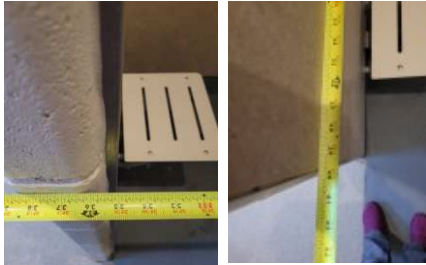
Finding Number	Area Description	Lat/Long	Finding	As Built	Recommendation	Citation	Photos	Figure
65	Camping Area - Site 63: Camping Area - Unisex Across Women's By 63	[30.3113984 , -98.247592 2]	Transfer type shower compartments shall be 36 inches (915 mm) by 36 inches (915 mm) clear inside dimensions measured at the center points of opposing sides and shall have a 36 inch (915 mm) wide minimum entry on the face of the shower compartment. Clearance of 36 inches (915 mm) wide minimum by 48 inches (1220 mm) long minimum measured from the control wall shall be provided.	Transfer shower dimensions fail - 35" x 40"	Reconfigure transfer shower to compliant 36" by 36" clear inside dimension.	2015 ABAAS Section: 608.2.1 2012 TAS Section: 608.2.1 2010 ADAS Section: 608.2.1

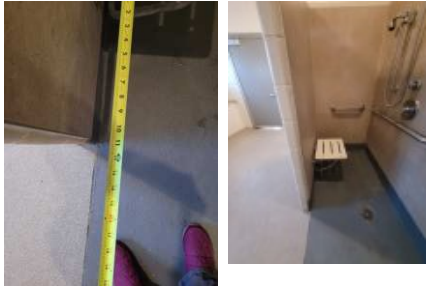
66	Camping Area - Site 63: Camping Area - Unisex Across Women's By 63	[30.3114285 , -98.247584 2]	Where a seat is provided in a standard roll-in shower compartment, it shall be a folding type, shall be installed on the side wall adjacent to the controls, and shall extend from the back wall to a point within 3 inches (75 mm) of the compartment entry. Where a seat is provided in an alternate roll-in type shower compartment, it shall be a folding type, shall be installed on the front wall opposite the back wall, and shall extend from the adjacent side wall to a point within 3 inches (75 mm) of the compartment entry. In transfer-type showers, the seat shall extend from the back wall to a point within 3 inches (75 mm) of the compartment entry. The top of the seat shall be 17 inches (430 mm) minimum and 19 inches (485 mm) maximum above the bathroom finish floor. Seats shall comply with 610.3.1 or 610.3.2.	shower seat mounted 11" from entry	Remount seat to be within 3" of the front of the compartment. Replace seat if a different model is needed.	2015 ABAAS Section: 610.3 2012 TAS Section: 610.3 2010 ADAS Section: 610.3

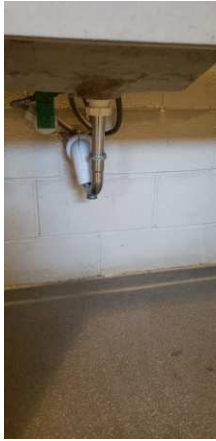
Finding Number	Area Description	Lat/Long	Finding	As Built	Recommendation	Citation	Photos	Figure
70	Camping Area - Site 63: Camping Area - Unisex Accross Men's Restroom By 63	[30.30802, -98.25768]	The water and drain pipes under the lavatory are not adequately insulated. Water supply and drain pipes under lavatories and sinks shall be insulated or otherwise configured to protect against contact. There shall be no sharp or abrasive surfaces under lavatories and sinks.	sink pipes not insulated	Insulate exposed pipes under one sink.	2015 ABAAS Section: 606.5 2012 TAS Section: 606.5 2010 ADAS Section: 606.5

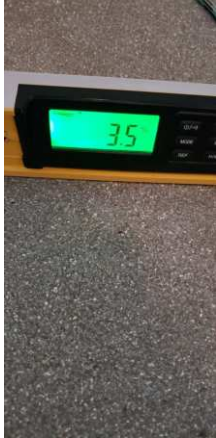
71	Camping Area - Site 63: Camping Area - Unisex Accross Men's Restroom By 63	[30.30802, -98.25768]	The accessible route contains running slopes greater than 5 percent and cross slopes greater than 2 percent across the width of the walk and has not been constructed as a ramp (i.e. handrails, wheel guides, etc.). When the slope in the direction of travel of any walk exceeds 1 unit vertical in 20 units horizontal (5-percent slope), it must be constructed as ramp. Surface cross slopes must not exceed one unit vertical in 48 units. Horizontal (2-percent slope).	3.5% cross slope in toilet clearance	Correct or repair slope to max 2.08% in restroom.	2015 ABAAS Section: 403.3 2012 TAS Section: 403.3 2010 ADAS Section: 403.3

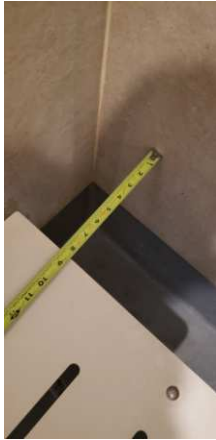
Finding Number	Area Description	Lat/Long	Finding	As Built	Recommendation	Citation	Photos	Figure
74	Camping Area - Site 63: Camping Area - Unisex Accross Men's Restroom By 63	[30.30802, -98.25768]	The shower seat does not have a compliant space between it and the seat wall. The folding seat must be mounted 17-19 inches above the floor, and have a maximum space of 2-1/2 inches between the edge of the seat and the seat wall and 1-1/2 inches maximum to the side wall.	seat mounted 8" from side wall	Remount shower seat to the correct location and height in the shower. See previous finding.	2015 ABAAS Section: 610.3.1 2012 TAS Section: 610.3.1 2010 ADAS Section: 610.3.1

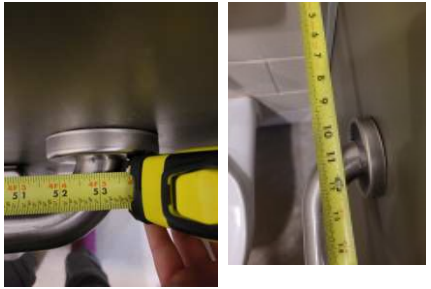
76	Camping Area - Site 63: Camping Area - Women's Restroom By 63	[30.30802, -98.25768]	The side grab bars are not in the correct location. Grab bars on the side wall must be installed so that the end closest to the rear wall is maximum 12" from the rear wall. The end furthest from the rear wall must be mounted minimum 54" from the rear wall.	side grab bar - mounted 11" from rear wall, 53" to grab bar end	Remount side grab bar to max 12" from the rear wall at the close end and min 54" on the far end, and 33" to 36" aff.	2015 ABAAS Section: 604.5.1 2012 TAS Section: 604.5.1 2010 ADAS Section: 604.5.1

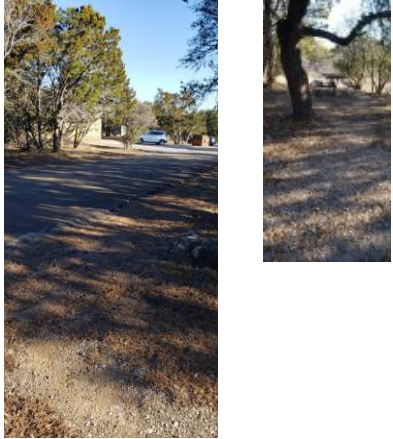
Finding Number	Area Description	Lat/Long	Finding	As Built	Recommendation	Citation	Photos	Figure
81	Camping Area - Site 63: Campsite Area - Site 67	[30.3118511 , -98.246216 2]	An accessible access route is not provided between elements, spaces and the facilities provided within the accessible camping unit. At least one outdoor recreation access route shall connect accessible elements, spaces and facilities provided within camping units with mobility features.	site 67 - no ORAR to bathroom or amenities	Create AR with crushed and compacted stone or similar outdoor material to camp sites and one of each type of amenity.	2015 ABAAS Section: F244.5.1

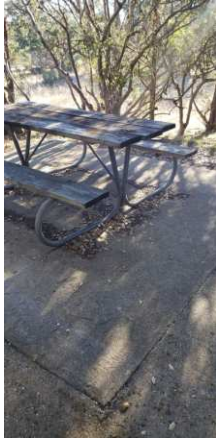
Finding Number	Area Description	Lat/Long	Finding	As Built	Recommendation	Citation	Photos	Figure
83	Camping Area - Site 63: Campsite Area - Site 67	[30.3117342 , -98.246318 2]	Picnic tables shall provide at least one wheelchair space for each 24 linear feet (7320 mm) of usable table surface perimeter. Wheelchair spaces shall be 30 inches (760 mm) minimum by 48 inches (1220 mm) minimum. Wheelchair spaces shall be positioned for a forward approach to the table and provide knee and toe clearance complying with 306 under the table	site 67 - 0 of 1 tables accessible	Replace picnic table with one of an accessible design as a smart practice	2015 ABAAS Section: 1011.4.2

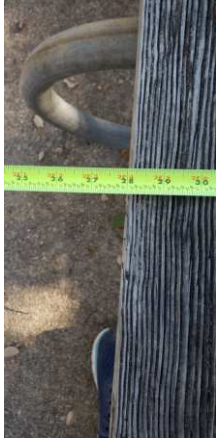
84	Camping Area - Site 63: Campsite Area - Site 67	[30.3117087 , -98.246366 4]	Picnic tables are required to have clear ground space 36 inches (915 mm) on all usable sides of the table measured from the back edge of the benches.	site 67 - 28" from edge of seat	Provide required 36" clear ground space around all usable portions of the table as a smart practice.	2015 ABAAS Section: 1011.2.1

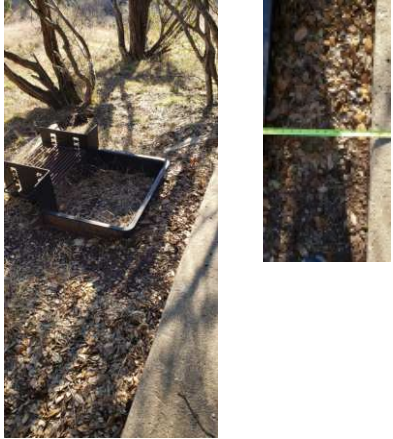
Finding Number	Area Description	Lat/Long	Finding	As Built	Recommendation	Citation	Photos	Figure
85	Camping Area - Site 63: Campsite Area - Site 67	[30.3117434 , -98.246296 7]	Clear ground space 48 inches (1220 mm) by 48 inches (1220 mm) should be provided on all usable sides of the fire ring, grill, fireplace, and woodstove. Center the space on each usable side of the grill, fireplace, and woodstove.	site 67 - fire ring not accessible, lacks CFS	Provide required 48" clear ground space centered along usable side of fire ring, grill, fireplace, or woodstove as a smart practice.	2015 ABAAS Section: 1011.2

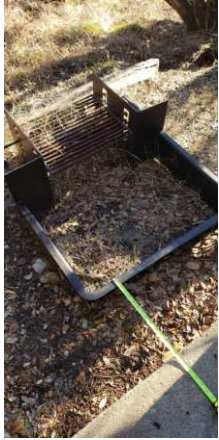
86	Camping Area - Site 63: Campsite Area - Site 67	[30.3117944 , -98.246275 2]	Fire building surfaces shall be 9 inches (230 mm) minimum above the ground.	site 67 - fire surface below surface	Correct fire building surface to be 9" min above the ground as a smart practice. In the alternative, replace fire ring with a compliant accessible fire ring.	2015 ABAAS Section: 1011.5.1

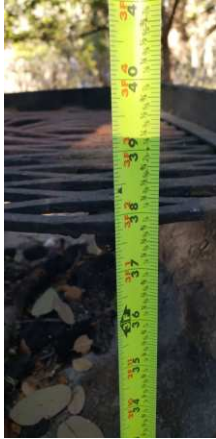
Finding Number	Area Description	Lat/Long	Finding	As Built	Recommendation	Citation	Photos	Figure
87	Camping Area - Site 63: Campsite Area - Site 67	[30.3118592 , -98.246275 2]	Where provided, cooking surfaces shall be 15 inches (380 mm) minimum and 34 inches (865 mm) maximum above the ground.	site 67 - cooking surface 38" aff	Raise or lower cooking surface to be 15" min to 34" max above the ground; in the alternative, replace with a compliant surface as a smart practice.	2015 ABAAS Section: 1011.5.2

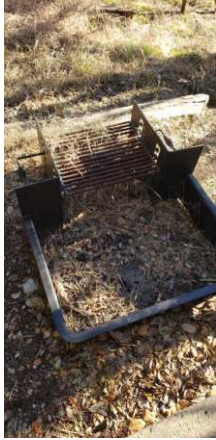
88	Camping Area - Site 63: Campsite Area - Site 67	[30.3117434 , -98.246328 9]	There are not enough outdoor constructed features with mobility features located in the common uses and public use areas. Where provided in common use and public use areas that serve picnic units with mobility features, at least 20 percent, but not less than one, of each type of outdoor constructed feature must be provided at each location.	site 67 - 0 of 2 cooking surface accessible	Replace 20%, but not less than one of each type of outdoor constructed feature in common areas. See previous findings.	2015 ABAAS Section: F245.3

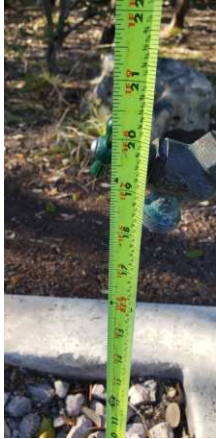
Finding Number	Area Description	Lat/Long	Finding	As Built	Recommendation	Citation	Photos	Figure
89	Camping Area - Site 63: Campsite Area - Site 67	[30.3117759 , -98.246323 5]	Water spouts at water hydrants and water utility hook-ups shall be 28 inches (710 mm) minimum and 36 inches (915 mm) maximum above the ground	site 67 - water hookup 18" aff	Remount water spouts to 28" min or 36" max above the ground as a smart practice	2015 ABAAS Section: 1011.6

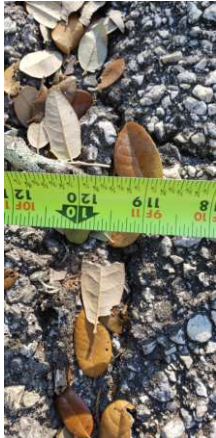
91	Camping Area - Site 63: Campsite Area - Site 67	[30.3118152 , -98.246320 8]	Parking spaces and pull-up spaces for recreational vehicles shall be 20 feet (6100 mm) wide minimum. EXCEPTION: Where two adjacent parking spaces are provided for recreational vehicles, one parking space shall be permitted to be 16 feet (4880 mm) wide minimum.	site 67 - 10' wide	Correct RV parking space to be 20' wide minimum; or a single spaces can be minimum 16' when two adjacent spaces are provided as a smart practice.	2015 ABAAS Section: 1012.2, 1012.2 EXCEPTION

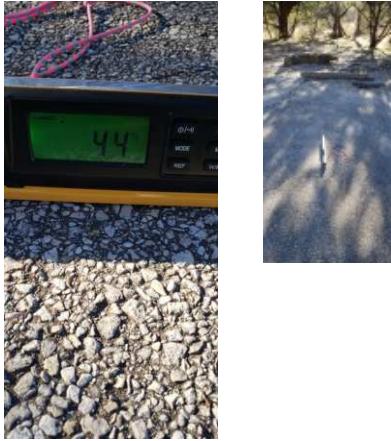
Finding Number	Area Description	Lat/Long	Finding	As Built	Recommendation	Citation	Photos	Figure
92	Camping Area - Site 63: Campsite Area - Site 67	[30.3118268 , -98.246286]	The surface of parking spaces and pull-up spaces shall be firm and stable. The slope of the surface of parking spaces and pull-up spaces shall not be steeper than 1:48 in any direction. EXCEPTION: Where the surface is other than asphalt, concrete, or boards, slopes not steeper than 1:20 shall be permitted when necessary for drainage.	site 67 - 4.4% slope	Correct surface of parking spaces to be firm and stable with slopes max of 2.08% as a smart practice.	2015 ABAAS Section: 1012.4, 1012.5, 1012.5 EXCEPTION

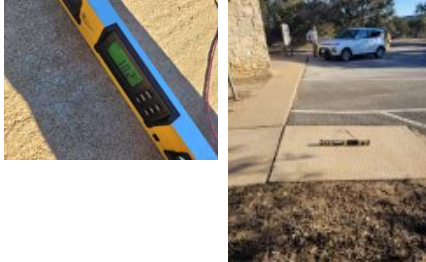
Finding Number	Area Description	Lat/Long	Finding	As Built	Recommendation	Citation	Photos	Figure
97	Camping Area - Site 68: Camping Area - Parking by Site 68	[30.3121093 , -98.246382 5]	The running slope of walking surfaces shall not be steeper than 1:20.	10.2% slope restroom building by site 68	Correct running slope along the AR to max 5%	2015 ABAAS Section: 403.3 2012 TAS Section: 403.3 2010 ADAS Section: 403.3

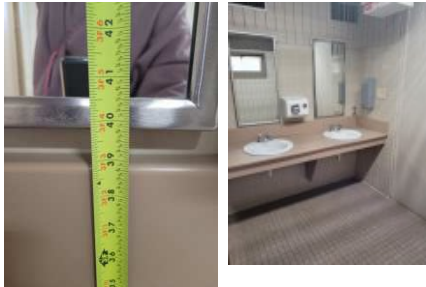
99	Camping Area - Site 68: Camping Area - Women's Restroom By 68	[30.3120861 , -98.246371 8]	The mirror is mounted too high. Mirrors must have the bottom edge of the reflecting surface a maximum of 40 inches above the floor if above a sink or counter. Mirrors not located above lavatories or countertops shall be installed with the bottom edge of the reflecting surface 35 inches maximum above the finish floor or ground.	mirrors 40.5" aff	Lower mirror so reflective surface is max 40" aff	2015 ABAAS Section: 603.3 2012 TAS Section: 603.3 2010 ADAS Section: 603.3

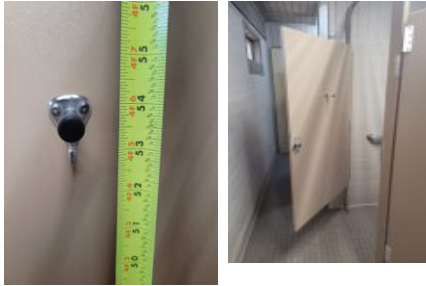
Finding Number	Area Description	Lat/Long	Finding	As Built	Recommendation	Citation	Photos	Figure
100	Camping Area - Site 68: Camping Area - Women's Restroom By 68	[30.3120815 , -98.246385 2]	The operable part is positioned too high for either a side or front approach. Where a clear floor or ground space allows a parallel approach to an element and the side reach is unobstructed, the high side reach shall be 48 inches maximum and the low side reach shall be 15 inches minimum above the finish floor or ground. Where a forward reach is unobstructed, the high forward reach shall be 48 inches maximum and the low forward reach shall be 15 inches minimum above the finish floor or ground.	hook in stall 53" AFF	Remount operable parts to be in reach range of 15" min to 48" max	2015 ABAAS Section: 308.1 2012 TAS Section: 308.1 2010 ADAS Section: 308.1

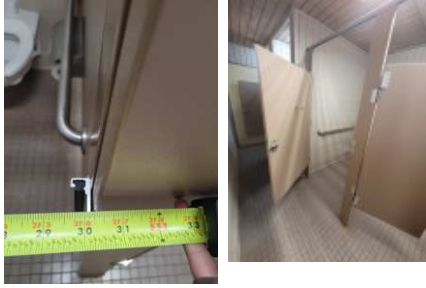
102	Camping Area - Site 68: Camping Area - Women's Restroom By 68	[30.3120792 , -98.246374 5]	The stall door fails to comply with all of the door requirements. The stall door must be a minimum of 32" wide and have compliant hardware on both sides. The stall door must be self-closing.	30.5" door width	Widen stall doors to 32" when opened to 90 degrees	2015 ABAAS Section: 404.2.3, 404.2.7, 604.8.2.2 2012 TAS Section: 404.2.3, 404.2.7, 604.8.2.2 2010 ADAS Section: 404.2.3, 404.2.7, 604.8.2.2

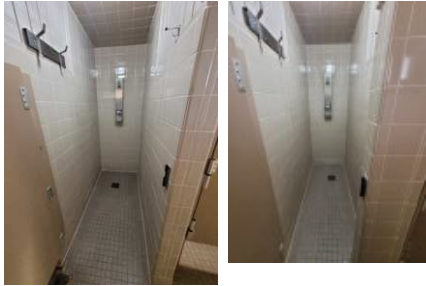
Finding Number	Area Description	Lat/Long	Finding	As Built	Recommendation	Citation	Photos	Figure
105	Camping Area - Site 68: Camping Area - Women's Restroom By 68	[30.3120861 , -98.2463825]	There are no accessible bathing or shower facilities. Where facilities for bathing are provided for the public, clients or employees, including showers or bathtubs, at least one shower or bathtub and support facilities such as lockers, and not less than 1 percent of all facilities, shall be accessible.	two standard showers only	Create an accessible shower in locker/bathing room	2015 ABAAS Section: F213.3.6 2012 TAS Section: 213.3.6 2010 ADAS Section: 213.3.6

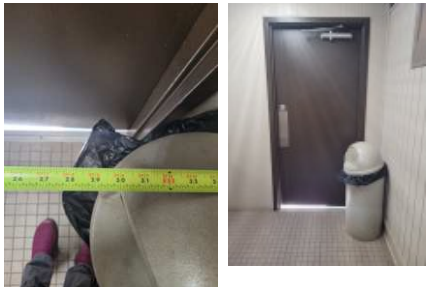
106	Camping Area - Site 68: Camping Area - Women's Restroom By 68	[30.3121023 , -98.2463745]	The door opening does not provide at least 32 inches between the face of the door and the opposite stop. Door openings shall provide a clear width of 32 inches minimum. Clear openings of doorways with swinging doors shall be measured between the face of the door and the stop, with the door open 90 degrees. There shall be no projections into the required clear opening width lower than 34 inches above the finish floor or ground. Projections into the clear opening width between 34 inches and 80 inches above the finish floor or ground shall not exceed 4 inches.	Door - trash projects into 32" clear width	Relocate trash to provide 32" clear width	2015 ABAAS Section: 404.2.3 2012 TAS Section: 404.2.3 2010 ADAS Section: 404.2.3

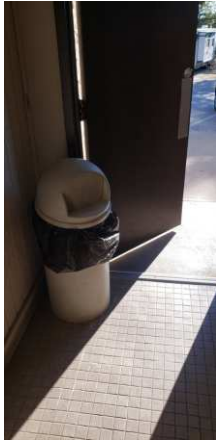
107	Camping Area - Site 68: Camping Area - Men's Restroom by 68	[30.3114239 , -98.2475842]	Minimum maneuvering clearances at doors and gates shall comply with 404.2.4. Maneuvering clearances shall extend the full width of the doorway and the required latch side or hinge side clearance.	trash can stored in door clearance	Relocate obstacles to provide 48" maneuvering clearance around door.	2015 ABAAS Section: 404.2.4.4, 404.2.4.1 2012 TAS Section: 404.2.4.4, 404.2.4.1 2010 ADAS Section: 404.2.4.4, 404.2.4.1

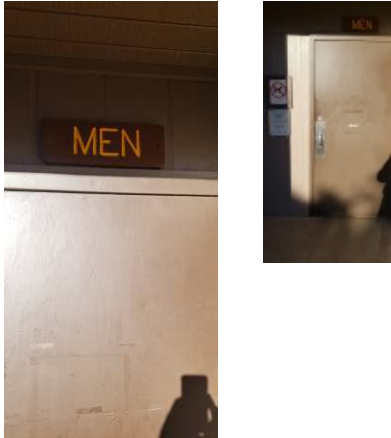
Finding Number	Area Description	Lat/Long	Finding	As Built	Recommendation	Citation	Photos	Figure
108	Camping Area - Site 68: Camping Area - Men's Restroom by 68	[30.3116, -98.24763]	The restroom sign does not comply with one or more applicable requirements for the location, height, and properties of the sign.	signage above door, lacks Braille and raised characters, no symbol of access	Acquire and mount signage, including Braille, raised lettering and access symbol mounted on wall, latch side of door, 48" to baseline of lowest character and 60" to baseline of highest character.	2015 ABAAS Section: F216.2, 703.1, 703.2, 703.5, 703.6 2012 TAS Section: 216.2, 703.1, 703.2, 703.5, 703.6 2010 ADAS Section: 216.2, 703.1, 703.2, 703.5, 703.6

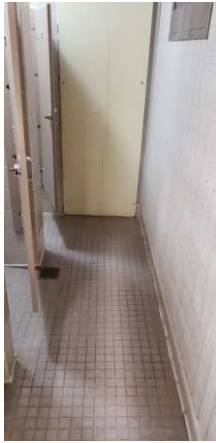
109	Camping Area - Site 68: Camping Area - Men's Restroom by 68	[30.31141, -98.2475976]	The bench is not deep enough or long enough or is missing. Benches shall be provided having seats that are 42 inches long minimum and 20 inches deep minimum and 24 inches deep maximum. The bench shall provide for back support or shall be affixed to a wall. Back support shall be 42 inches (1065 mm) long minimum and shall extend from a point 2 inches (51 mm) maximum above the seat surface to a point 18 inches (455 mm) minimum above the seat surface. Back support shall be 2½ inches (64 mm) maximum from the rear edge of the seat measured horizontally. The top of the bench seat surface shall be 17 inches (430 mm) minimum and 19 inches (485 mm) maximum above the finish floor or ground. Clear floor or ground space complying with 305 shall be provided and shall be positioned at the end of the bench seat and parallel to the short axis of the bench	shower area has no bench	Acquire and install bench in dressing area having a seat depth of 20" to 24" deep, 42" long, affixed to the wall or having a back and mounted 17" to 19" AFF and provide required clear floor space on the short axis of the bench.	2012 TAS Section: 903.4, 903.2, 903.3, 903.5 2010 ADAS Section: 903.4, 903.2, 903.3, 903.5

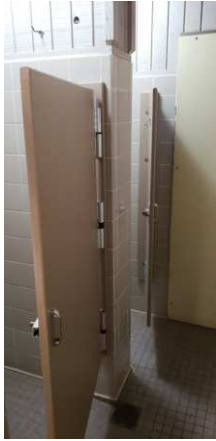
Finding Number	Area Description	Lat/Long	Finding	As Built	Recommendation	Citation	Photos	Figure
110	Camping Area - Site 68: Camping Area - Men's Restroom by 68	[30.3114193 , -98.247605 6]	There are no accessible bathing or shower facilities. Where facilities for bathing are provided for the public, clients or employees, including showers or bathtubs, at least one shower or bathtub and support facilities such as lockers, and not less than 1 percent of all facilities, shall be accessible.	no accesible shower	Create an accessible shower in locker/bathing room	2015 ABAAS Section: F213.3.6 2012 TAS Section: 213.3.6 2010 ADAS Section: 213.3.6

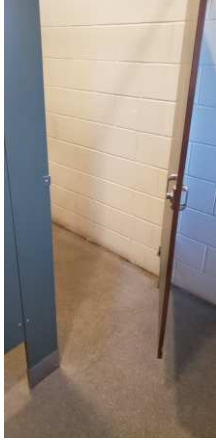
111	Camping Area - Site 68: Camping Area - Men's Restroom by 68	[30.3113915 , -98.247530 5]	The stall door fails to comply with all of the door requirements. The stall door must be a minimum of 32" wide and have compliant hardware on both sides. The stall door must be self-closing.	stall door not self closing	Adjust stall door to be self-closing	2015 ABAAS Section: 404.2.3, 404.2.7, 604.8.2.2 2012 TAS Section: 404.2.3, 404.2.7, 604.8.2.2 2010 ADAS Section: 404.2.3, 404.2.7, 604.8.2.2

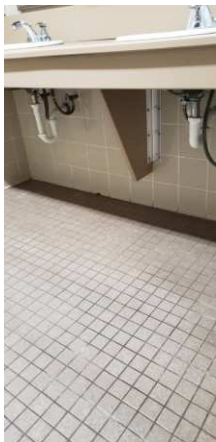
Finding Number	Area Description	Lat/Long	Finding	As Built	Recommendation	Citation	Photos	Figure
112	Camping Area - Site 68: Camping Area - Men's Restroom by 68	[30.3116, -98.24763]	The water and drain pipes under the lavatory are not adequately insulated. Water supply and drain pipes under lavatories and sinks shall be insulated or otherwise configured to protect against contact. There shall be no sharp or abrasive surfaces under lavatories and sinks.	lack insulation	Insulate exposed pipes under one sink.	2015 ABAAS Section: 606.5 2012 TAS Section: 606.5 2010 ADAS Section: 606.5

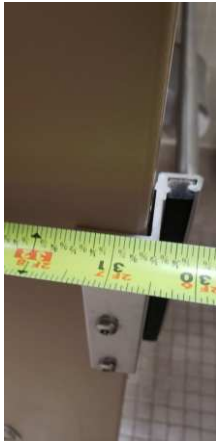
113	Camping Area - Site 68: Camping Area - Men's Restroom by 68	[30.3116, -98.24763]	There are not enough accessible toilet compartments. The room contains toilet compartments. A minimum of 1 must be wheelchair accessible .	ambulatory stall only, lacks wheelchair stall	Create a wheelchair accessible stall with grab bars and fixtures mounted in correct locations and at correct heights.	2015 ABAAS Section: F213.3.1 2012 TAS Section: 213.3.1 2010 ADAS Section: 213.3.1

114	Camping Area - Site 68: Camping Area - Men's Restroom by 68	[30.3116, -98.24763]	The ambulatory stall is not between 35" to 37" wide and 60" deep.	30.5" width	Correct ambulatory stall to be 35" to 37" wide and minimum 60" deep. In the alternative, use existing stall to create required wheelchair stall.	2015 ABAAS Section: 604.8.2.1 2012 TAS Section: 604.8.2.1 2010 ADAS Section: 604.8.2.1

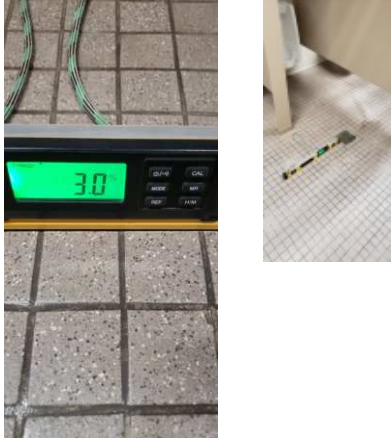
116	Camping Area - Site 68: Camping Area - Men's Restroom by 68	[30.3116, -98.24763]	The accessible route contains running slopes greater than 5 percent and cross slopes greater than 2 percent across the width of the walk and has not been constructed as a ramp (i.e. handrails, wheel guides, etc.). When the slope in the direction of travel of any walk exceeds 1 unit vertical in 20 units horizontal (5-percent slope), it must be constructed as ramp. Surface cross slopes must not exceed one unit vertical in 48 units. Horizontal (2-percent slope).	3% slope at urinal	Correct or repair slope to max 2.08% cross.	2015 ABAAS Section: 403.3 2012 TAS Section: 403.3 2010 ADAS Section: 403.3

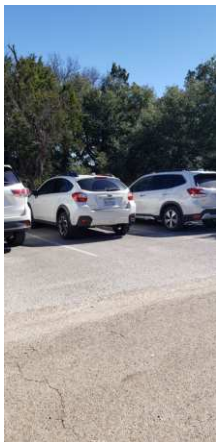
Finding Number	Area Description	Lat/Long	Finding	As Built	Recommendation	Citation	Photos	Figure
117	Trails: Trail Parking and Exterior Accessible Route	[30.3122343 , -98.245406 2]	There are no or not enough accessible parking stalls. Each lot where parking is provided for the public as clients, guests or employees, shall provide accessible parking and shall be located on the shortest accessible route of travel from adjacent parking to an accessible entrance. There are a total of (XX) parking stalls in the parking lot that could be reasonably associated with this facility. There should be a minimum of (XX) accessible stalls with a minimum of (XX) being designed as van accessible.	Trammell's trailhead parking- 0 of 7 parking stalls accessible	Create one or more 8' accessible parking stalls, with one 5' adjacent access aisle, with proper signage and striping based on the total number of stalls.	2015 ABAAS Section: F208.2 2012 TAS Section: 208.2 2010 ADAS Section: 208.2

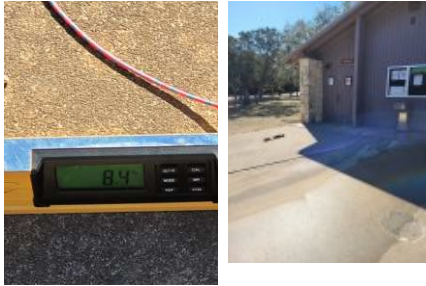
Finding Number	Area Description	Lat/Long	Finding	As Built	Recommendation	Citation	Photos	Figure
120	Trails: Trail Parking and Exterior Accessible Route	[30.3341251, -98.252392]	The running slope of walking surfaces shall not be steeper than 1:20.	8.4% slope outside of Pedernales Falls trailhead restroom building	Correct running slope along the AR to max 5%	2015 ABAAS Section: 403.3 2012 TAS Section: 403.3 2010 ADAS Section: 403.3

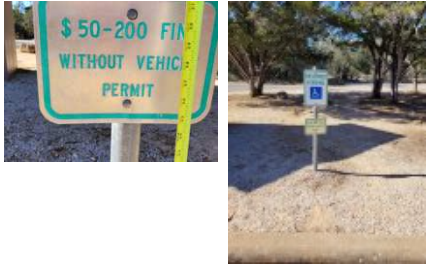
122	Trails: Trail Parking and Exterior Accessible Route	[30.3341899, -98.2524872]	The parking sign is mounted too low. Parking space identification signs shall include the International Symbol of Accessibility complying with. Signs identifying van parking spaces shall contain the designation "van accessible." Signs shall be 60 inches minimum above the finish floor or ground surface measured to the bottom of the sign.	Pedernales Falls trailhead restroom - fine sign 27" agl	Raise existing accessible parking signs so lowest end of bottom sign is min 60" agl.	2015 ABAAS Section: 502.6 2012 TAS Section: 502.6 2010 ADAS Section: 502.6

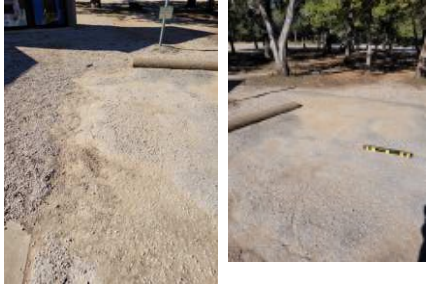
Finding Number	Area Description	Lat/Long	Finding	As Built	Recommendation	Citation	Photos	Figure
123	Trails: Trail Parking and Exterior Accessible Route	[30.3341784 , -98.252473 8]	The parking stall contains abrupt edges and surface irregularities over a 1/4 inch vertical. Parking spaces and access aisles serving them shall be stable, firm, and slip resistant. Access aisles shall be at the same level as the parking spaces they serve. Changes in level are not permitted and shall not be sloped steeper than 2% in any direction.	Pedernales Falls trailhead restroom - gravel present	Resurface accessible stalls and access aisles with a firm, stable, and slip resistant material	2015 ABAAS Section: 502.4 2012 TAS Section: 502.4 2010 ADAS Section: 502.4

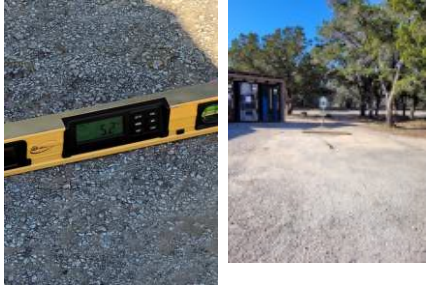
124	Trails: Trail Parking and Exterior Accessible Route	[30.3341633 , -98.252444 3]	The cross slopes (narrow dimension) and/or running slopes (long dimension) of the access aisle exceeds 2%. The running slope and the cross slope in an accessible parking stall and the access aisle must not exceed 2%.	Pedernales Falls trailhead restroom - 5.2% slope	Repair or correct slope of parking space and access aisle to max 2.08% in any direction.	2015 ABAAS Section: 502.4 2012 TAS Section: 502.4 2010 ADAS Section: 502.4

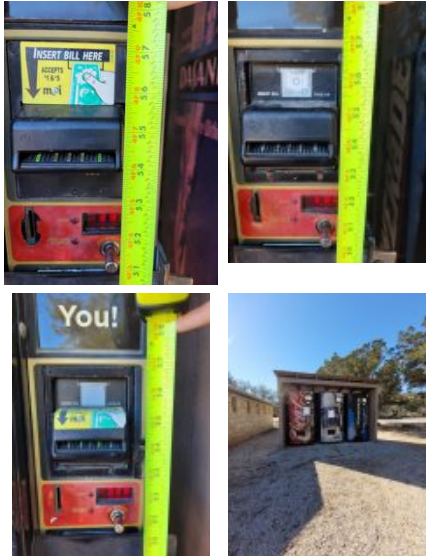
Finding Number	Area Description	Lat/Long	Finding	As Built	Recommendation	Citation	Photos	Figure
129	Trails: Trailhead	[30.3341043 , -98.252465 8]	The operable part is positioned too high for either a side or front approach. Where a clear floor or ground space allows a parallel approach to an element and the side reach is unobstructed, the high side reach shall be 48 inches maximum and the low side reach shall be 15 inches minimum above the finish floor or ground. Where a forward reach is unobstructed, the high forward reach shall be 48 inches maximum and the low forward reach shall be 15 inches minimum above the finish floor or ground.	3 of 3 vending at Pedernales Falls trailhead restroom building are 54" aff	Leave as is vending machines citing safe harbor.	2015 ABAAS Section: 308.1 2012 TAS Section: 308.1 2010 ADAS Section: 308.1

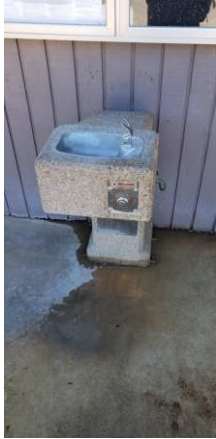
Finding Number	Area Description	Lat/Long	Finding	As Built	Recommendation	Citation	Photos	Figure
133	Trails: Trailhead	[30.3340823 , -98.252392]	There is no drinking fountain for standing persons. Spout outlets of drinking fountains for standing persons shall be 38 inches minimum and 43 inches maximum above the finish floor or ground.	Pedernales Falls trailhead - lacks fountain for standing person	Add second high bowl fountain for standing persons.	2015 ABAAS Section: 602.7 2012 TAS Section: 602.7 2010 ADAS Section: 602.7, 211.2

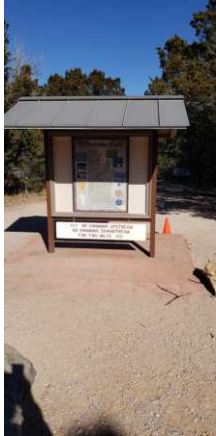
134	Trails: Trailhead	[30.3344793 , -98.252846 7]	The surface of trails, passing spaces, and resting intervals shall be firm and stable	Pedernales Falls Trailhead - no accessible route to trailhead or sign, loose rock surface	Establish protocols for regular and frequent inspection and maintenance of accessible trail surface as a smart practice	2015 ABAAS Section: 1017.2

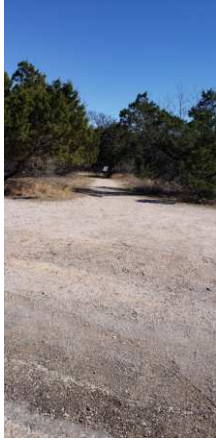
Finding Number	Area Description	Lat/Long	Finding	As Built	Recommendation	Citation	Photos	Figure
135	Trails: Trailhead	[30.3122806 , -98.244998 5]	The surface of trails, passing spaces, and resting intervals shall be firm and stable	Twin Falls Trail - no accessible route to trailhead or sign, loose rock surface	Establish protocols for regular and frequent inspection and maintenance of accessible trail surface as a smart practice	2015 ABAAS Section: 1017.2

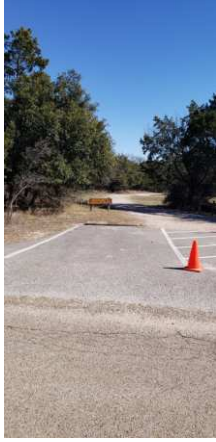
136	Trails: Trailhead	[30.3123084 , -98.245320 4]	The surface of trails, passing spaces, and resting intervals shall be firm and stable	trammel crossing river access trail - no accessible route to trailhead or sign, loose rock surface	Establish protocols for regular and frequent inspection and maintenance of accessible trail surface as a smart practice	2015 ABAAS Section: 1017.2

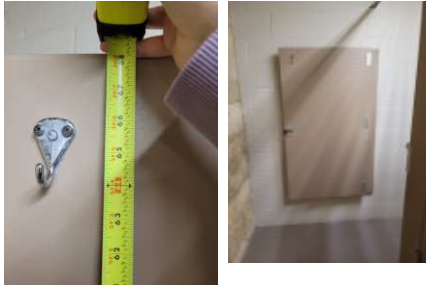
Finding Number	Area Description	Lat/Long	Finding	As Built	Recommendation	Citation	Photos	Figure
140	Trails: Pedernales Falls Trailhead - Women's Restroom	[30.3340811 , -98.2523907]	The operable part is positioned too high for either a side or front approach. Where a clear floor or ground space allows a parallel approach to an element and the side reach is unobstructed, the high side reach shall be 48 inches maximum and the low side reach shall be 15 inches minimum above the finish floor or ground. Where a forward reach is unobstructed, the high forward reach shall be 48 inches maximum and the low forward reach shall be 15 inches minimum above the finish floor or ground.	hook in ambulatory stall 64" AFF	Remount operable parts to be in reach range of 15" min to 48" max	2015 ABAAS Section: 308.1 2012 TAS Section: 308.1 2010 ADAS Section: 308.1

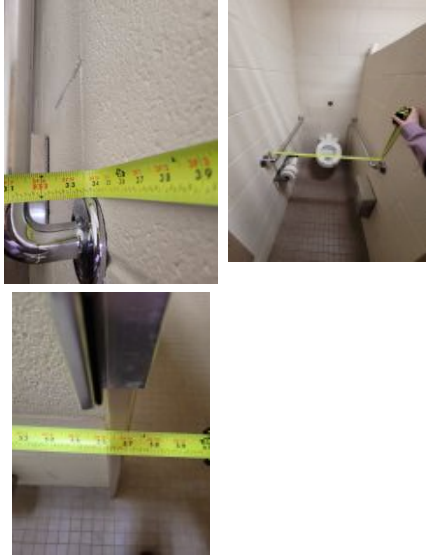
141	Trails: Pedernales Falls Trailhead - Women's Restroom	[30.3340904 , -98.25238]	There are not enough accessible toilet compartments. The room contains toilet compartments. A minimum of 1 must be wheelchair accessible .	2 standard, 1 ambulatory stall, no wheelchair accessible stall	Create a wheelchair accessible stall with grab bars and fixtures mounted in correct locations and at correct heights.	2015 ABAAS Section: F213.3.1 2012 TAS Section: 213.3.1 2010 ADAS Section: 213.3.1

142	Trails: Pedernales Falls Trailhead - Women's Restroom	[30.3340626 , -98.2523746]	The ambulatory stall is not between 35" to 37" wide and 60" deep.	34" width, 56" depth	Correct ambulatory stall to be 35" to 37" wide and minimum 60" deep. In the alternative, use existing stall to create required wheelchair stall.	2015 ABAAS Section: 604.8.2.1 2012 TAS Section: 604.8.2.1 2010 ADAS Section: 604.8.2.1

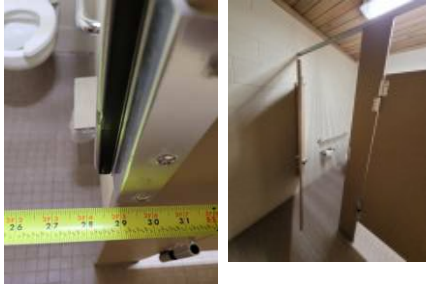
Finding Number	Area Description	Lat/Long	Finding	As Built	Recommendation	Citation	Photos	Figure
143	Trails: Pedernales Falls Trailhead - Women's Restroom	[30.3340765 , -98.252396]	The stall door fails to comply with all of the door requirements. The stall door must be a minimum of 32" wide and have compliant hardware on both sides. The stall door must be self-closing.	29" width	Widen stall doors to 32" when opened to 90 degrees	2015 ABAAS Section: 404.2.3, 404.2.7, 604.8.2.2 2012 TAS Section: 404.2.3, 404.2.7, 604.8.2.2 2010 ADAS Section: 404.2.3, 404.2.7, 604.8.2.2

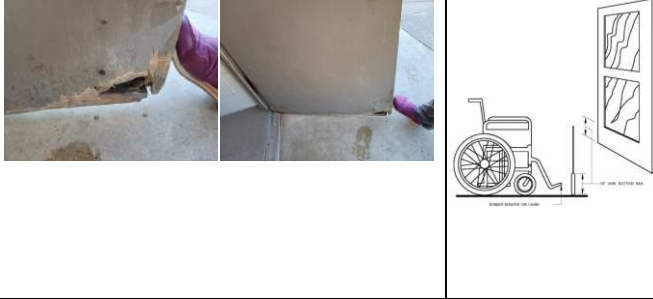
147	Trails: Pedernales Falls Trailhead - Women's Restroom	[30.3340811 , -98.25238]	The door must have a smooth surface within 10 inches of the floor on the push side. Swinging door surfaces within 10 inches of the finish floor or ground measured vertically must have a smooth surface on the push side extending the full width of the door. Parts creating horizontal or vertical joints in these surfaces shall be within 1/16 inch of the same plane as the other. All gates, including ticket gates, shall meet all applicable specifications for doors.	door has rust, toe hazard	Provide kick plate on push side of door from floor to 10" aff	2015 ABAAS Section: 404.2.10 2012 TAS Section: 404.2.10 2010 ADAS Section: 404.2.10

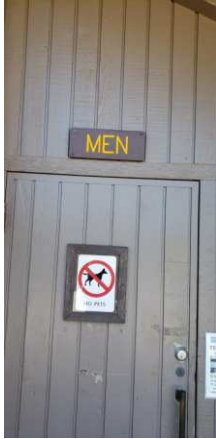
Finding Number	Area Description	Lat/Long	Finding	As Built	Recommendation	Citation	Photos	Figure
148	Trails: Pedernales Falls Trailhead - Men's Restroom	[30.3340626 , -98.2524014]	The restroom sign does not comply with one or more applicable requirements for the location, height, and properties of the sign.	sign mounted over the door, lacks Braille and symbol of access	Replace sign with one of contrasting colors that includes Braille, raised characters, and the symbol of accessibility and mount on the wall, latch side of the door, 48" to the baseline of the lowest character and 60" to the baseline of the highest character	2015 ABAAS Section: F216.2, 703.1, 703.2, 703.5, 703.6 2012 TAS Section: 216.2, 703.1, 703.2, 703.5, 703.6 2010 ADAS Section: 216.2, 703.1, 703.2, 703.5, 703.6

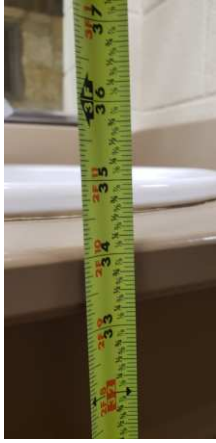
149	Trails: Pedernales Falls Trailhead - Men's Restroom	[30.3340626 , -98.25238]	The top rim of the sink is too high. All lavatories/sinks that are designated to be accessible shall be a minimum 17 inches in horizontal depth and mounted with the rim or counter edge no higher than 34 inches above the finished floor.	sink rim 35" aff	Lower sinks to max 34" above the finished floor (AFF) to front of rim.	2015 ABAAS Section: 606.3 2012 TAS Section: 606.3 2010 ADAS Section: 606.3

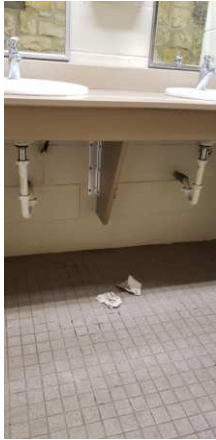
Finding Number	Area Description	Lat/Long	Finding	As Built	Recommendation	Citation	Photos	Figure
150	Trails: Pedernales Falls Trailhead - Men's Restroom	[30.3340834 , -98.2524121]	The water and drain pipes under the lavatory are not adequately insulated. Water supply and drain pipes under lavatories and sinks shall be insulated or otherwise configured to protect against contact. There shall be no sharp or abrasive surfaces under lavatories and sinks.	sink pipes lack insulation	Insulate exposed pipes under one sink.	2015 ABAAS Section: 606.5 2012 TAS Section: 606.5 2010 ADAS Section: 606.5

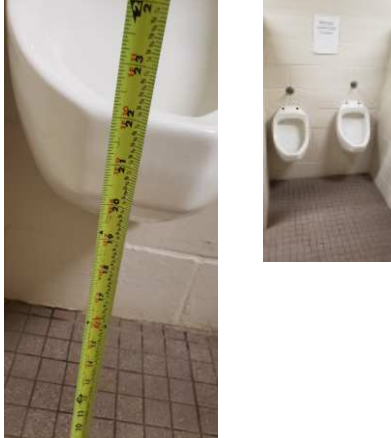
151	Trails: Pedernales Falls Trailhead - Men's Restroom	[30.3340765 , -98.252396]	The rim of the urinal is too high. Wall-hung urinals must be provided with an elongated rim projecting a minimum of 13 1/2 inches from the wall and a maximum of 17 inches above the floor.	urinal rim is 22" aff	Lower urinal so that rim height is max 17" aff	2015 ABAAS Section: 605.2 2012 TAS Section: 605.2 2010 ADAS Section: 605.2

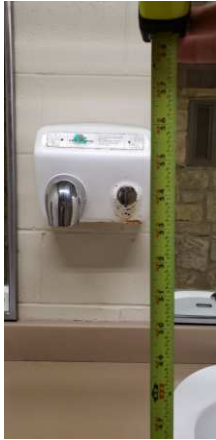
Finding Number	Area Description	Lat/Long	Finding	As Built	Recommendation	Citation	Photos	Figure
152	Trails: Pedernales Falls Trailhead - Men's Restroom	[30.3340904 , -98.252385 3]	Where a high forward reach is over an obstruction, the clear floor space shall extend beneath the element for a distance not less than the required reach depth over the obstruction. The high forward reach shall be 48 inches (1220 mm) maximum where the reach depth is 20 inches (510 mm) maximum. Where the reach depth exceeds 20 inches (510 mm), the high forward reach shall be 44 inches (1120 mm) maximum and the reach depth shall be 25 inches (635 mm) maximum. Where a clear floor or ground space allows a parallel approach to an element and the high side reach is over an obstruction, the height of the obstruction shall be 34 inches (865 mm) maximum and the depth of the obstruction shall be 24 inches (610 mm) maximum. The high side reach shall be 48 inches (1220 mm) maximum for a reach depth of 10 inches (255 mm) maximum. Where the reach depth exceeds 10 inches (255 mm), the high side reach shall be 46 inches (1170 mm) maximum for a reach depth of 24 inches (610 mm) maximum.	hand dryer 54" aff	Lower dryer to max 44" above the finished floor (AFF) for a forward reach over counter.	2015 ABAAS Section: 308.2.1, 308.3.2 2012 TAS Section: 308.2.1, 308.3.2 2010 ADAS Section: 308.2.1, 308.3.2
