Access Audit Site Report

Pedernales Falls State Park
2585 Park Rd 6026
Johnson City, TX 78636
Accessibility Evaluation
Inspection Date: 02/08/2022
Inspectors: Tanya Scheibe

Prepared By
WT Group

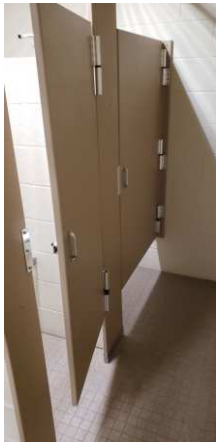
153	Trails: Pedernales Falls Trailhead - Men's Restroom	[30.3340742 , -98.252393 4]	There are not enough accessible toilet compartments. The room contains toilet compartments. A minimum of 1 must be wheelchair accessible .	restroom lacks wheelchair accessible stall, ambulatory only	Create a wheelchair accessible stall with grab bars and fixtures mounted in correct locations and at correct heights.	2015 ABAAS Section: F213.3.1 2012 TAS Section: 213.3.1 2010 ADAS Section: 213.3.1

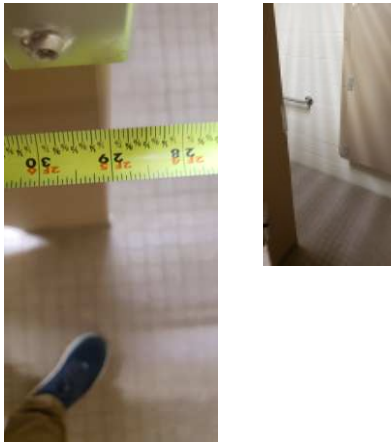
155	Trails: Pedernales Falls Trailhead - Men's Restroom	[30.3340742 , -98.2523907]	The stall door fails to comply with all of the door requirements. The stall door must be a minimum of 32" wide and have compliant hardware on both sides. The stall door must be self-closing.	29" width, not self closing	Widen stall doors to 32" when opened to 90 degrees Adjust stall door to be self-closing	2015 ABAAS Section: 404.2.3, 404.2.7, 604.8.2.2 2012 TAS Section: 404.2.3, 404.2.7, 604.8.2.2 2010 ADAS Section: 404.2.3, 404.2.7, 604.8.2.2

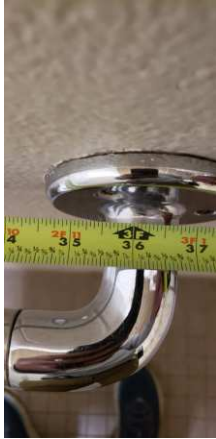
Finding Number	Area Description	Lat/Long	Finding	As Built	Recommendation	Citation	Photos	Figure
156	Trails: Pedernales Falls Trailhead - Men's Restroom	[30.3340811 , -98.252358 5]	Grab bars shall comply with 609. A side-wall grab bar complying with 604.5.1 shall be provided on both sides of the compartment. The space between the wall and the grab bar shall be 1½ inches (38 mm). The space between the grab bar and projecting objects below and at the ends shall be 1½ inches (38 mm) minimum. The space between the grab bar and projecting objects above shall be 12 inches (305 mm) minimum. Grab bars shall be installed in a horizontal position, 33 inches (840 mm) minimum and 36 inches (915 mm) maximum above the finish floor measured to the top of the gripping surface, except that at water closets for children's use complying with 604.9, grab bars shall be installed in a horizontal position 18 inches (455 mm) minimum and 27 inches (685 mm) max	36" bars	Replace or add side grab bars with a 42" long grab bar, mounted max 12" from the rear wall at the close end and min 54" on the far end and 33" to 36" aff	2015 ABAAS Section: 604.8.2.3, 609.3, 609.4 2012 TAS Section: 609.4, 609.3, 604.8.2.3 2010 ADAS Section: 609.3, 609.4, 604.8.2.3

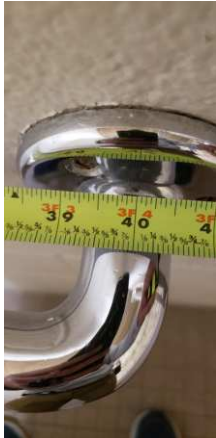
157	Trails: Pedernales Falls Trailhead - Men's Restroom	[30.3340892 , -98.252417 5]	The side grab bars are not in the correct location. Grab bars on the side wall must be installed so that the end closest to the rear wall is maximum 12" from the rear wall. The end furthest from the rear wall must be mounted minimum 54" from the rear wall.	mounted 40" from rear wall	Remount bars to max 12" from the rear wall at the close end and min 54" on the far end, and 33" to 36" aff. See previous finding for cost.	2015 ABAAS Section: 604.5.1 2012 TAS Section: 604.5.1 2010 ADAS Section: 604.5.1

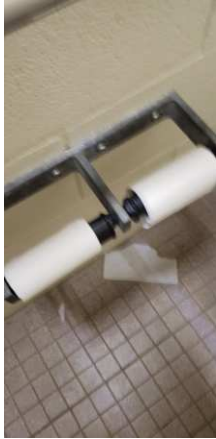
Finding Number	Area Description	Lat/Long	Finding	As Built	Recommendation	Citation	Photos	Figure
158	Trails: Pedernales Falls Trailhead - Men's Restroom	[30.3340661 , -98.252394 7]	The toilet paper dispenser does not allow a continuous flow. Toilet paper dispensers shall be 7 inches minimum and 9 inches maximum in front of the water closet measured to the centerline of the dispenser. The outlet of the dispenser shall be 15 inches minimum and 48 inches maximum above the finish floor and shall not be located behind grab bars. Dispensers shall not be of a type that controls delivery or that does not allow continuous paper flow. There shall be a clearance of 1 1/2 inches minimum below the grab bar.	TP dispenser does not allow for not continuous	Replace toilet paper dispenser with one that provides continuous flow of paper	2015 ABAAS Section: 604.7 2012 TAS Section: 604.7 2010 ADAS Section: 604.7

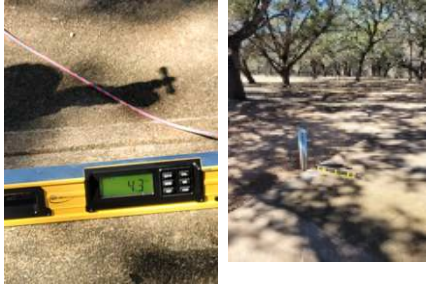
Finding Number	Area Description	Lat/Long	Finding	As Built	Recommendation	Citation	Photos	Figure
159	Beach Area: Beach - Parking and Exterior Accessible Route	[30.3135947 , -98.239555]	The 30 inches minimum by 48 inches minimum clear floor space required at the operable part is not flat (2% or 1:48 maximum slope) in all directions. Changes in level are not permitted at required clear floor or ground space except that slopes not steeper than 1:48 shall be permitted.	spigot at day use picnic beach restroom has 4.3% slope	Correct or repair slope in CFS to max 2.08% as a smart practice.	2015 ABAAS Section: 305.2 2012 TAS Section: 305.2 2010 ADAS Section: 305.2

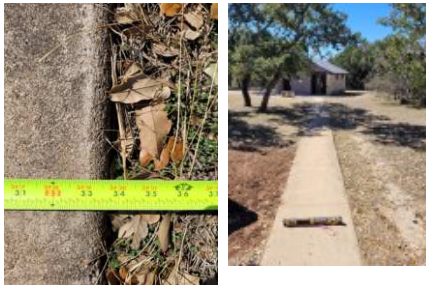
160	Beach Area: Beach - Parking and Exterior Accessible Route	[30.3135021 , -98.239524 1]	The route of travel at this location does not provide the required minimum width. The minimum clear width for sidewalks and walks is 36 inches.	33.5" walkway to swimming/ beach restroom building	Widen EAR to min 36" clear width.	2015 ABAAS Section: 403.5.1 2012 TAS Section: 403.5.1 2010 ADAS Section: 403.5.1

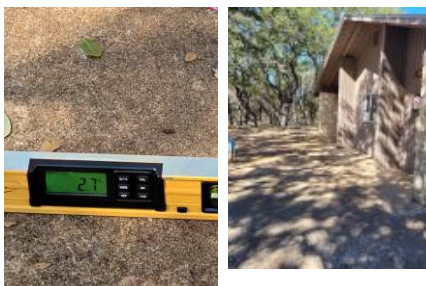
161	Beach Area: Beach - Parking and Exterior Accessible Route	[30.3136271 , -98.239576 4]	The accessible route of travel contains cross slopes greater than 2%. Cross slopes shall not exceed one unit vertical in 48 units horizontal (2-percent slope).	beach area, picnic area restroom building - 2.7% slope on outside of restroom entries	Correct or repair cross slope along AR to max 2.08%	2015 ABAAS Section: 403.3 2012 TAS Section: 403.3 2010 ADAS Section: 403.3

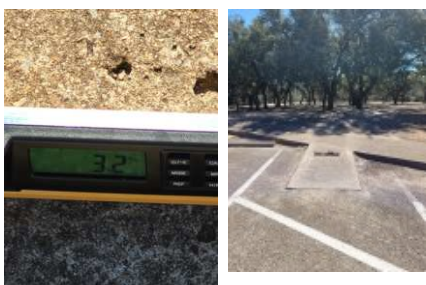
162	Beach Area: Beach - Parking and Exterior Accessible Route	[30.3136283 , -98.239587 2]	The accessible route of travel contains cross slopes greater than 2%. Cross slopes shall not exceed one unit vertical in 48 units horizontal (2-percent slope).	3.2% slope on ramp to picnic area restroom building in beach area	Correct or repair cross slope along AR to max 2.08%	2015 ABAAS Section: 403.3 2012 TAS Section: 403.3 2010 ADAS Section: 403.3

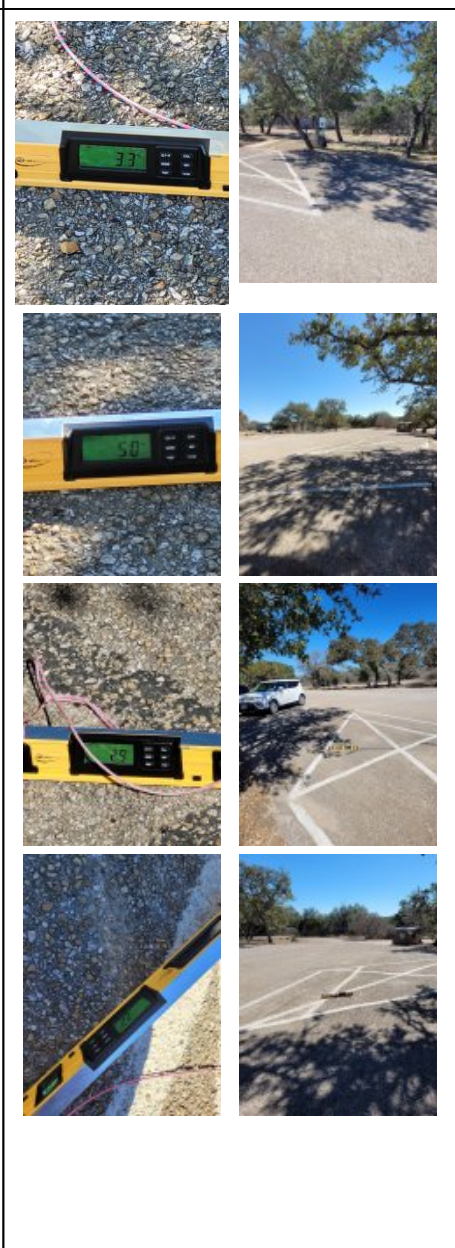
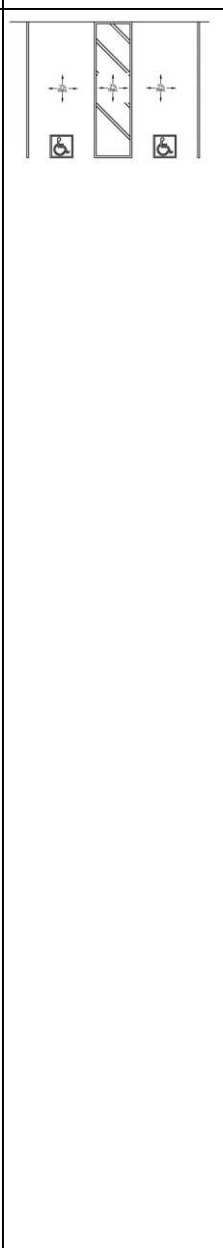
Finding Number	Area Description	Lat/Long	Finding	As Built	Recommendation	Citation	Photos	Figure
164	Beach Area: Beach - Parking and Exterior Accessible Route	[30.30802, -98.25768]	The cross slopes (narrow dimension) and/or running slopes (long dimension) of the access aisle exceeds 2%. The running slope and the cross slope in an accessible parking stall and the access aisle must not exceed 2%.	Swimming/ beach access, stall - 3.3%, 5%. access aisle - 2.9%, 2.2%	Repair or correct slope of parking space and access aisle to max 2.08% in any direction.	2015 ABAAS Section: 502.4 2012 TAS Section: 502.4 2010 ADAS Section: 502.4

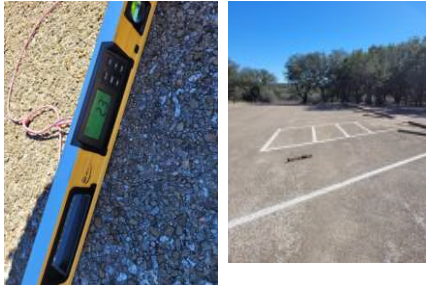
Finding Number	Area Description	Lat/Long	Finding	As Built	Recommendation	Citation	Photos	Figure
171	Beach Area: Beach - Parking and Exterior Accessible Route	[30.3138343 , -98.239416 8]	The cross slopes (narrow dimension) and/or running slopes (long dimension) of the access aisle exceeds 2%. The running slope and the cross slope in an accessible parking stall and the access aisle must not exceed 2%.	picnic/ restroom parking by beach - stall - 2.3% slope	Repair or correct slope of parking space and access aisle to max 2.08% in any direction.	2015 ABAAS Section: 502.4 2012 TAS Section: 502.4 2010 ADAS Section: 502.4

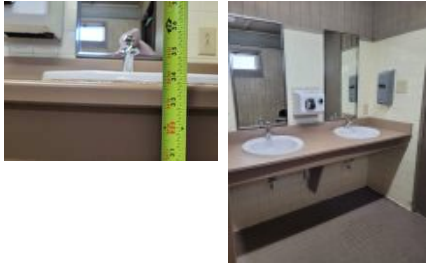
Finding Number	Area Description	Lat/Long	Finding	As Built	Recommendation	Citation	Photos	Figure
174	Beach Area: Beach - Women's Restroom Swimming	[30.3136144 , -98.2395805]	The top rim of the sink is too high. All lavatories/sinks that are designated to be accessible shall be a minimum 17 inches in horizontal depth and mounted with the rim or counter edge no higher than 34 inches above the finished floor.	rim 34.25" AFF	Lower sinks to max 34" above the finished floor (AFF) to front of rim. In the alternative, leave as is citing construction tolerance.	2015 ABAAS Section: 606.3 2012 TAS Section: 606.3 2010 ADAS Section: 606.3

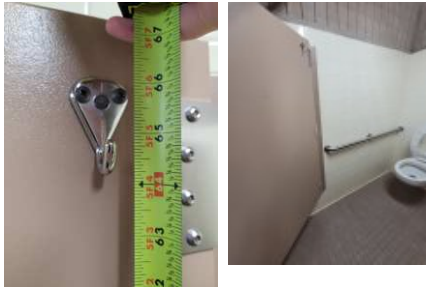
175	Beach Area: Beach - Women's Restroom Swimming	[30.3136306 , -98.2395885]	The operable part is positioned too high for either a side or front approach. Where a clear floor or ground space allows a parallel approach to an element and the side reach is unobstructed, the high side reach shall be 48 inches maximum and the low side reach shall be 15 inches minimum above the finish floor or ground. Where a forward reach is unobstructed, the high forward reach shall be 48 inches maximum and the low forward reach shall be 15 inches minimum above the finish floor or ground.	hook in stall 64" AFF	Remount operable parts to be in reach range of 15" min to 48" max	2015 ABAAS Section: 308.1 2012 TAS Section: 308.1 2010 ADAS Section: 308.1

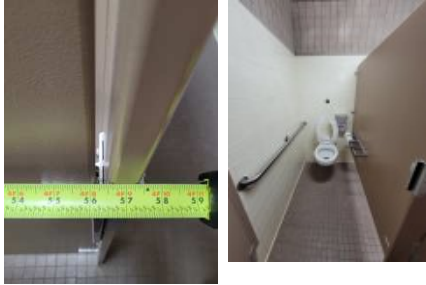
Finding Number	Area Description	Lat/Long	Finding	As Built	Recommendation	Citation	Photos	Figure
177	Beach Area: Beach - Women's Restroom Swimming	[30.3136283 , -98.239584 5]	The ambulatory stall is not between 35" to 37" wide and 60" deep.	ambulatory stall - 56" depth	Correct ambulatory stall to be 35" to 37" wide and minimum 60" deep. In the alternative, use existing stall to create required wheelchair stall.	2015 ABAAS Section: 604.8.2.1 2012 TAS Section: 604.8.2.1 2010 ADAS Section: 604.8.2.1

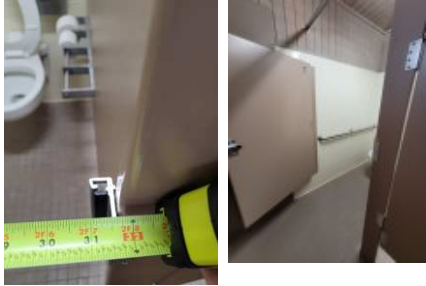
178	Beach Area: Beach - Women's Restroom Swimming	[30.3136283 , -98.239588 5]	The stall door fails to comply with all of the door requirements. The stall door must be a minimum of 32" wide and have compliant hardware on both sides. The stall door must be self-closing.	stall door - 31.5" width	Widen stall doors to 32" when opened to 90 degrees	2015 ABAAS Section: 404.2.3, 404.2.7, 604.8.2.2 2012 TAS Section: 404.2.3, 404.2.7, 604.8.2.2 2010 ADAS Section: 404.2.3, 404.2.7, 604.8.2.2

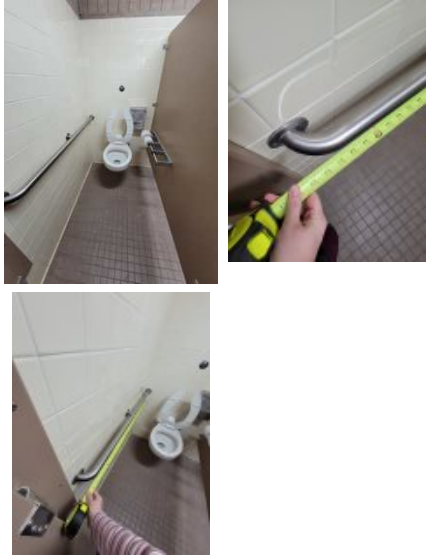
Finding Number	Area Description	Lat/Long	Finding	As Built	Recommendation	Citation	Photos	Figure
179	Beach Area: Beach - Women's Restroom Swimming	[30.3136236 , -98.2395805]	Grab bars shall comply with 609. A side-wall grab bar complying with 604.5.1 shall be provided on both sides of the compartment. The space between the wall and the grab bar shall be 1½ inches (38 mm). The space between the grab bar and projecting objects below and at the ends shall be 1½ inches (38 mm) minimum. The space between the grab bar and projecting objects above shall be 12 inches (305 mm) minimum. Grab bars shall be installed in a horizontal position, 33 inches (840 mm) minimum and 36 inches (915 mm) maximum above the finish floor measured to the top of the gripping surface, except that at water closets for children's use complying with 604.9, grab bars shall be installed in a horizontal position 18 inches (455 mm) minimum and 27 inches (685 mm) max	grab bar missing on partition side, grab bar 52" in length	Replace or add side grab bars with a 42" long grab bar, mounted max 12" from the rear wall at the close end and min 54" on the far end and 33" to 36" aff	2015 ABAAS Section: 604.8.2.3, 609.3, 609.4 2012 TAS Section: 609.4, 609.3, 604.8.2.3 2010 ADAS Section: 609.3, 609.4, 604.8.2.3

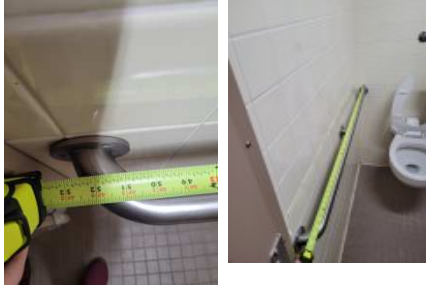
180	Beach Area: Beach - Women's Restroom Swimming	[30.3136341 , -98.2395845]	The side grab bars are not in the correct location. Grab bars on the side wall must be installed so that the end closest to the rear wall is maximum 12" from the rear wall. The end furthest from the rear wall must be mounted minimum 54" from the rear wall.	extends to 52" in length	See previous finding for replacement of bar.	2015 ABAAS Section: 604.5.1 2012 TAS Section: 604.5.1 2010 ADAS Section: 604.5.1

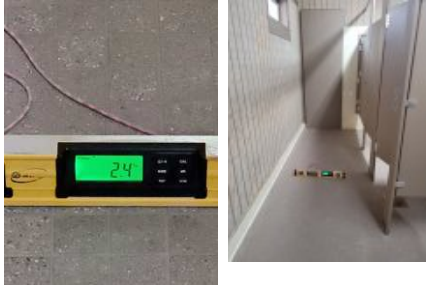
181	Beach Area: Beach - Women's Restroom Swimming	[30.3136213 , -98.2395805]	The accessible route contains running slopes greater than 5 percent and cross slopes greater than 2 percent across the width of the walk and has not been constructed as a ramp (i.e. handrails, wheel guides, etc.). When the slope in the direction of travel of any walk exceeds 1 unit vertical in 20 units horizontal (5-percent slope), it must be constructed as ramp. Surface cross slopes must not exceed one unit vertical in 48 units. Horizontal (2-percent slope).	2.4% cross slope at path to stalls	Correct or repair slope to max 2.08% in restroom.	2015 ABAAS Section: 403.3 2012 TAS Section: 403.3 2010 ADAS Section: 403.3

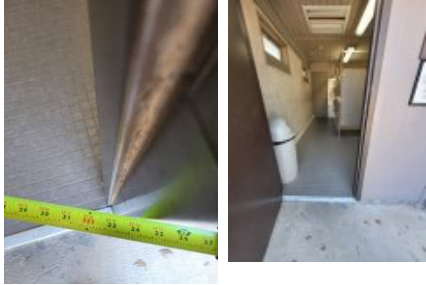
Finding Number	Area Description	Lat/Long	Finding	As Built	Recommendation	Citation	Photos	Figure
182	Beach Area: Beach - Women's Restroom Swimming	[30.3136422 , -98.239569 7]	Minimum maneuvering clearances at doors and gates shall comply with 404.2.4. Maneuvering clearances shall extend the full width of the doorway and the required latch side or hinge side clearance. Maneuvering clearances shall have a max slope of 2.08%.	Door - trash in back clearance	For all doors along the public circulation route, provide required maneuvering clearance on push and pull side of doors.	2010 ADAS Section: 404.2.3, 404.2.7, 404.2.4, 404.2.11, 404.2.11 Exception

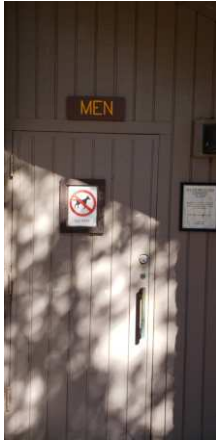
184	Beach Area: Beach - Men's Restroom Swimming	[30.3136329 , -98.239569 7]	The restroom sign does not comply with one or more applicable requirements for the location, height, and properties of the sign.	sign mounted above door, no Braille or symbol of access	Replace sign with one of contrasting colors that includes Braille, raised characters, and the symbol of accessibility and mount on the wall, latch side of the door, 48" to the baseline of the lowest character and 60" to the baseline of the highest character	2015 ABAAS Section: F216.2, 703.1, 703.2, 703.5, 703.6 2012 TAS Section: 216.2, 703.1, 703.2, 703.5, 703.6 2010 ADAS Section: 216.2, 703.1, 703.2, 703.5, 703.6

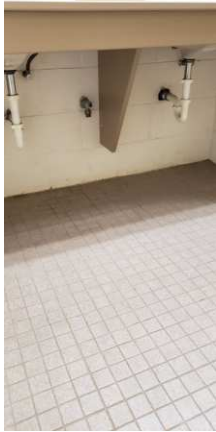
Finding Number	Area Description	Lat/Long	Finding	As Built	Recommendation	Citation	Photos	Figure
185	Beach Area: Beach - Men's Restroom Swimming	[30.313626, -98.239585 8]	The water and drain pipes under the lavatory are not adequately insulated. Water supply and drain pipes under lavatories and sinks shall be insulated or otherwise configured to protect against contact. There shall be no sharp or abrasive surfaces under lavatories and sinks.	sink pipes lack insulation	Insulate exposed pipes under one sink.	2015 ABAAS Section: 606.5 2012 TAS Section: 606.5 2010 ADAS Section: 606.5

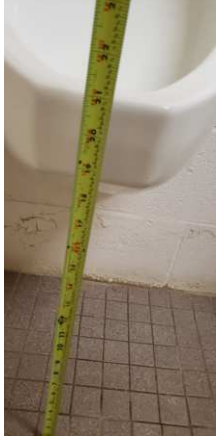
186	Beach Area: Beach - Men's Restroom Swimming	[30.3136283, -98.239572 4]	The rim of the urinal is too high. Wall-hung urinals must be provided with an elongated rim projecting a minimum of 13 1/2 inches from the wall and a maximum of 17 inches above the floor.	urinals - lowest 21" to rim	Lower urinal so that rim height is max 17" aff	2015 ABAAS Section: 605.2 2012 TAS Section: 605.2 2010 ADAS Section: 605.2

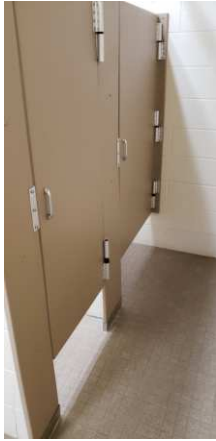
Finding Number	Area Description	Lat/Long	Finding	As Built	Recommendation	Citation	Photos	Figure
187	Beach Area: Beach - Men's Restroom Swimming	[30.3136317 , -98.2395885]	There are not enough accessible toilet compartments. The room contains toilet compartments. A minimum of 1 must be wheelchair accessible .	no wheelchair accessible stall	Create a wheelchair accessible stall with grab bars and fixtures mounted in correct locations and at correct heights.	2015 ABAAS Section: F213.3.1 2012 TAS Section: 213.3.1 2010 ADAS Section: 213.3.1

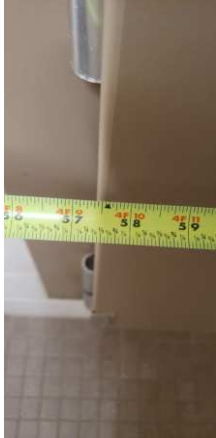
188	Beach Area: Beach - Men's Restroom Swimming	[30.3136306 , -98.2395751]	The ambulatory stall is not between 35" to 37" wide and 60" deep.	ambulatory stall - 57.9" deep	Correct ambulatory stall to be 35" to 37" wide and minimum 60" deep. In the alternative, use existing stall to create required wheelchair stall.	2015 ABAAS Section: 604.8.2.1 2012 TAS Section: 604.8.2.1 2010 ADAS Section: 604.8.2.1

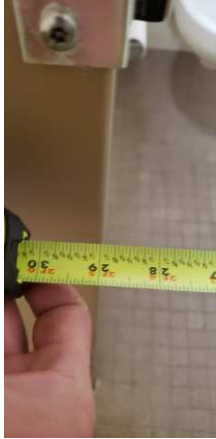
Finding Number	Area Description	Lat/Long	Finding	As Built	Recommendation	Citation	Photos	Figure
189	Beach Area: Beach - Men's Restroom Swimming	[30.313619, -98.239588 5]	The stall door fails to comply with all of the door requirements. The stall door must be a minimum of 32" wide and have compliant hardware on both sides. The stall door must be self-closing.	stall door - 29" wide	Widen stall doors to 32" when opened to 90 degrees	2015 ABAAS Section: 404.2.3, 404.2.7, 604.8.2.2 2012 TAS Section: 404.2.3, 404.2.7, 604.8.2.2 2010 ADAS Section: 404.2.3, 404.2.7, 604.8.2.2

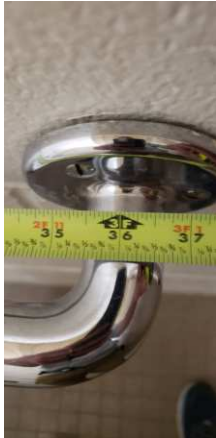
Finding Number	Area Description	Lat/Long	Finding	As Built	Recommendation	Citation	Photos	Figure
190	Beach Area: Beach - Men's Restroom Swimming	[30.3136236 , -98.239591 2]	Grab bars shall comply with 609. A side-wall grab bar complying with 604.5.1 shall be provided on both sides of the compartment. The space between the wall and the grab bar shall be 1½ inches (38 mm). The space between the grab bar and projecting objects below and at the ends shall be 1½ inches (38 mm) minimum. The space between the grab bar and projecting objects above shall be 12 inches (305 mm) minimum. Grab bars shall be installed in a horizontal position, 33 inches (840 mm) minimum and 36 inches (915 mm) maximum above the finish floor measured to the top of the gripping surface, except that at water closets for children's use complying with 604.9, grab bars shall be installed in a horizontal position 18 inches (455 mm) minimum and 27 inches (685 mm) max	side bars - 36" bars	Replace or add side grab bars with a 42" long grab bar, mounted max 12" from the rear wall at the close end and min 54" on the far end and 33" to 36" aff	2015 ABAAS Section: 604.8.2.3, 609.3, 609.4 2012 TAS Section: 609.4, 609.3, 604.8.2.3 2010 ADAS Section: 609.3, 609.4, 604.8.2.3

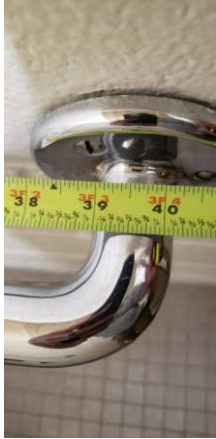
Finding Number	Area Description	Lat/Long	Finding	As Built	Recommendation	Citation	Photos	Figure
191	Beach Area: Beach - Men's Restroom Swimming	[30.313626, -98.239575 1]	The side grab bars are not in the correct location. Grab bars on the side wall must be installed so that the end closest to the rear wall is maximum 12" from the rear wall. The end furthest from the rear wall must be mounted minimum 54" from the rear wall.	grab bars mounted 39" from rear wall to end of grab bar	Remount grab bars - see previous finding.	2015 ABAAS Section: 604.5.1 2012 TAS Section: 604.5.1 2010 ADAS Section: 604.5.1

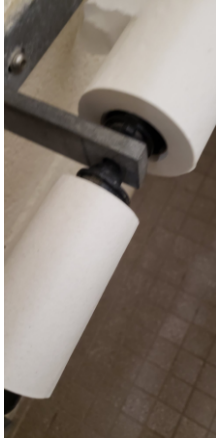
192	Beach Area: Beach - Men's Restroom Swimming	[30.3136375, -98.239593 9]	The toilet paper dispenser does not allow a continuous flow. Toilet paper dispensers shall be 7 inches minimum and 9 inches maximum in front of the water closet measured to the centerline of the dispenser. The outlet of the dispenser shall be 15 inches minimum and 48 inches maximum above the finish floor and shall not be located behind grab bars. Dispensers shall not be of a type that controls delivery or that does not allow continuous paper flow. There shall be a clearance of 1 1/2 inches minimum below the grab bar.	TP dispenser - does not allow for continuous flow of paper	Replace toilet paper dispenser with one that provides continuous flow of paper	2015 ABAAS Section: 604.7 2012 TAS Section: 604.7 2010 ADAS Section: 604.7

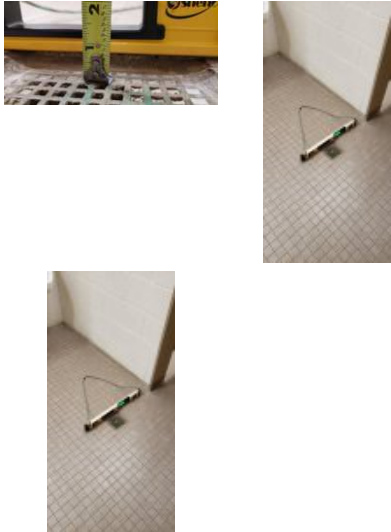
Finding Number	Area Description	Lat/Long	Finding	As Built	Recommendation	Citation	Photos	Figure
193	Beach Area: Beach - Men's Restroom Swimming	[30.3136213 , -98.2395805]	There is a change in level greater than 1/4 inch. 1/4 inch is the maximum vertical rise. Changes in level between 1/4 inch and 1/2 inch must be beveled at 1:2 or less. Changes in level greater than 1/2 inch must be by way of a ramp.	0.75" CIL at drain	Repair, bevel or ramp CIL along accessible route (AR) to max .25".	2015 ABAAS Section: 303.3 2012 TAS Section: 303.3 2010 ADAS Section: 303.3

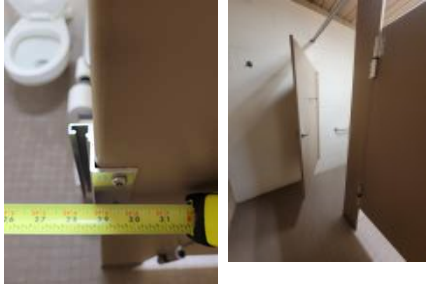
Finding Number	Area Description	Lat/Long	Finding	As Built	Recommendation	Citation	Photos	Figure
199	Beach Area: Beach - Women's Restroom Picnic	[30.3138876 , -98.241930 1]	The stall door fails to comply with all of the door requirements. The stall door must be a minimum of 32" wide and have compliant hardware on both sides. The stall door must be self-closing.	stall door - 29" width	Widen stall doors to 32" when opened to 90 degrees	2015 ABAAS Section: 404.2.3, 404.2.7, 604.8.2.2 2012 TAS Section: 404.2.3, 404.2.7, 604.8.2.2 2010 ADAS Section: 404.2.3, 404.2.7, 604.8.2.2

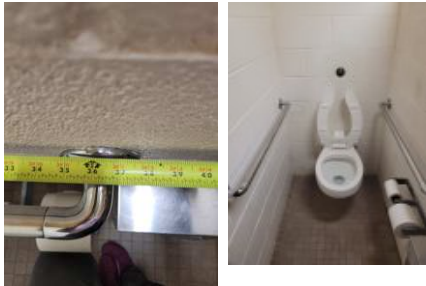
200	Beach Area: Beach - Women's Restroom Picnic	[30.313883, -98.241927 4]	Grab bars shall comply with 609. A side-wall grab bar complying with 604.5.1 shall be provided on both sides of the compartment. The space between the wall and the grab bar shall be 1½ inches (38 mm). The space between the grab bar and projecting objects below and at the ends shall be 1½ inches (38 mm) minimum. The space between the grab bar and projecting objects above shall be 12 inches (305 mm) minimum. Grab bars shall be installed in a horizontal position, 33 inches (840 mm) minimum and 36 inches (915 mm) maximum above the finish floor measured to the top of the gripping surface, except that at water closets for children's use complying with 604.9, grab bars shall be installed in a horizontal position 18 inches (455 mm) minimum and 27 inches (685 mm) max	grab bars - both 36" long	Replace or add side grab bars with a 42" long grab bar, mounted max 12" from the rear wall at the close end and min 54" on the far end and 33" to 36" aff	2015 ABAAS Section: 604.8.2.3, 609.3, 609.4 2012 TAS Section: 609.4, 609.3, 604.8.2.3 2010 ADAS Section: 609.3, 609.4, 604.8.2.3

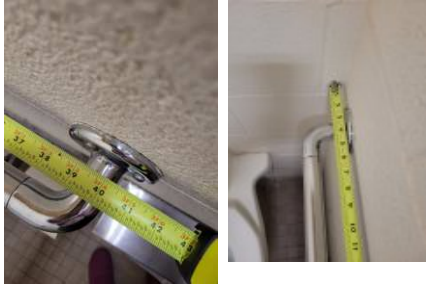
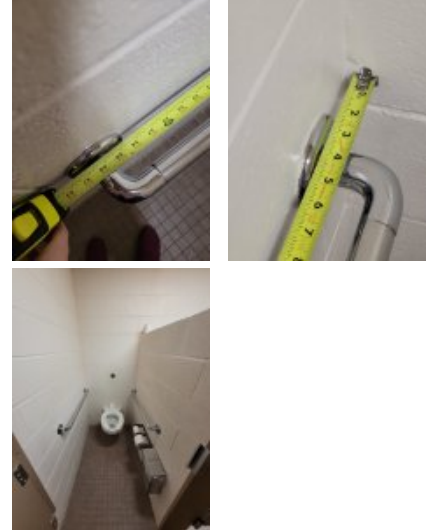
Finding Number	Area Description	Lat/Long	Finding	As Built	Recommendation	Citation	Photos	Figure
201	Beach Area: Beach - Women's Restroom Picnic	[30.3138876 , -98.241930 1]	The side grab bars are not in the correct location. Grab bars on the side wall must be installed so that the end closest to the rear wall is maximum 12" from the rear wall. The end furthest from the rear wall must be mounted minimum 54" from the rear wall.	both mounted 3" from wall and 40" to grab bar end from rear wall	Remount grab bars per previous finding.	2015 ABAAS Section: 604.5.1 2012 TAS Section: 604.5.1 2010 ADAS Section: 604.5.1

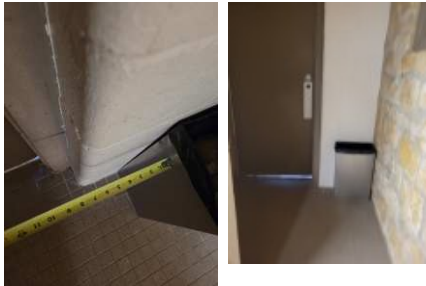
202	Beach Area: Beach - Women's Restroom Picnic	[30.3138876 , -98.241940 8]	Minimum maneuvering clearances at doors and gates shall comply with 404.2.4. Maneuvering clearances shall extend the full width of the doorway and the required latch side or hinge side clearance. Maneuvering clearances shall have a max slope of 2.08%. Exterior doors are recommended to be maintained at 8.5 lbf as a smart practice. Force is to be measured at the operating hardware or 30 inches from the hinges, whichever is greater.	Door - no clearance on push 9" due to trash, 17# push	For all doors along the public circulation route, provide required maneuvering clearance on push and pull side of doors. For all doors along the public circulation route, inspect, adjust, and maintain 8.5 lbf to open exterior doors as a smart practice.	2010 ADAS Section: 404.2.3, 404.2.7, 404.2.4, 404.2.11, 404.2.11 Exception

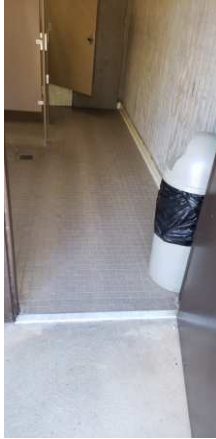
Finding Number	Area Description	Lat/Long	Finding	As Built	Recommendation	Citation	Photos	Figure
203	Beach Area: Beach - Men's Restroom Picnic	[30.3138922 , -98.241930 1]	Minimum maneuvering clearances at doors and gates shall comply with 404.2.4. Maneuvering clearances shall extend the full width of the doorway and the required latch side or hinge side clearance. Maneuvering clearances shall have a max slope of 2.08%. Exterior doors are recommended to be maintained at 8.5 lbf as a smart practice. Force is to be measured at the operating hardware or 30 inches from the hinges, whichever is greater.	Door - trash can in push side clearance, 10# push	For all doors along the public circulation route, provide required maneuvering clearance on push and pull side of doors. For all doors along the public circulation route, inspect, adjust, and maintain 8.5 lbf to open exterior doors as a smart practice.	2010 ADAS Section: 404.2.3, 404.2.7, 404.2.4, 404.2.11, 404.2.11 Exception

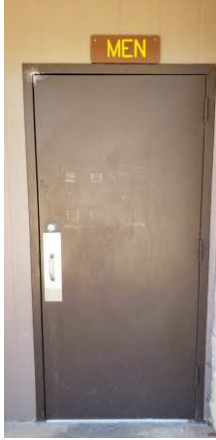
204	Beach Area: Beach - Men's Restroom Picnic	[30.3138922 , -98.241935 4]	The restroom sign does not comply with one or more applicable requirements for the location, height, and properties of the sign.	sign mounted over door, no Braille, no symbol of access	Replace sign with one of contrasting colors that includes Braille, raised characters, and the symbol of accessibility and mount on the wall, latch side of the door, 48" to the baseline of the lowest character and 60" to the baseline of the highest character	2015 ABAAS Section: F216.2, 703.1, 703.2, 703.5, 703.6 2012 TAS Section: 216.2, 703.1, 703.2, 703.5, 703.6 2010 ADAS Section: 216.2, 703.1, 703.2, 703.5, 703.6

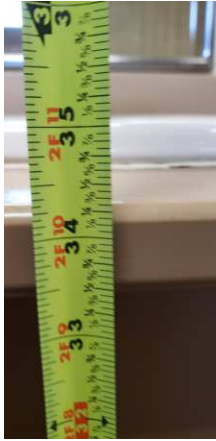
Finding Number	Area Description	Lat/Long	Finding	As Built	Recommendation	Citation	Photos	Figure
205	Beach Area: Beach - Men's Restroom Picnic	[30.3139108 , -98.241930 1]	The top rim of the sink is too high. All lavatories/sinks that are designated to be accessible shall be a minimum 17 inches in horizontal depth and mounted with the rim or counter edge no higher than 34 inches above the finished floor.	sink rim 35" aff	Lower sinks to max 34" above the finished floor (AFF) to front of rim.	2015 ABAAS Section: 606.3 2012 TAS Section: 606.3 2010 ADAS Section: 606.3

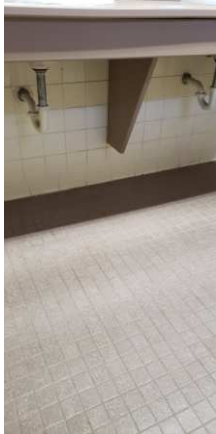
206	Beach Area: Beach - Men's Restroom Picnic	[30.3139108 , -98.241940 8]	The water and drain pipes under the lavatory are not adequately insulated. Water supply and drain pipes under lavatories and sinks shall be insulated or otherwise configured to protect against contact. There shall be no sharp or abrasive surfaces under lavatories and sinks.	sink pipes lack insulation	Insulate exposed pipes under one sink.	2015 ABAAS Section: 606.5 2012 TAS Section: 606.5 2010 ADAS Section: 606.5

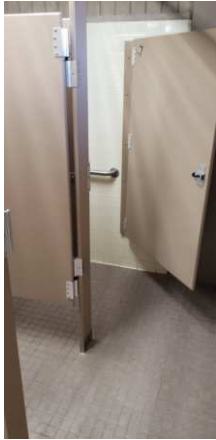
Finding Number	Area Description	Lat/Long	Finding	As Built	Recommendation	Citation	Photos	Figure
207	Beach Area: Beach - Men's Restroom Picnic	[30.3138922 , -98.2419086]	There are not enough accessible toilet compartments. The room contains toilet compartments. A minimum of 1 must be wheelchair accessible .	no wheelchair accessible stall	Create a wheelchair accessible stall with grab bars and fixtures mounted in correct locations and at correct heights.	2015 ABAAS Section: F213.3.1 2012 TAS Section: 213.3.1 2010 ADAS Section: 213.3.1

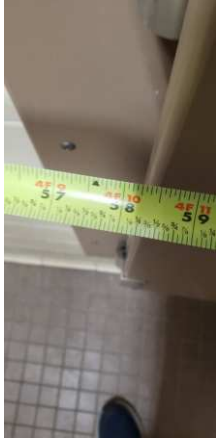
208	Beach Area: Beach - Men's Restroom Picnic	[30.3139061 , -98.2419462]	The ambulatory stall is not between 35" to 37" wide and 60" deep.	ambulatory stall - 58" deep	Correct ambulatory stall to be 35" to 37" wide and minimum 60" deep. In the alternative, use existing stall to create required wheelchair stall.	2015 ABAAS Section: 604.8.2.1 2012 TAS Section: 604.8.2.1 2010 ADAS Section: 604.8.2.1

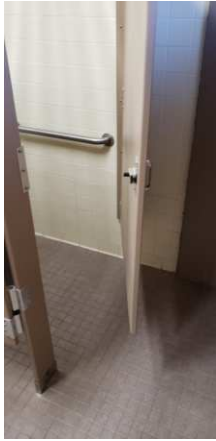
Finding Number	Area Description	Lat/Long	Finding	As Built	Recommendation	Citation	Photos	Figure
209	Beach Area: Beach - Men's Restroom Picnic	[30.3138922 , -98.2419408]	The stall door fails to comply with all of the door requirements. The stall door must be a minimum of 32" wide and have compliant hardware on both sides. The stall door must be self-closing.	stall door not self closing	Adjust stall door to be self-closing	2015 ABAAS Section: 404.2.3, 404.2.7, 604.8.2.2 2012 TAS Section: 404.2.3, 404.2.7, 604.8.2.2 2010 ADAS Section: 404.2.3, 404.2.7, 604.8.2.2

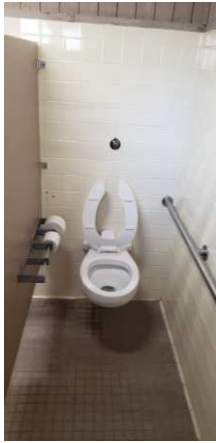
210	Beach Area: Beach - Men's Restroom Picnic	[30.3139015 , -98.241922]	Grab bars shall comply with 609. A side-wall grab bar complying with 604.5.1 shall be provided on both sides of the compartment. The space between the wall and the grab bar shall be 1½ inches (38 mm). The space between the grab bar and projecting objects below and at the ends shall be 1½ inches (38 mm) minimum. The space between the grab bar and projecting objects above shall be 12 inches (305 mm) minimum. Grab bars shall be installed in a horizontal position, 33 inches (840 mm) minimum and 36 inches (915 mm) maximum above the finish floor measured to the top of the gripping surface, except that at water closets for children's use complying with 604.9, grab bars shall be installed in a horizontal position 18 inches (455 mm) minimum and 27 inches (685 mm) max	bar only on one side	Replace or add side grab bars with a 42" long grab bar, mounted max 12" from the rear wall at the close end and min 54" on the far end and 33" to 36" aff	2015 ABAAS Section: 604.8.2.3, 609.3, 609.4 2012 TAS Section: 609.4, 609.3, 604.8.2.3 2010 ADAS Section: 609.3, 609.4, 604.8.2.3

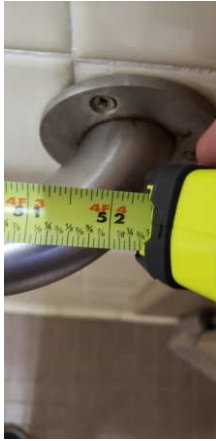
Finding Number	Area Description	Lat/Long	Finding	As Built	Recommendation	Citation	Photos	Figure
211	Beach Area: Beach - Men's Restroom Picnic	[30.3139038 , -98.241938 1]	The side grab bars are not in the correct location. Grab bars on the side wall must be installed so that the end closest to the rear wall is maximum 12" from the rear wall. The end furthest from the rear wall must be mounted minimum 54" from the rear wall.	mounted 52" from wall to grab bar end	Replace side grab bar with a 42" long bar mounted to max 12" from the rear wall at the close end and min 54" on the far end, and 33" to 36" aff.	2015 ABAAS Section: 604.5.1 2012 TAS Section: 604.5.1 2010 ADAS Section: 604.5.1

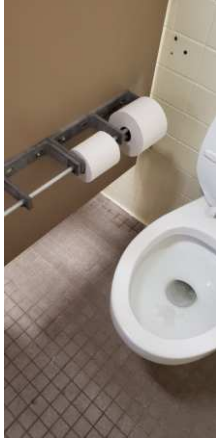
212	Beach Area: Beach - Men's Restroom Picnic	[30.3138922 , -98.241946 2]	The toilet paper is not installed within the compliant range in front of the toilet. Toilet paper dispensers shall be 7 inches minimum and 9 inches maximum in front of the water closet measured to the centerline of the dispenser. The outlet of the dispenser shall be 15 inches minimum and 48 inches maximum above the finish floor and shall not be located behind grab bars. Dispensers shall not be of a type that controls delivery or that does not allow continuous paper flow. There shall be a clearance of 1 1/2 inches minimum below the grab bar.	TP mounted behind front of toilet	Remount toilet paper dispenser max 7" to 9" from front of toilet, 15" to 48" aff and min 12" above or 1.5" below grab bar.	2015 ABAAS Section: 604.7 2012 TAS Section: 604.7 2010 ADAS Section: 604.7

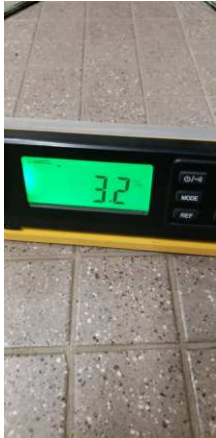
Finding Number	Area Description	Lat/Long	Finding	As Built	Recommendation	Citation	Photos	Figure
213	Beach Area: Beach - Men's Restroom Picnic	[30.3139038 , -98.241943 5]	The accessible route contains running slopes greater than 5 percent and cross slopes greater than 2 percent across the width of the walk and has not been constructed as a ramp (i.e. handrails, wheel guides, etc.). When the slope in the direction of travel of any walk exceeds 1 unit vertical in 20 units horizontal (5-percent slope), it must be constructed as ramp. Surface cross slopes must not exceed one unit vertical in 48 units. Horizontal (2-percent slope).	3.2% cross slope	Correct or repair slope to max 2.08% in restroom.	2015 ABAAS Section: 403.3 2012 TAS Section: 403.3 2010 ADAS Section: 403.3

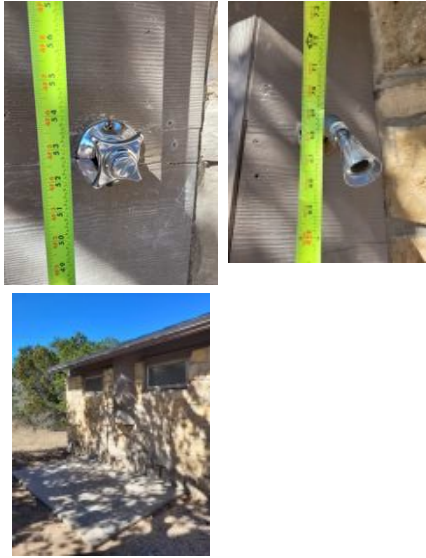
Finding Number	Area Description	Lat/Long	Finding	As Built	Recommendation	Citation	Photos	Figure
215	Beach Area: Beach - Picnic and Swimming Area	[30.3135727 , -98.239585 8]	Outdoor rinsing showers shall provide at least one hand-held shower spray unit with a hose 59 inches (1500 mm) long minimum. The hand-held shower spray unit shall have at least one fixed position located 15 inches minimum (380 mm) and 48 inches (1220 mm) maximum above the ground. EXCEPTION: Where vandalism is a consideration, a fixed shower head located at 48 in (1220 mm) above the ground shall be permitted in place of a hand-held shower spray unit.	swimming restroom building, shower head - 66.5" AFF, controls - 53" aff on 2 of 2 showers	Remount or replace shower head with one that is hand held and mounted with one fixed position 15" to 48" above the ground; in the alternative, mount a fixed shower head at 48" above the ground as a smart practice.	2015 ABAAS Section: 1011.7, 1011.7 EXCEPTION

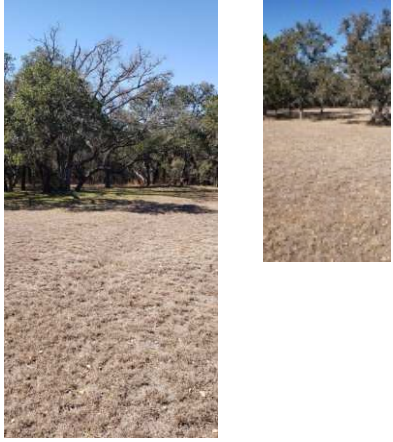
Finding Number	Area Description	Lat/Long	Finding	As Built	Recommendation	Citation	Photos	Figure
217	Beach Area: Beach - Picnic and Swimming Area	[30.3137533 , -98.239508]	An accessible access route is not provided between elements, spaces and the facilities provided within the accessible camping unit. At least one outdoor recreation access route shall connect accessible elements, spaces and facilities provided within camping units with mobility features.	0 of 40 picnic tables on AR	Create AR with crushed and compacted stone or similar outdoor material to eight picnic tables one of each type of amenity. Replace tables with ones of an accessible design.	2015 ABAAS Section: F244.5.1

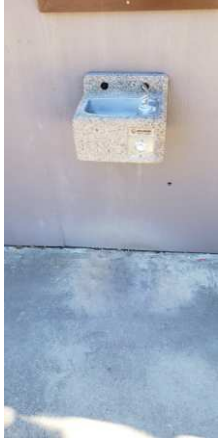
218	Beach Area: Beach - Picnic and Swimming Area	[30.3138297 , -98.239553 6]	There is no drinking fountain for standing persons. Spout outlets of drinking fountains for standing persons shall be 38 inches minimum and 43 inches maximum above the finish floor or ground.	lacks fountain for standing person	Add second high bowl fountain for standing persons.	2015 ABAAS Section: 602.7 2012 TAS Section: 602.7 2010 ADAS Section: 602.7, 211.2

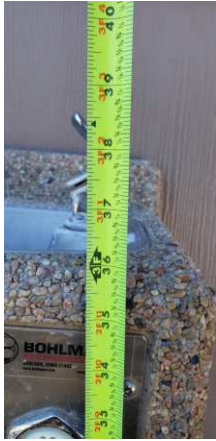
Finding Number	Area Description	Lat/Long	Finding	As Built	Recommendation	Citation	Photos	Figure
219	Beach Area: Beach - Picnic and Swimming Area	[30.3140265 , -98.239655 6]	The spout for the drinking fountain is too high. Spout outlets shall be 36 inches maximum above the finish floor or ground.	fountain spout is 37.5" aff	Remount fountain so spout outlet is max 36" aff	2015 ABAAS Section: 602.4 2012 TAS Section: 602.4 2010 ADAS Section: 602.4

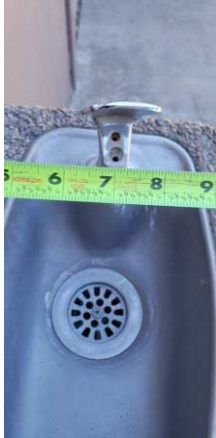
220	Beach Area: Beach - Picnic and Swimming Area	[30.3136283 , -98.239580 5]	The spout is not positioned correctly from the vertical support. The spout shall be located 15 inches minimum from the vertical support and 5 inches maximum from the front edge of the unit, including bumpers.	mounted 7" from wall	Remount or replace fountain to provide 15" from vertical support to the spout	2015 ABAAS Section: 602.5 2012 TAS Section: 602.5 2010 ADAS Section: 602.5

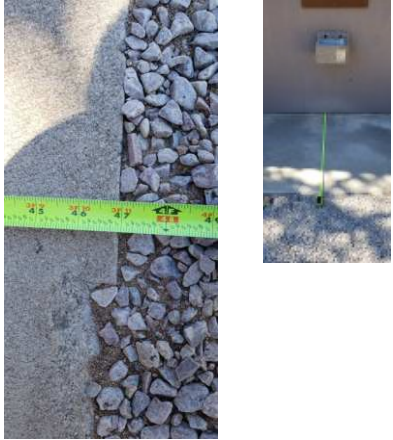
222	Beach Area: Beach - Picnic and Swimming Area	[30.313626, -98.239583 1]	The required clear floor space is not deep enough. The clear floor or ground space shall be 30 inches minimum by 48 inches minimum.	47" deep clear floor space (CFS) at fountain	Enlarge CFS to min 48" depth.	2015 ABAAS Section: 305.3 2012 TAS Section: 305.3 2010 ADAS Section: 305.3
