Access Audit Site Report

Ray Roberts Lake State Park/Complex

Accessibility Evaluation

Inspection Date: 10/18/2021

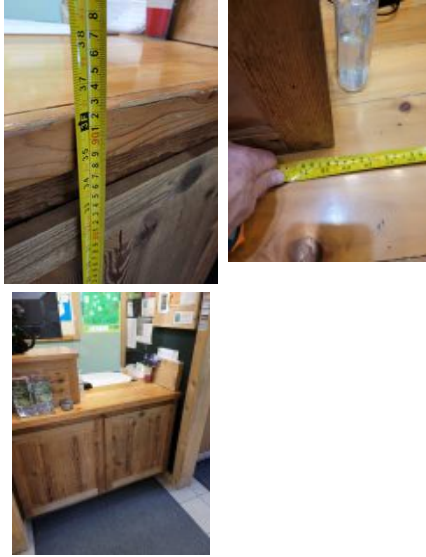
Finding Number	Area Description	Lat/Long	Finding	As Built	Recommendation	Citation	Photos	Figure
4	Isle Du Bois Unit: IDB - HQ	[33.36563, -97.01201]	The transaction counter is too high. A portion of the counter surface that is 36 inches long minimum and 36 inches high maximum above the finish floor shall be provided. Knee and toe space must be provided for a forward approach. A 30 inch by 48 inch clear floor space on an accessible route must be provided for either a forward or parallel approach.	36.25" above finished floor x 30.5" wide	Lower 36" wide segment of service counter to max 36" aff Lower 36" wide segment of service counter to max 36" aff, in the alternative, train staff to come out from around the counter to provide customer service	2015 ABAAS Section: 904.4.2, 904.4.1 2012 TAS Section: 904.4.1, 904.4.2 2010 ADAS Section: 904.4.2, 904.4.1

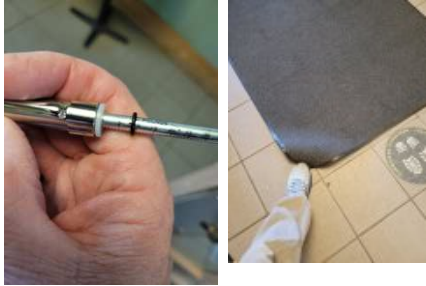
5	Isle Du Bois Unit: IDB - HQ	[33.3656107, -97.012074 1]	Minimum maneuvering clearances at doors and gates shall comply with 404.2.4. Maneuvering clearances shall extend the full width of the doorway and the required latch side or hinge side clearance. All interior doors must be maintained so that the operating pressure does not exceed 5 lb. force to open.	Vestibule Door - 9.5# push, edge of carpet not securely fastened	For all doors along the public circulation route, provide required maneuvering clearance on push and pull side of doors. Secure mat at door to prevent tripping hazard. For all doors along the public circulation route, inspect, adjust, and maintain 5 lbf to open interior doors.	2010 ADAS Section: 404.2.3, 404.2.7, 404.2.4, 404.2.11, 404.2.11 Exception

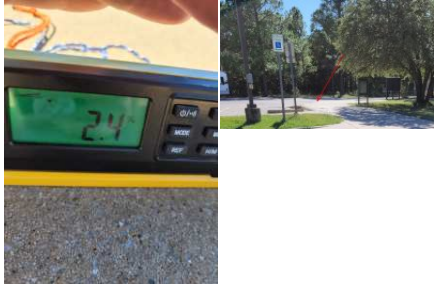
Finding Number	Area Description	Lat/Long	Finding	As Built	Recommendation	Citation	Photos	Figure
7	Isle Du Bois Unit: IDB - HQ	[33.3658392 , -97.011765 6]	The curb ramp on the accessible route contains cross slopes greater than 2%. Surface cross slopes shall not exceed one unit vertical in 48 units horizontal (2-percent slope).	Curb ramp at headquarters parking- 2.4% cross slope	Correct curb ramp cross slope to max 2.08%.	2015 ABAAS Section: 405.3 2012 TAS Section: 405.3 2010 ADAS Section: 405.3

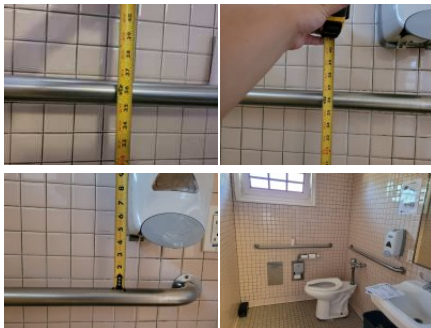
29	Isle Du Bois Unit: IDB - HQ Restroom Left	[33.3657003 , -97.012181 4]	The grab bar height and/or spacing fails. Grab bars must be mounted between 33" and 36" to the top of the gripping surface. There must be 1.5" of clearance between the grab bar and the wall. There must be a minimum of 1.5" of clearance below and minimum 12" above the grab bar to any dispenser or other obstruction.	36.5" above finish floor (AFF) to side grab bar (GB), rear 36.75" AFF, 3.5" to dispenser above rear bar	Remount grab bars in accessible stall to 33" to 36" aff Remount dispenser max 48" aff and min 12" above grab bar	2015 ABAAS Section: 609.3, 609.4 2012 TAS Section: 609.4, 609.3 2010 ADAS Section: 609.3, 609.4

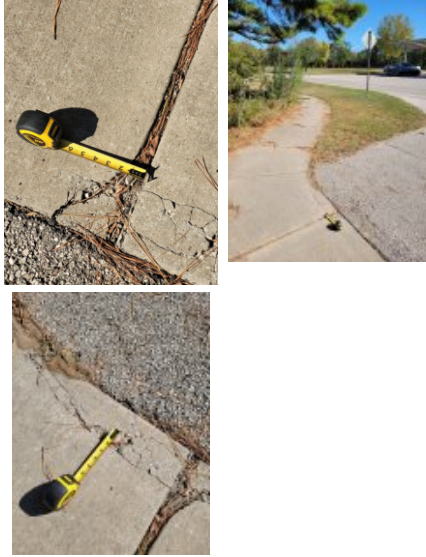
40	Isle Du Bois Unit: IDB - Trails	[33.3661188 , -97.011768 5]	Openings in the surface of outdoor recreation access routes shall not allow the passage of a sphere more than 1/2 inch (13 mm) in diameter. Advisory: Spaces between the boards in a boardwalk and drainage grates are examples of openings. Where possible, drainage grates should be located outside the minimum clear width of the outdoor recreation access route. Elongated openings should be placed so that the long dimension is perpendicular, or as close to perpendicular as possible, to the dominant direction of travel	Lost Pines - 1.5" gap along sidewalk	Correct or fill gaps along the ORAR to max .5" as a smart practice.	2015 ABAAS Section: 1016.6, Advisory 1016.6

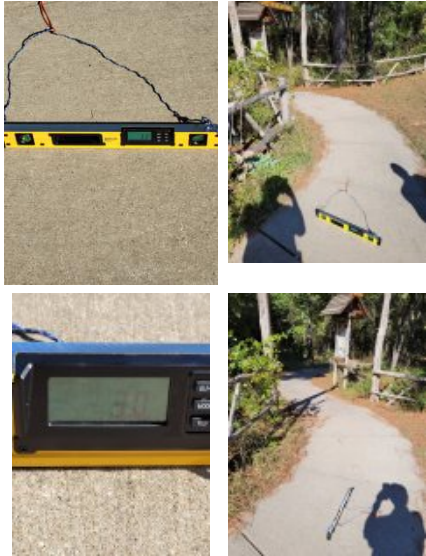
Finding Number	Area Description	Lat/Long	Finding	As Built	Recommendation	Citation	Photos	Figure
41	Isle Du Bois Unit: IDB - Trails	[33.3661174 , -97.011516 4]	The cross slope shall not be steeper than 1:48. EXCEPTION: Where the surface is other than concrete, asphalt, or boards, cross slopes not steeper than 1:20 shall be permitted when necessary for drainage.	Lost Pines - Cross slopes: 3.3%, 3%, and 2.2%	Correct or repair ORAR cross slope to max 2.08% or 5% for surfaces other than concrete, asphalt or board as a smart practices	2015 ABAAS Section: 1016.7.2, 1016.7.2 EXCEPTION

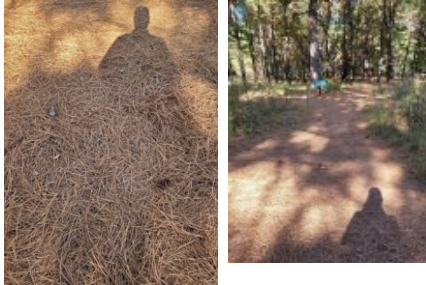
42	Isle Du Bois Unit: IDB - Trails	[33.36653, -97.01153]	The surface of trails, passing spaces, and resting intervals shall be firm and stable	Lost Pines - surface is dirt covered with pine needles	Leave as is and make other trails at this site as accessible	2015 ABAAS Section: 1017.2

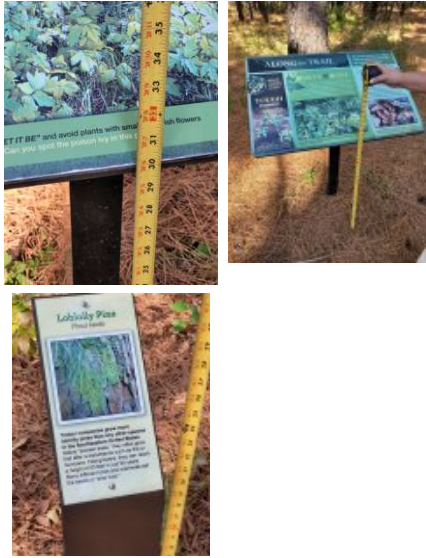
Finding Number	Area Description	Lat/Long	Finding	As Built	Recommendation	Citation	Photos	Figure
43	Isle Du Bois Unit: IDB - Trails	[33.36676, -97.01116]	Visual characters shall be 40 inches (1015 mm) minimum above the finish floor or ground. EXCEPTION: Visual characters indicating elevator car controls shall not be required to comply with 703.5.6.	Lost Pines - 30" Above Grade Level (AGL) to bottom of sign and 19" AGL to bottom of sign	Remount signage to min 40" aff.	2015 ABAAS Section: 703.5.6, 703.5.6 EXCEPTION 2012 TAS Section: 703.5.6, 703.5.6 Exception 2010 ADAS Section: 703.5.6, 703.5.6 Exception

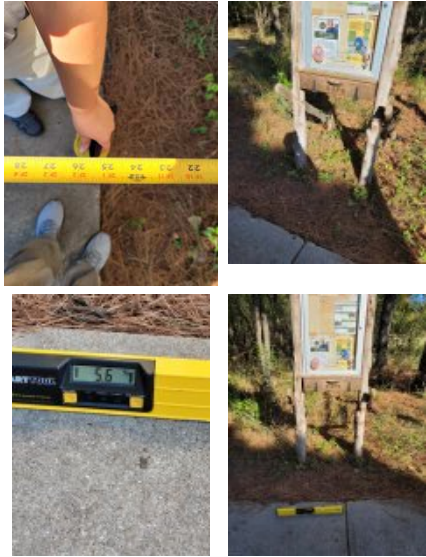
44	Isle Du Bois Unit: IDB - Trails	[33.3661394 , -97.011518 4]	The 30 inches minimum by 48 inches minimum clear floor space required at the operable part is not flat (2% or 1:48 maximum slope) in all directions. Changes in level are not permitted at required clear floor or ground space except that slopes not steeper than 1:48 shall be permitted.	Lost Pines - 5.6% slope in sign clear ground space	Correct or repair slope in CFS to max 2.08%	2015 ABAAS Section: 305.2 2012 TAS Section: 305.2 2010 ADAS Section: 305.2

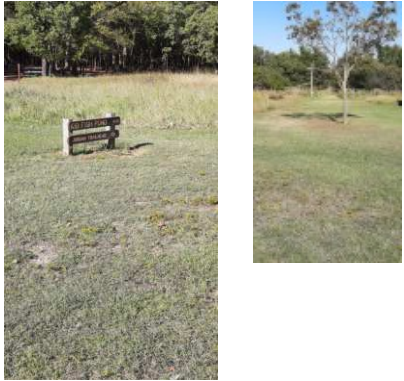
Finding Number	Area Description	Lat/Long	Finding	As Built	Recommendation	Citation	Photos	Figure
45	Isle Du Bois Unit: IDB - Trails	[33.3796955 , -97.011838]	The surface of trails, passing spaces, and resting intervals shall be firm and stable	Trail to kids fishing pond not accessible, grass	Create accessible route to fishing pond	2015 ABAAS Section: 1017.2

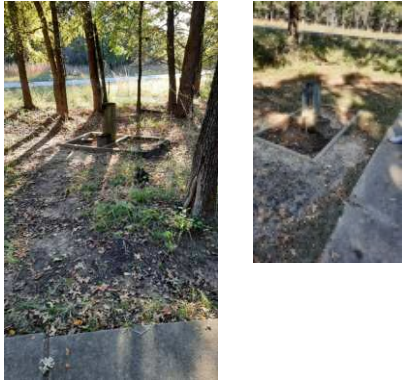
Finding Number	Area Description	Lat/Long	Finding	As Built	Recommendation	Citation	Photos	Figure
47	Isle Du Bois Unit: IDB - Trails	[33.3769718 , -97.0225378]	There is no accessible route to the water spigot. At least one accessible route shall connect accessible buildings, accessible facilities, accessible elements, and accessible spaces that are on the same site.	Lacks AR to 2 water spigots along roadway	Create an accessible route with crushed stone or other outdoor material from parking or walkway to spigot.	2015 ABAAS Section: F206.2.2 2012 TAS Section: 206.2.2 2010 ADAS Section: 206.2.2

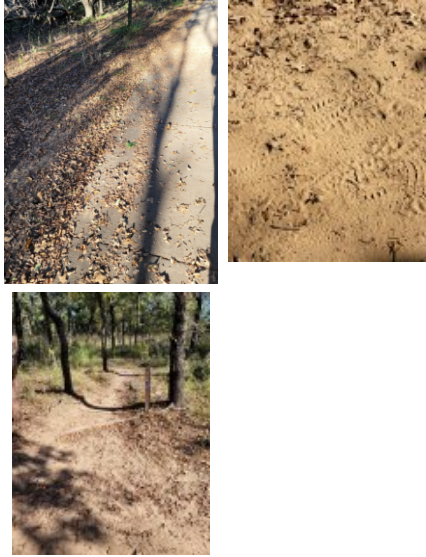
Finding Number	Area Description	Lat/Long	Finding	As Built	Recommendation	Citation	Photos	Figure
49	Isle Du Bois Unit: IDB - Trails	[33.380887, -97.016987 9]	The surface of the trails, passing spaces, and/or resting intervals is not firm and stable. The surface of trails, passing spaces, and resting intervals shall be firm and stable	Randy Bell Trail - Leaves on trail, trail D crossing sand on trail	Maintain trails so they are firm and stable.	2015 ABAAS Section: 1017.2

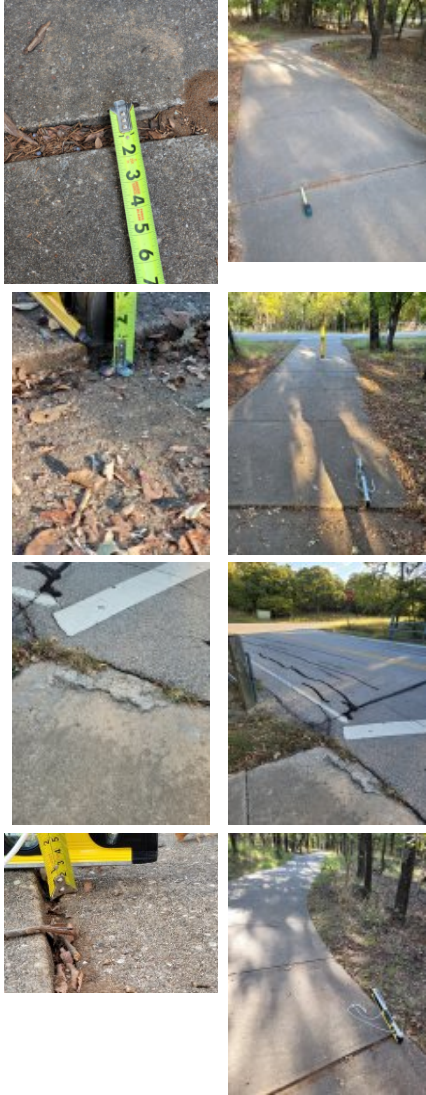
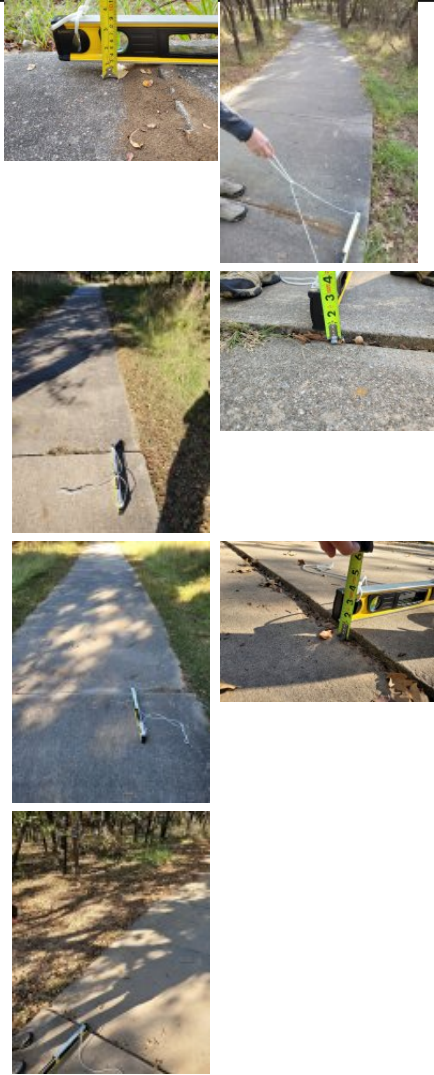
Finding Number	Area Description	Lat/Long	Finding	As Built	Recommendation	Citation	Photos	Figure
50	Isle Du Bois Unit: IDB - Trails	[33.3761297 , -97.018232 4]	Tread obstacles on trails, passing spaces, and resting intervals shall not exceed 1/2 inch (13 mm) in height measured vertically to the highest point. EXCEPTION: Where the surface is other than asphalt, concrete, or boards, tread obstacles shall be permitted to not exceed 2 inches (50 mm) in height measured vertically to the highest point.	Randy Bell Trail - 2" near intersection to Hawthorn camping, 2" gap approaching deer ridge campground, 1" rise near main road crossing, accumulated concrete near main road crossing, 1" rise past ravine, 1" & 1.5" past fire sign, 1" gap at trail C	Repair, bevel or ramp tread obstacle along pathway to max .5" as a smart practice	2015 ABAAS Section: 1017.5

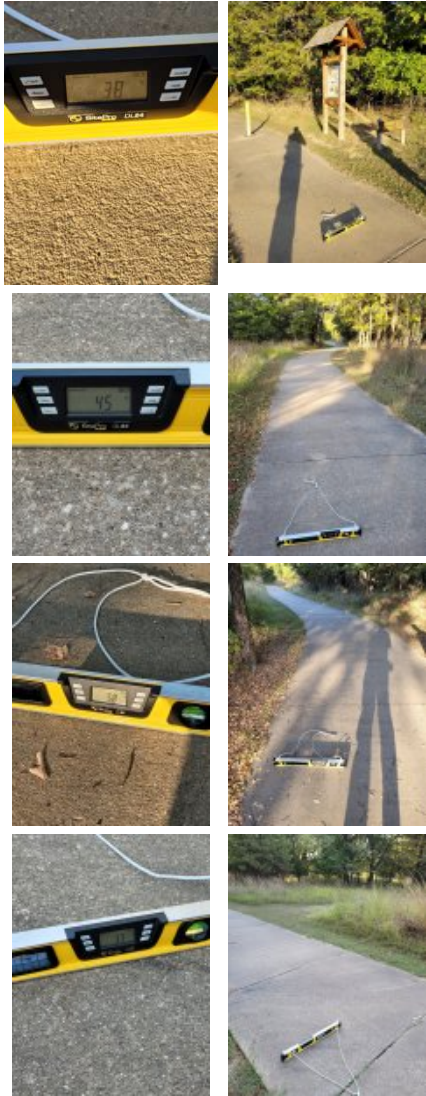
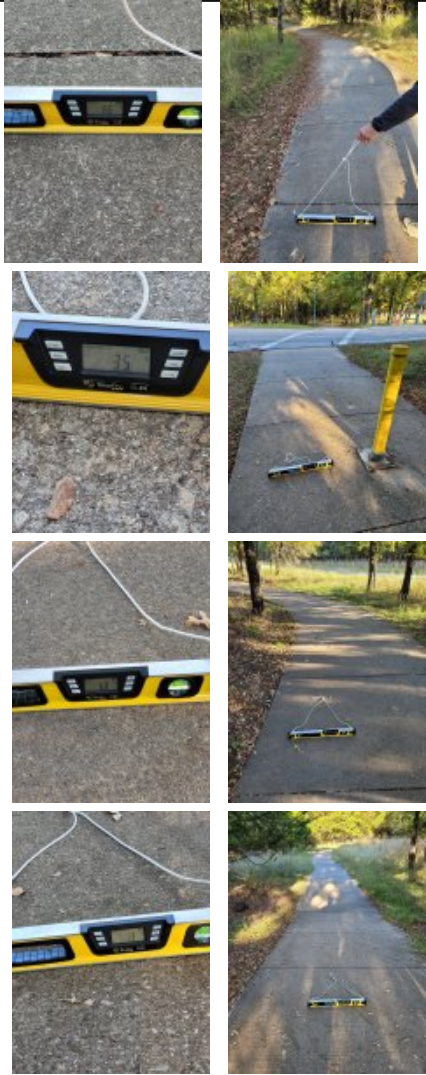
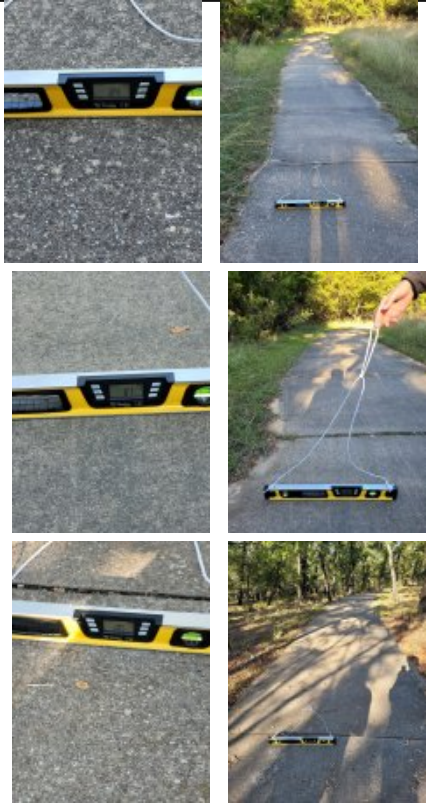
Finding Number	Area Description	Lat/Long	Finding	As Built	Recommendation	Citation	Photos	Figure
51	Isle Du Bois Unit: IDB - Trails	[33.3760558 , -97.018742]	The cross slope shall not be steeper than 1:48. EXCEPTION: Where the surface is other than concrete, asphalt, or boards, cross slopes not steeper than 1:20 shall be permitted when necessary for drainage.	Randy Bell Trail - Slopes: 3.8% near Hawthorn kiosk, inside path of trail has cross slope up to 10.5% on inside, 3.3% near campsite 3, 3.5% slope at bollard near main road crossing	Correct or repair pathway cross slope to max 2.08% as a smart practice.	2015 ABAAS Section: 1017.2

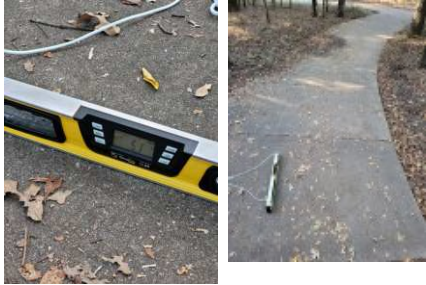
Finding Number	Area Description	Lat/Long	Finding	As Built	Recommendation	Citation	Photos	Figure
52	Isle Du Bois Unit: IDB - Trails	[33.3771332 , -97.022813 6]	The resting interval length shall be 60 inches (1525 mm) long minimum Where resting intervals are provided within an outdoor recreation access route, resting intervals shall be at least as wide as the widest segment of the outdoor recreation access route leading to the resting interval. Where resting intervals are provided adjacent to an outdoor recreation access route, the resting interval shall be 36 inches (915 mm) wide minimum Resting intervals shall have slopes not steeper than 1:48 in any direction. EXCEPTION: Where the surface is other than concrete, asphalt, or boards, slopes not steeper than 1:20 shall be permitted when necessary for drainage Where resting intervals are provided adjacent to an outdoor recreation access route, a turning space complying with 304.3.2 shall be provided.	Randy Bell Trail - Resting interval at 12% slope has 5.1% slope, 2 segments up to 12% lack level resting areas	Create 60" by 60" level resting areas every 200' along the ORAR as a smart practice.	2015 ABAAS Section: 1016.8.1, 1016.8.2, 1016.8.3, 1016.8.3 EXCEPTION, 1016.8.4

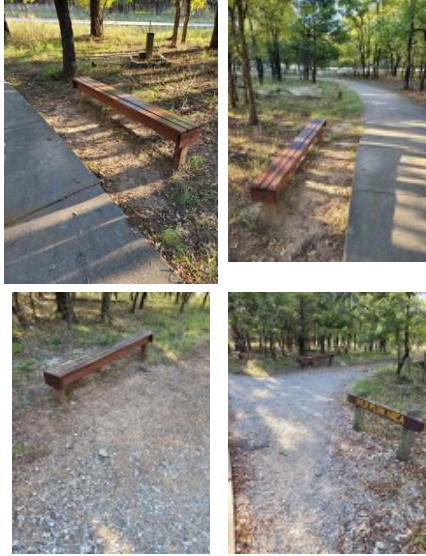
53	Isle Du Bois Unit: IDB - Trails	[33.3783875 , -97.026364 9]	36 inches (915 mm) by 48 inches (1220 mm) positioned near the bench with one side of the space adjoining an outdoor recreation access route or trail, as applicable The clear ground space shall not overlap the outdoor recreation access route or trail, or another clear ground space	Randy Bell Trail - Lacks clear ground space (CGS) at benches; no CGS at bench near wild plum area, no CGS past wild plumb, bench 171 no CGS.	Construct firm, stable, and slip resistant pads at least 36" by 48" adjacent to 20% of benches, and locate along an AR as a smart practice.	2015 ABAAS Section: 1011.2, 1011.2.1

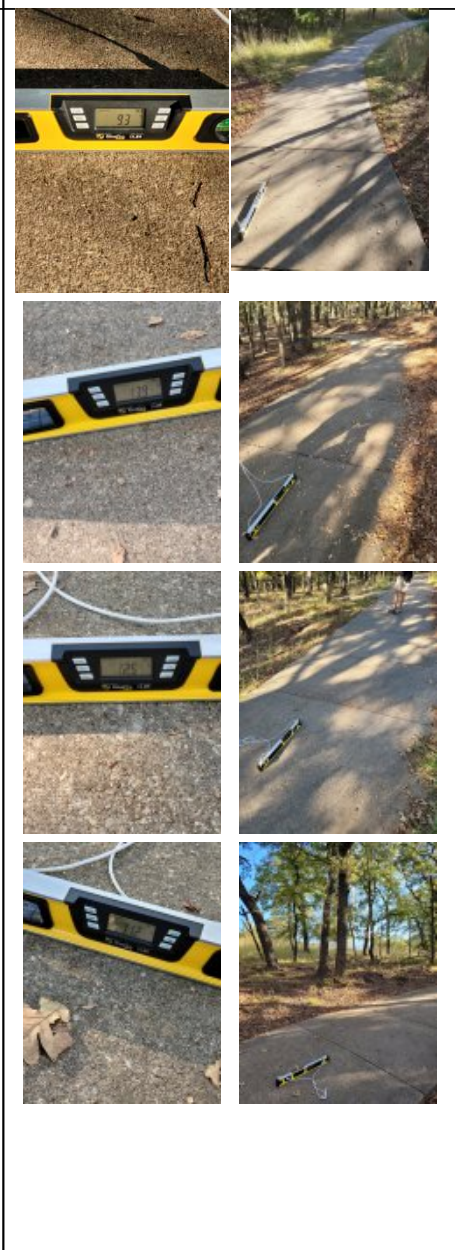
Finding Number	Area Description	Lat/Long	Finding	As Built	Recommendation	Citation	Photos	Figure
			<p>the maximum length of the segment shall be in accordance with Table 1017.7.1, and a resting interval complying with 1017.8 shall be provided at the top and bottom of each segment.</p>	<p>with slopes up to 13%. 12.3% section into and out of ravine, 12.8% just past wild plumb; spur to day use: 14.8% at ravine,</p>

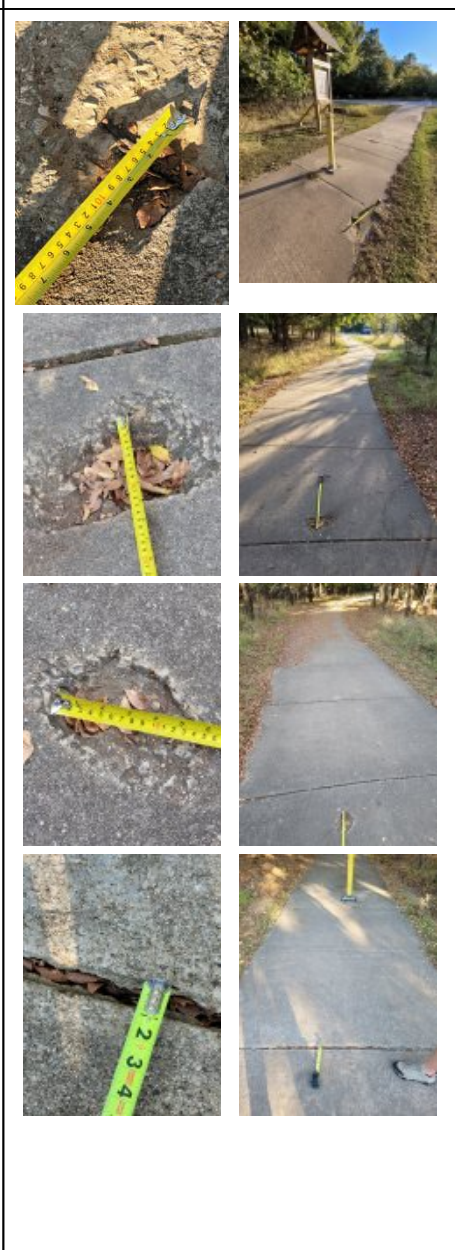
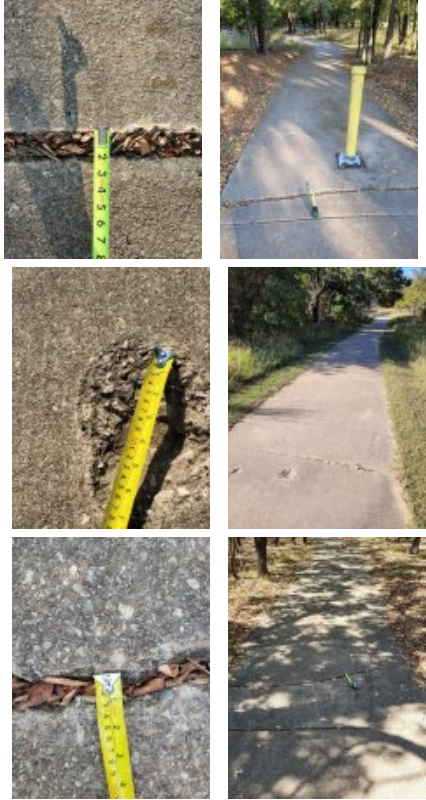
Finding Number	Area Description	Lat/Long	Finding	As Built	Recommendation	Citation	Photos	Figure
56	Isle Du Bois Unit: IDB - Trails	[33.3760468 , -97.018739 4]	There are openings in the surface of the trails, passing spaces, and resting intervals that allow the passage of a sphere more than 1/2 inch in diameter. Openings in the surface of trails, passing spaces, and resting intervals shall not allow the passage of a sphere more than 1/2 inch (13 mm) in diameter.	Randy Bell Trail - 4" near bollard at Hawthorn kiosk, 5" near path to Hawthorn camping area, 6" opening, 1" gap near bollard, 2" gap at bollard, 6" gap nearing main road, 1" gap along side of water tower; spur trail: 1.25" at ravine	Correct for fill gaps to max .5" as a smart practice.	2015 ABAAS Section: 1017.6

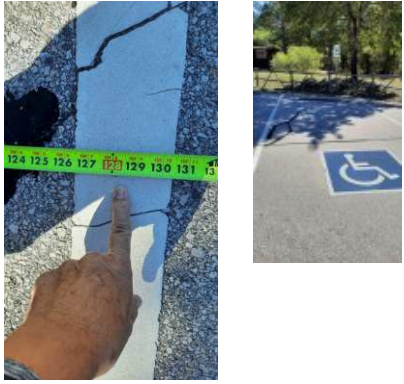
Finding Number	Area Description	Lat/Long	Finding	As Built	Recommendation	Citation	Photos	Figure
57	Isle Du Bois Unit: IDB - Interpretive Center	[33.3654763, -97.0116288]	There are no van accessible parking stalls. 1 in every 6, minimum of one, required accessible stalls must be a van accessible stall. There are a total of 6 parking stalls in the parking lot that could be reasonably associated with this facility. There should be a minimum of 1 accessible stalls with a minimum of 1 being designed as van accessible.	Van designated stall only 10' 8" wide	Add van parking sign to 1 accessible stall and repaint stall and access aisle to 11' and 5' or 8' and 8' per the table	2015 ABAAS Section: F208.2, F208.2.4 2012 TAS Section: 208.2, 208.2.4 2010 ADAS Section: 208.2, 208.2.4

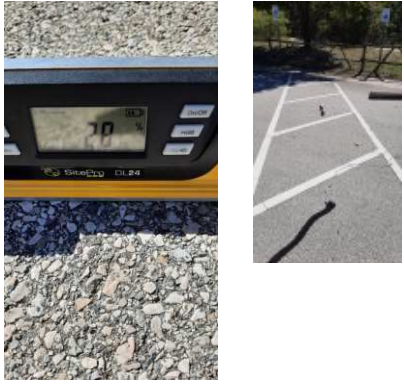
58	Isle Du Bois Unit: IDB - Interpretive Center	[33.3654976, -97.0115376]	The cross slopes (narrow dimension) and/or running slopes (long dimension) of the access aisle exceeds 2%. The running slope and the cross slope in an accessible parking stall and the access aisle must not exceed 2%.	Access aisle 2.8% slope	Repair or correct slope of parking space and access aisle to max 2.08% in any direction	2015 ABAAS Section: 502.4 2012 TAS Section: 502.4 2010 ADAS Section: 502.4

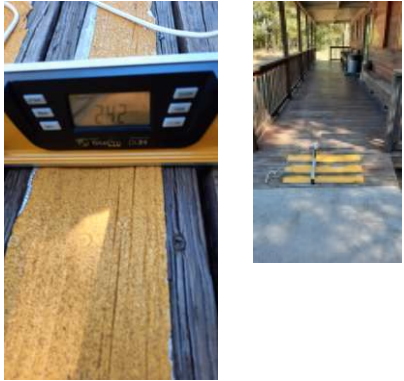
Finding Number	Area Description	Lat/Long	Finding	As Built	Recommendation	Citation	Photos	Figure
60	Isle Du Bois Unit: IDB - Interpretive Center	[33.365408, -97.011304 3]	The running slope of walking surfaces shall not be steeper than 1:20.	24.2% slope on transition to front porch	Correct running slope along the AR to max 5%	2015 ABAAS Section: 403.3 2012 TAS Section: 403.3 2010 ADAS Section: 403.3

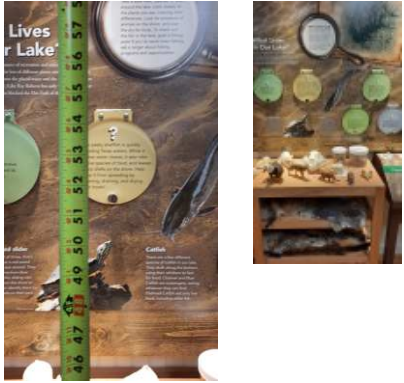
62	Isle Du Bois Unit: IDB - Interpretive Center	[33.3654159 -97.011269 4]	The knob is positioned too high for either a side or front approach. Where a clear floor or ground space allows a parallel approach to an element and the side reach is unobstructed, the high side reach shall be 48 inches maximum and the low side reach shall be 15 inches minimum above the finish floor or ground. Where a forward reach is unobstructed, the high forward reach shall be 48 inches maximum and the low forward reach shall be 15 inches minimum above the finish floor or ground.	Knobs on info panels at 51.5" over counter	Remount operable parts to be in reach range of 15" min to 48" max	2015 ABAAS Section: 308.1 2012 TAS Section: 308.1 2010 ADAS Section: 308.1

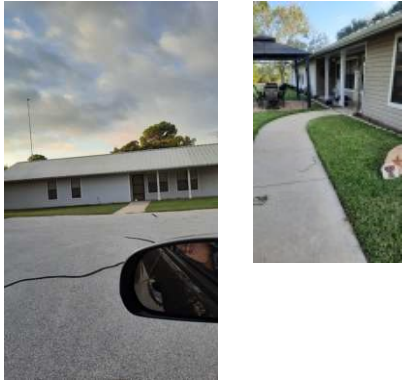
Finding Number	Area Description	Lat/Long	Finding	As Built	Recommendation	Citation	Photos	Figure																																																																																																																																																																																								
68	Isle Du Bois Unit: IDB - Residences	[33.42978, -97.05647]	Element meets all standards and requirements	Park residence near emtry complies, residence near maintenance complies	None	2010 ADAS Section: N/A

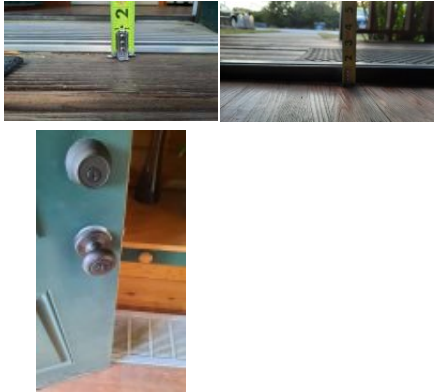
Finding Number	Area Description	Lat/Long	Finding	As Built	Recommendation	Citation	Photos	Figure
71	Isle Du Bois Unit: IDB - Maintenance	[33.3767726 , -97.007667 2]	<p>Minimum maneuvering clearances at doors and gates shall comply with 404.2.4. Maneuvering clearances shall extend the full width of the doorway and the required latch side or hinge side clearance. Door openings shall provide a clear width of 32 inches (815 mm) minimum. Clear openings of doorways with swinging doors shall be measured between the face of the door and the stop, with the door open 90 degrees. Openings more than 24 inches (610 mm) deep shall provide a clear opening of 36 inches (915 mm) minimum. There shall be no projections into the required clear opening width lower than 34 inches (865 mm) above the finish floor or ground. Projections into the clear opening width between 34 inches (865 mm) and 80 inches (2030 mm) above the finish floor or ground shall not exceed 4 inches (100 mm). The threshold has a vertical change greater than 1/4 inch high. The threshold at a doorway shall be no higher than 1/2 inch. Changes in level between 1/4 inch and 1/2 inch must be beveled at 1:2 or less. 1/4 inch is the maximum vertical rise. All interior doors must be maintained so that the operating pressure does not exceed 5 lb. force to open. The sweep period for doors with closers shall be adjusted so that from an open position of 70 degrees, the door will take at least 3 seconds to move to a point 3 inches from the latch, measured to the leading edge of the door. Exterior doors are recommended to be maintained at 8.5 lbf as a smart practice. Force is to be measured at the operating hardware or 30 inches from the hinges, whichever is greater. Hand-activated door opening hardware, handles, pulls, latches, locks, and other operating devices on accessible doors shall have a shape that is easy to grasp with one hand and does not require tight grasping, tight pinching or twisting of the wrist to operate. Hardware shall be 34 inches minimum and 48 inches maximum above the finish floor or</p>	Main entry- knob, .75" CIL on exterior, 1.5" interior	For all doors along the public circulation route, repair, bevel, or ramp CILs at door entries to max .25" For all doors along the public circulation route, replace hardware with lever hardware or hardware operable without a tight pinch or grasp	2010 ADAS Section: 404.2.3, 404.2.7, 404.2.4, 404.2.11, 404.2.11 Exception

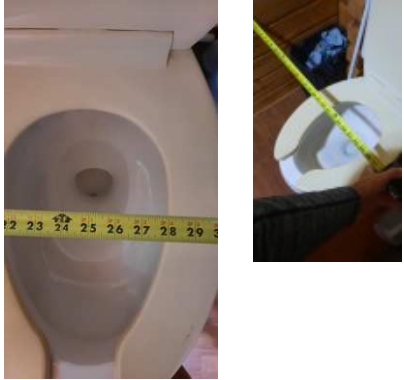
77	Isle Du Bois Unit: IDB - Maintenance	[33.3767894, -97.00769]	The toilet is not located within the range allowed from the side wall or partition. The centerline of the toilet must be 16 to 18 inches from the side wall.	Administration RR - 26" to toilet center line	Remount toilets to 16" to 18" from the side wall to centerline.	2015 ABAAS Section: 604.2 2012 TAS Section: 604.2 2010 ADAS Section: 604.2

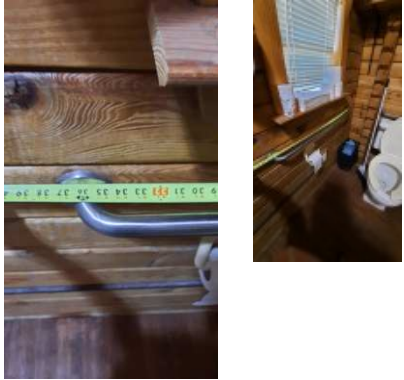
79	Isle Du Bois Unit: IDB - Maintenance	[33.3767838, -97.007686]	The side grab bars are not in the correct location. Grab bars on the side wall must be installed so that the end closest to the rear wall is maximum 12" from the rear wall. The end furthest from the rear wall must be mounted minimum 54" from the rear wall.	Administration RR - side bar 36" long	Replace side grab bar with a 42" long bar mounted to max 12" from the rear wall at the close end and min 54" on the far end, and 33" to 36" AFF.	2015 ABAAS Section: 604.5.1 2012 TAS Section: 604.5.1 2010 ADAS Section: 604.5.1

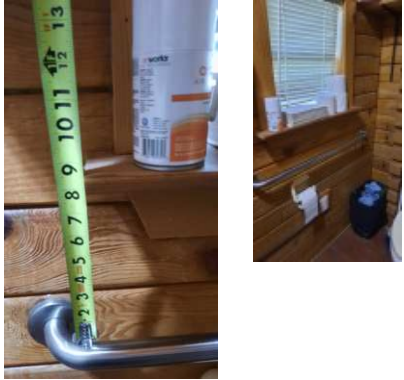
80	Isle Du Bois Unit: IDB - Maintenance	[33.3767793, -97.0076887]	The grab bar height and/or spacing fails. Grab bars must be mounted between 33" and 36" to the top of the gripping surface. There must be 1.5" of clearance between the grab bar and the wall. There must be a minimum of 1.5" of clearance below and minimum 12" above the grab bar to any dispenser or other obstruction.	Administration RR - window sill too close above	Replace or remove portion of window sill to allow min 12" above grab bar.	2015 ABAAS Section: 609.3, 609.4 2012 TAS Section: 609.4, 609.3 2010 ADAS Section: 609.3, 609.4

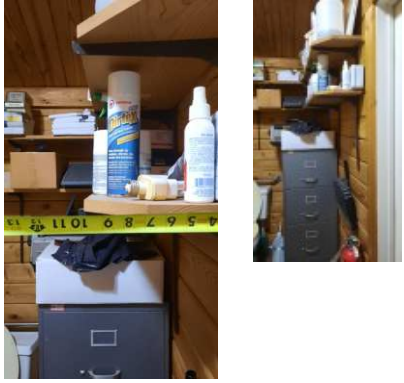
Finding Number	Area Description	Lat/Long	Finding	As Built	Recommendation	Citation	Photos	Figure
84	Isle Du Bois Unit: IDB - Maintenance	[33.3767748 , -97.007686]	The shelf projects more than 4 inches into the circulation path. Wall-mounted objects that have leading edges between 27 inches and 80 inches from the floor must not project more than 4 inches into the circulation path. Protruding objects that extend to the floor or within 27 inches of the floor are cane detectable and are therefore not hazardous. Where it is necessary or desirable to have objects protrude from the wall, a manner of cane detection must be provided.	Administration RR - shelf protrudes	Relocate protruding objects or place cane detectable warning or bollard at foot of item	2015 ABAAS Section: 307.2 2012 TAS Section: 307.2 2010 ADAS Section: 307.2

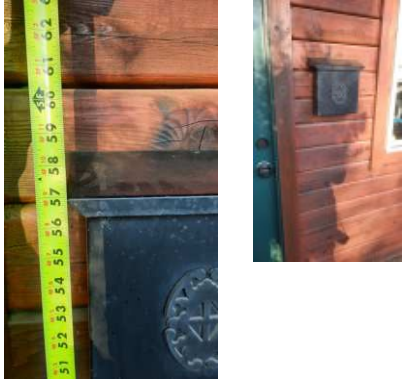
85	Isle Du Bois Unit: IDB - Maintenance	[33.3767479 , -97.0076484]	The mailbox is too high and is out of the maximum reach range for a side approach. Where a clear floor or ground space allows a parallel approach to an element and the side reach is unobstructed, the high side reach shall be 48 inches maximum to the finished floor.	Administration mailbox at 57" AFF	Lower operating mechanisms to max 48" aff to highest operable part; leave as is if employee only operated.	2015 ABAAS Section: 308.3.1 2012 TAS Section: 308.3.1 2010 ADAS Section: 308.3.1

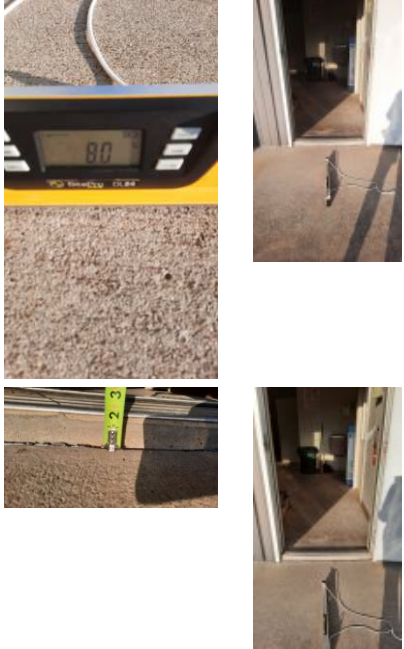
Finding Number	Area Description	Lat/Long	Finding	As Built	Recommendation	Citation	Photos	Figure
87	Isle Du Bois Unit: IDB - Maintenance	[33.3769719 , -97.007672 6]	Spaces and elements within employee work areas shall only be required to comply with 206.2.8, 207.1, and 215.3 and shall be designed and constructed so that individuals with disabilities can approach, enter, and exit the employee work area. Employee work areas, or portions of employee work areas, other than raised courtroom stations, that are less than 300 square feet (28 m2) and elevated 7 inches (180 mm) or more above the finish floor or ground where the elevation is essential to the function of the space shall not be required to comply with these requirements or to be on an accessible route.	Law enforcement building - 8% slope at entry door, 2" CIL	For employee spaces, relocate storage, furniture, and other obstacles at doorways to provide approach, enter and exit at the employee space. Provide required maneuvering clearance on push and pull side of doors. Correct slope in door clearance to max 2.08%. Repair, bevel, or ramp CILs at door entries to max .25".	2015 ABAAS Section: F203.9 2012 TAS Section: 203.9 2010 ADAS Section: 203.9

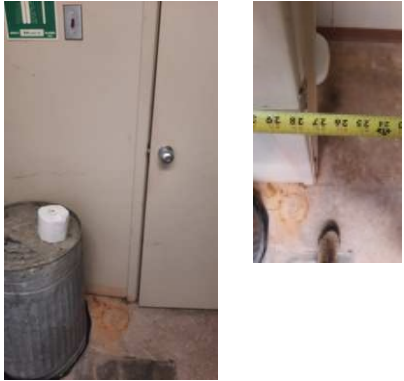
Finding Number	Area Description	Lat/Long	Finding	As Built	Recommendation	Citation	Photos	Figure
92	Isle Du Bois Unit: IDB - Maintenance	[33.3770301 , -97.007677 9]	Minimum maneuvering clearances at doors and gates shall comply with 404.2.4. Maneuvering clearances shall extend the full width of the doorway and the required latch side or hinge side clearance. Door openings shall provide a clear width of 32 inches (815 mm) minimum. Clear openings of doorways with swinging doors shall be measured between the face of the door and the stop, with the door open 90 degrees. Openings more than 24 inches (610 mm) deep shall provide a clear opening of 36 inches (915 mm) minimum. There shall be no projections into the required clear opening width lower than 34 inches (865 mm) above the finish floor or ground. Projections into the clear opening width between 34 inches (865 mm) and 80 inches (2030 mm) above the finish floor or ground shall not exceed 4 inches (100 mm). The threshold has a vertical change greater than 1/4 inch high. The threshold at a doorway shall be no higher than 1/2 inch. Changes in level between 1/4 inch and 1/2 inch must be beveled at 1:2 or less. 1/4 inch is the maximum vertical rise. All interior doors must be maintained so that the operating pressure does not exceed 5 lb. force to open. The sweep period for doors with closers shall be adjusted so that from an open position of 70 degrees, the door will take at least 3 seconds to move to a point 3 inches from the latch, measured to the leading edge of the door. Exterior doors are recommended to be maintained at 8.5 lbf as a smart practice. Force is to be measured at the operating hardware or 30 inches from the hinges, whichever is greater. Hand-activated door opening hardware, handles, pulls, latches, locks, and other operating devices on accessible doors shall have a shape that is easy to grasp with one hand and does not require tight grasping, tight pinching or twisting of the wrist to operate. Hardware shall be 34 inches minimum and 48 inches maximum above the finish floor or	Law Enforcement Restroom - door has knob, storage in clearance, 27" wide	For all doors along the public circulation route, provide required maneuvering clearance on push and pull side of doors For all doors along the public circulation route, replace doors with doors having 80" overhead clearance and 32" clear width For all doors along the public circulation route, replace hardware with lever hardware or hardware operable without a tight pinch or grasp	2010 ADAS Section: 404.2.3, 404.2.7, 404.2.4, 404.2.11, 404.2.11 Exception

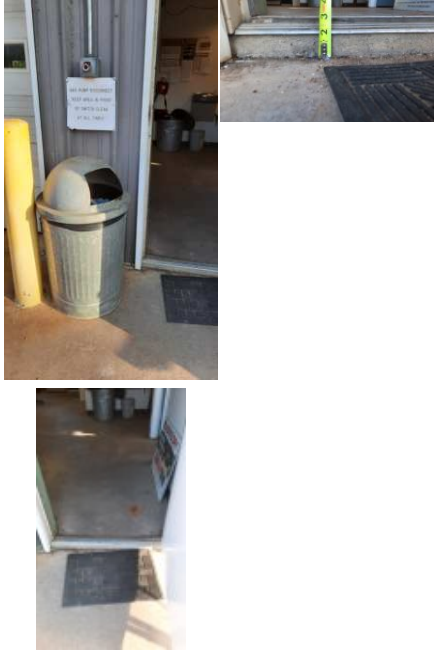
Finding Number	Area Description	Lat/Long	Finding	As Built	Recommendation	Citation	Photos	Figure
			ground. The bottom 10 inches on the push side must be smooth and free of obstructions (hold open devices). Opening hardware must be mounted between 30 and 44 inches above the floor or ground. Doors, gates, and side lights adjacent to doors or gates, containing one or more glazing panels that permit viewing through the panels shall have the bottom of at least one glazed panel located 43 inches (1090 mm) maximum above the finish floor. EXCEPTION: Vision lights with the lowest part more than 66 inches (1675 mm) from the finish floor or ground shall not be required to comply with 404.2.11.					
93	Isle Du Bois Unit: IDB - Maintenance	[33.3773168 , -97.007551 9]	Minimum maneuvering clearances at doors and gates shall comply with 404.2.4. Maneuvering clearances shall extend the full width of the doorway and the required latch side or hinge side clearance. Door openings shall provide a clear width of 32 inches (815 mm) minimum. Clear openings of doorways with swinging doors shall be measured between the face of the door and the stop, with the door open 90 degrees. Openings more than 24 inches (610 mm) deep shall provide a clear opening of 36 inches (915 mm) minimum. There shall be no projections into the required clear opening width lower than 34 inches (865 mm) above the finish floor or ground. Projections into the clear opening width between 34 inches (865 mm) and 80 inches (2030 mm) above the finish floor or ground shall not exceed 4 inches (100 mm). The threshold has a vertical change greater than 1/4 inch high. The threshold at a doorway shall be no higher than 1/2 inch. Changes in level between 1/4 inch and 1/2 inch must be beveled at 1:2 or less. 1/4 inch is the maximum vertical rise. All interior doors must be maintained so that the operating pressure does not exceed 5 lb. force to open. The sweep period for doors with closers shall be adjusted so that from an	Main bldg entry - garbage in pull side clearance, 2.5" CIL	For all doors along the public circulation route, provide required maneuvering clearance on push and pull side of doors For all doors along the public circulation route, repair, bevel, or ramp CILs at door entries to max .25"	2010 ADAS Section: 404.2.3, 404.2.7, 404.2.4, 404.2.11, 404.2.11 Exception

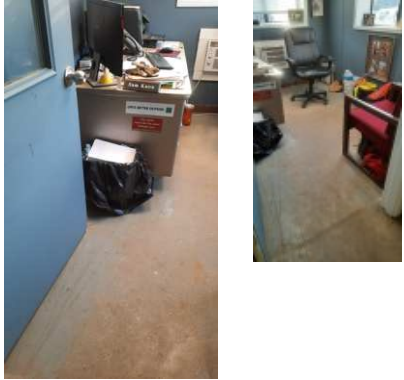
Finding Number	Area Description	Lat/Long	Finding	As Built	Recommendation	Citation	Photos	Figure
94	Isle Du Bois Unit: IDB - Maintenance	[33.3773213, -97.0075894]	Spaces and elements within employee work areas shall only be required to comply with 206.2.8, 207.1, and 215.3 and shall be designed and constructed so that individuals with disabilities can approach, enter, and exit the employee work area. Employee work areas, or portions of employee work areas, other than raised courtroom stations, that are less than 300 square feet (28 m2) and elevated 7 inches (180 mm) or more above the finish floor or ground where the elevation is essential to the function of the space shall not be required to comply with these requirements or to be on an accessible route.	Office 1 - knob, furniture back, shared office entry complies	For employee spaces, relocate storage, furniture, and other obstacles at doorways to provide approach, enter and exit at the employee space. Replace door knob with compliant lever hardware	2015 ABAAS Section: F203.9 2012 TAS Section: 203.9 2010 ADAS Section: 203.9

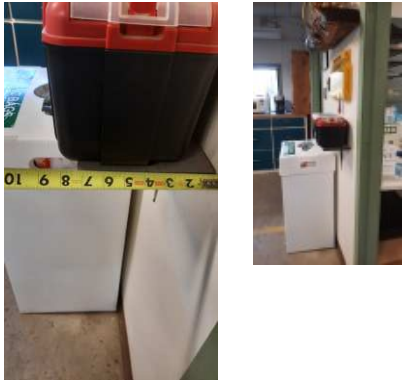
95	Isle Du Bois Unit: IDB - Maintenance	[33.3773213, -97.0074392]	The shelves projects more than 4 inches into the circulation path. Wall-mounted objects that have leading edges between 27 inches and 80 inches from the floor must not project more than 4 inches into the circulation path. Protruding objects that extend to the floor or within 27 inches of the floor are cane detectable and are therefore not hazardous. Where it is necessary or desirable to have objects protrude from the wall, a manner of cane detection must be provided.	Break room - Shelves protrude	Relocate protruding objects or place cane detectable warning or bollard at foot of item.	2015 ABAAS Section: 307.2 2012 TAS Section: 307.2 2010 ADAS Section: 307.2

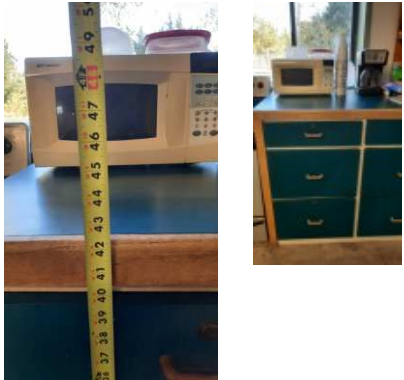
96	Isle Du Bois Unit: IDB - Maintenance	[33.3773482, -97.0073856]	The microwave and coffeemaker are positioned too high for either a side or front approach. Where a clear floor or ground space allows a parallel approach to an element and the side reach is unobstructed, the high side reach shall be 48 inches maximum and the low side reach shall be 15 inches minimum above the finish floor or ground. Where a forward reach is unobstructed, the high forward reach shall be 48 inches maximum and the low forward reach shall be 15 inches minimum above the finish floor or ground.	Break room - microwave and coffeemaker on 42" high chest	Remount or relocate operable parts to be in reach range of 15" min to 48" max	2015 ABAAS Section: 308.1 2012 TAS Section: 308.1 2010 ADAS Section: 308.1

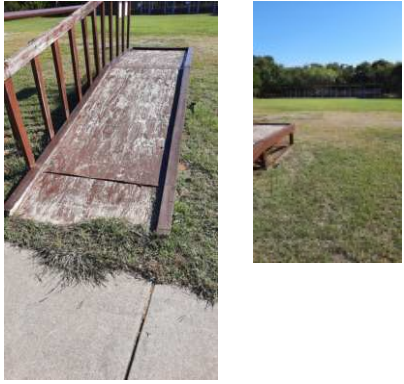
Finding Number	Area Description	Lat/Long	Finding	As Built	Recommendation	Citation	Photos	Figure
105	Isle Du Bois Unit: IDB - Bluestem Grove Campsites	[33.3776774 , -97.0128814]	There is no accessible route to the corrals. At least one accessible route shall connect accessible buildings, accessible facilities, accessible elements, and accessible spaces that are on the same site.	Route fails to connect to mounting platform, no route to corrals	Create an accessible route with crushed stone or other outdoor material from parking or walkway to corral.	2015 ABAAS Section: F206.2.2 2012 TAS Section: 206.2.2 2010 ADAS Section: 206.2.2

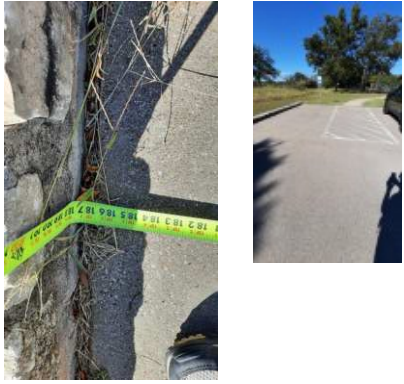
107	Isle Du Bois Unit: IDB - Bluestem Grove Parking	[33.3778544 , -97.0118903]	There are no van accessible parking stalls. 1 in every 6, minimum of one, required accessible stalls must be a van accessible stall. There are a total of 11 parking stalls in the parking lot that could be reasonably associated with this facility. There should be a minimum of 1 accessible stalls with a minimum of 1 being designed as van accessible.	Stall and aisle only 15'7"	Repaint van stall and access aisle to 11' and 5' or 8' and 8'.	2015 ABAAS Section: F208.2, F208.2.4 2012 TAS Section: 208.2, 208.2.4 2010 ADAS Section: 208.2, 208.2.4

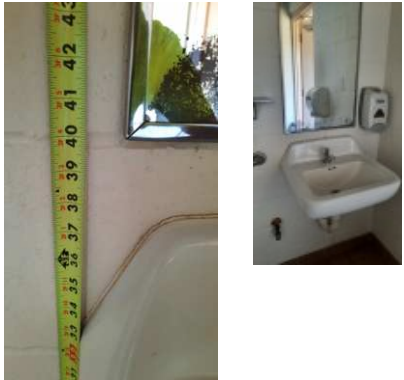
111	Isle Du Bois Unit: IDB - Bluestem Grove Men's Restroom	[33.3779238, -97.011767]	The mirror is mounted too high. Mirrors must have the bottom edge of the reflecting surface a maximum of 40 inches above the floor if above a sink or counter. Mirrors not located above lavatories or countertops shall be installed with the bottom edge of the reflecting surface 35 inches maximum above the finish floor or ground.	Mirror at 40.5" AFF	Lower mirror so reflective surface is max 40" aff.	2015 ABAAS Section: 603.3 2012 TAS Section: 603.3 2010 ADAS Section: 603.3

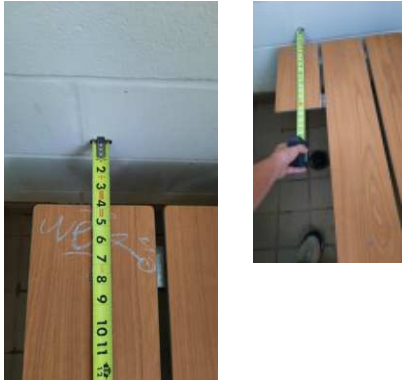
Finding Number	Area Description	Lat/Long	Finding	As Built	Recommendation	Citation	Photos	Figure
123	Isle Du Bois Unit: IDB - Bluestem Grove Men's Restroom	[33.3779205, -97.0117764]	The shower seat does not have a compliant space between it and the wall. The folding seat must be mounted 17-19 inches above the floor, and have a maximum space of 1-1/2 inches between the edge of the seat and the side wall and 2-1/2 inches maximum to the seat wall.	Rear gap at shower seat is 3.75"	Remount shower seat to the correct location and height in the shower.	2015 ABAAS Section: 610.3.2 2012 TAS Section: 610.3.2 2010 ADAS Section: 610.3.2

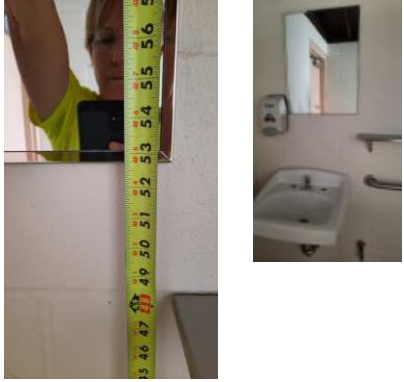
124	Isle Du Bois Unit: IDB - Bluestem Grove Women's Restroom	[33.3779171, -97.0118005]	The mirror is mounted too high. Mirrors must have the bottom edge of the reflecting surface a maximum of 40 inches above the floor if above a sink or counter. Mirrors not located above lavatories or countertops shall be installed with the bottom edge of the reflecting surface 35 inches maximum above the finish floor or ground.	Mirror at 53"	Lower mirror so reflective surface is max 40" aff.	2015 ABAAS Section: 603.3 2012 TAS Section: 603.3 2010 ADAS Section: 603.3

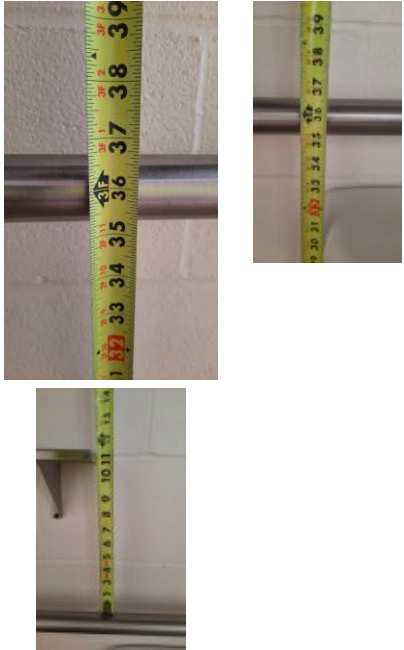
Finding Number	Area Description	Lat/Long	Finding	As Built	Recommendation	Citation	Photos	Figure
128	Isle Du Bois Unit: IDB - Bluestem Grove Women's Restroom	[33.3779305, -97.011779]	The grab bar height and/or spacing fails. Grab bars must be mounted between 33" and 36" to the top of the gripping surface. There must be 1.5" of clearance between the grab bar and the wall. There must be a minimum of 1.5" of clearance below and minimum 12" above the grab bar to any dispenser or other obstruction.	Both grab bars at 36.75" and shelf too close above rear bar	Remount grab bars in accessible stall to 33" to 36" aff. Remount shelf min 12" above or 1.5" below grab bar.	2015 ABAAS Section: 609.3, 609.4 2012 TAS Section: 609.4, 609.3 2010 ADAS Section: 609.3, 609.4

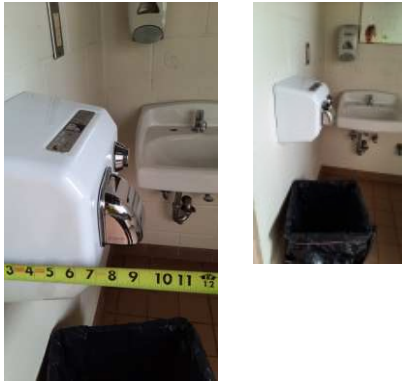
129	Isle Du Bois Unit: IDB - Bluestem Grove Women's Restroom	[33.3779283, -97.0117871]	The dryer projects more than 4 inches into the circulation path. Wall-mounted objects that have leading edges between 27 inches and 80 inches from the floor must not project more than 4 inches into the circulation path. Protruding objects that extend to the floor or within 27 inches of the floor are cane detectable and are therefore not hazardous. Where it is necessary or desirable to have objects protrude from the wall, a manner of cane detection must be provided.	Hand dryer protrudes	Relocate protruding objects or place cane detectable warning or bollard at foot of item.	2015 ABAAS Section: 307.2 2012 TAS Section: 307.2 2010 ADAS Section: 307.2

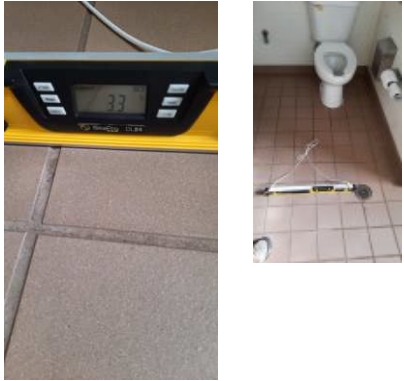
Finding Number	Area Description	Lat/Long	Finding	As Built	Recommendation	Citation	Photos	Figure
130	Isle Du Bois Unit: IDB - Bluestem Grove Women's Restroom	[33.3779193 , -97.011775]	The accessible route contains running slopes greater than 5 percent and cross slopes greater than 2 percent across the width of the walk and has not been constructed as a ramp (i.e. handrails, wheel guides, etc.). When the slope in the direction of travel of any walk exceeds 1 unit vertical in 20 units horizontal (5-percent slope), it must be constructed as ramp. Surface cross slopes must not exceed one unit vertical in 48 units. Horizontal (2-percent slope).	3.3% slope at drain	Correct or repair slope to max 2.08%.	2015 ABAAS Section: 403.3 2012 TAS Section: 403.3 2010 ADAS Section: 403.3

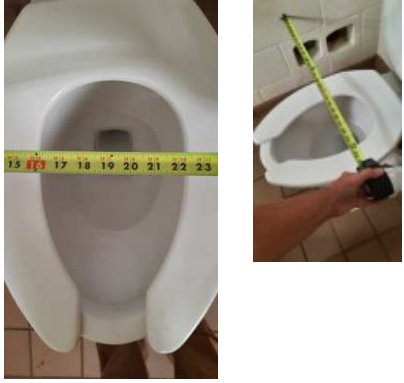
Finding Number	Area Description	Lat/Long	Finding	As Built	Recommendation	Citation	Photos	Figure
151	Isle Du Bois Unit: IDB - Hawthorn Men's Restroom	[33.3756549 , -97.018243 2]	The toilet is not located within the range allowed from the side wall or partition. The centerline of the toilet must be 16 to 18 inches from the side wall.	Toilet center line 19.25"	Remount toilets to 16" to 18" from the side wall to centerline.	2015 ABAAS Section: 604.2 2012 TAS Section: 604.2 2010 ADAS Section: 604.2

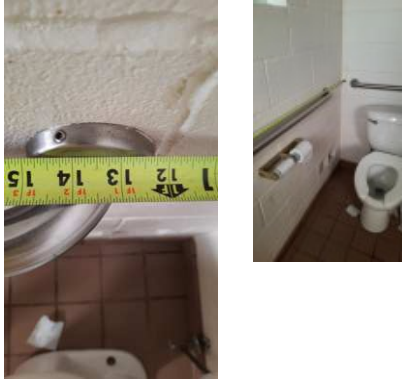
152	Isle Du Bois Unit: IDB - Hawthorn Men's Restroom	[33.3756101 , -97.018237 8]	The side grab bars are not in the correct location. Grab bars on the side wall must be installed so that the end closest to the rear wall is maximum 12" from the rear wall. The end furthest from the rear wall must be mounted minimum 54" from the rear wall.	Side bar 14" from rear wall	Remount side grab bar to max 12" from the rear wall at the close end and min 54" on the far end, and 33" to 36" aff.	2015 ABAAS Section: 604.5.1 2012 TAS Section: 604.5.1 2010 ADAS Section: 604.5.1

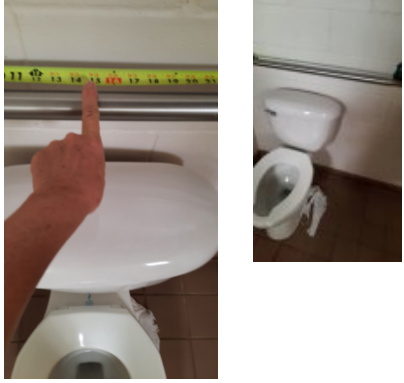
153	Isle Du Bois Unit: IDB - Hawthorn Men's Restroom	[33.3756101 , -97.018275 3]	The rear grab bar is not 36" long or is not mounted in the correct location. The rear grab bar must be a minimum of 36" long and extend from the toilet centerline a minimum 12" towards the wall side and a minimum 24" towards the open side of the toilet. Grab bars shall be installed in a horizontal position, 33 inches minimum and 36 inches maximum above the finish floor measured to the top of the gripping surface and the space between the grab bar and the top of the tank shall be 1-1/2 inches minimum.	Rear bar 15" to toilet center line	Remount rear grab bar to behind the toilet, 12" to one side of center and 24" to the other and 33" to 36" aff.	2015 ABAAS Section: 604.5.2 2012 TAS Section: 604.5.2 2010 ADAS Section: 604.5.2

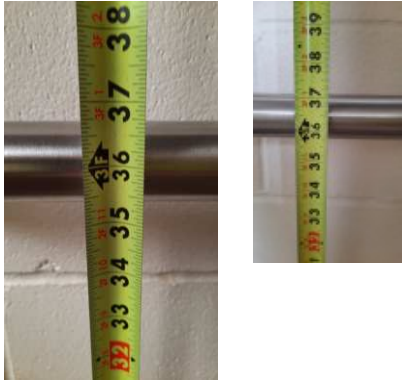
Finding Number	Area Description	Lat/Long	Finding	As Built	Recommendation	Citation	Photos	Figure
154	Isle Du Bois Unit: IDB - Hawthorn Men's Restroom	[33.3756235 , -97.018227 1]	The grab bar height and/or spacing fails. Grab bars must be mounted between 33" and 36" to the top of the gripping surface. There must be 1.5" of clearance between the grab bar and the wall. There must be a minimum of 1.5" of clearance below and minimum 12" above the grab bar to any dispenser or other obstruction.	Side 36.75", rear 37"	Remount grab bars in accessible stall to 33" to 36" aff.	2015 ABAAS Section: 609.3, 609.4 2012 TAS Section: 609.4, 609.3 2010 ADAS Section: 609.3, 609.4

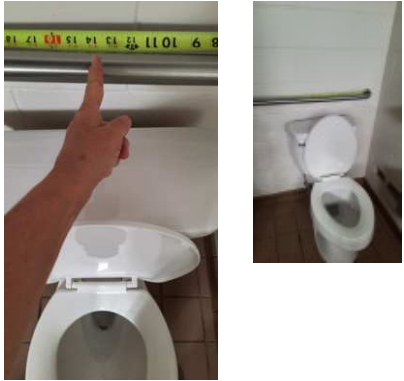
Finding Number	Area Description	Lat/Long	Finding	As Built	Recommendation	Citation	Photos	Figure
161	Isle Du Bois Unit: IDB - Hawthorn Women's Restroom	[33.375619, -97.018235 1]	The rear grab bar is not 36" long or is not mounted in the correct location. The rear grab bar must be a minimum of 36" long and extend from the toilet centerline a minimum 12" towards the wall side and a minimum 24" towards the open side of the toilet. Grab bars shall be installed in a horizontal position, 33 inches minimum and 36 inches maximum above the finish floor measured to the top of the gripping surface and the space between the grab bar and the top of the tank shall be 1-1/2 inches minimum.	14" to toilet center line	Remount rear grab bar to behind the toilet, 12" to one side of center and 24" to the other and 33" to 36" aff.	2015 ABAAS Section: 604.5.2 2012 TAS Section: 604.5.2 2010 ADAS Section: 604.5.2

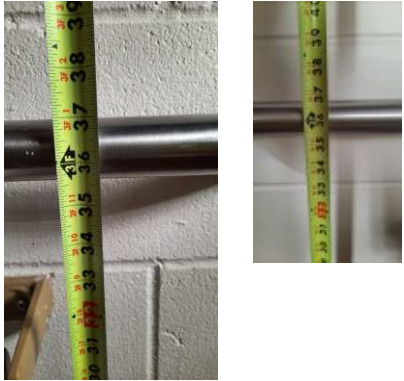
162	Isle Du Bois Unit: IDB - Hawthorn Women's Restroom	[33.3756325, -97.018275 3]	The grab bar height and/or spacing fails. Grab bars must be mounted between 33" and 36" to the top of the gripping surface. There must be 1.5" of clearance between the grab bar and the wall. There must be a minimum of 1.5" of clearance below and minimum 12" above the grab bar to any dispenser or other obstruction.	Grab bars: side 37", rear 36.75	Remount grab bars in accessible stall to 33" to 36" aff.	2015 ABAAS Section: 609.3, 609.4 2012 TAS Section: 609.4, 609.3 2010 ADAS Section: 609.3, 609.4
