Access Audit Site Report

Ray Roberts Lake State Park/Complex

Accessibility Evaluation

Inspection Date: 10/18/2021

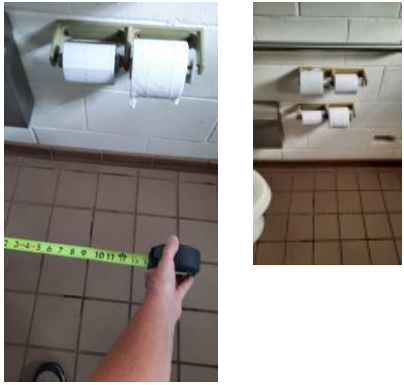
164	Isle Du Bois Unit: IDB - Hawthorn Women's Restroom	[33.3756146 , -97.018259 3]	The toilet paper is not installed within the compliant range in front of the toilet. Toilet paper dispensers shall be 7 inches minimum and 9 inches maximum in front of the water closet measured to the centerline of the dispenser. The outlet of the dispenser shall be 15 inches minimum and 48 inches maximum above the finish floor and shall not be located behind grab bars. Dispensers shall not be of a type that controls delivery or that does not allow continuous paper flow. There shall be a clearance of 1 1/2 inches minimum below the grab bar.	Toilet Paper (TP) too far	Remount toilet paper dispenser max 7" to 9" from front of toilet, 15" to 48" aff and min 12" above or 1.5" below grab bar.	2015 ABAAS Section: 604.7 2012 TAS Section: 604.7 2010 ADAS Section: 604.7

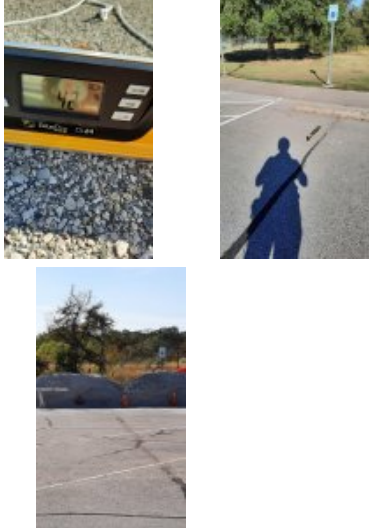
168	Isle Du Bois Unit: IDB - Hawthorn Parking	[33.3760166 , -97.018614 6]	The accessible parking is not located on the shortest accessible route to the building. Accessible parking spaces serving a particular building or facility entrance shall be located on the shortest accessible route of travel from the parking to an accessible entrance.	Lacks accessible stalls near trail head	Relocate one stall to be on the shortest AR to the trailhead.	2015 ABAAS Section: F208.3.1 2012 TAS Section: 208.3.1 2010 ADAS Section: 208.3.1

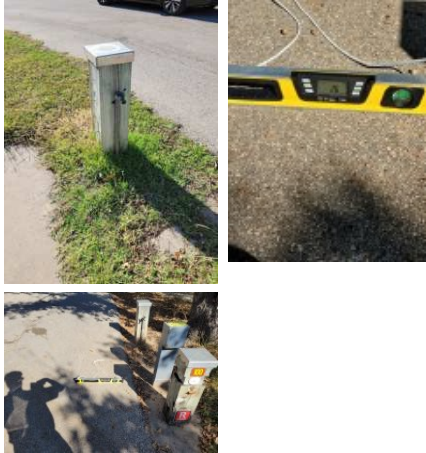
Finding Number	Area Description	Lat/Long	Finding	As Built	Recommendation	Citation	Photos	Figure
169	Isle Du Bois Unit: IDB - Deer Ridge Campsites	[33.375395, -97.025259 8]	Water spouts at water hydrants and water utility hook-ups shall be 28 inches (710 mm) minimum and 36 inches (915 mm) maximum above the ground	Site 100: water spout too low at 21" AFF, 2.6% slope in parking space	Remount water spouts to 28" min or 36" max above the ground as a smart practice and correct slope in parking space to max 2.08%.	2015 ABAAS Section: 1011.6

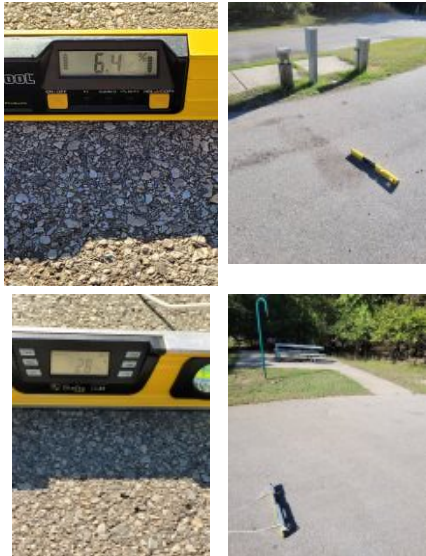
170	Isle Du Bois Unit: IDB - Deer Ridge Campsites	[33.3773392, -97.024632 2]	The surface of parking spaces and pull-up spaces shall be firm and stable. The slope of the surface of parking spaces and pull-up spaces shall not be steeper than 1:48 in any direction. EXCEPTION: Where the surface is other than asphalt, concrete, or boards, slopes not steeper than 1:20 shall be permitted when necessary for drainage.	Site 47: 6.4% slope near hook up, site 51: 2.8% slope	Correct surface of parking spaces to be firm and stable with slopes max of 2.08% or 5% for surfaces other than concrete, asphalt or boards as a smart practice.	2015 ABAAS Section: 1012.4, 1012.5, 1012.5 EXCEPTION

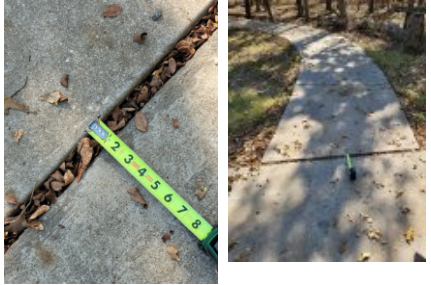
Finding Number	Area Description	Lat/Long	Finding	As Built	Recommendation	Citation	Photos	Figure
173	Isle Du Bois Unit: IDB - Deer Ridge Campsites	[33.42978, -97.05647]	The surface of the outdoor recreation access route, passing spaces, and/or resting intervals are not firm and stable. The surface of outdoor recreation access route, passing spaces, and resting intervals shall be firm and stable, having a width of 36", max gaps of .5" and tread obstacles of .5" or less.	Site 71: 1.5" gap	Correct surface of ORAR to be firm and stable, a min 36" wide and having gaps and changes in level of max .5".	2015 ABAAS Section: 1016.2

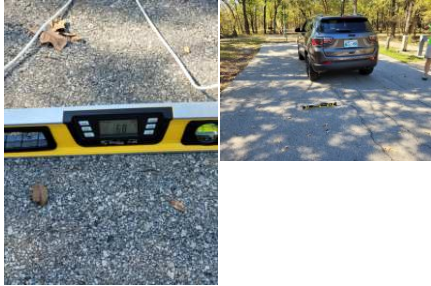
174	Isle Du Bois Unit: IDB - Deer Ridge Campsites	[33.42978, -97.05647]	The cross slope shall not be steeper than 1:48. EXCEPTION: Where the surface is other than concrete, asphalt, or boards, cross slopes not steeper than 1:20 shall be permitted when necessary for drainage.	Site 71: 6.8% slope	Correct or repair ORAR cross slope to max 2.08% as a smart practice.	2015 ABAAS Section: 1016.7.2, 1016.7.2 EXCEPTION

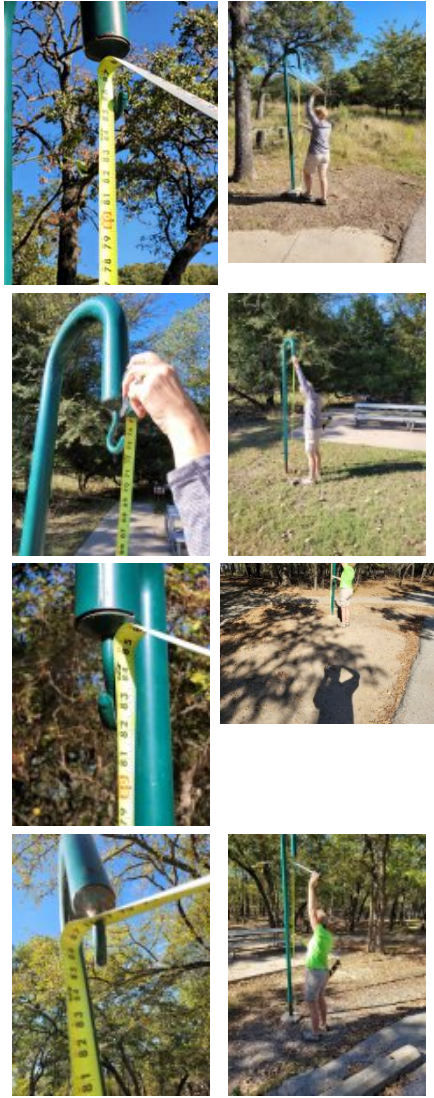
Finding Number	Area Description	Lat/Long	Finding	As Built	Recommendation	Citation	Photos	Figure
175	Isle Du Bois Unit: IDB - Deer Ridge Campsites	[33.42978, -97.05647]	A minimum of one of each type of outdoor constructed feature does not have mobility features. Where provided, at least one of each type of outdoor constructed features with mobility features must be provided.	No CFS not on AR; site 47: 86" to hook, site 51: 73" to hook, site 100: 83" , site 71: 86" to hook	Provide accessible outdoor constructed features at the required number of camp units based on the total number provided.	2015 ABAAS Section: F244.2.3.1, F245.2.5.1

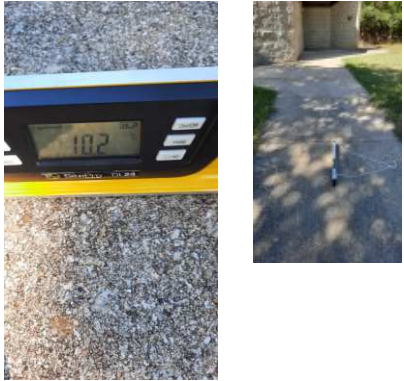
Finding Number	Area Description	Lat/Long	Finding	As Built	Recommendation	Citation	Photos	Figure
179	Isle Du Bois Unit: IDB - Deer Ridge East Men's Restroom	[33.42978, -97.05647]	The running slope of walking surfaces shall not be steeper than 1:20.	10.2% slope to restroom entry	Correct running slope along the AR to max 5%	2015 ABAAS Section: 403.3 2012 TAS Section: 403.3 2010 ADAS Section: 403.3

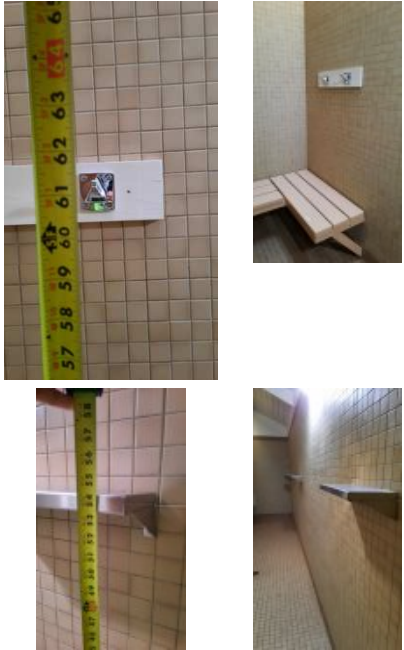
180	Isle Du Bois Unit: IDB - Deer Ridge East Men's Restroom	[33.42978, -97.05647]	Coat hooks provided within the room shall be located within one of the reach ranges specified in 308. Shelves shall be 40 inches (1015 mm) minimum and 48 inches (1220 mm) maximum above the finish floor or ground. Where coat hooks or shelves are provided in dressing, fitting or locker rooms without individual compartments, at least one of each type shall comply with 803.5. Where coat hooks or shelves are provided in individual compartments at least one of each type complying with 803.5 shall be provided in individual compartments in dressing, fitting, or locker rooms required to comply with 222.1.	Coat hooks 61.5" above finish floor (AFF) mounted over benches, 54.5" above finish floor (AFF) to shelves	Remount at least one hook to max 48" aff and shelves to 40" - 48" aff	2015 ABAAS Section: 308.2.1, 308.1, F222.2, 803.5 2012 TAS Section: 308.2.1, 308.1, 222.2, 803.5 2010 ADAS Section: 308.2.1, 308.1, 222.2, 803.5

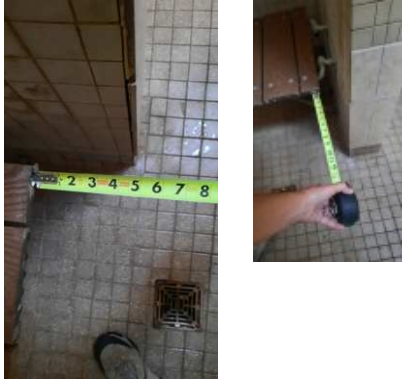
Finding Number	Area Description	Lat/Long	Finding	As Built	Recommendation	Citation	Photos	Figure
186	Isle Du Bois Unit: IDB - Deer Ridge East Men's Restroom	[33.42978, -97.05647]	Where a seat is provided in a standard roll-in shower compartment, it shall be a folding type, shall be installed on the side wall adjacent to the controls, and shall extend from the back wall to a point within 3 inches (75 mm) of the compartment entry. Where a seat is provided in an alternate roll-in type shower compartment, it shall be a folding type, shall be installed on the front wall opposite the back wall, and shall extend from the adjacent side wall to a point within 3 inches (75 mm) of the compartment entry. In transfer-type showers, the seat shall extend from the back wall to a point within 3 inches (75 mm) of the compartment entry. The top of the seat shall be 17 inches (430 mm) minimum and 19 inches (485 mm) maximum above the bathroom finish floor. Seats shall comply with 610.3.1 or 610.3.2.	Seat 5" from front wall	Provide the correct seat based on shower type.	2015 ABAAS Section: 610.3 2012 TAS Section: 610.3 2010 ADAS Section: 610.3

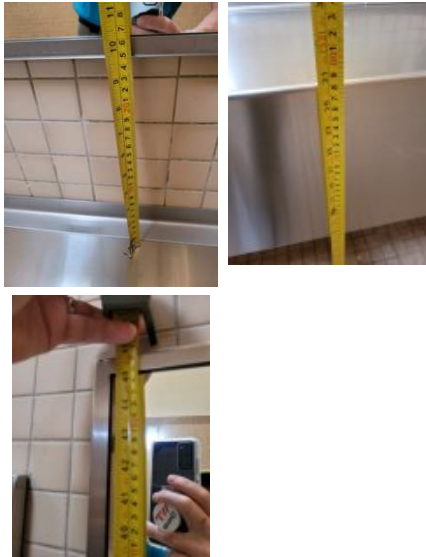
189	Isle Du Bois Unit: IDB - Deer Ridge East Men's Restroom	[33.42978, -97.05647]	The mirror is mounted too high. Mirrors must have the bottom edge of the reflecting surface a maximum of 40 inches above the floor if above a sink or counter. Mirrors not located above lavatories or countertops shall be installed with the bottom edge of the reflecting surface 35 inches maximum above the finish floor or ground.	41" above finish floor to reflective surface (31" to counter + 10" to mirror), 76" to top	Lower mirror so reflective surface is max 40" aff.	2015 ABAAS Section: 603.3 2012 TAS Section: 603.3 2010 ADAS Section: 603.3

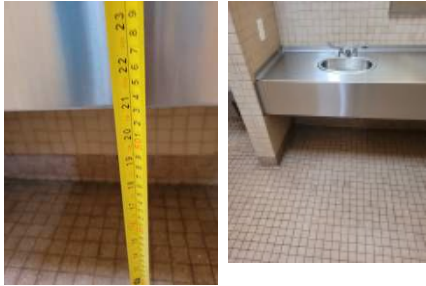
Finding Number	Area Description	Lat/Long	Finding	As Built	Recommendation	Citation	Photos	Figure
190	Isle Du Bois Unit: IDB - Deer Ridge East Men's Restroom	[33.42978, -97.05647]	Knee clearance at 27 inches off the floor is not 8 inches minimum deep. The knee clearance, measured from the bottom of the apron or the outside bottom edge of the lavatory, must be 27 inches at a point located 8 inches back from the front edge and continuing to 11 inches minimum in depth at 9 inches above the floor. The top of the lavatory rim may be no higher than 34 inches.	21" knee space	Replace sink with one providing 27" knee clearance that is a min 8" deep.	2015 ABAAS Section: 306.3.1, 306.3.2, 306.3.3, 306.3.4 , 306.3.5 2012 TAS Section: 306.3.2, 306.3.3, 306.3.4, 306.3.5, 306.3.1 2010 ADAS Section: 306.3.3, 306.3.2, 306.3.4, 306.3.5, 306.3.1

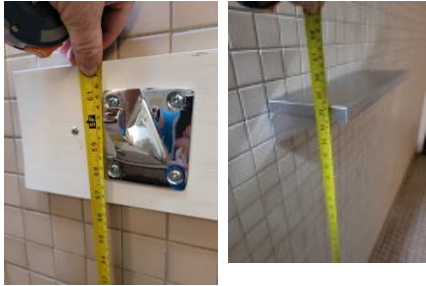
Finding Number	Area Description	Lat/Long	Finding	As Built	Recommendation	Citation	Photos	Figure
192	Isle Du Bois Unit: IDB - Deer Ridge East Men's Restroom	[33.42978, -97.05647]	The operable part is positioned too high for either a side or front approach. Where a clear floor or ground space allows a parallel approach to an element and the side reach is unobstructed, the high side reach shall be 48 inches maximum and the low side reach shall be 15 inches minimum above the finish floor or ground. Where a forward reach is unobstructed, the high forward reach shall be 48 inches maximum and the low forward reach shall be 15 inches minimum above the finish floor or ground.	60" to coat hook, 54" to shelf,	Remount operable parts to be in reach range of 15" min to 48" max	2015 ABAAS Section: 308.1 2012 TAS Section: 308.1 2010 ADAS Section: 308.1

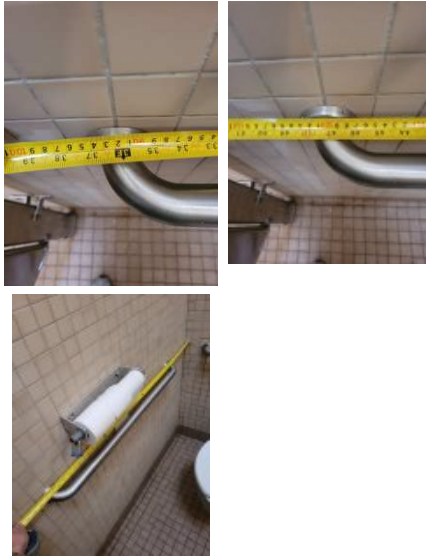
196	Isle Du Bois Unit: IDB - Deer Ridge East Men's Restroom	[33.42978, -97.05647]	The side grab bars are not in the correct location. Grab bars on the side wall must be installed so that the end closest to the rear wall is maximum 12" from the rear wall. The end furthest from the rear wall must be mounted minimum 54" from the rear wall.	36" grab bar, 48" from wall	Replace side grab bar with 42" long GB. Install to max 12" from the rear wall at the close end and min 54" on the far end, and 33" to 36" aff.	2015 ABAAS Section: 604.5.1 2012 TAS Section: 604.5.1 2010 ADAS Section: 604.5.1

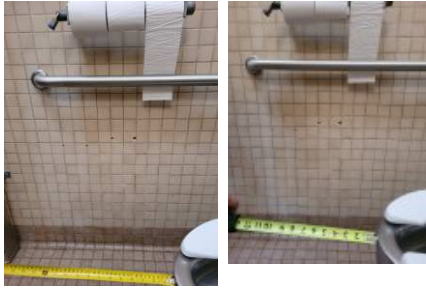
201	Isle Du Bois Unit: IDB - Deer Ridge East Men's Restroom	[33.42978, -97.05647]	The toilet paper is not installed within the compliant range in front of the toilet. Toilet paper dispensers shall be 7 inches minimum and 9 inches maximum in front of the water closet measured to the centerline of the dispenser. The outlet of the dispenser shall be 15 inches minimum and 48 inches maximum above the finish floor and shall not be located behind grab bars. Dispensers shall not be of a type that controls delivery or that does not allow continuous paper flow. There shall be a clearance of 1 1/2 inches minimum below the grab bar.	TP too close to toilet	Remount toilet paper dispenser max 7" to 9" from front of toilet, 15" to 48" aff and min 12" above or 1.5" below grab bar.	2015 ABAAS Section: 604.7 2012 TAS Section: 604.7 2010 ADAS Section: 604.7

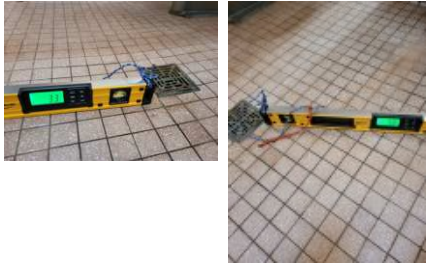
Finding Number	Area Description	Lat/Long	Finding	As Built	Recommendation	Citation	Photos	Figure
203	Isle Du Bois Unit: IDB - Deer Ridge East Men's Restroom	[33.42978, -97.05647]	The accessible route contains running slopes greater than 5 percent and cross slopes greater than 2 percent across the width of the walk and has not been constructed as a ramp (i.e. handrails, wheel guides, etc.). When the slope in the direction of travel of any walk exceeds 1 unit vertical in 20 units horizontal (5-percent slope), it must be constructed as ramp. Surface cross slopes must not exceed one unit vertical in 48 units. Horizontal (2-percent slope).	3.3% and 5.0% slope	Correct or repair slope to 2.08%.	2015 ABAAS Section: 403.3 2012 TAS Section: 403.3 2010 ADAS Section: 403.3

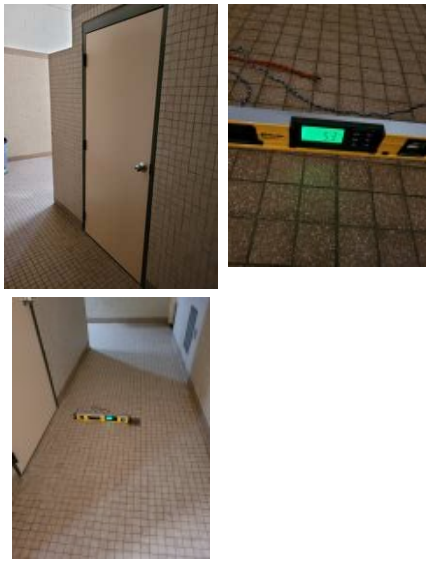
204	Isle Du Bois Unit: IDB - Deer Ridge East Men's Restroom	[33.42978, -97.05647]	Spaces and elements within employee work areas shall only be required to comply with 206.2.8, 207.1, and 215.3 and shall be designed and constructed so that individuals with disabilities can approach, enter, and exit the employee work area. Employee work areas, or portions of employee work areas, other than raised courtroom stations, that are less than 300 square feet (28 m2) and elevated 7 inches (180 mm) or more above the finish floor or ground where the elevation is essential to the function of the space shall not be required to comply with these requirements or to be on an accessible route.	Pipe chase - door was locked, knob hardware, 5.3% slope in door clearance	For employee spaces, relocate storage, furniture, and other obstacles at doorways to provide approach, enter and exit at the employee space. Provide required maneuvering clearance on push and pull side of doors. Correct slope in door clearance to max 2.08%. Hardware with lever hardware or hardware operable without a tight pinch or grasp.	2015 ABAAS Section: F203.9 2012 TAS Section: 203.9 2010 ADAS Section: 203.9

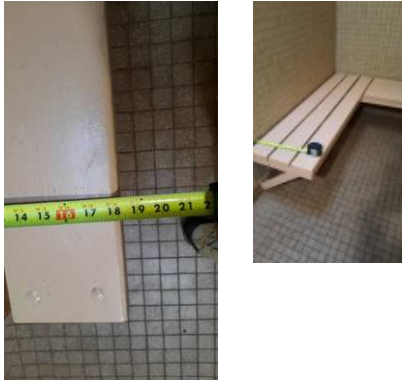
Finding Number	Area Description	Lat/Long	Finding	As Built	Recommendation	Citation	Photos	Figure
207	Isle Du Bois Unit: IDB - Deer Ridge East Women's Restroom	[33.42978, -97.05647]	The bench is not deep enough or long enough or is missing. Benches shall be provided having seats that are 42 inches long minimum and 20 inches deep minimum and 24 inches deep maximum. The bench shall provide for back support or shall be affixed to a wall. Back support shall be 42 inches (1065 mm) long minimum and shall extend from a point 2 inches (51 mm) maximum above the seat surface to a point 18 inches (455 mm) minimum above the seat surface. Back support shall be 2½ inches (64 mm) maximum from the rear edge of the seat measured horizontally. The top of the bench seat surface shall be 17 inches (430 mm) minimum and 19 inches (485 mm) maximum above the finish floor or ground.	Bench only 18" deep	Replace bench in dressing area with one having a seat depth of 20" to 24" deep, 42" long, affixed to the wall or having a back and mounted 17" to 19" aff.	2012 TAS Section: 903.4, 903.2, 903.3, 903.5 2010 ADAS Section: 903.4, 903.2, 903.3, 903.5

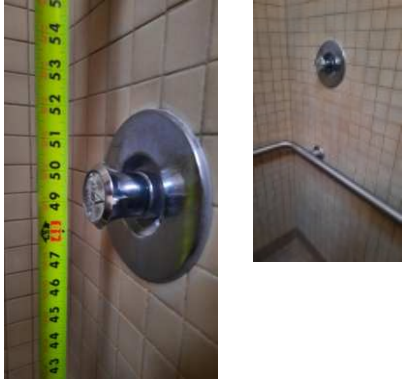
Finding Number	Area Description	Lat/Long	Finding	As Built	Recommendation	Citation	Photos	Figure
209	Isle Du Bois Unit: IDB - Deer Ridge East Women's Restroom	[33.42978, -97.05647]	The operable parts of controls are incorrectly installed. In alternate roll-in type shower compartments, the controls, faucets, and shower spray unit shall be located above the grab bar, but no higher than 48 inches (1220 mm) above the shower floor. Where a seat is provided, the controls, faucets, and shower spray unit shall be located on the side wall adjacent to the seat 27 inches (685 mm) maximum from the side wall behind the seat or shall be located on the back wall opposite the seat 15 inches (380 mm) maximum, left or right, of the centerline of the seat. Where a seat is not provided, the controls, faucets, and shower spray unit shall be installed on the side wall farthest from the compartment entry.	Shower control at 49"	Remount shower controls to the correct location in the alternate shower with compliant lever hardware.	2015 ABAAS Section: 608.5.3 2012 TAS Section: 608.5.3 2010 ADAS Section: 608.5.3

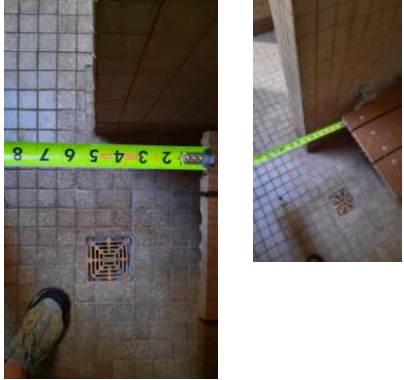
Finding Number	Area Description	Lat/Long	Finding	As Built	Recommendation	Citation	Photos	Figure
213	Isle Du Bois Unit: IDB - Deer Ridge East Women's Restroom	[33.42978, -97.05647]	Where a seat is provided in a standard roll-in shower compartment, it shall be a folding type, shall be installed on the side wall adjacent to the controls, and shall extend from the back wall to a point within 3 inches (75 mm) of the compartment entry. Where a seat is provided in an alternate roll-in type shower compartment, it shall be a folding type, shall be installed on the front wall opposite the back wall, and shall extend from the adjacent side wall to a point within 3 inches (75 mm) of the compartment entry. In transfer-type showers, the seat shall extend from the back wall to a point within 3 inches (75 mm) of the compartment entry. The top of the seat shall be 17 inches (430 mm) minimum and 19 inches (485 mm) maximum above the bathroom finish floor. Seats shall comply with 610.3.1 or 610.3.2.	4.75" from front	Remount shower bench to be within 3" of the front of the compartment.	2015 ABAAS Section: 610.3 2012 TAS Section: 610.3 2010 ADAS Section: 610.3

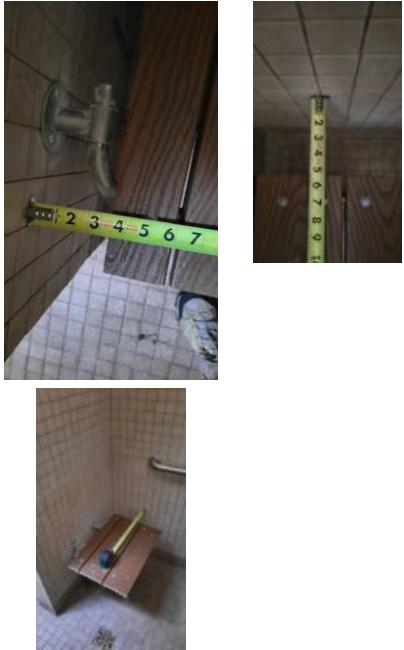
214	Isle Du Bois Unit: IDB - Deer Ridge East Women's Restroom	[33.42978, -97.05647]	The shower seat does not have a compliant space between it and the seat wall. The folding seat must be mounted 17-19 inches above the floor, and have a maximum space of 2-1/2 inches between the edge of the seat and the seat wall and 1-1/2 inches maximum to the side wall.	3.5" from seat wall, 5" from side	Remount shower seat to the correct location and height in the shower.	2015 ABAAS Section: 610.3.1 2012 TAS Section: 610.3.1 2010 ADAS Section: 610.3.1

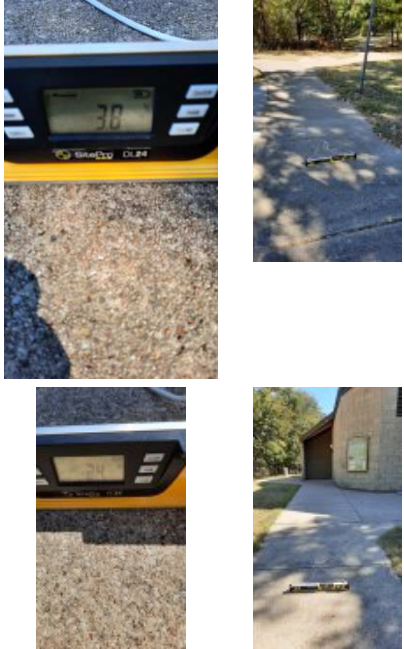
Finding Number	Area Description	Lat/Long	Finding	As Built	Recommendation	Citation	Photos	Figure
228	Isle Du Bois Unit: IDB - Deer Ridge West Men's Restroom	[33.37521, -97.02203]	The accessible route of travel contains cross slopes greater than 2%. Cross slopes shall not exceed one unit vertical in 48 units horizontal (2-percent slope).	Slopes: 3.8% and 2.4% from parking to RR	Correct or repair cross slope along AR to max 2.08%.	2015 ABAAS Section: 403.3 2012 TAS Section: 403.3 2010 ADAS Section: 403.3

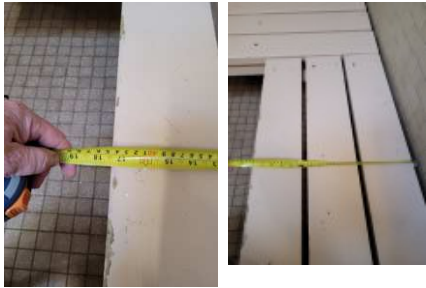
231	Isle Du Bois Unit: IDB - Deer Ridge West Men's Restroom	[33.42978, -97.05647]	The bench is not deep enough or long enough or is missing. Benches shall be provided having seats that are 42 inches long minimum and 20 inches deep minimum and 24 inches deep maximum. The bench shall provide for back support or shall be affixed to a wall. Back support shall be 42 inches (1065 mm) long minimum and shall extend from a point 2 inches (51 mm) maximum above the seat surface to a point 18 inches (455 mm) minimum above the seat surface. Back support shall be 2½ inches (64 mm) maximum from the rear edge of the seat measured horizontally. The top of the bench seat surface shall be 17 inches (430 mm) minimum and 19 inches (485 mm) maximum above the finish floor or ground.	17.5" deep seat	Replace bench in dressing area with one having a seat depth of 20" to 24" deep, 42" long, affixed to the wall or having a back and mounted 17" to 19" aff.	2012 TAS Section: 903.4, 903.2, 903.3, 903.5 2010 ADAS Section: 903.4, 903.2, 903.3, 903.5

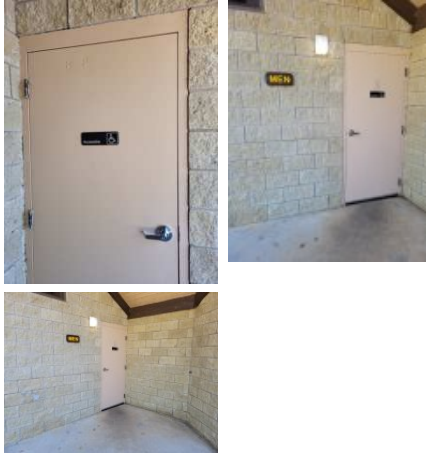
Finding Number	Area Description	Lat/Long	Finding	As Built	Recommendation	Citation	Photos	Figure
240	Isle Du Bois Unit: IDB - Deer Ridge West Men's Restroom	[33.42978, -97.05647]	The restroom sign does not comply with one or more applicable requirements for the location, height, and properties of the sign.	Door mounted, no braille	Replace sign with one of contrasting colors that includes Braille, raised characters, and the symbol of accessibility and mount on the wall, latch side of the door, 48" to the baseline of the lowest character and 60" to the baseline of the highest character	2015 ABAAS Section: F216.2, 703.1, 703.2, 703.5, 703.6 2012 TAS Section: 216.2, 703.1, 703.2, 703.5, 703.6 2010 ADAS Section: 216.2, 703.1, 703.2, 703.5, 703.6

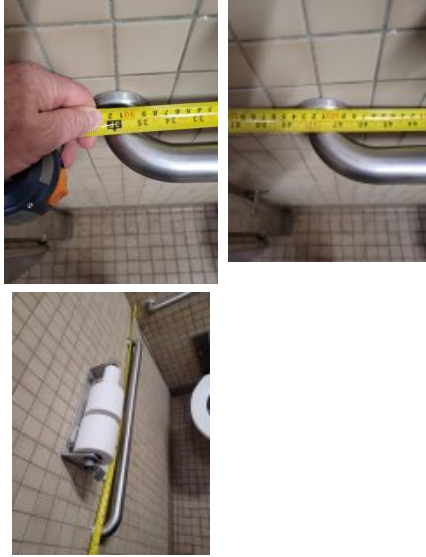
Finding Number	Area Description	Lat/Long	Finding	As Built	Recommendation	Citation	Photos	Figure
247	Isle Du Bois Unit: IDB - Deer Ridge West Men's Restroom	[33.42978, -97.05647]	The side grab bars are not in the correct location. Grab bars on the side wall must be installed so that the end closest to the rear wall is maximum 12" from the rear wall. The end furthest from the rear wall must be mounted minimum 54" from the rear wall.	36" grab bar, 48" dimension to wall	Replace side grab bar with 42" long GB. Install to max 12" from the rear wall at the close end and min 54" on the far end, and 33" to 36" aff.	2015 ABAAS Section: 604.5.1 2012 TAS Section: 604.5.1 2010 ADAS Section: 604.5.1

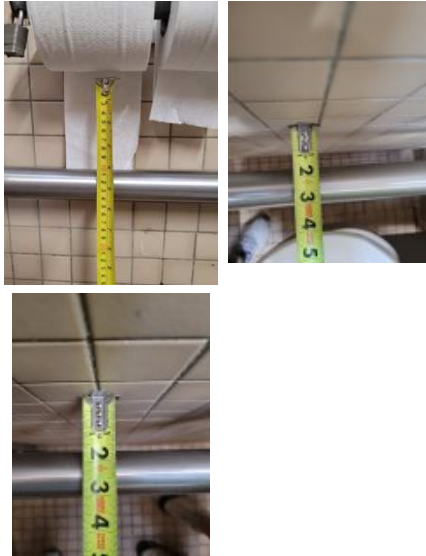
Finding Number	Area Description	Lat/Long	Finding	As Built	Recommendation	Citation	Photos	Figure
249	Isle Du Bois Unit: IDB - Deer Ridge West Men's Restroom	[33.42978, -97.05647]	The grab bar height and/or spacing fails. Grab bars must be mounted between 33" and 36" to the top of the gripping surface. There must be 1.5" of clearance between the grab bar and the wall. There must be a minimum of 1.5" of clearance below and minimum 12" above the grab bar to any dispenser or other obstruction.	4" between grab bar & toilet tissue dispenser, two grab bar's 1.75" from wall to grab bar	Replace grab bars with ones providing max 1.5" gap between bar and wall. See previous finding for grab bar replacment. Remount toilet paper dispenser max 7" to 9" from front of toilet, 15" to 48" aff and min 12" above or 1.5" below grab bar	2015 ABAAS Section: 609.3, 609.4 2012 TAS Section: 609.4, 609.3 2010 ADAS Section: 609.3, 609.4

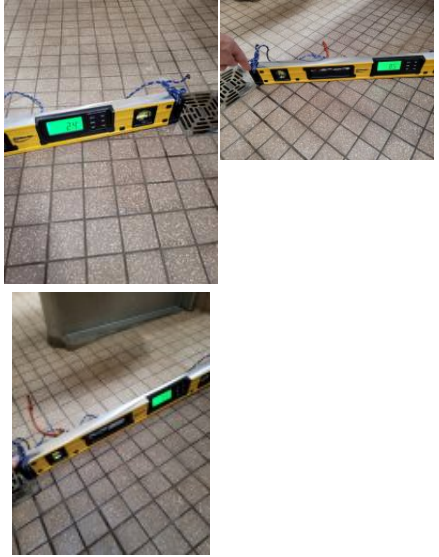
Finding Number	Area Description	Lat/Long	Finding	As Built	Recommendation	Citation	Photos	Figure
254	Isle Du Bois Unit: IDB - Deer Ridge West Men's Restroom	[33.42978, -97.05647]	The accessible route contains running slopes greater than 5 percent and cross slopes greater than 2 percent across the width of the walk and has not been constructed as a ramp (i.e. handrails, wheel guides, etc.). When the slope in the direction of travel of any walk exceeds 1 unit vertical in 20 units horizontal (5-percent slope), it must be constructed as ramp. Surface cross slopes must not exceed one unit vertical in 48 units. Horizontal (2-percent slope).	8.9% slope at urinal	Correct or repair slope to 2.08%.	2015 ABAAS Section: 403.3 2012 TAS Section: 403.3 2010 ADAS Section: 403.3

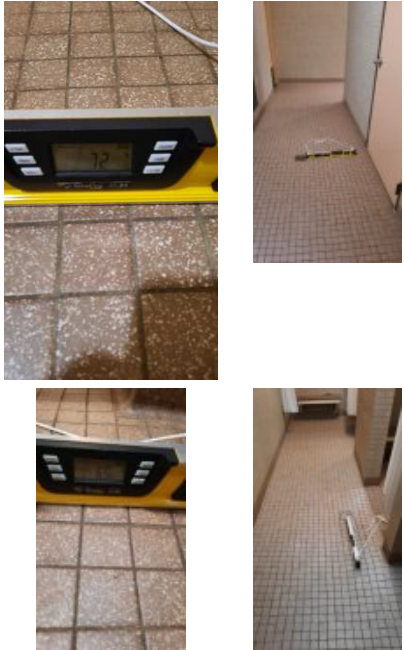
Finding Number	Area Description	Lat/Long	Finding	As Built	Recommendation	Citation	Photos	Figure
256	Isle Du Bois Unit: IDB - Deer Ridge West Women's Restroom	[33.42978, -97.05647]	The accessible route contains running slopes greater than 5 percent and cross slopes greater than 2 percent across the width of the walk and has not been constructed as a ramp (i.e. handrails, wheel guides, etc.). When the slope in the direction of travel of any walk exceeds 1 unit vertical in 20 units horizontal (5-percent slope), it must be constructed as ramp. Surface cross slopes must not exceed one unit vertical in 48 units. Horizontal (2-percent slope).	7.2% slope at drain near pipe chase, 6.5% slope at drain near accessible shower	Correct or repair slope to 2.08%.	2015 ABAAS Section: 403.3 2012 TAS Section: 403.3 2010 ADAS Section: 403.3

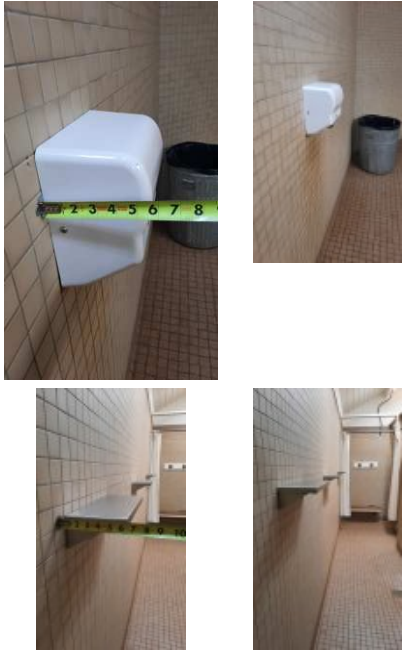
Finding Number	Area Description	Lat/Long	Finding	As Built	Recommendation	Citation	Photos	Figure
257	Isle Du Bois Unit: IDB - Deer Ridge West Women's Restroom	[33.42978, -97.05647]	The elements project more than 4 inches into the circulation path. Wall-mounted objects that have leading edges between 27 inches and 80 inches from the floor must not project more than 4 inches into the circulation path. Protruding objects that extend to the floor or within 27 inches of the floor are cane detectable and are therefore not hazardous. Where it is necessary or desirable to have objects protrude from the wall, a manner of cane detection must be provided.	Hand dryer and shelves protrude	Relocate protruding objects or place cane detectable warning or bollard at foot of items.	2015 ABAAS Section: 307.2 2012 TAS Section: 307.2 2010 ADAS Section: 307.2

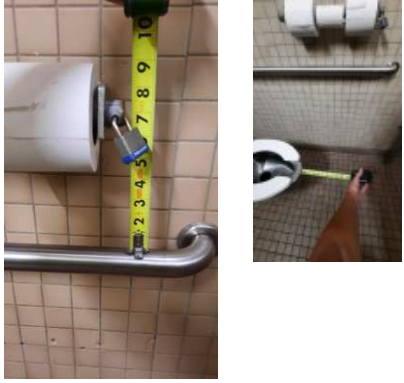
Finding Number	Area Description	Lat/Long	Finding	As Built	Recommendation	Citation	Photos	Figure
259	Isle Du Bois Unit: IDB - Deer Ridge West Women's Restroom	[33.42978, -97.05647]	The grab bar height and/or spacing fails. Grab bars must be mounted between 33" and 36" to the top of the gripping surface. There must be 1.5" of clearance between the grab bar and the wall. There must be a minimum of 1.5" of clearance below and minimum 12" above the grab bar to any dispenser or other obstruction.	Toilet paper dispenser too close above side bar and too close to toilet	Remount toilet paper dispenser max 7" to 9" from front of toilet, 15" to 48" aff and min 12" above or 1.5" below grab bar	2015 ABAAS Section: 609.3, 609.4 2012 TAS Section: 609.4, 609.3 2010 ADAS Section: 609.3, 609.4

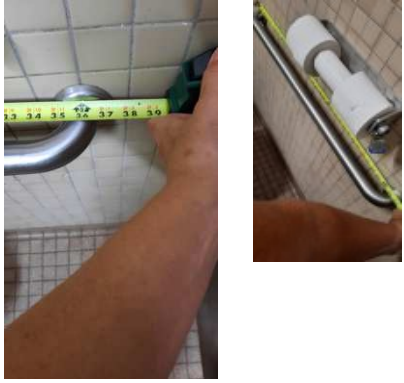
260	Isle Du Bois Unit: IDB - Deer Ridge West Women's Restroom	[33.42978, -97.05647]	The side grab bars are not in the correct location. Grab bars on the side wall must be installed so that the end closest to the rear wall is maximum 12" from the rear wall. The end furthest from the rear wall must be mounted minimum 54" from the rear wall.	Side grab bar 36" long	Replace side grab bar with 42" long GB. Install to max 12" from the rear wall at the close end and min 54" on the far end, and 33" to 36" aff.	2015 ABAAS Section: 604.5.1 2012 TAS Section: 604.5.1 2010 ADAS Section: 604.5.1

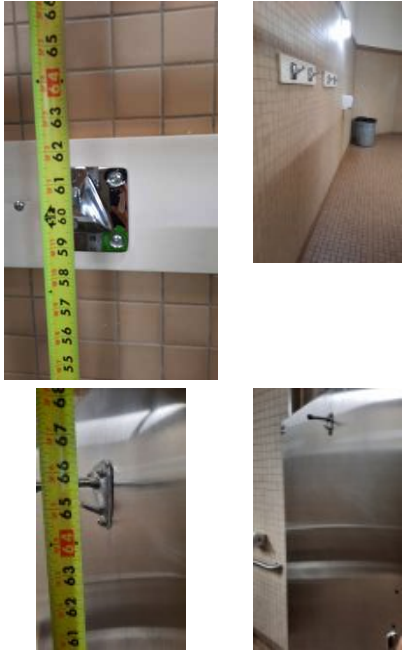
Finding Number	Area Description	Lat/Long	Finding	As Built	Recommendation	Citation	Photos	Figure
261	Isle Du Bois Unit: IDB - Deer Ridge West Women's Restroom	[33.42978, -97.05647]	The operable part is positioned too high for either a side or front approach. Where a clear floor or ground space allows a parallel approach to an element and the side reach is unobstructed, the high side reach shall be 48 inches maximum and the low side reach shall be 15 inches minimum above the finish floor or ground. Where a forward reach is unobstructed, the high forward reach shall be 48 inches maximum and the low forward reach shall be 15 inches minimum above the finish floor or ground.	Hooks in main room at 61", hook in stall at 65"	Remount operable parts to be in reach range of 15" min to 48" max.	2015 ABAAS Section: 308.1 2012 TAS Section: 308.1 2010 ADAS Section: 308.1

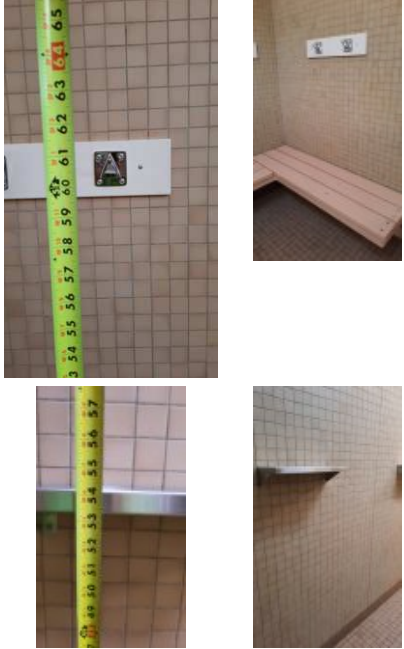
Finding Number	Area Description	Lat/Long	Finding	As Built	Recommendation	Citation	Photos	Figure
			ground. The bottom 10 inches on the push side must be smooth and free of obstructions (hold open devices). Opening hardware must be mounted between 30 and 44 inches above the floor or ground. Doors, gates, and side lights adjacent to doors or gates, containing one or more glazing panels that permit viewing through the panels shall have the bottom of at least one glazed panel located 43 inches (1090 mm) maximum above the finish floor. EXCEPTION: Vision lights with the lowest part more than 66 inches (1675 mm) from the finish floor or ground shall not be required to comply with 404.2.11.					
268	Isle Du Bois Unit: IDB - Deer Ridge West Women's Restroom	[33.42978, -97.05647]	Coat hooks provided within the room shall be located within one of the reach ranges specified in 308. Shelves shall be 40 inches (1015 mm) minimum and 48 inches (1220 mm) maximum above the finish floor or ground. Where coat hooks or shelves are provided in dressing, fitting or locker rooms without individual compartments, at least one of each type shall comply with 803.5. Where coat hooks or shelves are provided in individual compartments at least one of each type complying with 803.5 shall be provided in individual compartments in dressing, fitting, or locker rooms required to comply with 222.1.	Hooks 61" behind bench, shelves at 54.25"	Remount at least one hook to max 48" aff and shelves to 40" - 48" aff. Mount shelf so it is not a protruding object	2015 ABAAS Section: 308.2.1, 308.1, F222.2, 803.5 2012 TAS Section: 308.2.1, 308.1, 222.2, 803.5 2010 ADAS Section: 308.2.1, 308.1, 222.2, 803.5

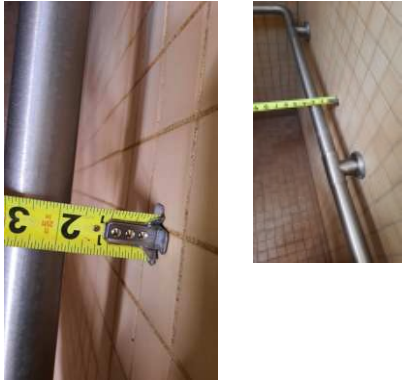
273	Isle Du Bois Unit: IDB - Deer Ridge West Women's Restroom	[33.42978, -97.05647]	Grab bars shall be installed in a horizontal position, 33 inches (840 mm) minimum and 36 inches (915 mm) maximum above the finish floor measured to the top of the gripping surface	1.75" gap	Remount or replace shower grab bar to 33" min and 36" max aff and 1.5" from wall to grab bar.	2015 ABAAS Section: 609.3 Exception, 609.4 2012 TAS Section: 609.4, 609.3 Exception 2010 ADAS Section: 609.4, 609.3 Exception

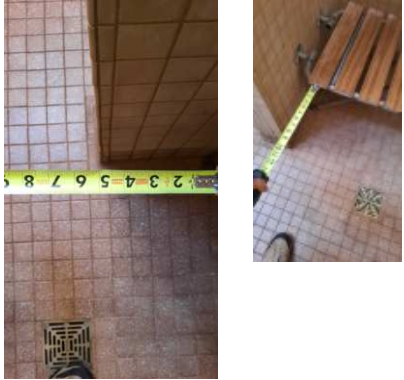
Finding Number	Area Description	Lat/Long	Finding	As Built	Recommendation	Citation	Photos	Figure
274	Isle Du Bois Unit: IDB - Deer Ridge West Women's Restroom	[33.42978, -97.05647]	Where a seat is provided in a standard roll-in shower compartment, it shall be a folding type, shall be installed on the side wall adjacent to the controls, and shall extend from the back wall to a point within 3 inches (75 mm) of the compartment entry. Where a seat is provided in an alternate roll-in type shower compartment, it shall be a folding type, shall be installed on the front wall opposite the back wall, and shall extend from the adjacent side wall to a point within 3 inches (75 mm) of the compartment entry. In transfer-type showers, the seat shall extend from the back wall to a point within 3 inches (75 mm) of the compartment entry. The top of the seat shall be 17 inches (430 mm) minimum and 19 inches (485 mm) maximum above the bathroom finish floor. Seats shall comply with 610.3.1 or 610.3.2.	seat mounted 5" from front	Remount seat to max 3" from front of compartment.	2015 ABAAS Section: 610.3 2012 TAS Section: 610.3 2010 ADAS Section: 610.3

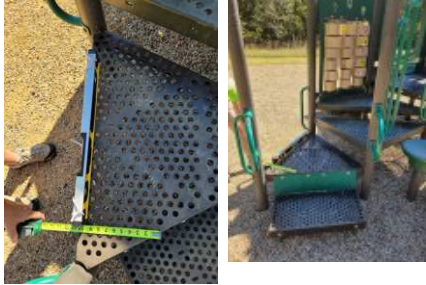
Finding Number	Area Description	Lat/Long	Finding	As Built	Recommendation	Citation	Photos	Figure
281	Isle Du Bois Unit: IDB - Deer Ridge Playground	[33.3763358 , -97.0251364]	The transfer platform is not a compliant size. Transfer platforms shall have level surfaces 14 inches deep minimum and 24 inches wide minimum.	10.5" deep	Replace transfer platform with one that is 14" deep and 24" wide. In the alternative, leave as is inaccessible play area until replaced in the future.	2012 TAS Section: 1008.3.1.1 2010 ADAS Section: 1008.3.1.1

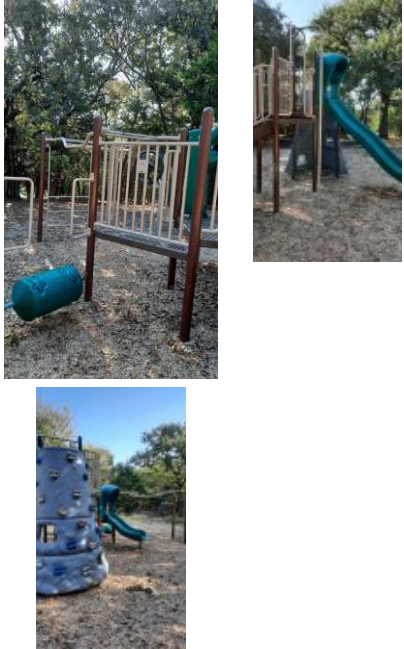
Finding Number	Area Description	Lat/Long	Finding	As Built	Recommendation	Citation	Photos	Figure
287	Isle Du Bois Unit: IDB - Quail Run Playground	[33.3851021 , -97.028027 9]	There are not enough accessible elevated play components. Where Elevated Play Components are provided, at least 50 percent shall be on an accessible route. An accessible route may be a ramp of transfer system.	7 of 7 elevated play components would be compliant with new surface: steering wheel, overhead bars, slide, fire pole, tall slide, crows nest, climbing wall	See previous finding for surface correction.	2012 TAS Section: 240.2.2 2010 ADAS Section: 240.2.2

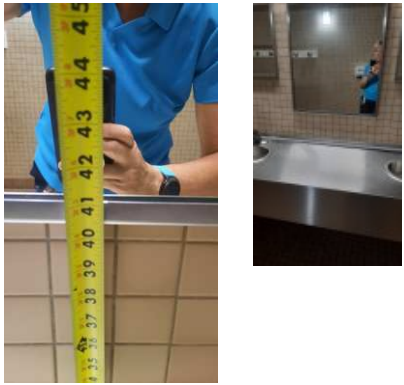
292	Isle Du Bois Unit: IDB - Quail Run Men's Restroom	[33.3849229 , -97.028403 4]	The mirror is mounted too high. Mirrors must have the bottom edge of the reflecting surface a maximum of 40 inches above the floor if above a sink or counter. Mirrors not located above lavatories or countertops shall be installed with the bottom edge of the reflecting surface 35 inches maximum above the finish floor or ground.	Mirror at 41.25"	Lower mirror so reflective surface is max 40" aff.	2015 ABAAS Section: 603.3 2012 TAS Section: 603.3 2010 ADAS Section: 603.3

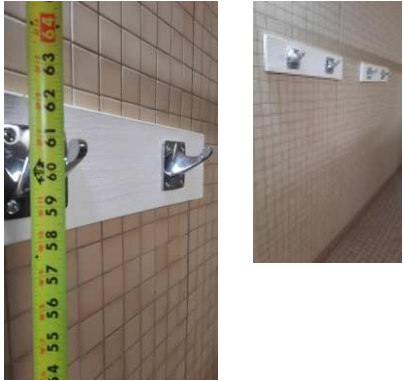
Finding Number	Area Description	Lat/Long	Finding	As Built	Recommendation	Citation	Photos	Figure
295	Isle Du Bois Unit: IDB - Quail Run Men's Restroom	[33.3849453, -97.0283604]	The operable part is positioned too high for either a side or front approach. Where a clear floor or ground space allows a parallel approach to an element and the side reach is unobstructed, the high side reach shall be 48 inches maximum and the low side reach shall be 15 inches minimum above the finish floor or ground. Where a forward reach is unobstructed, the high forward reach shall be 48 inches maximum and the low forward reach shall be 15 inches minimum above the finish floor or ground.	Hooks in main room at 61"	Remount operable parts to be in reach range of 15" min to 48" max.	2015 ABAAS Section: 308.1 2012 TAS Section: 308.1 2010 ADAS Section: 308.1

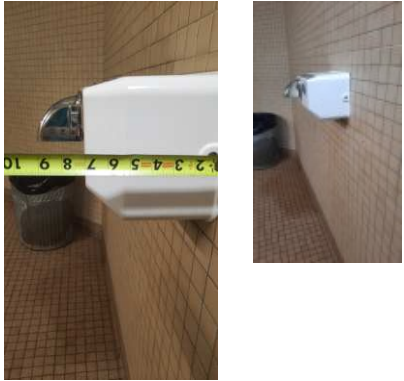
296	Isle Du Bois Unit: IDB - Quail Run Men's Restroom	[33.3848916, -97.0284248]	The hand dryer projects more than 4 inches into the circulation path. Wall-mounted objects that have leading edges between 27 inches and 80 inches from the floor must not project more than 4 inches into the circulation path. Protruding objects that extend to the floor or within 27 inches of the floor are cane detectable and are therefore not hazardous. Where it is necessary or desirable to have objects protrude from the wall, a manner of cane detection must be provided.	Hand dryer protrudes into the route	Relocate protruding objects or place cane detectable warning or bollard at foot of item.	2015 ABAAS Section: 307.2 2012 TAS Section: 307.2 2010 ADAS Section: 307.2

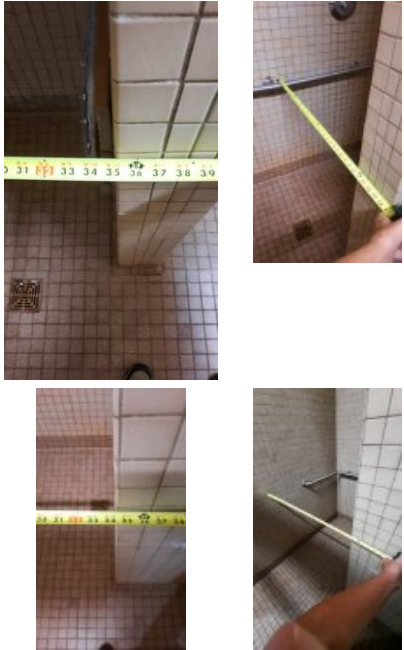
Finding Number	Area Description	Lat/Long	Finding	As Built	Recommendation	Citation	Photos	Figure
300	Isle Du Bois Unit: IDB - Quail Run Men's Restroom	[33.3849364, -97.0284141]	Alternate roll-in type shower compartments shall be 36 inches (915 mm) wide and 60 inches (1525 mm) deep minimum clear inside dimensions measured at center points of opposing sides. A 36 inch (915 mm) wide minimum entry shall be provided at one end of the long side of the compartment.	35" deep, entry 34.25"	Enlarge shower stall, if feasible, to compliant dimensions for an alternate roll in shower of 36" deep by 60" wide with a 36" opening on the long dimension. In the alternative, leave as is citing construction tolerance.	2015 ABAAS Section: 608.2.3 2012 TAS Section: 608.2.3 2010 ADAS Section: 608.2.3

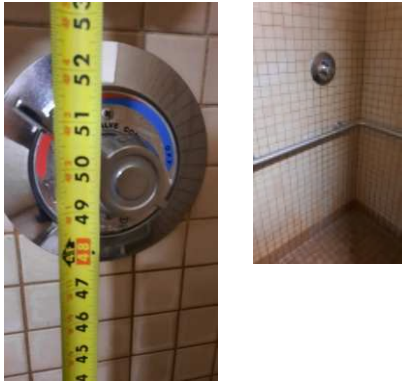
301	Isle Du Bois Unit: IDB - Quail Run Men's Restroom	[33.3849095, -97.0284677]	The operable parts of controls are incorrectly installed. In alternate roll-in type shower compartments, the controls, faucets, and shower spray unit shall be located above the grab bar, but no higher than 48 inches (1220 mm) above the shower floor. Where a seat is provided, the controls, faucets, and shower spray unit shall be located on the side wall adjacent to the seat 27 inches (685 mm) maximum from the side wall behind the seat or shall be located on the back wall opposite the seat 15 inches (380 mm) maximum, left or right, of the centerline of the seat. Where a seat is not provided, the controls, faucets, and shower spray unit shall be installed on the side wall farthest from the compartment entry.	Controls at 49.5"	Remount shower controls to the correct location in the alternate shower.	2015 ABAAS Section: 608.5.3 2012 TAS Section: 608.5.3 2010 ADAS Section: 608.5.3

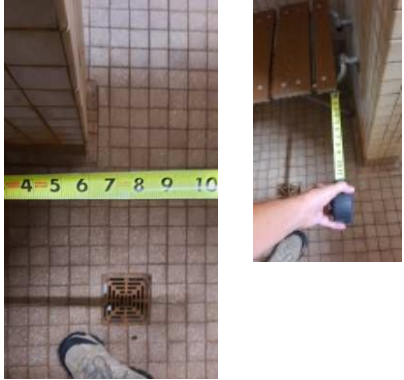
Finding Number	Area Description	Lat/Long	Finding	As Built	Recommendation	Citation	Photos	Figure
304	Isle Du Bois Unit: IDB - Quail Run Men's Restroom	[33.42978, -97.05647]	Where a seat is provided in a standard roll-in shower compartment, it shall be a folding type, shall be installed on the side wall adjacent to the controls, and shall extend from the back wall to a point within 3 inches (75 mm) of the compartment entry. Where a seat is provided in an alternate roll-in type shower compartment, it shall be a folding type, shall be installed on the front wall opposite the back wall, and shall extend from the adjacent side wall to a point within 3 inches (75 mm) of the compartment entry. In transfer-type showers, the seat shall extend from the back wall to a point within 3 inches (75 mm) of the compartment entry. The top of the seat shall be 17 inches (430 mm) minimum and 19 inches (485 mm) maximum above the bathroom finish floor. Seats shall comply with 610.3.1 or 610.3.2.	shower seat mounted 6" from front	Provide the correct seat based on shower type.	2015 ABAAS Section: 610.3 2012 TAS Section: 610.3 2010 ADAS Section: 610.3

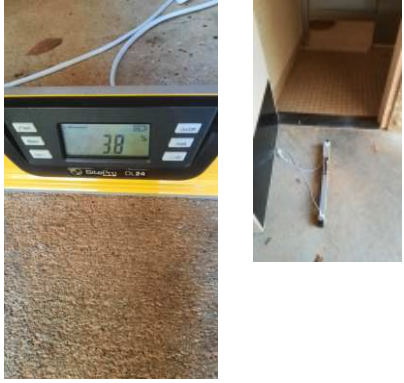
Finding Number	Area Description	Lat/Long	Finding	As Built	Recommendation	Citation	Photos	Figure
306	Isle Du Bois Unit: IDB - Quail Run Men's Restroom	[33.42978, -97.05647]	Minimum maneuvering clearances at doors and gates shall comply with 404.2.4. Maneuvering clearances shall extend the full width of the doorway and the required latch side or hinge side clearance. Maneuvering clearances shall have a max slope of 2.08%. The sweep period for doors with closers shall be adjusted so that from an open position of 70 degrees, the door will take at least 3 seconds to move to a point 3 inches from the latch, measured to the leading edge of the door.	Restroom side - 3.8% slope on exterior, shower side - fast close	For all doors along the public circulation route, provide required maneuvering clearance on push and pull side of doors. For all doors along the public circulation route, correct slope in door clearance to max 2.08%. For all doors along the public circulation route, inspect, adjust, and maintain closing speed on door closers.	2010 ADAS Section: 404.2.3, 404.2.7, 404.2.4, 404.2.11, 404.2.11 Exception

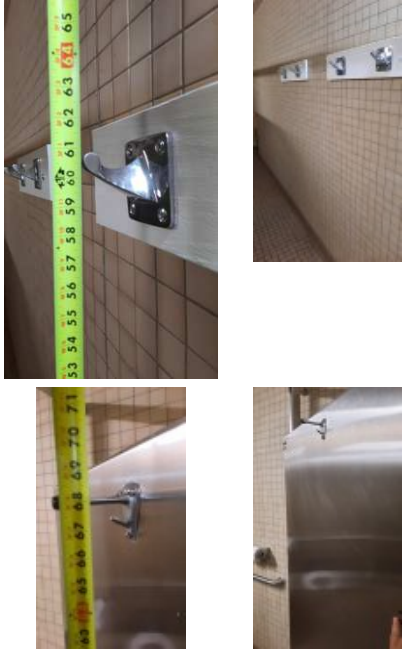
Finding Number	Area Description	Lat/Long	Finding	As Built	Recommendation	Citation	Photos	Figure
314	Isle Du Bois Unit: IDB - Quail Run Women's Restroom	[33.3849274 , -97.028435 6]	The operable part is positioned too high for either a side or front approach. Where a clear floor or ground space allows a parallel approach to an element and the side reach is unobstructed, the high side reach shall be 48 inches maximum and the low side reach shall be 15 inches minimum above the finish floor or ground. Where a forward reach is unobstructed, the high forward reach shall be 48 inches maximum and the low forward reach shall be 15 inches minimum above the finish floor or ground.	Hooks in main area at 61", hook install at 67.5"	Remount operable parts to be in reach range of 15" min to 48" max.	2015 ABAAS Section: 308.1 2012 TAS Section: 308.1 2010 ADAS Section: 308.1

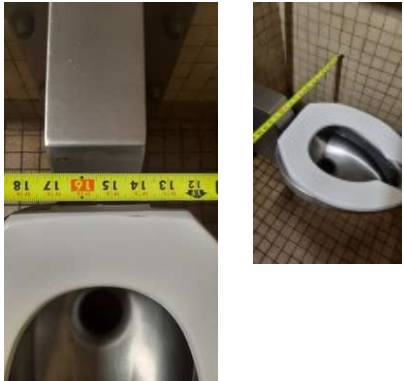
315	Isle Du Bois Unit: IDB - Quail Run Women's Restroom	[33.3849453 , -97.028403 4]	The toilet is not located within the range allowed from the side wall or partition. The centerline of the toilet must be 16 to 18 inches from the side wall.	15.5" to toilet center line	Remount toilets to 16" to 18" from the side wall to centerline.	2015 ABAAS Section: 604.2 2012 TAS Section: 604.2 2010 ADAS Section: 604.2

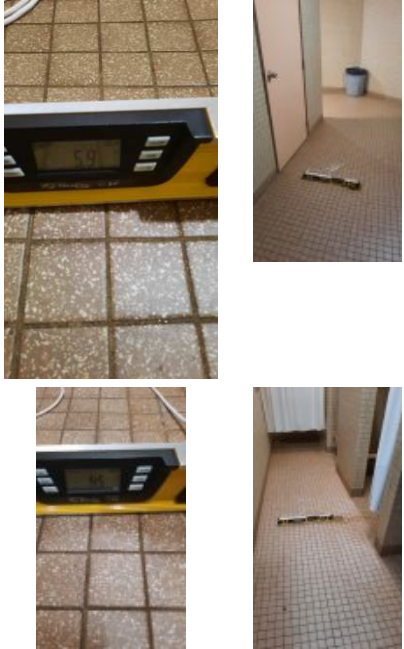
Finding Number	Area Description	Lat/Long	Finding	As Built	Recommendation	Citation	Photos	Figure
321	Isle Du Bois Unit: IDB - Quail Run Women's Restroom	[33.3849453 , -97.028424 8]	The accessible route contains running slopes greater than 5 percent and cross slopes greater than 2 percent across the width of the walk and has not been constructed as a ramp (i.e. handrails, wheel guides, etc.). When the slope in the direction of travel of any walk exceeds 1 unit vertical in 20 units horizontal (5-percent slope), it must be constructed as ramp. Surface cross slopes must not exceed one unit vertical in 48 units. Horizontal (2-percent slope).	5.9% at pipe chase drain, 4.5% at drain near shower	Correct or repair slope to max 2.08%.	2015 ABAAS Section: 403.3 2012 TAS Section: 403.3 2010 ADAS Section: 403.3

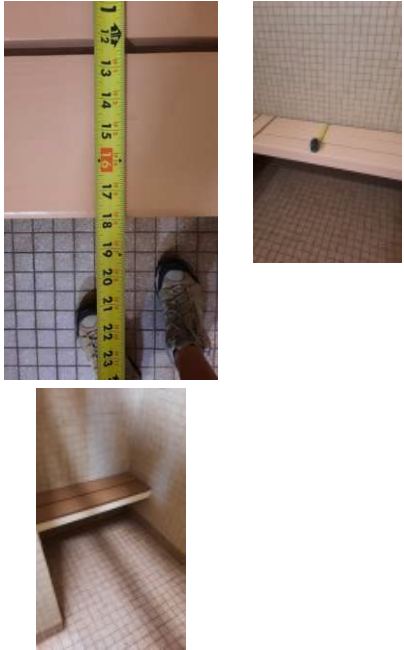
Finding Number	Area Description	Lat/Long	Finding	As Built	Recommendation	Citation	Photos	Figure
323	Isle Du Bois Unit: IDB - Quail Run Women's Restroom	[33.3849453 , -97.028446 3]	The bench is not deep enough or long enough or is missing. Benches shall be provided having seats that are 42 inches long minimum and 20 inches deep minimum and 24 inches deep maximum. The bench shall provide for back support or shall be affixed to a wall. Back support shall be 42 inches (1065 mm) long minimum and shall extend from a point 2 inches (51 mm) maximum above the seat surface to a point 18 inches (455 mm) minimum above the seat surface. Back support shall be 2½ inches (64 mm) maximum from the rear edge of the seat measured horizontally. The top of the bench seat surface shall be 17 inches (430 mm) minimum and 19 inches (485 mm) maximum above the finish floor or ground. Clear floor or ground space complying with 305 shall be provided and shall be positioned at the end of the bench seat and parallel to the short axis of the bench	Bench only 18" deep, small bench in showers	Replace bench in dressing area with one having a seat depth of 20" to 24" deep, 42" long, affixed to the wall or having a back and mounted 17" to 19" AFF and provide required clear floor space on the short axis of the bench.	2012 TAS Section: 903.4, 903.2, 903.3, 903.5 2010 ADAS Section: 903.4, 903.2, 903.3, 903.5

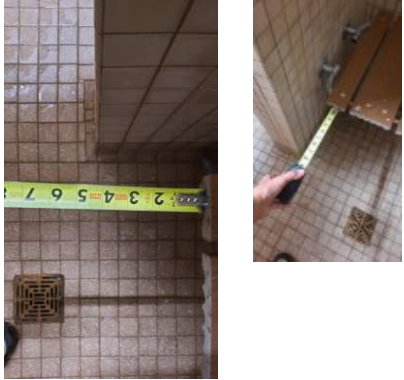
327	Isle Du Bois Unit: IDB - Quail Run Women's Restroom	[33.3849543, -97.0283926]	Where a seat is provided in a standard roll-in shower compartment, it shall be a folding type, shall be installed on the side wall adjacent to the controls, and shall extend from the back wall to a point within 3 inches (75 mm) of the compartment entry. Where a seat is provided in an alternate roll-in type shower compartment, it shall be a folding type, shall be installed on the front wall opposite the back wall, and shall extend from the adjacent side wall to a point within 3 inches (75 mm) of the compartment entry. In transfer-type showers, the seat shall extend from the back wall to a point within 3 inches (75 mm) of the compartment entry. The top of the seat shall be 17 inches (430 mm) minimum and 19 inches (485 mm) maximum above the bathroom finish floor. Seats shall comply with 610.3.1 or 610.3.2.	seat mounted 4.5" from front of compartment	Remount seat to be within 3" of the front of the compartment.	2015 ABAAS Section: 610.3 2012 TAS Section: 610.3 2010 ADAS Section: 610.3

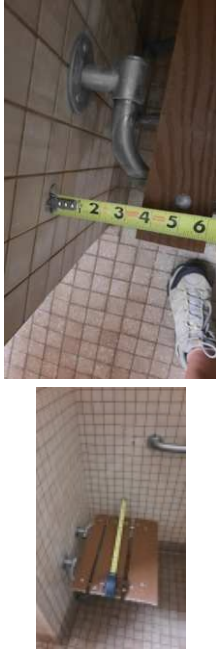
Finding Number	Area Description	Lat/Long	Finding	As Built	Recommendation	Citation	Photos	Figure
328	Isle Du Bois Unit: IDB - Quail Run Women's Restroom	[33.3849453, -97.0284248]	The shower seat does not have a compliant space between it and the seat wall. The folding seat must be mounted 17-19 inches above the floor, and have a maximum space of 2-1/2 inches between the edge of the seat and the seat wall and 1-1/2 inches maximum to the side wall.	3.5" from seat wall, 5.25" from side	Remount shower seat to the correct location and height in the shower.	2015 ABAAS Section: 610.3.1 2012 TAS Section: 610.3.1 2010 ADAS Section: 610.3.1

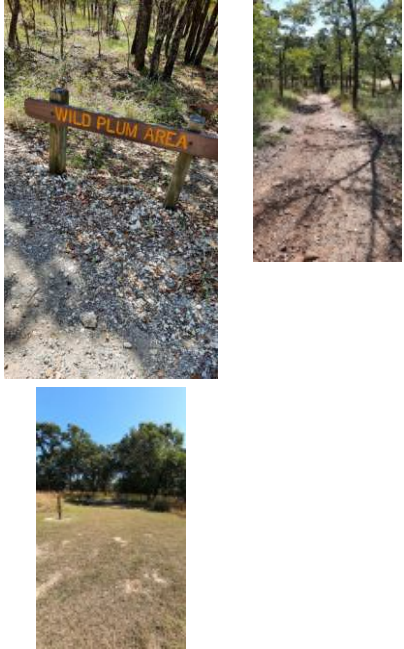
Finding Number	Area Description	Lat/Long	Finding	As Built	Recommendation	Citation	Photos	Figure
330	Isle Du Bois Unit: IDB - Wild Plum Campsites	[33.3790056 , -97.026026 9]	Camping facilities shall provide camping units with mobility features complying with F244.2 in accordance with Table F244.2. Where a camping facility provides different types of camping units, Table F244.2 shall apply to each type of camping unit provided. Total Number of Camping Units Provided in Camping Facility Minimum Number of Camping Units with Mobility Features Required 1 1 2 to 25 2 26 to 50 3 51 to 75 4 76 to 100 5 101 to 150 7 151 to 200 8 201 and over 8, plus 2 percent of the number over 200	14 sites, 0 accessible	Create the required number of accessible camp sites per table F244.2 as a smart practice.	2015 ABAAS Section: F244.2

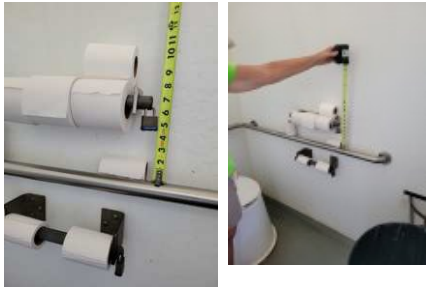
336	Isle Du Bois Unit: IDB - Wild Plum Restrooms	[33.378934, -97.025780 2]	The grab bar height and/or spacing fails. Grab bars must be mounted between 33" and 36" to the top of the gripping surface. There must be 1.5" of clearance between the grab bar and the wall. There must be a minimum of 1.5" of clearance below and minimum 12" above the grab bar to any dispenser or other obstruction.	4" from grab bar to toilet tissue dispenser, 10" to centerline, too far from toilet	Remount toilet paper dispenser max 7" to 9" from front of toilet, 15" to 48" aff and min 12" above or 1.5" below grab bar.	2015 ABAAS Section: 609.3, 609.4 2012 TAS Section: 609.4, 609.3 2010 ADAS Section: 609.3, 609.4
