Access Audit Site Report

Ray Roberts Lake State Park/Complex

Accessibility Evaluation

Inspection Date: 10/18/2021

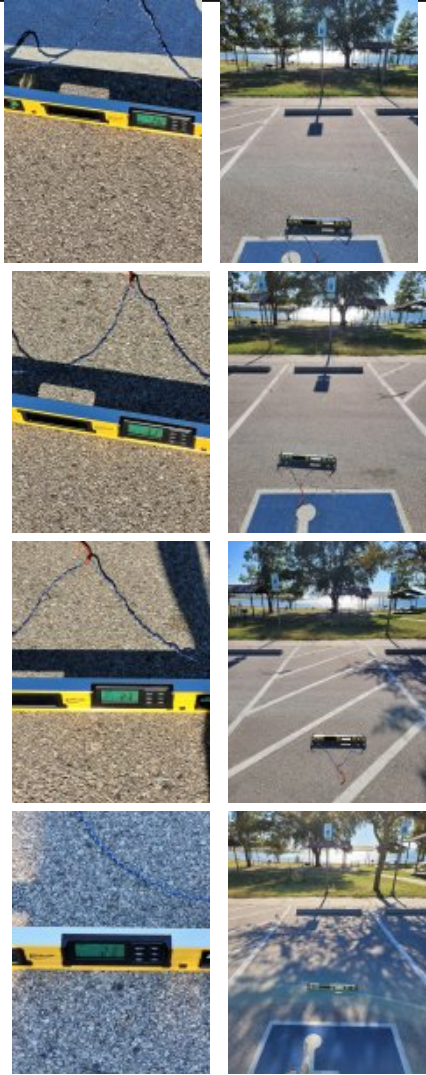
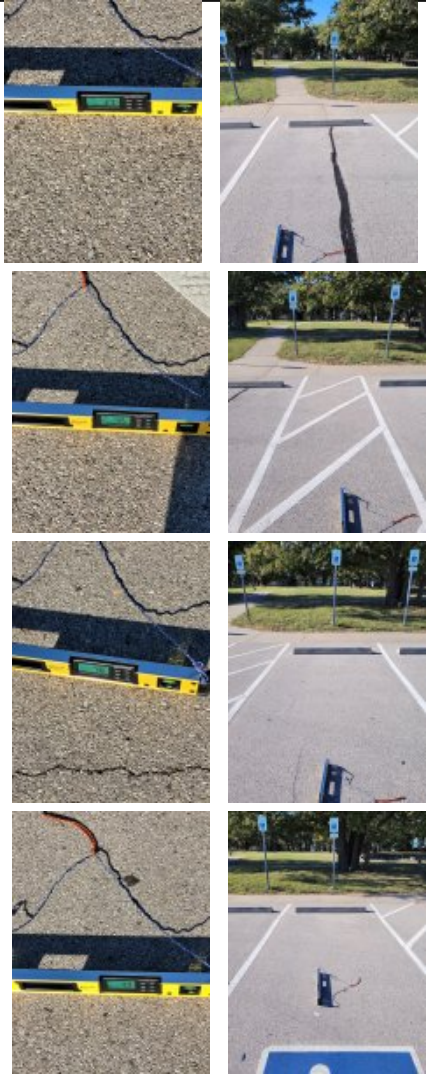
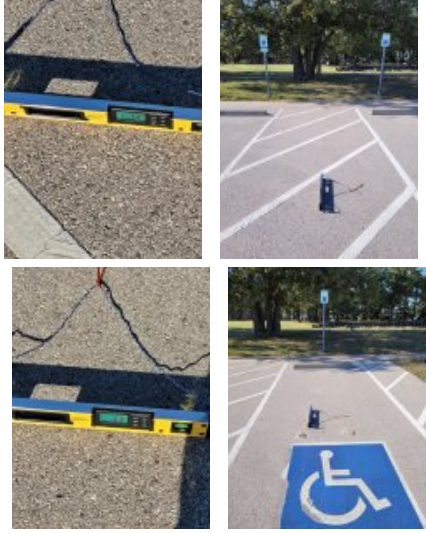
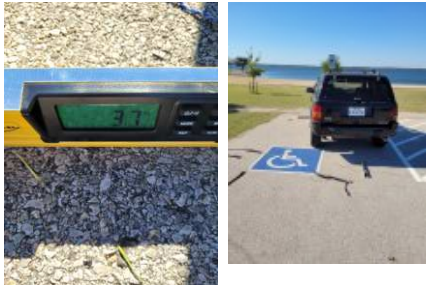
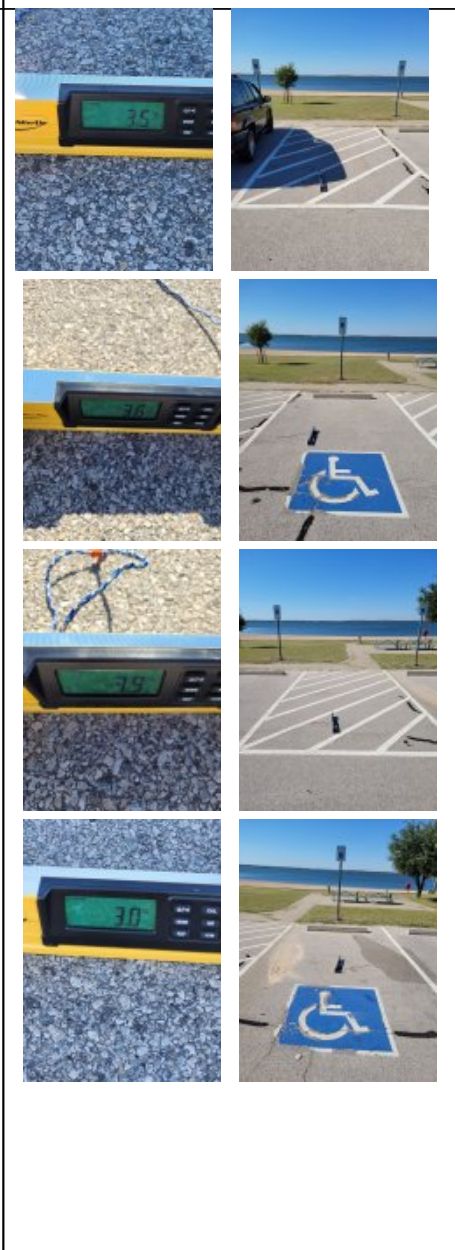
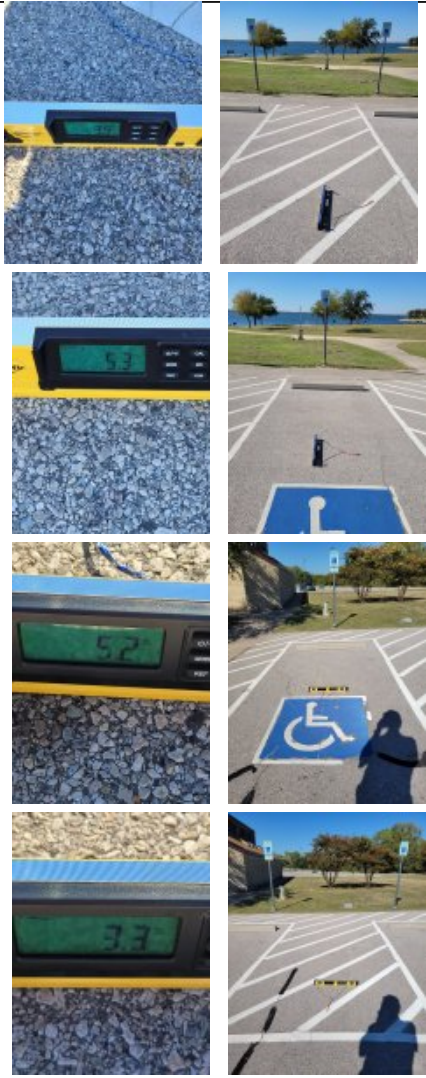
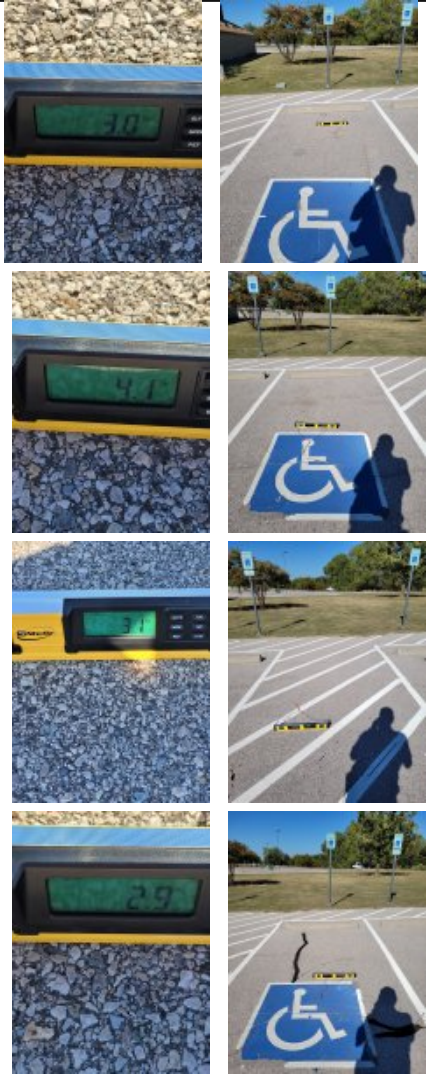
340	Isle Du Bois Unit: IDB - Day Use Parking	[33.42978, -97.05647]	Element meets all standards and requirements	Beach Area: left of restrooms - 21 standard stall, 12 accessible right of restroom - 29 standard stalls, 5 accessible	None	2010 ADAS Section: N/A		
341	Isle Du Bois Unit: IDB - Day Use Parking	[33.3815925, -97.0314343]	The cross slopes (narrow dimension) and/or running slopes (long dimension) of the access aisle exceeds 2%. The running slope and the cross slope in an accessible parking stall and the access aisle must not exceed 2%.	Beach Area: Open area to Left of RR: L-1 slopes: 1st space 3.7%, 1st aisle 3.5%, 2nd space 3.6%, 2nd aisle 3.9%, 3rd space 3.0%. L-2 RR 1st space 4.1%, 1st aisle 3.8%, 2nd space 4.2%, 3rd space 4.0%, 2nd aisle 3.9%, 4th space 5.3%, 3rd aisle 5.0%. L-3 1st space 5.2%, 1st aisle 3.4%, 2nd space 3.0%, 3rd space 4.1%, 2nd aisle 3.1%, 4th space 2.9%, 5th	Repair or correct slope of parking space and access aisle to max 2.08% in any direction.	2015 ABAAS Section: 502.4 2012 TAS Section: 502.4 2010 ADAS Section: 502.4

Finding Number	Area Description	Lat/Long	Finding	As Built	Recommendation	Citation	Photos	Figure
				space 2.8%, 3rd aisle 2.8% Open area to right of RR-1 2nd space 3.0%, 3rd space 3.1%, 2nd aisle 2.6%, 4th space 2.8%, 5th space 3.0%

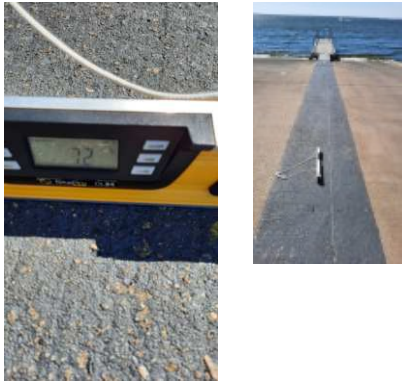
346	Isle Du Bois Unit: IDB - Day Use Boat Ramp	[33.3786786 , -97.031812 5]	There is no accessible route to/on the boating facility. Accessible routes serving recreational boating facilities, including gangways and floating piers, shall comply with accessible route requirements except as modified by section Recreational Boating Facilities - Accessible Routes.	7.2%, 8.7% slope to pier, 14.4% at transition, only 35" wide	Create an accessible route to the boat pier or make corrections for a compliant route.	2015 ABAAS Section: 1003.2 2010 ADAS Section: 1003.2

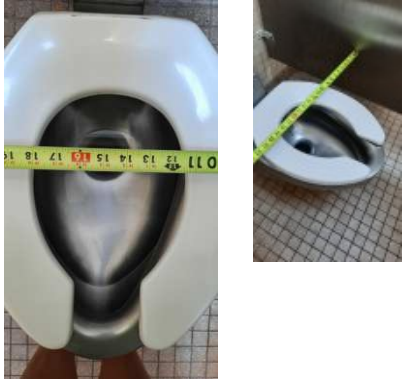
Finding Number	Area Description	Lat/Long	Finding	As Built	Recommendation	Citation	Photos	Figure
352	Isle Du Bois Unit: IDB - Day Use Boat Ramp Men's Restroom	[33.3791042 , -97.032394 5]	The toilet is not located within the range allowed from the side wall or partition. The centerline of the toilet must be 16 to 18 inches from the side wall.	toilet 15" to center line	Remount toilets to 16" to 18" from the side wall to centerline.	2015 ABAAS Section: 604.2 2012 TAS Section: 604.2 2010 ADAS Section: 604.2

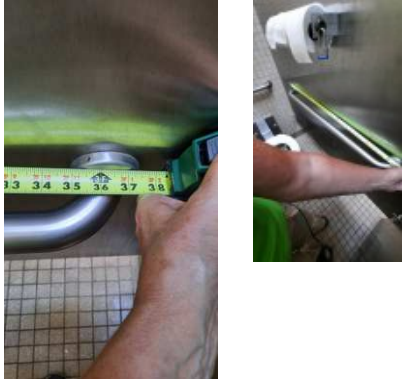
354	Isle Du Bois Unit: IDB - Day Use Boat Ramp Men's Restroom	[33.3791132 , -97.032362 3]	The side grab bars are not in the correct location. Grab bars on the side wall must be installed so that the end closest to the rear wall is maximum 12" from the rear wall. The end furthest from the rear wall must be mounted minimum 54" from the rear wall.	Side grab bar 36" long	Replace side grab bar with 42" long GB. Install to max 12" from the rear wall at the close end and min 54" on the far end, and 33" to 36" aff.	2015 ABAAS Section: 604.5.1 2012 TAS Section: 604.5.1 2010 ADAS Section: 604.5.1

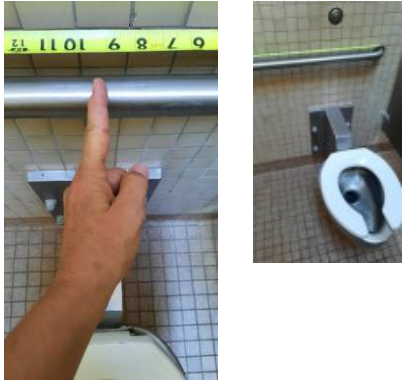
Finding Number	Area Description	Lat/Long	Finding	As Built	Recommendation	Citation	Photos	Figure
355	Isle Du Bois Unit: IDB - Day Use Boat Ramp Men's Restroom	[33.3790773, -97.0323623]	The rear grab bar is not 36" long or is not mounted in the correct location. The rear grab bar must be a minimum of 36" long and extend from the toilet centerline a minimum 12" towards the wall side and a minimum 24" towards the open side of the toilet. Grab bars shall be installed in a horizontal position, 33 inches minimum and 36 inches maximum above the finish floor measured to the top of the gripping surface and the space between the grab bar and the top of the tank shall be 1-1/2 inches minimum.	rear grab bar mounted 9.5" to toilet center line	Remount rear grab bar to behind the toilet, 12" to one side of center and 24" to the other and 33" to 36" aff.	2015 ABAAS Section: 604.5.2 2012 TAS Section: 604.5.2 2010 ADAS Section: 604.5.2

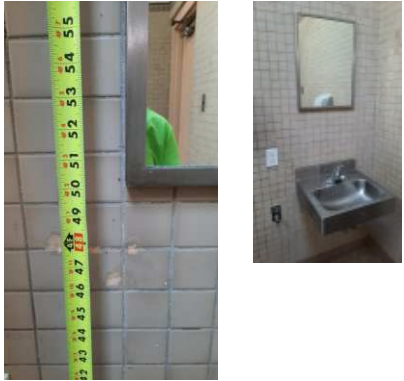
Finding Number	Area Description	Lat/Long	Finding	As Built	Recommendation	Citation	Photos	Figure
362	Isle Du Bois Unit: IDB - Day Use Boat Ramp Women's Restroom	[33.3790863, -97.0323838]	The mirror is mounted too high. Mirrors must have the bottom edge of the reflecting surface a maximum of 40 inches above the floor if above a sink or counter. Mirrors not located above lavatories or countertops shall be installed with the bottom edge of the reflecting surface 35 inches maximum above the finish floor or ground.	Mirror at 50.5"	Lower mirror so reflective surface is max 40" aff	2015 ABAAS Section: 603.3 2012 TAS Section: 603.3 2010 ADAS Section: 603.3

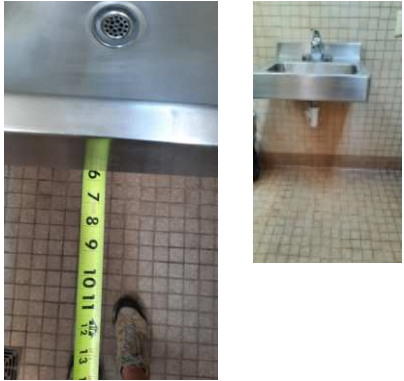
363	Isle Du Bois Unit: IDB - Day Use Boat Ramp Women's Restroom	[33.3790773, -97.0323516]	Knee clearance at 27 inches off the floor is not 8 inches minimum deep. The knee clearance, measured from the bottom of the apron or the outside bottom edge of the lavatory, must be 27 inches at a point located 8 inches back from the front edge and continuing to 11 inches minimum in depth at 9 inches above the floor. The top of the lavatory rim may be no higher than 34 inches.	Pipes prevent 8" knee clearance	Replace sink with one providing 27" knee clearance that is a min 8" deep.	2015 ABAAS Section: 306.3.1, 306.3.2, 306.3.3, 306.3.4, 306.3.5 2012 TAS Section: 306.3.2, 306.3.3, 306.3.4, 306.3.5, 306.3.1 2010 ADAS Section: 306.3.3, 306.3.2, 306.3.4, 306.3.5, 306.3.1

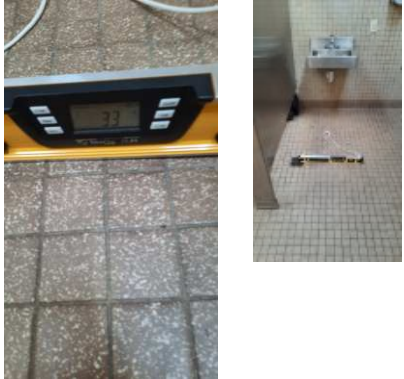
Finding Number	Area Description	Lat/Long	Finding	As Built	Recommendation	Citation	Photos	Figure
371	Isle Du Bois Unit: IDB - Day Use Boat Ramp Women's Restroom	[33.3790908 , -97.032389 1]	The accessible route contains running slopes greater than 5 percent and cross slopes greater than 2 percent across the width of the walk and has not been constructed as a ramp (i.e. handrails, wheel guides, etc.). When the slope in the direction of travel of any walk exceeds 1 unit vertical in 20 units horizontal (5-percent slope), it must be constructed as ramp. Surface cross slopes must not exceed one unit vertical in 48 units. Horizontal (2-percent slope).	2.3% slope at drain	Correct or repair slope to max 2.08%.	2015 ABAAS Section: 403.3 2012 TAS Section: 403.3 2010 ADAS Section: 403.3

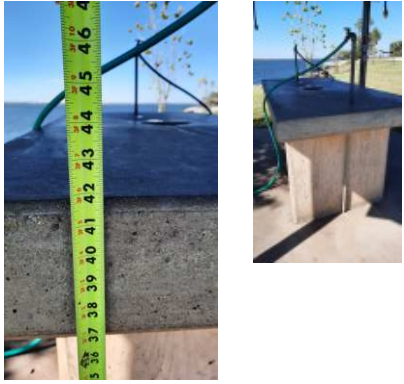
Finding Number	Area Description	Lat/Long	Finding	As Built	Recommendation	Citation	Photos	Figure
373	Isle Du Bois Unit: IDB - Day Use Fishing	[33.3790191, -97.032711]	The transaction counter is too high. A portion of the counter surface that is 36 inches long minimum and 36 inches high maximum above the finish floor shall be provided. Knee and toe space must be provided for a forward approach. A 30 inch by 48 inch clear floor space on an accessible route must be provided for either a forward or parallel approach.	Fish cleaning station at 42"	Lower 36" wide segment of counter to max 34" aff. In the alternative, add a second lowered fish cleaning station.	2015 ABAAS Section: 904.4.2, 904.4.1 2012 TAS Section: 904.4.1, 904.4.2 2010 ADAS Section: 904.4.2, 904.4.1

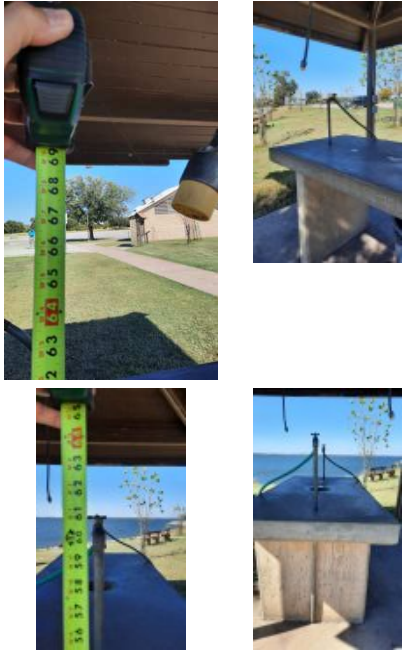
374	Isle Du Bois Unit: IDB - Day Use Fishing	[33.3790101, -97.0327056]	The clear floor space only allows for a forward approach and the element is out of reach range. Where a forward reach is unobstructed, the high forward reach shall be 48 inches maximum and the low forward reach shall be 15 inches minimum above the finish floor or ground.	Water spigot 61" and outlet 67" high	Lower water spigot and outlet to max 48".	2015 ABAAS Section: 308.2.1 2012 TAS Section: 308.2.1 2010 ADAS Section: 308.2.1

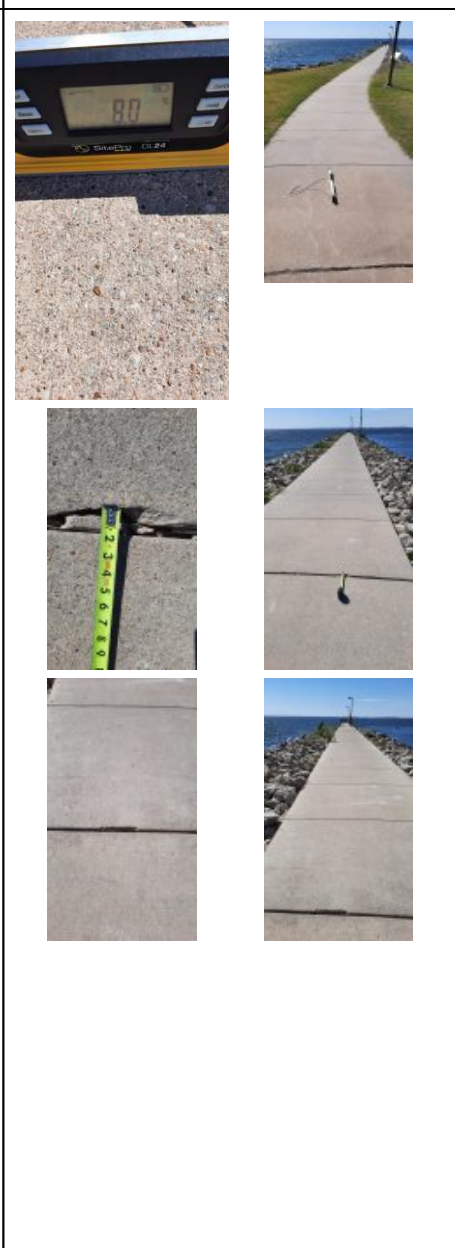
Finding Number	Area Description	Lat/Long	Finding	As Built	Recommendation	Citation	Photos	Figure
375	Isle Du Bois Unit: IDB - Day Use Fishing	[33.3790236 , -97.032673 4]	Accessible routes serving fishing piers and platforms, including gangways and floating piers, shall comply with Chapter 4. EXCEPTIONS: 1. Accessible routes serving floating fishing piers and platforms shall be permitted to use Exceptions 1, 2, 5, 6, 7 and 8 in 1003.2.1. 2. Where the total length of the gangway or series of gangways serving as part of a required accessible route is 30 feet (9145 mm) minimum, gangways shall not be required to comply with 405.2.	8% running slope, 1.5" gaps	Create an accessible route to the fishing pier or make corrections for a compliant route.	2015 ABAAS Section: 1005.1, 1005.1 EXCEPTIONS: 1, 1005.1 EXCEPTIONS: 2 2010 ADAS Section: 1005.1, 1005.1 Exception 1, 1005.1 Exception 2

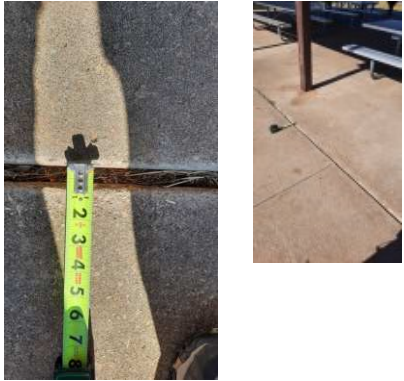
Finding Number	Area Description	Lat/Long	Finding	As Built	Recommendation	Citation	Photos	Figure
378	Isle Du Bois Unit: IDB - Day Use Group Picnic	[33.3835814, -97.0311875]	Openings in floor or ground surfaces shall not allow passage of a sphere more than 1/2 inch (13 mm) diameter except as allowed in 407.4.3, 409.4.3, 410.4, 810.5.3 and 810.10. Elongated openings shall be placed so that the long dimension is perpendicular to the dominant direction of travel. Floor or ground surface within required maneuvering clearances shall comply with 302. Changes in level are not permitted.	Pavilion 1 - .75" gap at edge	Correct or fill gap in doorway to max .5"	2010 ADAS Section: 302.3, 404.2.4.4

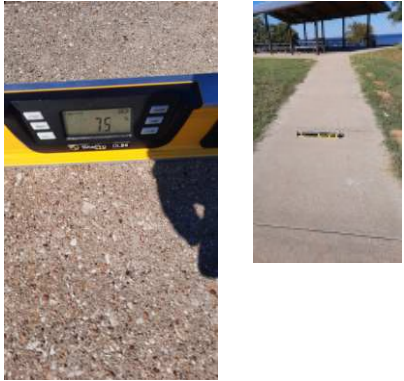
380	Isle Du Bois Unit: IDB - Day Use Group Picnic	[33.380457, -97.0332313]	Picnic facilities shall provide outdoor recreation access routes complying with 1016 in accordance with F245.4 and 245.4 of IAC	Pavilion 2 - 7.5% cross slope on route	Create ORAR with crushed and compacted stone or similar outdoor material from parking or sidewalk to shelter or picnic area.	2015 ABAAS Section: F245.4

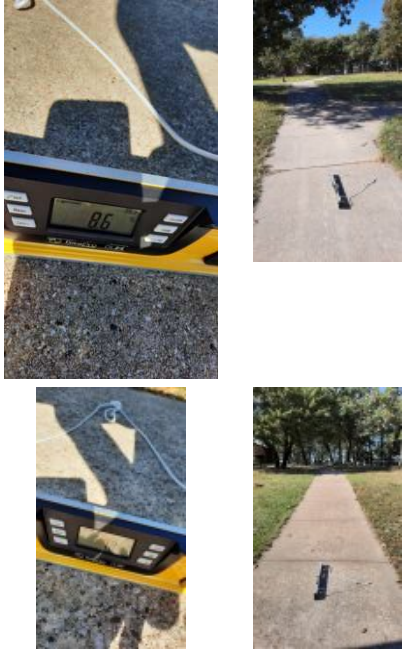
Finding Number	Area Description	Lat/Long	Finding	As Built	Recommendation	Citation	Photos	Figure
383	Isle Du Bois Unit: IDB - Day Use Group Picnic	[33.3834224 , -97.031809 8]	The running slope of walking surfaces shall not be steeper than 1:20.	8.6%, 7% slopes from parking to far restrooms	Correct running slope along the AR to max 5%.	2015 ABAAS Section: 403.3 2012 TAS Section: 403.3 2010 ADAS Section: 403.3

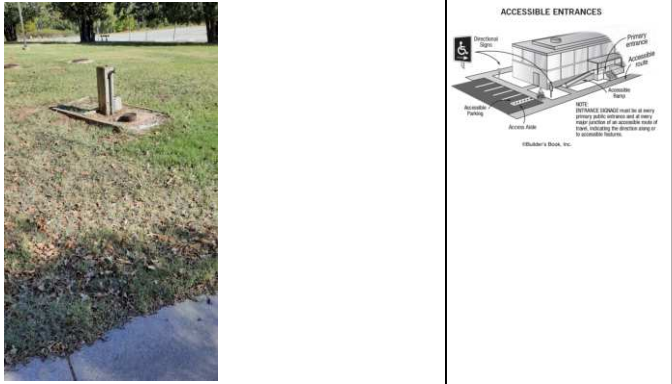
384	Isle Du Bois Unit: IDB - Day Use Group Picnic	[33.3834492 , -97.032029 7]	There is no accessible route to the water spigot. At least one accessible route shall connect accessible buildings, accessible facilities, accessible elements, and accessible spaces that are on the same site.	No route to water spigot near picnic restrooms	Create an accessible route with crushed stone or other outdoor material from parking or walkway to the water spigot as a smart practice.	2015 ABAAS Section: F206.2.2 2012 TAS Section: 206.2.2 2010 ADAS Section: 206.2.2

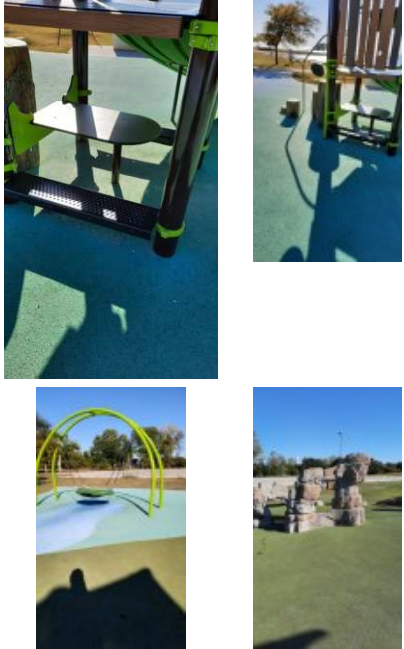
Finding Number	Area Description	Lat/Long	Finding	As Built	Recommendation	Citation	Photos	Figure
385	Isle Du Bois Unit: IDB - Day Use Playground	[33.42978, -97.05647]	Element meets all standards and requirements	One of each type one the route: talk tube, swing, rock structures; 4 of 3 types; Play table under structure, not on route	None	2010 ADAS Section: N/A

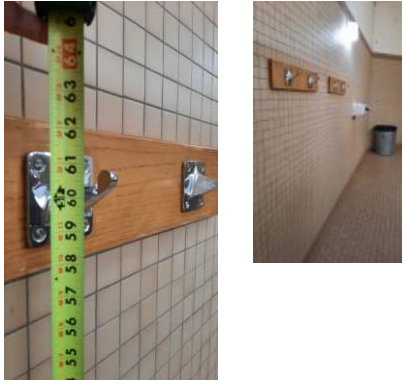
Finding Number	Area Description	Lat/Long	Finding	As Built	Recommendation	Citation	Photos	Figure
399	Isle Du Bois Unit: IDB - Day Use Swimming Women's Restroom	[33.3813417 , -97.0314879]	The operable part is positioned too high for either a side or front approach. Where a clear floor or ground space allows a parallel approach to an element and the side reach is unobstructed, the high side reach shall be 48 inches maximum and the low side reach shall be 15 inches minimum above the finish floor or ground. Where a forward reach is unobstructed, the high forward reach shall be 48 inches maximum and the low forward reach shall be 15 inches minimum above the finish floor or ground.	Hooks in main area at 61"	Remount operable parts to be in reach range of 15" min to 48" max.	2015 ABAAS Section: 308.1 2012 TAS Section: 308.1 2010 ADAS Section: 308.1

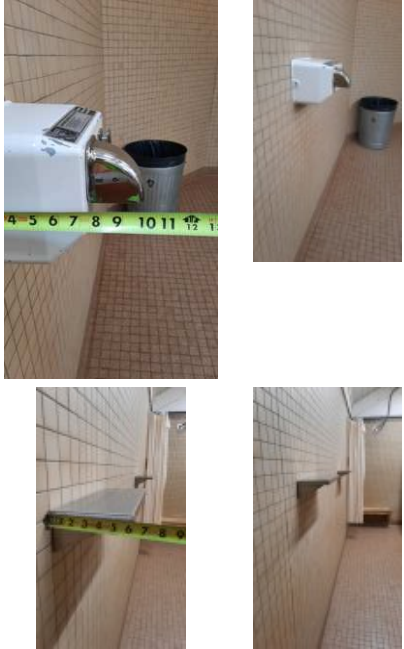
Finding Number	Area Description	Lat/Long	Finding	As Built	Recommendation	Citation	Photos	Figure
405	Isle Du Bois Unit: IDB - Day Use Swimming Women's Restroom	[33.3813484 , -97.031487 9]	The dryer and shelves projects more than 4 inches into the circulation path. Wall-mounted objects that have leading edges between 27 inches and 80 inches from the floor must not project more than 4 inches into the circulation path. Protruding objects that extend to the floor or within 27 inches of the floor are cane detectable and are therefore not hazardous. Where it is necessary or desirable to have objects protrude from the wall, a manner of cane detection must be provided.	Hand dryer and shelves protrude	Relocate protruding objects or place cane detectable warning or bollard at foot of items.	2015 ABAAS Section: 307.2 2012 TAS Section: 307.2 2010 ADAS Section: 307.2

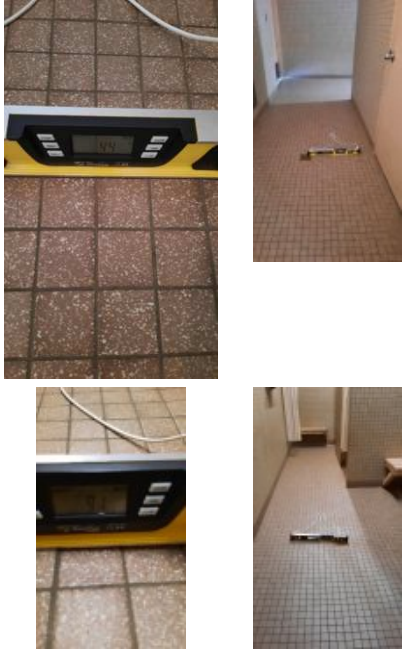
Finding Number	Area Description	Lat/Long	Finding	As Built	Recommendation	Citation	Photos	Figure
406	Isle Du Bois Unit: IDB - Day Use Swimming Women's Restroom	[33.381335, -97.031482 5]	The accessible route contains running slopes greater than 5 percent and cross slopes greater than 2 percent across the width of the walk and has not been constructed as a ramp (i.e. handrails, wheel guides, etc.). When the slope in the direction of travel of any walk exceeds 1 unit vertical in 20 units horizontal (5-percent slope), it must be constructed as ramp. Surface cross slopes must not exceed one unit vertical in 48 units. Horizontal (2-percent slope).	Slopes: 4.4% at pipe chase drain, 9.1% at drain near benches	Correct or repair slope to max 2.08%.	2015 ABAAS Section: 403.3 2012 TAS Section: 403.3 2010 ADAS Section: 403.3

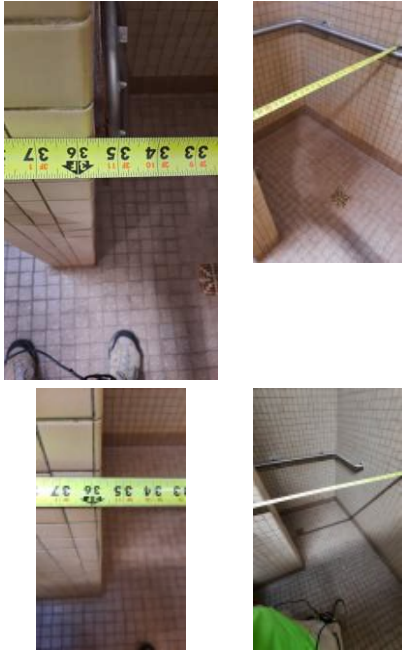
Finding Number	Area Description	Lat/Long	Finding	As Built	Recommendation	Citation	Photos	Figure
409	Isle Du Bois Unit: IDB - Day Use Swimming Women's Restroom	[33.3813462, -97.0314718]	Alternate roll-in type shower compartments shall be 36 inches (915 mm) wide and 60 inches (1525 mm) deep minimum clear inside dimensions measured at center points of opposing sides. A 36 inch (915 mm) wide minimum entry shall be provided at one end of the long side of the compartment.	35.5" wide, opening 35.75"	Enlarge shower stall, if feasible, to compliant dimensions for an alternate roll in shower of 36" deep by 60" wide with a 36" opening on the long dimension. In the alternative, leave as is citing construction tolerance.	2015 ABAAS Section: 608.2.3 2012 TAS Section: 608.2.3 2010 ADAS Section: 608.2.3

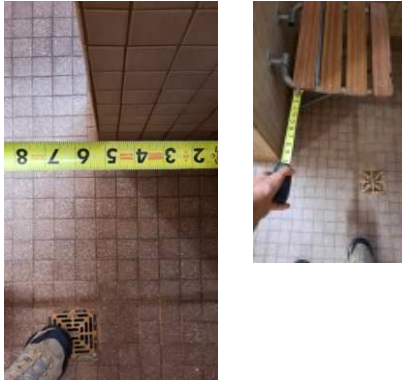
412	Isle Du Bois Unit: IDB - Day Use Swimming Women's Restroom	[33.3813081, -97.0314879]	Where a seat is provided in a standard roll-in shower compartment, it shall be a folding type, shall be installed on the side wall adjacent to the controls, and shall extend from the back wall to a point within 3 inches (75 mm) of the compartment entry. Where a seat is provided in an alternate roll-in type shower compartment, it shall be a folding type, shall be installed on the front wall opposite the back wall, and shall extend from the adjacent side wall to a point within 3 inches (75 mm) of the compartment entry. In transfer-type showers, the seat shall extend from the back wall to a point within 3 inches (75 mm) of the compartment entry. The top of the seat shall be 17 inches (430 mm) minimum and 19 inches (485 mm) maximum above the bathroom finish floor. Seats shall comply with 610.3.1 or 610.3.2.	seat mounted 5.5" from front	Remount shower seat to be within 3" of the front of the compartment.	2015 ABAAS Section: 610.3 2012 TAS Section: 610.3 2010 ADAS Section: 610.3

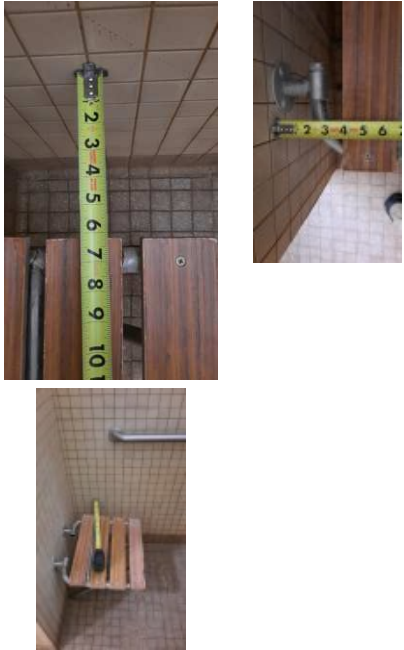
Finding Number	Area Description	Lat/Long	Finding	As Built	Recommendation	Citation	Photos	Figure
413	Isle Du Bois Unit: IDB - Day Use Swimming Women's Restroom	[33.381335, -97.031525 5]	The shower seat does not have a compliant space between it and the seat wall. The folding seat must be mounted 17-19 inches above the floor, and have a maximum space of 2-1/2 inches between the edge of the seat and the seat wall and 1-1/2 inches maximum to the side wall.	3.75" from seat wall, 6" from side	Remount shower seat to the correct location and height in the shower.	2015 ABAAS Section: 610.3.1 2012 TAS Section: 610.3.1 2010 ADAS Section: 610.3.1

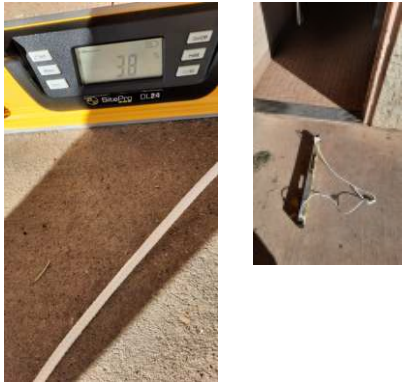
414	Isle Du Bois Unit: IDB - Day Use Swimming Men's Restroom	[33.42978, -97.05647]	Element meets all standards and requirements	Entry - shower doors complies	None	2010 ADAS Section: N/A		
415	Isle Du Bois Unit: IDB - Day Use Swimming Men's Restroom	[33.381335, -97.031504]	The accessible route of travel contains cross slopes greater than 2%. Cross slopes shall not exceed one unit vertical in 48 units horizontal (2-percent slope).	RR entry - 3.8% slope on exterior	Correct or repair cross slope along AR to max 2.08%.	2015 ABAAS Section: 403.3 2012 TAS Section: 403.3 2010 ADAS Section: 403.3

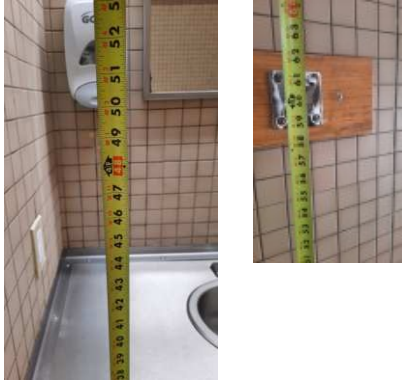
421	Isle Du Bois Unit: IDB - Day Use Swimming Men's Restroom	[33.3813484 , -97.031493 3]	Where a high forward reach is over an obstruction, the clear floor space shall extend beneath the element for a distance not less than the required reach depth over the obstruction. The high forward reach shall be 48 inches (1220 mm) maximum where the reach depth is 20 inches (510 mm) maximum. Where the reach depth exceeds 20 inches (510 mm), the high forward reach shall be 44 inches (1120 mm) maximum and the reach depth shall be 25 inches (635 mm) maximum. Where a clear floor or ground space allows a parallel approach to an element and the high side reach is over an obstruction, the height of the obstruction shall be 34 inches (865 mm) maximum and the depth of the obstruction shall be 24 inches (610 mm) maximum. The high side reach shall be 48 inches (1220 mm) maximum for a reach depth of 10 inches (255 mm) maximum. Where the reach depth exceeds 10 inches (255 mm), the high side reach shall be 46 inches (1170 mm) maximum for a reach depth of 24 inches (610 mm) maximum.	Soap at 50" over sink, hooks in main area at 61" AFF	Lower coat hook to max 48" aff to highest operable part. Lower soap dispenser to max 44" aff for a forward reach over counter.	2015 ABAAS Section: 308.2.1, 308.3.2 2012 TAS Section: 308.2.1, 308.3.2 2010 ADAS Section: 308.2.1, 308.3.2

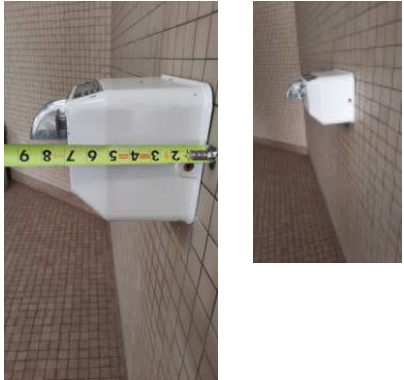
Finding Number	Area Description	Lat/Long	Finding	As Built	Recommendation	Citation	Photos	Figure
427	Isle Du Bois Unit: IDB - Day Use Swimming Men's Restroom	[33.3813529 , -97.031504]	The dryer projects more than 4 inches into the circulation path. Wall-mounted objects that have leading edges between 27 inches and 80 inches from the floor must not project more than 4 inches into the circulation path. Protruding objects that extend to the floor or within 27 inches of the floor are cane detectable and are therefore not hazardous. Where it is necessary or desirable to have objects protrude from the wall, a manner of cane detection must be provided.	Hand dryer protrudes	Relocate protruding objects or place cane detectable warning or bollard at foot of item.	2015 ABAAS Section: 307.2 2012 TAS Section: 307.2 2010 ADAS Section: 307.2

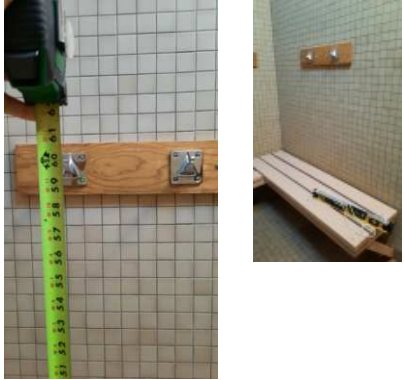
Finding Number	Area Description	Lat/Long	Finding	As Built	Recommendation	Citation	Photos	Figure
429	Isle Du Bois Unit: IDB - Day Use Swimming Men's Restroom	[33.3813484, -97.0314933]	Coat hooks provided within the room shall be located within one of the reach ranges specified in 308. Shelves shall be 40 inches (1015 mm) minimum and 48 inches (1220 mm) maximum above the finish floor or ground. Where coat hooks or shelves are provided in dressing, fitting or locker rooms without individual compartments, at least one of each type shall comply with 803.5. Where coat hooks or shelves are provided in individual compartments at least one of each type complying with 803.5 shall be provided in individual compartments in dressing, fitting, or locker rooms required to comply with 222.1.	Hooks at 60" AFF over benches	Remount at least one hook to max 44" aff for a reach over the benche and shelves to 40" - 48" aff	2015 ABAAS Section: 308.2.1, 308.1, F222.2, 803.5 2012 TAS Section: 308.2.1, 308.1, 222.2, 803.5 2010 ADAS Section: 308.2.1, 308.1, 222.2, 803.5

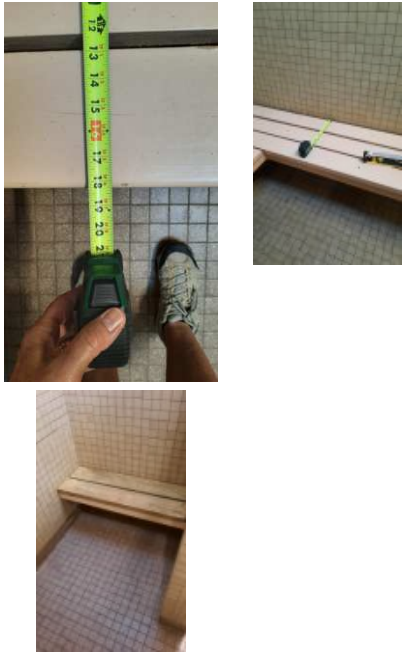
430	Isle Du Bois Unit: IDB - Day Use Swimming Men's Restroom	[33.3813417, -97.0314933]	The bench is not deep enough or long enough or is missing. Benches shall be provided having seats that are 42 inches long minimum and 20 inches deep minimum and 24 inches deep maximum. The bench shall provide for back support or shall be affixed to a wall. Back support shall be 42 inches (1065 mm) long minimum and shall extend from a point 2 inches (51 mm) maximum above the seat surface to a point 18 inches (455 mm) minimum above the seat surface. Back support shall be 2½ inches (64 mm) maximum from the rear edge of the seat measured horizontally. The top of the bench seat surface shall be 17 inches (430 mm) minimum and 19 inches (485 mm) maximum above the finish floor or ground. Clear floor or ground space complying with 305 shall be provided and shall be positioned at the end of the bench seat and parallel to the short axis of the bench	Bench depth 18", small bench in shower	Replace bench in dressing area with one having a seat depth of 20" to 24" deep, 42" long, affixed to the wall or having a back and mounted 17" to 19" AFF and provide required clear floor space on the short axis of the bench.	2012 TAS Section: 903.4, 903.2, 903.3, 903.5 2010 ADAS Section: 903.4, 903.2, 903.3, 903.5

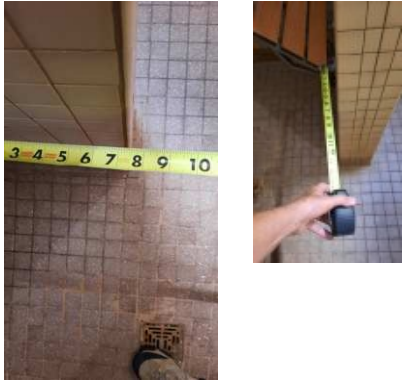
Finding Number	Area Description	Lat/Long	Finding	As Built	Recommendation	Citation	Photos	Figure
436	Isle Du Bois Unit: IDB - Day Use Swimming Men's Restroom	[33.381326, -97.031493 3]	Where a seat is provided in a standard roll-in shower compartment, it shall be a folding type, shall be installed on the side wall adjacent to the controls, and shall extend from the back wall to a point within 3 inches (75 mm) of the compartment entry. Where a seat is provided in an alternate roll-in type shower compartment, it shall be a folding type, shall be installed on the front wall opposite the back wall, and shall extend from the adjacent side wall to a point within 3 inches (75 mm) of the compartment entry. In transfer-type showers, the seat shall extend from the back wall to a point within 3 inches (75 mm) of the compartment entry. The top of the seat shall be 17 inches (430 mm) minimum and 19 inches (485 mm) maximum above the bathroom finish floor. Seats shall comply with 610.3.1 or 610.3.2.	seat mounted 7.5" from front	Remount seat to be within 3" of the front of the compartment.	2015 ABAAS Section: 610.3 2012 TAS Section: 610.3 2010 ADAS Section: 610.3

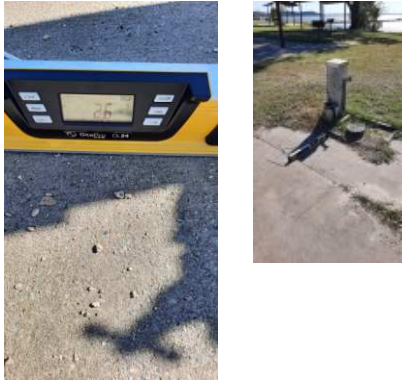
Finding Number	Area Description	Lat/Long	Finding	As Built	Recommendation	Citation	Photos	Figure
438	Isle Du Bois Unit: IDB - Day Use Picnic Areas	[33.3828378, -97.0324455]	The 30 inches minimum by 48 inches minimum clear floor space required at the operable part is not flat (2% or 1:48 maximum slope) in all directions. Changes in level are not permitted at required clear floor or ground space except that slopes not steeper than 1:48 shall be permitted.	Water spigot has 2.6% slope	Correct or repair slope in CFS to max 2.08%.	2015 ABAAS Section: 305.2 2012 TAS Section: 305.2 2010 ADAS Section: 305.2

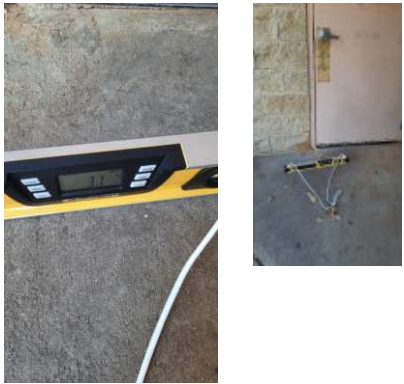
439	Isle Du Bois Unit: IDB - Day Use Picnic Areas	[33.42978, -97.05647]	Element meets all standards and requirements	5 of 15 plus picnic shelters comply	None	2010 ADAS Section: N/A		
440	Isle Du Bois Unit: IDB - Day Use Picnic Men's Restroom	[33.3834784, -97.0320753]	Minimum maneuvering clearances at doors and gates shall comply with 404.2.4. Maneuvering clearances shall extend the full width of the doorway and the required latch side or hinge side clearance.	Entry - 3.1% slope on pull	Correct slope in door clearance to max 2.08%	2015 ABAAS Section: 404.2.4.4, 404.2.4.1 2012 TAS Section: 404.2.4.4, 404.2.4.1 2010 ADAS Section: 404.2.4.4, 404.2.4.1

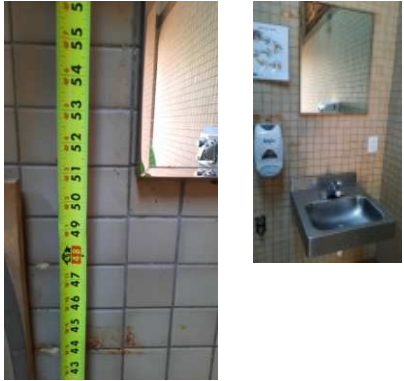
Finding Number	Area Description	Lat/Long	Finding	As Built	Recommendation	Citation	Photos	Figure
443	Isle Du Bois Unit: IDB - Day Use Picnic Men's Restroom	[33.3834672, -97.032078]	The mirror is mounted too high. Mirrors must have the bottom edge of the reflecting surface a maximum of 40 inches above the floor if above a sink or counter. Mirrors not located above lavatories or countertops shall be installed with the bottom edge of the reflecting surface 35 inches maximum above the finish floor or ground.	Mirror at 51.5" AFF	Lower mirror so reflective surface is max 40" aff.	2015 ABAAS Section: 603.3 2012 TAS Section: 603.3 2010 ADAS Section: 603.3

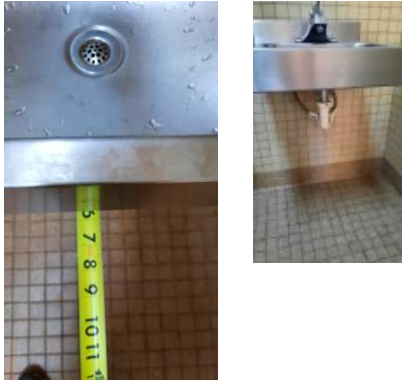
444	Isle Du Bois Unit: IDB - Day Use Picnic Men's Restroom	[33.3834828, -97.0320619]	Knee clearance at 27 inches off the floor is not 8 inches minimum deep. The knee clearance, measured from the bottom of the apron or the outside bottom edge of the lavatory, must be 27 inches at a point located 8 inches back from the front edge and continuing to 11 inches minimum in depth at 9 inches above the floor. The top of the lavatory rim may be no higher than 34 inches.	Pipes prevent 8" knee clearance	Replace sink with one providing 27" knee clearance that is a min 8" deep.	2015 ABAAS Section: 306.3.1, 306.3.2, 306.3.3, 306.3.4, 306.3.5 2012 TAS Section: 306.3.2, 306.3.3, 306.3.4, 306.3.5, 306.3.1 2010 ADAS Section: 306.3.3, 306.3.2, 306.3.4, 306.3.5, 306.3.1

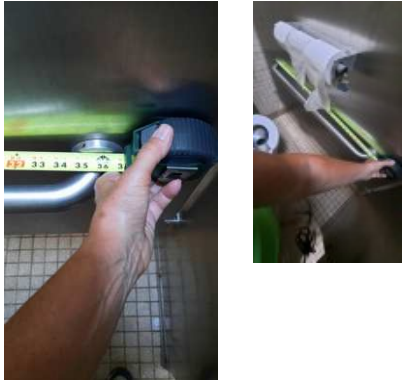
447	Isle Du Bois Unit: IDB - Day Use Picnic Men's Restroom	[33.3834761, -97.0320834]	The side grab bars are not in the correct location. Grab bars on the side wall must be installed so that the end closest to the rear wall is maximum 12" from the rear wall. The end furthest from the rear wall must be mounted minimum 54" from the rear wall.	side grab bar is a 36" long bar	Replace side grab bar with 42" bar. Install to max 12" from the rear wall at the close end and min 54" on the far end, and 33" to 36" aff.	2015 ABAAS Section: 604.5.1 2012 TAS Section: 604.5.1 2010 ADAS Section: 604.5.1

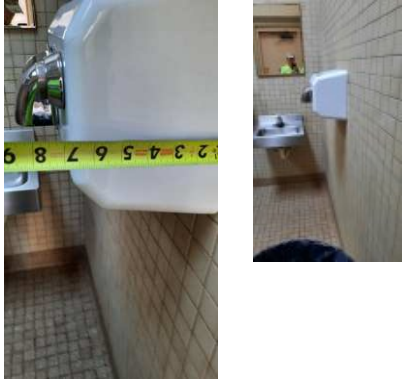
Finding Number	Area Description	Lat/Long	Finding	As Built	Recommendation	Citation	Photos	Figure
450	Isle Du Bois Unit: IDB - Day Use Picnic Men's Restroom	[33.3834806 , -97.0320834]	The dryer projects more than 4 inches into the circulation path. Wall-mounted objects that have leading edges between 27 inches and 80 inches from the floor must not project more than 4 inches into the circulation path. Protruding objects that extend to the floor or within 27 inches of the floor are cane detectable and are therefore not hazardous. Where it is necessary or desirable to have objects protrude from the wall, a manner of cane detection must be provided.	Hand dryer protrudes	Relocate protruding objects or place cane detectable warning or bollard at foot of item	2015 ABAAS Section: 307.2 2012 TAS Section: 307.2 2010 ADAS Section: 307.2

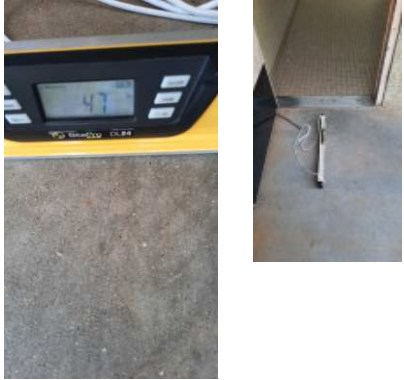
451	Isle Du Bois Unit: IDB - Day Use Picnic Women's Restroom	[33.3834806 , -97.0320834]	Minimum maneuvering clearances at doors and gates shall comply with 404.2.4. Maneuvering clearances shall extend the full width of the doorway and the required latch side or hinge side clearance.	Entry- 4.7% slope on exterior	Correct slope in door clearance to max 2.08%.	2015 ABAAS Section: 404.2.4.1 , 404.2.4.4 2012 TAS Section: 404.2.4.4, 404.2.4.1 2010 ADAS Section: 404.2.4.4, 404.2.4.1

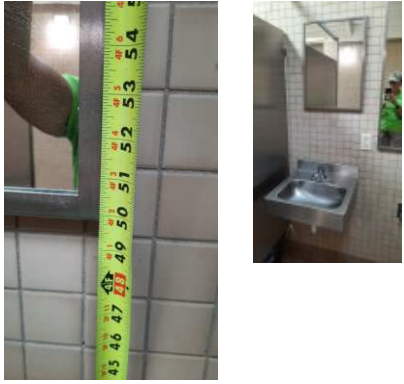
Finding Number	Area Description	Lat/Long	Finding	As Built	Recommendation	Citation	Photos	Figure
454	Isle Du Bois Unit: IDB - Day Use Picnic Women's Restroom	[33.3834672, -97.0320834]	The mirror is mounted too high. Mirrors must have the bottom edge of the reflecting surface a maximum of 40 inches above the floor if above a sink or counter. Mirrors not located above lavatories or countertops shall be installed with the bottom edge of the reflecting surface 35 inches maximum above the finish floor or ground.	Mirror at 50.5" AFF	Lower mirror so reflective surface is max 40" aff.	2015 ABAAS Section: 603.3 2012 TAS Section: 603.3 2010 ADAS Section: 603.3

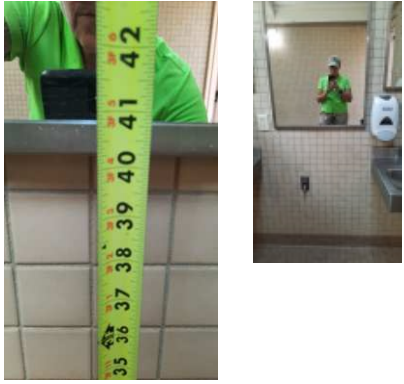
455	Isle Du Bois Unit: IDB - Day Use Picnic Women's Restroom	[33.3834716, -97.0320726]	The mirror is mounted too high. Mirrors not located above lavatories or countertops shall be installed with the bottom edge of the reflecting surface 35 inches maximum above the finish floor or ground.	Mirror at 40.75" AFF not above sink	Lower mirror not over a sink or counter to max 35" aff to the reflective surface.	2015 ABAAS Section: 603.3 2012 TAS Section: 603.3 2010 ADAS Section: 603.3

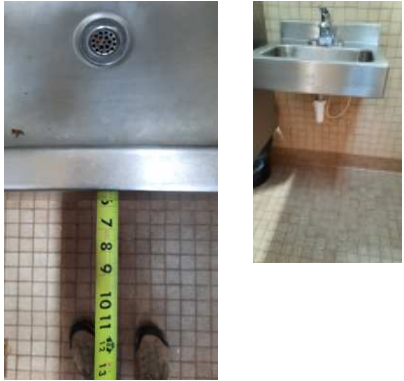
Finding Number	Area Description	Lat/Long	Finding	As Built	Recommendation	Citation	Photos	Figure
456	Isle Du Bois Unit: IDB - Day Use Picnic Women's Restroom	[33.3834672 , -97.0320673]	Knee clearance at 27 inches off the floor is not 8 inches minimum deep. The knee clearance, measured from the bottom of the apron or the outside bottom edge of the lavatory, must be 27 inches at a point located 8 inches back from the front edge and continuing to 11 inches minimum in depth at 9 inches above the floor. The top of the lavatory rim may be no higher than 34 inches.	Sink pipes prevent knee clearance	Replace sink with one providing 27" knee clearance that is a min 8" deep.	2015 ABAAS Section: 306.3.1, 306.3.2, 306.3.3, 306.3.4 , 306.3.5 2012 TAS Section: 306.3.2, 306.3.3, 306.3.4, 306.3.5, 306.3.1 2010 ADAS Section: 306.3.3, 306.3.2, 306.3.4, 306.3.5, 306.3.1

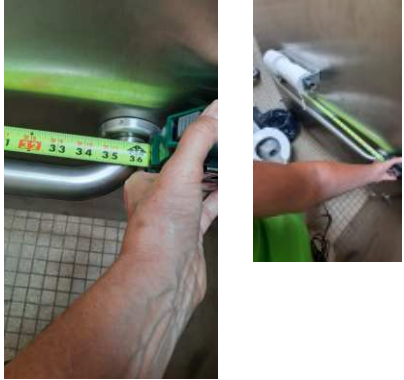
Finding Number	Area Description	Lat/Long	Finding	As Built	Recommendation	Citation	Photos	Figure
458	Isle Du Bois Unit: IDB - Day Use Picnic Women's Restroom	[33.3834875 , -97.032081 9]	The side grab bars are not in the correct location. Grab bars on the side wall must be installed so that the end closest to the rear wall is maximum 12" from the rear wall. The end furthest from the rear wall must be mounted minimum 54" from the rear wall.	Side grab bar only 36"	Replace side grab bar with 42" bar. Install to max 12" from the rear wall at the close end and min 54" on the far end, and 33" to 36" aff.	2015 ABAAS Section: 604.5.1 2012 TAS Section: 604.5.1 2010 ADAS Section: 604.5.1

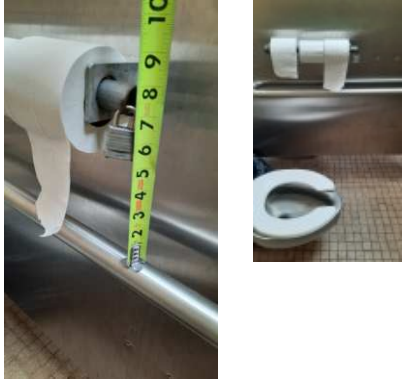
459	Isle Du Bois Unit: IDB - Day Use Picnic Women's Restroom	[33.3834739 , -97.032094 1]	The grab bar height and/or spacing fails. Grab bars must be mounted between 33" and 36" to the top of the gripping surface. There must be 1.5" of clearance between the grab bar and the wall. There must be a minimum of 1.5" of clearance below and minimum 12" above the grab bar to any dispenser or other obstruction.	TP too close above side bar and too close to toilet	Remount toilet paper dispenser max 7" to 9" from front of toilet, 15" to 48" aff and min 12" above or 1.5" below grab bar.	2015 ABAAS Section: 609.3, 609.4 2012 TAS Section: 609.4, 609.3 2010 ADAS Section: 609.3, 609.4

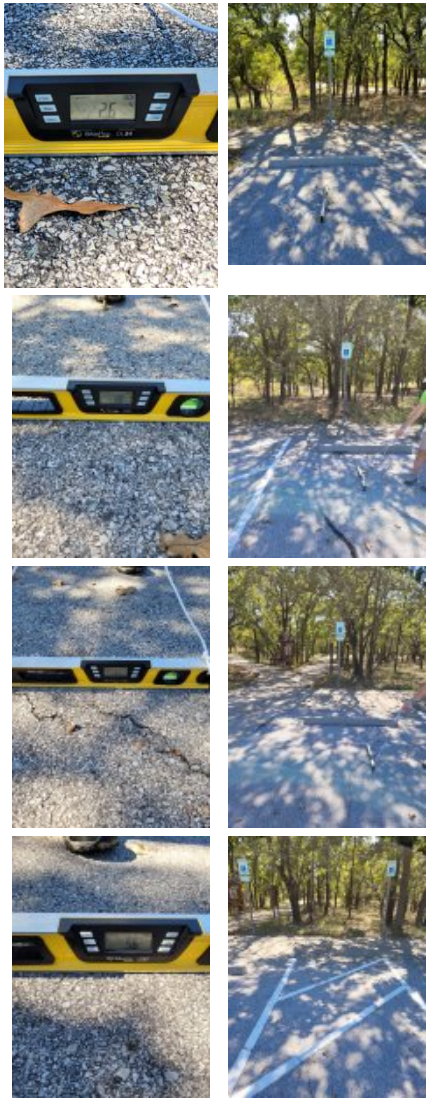
Finding Number	Area Description	Lat/Long	Finding	As Built	Recommendation	Citation	Photos	Figure
461	Isle Du Bois Unit: IDB - DOBRA Trailhead Parking	[33.3802218 , -97.030074 4]	Element meets all standards and requirements	Parking lot complies with scoping - 18 standard stalls, 4 accessible	None	2010 ADAS Section: N/A		
462	Isle Du Bois Unit: IDB - DOBRA Trailhead Parking	[33.3802532 , -97.030077 1]	The cross slopes (narrow dimension) and/or running slopes (long dimension) of the access aisle exceeds 2%. The running slope and the cross slope in an accessible parking stall and the access aisle must not exceed 2%.	Slopes from L to R: 1st 2.6%, 2nd 3.0%, 3rd 3.1%, 2nd access aisle 5.6% , 4th 4.0%	Repair or correct slope of parking space and access aisle to max 2.08% in any direction.	2015 ABAAS Section: 502.4 2012 TAS Section: 502.4 2010 ADAS Section: 502.4

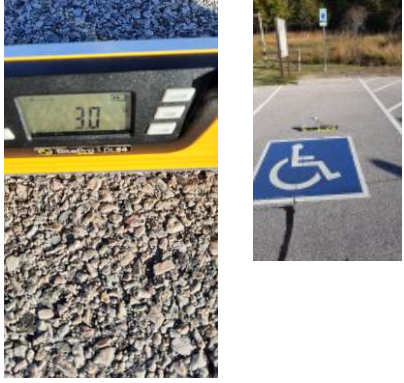
465	Isle Du Bois Unit: IDB - DOBRA Trailhead Parking	[33.380242, -97.0300771]	The cross slopes (narrow dimension) and/or running slopes (long dimension) of the access aisle exceeds 2%. The running slope and the cross slope in an accessible parking stall and the access aisle must not exceed 2%.	Trailhead near day use - Slopes: 3% in 1st left stall, 2.6% next stall, 2.4% 3rd stall, 2.3% 2nd aisle	Repair or correct slope of parking space and access aisle to max 2.08% in any direction	2015 ABAAS Section: 502.4 2012 TAS Section: 502.4 2010 ADAS Section: 502.4

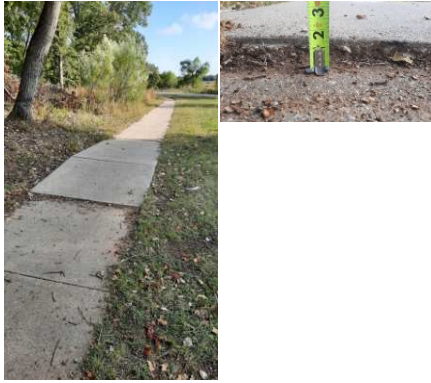
472	Isle Du Bois Unit: IDB - Deer Ridge Parking - West Restroom	[33.42978, -97.05647]	Element meets all standards and requirements	Lot meets scoping - 10 standards stalls, 2 accessible	None	2010 ADAS Section: N/A		
473	Isle Du Bois Unit: IDB - Quail Run Campsites	[33.3845332, -97.0267082]	The walkway contains abrupt vertical edges and/or variations over a 1/4 inch. 1/4 inch is the maximum vertical rise. Changes in level between 1/4 inch and 1/2 inch must be beveled at 1:2 or less. Changes in level greater than 1/2 inch must be by way of a ramp.	Large heaved sidewalk panels from trail parking towards campsites	Repair, bevel or ramp CIL along ORAR.	2012 TAS Section: 303.2, 303.3 2010 ADAS Section: 303.2, 303.3

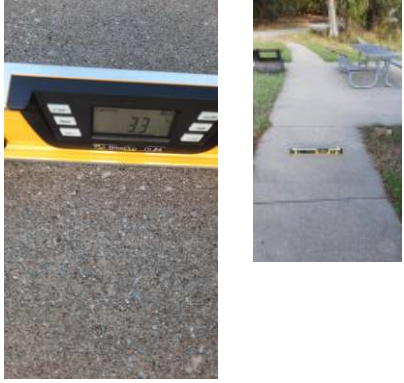
Finding Number	Area Description	Lat/Long	Finding	As Built	Recommendation	Citation	Photos	Figure
474	Isle Du Bois Unit: IDB - Quail Run Campsites	[33.3847516 , -97.0262804]	The cross slope shall not be steeper than 1:48. EXCEPTION: Where the surface is other than concrete, asphalt, or boards, cross slopes not steeper than 1:20 shall be permitted when necessary for drainage.	132 - 3.3% near picnic table	Correct or repair ORAR cross slope to max 2.08% or 5% for surfaces other than concrete, asphalt or board as a smart practice.	2015 ABAAS Section: 1016.7.2, 1016.7.2 EXCEPTION

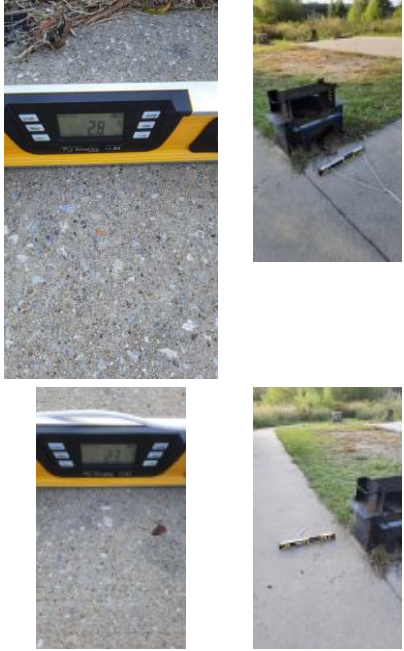
475	Isle Du Bois Unit: IDB - Quail Run Campsites	[33.3847035 , -97.0263273]	48 inches (1220 mm) by 48 inches (1220 mm) on all usable sides of the fire ring, grill, fireplace, and woodstove Center the space on each usable side of the grill, fireplace, and woodstove	Site #132 - clear space has slopes	Correct slopes in required 48" clear ground space centered along usable side of fire ring, grill, fireplace, or woodstove as a smart practice.	2015 ABAAS Section: 1011.2

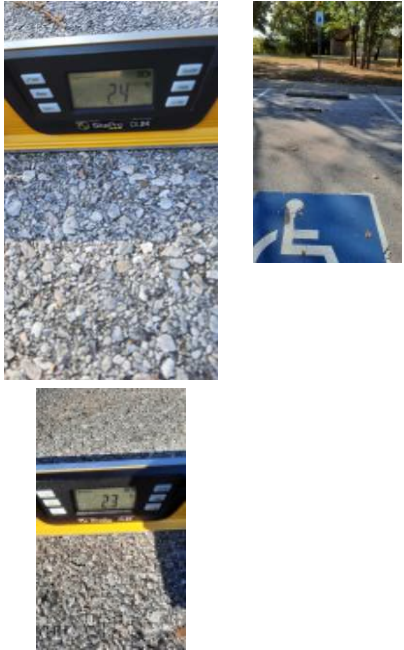
Finding Number	Area Description	Lat/Long	Finding	As Built	Recommendation	Citation	Photos	Figure																																																																																																																																																																				
483	Isle Du Bois Unit: IDB - Quail Run Parking	[33.3852656 , -97.028259 9]	The cross slopes (narrow dimension) and/or running slopes (long dimension) of the access aisle exceeds 2%. The running slope and the cross slope in an accessible parking stall and the access aisle must not exceed 2%.	Restroom parking: slopes - right stall 2.4%, access aisle 2.3%	Repair or correct slope of parking space and access aisle to max 2.08% in any direction	2015 ABAAS Section: 502.4 2012 TAS Section: 502.4 2010 ADAS Section: 502.4

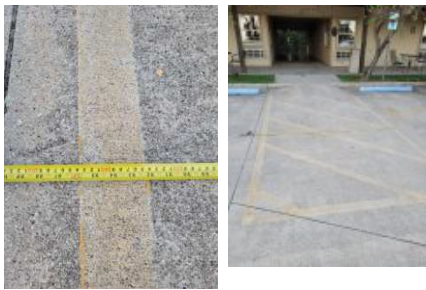
Finding Number	Area Description	Lat/Long	Finding	As Built	Recommendation	Citation	Photos	Figure
485	Jordan Park: Jordan - Lone Star Lodge Parking	[33.4059953 , -96.999878 1]	The access aisle is not a minimum 8 feet to the centerline of the stripe. The accessible parking stall access aisle must be a minimum of 8 feet wide measured from centerline to centerline. Where parking spaces or access aisles are not adjacent to another parking space or access aisle, measurements shall be permitted to include the full width of the line defining the parking space or access aisle. Alternatively, the stall can be 11 feet wide and the access aisle may be 5 feet wide.	Right side van stall - 7'8" wide access aisle	Repaint van access aisles to be 8' each.	2015 ABAAS Section: 502.2 2012 TAS Section: 502.2 2010 ADAS Section: 502.2

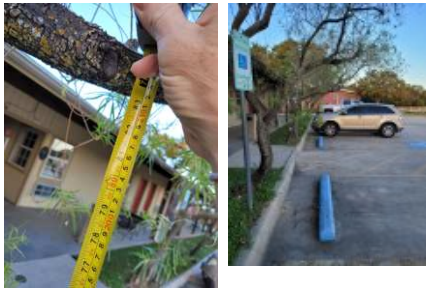
486	Jordan Park: Jordan - Lone Star Lodge Parking	[33.4059762 , -96.999898 2]	The vehicle route to the accessible parking contains vertical clearances less than 98 inches. A minimum vertical clearance of 98 inches must be provided at accessible parking spaces and along at least one vehicle access route to such spaces from site entrances and exits.	Right side van space: 84" AFF to tree limb at van space	Raise obstructions over van stalls to provide 98" vertical clearance.	2015 ABAAS Section: 502.5 2012 TAS Section: 502.5 2010 ADAS Section: 502.5

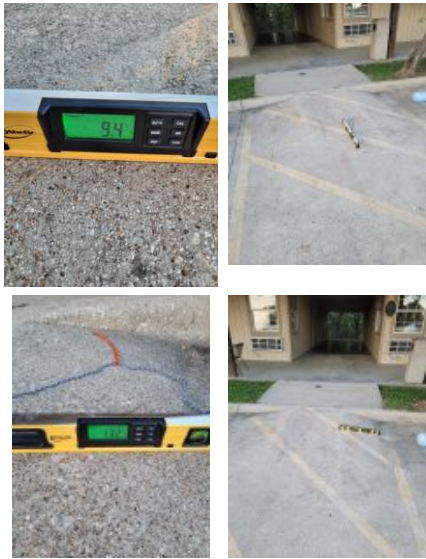
487	Jordan Park: Jordan - Lone Star Lodge Parking	[33.4059785 , -96.999914 3]	The cross slopes (narrow dimension) and/or running slopes (long dimension) of the access aisle exceeds 2%. The running slope and the cross slope in an accessible parking stall and the access aisle must not exceed 2%.	R side: 9.4%, 13.2% slope in access aisle	Repair or correct slope of parking space and access aisle to max 2.08% in any direction.	2015 ABAAS Section: 502.4 2012 TAS Section: 502.4 2010 ADAS Section: 502.4
