Access Audit Site Report

Ray Roberts Lake State Park/Complex

Accessibility Evaluation

Inspection Date: 10/18/2021

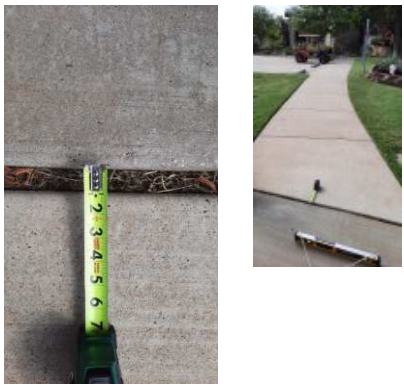
Finding Number	Area Description	Lat/Long	Finding	As Built	Recommendation	Citation	Photos	Figure
491	Jordan Park: Jordan - Lone Star Lodge Exterior Accessible Route	[33.4060658 , -96.999852 6]	There is a gap spaced greater than a 1/2 inch. Openings in floor or ground surfaces shall not allow passage of a sphere more than 1/2 inch diameter. Elongated openings shall be placed so that the long dimension is perpendicular to the dominant direction of travel.	1" gap from blg 1 to lodge	Correct or fill gaps to be max .5".	2015 ABAAS Section: 302.3 2012 TAS Section: 302.3 2010 ADAS Section: 302.3

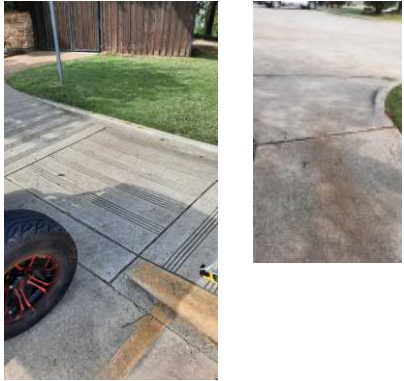
Finding Number	Area Description	Lat/Long	Finding	As Built	Recommendation	Citation	Photos	Figure
493	Jordan Park: Jordan - Lone Star Lodge Exterior Accessible Route	[33.406012, -96.999922 3]	Detectable warning surfaces complying with R305 shall be provided at the following locations on pedestrian access routes and at transit stops: Curb ramps and blended transitions at pedestrian street crossings; Pedestrian refuge islands; Pedestrian at-grade rail crossings not located within a street or highway; Boarding platforms at transit stops for buses and rail vehicles where the edges of the boarding platform are not protected by screens or guards; and Boarding and alighting areas at sidewalk or street level transit stops for rail vehicles where the side of the boarding and alighting areas facing the rail vehicles is not protected by screens or guards. Detectable warning surfaces are not required at pedestrian refuge islands that are cut-through at street level and are less than 1.8 meters (6.0 ft) in length in the direction of pedestrian travel.	Ramps lack detectable warnings	Install required detectable warnings at curb ramps along the public right of way or at curb ramps within a site as a smart practice.	2012 TAS Section: 705.1 2010 ADAS Section: 705

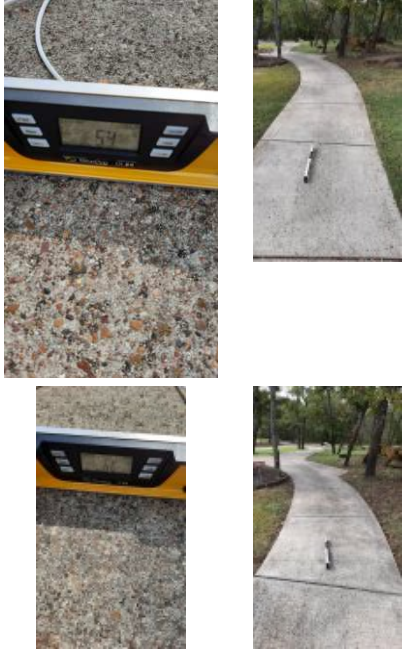
494	Jordan Park: Jordan - Lone Star Lodge Exterior Accessible Route	[33.4059594 , -97.000036 3]	The running slope of walking surfaces shall not be steeper than 1:20.	Slopes: route from parking to blg 2 - 5.4%, 6.3%, 6.6%, 8.2%, ramp up to walkway - 9.1%	Correct running slope along the AR to max 5%	2015 ABAAS Section: 403.3 2012 TAS Section: 403.3 2010 ADAS Section: 403.3

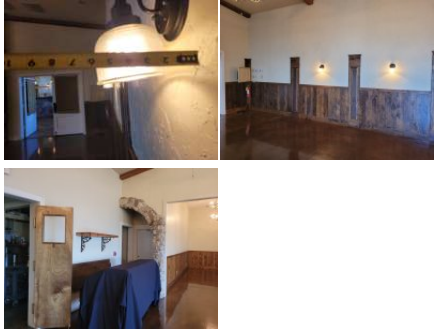
Finding Number	Area Description	Lat/Long	Finding	As Built	Recommendation	Citation	Photos	Figure
504	Jordan Park: Jordan - Lone Star Lodge Public Spaces	[33.4057982 , -97.000170 4]	The sconces and shelf projects more than 4 inches into the circulation path. Wall-mounted objects that have leading edges between 27 inches and 80 inches from the floor must not project more than 4 inches into the circulation path. Protruding objects that extend to the floor or within 27 inches of the floor are cane detectable and are therefore not hazardous. Where it is necessary or desirable to have objects protrude from the wall, a manner of cane detection must be provided.	Dining Hall - Sconces protrude 6", shelf protrudes	Relocate protruding objects or place cane detectable warning or bollard at foot of items.	2015 ABAAS Section: 307.2 2012 TAS Section: 307.2 2010 ADAS Section: 307.2

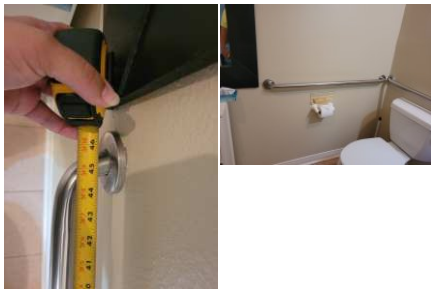
523	Jordan Park: Jordan - Lone Star Lodge Guest Rooms	[33.4062281 , -96.999671 5]	The side grab bars are not in the correct location. Grab bars on the side wall must be installed so that the end closest to the rear wall is maximum 12" from the rear wall. The end furthest from the rear wall must be mounted minimum 54" from the rear wall.	Rm 114 - side grab bar extends to 45.5"	Remount side grab bar to max 12" from the rear wall at the close end and min 54" on the far end, and 33" to 36" AFF.	2015 ABAAS Section: 604.5.1 2012 TAS Section: 604.5.1 2010 ADAS Section: 604.5.1

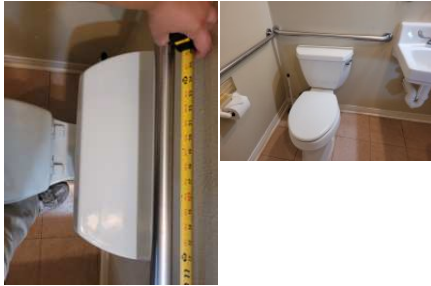
Finding Number	Area Description	Lat/Long	Finding	As Built	Recommendation	Citation	Photos	Figure
524	Jordan Park: Jordan - Lone Star Lodge Guest Rooms	[33.4062147 , -96.999660 8]	The rear grab bar is not 36" long or is not mounted in the correct location. The rear grab bar must be a minimum of 36" long and extend from the toilet centerline a minimum 12" towards the wall side and a minimum 24" towards the open side of the toilet. Grab bars shall be installed in a horizontal position, 33 inches minimum and 36 inches maximum above the finish floor measured to the top of the gripping surface and the space between the grab bar and the top of the tank shall be 1-1/2 inches minimum.	Rm 114 - rear grab bar mounted 19" to open side	Remount rear grab bar to behind the toilet, 12" to one side of center and 24" to the other and 33" to 36" AFF.	2015 ABAAS Section: 604.5.2 2012 TAS Section: 604.5.2 2010 ADAS Section: 604.5.2

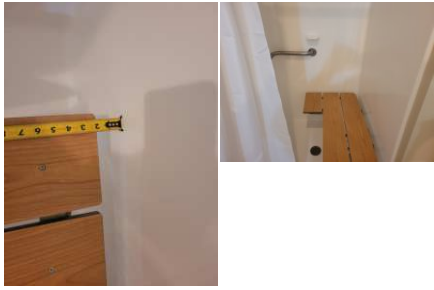
529	Jordan Park: Jordan - Lone Star Lodge Guest Rooms	[33.4061833 , -96.999725 2]	The shower seat does not have a compliant space between it and the wall. The folding seat must be mounted 17-19 inches above the floor, and have a maximum space of 1-1/2 inches between the edge of the seat and the side wall and 2-1/2 inches maximum to the seat wall.	Rm 114 - seat mounted with 2" gap at back wall	Remount shower seat to the correct location and height in the shower.	2015 ABAAS Section: 610.3.2 2012 TAS Section: 610.3.2 2010 ADAS Section: 610.3.2

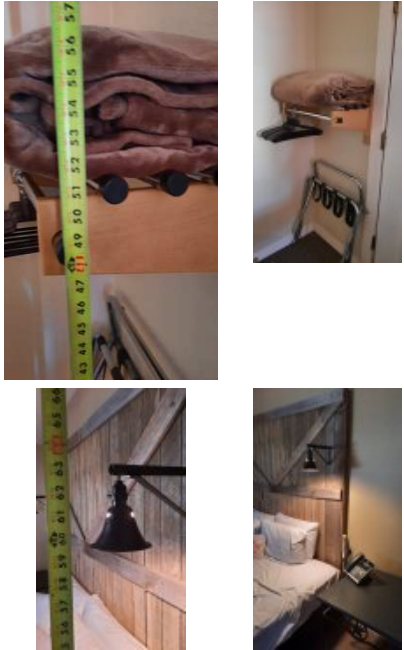
Finding Number	Area Description	Lat/Long	Finding	As Built	Recommendation	Citation	Photos	Figure
533	Jordan Park: Jordan - Lone Star Lodge Guest Rooms	[33.4054041 , -96.999961 2]	The shelf and light are positioned too high for either a side or front approach. Where a clear floor or ground space allows a parallel approach to an element and the side reach is unobstructed, the high side reach shall be 48 inches maximum and the low side reach shall be 15 inches minimum above the finish floor or ground. Where a forward reach is unobstructed, the high forward reach shall be 48 inches maximum and the low forward reach shall be 15 inches minimum above the finish floor or ground.	Room 214 - clothing shelf at 51", light over bed at 62"	Remount operable parts to be in reach range of 15" min to 48" max.	2015 ABAAS Section: 308.1 2012 TAS Section: 308.1 2010 ADAS Section: 308.1

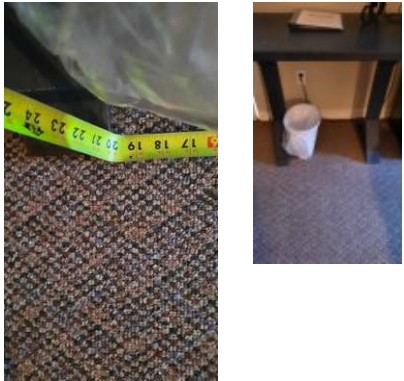
534	Jordan Park: Jordan - Lone Star Lodge Guest Rooms	[33.4053593 , -97.00009]	The top of the work surface is not within a compliant height range. The tops of tables and counters shall be 28 inches to 34 inches from the floor or ground.	Room 214 - toe clearance under table only 20" wide	Provide tables and work surfaces at 28" to 34" aff with required 30" wide knee and toe clearances.	2015 ABAAS Section: 902.3 2012 TAS Section: 902.3 2010 ADAS Section: 902.3

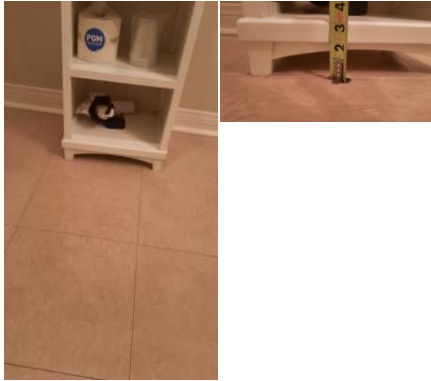
Finding Number	Area Description	Lat/Long	Finding	As Built	Recommendation	Citation	Photos	Figure
538	Jordan Park: Jordan - Lone Star Lodge Guest Rooms	[33.4053773 , -96.999939 8]	Where a high forward reach is over an obstruction, the clear floor space shall extend beneath the element for a distance not less than the required reach depth over the obstruction. The high forward reach shall be 48 inches (1220 mm) maximum where the reach depth is 20 inches (510 mm) maximum. Where the reach depth exceeds 20 inches (510 mm), the high forward reach shall be 44 inches (1120 mm) maximum and the reach depth shall be 25 inches (635 mm) maximum. Where a clear floor or ground space allows a parallel approach to an element and the high side reach is over an obstruction, the height of the obstruction shall be 34 inches (865 mm) maximum and the depth of the obstruction shall be 24 inches (610 mm) maximum. The high side reach shall be 48 inches (1220 mm) maximum for a reach depth of 10 inches (255 mm) maximum. Where the reach depth exceeds 10 inches (255 mm), the high side reach shall be 46 inches (1170 mm) maximum for a reach depth of 24 inches (610 mm) maximum.	Room 214 - hair dryer too low	Relocate hair dryer to between min. 15" and max 48" aff.	2015 ABAAS Section: 308.2.1, 308.3.2 2012 TAS Section: 308.2.1, 308.3.2 2010 ADAS Section: 308.2.1, 308.3.2

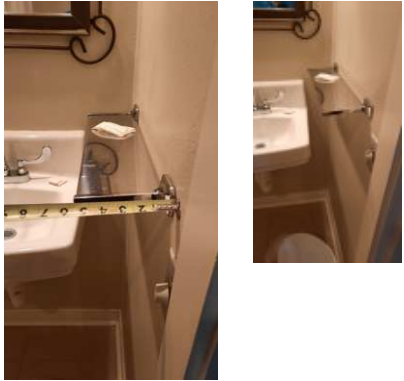
Finding Number	Area Description	Lat/Long	Finding	As Built	Recommendation	Citation	Photos	Figure
542	Jordan Park: Jordan - Lone Star Lodge Guest Rooms	[33.4053683 , -97.000036 3]	The shelf projects more than 4 inches into the circulation path. Wall-mounted objects that have leading edges between 27 inches and 80 inches from the floor must not project more than 4 inches into the circulation path. Protruding objects that extend to the floor or within 27 inches of the floor are cane detectable and are therefore not hazardous. Where it is necessary or desirable to have objects protrude from the wall, a manner of cane detection must be provided.	Room 214 - shelf protrudes at sink	Relocate protruding objects or place cane detectable warning or bollard at foot of item.	2015 ABAAS Section: 307.2 2012 TAS Section: 307.2 2010 ADAS Section: 307.2

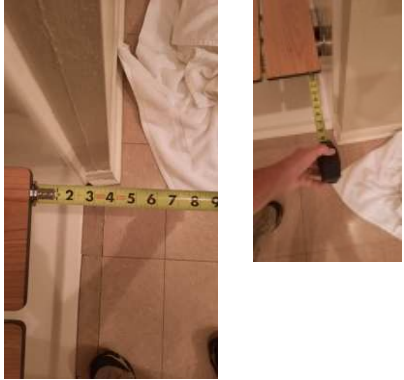
Finding Number	Area Description	Lat/Long	Finding	As Built	Recommendation	Citation	Photos	Figure
544	Jordan Park: Jordan - Lone Star Lodge Guest Rooms	[33.4053146 , -96.999961 2]	Where a seat is provided in a standard roll-in shower compartment, it shall be a folding type, shall be installed on the side wall adjacent to the controls, and shall extend from the back wall to a point within 3 inches (75 mm) of the compartment entry. Where a seat is provided in an alternate roll-in type shower compartment, it shall be a folding type, shall be installed on the front wall opposite the back wall, and shall extend from the adjacent side wall to a point within 3 inches (75 mm) of the compartment entry. In transfer-type showers, the seat shall extend from the back wall to a point within 3 inches (75 mm) of the compartment entry. The top of the seat shall be 17 inches (430 mm) minimum and 19 inches (485 mm) maximum above the bathroom finish floor. Seats shall comply with 610.3.1 or 610.3.2.	Room 214 - 4" from front	Remount seat to be within 3" of the front of the compartment.	2015 ABAAS Section: 610.3 2012 TAS Section: 610.3 2010 ADAS Section: 610.3

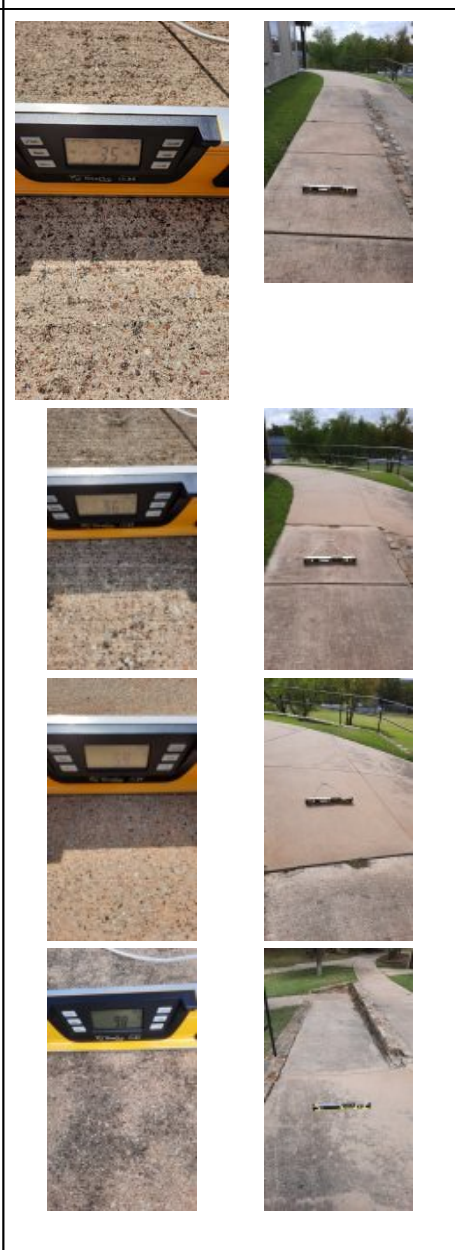
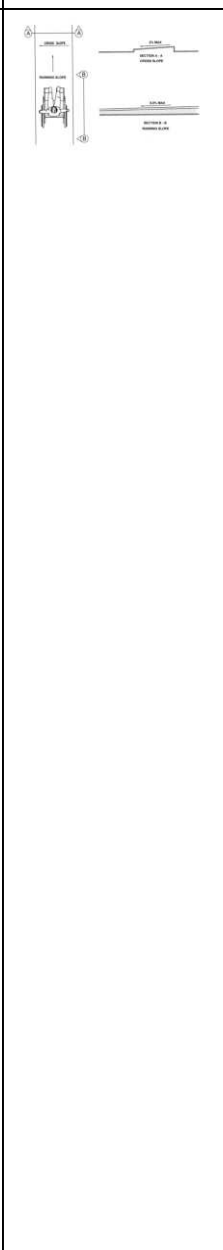
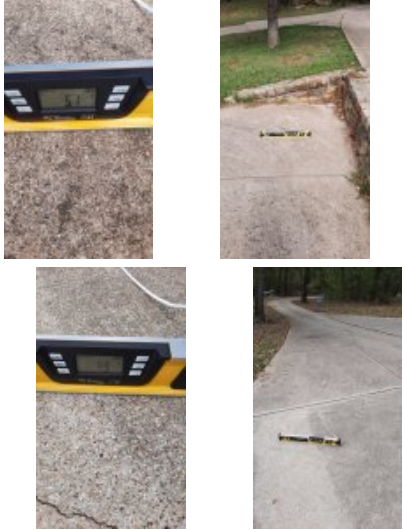
Finding Number	Area Description	Lat/Long	Finding	As Built	Recommendation	Citation	Photos	Figure
569	Jordan Park: Jordan - Marina	[33.4053235 , -97.000401 1]	The accessible route contains cross slopes greater than 2%. Cross slopes shall not exceed one unit vertical in 48 units horizontal (2-percent slope).	Route to marina from building (blg) 2 - 3.5% cross slope, 5.6%, 5.9%, 9.8%, 5.1% at turn, 4.9%	Correct or repair cross slope along AR to max 2.08%.	2015 ABAAS Section: 403.3 2012 TAS Section: 403.3 2010 ADAS Section: 403.3

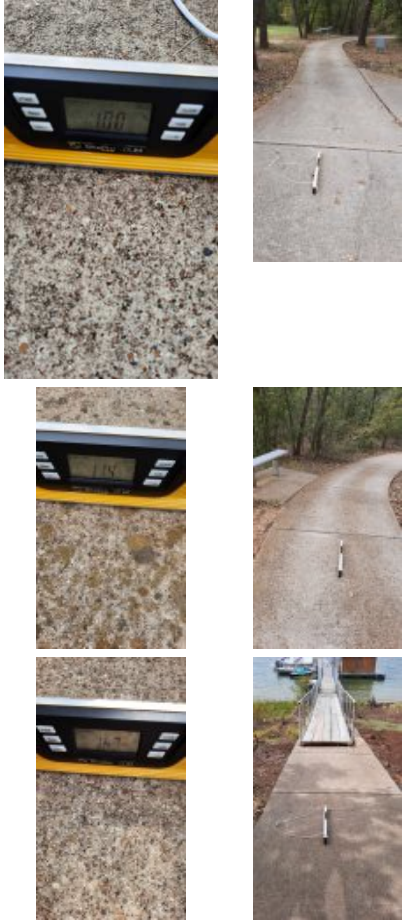
Finding Number	Area Description	Lat/Long	Finding	As Built	Recommendation	Citation	Photos	Figure
570	Jordan Park: Jordan - Marina	[33.4051892 , -97.000851 7]	The running slope of walking surfaces shall not be steeper than 1:20.	Route to marina from blg 2 - majority of route to pier excess slopes: 8.33%, very steep, 8.7%, 10.5%, 10%, 11.4% running, bottom to pier is 16.7%	Correct running slope along the AR to max 5%	2015 ABAAS Section: 403.3 2012 TAS Section: 403.3 2010 ADAS Section: 403.3

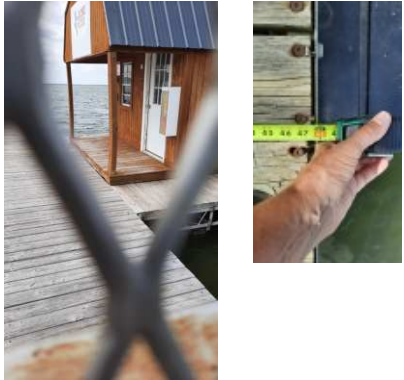
Finding Number	Area Description	Lat/Long	Finding	As Built	Recommendation	Citation	Photos	Figure
571	Jordan Park: Jordan - Marina	[33.4047302 , -97.001687 2]	The boat slip/pier is not wide enough. Boat slips and boarding piers shall provide clear pier space 60 inches wide minimum and at least as long as the boat slips/boarding pier. Each 10 feet maximum of linear pier edge serving boat slips and boarding piers shall contain at least one continuous clear opening 60 inches wide minimum. The clear width shall be permitted to be reduced to 36 inches minimum for a length of 24 inches maximum provided that reduced width segments are separated by segments that are 60 inches long minimum and 60 inches wide minimum.	Step entry to concessions bldg, knob at door, piers only 48" wide	Provide 60" wide clearance at accessible slips and a 60" wide opening every 10'. Provide lever compliant hardware and compliant ramp to entry.	2015 ABAAS Section: 1003.3.1 2012 TAS Section: 1003.3.1 2010 ADAS Section: 1003.3.1

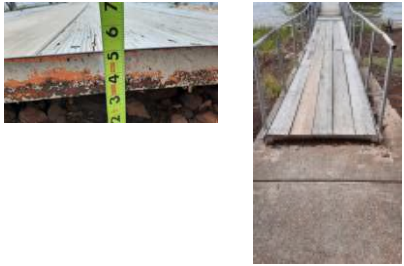
572	Jordan Park: Jordan - Marina	[33.4047861 , -97.001463 3]	The walkway contains abrupt vertical edges and/or variations over a 1/4 inch. 1/4 inch is the maximum vertical rise. Changes in level between 1/4 inch and 1/2 inch must be beveled at 1:2 or less. Changes in level greater than 1/2 inch must be by way of a ramp.	5" CIL at pier entry, multiple CIL along pier	Ramp entry to the pier and correct changes in level along the pier to max .25".	2012 TAS Section: 303.2, 303.3 2010 ADAS Section: 303.2, 303.3

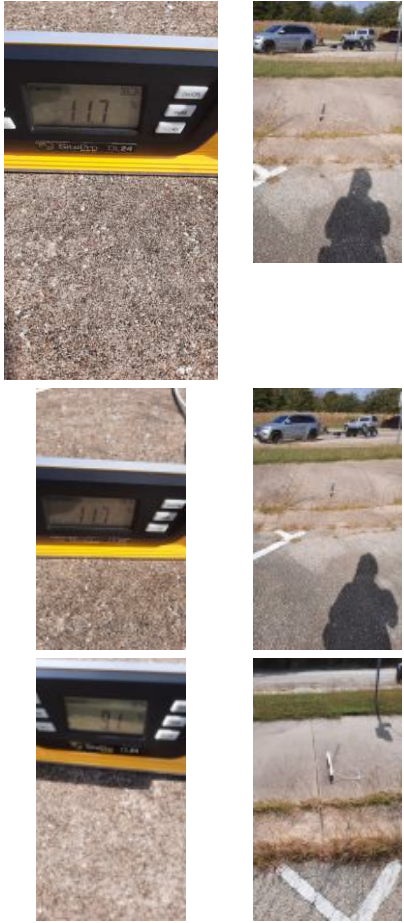
Finding Number	Area Description	Lat/Long	Finding	As Built	Recommendation	Citation	Photos	Figure
581	Jordan Park: Jordan - Boat Ramp	[33.4010176 , -97.005226 4]	The curb ramp slope exceeds the maximum running slope (Parallel to the direction of travel) allowable of 8.33%. Curb ramps should have the least possible slope but in no case more than 8.3% (1:12).	1st ramp 9.6%, 2nd ramp 11.7%, 4th ramp 9.1%	Correct curb ramp running slope to max 8.33%	2015 ABAAS Section: 406.1 2012 TAS Section: 406.1 2010 ADAS Section: 406.1

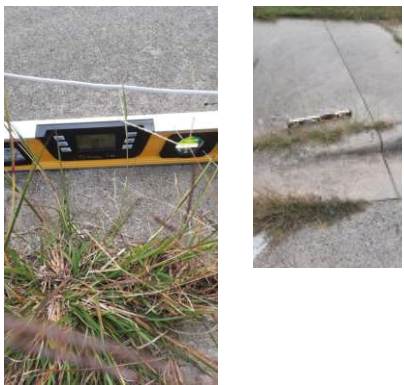
583	Jordan Park: Jordan - Boat Ramp	[33.4010781 , -97.005269 3]	The curb ramp side flares are too steep. The sides of curb ramps (curb ramp flares) where provided, shall not be steeper than 1:10.	Slopes: ramp 1 - left flare 12.6%, right 12.8%; ramp 2 - left 15.7%, right 16.4%; 3rd ramp - left 11.6%, right 18.7%; 4th ramp - left 14.6%, right 18.7%	Correct slope of curb ramp side flares to max 10%.	2015 ABAAS Section: 406.3 2012 TAS Section: 406.1, 406.3 2010 ADAS Section: 406.1, 406.3

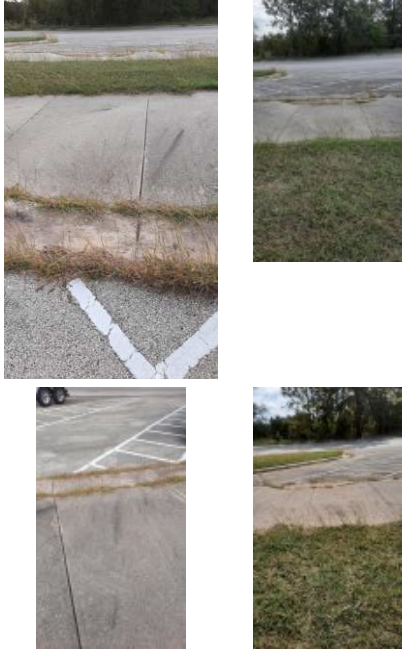
Finding Number	Area Description	Lat/Long	Finding	As Built	Recommendation	Citation	Photos	Figure
584	Jordan Park: Jordan - Boat Ramp	[33.4010288 , -97.005213]	Detectable warning surfaces complying with R305 shall be provided at the following locations on pedestrian access routes and at transit stops: Curb ramps and blended transitions at pedestrian street crossings; Pedestrian refuge islands; Pedestrian at-grade rail crossings not located within a street or highway; Boarding platforms at transit stops for buses and rail vehicles where the edges of the boarding platform are not protected by screens or guards; and Boarding and alighting areas at sidewalk or street level transit stops for rail vehicles where the side of the boarding and alighting areas facing the rail vehicles is not protected by screens or guards. Detectable warning surfaces are not required at pedestrian refuge islands that are cut-through at street level and are less than 1.8 meters (6.0 ft) in length in the direction of pedestrian travel.	All ramps have plant overgrowth and no detectable warning	Install required detectable warnings at curb ramps along the public right of way or at curb ramps within a site as a smart practice. Maintain ramps to be free of plant overgrowth.	2012 TAS Section: 705.1 2010 ADAS Section: 705

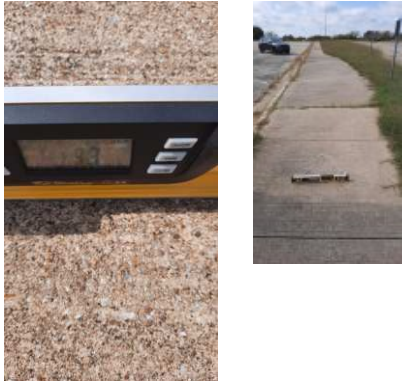
585	Jordan Park: Jordan - Boat Ramp	[33.42978, -97.05647]	Element meets all standards and requirements	Kiosk, sign and pay station comply	None	2010 ADAS Section: N/A		
586	Jordan Park: Jordan - Boat Ramp	[33.4010053 , -97.0052358]	The accessible route of travel contains cross slopes greater than 2%. Cross slopes shall not exceed one unit vertical in 48 units horizontal (2-percent slope).	3.3% cross slope from kiosk side stalls	Correct or repair cross slope along AR to max 2.08%.	2015 ABAAS Section: 403.3 2012 TAS Section: 403.3 2010 ADAS Section: 403.3

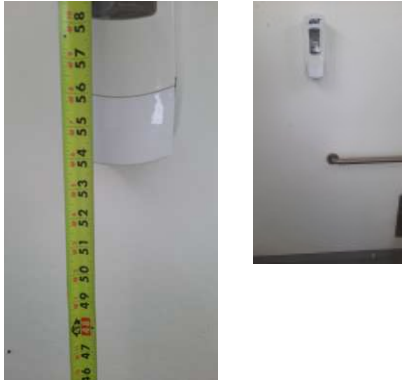
Finding Number	Area Description	Lat/Long	Finding	As Built	Recommendation	Citation	Photos	Figure
587	Jordan Park: Jordan - Boat Ramp	[33.42978, -97.05647]	Element meets all standards and requirements	Restroom door complies	None	2010 ADAS Section: N/A		
588	Jordan Park: Jordan - Boat Ramp	[33.40119, -97.0051245]	Where a high forward reach is over an obstruction, the clear floor space shall extend beneath the element for a distance not less than the required reach depth over the obstruction. The high forward reach shall be 48 inches (1220 mm) maximum where the reach depth is 20 inches (510 mm) maximum. Where the reach depth exceeds 20 inches (510 mm), the high forward reach shall be 44 inches (1120 mm) maximum and the reach depth shall be 25 inches (635 mm) maximum. Where a clear floor or ground space allows a parallel approach to an element and the high side reach is over an obstruction, the height of the obstruction shall be 34 inches (865 mm) maximum and the depth of the obstruction shall be 24 inches (610 mm) maximum. The high side reach shall be 48 inches (1220 mm) maximum for a reach depth of 10 inches (255 mm) maximum. Where the reach depth exceeds 10 inches (255 mm), the high side reach shall be 46 inches (1170 mm) maximum for a reach depth of 24 inches (610 mm) maximum.	Hand sanitizer at 54" aff	Lower soap dispenser in restroom to max 48" aff to highest operable part	2015 ABAAS Section: 308.2.1, 308.3.2 2012 TAS Section: 308.2.1, 308.3.2 2010 ADAS Section: 308.2.1, 308.3.2

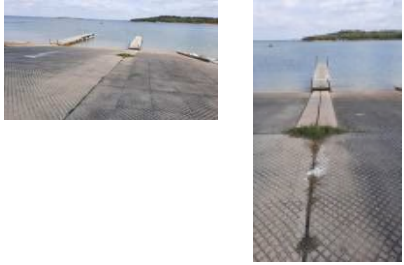
Finding Number	Area Description	Lat/Long	Finding	As Built	Recommendation	Citation	Photos	Figure
590	Jordan Park: Jordan - Boat Ramp	[33.4016692 , -97.0047624]	The minimum number of boarding piers are not accessible. Where boarding piers are provided at boat launch ramps, at least 5 percent, but no fewer than one, of the boarding piers be accessible.	Both boat piers have significant CIL	Provide 5%, but not less than one accessible boarding pier at boat launches. Ramp change in level at entry to one.	2015 ABAAS Section: F235.3 2010 ADAS Section: 235.3

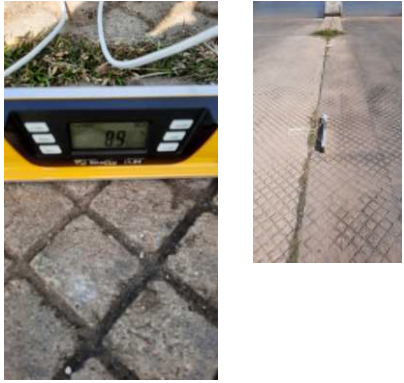
591	Jordan Park: Jordan - Boat Ramp	[33.401611 , -97.0047838]	There is no accessible route to/on the boating facility. Accessible routes serving recreational boating facilities, including gangways and floating piers, shall comply with accessible route requirements except as modified by section Recreational Boating Facilities - Accessible Routes.	8.9% slope to pier	Correct slope of route to pier to max 5% running, or correct to 8.33% and add handrails for a compliant ramp.	2015 ABAAS Section: 1003.2 2010 ADAS Section: 1003.2

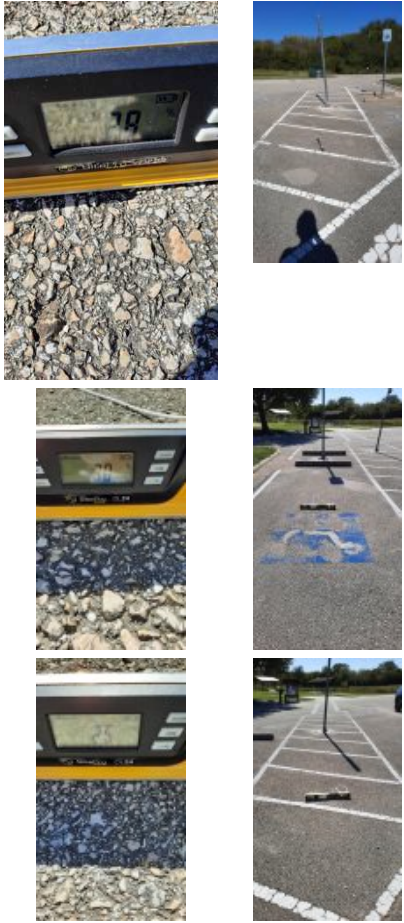
Finding Number	Area Description	Lat/Long	Finding	As Built	Recommendation	Citation	Photos	Figure
595	Elm Fork Area - Greenbelt 455 Access: Elm Fork - Equestrian Parking	[33.3512212 , -97.035051 2]	The cross slopes (narrow dimension) and/or running slopes (long dimension) of the access aisle exceeds 2%. The running slope and the cross slope in an accessible parking stall and the access aisle must not exceed 2%.	Slopes: access aisle 2.8%, left stall trail side 3%, 2.6% access aisle trail side	Repair or correct slope of parking space and access aisle to max 2.08% in any direction	2015 ABAAS Section: 502.4 2012 TAS Section: 502.4 2010 ADAS Section: 502.4

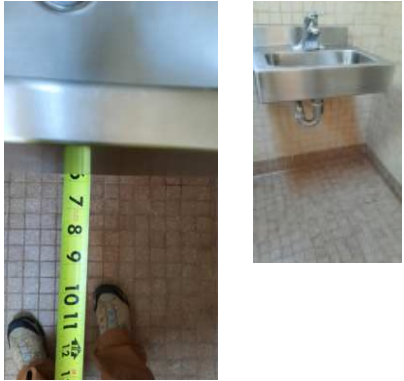
Finding Number	Area Description	Lat/Long	Finding	As Built	Recommendation	Citation	Photos	Figure
606	Elm Fork Area - Greenbelt 455 Access: Elm Fork - Women's Restroom Equestrian	[33.3510129, -97.0349587]	Knee clearance at 27 inches off the floor is not 8 inches minimum deep. The knee clearance, measured from the bottom of the apron or the outside bottom edge of the lavatory, must be 27 inches at a point located 8 inches back from the front edge and continuing to 11 inches minimum in depth at 9 inches above the floor. The top of the lavatory rim may be no higher than 34 inches.	Pipe prevents 8" deep knee clearance	Replace sink with one providing 27" knee clearance that is a min 8" deep.	2015 ABAAS Section: 306.3.1, 306.3.2, 306.3.3, 306.3.4, 306.3.5 2012 TAS Section: 306.3.2, 306.3.3, 306.3.4, 306.3.5, 306.3.1 2010 ADAS Section: 306.3.3, 306.3.2, 306.3.4, 306.3.5, 306.3.1

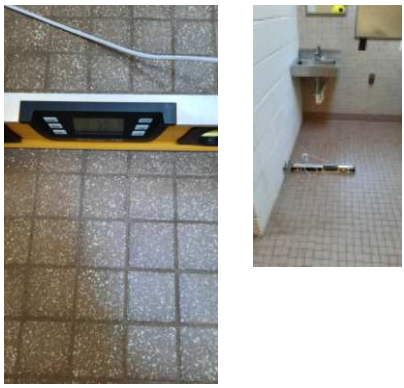
Finding Number	Area Description	Lat/Long	Finding	As Built	Recommendation	Citation	Photos	Figure
614	Elm Fork Area - Greenbelt 455 Access: Elm Fork - Women's Restroom Equestrian	[33.3510218 , -97.034969 4]	The accessible route contains running slopes greater than 5 percent and cross slopes greater than 2 percent across the width of the walk and has not been constructed as a ramp (i.e. handrails, wheel guides, etc.). When the slope in the direction of travel of any walk exceeds 1 unit vertical in 20 units horizontal (5-percent slope), it must be constructed as ramp. Surface cross slopes must not exceed one unit vertical in 48 units. Horizontal (2-percent slope).	3% slope to drain	Correct or repair slope to max 2.08%.	2015 ABAAS Section: 403.3 2012 TAS Section: 403.3 2010 ADAS Section: 403.3

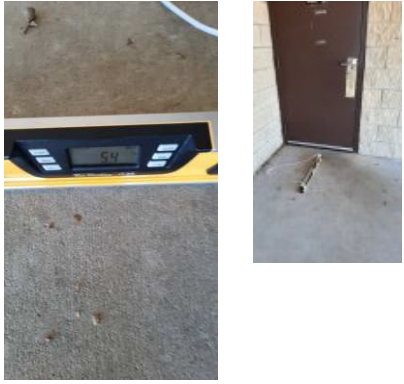
615	Elm Fork Area - Greenbelt 455 Access: Elm Fork - Women's Restroom Equestrian	[33.3510174 , -97.034985 5]	Floor or ground surface within required maneuvering clearances shall comply with 302. Changes in level are not permitted. Floor and ground surfaces shall be stable, firm, and slip resistant Carpet or carpet tile shall be securely attached and shall have a firm cushion, pad, or backing or no cushion or pad. Carpet or carpet tile shall have a level loop, textured loop, level cut pile, or level cut/uncut pile texture. Pile height shall be 1/2 inch (13 mm) maximum. Exposed edges of carpet shall be fastened to floor surfaces and shall have trim on the entire length of the exposed edge. Openings in floor or ground surfaces shall not allow passage of a sphere more than 1/2 inch (13 mm) diameter except as allowed in 407.4.3, 409.4.3, 410.4, 810.5.3 and 810.10. Elongated openings shall be placed so that the long dimension is perpendicular to the dominant direction of travel.	Entry - 5.4% slope on exterior	For all doors along the public circulation route, repair slope in door maneuvering clearances to max. 2%	2015 ABAAS Section: 302.1, 302.2, 302.3, 302.1 EXCEPTION S: 1, 404.2.4.4, 404.2.4.4 EXCEPTIONS: 1, 404.2.4.4 EXCEPTIONS: 2 2012 TAS Section: 302.1, 302.1 Exception 1, 302.3, 404.2.4.4, 404.2.4.4 Exception 1, 404.2.4.4 Exception 2, 302.2 2010 ADAS Section: 302.3, 302.1, 302.2, 404.2.4.4

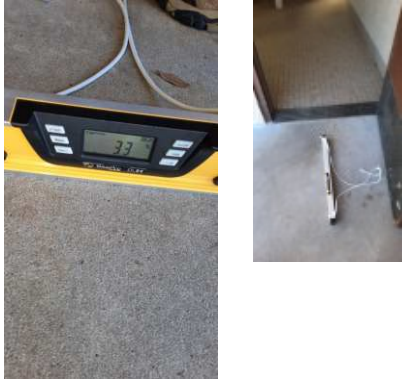
Finding Number	Area Description	Lat/Long	Finding	As Built	Recommendation	Citation	Photos	Figure
616	Elm Fork Area - Greenbelt 455 Access: Elm Fork - Men's Restroom Equestrian	[33.3510263 , -97.034964]	Floor or ground surface within required maneuvering clearances shall comply with 302. Changes in level are not permitted. Floor and ground surfaces shall be stable, firm, and slip resistant Carpet or carpet tile shall be securely attached and shall have a firm cushion, pad, or backing or no cushion or pad. Carpet or carpet tile shall have a level loop, textured loop, level cut pile, or level cut/uncut pile texture. Pile height shall be ½ inch (13 mm) maximum. Exposed edges of carpet shall be fastened to floor surfaces and shall have trim on the entire length of the exposed edge. Openings in floor or ground surfaces shall not allow passage of a sphere more than ½ inch (13 mm) diameter except as allowed in 407.4.3, 409.4.3, 410.4, 810.5.3 and 810.10. Elongated openings shall be placed so that the long dimension is perpendicular to the dominant direction of travel.	Entry - 3.3% slope on exterior	For all doors along the public circulation route, repair slope in door maneuvering clearances to max. 2%	<p>2015 ABAAS Section: 302.1, 302.2, 302.3, 302.1 EXCEPTION S: 1, 404.2.4.4, 404.2.4.4 EX CEPTIONS: 1, 404.2.4.4 E XCEPTIONS: 2</p> <p>2012 TAS Section: 302.1, 302.1 Exception 1, 302.3, 404.2.4.4, 404.2.4.4 Exception 1, 404.2.4.4 Exception 2, 302.2</p> <p>2010 ADAS Section: 302.3, 302.1, 302.2, 404.2.4.4</p>

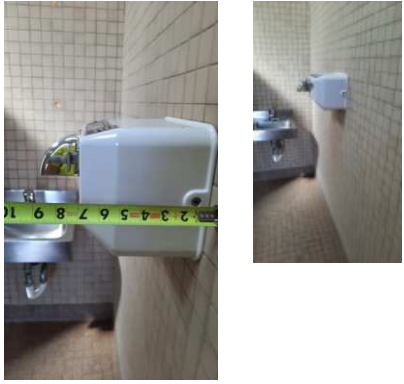
626	Elm Fork Area - Greenbelt 455 Access: Elm Fork - Men's Restroom Equestrian	[33.3510039 , -97.034985 5]	The hand dryer projects more than 4 inches into the circulation path. Wall-mounted objects that have leading edges between 27 inches and 80 inches from the floor must not project more than 4 inches into the circulation path. Protruding objects that extend to the floor or within 27 inches of the floor are cane detectable and are therefore not hazardous. Where it is necessary or desirable to have objects protrude from the wall, a manner of cane detection must be provided.	Hand dryer protrudes	Relocate protruding objects or place cane detectable warning or bollard at foot of item	2015 ABAAS Section: 307.2 2012 TAS Section: 307.2 2010 ADAS Section: 307.2

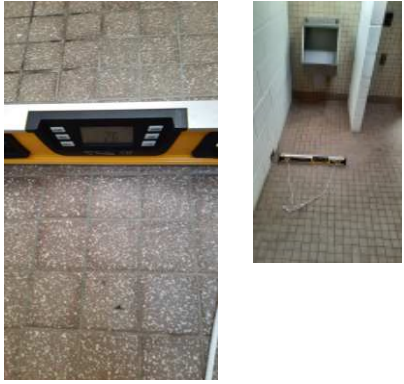
Finding Number	Area Description	Lat/Long	Finding	As Built	Recommendation	Citation	Photos	Figure
627	Elm Fork Area - Greenbelt 455 Access: Elm Fork - Men's Restroom Equestrian	[33.3510129 , -97.034926 5]	The accessible route contains running slopes greater than 5 percent and cross slopes greater than 2 percent across the width of the walk and has not been constructed as a ramp (i.e. handrails, wheel guides, etc.). When the slope in the direction of travel of any walk exceeds 1 unit vertical in 20 units horizontal (5-percent slope), it must be constructed as ramp. Surface cross slopes must not exceed one unit vertical in 48 units. Horizontal (2-percent slope).	2.6% slope at drain	Correct or repair slope to max 5% running and 2.08% cross	2015 ABAAS Section: 403.3 2012 TAS Section: 403.3 2010 ADAS Section: 403.3

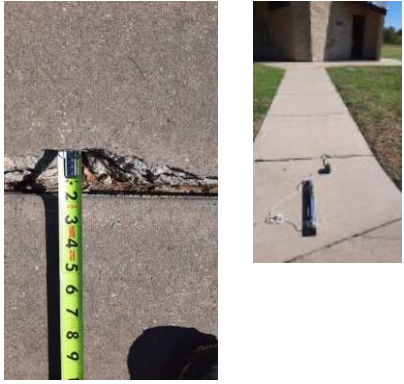
628	Elm Fork Area - Greenbelt 455 Access: Elm Fork - Men's Restroom Equestrian	[33.3510174 , -97.034990 9]	There is a gap spaced greater than a 1/2 inch. Openings in floor or ground surfaces shall not allow passage of a sphere more than 1/2 inch diameter. Elongated openings shall be placed so that the long dimension is perpendicular to the dominant direction of travel.	2" gap on route to Men's Restroom	Correct or fill gaps to be max .5"	2015 ABAAS Section: 302.3 2012 TAS Section: 302.3 2010 ADAS Section: 302.3

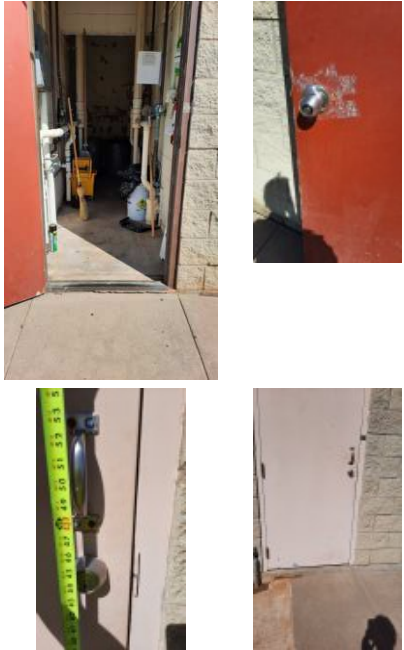
Finding Number	Area Description	Lat/Long	Finding	As Built	Recommendation	Citation	Photos	Figure
629	Elm Fork Area - Greenbelt 455 Access: Elm Fork - Men's Restroom Equestrian	[33.3510129 , -97.034969 4]	Spaces and elements within employee work areas shall only be required to comply with 206.2.8, 207.1, and 215.3 and shall be designed and constructed so that individuals with disabilities can approach, enter, and exit the employee work area. Employee work areas, or portions of employee work areas, other than raised courtroom stations, that are less than 300 square feet (28 m2) and elevated 7 inches (180 mm) or more above the finish floor or ground where the elevation is essential to the function of the space shall not be required to comply with these requirements or to be on an accessible route.	Pipe chase - narrow space, knob hardware, Equestrian area - CIL, hardware too high	For employee spaces, relocate storage, furniture, and other obstacles at doorways to provide approach, enter and exit at the employee space. Provide required maneuvering clearance on push and pull side of doors. Repair, bevel, or ramp CILs at door entries to max .25". Replace hardware with lever hardware or hardware operable without a tight pinch or grasp.	2015 ABAAS Section: F203.9 2012 TAS Section: 203.9 2010 ADAS Section: 203.9

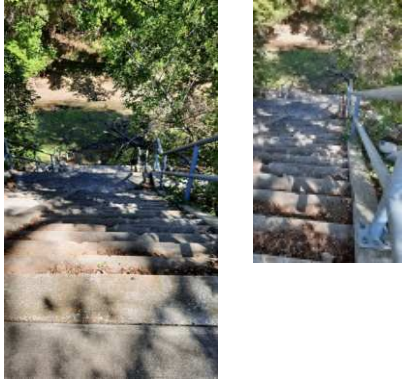
630	Elm Fork Area - Greenbelt 455 Access: Elm Fork - Canoe Launch	[33.3502713 , -97.035076 7]	There is no accessible route to the canoe launch. At least one accessible route shall connect accessible buildings, accessible facilities, accessible elements, and accessible spaces that are on the same site.	Steep staircase to water at canoe launch	Create an accessible route with crushed stone or other outdoor material from parking or walkway to canoe launch. In the alternative, leave as is and create an accessible canoe launch elsewhere.	2015 ABAAS Section: F206.2.2 2012 TAS Section: 206.2.2 2010 ADAS Section: 206.2.2

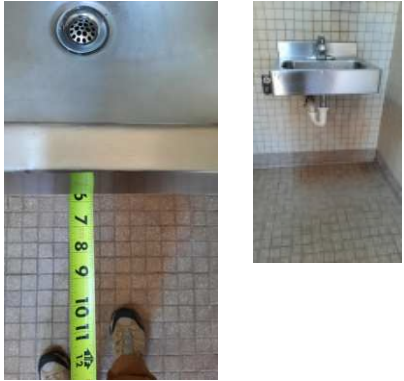
Finding Number	Area Description	Lat/Long	Finding	As Built	Recommendation	Citation	Photos	Figure
633	Elm Fork Area - Greenbelt 455 Access: Elm Fork - Men's Restroom	[33.3524871 , -97.047591 9]	Knee clearance at 27 inches off the floor is not 8 inches minimum deep. The knee clearance, measured from the bottom of the apron or the outside bottom edge of the lavatory, must be 27 inches at a point located 8 inches back from the front edge and continuing to 11 inches minimum in depth at 9 inches above the floor. The top of the lavatory rim may be no higher than 34 inches.	Pipe prevents 8" deep knee clearance	Replace sink with one providing 27" knee clearance that is a min 8" deep	2015 ABAAS Section: 306.3.1, 306.3.2, 306.3.3, 306.3.4 , 306.3.5 2012 TAS Section: 306.3.2, 306.3.3, 306.3.4, 306.3.5, 306.3.1 2010 ADAS Section: 306.3.3, 306.3.2, 306.3.4, 306.3.5, 306.3.1

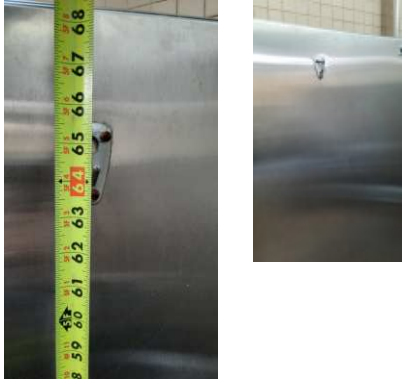
Finding Number	Area Description	Lat/Long	Finding	As Built	Recommendation	Citation	Photos	Figure
635	Elm Fork Area - Greenbelt 455 Access: Elm Fork - Men's Restroom	[33.3524737 , -97.047570 4]	The operable part is positioned too high for either a side or front approach. Where a clear floor or ground space allows a parallel approach to an element and the side reach is unobstructed, the high side reach shall be 48 inches maximum and the low side reach shall be 15 inches minimum above the finish floor or ground. Where a forward reach is unobstructed, the high forward reach shall be 48 inches maximum and the low forward reach shall be 15 inches minimum above the finish floor or ground.	Hook in stall at 64.5"	Remount hook in stall to max 48" AFF.	2015 ABAAS Section: 308.1 2012 TAS Section: 308.1 2010 ADAS Section: 308.1

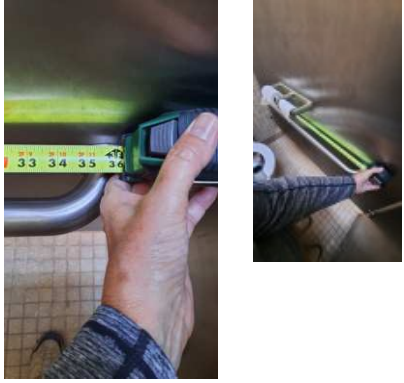
637	Elm Fork Area - Greenbelt 455 Access: Elm Fork - Men's Restroom	[33.3525095 , -97.047608]	The side grab bars are not in the correct location. Grab bars on the side wall must be installed so that the end closest to the rear wall is maximum 12" from the rear wall. The end furthest from the rear wall must be mounted minimum 54" from the rear wall.	Side grab bar 36" long	Replace side grab bar with 42" long bar. Install to max 12" from the rear wall at the close end and min 54" on the far end, and 33" to 36" AFF.	2015 ABAAS Section: 604.5.1 2012 TAS Section: 604.5.1 2010 ADAS Section: 604.5.1

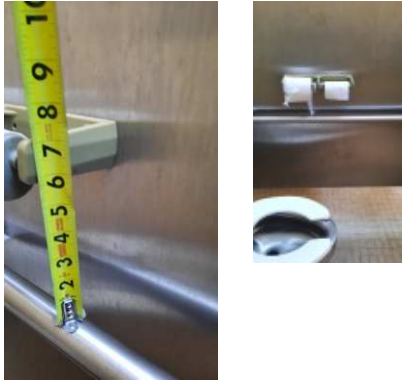
639	Elm Fork Area - Greenbelt 455 Access: Elm Fork - Men's Restroom	[33.3524826 , -97.047575 8]	The grab bar height and/or spacing fails. Grab bars must be mounted between 33" and 36" to the top of the gripping surface. There must be 1.5" of clearance between the grab bar and the wall. There must be a minimum of 1.5" of clearance below and minimum 12" above the grab bar to any dispenser or other obstruction.	TP too close above grab bar and too close to toilet	Remount toilet paper dispenser max 7" to 9" from front of toilet, 15" to 48" aff and min 12" above or 1.5" below grab bar	2015 ABAAS Section: 609.3, 609.4 2012 TAS Section: 609.4, 609.3 2010 ADAS Section: 609.3, 609.4

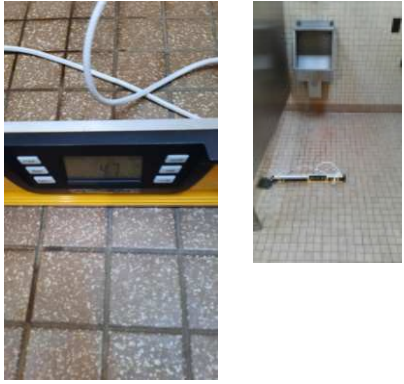
Finding Number	Area Description	Lat/Long	Finding	As Built	Recommendation	Citation	Photos	Figure
642	Elm Fork Area - Greenbelt 455 Access: Elm Fork - Men's Restroom	[33.3524871, -97.0475812]	The accessible route contains running slopes greater than 5 percent and cross slopes greater than 2 percent across the width of the walk and has not been constructed as a ramp (i.e. handrails, wheel guides, etc.). When the slope in the direction of travel of any walk exceeds 1 unit vertical in 20 units horizontal (5-percent slope), it must be constructed as ramp. Surface cross slopes must not exceed one unit vertical in 48 units. Horizontal (2-percent slope).	4.7% slope at drain	Correct or repair slope to max 2.08%.	2015 ABAAS Section: 403.3 2012 TAS Section: 403.3 2010 ADAS Section: 403.3

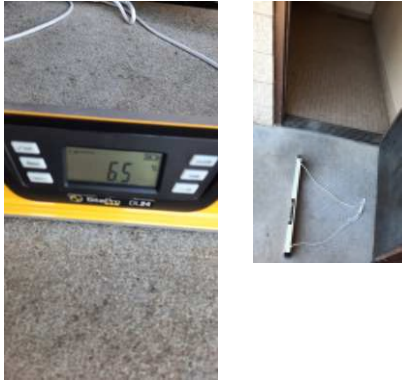
643	Elm Fork Area - Greenbelt 455 Access: Elm Fork - Men's Restroom	[33.3524737, -97.0475758]	Floor or ground surface within required maneuvering clearances shall comply with 302. Changes in level are not permitted. Floor and ground surfaces shall be stable, firm, and slip resistant Carpet or carpet tile shall be securely attached and shall have a firm cushion, pad, or backing or no cushion or pad. Carpet or carpet tile shall have a level loop, textured loop, level cut pile, or level cut/uncut pile texture. Pile height shall be 1/2 inch (13 mm) maximum. Exposed edges of carpet shall be fastened to floor surfaces and shall have trim on the entire length of the exposed edge. Openings in floor or ground surfaces shall not allow passage of a sphere more than 1/2 inch (13 mm) diameter except as allowed in 407.4.3, 409.4.3, 410.4, 810.5.3 and 810.10. Elongated openings shall be placed so that the long dimension is perpendicular to the dominant direction of travel.	Entry - 6.5% slope on exterior	For all doors along the public circulation route, repair slope in door maneuvering clearances to max 2%.	2015 ABAAS Section: 302.1, 302.2, 302.3, 302.1 EXCEPTION S: 1, 404.2.4.4, 404.2.4.4 EXCEPTIONS: 1, 404.2.4.4 EXCEPTIONS: 2 2012 TAS Section: 302.1, 302.1 Exception 1, 302.3, 404.2.4.4, 404.2.4.4 Exception 1, 404.2.4.4 Exception 2, 302.2 2010 ADAS Section: 302.3, 302.1, 302.2, 404.2.4.4

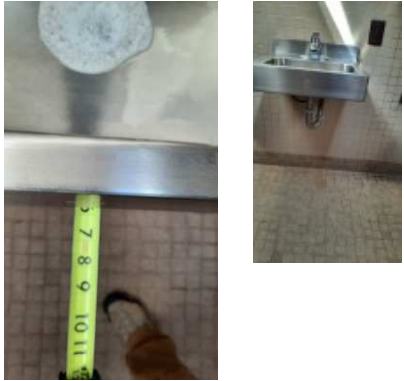
Finding Number	Area Description	Lat/Long	Finding	As Built	Recommendation	Citation	Photos	Figure
646	Elm Fork Area - Greenbelt 455 Access: Elm Fork - Women's Restroom	[33.3524916 , -97.047586 5]	Knee clearance at 27 inches off the floor is not 8 inches minimum deep. The knee clearance, measured from the bottom of the apron or the outside bottom edge of the lavatory, must be 27 inches at a point located 8 inches back from the front edge and continuing to 11 inches minimum in depth at 9 inches above the floor. The top of the lavatory rim may be no higher than 34 inches.	Pipes prevent 8" depth knee clearance	Replace sink with one providing 27" knee clearance that is a min 8" deep	2015 ABAAS Section: 306.3.1, 306.3.2, 306.3.3, 306.3.4 , 306.3.5 2012 TAS Section: 306.3.2, 306.3.3, 306.3.4, 306.3.5, 306.3.1 2010 ADAS Section: 306.3.3, 306.3.2, 306.3.4, 306.3.5, 306.3.1

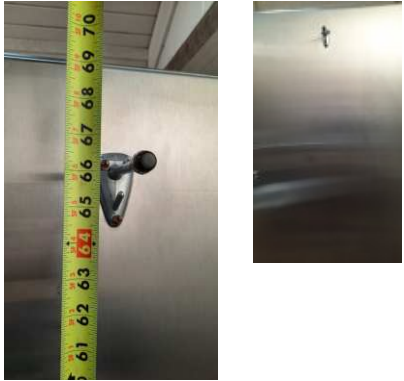
Finding Number	Area Description	Lat/Long	Finding	As Built	Recommendation	Citation	Photos	Figure
648	Elm Fork Area - Greenbelt 455 Access: Elm Fork - Women's Restroom	[33.3525006 , -97.047565 1]	The operable part is positioned too high for either a side or front approach. Where a clear floor or ground space allows a parallel approach to an element and the side reach is unobstructed, the high side reach shall be 48 inches maximum and the low side reach shall be 15 inches minimum above the finish floor or ground. Where a forward reach is unobstructed, the high forward reach shall be 48 inches maximum and the low forward reach shall be 15 inches minimum above the finish floor or ground.	Hook in stall at 65.5"	Remount hook in stall to max 48" AFF.	2015 ABAAS Section: 308.1 2012 TAS Section: 308.1 2010 ADAS Section: 308.1

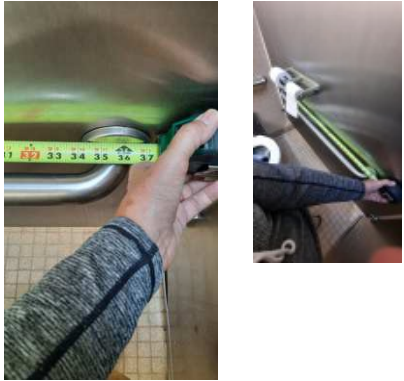
650	Elm Fork Area - Greenbelt 455 Access: Elm Fork - Women's Restroom	[33.3524826 , -97.047602 6]	The side grab bars are not in the correct location. Grab bars on the side wall must be installed so that the end closest to the rear wall is maximum 12" from the rear wall. The end furthest from the rear wall must be mounted minimum 54" from the rear wall.	Side bar only 36" long	Replace side grab bar with 42" long bar. Install to max 12" from the rear wall at the close end and min 54" on the far end, and 33" to 36" aff	2015 ABAAS Section: 604.5.1 2012 TAS Section: 604.5.1 2010 ADAS Section: 604.5.1

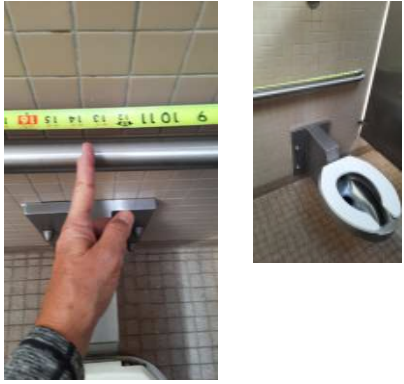
Finding Number	Area Description	Lat/Long	Finding	As Built	Recommendation	Citation	Photos	Figure
651	Elm Fork Area - Greenbelt 455 Access: Elm Fork - Women's Restroom	[33.3524737 , -97.047591 9]	The rear grab bar is not 36" long or is not mounted in the correct location. The rear grab bar must be a minimum of 36" long and extend from the toilet centerline a minimum 12" towards the wall side and a minimum 24" towards the open side of the toilet. Grab bars shall be installed in a horizontal position, 33 inches minimum and 36 inches maximum above the finish floor measured to the top of the gripping surface and the space between the grab bar and the top of the tank shall be 1-1/2 inches minimum.	Rear bar 13.75" to toilet center line	Remount rear grab bar to behind the toilet, 12" to one side of center and 24" to the other and 33" to 36" aff	2015 ABAAS Section: 604.5.2 2012 TAS Section: 604.5.2 2010 ADAS Section: 604.5.2

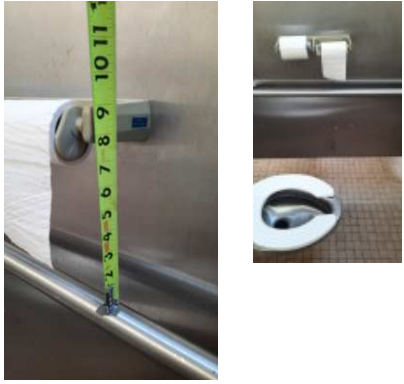
652	Elm Fork Area - Greenbelt 455 Access: Elm Fork - Women's Restroom	[33.3525095 , -97.047575 8]	The grab bar height and/or spacing fails. Grab bars must be mounted between 33" and 36" to the top of the gripping surface. There must be 1.5" of clearance between the grab bar and the wall. There must be a minimum of 1.5" of clearance below and minimum 12" above the grab bar to any dispenser or other obstruction.	TP too close above side bar and too close to toilet	Remount toilet paper dispenser max 7" to 9" from front of toilet, 15" to 48" aff and min 12" above or 1.5" below grab bar	2015 ABAAS Section: 609.3, 609.4 2012 TAS Section: 609.4, 609.3 2010 ADAS Section: 609.3, 609.4

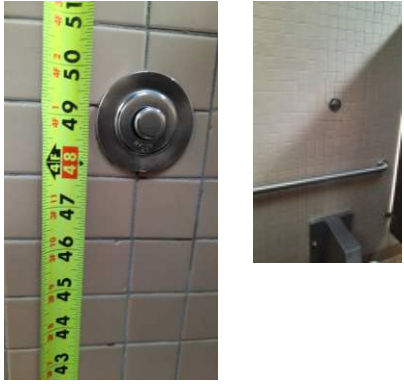
653	Elm Fork Area - Greenbelt 455 Access: Elm Fork - Women's Restroom	[33.3524871 , -97.047578 5]	The flush handle is too high. Controls shall be operable with one hand and shall not require tight grasping, pinching or twisting. Controls for the flush valves shall be mounted on the wide side of toilet areas, no more than 44 inches above the floor.	Flush 49" aff	Remount flush handle to max 44" aff centered on the toilet	2015 ABAAS Section: 604.6 2012 TAS Section: 604.6 2010 ADAS Section: 604.6

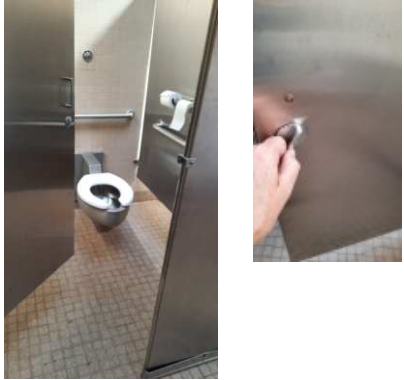
Finding Number	Area Description	Lat/Long	Finding	As Built	Recommendation	Citation	Photos	Figure
654	Elm Fork Area - Greenbelt 455 Access: Elm Fork - Women's Restroom	[33.3524894 , -97.047578 5]	The stall door fails to comply with all of the door requirements. The stall door must be a minimum of 32" wide and have compliant hardware on both sides. The stall door must be self-closing.	Stall door not self closing and pull side hardware requires a pinch	Adjust stall door to be self-closing Replace stall hardware with hardware operable without a tight pinch or grasp on both sides of the stall door	2015 ABAAS Section: 404.2.3, 404.2.7, 604.8.2.2 2012 TAS Section: 404.2.3, 404.2.7, 604.8.2.2 2010 ADAS Section: 404.2.3, 404.2.7, 604.8.2.2

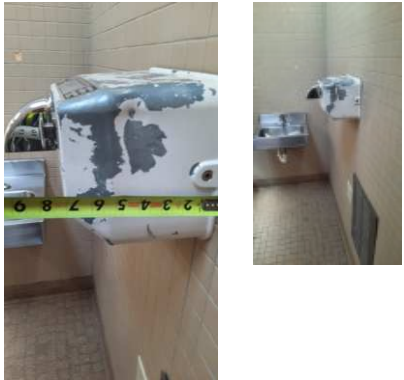
655	Elm Fork Area - Greenbelt 455 Access: Elm Fork - Women's Restroom	[33.3524647 , -97.047581 2]	The hand dryer projects more than 4 inches into the circulation path. Wall-mounted objects that have leading edges between 27 inches and 80 inches from the floor must not project more than 4 inches into the circulation path. Protruding objects that extend to the floor or within 27 inches of the floor are cane detectable and are therefore not hazardous. Where it is necessary or desirable to have objects protrude from the wall, a manner of cane detection must be provided.	Hand dryer protrudes into route	Relocate protruding objects or place cane detectable warning or bollard at foot of item	2015 ABAAS Section: 307.2 2012 TAS Section: 307.2 2010 ADAS Section: 307.2

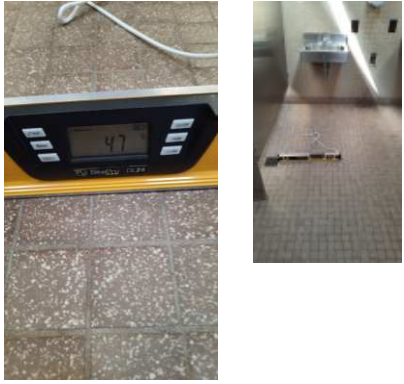
Finding Number	Area Description	Lat/Long	Finding	As Built	Recommendation	Citation	Photos	Figure
656	Elm Fork Area - Greenbelt 455 Access: Elm Fork - Women's Restroom	[33.3524894 , -97.047578 5]	The accessible route contains running slopes greater than 5 percent and cross slopes greater than 2 percent across the width of the walk and has not been constructed as a ramp (i.e. handrails, wheel guides, etc.). When the slope in the direction of travel of any walk exceeds 1 unit vertical in 20 units horizontal (5-percent slope), it must be constructed as ramp. Surface cross slopes must not exceed one unit vertical in 48 units. Horizontal (2-percent slope).	4.7% slope to drain	Correct or repair slope to max 2.08%.	2015 ABAAS Section: 403.3 2012 TAS Section: 403.3 2010 ADAS Section: 403.3

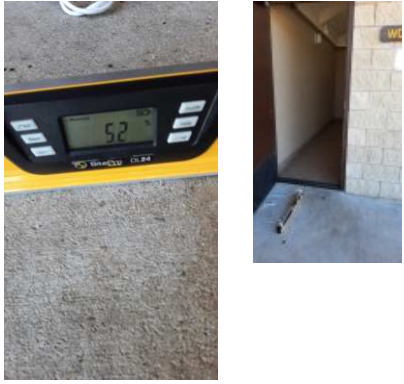
657	Elm Fork Area - Greenbelt 455 Access: Elm Fork - Women's Restroom	[33.3524916 , -97.047608]	Minimum maneuvering clearances at doors and gates shall comply with 404.2.4. Maneuvering clearances shall extend the full width of the doorway and the required latch side or hinge side clearance. Door openings shall provide a clear width of 32 inches (815 mm) minimum. Clear openings of doorways with swinging doors shall be measured between the face of the door and the stop, with the door open 90 degrees. Openings more than 24 inches (610 mm) deep shall provide a clear opening of 36 inches (915 mm) minimum. There shall be no projections into the required clear opening width lower than 34 inches (865 mm) above the finish floor or ground. Projections into the clear opening width between 34 inches (865 mm) and 80 inches (2030 mm) above the finish floor or ground shall not exceed 4 inches (100 mm). The threshold has a vertical change greater than 1/4 inch high. The threshold at a doorway shall be no higher than 1/2 inch. Changes in level between 1/4 inch and 1/2 inch must be beveled at 1:2 or less. 1/4 inch is the maximum vertical rise. All interior doors must be maintained so that the operating pressure does not exceed 5 lb. force to open. The sweep period for doors with closers shall be adjusted so that from an open position of 70 degrees, the door will	Entry - 5.2% slope on exterior, fast close	For all doors along the public circulation route, repair slope at door entries to max 2% For all doors along the public circulation route, inspect, adjust, and maintain closing speed on door closers	2010 ADAS Section: 404.2.3, 404.2.7, 404.2.4, 404.2.11, 404.2.11 Exception

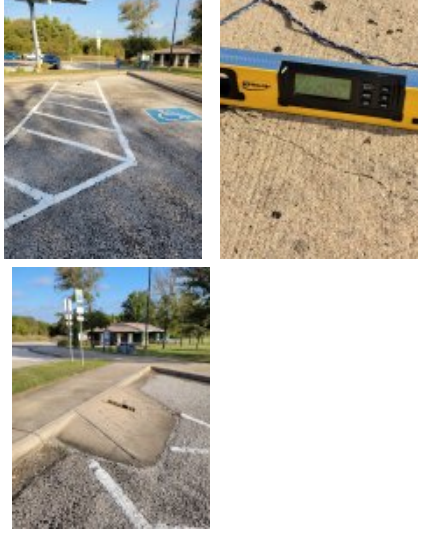
Finding Number	Area Description	Lat/Long	Finding	As Built	Recommendation	Citation	Photos	Figure
663	Johnson Branch Unit: Johnson - HQ Parking	[33.4293793 , -97.0564459]	The cross slopes (narrow dimension) and/or running slopes (long dimension) of the access aisle exceeds 2%. The running slope and the cross slope in an accessible parking stall and the access aisle must not exceed 2%.	Ramp projects into access aisle on both aisles, Slopes: 3.9% slope in aisle near HQ, 2.3% slope in space near HQ, ramp aisle slope 8.5% at far aisle	Repair or correct slope of parking space and access aisle to max 2.08% in any direction and remove built up ramps in access aisles.	2015 ABAAS Section: 502.4 2012 TAS Section: 502.4 2010 ADAS Section: 502.4

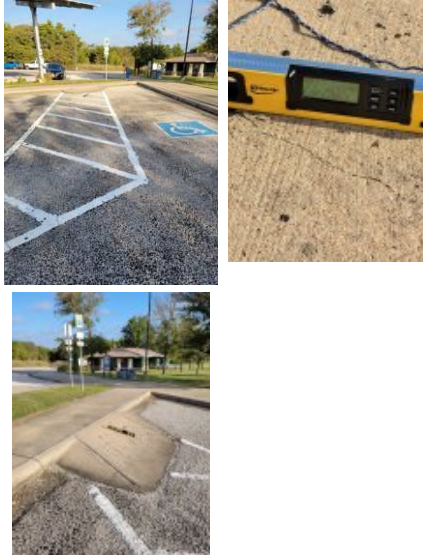
664	Johnson Branch Unit: Johnson - HQ Parking	[33.4294017 , -97.056448 5]	The access aisle is on the driver's side of the stall. Access aisles must be located on the passenger side of the stall for angled van accessible stalls.	Access aisle on driver side at far van space	Relocate access aisle to the passenger side of the stall.	2015 ABAAS Section: 502.3.4 2012 TAS Section: 502.3.4 2010 ADAS Section: 502.3.4

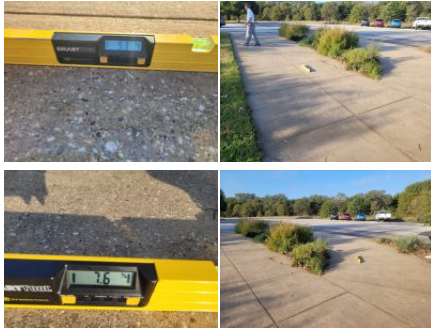
667	Johnson Branch Unit: Johnson - HQ Exterior Accessible Route	[33.4296529, -97.056569 9]	The running slope of walking surfaces shall not be steeper than 1:20.	9.3% running on direct path, 6.6% on kiosk path	Correct running slope along the AR to max 5%.	2015 ABAAS Section: 403.3 2012 TAS Section: 403.3 2010 ADAS Section: 403.3
