Access Audit Site Report

Ray Roberts Lake State Park/Complex

Accessibility Evaluation

Inspection Date: 10/18/2021

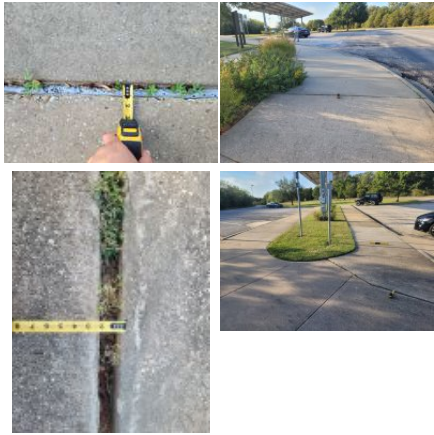
671	Johnson Branch Unit: Johnson - HQ Exterior Accessible Route	[33.4296251 , -97.056532 6]	There is a gap spaced greater than a 1/2 inch. Openings in floor or ground surfaces shall not allow passage of a sphere more than 1/2 inch diameter. Elongated openings shall be placed so that the long dimension is perpendicular to the dominant direction of travel.	1" gap on path to kiosk, two 2" gaps at parking	Correct or fill gaps to be max .5".	2015 ABAAS Section: 302.3 2012 TAS Section: 302.3 2010 ADAS Section: 302.3

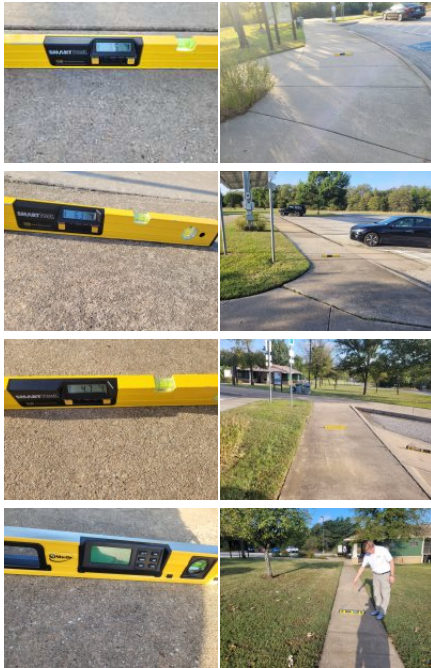
677	Johnson Branch Unit: Johnson - HQ Exterior Accessible Route	[33.4296744, -97.0565558]	The accessible route of travel contains cross slopes greater than 2%. Cross slopes shall not exceed one unit vertical in 48 units horizontal (2-percent slope).	3.5% near accessible parking, 6.3% at top landing, 4.7% at top landing, 3.6% to survey mailbox	Correct or repair cross slope along AR to max 2.08%.	2015 ABAAS Section: 403.3 2012 TAS Section: 403.3 2010 ADAS Section: 403.3

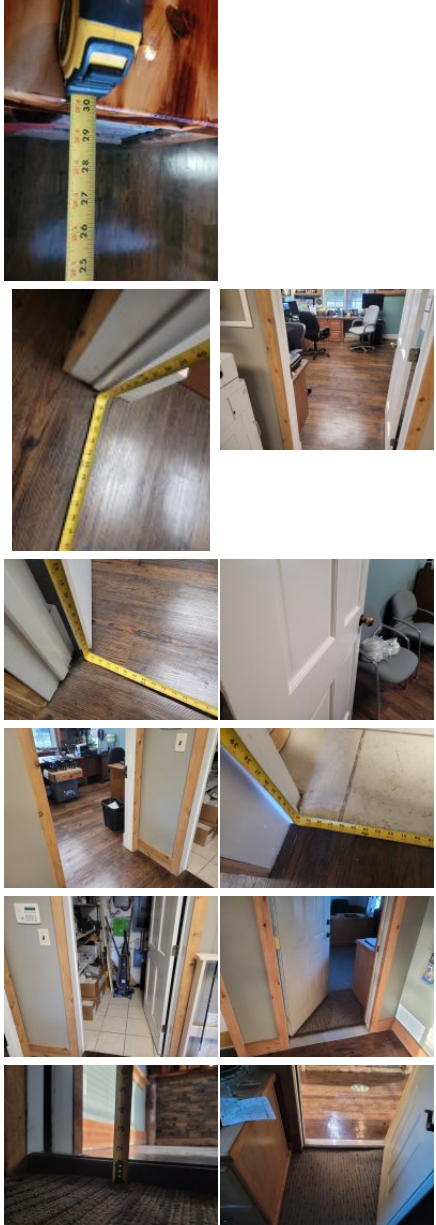
678	Johnson Branch Unit: Johnson - HQ	[33.42978, -97.05647]	Spaces and elements within employee work areas shall only be required to comply with 206.2.8, 207.1, and 215.3 and shall be designed and constructed so that individuals with disabilities can approach, enter, and exit the employee work area.	30" at reception desk; left office- 30", knob, desk pull side; right office- 30.5" wide, knob, desk and garbage can pull side;	For employee spaces, relocate storage, furniture, and other obstacles at doorways to provide approach, enter and exit at the employee space. Provide required maneuvering clearance on push and pull side of doors. Replace doors with doors	2015 ABAAS Section: F203.9 2012 TAS Section:

Finding Number	Area Description	Lat/Long	Finding	As Built	Recommendation	Citation	Photos	Figure
			Employee work areas, or portions of employee work areas, other than raised courtroom stations, that are less than 300 square feet (28 m2) and elevated 7 inches (180 mm) or more above the finish floor or ground where the elevation is essential to the function of the space shall not be required to comply with these requirements or to be on an accessible route.	supplies- 30" wide, knob, shelves pull side; front office- desk pull side, 1.5" threshold	having 80" overhead clearance and 32" clear width. Repair, bevel, or ramp CILs at door entries to max .25". Replace hardware with lever hardware or hardware operable without a tight pinch or grasp.	203.9 2010 ADAS Section: 203.9

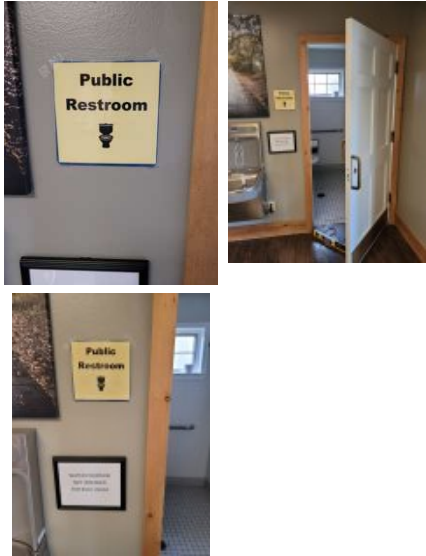
Finding Number	Area Description	Lat/Long	Finding	As Built	Recommendation	Citation	Photos	Figure
696	Johnson Branch Unit: Johnson - HQ Restrooms	[33.42978, -97.05647]	The restroom sign does not comply with one or more applicable requirements for the location, height, and properties of the sign.	Right Restroom, public - Sign is covered up, lacks symbol of access	Replace sign with one of contrasting colors that includes Braille, raised characters, and the symbol of accessibility and mount on the wall, latch side of the door, 48" to the baseline of the lowest character and 60" to the baseline of the highest character	2015 ABAAS Section: F216.2, 703.1, 703.2, 703.5, 703.6 2012 TAS Section: 216.2, 703.1, 703.2, 703.5, 703.6 2010 ADAS Section: 216.2, 703.1, 703.2, 703.5, 703.6

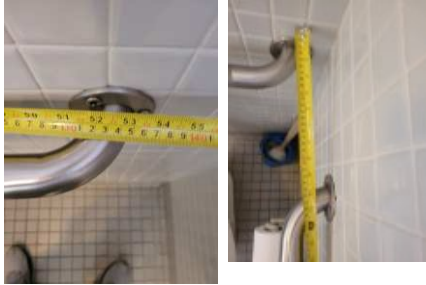
Finding Number	Area Description	Lat/Long	Finding	As Built	Recommendation	Citation	Photos	Figure
701	Johnson Branch Unit: Johnson - HQ Restrooms	[33.42978, -97.05647]	The side grab bars are not in the correct location. Grab bars on the side wall must be installed so that the end closest to the rear wall is maximum 12" from the rear wall. The end furthest from the rear wall must be mounted minimum 54" from the rear wall.	Right Restroom, public - 53" to end of grab bar	Remount side grab bar to max 12" from the rear wall at the close end and min 54" on the far end, and 33" to 36" AFF.	2015 ABAAS Section: 604.5.1 2012 TAS Section: 604.5.1 2010 ADAS Section: 604.5.1

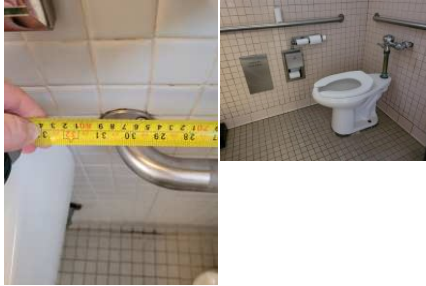
702	Johnson Branch Unit: Johnson - HQ Restrooms	[33.42978, -97.05647]	The rear grab bar is not 36" long or is not mounted in the correct location. The rear grab bar must be a minimum of 36" long and extend from the toilet centerline a minimum 12" towards the wall side and a minimum 24" towards the open side of the toilet. Grab bars shall be installed in a horizontal position, 33 inches minimum and 36 inches maximum above the finish floor measured to the top of the gripping surface and the space between the grab bar and the top of the tank shall be 1-1/2 inches minimum.	Right Restroom, public - 30" rear grab bar, centered	Leave as is rear grab bar placement due to sink. Meets exception.	2015 ABAAS Section: 604.5.2 2012 TAS Section: 604.5.2 2010 ADAS Section: 604.5.2

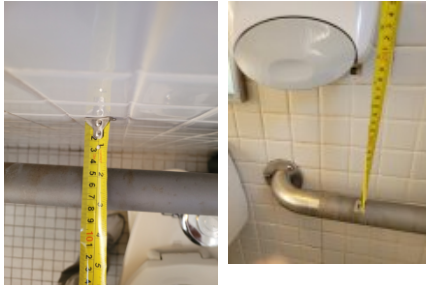
703	Johnson Branch Unit: Johnson - HQ Restrooms	[33.42978, -97.05647]	The grab bar height and/or spacing fails. Grab bars must be mounted between 33" and 36" to the top of the gripping surface. There must be 1.5" of clearance between the grab bar and the wall. There must be a minimum of 1.5" of clearance below and minimum 12" above the grab bar to any dispenser or other obstruction.	Right Restroom, public - 1.75" gap to grab bar, 8" between soap dispenser & grab bar	Remount soap dispenser to 15" to 48" aff and min 12" above or 1.5" below grab bar. Leave as is gap citing construction tolerance.	2015 ABAAS Section: 609.3, 609.4 2012 TAS Section: 609.4, 609.3 2010 ADAS Section: 609.3, 609.4

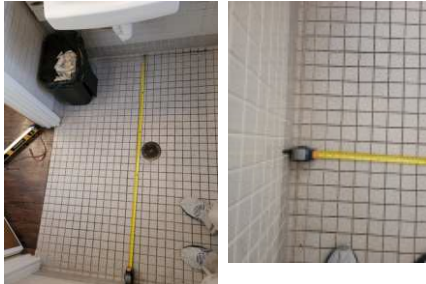
705	Johnson Branch Unit: Johnson - HQ Restrooms	[33.42978, -97.05647]	There is insufficient turning space within this room or space. The space required for a wheelchair to make a 180-degree turn is a clear space of 60 inches in diameter or a T-shaped space.	Turning space too tight and under lav	Widen restroom if feasible to provide turning space.	2015 ABAAS Section: 304.3.1, 304.3.2 2012 TAS Section: 304.3.1, 304.3.2 2010 ADAS Section: 304.3.1, 304.3.2

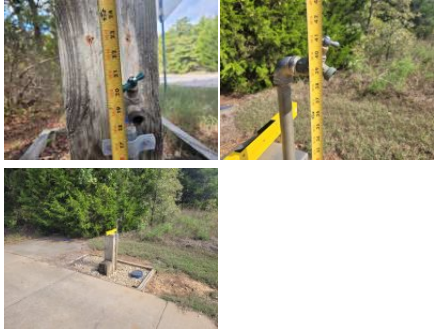
Finding Number	Area Description	Lat/Long	Finding	As Built	Recommendation	Citation	Photos	Figure
707	Johnson Branch Unit: Johnson - Trails	[33.42211, -97.05482]	Water spouts at water hydrants and water utility hook-ups shall be 28 inches (710 mm) minimum and 36 inches (915 mm) maximum above the ground	Spout at road crossing 18", lacks clear ground space (CGS); spout high at access road crossing	Remount water spouts to 28" min or 36" max above the ground and provide 30" by 48" CGS as a smart practice.	2015 ABAAS Section: 1011.6

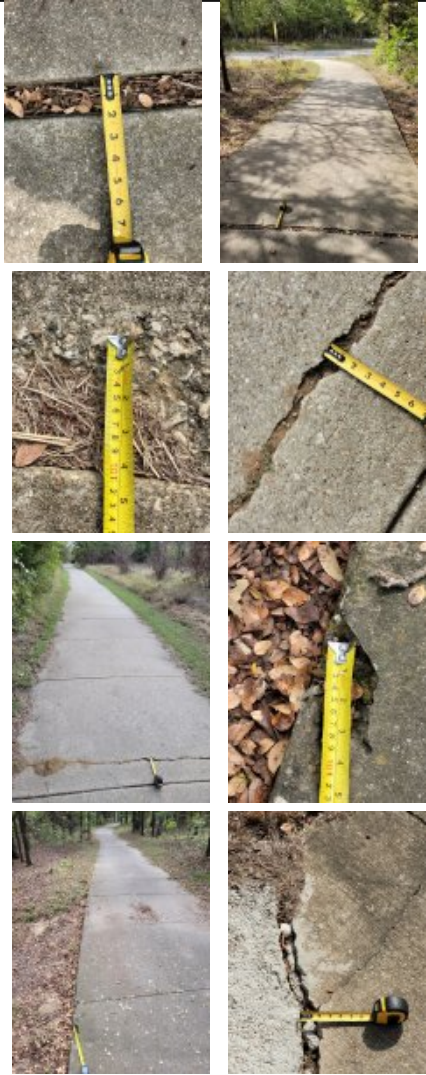
Finding Number	Area Description	Lat/Long	Finding	As Built	Recommendation	Citation	Photos	Figure
709	Johnson Branch Unit: Johnson - Trails	[33.4241031, -97.053423]	There are openings in the surface of the trails, passing spaces, and resting intervals that allow the passage of a sphere more than 1/2 inch in diameter. Openings in the surface of trails, passing spaces, and resting intervals shall not allow the passage of a sphere more than 1/2 inch (13 mm) in diameter.	Paved Loop Trail - 7" gap near Dogwood crossing, 2" gap across main crossing near Dogwood, 4.5" gap past dogwood, 1.25" gap, 3" gap, (multiple gaps in 1-2").	Correct for fill gaps to max .5" as a smart practice.	2015 ABAAS Section: 1017.6

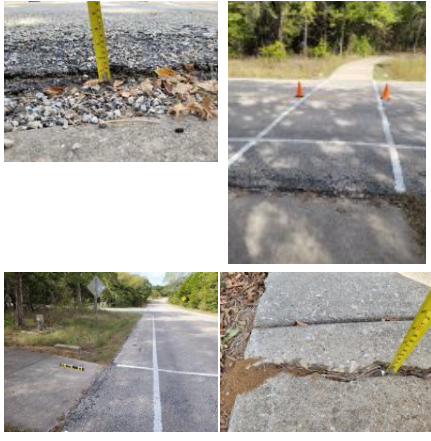
710	Johnson Branch Unit: Johnson - Trails	[33.4238882 , -97.053423]	Tread obstacles on trails, passing spaces, and resting intervals shall not exceed 1/2 inch (13 mm) in height measured vertically to the highest point. EXCEPTION: Where the surface is other than asphalt, concrete, or boards, tread obstacles shall be permitted to not exceed 2 inches (50 mm) in height measured vertically to the highest point.	Paved Loop Trail - 1" rise at main road crossing to Dogwood & 3/4" rise at crack, 1" rise at cross timbers sign (multiple areas with 1"-2" rise), 1.5" broken/repared section (multiple patches), 2" rise at playground	Repair, bevel or ramp tread obstacle along pathway to max .5" as a smart practice.	2015 ABAAS Section: 1017.5

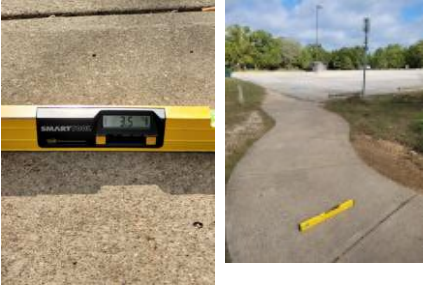
711	Johnson Branch Unit: Johnson - Trails	[33.4221599 , -97.054839 2]	The cross slope shall not be steeper than 1:48. EXCEPTION: Where the surface is other than concrete, asphalt, or boards, cross slopes not steeper than 1:20 shall be permitted when necessary for drainage.	Paved Loop Trail - 3.5% at dogwood trailhead, multiple cross slopes not to exceed 13.5%	Correct or repair pathway cross slope to max 2.08% as a smart practice.	2015 ABAAS Section: 1017.2

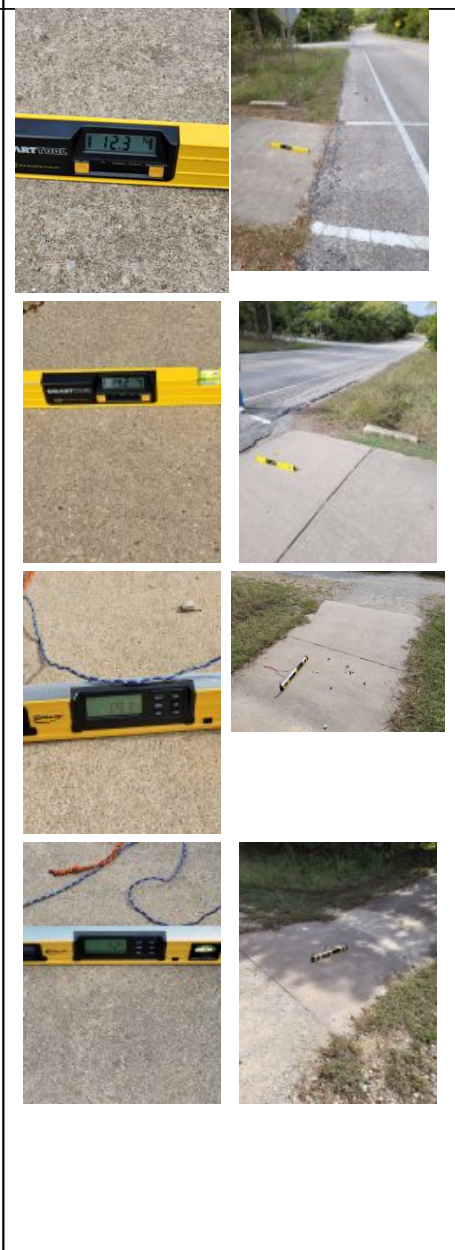
Finding Number	Area Description	Lat/Long	Finding	As Built	Recommendation	Citation	Photos	Figure
			<p>segment of a trail is steeper than 1:20 (5%), the maximum length of the segment shall be in accordance with Table 1017.7.1, and a resting interval complying with 1017.8 shall be provided at the top and bottom of each segment.</p>	<p>14.1% slope at gravel rd crossing and 9.2% other side, sections exceed 1:8 10.4% & 8.9%, segment exceeds 5% without compliant resting intervals (multiple areas), area at gravel rd crossing 21.6% slope, 12.4% slope past culvert.</p>

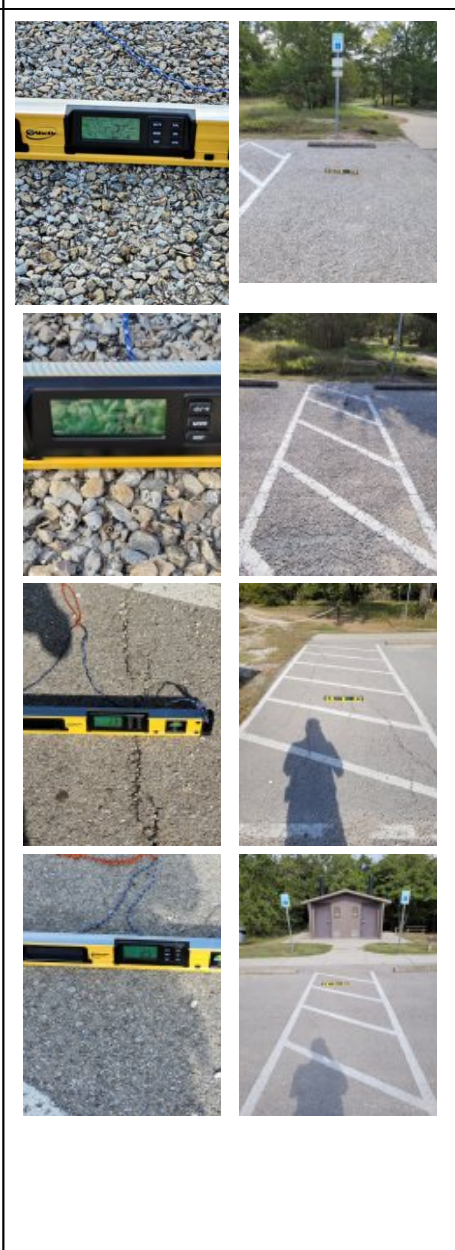
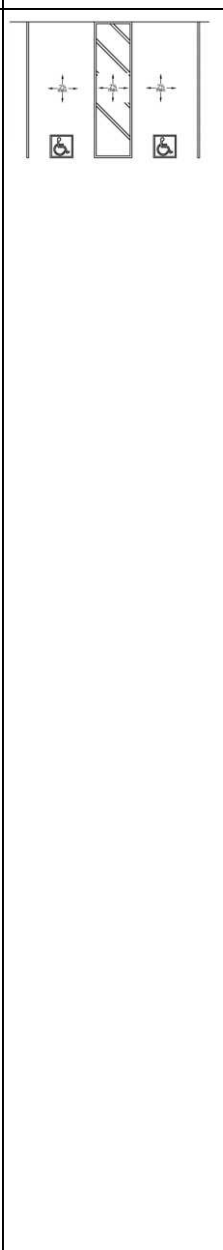
Finding Number	Area Description	Lat/Long	Finding	As Built	Recommendation	Citation	Photos	Figure
714	Johnson Branch Unit: Johnson - Dogwood Canyon Parking	[33.4227084 , -97.054957 2]	The cross slopes (narrow dimension) and/or running slopes (long dimension) of the access aisle exceeds 2%. The running slope and the cross slope in an accessible parking stall and the access aisle must not exceed 2%.	Slopes: L to R: 1. 2.5% in stall, 3.0% aisle, 2. 2.3% aisle, 3. 2.5% aisle, 2.2% 2nd stall, 3.6% 3rd stall	Repair or correct slope of parking space and access aisle to max 2.08% in any direction. Leave as is 2.2% slope citing construction tolerance.	2015 ABAAS Section: 502.4 2012 TAS Section: 502.4 2010 ADAS Section: 502.4

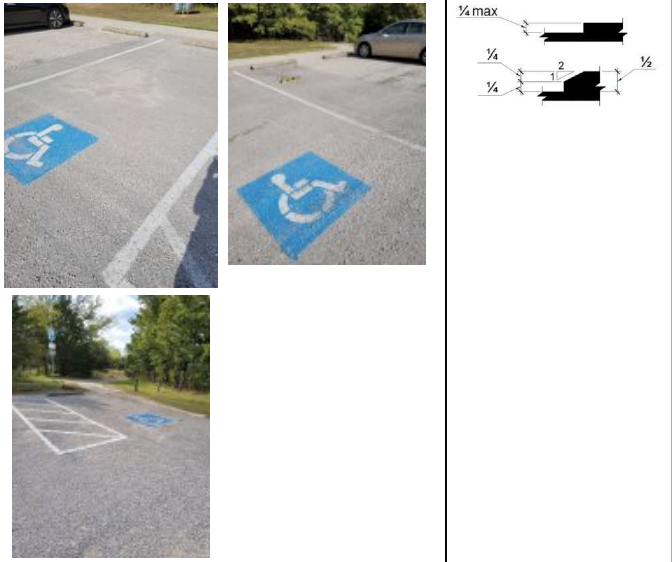
715	Johnson Branch Unit: Johnson - Dogwood Canyon Parking	[33.4227017 , -97.054941 1]	The parking stall contains abrupt edges and surface irregularities over a 1/4 inch vertical. Parking spaces and access aisles serving them shall be stable, firm, and slip resistant. Access aisles shall be at the same level as the parking spaces they serve. Changes in level are not permitted and shall not be sloped steeper than 2% in any direction.	2 types: loose gravel on asphalt, loose gravel on binder	Resurface accessible stalls and access aisles with a firm, stable, and slip resistant material. Cost included in slope correction.	2015 ABAAS Section: 502.4 2012 TAS Section: 502.4 2010 ADAS Section: 502.4

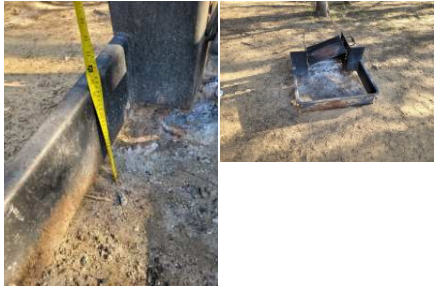
719	Johnson Branch Unit: Johnson - Dogwood Canyon Campsites	[33.4215465 , -97.054689]	Fire building surfaces shall be 9 inches (230 mm) minimum above the ground	Site 135: fire building surface not raised	Correct fire building surface to be 9" min above the ground as a smart practice. In the alternative, acquire an ADA model as a smart practice.	2015 ABAAS Section: 1011.5.1

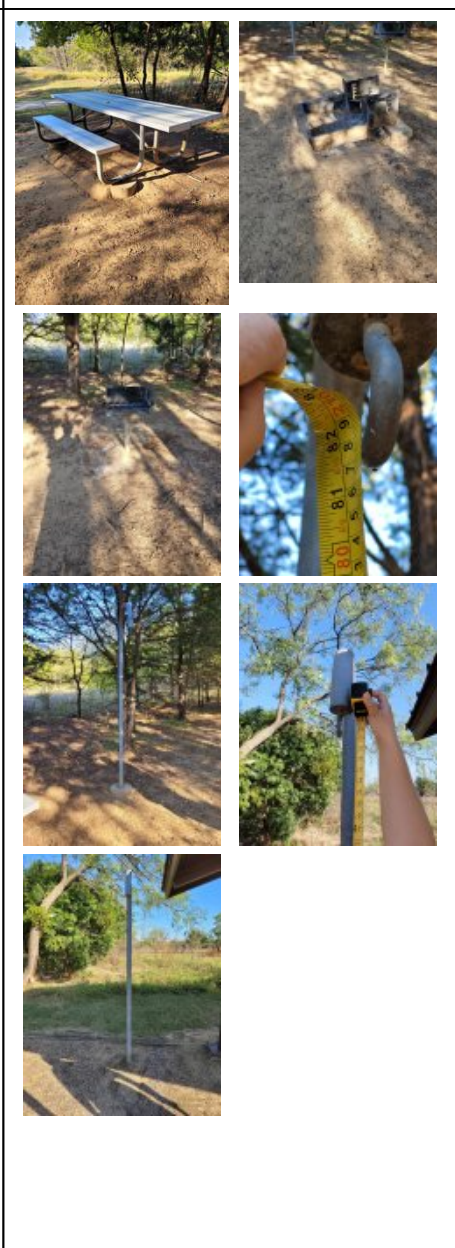
Finding Number	Area Description	Lat/Long	Finding	As Built	Recommendation	Citation	Photos	Figure
721	Johnson Branch Unit: Johnson - Dogwood Canyon Campsites	[33.421542, -97.054710 5]	A minimum of one of each type of outdoor constructed feature does not have mobility features. Where provided, at least one of each type of outdoor constructed features with mobility features must be provided.	Site 135: hook is too high at 82"	Lower hook or replace with one mounted to max 48" AGL as a smart practice.	2015 ABAAS Section: F244.2.3.1, F245.2.5.1

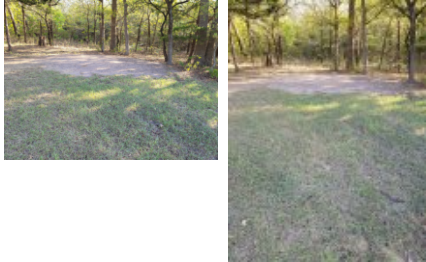
Finding Number	Area Description	Lat/Long	Finding	As Built	Recommendation	Citation	Photos	Figure
722	Johnson Branch Unit: Johnson - Dogwood Canyon Campsites	[33.4215241 , -97.054694 4]	A clear floor space at the tent pad and/or tent platform is not provided. Clear ground space shall be provided on all usable sides of tent pads and tent platforms. The clear ground space shall be 48 inches wide minimum. The surface of the clear ground space shall be firm and stable. The surface shall allow use of tent stakes and other tent securement devices. The slope of the surface of tent pads, tent platforms, and clear ground spaces shall not be steeper than 1:48 in any direction. Where the surface is other than asphalt, concrete, or boards, slopes not steeper than 1:20 shall be permitted where necessary for drainage.	Site 135 - no ORAR to tent pad	Create ORAR with crushed and compacted stone or similar outdoor material to tent pad, with a 36" x 48" clear space at entry as a smart practice.	2015 ABAAS Section: 1013.2

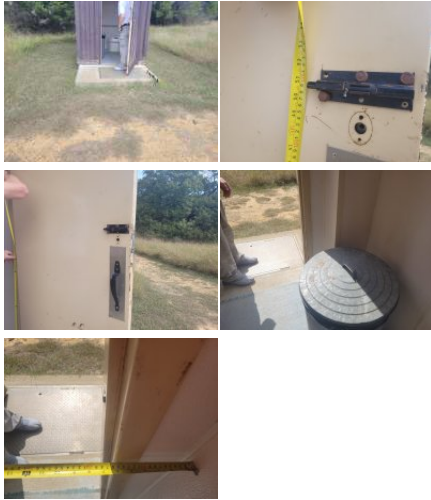
730	Johnson Branch Unit: Johnson - Dogwood Canyon Trail Restrooms at Camping	[33.4212463 , -97.0551415]	Minimum maneuvering clearances at doors and gates shall comply with 404.2.4. Maneuvering clearances shall extend the full width of the doorway and the required latch side or hinge side clearance. Door openings shall provide a clear width of 32 inches (815 mm) minimum. Clear openings of doorways with swinging doors shall be measured between the face of the door and the stop, with the door open 90 degrees. Openings more than 24 inches (610 mm) deep shall provide a clear opening of 36 inches (915 mm) minimum. There shall be no projections into the required clear opening width lower than 34 inches (865 mm) above the finish floor or ground. Projections into the clear opening width between 34 inches (865 mm) and 80 inches (2030 mm) above the finish floor or ground shall not exceed 4 inches (100 mm). The threshold has a vertical change greater than 1/4 inch high. The threshold at a doorway shall be no higher than 1/2 inch. Changes in level between 1/4 inch and 1/2 inch must be beveled at 1:2 or less. 1/4 inch is the maximum vertical rise. All interior doors must be maintained so that the operating pressure does not exceed 5 lb. force to open. The sweep period for doors with closers shall be adjusted so that from an open position of 70 degrees, the door will	Pit toilet- lacks AR, large change in level (CIL), garbage can and wall pull side, lock 50.5"	Provide accessible route to the pit toilet For all doors along the public circulation route, repair, bevel, or ramp CILs at door entries to max .25" Remount lock to max 48" AFF.	2010 ADAS Section: 404.2.3, 404.2.7, 404.2.4, 404.2.11, 404.2.11 Exception

Finding Number	Area Description	Lat/Long	Finding	As Built	Recommendation	Citation	Photos	Figure
			<p>take at least 3 seconds to move to a point 3 inches from the latch, measured to the leading edge of the door. Exterior doors are recommended to be maintained at 8.5 lbf as a smart practice. Force is to be measured at the operating hardware or 30 inches from the hinges, whichever is greater. Hand-activated door opening hardware, handles, pulls, latches, locks, and other operating devices on accessible doors shall have a shape that is easy to grasp with one hand and does not require tight grasping, tight pinching or twisting of the wrist to operate. Hardware shall be 34 inches minimum and 48 inches maximum above the finish floor or ground. The bottom 10 inches on the push side must be smooth and free of obstructions (hold open devices). Opening hardware must be mounted between 30 and 44 inches above the floor or ground. Doors, gates, and side lights adjacent to doors or gates, containing one or more glazing panels that permit viewing through the panels shall have the bottom of at least one glazed panel located 43 inches (1090 mm) maximum above the finish floor.</p> <p>EXCEPTION: Vision lights with the lowest part more than 66 inches (1675 mm) from the finish floor or ground shall not be required to comply with 404.2.11.</p>

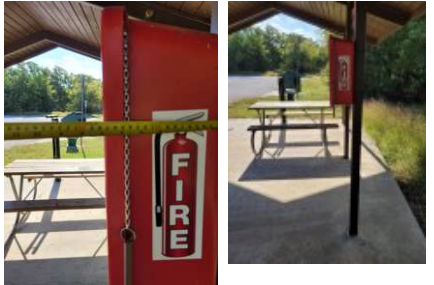
738	Johnson Branch Unit: Johnson - Dogwood Canyon DOBRA Trailhead	[33.4224845 , -97.0552013]	Objects project more than 4 inches into the circulation path. Wall-mounted objects that have leading edges between 27 inches and 80 inches from the floor must not project more than 4 inches into the circulation path. Protruding objects that extend to the floor or within 27 inches of the floor are cane detectable and are therefore not hazardous. Where it is necessary or desirable to have objects protrude from the wall, a manner of cane detection must be provided.	Shelter - 7" projection at fire extinguisher	Provide cane detectable warning at base of object along the route.	2015 ABAAS Section: 307.2 2012 TAS Section: 307.2 2010 ADAS Section: 307.2

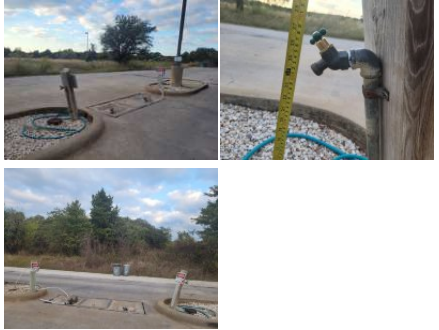
Finding Number	Area Description	Lat/Long	Finding	As Built	Recommendation	Citation	Photos	Figure
741	Johnson Branch Unit: Johnson - RV Dump Station	[33.42169, -97.0504]	Water spouts at water hydrants and water utility hook-ups shall be 28 inches (710 mm) minimum and 36 inches (915 mm) maximum above the ground	water spout 24", garbage cans on gravel	Provide CGS at drain, water spout, and garbage cans as a smart practice.	2015 ABAAS Section: 1011.6

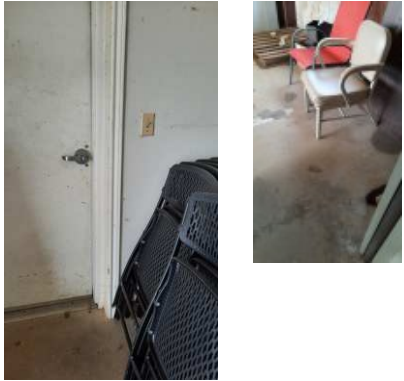
Finding Number	Area Description	Lat/Long	Finding	As Built	Recommendation	Citation	Photos	Figure
745	Johnson Branch Unit: Johnson - Maintenance	[33.4179601 , -97.048831 1]	Employee Work Areas. Common use circulation paths within employee work areas shall comply with 402. EXCEPTIONS: 1. Common use circulation paths located within employee work areas that are less than 1000 square feet (93 m2) and defined by permanently installed partitions, counters, casework, or furnishings shall not be required to comply with 402. 2. Common use circulation paths located within employee work areas that are an integral component of work area equipment shall not be required to comply with 402. 3. Common use circulation paths located within exterior employee work areas that are fully exposed to the weather shall not be required to comply with 402.	Main blg - chairs on both sides of door connecting bays	Make corrections for compliant circulation path. Relocate chairs in door clearances.	2015 ABAAS Section: F206.2.8, F206.2.8.1, F206.2.8.2 2012 TAS Section: 206.2.8, 206.2.8 Exception 1, 206.2.8 Exception 2, 206.2.8 Exception 3, 206.2.8 Advisory 1, 206.2.8 Advisory 2 2010 ADAS Section: 206.2.8, 206.2.8 Exception 1, 206.2.8 Exception 2, 206.2.8 Exception 3

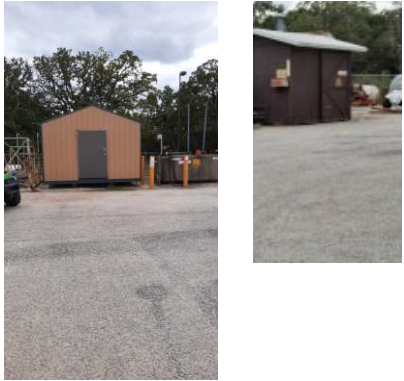
Finding Number	Area Description	Lat/Long	Finding	As Built	Recommendation	Citation	Photos	Figure
755	Johnson Branch Unit: Johnson - Maintenance	[33.4181526 , -97.048729 1]	Spaces and elements within employee work areas shall only be required to comply with 206.2.8, 207.1, and 215.3 and shall be designed and constructed so that individuals with disabilities can approach, enter, and exit the employee work area. Employee work areas, or portions of employee work areas, other than raised courtroom stations, that are less than 300 square feet (28 m2) and elevated 7 inches (180 mm) or more above the finish floor or ground where the elevation is essential to the function of the space shall not be required to comply with these requirements or to be on an accessible route.	Outbuildings lack route, have large change in level (CIL) at entry	For employee spaces, provide route and provide ramps at outbuilding entries.	2015 ABAAS Section: F203.9 2012 TAS Section: 203.9 2010 ADAS Section: 203.9

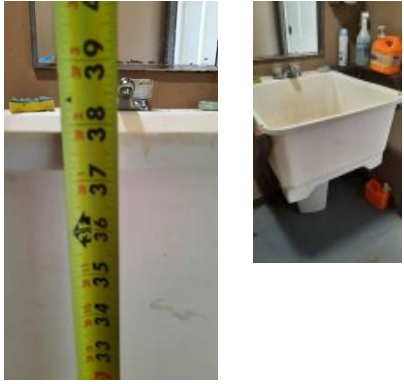
767	Johnson Branch Unit: Johnson - Maintenance Restrooms	[33.4179959 , -97.048788 2]	The top rim of the sink is too high. All lavatories/sinks that are designated to be accessible shall be a minimum 17 inches in horizontal depth and mounted with the rim or counter edge no higher than 34 inches above the finished floor.	Right Restroom - sink rim 38"	Replace sink noted in other finding.	2015 ABAAS Section: 606.3 2012 TAS Section: 606.3 2010 ADAS Section: 606.3

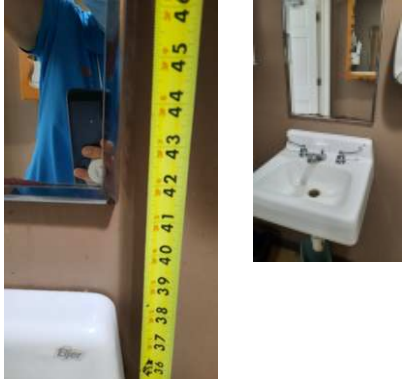
Finding Number	Area Description	Lat/Long	Finding	As Built	Recommendation	Citation	Photos	Figure
774	Johnson Branch Unit: Johnson - Maintenance Restrooms	[33.4181034 , -97.048916 9]	The mirror is mounted too high. Mirrors must have the bottom edge of the reflecting surface a maximum of 40 inches above the floor if above a sink or counter. Mirrors not located above lavatories or countertops shall be installed with the bottom edge of the reflecting surface 35 inches maximum above the finish floor or ground.	Left Restroom - mirror at 42"	Lower mirror so reflective surface is max 40" AFF.	2015 ABAAS Section: 603.3 2012 TAS Section: 603.3 2010 ADAS Section: 603.3

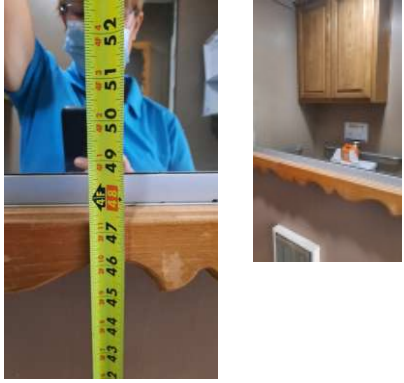
775	Johnson Branch Unit: Johnson - Maintenance Restrooms	[33.4181392 , -97.048788 2]	The mirror is mounted too high. Mirrors not located above lavatories or countertops shall be installed with the bottom edge of the reflecting surface 35 inches maximum above the finish floor or ground.	Left Restroom - mirror at 48.75"	Lower mirror not over a sink or counter to max 35" aff to the reflective surface.	2015 ABAAS Section: 603.3 2012 TAS Section: 603.3 2010 ADAS Section: 603.3

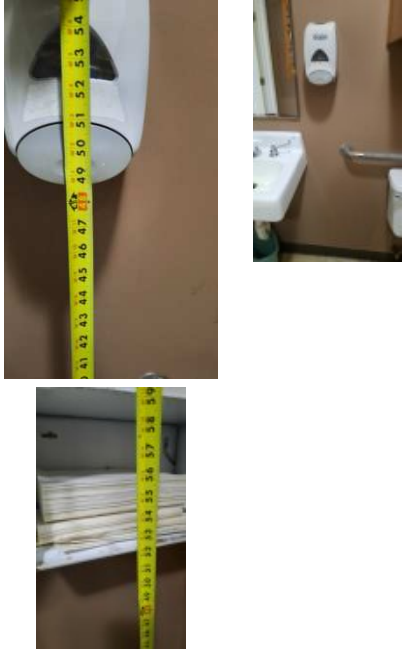
Finding Number	Area Description	Lat/Long	Finding	As Built	Recommendation	Citation	Photos	Figure
777	Johnson Branch Unit: Johnson - Maintenance Restrooms	[33.4181034 , -97.048788 2]	Where a high forward reach is over an obstruction, the clear floor space shall extend beneath the element for a distance not less than the required reach depth over the obstruction. The high forward reach shall be 48 inches (1220 mm) maximum where the reach depth is 20 inches (510 mm) maximum. Where the reach depth exceeds 20 inches (510 mm), the high forward reach shall be 44 inches (1120 mm) maximum and the reach depth shall be 25 inches (635 mm) maximum. Where a clear floor or ground space allows a parallel approach to an element and the high side reach is over an obstruction, the height of the obstruction shall be 34 inches (865 mm) maximum and the depth of the obstruction shall be 24 inches (610 mm) maximum. The high side reach shall be 48 inches (1220 mm) maximum for a reach depth of 10 inches (255 mm) maximum. Where the reach depth exceeds 10 inches (255 mm), the high side reach shall be 46 inches (1170 mm) maximum for a reach depth of 24 inches (610 mm) maximum.	Left Restroom - soap 48.5" behind sink, paper towels 56"	Lower soap dispenser to max 44" AFF for a forward reach over sink. Lower paper towels to max 48" AFF.	2015 ABAAS Section: 308.2.1, 308.3.2 2012 TAS Section: 308.2.1, 308.3.2 2010 ADAS Section: 308.2.1, 308.3.2

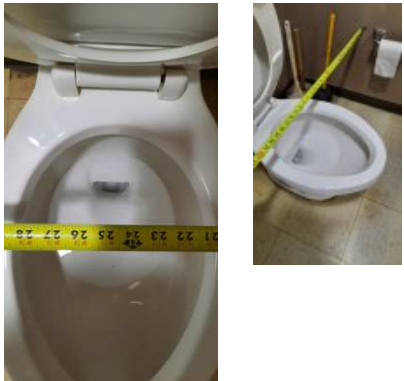
778	Johnson Branch Unit: Johnson - Maintenance Restrooms	[33.4181034 , -97.048788 2]	The toilet is not located within the range allowed from the side wall or partition. The centerline of the toilet must be 16 to 18 inches from the side wall.	Left Restroom - toilet center line at 24.5"	Remount toilets to 16" to 18" from the side wall to centerline.	2015 ABAAS Section: 604.2 2012 TAS Section: 604.2 2010 ADAS Section: 604.2

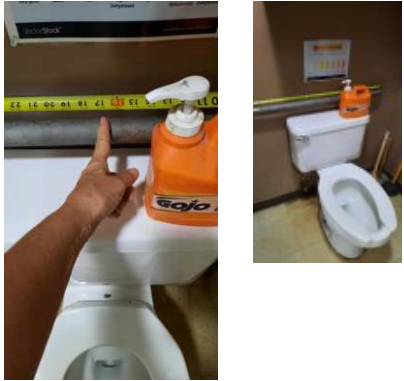
Finding Number	Area Description	Lat/Long	Finding	As Built	Recommendation	Citation	Photos	Figure
779	Johnson Branch Unit: Johnson - Maintenance Restrooms	[33.4182466 , -97.048916 9]	The rear grab bar is not 36" long or is not mounted in the correct location. The rear grab bar must be a minimum of 36" long and extend from the toilet centerline a minimum 12" towards the wall side and a minimum 24" towards the open side of the toilet. Grab bars shall be installed in a horizontal position, 33 inches minimum and 36 inches maximum above the finish floor measured to the top of the gripping surface and the space between the grab bar and the top of the tank shall be 1-1/2 inches minimum.	Left Restroom - rear grab bar centered at 17"	Remount rear grab bar to behind the toilet, 12" to one side of center and 24" to the other and 33" to 36" AFF.	2015 ABAAS Section: 604.5.2 2012 TAS Section: 604.5.2 2010 ADAS Section: 604.5.2

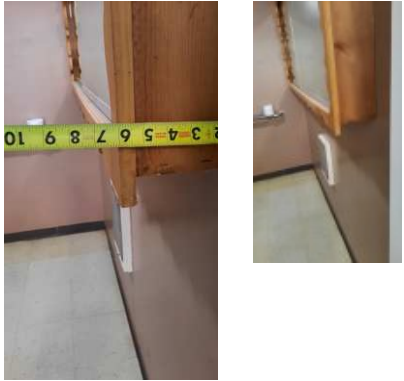
781	Johnson Branch Unit: Johnson - Maintenance Restrooms	[33.4182466 , -97.048916 9]	The cabinet projects more than 4 inches into the circulation path. Wall-mounted objects that have leading edges between 27 inches and 80 inches from the floor must not project more than 4 inches into the circulation path. Protruding objects that extend to the floor or within 27 inches of the floor are cane detectable and are therefore not hazardous. Where it is necessary or desirable to have objects protrude from the wall, a manner of cane detection must be provided.	Left Restroom - cabinet protrudes	Relocate protruding objects or place cane detectable warning or bollard at foot of item.	2015 ABAAS Section: 307.2 2012 TAS Section: 307.2 2010 ADAS Section: 307.2

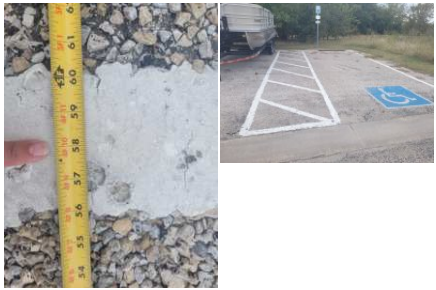
Finding Number	Area Description	Lat/Long	Finding	As Built	Recommendation	Citation	Photos	Figure
782	Johnson Branch Unit: Johnson - Juniper Cove Parking	[33.42978, -97.05647]	Element meets all standards and requirements	Lot at Site 1 - lot complies with scoping, 7 standard stalls, 1 accessible	None	2010 ADAS Section: N/A		
783	Johnson Branch Unit: Johnson - Juniper Cove Parking	[33.4188948, -97.0522039]	The access aisle is not a minimum 5 feet wide. A car accessible parking stall's access aisle must be a minimum of 5 feet wide measured from centerline to centerline. Where the access aisle is not adjacent to another parking space or access aisle, measurements shall be permitted to include the full width of the line defining the access aisle.	Lot at Site 1 - access aisle 58", stall exceeds 8'	Repaint access aisles to be 5' each.	2015 ABAAS Section: 502.3.1 2012 TAS Section: 502.3.1 2010 ADAS Section: 502.3.1

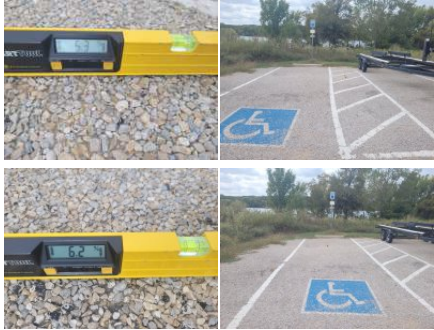
Finding Number	Area Description	Lat/Long	Finding	As Built	Recommendation	Citation	Photos	Figure
790	Johnson Branch Unit: Johnson - Juniper Cove Parking	[33.4186541, -97.0549519]	The cross slopes (narrow dimension) and/or running slopes (long dimension) of the access aisle exceeds 2%. The running slope and the cross slope in an accessible parking stall and the access aisle must not exceed 2%.	Lot at Site 31 - slopes 5.3% aisle, 6.2% stall	Repair or correct slope of parking space and access aisle to max 2.08% in any direction.	2015 ABAAS Section: 502.4 2012 TAS Section: 502.4 2010 ADAS Section: 502.4

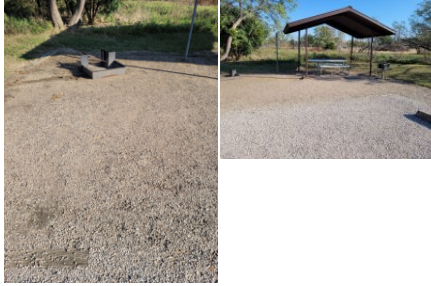
799	Johnson Branch Unit: Johnson - Juniper Cove Campsite 104	[33.4189675 , -97.0518995]	An accessible access route is not provided between elements, spaces and the facilities provided within the accessible camping unit. At least one outdoor recreation access route shall connect accessible elements, spaces and facilities provided within camping units with mobility features.	Site 1 - lacks outdoor recreation access route (ORAR) to elements	Create ORAR with crushed and compacted stone or similar outdoor material to camp sites and one of each type of amenity as a smart practice.	2015 ABAAS Section: F244.5.1

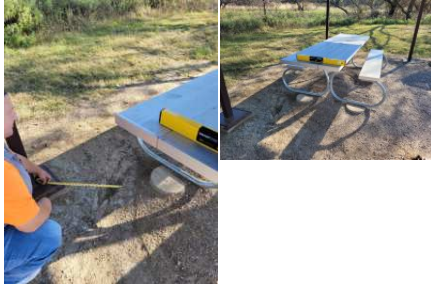
Finding Number	Area Description	Lat/Long	Finding	As Built	Recommendation	Citation	Photos	Figure
800	Johnson Branch Unit: Johnson - Juniper Cove Campsite 104	[33.4189854 , -97.051899 5]	36 inches (915 mm) on all usable sides of the table measured from the back edge of the benches	Site 1 - 17" width at shelter post, lacks ORAR	Provide required 36" clear ground space around all usable portions of the table as a smart practice and connect an ORAR to the shelter.	2015 ABAAS Section: 1011.2.1

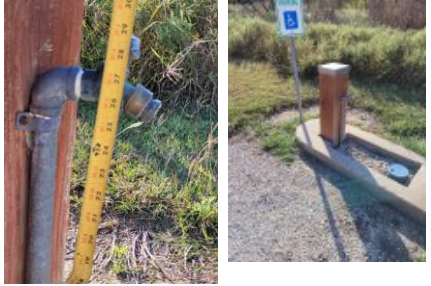
802	Johnson Branch Unit: Johnson - Juniper Cove Campsite 104	[33.4190168 , -97.051942 4]	Water spouts at water hydrants and water utility hook-ups shall be 28 inches (710 mm) minimum and 36 inches (915 mm) maximum above the ground	Site 1 - 26" to spout, no route	Remount water spouts to 28" min or 36" max above the ground as a smart practice. Install accessible route from parking space.	2015 ABAAS Section: 1011.6

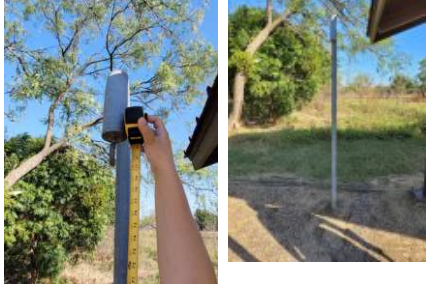
803	Johnson Branch Unit: Johnson - Juniper Cove Campsite 104	[33.418963, -97.051899 5]	A minimum of one of each type of outdoor constructed feature does not have mobility features. Where provided, at least one of each type of outdoor constructed features with mobility features must be provided.	Site 1 - 80" to hook, no route to any elements	Provide accessible outdoor constructed features at the required number of camp units based on the total number provided.	2015 ABAAS Section: F244.2.3.1, F245.2.5.1

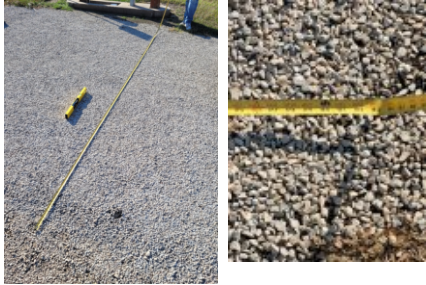
Finding Number	Area Description	Lat/Long	Finding	As Built	Recommendation	Citation	Photos	Figure
804	Johnson Branch Unit: Johnson - Juniper Cove Campsite 104	[33.418972, -97.051974 6]	Parking spaces and pull-up spaces for recreational vehicles shall be 20 feet (6100 mm) wide minimum. EXCEPTION: Where two adjacent parking spaces are provided for recreational vehicles, one parking space shall be permitted to be 16 feet (4880 mm) wide minimum.	Site 1 - 15' wide parking space	Correct RV parking space to be 20' wide minimum; or 16' for two adjacent spaces as a smart practice.	2015 ABAAS Section: 1012.2, 1012.2 EXCEPTION

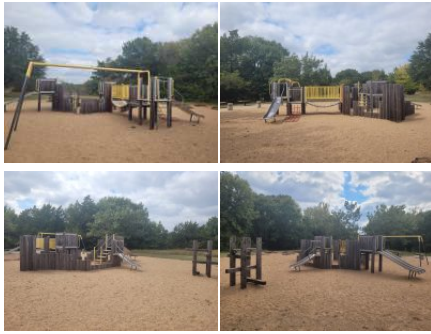
810	Johnson Branch Unit: Johnson - Juniper Cove Playground	[33.4188198 , -97.0540667]	There are not enough accessible elevated play components. Where Elevated Play Components are provided, at least 50 percent shall be on an accessible route. An accessible route may be a ramp of transfer system.	0 of 4 EPCs comply-ladder, slide, cargo net, clatter bridge	Install a transfer system to the structure, if feasible, for access to at least two elevated play components.	2012 TAS Section: 240.2.2 2010 ADAS Section: 240.2.2

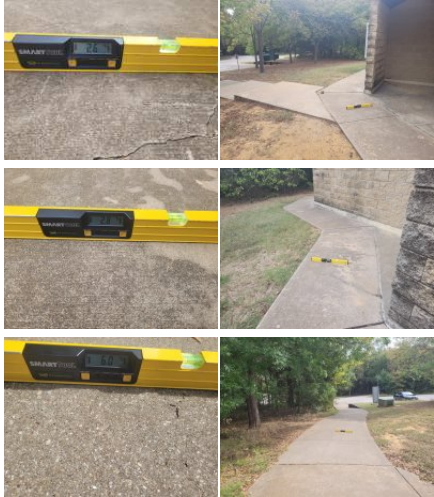
Finding Number	Area Description	Lat/Long	Finding	As Built	Recommendation	Citation	Photos	Figure
819	Johnson Branch Unit: Johnson - Juniper Cove Men's Restroom	[33.41855, -97.05336]	The accessible route of travel contains cross slopes greater than 2%. Cross slopes shall not exceed one unit vertical in 48 units horizontal (2-percent slope).	2.6% along front of men's side, 2.8% at women's side; 6% along trail	Correct or repair cross slope along AR to max 2.08%.	2015 ABAAS Section: 403.3 2012 TAS Section: 403.3 2010 ADAS Section: 403.3

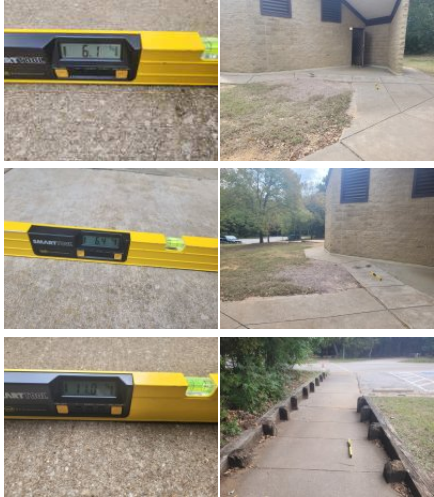
820	Johnson Branch Unit: Johnson - Juniper Cove Men's Restroom	[33.41864, -97.05341]	The running slope of walking surfaces shall not be steeper than 1:20.	6.1% from trail to access restrooms, 6.4% towards front of building, 11% on trail	Correct running slope along the AR to max 5%.	2015 ABAAS Section: 403.3 2012 TAS Section: 403.3 2010 ADAS Section: 403.3

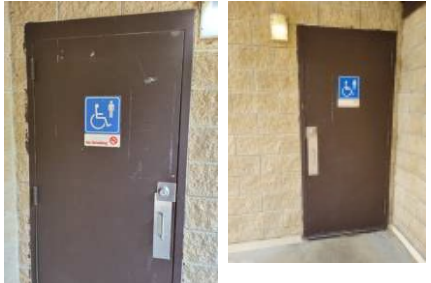
822	Johnson Branch Unit: Johnson - Juniper Cove Men's Restroom	[33.4185556 , -97.0534284]	The restroom sign does not comply with one or more applicable requirements for the location, height, and properties of the sign.	2 entrances; no braille, no raised characters, sign mounted on door	Replace sign with one of contrasting colors that includes Braille, raised characters, and the symbol of accessibility and mount on the wall, latch side of the door, 48" to the baseline of the lowest character and 60" to the baseline of the highest character.	2015 ABAAS Section: F216.2, 703.1, 703.2, 703.5, 703.6 2012 TAS Section: 216.2, 703.1, 703.2, 703.5, 703.6 2010 ADAS Section: 216.2, 703.1, 703.2, 703.5, 703.6

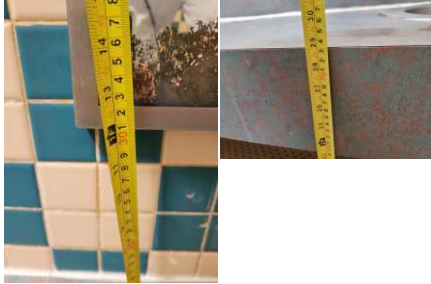
823	Johnson Branch Unit: Johnson - Juniper Cove Men's Restroom	[33.4186407 , -97.0533372]	The mirror is mounted too high. Mirrors must have the bottom edge of the reflecting surface a maximum of 40 inches above the floor if above a sink or counter. Mirrors not located above lavatories or countertops shall be installed with the bottom edge of the reflecting surface 35 inches maximum above the finish floor or ground.	41.5" above finish floor to bottom of mirror	Lower mirror so reflective surface is max 40" aff.	2015 ABAAS Section: 603.3 2012 TAS Section: 603.3 2010 ADAS Section: 603.3

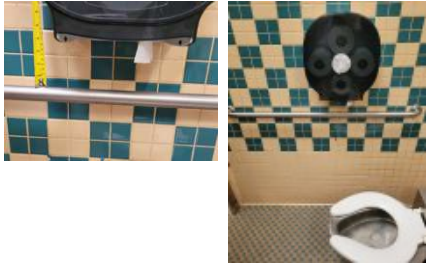
Finding Number	Area Description	Lat/Long	Finding	As Built	Recommendation	Citation	Photos	Figure
826	Johnson Branch Unit: Johnson - Juniper Cove Men's Restroom	[33.418569, -97.053465 9]	The grab bar height and/or spacing fails. Grab bars must be mounted between 33" and 36" to the top of the gripping surface. There must be 1.5" of clearance between the grab bar and the wall. There must be a minimum of 1.5" of clearance below and minimum 12" above the grab bar to any dispenser or other obstruction.	4" between grab bar and toilet tissue dispenser, too close to front of toilet	Remount toilet paper dispenser max 7" to 9" from front of toilet, 15" to 48" aff and min 12" above or 1.5" below grab bar.	2015 ABAAS Section: 609.3, 609.4 2012 TAS Section: 609.4, 609.3 2010 ADAS Section: 609.3, 609.4

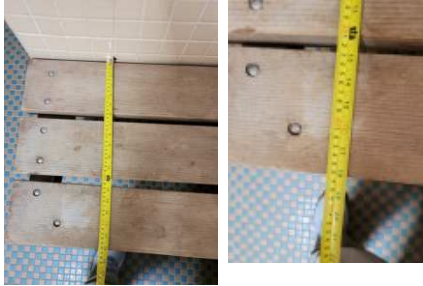
830	Johnson Branch Unit: Johnson - Juniper Cove Men's Restroom	[33.4185959 , -97.053433 7]	The bench is not deep enough or long enough or is missing. Benches shall be provided having seats that are 42 inches long minimum and 20 inches deep minimum and 24 inches deep maximum. The bench shall provide for back support or shall be affixed to a wall. Back support shall be 42 inches (1065 mm) long minimum and shall extend from a point 2 inches (51 mm) maximum above the seat surface to a point 18 inches (455 mm) minimum above the seat surface. Back support shall be 2½ inches (64 mm) maximum from the rear edge of the seat measured horizontally. The top of the bench seat surface shall be 17 inches (430 mm) minimum and 19 inches (485 mm) maximum above the finish floor or ground. Clear floor or ground space complying with 305 shall be provided and shall be positioned at the end of the bench seat and parallel to the short axis of the bench	18" deep bench	Replace bench in dressing area with one having a seat depth of 20" to 24" deep, 42" long, affixed to the wall or having a back and mounted 17" to 19" AFF and provide required clear floor space on the short axis of the bench.	2012 TAS Section: 903.4, 903.2, 903.3, 903.5 2010 ADAS Section: 903.4, 903.2, 903.3, 903.5

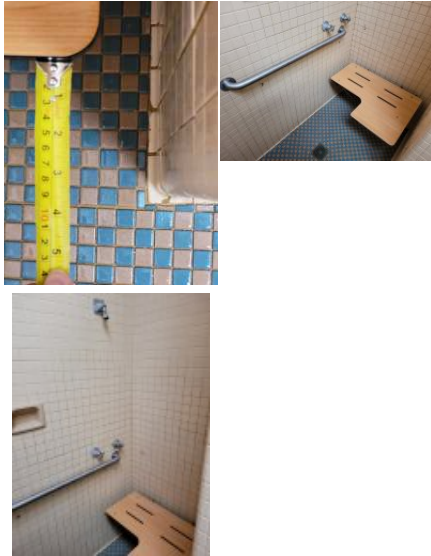
Finding Number	Area Description	Lat/Long	Finding	As Built	Recommendation	Citation	Photos	Figure
835	Johnson Branch Unit: Johnson - Juniper Cove Men's Restroom	[33.418578, -97.053423]	Where a seat is provided in a standard roll-in shower compartment, it shall be a folding type, shall be installed on the side wall adjacent to the controls, and shall extend from the back wall to a point within 3 inches (75 mm) of the compartment entry. Where a seat is provided in an alternate roll-in type shower compartment, it shall be a folding type, shall be installed on the front wall opposite the back wall, and shall extend from the adjacent side wall to a point within 3 inches (75 mm) of the compartment entry. In transfer-type showers, the seat shall extend from the back wall to a point within 3 inches (75 mm) of the compartment entry. The top of the seat shall be 17 inches (430 mm) minimum and 19 inches (485 mm) maximum above the bathroom finish floor. Seats shall comply with 610.3.1 or 610.3.2.	Seat not in correct location, 3.5" to edge	Replace seat and mount in the correct location.	2015 ABAAS Section: 610.3 2012 TAS Section: 610.3 2010 ADAS Section: 610.3

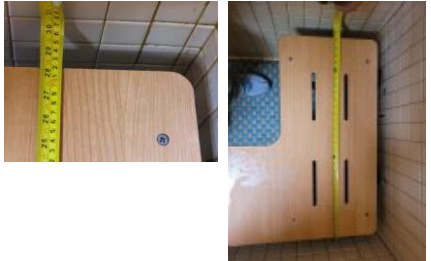
836	Johnson Branch Unit: Johnson - Juniper Cove Men's Restroom	[33.418578, -97.053444 5]	The shower seat does not have a compliant space between it and the wall. The folding seat must be mounted 17-19 inches above the floor, and have a maximum space of 1-1/2 inches between the edge of the seat and the side wall and 2-1/2 inches maximum to the seat wall.	28" Length at L end	Remount shower seat to the correct location and height in the shower. Seat to be replaced as noted in other finding.	2015 ABAAS Section: 610.3.2 2012 TAS Section: 610.3.2 2010 ADAS Section: 610.3.2

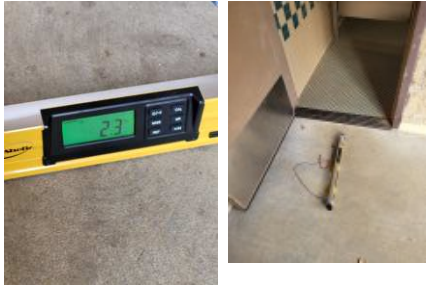
Finding Number	Area Description	Lat/Long	Finding	As Built	Recommendation	Citation	Photos	Figure
839	Johnson Branch Unit: Johnson - Juniper Cove Men's Restroom	[33.4189272 , -97.053423]	<p>Minimum maneuvering clearances at doors and gates shall comply with 404.2.4. Maneuvering clearances shall extend the full width of the doorway and the required latch side or hinge side clearance. Maneuvering clearances shall have a max slope of 2.08%. Door openings shall provide a clear width of 32 inches (815 mm) minimum. Clear openings of doorways with swinging doors shall be measured between the face of the door and the stop, with the door open 90 degrees. Openings more than 24 inches (610 mm) deep shall provide a clear opening of 36 inches (915 mm) minimum. There shall be no projections into the required clear opening width lower than 34 inches (865 mm) above the finish floor or ground. Projections into the clear opening width between 34 inches (865 mm) and 80 inches (2030 mm) above the finish floor or ground shall not exceed 4 inches (100 mm). The threshold has a vertical change greater than 1/4 inch high. The threshold has a gap greater than 1/2 inch wide. The threshold at a doorway shall be no higher than 1/2 inch. Changes in level between 1/4 inch and 1/2 inch must be beveled at 1:2 or less. 1/4 inch is the maximum vertical rise. All interior doors must be maintained so that the operating pressure does not exceed 5 lbf to open. The sweep period for doors with closers shall be adjusted so that from an open position of 70 degrees, the door will take at least 3 seconds to move to a point 3 inches from the latch, measured to the leading edge of the door. Exterior doors are recommended to be maintained at 8.5 lbf as a smart practice. Force is to be measured at the operating hardware or 30 inches from the hinges, whichever is greater. Hand-activated door opening hardware, handles, pulls, latches, locks, and other operating devices on accessible doors shall have a shape that is easy to grasp with one hand and does not require tight grasping, tight pinching or twisting of the wrist to operate.</p>	Restroom door - 2.3% slope on pull side, 10# push	For all doors along the public circulation route, provide required maneuvering clearance on push and pull side of doors. For all doors along the public circulation route, correct slope in door clearance to max 2.08%. For all doors along the public circulation route, inspect, adjust, and maintain 8.5 lbf to open exterior doors as a smart practice.	2010 ADAS Section: 404.2.3, 404.2.7, 404.2.4, 404.2.11, 404.2.11 Exception

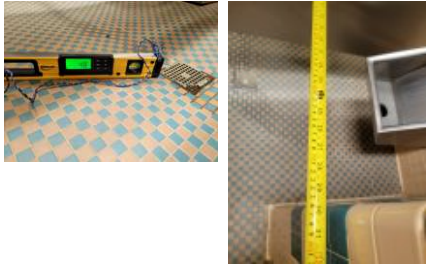
840	Johnson Branch Unit: Johnson - Juniper Cove Men's Restroom	[33.4185601 , -97.053455 2]	The accessible route contains running slopes greater than 5 percent and cross slopes greater than 2 percent across the width of the walk and has not been constructed as a ramp (i.e. handrails, wheel guides, etc.). When the slope in the direction of travel of any walk exceeds 1 unit vertical in 20 units horizontal (5-percent slope), it must be constructed as ramp. Surface cross slopes must not exceed one unit vertical in 48 units. Horizontal (2-percent slope).	4.8% slope at drain	Correct or repair slope to max 5% running and 2.08% cross	2015 ABAAS Section: 403.3 2012 TAS Section: 403.3 2010 ADAS Section: 403.3

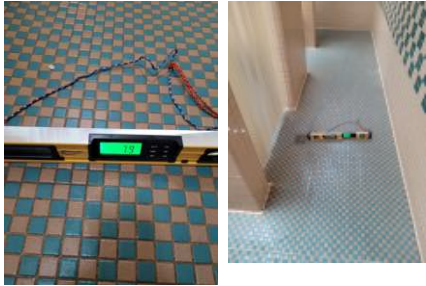
Finding Number	Area Description	Lat/Long	Finding	As Built	Recommendation	Citation	Photos	Figure
841	Johnson Branch Unit: Johnson - Juniper Cove Men's Restroom	[33.4185959 , -97.053444 5]	The accessible route contains running slopes greater than 5 percent and cross slopes greater than 2 percent across the width of the walk and has not been constructed as a ramp (i.e. handrails, wheel guides, etc.). When the slope in the direction of travel of any walk exceeds 1 unit vertical in 20 units horizontal (5-percent slope), it must be constructed as ramp. Surface cross slopes must not exceed one unit vertical in 48 units. Horizontal (2-percent slope).	7.9% slope at shower drain	Correct or repair slope to max 5% running and 2.08% cross	2015 ABAAS Section: 403.3 2012 TAS Section: 403.3 2010 ADAS Section: 403.3

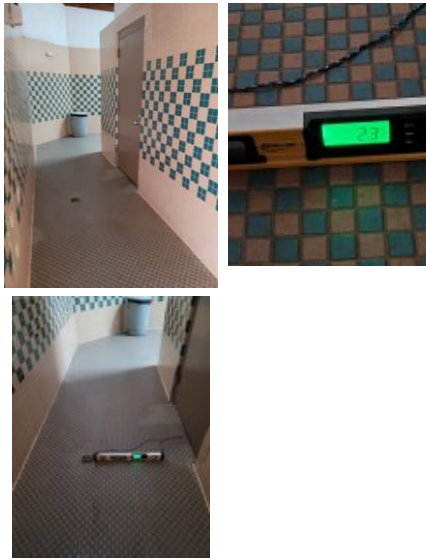
842	Johnson Branch Unit: Johnson - Juniper Cove Men's Restroom	[33.4186228 , -97.053412 3]	Spaces and elements within employee work areas shall only be required to comply with 206.2.8, 207.1, and 215.3 and shall be designed and constructed so that individuals with disabilities can approach, enter, and exit the employee work area. Employee work areas, or portions of employee work areas, other than raised courtroom stations, that are less than 300 square feet (28 m2) and elevated 7 inches (180 mm) or more above the finish floor or ground where the elevation is essential to the function of the space shall not be required to comply with these requirements or to be on an accessible route.	Employee door locked, knob hardware, 2.3% slope	For employee spaces, relocate storage, furniture, and other obstacles at doorways to provide approach, enter and exit at the employee space. Provide required maneuvering clearance on push and pull side of doors. Correct slope in door clearance to max 2.08%. Replace hardware with lever hardware or hardware operable without a tight pinch or grasp.	2015 ABAAS Section: F203.9 2012 TAS Section: 203.9 2010 ADAS Section: 203.9

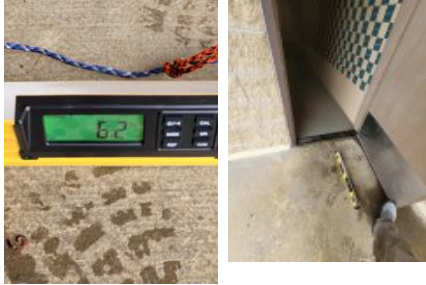
Finding Number	Area Description	Lat/Long	Finding	As Built	Recommendation	Citation	Photos	Figure
843	Johnson Branch Unit: Johnson - Juniper Cove Men's Restroom	[33.4185601 , -97.0534337]	Floor or ground surface within required maneuvering clearances shall comply with 302. Changes in level are not permitted. EXCEPTIONS: 1. Slopes not steeper than 1:48 shall be permitted. 2. Changes in level at thresholds complying with 404.2.5 shall be permitted.	Entry door - 6.2% slope on pull side	Correct or repair slope at doorway landing to max 2.08% in any direction for level	<p>2015 ABAAS Section: 404.2.4.4, 404.2.4.4 EX CEPTIONS: 1, 404.2.4.4 E XCEPTIONS: 2</p> <p>2012 TAS Section: 404.2.4.4, 404.2.4.4 Exception 1, 404.2.4.4 Exception 2</p> <p>2010 ADAS Section: 404.2.4.4, 404.2.4.4 Exception 1, 404.2.4.4 Exception 2</p>

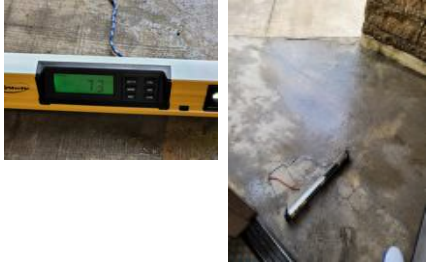
Finding Number	Area Description	Lat/Long	Finding	As Built	Recommendation	Citation	Photos	Figure
844	Johnson Branch Unit: Johnson - Juniper Cove Men's Restroom	[33.4185377 , -97.053444 5]	Floor or ground surface within required maneuvering clearances shall comply with 302. Changes in level are not permitted. EXCEPTIONS: 1. Slopes not steeper than 1:48 shall be permitted. 2. Changes in level at thresholds complying with 404.2.5 shall be permitted.	7.3% slope on pull side	Correct or repair slope at doorway landing to max 2.08% in any direction for level	<p>2015 ABAAS Section: 404.2.4.4, 404.2.4.4 EX CEPTIONS: 1, 404.2.4.4 E XCEPTIONS: 2</p> <p>2012 TAS Section: 404.2.4.4, 404.2.4.4 Exception 1, 404.2.4.4 Exception 2</p> <p>2010 ADAS Section: 404.2.4.4, 404.2.4.4 Exception 1, 404.2.4.4 Exception 2</p>
