Access Audit Site Report

Ray Roberts Lake State Park/Complex

Accessibility Evaluation

Inspection Date: 10/18/2021

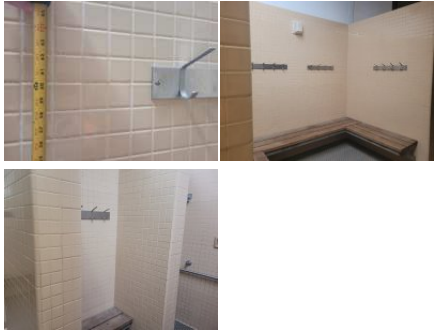
Finding Number	Area Description	Lat/Long	Finding	As Built	Recommendation	Citation	Photos	Figure
845	Johnson Branch Unit: Johnson - Juniper Cove Women's Restroom	[33.418569, -97.053412 3]	Coat hooks provided within the room shall be located within one of the reach ranges specified in 308. Shelves shall be 40 inches (1015 mm) minimum and 48 inches (1220 mm) maximum above the finish floor or ground. Where coat hooks or shelves are provided in dressing, fitting or locker rooms without individual compartments, at least one of each type shall comply with 803.5. Where coat hooks or shelves are provided in individual compartments at least one of each type complying with 803.5 shall be provided in individual compartments in dressing, fitting, or locker rooms required to comply with 222.1.	Hooks 59" above finish floor and located over benches	Add at least one hook at max 48" AFF mounted in an area not obstructed by benches.	2015 ABAAS Section: 308.2.1, 308.1, F222.2, 803.5 2012 TAS Section: 308.2.1, 308.1, 222.2, 803.5 2010 ADAS Section: 308.2.1, 308.1, 222.2, 803.5

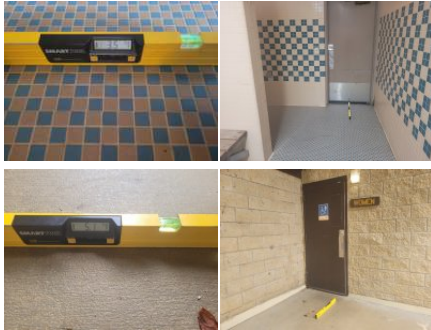
851	Johnson Branch Unit: Johnson - Juniper Cove Women's Restroom	[33.4185343 , -97.053449 3]	Minimum maneuvering clearances at doors and gates shall comply with 404.2.4. Maneuvering clearances shall extend the full width of the doorway and the required latch side or hinge side clearance. Door openings shall provide a clear width of 32 inches (815 mm) minimum. Clear openings of doorways with swinging doors shall be measured between the face of the door and the stop, with the door open 90 degrees. Openings more than 24 inches (610 mm) deep shall provide a clear opening of 36 inches (915 mm) minimum. There shall be no projections into the required clear opening width lower than 34 inches (865 mm) above the finish floor or ground. Projections into the clear opening width between 34 inches (865 mm) and 80 inches (2030 mm) above the finish floor or ground shall not exceed 4 inches (100 mm). The threshold has a vertical change greater than 1/4 inch high. The threshold at a doorway shall be no higher than 1/2 inch. Changes in level between 1/4 inch and 1/2 inch must be beveled at 1:2 or less. 1/4 inch is the maximum vertical rise. All interior doors	Women's shower- 3.5%, 5.1% slopes, closes fast	For all doors along the public circulation route, correct ground or floor slope on push and pull side of doors to max 2.08%. For all doors along the public circulation route, inspect, adjust, and maintain closing speed on door closers.	2010 ADAS Section: 404.2.3, 404.2.7, 404.2.4, 404.2.11, 404.2.11 Exception

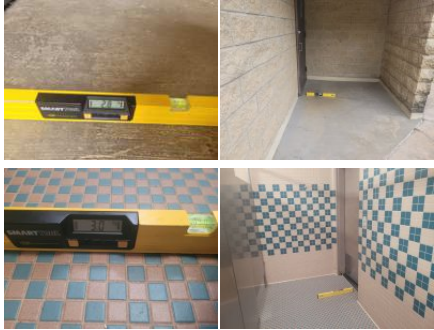
Finding Number	Area Description	Lat/Long	Finding	As Built	Recommendation	Citation	Photos	Figure
852	Johnson Branch Unit: Johnson - Juniper Cove Women's Restroom	[33.41848, -97.05341]	<p>Minimum maneuvering clearances at doors and gates shall comply with 404.2.4. Maneuvering clearances shall extend the full width of the doorway and the required latch side or hinge side clearance. Door openings shall provide a clear width of 32 inches (815 mm) minimum. Clear openings of doorways with swinging doors shall be measured between the face of the door and the stop, with the door open 90 degrees. Openings more than 24 inches (610 mm) deep shall provide a clear opening of 36 inches (915 mm) minimum. There shall be no projections into the required clear opening width lower than 34 inches (865 mm) above the finish floor or ground. Projections into the clear opening width between 34 inches (865 mm) and 80 inches (2030 mm) above the finish floor or ground shall not exceed 4 inches (100 mm). The threshold has a vertical change greater than 1/4 inch high. The threshold at a doorway shall be no higher than 1/2 inch. Changes in level between 1/4 inch and 1/2 inch must be beveled at 1:2 or less. 1/4 inch is the maximum vertical rise. All interior doors must be maintained so that the operating pressure does not exceed 5 lb. force to open. The sweep period for doors with closers shall be adjusted so that from an open position of 70 degrees, the door will take at least 3 seconds to move to a point 3 inches from the latch, measured to the leading edge of the door. Exterior doors are recommended to be maintained at 8.5 lbf as a smart practice. Force is to be measured at the operating hardware or 30 inches from the hinges, whichever is greater. Hand-activated door opening hardware, handles, pulls, latches, locks, and other operating devices on accessible doors shall have a shape that is easy to grasp with one hand and does not require tight grasping, tight pinching or twisting of the wrist to operate. Hardware shall be 34 inches minimum and 48 inches maximum above the finish floor or</p>	Women's restroom- 2.8%, 3% slopes, closes fast	For all doors along the public circulation route, correct slope at floor or ground on push and pull side of doors to max 2.08%. For all doors along the public circulation route, inspect, adjust, and maintain closing speed on door closers.	2010 ADAS Section: 404.2.3, 404.2.7, 404.2.4, 404.2.11, 404.2.11 Exception

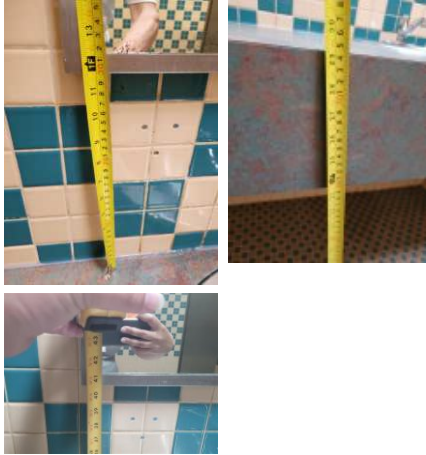
Finding Number	Area Description	Lat/Long	Finding	As Built	Recommendation	Citation	Photos	Figure
			ground. The bottom 10 inches on the push side must be smooth and free of obstructions (hold open devices). Opening hardware must be mounted between 30 and 44 inches above the floor or ground. Doors, gates, and side lights adjacent to doors or gates, containing one or more glazing panels that permit viewing through the panels shall have the bottom of at least one glazed panel located 43 inches (1090 mm) maximum above the finish floor. EXCEPTION: Vision lights with the lowest part more than 66 inches (1675 mm) from the finish floor or ground shall not be required to comply with 404.2.11.					
853	Johnson Branch Unit: Johnson - Juniper Cove Women's Restroom	[33.418569, -97.053444 5]	The mirror is mounted too high. Mirrors must have the bottom edge of the reflecting surface a maximum of 40 inches above the floor if above a sink or counter. Mirrors not located above lavatories or countertops shall be installed with the bottom edge of the reflecting surface 35 inches maximum above the finish floor or ground.	41.5" to bottom	Lower mirror so reflective surface is max 40" AFF.	2015 ABAAS Section: 603.3 2012 TAS Section: 603.3 2010 ADAS Section: 603.3

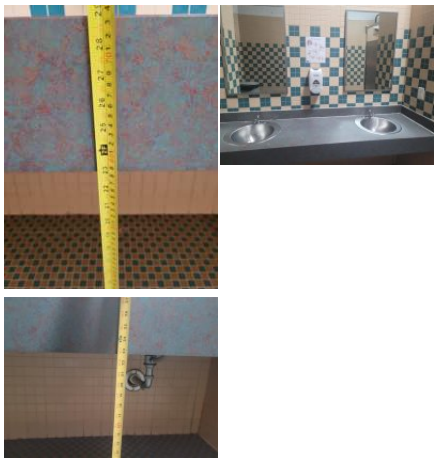
Finding Number	Area Description	Lat/Long	Finding	As Built	Recommendation	Citation	Photos	Figure
854	Johnson Branch Unit: Johnson - Juniper Cove Women's Restroom	[33.4185869 , -97.053390 8]	Knee clearance at 27 inches off the floor is not 8 inches minimum deep. The knee clearance, measured from the bottom of the apron or the outside bottom edge of the lavatory, must be 27 inches at a point located 8 inches back from the front edge and continuing to 11 inches minimum in depth at 9 inches above the floor. The top of the lavatory rim may be no higher than 34 inches.	23" knee clearance at sink	Replace counter with one providing 27" knee clearance that is a min 8" deep.	2015 ABAAS Section: 306.3.1, 306.3.2, 306.3.3, 306.3.4 , 306.3.5 2012 TAS Section: 306.3.2, 306.3.3, 306.3.4, 306.3.5, 306.3.1 2010 ADAS Section: 306.3.3, 306.3.2, 306.3.4, 306.3.5, 306.3.1

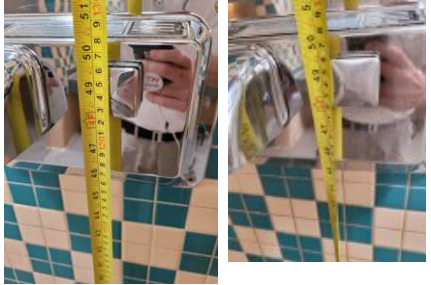
Finding Number	Area Description	Lat/Long	Finding	As Built	Recommendation	Citation	Photos	Figure
856	Johnson Branch Unit: Johnson - Juniper Cove Women's Restroom	[33.418569, -97.053444 5]	Where a high forward reach is over an obstruction, the clear floor space shall extend beneath the element for a distance not less than the required reach depth over the obstruction. The high forward reach shall be 48 inches (1220 mm) maximum where the reach depth is 20 inches (510 mm) maximum. Where the reach depth exceeds 20 inches (510 mm), the high forward reach shall be 44 inches (1120 mm) maximum and the reach depth shall be 25 inches (635 mm) maximum. Where a clear floor or ground space allows a parallel approach to an element and the high side reach is over an obstruction, the height of the obstruction shall be 34 inches (865 mm) maximum and the depth of the obstruction shall be 24 inches (610 mm) maximum. The high side reach shall be 48 inches (1220 mm) maximum for a reach depth of 10 inches (255 mm) maximum. Where the reach depth exceeds 10 inches (255 mm), the high side reach shall be 46 inches (1170 mm) maximum for a reach depth of 24 inches (610 mm) maximum.	49" above finish floor to dryer button	Lower hand dryer to max 48" aff to highest operable part, in the alternative, leave as is citing safe harbor.	2015 ABAAS Section: 308.2.1, 308.3.2 2012 TAS Section: 308.2.1, 308.3.2 2010 ADAS Section: 308.2.1, 308.3.2

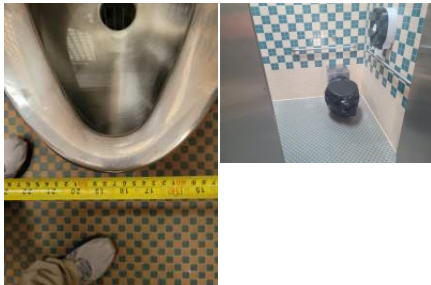
857	Johnson Branch Unit: Johnson - Juniper Cove Women's Restroom	[33.4185601, -97.053417 6]	The toilet is not located within the range allowed from the side wall or partition. The centerline of the toilet must be 16 to 18 inches from the side wall.	18.5" to centerline of toilet	Remount toilets to 16" to 18" from the side wall to centerline. In the alternative, leave as is citing construction tolerance.	2015 ABAAS Section: 604.2 2012 TAS Section: 604.2 2010 ADAS Section: 604.2

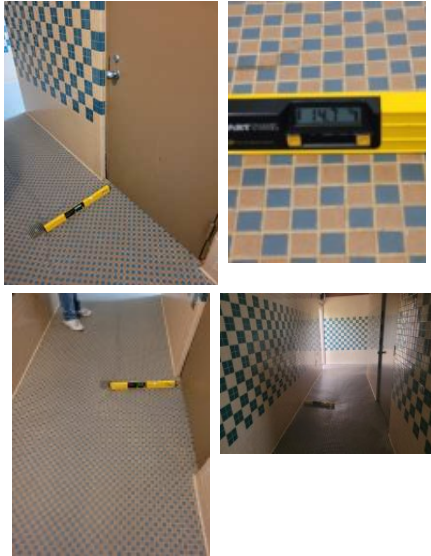
Finding Number	Area Description	Lat/Long	Finding	As Built	Recommendation	Citation	Photos	Figure																																								
863	Johnson Branch Unit: Johnson - Juniper Cove Women's Restroom	[33.418569, -97.053423]	Spaces and elements within employee work areas shall only be required to comply with 206.2.8, 207.1, and 215.3 and shall be designed and constructed so that individuals with disabilities can approach, enter, and exit the employee work area. Employee work areas, or portions of employee work areas, other than raised courtroom stations, that are less than 300 square feet (28 m2) and elevated 7 inches (180 mm) or more above the finish floor or ground where the elevation is essential to the function of the space shall not be required to comply with these requirements or to be on an accessible route.	Maintenance/Pipe chase - Door locked, knob hardware, 14.7% slope at pull side	For employee spaces, relocate storage, furniture, and other obstacles at doorways to provide approach, enter and exit at the employee space. Correct slope in door clearance to max 2.08%. Replace hardware with lever hardware or hardware operable without a tight pinch or grasp.	2015 ABAAS Section: F203.9 2012 TAS Section: 203.9 2010 ADAS Section: 203.9

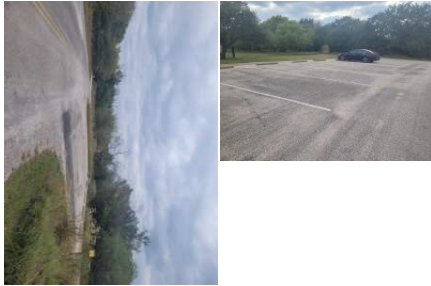
Finding Number	Area Description	Lat/Long	Finding	As Built	Recommendation	Citation	Photos	Figure
868	Johnson Branch Unit: Johnson - Walnut Parking	[33.4154974 , -97.049965 6]	The van stall is missing a sign identifying it as a van accessible stall. Parking space identification signs shall include the International Symbol of Accessibility. Signs identifying van parking spaces shall contain the designation "van accessible."	Restroom - 15 total, none marked accessible, access aisle present	Add one van parking sign to van accessible stall and ensure stall and access aisle are 11' and 5' or 8' and 8'.	2015 ABAAS Section: 502.6 2012 TAS Section: 502.6 2010 ADAS Section: 502.6

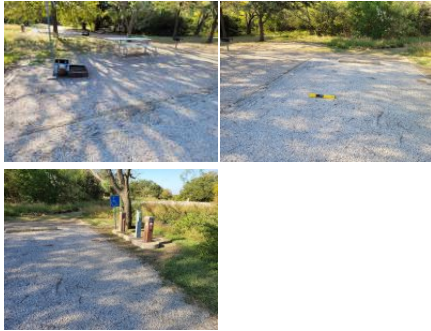
869	Johnson Branch Unit: Johnson - Walnut Campsite 40	[33.4155064 , -97.049732 3]	An accessible access route is not provided between elements, spaces and the facilities provided within the accessible camping unit. At least one outdoor recreation access route shall connect accessible elements, spaces and facilities provided within camping units with mobility features.	Site 40 - Lacks accessible route to any elements	Create outdoor recreation accessible route with crushed and compacted stone or similar outdoor material to camp sites and one of each type of amenity as a smart practice.	2015 ABAAS Section: F244.5.1

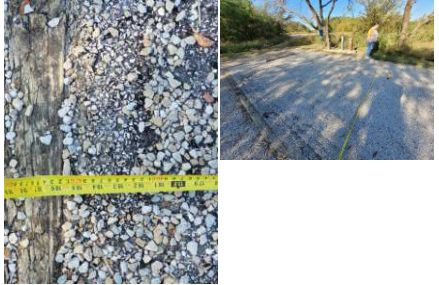
Finding Number	Area Description	Lat/Long	Finding	As Built	Recommendation	Citation	Photos	Figure
874	Johnson Branch Unit: Johnson - Walnut Campsite 40	[33.4155825 , -97.049667 9]	Parking spaces and pull-up spaces for recreational vehicles shall be 20 feet (6100 mm) wide minimum. EXCEPTION: Where two adjacent parking spaces are provided for recreational vehicles, one parking space shall be permitted to be 16 feet (4880 mm) wide minimum.	Site 40 - RV stall only 15.5' wide	Correct RV parking space to be 20' wide minimum as a smart practice.	2015 ABAAS Section: 1012.2, 1012.2 EXCEPTION

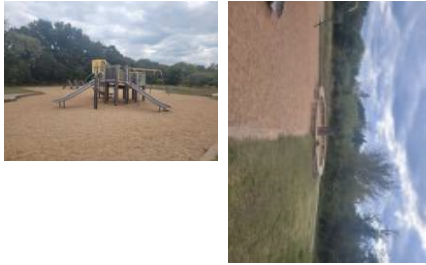
Finding Number	Area Description	Lat/Long	Finding	As Built	Recommendation	Citation	Photos	Figure																													
882	Johnson Branch Unit: Johnson - Walnut Playground	[33.414575, -97.050907 1]	A minimum of one of each type of ground level play components is not on an accessible route. Where ground level play components are provided, at least one of each type shall be on an accessible route and shall comply.	no route to 2 climbers only (no swings, other feature broken), sand surface	See previous finding for surface replacement.	2012 TAS Section: 240.2.1.1 2010 ADAS Section: 240.2.1.1

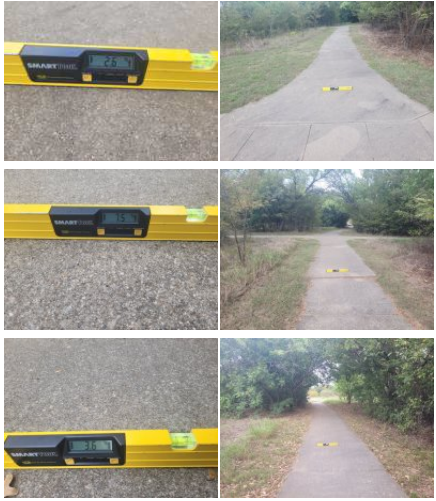
Finding Number	Area Description	Lat/Long	Finding	As Built	Recommendation	Citation	Photos	Figure
886	Johnson Branch Unit: Johnson - Walnut Playground	[33.4147, -97.05077]	The accessible route of travel contains cross slopes greater than 2%. Cross slopes shall not exceed one unit vertical in 48 units horizontal (2-percent slope).	2.6% at play area, 7.5% from trail near play area, 3.6% between parking and trail	Correct or repair cross slope along AR to max 2.08%.	2015 ABAAS Section: 403.3 2012 TAS Section: 403.3 2010 ADAS Section: 403.3

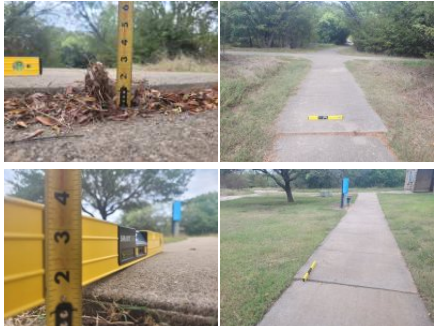
887	Johnson Branch Unit: Johnson - Walnut Playground	[33.41483, -97.05077]	The walkway contains abrupt vertical edges and/or variations over a 1/4 inch. 1/4 inch is the maximum vertical rise. Changes in level between 1/4 inch and 1/2 inch must be beveled at 1:2 or less. Changes in level greater than 1/2 inch must be by way of a ramp.	1.25" from trail to playground, 1.25" near restroom area	Repair, bevel or ramp change in level along route.	2012 TAS Section: 303.2, 303.3 2010 ADAS Section: 303.2, 303.3

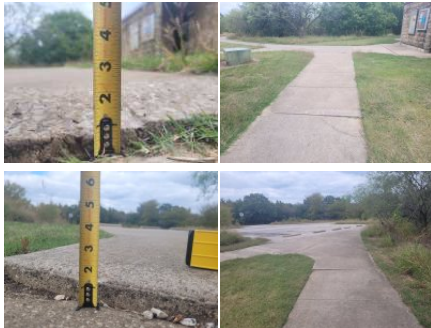
890	Johnson Branch Unit: Johnson - Walnut Men's Restroom	[33.41524, -97.05031]	The walkway contains abrupt vertical edges and/or variations over a 1/4 inch. 1/4 inch is the maximum vertical rise. Changes in level between 1/4 inch and 1/2 inch must be beveled at 1:2 or less. Changes in level greater than 1/2 inch must be by way of a ramp.	.75" where previously ground, 1.25" to parking	Repair, bevel or ramp changes in level along route.	2012 TAS Section: 303.2, 303.3 2010 ADAS Section: 303.2, 303.3

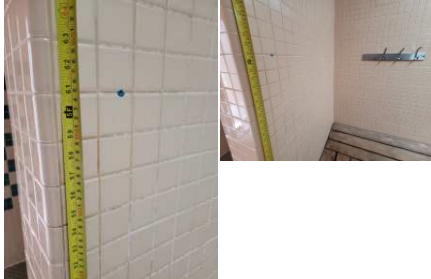
891	Johnson Branch Unit: Johnson - Walnut Men's Restroom	[33.4151123, -97.0501614]	Coat hooks provided within the room shall be located within one of the reach ranges specified in 308. Shelves shall be 40 inches (1015 mm) minimum and 48 inches (1220 mm) maximum above the finish floor or ground. Where coat hooks or shelves are provided in dressing, fitting or locker rooms without individual compartments, at least one of each type shall comply with 803.5. Where coat hooks or shelves are provided in individual compartments at least one of each type complying with 803.5 shall be provided in individual compartments in dressing, fitting, or locker rooms required to comply with 222.1.	59" to hooks	Remount at least one hook to max 48" aff.	2015 ABAAS Section: 308.2.1, 308.1, F222.2, 803.5 2012 TAS Section: 308.2.1, 308.1, 222.2, 803.5 2010 ADAS Section: 308.2.1, 308.1, 222.2, 803.5

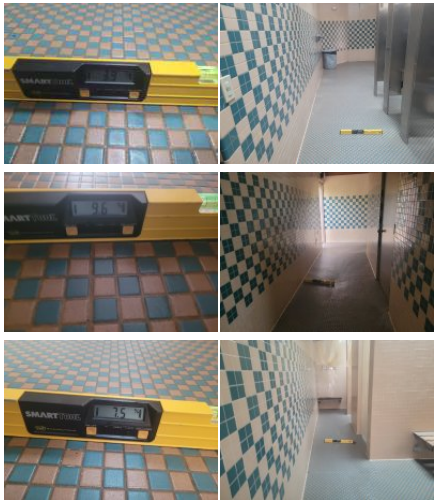
909	Johnson Branch Unit: Johnson - Walnut Women's Restroom	[33.4151481 , -97.050193 6]	The accessible route contains running slopes greater than 5 percent and cross slopes greater than 2 percent across the width of the walk and has not been constructed as a ramp (i.e. handrails, wheel guides, etc.). When the slope in the direction of travel of any walk exceeds 1 unit vertical in 20 units horizontal (5-percent slope), it must be constructed as ramp. Surface cross slopes must not exceed one unit vertical in 48 units. Horizontal (2-percent slope).	3.9% slope at toilets, 9.6% slope at chase, 7.5% slope at shower	Correct or repair slope to max 5% running and 2.08% cross	2015 ABAAS Section: 403.3 2012 TAS Section: 403.3 2010 ADAS Section: 403.3

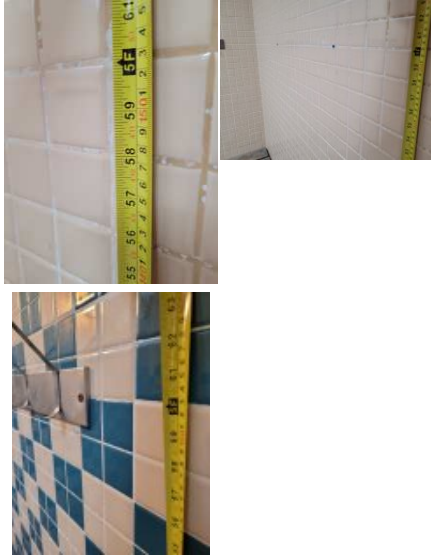
Finding Number	Area Description	Lat/Long	Finding	As Built	Recommendation	Citation	Photos	Figure
912	Johnson Branch Unit: Johnson - Walnut Women's Restroom	[33.415119, -97.050215 1]	Coat hooks provided within the room shall be located within one of the reach ranges specified in 308. Shelves shall be 40 inches (1015 mm) minimum and 48 inches (1220 mm) maximum above the finish floor or ground. Where coat hooks or shelves are provided in dressing, fitting or locker rooms without individual compartments, at least one of each type shall comply with 803.5. Where coat hooks or shelves are provided in individual compartments at least one of each type complying with 803.5 shall be provided in individual compartments in dressing, fitting, or locker rooms required to comply with 222.1.	58 inches above finish floor to coat hooks	Remount at least one hook to max 48" aff	2015 ABAAS Section: 308.2.1, 308.1, F222.2, 803.5 2012 TAS Section: 308.2.1, 308.1, 222.2, 803.5 2010 ADAS Section: 308.2.1, 308.1, 222.2, 803.5

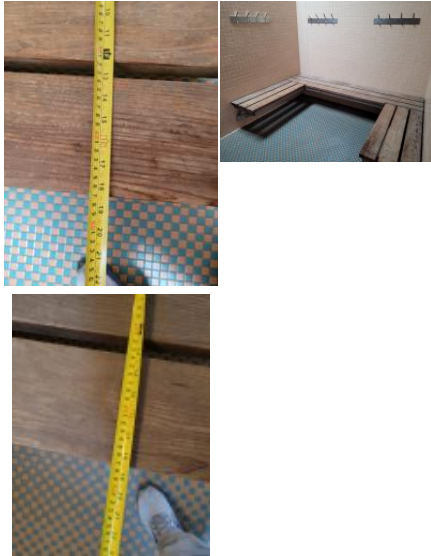
913	Johnson Branch Unit: Johnson - Walnut Women's Restroom	[33.4150944, -97.050193 6]	The bench is not deep enough or long enough or is missing. Benches shall be provided having seats that are 42 inches long minimum and 20 inches deep minimum and 24 inches deep maximum. The bench shall provide for back support or shall be affixed to a wall. Back support shall be 42 inches (1065 mm) long minimum and shall extend from a point 2 inches (51 mm) maximum above the seat surface to a point 18 inches (455 mm) minimum above the seat surface. Back support shall be 2½ inches (64 mm) maximum from the rear edge of the seat measured horizontally. The top of the bench seat surface shall be 17 inches (430 mm) minimum and 19 inches (485 mm) maximum above the finish floor or ground. Clear floor or ground space complying with 305 shall be provided and shall be positioned at the end of the bench seat and parallel to the short axis of the bench	bench is 18.5" deep	Replace bench in dressing area with one having a seat depth of 20" to 24" deep, 42" long, affixed to the wall or having a back and mounted 17" to 19" AFF and provide required clear floor space on the short axis of the bench.	2012 TAS Section: 903.4, 903.2, 903.3, 903.5 2010 ADAS Section: 903.4, 903.2, 903.3, 903.5

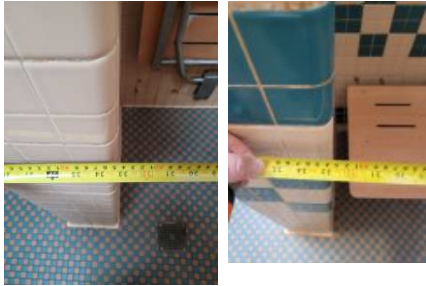
Finding Number	Area Description	Lat/Long	Finding	As Built	Recommendation	Citation	Photos	Figure
914	Johnson Branch Unit: Johnson - Walnut Women's Restroom	[33.4151213 , -97.0502097]	Alternate roll-in type shower compartments shall be 36 inches (915 mm) wide and 60 inches (1525 mm) deep minimum clear inside dimensions measured at center points of opposing sides. A 36 inch (915 mm) wide minimum entry shall be provided at one end of the long side of the compartment.	Shower is only 33.5 inches wide	Enlarge shower stall, if feasible, to compliant dimensions for an alternate roll in shower of 36" deep by 60" wide with a 36" opening on the long dimension	2015 ABAAS Section: 608.2.3 2012 TAS Section: 608.2.3 2010 ADAS Section: 608.2.3

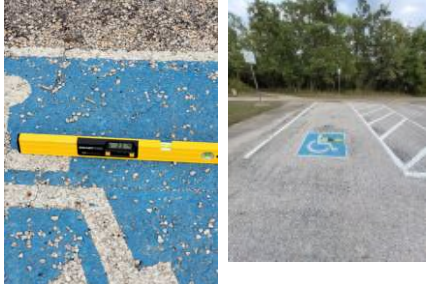
918	Johnson Branch Unit: Johnson - Willow Cove Parking	[33.4118256 , -97.046046 9]	The cross slopes (narrow dimension) and/or running slopes (long dimension) of the access aisle exceeds 2%. The running slope and the cross slope in an accessible parking stall and the access aisle must not exceed 2%.	2.3% slope	Repair or correct slope of parking space and access aisle to max 2.08% in any direction	2015 ABAAS Section: 502.4 2012 TAS Section: 502.4 2010 ADAS Section: 502.4

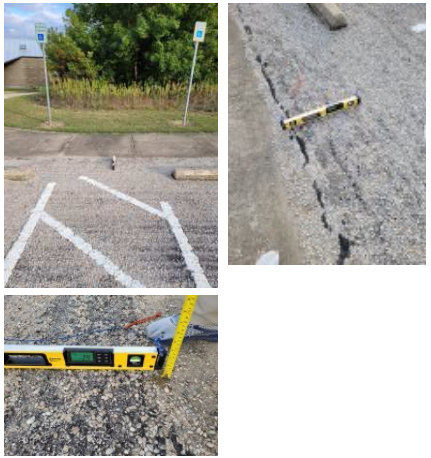
Finding Number	Area Description	Lat/Long	Finding	As Built	Recommendation	Citation	Photos	Figure
925	Johnson Branch Unit: Johnson - Nature Center Parking	[33.4102472 , -97.0473317]	Element meets all standards and requirements	Parking lot complies with scoping - 97 standards stalls, 5 accessible	None	2010 ADAS Section: N/A		
926	Johnson Branch Unit: Johnson - Nature Center Parking	[33.4101151 , -97.0474256]	The cross slopes (narrow dimension) and/or running slopes (long dimension) of the access aisle exceeds 2%. The running slope and the cross slope in an accessible parking stall and the access aisle must not exceed 2%.	Slopes: 2.9%, 2.2%	Repair or correct slope of parking space and access aisle to max 2.08% in any direction.	2015 ABAAS Section: 502.4 2012 TAS Section: 502.4 2010 ADAS Section: 502.4

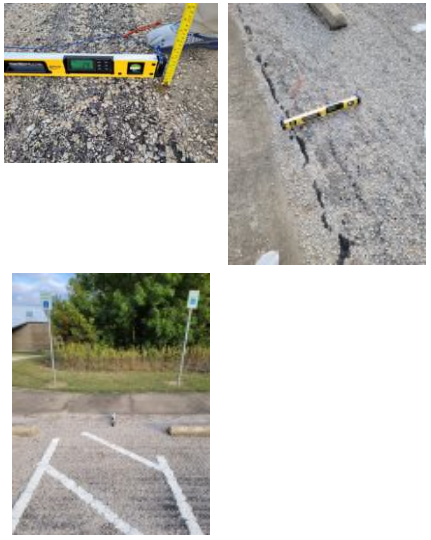
927	Johnson Branch Unit: Johnson - Nature Center Parking	[33.410236, -97.0473532]	The parking stall contains abrupt edges and surface irregularities over a 1/4 inch vertical. Parking spaces and access aisles serving them shall be stable, firm, and slip resistant. Access aisles shall be at the same level as the parking spaces they serve. Changes in level are not permitted and shall not be sloped steeper than 2% in any direction.	Many changes in level locations (loose gravel from binder) access aisle to AR, 2.9%, 2.2%, 1" CIL typical	Resurface accessible stalls and access aisles with a firm, stable, and slip resistant material.	2015 ABAAS Section: 502.4 2012 TAS Section: 502.4 2010 ADAS Section: 502.4

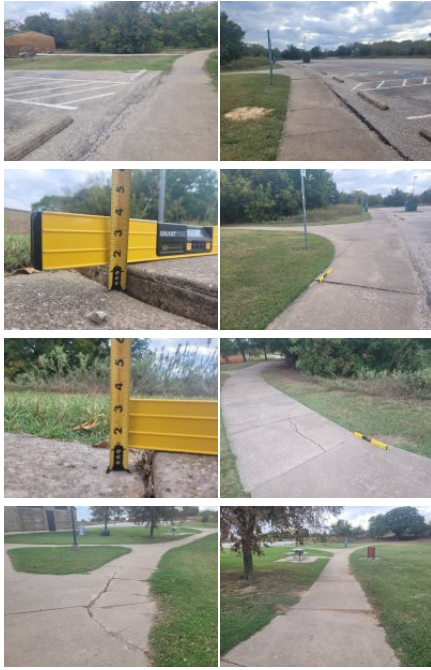
Finding Number	Area Description	Lat/Long	Finding	As Built	Recommendation	Citation	Photos	Figure
932	Johnson Branch Unit: Johnson - Nature Center Area	[33.41057, -97.04698]	The walkway contains abrupt vertical edges and/or variations over a 1/4 inch. 1/4 inch is the maximum vertical rise. Changes in level between 1/4 inch and 1/2 inch must be beveled at 1:2 or less. Changes in level greater than 1/2 inch must be by way of a ramp.	built up asphalt at head of parking aisles to sidewalk, 1.25" near restroom parking, 1" to restrooms, multiple near swimming beach picnic areas	Repair, bevel or ramp changes in level along route	2012 TAS Section: 303.2, 303.3 2010 ADAS Section: 303.2, 303.3

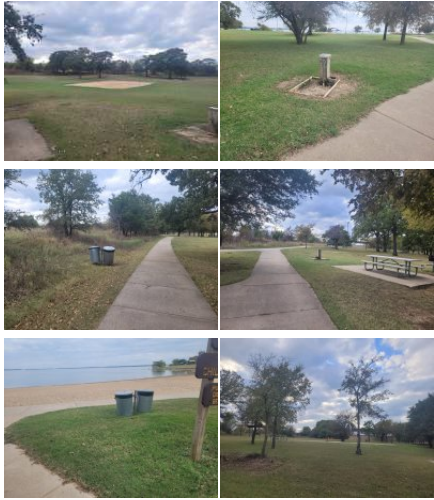
939	Johnson Branch Unit: Johnson - Nature Center Area	[33.4097434 , -97.046529 7]	Where picnic facilities contain two or fewer picnic units, each picnic unit shall provide mobility features complying with F245.2.	picnic areas near swimming beach (13) - Lacks route to two volleyball courts, lacks to water spouts, garbage cans	Extend an ORAR from shelter or picnic area to shelter features as a smart practice.	2015 ABAAS Section: F245.2.1

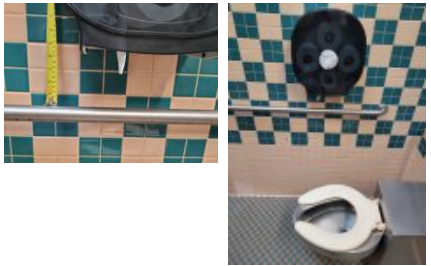
948	Johnson Branch Unit: Johnson - Willow Cove Men's Restroom	[33.4101419 , -97.047071 5]	The grab bar height and/or spacing fails. Grab bars must be mounted between 33" and 36" to the top of the gripping surface. There must be 1.5" of clearance between the grab bar and the wall. There must be a minimum of 1.5" of clearance below and minimum 12" above the grab bar to any dispenser or other obstruction.	4" between grab bar and toilet tissue dispenser, TP to close to toilet	Remount toilet paper dispenser max 7" to 9" from front of toilet, 15" to 48" aff and min 12" above or 1.5" below grab bar.	2015 ABAAS Section: 609.3, 609.4 2012 TAS Section: 609.4, 609.3 2010 ADAS Section: 609.3, 609.4

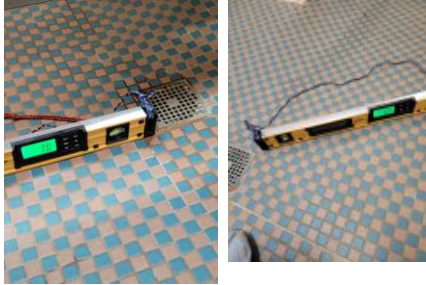
Finding Number	Area Description	Lat/Long	Finding	As Built	Recommendation	Citation	Photos	Figure
952	Johnson Branch Unit: Johnson - Willow Cove Men's Restroom	[33.4101509 , -97.0470608]	The accessible route contains running slopes greater than 5 percent and cross slopes greater than 2 percent across the width of the walk and has not been constructed as a ramp (i.e. handrails, wheel guides, etc.). When the slope in the direction of travel of any walk exceeds 1 unit vertical in 20 units horizontal (5-percent slope), it must be constructed as ramp. Surface cross slopes must not exceed one unit vertical in 48 units. Horizontal (2-percent slope).	3.0% slope to drain, 6.7% slope at shower area drain	Correct or repair slope to max 2.08%.	2015 ABAAS Section: 403.3 2012 TAS Section: 403.3 2010 ADAS Section: 403.3

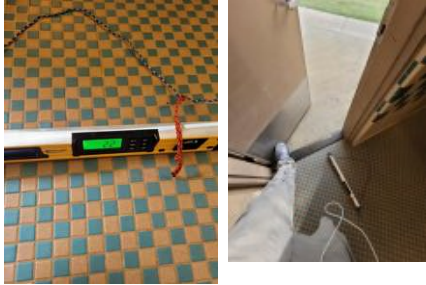
Finding Number	Area Description	Lat/Long	Finding	As Built	Recommendation	Citation	Photos	Figure
960	Johnson Branch Unit: Johnson - Willow Cove Men's Restroom	[33.4101598 , -97.047050 1]	The accessible route contains running slopes greater than 5 percent and cross slopes greater than 2 percent across the width of the walk and has not been constructed as a ramp (i.e. handrails, wheel guides, etc.). When the slope in the direction of travel of any walk exceeds 1 unit vertical in 20 units horizontal (5-percent slope), it must be constructed as ramp. Surface cross slopes must not exceed one unit vertical in 48 units. Horizontal (2-percent slope).	2.3% slope	Correct or repair slope to max and 2.08%. In the alternative, leave as is citing construction tolerance.	2015 ABAAS Section: 403.3 2012 TAS Section: 403.3 2010 ADAS Section: 403.3

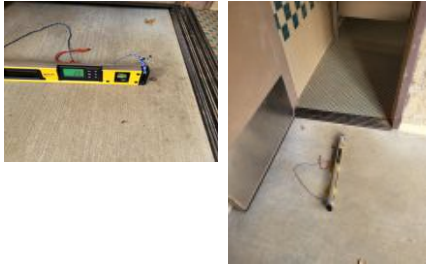
961	Johnson Branch Unit: Johnson - Willow Cove Men's Restroom	[33.4101509 , -97.047028 6]	Minimum maneuvering clearances at doors and gates shall comply with 404.2.4. Maneuvering clearances shall extend the full width of the doorway and the required latch side or hinge side clearance.	Door - 2.9% slope in pull side clearance	Provide required maneuvering clearance around pull side of door. Correct slope in door clearance to max 2.08%.	2015 ABAAS Section: 404.2.4.1 , 404.2.4.4 2012 TAS Section: 404.2.4.4, 404.2.4.1 2010 ADAS Section: 404.2.4.4, 404.2.4.1

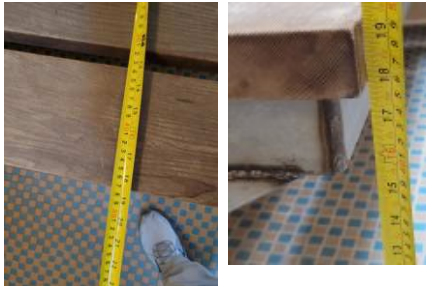
964	Johnson Branch Unit: Johnson - Willow Cove Women's Restroom	[33.4101419 , -97.047050 1]	The bench is not deep enough or long enough or is missing. Benches shall be provided having seats that are 42 inches long minimum and 20 inches deep minimum and 24 inches deep maximum. The bench shall provide for back support or shall be affixed to a wall. Back support shall be 42 inches (1065 mm) long minimum and shall extend from a point 2 inches (51 mm) maximum above the seat surface to a point 18 inches (455 mm) minimum above the seat surface. Back support shall be 2½ inches (64 mm) maximum from the rear edge of the seat measured horizontally. The top of the bench seat surface shall be 17 inches (430 mm) minimum and 19 inches (485 mm) maximum above the finish floor or ground. Clear floor or ground space complying with 305 shall be provided and shall be positioned at the end of the bench seat and parallel to the short axis of the bench	bench - 18.5" seat depth, 19.25" to seat height (near drain-floor slopes)	Replace bench in dressing area with one having a seat depth of 20" to 24" deep, 42" long, affixed to the wall or having a back and mounted 17" to 19" AFF and provide required clear floor space on the short axis of the bench.	2012 TAS Section: 903.4, 903.2, 903.3, 903.5 2010 ADAS Section: 903.4, 903.2, 903.3, 903.5

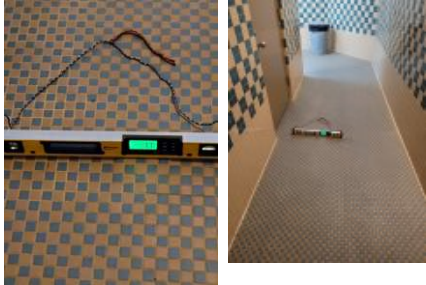
969	Johnson Branch Unit: Johnson - Willow Cove Women's Restroom	[33.4101598, -97.0470823]	Spaces and elements within employee work areas shall only be required to comply with 206.2.8, 207.1, and 215.3 and shall be designed and constructed so that individuals with disabilities can approach, enter, and exit the employee work area. Employee work areas, or portions of employee work areas, other than raised courtroom stations, that are less than 300 square feet (28 m2) and elevated 7 inches (180 mm) or more above the finish floor or ground where the elevation is essential to the function of the space shall not be required to comply with these requirements or to be on an accessible route.	Pipe Chase - door locked, knob hardware, 7.7% slope on pull side	For employee spaces, relocate storage, furniture, and other obstacles at doorways to provide approach, enter and exit at the employee space. Correct slope in door clearance to max 2.08%. Replace hardware with lever hardware or hardware operable without a tight pinch or grasp.	2015 ABAAS Section: F203.9 2012 TAS Section: 203.9 2010 ADAS Section: 203.9

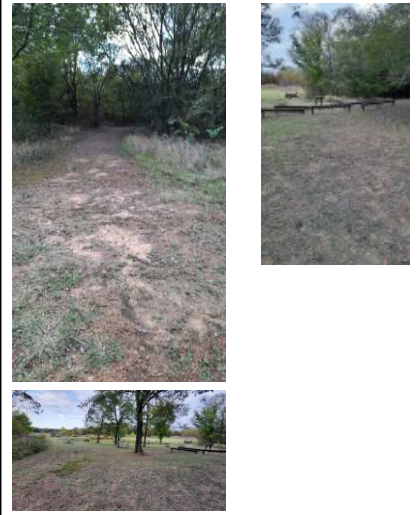
972	Johnson Branch Unit: Johnson - Kid Fish Pond	[33.4103748, -97.048747 9]	There is no accessible route to the fishing pond, tables, and benches. At least one accessible route shall connect accessible buildings, accessible facilities, accessible elements, and accessible spaces that are on the same site.	Dirt path to kids fishing pond and seating area, tables and benches	Create an accessible route with crushed stone or other outdoor material from parking or walkway to the fishing pond, tables, and benches.	2015 ABAAS Section: F206.2.2 2012 TAS Section: 206.2.2 2010 ADAS Section: 206.2.2

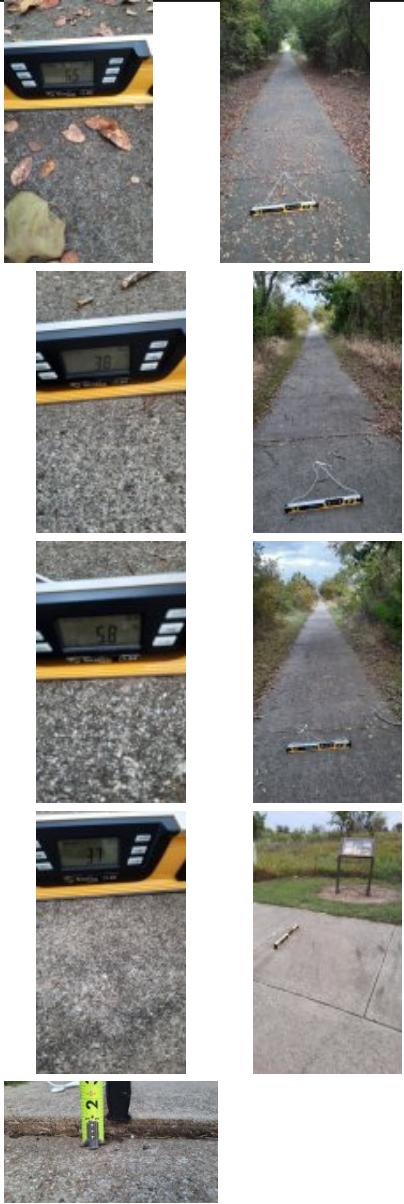
975	Johnson Branch Unit: Johnson - Kid Fish Pond Trail	[33.4095285 , -97.047878 9]	The cross slope shall not be steeper than 1:48. EXCEPTION: Where the surface is other than concrete, asphalt, or boards, cross slopes not steeper than 1:20 shall be permitted when necessary for drainage.	7.2% at entry, 4.9% past entry, 3.1% at turn, 3.3% at crossing, 6.5%, 3.8%, 5.8% near road, 3.7% at eco health sign	Correct or repair pathway cross slope to max 2.08% as a smart practice.	2015 ABAAS Section: 1017.2

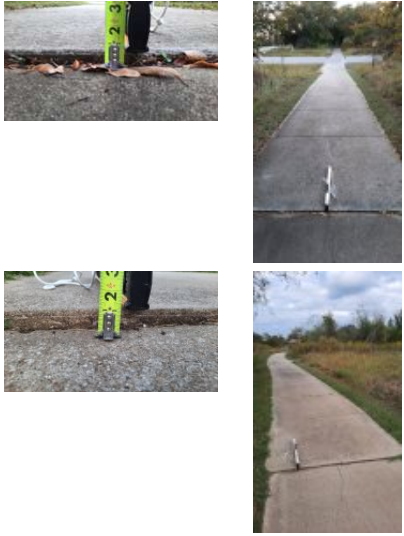
Finding Number	Area Description	Lat/Long	Finding	As Built	Recommendation	Citation	Photos	Figure
976	Johnson Branch Unit: Johnson - Kid Fish Pond Trail	[33.4095419 , -97.047929 8]	Tread obstacles on trails, passing spaces, and resting intervals shall not exceed 1/2 inch (13 mm) in height measured vertically to the highest point. EXCEPTION: Where the surface is other than asphalt, concrete, or boards, tread obstacles shall be permitted to not exceed 2 inches (50 mm) in height measured vertically to the highest point.	1" change in level (CIL) near road crossing, 1" just past eco health sign	Repair, bevel or ramp tread obstacle along pathway to max .5" as a smart practice.	2015 ABAAS Section: 1017.5

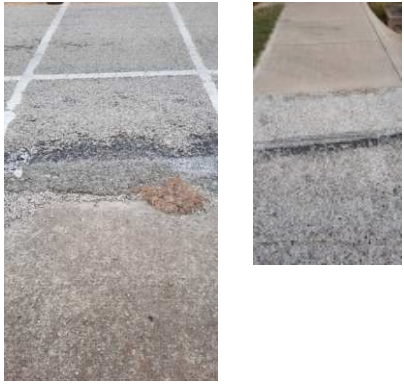
977	Johnson Branch Unit: Johnson - Kid Fish Pond Trail	[33.4095419 , -97.048080 1]	The surface of trails, passing spaces, and resting intervals shall be firm and stable	Surface at street crossing deteriorated on both sides	Resurface trail crossing to be firm and stable as a smart practice.	2015 ABAAS Section: 1017.2

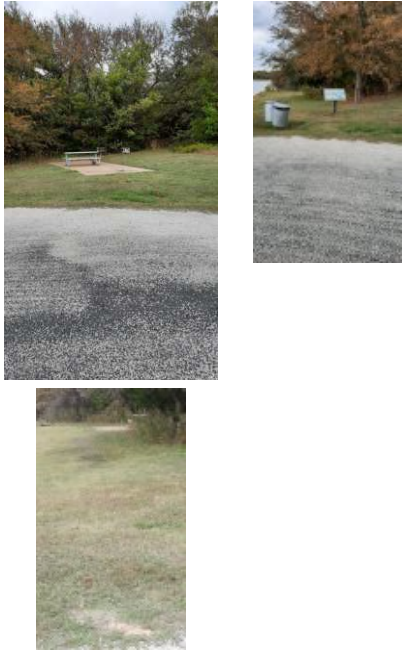
Finding Number	Area Description	Lat/Long	Finding	As Built	Recommendation	Citation	Photos	Figure
992	Johnson Branch Unit: Johnson - Boat Ramp	[33.4079746 , -97.049158 3]	There is no accessible route to the boat ramp, picnic table, and garbage. At least one accessible route shall connect accessible buildings, accessible facilities, accessible elements, and accessible spaces that are on the same site.	Picnic areas (3) at boat ramp lack route, sign and garbage off route; 1 of 5 complies	Create an accessible route with crushed stone or other outdoor material from parking or walkway to the boat ramp, picnic table, and garbage.	2015 ABAAS Section: F206.2.2 2012 TAS Section: 206.2.2 2010 ADAS Section: 206.2.2

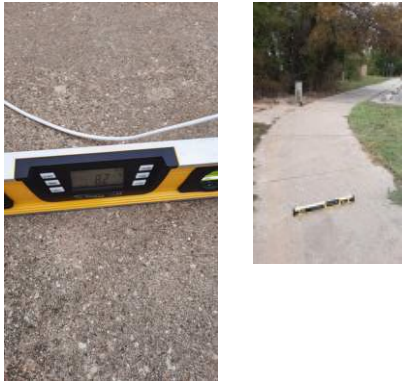
993	Johnson Branch Unit: Johnson - Boat Ramp	[33.4089586 , -97.049965 6]	The accessible route of travel contains cross slopes greater than 2%. Cross slopes shall not exceed one unit vertical in 48 units horizontal (2-percent slope).	8.2% from parking to picnic areas	Correct or repair cross slope along AR to max 2.08%.	2015 ABAAS Section: 403.3 2012 TAS Section: 403.3 2010 ADAS Section: 403.3

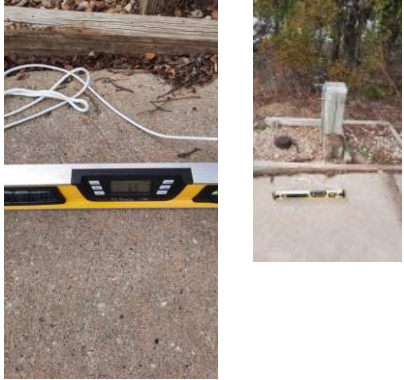
Finding Number	Area Description	Lat/Long	Finding	As Built	Recommendation	Citation	Photos	Figure
994	Johnson Branch Unit: Johnson - Boat Ramp	[33.4088355 , -97.049965 6]	The 30 inches minimum by 48 inches minimum clear floor space required at the operable part is not flat (2% or 1:48 maximum slope) in all directions. Changes in level are not permitted at required clear floor or ground space except that slopes not steeper than 1:48 shall be permitted.	clear ground space (CGS) at water spigot has 6.5% slope	Correct or repair slope in CGS to max 2.08%.	2015 ABAAS Section: 305.2 2012 TAS Section: 305.2 2010 ADAS Section: 305.2

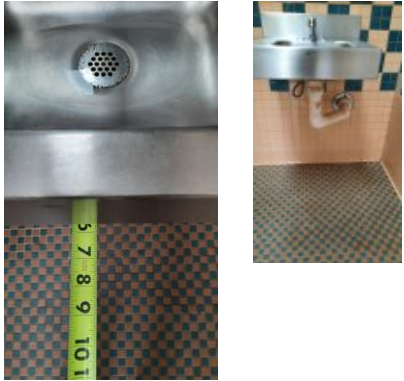
Finding Number	Area Description	Lat/Long	Finding	As Built	Recommendation	Citation	Photos	Figure
999	Johnson Branch Unit: Johnson - Boat Ramp Men's Restroom	[33.4091702 , -97.050086 3]	Knee clearance at 27 inches off the floor is not 8 inches minimum deep. The knee clearance, measured from the bottom of the apron or the outside bottom edge of the lavatory, must be 27 inches at a point located 8 inches back from the front edge and continuing to 11 inches minimum in depth at 9 inches above the floor. The top of the lavatory rim may be no higher than 34 inches.	Sink pipes prevent 8" knee clearance	Replace sink with one providing 27" knee clearance that is a min 8" deep.	2015 ABAAS Section: 306.3.1, 306.3.2, 306.3.3, 306.3.4 , 306.3.5 2012 TAS Section: 306.3.2, 306.3.3, 306.3.4, 306.3.5, 306.3.1 2010 ADAS Section: 306.3.3, 306.3.2, 306.3.4, 306.3.5, 306.3.1

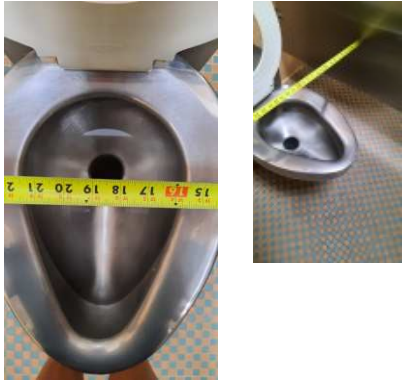
Finding Number	Area Description	Lat/Long	Finding	As Built	Recommendation	Citation	Photos	Figure
1001	Johnson Branch Unit: Johnson - Boat Ramp Men's Restroom	[33.4091904 , -97.0500702]	The toilet is not located within the range allowed from the side wall or partition. The centerline of the toilet must be 16 to 18 inches from the side wall.	toilet center line 18.5"	Remount toilets to 16" to 18" from the side wall to centerline. In the alternative, leave as is citing construction tolerance.	2015 ABAAS Section: 604.2 2012 TAS Section: 604.2 2010 ADAS Section: 604.2

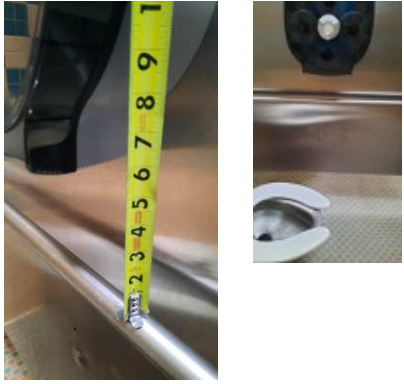
1003	Johnson Branch Unit: Johnson - Boat Ramp Men's Restroom	[33.4091635 , -97.050089]	The grab bar height and/or spacing fails. Grab bars must be mounted between 33" and 36" to the top of the gripping surface. There must be 1.5" of clearance between the grab bar and the wall. There must be a minimum of 1.5" of clearance below and minimum 12" above the grab bar to any dispenser or other obstruction.	TP too close above and too close to toilet	Remount toilet paper dispenser max 7" to 9" from front of toilet, 15" to 48" aff and min 12" above or 1.5" below grab bar.	2015 ABAAS Section: 609.3, 609.4 2012 TAS Section: 609.4, 609.3 2010 ADAS Section: 609.3, 609.4

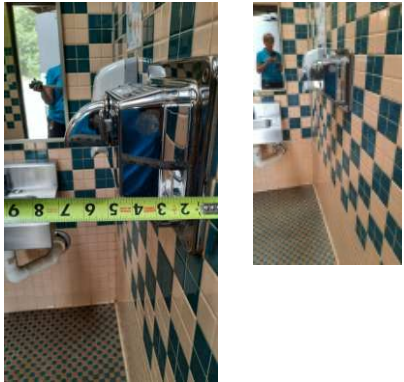
1005	Johnson Branch Unit: Johnson - Boat Ramp Men's Restroom	[33.4091702 , -97.050064 9]	The dryer projects more than 4 inches into the circulation path. Wall-mounted objects that have leading edges between 27 inches and 80 inches from the floor must not project more than 4 inches into the circulation path. Protruding objects that extend to the floor or within 27 inches of the floor are cane detectable and are therefore not hazardous. Where it is necessary or desirable to have objects protrude from the wall, a manner of cane detection must be provided.	Hand dryer protrudes	Relocate protruding objects or place cane detectable warning or bollard at foot of item.	2015 ABAAS Section: 307.2 2012 TAS Section: 307.2 2010 ADAS Section: 307.2

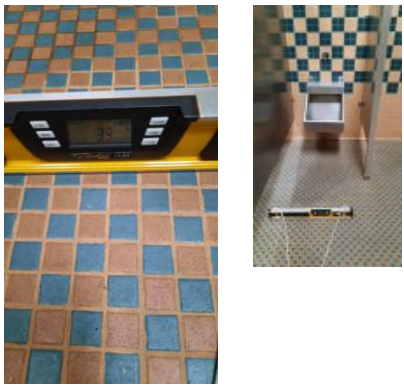
Finding Number	Area Description	Lat/Long	Finding	As Built	Recommendation	Citation	Photos	Figure
1006	Johnson Branch Unit: Johnson - Boat Ramp Men's Restroom	[33.4091881 , -97.050072 9]	The accessible route contains running slopes greater than 5 percent and cross slopes greater than 2 percent across the width of the walk and has not been constructed as a ramp (i.e. handrails, wheel guides, etc.). When the slope in the direction of travel of any walk exceeds 1 unit vertical in 20 units horizontal (5-percent slope), it must be constructed as ramp. Surface cross slopes must not exceed one unit vertical in 48 units. Horizontal (2-percent slope).	3.2% slope at urinal	Correct or repair slope to max 2.08%.	2015 ABAAS Section: 403.3 2012 TAS Section: 403.3 2010 ADAS Section: 403.3

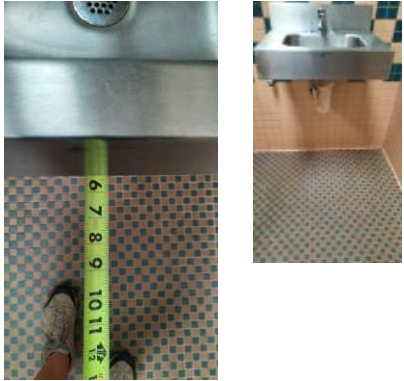
Finding Number	Area Description	Lat/Long	Finding	As Built	Recommendation	Citation	Photos	Figure
1009	Johnson Branch Unit: Johnson - Boat Ramp Women's Restroom	[33.4091724 , -97.050083 7]	Knee clearance at 27 inches off the floor is not 8 inches minimum deep. The knee clearance, measured from the bottom of the apron or the outside bottom edge of the lavatory, must be 27 inches at a point located 8 inches back from the front edge and continuing to 11 inches minimum in depth at 9 inches above the floor. The top of the lavatory rim may be no higher than 34 inches.	Pipe prevents 8" knee clearance	Replace sink with one providing 27" knee clearance that is a min 8" deep.	2015 ABAAS Section: 306.3.1, 306.3.2, 306.3.3, 306.3.4 , 306.3.5 2012 TAS Section: 306.3.2, 306.3.3, 306.3.4, 306.3.5, 306.3.1 2010 ADAS Section: 306.3.3, 306.3.2, 306.3.4, 306.3.5, 306.3.1

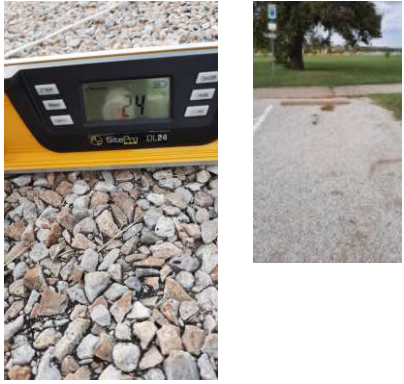
Finding Number	Area Description	Lat/Long	Finding	As Built	Recommendation	Citation	Photos	Figure
1030	Johnson Branch Unit: Johnson - Picnic Areas	[33.4078828 , -97.044569]	The cross slopes (narrow dimension) and/or running slopes (long dimension) of the access aisle exceeds 2%. The running slope and the cross slope in an accessible parking stall and the access aisle must not exceed 2%.	Picnic - 2.4% slope playground side stall	Repair or correct slope of parking space and access aisle to max 2.08% in any direction.	2015 ABAAS Section: 502.4 2012 TAS Section: 502.4 2010 ADAS Section: 502.4

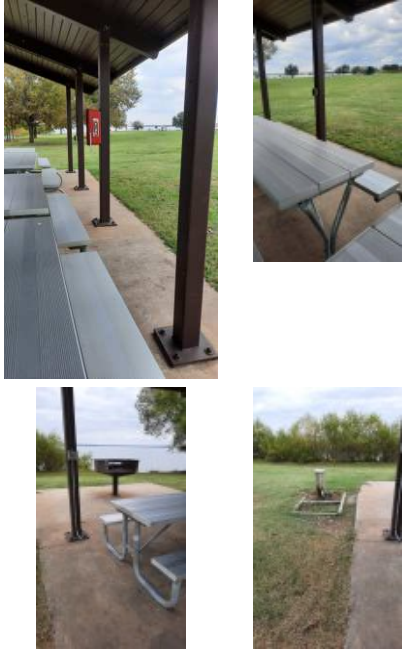
Finding Number	Area Description	Lat/Long	Finding	As Built	Recommendation	Citation	Photos	Figure
1033	Johnson Branch Unit: Johnson - Picnic Areas	[33.4080104 , -97.0441318]	Where picnic facilities contain two or fewer picnic units, each picnic unit shall provide mobility features complying with F245.2.	Pavilion 2 - route to fire extinguisher, outlet and grill blocked by tables, lacks connection to water spigot	Create an ORAR from shelter or picnic area to water spigot. Relocate picnic tables to provide route to elements as a smart practice.	2015 ABAAS Section: F245.2.1

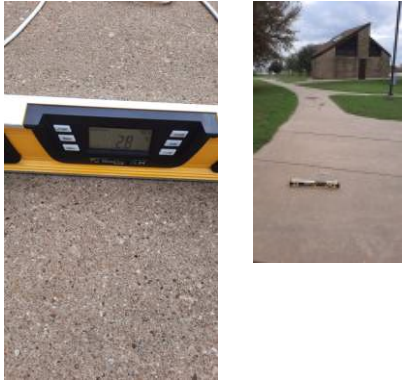
Finding Number	Area Description	Lat/Long	Finding	As Built	Recommendation	Citation	Photos	Figure
1035	Johnson Branch Unit: Johnson - Picnic Areas	[33.4081627 , -97.045451 5]	The accessible route of travel on the accessible route contains cross slopes greater than 2%. Cross slopes shall not exceed one unit vertical in 48 units horizontal (2-percent slope).	2.8% slope near restrooms	Correct or repair cross slope along AR to max 2.08%.	2015 ABAAS Section: 403.3 2012 TAS Section: 403.3 2010 ADAS Section: 403.3

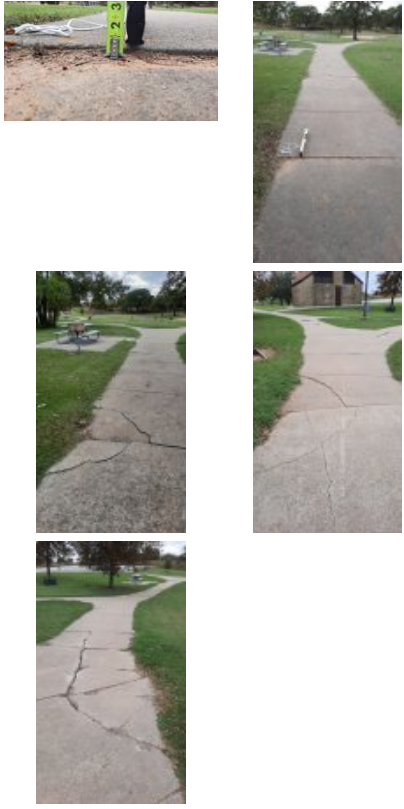
1036	Johnson Branch Unit: Johnson - Picnic Areas	[33.4083418 , -97.045220 8]	The walkway contains abrupt vertical edges and/or variations over a 1/4 inch. 1/4 inch is the maximum vertical rise. Changes in level between 1/4 inch and 1/2 inch must be beveled at 1:2 or less. Changes in level greater than 1/2 inch must be by way of a ramp.	.75" from play area to restroom, cracked panels	Repair, bevel or ramp change in level along walkway. Repair or replace cracked panels.	2012 TAS Section: 303.2, 303.3 2010 ADAS Section: 303.2, 303.3

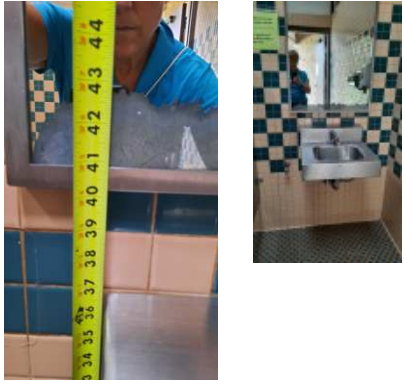
Finding Number	Area Description	Lat/Long	Finding	As Built	Recommendation	Citation	Photos	Figure
1054	Johnson Branch Unit: Johnson - Picnic Men's Restroom	[33.4082477 , -97.045285 2]	The mirror is mounted too high. Mirrors must have the bottom edge of the reflecting surface a maximum of 40 inches above the floor if above a sink or counter. Mirrors not located above lavatories or countertops shall be installed with the bottom edge of the reflecting surface 35 inches maximum above the finish floor or ground.	Mirror at 41"	Lower mirror so reflective surface is max 40" AFF.	2015 ABAAS Section: 603.3 2012 TAS Section: 603.3 2010 ADAS Section: 603.3

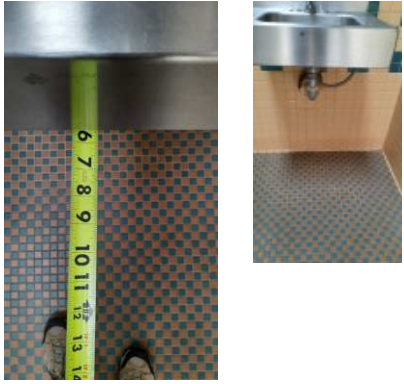
1055	Johnson Branch Unit: Johnson - Picnic Men's Restroom	[33.4082701 , -97.045269 1]	Knee clearance at 27 inches off the floor is not 8 inches minimum deep. The knee clearance, measured from the bottom of the apron or the outside bottom edge of the lavatory, must be 27 inches at a point located 8 inches back from the front edge and continuing to 11 inches minimum in depth at 9 inches above the floor. The top of the lavatory rim may be no higher than 34 inches.	Sink pipe prevents 8" knee clearance	Replace sink with one providing 27" knee clearance that is a min 8" deep.	2015 ABAAS Section: 306.3.1, 306.3.2, 306.3.3, 306.3.4 , 306.3.5 2012 TAS Section: 306.3.2, 306.3.3, 306.3.4, 306.3.5, 306.3.1 2010 ADAS Section: 306.3.3, 306.3.2, 306.3.4, 306.3.5, 306.3.1

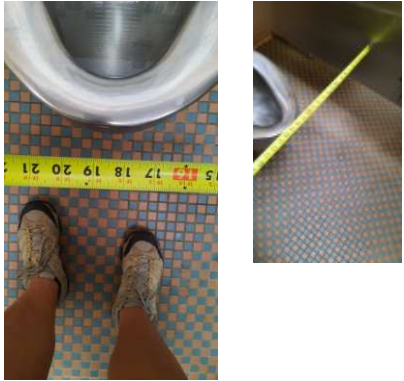
Finding Number	Area Description	Lat/Long	Finding	As Built	Recommendation	Citation	Photos	Figure
1067	Johnson Branch Unit: Johnson - Picnic Women's Restroom	[33.4082298 , -97.045278 5]	The toilet is not located within the range allowed from the side wall or partition. The centerline of the toilet must be 16 to 18 inches from the side wall.	18.5" to toilet center line	Remount toilets to 16" to 18" from the side wall to centerline. In the alternative, leave as is citing construction .	2015 ABAAS Section: 604.2 2012 TAS Section: 604.2 2010 ADAS Section: 604.2

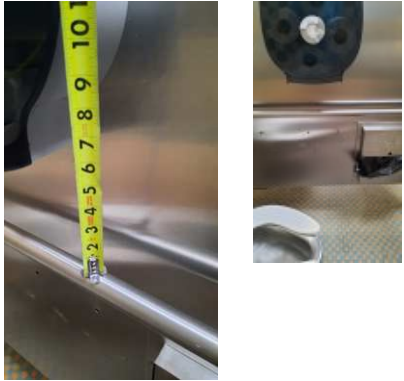
1069	Johnson Branch Unit: Johnson - Picnic Women's Restroom	[33.4082253 , -97.045285 2]	The grab bar height and/or spacing fails. Grab bars must be mounted between 33" and 36" to the top of the gripping surface. There must be 1.5" of clearance between the grab bar and the wall. There must be a minimum of 1.5" of clearance below and minimum 12" above the grab bar to any dispenser or other obstruction.	TP too close above bar and too close to toilet	Remount toilet paper dispenser max 7" to 9" from front of toilet, 15" to 48" aff and min 12" above or 1.5" below grab bar.	2015 ABAAS Section: 609.3, 609.4 2012 TAS Section: 609.4, 609.3 2010 ADAS Section: 609.3, 609.4

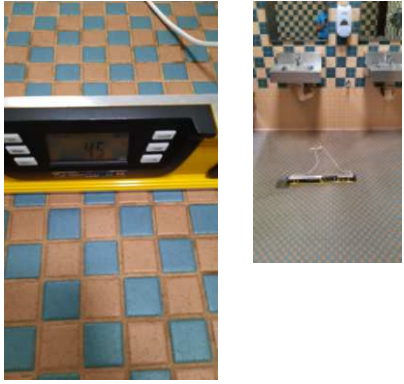
Finding Number	Area Description	Lat/Long	Finding	As Built	Recommendation	Citation	Photos	Figure
1072	Johnson Branch Unit: Johnson - Picnic Women's Restroom	[33.4082253 , -97.045274 5]	The accessible route contains running slopes greater than 5 percent and cross slopes greater than 2 percent across the width of the walk and has not been constructed as a ramp (i.e. handrails, wheel guides, etc.). When the slope in the direction of travel of any walk exceeds 1 unit vertical in 20 units horizontal (5-percent slope), it must be constructed as ramp. Surface cross slopes must not exceed one unit vertical in 48 units. Horizontal (2-percent slope).	4.5% slope at drain	Correct or repair slope to max 2.08%.	2015 ABAAS Section: 403.3 2012 TAS Section: 403.3 2010 ADAS Section: 403.3

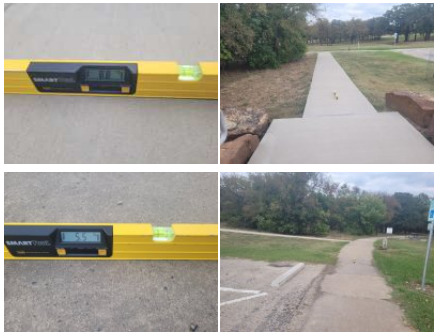
1085	Johnson Branch Unit: Johnson - Nature Center	[33.41074, -97.04692]	The running slope of walking surfaces shall not be steeper than 1:20.	8.8% to nature center, 5.5% at parking	Correct running slope along the AR to max 5%.	2015 ABAAS Section: 403.3 2012 TAS Section: 403.3 2010 ADAS Section: 403.3

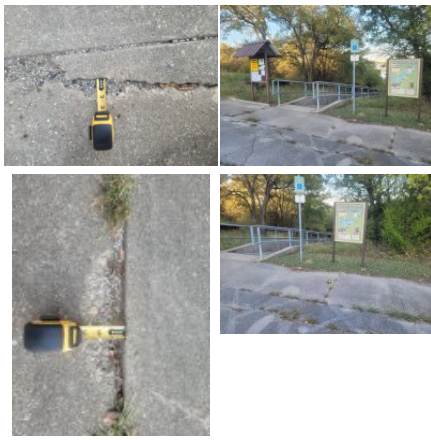
1092	Buck Creek Boat Launch: Buck Creek - Exterior Accessible Route	[33.44479, -96.92638]	There is a gap spaced greater than a 1/2 inch. Openings in floor or ground surfaces shall not allow passage of a sphere more than 1/2 inch diameter. Elongated openings shall be placed so that the long dimension is perpendicular to the dominant direction of travel.	2" and 2.5" gaps near park sign	Correct or fill gaps to be max .5"	2015 ABAAS Section: 302.3 2012 TAS Section: 302.3 2010 ADAS Section: 302.3

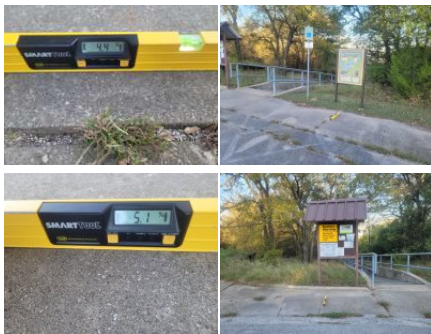
Finding Number	Area Description	Lat/Long	Finding	As Built	Recommendation	Citation	Photos	Figure
1093	Buck Creek Boat Launch: Buck Creek - Exterior Accessible Route	[33.44471, -96.92647]	The 30 inches minimum by 48 inches minimum clear floor space required at the operable part is not flat (2% or 1:48 maximum slope) in all directions. Changes in level are not permitted at required clear floor or ground space except that slopes not steeper than 1:48 shall be permitted.	4.4% slope in clear ground space (CGS) at park sign, 5.1% at fishing sign	Correct or repair slope in CGS to max 2.08%	2015 ABAAS Section: 305.2 2012 TAS Section: 305.2 2010 ADAS Section: 305.2
