Access Audit Site Report

Ray Roberts Lake State Park/Complex

Accessibility Evaluation

Inspection Date: 10/18/2021

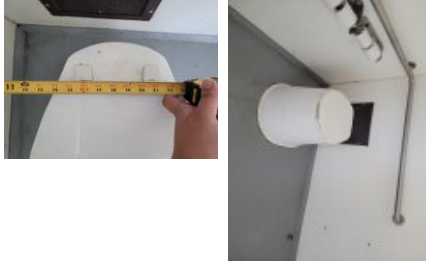
1095	Buck Creek Boat Launch: Buck Creek - Restroom	[33.44483, -96.92664]	Element meets all standards and requirements	Pit toilet door complies	None	2010 ADAS Section: N/A		
1096	Buck Creek Boat Launch: Buck Creek - Restroom	[33.42978, -97.05647]	The toilet is not located within the range allowed from the side wall or partition. The centerline of the toilet must be 16 to 18 inches from the side wall.	toilet centerline 18.25"	Remount toilets to 16" to 18" from the side wall to centerline. In the alternative, leave as is citing construction tolerance.	2015 ABAAS Section: 604.2 2012 TAS Section: 604.2 2010 ADAS Section: 604.2

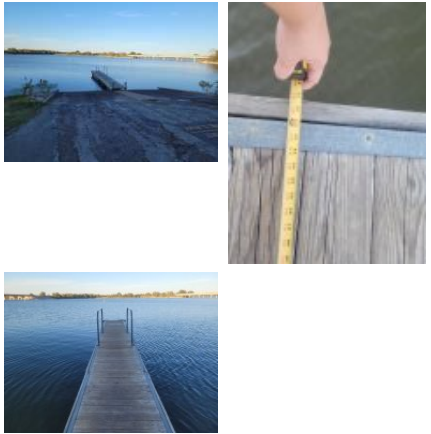
1099	Buck Creek Boat Launch: Buck Creek - Boat Ramp	[33.4452, -96.92569]	The minimum number of boarding piers are not accessible. Where boarding piers are provided at boat launch ramps, at least 5 percent, but no fewer than one, of the boarding piers be accessible.	step from ramp to pier, 50" wide with 6 tie offs	Provide 5%, but not less than one accessible boarding pier at boat launches.	2015 ABAAS Section: F235.3 2010 ADAS Section: 235.3

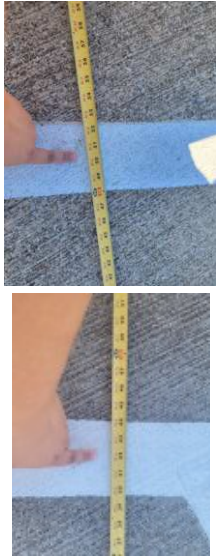
1103	Sanger Park: Sanger - Marina Parking	[33.376945, -97.107748 5]	The access aisle is not a minimum 5 feet wide. A car accessible parking stall's access aisle must be a minimum of 5 feet wide measured from centerline to centerline. Where the access aisle is not adjacent to another parking space or access aisle, measurements shall be permitted to include the full width of the line defining the access aisle.	Boathouse 5 - aisle only 50" wide but total with stall exceeds 13'; boathouse 7- 42" aisle	Repaint access aisles to be 5' each.	2015 ABAAS Section: 502.3.1 2012 TAS Section: 502.3.1 2010 ADAS Section: 502.3.1

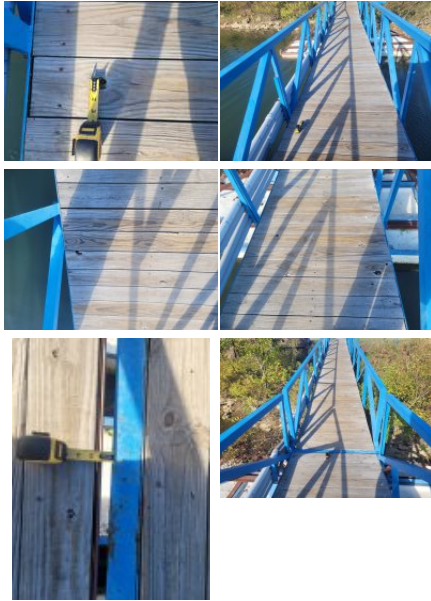
Finding Number	Area Description	Lat/Long	Finding	As Built	Recommendation	Citation	Photos	Figure
1109	Sanger Park: Sanger - Marina Boathouse 1	[33.3772751 , -97.107405 4]	There is a gap spaced greater than a 1/2 inch. Openings in floor or ground surfaces shall not allow passage of a sphere more than 1/2 inch diameter. Elongated openings shall be placed so that the long dimension is perpendicular to the dominant direction of travel.	Boathouse 1- four 1" gaps at knots on gangway; 1" at transition	Correct or fill gaps to be max .5".	2015 ABAAS Section: 302.3 2012 TAS Section: 302.3 2010 ADAS Section: 302.3

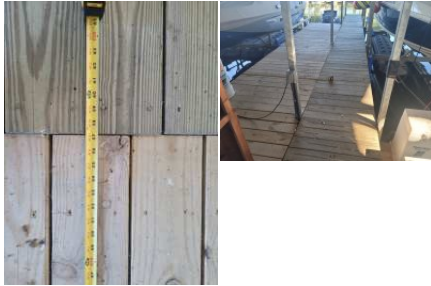
Finding Number	Area Description	Lat/Long	Finding	As Built	Recommendation	Citation	Photos	Figure
1121	Sanger Park: Sanger - Marina Boathouse 2	[33.3768375, -97.1072067]	The boat slip segments are not wide enough. Boat slips shall provide clear pier space 60 inches wide minimum and at least as long as the boat slips. Each 10 feet maximum of linear pier edge serving boat slips shall contain at least one continuous clear opening 60 inches wide minimum. The clear width shall be permitted to be reduced to 36 inches minimum for a length of 24 inches maximum provided that reduced width segments are separated by segments that are 60 inches long minimum and 60 inches wide minimum.	Largest boarding at boat slip is 57" before supports	Provide 60" clear pier space for the entire length of pier.	2015 ABAAS Section: 1003.3.1, 1003.3.1 EXC EPTIONS: 1 2012 TAS Section: 1003.3.1, 1003.3.1 Exceptions (3) 2010 ADAS Section: 1003.3.1, 1003.3.1 Exception 1

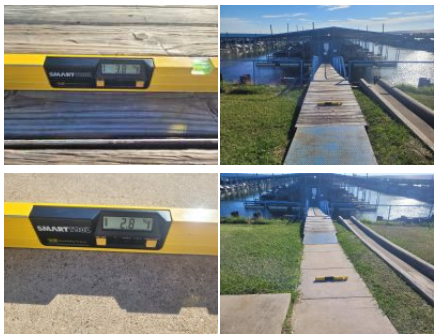
Finding Number	Area Description	Lat/Long	Finding	As Built	Recommendation	Citation	Photos	Figure
1124	Sanger Park: Sanger - Marina Boathouse 2	[33.37696, -97.10771]	The accessible route of travel contains cross slopes greater than 2%. Cross slopes shall not exceed one unit vertical in 48 units horizontal (2-percent slope).	3.8% cross slope on upper section, 2.8% on sidewalk	Correct or repair cross slope along AR to max 2.08%.	2015 ABAAS Section: 403.3 2012 TAS Section: 403.3 2010 ADAS Section: 403.3

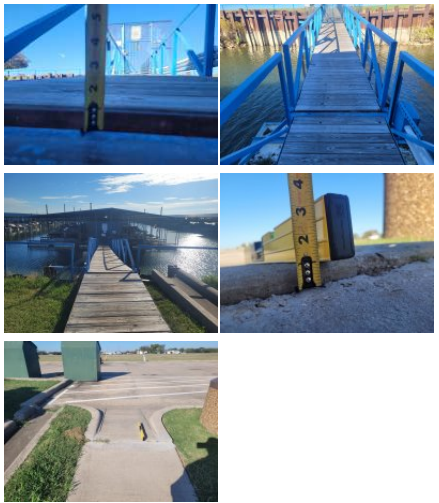
1126	Sanger Park: Sanger - Marina Boathouse 2	[33.37691, -97.10741]	The walkway contains abrupt vertical edges and/or variations over a 1/4 inch. 1/4 inch is the maximum vertical rise. Changes in level between 1/4 inch and 1/2 inch must be beveled at 1:2 or less. Changes in level greater than 1/2 inch must be by way of a ramp.	1" change in level (CIL) at middle transition and top transition, 1" at curb ramp	Repair, bevel or ramp CIL along route.	2012 TAS Section: 303.2, 303.3 2010 ADAS Section: 303.2, 303.3

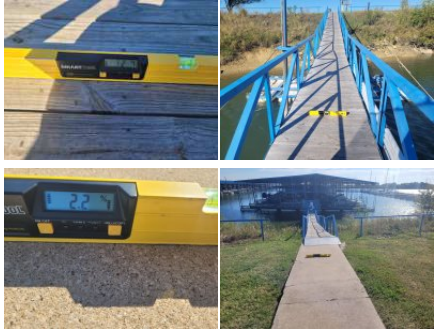
Finding Number	Area Description	Lat/Long	Finding	As Built	Recommendation	Citation	Photos	Figure
1137	Sanger Park: Sanger - Marina Boathouse 3	[33.37635, -97.10752]	The accessible route of travel contains cross slopes greater than 2%. Cross slopes shall not exceed one unit vertical in 48 units horizontal (2-percent slope).	3.2% slope before gate, 2.2% slope on sidewalk	Correct or repair cross slope along AR to max 2.08%	2015 ABAAS Section: 403.3 2012 TAS Section: 403.3 2010 ADAS Section: 403.3

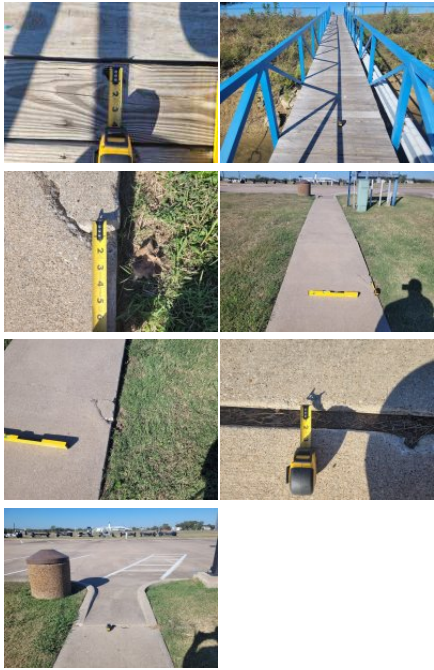
1138	Sanger Park: Sanger - Marina Boathouse 3	[33.37638, -97.10741]	There is a gap spaced greater than a 1/2 inch. Openings in floor or ground surfaces shall not allow passage of a sphere more than 1/2 inch diameter. Elongated openings shall be placed so that the long dimension is perpendicular to the dominant direction of travel.	1" gap at knot on gangway, gap up to 2" where damaged at edge, 2" gap at curb ramp	Correct or fill gaps to be max .5".	2015 ABAAS Section: 302.3 2012 TAS Section: 302.3 2010 ADAS Section: 302.3

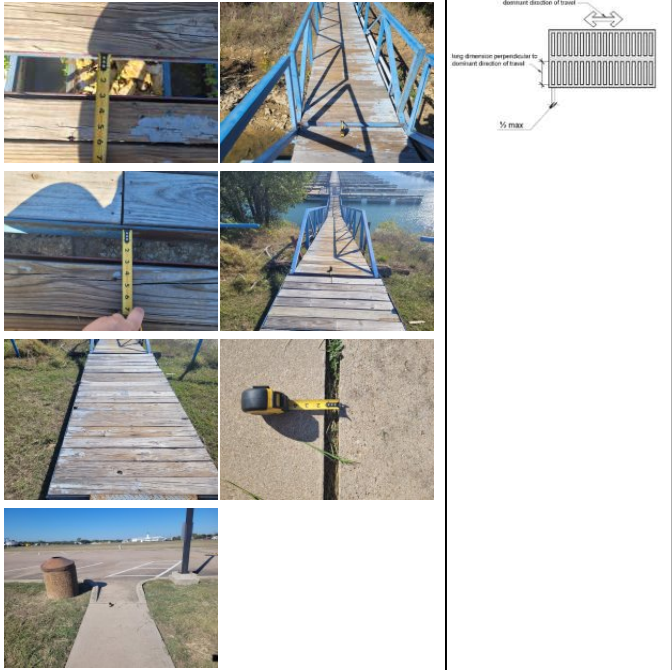
1153	Sanger Park: Sanger - Marina Boathouse 4	[33.37589, -97.1076]	There is a gap spaced greater than a 1/2 inch. Openings in floor or ground surfaces shall not allow passage of a sphere more than 1/2 inch diameter. Elongated openings shall be placed so that the long dimension is perpendicular to the dominant direction of travel.	3" gap at transition, 2.5" gap at top transition, gaps where damaged near top, 1.25" gap at curb ramp	Correct or fill gaps to be max .5".	2015 ABAAS Section: 302.3 2012 TAS Section: 302.3 2010 ADAS Section: 302.3

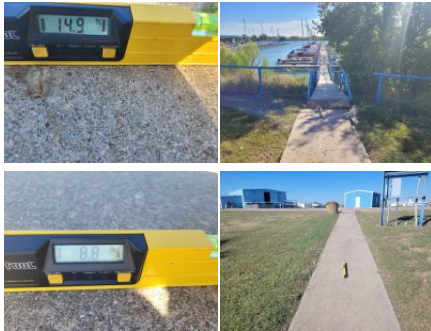
1164	Sanger Park: Sanger - Marina Boathouse 5	[33.37553, -97.10783]	The running slope of walking surfaces shall not be steeper than 1:20.	14.9% adjacent to gangway transition plate, 8.8% on remaining	Correct running slope along the AR to max 5%, or treat as a ramp and correct slope to max 8.33% and add handrails.	2015 ABAAS Section: 403.3 2012 TAS Section: 403.3 2010 ADAS Section: 403.3

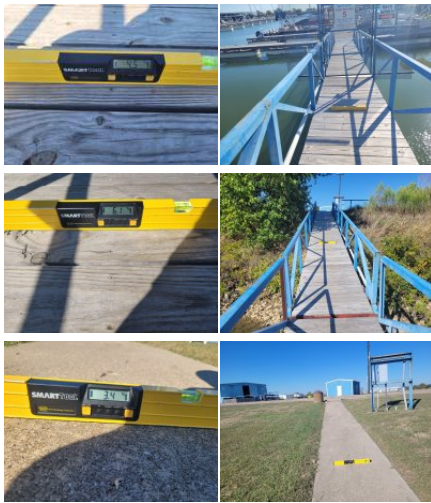
1165	Sanger Park: Sanger - Marina Boathouse 5	[33.37553, -97.10773]	The accessible route of travel contains cross slopes greater than 2%. Cross slopes shall not exceed one unit vertical in 48 units horizontal (2-percent slope).	4.5% and 6.1% cross on gangway, 3.4% on sidewalk	Correct or repair cross slope along AR to max 2.08%.	2015 ABAAS Section: 403.3 2012 TAS Section: 403.3 2010 ADAS Section: 403.3

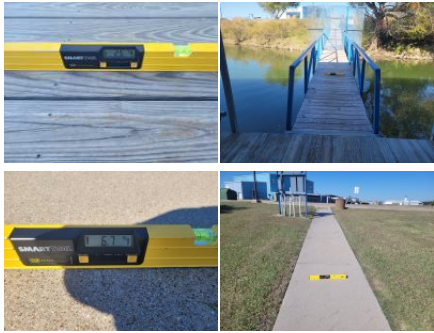
1172	Sanger Park: Sanger - Marina Boathouse 6	[33.37529, -97.10771]	The accessible route of travel contains cross slopes greater than 2%. Cross slopes shall not exceed one unit vertical in 48 units horizontal (2-percent slope).	2.5% cross slope on gangway, 6.7% on sidewalk	Correct or repair cross slope along AR to max 2.08%.	2015 ABAAS Section: 403.3 2012 TAS Section: 403.3 2010 ADAS Section: 403.3

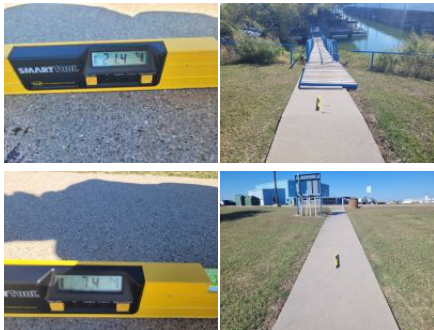
1175	Sanger Park: Sanger - Marina Boathouse 6	[33.37528, -97.10804]	The running slope of walking surfaces shall not be steeper than 1:20.	21.4% and 7.4% to gangway	Correct running slope along the AR to max 5%, or treat as a ramp and correct to max 8.33% and add handrails.	2015 ABAAS Section: 403.3 2012 TAS Section: 403.3 2010 ADAS Section: 403.3

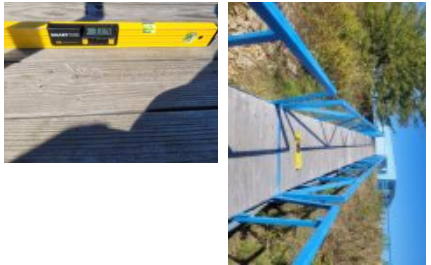
1184	Sanger Park: Sanger - Marina Boathouse 7	[33.375, -97.10811]	The accessible route of travel on the accessible route contains cross slopes greater than 2%. Cross slopes shall not exceed one unit vertical in 48 units horizontal (2-percent slope).	3.1% cross slope on gangway	Correct or repair cross slope along AR to max 2.08%.	2015 ABAAS Section: 403.3 2012 TAS Section: 403.3 2010 ADAS Section: 403.3

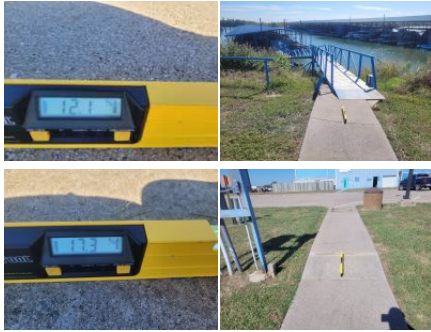
1200	Sanger Park: Sanger - Marina Boathouse 8	[33.37486, -97.10849]	The running slope of walking surfaces shall not be steeper than 1:20.	12.1% and 17.3% on sidewalk	Correct running slope along the route to max 5% or treat as a ramp and correct to max 8.33% and install handrails.	2015 ABAAS Section: 403.3 2012 TAS Section: 403.3 2010 ADAS Section: 403.3

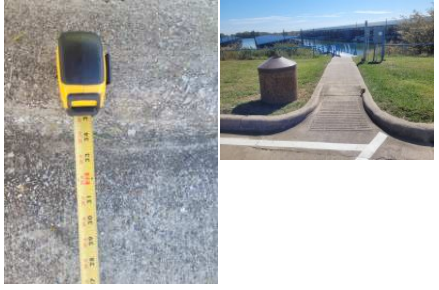
Finding Number	Area Description	Lat/Long	Finding	As Built	Recommendation	Citation	Photos	Figure
1205	Sanger Park: Sanger - Marina Boathouse 8	[33.37488, -97.10854]	The curb ramp does not meet minimum width requirements. Curb ramps must be a minimum 36 inches in width.	35" wide at curb ramp	Recut or repour ramp to be min. 36" clear width.	2015 ABAAS Section: 405.5, 406.1 2010 ADAS Section: 405.5, 406.1

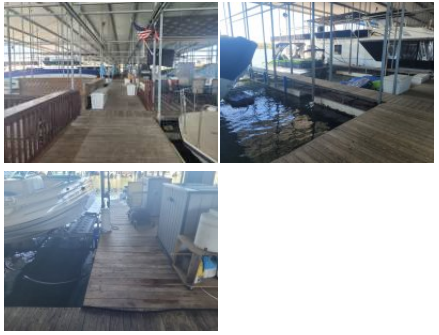
1206	Sanger Park: Sanger - Marina Boathouse 9	[33.3742303 , -97.108397 6]	The minimum number of boat slips is not provided. Where the number of boat slips is not identified, each 40 feet of boat slip edge provided along the perimeter of the pier shall be counted as one boat slip.	0 of 56 boat slips accessible in this boathouse, though 2 have wider boarding piers; 501 present at site requiring minimum of 8 accessible boat slips dispersed throughout the types and locations provided	Provide the required number of boat slips based on the total provided, or for every 40' of boat slip edge; price included in Boathouse 1 scoping finding	2015 ABAAS Section: F235.2 2010 ADAS Section: 235.2

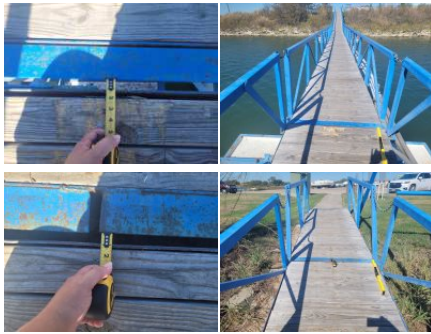
1212	Sanger Park: Sanger - Marina Boathouse 9	[33.37441, -97.10865]	There is a gap spaced greater than a 1/2 inch. Openings in floor or ground surfaces shall not allow passage of a sphere more than 1/2 inch diameter. Elongated openings shall be placed so that the long dimension is perpendicular to the dominant direction of travel.	1" gap and .75" gap at transition, 1" gap at top transition	Correct or fill gaps to be max .5".	2015 ABAAS Section: 302.3 2012 TAS Section: 302.3 2010 ADAS Section: 302.3

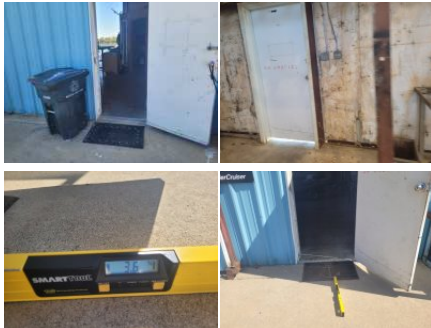
1215	Sanger Park: Sanger - Marina Shop	[33.3752651 , -97.108883]	Spaces and elements within employee work areas shall only be required to comply with 206.2.8, 207.1, and 215.3 and shall be designed and constructed so that individuals with disabilities can approach, enter, and exit the employee work area. Employee work areas, or portions of employee work areas, other than raised courtroom stations, that are less than 300 square feet (28 m2) and elevated 7 inches (180 mm) or more above the finish floor or ground where the elevation is essential to the function of the space shall not be required to comply with these requirements or to be on an accessible route.	Main shop rear door - knob, garbage can pull side, change in level (CIL); entry - 3.6% slope in clearance, knob, CIL	For employee spaces, relocate storage, furniture, and other obstacles at doorways to provide approach, enter and exit at the employee space. Provide required maneuvering clearance on push and pull side of doors. Correct slope in door clearance to max 2.08%. Repair, bevel, or ramp CILs at door entries to max .25". Replace hardware with lever hardware or hardware operable without a tight pinch or grasp.	2015 ABAAS Section: F203.9 2012 TAS Section: 203.9 2010 ADAS Section: 203.9

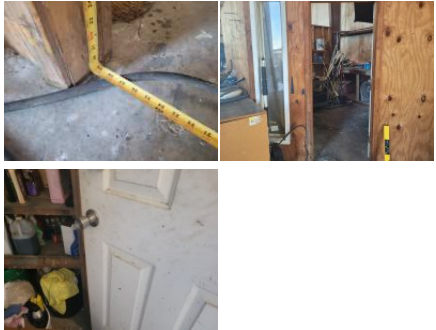
Finding Number	Area Description	Lat/Long	Finding	As Built	Recommendation	Citation	Photos	Figure
1219	Sanger Park: Sanger - Marina Shop	[33.3752607 , -97.108869 6]	Spaces and elements within employee work areas shall only be required to comply with 206.2.8, 207.1, and 215.3 and shall be designed and constructed so that individuals with disabilities can approach, enter, and exit the employee work area. Employee work areas, or portions of employee work areas, other than raised courtroom stations, that are less than 300 square feet (28 m2) and elevated 7 inches (180 mm) or more above the finish floor or ground where the elevation is essential to the function of the space shall not be required to comply with these requirements or to be on an accessible route.	Paint Room - door 29" wide, knob	For employee spaces, relocate storage, furniture, and other obstacles at doorways to provide approach, enter and exit at the employee space. Replace doors with doors having 80" overhead clearance and 32" clear width. Replace hardware with lever hardware or hardware operable without a tight pinch or grasp.	2015 ABAAS Section: F203.9 2012 TAS Section: 203.9 2010 ADAS Section: 203.9

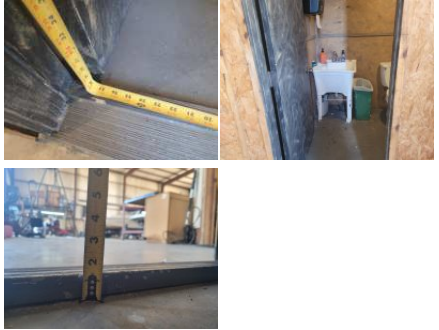
Finding Number	Area Description	Lat/Long	Finding	As Built	Recommendation	Citation	Photos	Figure
1222	Sanger Park: Sanger - Marina Shop	[33.3752095 , -97.108883 1]	Minimum maneuvering clearances at doors and gates shall comply with 404.2.4. Maneuvering clearances shall extend the full width of the doorway and the required latch side or hinge side clearance. Maneuvering clearances shall have a max slope of 2.08%. Door openings shall provide a clear width of 32 inches (815 mm) minimum. Clear openings of doorways with swinging doors shall be measured between the face of the door and the stop, with the door open 90 degrees. Openings more than 24 inches (610 mm) deep shall provide a clear opening of 36 inches (915 mm) minimum. There shall be no projections into the required clear opening width lower than 34 inches (865 mm) above the finish floor or ground. Projections into the clear opening width between 34 inches (865 mm) and 80 inches (2030 mm) above the finish floor or ground shall not exceed 4 inches (100 mm). The threshold at a doorway shall be no higher than 1/2 inch. Changes in level between 1/4 inch and 1/2 inch must be beveled at 1:2 or less. 1/4 inch is the maximum vertical rise. Hand-activated door opening hardware, handles, pulls, latches, locks, and other operating devices on accessible doors shall have a shape that is easy to grasp with one hand and does not require tight grasping, tight pinching or twisting of the wrist to operate. Hardware shall be 34 inches minimum and 48 inches maximum above the finish floor or ground.	Restroom - door 27" wide, knob, 1" threshold, sink back pull side	For all doors along the public circulation route, provide required maneuvering clearance on push and pull side of doors. For all doors along the public circulation route, replace doors with doors having 80" overhead clearance and 32" clear width. For all doors along the public circulation route, provide beveled threshold. For all doors along the public circulation route, replace hardware with lever hardware or hardware operable without a tight pinch or grasp.	2010 ADAS Section: 404.2.3, 404.2.7, 404.2.4, 404.2.11, 404.2.11 Exception

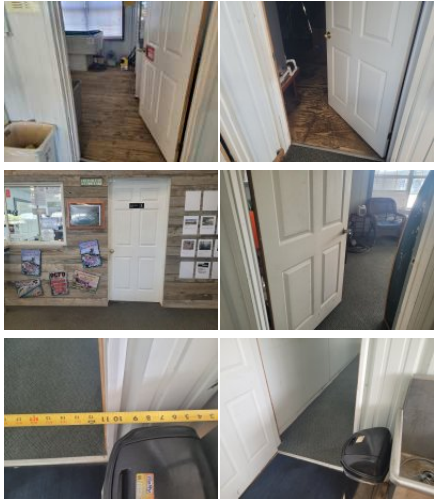
Finding Number	Area Description	Lat/Long	Finding	As Built	Recommendation	Citation	Photos	Figure
1230	Sanger Park: Sanger - Marina Office/Store	[33.3776, -97.10707]	Element meets all standards and requirements	Entry door complies	None	2010 ADAS Section: N/A		
1231	Sanger Park: Sanger - Marina Office/Store	[33.377617, -97.106938 4]	Spaces and elements within employee work areas shall only be required to comply with 206.2.8, 207.1, and 215.3 and shall be designed and constructed so that individuals with disabilities can approach, enter, and exit the employee work area. Employee work areas, or portions of employee work areas, other than raised courtroom stations, that are less than 300 square feet (28 m2) and elevated 7 inches (180 mm) or more above the finish floor or ground where the elevation is essential to the function of the space shall not be required to comply with these requirements or to be on an accessible route.	Bait - door has knob, garbage can pull side; storage- knob, equipment pull side; office- knob; back office- knob; back storage- knob, garbage can and sink pull side	For employee spaces, relocate storage, furniture, and other obstacles at doorways to provide approach, enter and exit at the employee space. For all doors along the public circulation route, replace hardware with lever hardware where indicated	2015 ABAAS Section: F203.9 2012 TAS Section: 203.9 2010 ADAS Section: 203.9

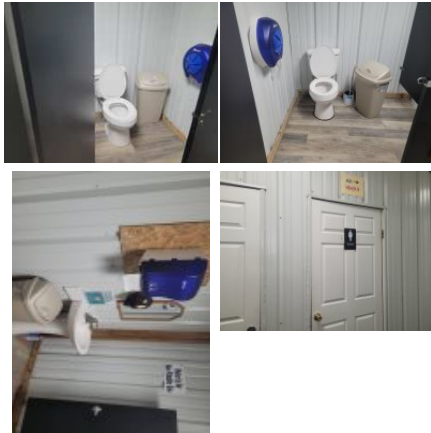
1235	Sanger Park: Sanger - Marina Office/Store	[33.3776259 , -97.106992 1]	This restroom is not accessible. Where existing toilet rooms or bathing rooms do not comply, directional signs indicating the location of the nearest accessible toilet room or bathing room within the facility shall be provided. Signs shall include the International Symbol of Accessibility. Where existing toilet rooms or bathing rooms do comply), the accessible toilet rooms or bathing rooms shall be identified by the International Symbol of Where clustered single user toilet rooms or bathing facilities are permitted, accessible toilet rooms or bathing facilities shall be identified by the International Symbol of Accessibility unless all toilet rooms and bathing facilities are accessible.	Women's Restroom - lacks signage to accessible restroom	Restroom not accessible, acquire and mount signage directing patrons to accessible restroom.	2015 ABAAS Section: F216.8 2012 TAS Section: 216.8 2010 ADAS Section: 216.8

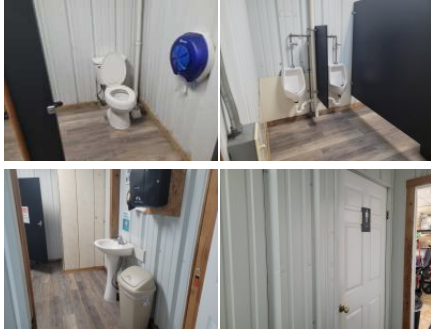
Finding Number	Area Description	Lat/Long	Finding	As Built	Recommendation	Citation	Photos	Figure
			ground. The bottom 10 inches on the push side must be smooth and free of obstructions (hold open devices). Opening hardware must be mounted between 30 and 44 inches above the floor or ground. Doors, gates, and side lights adjacent to doors or gates, containing one or more glazing panels that permit viewing through the panels shall have the bottom of at least one glazed panel located 43 inches (1090 mm) maximum above the finish floor. EXCEPTION: Vision lights with the lowest part more than 66 inches (1675 mm) from the finish floor or ground shall not be required to comply with 404.2.11.					
1239	Sanger Park: Sanger - Marina Office/Store	[33.377608, -97.106959 9]	This restroom is not accessible. Where existing toilet rooms or bathing rooms do not comply, directional signs indicating the location of the nearest accessible toilet room or bathing room within the facility shall be provided. Signs shall include the International Symbol of Accessibility. Where existing toilet rooms or bathing rooms do comply, the accessible toilet rooms or bathing rooms shall be identified by the International Symbol of Where clustered single user toilet rooms or bathing facilities are permitted, accessible toilet rooms or bathing facilities shall be identified by the International Symbol of Accessibility unless all toilet rooms and bathing facilities are accessible.	Men's Restroom - Lacks accessible features, lacks directional signage	Restroom not accessible, acquire and mount signage directing patrons to accessible restroom until renovated. Create an accessible restroom in the marina.	2015 ABAAS Section: F216.8 2012 TAS Section: 216.8 2010 ADAS Section: 216.8

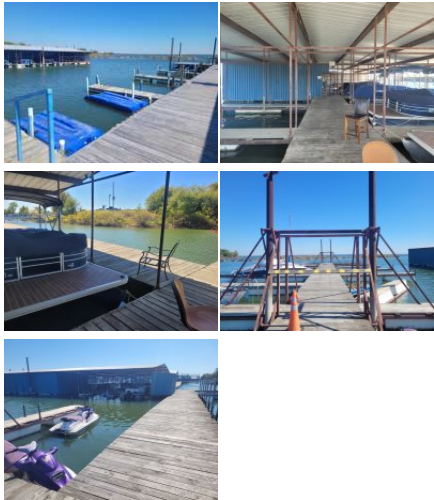
1244	Sanger Park: Sanger - Marina Office/Store	[33.377267, -97.107059 1]	The minimum number of boarding piers are not accessible. Where boarding piers are provided at boat launch ramps, at least 5 percent, but no fewer than one, of the boarding piers be accessible.	0 of 7 piers comply at fueling; 1 of 8 piers complies at rentals; 1 of 16 at furthest pier	Provide 5%, but not less than one accessible boarding pier at boat fueling.	2015 ABAAS Section: F235.3 2010 ADAS Section: 235.3

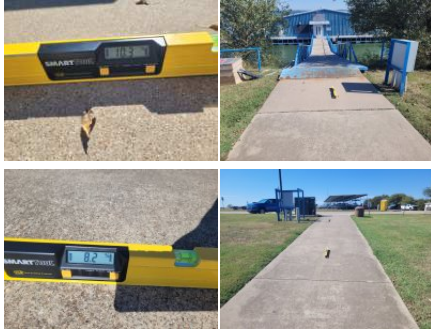
1248	Sanger Park: Sanger - Marina Office/Store	[33.37759, -97.10743]	The running slope of walking surfaces shall not be steeper than 1:20.	10.3% at on sidewalk gangway, 8.2% on sidewalk	Correct running slope along the AR to max 5%, or treat as a ramp and correct slope to max 8.33% and add handrails.	2015 ABAAS Section: 403.3 2012 TAS Section: 403.3 2010 ADAS Section: 403.3

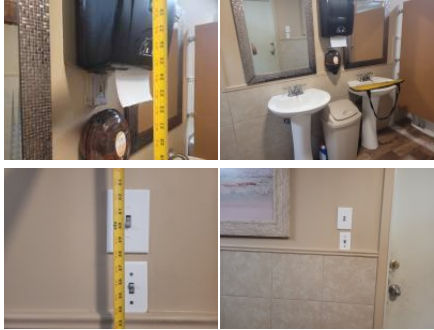
Finding Number	Area Description	Lat/Long	Finding	As Built	Recommendation	Citation	Photos	Figure
1255	Sanger Park: Sanger - Marina Women's Restroom	[33.3756482 , -97.108279 5]	Where a high forward reach is over an obstruction, the clear floor space shall extend beneath the element for a distance not less than the required reach depth over the obstruction. The high forward reach shall be 48 inches (1220 mm) maximum where the reach depth is 20 inches (510 mm) maximum. Where the reach depth exceeds 20 inches (510 mm), the high forward reach shall be 44 inches (1120 mm) maximum and the reach depth shall be 25 inches (635 mm) maximum. Where a clear floor or ground space allows a parallel approach to an element and the high side reach is over an obstruction, the height of the obstruction shall be 34 inches (865 mm) maximum and the depth of the obstruction shall be 24 inches (610 mm) maximum. The high side reach shall be 48 inches (1220 mm) maximum for a reach depth of 10 inches (255 mm) maximum. Where the reach depth exceeds 10 inches (255 mm), the high side reach shall be 46 inches (1170 mm) maximum for a reach depth of 24 inches (610 mm) maximum.	Paper towel dispenser at 55" and outlets at 53" with reach over sink, light switches at 60"	Lower dispenser, light switch, and electrical outlet to max 44" AFF for a forward reach over counter. Lower light switch to max 48" AFF.	2015 ABAAS Section: 308.2.1, 308.3.2 2012 TAS Section: 308.2.1, 308.3.2 2010 ADAS Section: 308.2.1, 308.3.2

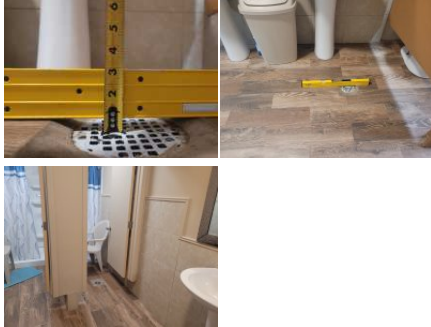
1265	Sanger Park: Sanger - Marina Women's Restroom	[33.3756504 , -97.108279 5]	There is a change in level greater than 1/4 inch. 1/4 inch is the maximum vertical rise. Changes in level between 1/4 inch and 1/2 inch must be beveled at 1:2 or less. Changes in level greater than 1/2 inch must be by way of a ramp.	.75" CIL at drains	Repair, bevel or ramp CIL along AR to max .25".	2015 ABAAS Section: 303.3 2012 TAS Section: 303.3 2010 ADAS Section: 303.3

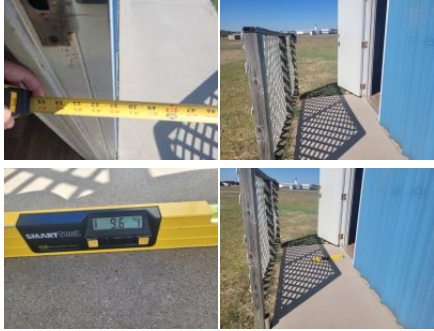
Finding Number	Area Description	Lat/Long	Finding	As Built	Recommendation	Citation	Photos	Figure
1270	Sanger Park: Sanger - Marina Women's Restroom	[33.3756526 , -97.108271]	Minimum maneuvering clearances at doors and gates shall comply with 404.2.4. Maneuvering clearances shall extend the full width of the doorway and the required latch side or hinge side clearance. Maneuvering clearances shall have a max slope of 2.08%. Hand-activated door opening hardware, handles, pulls, latches, locks, and other operating devices on accessible doors shall have a shape that is easy to grasp with one hand and does not require tight grasping, tight pinching or twisting of the wrist to operate. Hardware shall be 34 inches minimum and 48 inches maximum above the finish floor or ground.	Women's Door - 51" approach, 9.6% slope, knob	For all doors along the public circulation route, provide required maneuvering clearance on push and pull side of doors. For all doors along the public circulation route, correct slope in door clearance to max 2.08%. For all doors along the public circulation route, replace hardware with lever hardware or hardware operable without a tight pinch or grasp.	2010 ADAS Section: 404.2.3, 404.2.7, 404.2.4, 404.2.11, 404.2.11 Exception

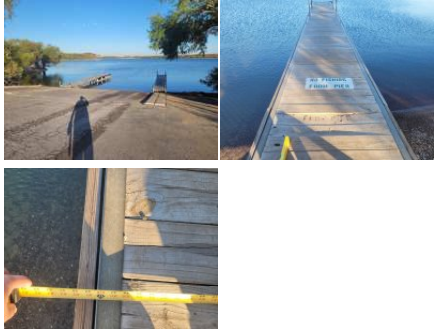
Finding Number	Area Description	Lat/Long	Finding	As Built	Recommendation	Citation	Photos	Figure
1309	Pond Boat Launch: Pond - Boat Ramp	[33.38705, -97.10703]	The minimum number of boarding piers are not accessible. Where boarding piers are provided at boat launch ramps, at least 5 percent, but no fewer than one, of the boarding piers be accessible.	2 piers with 8 or 6 tie offs, change in level (CIL) to access piers, one pier has CILs along pier, 50" wide	Provide 5%, but not less than one accessible boarding pier at boat launches.	2015 ABAAS Section: F235.3 2010 ADAS Section: 235.3

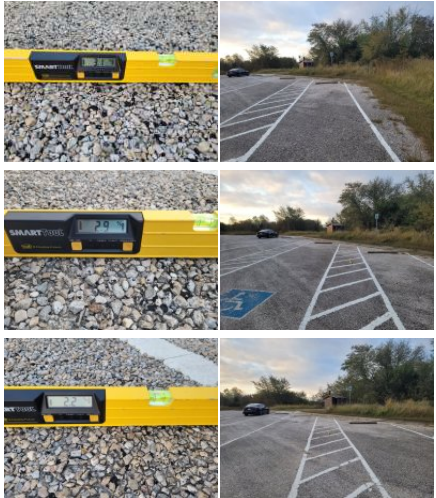
Finding Number	Area Description	Lat/Long	Finding	As Built	Recommendation	Citation	Photos	Figure
1310	Pecan Creek Boat Launch: Pecan - Parking and Exterior Accessible Route	[33.42978, -97.05647]	Element meets all standards and requirements	Parking lot complies with scoping - 40 standard stalls, 2 accessible	None	2010 ADAS Section: N/A		
1311	Pecan Creek Boat Launch: Pecan - Parking and Exterior Accessible Route	[33.4299815, -97.1039277]	The cross slopes (narrow dimension) and/or running slopes (long dimension) of the access aisle exceeds 2%. The running slope and the cross slope in an accessible parking stall and the access aisle must not exceed 2%.	3.1% right stall, 2.9% right aisle, 2.2% left aisle	Repair or correct slope of parking space and access aisle to max 2.08% in any direction	2015 ABAAS Section: 502.4 2012 TAS Section: 502.4 2010 ADAS Section: 502.4

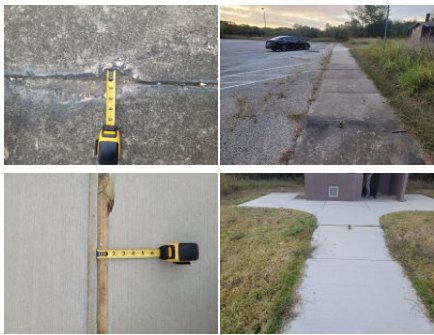
Finding Number	Area Description	Lat/Long	Finding	As Built	Recommendation	Citation	Photos	Figure
1316	Pecan Creek Boat Launch: Pecan - Parking and Exterior Accessible Route	[33.42988, -97.10377]	There is a gap spaced greater than a 1/2 inch. Openings in floor or ground surfaces shall not allow passage of a sphere more than 1/2 inch diameter. Elongated openings shall be placed so that the long dimension is perpendicular to the dominant direction of travel.	3" gap along parking, 1.25" near restroom	Correct or fill gaps to be max .5".	2015 ABAAS Section: 302.3 2012 TAS Section: 302.3 2010 ADAS Section: 302.3

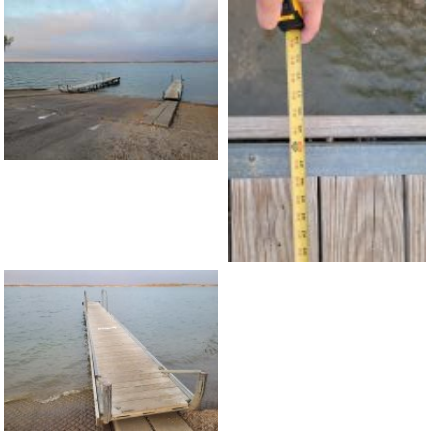
Finding Number	Area Description	Lat/Long	Finding	As Built	Recommendation	Citation	Photos	Figure
1319	Pecan Creek Boat Launch: Pecan - Boat Ramp	[33.4300749 , -97.104669 7]	The minimum number of boarding piers are not accessible. Where boarding piers are provided at boat launch ramps, at least 5 percent, but no fewer than one, of the boarding piers be accessible.	2 piers with 7 or 6 tie offs, 50" wide	Provide 5%, but not less than one accessible boarding pier at boat launches.	2015 ABAAS Section: F235.3 2010 ADAS Section: 235.3
