Access Audit Site Report

Resaca de la Palma State Park
1000 New Carmen Ave
Brownsville, TX 78520
Accessibility Evaluation
Inspection Date: 07/12/2022
Inspectors: Tanya Scheibe

Prepared By
WT Group

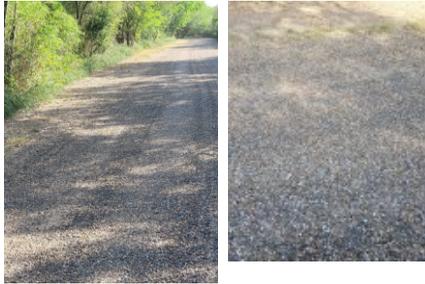
8	Exterior: Exterior Accessible Route	[25.9971779 , -97.569004 4]	The surface of trails, passing spaces, and resting intervals shall be firm and stable	tram road is full of gravel, many use as trail to walk on, listed as trail on park map	Establish protocols for regular and frequent inspection and maintenance of accessible trail surface as a smart practice. Frequently maintain trail surface in identified washout areas to assure CIL's remain 2" or less and gaps are filled as a smart practice.	2015 ABAAS Section: 1017.2

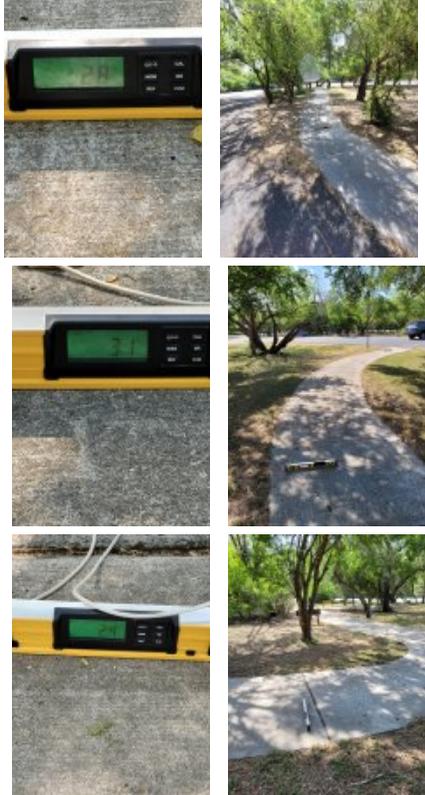
Finding Number	Area Description	Lat/Long	Finding	As Built	Recommendation	Citation	Photos	Figure
16	Exterior: Exterior Accessible Route	[25.9960422 , -97.568934 5]	There is a gap spaced greater than a 1/2 inch. Openings in floor or ground surfaces shall not allow passage of a sphere more than 1/2 inch diameter. Elongated openings shall be placed so that the long dimension is perpendicular to the dominant direction of travel.	1" near shelter; 1" from bus lot to HQ; 1.25" from parking area	Correct or fill gaps to be max .5"	2015 ABAAS Section: 302.3 2012 TAS Section: 302.3 2010 ADAS Section: 302.3

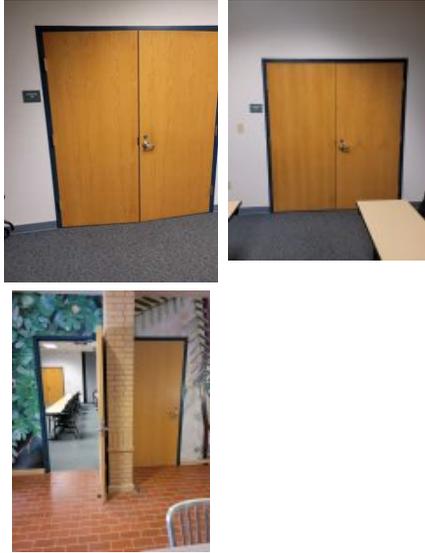
30	Headquarters (HQ) : HQ - Public Spaces	[25.996713, -97.5688281]	Minimum maneuvering clearances at doors and gates shall comply with 404.2.4. Maneuvering clearances shall extend the full width of the doorway and the required latch side or hinge side clearance. Exterior doors are recommended to be maintained at 8.5 lbf as a smart practice. Force is to be measured at the operating hardware or 30 inches from the hinges, whichever is greater. The bottom 10 inches on the push side must be smooth and free of obstructions (hold open devices). Opening hardware must be mounted between 30 and 44 inches above the floor or ground.	Right exit doors to parking - window starts at 8", left door 13 lbf, rug not secure, outdoor rug loose also	For all doors along the public circulation route, provide required maneuvering clearance on push and pull side of doors. For all doors along the public circulation route, secure rug in door clearance to prevent trip hazard. For all doors along the public circulation route, inspect, adjust, and maintain 8.5 lbf to open exterior doors as a smart practice. For all doors along the public circulation route, provide kick plate on push side of door from floor to 10" AFF.	2010 ADAS Section: 404.2.3, 404.2.7, 404.2.4, 404.2.11, 404.2.11 Exception

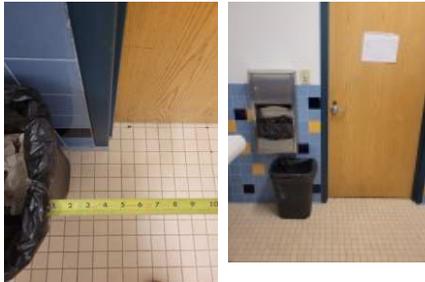
47	Headquarters (HQ) : HQ - Women's Restroom	[25.9967319 , -97.568795 2]	Element meets all standards and requirements	door complies	None	2010 ADAS Section: N/A		
48	Headquarters (HQ) : HQ Single Use Restrooms In Employee Area - Mens	[25.9968549 , -97.568650 3]	Minimum maneuvering clearances at doors and gates shall comply with 404.2.4. Maneuvering clearances shall extend the full width of the doorway and the required latch side or hinge side clearance.	Trash in push clearance	Relocate obstacles to provide 48" maneuvering clearance around door.	2015 ABAAS Section: 404.2.4.4, 404.2.4.1 2012 TAS Section: 404.2.4.4, 404.2.4.1 2010 ADAS Section: 404.2.4.4, 404.2.4.1

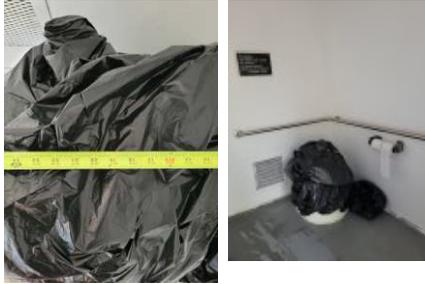
63	Restrooms: Mexican Olive Trail - Women's Restroom	[25.9886313 , -97.5641496]	The toilet is not located within the range allowed from the side wall or partition. The centerline of the toilet must be 16 to 18 inches from the side wall.	in middle of painting so hard to tell, seems to be 19"	Assure toilets are 16" to 18" from the side wall to centerline	2015 ABAAS Section: 604.2 2012 TAS Section: 604.2 2010 ADAS Section: 604.2

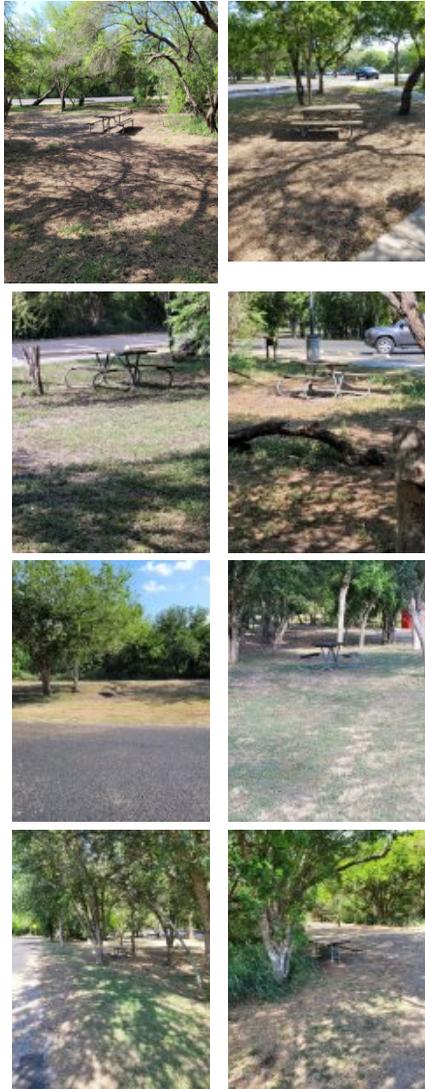
Finding Number	Area Description	Lat/Long	Finding	As Built	Recommendation	Citation	Photos	Figure
74	Park Site: Park Elements	[25.99639, -97.56999]	There is no accessible route to the picnic tables. At least one accessible route shall connect accessible buildings, accessible facilities, accessible elements, and accessible spaces that are on the same site.	Picnic area at HQ parking - 9 of 9 picnic tables spaced through area lack accessible route; none of the picnic tables are accessible	Replace two table with ones of an accessible design and create a route and firm and stable pad for 36" access around the table.	2015 ABAAS Section: F206.2.2 2012 TAS Section: 206.2.2 2010 ADAS Section: 206.2.2

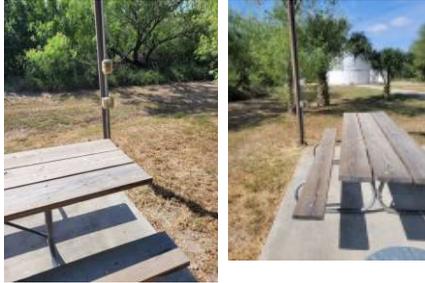
Finding Number	Area Description	Lat/Long	Finding	As Built	Recommendation	Citation	Photos	Figure
78	Park Site: Pavilions/ Picnic Areas	[25.9960472 , -97.568832 7]	Where picnic facilities contain two or fewer picnic units, each picnic unit shall provide mobility features complying with F245.2.	Pavilion near HQ - No accessible route to outlets	Create an ORAR to shelter or picnic area and provide accessible features as a smart practice.	2015 ABAAS Section: F245.2.1

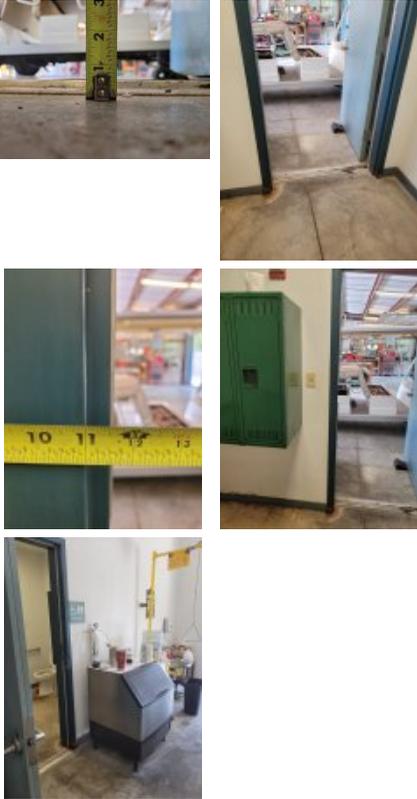
Finding Number	Area Description	Lat/Long	Finding	As Built	Recommendation	Citation	Photos	Figure
88	Employee Areas: Maintenance	[25.9976215 , -97.570688 8]	Minimum maneuvering clearances at doors and gates shall comply with 404.2.4. Maneuvering clearances shall extend the full width of the doorway and the required latch side or hinge side clearance. The threshold has a vertical change greater than 1/4 inch high. The threshold at a doorway shall be no higher than 1/2 inch. Changes in level between 1/4 inch and 1/2 inch must be beveled at 1:2 or less. 1/4 inch is the maximum vertical rise. All interior doors must be maintained so that the operating pressure does not exceed 5 lb. force to open. The sweep period for doors with closers shall be adjusted so that from an open position of 70 degrees, the door will take at least 3 seconds to move to a point 3 inches from the latch, measured to the leading edge of the door.	Restroom - .5" lipped threshold, 11.5" on push due to lockers, clearance on pull reduced by ice, 11 lbf, fast closing	For all doors along the public circulation route, provide required maneuvering clearance on push and pull side of doors. For all doors along the public circulation route, repair, bevel, or ramp CILs at door entries to max .25". For all doors along the public circulation route, inspect, adjust, and maintain 5 lbf to open interior doors. For all doors along the public circulation route, inspect, adjust, and maintain closing speed on door closers.	2010 ADAS Section: 404.2.3, 404.2.7, 404.2.4, 404.2.11, 404.2.11 Exception

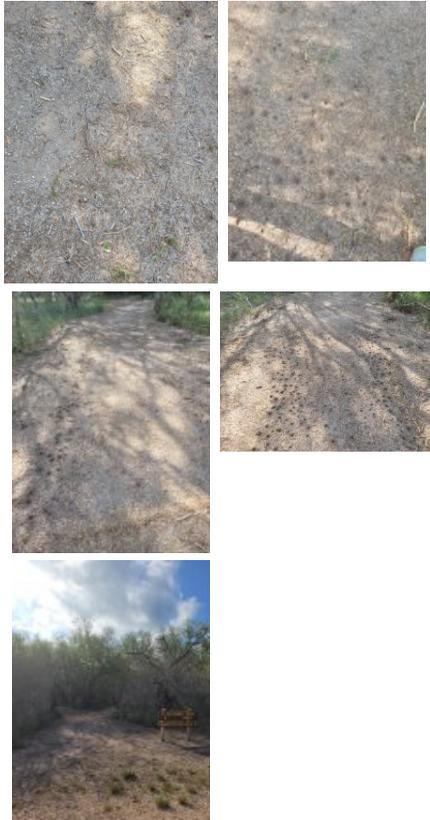
Finding Number	Area Description	Lat/Long	Finding	As Built	Recommendation	Citation	Photos	Figure
95	Trails: Trail Surface	[25.9886433 , -97.560035 1]	The surface of outdoor recreation access routes, passing spaces, and resting intervals shall be firm and stable	Lacks AR to observation deck on North Mexican Olive trail and Fly Catcher trail	Repair surface or ORAR to be firm and stable as a smart practice.	2015 ABAAS Section: 1016.2

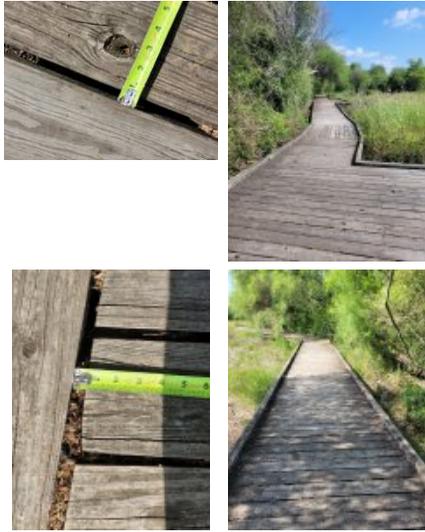
Finding Number	Area Description	Lat/Long	Finding	As Built	Recommendation	Citation	Photos	Figure
103	Trails: ADA Accessible Trails	[25.99658, -97.568148 7]	There is a gap spaced greater than a 1/2 inch. Openings in floor or ground surfaces shall not allow passage of a sphere more than 1/2 inch diameter. Elongated openings shall be placed so that the long dimension is perpendicular to the dominant direction of travel.	Boardwalk/outlook on Ebony trail - twenty .75" gaps	Correct or fill gaps to be max .5".	2015 ABAAS Section: 302.3 2012 TAS Section: 302.3 2010 ADAS Section: 302.3

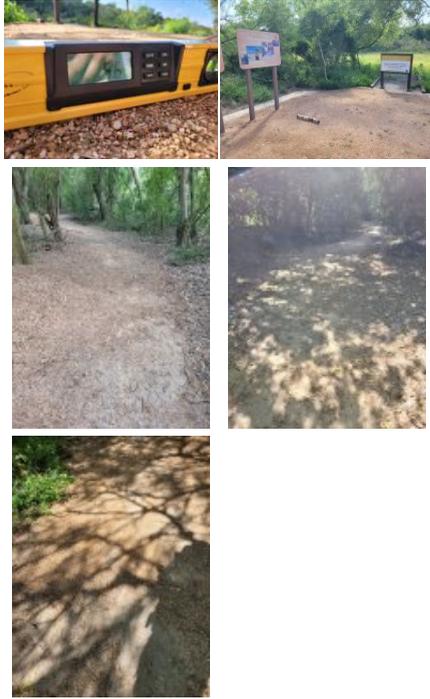
Finding Number	Area Description	Lat/Long	Finding	As Built	Recommendation	Citation	Photos	Figure
106	Trails: ADA Accessible Trails	[25.9958327 , -97.5659198]	Where the surface is other than concrete, asphalt, or boards, cross slopes not steeper than 1:20 shall be permitted when necessary for drainage.	End of Ebony trail - 5.6% cross at signs	Frequently maintain trail cross slope to assure it does not exceed 5% for surfaces other than concrete, boards or asphalt as a smart practice.	2015 ABAAS Section: 1017.7.2 EXCEPTION:
